## An Archaeological Evaluation at 47 Houldsworth Street, Greater Manchester

**ARS Ltd Report No.** 2016/79  
**Oasis No.** archaeol5-253432

# An Archaeological Evaluation at 47 Houldsworth Street, Greater Manchester

*Project Name: An Archaeological Evaluation at 47 Houldsworth Street, Greater Manchester*

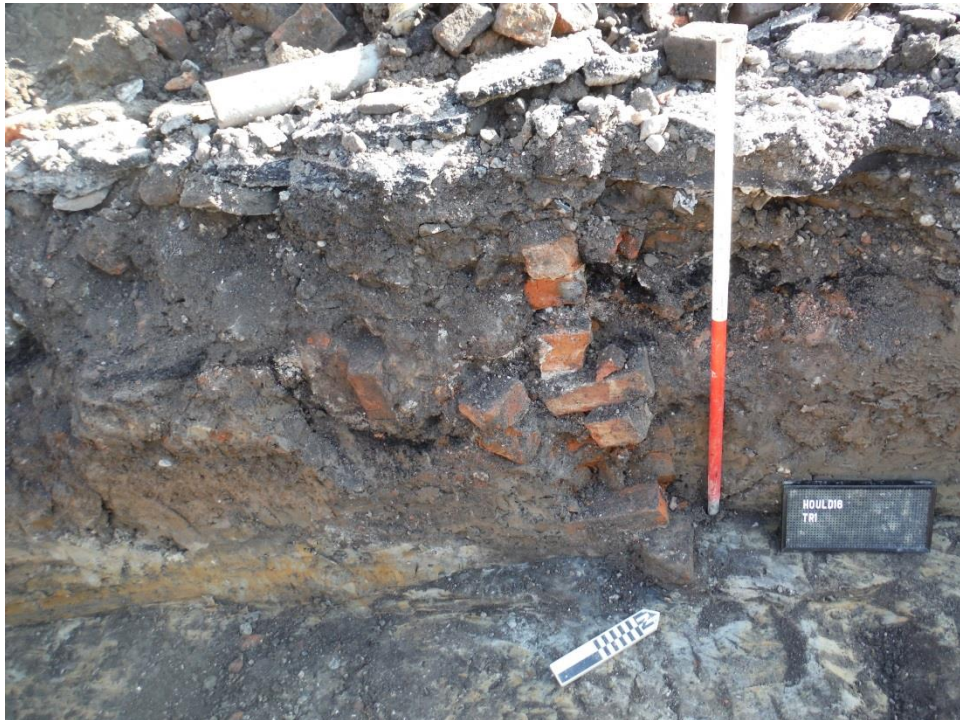
Figure 12. Southwest facing section of Trench 1 showing wall F102 (scale 1m)

7.3. Beneath this overburden there were four walls, F101, F102, F103, and F104. F101 was northwest-southeast aligned and constructed from handmade red bricks and sandy lime mortar, laid to an English Garden Wall bond. The construction cut for this wall was [109]. F102, F103 and F104 were cross walls laid at right angles to wall F101. They were also constructed of handmade red bricks and sandy lime mortar, laid to an English Garden Wall

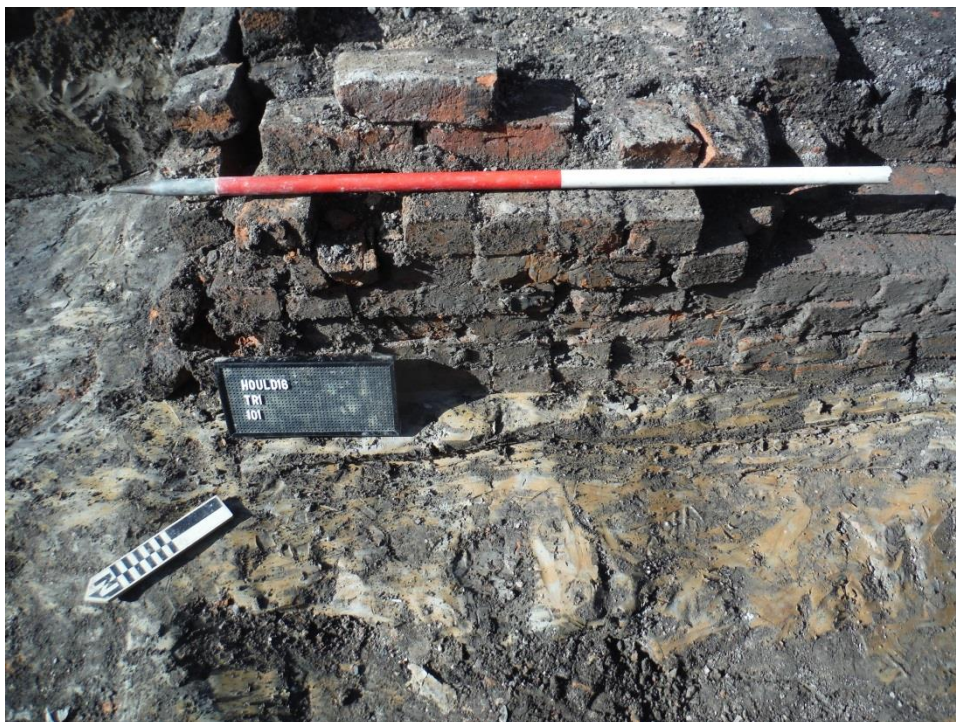
Figure 13. Representative section of wall F101, northeast facing (scale 1m)

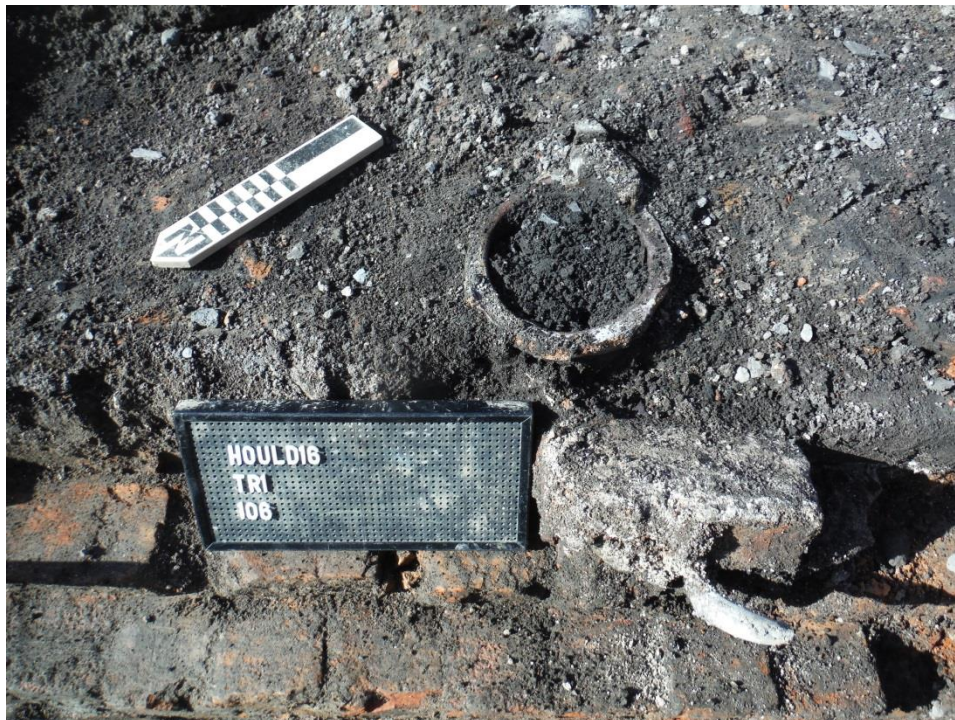
Figure 14. Detail of salt glazed drain (106), looking southwest (scale 0.25m)

7.4. A sandy levelling deposit (118), 0.17 m thick, containing crushed brick and stone abuts the walls on the southwestern side. In the section it was evident that this deposit was directly overlaid by a redbrick yard surface (107) although this surface was not visible elsewhere in the trench and must have been lost during the demolition of the houses. A salt-glazed ceramic drain pipe (106) cut through the levelling deposit (118), with a maximum diameter of 0.2 m and 0.03 m thick walls.

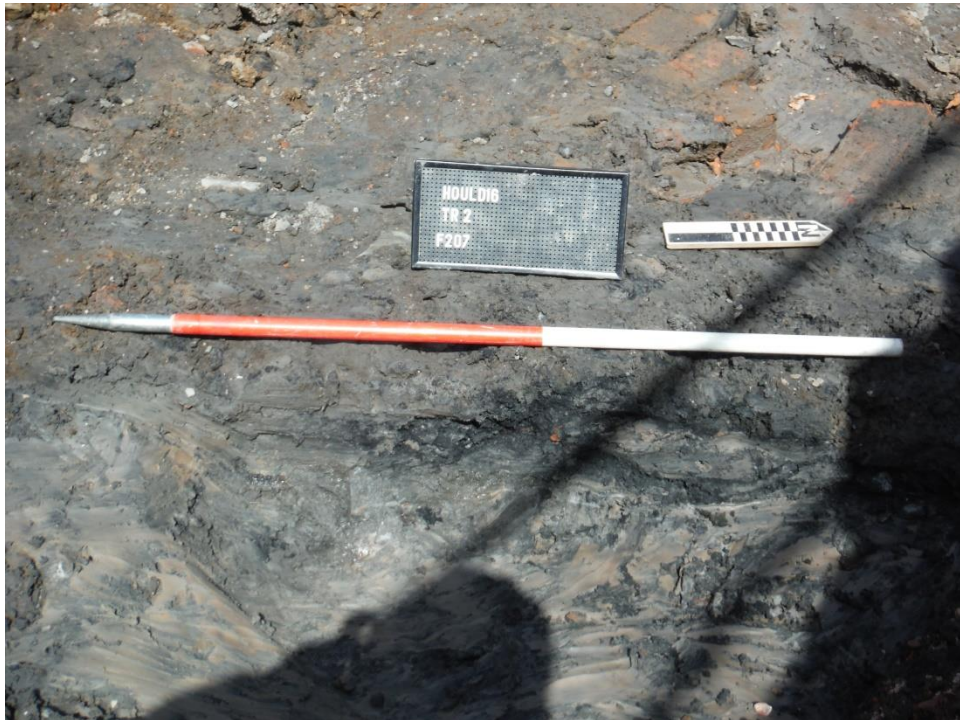
Figure 17. Southwest facing section through 18<sup>th</sup> century field boundary ditch (207)/[211] (scale 1m)

7.9. Feature (207)/[211] was an 18<sup>th</sup> century boundary ditch which truncated the clay trample layer (212). A 2.4 x 1.3 m section of the ditch was visible in Trench 2, against the south-eastern baulk. The cut [211] had a gradual break of slope and a rounded uneven bottom with a surviving depth of 0.22 m. The fill (207) had a high organic content and was probably filled with water, as also indicated by the discoloration of the Creamware sherds recovered from the fill. Eight sherds were recovered from the ditch fill (Brown Glazed Coarseware, Creamware, Pearlware and Redware) ranging in date from the 18<sup>th</sup> to the early

to mid-19<sup>th</sup> century. The trample layer (212) comprised a dark grey-brown silty clay, 0.08 m thick, with occasional stone and brick inclusions, directly overlying the natural blue-orange clay (208). A single sherd of Creamware was recovered from (212), dating to between 1740 and 1820.

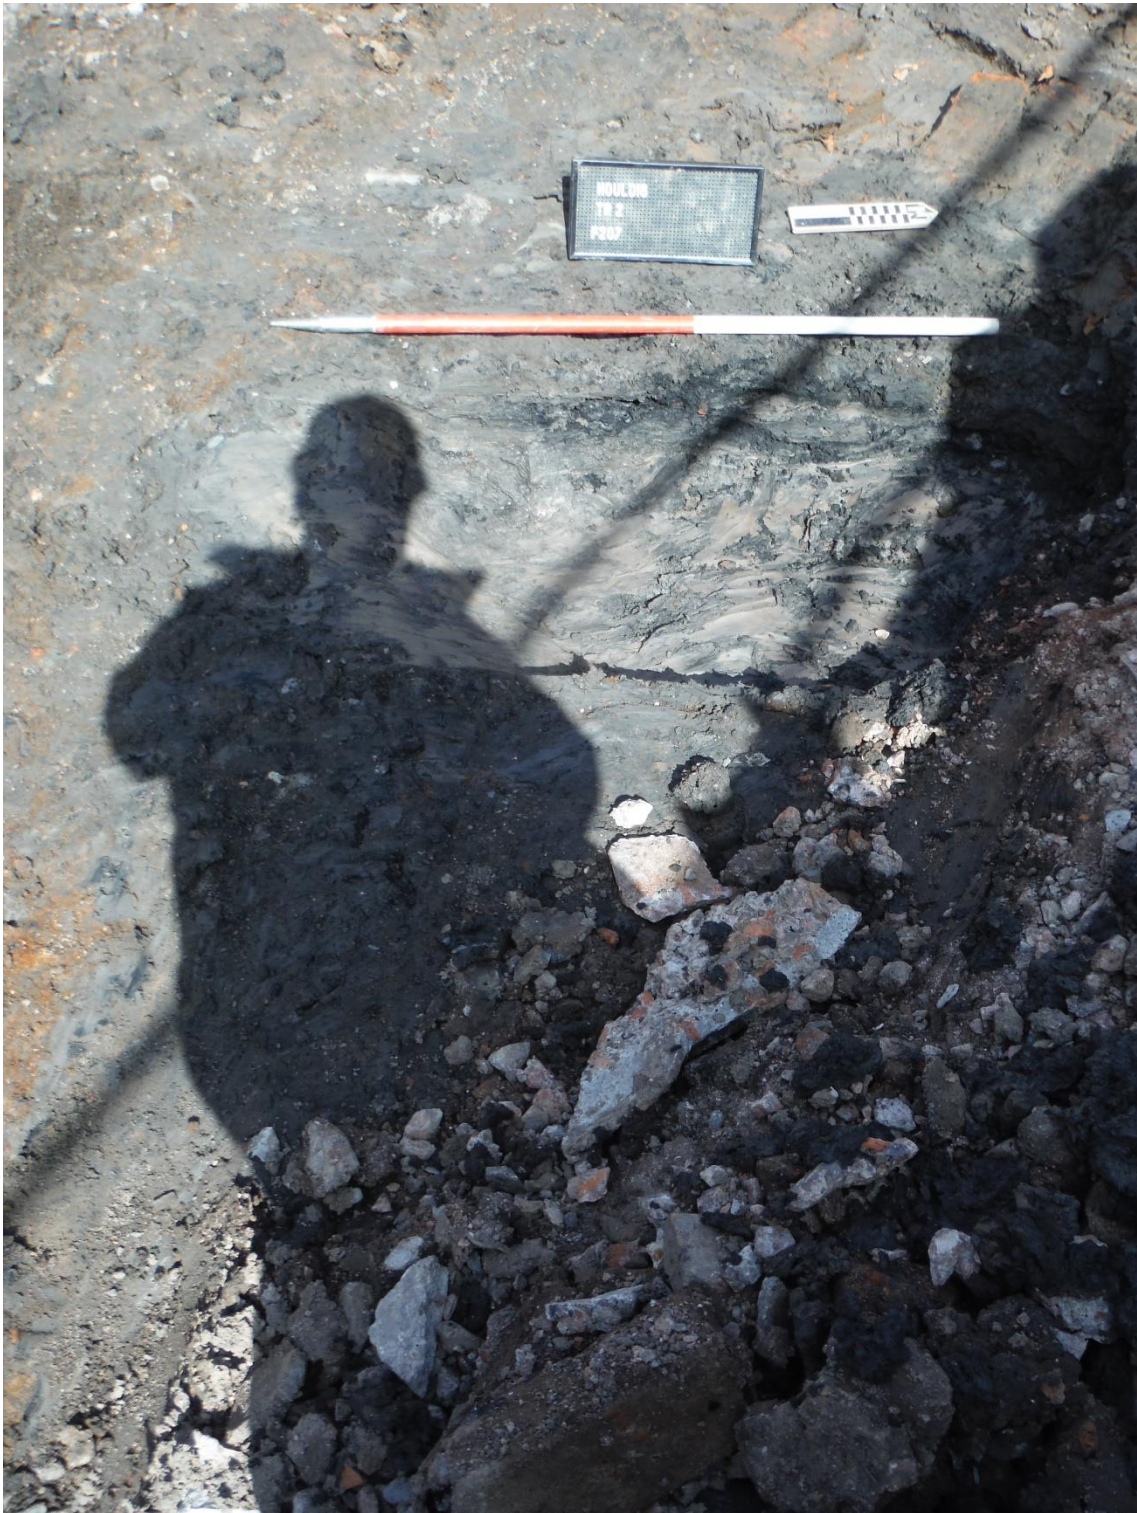
Figure 18. 18<sup>th</sup> century field boundary ditch (207)/[211], looking northeast (scale 1m)

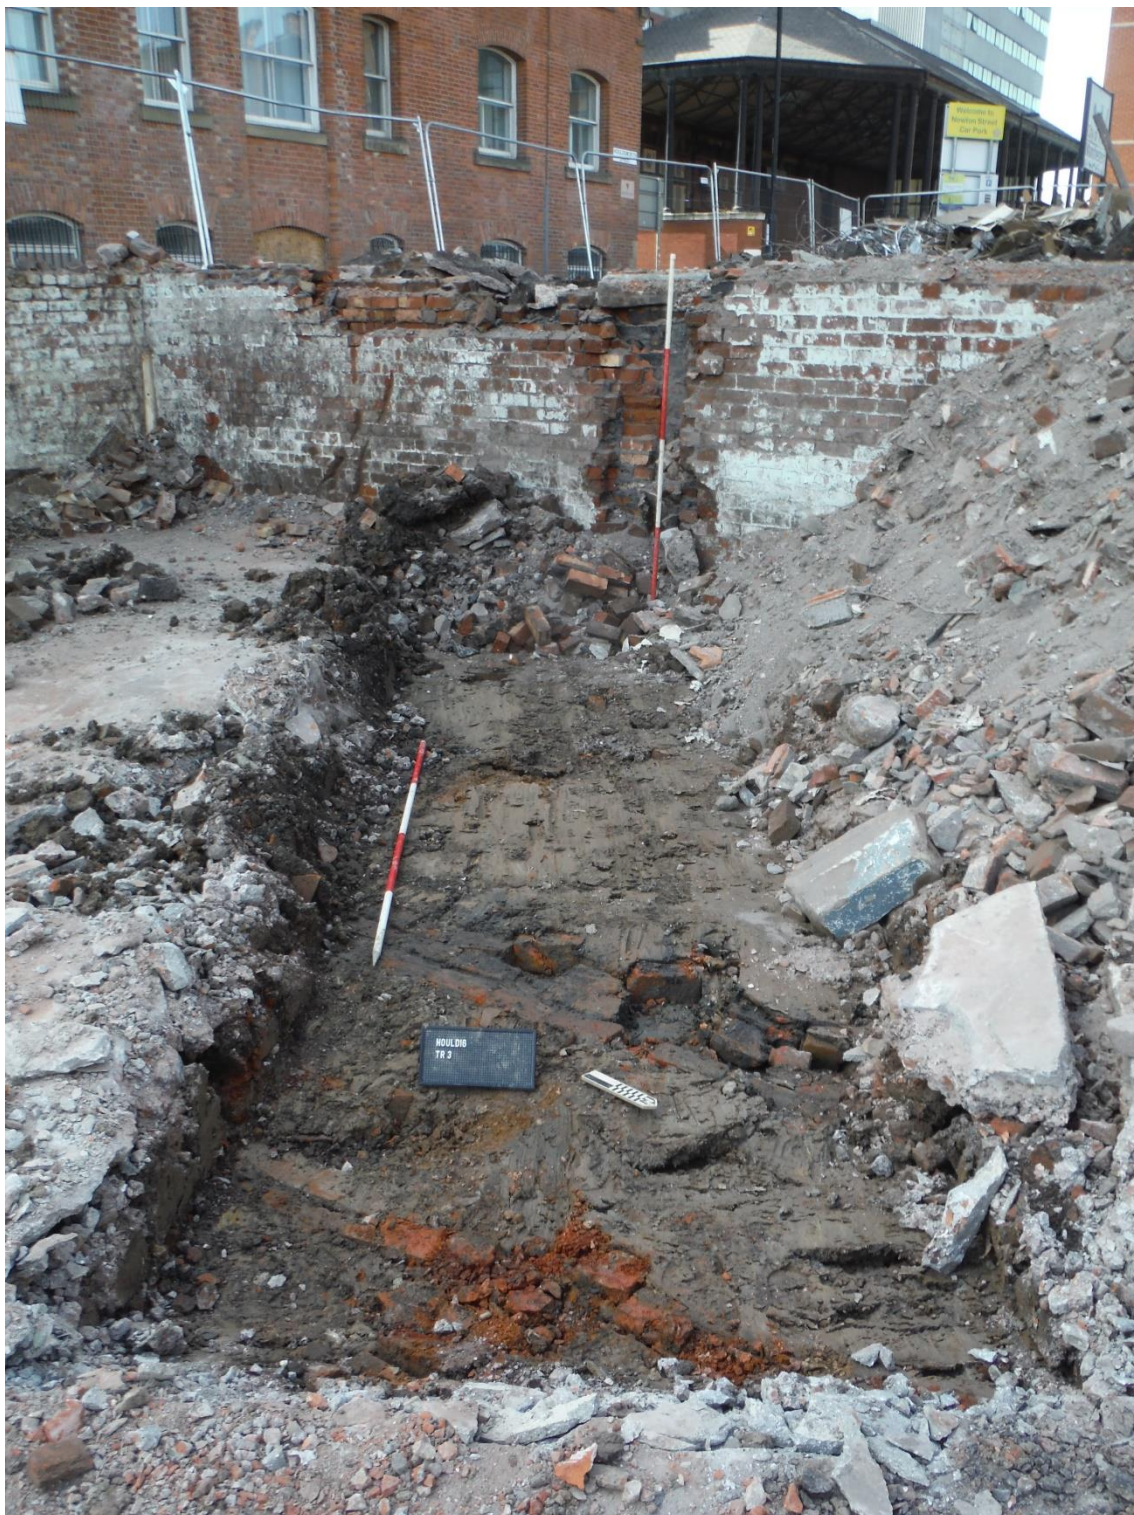
Figure 19. Overview of eastern end of Trench 3, with wall of 47 Houldsworth Street still standing in background, looking east (scale 2 x 2m)

7.10. Trench 3 was 10 x 2 m and ran east-west in the southwestern part of the site. It was placed to attempt to find any features predating the construction of 47 Houldsworth Street. The south-eastern end of the trench was sealed by the floor of the cellar of 47 Houldsworth Street (301) whilst the north-western end was sealed by the modern carpark surface (306). This meant that the trench was on two different levels with the car park surface sitting almost 2 m higher than the cellar floor, and the wall of 47 Houldsworth Street, F305, dividing the trench in two.

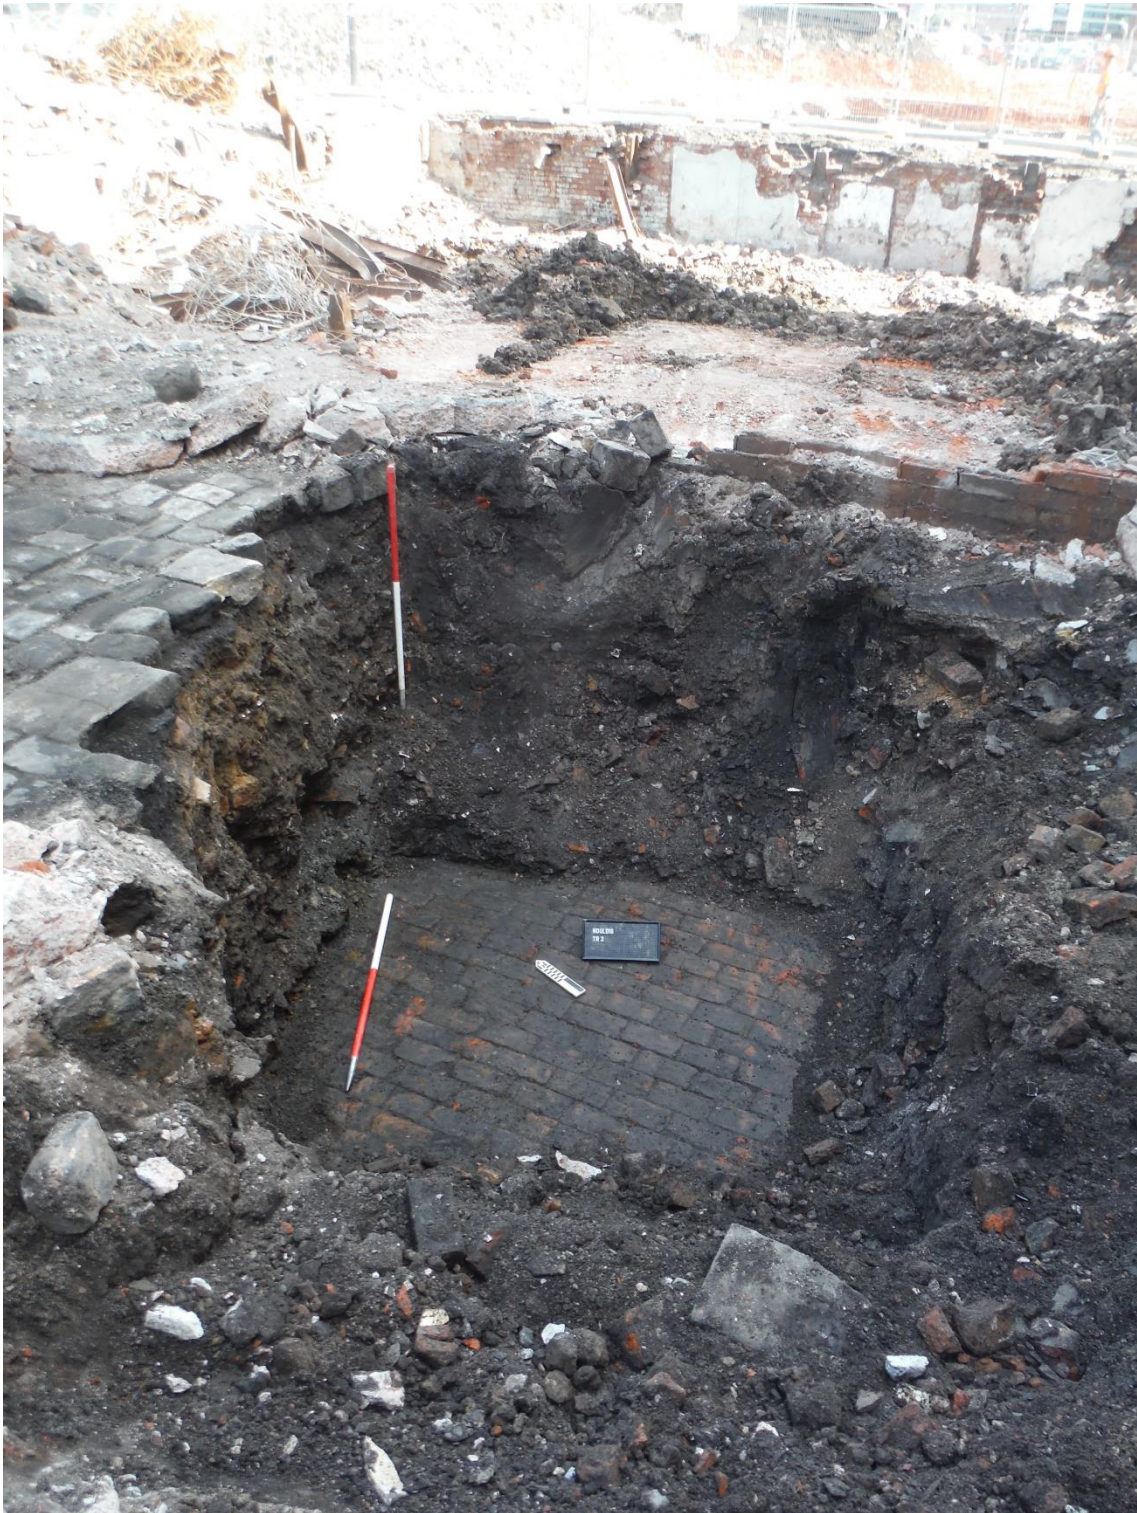
Figure 20. Overview of western end of Trench 3, with cobbled surface (307) on the left and brick surface (312) in foreground, looking west (scale 2 x 1m)

7.11. The modern carpark surface (306) in the north-western half of the trench was a layer of 0.17 m thick concrete which directly overlaid a cobbled surface (307). This surface (307) comprised granite cobble stones, on average 0.18 x 0.21 x 0.2 m in size laid onto a layer of fine silty-sand bedding (308) which was 0.18 m thick. This bedding overlay a levelling deposit (320), which comprised a 0.12 m thick layer of yellow-brown sandy gravel.

7.12. Beneath the cobbled surface and associated levelling deposits were three demolition layers (309), (310), (311), which lay on top of a brick surface (312). The latest of these, (309) was a dark grey-black layer of sandy gravel, 0.09 m thick with frequent inclusions of broken brick. Deposit (310) was a 0.48 m thick dark grey-black sandy clay layer, with frequent brick fragment inclusions. This deposit produced 10 sherds (Pearlware, Stoneware and Whiteware) dating predominantly to the mid-late 19<sup>th</sup> century, with the exception of a single sherd of 18<sup>th</sup>-early 19<sup>th</sup> century pottery. The earliest of these demolition deposits, (311), was also a dark grey-black sandy clay layer, 0.80 m thick, with frequent inclusion of brick fragments and pieces of coal. These three demolition layers were laid down at broadly the same time as part of the intentional backfill of an 18<sup>th</sup> century cellar. They were truncated by the wall of the cellar of 47 Houldsworth Street (F305). The floor surface (312) is likely the floor of this 18<sup>th</sup> century cellar and possibly related to the C-shaped building seen on the 1787 map of the site. This brick floor was laid directly onto the natural clay (314).

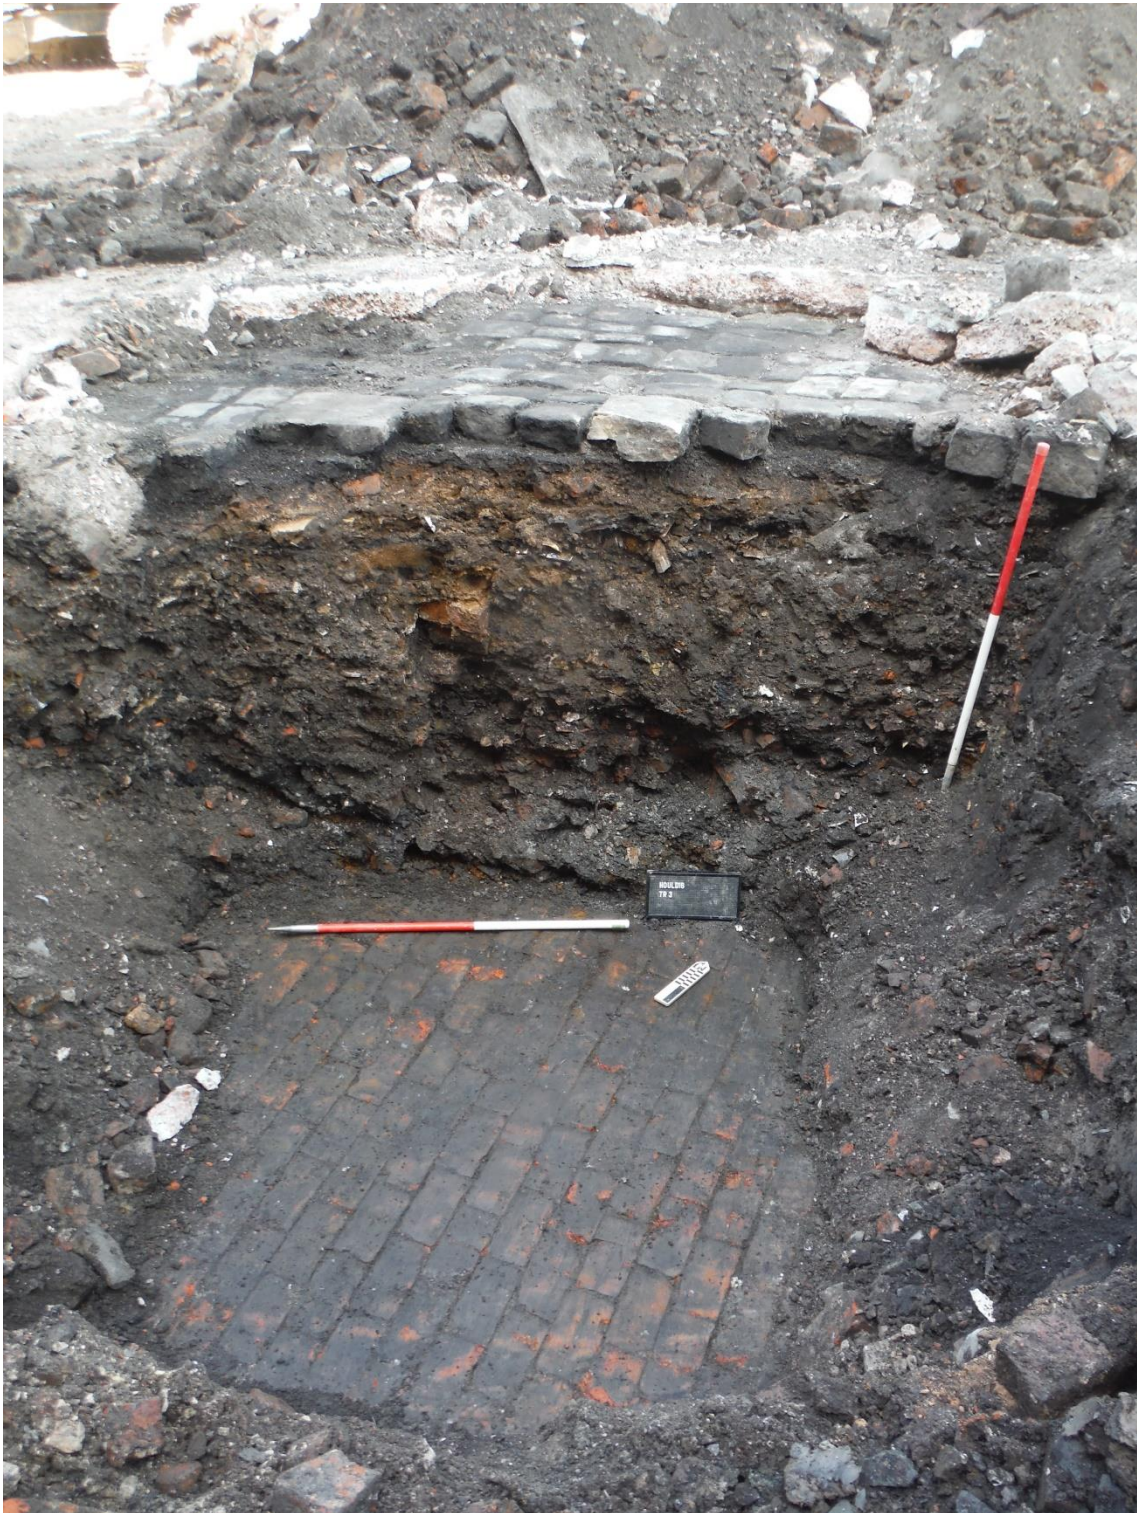
Figure 21. South-facing section in Trench 3, showing cobbles (307), demolition layers (309), (310), (311) and brick surface (312) (scale 2 x 1m)

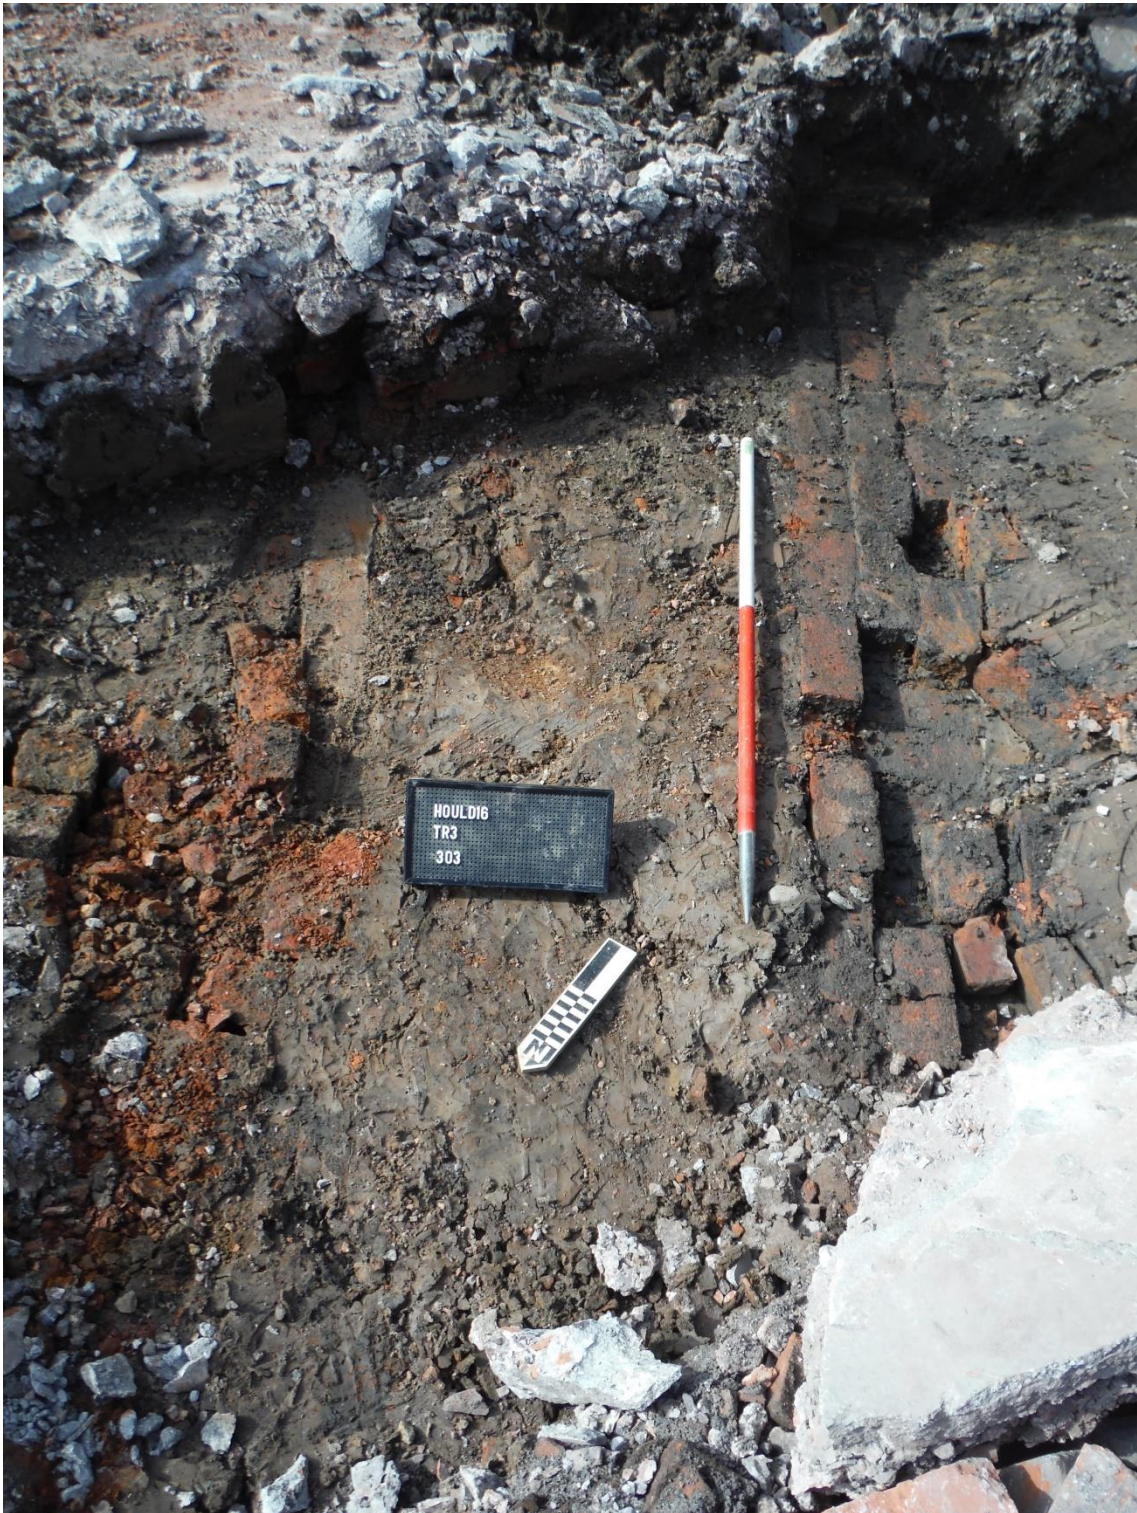
Figure 22. Brick walls F303 and F304 (19th century) in the western end of Trench 3, looking southwest (scale 1m)

7.14. The clay layer (302) sealed walls F303 and F404 which had been truncated by the cut of the cellar [319]. These two walls ran parallel to each other, northeast-southwest across the eastern end of Trench 3. Both were constructed from handmade red bricks laid to a stretcher bond and date to the 19<sup>th</sup> century. The cuts for these walls, [315] and [316] respectively, truncate the natural clay (314).

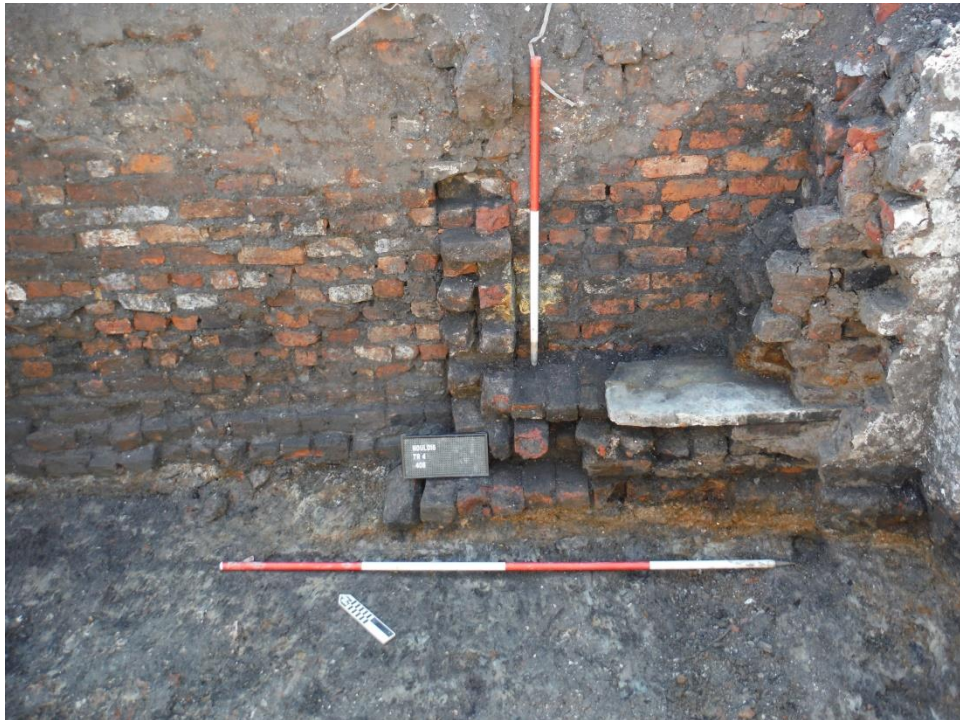
Figure 25. Walls F406, F408, & F412, and surfaces (409, (410), (419), & (422), looking southeast (scale 2m & 1m)

7.17. The earliest walls of the cellar, F408, F405 and F413 were constructed of handmade red bricks laid to a stretcher bond with a sandy grey mortar. F408 is the south-eastern wall and F413, laid at a right angle to it, the north-eastern wall. F405 comprised a doorway and window pillars, laid at a right angle to wall F408, around halfway along its excavated extent. The presence of a window suggests that this was the outside wall of the building while the continuation of wall F408 to the southwest of F405 probably represents the outside yard wall of the pub. Two stubs of partition walls F411 and F412 were inserted into wall F408 and would have run at right angles to it. A red brick surface (409), most likely relates to this earliest phase of the cellar though it is only preserved as a single row of bricks along wall F408. A second brick surface (410) overlaid (409) and again is only preserved along wall F408 in the southern corner of the room. A final brick surface (419) was added directly on top of (410) and is also only preserved in the southern corner of the room. Brick surface (419) was overlaid by a flagstone surface (422) made from sandstone flags and only preserved as a single flagstone in the southern corner of the room, against wall F408. The remains of another flagstone surface (404) were found against wall F405 though only two limestone flags are preserved. This surface sits on top of a levelling deposit (403). It is unclear how this surface related to the surfaces mentioned above, though it seems unlikely to be contemporary with the other flagged surface since it sits considerably lower. A stone step (415) lay in the corner of walls F413 and F408. It is possible that this was the remains of a staircase leading down into the cellar. Wall F406 lay directly on top of (415).

7.18. These surfaces were truncated by the insertion of a modern facing wall (F406) constructed from machine made red bricks laid to an English Garden Wall bond. This wall ran along wall F408, north-eastwards from the junction with F405. The window and door in the southwest of the room were at some point blocked up by wall F407, constructed of machine made red bricks laid to a stretcher bond. F407 sits on top of the flagstones (404). A modern facing wall (F421) was also added to the southwestern face of walls F405 and F407.

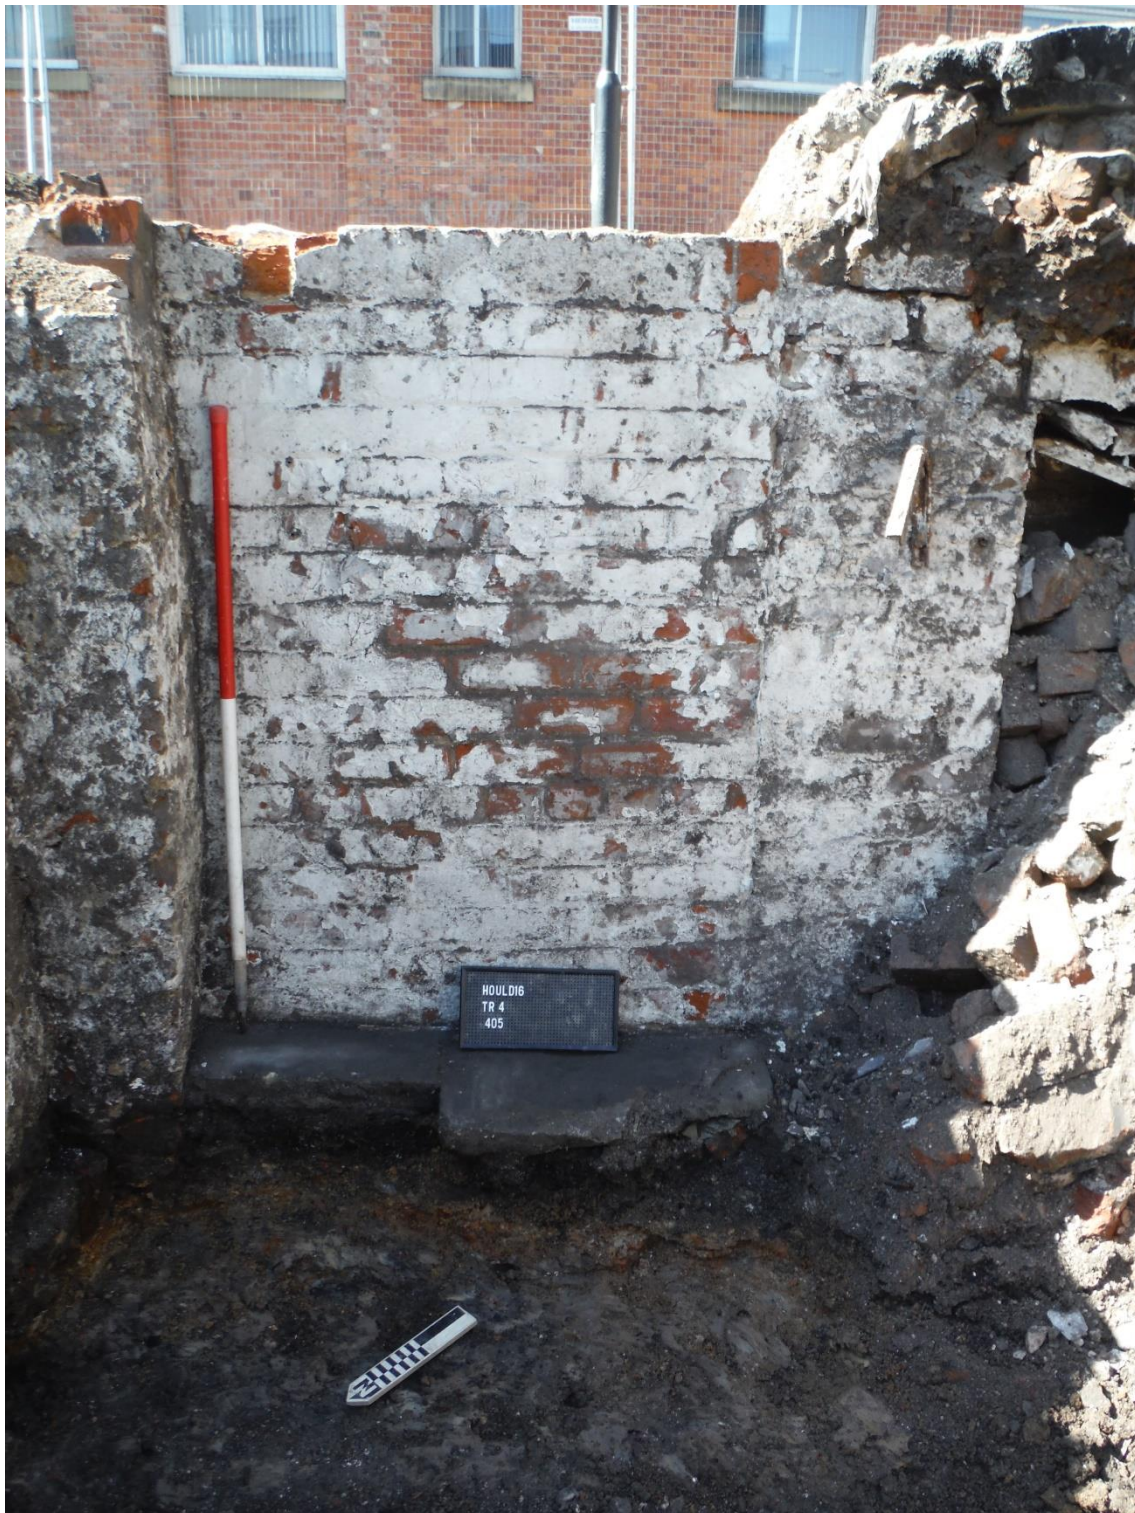
Figure 26. Walls F405 & F407, and flagstones (404), looking southwest (scale 1m)

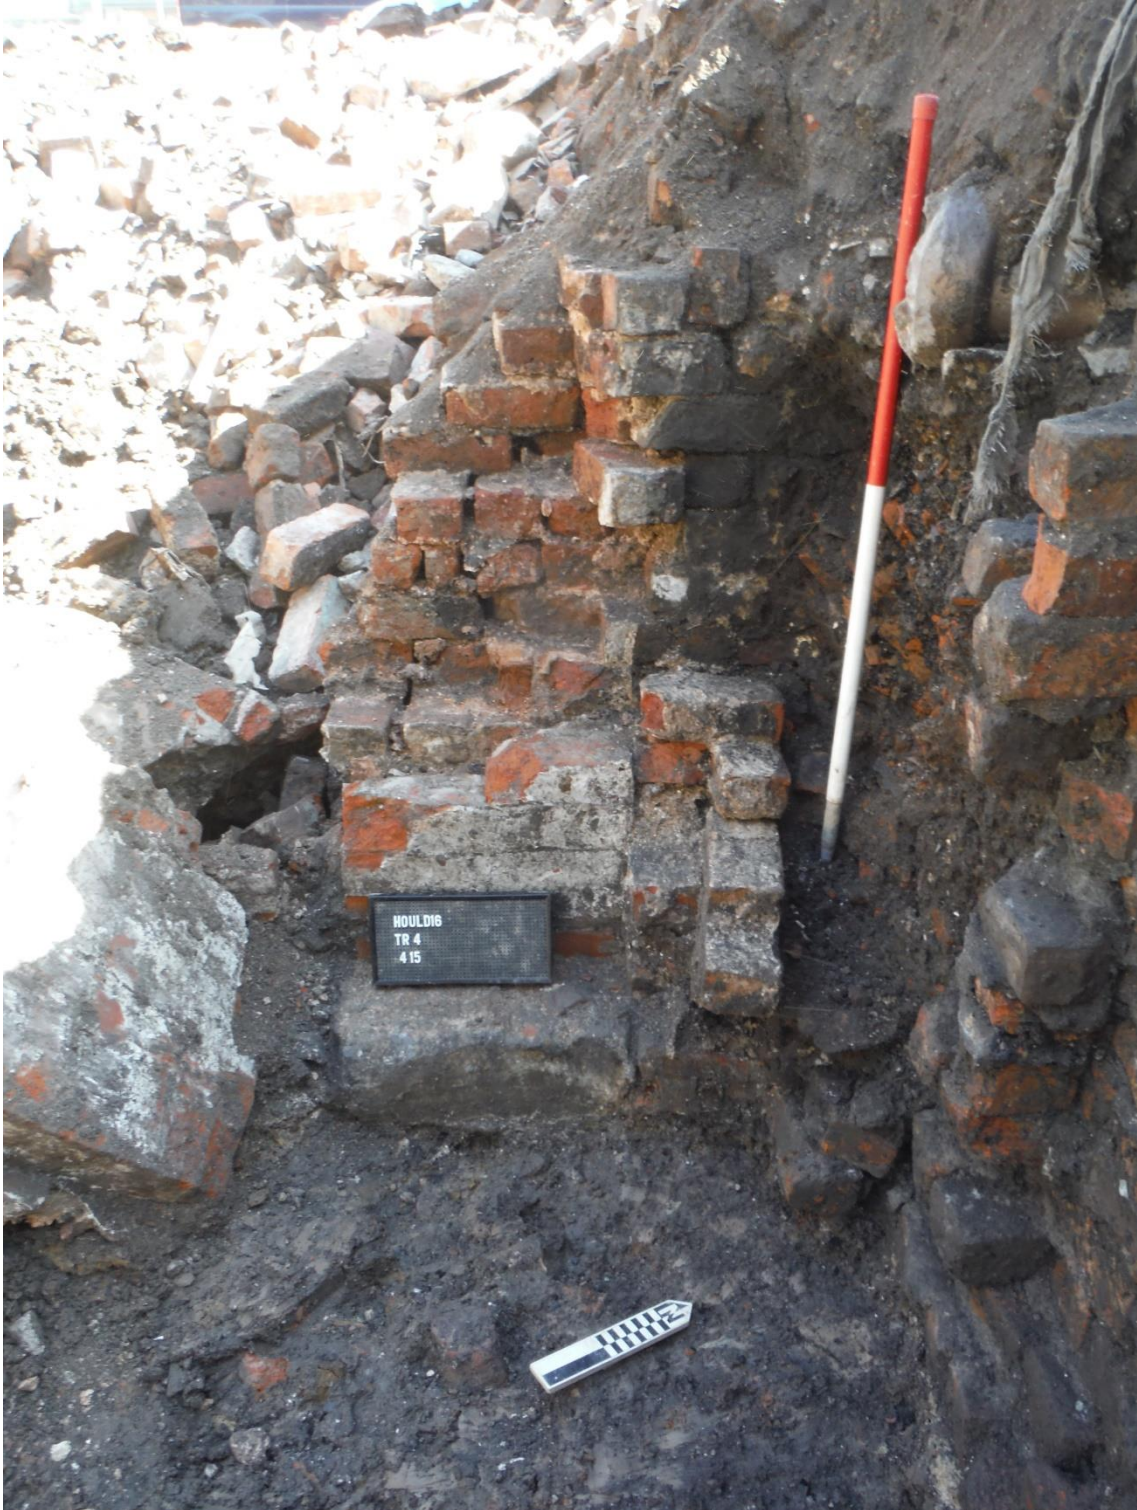
Figure 27. Wall F413 and stone step (415), looking northeast (scale 1m)

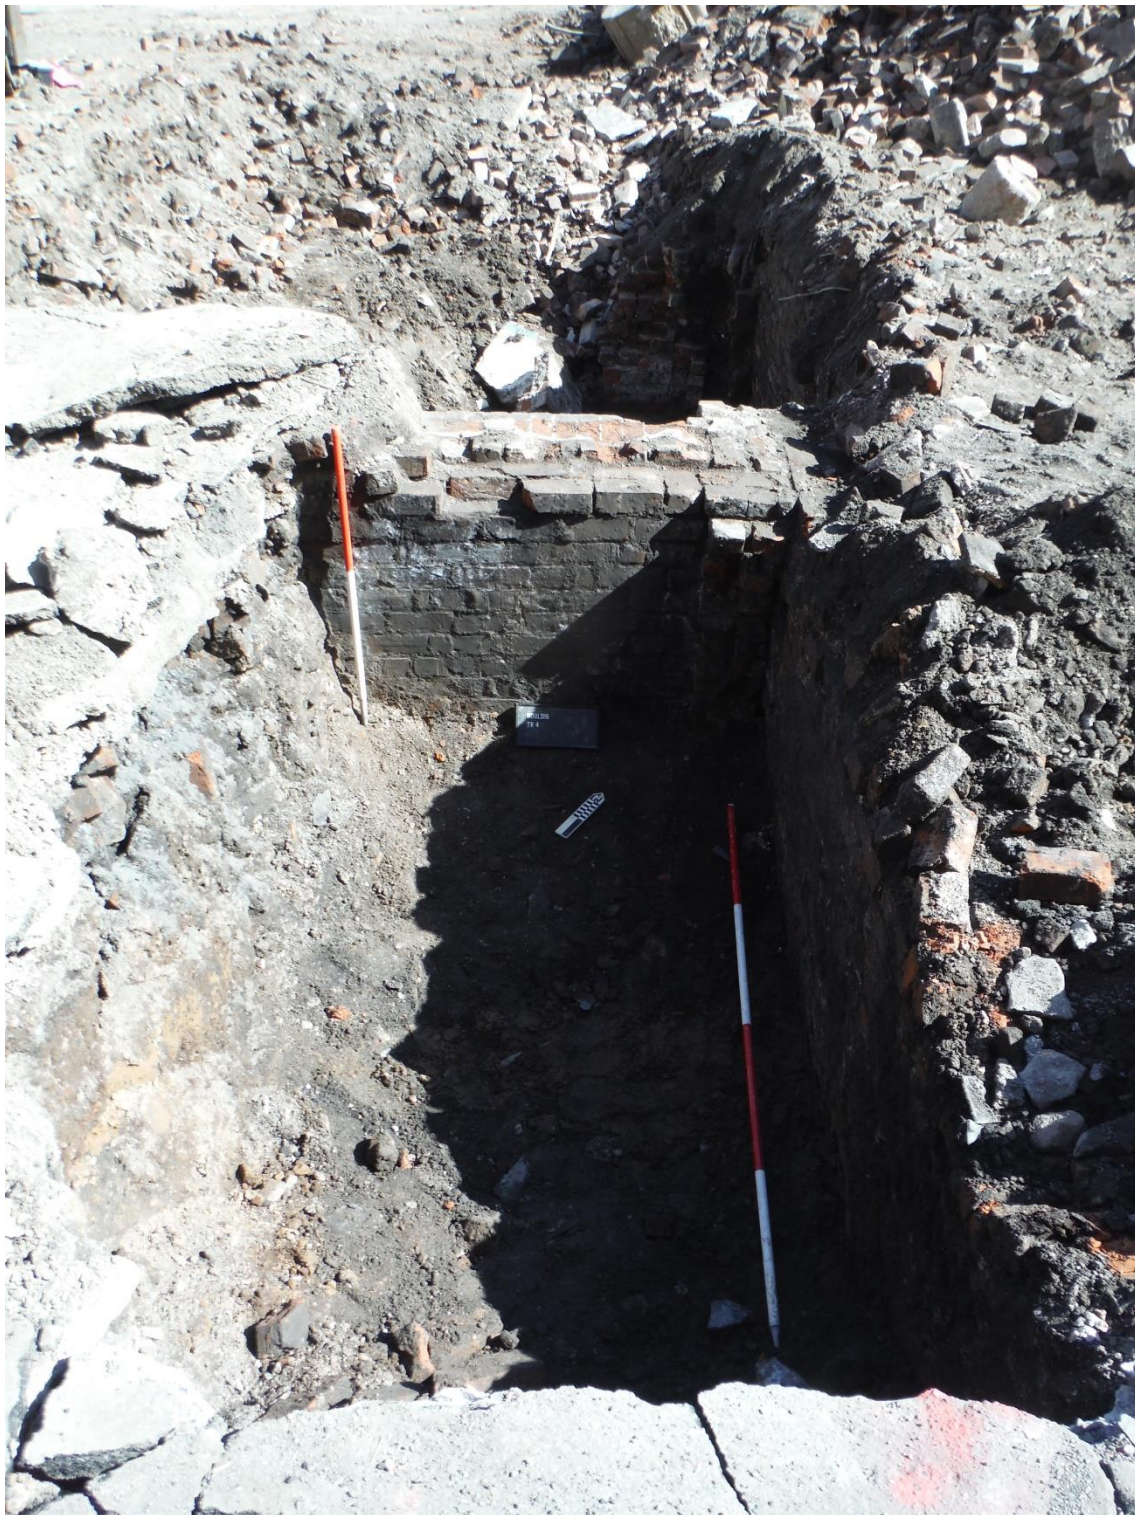
Figure 28. Wall F421 & F408, looking northeast (scale 2m & 1m)

7.19. A modern drain pipe (417) and its associated trench [416] cut through wall (F408) in the eastern corner of the room. The trench is backfilled with (418), a gritty deposit with a high number of rubble inclusions.
