**Stocksbridge NI School – Outreach Children’s Centre,
Nr: Sheffield, South Yorkshire.**

**Report on a Watching Brief
undertaken during ground investigations.**

ARS Ltd Report 2007/10
February 2007

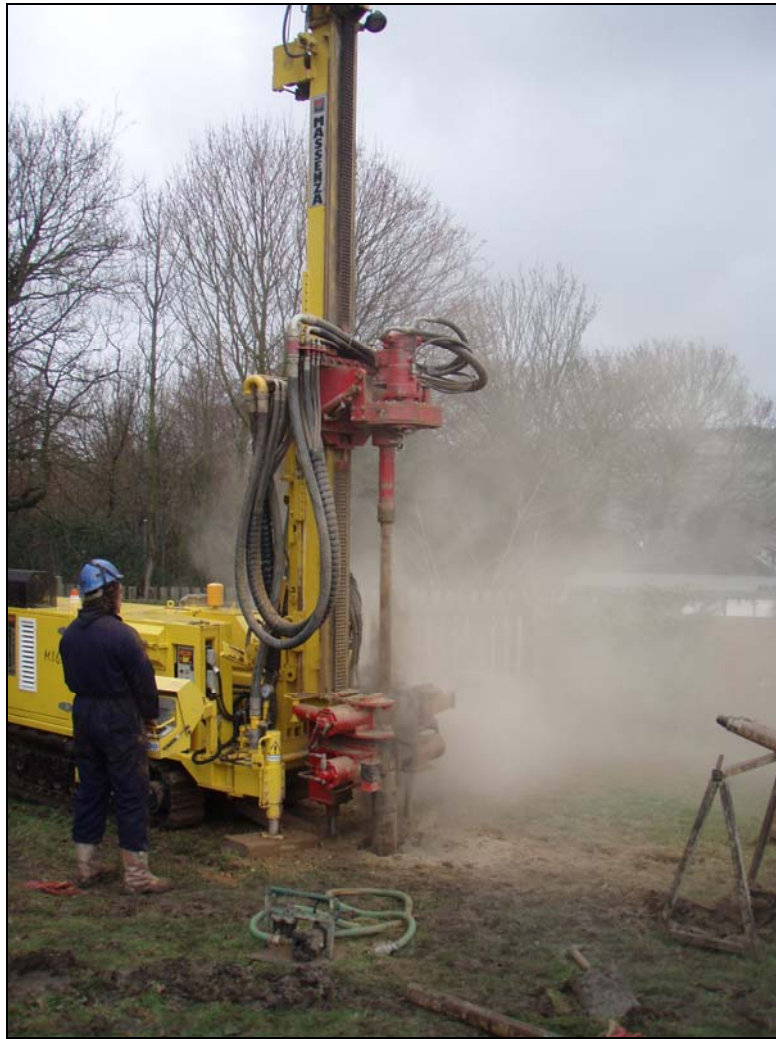
- 6.1.1 Bore hole one was located on the west of the site, 12.2m from the south-west corner of the school where the fence joined the building. The topsoil (001), which existed to a depth of 0.3m, was a fine grained, sandy silt that was dark brown (7.5YR 3/2) in colour. At a depth of 0.3m below the surface of the ground a natural sandstone substratum (002) was revealed. The sandstone was between four and five metres thick and had a particularly strong band at about 3.9m below the surface of the ground. Beneath the sandstone a void was uncovered which was approximately 5.5m below the surface of the ground. The vertical extent of the void was 1.5m to 2.5m. Below the void a series of mudstones and shales (003) were excavated for the rest of the bore hole, a length of approximately 22m.

Figure 4. Rotary bore hole 1 under excavation.

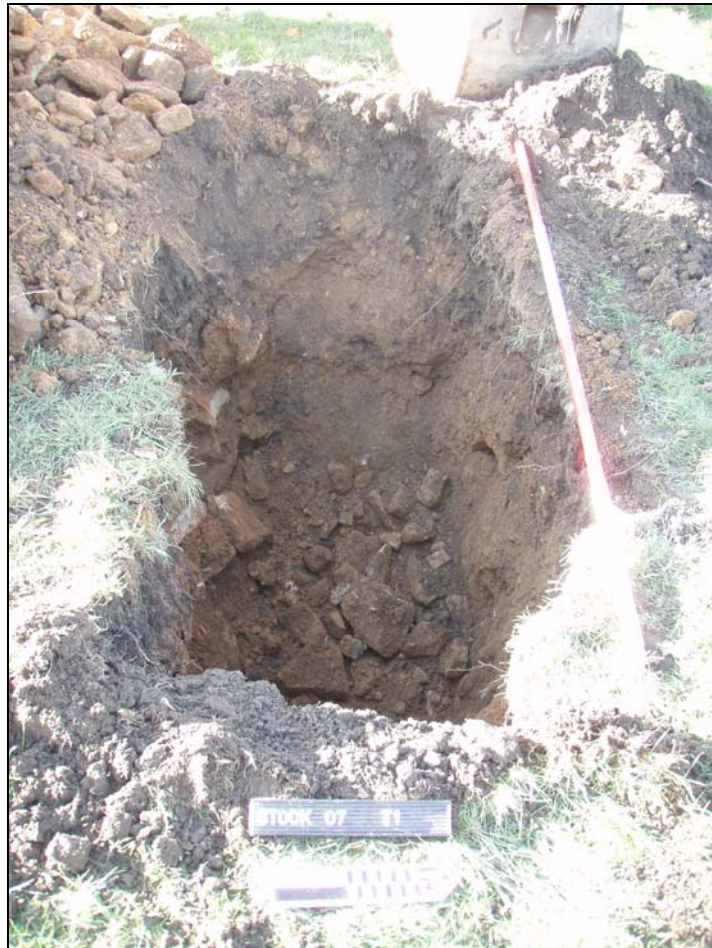
6.2.1 Trench 1 was located on the east side of the site, 25.26m from the access gate next to the road (Fig. 10). The trench was 2.32m long and 0.92m wide with a depth of 1.35m. The topsoil (001) (7.5 YR 3/2) existed to a depth of 0.38m, which overlay a natural sandstone substratum (002) which comprised a fine-grained, sandy clay (10 YR 5/6) with broken pieces of sandstone ranging in size from 0.30m x 0.25m to 0.5m x 0.45m (Fig. 5). The sandstone (002) was excavated to a depth of 0.97m. No archaeological finds or deposits were uncovered in this trench.

Figure 5. View of Trench 1 looking west (Scale: 2m).

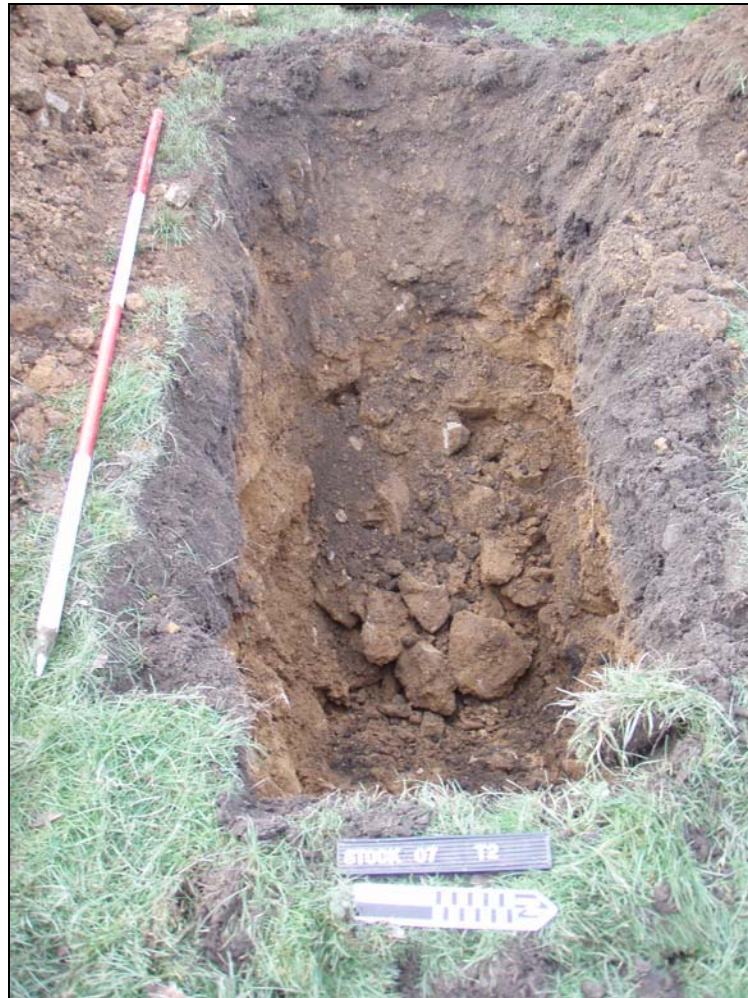
6.2.2 Trench 2 was located on the east of the site, 20.1m from the access gate next to the road (Fig. 10). The trench was 2.3m long and 0.95m wide, with a depth of 1.35m. The topsoil (001) existed to a depth of 0.35m which overlay a natural sandstone substratum (002), excavated to a depth of 1m (Fig. 6). No archaeological finds or deposits were uncovered within this trench.

Figure 6. View of Trench 2 looking west (Scale: 2m).

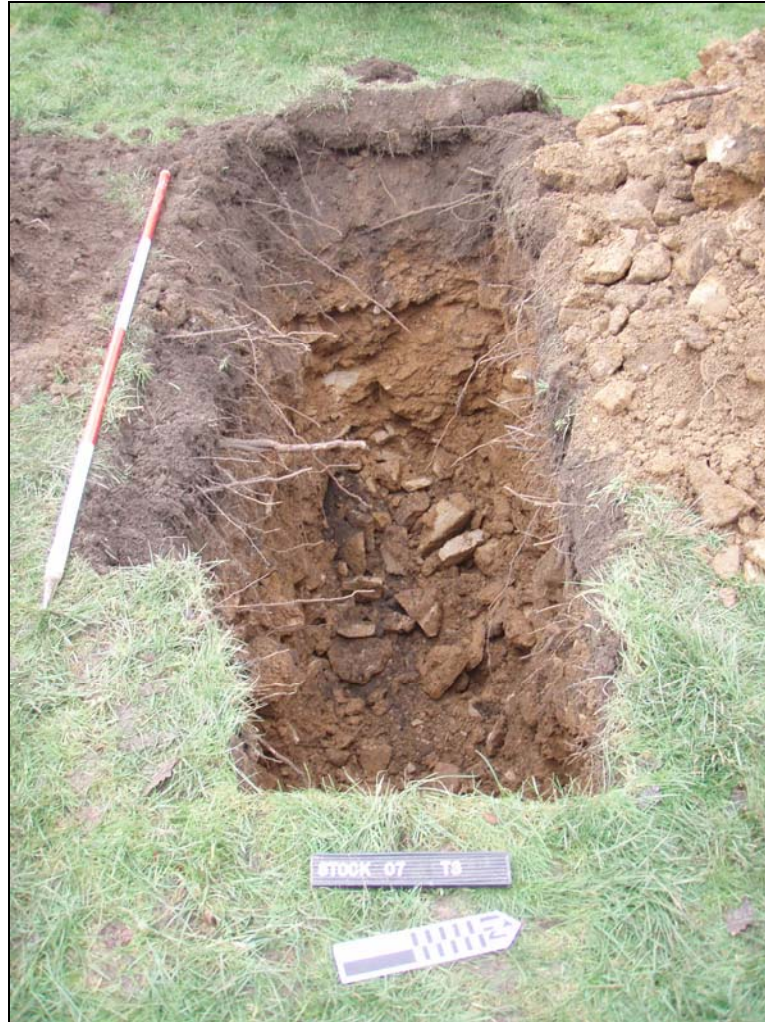
6.2.3 Trench 3 was located on the east of the site 30.5m from the from the access gate next to the road (Fig. 10). The trench was 2.83m long and 0.9m wide, with a depth of 1.7m. The topsoil (001) existed to a depth of 0.3m which overlay a natural sandstone substratum (002), excavated to a depth of 1.4m (Fig. 7). No archaeological finds or deposits were uncovered within this trench.

Figure 7. View of Trench 3 looking west (Scale: 2m).

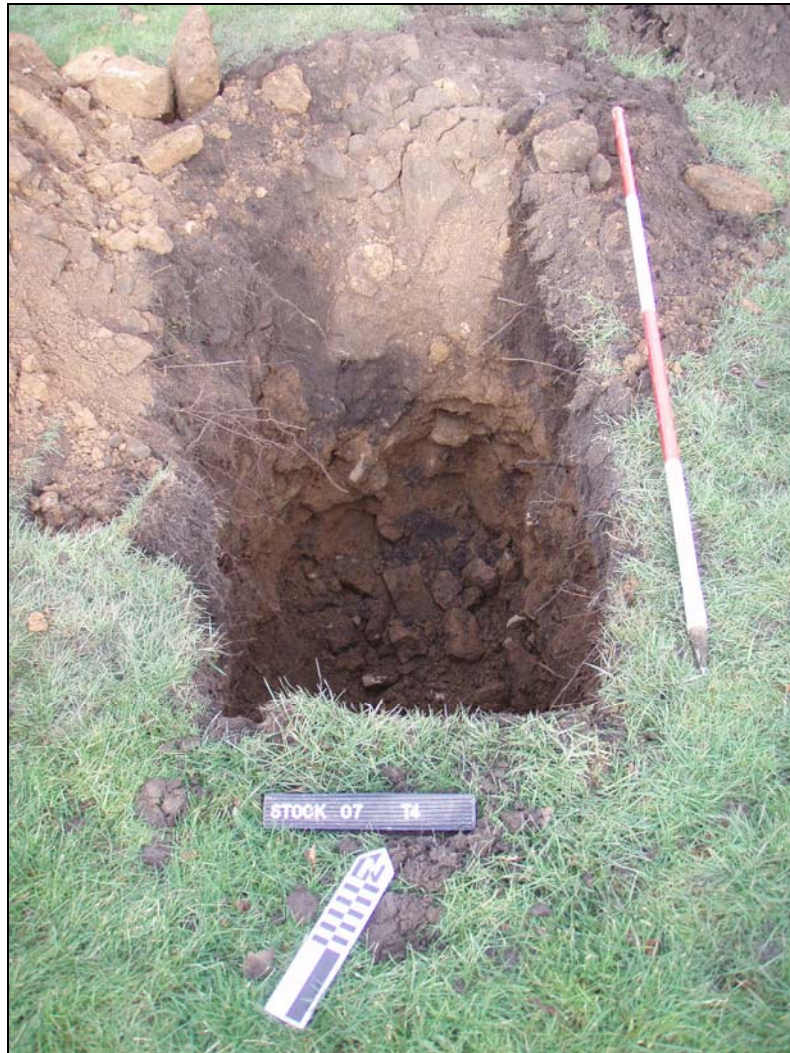
6.2.4 Trench 4 was located on the east of the site 7.13m from the wall next to the road (Fig. 10). The trench was 0.8m long and 0.7m wide, with a depth of 1.6m. The topsoil (001) existed to a depth of 0.4m which overlay a natural sandstone substratum (002), excavated to a depth of 1.2m (Fig. 8). No archaeological finds or deposits were uncovered within this trench.

Figure 8. View of Trench 4 looking north (Scale: 2m).

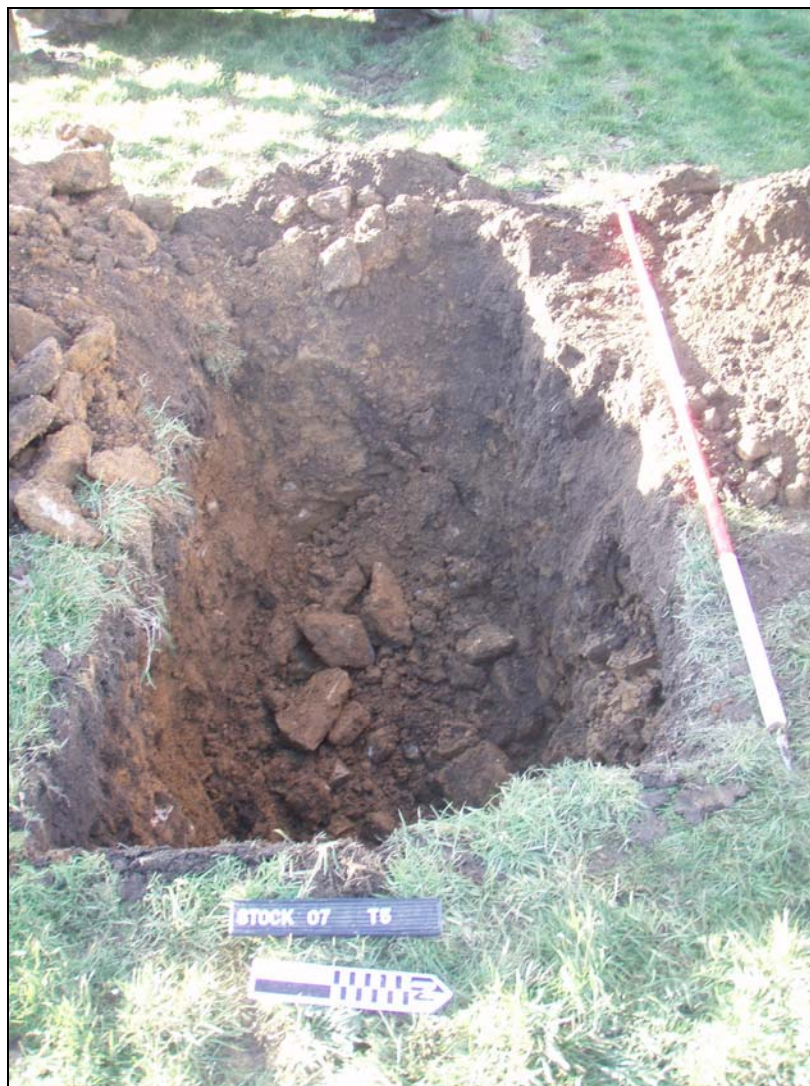
6.2.5 Trench 5 was located in the centre of the site close to the school and bore hole three (Fig. 10). The trench was 1.96m long and 1.03m wide, with a depth of 1.1m. The topsoil existed to a depth of 0.29m which overlay a natural sandstone substratum (002), excavated to a depth of 0.81m (Fig. 9). No archaeological finds or deposits were uncovered within this trench.

Figure 9. View of Trench 5 looking west (Scale: 2m).

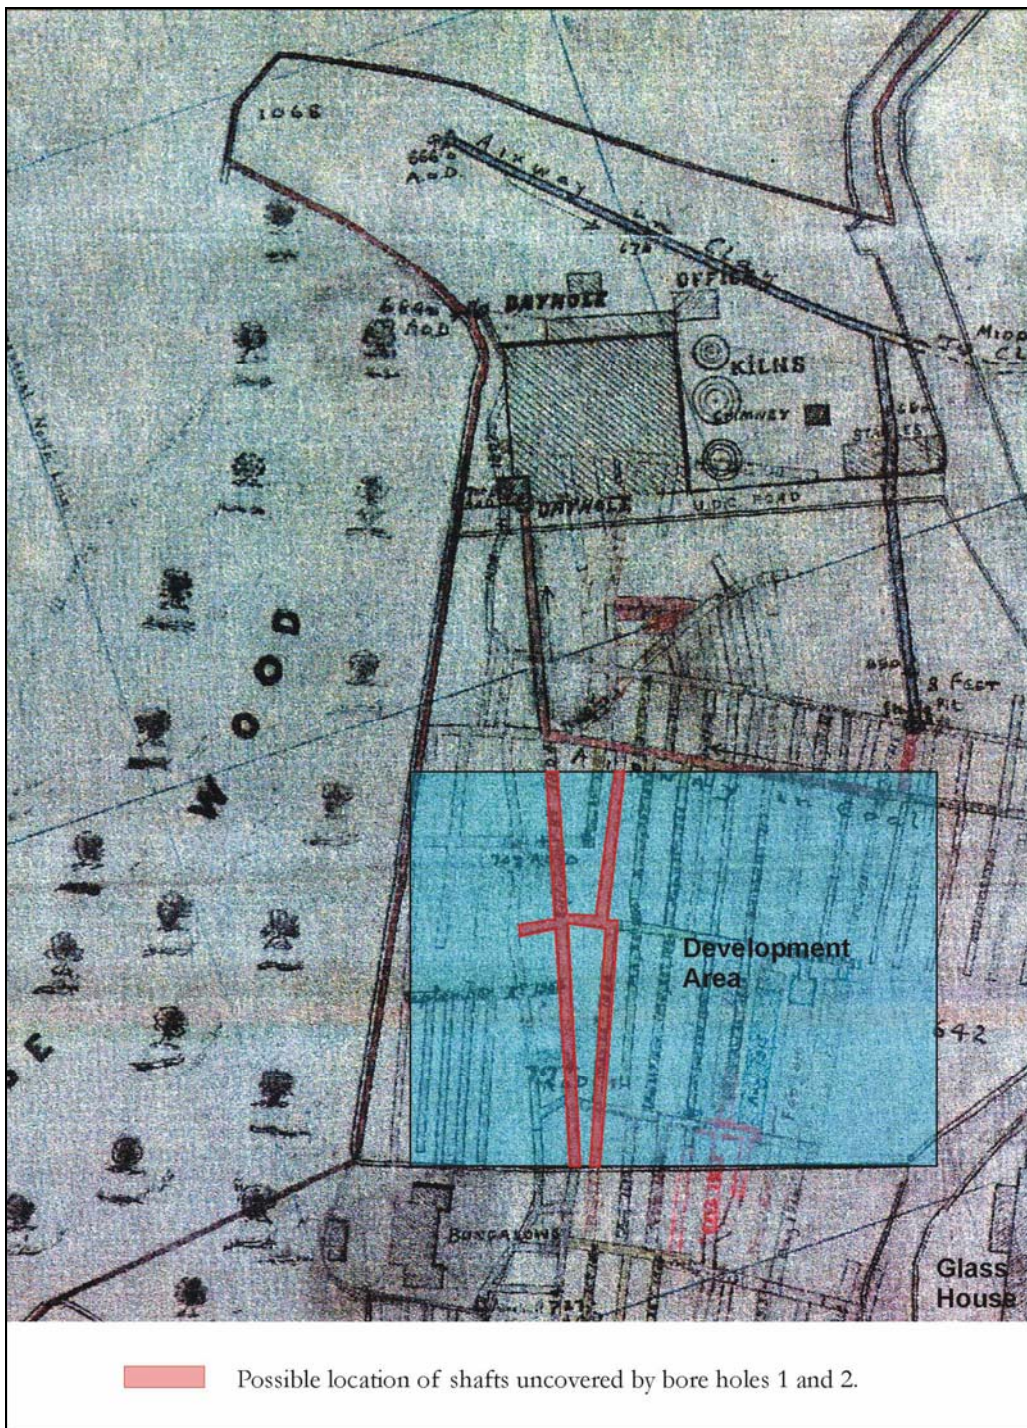
7.1 The bore hole excavations revealed mine workings already known to be located under the school and the development site. Geological maps of the area from the early 1920's show a network of shafts probably associated with the pipeworks at Pot House Works (Figs. 11 and 12). The locations of the voids correspond with the old maps and were between 1.5m and 2m in depth. A deposit of coal was uncovered in bore hole three at the same depth as the voids found in the other bore holes. The deposit probably indicates a column of coal left between mine shafts for structural reasons.

Figure 12. Map showing clay shale workings of Halifax Middle Coal Bed, 1902 -1925, Scale 1:1200.
