Hetton House, Hetton-le-Hole, Sunderland, Tyne and Wear

Historic Building Assessment

ARS Ltd Report 2016/87

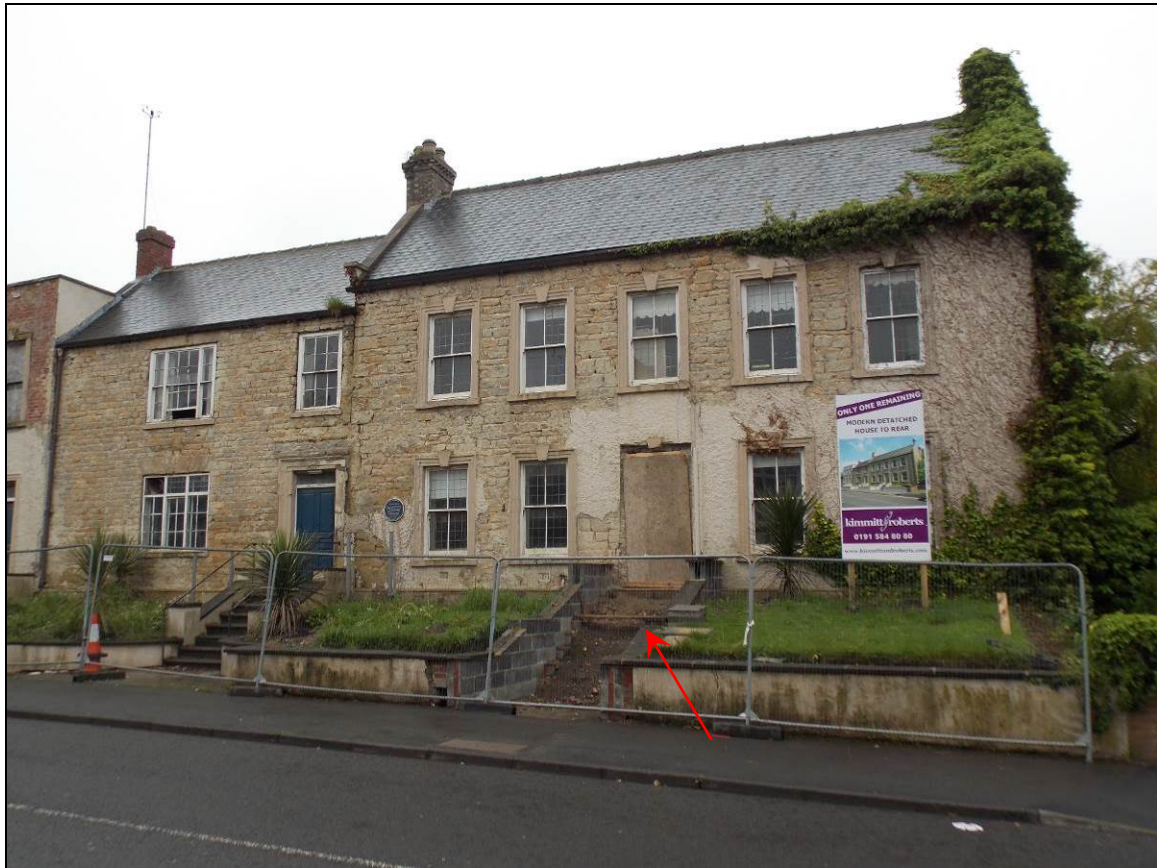
6.1 The research into the primary entrance of the western range of Hetton House was somewhat limited due to significant alterations (both external and internal) of the original construction which had taken place through time. At the time of the site inspection a central doorway had been inserted within the central window opening on the ground floor. An associated ramp for a proposed staircase leading into the doorway had also been produced with side retaining walls built with concrete blocks (Fig. 3). No evidence of former steps or similar access arrangement was discerned within the ramp which

Figure 3: Front facade of Hetton House with inserted doorway and stairwell (arrow).

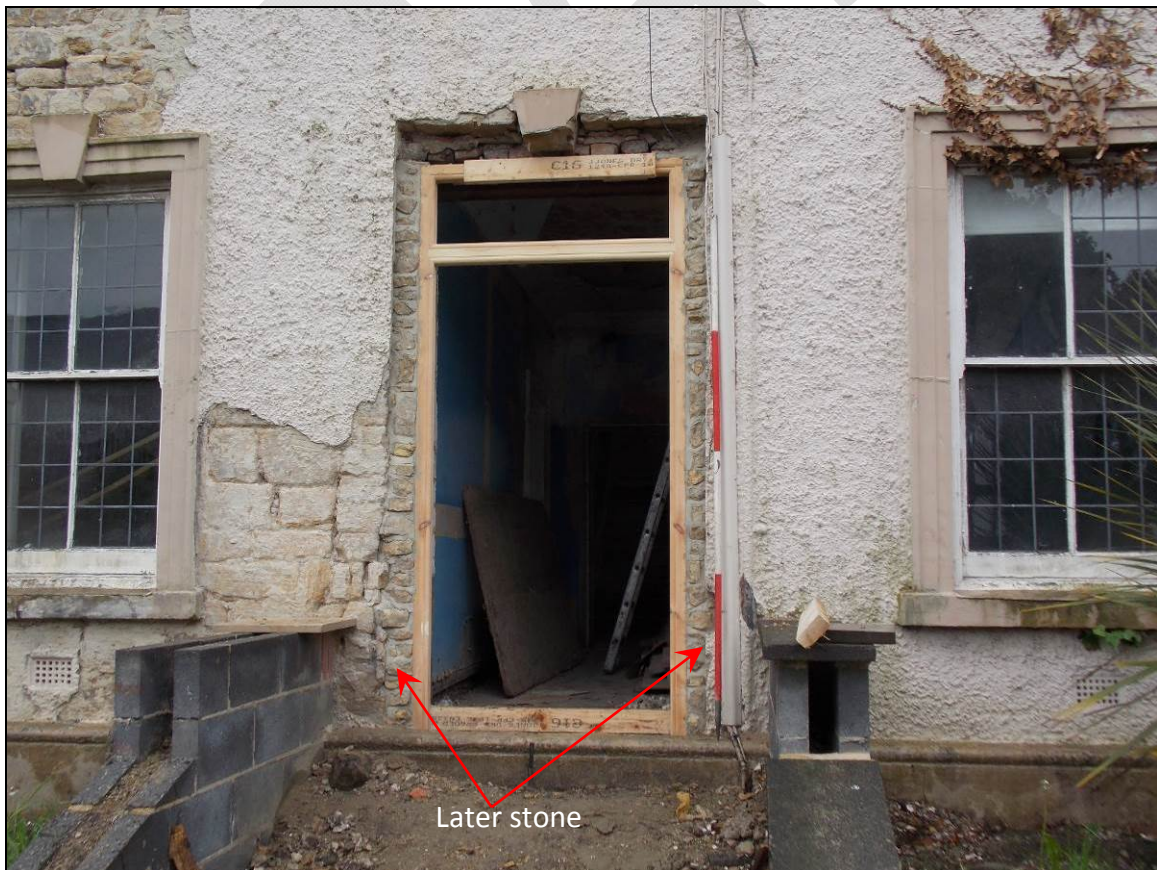
6.2 Despite the recent alteration removing the lower section of the central window opening, it was possible to identify that the outer masonry would have extended across the inserted opening as the present stone jambs have been produced cutting existing masonry and/or removing several stone blocks. A modern door frame had been placed within the doorway and the sides filled with later stones (Fig. 4).

Figure 4: Detail of the central window opening modified into a doorway (scale 2m).

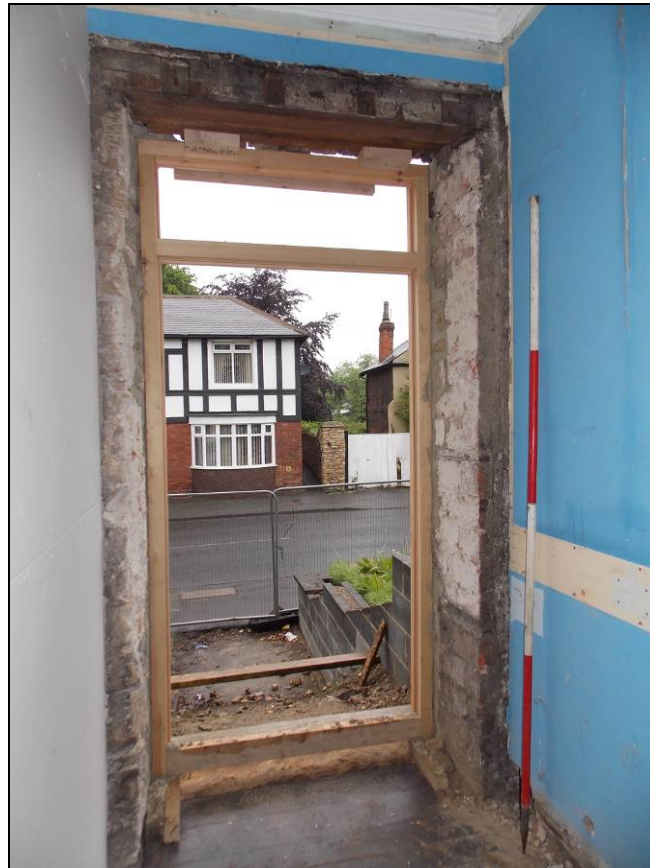
6.3 Internal examination established that the innermost veneer of the masonry had not been modified as the original window openings of the ground floor of the western range extends to the floor level creating additional space resembling bay windows. This can be seen on the unmodified windows within rooms G1 and G2 with their architraves, shutters and panels (Fig 9). The upper section recently occupied by the actual window is lime washed around the inner wall face and jamb sides whereas the lower area is devoid of such application. Of interest is the east jamb which is built with a single veneer of hand-made bricks laid on edge extending throughout the entire length of the original opening (Figs 5 and 6). The brick veneer measure c.100mm in thickness and width of the inner opening, which is slightly splayed, measured 1.20 metres. The height of the window opening is 2.50 metres from the present timber floorboard to the underside of the lintel.

Figure 5: Internal view of the inserted doorway (scale 2m).

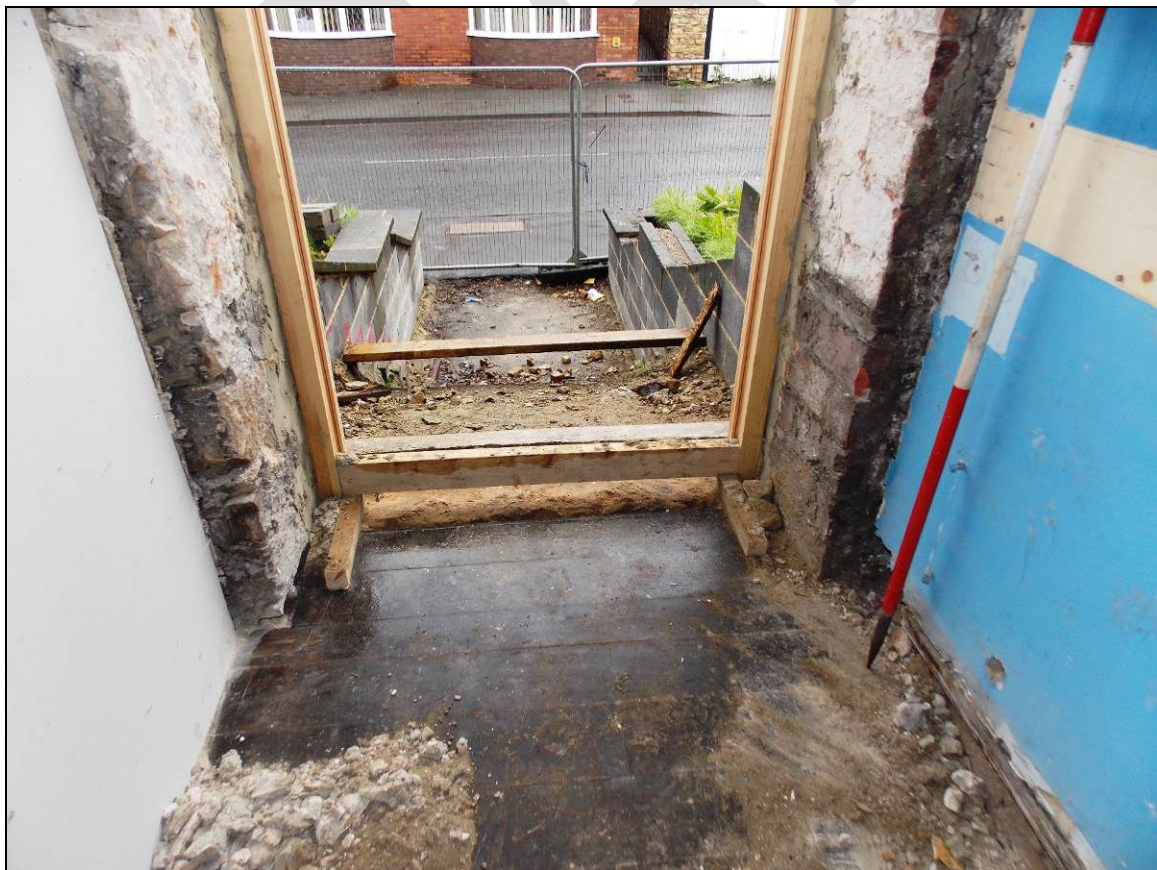
Figure 6: Lower section of the inserted opening.

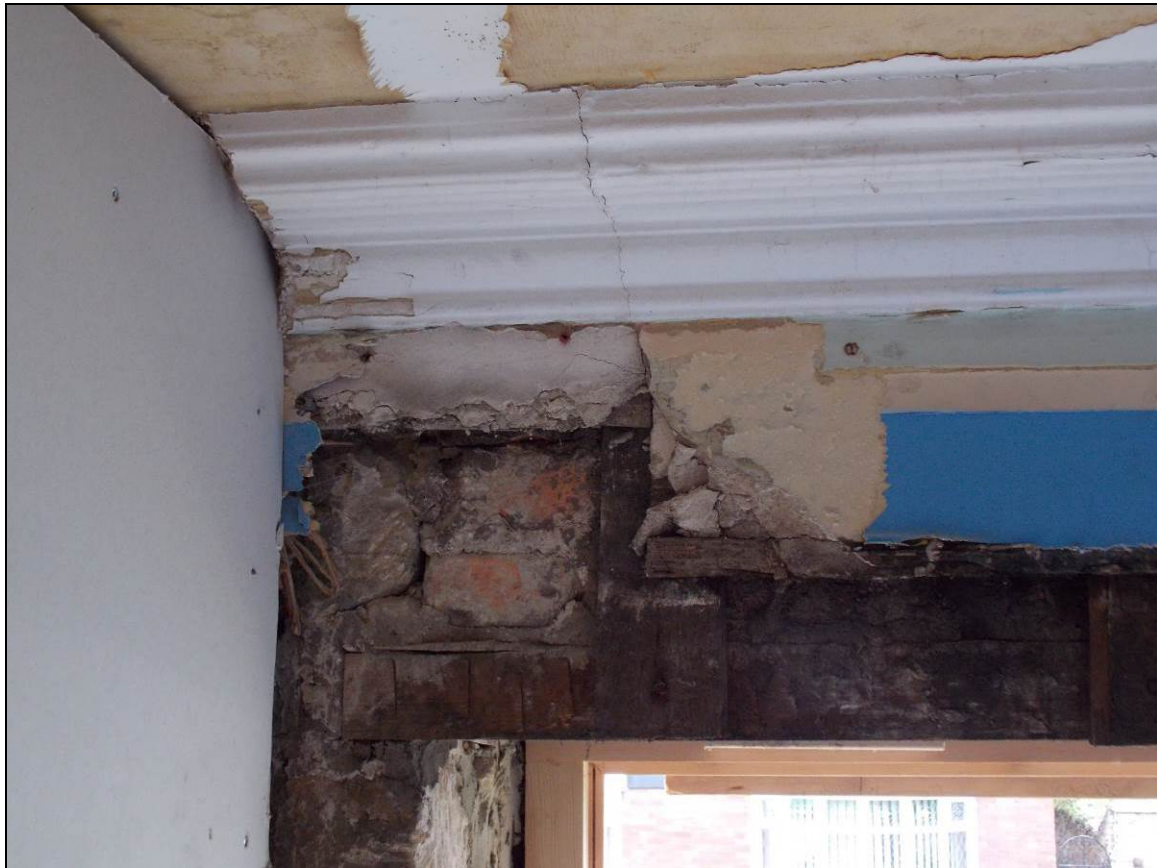
6.4 A scantling sawn timber lintel was exposed following the removal of the window architrave and the insertion of the modern door frame. In order to verify its authenticity a small section of lath-and-plaster wall above it was detached revealing that the timber is indeed the primary window lintel supporting at least three courses of bricks (Fig. 7).

Figure 7: Detail of original timber lintel and brickwork above it.

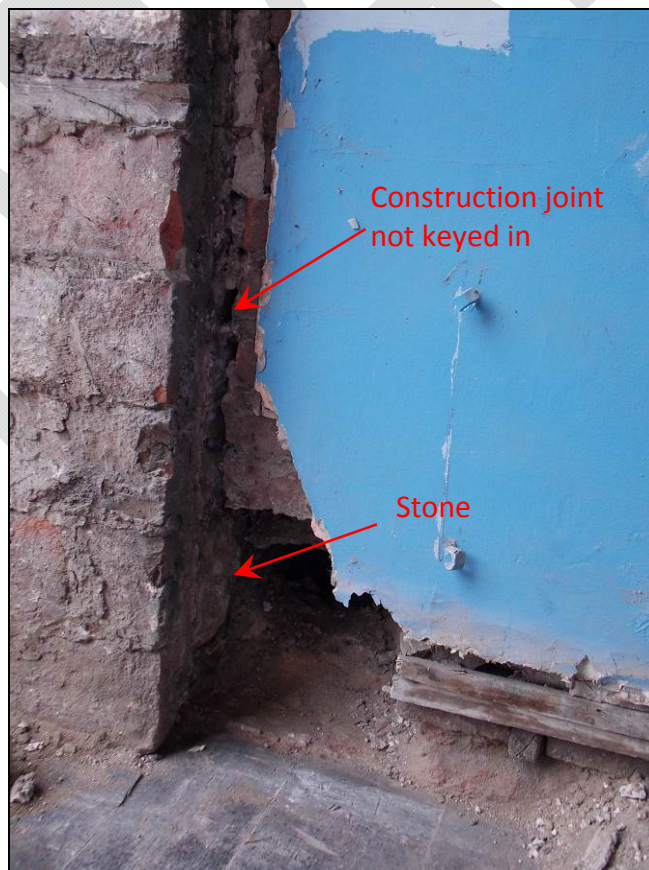
6.5 The wall dividing rooms G1 and G2 consists of a single brick wall abutting the stone masonry of the range adjacent to the eastern jamb of the recently opened up doorway. The partition wall is clearly a later insertion which is not even keyed in properly with the stone wall (Fig. 8). The internal arrangement of the original windows was observed within the remaining windows. Another small plaster removal was conducted within the adjacent window revealing an equivalent arrangement of scantling lintel supporting at least three courses of hand-made bricks (Figs 9 and 10).

Figure 8: Brick jamb and later brick wall abutting the stone north wall.

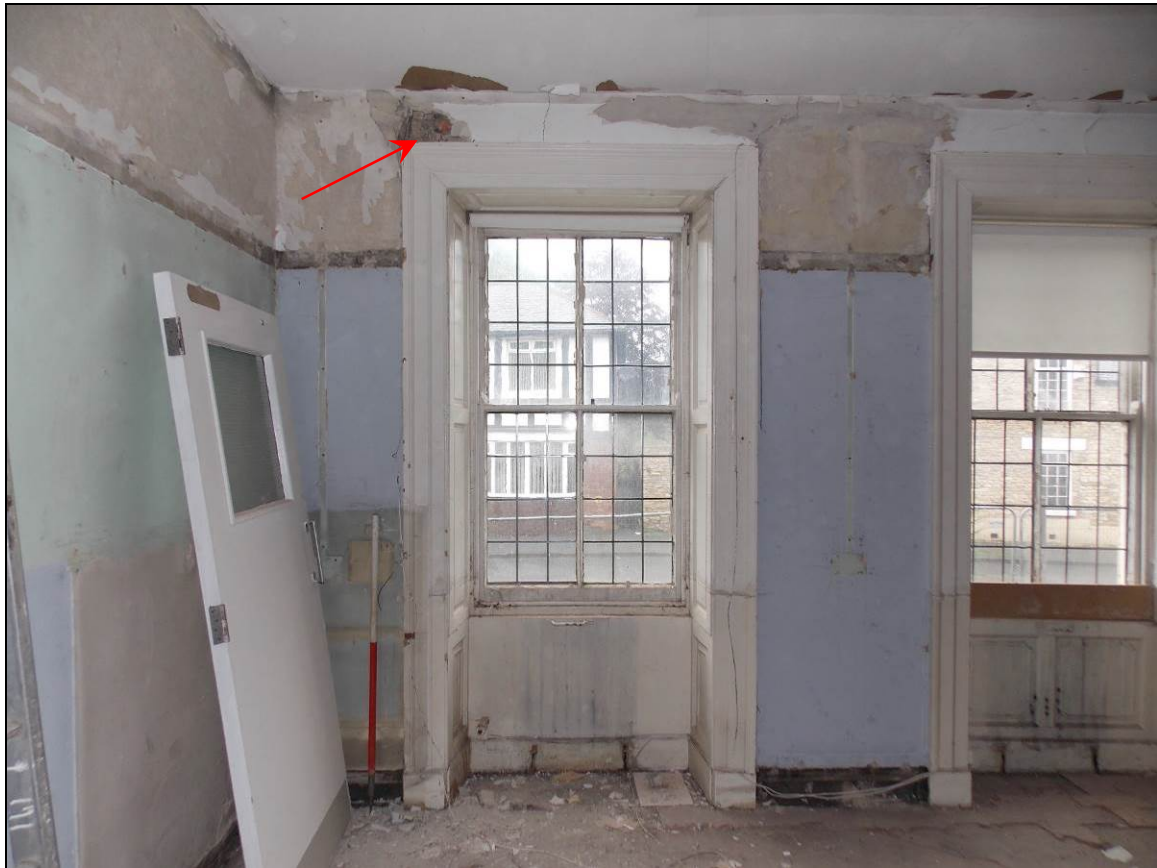
Figure 9: Window opening within the adjacent room G2 with comparable brickwork above the lintel (arrow).

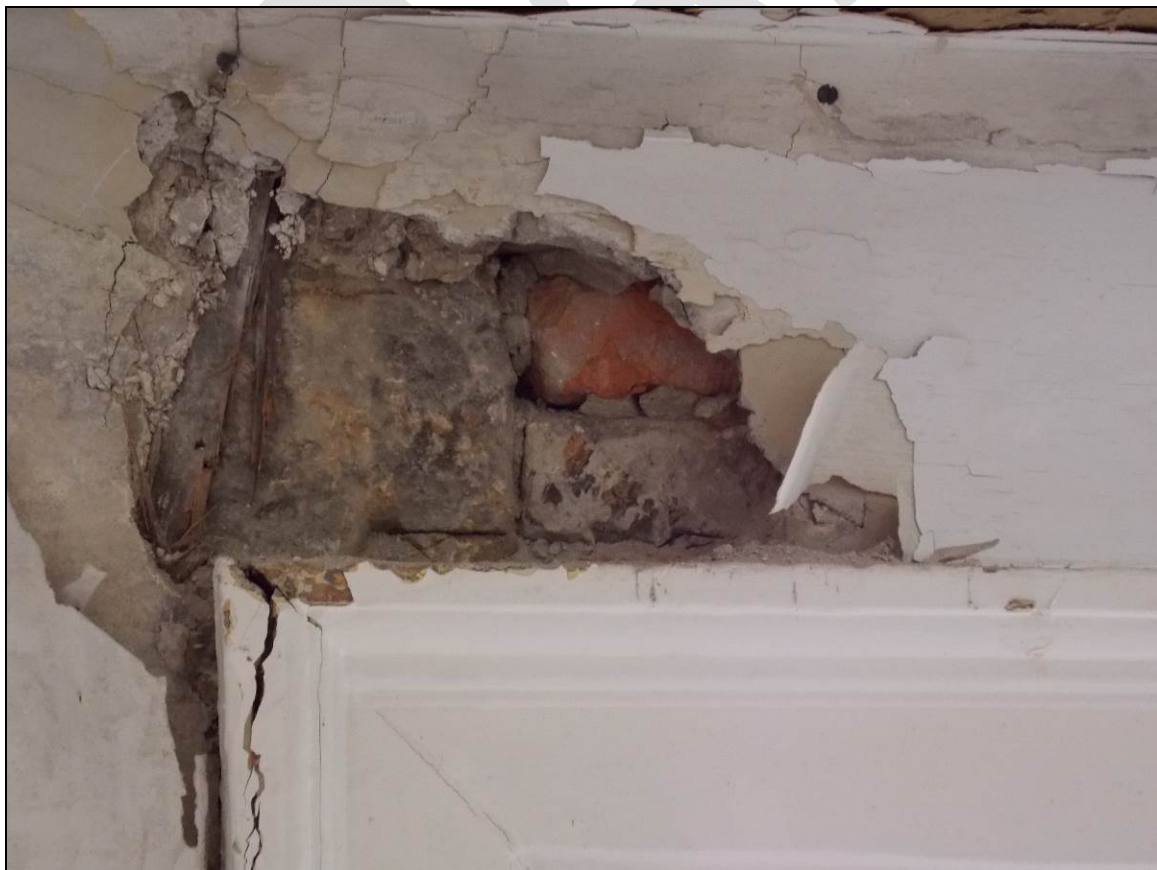
Figure 10: Detail of brickwork above window lintel within room G2.

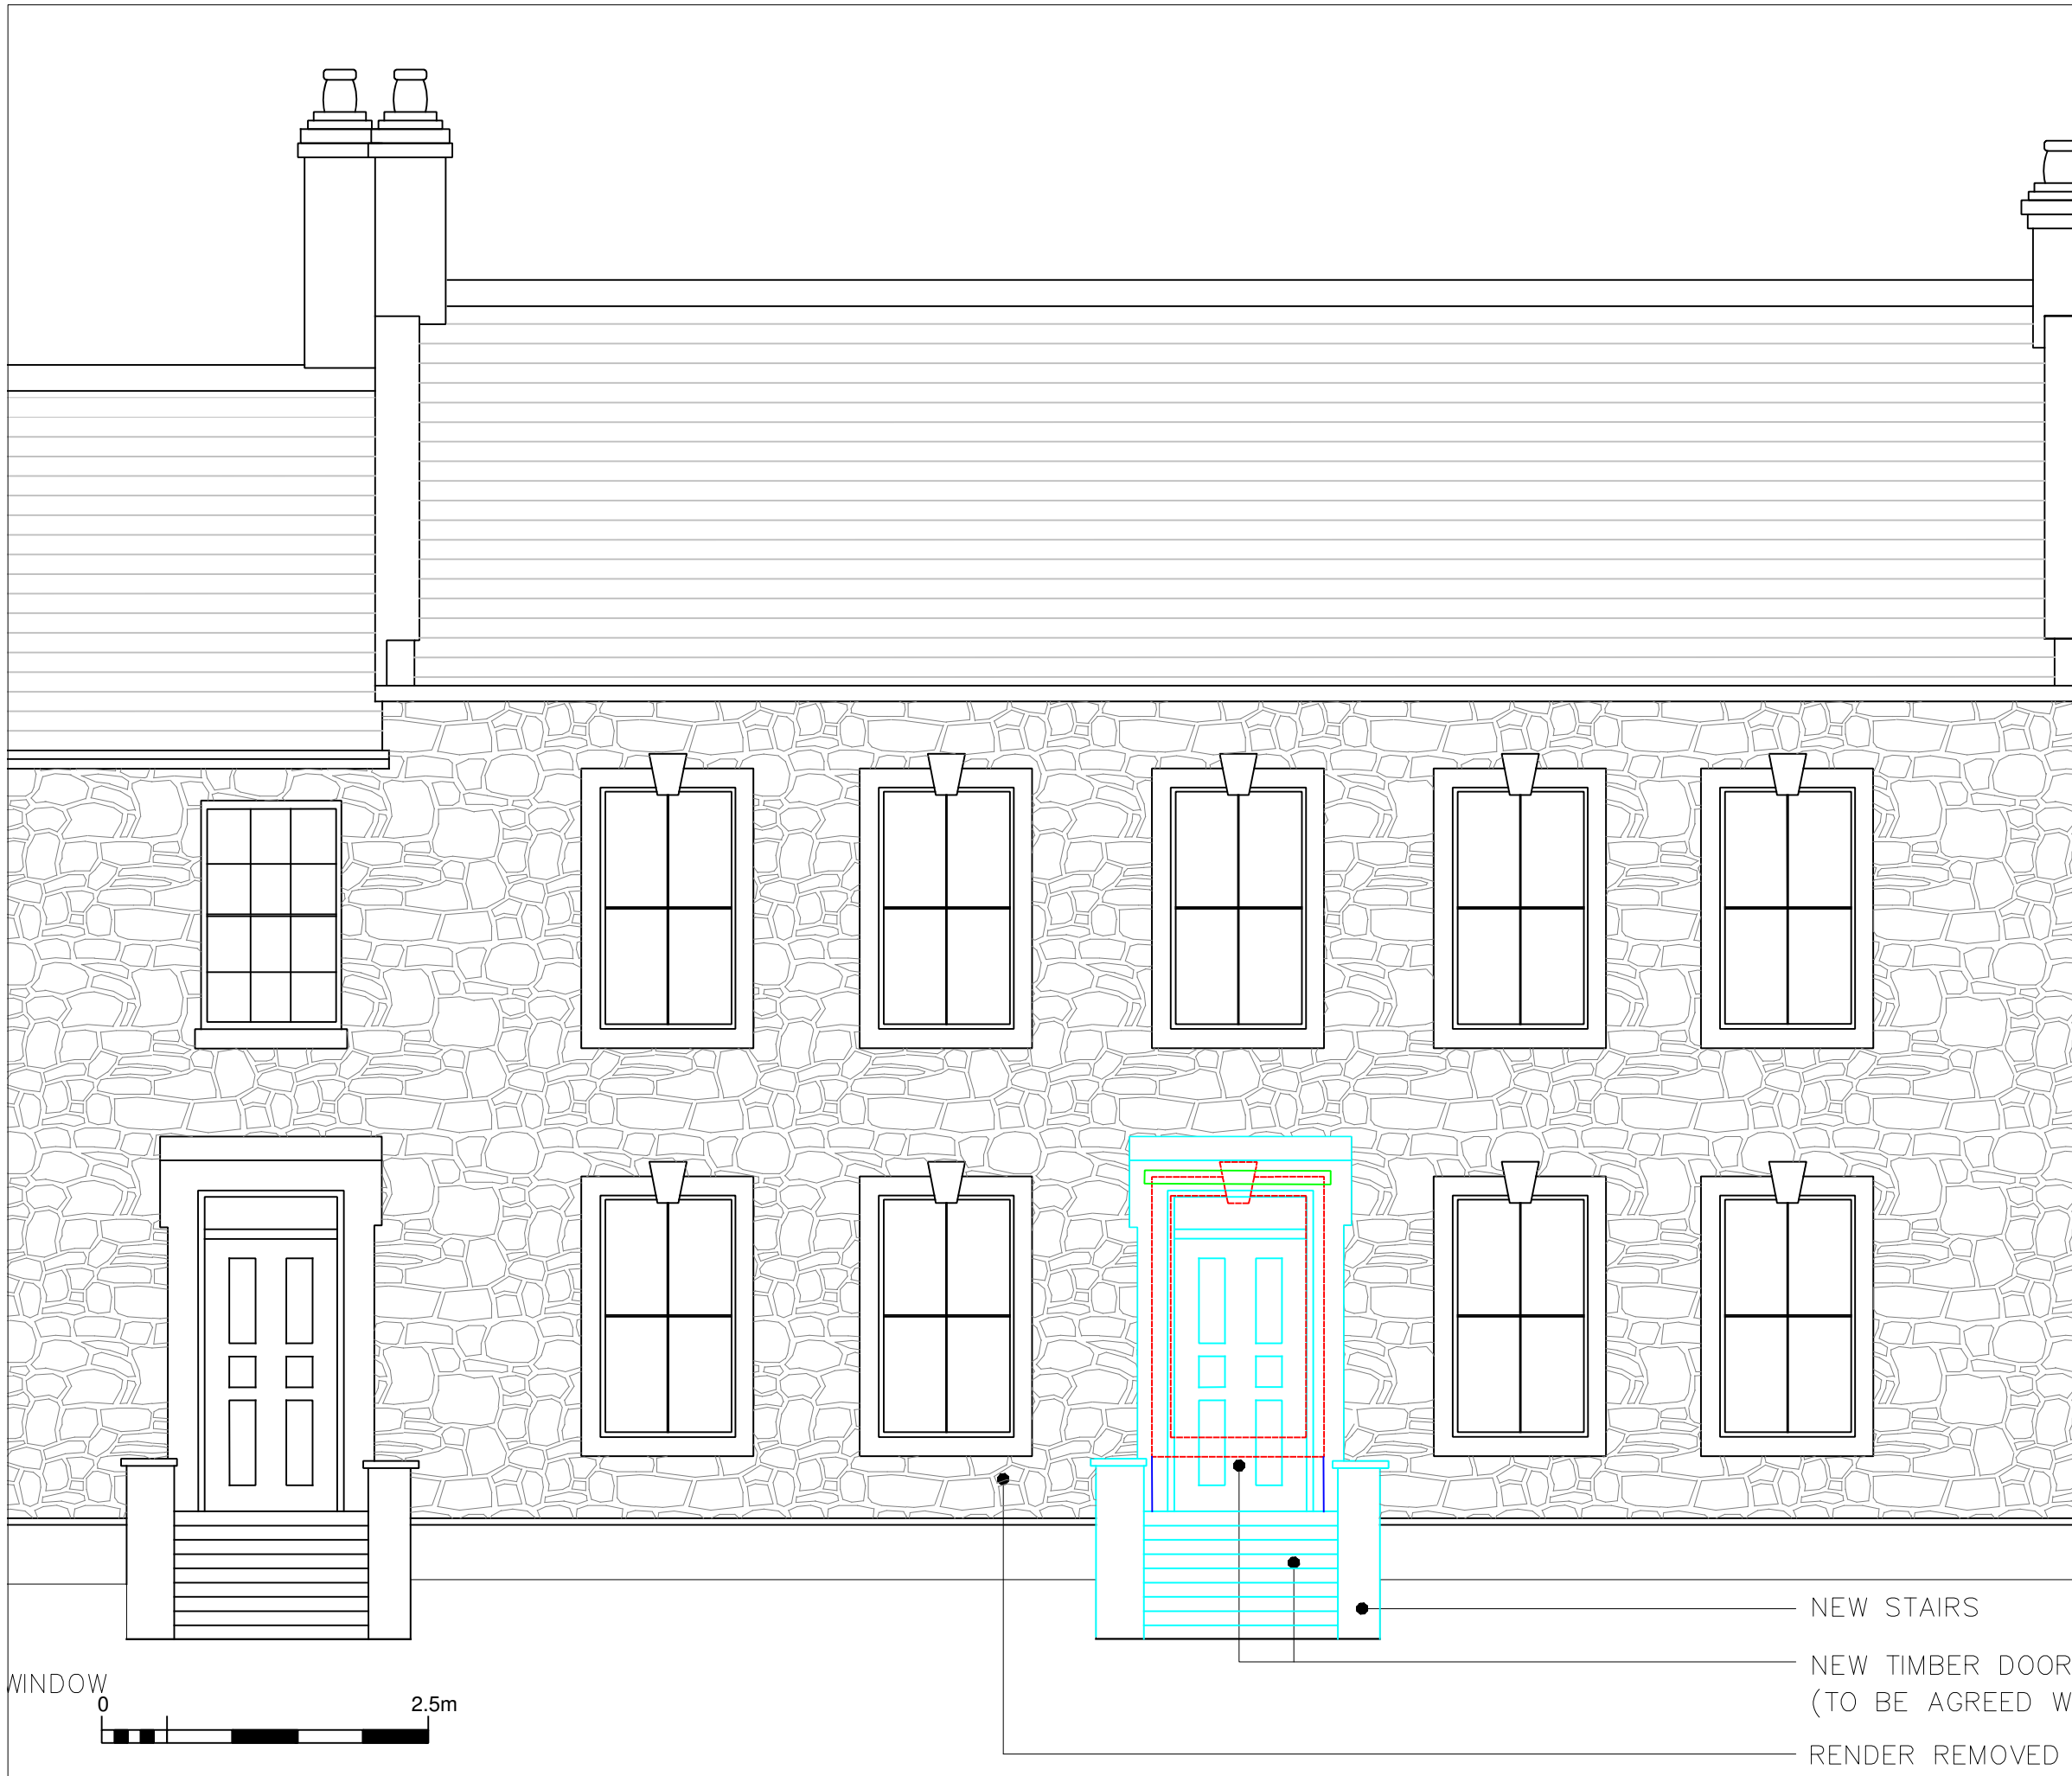
Figure 11:
 Detail of proposed inserted doorway within the front elevation

NEW STAIRS
 NEW TIMBER DOOR
 (TO BE AGREED WITH LA)
 RENDER REMOVED AND EXPOSED

7.2 A drawing showing the proposed design is included below showing the fabrics to be impacted upon the proposed development work (Fig. 11). A series of parallel examples has been selected in case they may be useful to assist with a final design for the proposed doorway. The gazetteer is somewhat limited as similar criteria of construction, date, building type and listing grade were seldom obtained.

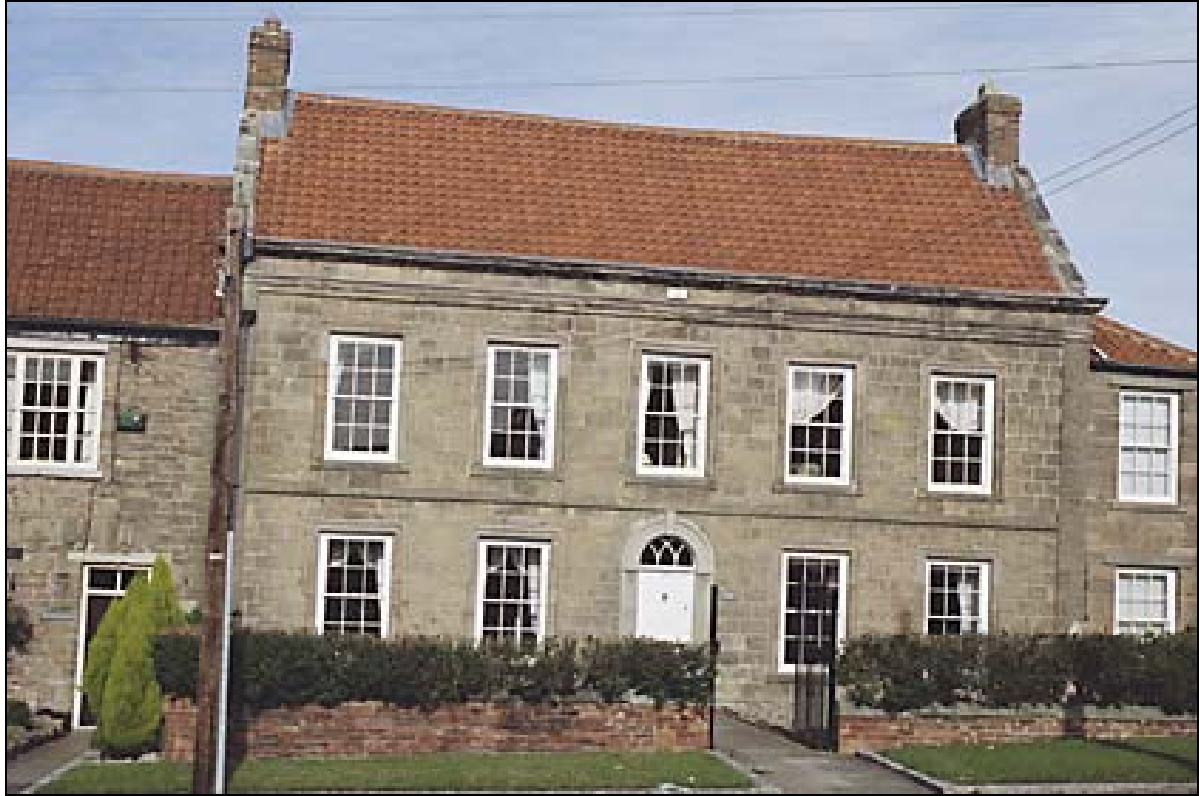
Figure 12: Example 1.

7.3 Example 1 is a Grade II Listed Building of similar date located in the neighbouring town of Houghton Le Spring. The accompanying photograph and information were obtained from Image of England (www.imagesofengland.org.uk):
Ga 20 and 20A Front Street (north side) Houghton Le Spring IoE Number 303194 GII circa 1720

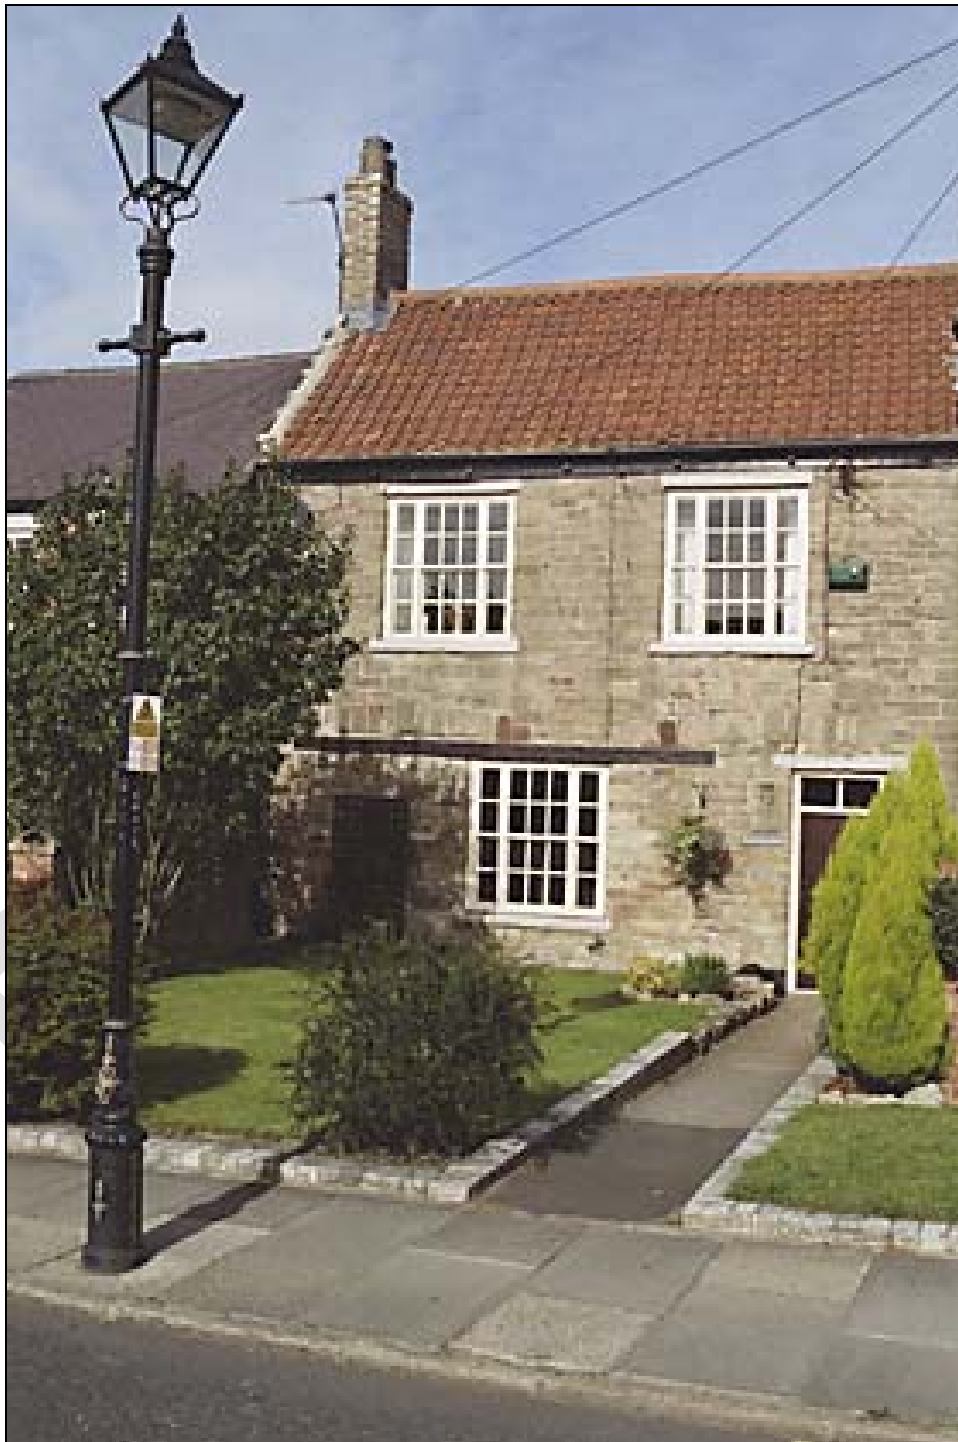
Figure 13: Example 2.

7.4 Example 2 is also from the same nearby town. The accompanying photograph and information were obtained from Image of England (www.imagesofengland.org.uk): 18 FRONT STREET (north side) Houghton Le Spring IoE Number 303193GII House, 1720, refurbished c.1800.

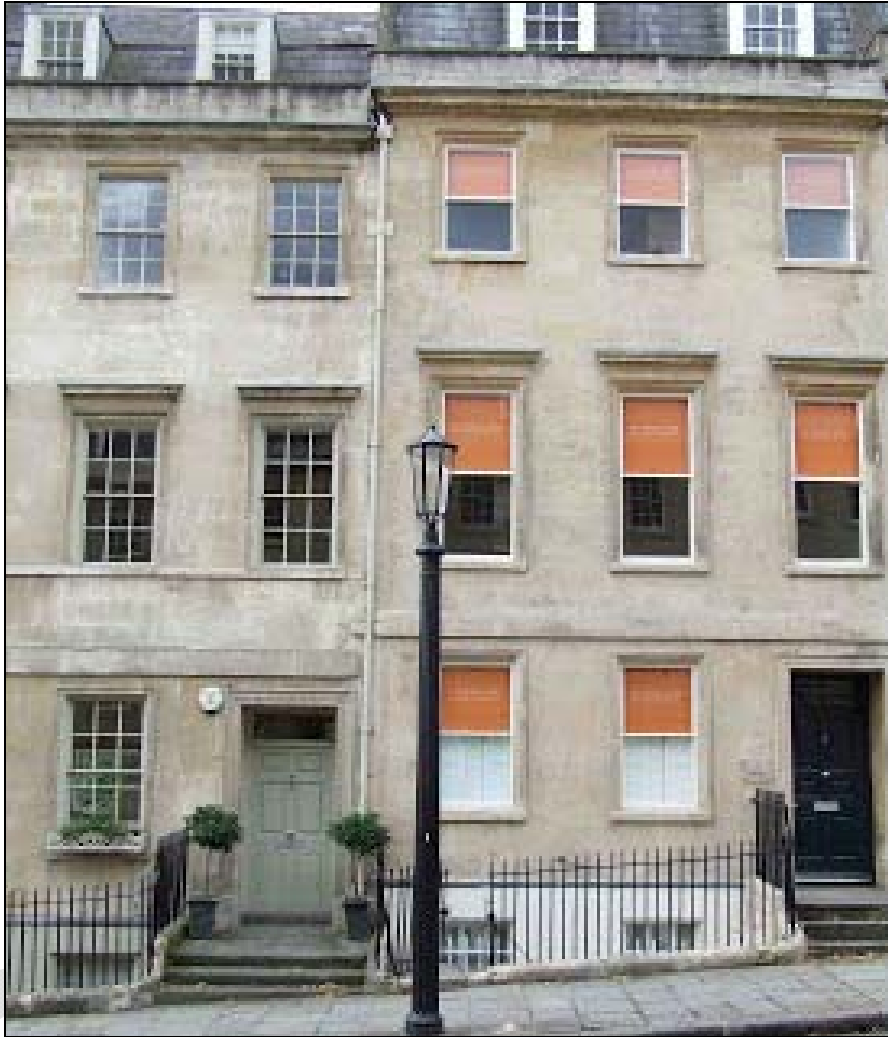
Figure 14: Example 3.

7.5 Example 3 is a town terraced house from Bath 18th century. Photograph obtained from <http://englishbuildings.blogspot.co.uk/p/c-1700-1837.html>
