**Archaeological Building Recording at
The Coach House, 33 The Grove,
Gosforth**

ARS Ltd Report 2007/25
April 2007

Planning ref: 2006/2383/01/LBC
2006/2384/01/DET
Oasis no.: archaeol5-26122

Archaeological Building at the Coach House, 33 The Grove, Gosforth

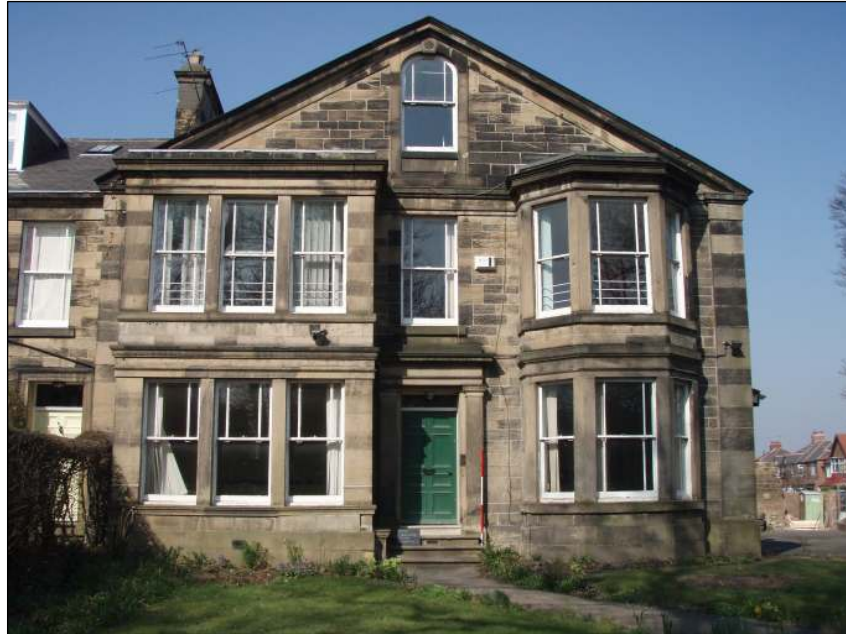
The south elevation (Fig. 7) was the gable end of the building. Three sandstone steps lead to a central doorway which was constructed using large sandstone columns on either side with a sandstone lintel. The doorway held a wooden frame with a large wooden door. A metal ventilation grate was set into the third sandstone step leading to the door and provided ventilation to the basement (Fig. 8). A later square bay extension of the ground and first floors had been added to the west side of the elevation and was constructed using sandstone blocks. Three large sash windows existed on the ground and first floor. Set into the sandstone construction, below the ground floor level, was a ventilation grate (Fig. 9). To the

Fig. 7 South elevation, scale 2m

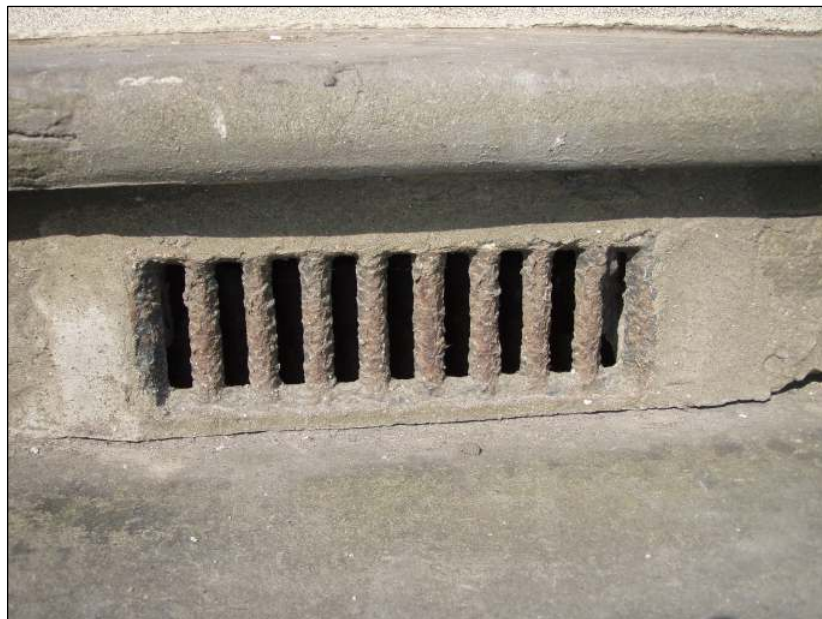
Fig. 8 Ventilation grate in doorway step, south elevation

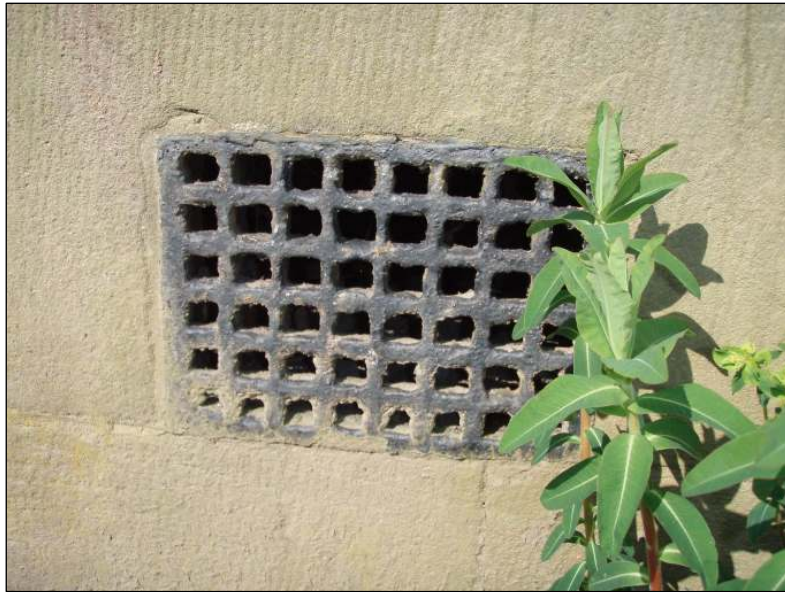
Fig. 9 Ventilation grate under west window, south elevation

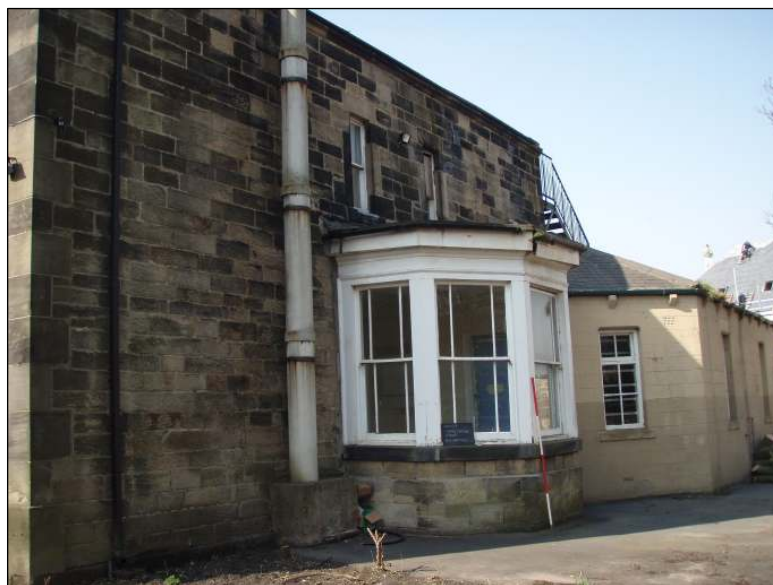
The east elevation (Fig. 10) comprised two sash windows, smaller than those in the south elevation, on the first floor (Fig. 11). They were constructed using sandstone blocks and held wooden frames. The glass remained in the south window but the north window was boarded up. A later bay window had been constructed onto the ground floor using sandstone blocks and comprising four large sash windows. The bay had suffered from subsidence. A later extension had been erected at the north end of the elevation (Fig. 12). This was constructed using sandstone blocks which were then plastered and painted. The roof was a slate covered timber frame. Two sash windows existed, one at the north end and one at the south end (Fig. 13). A third sash window existed on the wall of the extension which joined the main building at a 45 degree angle.

Fig. 10 East elevation, main building, scale 2m

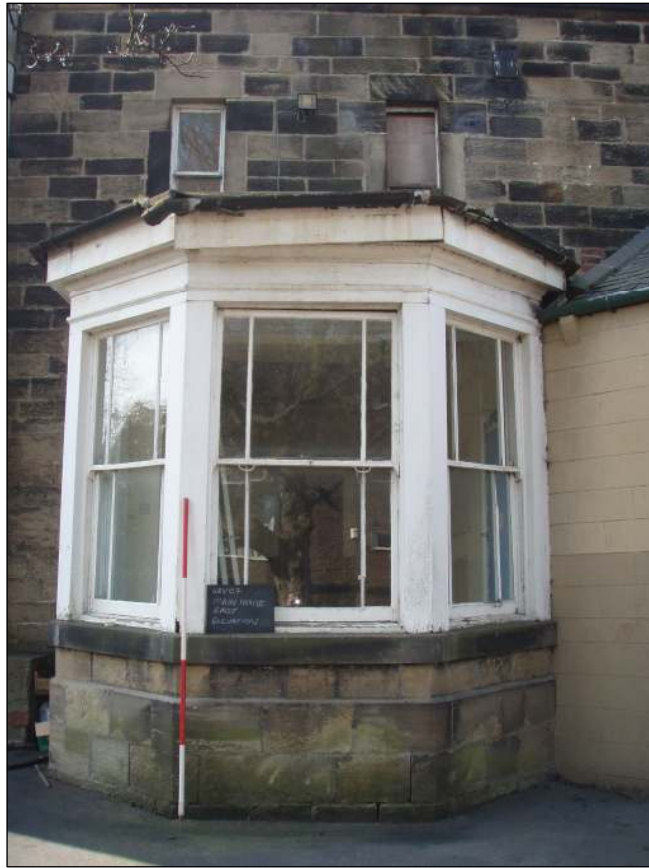
Fig. 11 East elevation bay window, scale 2m

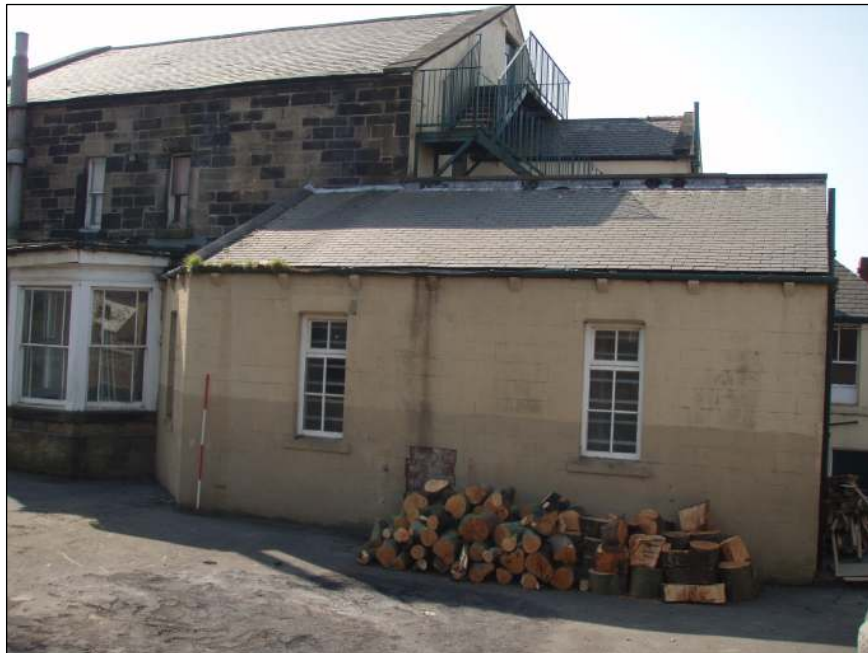
Fig. 12 East elevation, later extension, scale 2m

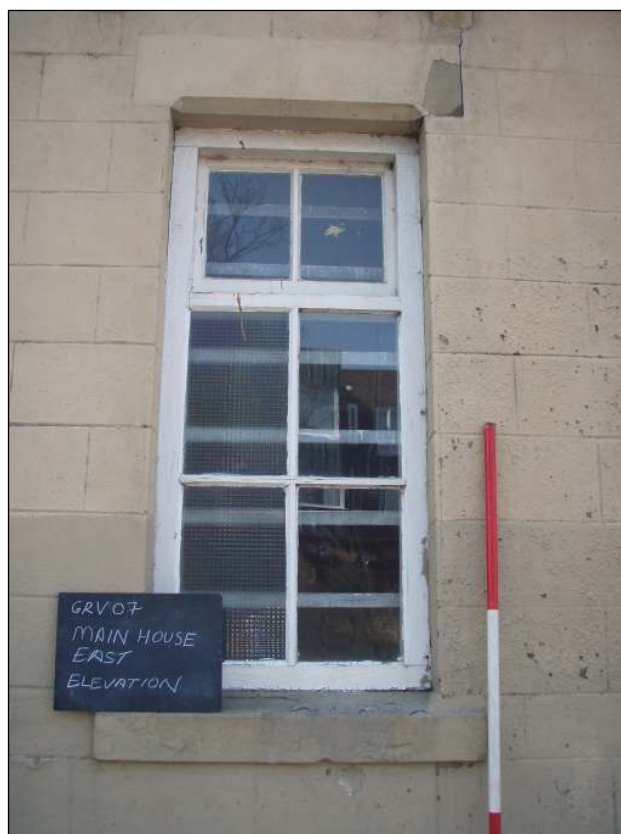
Fig. 13 East elevation, later extension window, scale 2m

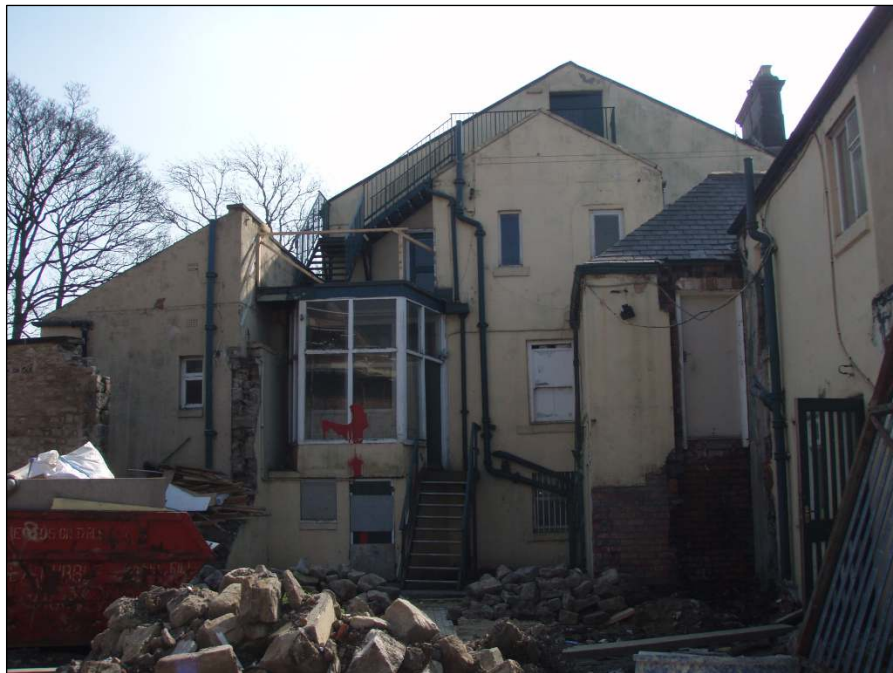
The north elevation of the original building was almost entirely obscured by later extensions (Fig. 14). The sandstone blocks had been covered with plaster and painted. A large window existed at the west end of the main building on the first floor but was obscured by the later extensions. It was constructed with a wooden frame which held five large panes of glass with five smaller panes located above the larger ones. The window in the attic of the original building had been removed and replaced with a doorway, which lead out to a metal staircase. The stairs ran down to the roof of a later bay extension at the east end of the elevation. At this level another doorway existed in the original building. The bay extension was divided into three sections. The east and central section were made up of large windows held by wooden frames. The west section consisted of a wooden doorframe and door where the bottom-right pane of glass would have been held. A set of metal stairs ran from this door down to ground level. Below the bay a boarded up doorway and window existed. This doorway was situated at ground level. To the east of the bay lay the north elevation of the extension, which was added to the east elevation discussed above. This comprised a very small window with a sandstone block sill and wooden frame. Damage to the wall showed that they were constructed using sandstone blocks and modern bricks (Fig. 15). A later extension had been erected at the centre of the original building and comprised two small windows at the first floor level. The window to the east was narrower than the window on the west but both held wooden frames. A

Fig. 14 North elevation

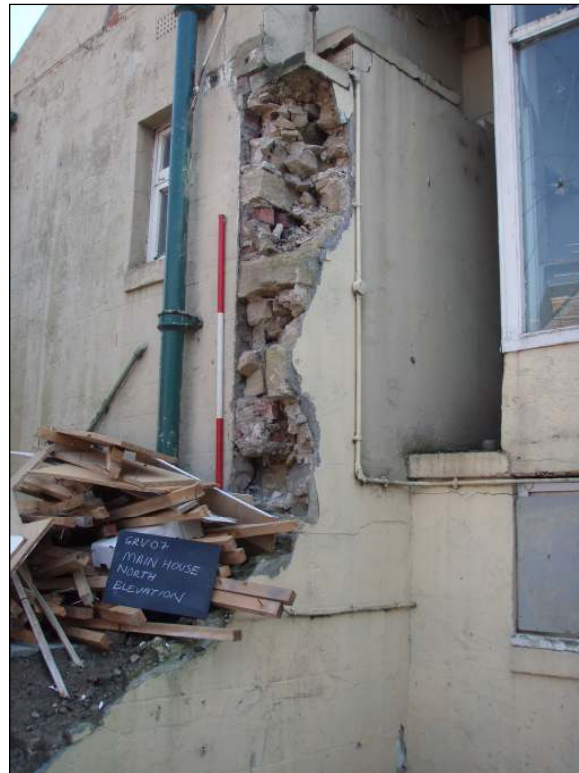
Fig. 15 Damage to wall in north elevation, scale 2m

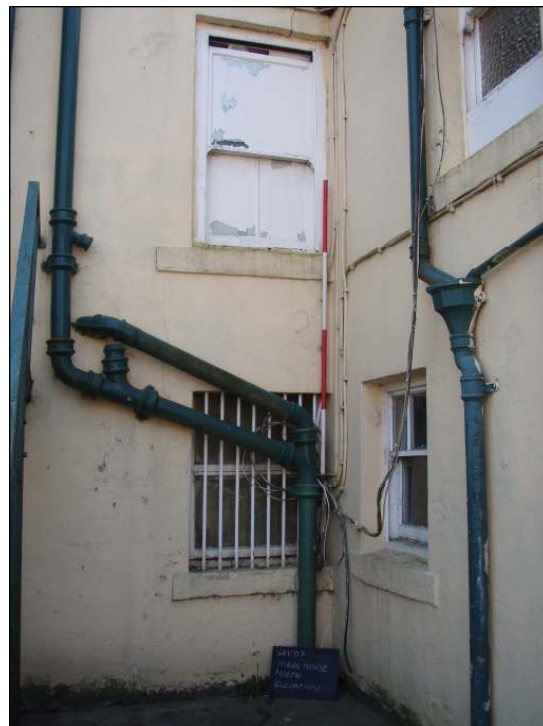
larger window existed at ground floor level which consisted of a sandstone block sill and wooden frame but was boarded up (Fig. 16). Another window existed below and was also constructed with a large sandstone sill and wooden frame. This window was covered with metal bars. To the west end of the elevation a later extension ran to the north which joined the main building to the coach house. It was constructed using sandstone blocks which were plastered and painted, with a slate-covered timber-frame roof. It contained a modern doorway situated at ground floor level. The east facing wall of this extension contained two small sash windows at the centre on the first floor level constructed with sandstone sills (Fig. 17). A third small sash window existed on the ground floor level at the south end and also built with a sandstone sill.

Fig. 16 North elevation, west corner, scale 2m

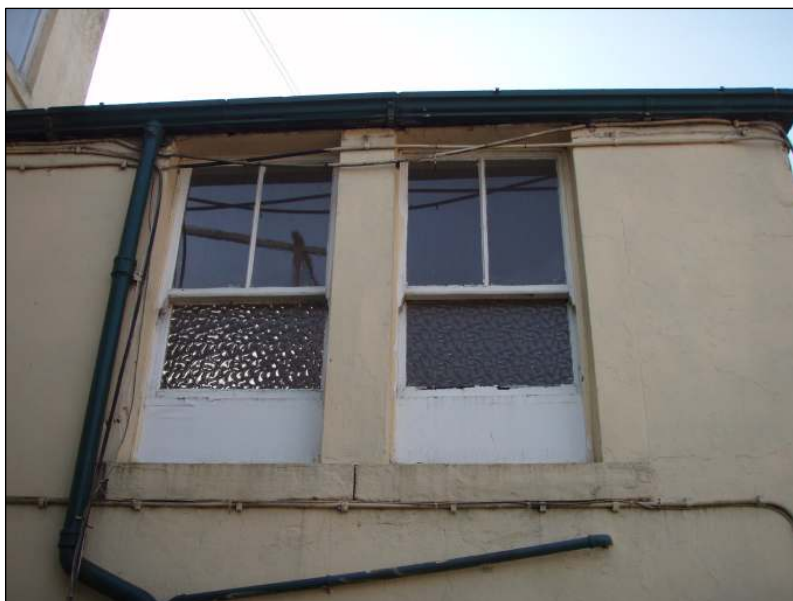
Fig. 17 Windows in east facing wall of extension in north elevation

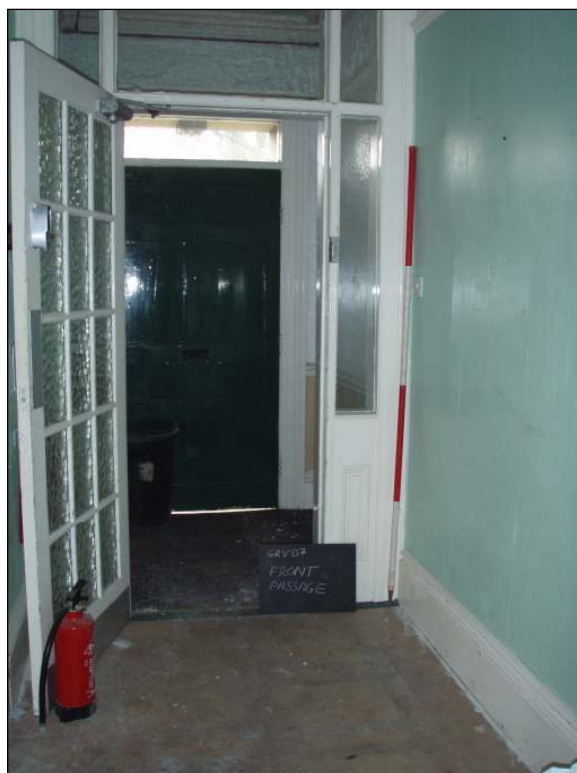
Fig. 18 Front passageway, scale 2m

A corridor ran from the front of the house to the rear of the original building. The area at the far south end of the corridor which lay directly behind the front door, was divided by a doorway to the north (Fig. 18). This section contained a decorative ceiling (Fig. 19) and patterned frieze at the top of the wall. A picture rail lay below the frieze, and a dado rail was situated approximately 0.50m above the skirting board. The doorway to the north was made up of a large wooden frame with glass panes at the top and sides. The door was a large wooden frame with fifteen smaller glass panes inset. The area of the corridor to the north of this contained lath and plaster walls and ceiling with plain cornices. A plain border lay below the cornices with a picture rail below that. A doorway led from the east wall into Room One. An archway divided this section from the next passage area, which contained a staircase to the north (Fig. 20). In the south-west corner of this section a doorway led to Room Five. In the south-east corner a decorative archway led to Room Two (Fig. 21). The west wall was boarded up but would normally lead to the old Headmaster's office. The east side consisted of the main staircase which led to the first floor. The banister and connecting posts were original and are to be restored (Fig. 22). An original decorative trim on the outside of the staircase is also to remain. As the staircase doubled back on itself, from the landing up to the first floor, the wall also doubled back on itself (Fig. 23). The passage continued north into the later twentieth-century extensions. The floor level here was higher by 0.32m. The girls and boys toilets were accessed through doors on the east wall. A doorway on the west wall led to an outside staircase, which led down to Room Eight. Directly across from this door

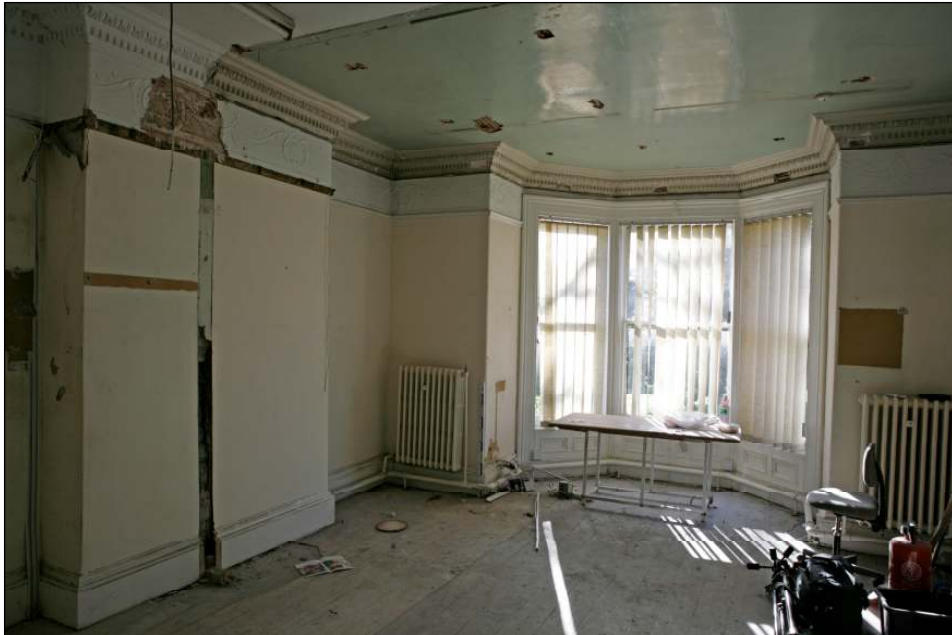
Room One contained a number of original features. A large bay window existed to the south of the room and held three large sash windows which are to be restored (Fig. 24). An original pipe serving the heating system ran around the room and underneath the bay window. The walls were constructed using sandstone blocks which were covered with lath and horse hair plaster. The ceiling was also covered with lath and plaster. The floor was constructed with timber beams overlaid with wooden boards. The doors and doorframes were original fittings as were the skirting boards (Figures 25 and 26). Decorative cornices surrounded the entire room and are to be restored, and replica replacements are to be placed throughout the rest of the building (Fig. 27). Below the cornices lay a patterned frieze which sat above an original picture rail. A fireplace opening existed at the centre of the east wall which was constructed using brick with a large sandstone lintel. The fire and surrounds had been removed (Fig. 28).

Fig. 24 Room One

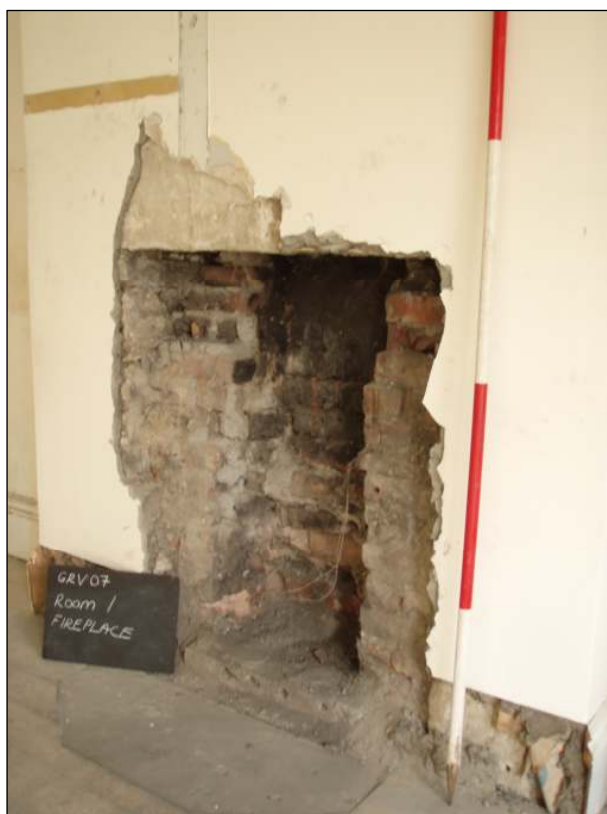
Fig. 28 Fireplace in Room One, scale 2m

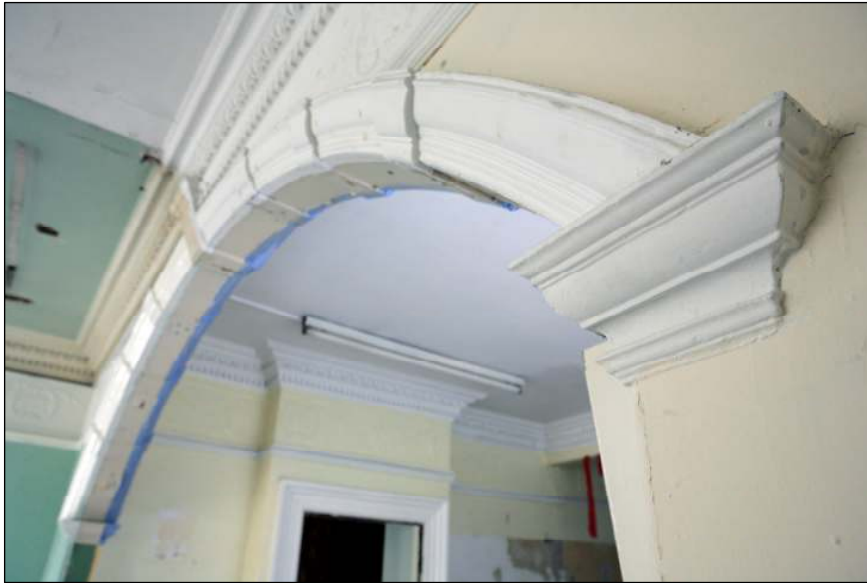
An archway led from Room One to Room Two and was finished with a decorative wooden trim (Fig. 29). The walls and ceiling in Room Two were constructed using lath and plaster and the decorative cornice the same as that in Room One was present around the whole room. The patterned frieze and picture rail were also present in Room Two. A large bay window lay on the east wall and contained four large sash windows (Fig. 30).

Fig. 29 Archway from Room One into Room Two

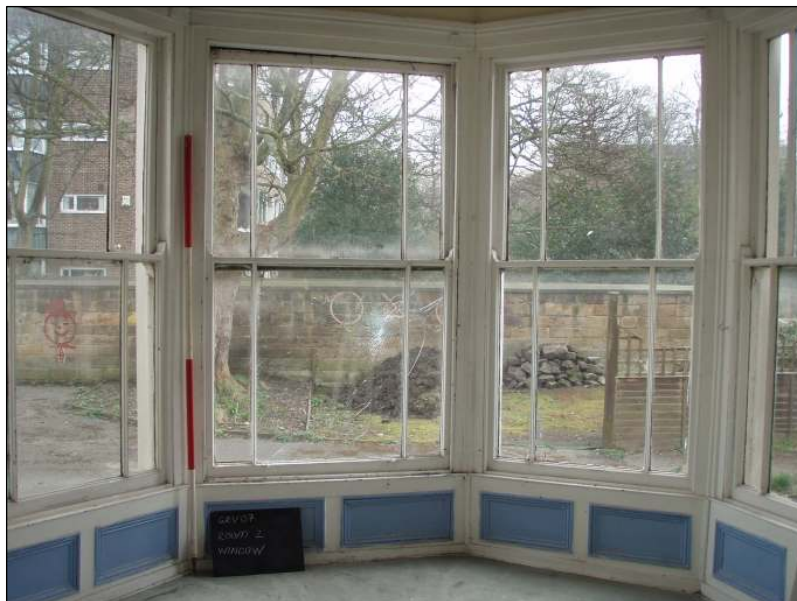
Fig. 30 Bay window in Room Two, scale 2m

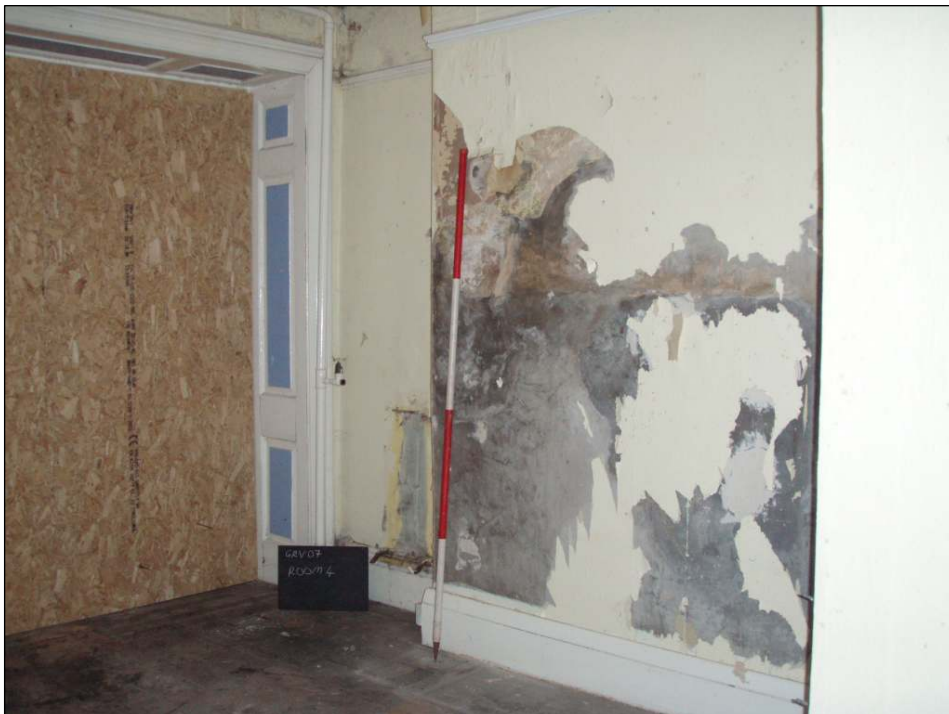
The walls and ceiling were covered with lath and plaster and the ceiling was covered with a decorative design (Fig. 31). The cornices in Room Four were the original mouldings but were not decorative as in Rooms One and Two. A patterned frieze existed below the cornice and was of a different design to that in Rooms One and Two (Fig. 32). The skirting boards appeared to have been replaced with later fittings on the eastern and northern walls but the originals existed elsewhere in the room. In the far south-east corner of the room a heating pipe ran from the floor to ceiling. A boarded-up double doorway existed at the east end of the north wall, along with an old heating pipe which ran from floor to ceiling (Fig. 33).

Fig. 33 Blocked access in Room Four. The heating pipe can be seen in the far corner, scale 2m

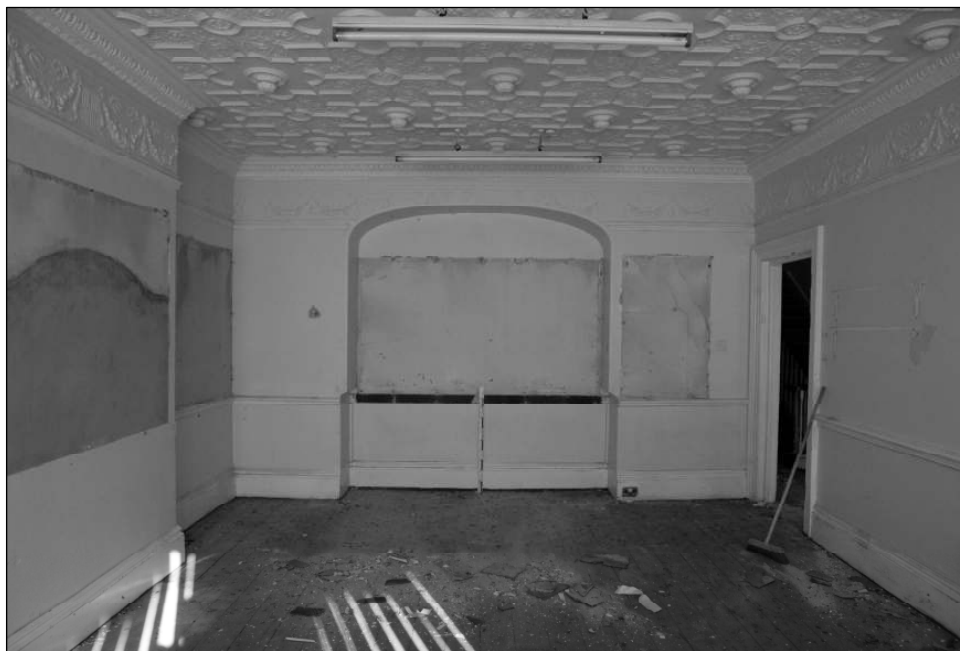
Fig. 34 Room Five

Room Five was a large room at the front of the house. The walls were constructed using sandstone blocks covered with lath and plaster. An arched niche was located in the centre of the north wall (Fig. 34). A patterned frieze ran around the whole room at the top of the wall with a picture rail directly underneath (Fig. 35). A dado rail ran around the room approximately 0.50m above the skirting board. It is doubtful that this dado rail was an original feature as behind a removed section within the arched niche a small strip of wallpaper lay beneath which had been covered by the later rail (Fig. 36). Above the border was a decorative cornice identical to that in Rooms One and Two. The ceiling in Room Five was made up of decorative moulding and is to remain (Fig. 37). The skirting boards and doorframes were original fittings. A pipe from the old heating system ran around the room but the radiators had been removed. A large window took up the south wall which was a later extension to the main building (Fig. 38). Three large sash windows were held in a wooden frame. A fireplace opening was located in the centre of the west wall but had been removed. It was of brick construction with a large sandstone lintel (Fig. 39).

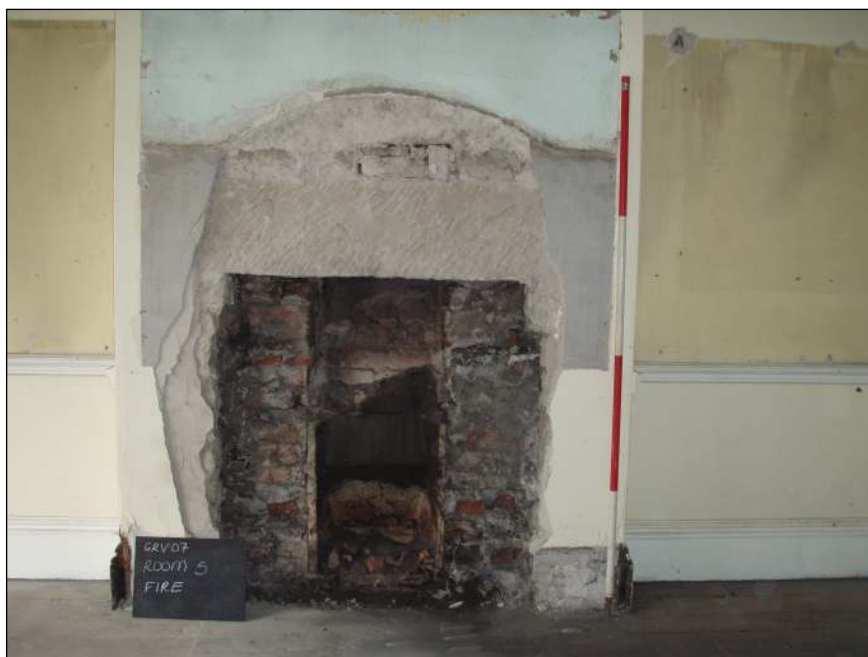
Fig. 39 Fireplace in Room Five

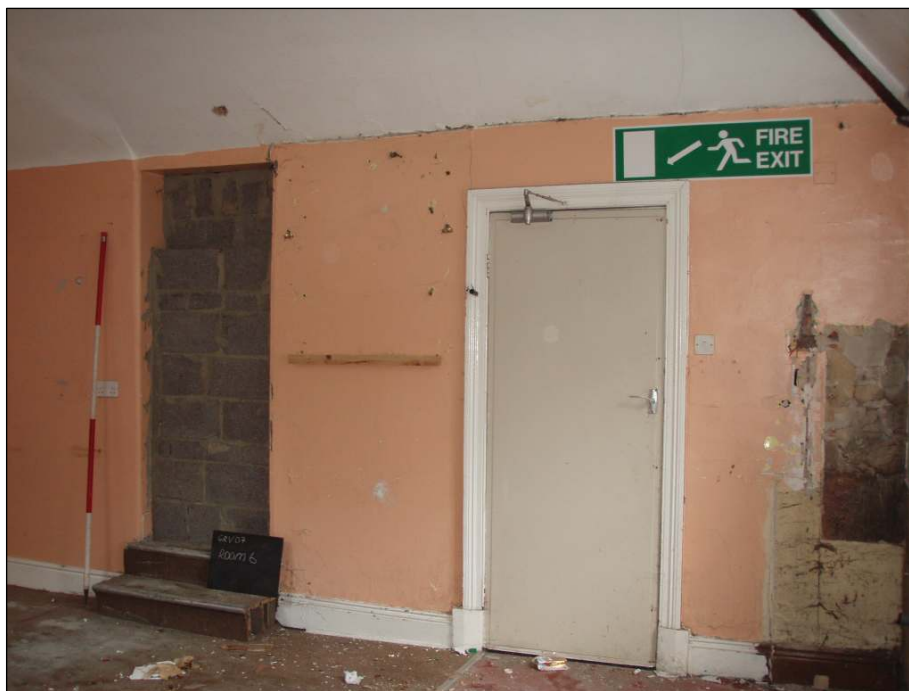
Room Six was a later twentieth century extension at the north of the main building. One window was located at the north end of the east wall and contained two sash windows. On the south wall the wooden beams were exposed along the line of the ceiling and down the south-west corner of the room. A skylight was located in the sloping ceiling above the south wall. On the north wall two steps led up to a doorway, which had been blocked up with breeze blocks (Fig. 40). Another door, was located to the east end of the north wall, was in use but locked. There were no further features of architectural interest.

Fig. 40 Room Six, scale 2m

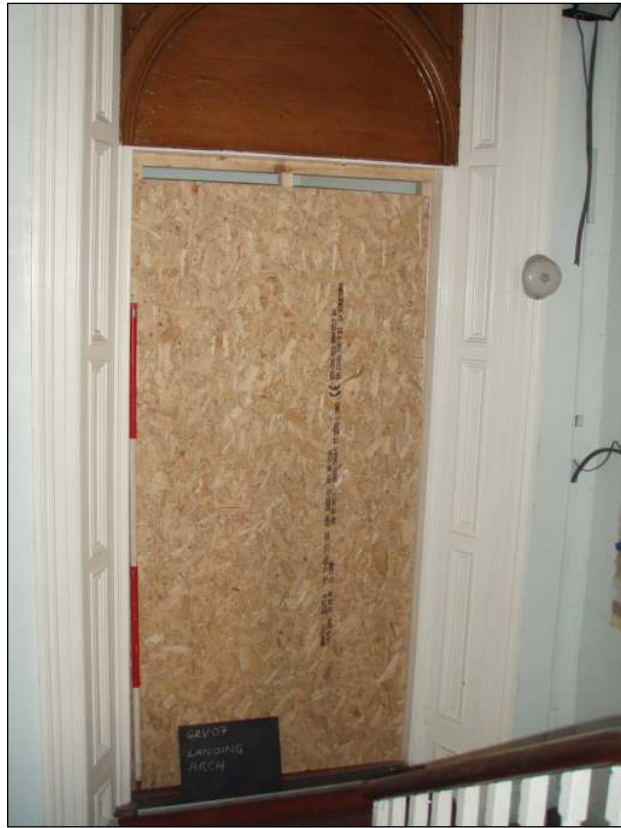
Fig. 41 Landing between Ground and First Floor, scale 2m

The stairs led from the ground floor to the centre landing, which held a blocked doorway. It consisted of a wooden frame with dark wood panelling at the top which had been varnished, rather than painted white (Fig. 41). The stairs doubled back and ran south to the first floor landing from which all rooms on the first floor could be accessed. The doorframes were original fittings, as were the skirting boards. A picture rail ran around the landing area approximately 0.40m below the cornice. The ceiling was plastered with a decorative ceiling rose at the centre (Fig. 42). The floor was constructed using wooden floor boards. The staircase which led up to the attic was a smaller version of that which led from the ground floor to the first. The feature of the skirting board and wall doubling back on itself was also present (Fig. 43).

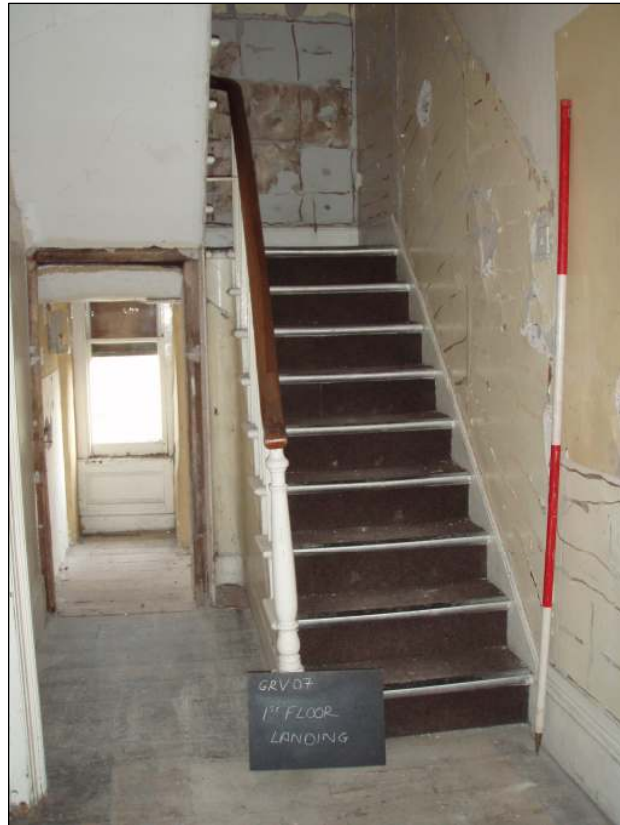
Fig. 43 First Floor landing

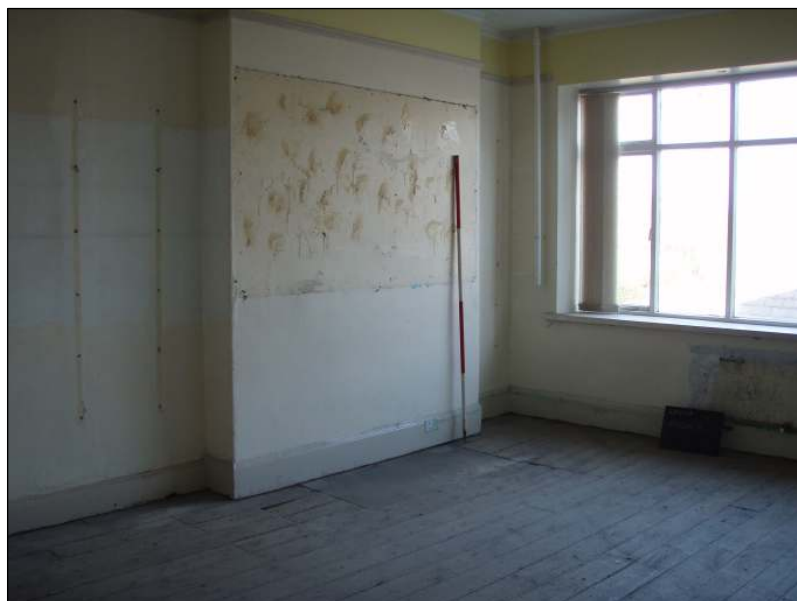
Room Nine contained a large window which was located in the north wall but did not appear to be the original fitting (Fig. 44). The skirting boards appeared original and a picture rail was located below the cornice. A small niche was located at the north end of the west wall and larger niche was located at the south end. The floor was constructed using wooden floor boards.

Fig. 44 Room Nine, scale 2m

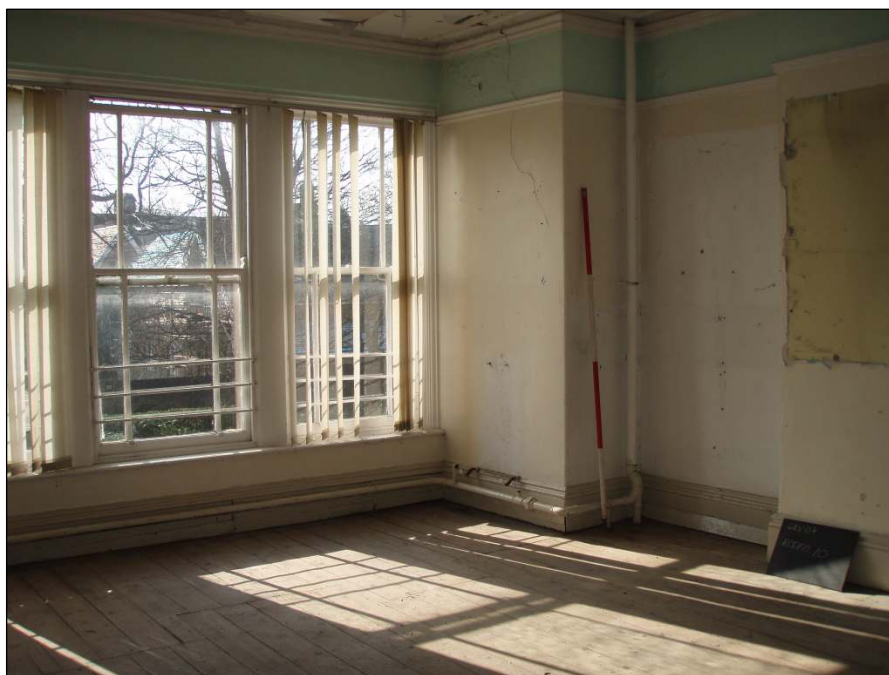
Room Ten contained a large window in the south wall which was made up of three large sash windows (Fig. 45). The area of the window is a later extension onto the front of the house. The floor, ceiling, skirting boards, cornice and picture rail were the same as those discussed for Room Nine, but an old heating pipe was present in Room Ten underneath the window. As the pipe runs through the extended area it is likely that the heating system was not an original feature.

Fig. 45 Room Ten, scale 2m

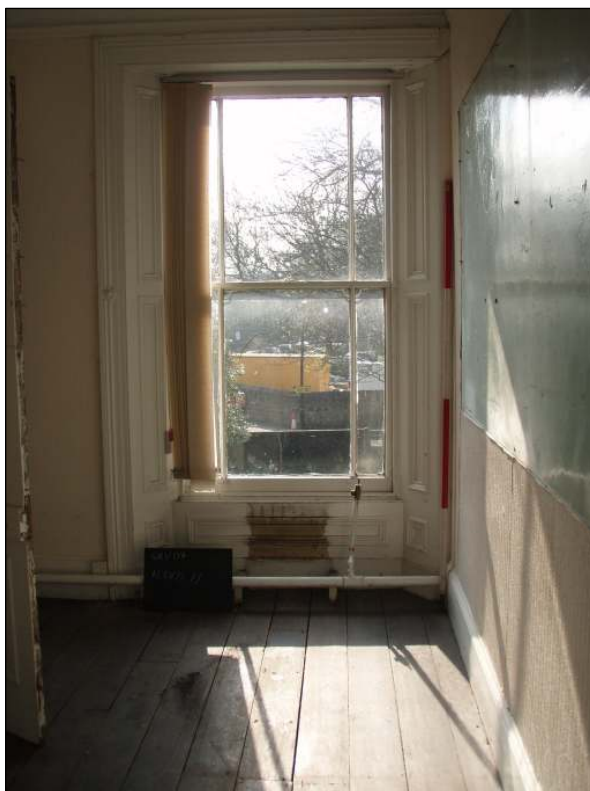
Room Eleven was a very small room at the centre of the front of the house (Fig. 46). It contained one large sash window on the south wall. The floor, ceiling, skirting boards, cornice and picture rail were the same as those discussed for Rooms Nine and Ten. A heating pipe was located in this room, but the radiator had been removed from its position in front of the window.

Fig. 46 Room Eleven, scale 2m

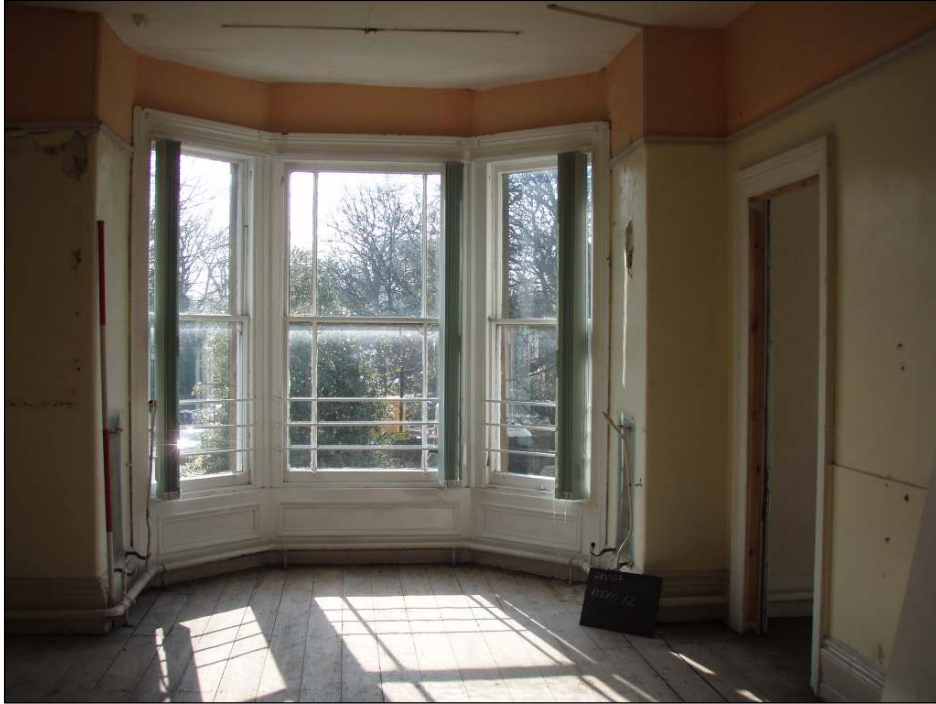
Room Twelve contained a large bay window on the south wall (Fig. 47). This held three large sash windows. The floor, ceiling, skirting boards, cornice and picture rail were the same as those discussed for Rooms Nine, Ten and Eleven. An old heating pipe was also present in this room. A doorway located in the north-east corner of the room led into Room Thirteen. Damage to the walls around the doorframe revealed that they had been constructed using lath and plaster (Fig. 48). The doorway was not an original feature and had been cut into the original wall.

Fig. 47 Room Twelve, scale 2m

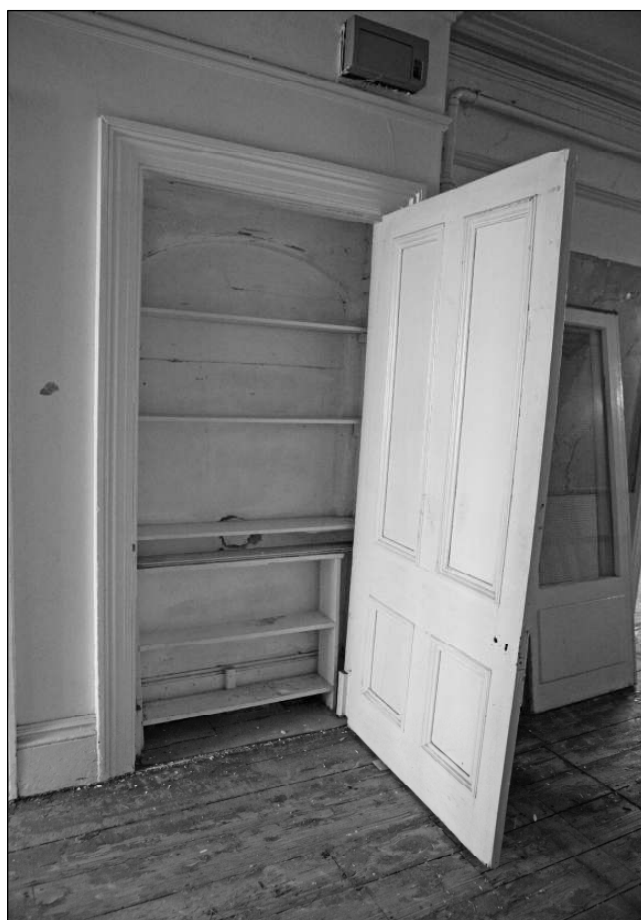
Fig. 49 Cupboard in Room Fourteen

Room Fourteen contained one large original window frame on the north wall but the window had been replaced with a fire exit door. Steps appear to have led up to the door as it was situated above the floor level, but these had been removed prior to this investigation. The floor, ceiling, skirting boards, cornice and picture rail were the same as those discussed for the other rooms on this floor and the old heating pipes were also present. A cupboard existed in the north-east corner of the room (Fig. 49).

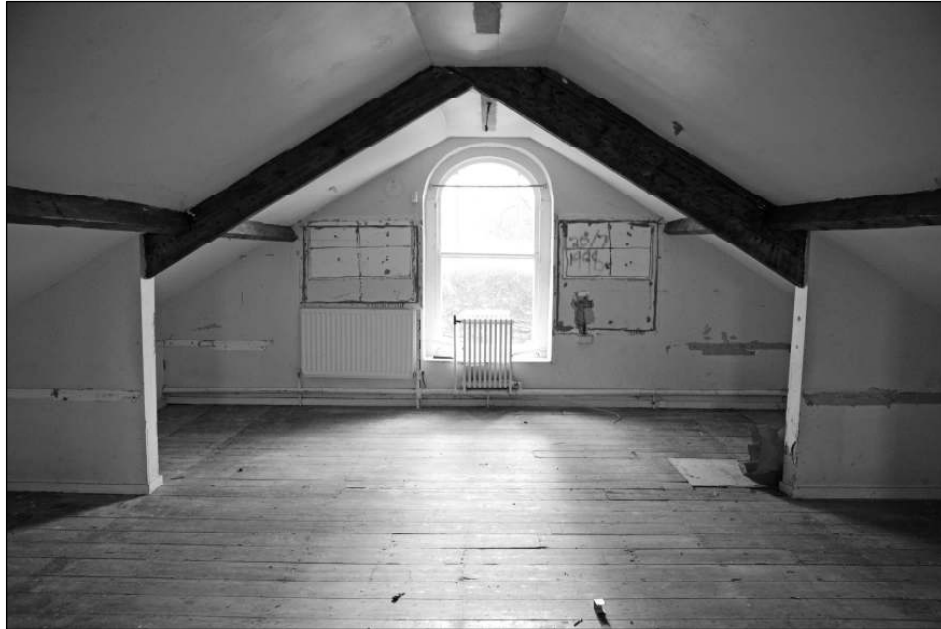
Fig. 50 Attic, south wall

The attic area was accessed from the first floor staircase which ran up to the east side. The attic ran for the full length of the original house. The wooden roof beams were exposed showing the natural wood. The floor was constructed with wooden floor boards and the walls were covered with lath and plaster. Located in the south wall was a large sash window with an arched top (Fig. 50). In the north wall was a doorway which had been used as a fire escape. This was located above the floor level and could be reached by three small steps (Fig. 51). At the west

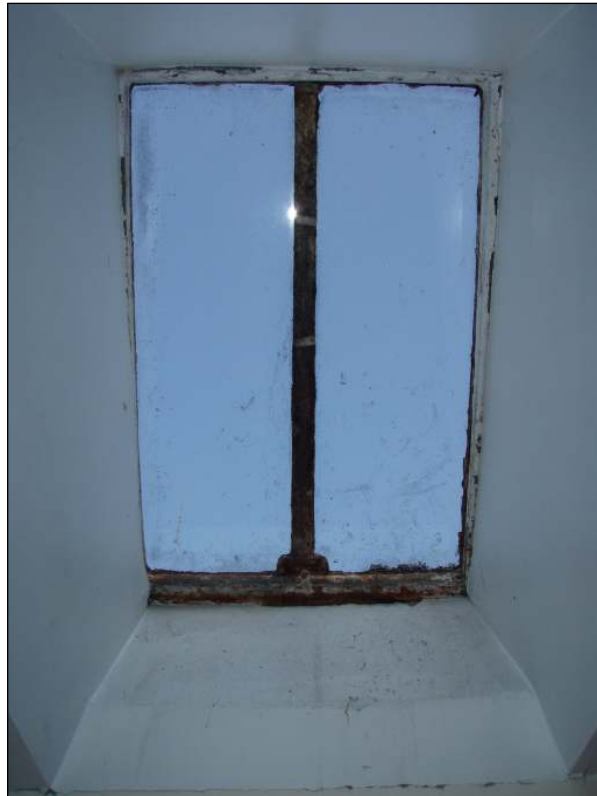
side of the attic, located in one of the niches, was a small skylight. This had a metal frame and two small panes of glass (Fig. 52). The area of attic extended to the west and here the ends of the timber roof beams were visible (Fig. 53). A number of holes located in the ceiling revealed the timber roof construction which was overlain with slate tiles.

Fig. 52 Skylight in western niche of attic
