**Archaeological Building Recording at
The Coach House, 33 The Grove,
Gosforth**

ARS Ltd Report 2007/25
April 2007

Planning ref: 2006/2383/01/LBC
2006/2384/01/DET
Oasis no.: archaeol5-26122

Archaeological Building at the Coach House, 33 The Grove, Gosforth

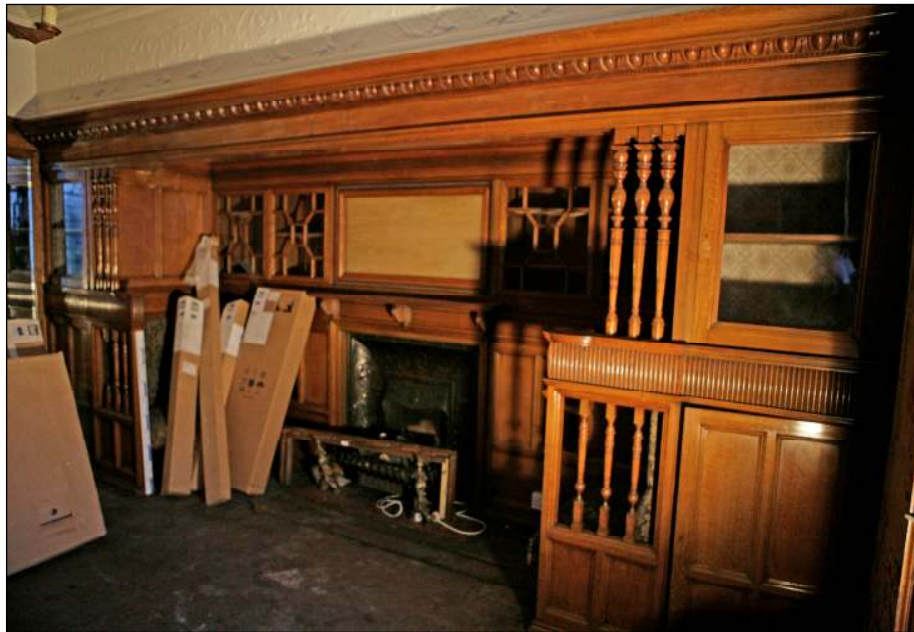
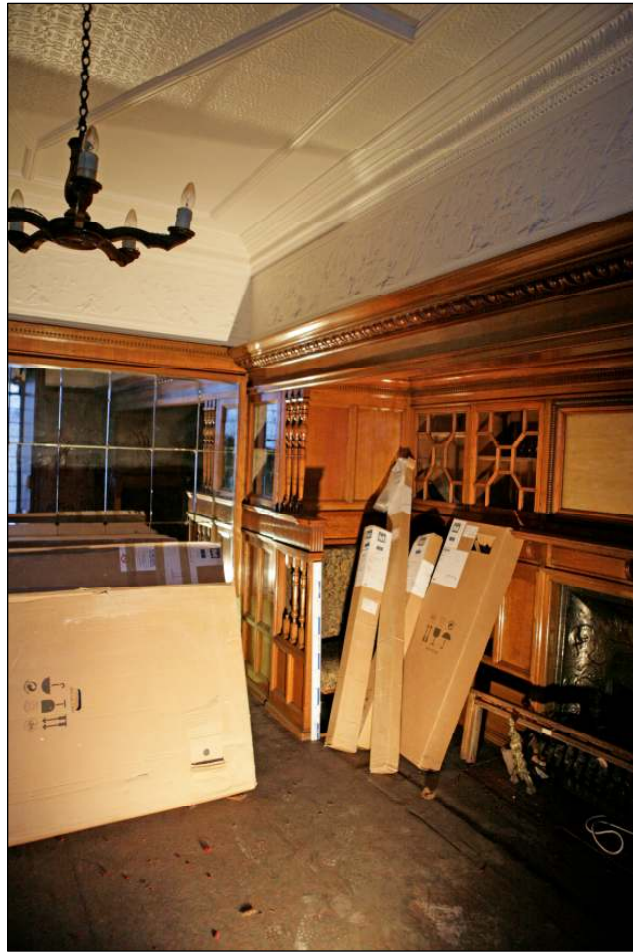
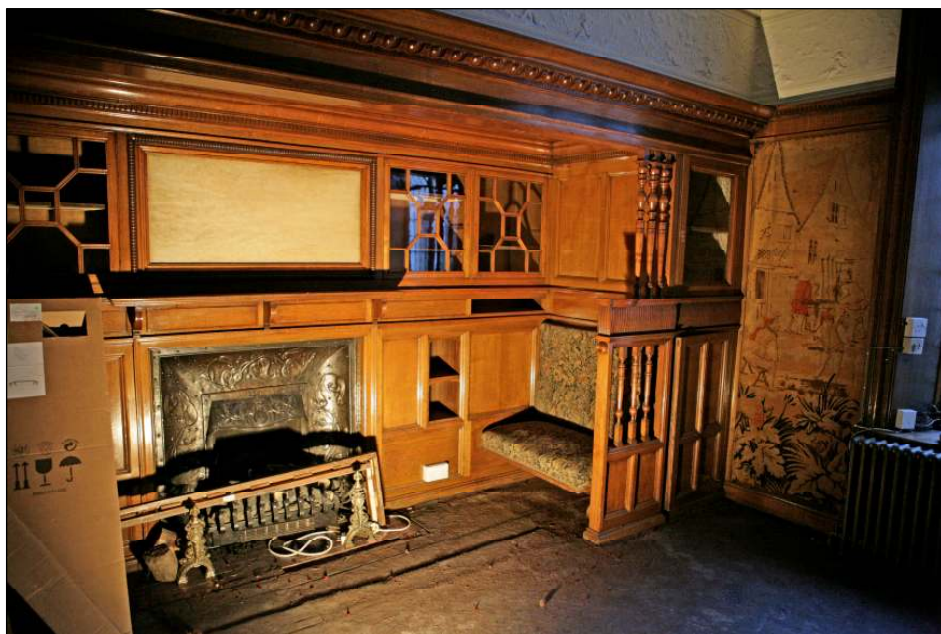
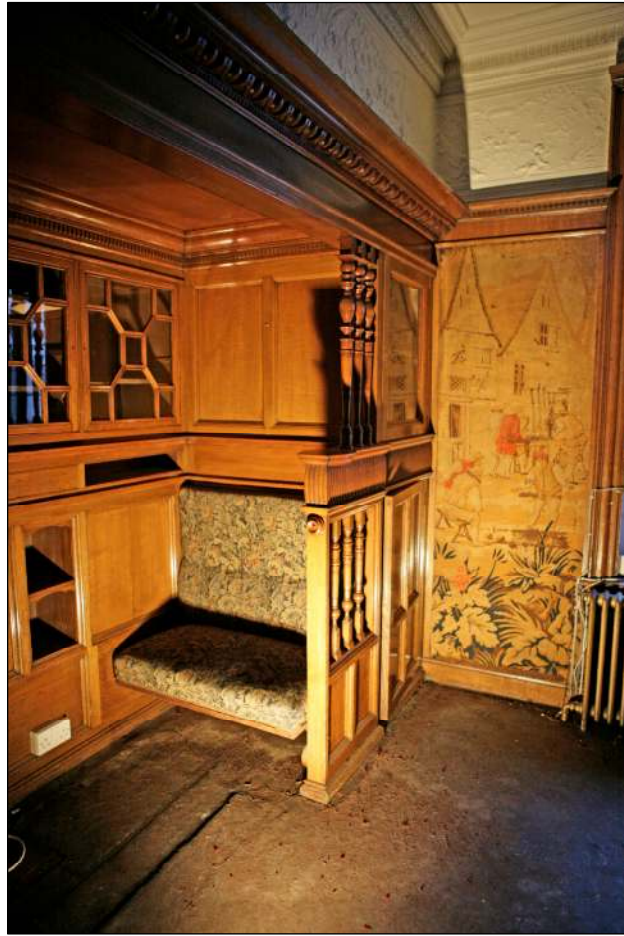
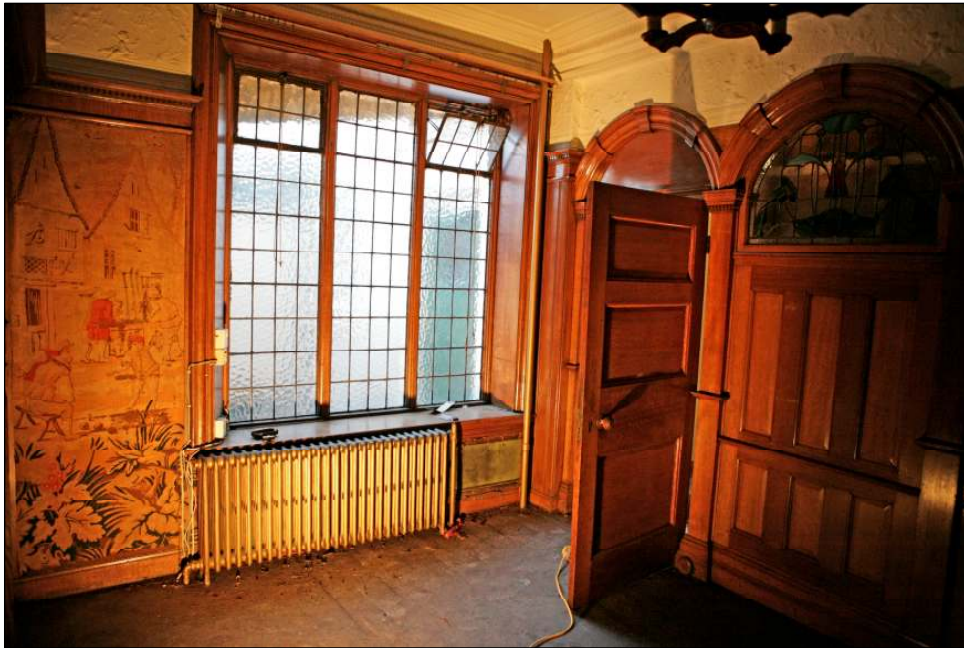
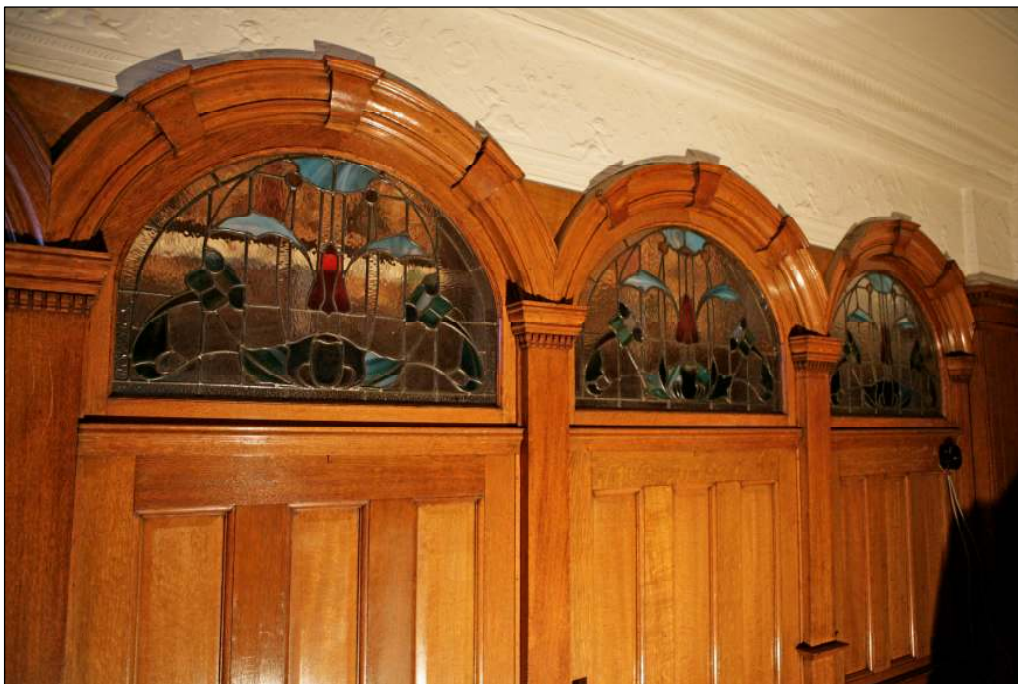
There were a number of areas blocked off in order to protect them during renovation work. Access could not be gained but these areas are to remain untouched and all original features will remain. The most interesting area is the Head Teacher's Room which is made up of old ship panelling. A previous owner had this fitted by shipping joiners (pers. comm. Mr Perry 26th March 2007). Photographs taken by Three Six Nine Photographic on behalf of Hopper Howe Sadler are shown below in Figures 54 to 59.

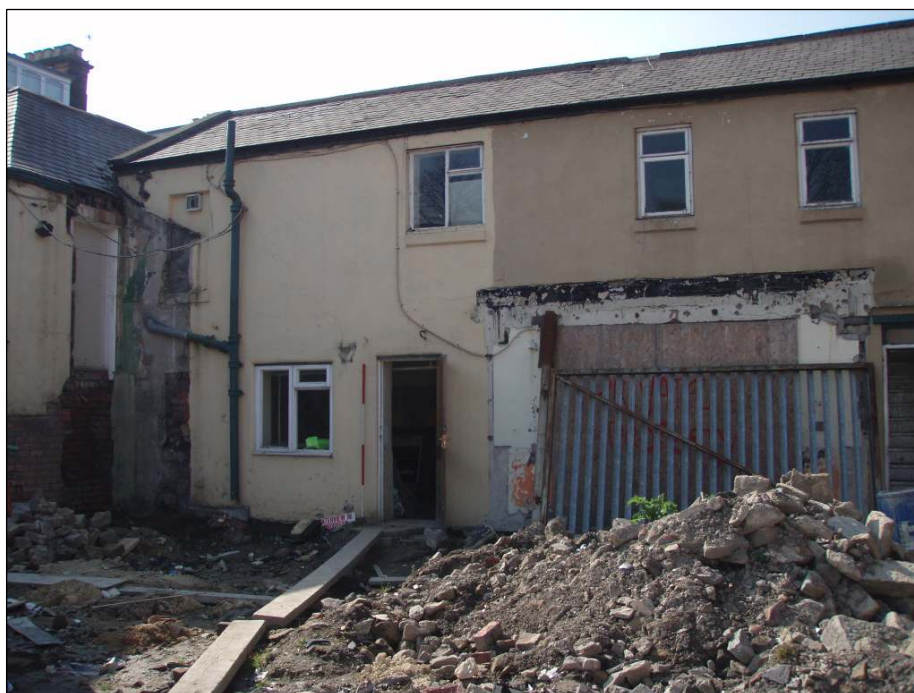
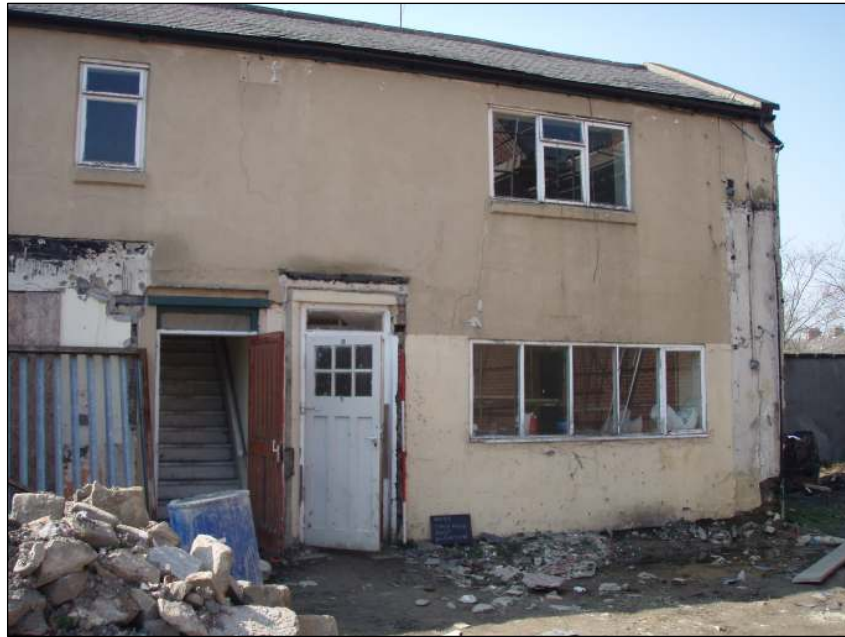
Fig. 60 The Coach House, east elevation, scale 2m

The south end of the east elevation adjoined the extension at the west end of the main building's north elevation (Figures 60 and 61). The first floor of the elevation comprised four modern windows with painted sandstone sills. The window to the north was larger, comprising three sections of glass held by a modern, wooden frame. The middle section was split in two with a small section at the top which opened. Two modern windows lay at the centre of the elevation, measuring only a third of the width of that at the north end. They were also split with a small opening section at the top. A fourth window lay towards the south of the elevation and comprised a pane of glass to the south and a split pane to the north which also had a small opening section at the top. At the very far south end of the elevation lay a window which had been blocked up, plastered over and painted. At the top of this lay an air vent. The ground floor consisted of a large modern window to the north end of the elevation. This measured the same depth as those on the first floor but consisted of five panes of glass held in a wooden frame. Two doorways existed side by side towards the north end. Both held a wooden frame and modern doors. At the south end of the elevation lay a third doorway also holding a wooden frame and modern door. To the south of the doorway lay a window comprising a pane of glass to the south and a split pane to the north, which also had a small opening section at the top. Markings to the wall indicate that a further modern extension had been added to this section of the elevation, but the dimensions are unknown as it had been demolished prior to this investigation. An modern extension had also been erected, running east from the east elevation, but had also been demolished prior to this investigation.

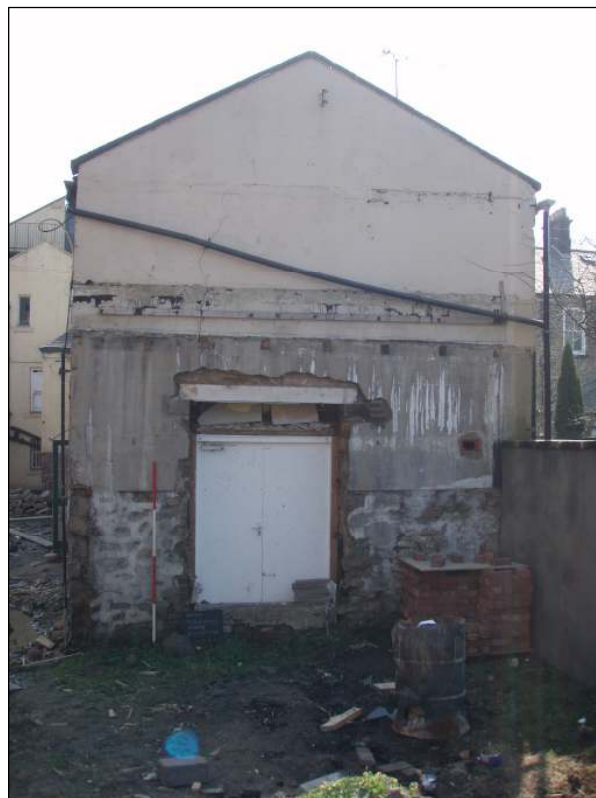
The north elevation showed the exposed sandstone construction at the base of the building (Fig. 62). It comprised a modern double doorway with a large lintel. Markings to this elevation along with floor joist holes indicated that another building had once been adjoined.

Fig. 62 The Coach House, north elevation

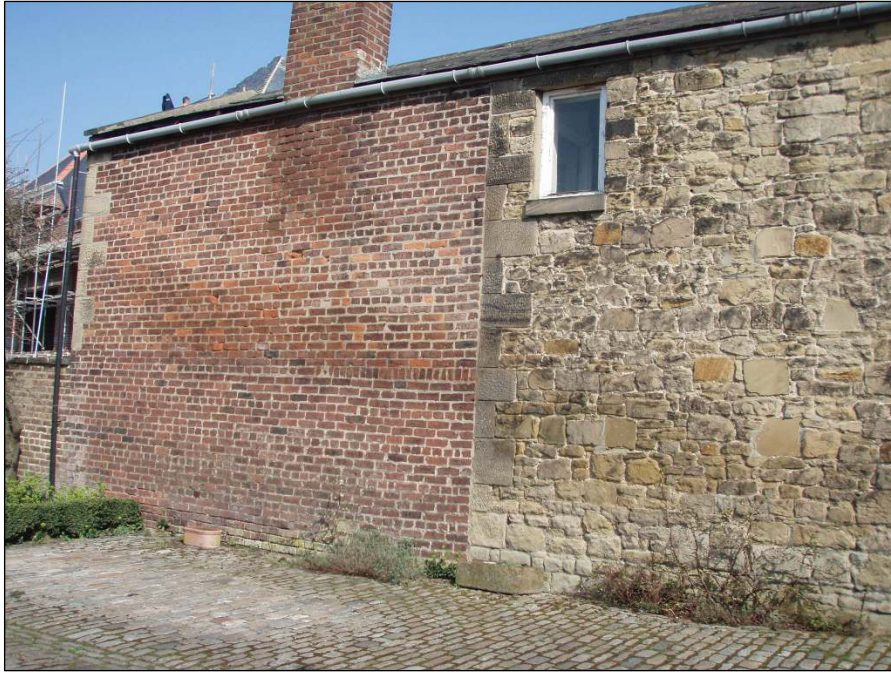
It appeared that the north end of the west elevation was a later edition. The south and central sections were constructed using sandstone blocks and the larger blocks that would have been used to finish the north-west corner of the building were visible. The section of the building to the north end was faced with modern bricks (Fig. 63). Only one feature existed in the west elevation. This was a small window located on the first floor at the northern end of the original building which had been constructed with a sandstone sill and wooden frame. There were no other features of architectural interest in the west elevation.

Fig. 63 The Coach House, west elevation, scale 2m

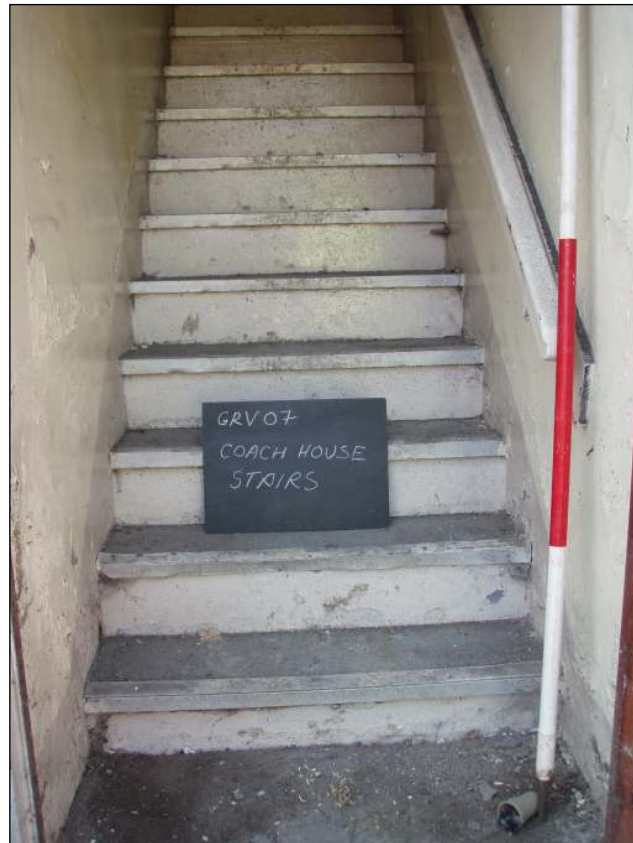
Fig. 64 Coach House stairs, scale 2m

Rooms One, Two and Three were in use as storage rooms for building material related to the developments taking place on the site. There were no features of architectural interest evident in any of the rooms. The stairway leading up to the first floor was constructed using concrete and no features of architectural interest were present (Fig. 64).

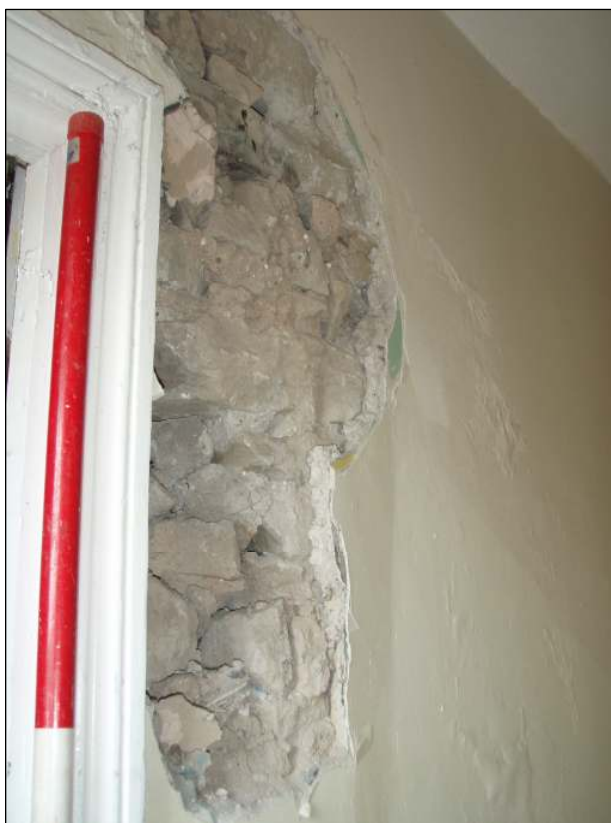
Damage to the walls in the landing area of the first floor showed that the internal walls had been constructed using small sandstone blocks which had then been plastered over and painted (Fig. 65). Room Four was empty and all fittings were modern. The only feature of architectural interest was the exposed roof construction (Fig. 66) which showed the timber frame and joists. The ceiling in Room Five had also been removed, exposing the roof construction which was the same as that in Room Four. It appeared that the original lower lying beams had been exposed as they were painted and had decorative fittings attached (Fig. 67). An original roller blackboard was located on the south wall of Room Five and damage to the wall to which it was attached showed that they were constructed using lath and plaster which had then been painted. Leading off Room Five to the south were the toilets which contained only modern features and nothing of architectural interest.

Fig. 65 Damage to wall on first floor landing of Coach House
(red section of scale bar measures 0.50m)

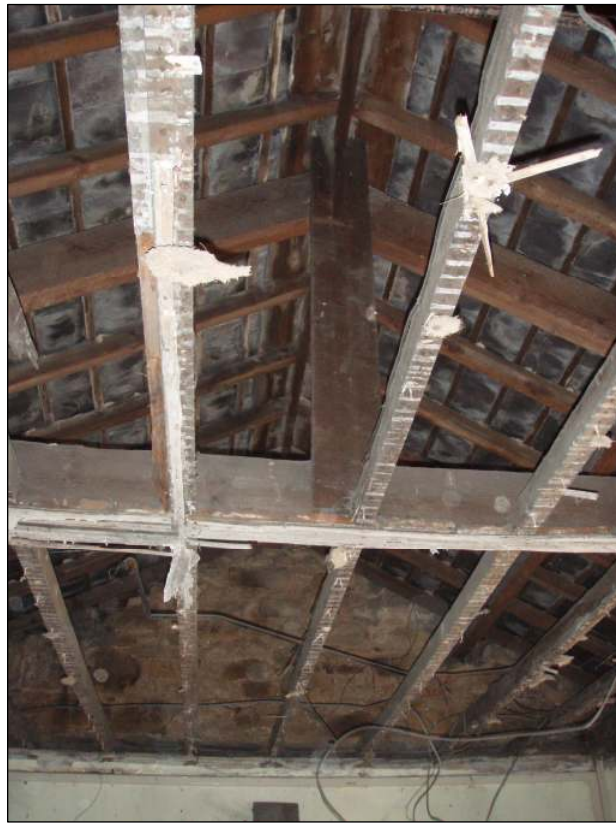
Fig. 66 Timber framed roof in Room Four of the Coach House

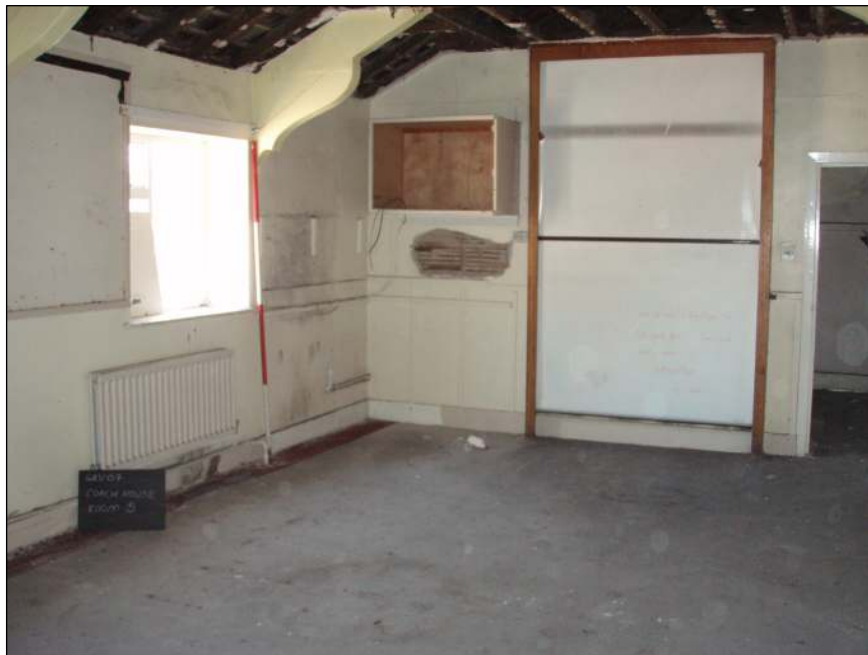
Fig. 67 Room Five showing decorative fittings attached to original roof beams, scale 2m
