# Archaeological Watching Brief at St Thomas' Community Hall, Kilnhurst, South Yorkshire

ARS Ltd Report No-2016/155  
OASIS No: archaeo15-267003

*Project Name: St Thomas Community Hall*

*In September 2016 Archaeological Research Services Ltd (ARS Ltd) was commissioned to undertake an archaeological watching brief during the excavation of test pits on the ground of St Thomas Community Hall, Kilnhurst. Archaeological monitoring was requested as the area of proposed development lies adjacent to St Thomas Church and associated cemetery and human remains may have been encountered. The project was undertaken by Elise McLellan Assistant Project Officer at Archaeological Research Services Ltd (ARS) and was managed by Tony Brennan, Operations Manager at ARS Ltd.*

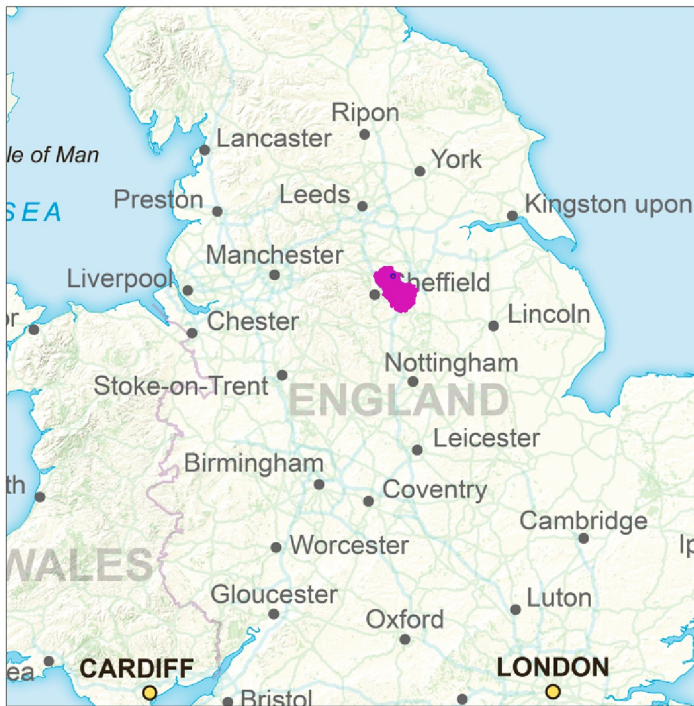
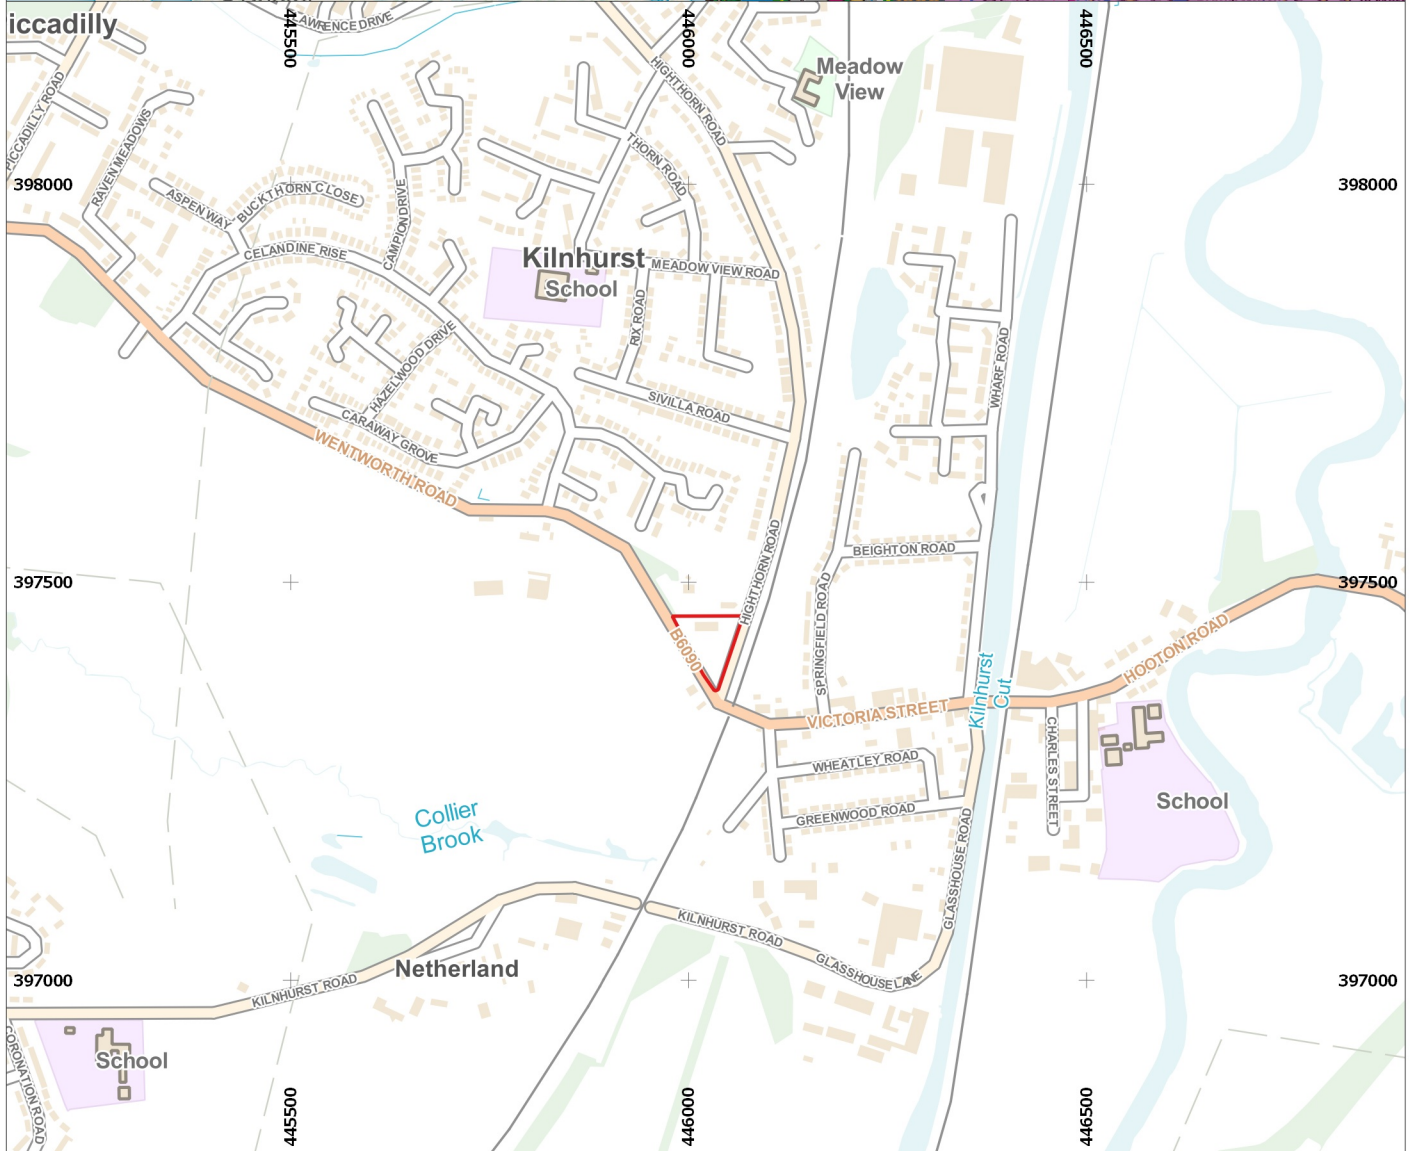
Site name: St Thomas Kilnhurst  
 Date: November 2016  
 Drawn by: RXT  
 Scale: Varies

4.1 A total of three geotechnical test pits were excavated to assess the conditions of subsurface soils and the bedrock. All three test pits were located north of the church between the church and the garden wall separating the church and former vicarage building.

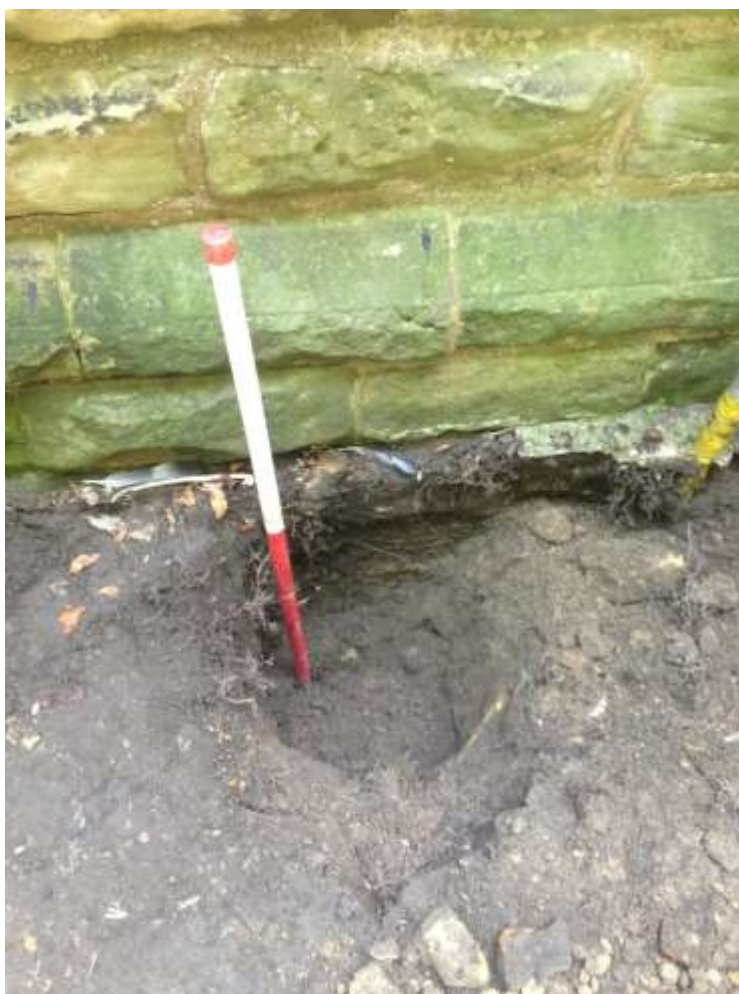
Figure 3. Test pit 1 against the north wall of St Thomas Church

4.2 Test pit 1, which measured 0.5m x 0.6m, was located against the northern wall of the church and was hand-excavated to a depth of 0.6m BGL (below ground level). This test pit was sited specifically to locate existing electrical and water services for the church building.

4.3 An area of flagstones was removed which overlies topsoil (101). Below this topsoil service trench (103) was filled by modern service pipes overlain by sand and gravel

(102). This service trench directly truncated and overlies the natural sandstone bedrock (104).

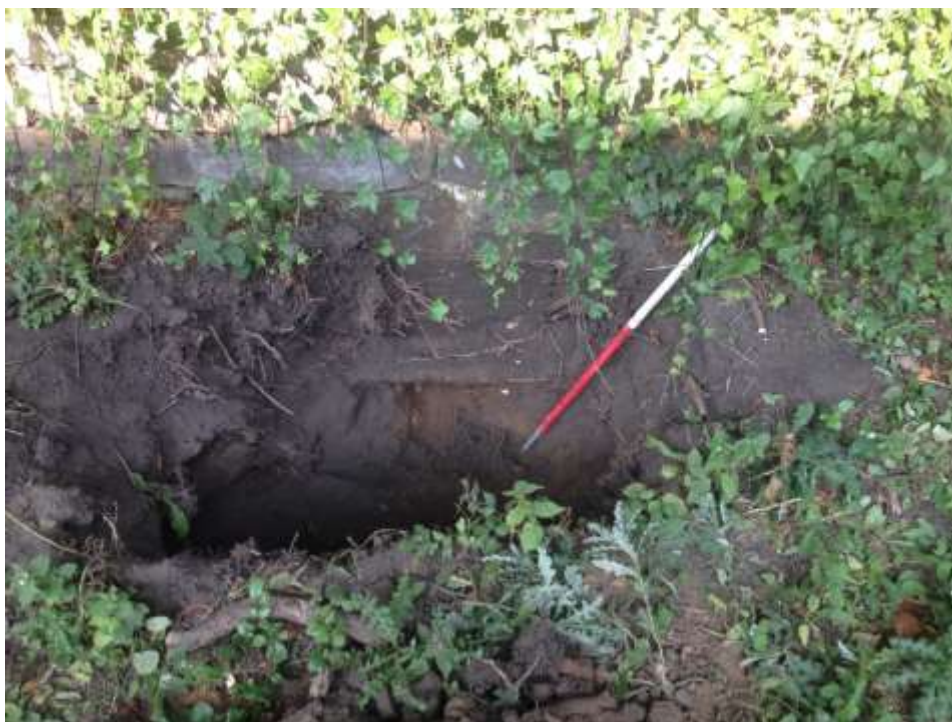
Figure 4. Test pit 2 against the south face of the garden wall

4.3 Test pit 2, was excavated by machine to a depth of 1m BGL and measured 1.2m x 0.6m. This test pit was located against the southern face of the garden wall that separates the churchyard from the grounds around the former vicarage to the north.

4.4 A black silty topsoil (201), some 0.45m thick, was encountered above subsoil (202). The line of the construction trench for garden wall (204) had also been utilised for laying services and a modern metal service pipe was encountered at a depth of 0.5m BGL. Undisturbed sandstone bedrock (203) was encountered some 0.8m-1m BGL.

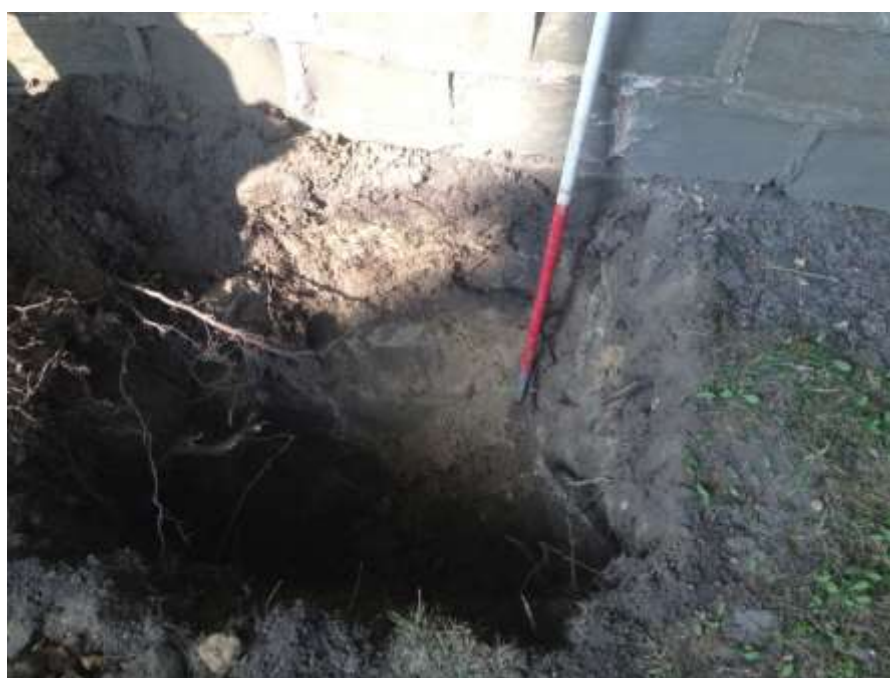
Figure 5. Test pit 3 against southern face of the garden wall

4.5 Test pit 3, was also excavated by machine to a depth of 1m and measured 1.2m x 0.6m. This test pit was also sited along the south face of the garden wall separating church and vicarage, to the west of test pit 2.

4.6 A similar sequence of deposits was encountered as those in Test pit 2. A dark silty topsoil (301) overlay natural sand and sandstone gravel subsoil (302) which in turn lay above the natural sandstone (303) the latter of which was encountered between 0.8m and 1m BGL. The construction trench (304) for the garden wall was also present filled by silty sand (305) and a modern metal service pipe running parallel to the base of the garden wall.

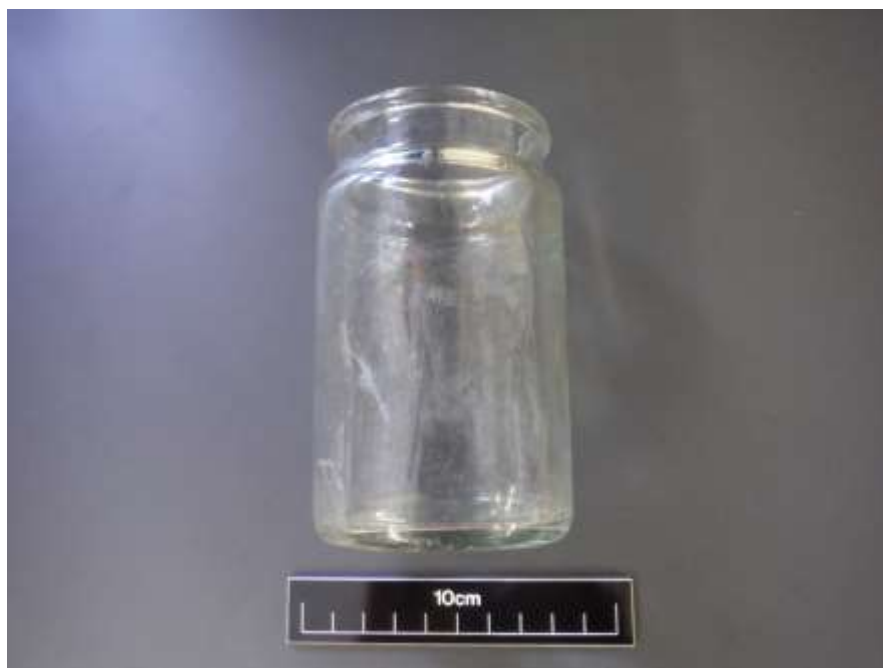
Figure 6. Jar 1

4.7 Two glass jars were recovered from Test pits 2 and 3, within the fill of the construction trench of the garden wall (205 and 305). Jar 1 was recovered from Test pit 2 (205) and was marked only with an indistinct symbol on the base, possibly reading "MF". Jar 1 was complete, and had an unthreaded neck with a narrow lip. Jar 2 was recovered from Test pit 3 (305) and was partially damaged. Jar 2 was marked with the trademark name "HORLICKS", a popular malted drink, and had a threaded neck to receive a screw-on lid.

4.8 Both jars were recovered from the fill of the foundation trench of the garden wall but are probably residual in this context.
