Watching Brief at Makeney Garage, Derbyshire

ARS Ltd Report 2007/33
June 2007

Watching Brief at Makeney Garage, Makeney, Milford.

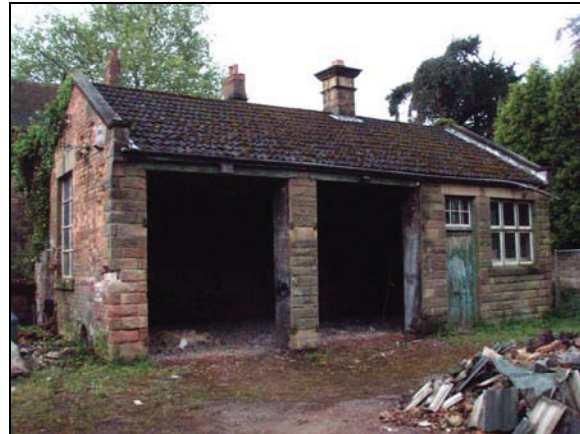
Makeney Garage, Makeney, Milford (facing south)

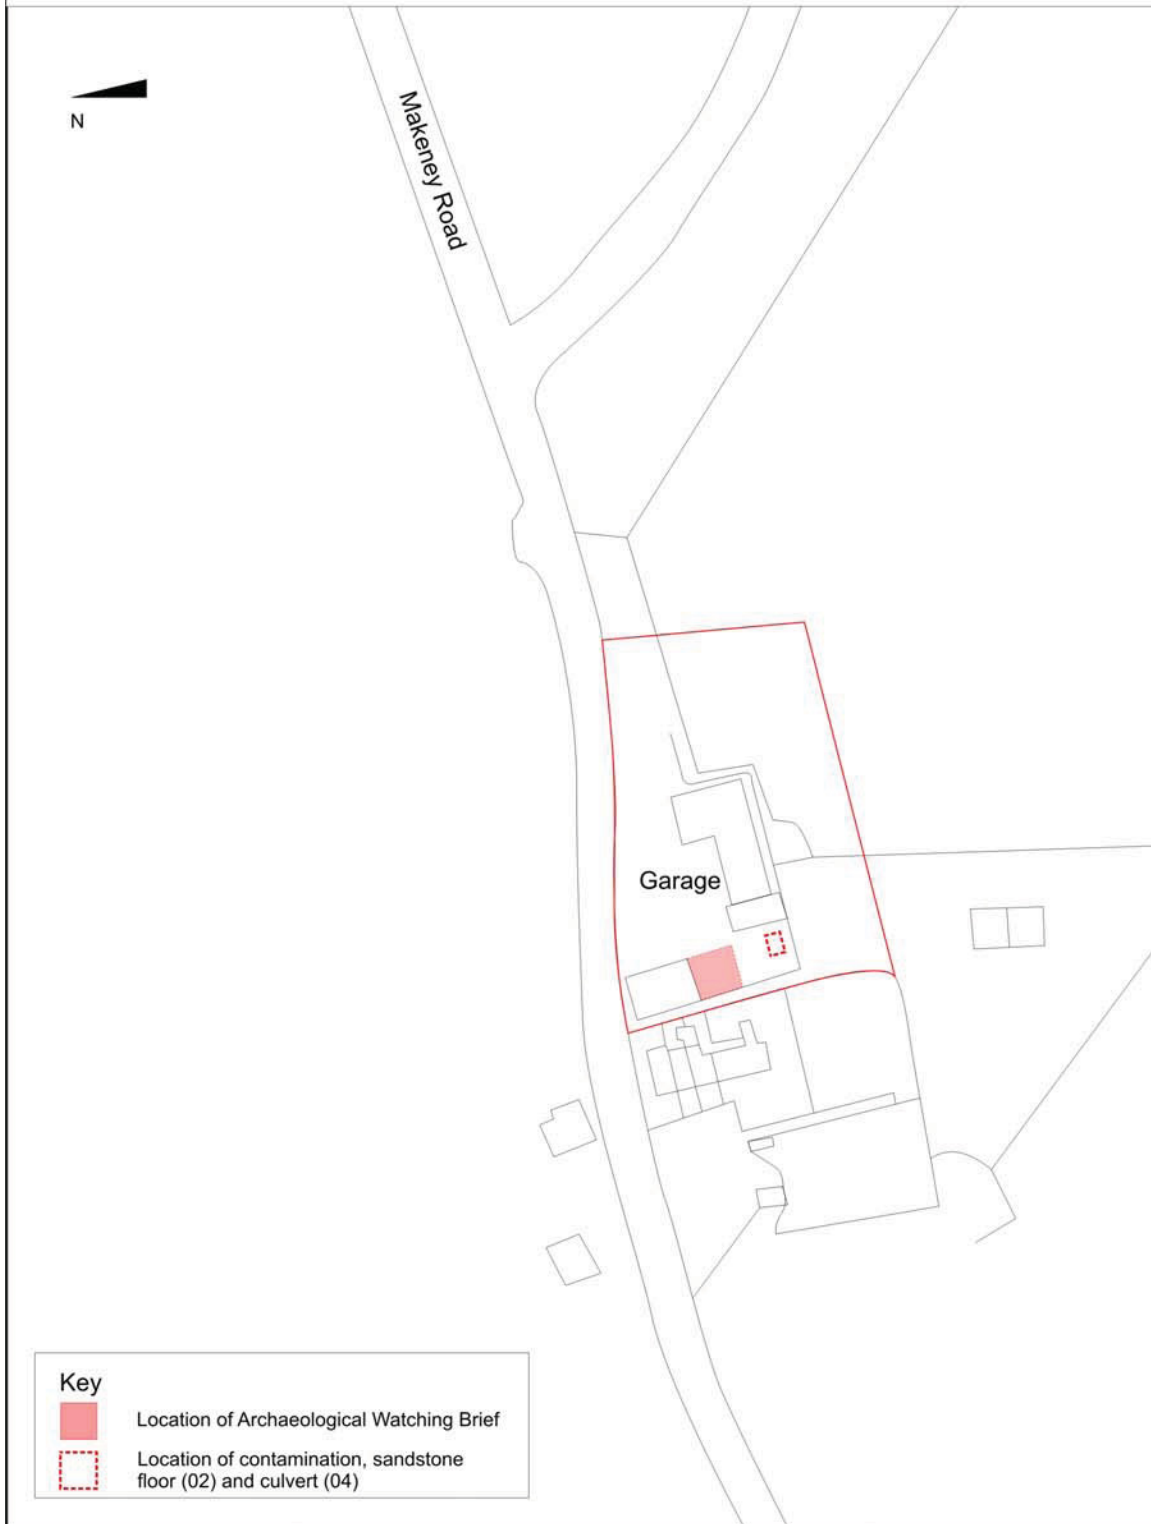
Fig. 2
Location of Archaeological Watching Brief at Makeney
Garage

- 2.1 Makeney Garage is located at SK 3513 4450 on Makeney Road in Makeney, near Milford, Derbyshire (Figs. 1 and 2). Makeney is approximately 8km north of Derby and 7km south-west of Ripley (Fig. 1). The site falls within both the Belper and Milford Conservation Area and the Derwent Valley Mills World Heritage Site.
- 2.2 The watching brief was undertaken at the site of Makeney Garage where the underlying geology is the carboniferous mudstone of the Chatsworth Grit group (BGS 1993).

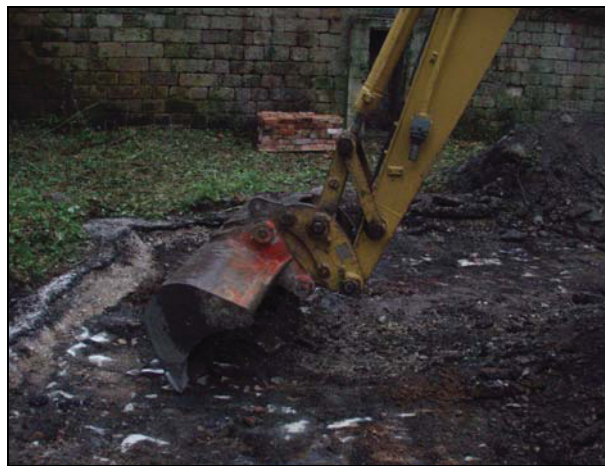
Fig. 3. Excavation of the contaminated area (facing east)

- 5.4 The machine, using a toothless digging bucket, excavated in level spits around the contaminated region to establish the size of the affected area (Figs. 3 and 4). This uncovered the remains of a sandstone floor possibly associated with the site's use as a Coach House for the new Makeney Hall. The floor was recorded and photographed and upon confirmation from the Development Control Archaeologist, was removed so that the contaminated area could be eliminated.

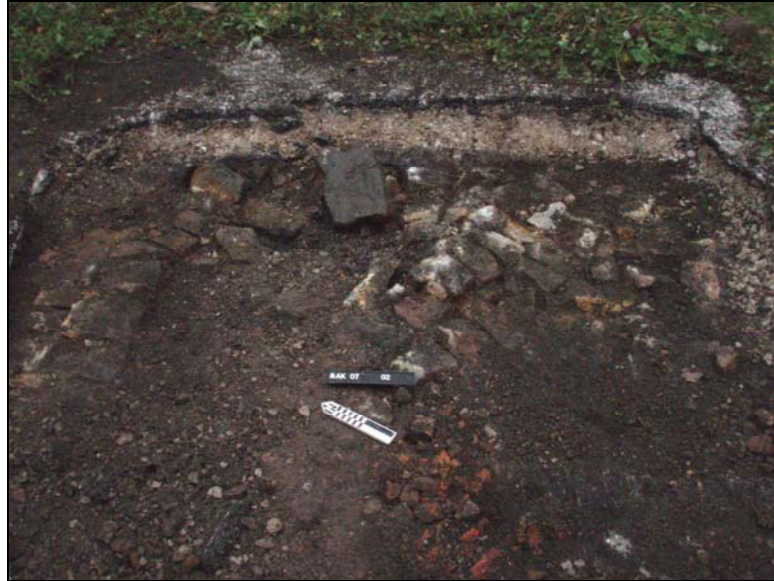
- 6.1 The sandstone flags (02) encountered during the excavation of the contaminated area were positioned in a relatively regular pattern (Fig. 5 and Appendix 1),

suggesting they may be the remains of a floor level. Although the floor level appeared to exist in two separate areas, it had probably been disturbed during previous work undertaken to establish the extent of the contamination. The flagged floor level continued in Trench 1, revealing the extent of the floor across the site. The flags varied in shape and size and are most likely to date from the 19th century when the site was the location of a Coach House. No archaeological finds were found in association with this context.

Fig. 5. Sandstone blocks reminiscent of a floor (scale = 0.25m) (facing north-east)

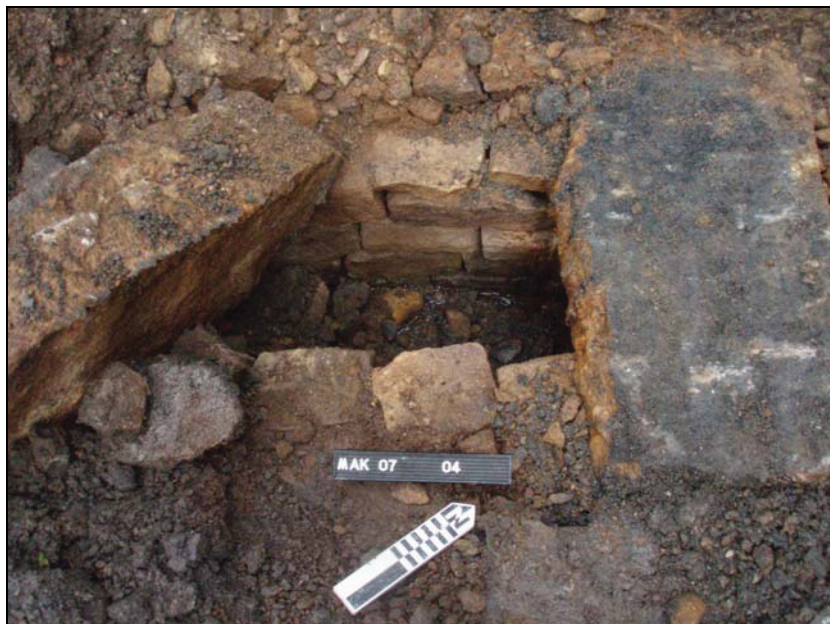
- 6.2 Upon deeper excavation of the contaminated area, a sandstone culvert (04) was uncovered (Fig. 6 and Appendix 1). The culvert walls were constructed from sandstone bricks, capped by large sandstone blocks. It measured 0.56m in width and 0.58m in depth and was exposed for a length of 4m. The bricks were not mortared into position. The culvert probably dates from the same period as the sandstone floor level although this could not be confirmed. As this area of the site was still contaminated the culvert had to be fully recorded and then demolished. Further excavation revealed the lower regions of the culvert were constructed of red brick (Figs. 7 and 8).

Fig. 6. Sandstone culvert uncovered during excavation of the hydrocarbon contamination (scale = 0.25m) (facing north-west).

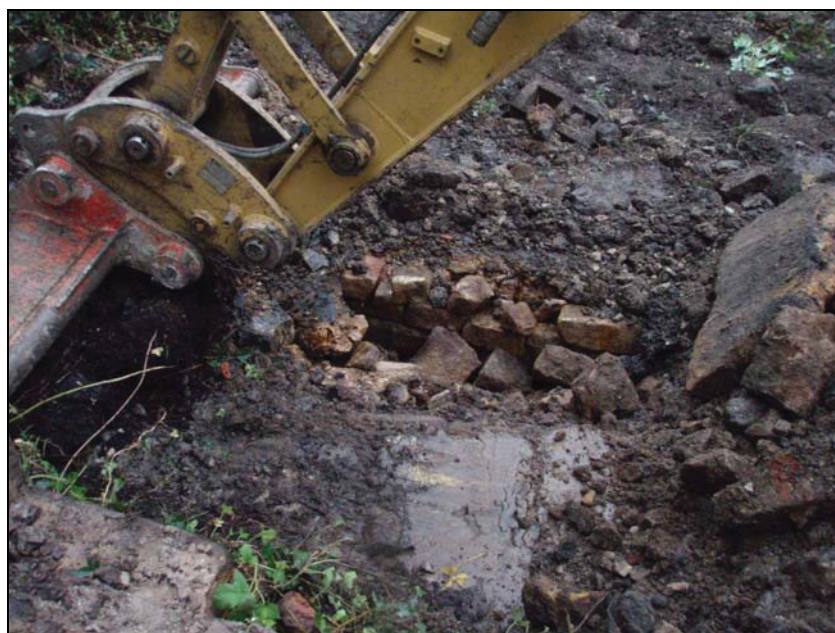
Fig. 7. Excavation of the area of contamination and the sandstone culvert (facing east)

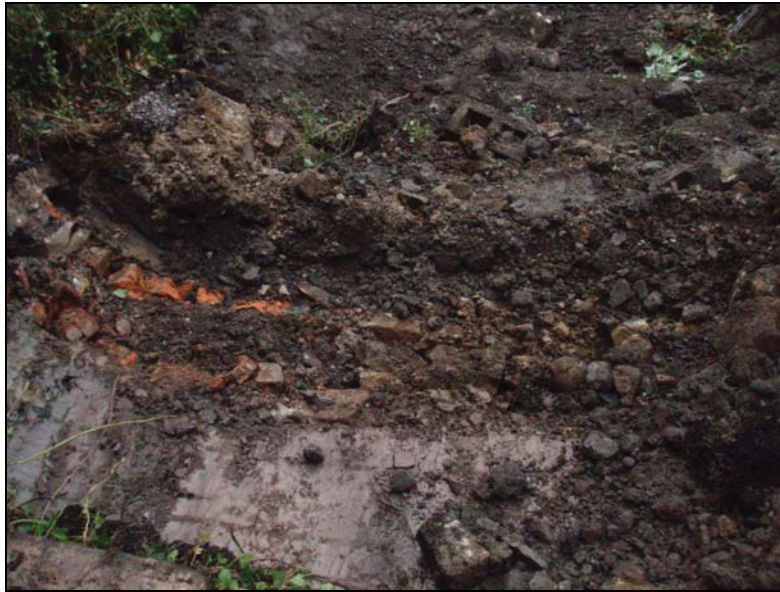
Fig. 8. Post-excavation of the sandstone culvert showing the ed brick footings (facing east)

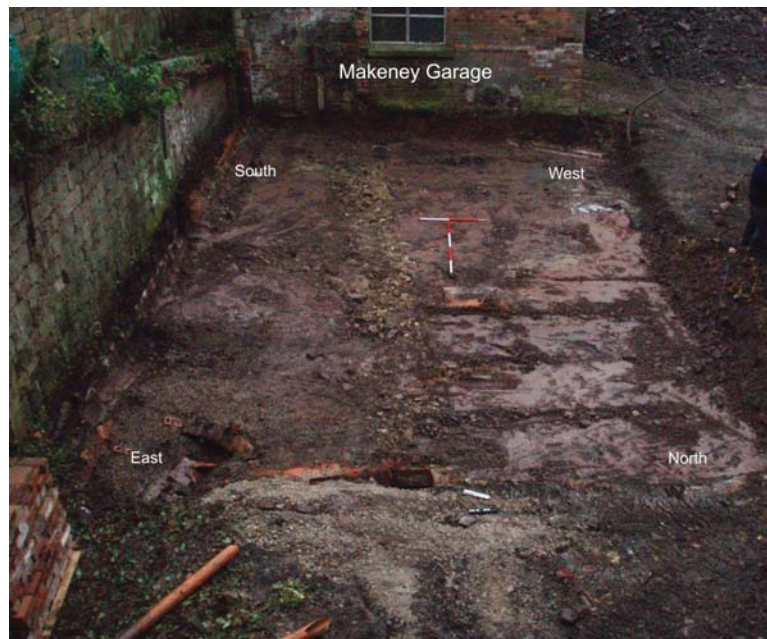
- 6.3 On complete removal of the hydrocarbon contamination trench 1 was opened to the north-east of Makeney Garage, abutting the wall (Fig. 9 and 10). The trench was excavated in level spits of a maximum depth of 0.2m and measured 10.6m x 8.12m, with a depth of 0.58m.

Fig. 9. Trench 1 which abuts Makeney Garage at the top of the photograph (scale = 2m) (facing south-west)

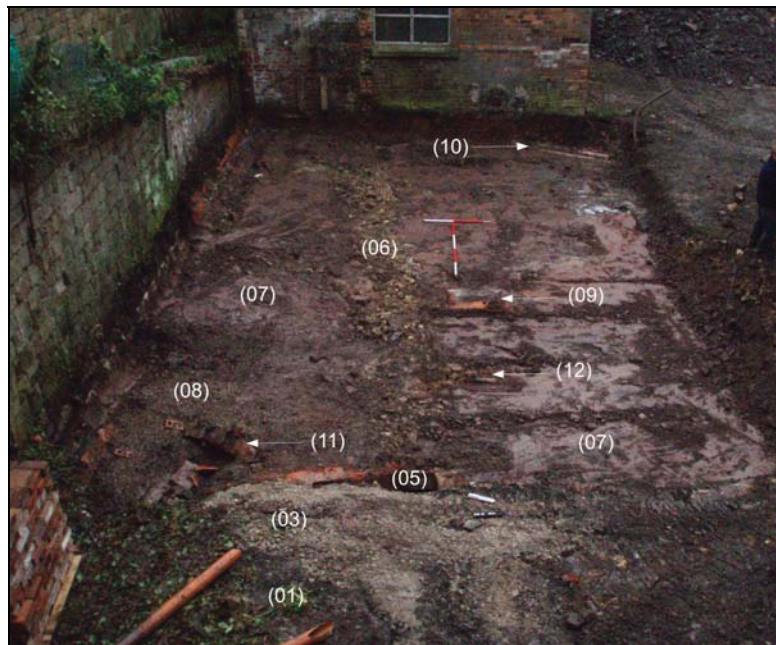
Fig. 13. Photograph showing the contexts within Trench 1 (scale = 2m) (facing south-west)

- 6.6 In the east of the trench (Fig. 7) a red brick culvert was uncovered (Fig. 13). It was bedded in with a deposit of pebbles (08) and capped by a modern manhole, almost certainly at a later date. This culvert existed to a depth of at least 0.7m and was cut into the natural substratum (07).
- 6.7 In the west corner of trench 1 (Fig. 7) a modern red brick drain (10) which supplied Makeney Garage was exposed for an area of 2.62m (Fig. 13).
- 6.8 In the centre of trench 1, a rectangular red brick manhole cover (09) was excavated (Fig. 13). The manhole is most likely to be of modern construction as it was a different shape and style of construction to the other drains. Furthermore, a piece of modern metal pipe was recovered from this region.

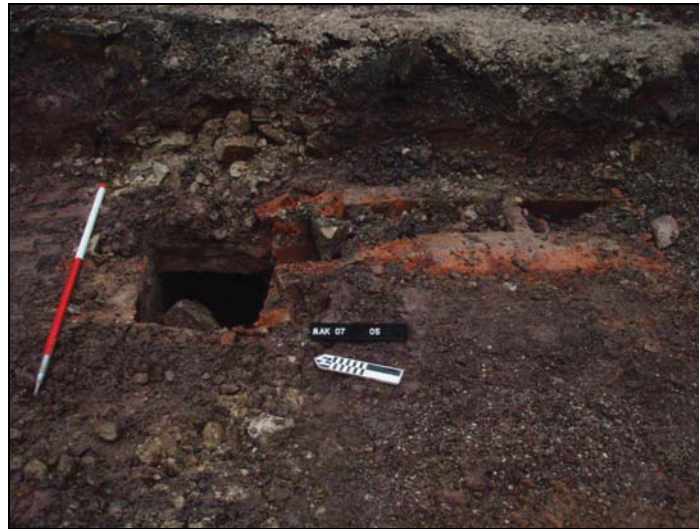
- 6.5 During the excavation of trench 1, four brick drains and a brick manhole cover were exposed. These features had all been cut into the alluvial clay (07) and existed within, or partially within, the area containing the sandstone floor (02). In

the north-east section of the trench (Figs. 9 and 14), a drain was uncovered which was built from red brick and capped by a sandstone block in the same fashion as with the sandstone culvert (04) found in the contaminated area. The similarity in construction material suggests that this brick drain was added to the site at a similar date to the sandstone culvert. The drain appears to lie within the trench of crushed sandstone chippings (06) suggesting that the trench may have been used as a drainage ditch. Furthermore, this drain seems to be in line with the sandstone culvert and is therefore possibly connected via the drainage ditch (06). A ceramic bottle which still contains its original cork was recovered from within the drain.

Fig. 14. Brick drain in the north-east section of Trench 1 (scale = 1m) (facing north-east)
