**Darley Abbey Pump House, Derby.
Results of an Archaeological Watching Brief.**

ARS Ltd Report 2007/51
August 2007

1.1 Archaeological Research Services Ltd were commissioned by Derby City Council to undertake an archaeological watching brief on work being undertaken to redevelop the disused Pump House into a canoe store for the Darley Barn Outdoor Centre. The work involved creating an access track, across Dean's Field, from the road leading to the car park to the rear of the Pump House. A build up of modern debris and vegetation around the Pump House will also be cleared so that gravel could be laid around the building. A section of brick wall was also demolished and partially re-built to allow access to the Pump House from Dean's Field.

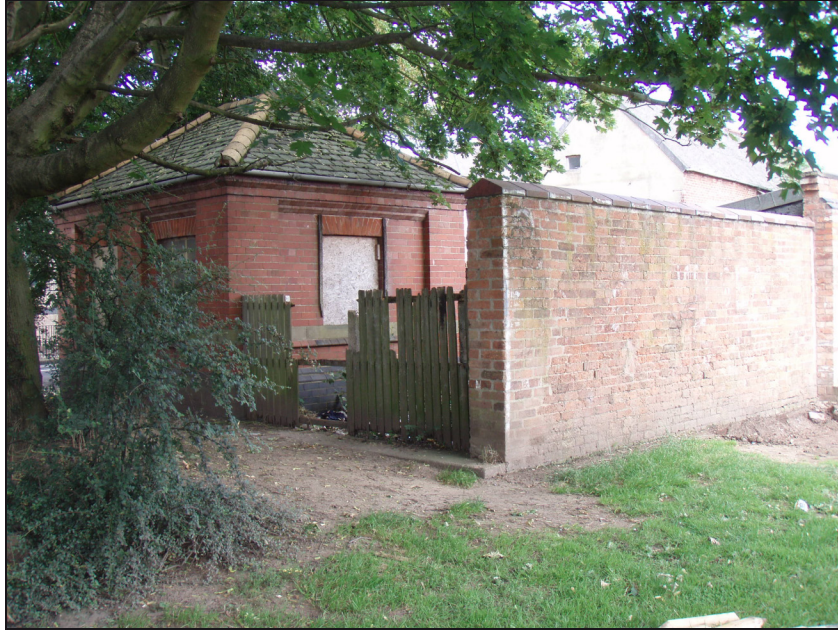
Fig. 2 View to the rear of the Pump House .

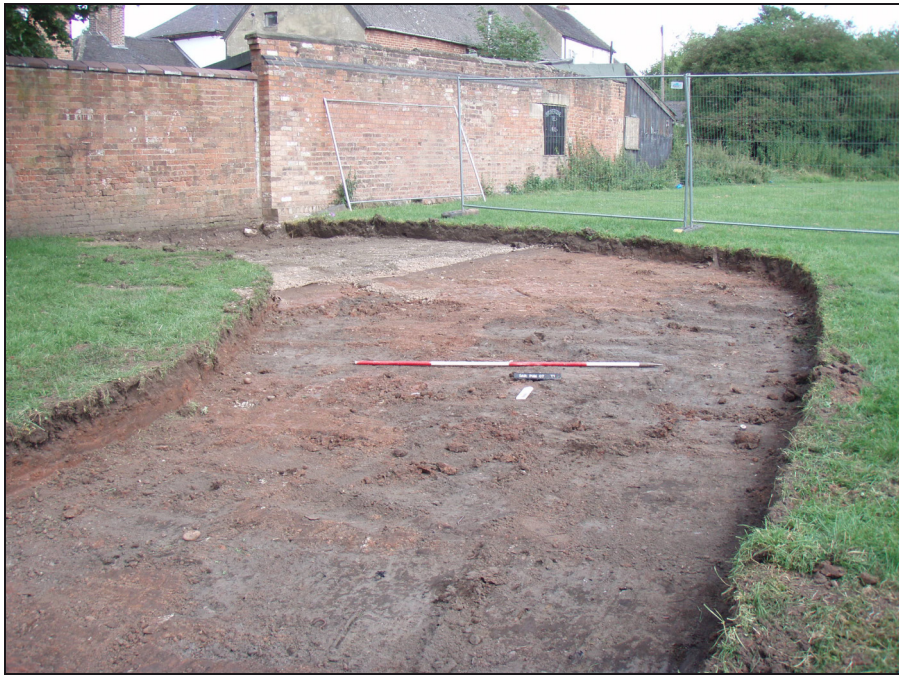
Fig. 4 View of the access track showing the brick wall, looking south. Scale: 2m

- 6.1 The access track across Dean's Field was excavated in level spits by a machine using a toothless bucket. The trench was 0.3m in depth and between 3m and 5m in width (Figs. 4 and 5). The track becomes wider in places to allow for a turning circle for vehicles transporting the canoes. The track is going to be covered with green plastic grids so that the grass can be allowed to re-grow. In this way the track will be less visible. The topsoil (001) existed to a depth of 0.15m. Below this was a thin layer of redeposited clay, approximately 0.2m in thickness. The clay overlay a dark brown loam (003), although the depth of this deposit was not determined.

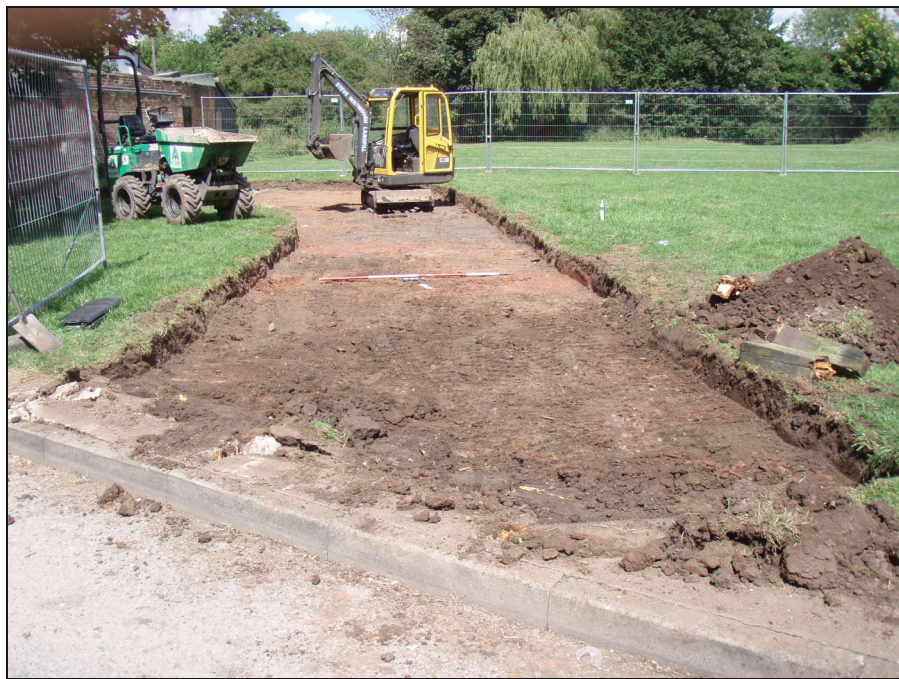
Fig. 5 View of the access track abutting kerbstones of road leading to the car park, looking south.
Scale: 2m

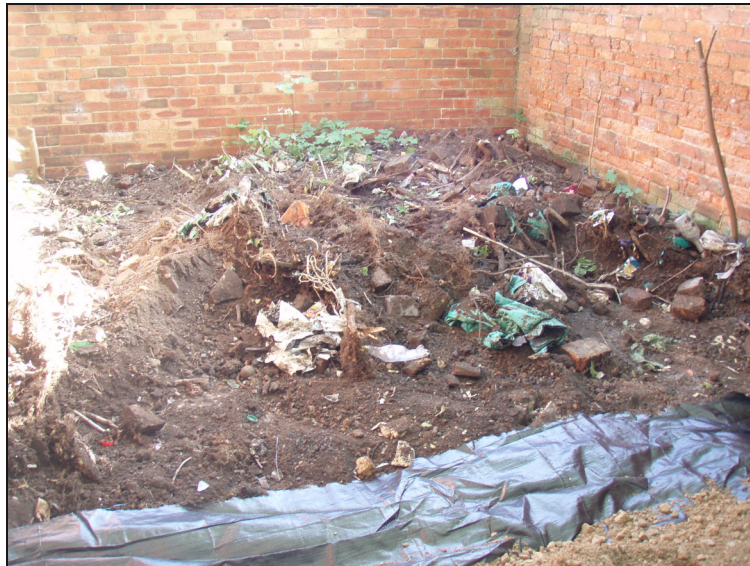
Fig. 6 View of the area surrounding the Pump House before clearance

- 6.2 The second phase of work involved clearing the area immediately surrounding the Pump House which had become overgrown with vegetation and modern waste (Fig. 6). The cleared area was to be covered with a layer of builders gravel. No archaeological deposits or finds were discovered during this phase of the work.

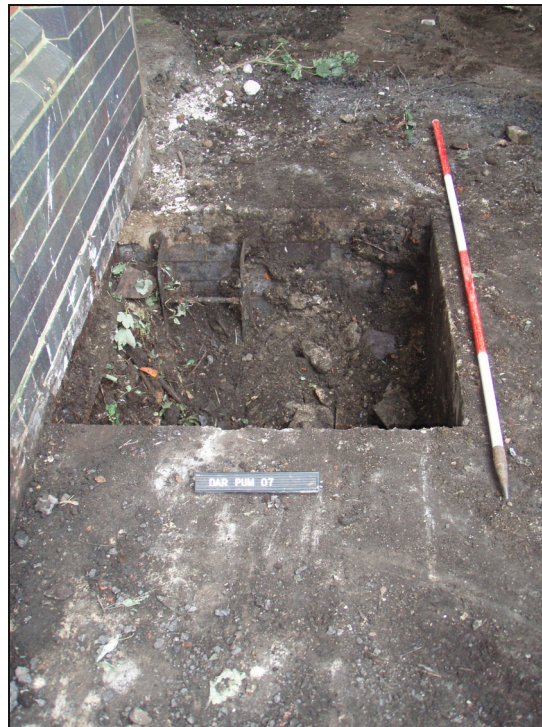
- 6.3 Whilst clearing the north side of the Pump House an opening to a cellar or air raid shelter at the side of the building was revealed (Figs. 7 and 8). The opening was 1m x 1m and had a metal access ladder attached to the west side. The cellar was filled with rubble so its depth could not be established but it was approximately 5m in length and 2m in width. This estimate is based on the dimensions of the concrete raft, visible from the surface that is probably the cellar's roof. To maintain the safety of the site the opening was protected on all sides and filled with gravel. A concrete raft was then placed on top to conceal the entrance.

Fig. 7 View of the cellar entrance, looking west. Scale: 2m

- 7.1 The excavation to create a path across Dean's Field did not reveal any archaeological features or deposits.
- 7.2 Work undertaken to clear the overgrown area adjacent to the Pump House revealed a small opening to a probable cellar. The cellar was infilled with rubble and had a metal descent ladder on the east side. The cellar entrance was protected with a concrete raft and left undisturbed.

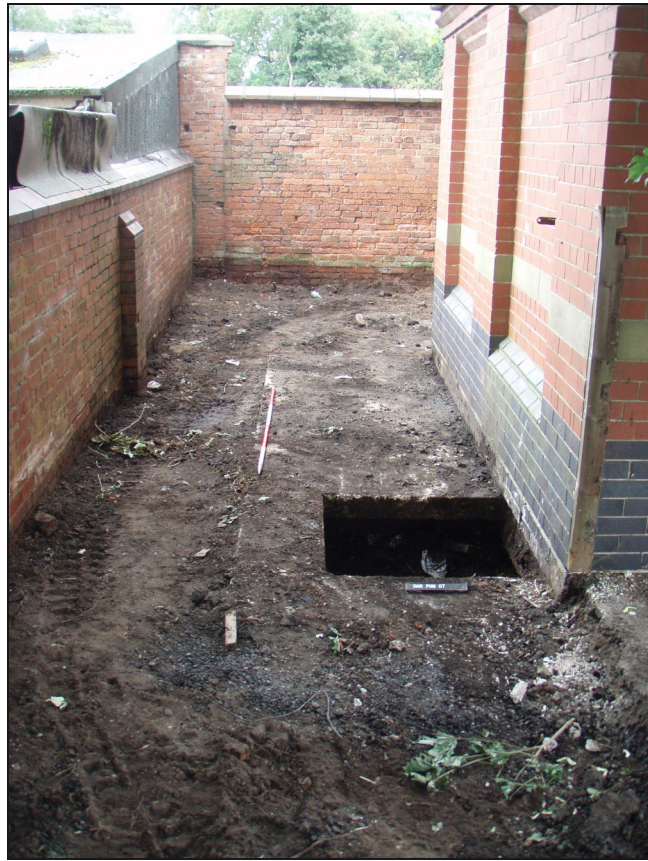
Fig. 8. View of the cellar entrance, looking east. Scale: 2m

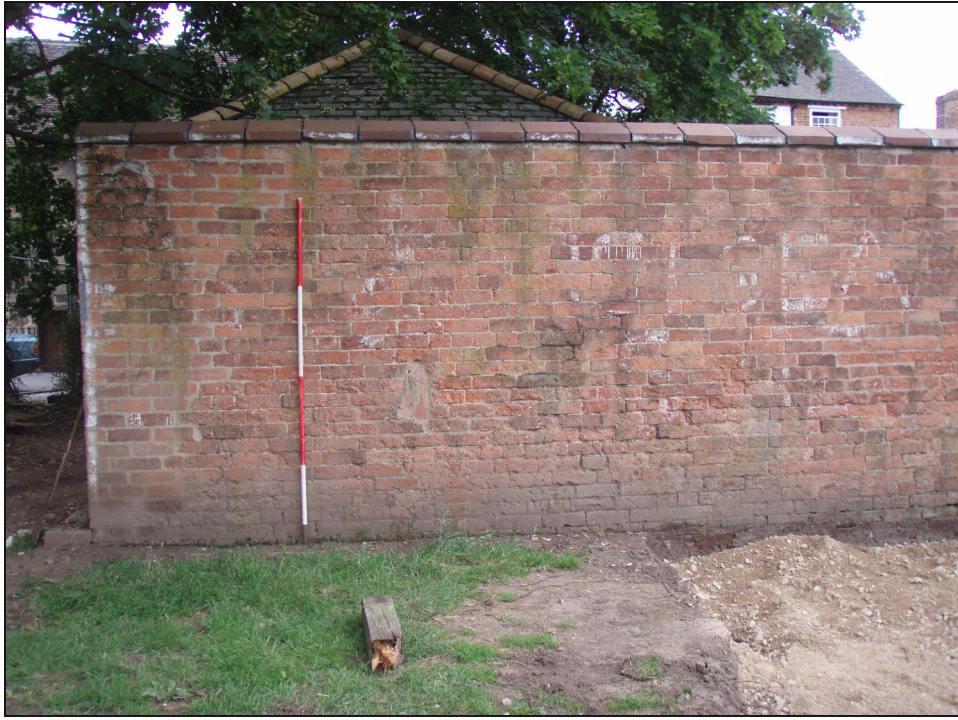
- 6.4 The final phase of work consisted of dismantling the wall that currently obstructs access to the pump house from Dean's Field. The wall appears on the 2nd Edition Ordnance Survey map of Darley Abbey, 1889 (Fig. 11) and was constructed from coarsely made red bricks (Figs.9 & 10). Frost damage to the wall meant that the lower 12 courses were in poor condition. It was decided that these lower bricks could not be saved and that the wall should be re-built using the bricks from the top courses. The wall was re-built leaving a 2m gap for a gate allowing access to the pump house. The footings for the wall were excavated to a depth of 0.9m. The base of the original wall footings were not reached at this depth.

Fig. 9 View of the brick wall from Dean's Field, looking west (Scale: 2m).

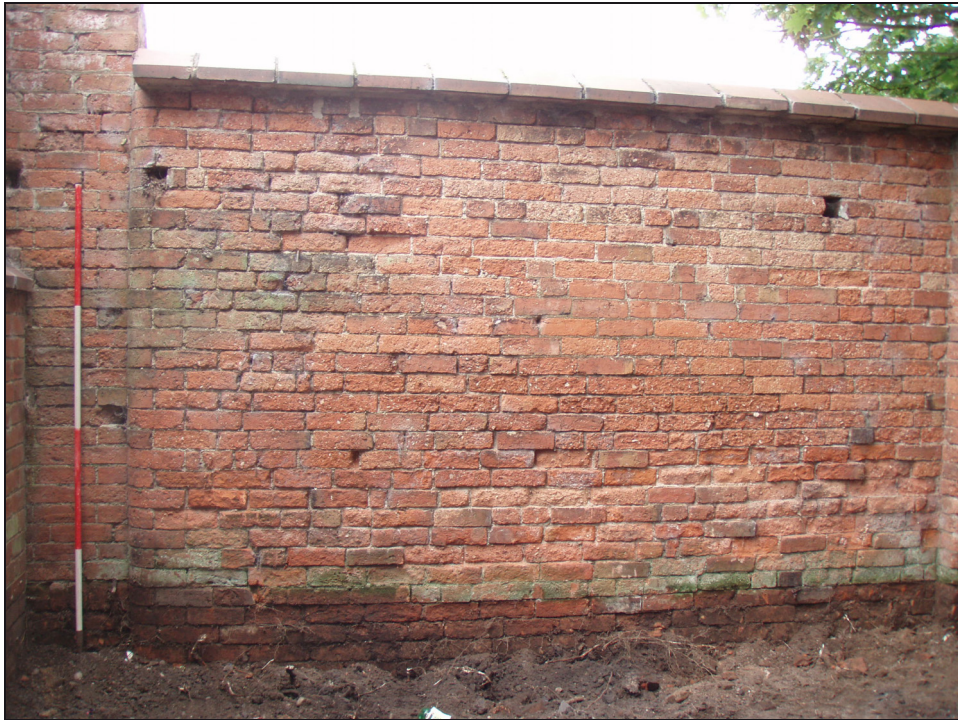
Fig. 10 View of the brick wall from the rear, looking east (Scale: 2m).
