# An Archaeological Desk-Based Assessment and Building Recording at Offerton Grange Farm, Sunderland

Archaeological Research Services Ltd Report 2007/49  
July 2007

1.1.1. In July 2007 Archaeological Research Services Ltd were commissioned by Hopper Howe Sadler to undertake an archaeological desk-based assessment and building recording for Offerton Grange Farm, Sunderland (Fig. 1). The work was carried out prior to the demolition of Ivy House in order to make way for two new dwellings, the extension of the farmhouse and the conversion of the barn into a dwelling.

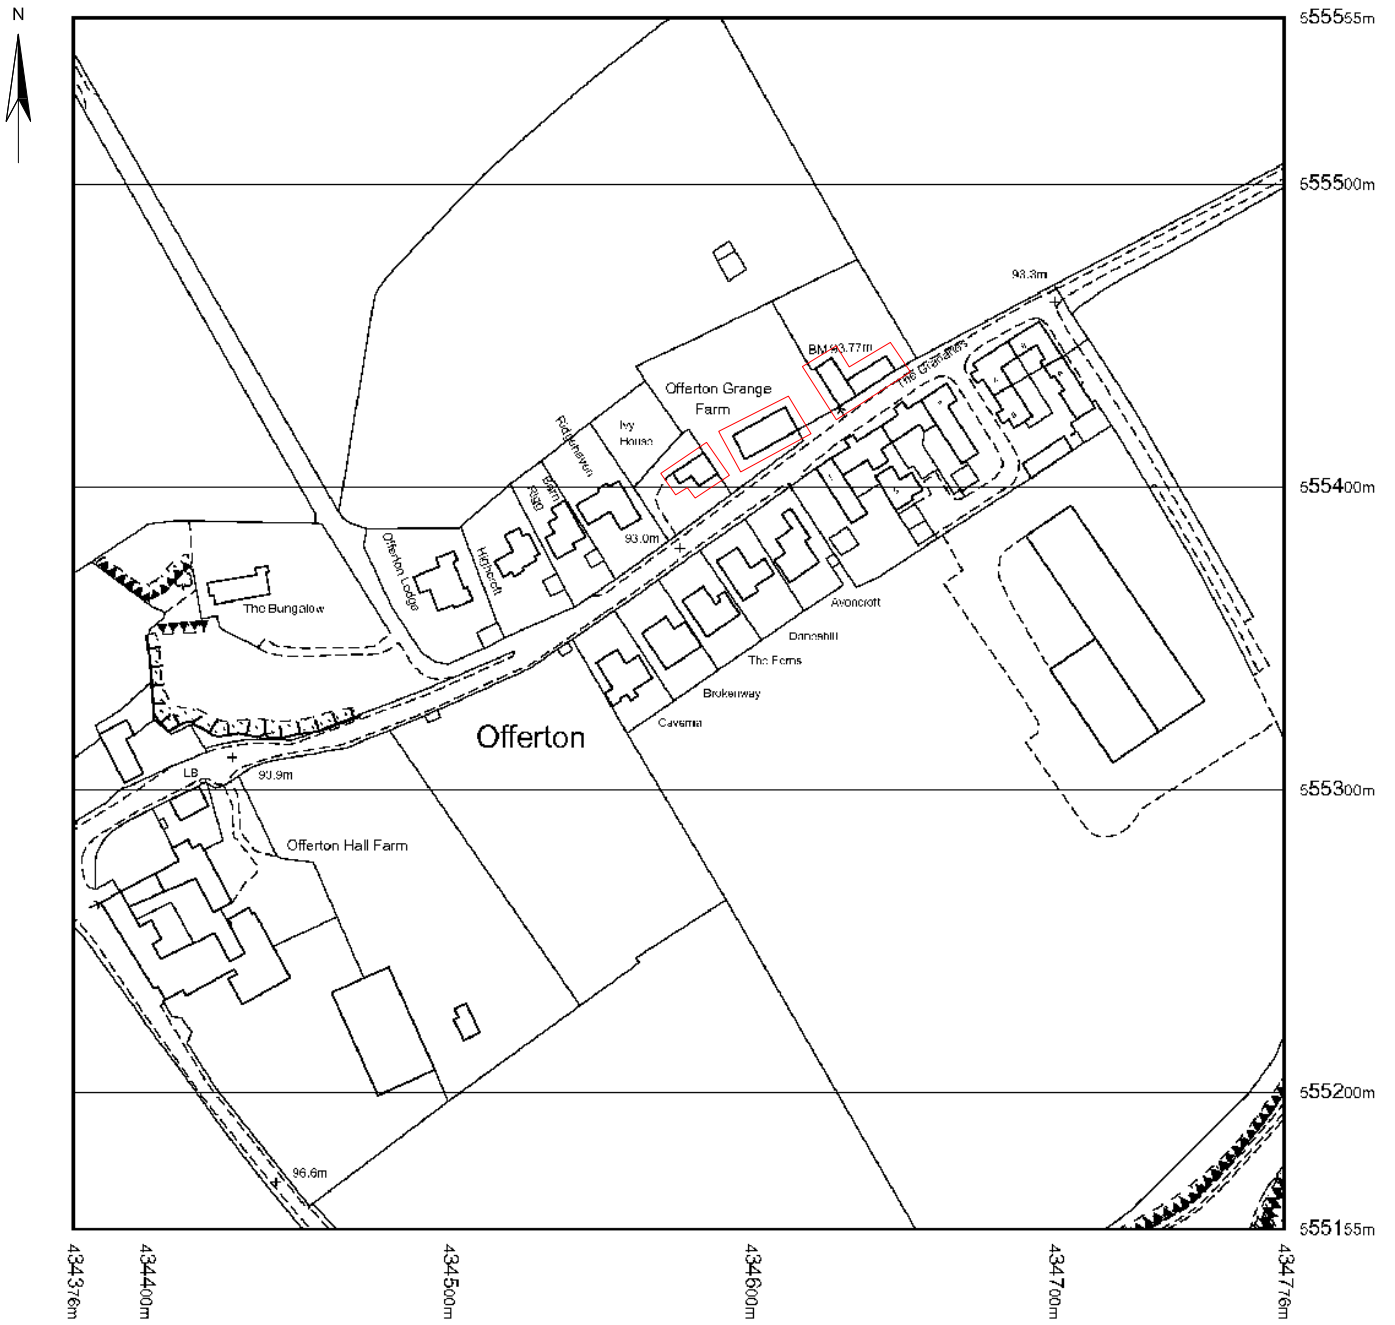
<p>Archaeological Research Services Ltd Baltic Business Centre Saltmeadows Road Gateshead NE8 3DA</p>	<p>Figure 2: Site plan</p>	<p>Key:</p>

1.2.1. The site is centred at NZ 34592 55415 (Fig. 2) in the village of Offerton, just west of the A19, on land at approximately 70m aOD. The village of Offerton is Medieval in origin and is designated as an area of potential archaeological importance in the City of Sunderland's Unitary Development Plan (UDP). A desk-based assessment has been undertaken in order to assess the likelihood that archaeological deposits survive on the site and a building recording has been undertaken in order to record the buildings as they stand today, as well as any features of architectural significance.

- 4.9.7. The Ordnance Survey revised edition of 2004 (Fig. 2) shows the study area as it exists today and there appears to have been no major changes to the study area since the third edition Ordnance Survey of 1920.

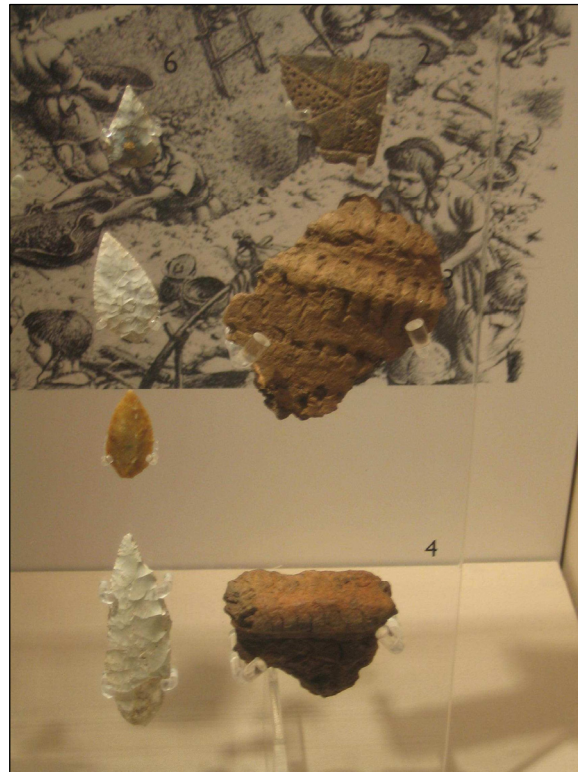
Fig. 11 Three decorated pieces of Neolithic pottery from Hasting Hill  
(the flint was found at Monkwearmouth)

4.7.1. There were no archives held at Sunderland Museum and Art Gallery as they are all held at Tyne and Wear Archives in the Discovery Museum. There were a number of artefacts however that were recovered from Hasting Hill, a number of which are shown below in Figures 11 to 13.

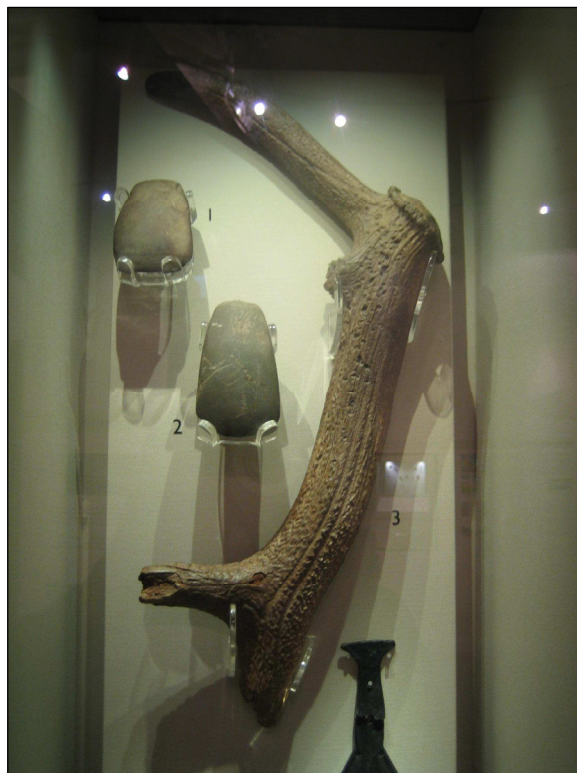
Fig. 12 Red deer antler pick from Hasting Hill

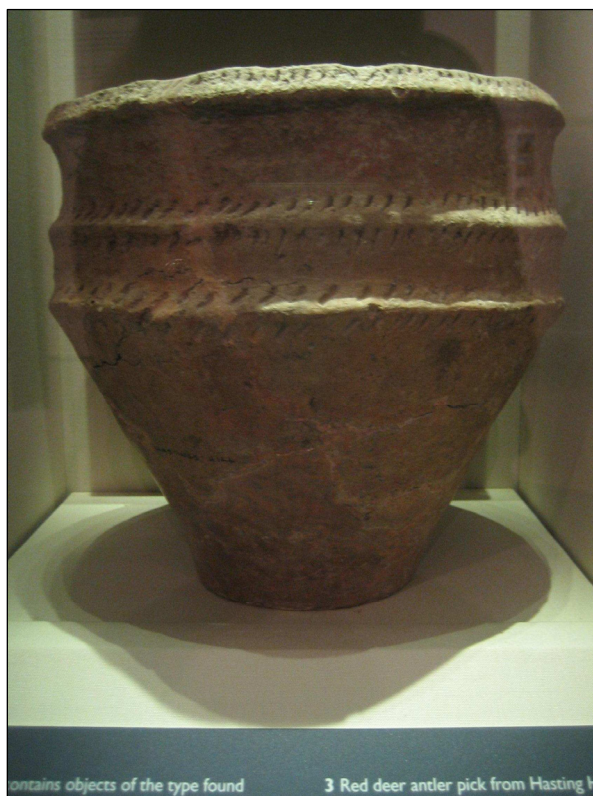
Fig. 13 Bronze Age food vessel from Hasting Hill

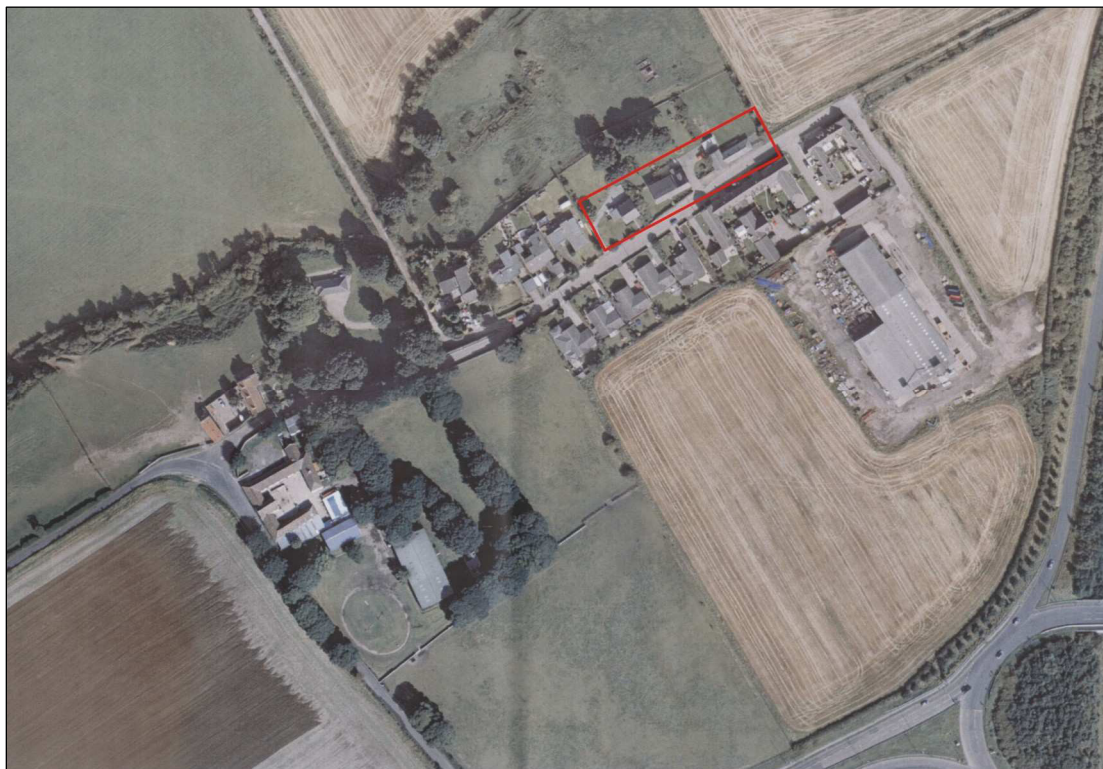
Fig. 15 Aerial photograph taken in 2003 courtesy of Sunderland City Council.  
The study area is outlined in red

- 4.8.1. Aerial photographs covering the study area are held at Sunderland City Council. They provided no in depth information about the study area as the buildings concerned existed prior to the first survey. Photographs taken in 1981 (Fig. 14) and 2005 (Fig. 15) show that there have been no changes to the study area during this time, apart from the erection of a large building on land to the south-east of the study area.

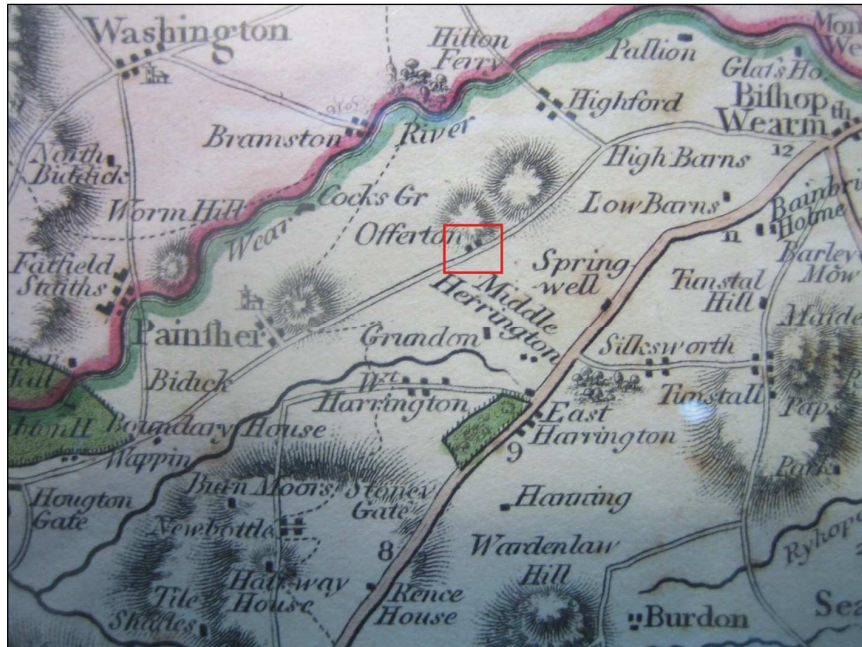
Fig. 16 Cary's 1794 map of County Durham.  
The study area is outlined in red

- 4.9.1. The study area is covered by a number of historic maps which predate the Ordnance Survey but are at too large a scale to show any significant detail. The earliest map to show any detail is Cary's 1794 map of County Durham (Fig. 16). Only two buildings are represented here and it is likely that this is symbolic of a small settlement, rather than an indication that only two buildings were present.

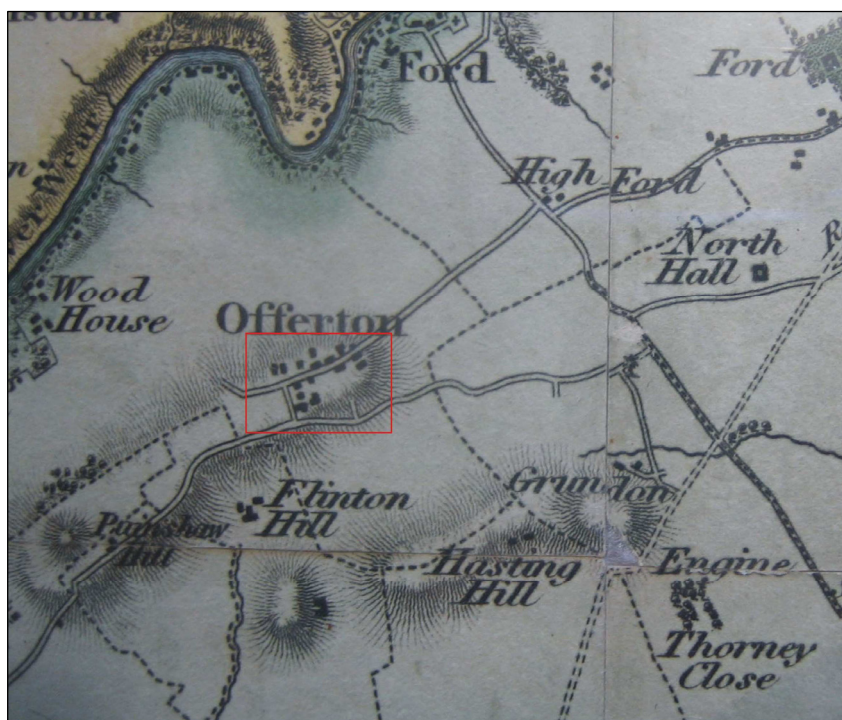
Fig. 17 Greenwood's 1820 map of County Durham,  
The study area is outlined in red

- 4.9.2. Greenwood's 1820 map of County Durham (Fig. 17) illustrates the study area in more detail although identifying individual buildings is not possible.

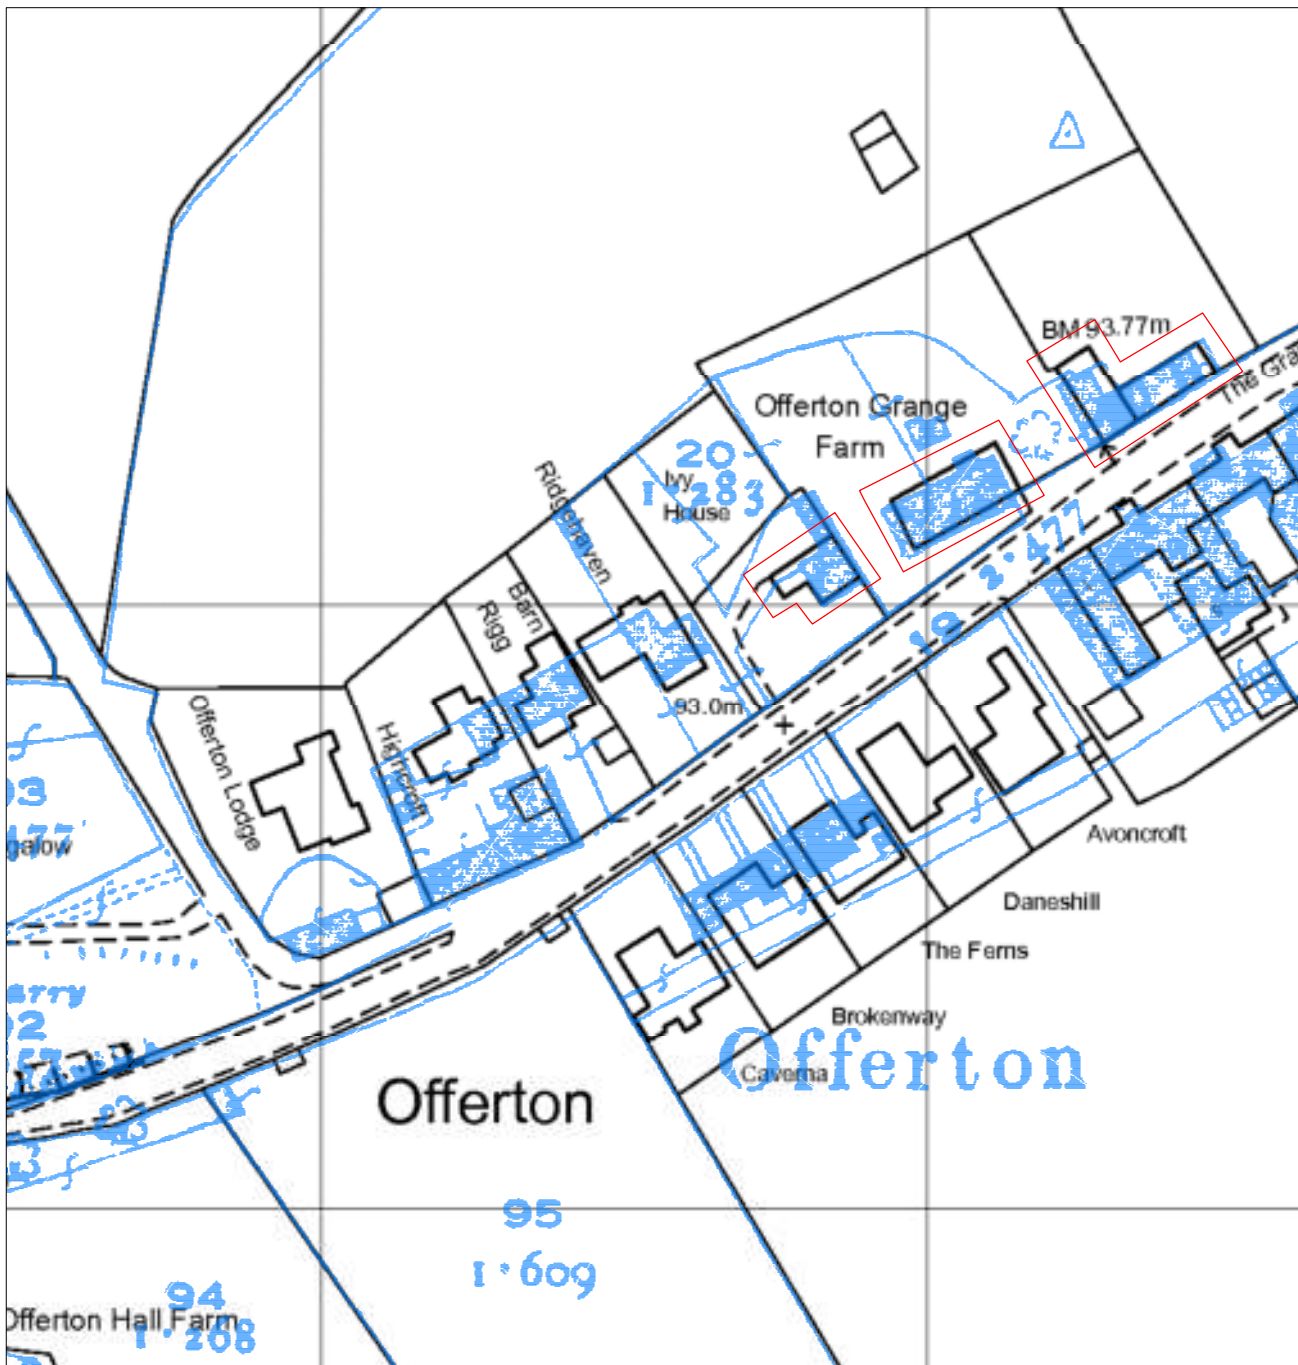
Figure 20:  
Third edition Ordnance Survey  
Map of 1920

- 4.9.5. The third edition Ordnance Survey Map of 1920 (Fig. 20) displays the farmhouse and associated barn in the same layout as it was on the second edition map of 1896. There is now a building located on the plot of Ivy House but the layout is different to that of today. A wing extends to the north which is not present today, and there is no extensions to the west as there is today. Offerton Hall appears to remain unchanged and the quarry to the north is now labelled as 'Old'. The well to the north is no longer recorded.

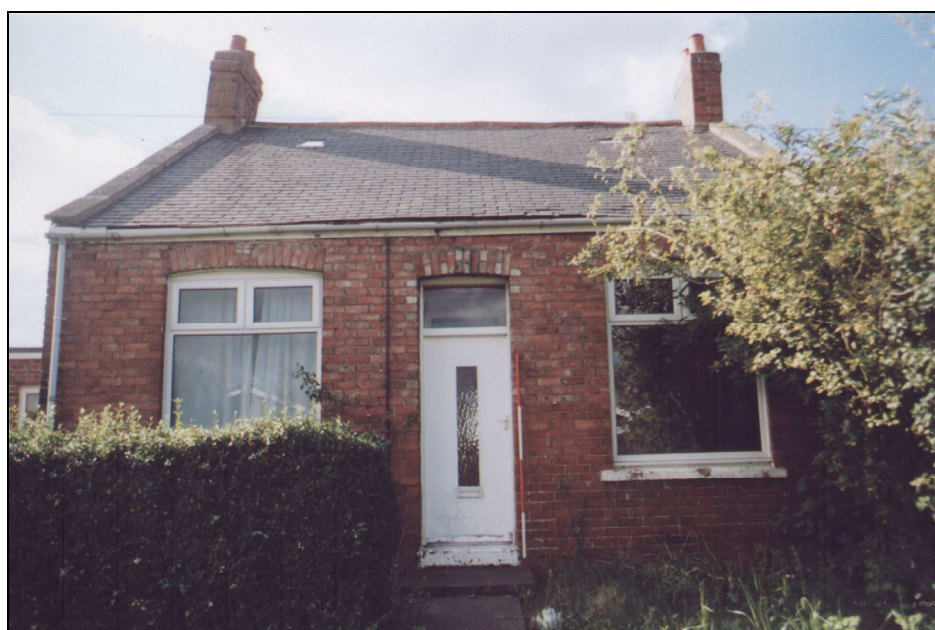
Figure 21: Ivy House south (front) elevation. Scale = 2m

- 5.2.1 *General:* The first of the building group encountered as the village is entered from the west is Ivy House (Fig 21). This is a small, single storey building in red brick (stretcher bond throughout) with a slate roof with sandstone coping and stacks at either end. A pair of rooflights on both aspects of the roof indicate that there is an attic above.

- 5.2.2 *South elevation:* The south front, facing onto the road from which the property is entered, is of two bays either side of an entrance hall accessed via a central doorway approximately 1.4m high by 1m width, with a single plain light over. There are two large UPVC framed casement windows either side of the front door.

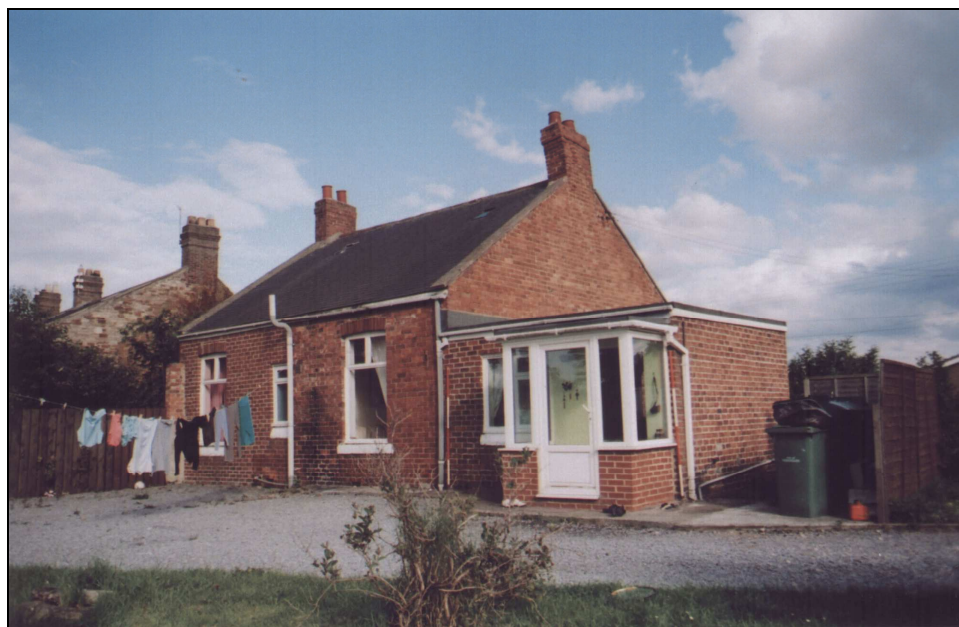
Figure 22: Ivy House north (rear) elevation. Scales = 2m

- 5.2.3 *North Elevation:* To the rear of the property (Fig 22) a freestanding wall segment projecting slightly northwards at the east end of the house and a difference in brick type and mortar indicate that part of the house has been demolished, the gap infilled and the eastern window added. Though the style of the window is sympathetic to its western counterpart, the window sills are different styles. The earlier sill below the eastern window is a rectangular sandstone block with a square cross-section, while the later sill is wedge-shaped in cross-section and slopes outward and downward. The small central window has the later style sill, but appears to have been knocked through at a later date and so may represent a third phase of alteration to the rear.

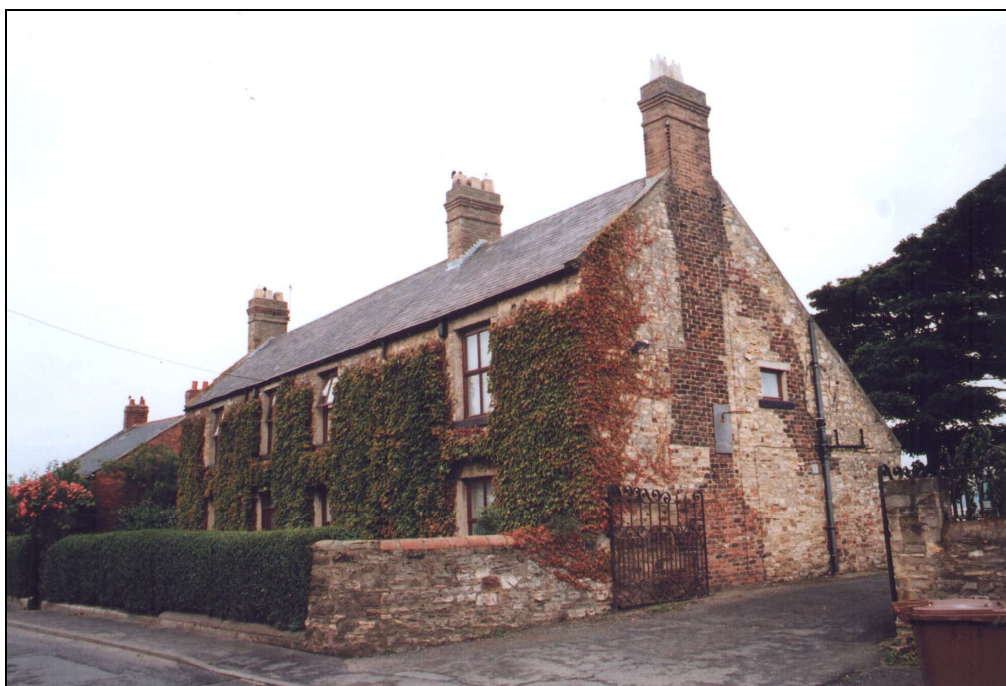
Figure 23: Farmhouse south (front) elevation.

- 5.3.1 *General:* The Farmhouse (Fig 23) is the only building of the group that appears on the first edition Ordnance Survey Map of 1855. It is the second, and much the largest of the group, and is easily recognisable as the south elevation and much of the west elevation are entirely covered in ivy. It is a rectangular building on two storeys with a slate roof with sandstone coping at either end and three stacks. These are of brick, as chimneys had to withstand intense heat, and brick, a fired material is a more suitable material than sandstone for chimney stacks and flues.

- 5.3.2 *South Elevation:* Much of this elevation is obscured by ivy (Fig 23, above). The south front is of four bays, symmetrically positioned, with four openings on each floor with plain sandstone lintels and sills. It is well-built of rectangular, evenly coursed, mortared sandstone blocks. The sandstone varies in colour between pale cream to yellow, greying with age, and a light orange red. The former may be Northumberland sandstone, while the latter resembles that found on the banks of the River Wear, as at Kepier quarry, near Durham. Windows (four upper, three lower) are wooden framed outward opening casements hinged at the top. The south front has seen little alteration, though the window frames and door are modern.

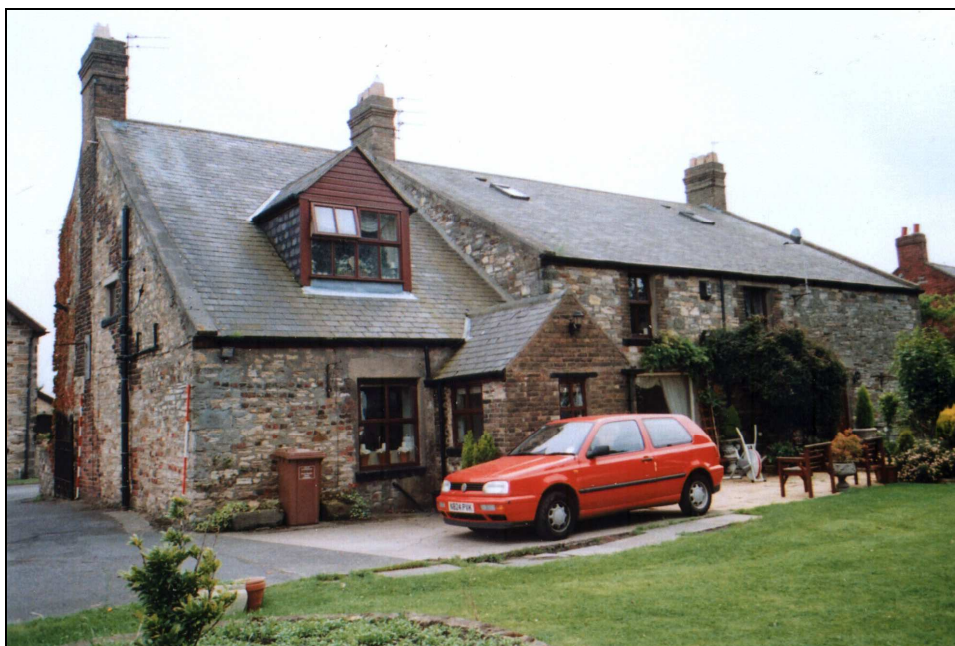
Figure 24: Farmhouse north (rear) elevation.

- 5.3.3 *North Elevation:* From the rear, at first glance, the building appears to comprise two ranges, an earlier range of one bay having a catslide roof, abutted by a rectangular range of three bays to the west (Fig 24). The patterned brick surrounds to the openings belonging to the three western bays clearly mark this part of the building out as a later addition. However, the addition of three bays to the western side of the house would be expected to appear on Ordnance survey mapping, and no such alteration is shown, though it is of course possible that all alterations were carried out by 1855 when the building was mapped by the Ordnance Survey. However, examination of the south front (above) does not support this theory either, as this elevation is clearly virtually unaltered.

Further inspection of the north elevation suggests that in fact, the original, nineteenth (or possibly eighteenth) century farmhouse comprised a single range of two storeys to the front, reduced to one storey at the rear, with the catslide roof perhaps continuing all the way along. At some point thereafter, perhaps in the later nineteenth century, a second storey has been added to the rear of the building. There was also some extension northwards toward the west end of the building, as the end of the earlier building can be very clearly seen in the west elevation. This may indicate that the east end did in fact project slightly further north than the rest of the building. If this were the case, the catslide roof may originally have extended no further than it does today, and the original building may have been roughly L-shaped. This is in fact a relatively common arrangement on local farmhouses and cottages of the nineteenth century. The extension and addition of an upper storey to the rear would have resulted in very minor changes to the plan of the building, which explains why no alterations can be discerned on successive editions of the Ordnance Survey mapping.

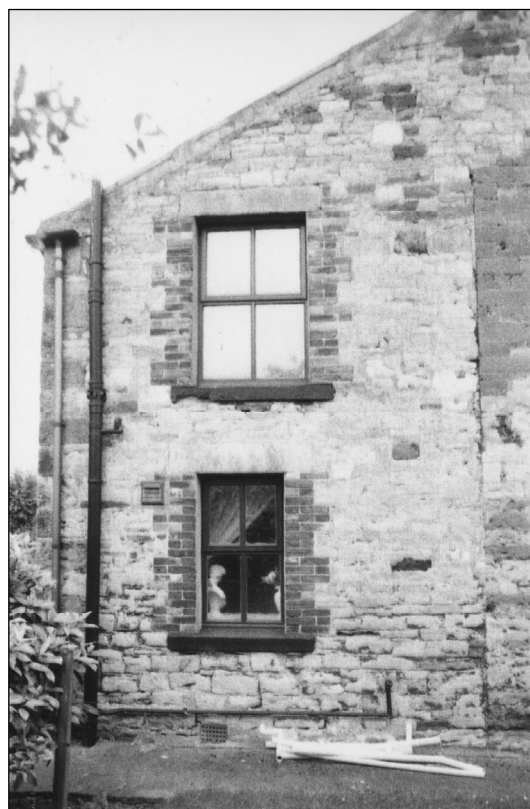
Figure 25:

- 5.3.6 *West Elevation:* As noted above, the primary feature of interest in the west elevation is the line of the former north front, clearly visible with the later extension abutting (Fig 25). Three openings are visible. The earliest, to the south, is part of the original farmhouse with chamfered sandstone lintel and sloping sill. Within the extension are two further openings, first and ground floor windows, with patterned brick surrounds, something that appears to be characteristic of the

Farmhouse west elevation. Note the marked outline of the original north elevation abutted by the later extension, which possibly dates to the late nineteenth century.

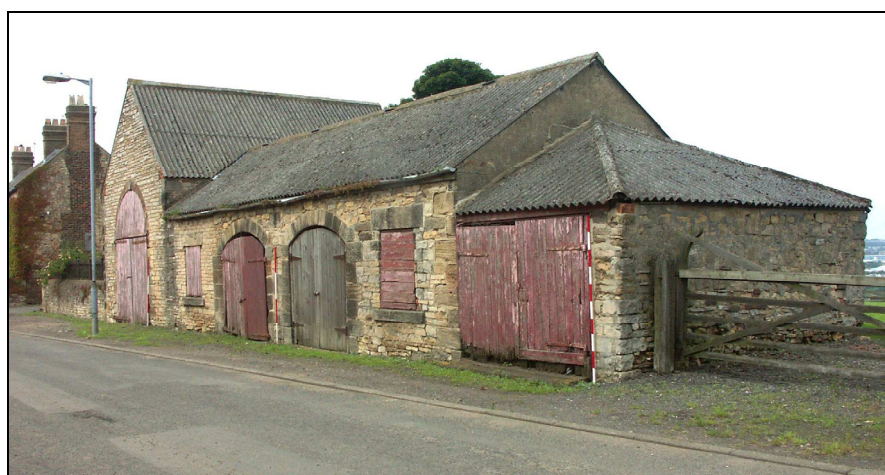
Figure 26: L-Plan barn, general view looking north-west

- 5.4.1 *General:* The barn forms an L-shape in plan with two ranges, an east-west aligned range to the east, with an outshot abutting (Fig 26, 27), and a north-south aligned range adjoining it to the west. The buildings are in sandstone throughout with functional modern roofs of corrugated asbestos.

- 5.4.2 *South Elevation (Front):* Three distinct phases of construction can be identified. The earliest phase is represented by the central east-west aligned range of two

bays with a central dividing wall of dimensions 12.6m long by 6m wide and 5m high. It is constructed of flattish sandstone blocks in regular courses with sandstone alternating block quoins at the east end. Some areas of rougher random-rubble construction may indicate repairs. The absence of alternating block quoins and the area of much darker masonry caused by heavy repointing where the north-south range joins indicates that the E-W range originally extended further to the west. The heavy repointing draws attention to the joint which may have resulted in some structural weakness (Fig 28). A large sandstone sill and lintel are also present in the wall at this point, indicating either a blocked opening, or re-use of masonry from a demolished part of the barn to key-in the north-south range.

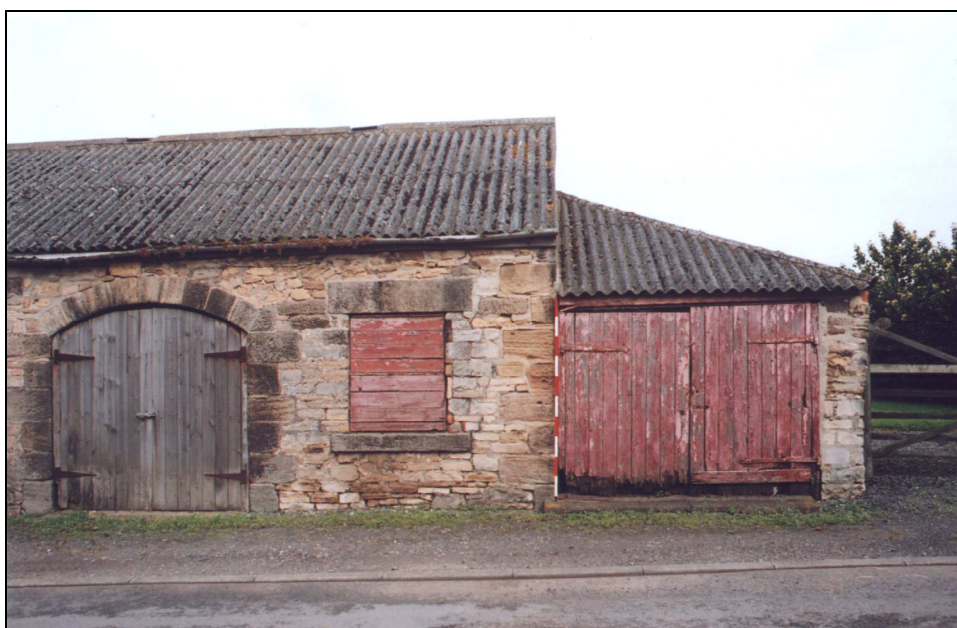
Figure 27: L-Plan barn east-west range east end, showing outshot

At the east end of the east-west range an outshot measuring 3m east-west by 6m north-south with a height of 3.7m has been added (Fig 26,27). This is of sandstone rubble construction and has a single square opening set directly against the original wall of the east-west range. The opening is enclosed by vertical-timber boarded double doors. Access is blocked behind the wooden doors by a modern breezeblock wall.

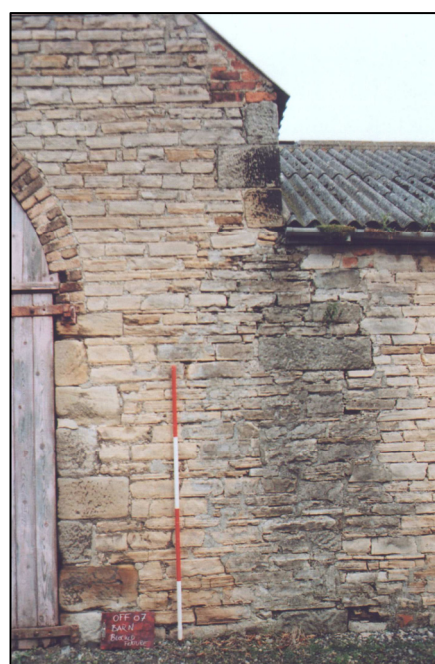
The north-south range measures 15m long by 7m wide, and rises to approximately 7m in height, considerably higher than the east-west range. The north-south range is a later addition, as evidenced by the different

treatment of the openings and the clearly visible join to the east-west range. The south elevation of this range includes the gable end with a very large central double doorway with sandstone alternating block surrounds and a Roman arch edged in brick and lime mortared above. The whole north-south range is of similar construction to the east-west range in flattish sandstone blocks with sandstone alternating block quoins. The opening is enclosed by large rectangular double doors with a hemispherical panel above, all of vertical timber boarding (Fig 29).

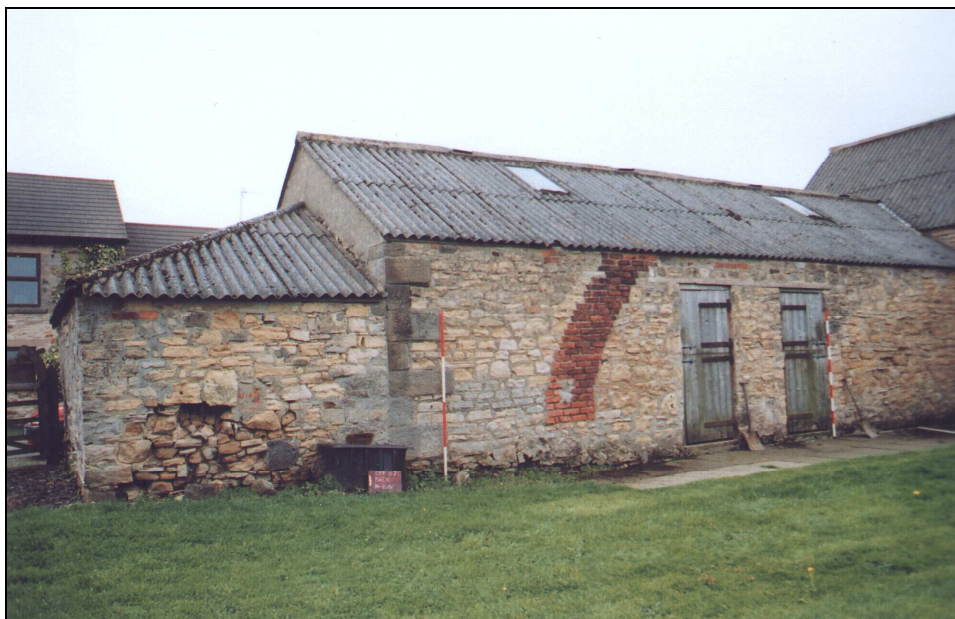
Figure 30: L-Plan Barn east-west range, north elevation

- 5.4.3 *North Elevation (Rear, east-west range):* To the rear, each of the two bays is accessed by wooden stable-type doors on either side of the central dividing wall. The east-west range shows signs of a major phase of rebuilding, with large, roughly-coursed sandstone blocks replacing more regularly coursed sandstone blocks similar to those in evidence on the south elevation. This phase of reconstruction is probably associated with a diagonal block of brickwork running from 0.7m above the ground and sloping up westwards to meet the roofline. The most likely interpretation for this brick feature is a chimney or flue, inserted to vent smoke or gases from a mechanised agricultural process, such as steam-powered threshing. The north-south range is accessed by a single outward-opening door of vertical-timber boards. The north-elevation of the outshot is in poor repair, with some masonry collapsed in the lower part of the wall (Fig. 30).

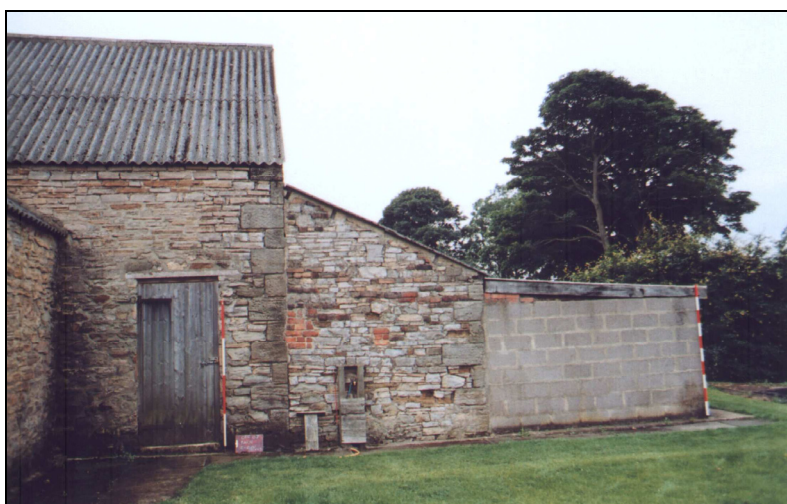
Figure 31: L-Plan Barn, north-south range, east elevation.

- 5.4.5 *East Elevation (north-south Range):* The north-south range has a further addition to its north end in the form of a second roughly-constructed single-storey extension in re-used sandstone blocks and bricks of varying shapes and sizes, obviously from a variety of sources (Fig. 31). This building is currently in use as a garage and the interior was not accessible at the time of the survey. A modern breezeblock garage of no architectural or historic interest abuts this building to the north.

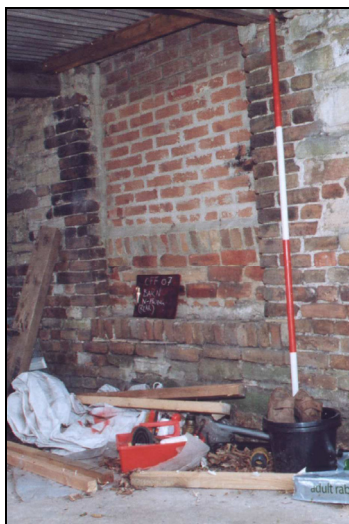
Figure 32: Blocked window, north-south range extension

- 5.4.6 *North Elevation (extension)*: The interior of the north-south range extension, currently in use as a garage, could not be accessed, but its north elevation was investigated from within the modern breezeblock garage. As with the east elevation, the north elevation was constructed from roughly-coursed sandstone blocks mixed with patches of brickwork. The elevation has a single opening, a window with a decorative brick surround, similar to those on the farmhouse north elevation and the barn north-south range west elevation (below). This had been bricked up on two separate occasions, one evidently in the recent past (Fig 32, below).

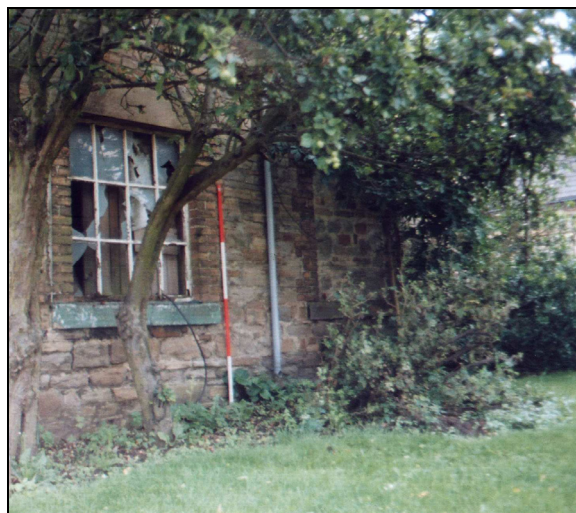
Figure 33: windows, north-south range, western elevation

- 5.4.7 *North-South Range, western elevation*: As elsewhere on the north-south range, this elevation is constructed of regular courses of flattish sandstone blocks. There are two openings on this elevation, both windows with decorative brick surrounds similar to those on the farmhouse north elevation (Fig. 33, above). Sill and lintels are of even, perhaps even machine-cut, sandstone blocks. The southern opening is blocked with sandstone rubble. The northern opening still has a window with a rotten timber frame with 12 lights in three rows by four columns, mostly broken. The view that the north-south range is a later addition to the original east-west range is reinforced by the considerable difference in the style of the openings on this elevation.

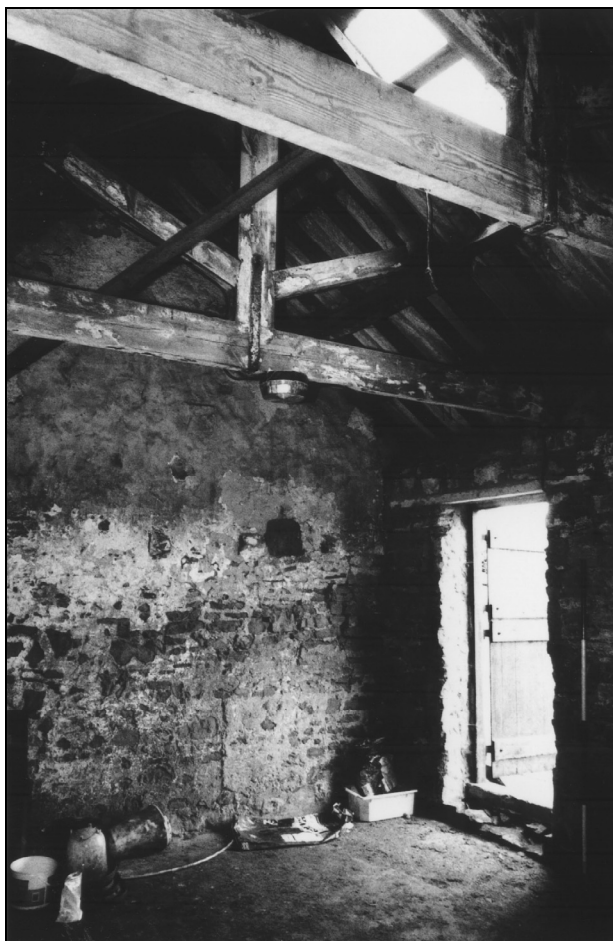
Figure 34: L-Plan barn, Room 2

- 5.5.2 *Room 2* (Fig. 34): The eastern bay of east-west range was 4.9 metres square, and of more interest than its counterpart to the west. The timber A-frame roof is virtually identical to that in Room 1 and of little interest. The west wall, which is probably the original partition wall between the two bays, is of rough rubble construction, clash-pointed and rendered, with the render surviving on the upper part of the wall. The north wall is similar, with the block of diagonal brickwork probably originally associated with a chimney or flue noted from the outside clearly in evidence. Just beside it, set into the floor, was a square pit 2m by 2m, roughly infilled and edged in brick (Fig 36).

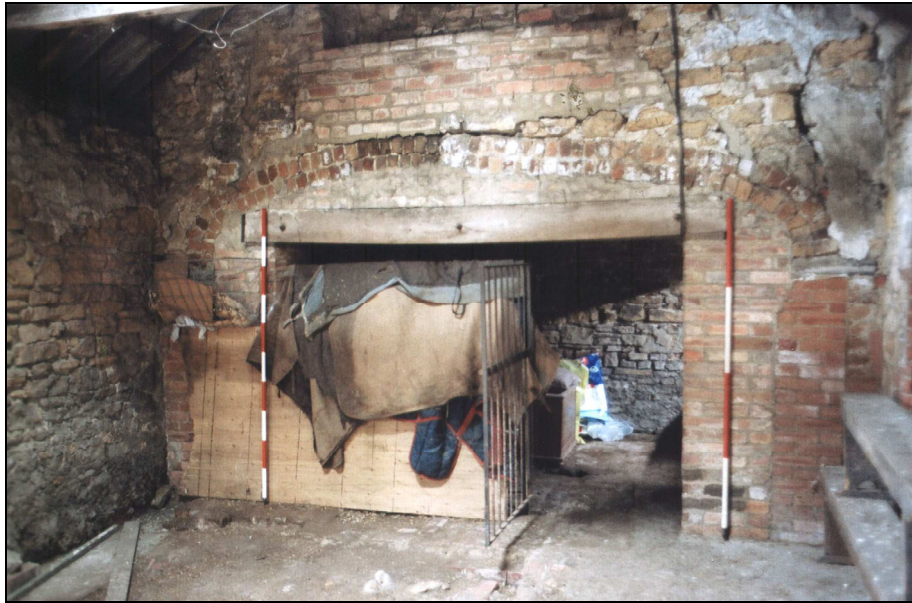
Figure 35: L-Plan barn, Room 2, looking east, showing brick arch knocked through to communicate with outshot, Room 3

The east wall, of rough sandstone rubble construction like the others, has been knocked through to provide access to the outshot, and it seems logical to assume that these two phases of modification occurred simultaneously. The opening is framed by a brick arch comprising two courses of headers with timber springers. The opening has been considerably reduced in size at a later date with brick piers and a wooden lintel and is closed by an iron gate set in the floor (Fig. 35). The floor seems to be of earth and mortar, though it is possible flagstones or brickwork may be concealed beneath layers of earth.

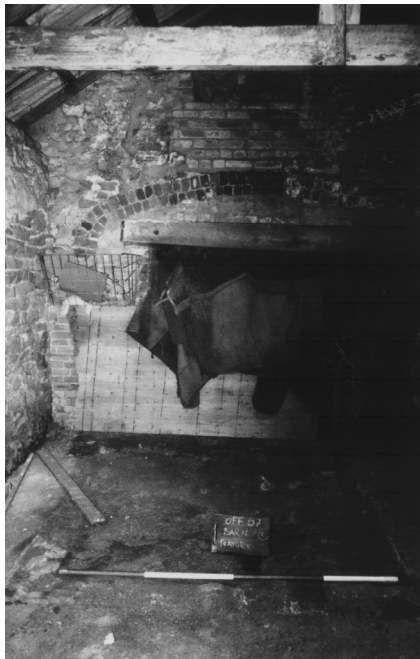
Figure 36: possible boiler base, Room 2

This may represent the remains of the base of a metal boiler or furnace, perhaps originally having a flue mounted to the north wall of the barn where the brickwork insertion prevented damage to the masonry and lessened the risk of fire. The boiler flue would have exited at roof level. These flues were often utilised in agriculture as mechanical steam threshers, but by the 1930's advances in agricultural technology had rendered steam engines obsolete on most farms, and the boiler, machinery and flues were probably removed some time after 1930. The re-roofing of the whole barn may date to the same period.

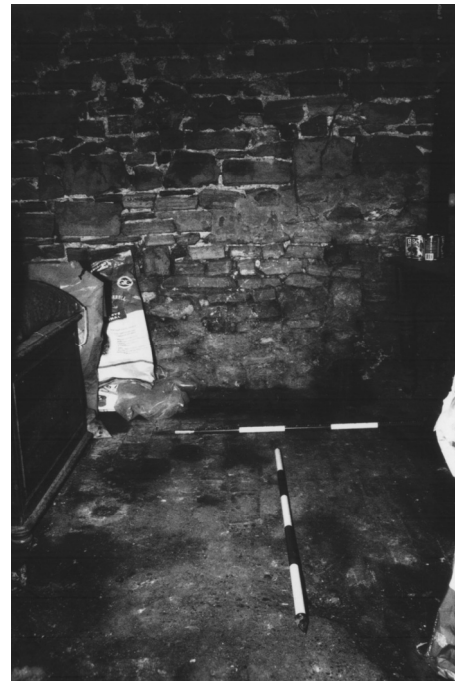
Figure 37: brick floor, Room 3

- 5.5.3 *Room 3 (see figure 37)*: The outshot [Room 3] measures 2.45m north-south by 5.25m east-west. Internally all surfaces are roughly faced and un-rendered. This room has a brick floor, perhaps to support a stationary steam engine fed by a boiler in Room 2. On this basis, the diagonal brickwork inserted into the north wall of Room 2, the brick pit in Room 2 which may be a boiler base, the communicating brick arch between Room 2 and Room 3, and Room 3 itself, the outshot can all be interpreted as a single phase of reconstruction work within the building probably associated with the introduction of steam power during the late nineteenth century.
