**An Archaeological Watching Brief at
Newall Green Farm, Newall Road,
Wythenshawe, Manchester**

ARS Ltd Report No. 2017/123

October 2017

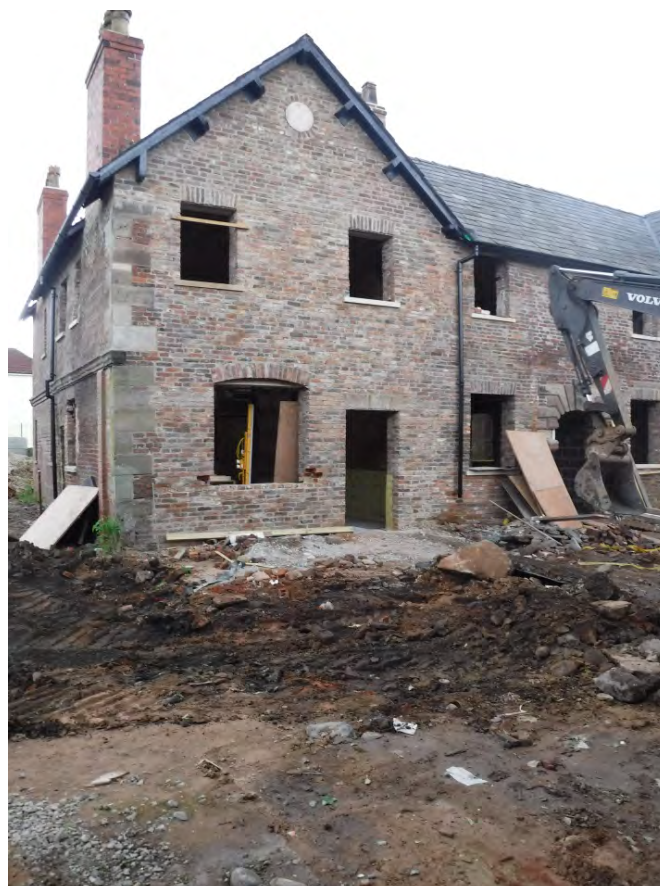
Figure 3. Block A outbuilding prior to removal of footings, looking south-east.

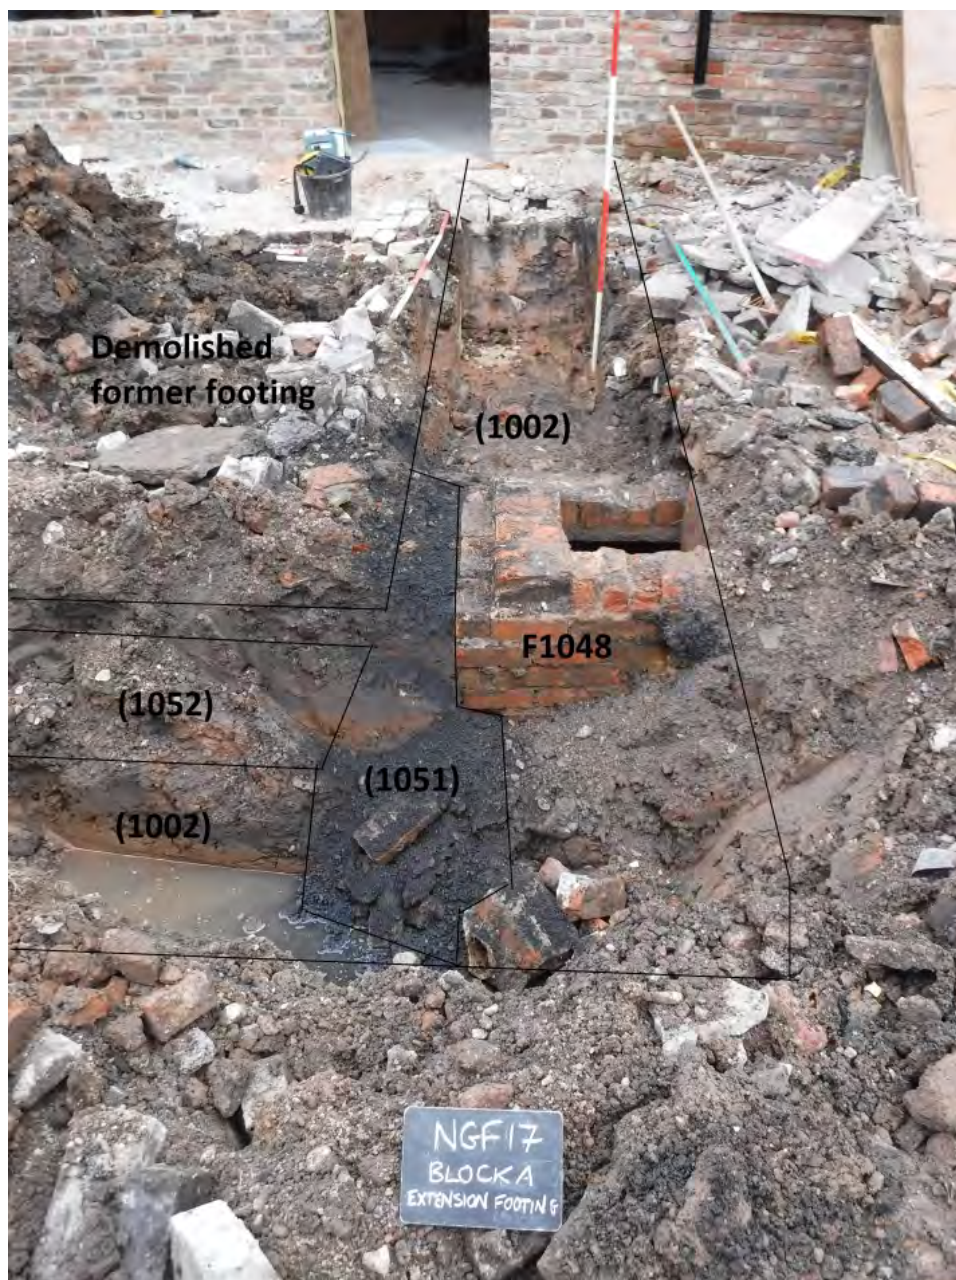
Figure 4. Manhole (F1048) within footing trench for new Block A extension. Note the bitumen deposit (1051) adjacent to manhole and below demolished former footing. Section also shows disturbed subsoil (1052) overlying natural clay (1002). Scale: 0.5m graduations.

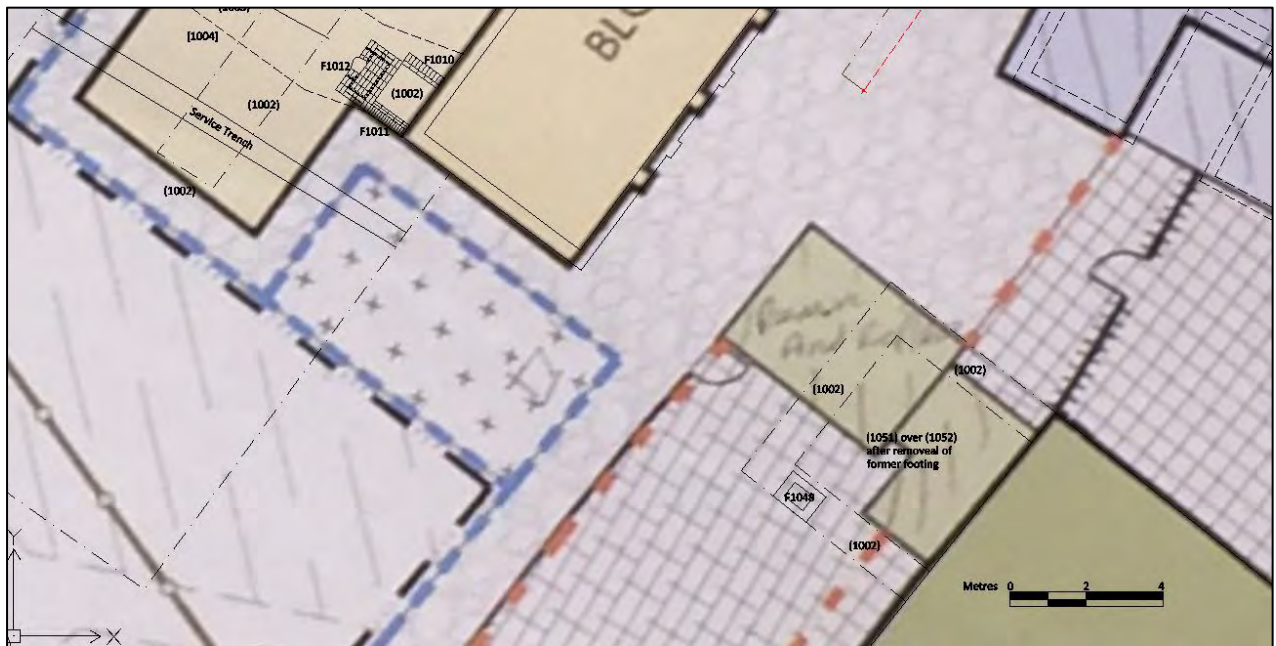
Figure 5. Plan showing excavated area for new Block A outbuilding. Note alignment of the service trench (top left) with the manhole (F1048). Scale: as shown.

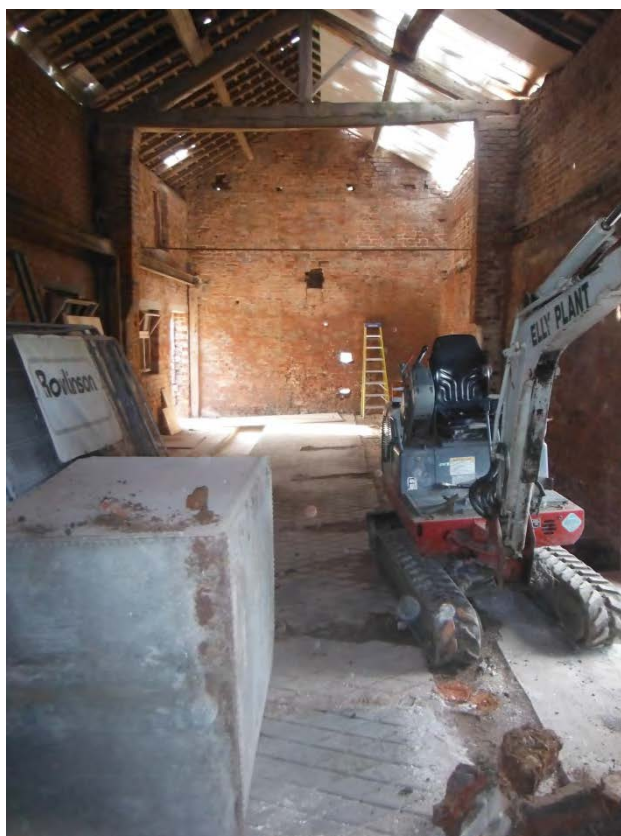
Figure 7. Concrete floor within room G1 of Block B prior to removal, looking south-west.

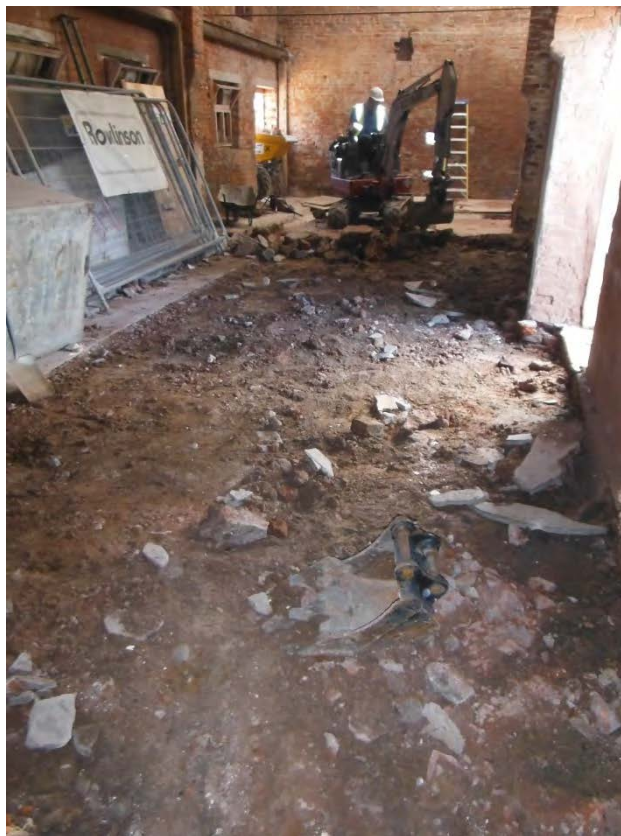
Figure 8. Undisturbed natural clay (1002) exposed by removal of concrete floors in room G1 of Block B, looking south-west.

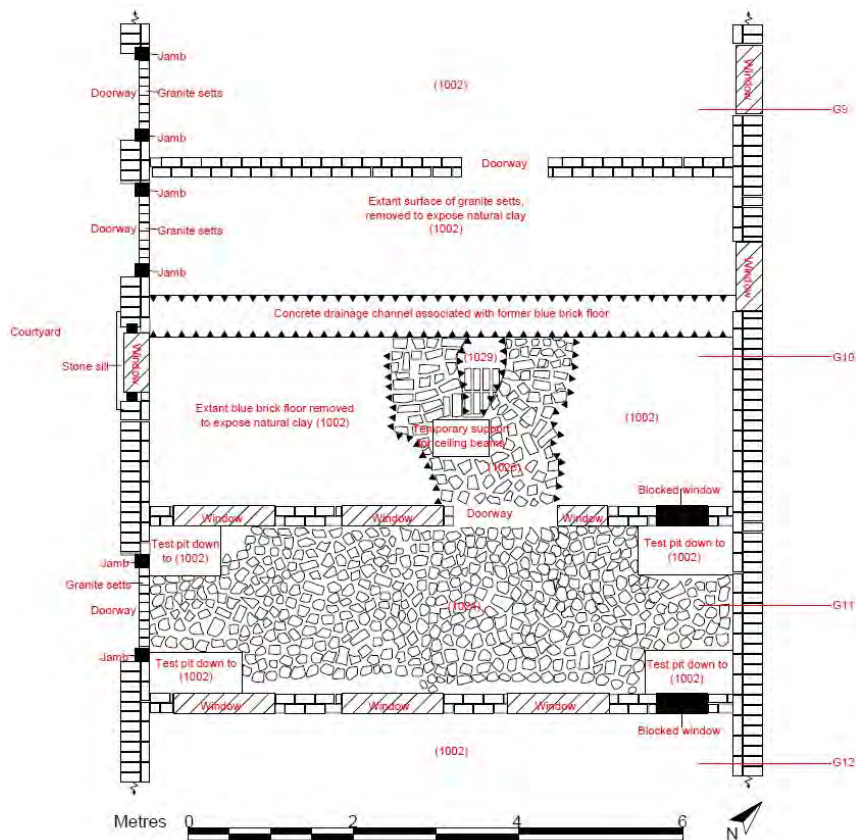
5.3.3 In rooms G9-G12 (the north-east/south-west range of Block B) the extant floors were laid with granite setts and blue paving bricks. Three of the four rooms were divided into two by a concrete drainage channel running north-east/south-west to the edge of the external doorways. The wider areas on one side of the drainage channels were constructed of blue paving bricks laid on edge in rows, whilst the narrower areas on the other side of the channels were laid with granite setts (0.15 x 0.15 x 0.15m in size) and provided access from the exterior doors. The sides of the rooms paved with blue bricks once formed the stalls for the cattle and the cobbled sides formed the entrance corridors. Room G11 was an exception to this pattern, consisting of a narrower room paved entirely with rows of blue bricks laid on edge. This probably formed a feeding passage between rooms G12 and G10 and also provided access to the hayloft via a ladder. The dividing walls between rooms G10, G11, and G12 each had four windows. These would have provided access for fodder via the feeding passage (G11) into rooms G10 and G12 (Figure 9).

Figure 9. Plan of rooms G9-G12 in Block B after removal of extant surfaces.
Scale: as shown.

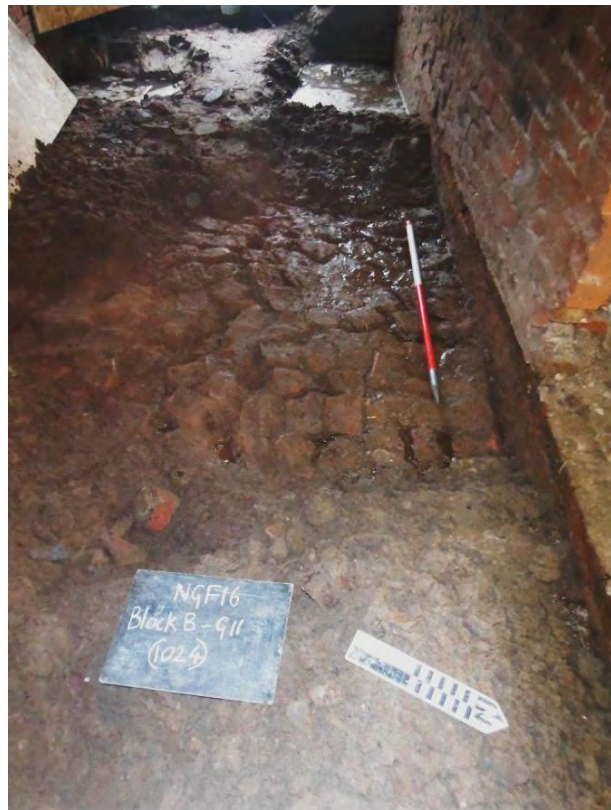
5.3.4 In rooms G10 and G11 similar brick surfaces to that found in room G3 were exposed beneath the removed floors. In room G11 removal of the extant blue brick surface revealed a surface (1024) laid with randomly coursed pieces of handmade red-bricks, mostly half or three quarter bat (Figure 10). In room G10 a patch of a similarly constructed floor (1028) was uncovered that is likely to have once formed a walkway between the doors on either side of the room, though it had been truncated by the drainage channel running through the most recent concrete surface. During removal of the rough brick surface (1028), a small area of more regularly laid bricks was identified (1029) (Figure 11). This was just a single course thick and lay directly on the natural substrate (1002). This suggests that the original floor (1029) was re-surfaced at least once by the bricks of (1028) prior to the eventual covering of both surfaces by concrete.

Figure 10. Floor surface (1024) within room G11 of Block B. Note ground water within test pits (background) excavated through the natural clay (1002). Scale: 1m.

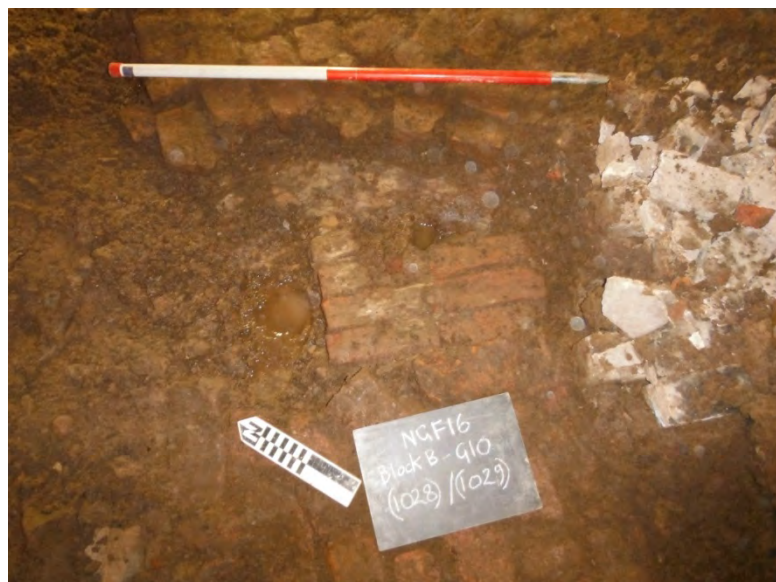
Figure 11. Single course of a regularly laid brick surface (1029) below rough brick surface (1028) within room G10 of Block B. Scale: 1m.

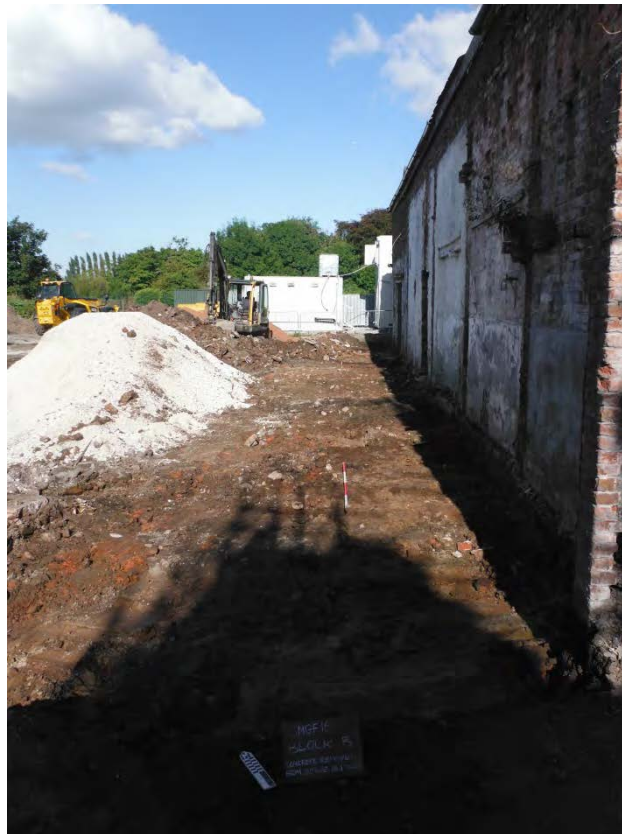
Figure 13. Exterior strip exposing natural clay (1002) beneath footings of former structures along north-west side of Block B. Scale: 2m.

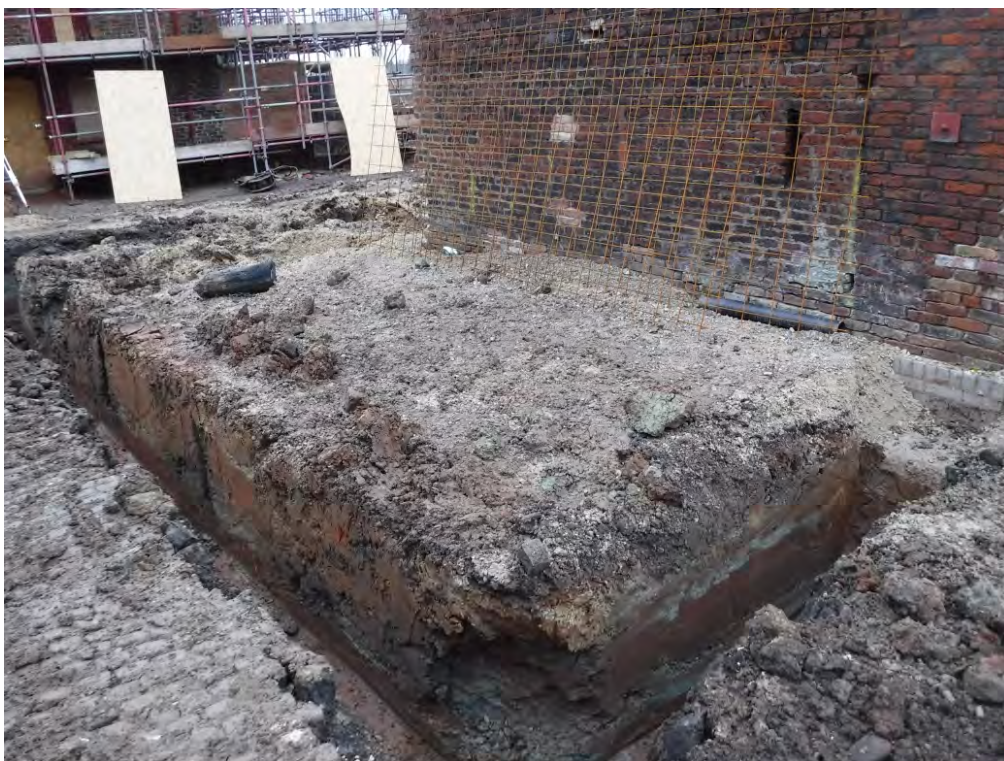
Figure 14. Newly excavated footings through natural clay (1002) after removal of former lean-to footing by the Block B south-west gable end. Two vertical black lines through the clay represent the timber slots for posts associated with the former lean-to. No scale.

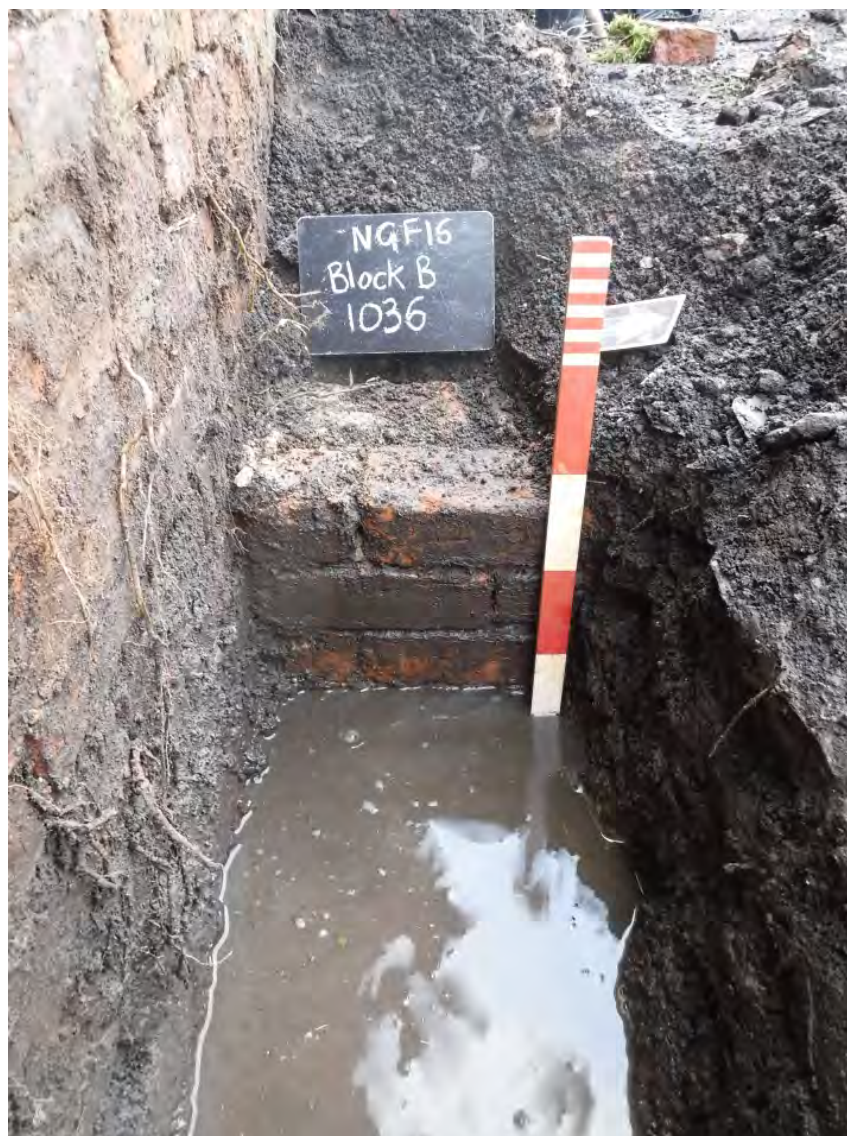
5.4.2 A trial pit, c.1.5 x 0.5m, was excavated on the northern corner of the building, abutting the north-western gable end in an attempt to locate a known drain. The upper part of this trench was excavated through a rubble levelling deposit (1034), c.0.4m deep, which overlay a layer of broken roofing slates which had been used to cap the field drain. In the southwestern end of the trench a short stretch of a north-west/south-east aligned wall was revealed (F1036) that was constructed of handmade red bricks, two skins thick, three courses high and laid in stretcher bond. Although only 0.5m of the wall was exposed, its location: at right angles to and abutting the main wall of the northwest gable end, suggests that it is the foundation of another outbuilding that had been demolished some time before rooms G4-G8 were left to fall into disrepair, or perhaps associated with a brick housing for the drain (Figure 15). Given that this area was not due to be affected by the development no further excavation was undertaken in the vicinity of the wall.

Figure 15. Wall foundation F1036, exposed during the excavation of a small trench dug to locate a known drain at the north-west corner of Block B. Scale: 0.5m.

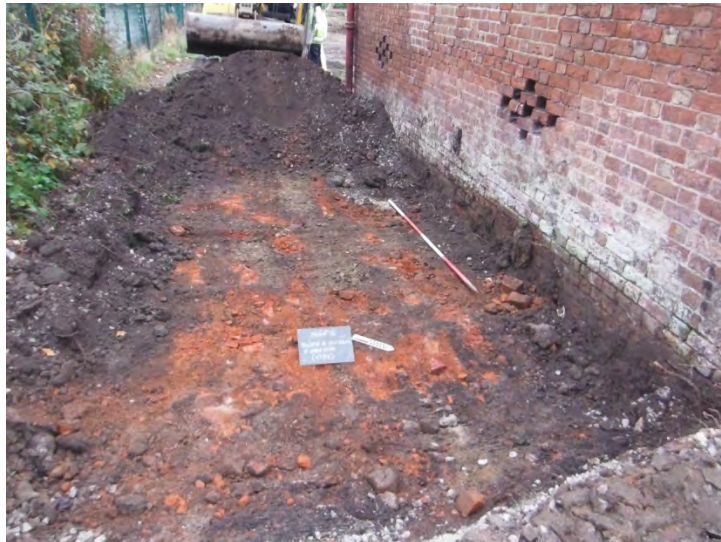
5.5.2 The slots excavated along the exterior of the south-eastern gable end were excavated through c.0.25m of modern overburden (1001) and c.0.25m of rubble (1032) before the clay substrate (1002) was encountered (Figure 18). This rubble spread (1032) was interpreted as a levelling/hardstanding deposit that had been intentionally spread across the natural clay substrate (1002) to bring the ground surface to the same level as the courtyard. A substantial amount of pottery was recovered from this deposit.

Figure 18. Rubble levelling/hardstanding deposit (1032) by south-east gable end of Block B. Scale: 2m.

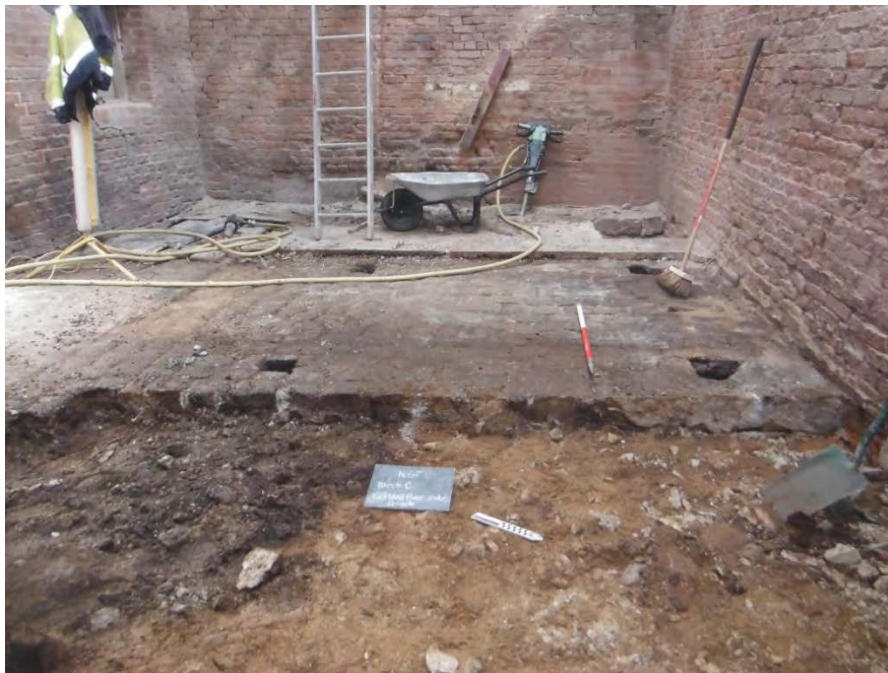
Figure 20. Granite-setts (1021) with sand bedding material (1025) after removal of concrete (1020) in room G1 of Block C, looking south-west. Note remnant of concrete surface beneath wheelbarrow and post-holes through the cobbled floor. Scale: 1m.

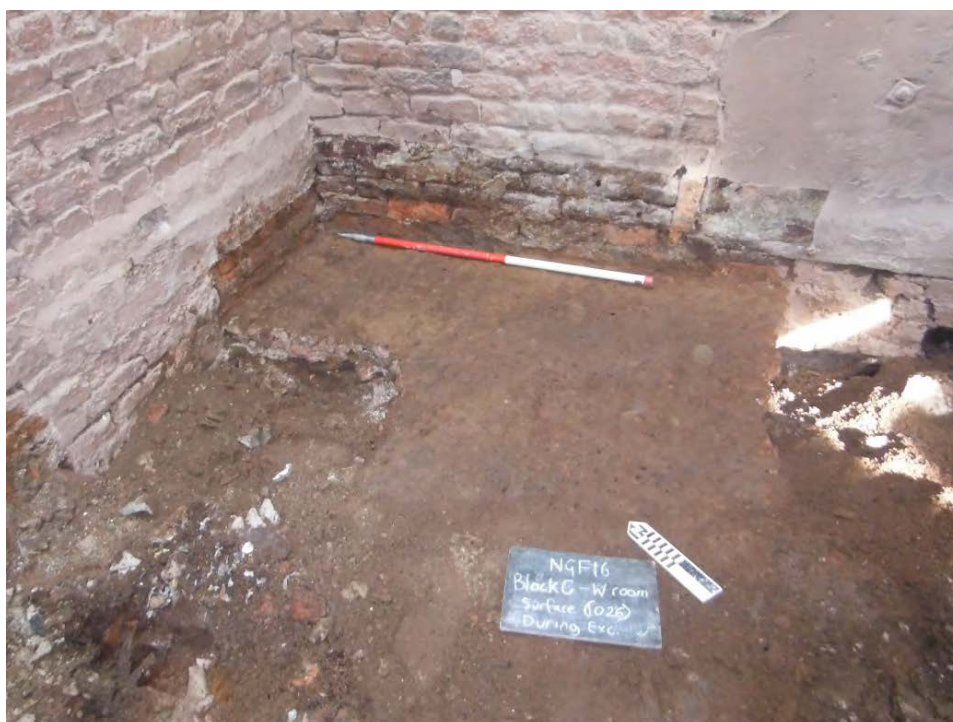
5.6.2 The reduction of all floors within Block C was monitored down to the natural substrate (1002). In room G1 the 0.07m thick concrete surface (1020) was removed to expose a continuation of the granite sett-paved surface (1021). The entire room had been paved with granite setts which were laid onto a bed of sand (1025) 0.08m thick. There were eight postholes arranged in two parallel rows of four through the paved surface, each one represented by a missing sett and a void beneath (Figure 20). The arrangement of these postholes suggests that they were the supports for wooden stalls inside the stable. Removal of the paved surface (1021) and its bedding sand (1025) revealed another surface (1026) comprising hard, compacted crushed brick and lime (brickcrete), 0.1m thick. A single piece of pottery was found on top of this surface, beneath the bedding sand (1025). Removal of surface (1026) revealed a 0.3m thick deposit of mixed clay and silty earth with frequent rubble inclusions (1030). This is likely to represent a levelling deposit for the crushed brick surface (1026) (Figure 21).

Figure 21. Brickcrete surface (1026) after removal of bedding sand (1025) in the north-west corner of room G1 (Block C). Levelling deposit (1030) is visible beneath the crushed brick surface. Undisturbed natural substrate (1002) was encountered below deposit (1030). Scale: 1m.

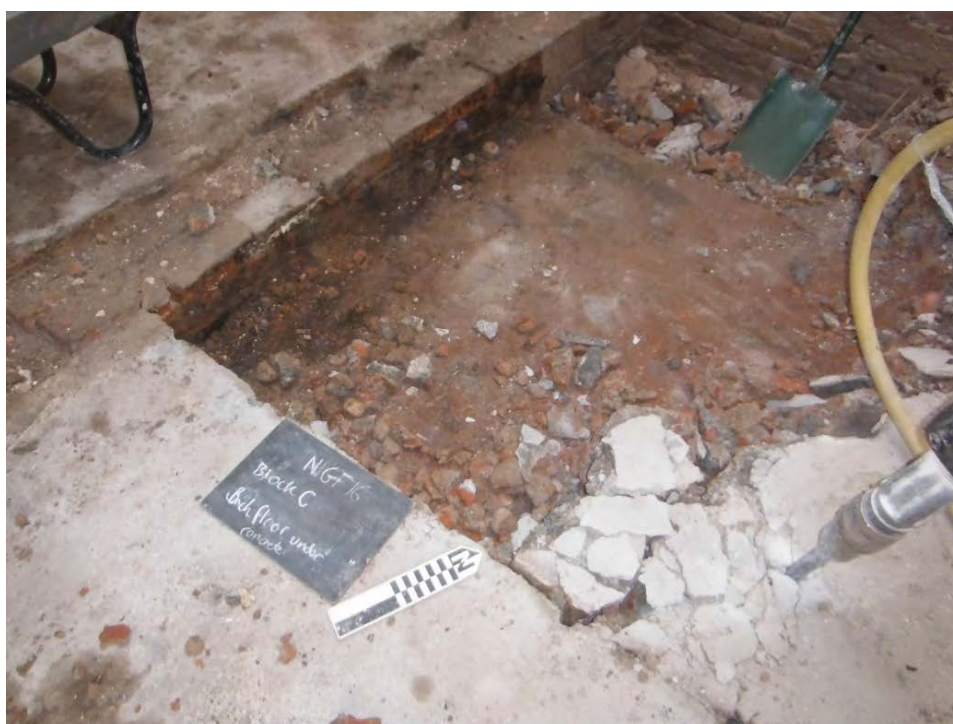
Figure 22. Exposing blue engineering brick surface (1019) after removal of concrete (1017) and brickcrete (1018) surfaces in room G3 of Block C, looking north-west. Visible wall is the remnant footing of the dividing wall between rooms G2 and G3. Scale: 0.25m.

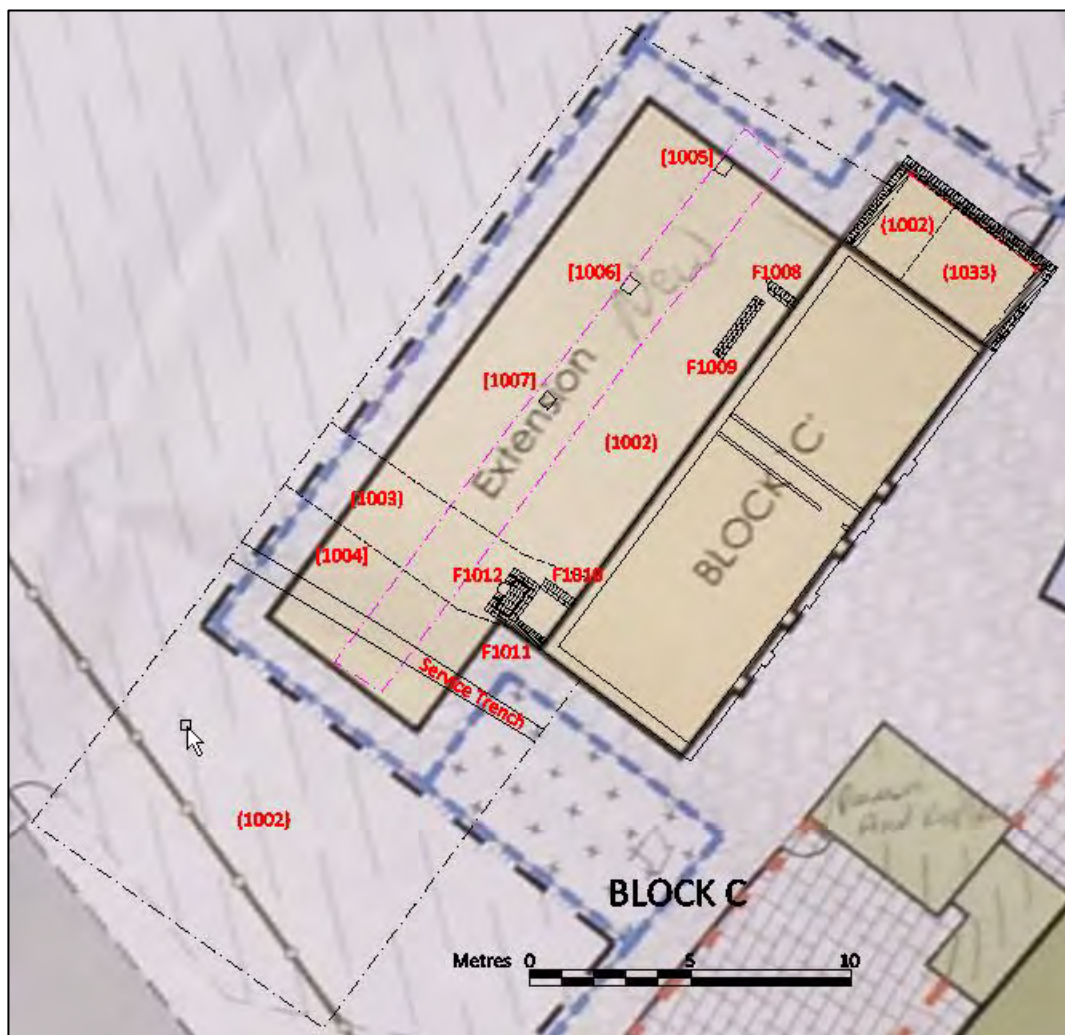
Figure 23. Plan showing exterior excavation areas around Block C. Magenta line indicates initial trench prior to open area investigations. Scale: as shown.

5.7.1 The watching brief monitored ground reduction works around the exterior of Block C in preparation for the construction of outbuildings along the north-west and north-east sides of the building (Figure 23). Initially this entailed the excavation of a 1.7m wide, 20m long investigation trench parallel to the north-west wall of Block C, 3m away from the wall (Figure 24). Following the excavation of the trial trench, the level of the entire area to the north-west of Block C was reduced to formation depth for the construction of a new extension. In total an area c.30 x 11m was excavated (Figure 25).

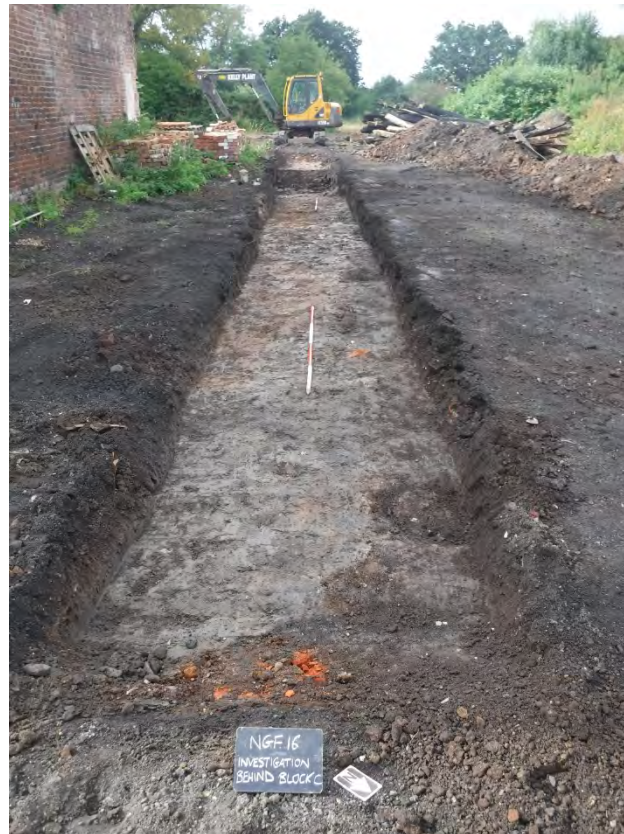
Figure 24. Initial investigation trench behind Block C. Note the concrete stanchion bases along the right hand side of the base of the trench which reflect the outer extent of a former lean-to structure, looking south-west. Scale: 2x2m.

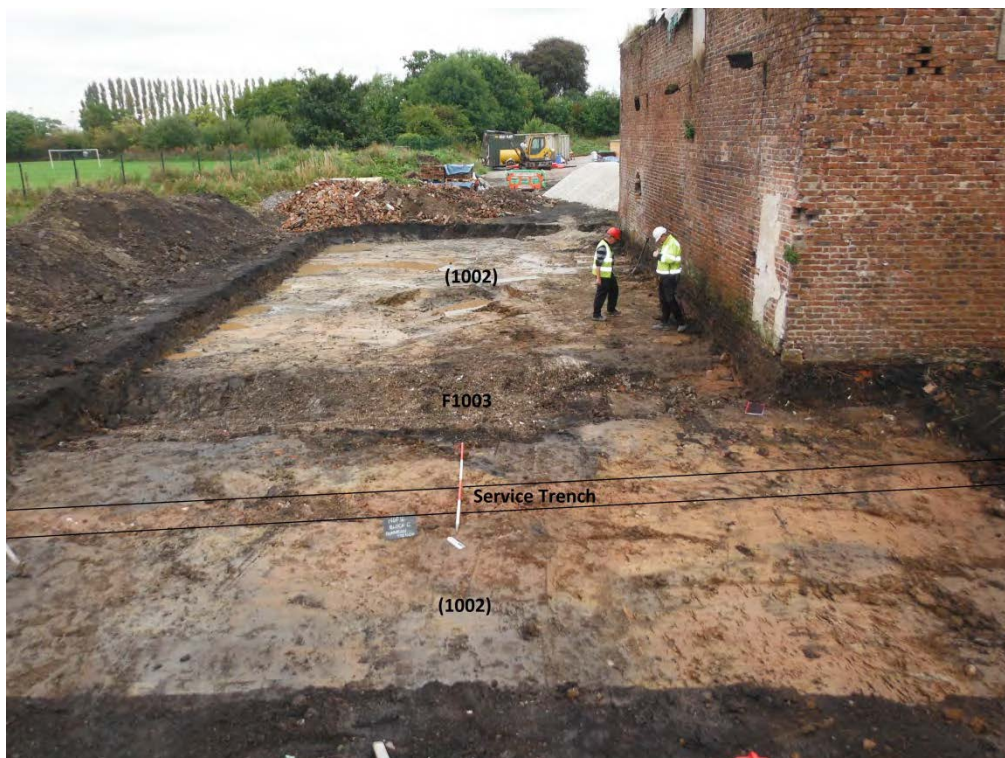
Figure 25. Area behind Block C after open area strip had been completed, looking north-east. Scale: 2x2m.

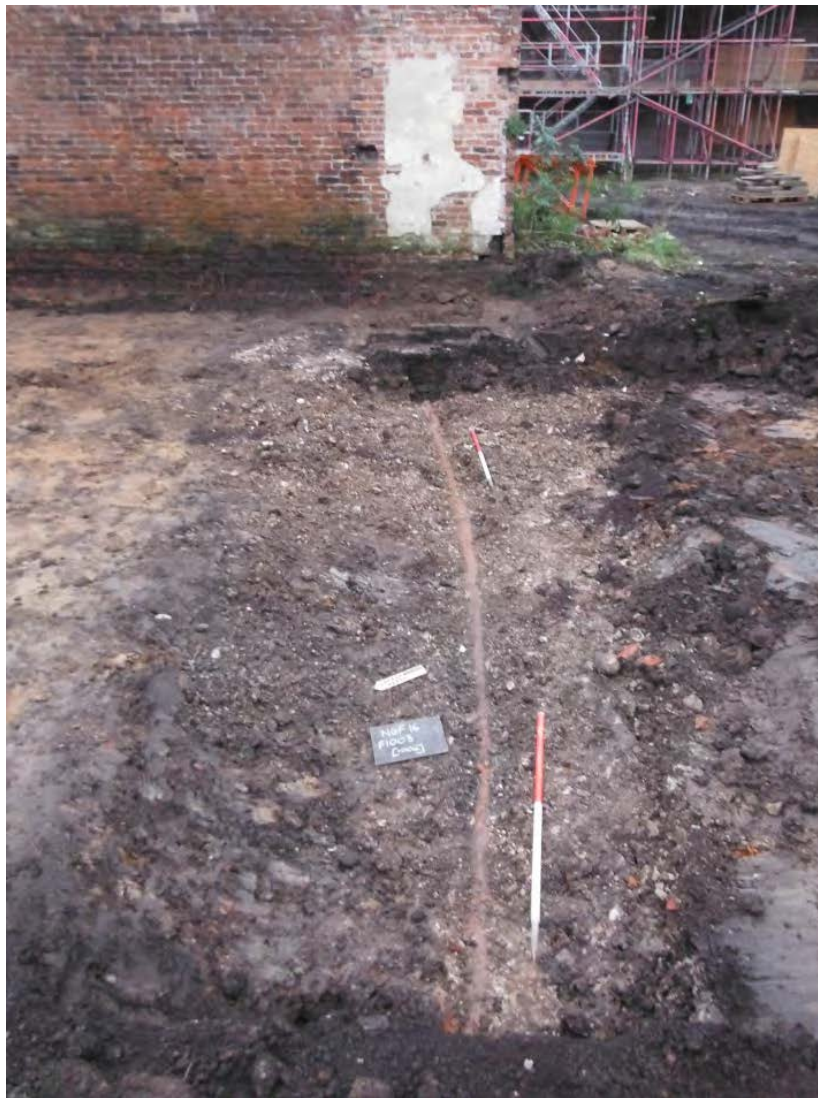
5.7.3 A linear ditched feature (F1003) was encountered, aligned north-west/south-east, extending from the south-western end of Block C. The fill comprised a mortar-rich, mixed silty sand deposit with frequent inclusions of 19th and 20th century pottery, glass, metal and animal bone. The fill overlaid a disused drainage pipe in the base of the ditch cut [1004]. The ditch was U-shaped; it is likely to have been cut to hold the drainage pipe and then intentionally backfilled with subsoil from elsewhere on the estate along with household waste (Figure 26).

Figure 26. Ditch F1003 showing drainage pipe in the base and some of the mortar-rich backfill either side, looking south-east. Base of ditch not observed due to presence of drainage pipe. Scale: 2x1m.

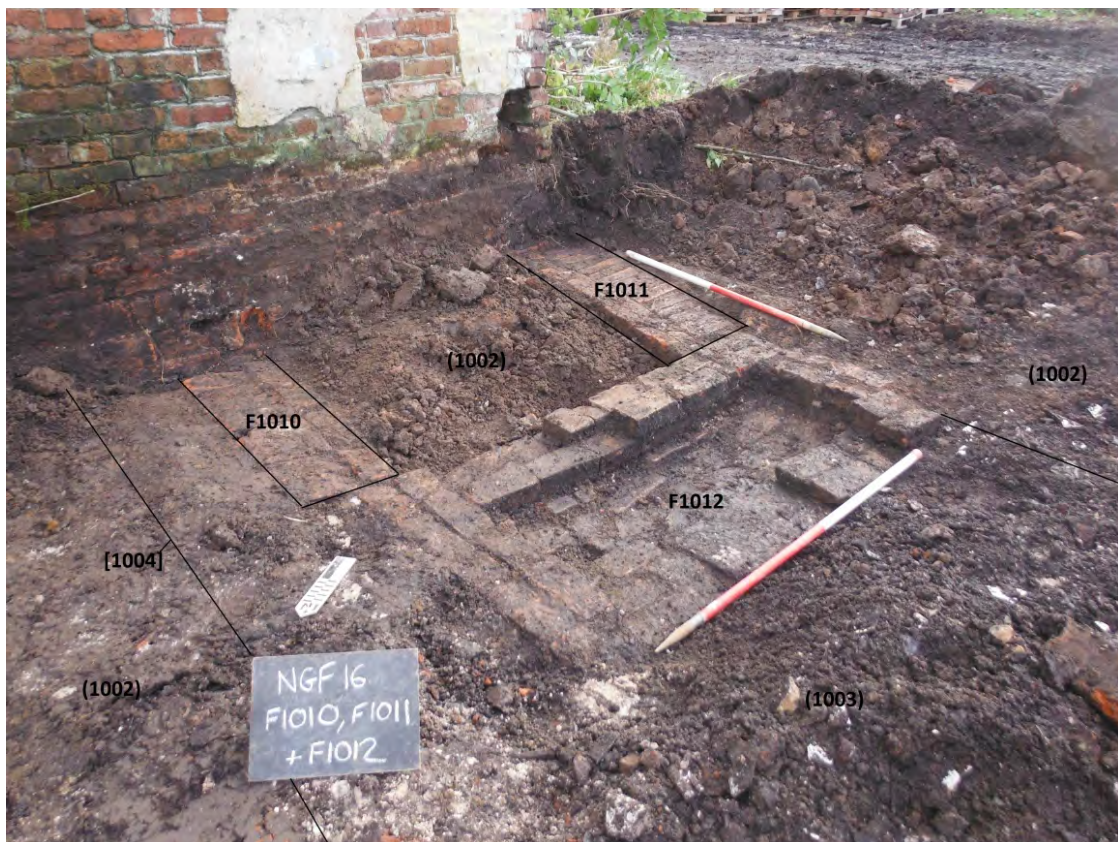
5.7.4 The south-eastern end of ditch F1003 abutted a small structure, F1012, which was 1.6 x 1m in size. Structure F1012 was constructed of handmade red bricks with no mortar. It was rectangular, five courses deep with a central rectangular depression and abutted two short stretches of wall (F1010 and F1011) that extended outwards from the north-western wall of Block C at the south-western corner of the building (Figure 27). The purpose of this structure was unclear; however, the drainage pipe within ditch F1003 ran up to the north-western face of it and the structure was overlaid by the same fill as the ditch (1003). This suggests that the two features were backfilled at the same time and that structure F1012 was probably related to the drainage trench.

Figure 27. Brick structures F1010, F1011 and F1012 at the south-western corner of Block C, revealed after removal of the upper 0.1m of ditch fill (1003) that covered the drainage pipe in the base of ditch F1003, looking south. Note the whitewashing on the wall above walls F1010 and F1011. Scale: 2x1m.

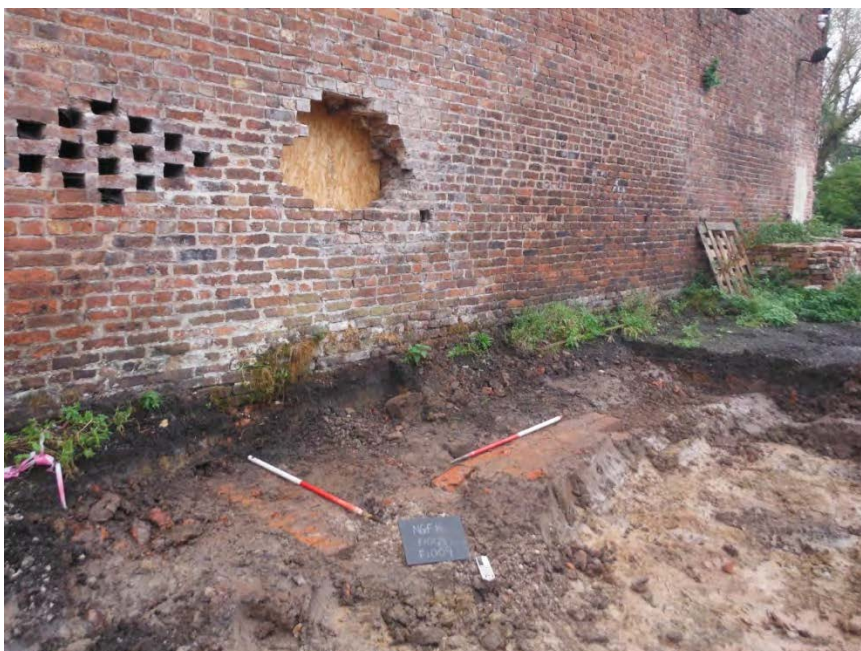
5.7.6 Two further segments of brickwork were found adjacent to the north-western wall of Block C towards the north-eastern end of the building. Brick structure F1008 (aligned north-west/south-east) was two courses high, constructed of handmade red bricks and lime mortar, laid as a row of stretchers with a row of headers along the north-eastern face. Structure F1009 was also two courses high, constructed of handmade red bricks and lime mortar, laid as three rows of stretchers. It is possible that these structures represent part of a brick surface beneath the former lean-to structure that existed along this side of Block C (Figure 29).

Figure 29. Brick structures F1008 and F1009, looking south. Likely to be remnants of a brick surface under the former lean-to structure of Block C. Scale: 2x1m.

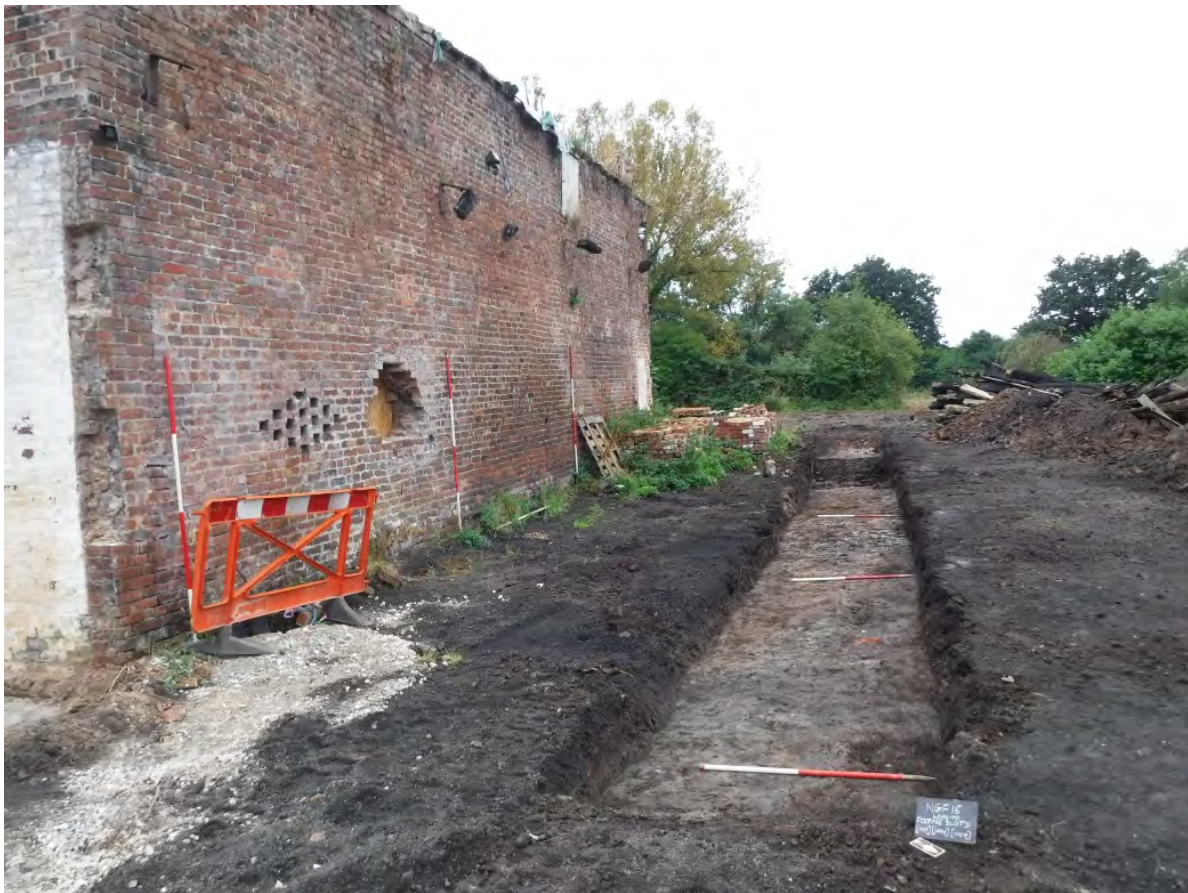
5.7.7 In the initial investigation trench behind Block C, three square holes were observed, (F1005, F1006 and F1007) which marked the bases of post-holes for stanchions belonging to the former lean-to structure. The stanchion base in post-hole F1005 was still *in-situ* as an iron girder concreted into the base of the hole. Where the stanchions had been removed, the holes had been filled with the same stony material that made up the overburden deposit (1001). The locations of the post-holes corresponded with the positions of iron brackets still attached to the north-western wall of Block C, giving a suggestion of the height and width of the former structure (Figure 30).

Figure 30. Locations of stanchion post-holes F1005, F1006 and F1007 (marked by 3x1m ranging rods within trench), corresponding with the positions of three brackets on the north-western wall of Block C (marked by 3x2m ranging rods against wall), looking south-west.

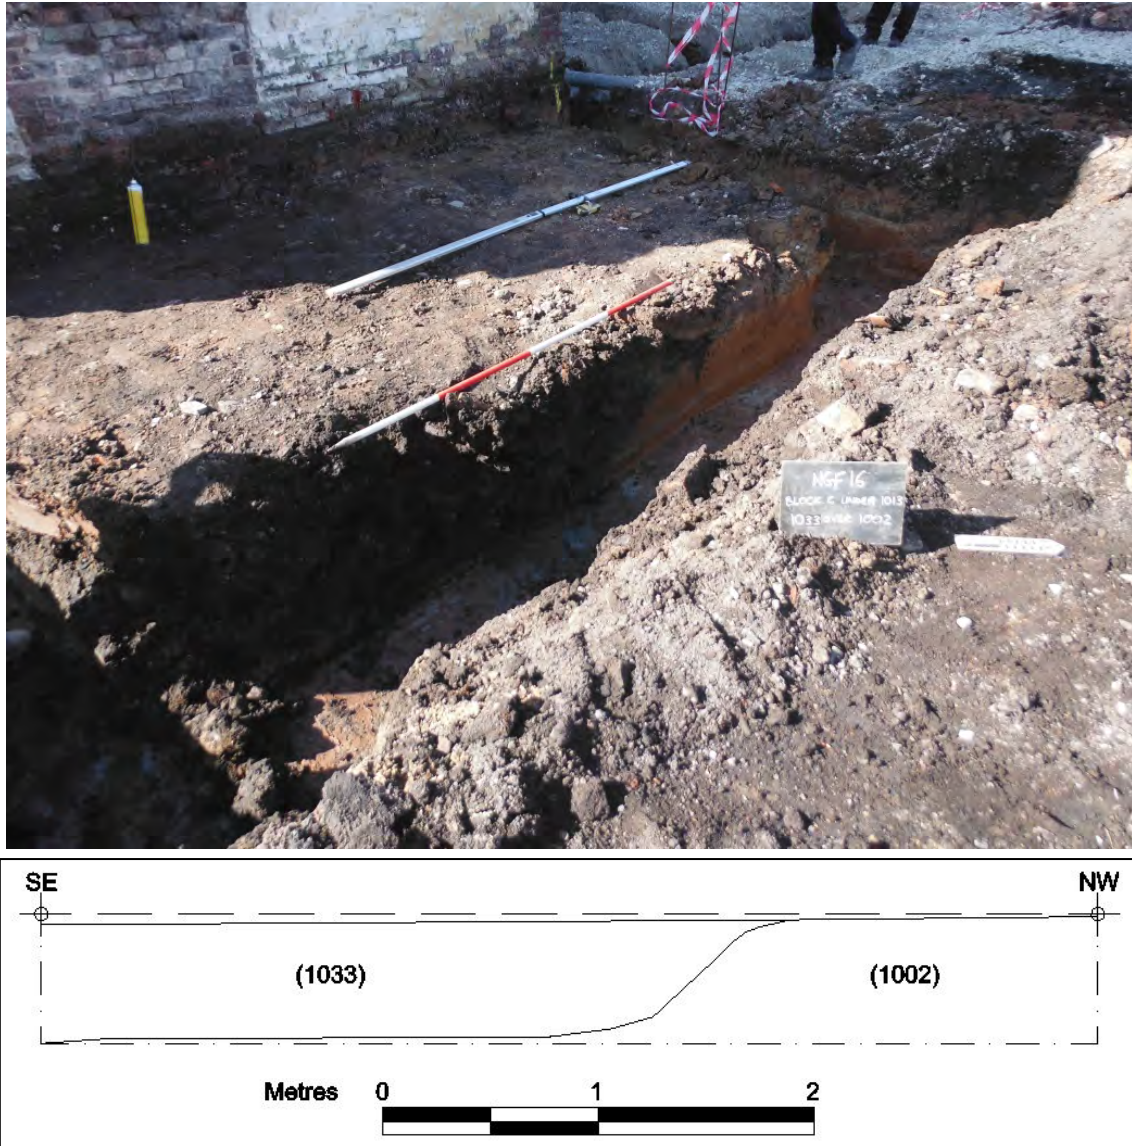
Figure 31. (Upper) Footings for extension at north-east end of Block C after removal of former outbuilding, looking west. (Lower) North-east facing section showing levelling deposit (1033) overlying natural substrate (1002).

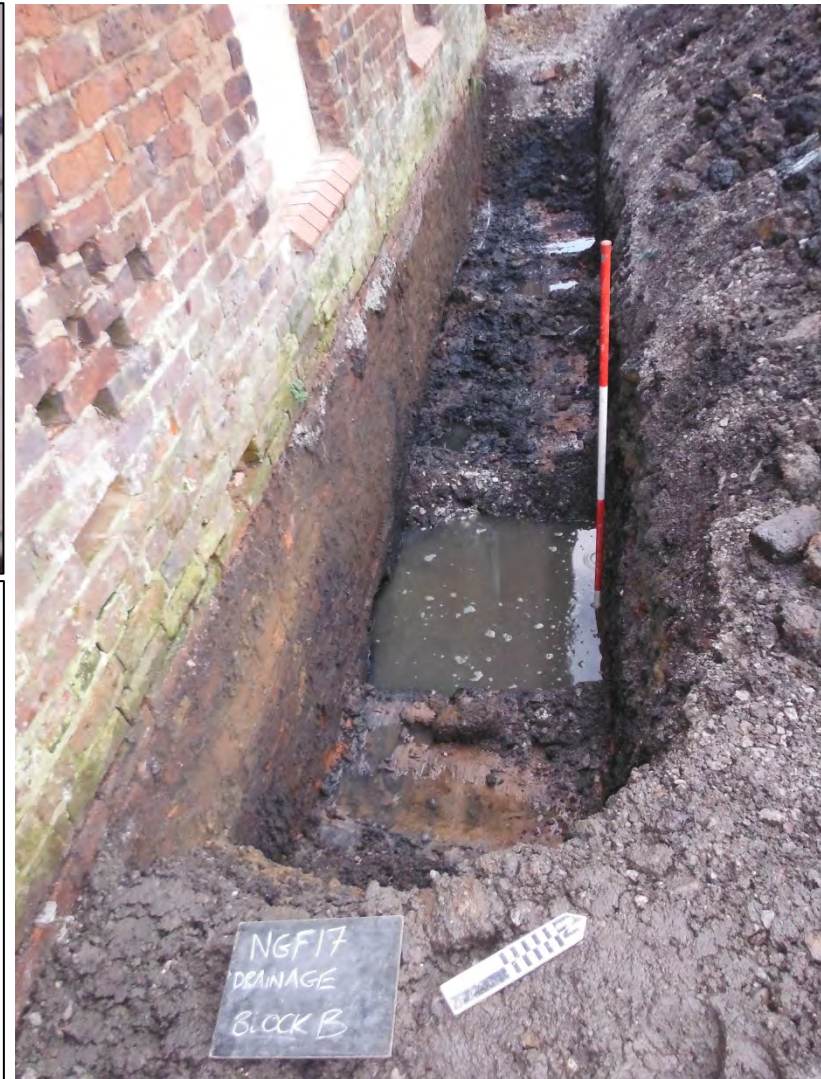
5.8.2 Drainage Trench 1 was observed along the north-eastern edge of Block B. It was 1m wide and 28m long. The trench was excavated through a layer of made ground (1039), up to 1.2m thick that comprised mixed deposits of clay, ash and sand with frequent stone, brick and roofing slate inclusions. A drainage trench (F1042) was also observed abutting Block B that had been backfilled with the same made ground rubble deposit (Figure 32).

Figure 32. (Upper) Plan showing location of Drainage Trench 1. (Lower) SW facing section showing pipe trench F1042 sealed by made ground deposit (1039). (Right) Cut of drainage trench (1042) filled by made ground deposit (1039), looking north-west. Scale: 0.5m graduations.

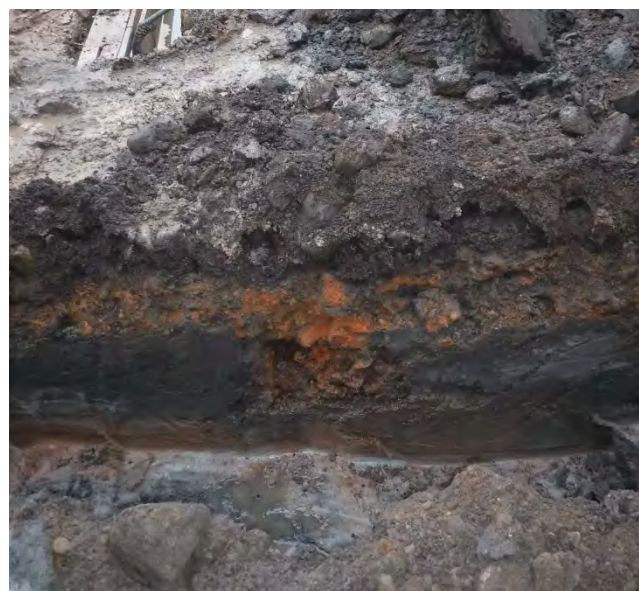
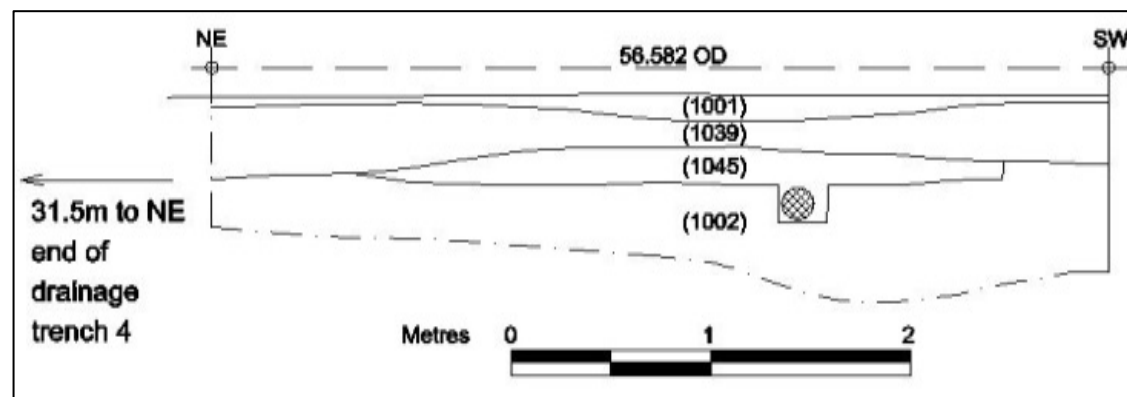
5.8.5 Drainage Trench 4 was 0.7m wide and 35m in length, excavated on a north-east/south-west axis alongside the former outbuildings on the north-west side of Block B down towards Block C. The trench was excavated, recorded and backfilled in short lengths to facilitate the continuation of plant movements around the site between Blocks B and C (Figure 34). The stratigraphy observed within the trench was similar to that seen in Drainage Trench 1, with a variable depth (0.4-0.9m) of made ground (1039) overlying the natural clay substrate (1002). The made ground deposit is likely to have been the same material as that recorded under the concrete slab at the north-eastern end of Block C (1033), and below the cobbled surface of the courtyard south-east of Block B (1041), containing ash, clinker, rounded pebbles and brick fragments. Towards the south-western end of the trench a disturbed lens of rubble (1045) was encountered just below the modern overburden (1001) that had been laid down as part of the made ground deposit (1039) as protection around and above a drainage pipe (now redundant) (Figure 34).

Figure 34. (Clockwise) Plan showing location of Drainage Trench 4. Scale: as shown. (Middle) NW facing section showing rubble lens (1045) overlying natural substrate. Section drawing. Scale: as shown.
