**An Archaeological Watching Brief at
Newall Green Farm, Newall Road,
Wythenshawe, Manchester**

ARS Ltd Report No. 2017/123

October 2017

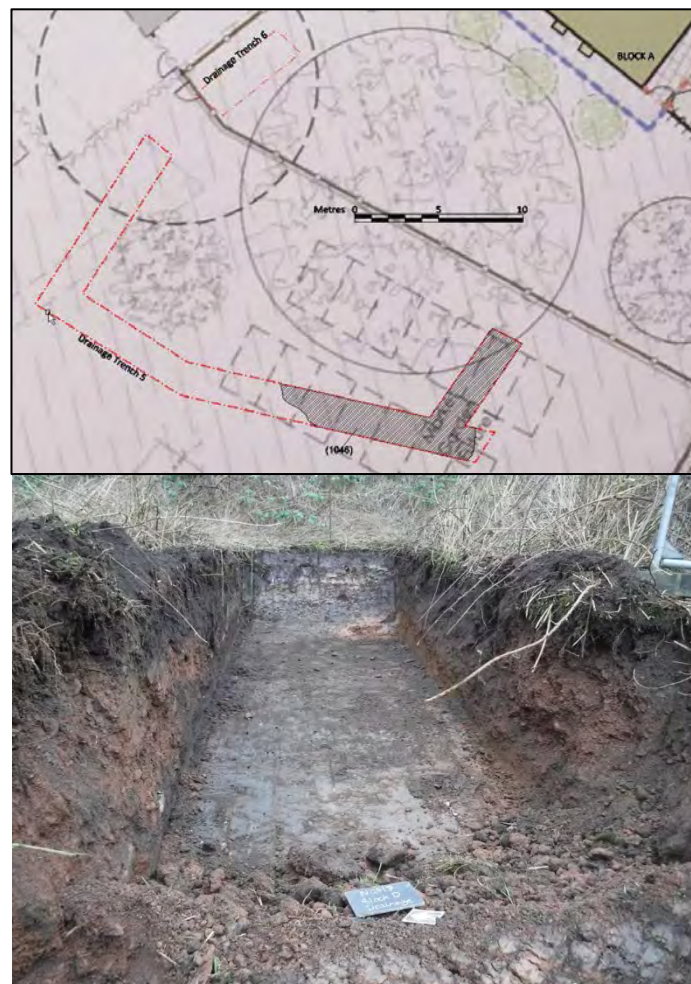
5.8.6 Drainage Trenches 5 and 6 were located to the south-west of Block A, either side of an existing fence line. Trench 5 was roughly U-shaped and extended for a total length of c.44m at a width of 2m. Trench 6 was much smaller, measuring c.6x2m. Across the majority of the area, topsoil (1050) with a maximum depth of 0.3m, was mechanically removed down to the upper horizon of the natural substrate (1002). Once it was ascertained that no archaeological features or deposits were present then the trench was excavated down to formation depth for the new drainage. Towards the eastern extent of Trench 5 an area of rubble with brick fragments, stone sand and occasional fragments of pottery and clay pipe (1046) was identified that was interpreted as an area of intentional deposition associated with either the construction or demolition of structures in the wider area. The deposit was only 0.25m thick and its maximum observed extents were recorded prior to being removed during excavation of the trench down to formation depth (Figure 35).

Figure 35. (Upper) Plan showing location of Drainage Trenches 5 and 6. Scale: as shown. (Lower) Rubble spread (1046) within Drainage Trench 5.

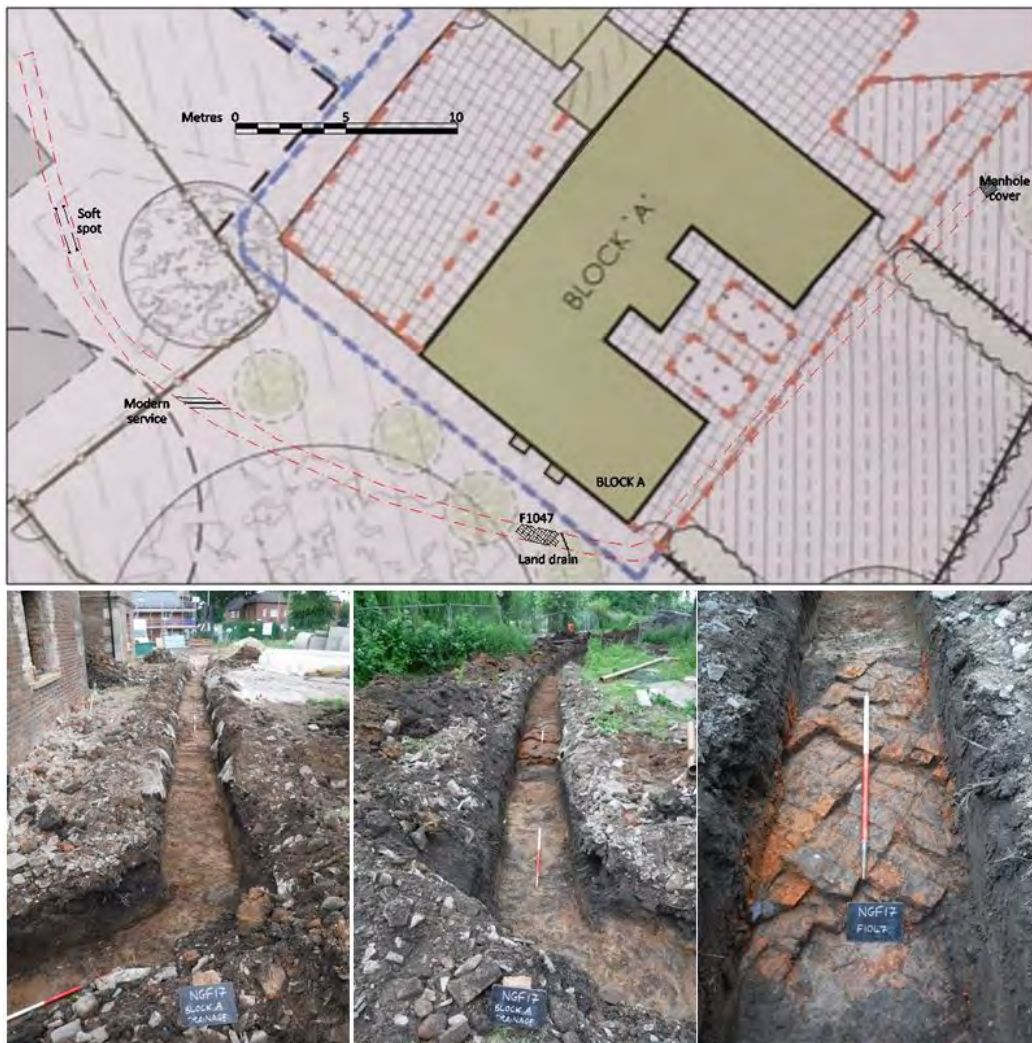
Figure 36. (Upper) Plan showing location of Drainage Trench 7. Scale: as shown. (Lower left) Drainage Trench 7 showing undisturbed natural substrate in front of Block A, looking north-east. Scale: 0.5m graduations. (Lower middle) West-north-west stretch of Drainage Trench 7. Scale: 2x1m. (Lower right) Detailed shot of brick structure F1047. Scale: 1m.

7.7 To the south-west of the main farm complex, a drainage trench through the garden of the farmhouse identified the foundation courses of a square brick structure (F1047). No finds or associated structures were identified to suggest a date or function for the structure, though OS mapping from the 1870's shows that a junction of footpaths through the garden was located at this point. The structure, therefore, might represent the footings of a gate-post, wall or ornamental feature that was never documented.

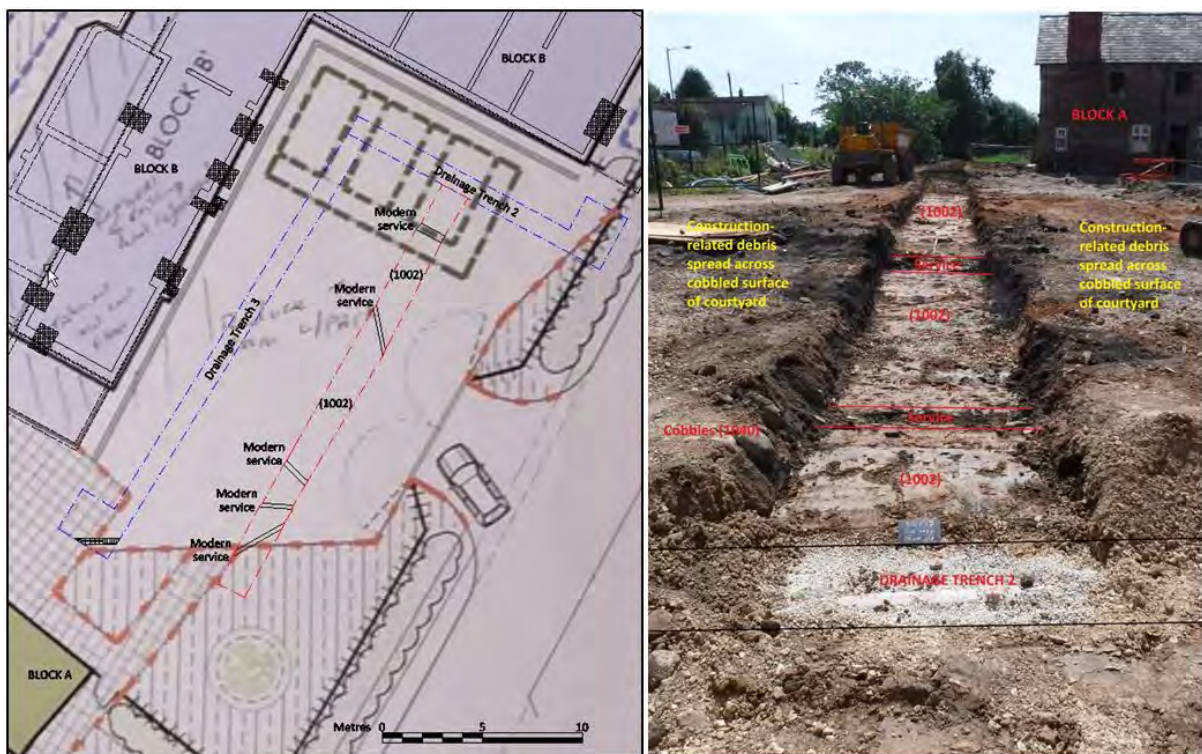
5.9.2 A trench measuring c.23m in length by 1.6m in width was excavated across the courtyard from the south-western edge of Drainage Trench 2 in a south-westerly direction towards Block A (Figure 38). The stratigraphy observed within the trench was the same as that which was recorded in the drainage trenches through the courtyard: an intermittent rounded-cobble surface (1040) overlying a variable depth (0.1-0.3m, shallower to the south-west) of dirty ash/clinker/clay-rich bedding material (1041) and natural substrate (1002). A number of service trenches were observed along the length of the trench, cutting into the natural substrate, but no archaeological features or deposits were encountered. No further archaeological observation was undertaken in this area.

Figure 38. (Left) Plan showing location of investigation trench through the courtyard/carpark area. Scale: as shown. (Right) Annotated photo showing courtyard/carpark trench, looking south-west. Scale: 2m.

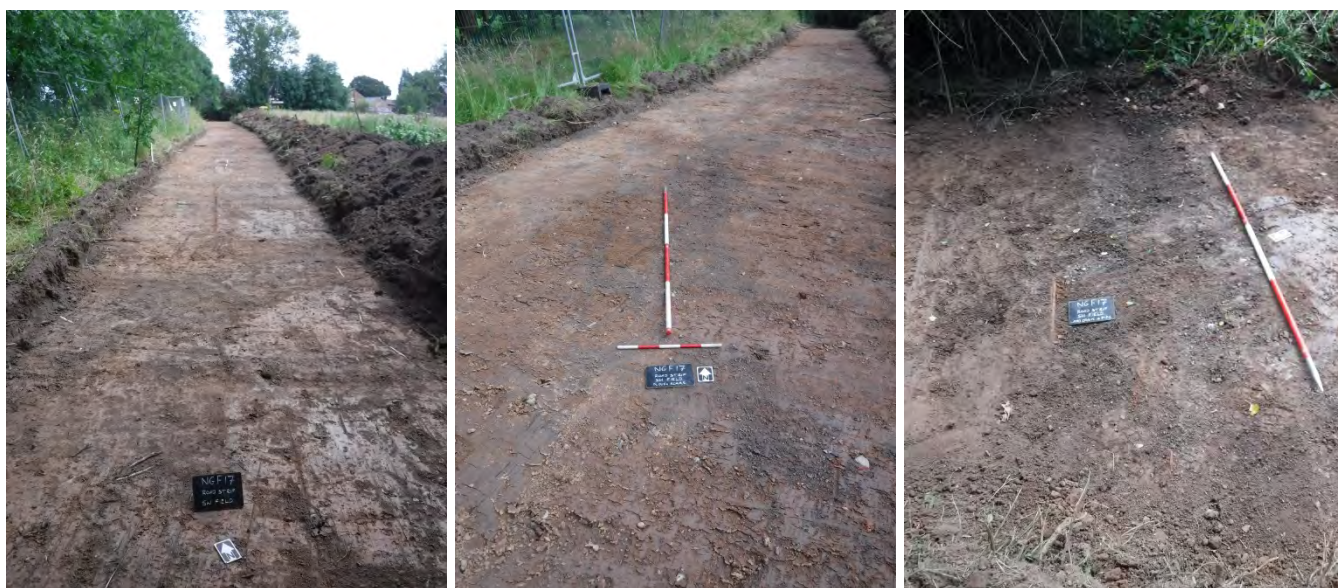
5.10.2 Along the length of the stripped area, removal of a maximum depth of 0.25m of topsoil revealed the natural clay substrate (1002) below. Occasional parallel striations were observed in the upper horizon of the clay that were 0.03m wide, 0.01m deep and spaced 0.7m apart (Figure 40). This is likely to indicate that light ploughing has taken place in this field, an activity which has contributed in the dispersal of pottery, charcoal and brick fragments throughout the topsoil. Pottery from the stripped area was retained for assessment.

5.10.3 At the north-eastern extent of the strip a narrow band of disturbance (1.12m wide) was identified within the substrate that had a coarse, gritty texture and was on the same alignment as a hedgerow that separated the main building complex of the farm from the south-western field. Upon excavation this material was found to be only 0.06m in depth and contained a redundant lead pipe and a broken field drain (Figure 40).

Figure 39. (Left) Access road strip, looking north-east. (Middle) Light plough marks through natural substrate (1002). Scale: 0.5m and 2m. (Right) Disturbance at north-east extent of strip containing redundant pipe and land drain, looking south-east. Scale: 2m.

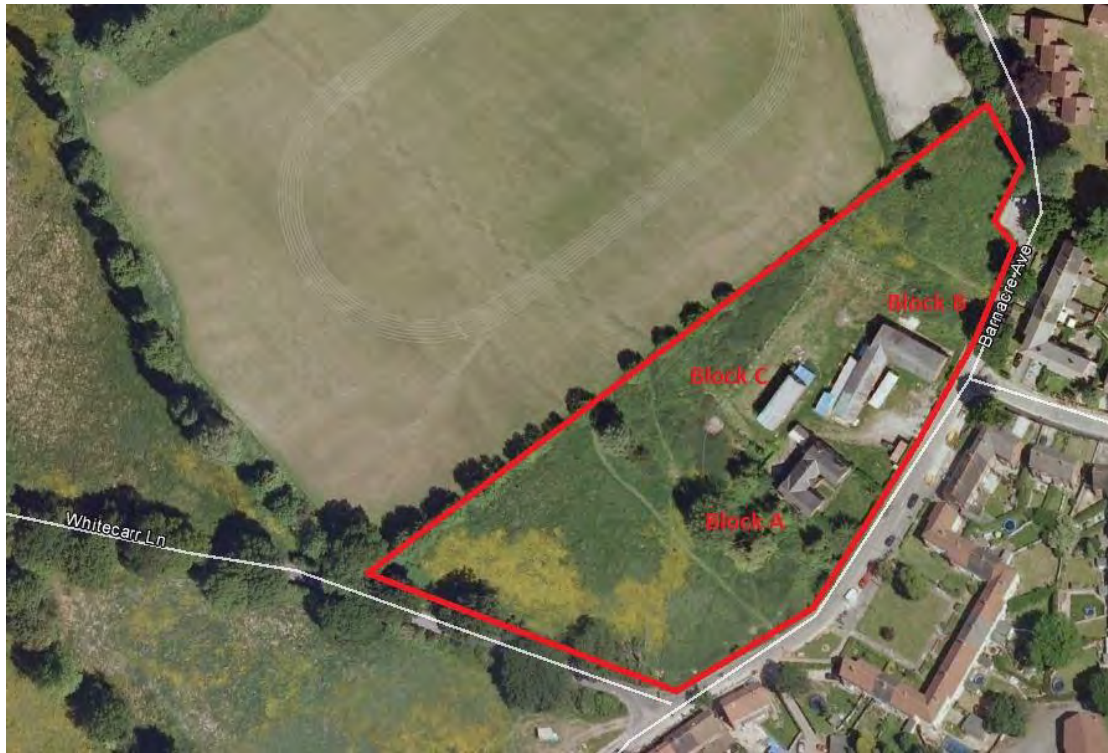
Figure 1. Redline boundary of the proposed development area showing the locations of Blocks A, B and C. (Ordnance Survey Data © Crown copyright. All rights reserved. Licence No. 100045420)

1.3.1 The 'red line boundary' of the proposed development area (PDA) is outlined in red on Figure 1 and covers approximately 1.35 Ha. The site is bounded by the curve of Newall Road and Barnacre Road along the south, south-east and north-east sides; by Whitecarr Lane to the south-west and by a playing field associated with Newall Green High School along the western and north-western side.
