Archaeological Excavations at Nos. 77-81 Sidney Street, Sheffield, South Yorkshire

ARS Ltd Report 2018/43 April 2018

Report Excavations at 77-81 Sidney Street, Sheffield, South Yorkshire

Archaeological Research Services Ltd Report 2018/43

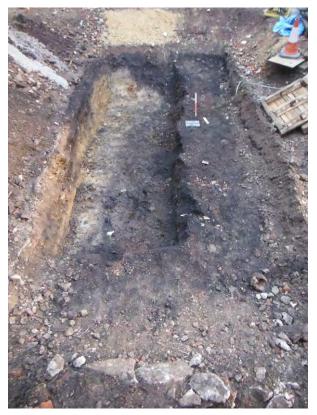
Figure 2 – Trench 1, looking north. Scale, 1m in 0.5m subdivisions

A 10m x 4m east to west aligned evaluation trench (Figure 2) was opened by mechanical excavator to the rear of the former Speedwell Works. The trench was stepped on the eastern side to create safe access.

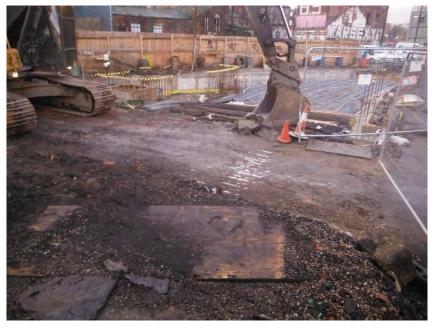
Figure 4 - Site B (Phase 2), pre-excavation, looking South

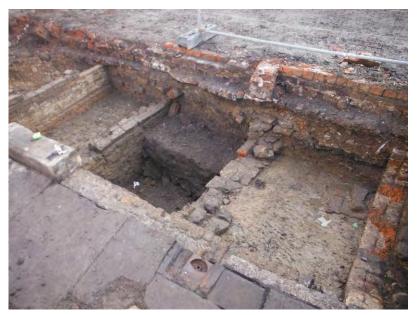
Figure 6 - Phase A cellaring, looking Southeast

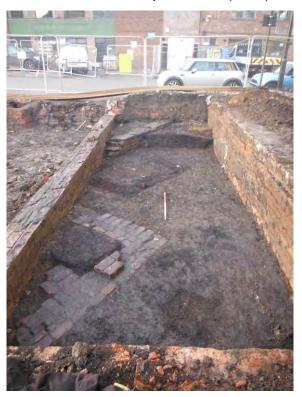
Figure 9 - Phase B brick structures, looking north. Scale 1m in 0.5m subdivisions.

This phase, described below, is represented by two sub-groups; Phase B.1, a cut feature [4007] truncated by structures (4002,4004), and Phase B.2, a brick built structure (4009-4014) (Figure 9), identified towards the centre of the mitigation area. This structure was visible on either side of the *Phase J* 20^{th} century brick wall (4002).

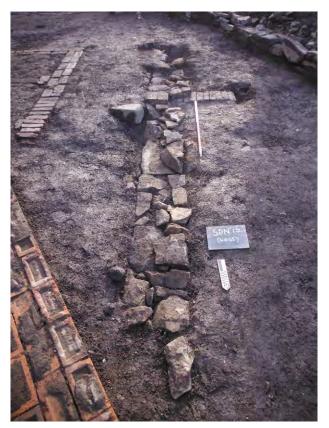
Figure 11-Stone wall (4005), looking south. Scale 1m in 0.5m subdivisions.

It is likely that (4004) and (4005) were originally the same wall, as the alignment, construction style and materials were virtually identical. It is likely that wall (4004; 4005) was the external wall of a large building, potentially that seen on the 1832 Taylor's Map of Sheffield (Figure 10).

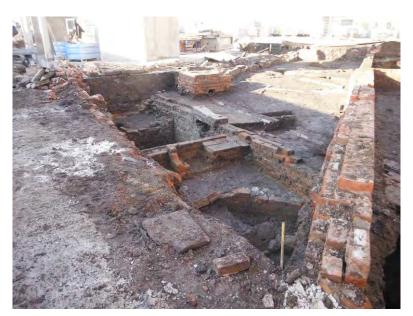
Figure 15-View of Phase F.1 housing, looking Northwest.

It was notable that the lime mortar used in construction was visibly different in colour from the *Phase F.2* structures. Within this phase it was noticeably more yellow than the paler mortar used in *Phase F.2*. This aids the understanding of the phasing as well as demonstrating differences in construction techniques.

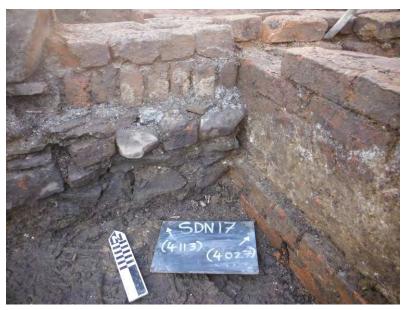
Figure 16-Wall foundation (4113), overlying wall (4027), looking Northeast

Within this phase of deposition/truncation, a wall foundation (4113) and associated redbrick wall (4024) was seen to be overlying (4027), (Figure 16). Wall foundation (4113) was also seen to be built directly over the remains of the earlier cellaring, incorporating it into the foundations of the overlying structures. A stone lintel (4031) was identified keyed into the brick wall (4024), and also into brick wall (4030). Brick wall (4030) and associated stone foundation (4115), ran on the same alignment as (4024), and also utilised the demolished cellar walls as foundations.

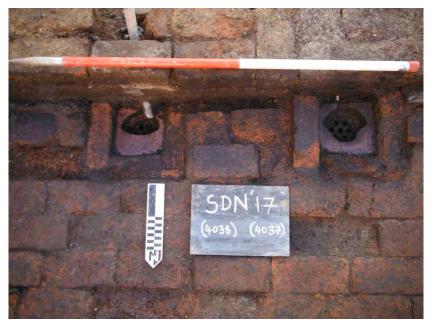
Figure 17-Ceramic drain hoppers (4038) and (4039) also showing insertion of later lead pipe, looking South. Scale 1m in 0.5m subdivisions.

This phase of deposition/truncation describes a remodelling identified along the rear of the workers housing., in the form of an insertion of lead pipe and associated drainage. A surviving lead pipe was identified cutting through exterior wall (4028) and draining into the abutting ceramic hopper (4038). An identical hopper (4037) was identified butting against the north face of (4024). The hoppers in turn fed into buried ceramic drains (4103) and (4104). The drainage was seen to have flowed in a broadly easterly direction, although the final location of a main-drain or sewer was not identified.

The hoppers were of an unusual type (Figure 17) and an example has been retained for archiving and any future analysis.

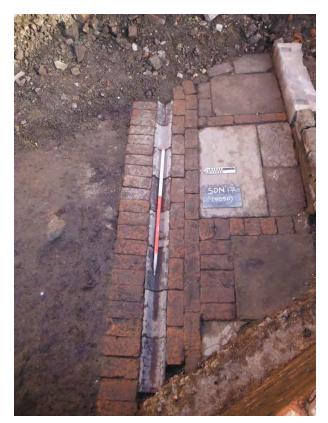
Figure 18-Pathway to rear of workers housing, showing drainage gully (4051) Scale 1m in 0.5m subdivisions.

It is not certain if the pathway had been repaired at some point, however the mixture of brick and stone, laid irregularly could support that interpretation.

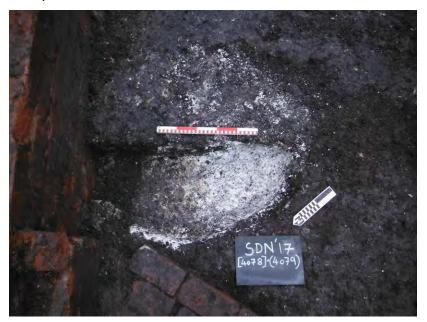
Figure 19-Mortar mixing pit [4078], looking Southeast. Scale 0.5m in 0.1m subdivisions.

A bowl-shaped pit [4078], circa 1m - 1.2m in diameter and 0.25m deep cut through the phase G.1 yard surface at 60.49m aOD. This pit was filled entirely by (4079) a soft lime mortar deposit (Figure 19) and represents a mortar mixing pit possibly denoting small scale structural repairs which required fresh mortar and were likely taking place, *ad-hoc* throughout the lifespan of the site.

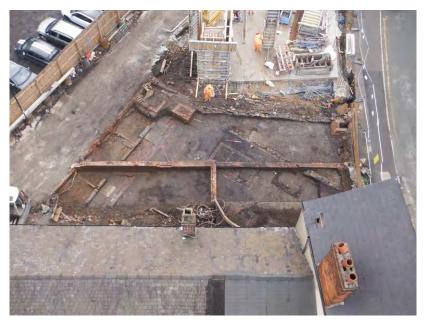
Figure 23-Aerial shot of site, showing Substation walls in bottom left of shot and modern wall (4002). Looking West. Scale 1m in 0.5m subdivisions.

This phase describes the construction of an electricity substation, first seen on the 1923 Ordnance Survey Map of Sheffield (Figures 22). The walls (4015) and (4016) were triple skinned, built from frogged machine made red brick in alternating courses of headers and stretchers, and built on a concrete raft foundation which overlay the Phase H demolition rubble as well as the surviving 19th century yard surfaces. The walls were built from typical early 20th century materials, namely machine made frogged brick bonded with a hard, grey cement-type mortar.

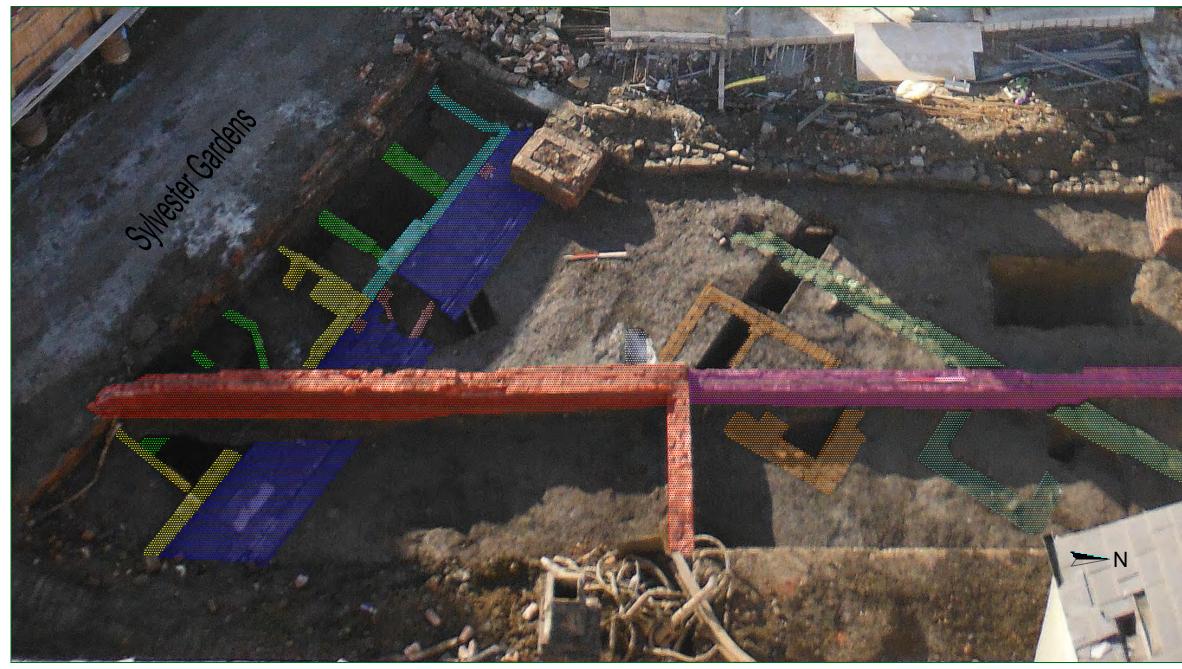
Figure 25 - Aerial photo with overlay of different phases
