**Clayton Hospital, Wakefield, West
Yorkshire**
Historic Building Recording

ARS Ltd Report 2018/77
OASIS ID: archaeol5-318560
March 2018

Clayton Hospital, Wakefield, West Yorkshire Historic Building Recording

Archaeological Research Services Ltd Report 2018/77

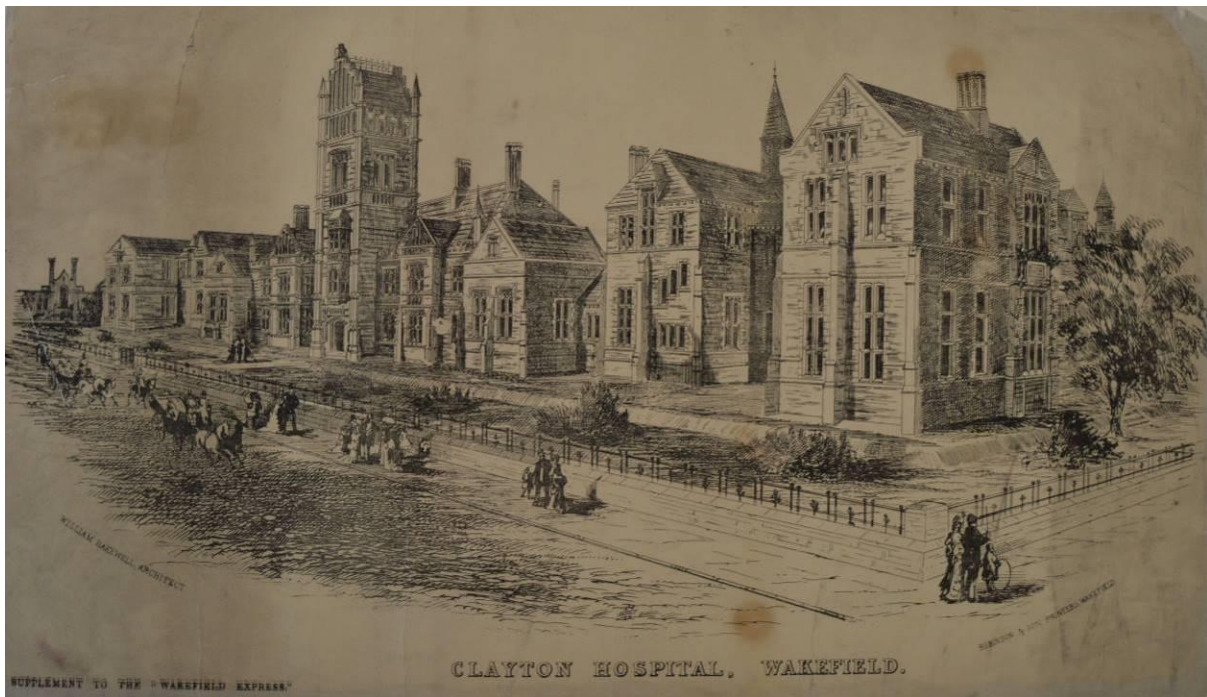
Figure 2: A contemporary engraving of the original hospital ranges (Wakefield Archives).

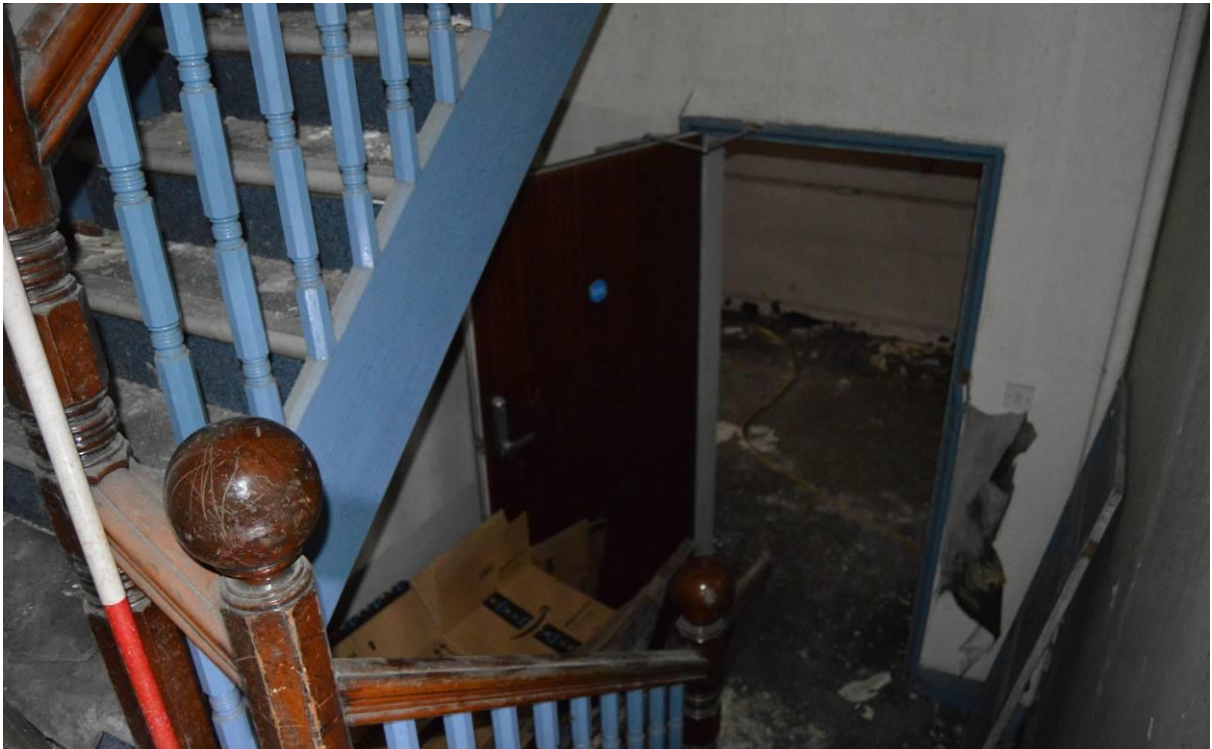
To the west of the visitor's hall was Room G3 which contained a staircase to the first floor level (**Appendix II, Figure 7, p.192**). This was accessed via a late flush fire door with dark veneer face, hung with stainless steel hinges and closing mechanism. The casement conformed to the thickness of the wall with a simple chamfered architrave. The staircase had a dog-leg with half-landing to the west wall. The balustrades were octagonal with large spherical finials over a spun base. The spindles similarly comprised octagonal segments interspersed with machine turned sections. The first flight of stairs and half-landing were enclosed below with timber panelling. There were no windows or other sources of natural light at the time of the recording.

Plate 21: View from the half-landing in room G3 of the administration range. Scale 2m. Facing north.

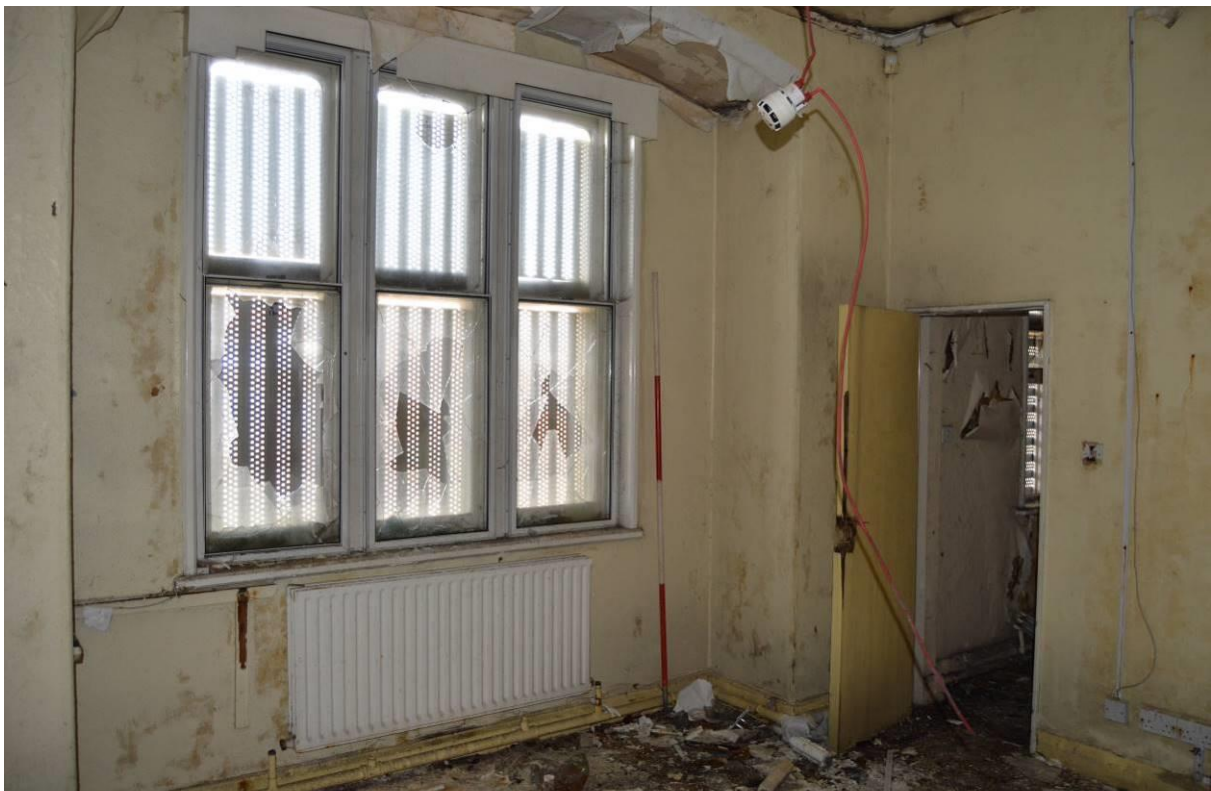
The room F8 could be accessed through doorways to the east and south walls. The east door, a modern flush type, was found to be a later addition; the south access would originally have been the only door, from the nurses' corridor, maintaining the separation of the surgeon's accommodation from lower ranked staff. Designated as the matron's bedroom the room had three bays of sash windows set under an arched recess with segmental head and chamfered edges. The east elevation had a centrally placed chimney breast although the hearth had not been retained. A thin wood mantle shelf remained supported on three simple brackets. The room retained more of the simple torus coving still in place.

Plate 49.1: Matron's bedroom. Note later door inserted. Scale 2m. Facing north.

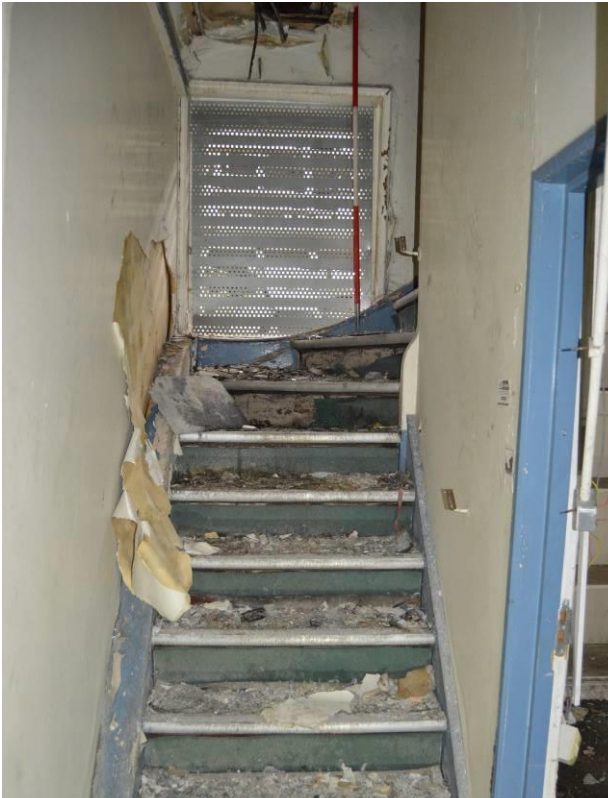
F10 was the staircase to the second floor level at the west end of the nurses' corridor (**Appendix II, Figure 8, p.193**). This was not on the original plans and was thought to have been added later when the second floor was adapted for further living accommodation. The cut to the coving above the corridor and adjacent nurse's bedroom would corroborate this. The stairs were constructed of timber with spiralling steps incorporating a dog-leg around a square chamfered newel post.

Plate 52.1: Stairs to the west of the nurses' accommodation. Scale 2m. Facing south west.

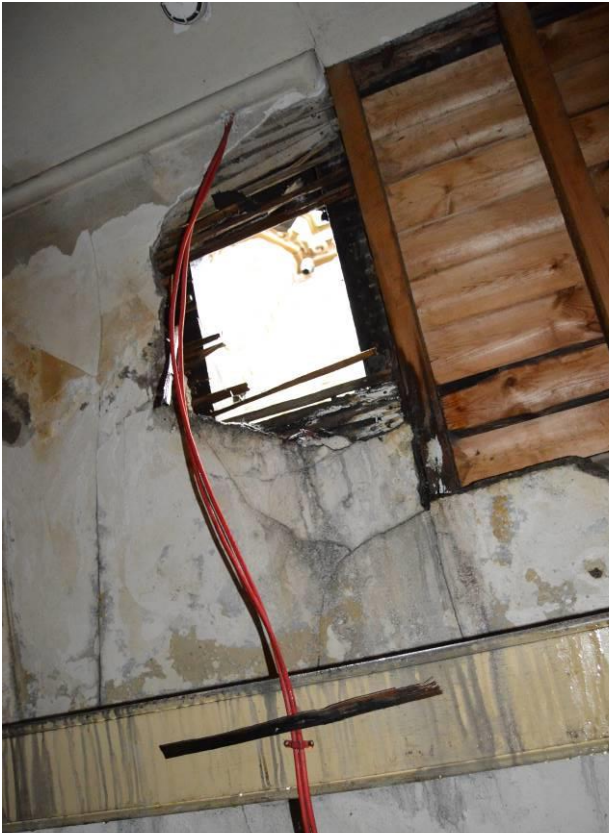
Plate 61.5: Damage to roof behind tower. Note later wood planks. Facing south east.

Plate 61.5: Damage to roof behind tower. Note later wood planks.

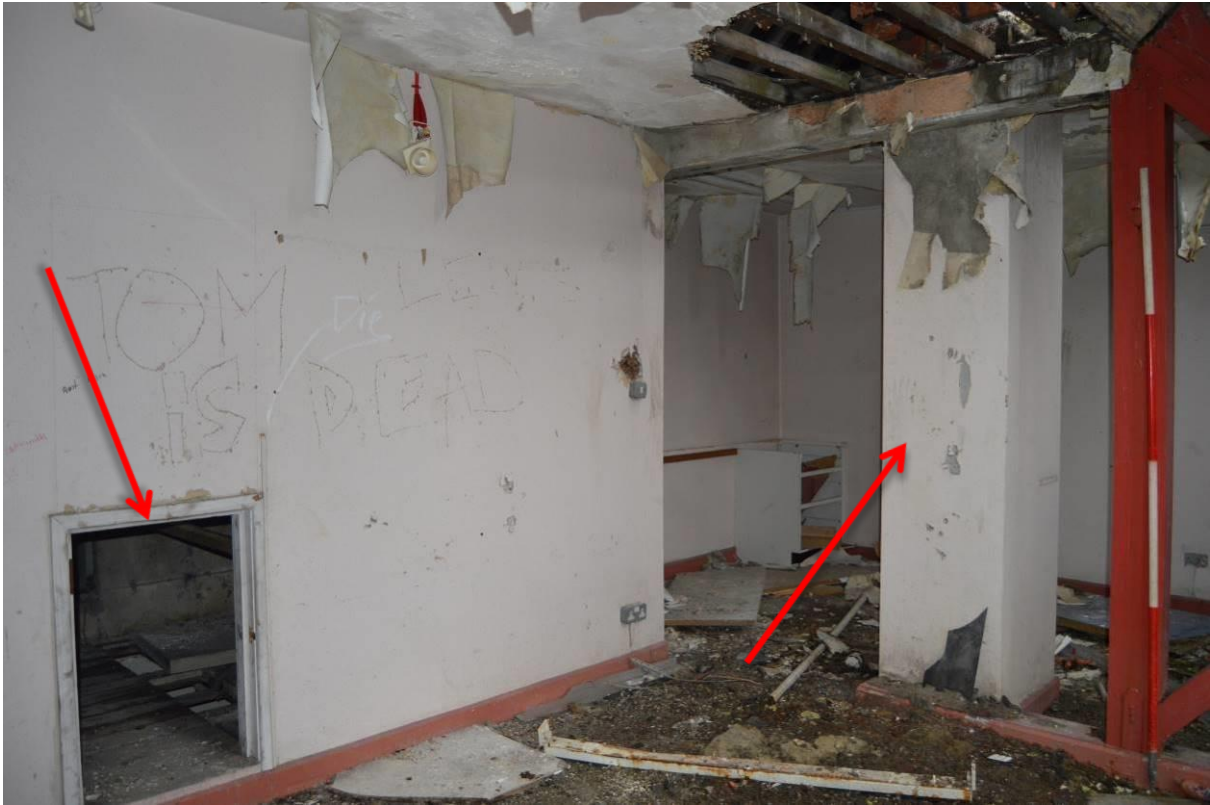
The largest room in this section S3 had undergone some modern re-arrangement, most notably insertion of a modern timber truss which appeared to be a repair to an older, failed roof timber. The window was a wide dormer of two bays, each with two casements. Below the window due to disrepair was evidence of a different construction method for plasterwork. Most historic surfaces to the lower levels were of lathe and plaster, the second floor structure utilised a metal mesh as support for the plaster. Interestingly there was a squint style opening (similar to that seen in the visitor entrance/waiting room) from room S3 into the light well, room S2.

Plate 65.1: Room S3 with hatch to tower and chimney flue in the centre of the room. Scale 2m. Facing north.

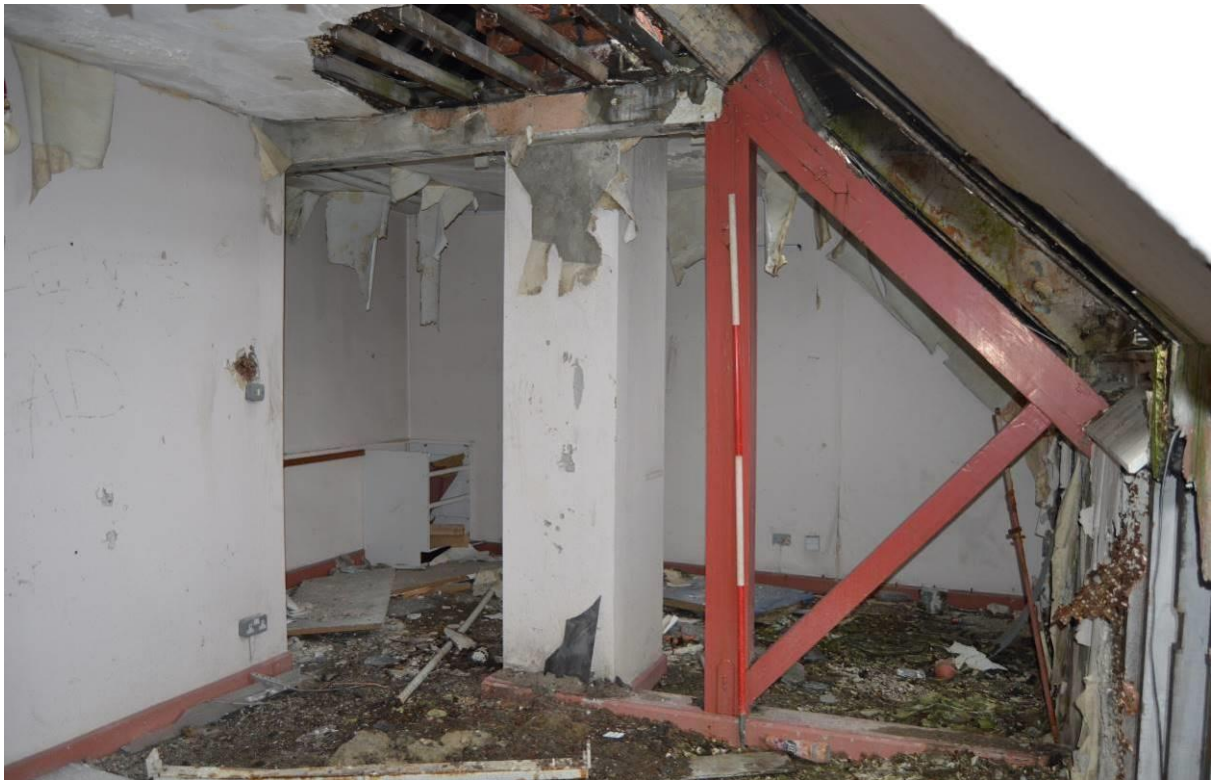
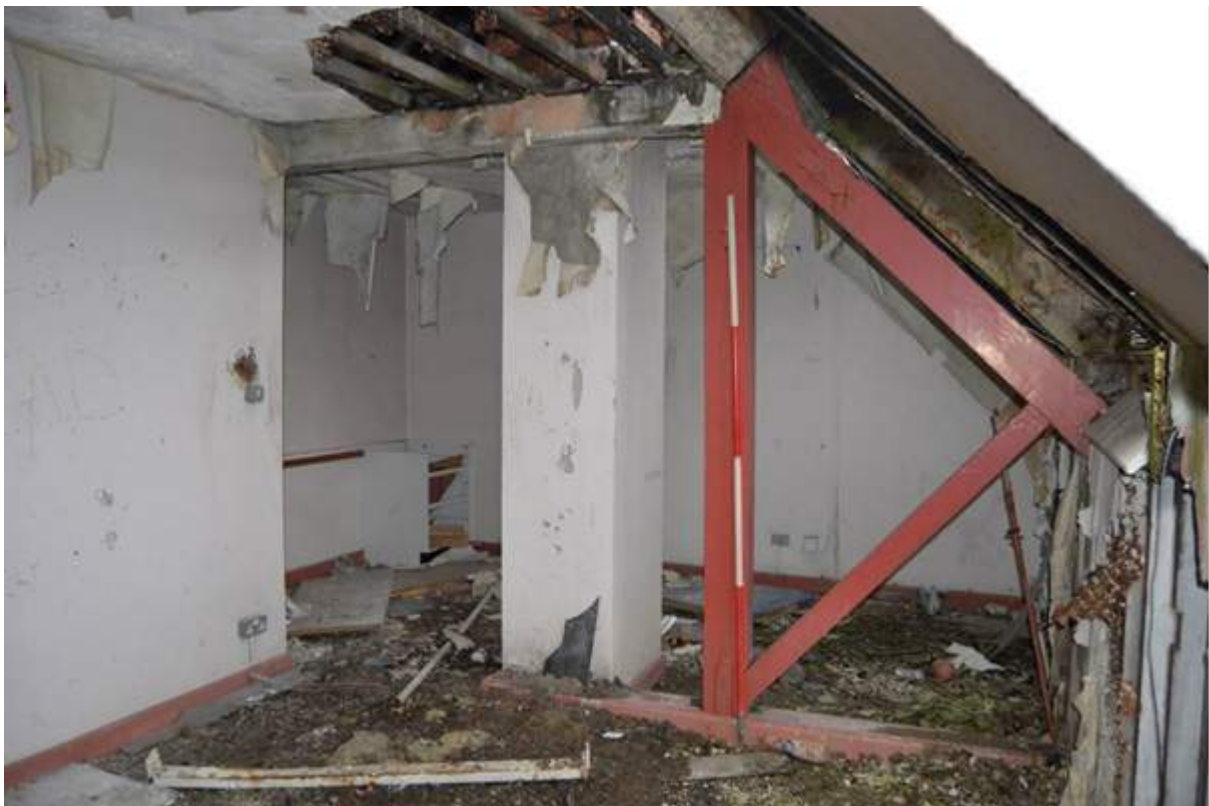
Plate 65.2: Repaired timber truss to room S3. Scale 2m. Facing north east.

Plate 65.2: Repaired timber truss to room S3. Scale 2m.

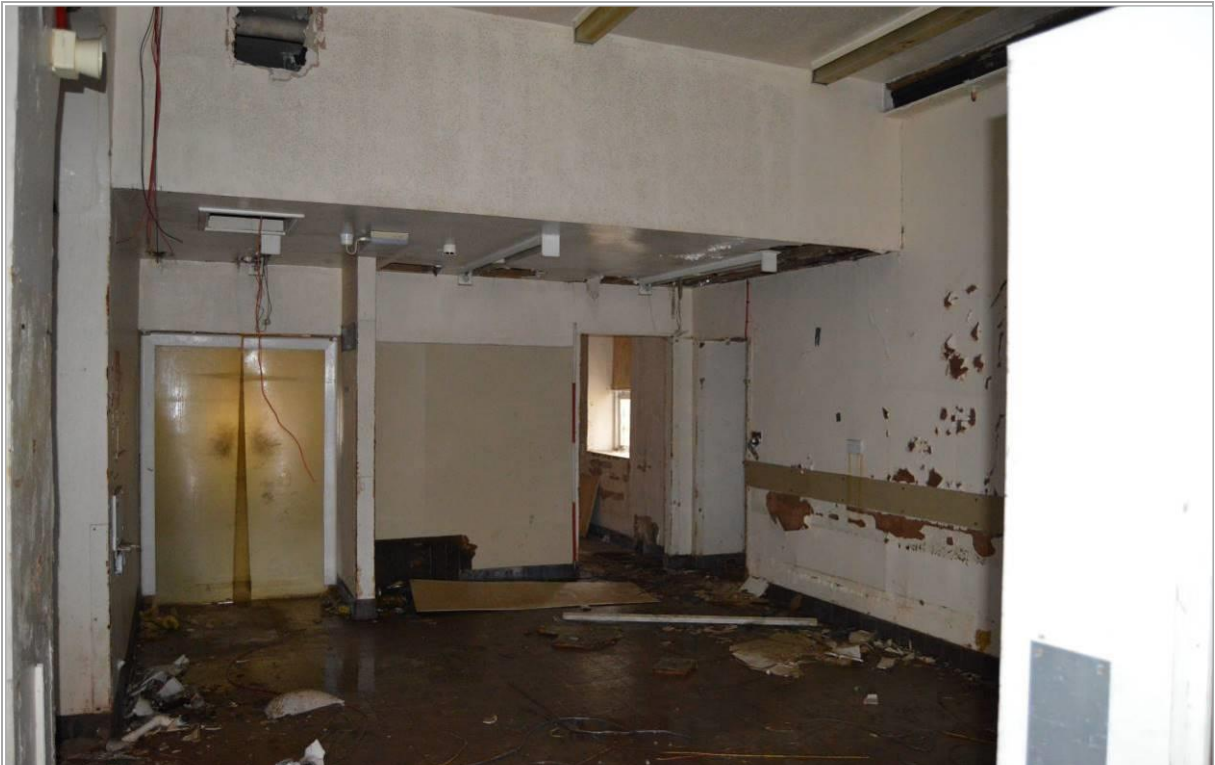
The kitchen remained in operational use until the end of the health authority's occupation. A room identified as the original staff/servants mess room had been subsumed into one large modern kitchen. However, the entrance to the room was in its historical location. Two relieving arches with segmental heads were observed in place of the western dividing wall of the original configuration; these structures were the remnants of a scullery and crockery room adjacent to the original kitchen prior the opening up of the space. To the south was a dividing wall with two double width doorways (one with Perspex curtains used for temperature control); this wall was the original south elevation of the mess before the later 20th century addition. To the south east corner was door into the single storey extension observed externally. Most superficial fabric originated with the modern use of the space.

Plate 75: View of the modern kitchen area in the service range, the location of the staff dining room originally. The lowered ceiling is not a structural element, most probably housing modern services and equipment. Scale 2m. Facing south east.

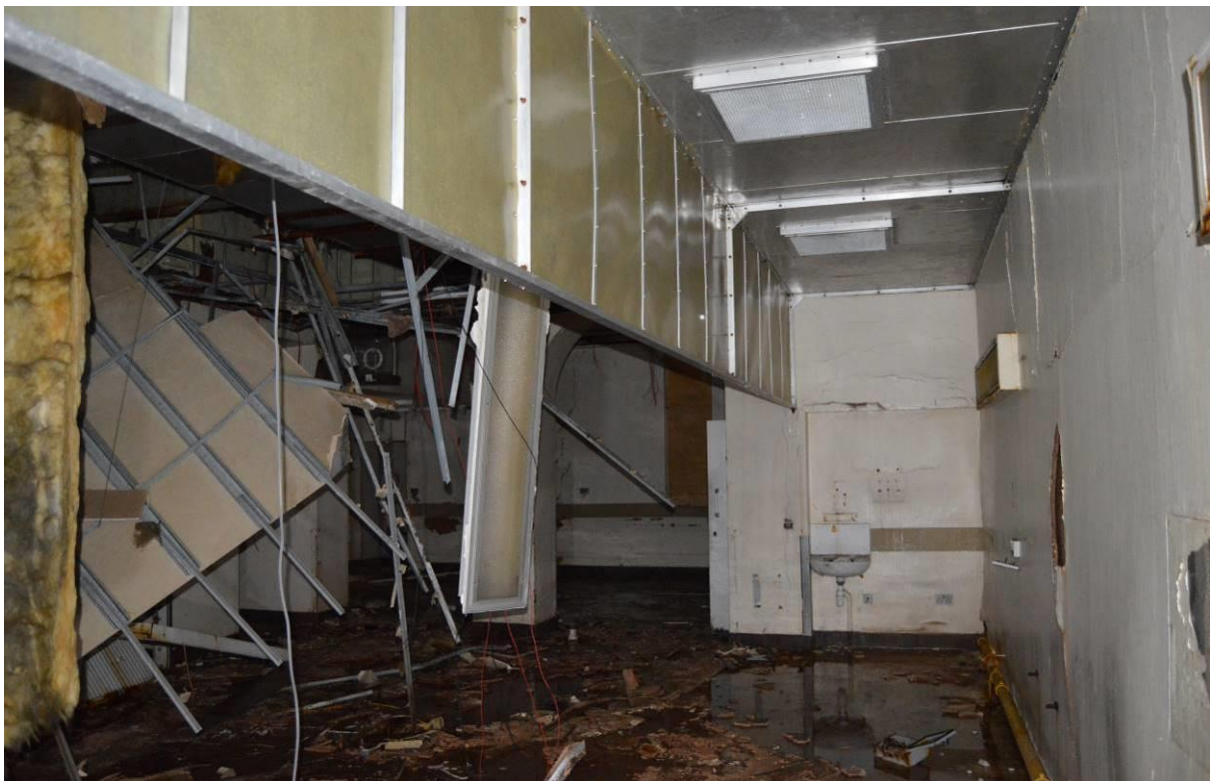
In poor condition, the hospital kitchen was of a modern finish with little observable historic fabric. The north east corner was the location of a lobby and servery, with hatches to the scullery. Differences to the wall thicknesses in this area were remnants of this configuration. The dividing wall and the south elevation of the original kitchen remained in situ, where there were originally a series of smaller rooms including pantries and stores. The doorways had been utilised to give access to modern structures added to the rear of the kitchen. The modern fixtures and fittings included extraction hoods, cold store doors and salt-glazed clinker floor tiles (dark grey to the skirting around terracotta coloured flooring).

Plate 77: View of the modernised kitchen area. Facing south west.

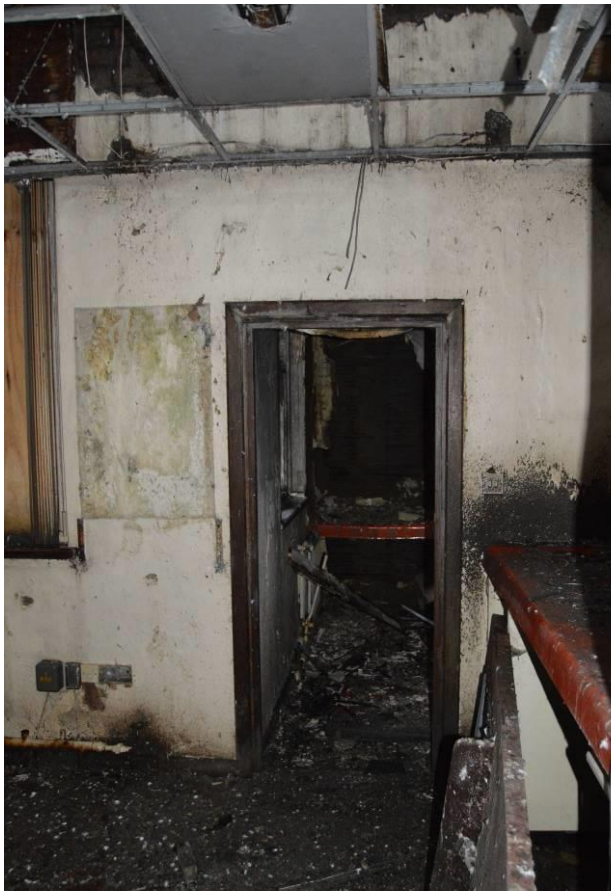
The room G15, the former operating theatre, had restricted access due to pigeon ingress, vandalism and water damage. The room had modern partition walls, which had divided the area in two, and a suspended ceiling. Above this it was possible to see some historic material although in poor condition. There was a metal framework in place that may have been an older suspended ceiling. Above this were elements of the original one and a half height ceiling; there was a series of timber trusses sprung on hammer beams with arched elbows, the timbers had chamfered edges and were painted. Also *in situ* were parts of a central skylight, with tongue and groove sides finished in white paint.

Plate 89.1: View through the theatre (facing north east).

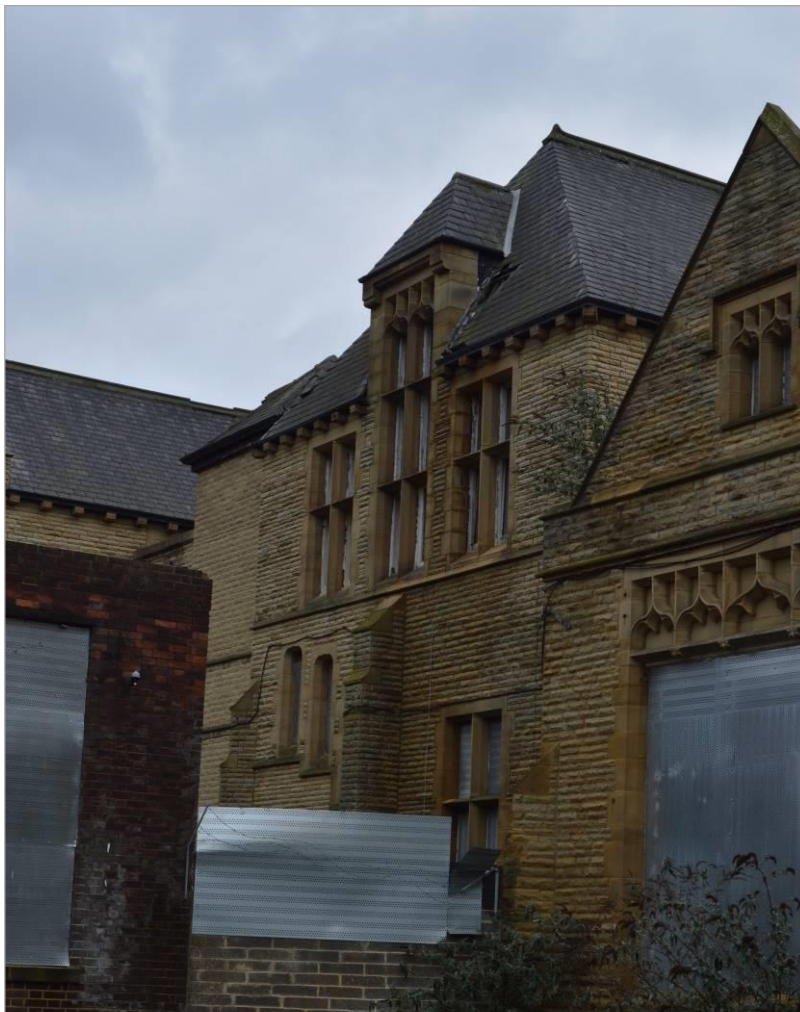
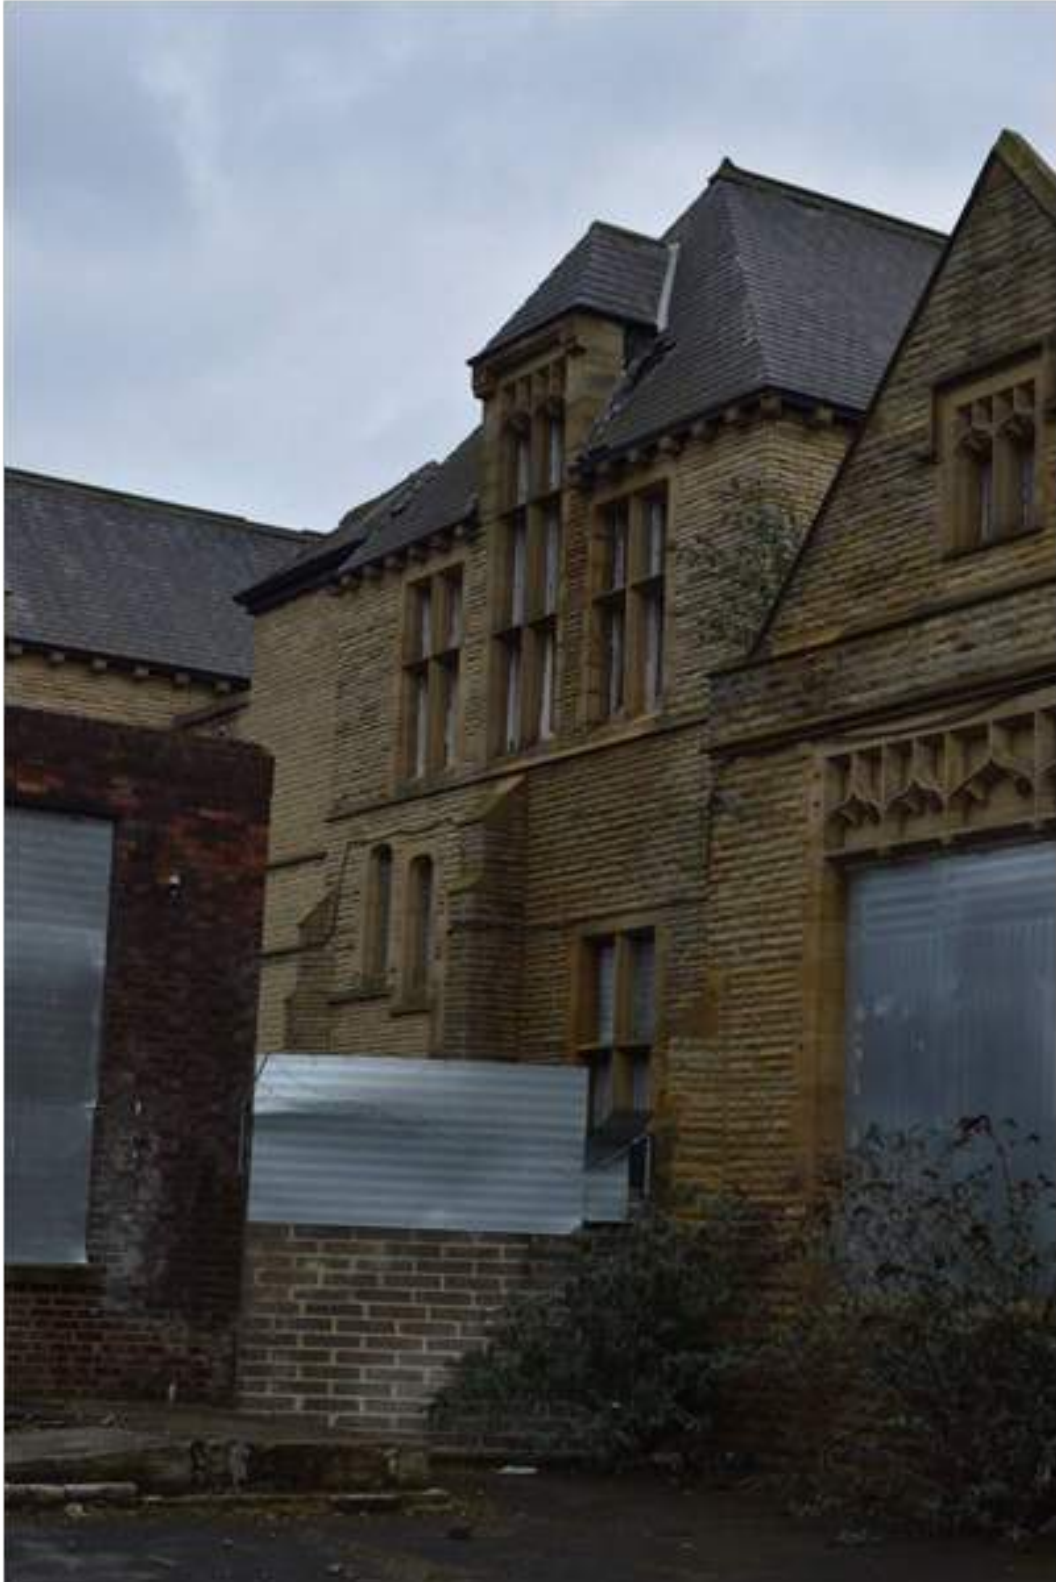
The eastern pavilion wing was over two storeys with an area of basement (**Appendix II, Figure 13, p.198**). There was restricted access to record the north elevation due to walls built to aid the site's security. It could be observed however that at the level between the ground and first floors there three windows at stepped intervals corresponding with the stairs. Buttresses could be observed on the corners and to middle of the elevation. The principal roof was hipped with slate. In contrast to previously recorded features, the roof overhung at the eaves, having a series of stone corbels.

Plate 90: View of the north elevation of the eastern pavilion wing, facing east.

Plate 90: View of the north elevation of the eastern pavilion wing.

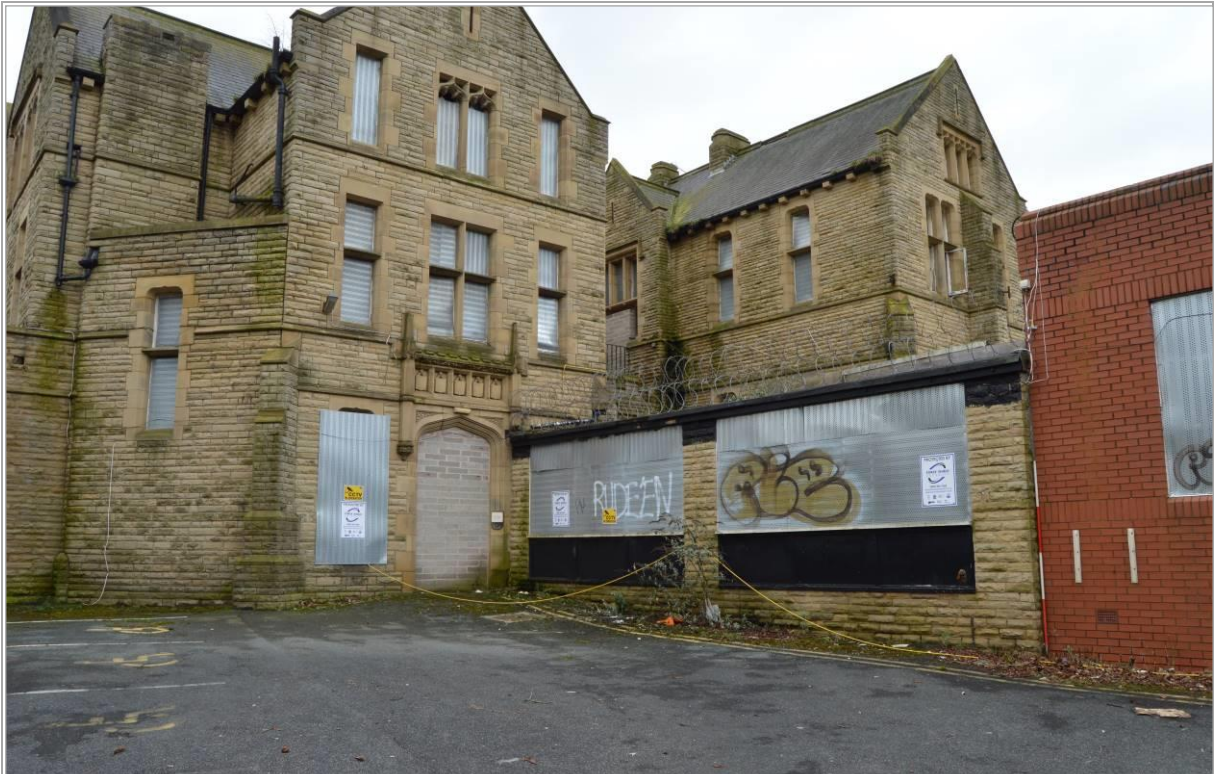
The Shaw Nurses' Home was added to the eastern portion of the site in 1902 (Building M) (**Figure 4, p.10**). The building was over three floors, faced in rusticated stone blocks of a similar Tudor Revival style, complimentary to the rest of the historic hospital at that time. Externally the building presented a series of gabled wings and appearing disparate sections of structure but internally had a homogenous and functional layout; it had nineteen bedrooms, a dining and sitting rooms. The north facing elevation contained the principal double-width entrance comprising a Tudor arch with chamfered profile. The doorway echoes the main entrance in design although in a more basic form. Across the head of the entrance way is a relief of five heraldic shields flanked by corbelled pinnacles. The south elevation had evidence of later fire escapes being added, facilitated by lowering the sills of the hall windows.

Plate 100: The Nurses' home extension to the east of the original hospital building (facing south). Scale 2m.

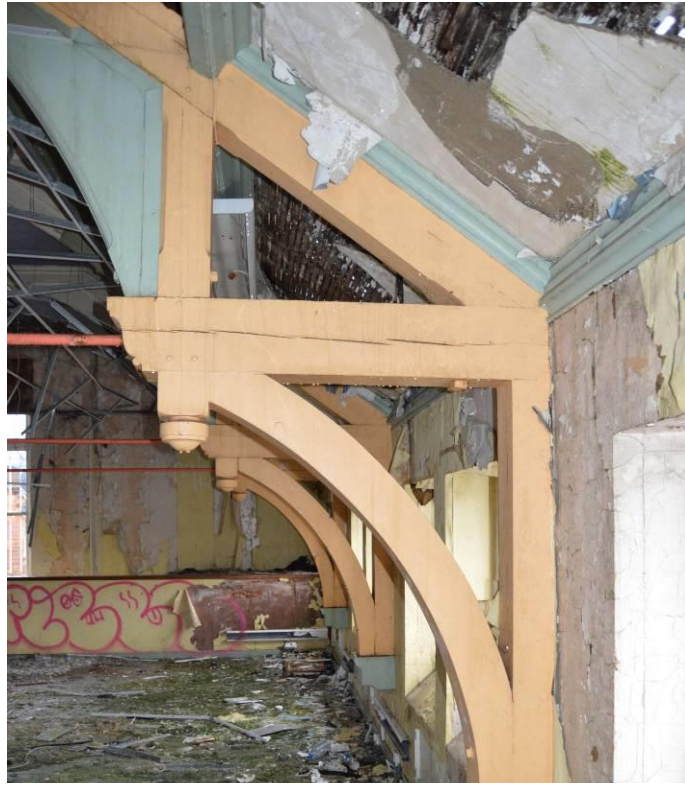
Of note was the later insertion of an upper floor to the out-patients waiting hall. In addition to a modern staircase this created a new room thought to have housed the hospital call centre. Within the room the original out-patients' ceiling was observed, this included timber pseudo-hammer-beam trusses with knee-braces and short hammer-posts.

Plate 103: Upper level, retained ceiling features to out-patient's waiting room (facing north east).

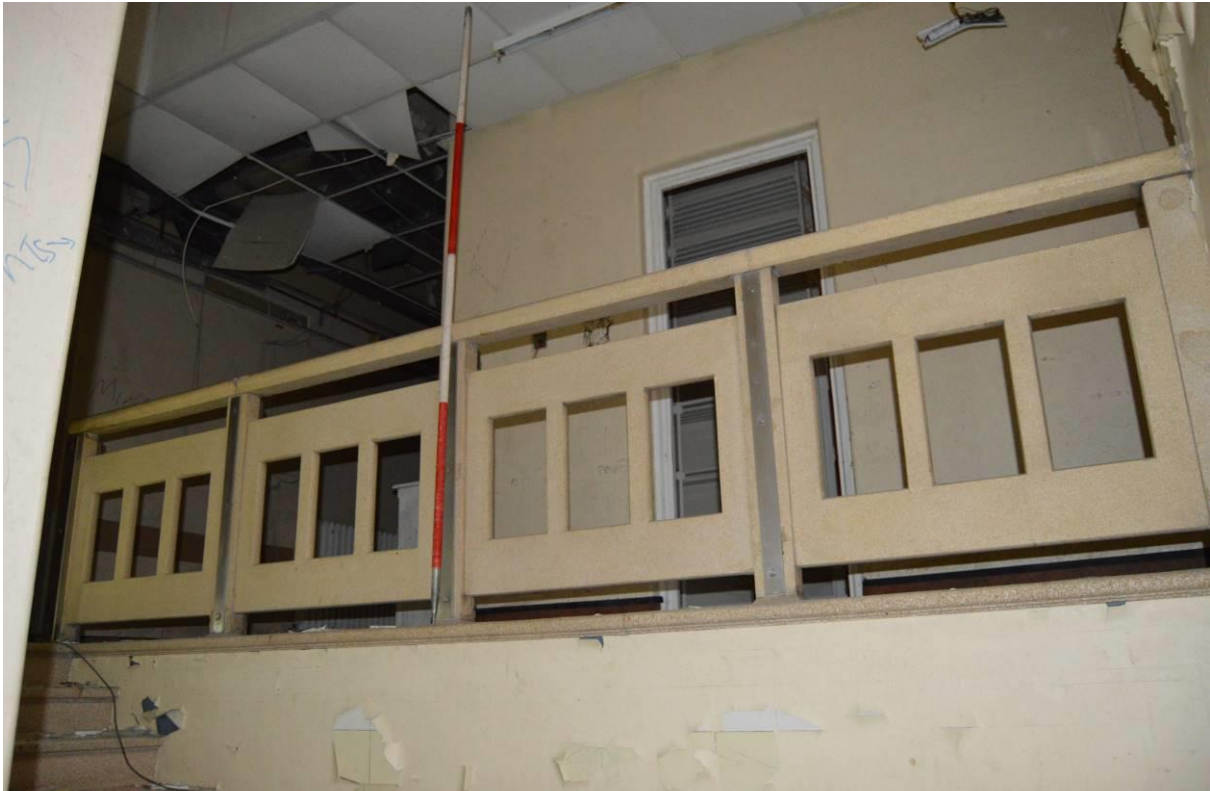
The first floor of the Ann Canning Building could be accessed via a centrally located staircase, the only apparent additional stair being housed in the modern extension building at the westernmost end. The stairs were broken into three flights with two half landings, constructed in concrete with a buff coloured terrazzo finish. The central core of the stairwell housed a good-sized lift with concertina doors. The landing was in part open to one side, with a balustrade composed of four cast panels each with three rectangular openings.

Plate 105.14: The Ann Canning Childs' Ward for Women stairs landing balustrade (facing south west). Scale 2m.

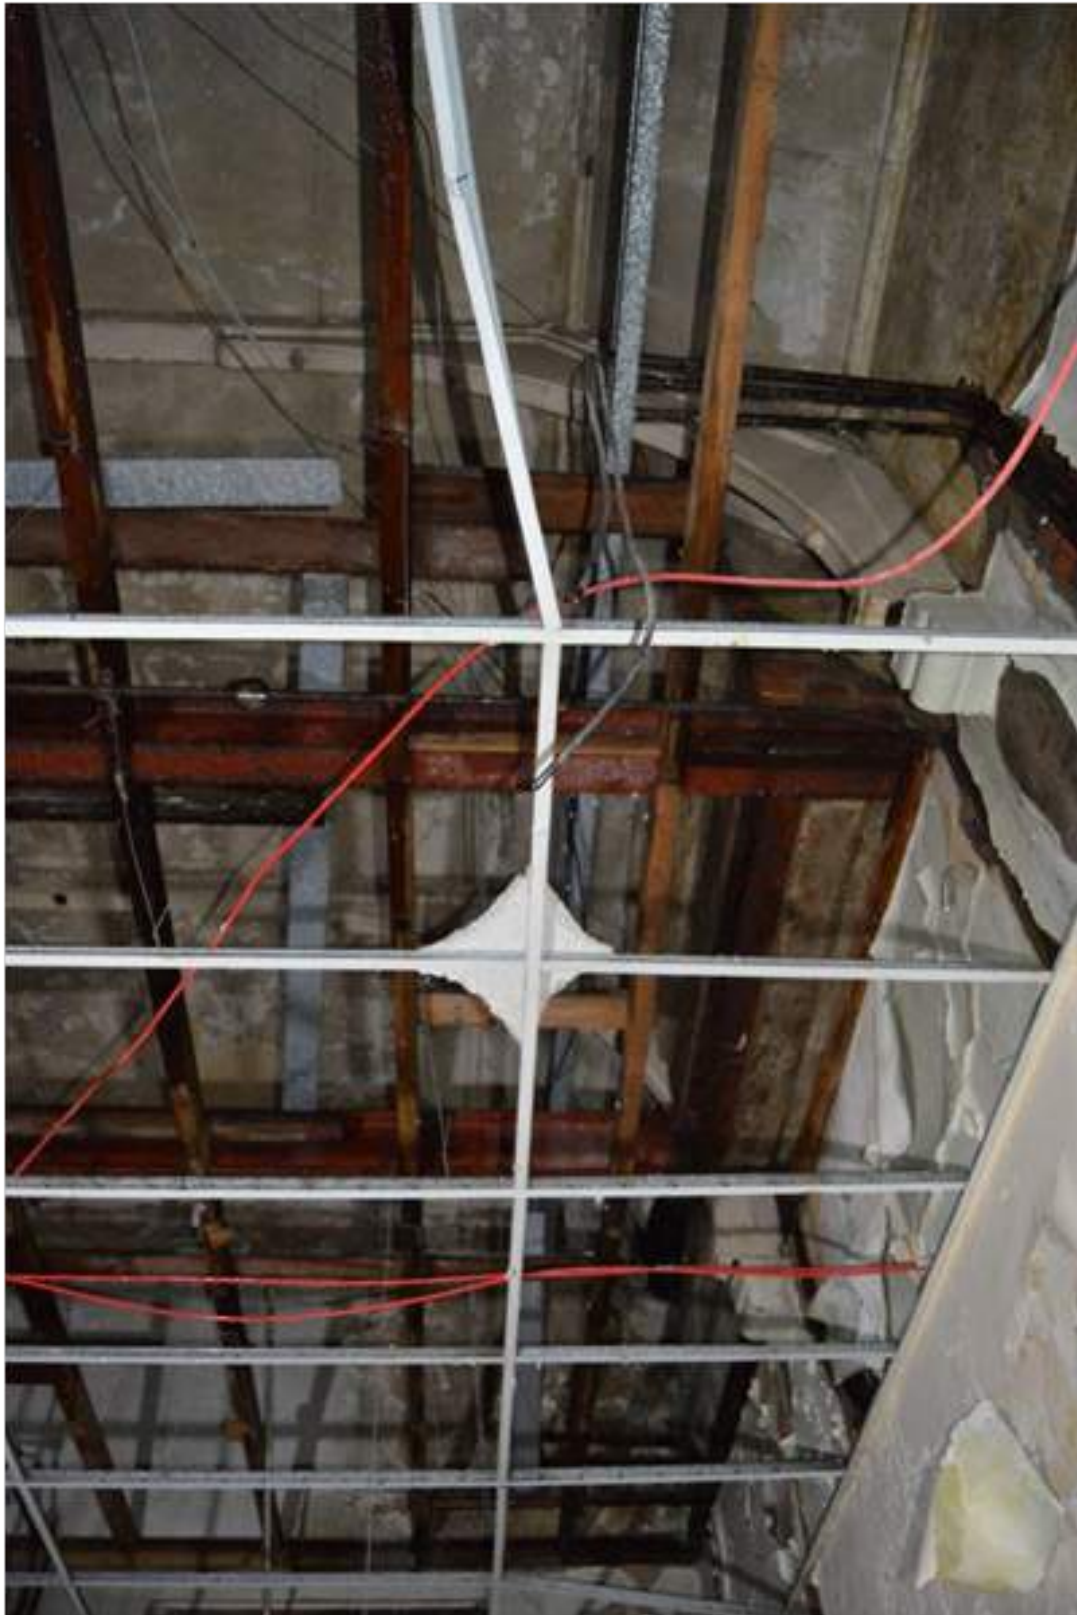
Plate 86.1: View of the board room ornate ceiling with hammer beam details.
