**Land on Woodhorn Lane, Newbiggin-
by-the-Sea, Northumberland.
An Archaeological Evaluation**

**ARS Ltd Report No. 2018/146
OASIS ID - archaeo15-325000**

ARS Ltd Report 2018/146
August 2018

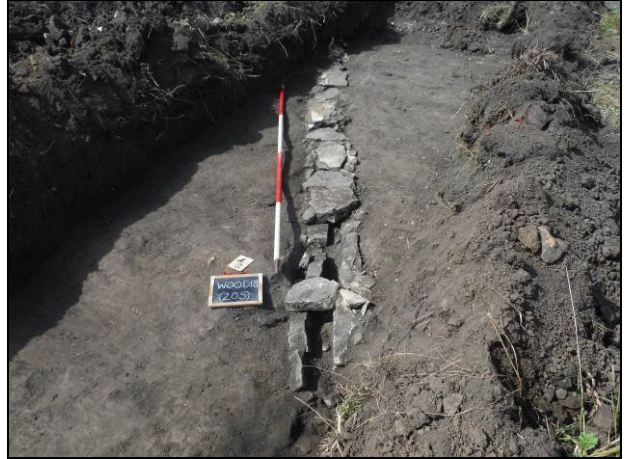
Post-medieval culvert, or cundy, found within Trench 2 (scale = 2m).

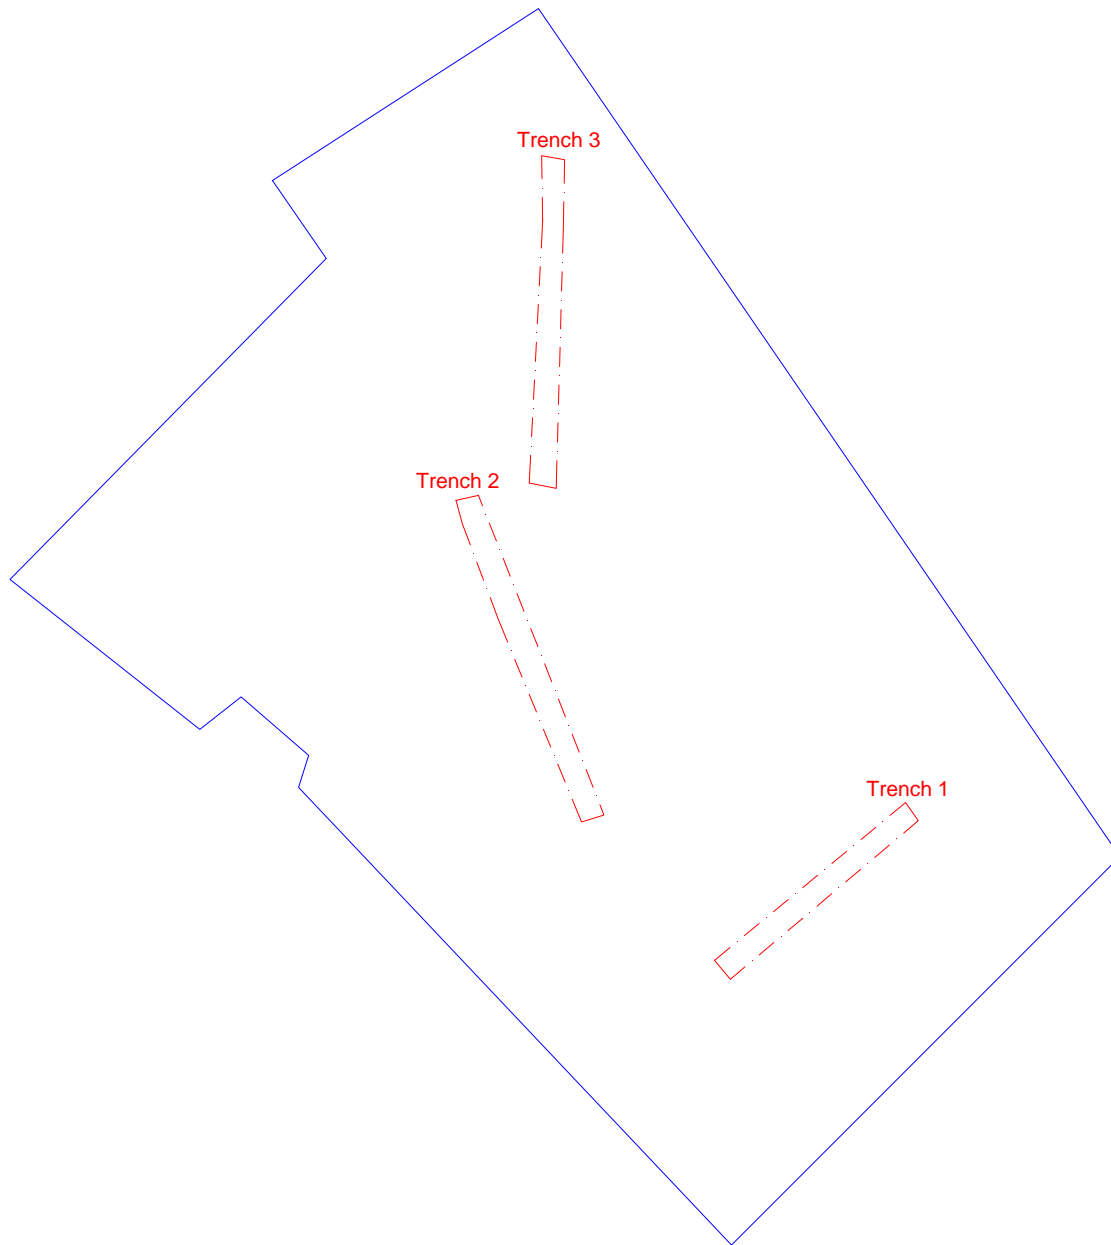
Figure 2:
Trench plan.
Scale = 1:500 at A4

5.1.1 The archaeological evaluation consisted of three trenches. Two of these trenches measured 2 x 20m while the remaining trench measured 2 x 25m (Figure 2).

5.1.2 The indicative location of the evaluation trenches was agreed with the Assistant County Archaeologist for Northumberland County Council as sufficient to cover the proposed works. However, upon conducting a scan of the site for underground cables and finding the results to be inconclusive, it was decided to move Trench 2 c.10m to the west. In turn, this resulted in the southern end of Trench 3 having to be moved c.8m to the east.

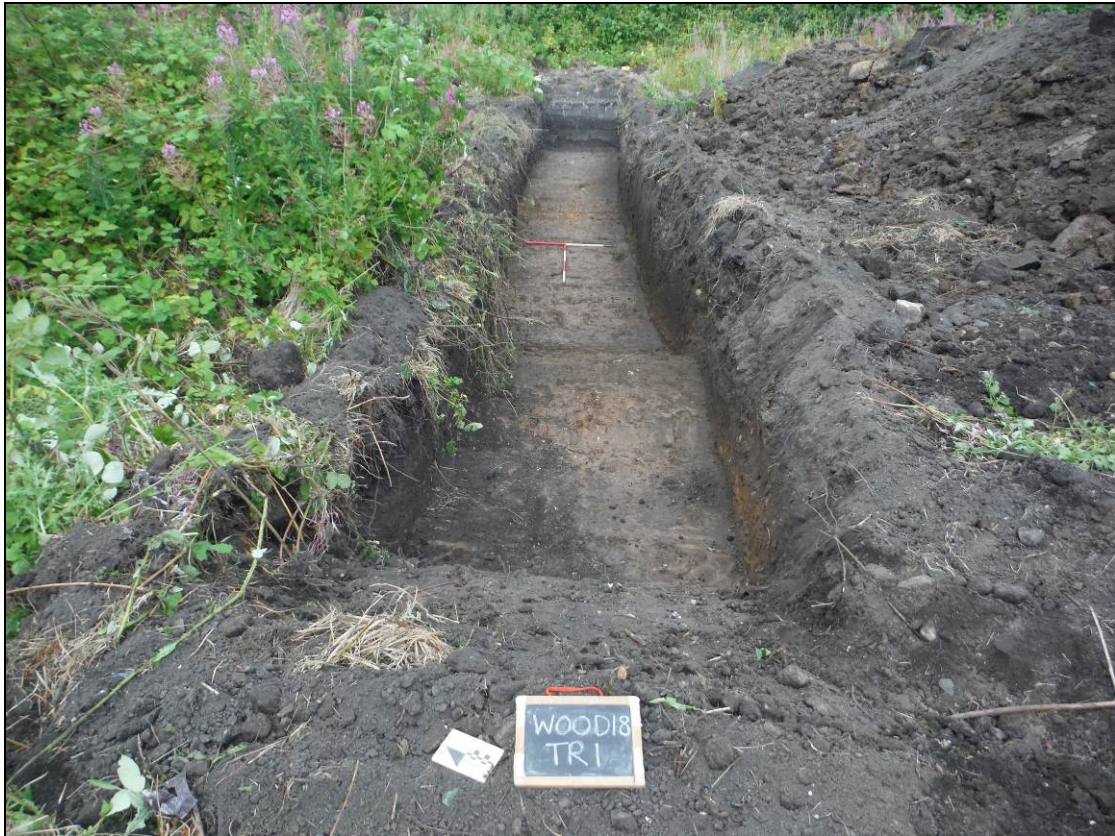
Figure 7. Trench 1 general shot, looking north-east (scale = 2m + 1m).

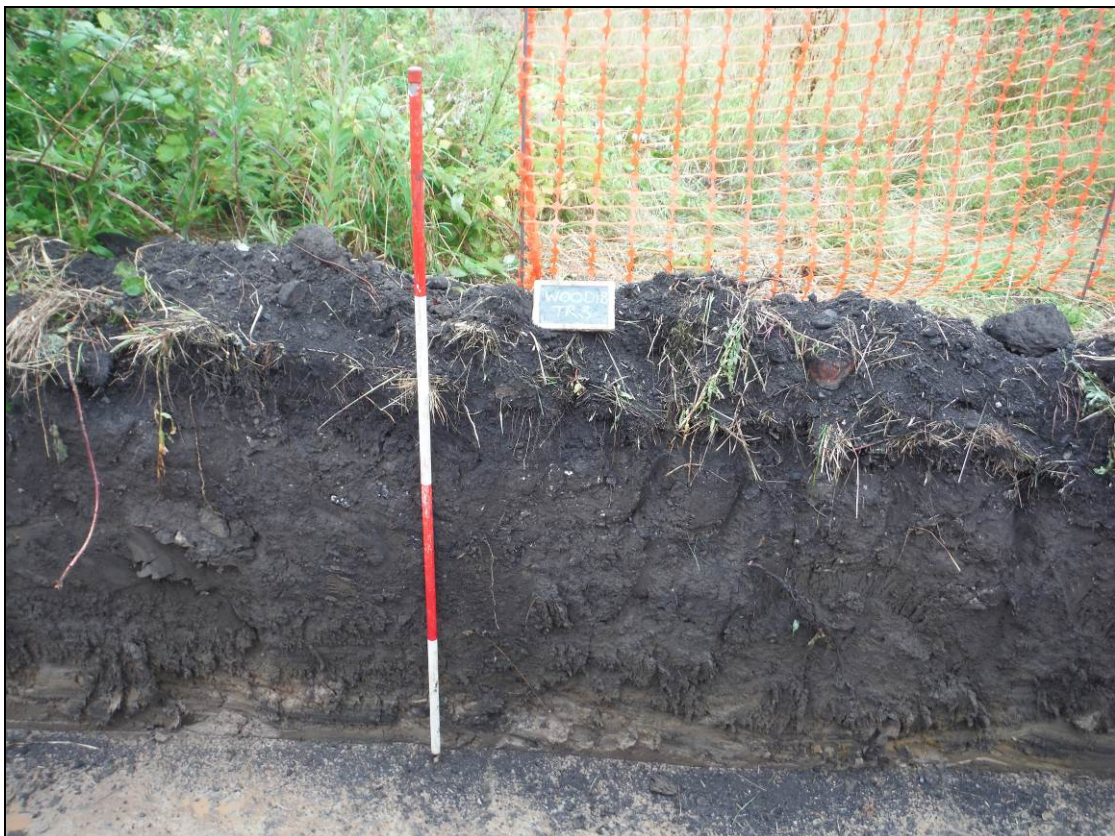
6.2.2 Trench 1 was excavated through very dark brown/black clay loam topsoil (101) that had a maximum depth of 0.5m and contained occasional stones. Sitting below the topsoil was a 0.2m deep deposit of made ground (102). This made ground consisted of ash, clinker and coal and was black/grey in colour. A further deposit of made ground (103), which consisted of very dark brown clay containing crushed stone, broken brick and broken pottery, sat beneath made ground (102). Made ground deposit (103) had a maximum depth of 0.5m. The natural orange clay (104) was encountered beneath made ground deposit (103) at a maximum depth of 1.2m. Towards the south-western

end of the trench, the depth of the made ground deposits was reduced so that the natural orange clay (104) was encountered at a depth of 0.5m.

Figure 8. South-east facing section of Trench 1 (scale = 2m).

burnt down. The deposits of made ground encountered within Trench 1 and Trench 3 containing ash, clinker and broken sandstone are likely to have derived from the demolition of this building and the spreading of the material across the site.

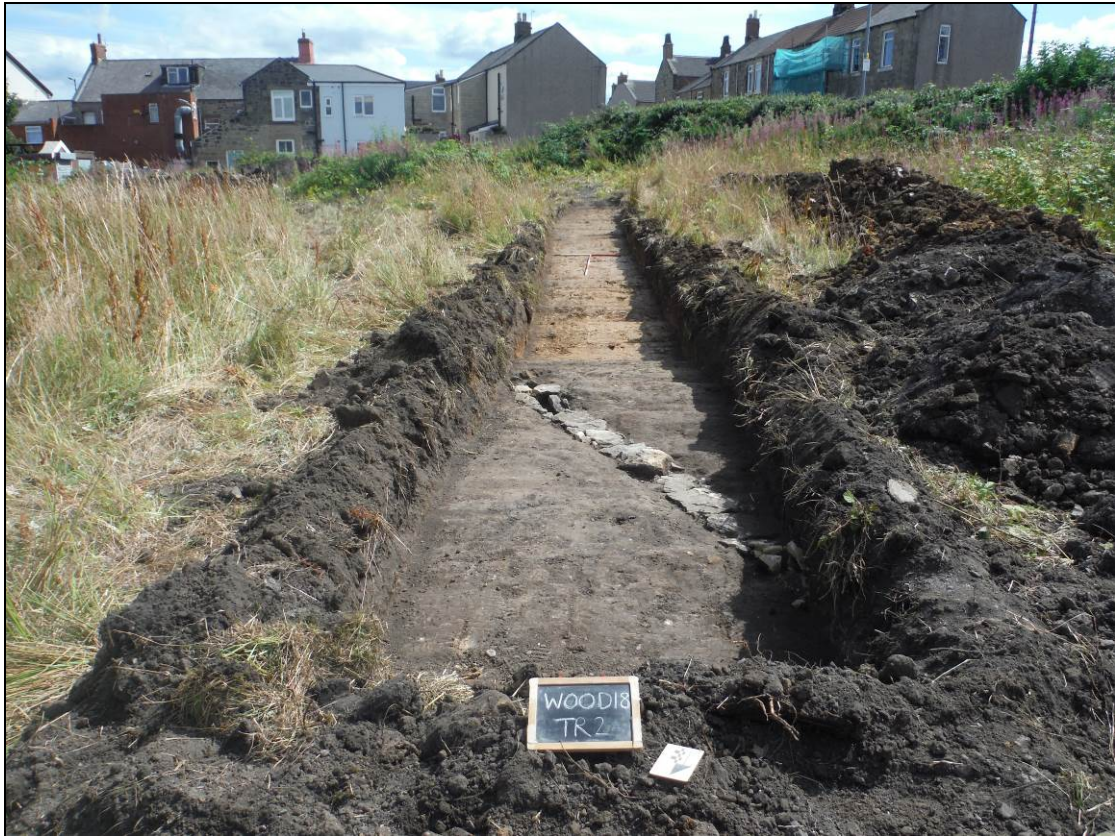
Figure 9. Trench 2 general shot, looking south-east (scale = 2m + 1m).

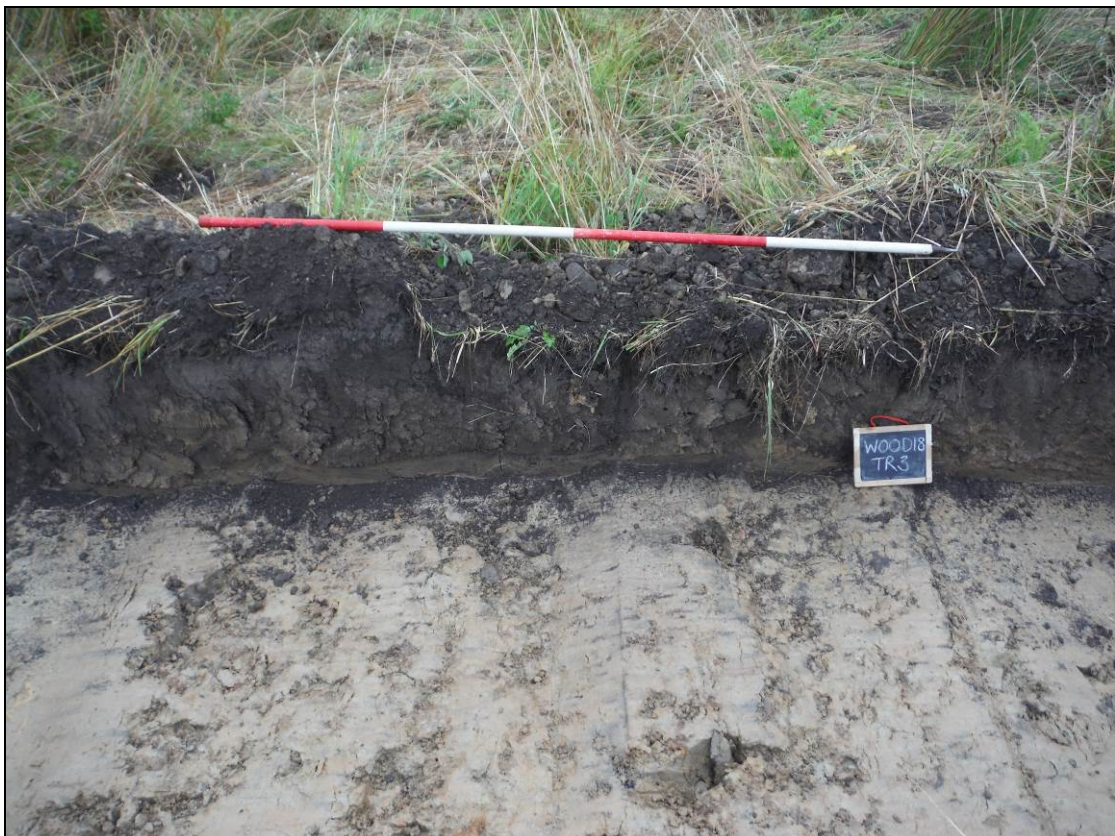
Figure 10. North-east facing section of Trench 2 (scale = 2m).

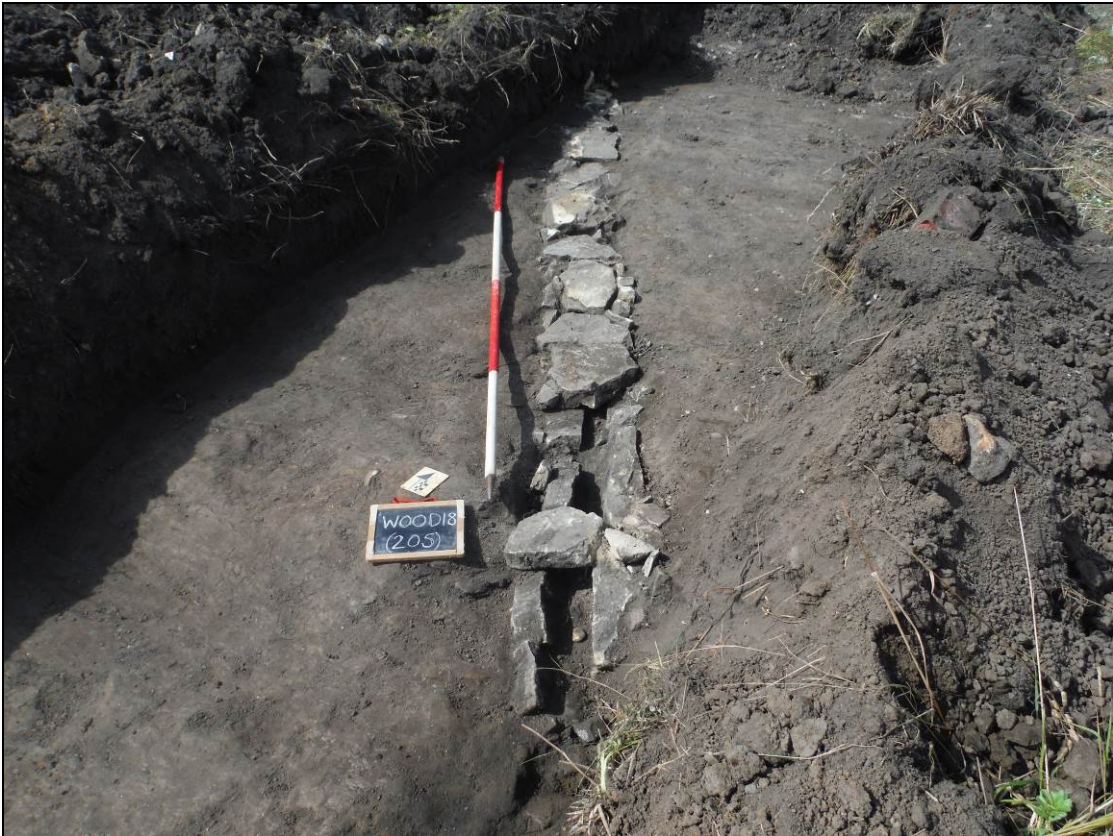
6.3.1 Trench 2 was excavated centrally within the site, measured 25m in length and was orientated north-north-west to south-south-east. The trench was excavated through very dark brown/black topsoil (201) that had a maximum depth of 0.25m and contained occasional stones. Beneath the topsoil was a 0.15m deep deposit of orange/brown subsoil (202) which sat directly upon the natural orange clay (203). Located towards the northern end of the trench and cut into the subsoil (202) was a 3.9m long length of stone-built culvert orientated in a north-west to south-east direction. The sandstone culvert (205) had been laid within a straight-sided, shallow cut [204] measuring 0.2m deep and had been constructed using small, flat stones laid on their side to create the sides of the channel with further flat, capping stones laid on top. The base of the culvert had been left bare. Some sherds of white and blue, post-medieval willow-pattern pottery were recovered from within the culvert.

Figure 11. The post-medieval stone-built culvert found within Trench 2, looking north-west (scale = 2m).

7.1 The archaeological evaluation at Woodhorn Lane did not reveal any features of significance. The stone-built culvert within Trench 2 is of a type that is very common to the region and, furthermore, it contained pottery dating to the post-medieval period.

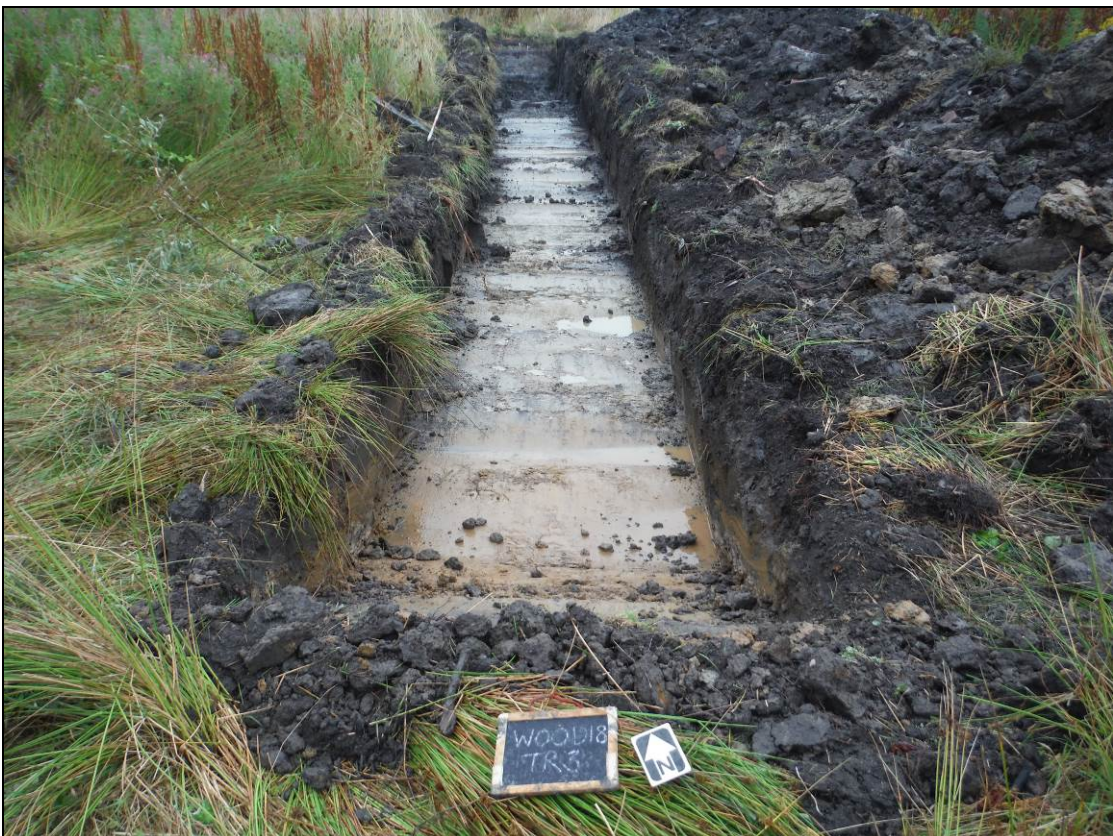
6.4.1 Trench 3 was excavated towards the northern corner of the site and measured 25m in length. The trench was orientated from north to south and was excavated to a maximum depth of 1.24m. At its northern extent, the trench was excavated through a layer of tarmac (301) measuring 0.05m in depth which was overlying a layer of bedding (302) which had a depth of 0.1m. Beneath the bedding was a layer of levelling material (303) which consisted of crushed sandstone and brick and had a maximum depth of 0.2m. Below the levelling layer was a 0.5m deep layer of made ground which comprised ash, clinker and rubble (304), similar to made ground deposit (102) seen in Trench 1. Below made ground deposit (304) in Trench 3 was 0.25m deep deposit of grey clay containing very little no to inclusions (305). Encountered amongst this clay was a line of flat sandstone slabs (307). There was no bonding material between the stones and there was no visible cut, so it is unlikely that they were the remains of a wall. The natural orange clay (306) was encountered at a maximum depth of 1.24m below the modern ground surface.

Figure 12. Trench 3 general shot, looking north (scale = 2m).

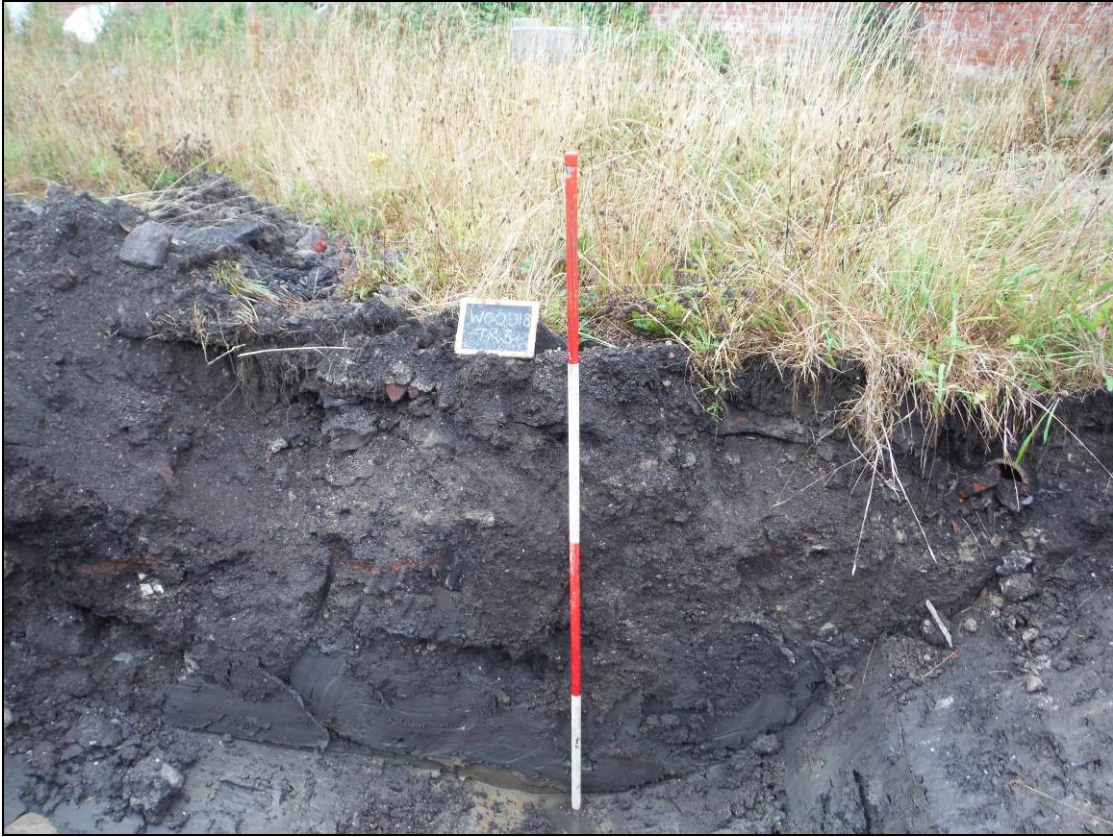
Figure 13. east-facing section of Trench 3 (scale = 2m).

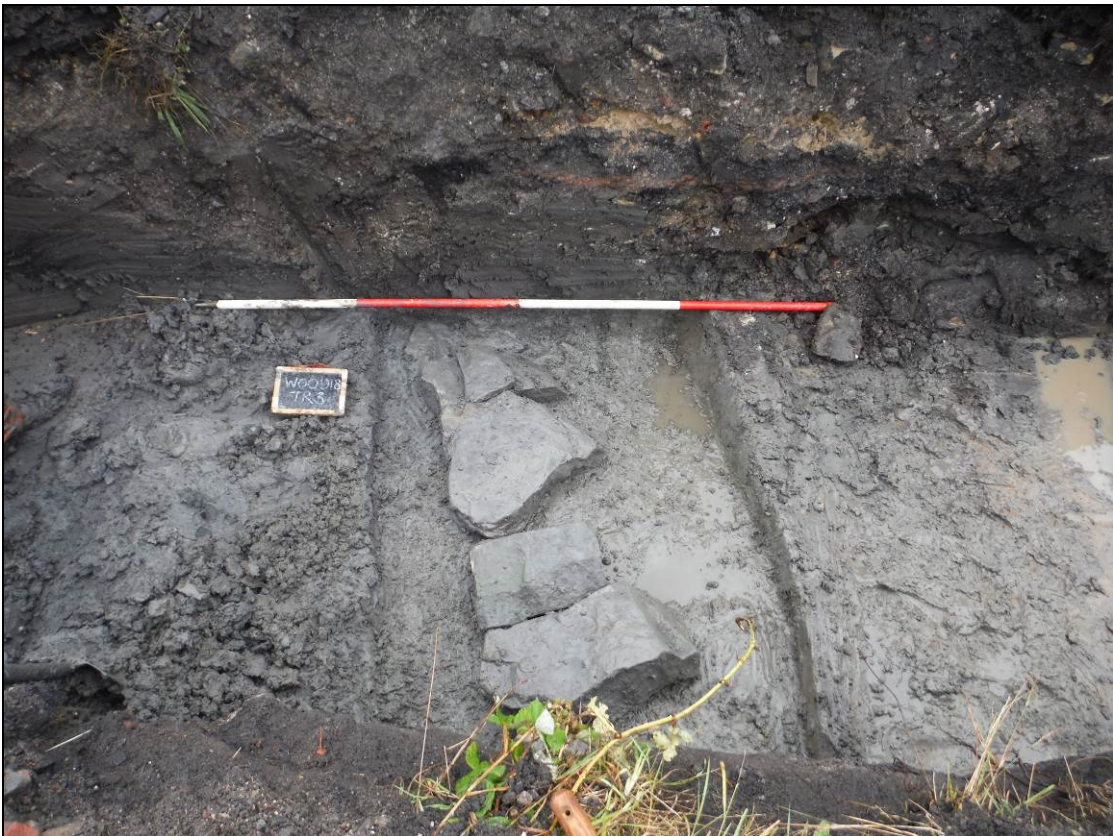
Figure 14. Line of stones within the base of Trench 3 (scale = 2m).

7.3 Conversations with local residents also revealed that a row of stables had once stood at the very northern extent of the site where there is still an area of concrete hard-standing and a tarmac surface. During excavation the northern end of Trench 3 was found to be quite wet and therefore it is believed that the build-up of made ground encountered within the trench had been used to create a more stable, dry area for the construction of the stables. Due to the lack of a visible cut or any bonding material, it is unlikely that the line of stones found within Trench 3 were the remains of a wall. The stones were located at the northern extent of the trench where it was wetter and it is possible, therefore, that the stones had been laid during the levelling and building-up of this area of the site in order to provide a steady, dry surface for walking and standing on.
