# Old Coppice Side, Marlpool, Derbyshire. Report on an Archaeological Watching Brief.

ARS Ltd Report 2007/65 May 2008

# Old Coppice Side, Marlpool, Derbyshire Report on an Archaeological Watching Brief

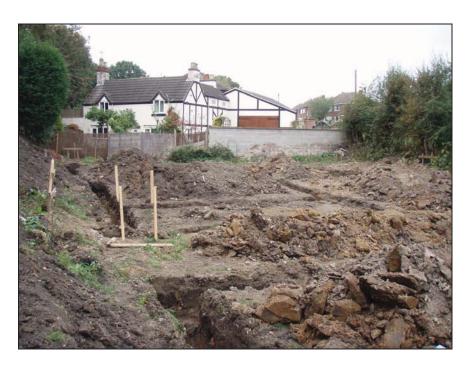
Fig. 7 View of House One (looking north)

6.1.1.1 The excavation trenches are shown in Fig. 6. House One measured 11m x 15m and was situated at the north east end of the site (Fig. 7). The foundations for the house consisted of nine footings. Six of these were external footings, the remaining three being smaller, internal footings. The footings were 0.7m to 0.9m wide and between 1m to 1.5m in depth but averaged at a depth of 1.1m (Figs. 9 and 10). The stratigraphy for all nine footings was the same. The first visible layer was a re-deposited clay (002) which contained sandstone aggregate inclusions and was between 0.14m to 0.25m in thickness, which represented material deposited in the construction of the embankment. Beneath this deposit was a buried topsoil deposit (001) which was between 0.17m to 0.2m thick and contained small

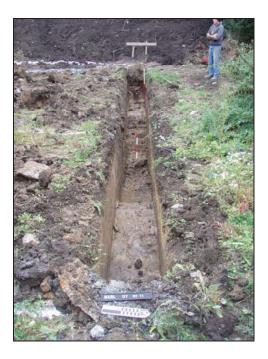
Fig. 8 Footing one looking west (Scales: 2m and 1m)

rounded stones, post-medieval pottery, clay pipe, glass and broken brick. Below (001) was a natural substratum of orange/yellow boulder clay (003) which existed for approximately 2m before encountering sandstone bedrock (004). The sandstone bedrock was only reached in footing one at the north-west end.

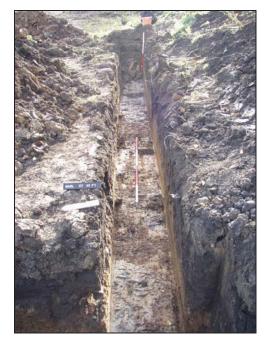
Fig. 9 Footing eight looking east (Scales: 2m and 1m)

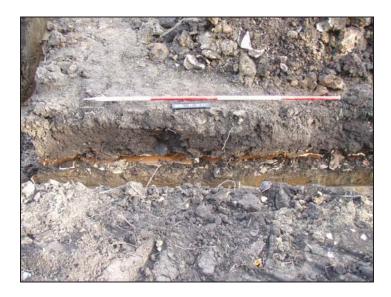
Fig. 10 Footing seven showing the broken ceramic drain, looking north (Scale: 2m)

6.1.1.2 During the excavation of footings three, six and seven two disused ceramic drains were encountered (Figs. 10 and 11). The drains were removed during the excavation and were found to be bedded on to the natural clay substrate (003). No archaeological finds or deposits were found during the excavation of the footings for House One.

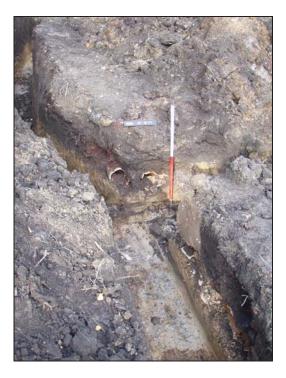
Fig. 11 Footing seven showing the two ceramic drains, looking west (Scale: 2m)

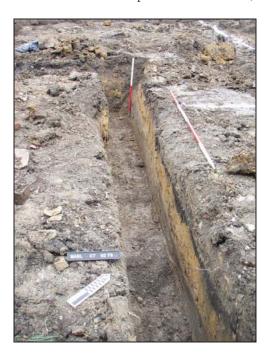
Fig. 12 Footing six looking north west (Scale: 2m and 1m)

6.1.2.1 House Two was positioned 3m south west of House One and measured 10m x 11m. The foundations for the house consisted of ten footings. Five of these were external footings, the remaining five being smaller, internal footings. The footings were 0.7m to 1m wide and between 1m to 2.8m in depth but averaged at a depth of 1.2m (Figs. 12 and 13). The stratigraphy for all ten footings was the same except for footings one and two which encountered a deposit of building rubble (006). Below the redeposited clay (002), which was between 0.14m to 0.25m in thickness, buried topsoil (001) was again found. (001) was between 0.17m to 0.2m thick and contained small rounded stones, post-medieval pottery, glass and broken brick. Below (001) a natural substratum of orange/yellow boulder clay (003) was identified which existed for approximately 2m before encountering sandstone bedrock (004). The sandstone bedrock was only reached in footing one and two at the west end due to the removal of building rubble (006) which had been deposited in this area, containing modern brick and concrete.

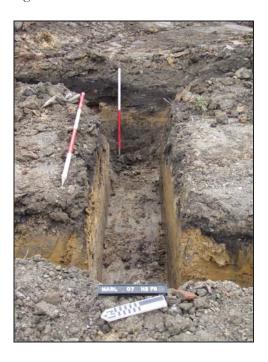
Fig. 13 Footing nine looking east (Scale: 2m and 1m)

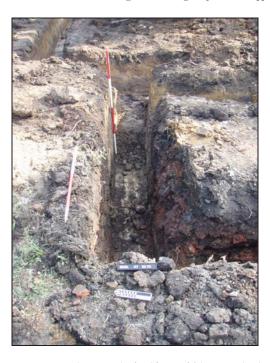
Fig. 14 Footing two showing the building rubble (006), looking east (Scales: 2m and 1m)

6.1.2.2 The building rubble (006) encountered in footings one and two existed below the redeposited clay (002) and was 1.6m in depth (Fig.14). No other archaeological finds or deposits were uncovered during the excavation of the footings for House Two.

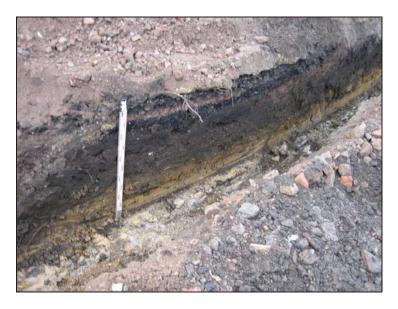
Fig 17 Northern end of the trench.

6.2.1 The trench was 38.5m long by 1m wide and ran the length of the proposed pipeline, oriented north east-south west. The maximum depth achieved was 1.20 m. The stratigraphy for the pipe trench was the same as the stratigraphy recorded for the foundation trenches of all the three houses (Fig. 17).

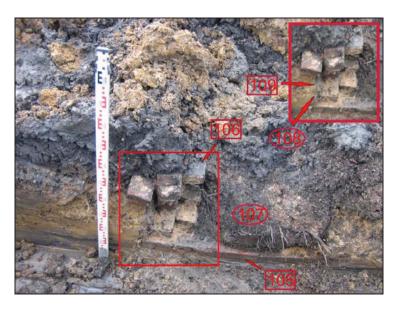
Fig. 18 Red brick structure.

6.2.2 A modern service trench cut across the trench from west to east, between House One and Two. The corner of a modern red brick structure was also recorded opposite to the southern end of House Two and related to the building rubble recorded in the previous watching brief (Figs. 18 and 19). The presence of Post-Medieval pottery, glass and broken brick from the construction of the embankment was recorded. No features of archaeological importance were found within the trench.

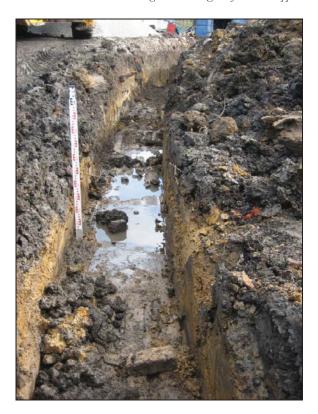
Fig 19 Southern end of the trench.

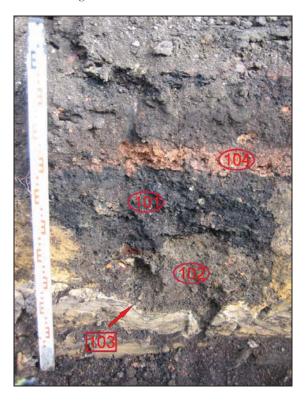
Fig 20 East side of modern service trench

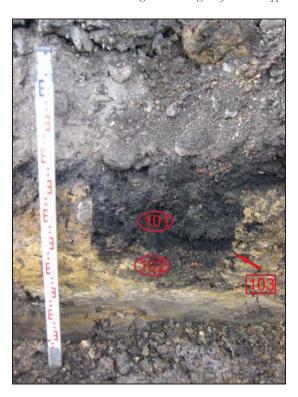
Fig. 21 West side of modern service trench
