An Archaeological Evaluation at Flowers Way, Luton, Bedfordshire

**ARS Ltd Report No. 2018/165
OASIS ID - archaeol5-329887**

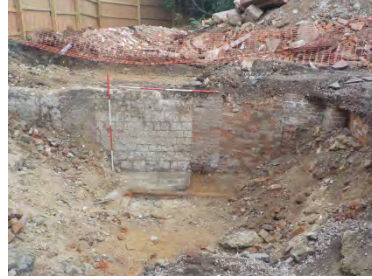
Chalk block wall in trench 1 looking north

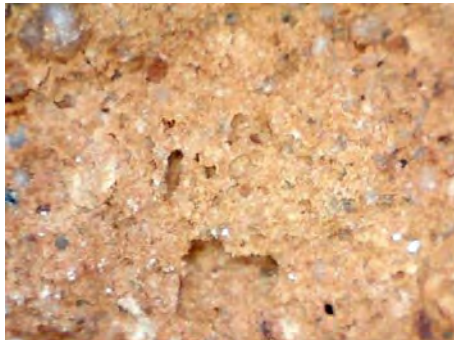
This is a pale red very hard sandy fabric with an irregular fracture. It has inclusions of common medium sub angular quartz with occasional red clay pellets and black grits.

6mm wide cross-section for a fresh break of TZ11

Fabric TZ11 An unfrosted brick with rounded regular arrises, some creasing on stretcher with traces of mortar M11. No = 1, Wt = 2008g, Cnr = 6, Dimensions: 210 mm x 110 mm x 65 mm, C18+, probably LC18+

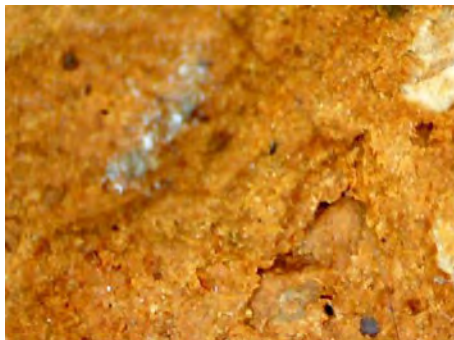
TZ12

This is a hard-red fabric with a sandy feel and irregular fracture. It has inclusions of moderate fine sand, occasional clay pellets and sparse mica.

6mm wide cross-section for a fresh break of TZ112

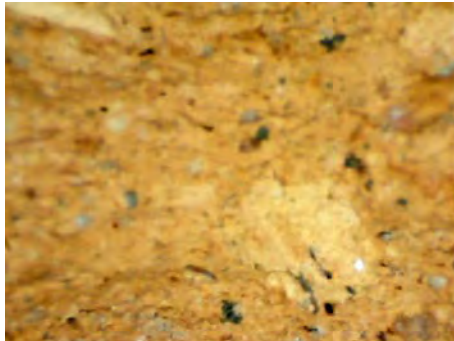
This is a reddish yellow fabric which is hard, sandy with an irregular fracture, with moderate rounded sand moderate black iron stone inclusions and some red grit.

6mm wide cross-section for a fresh break of TZ13

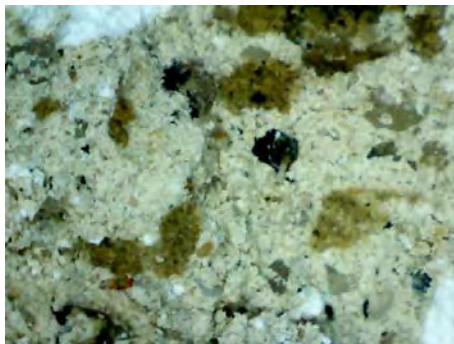
This is a fine white mortar with common coarse charcoal inclusions and moderate medium sub angular quartz and sparse coarse lime.

6mm wide cross-section for a fresh break of M11

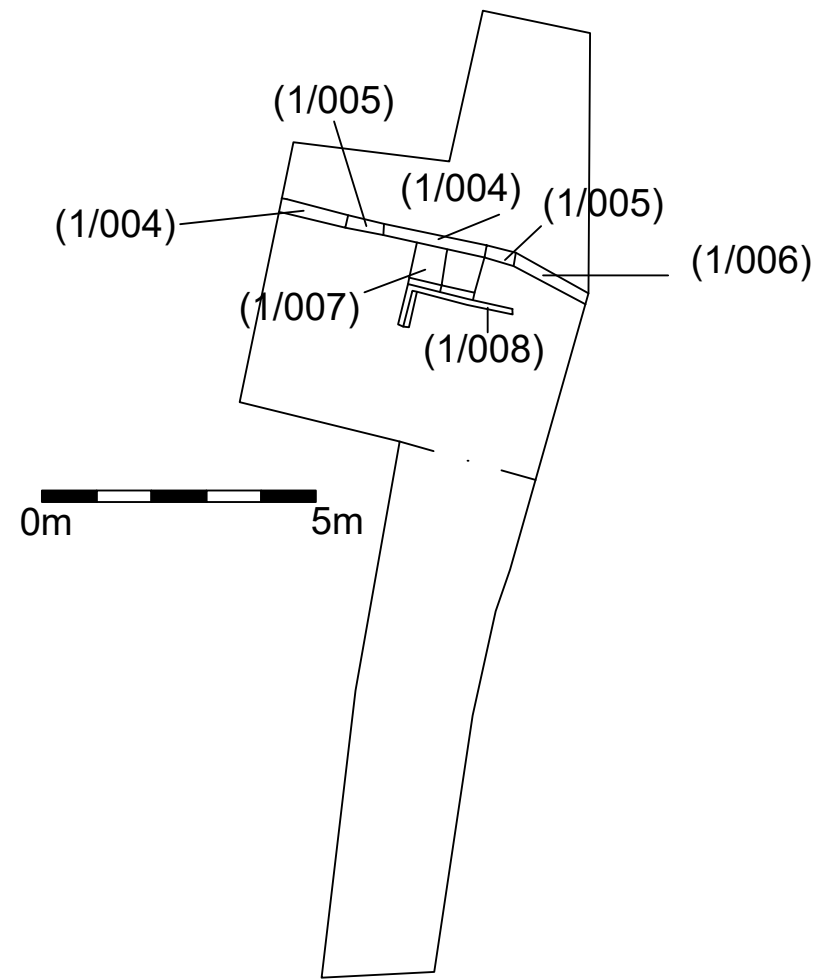
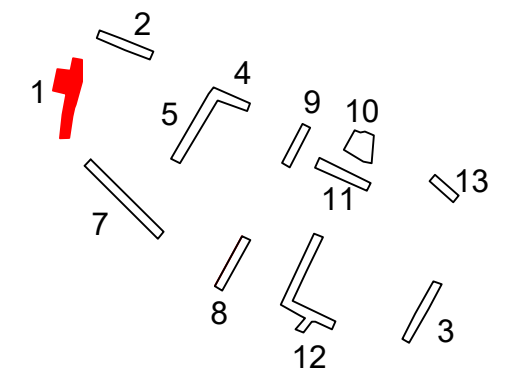
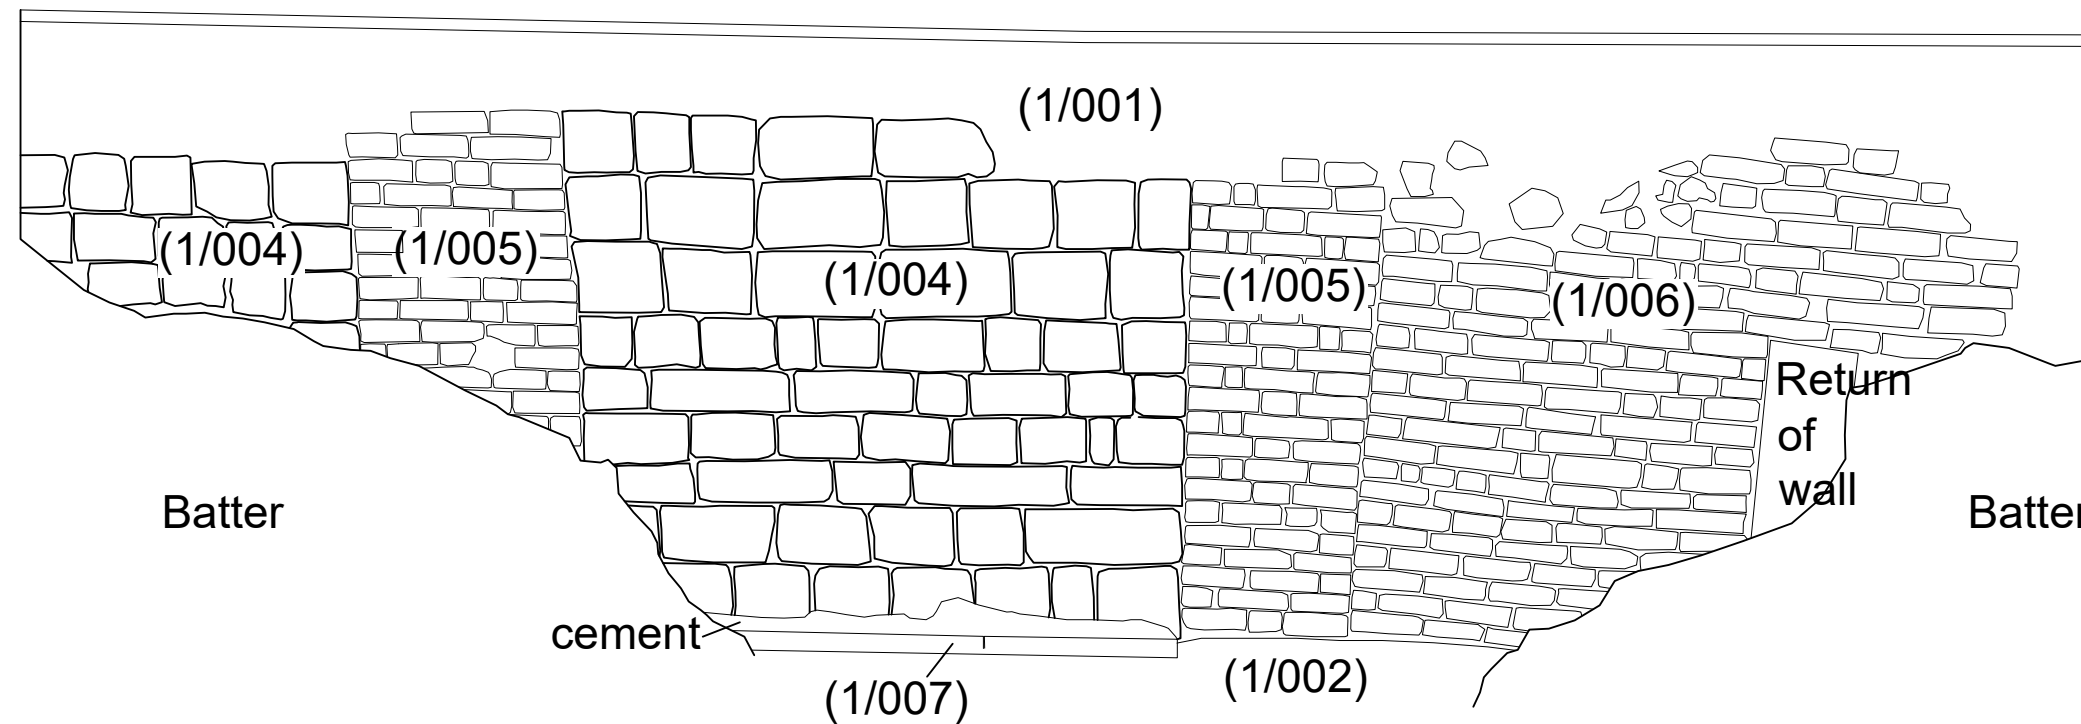
Title: Figure 3

- 5.2.1 Modern overburden comprising tarmac and type 1 gravel (1/001) was removed by machine under archaeological supervision to a depth of 0.25m BGL, the level at which natural geology (1/002) was encountered in both the north east and south west ends of the trench. In the centre of the trench a deposit of loose brick and concrete rubble was encountered. This material was backfilling a cellar/undercroft (1/003) and so the trench was extended to the north west and south east to expose as much of the structure as possible.

- 5.2.3 The loose rubble backfill was removed from the centre of the cellar/undercroft. On the north east and south west sides the in situ walls could be exposed safely but it was necessary to create a batter on the north west and south east sides to prevent the loose rubble from collapsing into the trench and allow safe access to the floor of the cellar.

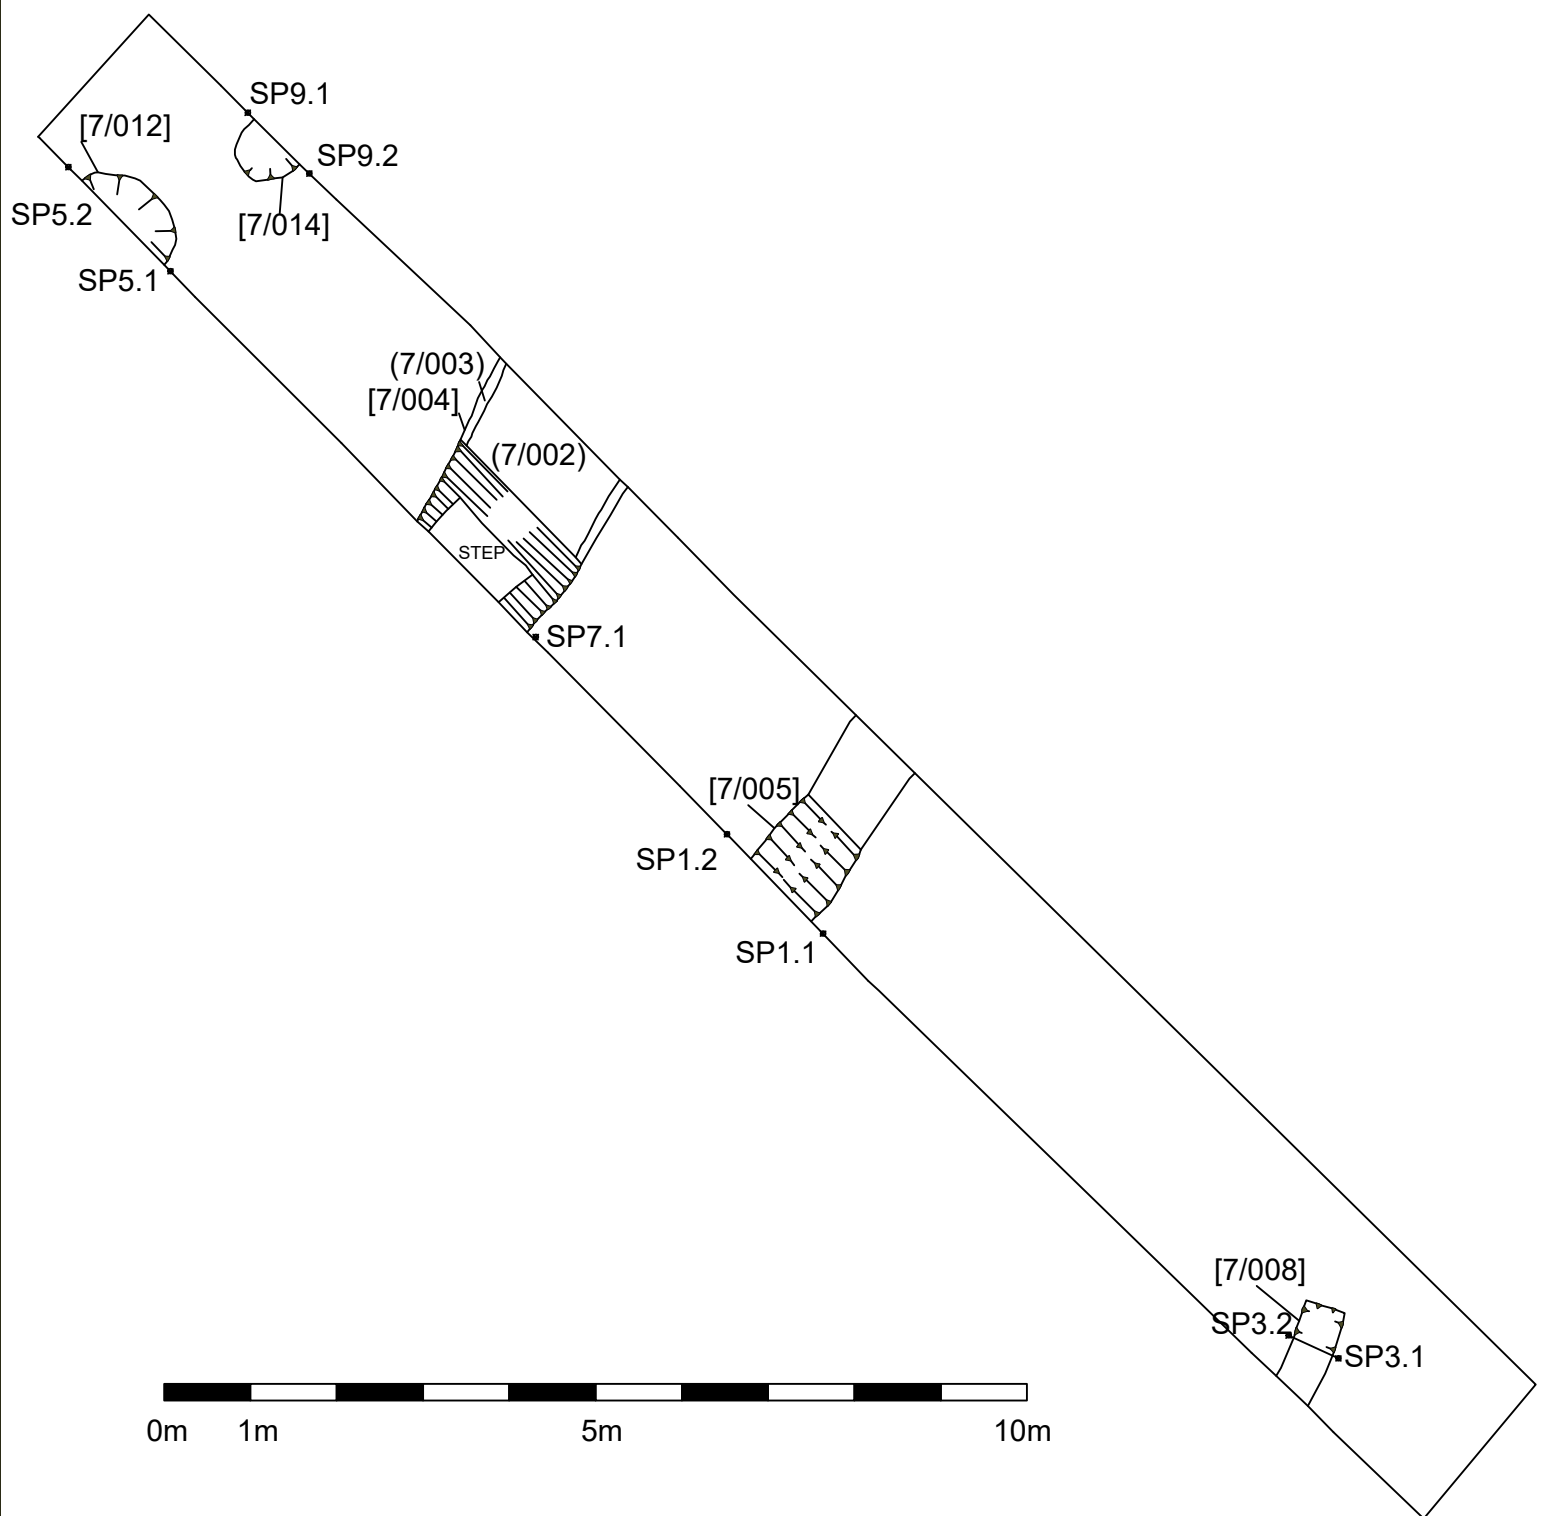
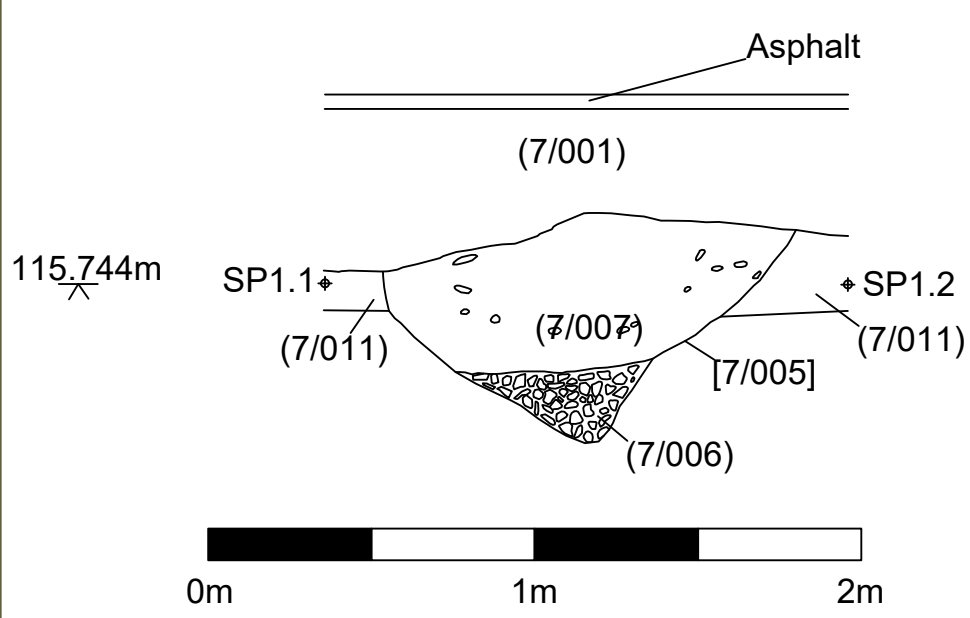
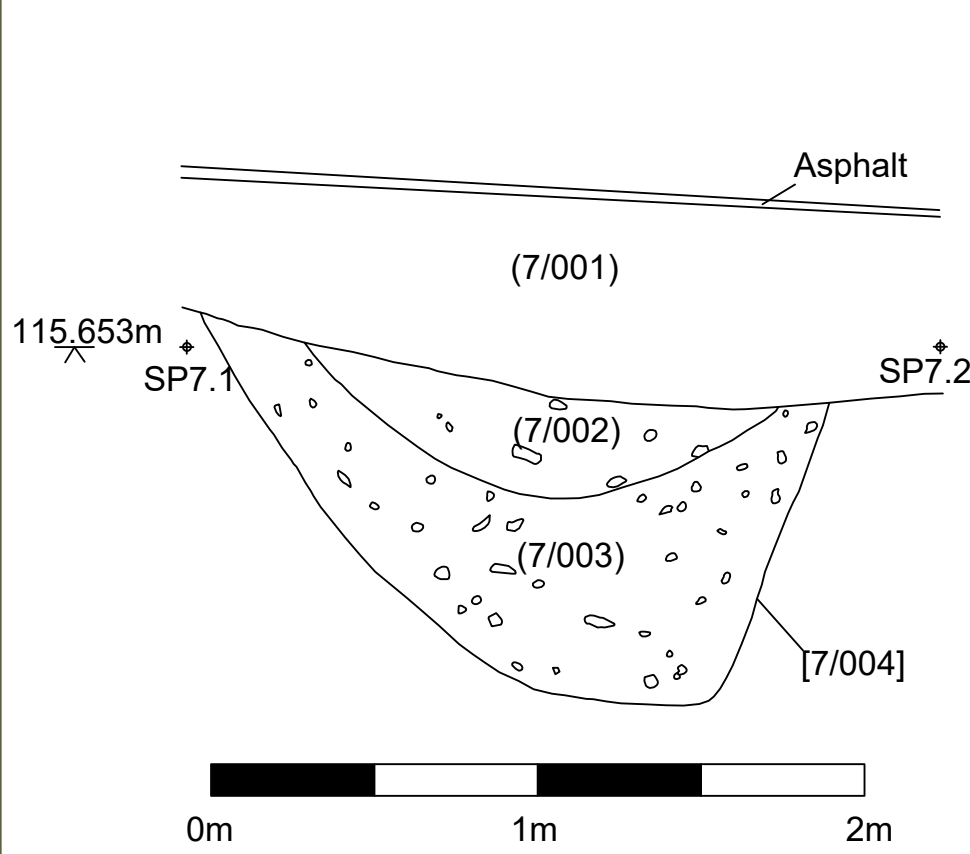
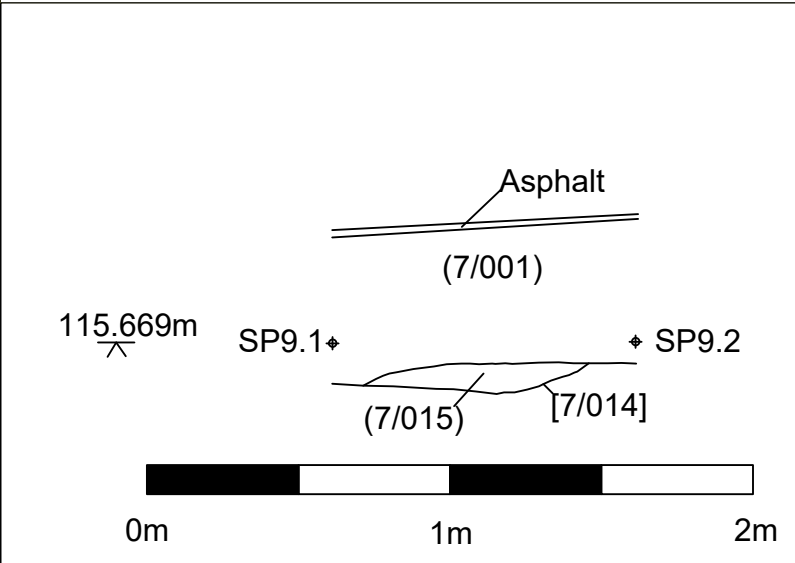
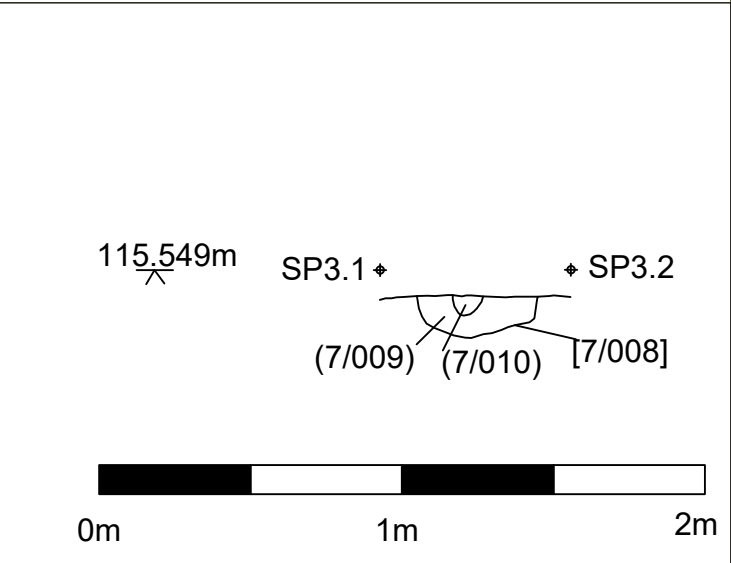
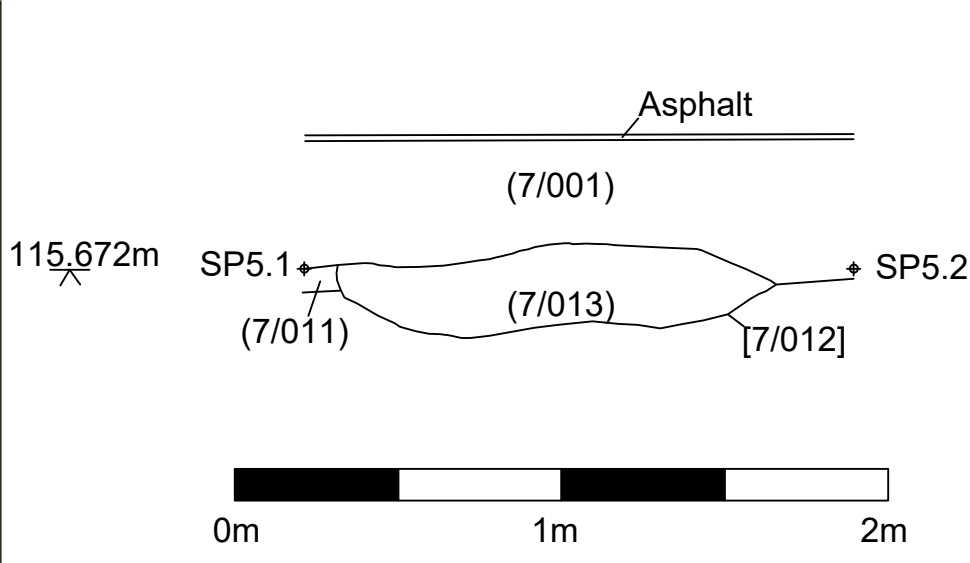
Title: Figure 4

- 5.2.22 Lower fill (7/003), a friable dark greyish brown sandy silt, contained pottery dating to the mid-18th century along with animal bone, CBM, clay tobacco pipe, glass, metal, oyster shell and a gunflint from a flintlock musket. Upper fill (7/002), a loose light yellowish brown sandy silt, contained late 18th century pottery along with animal bone, CBM, clay tobacco pipe, glass, metal and metal working slag and oyster shell.

- 5.2.26 Lower fill (7/009) was a dark blackish brown silty clay with a high concentration of charcoal and burnt bone. It is thought that this burnt material was deliberately dug in to improve the chemical composition of the soil for cultivation. Upper fill (7/010) was a mid yellowish brown clayey silt backfill. Neither deposit contained any artefacts.

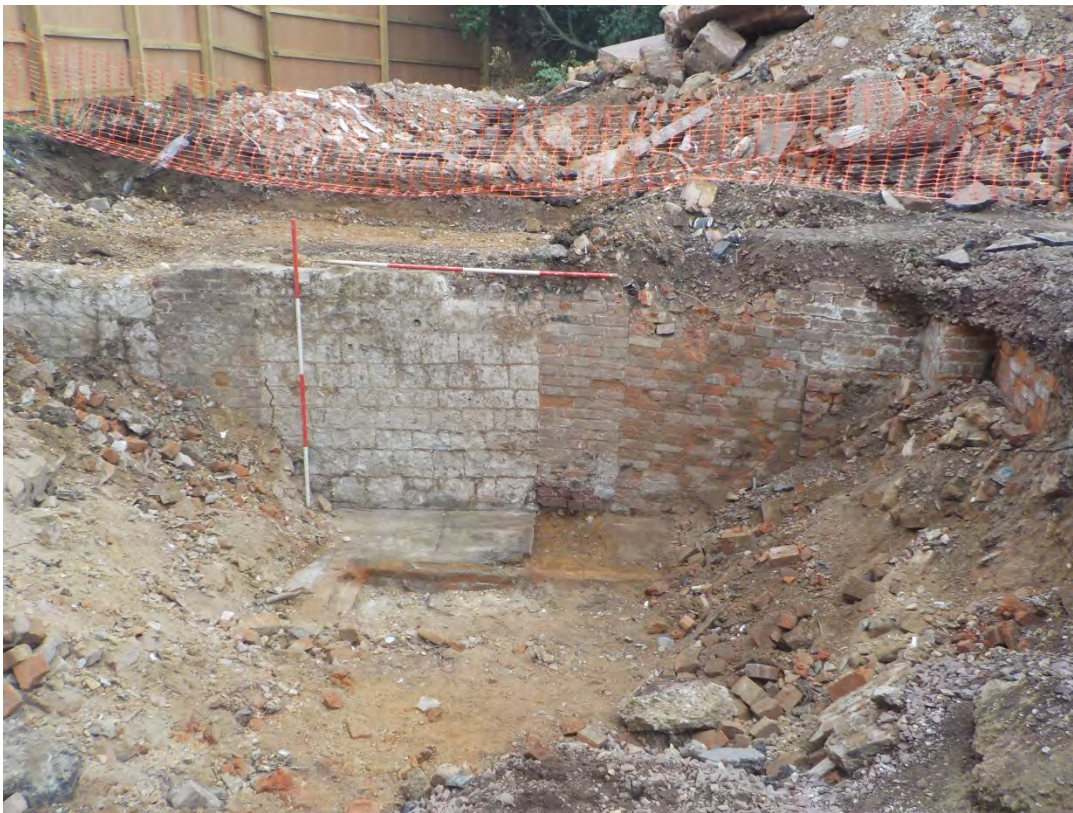
Figure 6: Cellar structure (1/003)

- 5.2.8 Bricks from the supporting columns, the extension/repair and the possible stairwell structure were dated to the mid/late 18th Century.

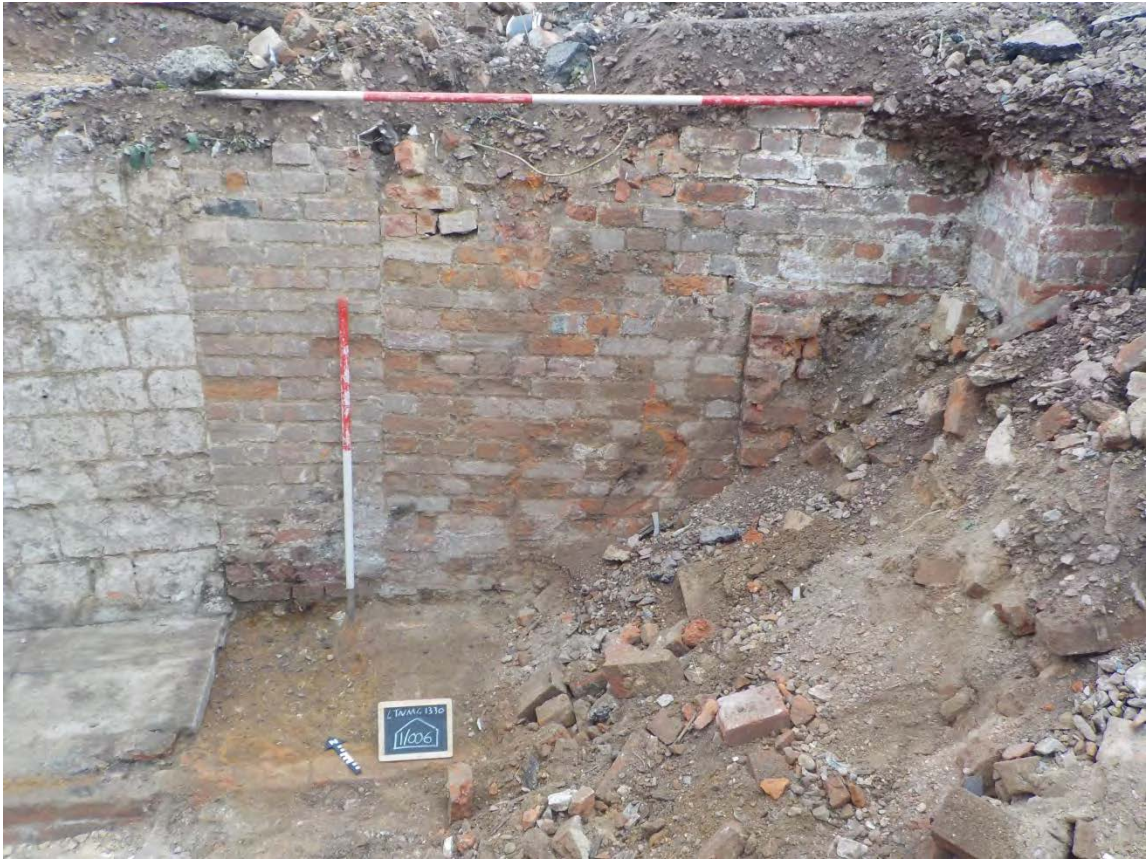
Figure 9: Wall (1/006) looking north east

- 5.2.5 The south east and south west walls (1/006) were butted onto the north east wall, so clearly represented a later phase of construction, but use very similar brick, mortar and coursing and so are unlikely to be significantly later. It is thought that this represents either repair work which replaced a stretch of chalk block wall built in a similar manner to the surviving section or it could simply represent an extension to the original basement.

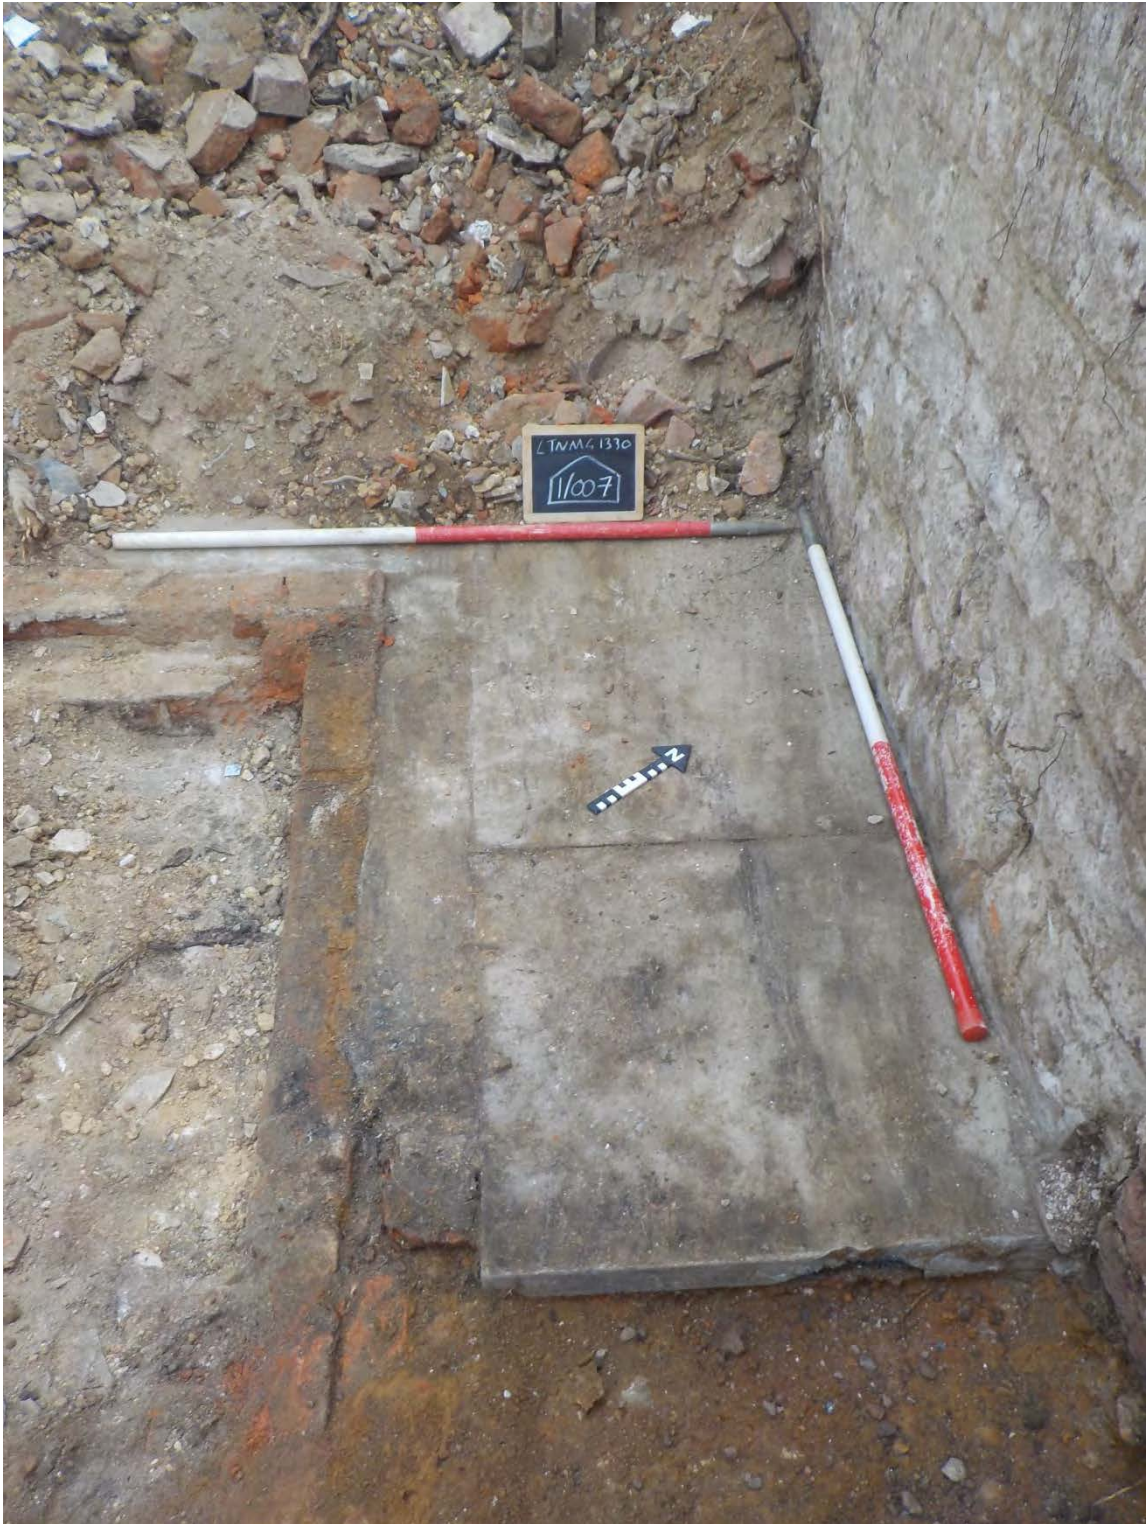
Figure 10: Floor (1/007) looking north west

- 5.2.6 A small section of floor surface made from concrete paving slabs (1/007) survived in the centre of the trench. The slabs were fixed in position with cement on their underside and cemented to the chalk blocks. This floor surface seemed to have completely replaced the original floor and no trace could be found when the concrete slabs were lifted.
