## Archaeological Works at Manchester Museum, Oxford Road, Manchester

ARS Ltd Report No. 2019/46  
OASIS No: archaeo15-343437

# Archaeological Works at Manchester Museum, Oxford Road, Manchester

ARS Ltd Report 2019/46

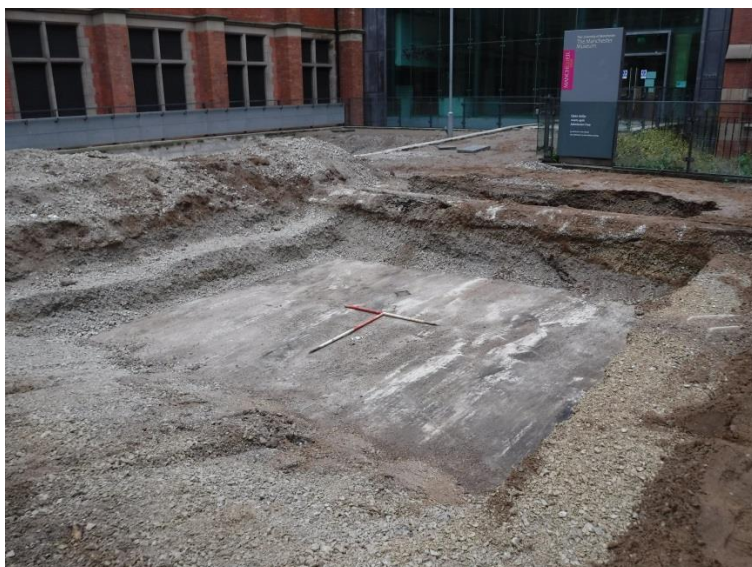
Trench 2, looking north-west.

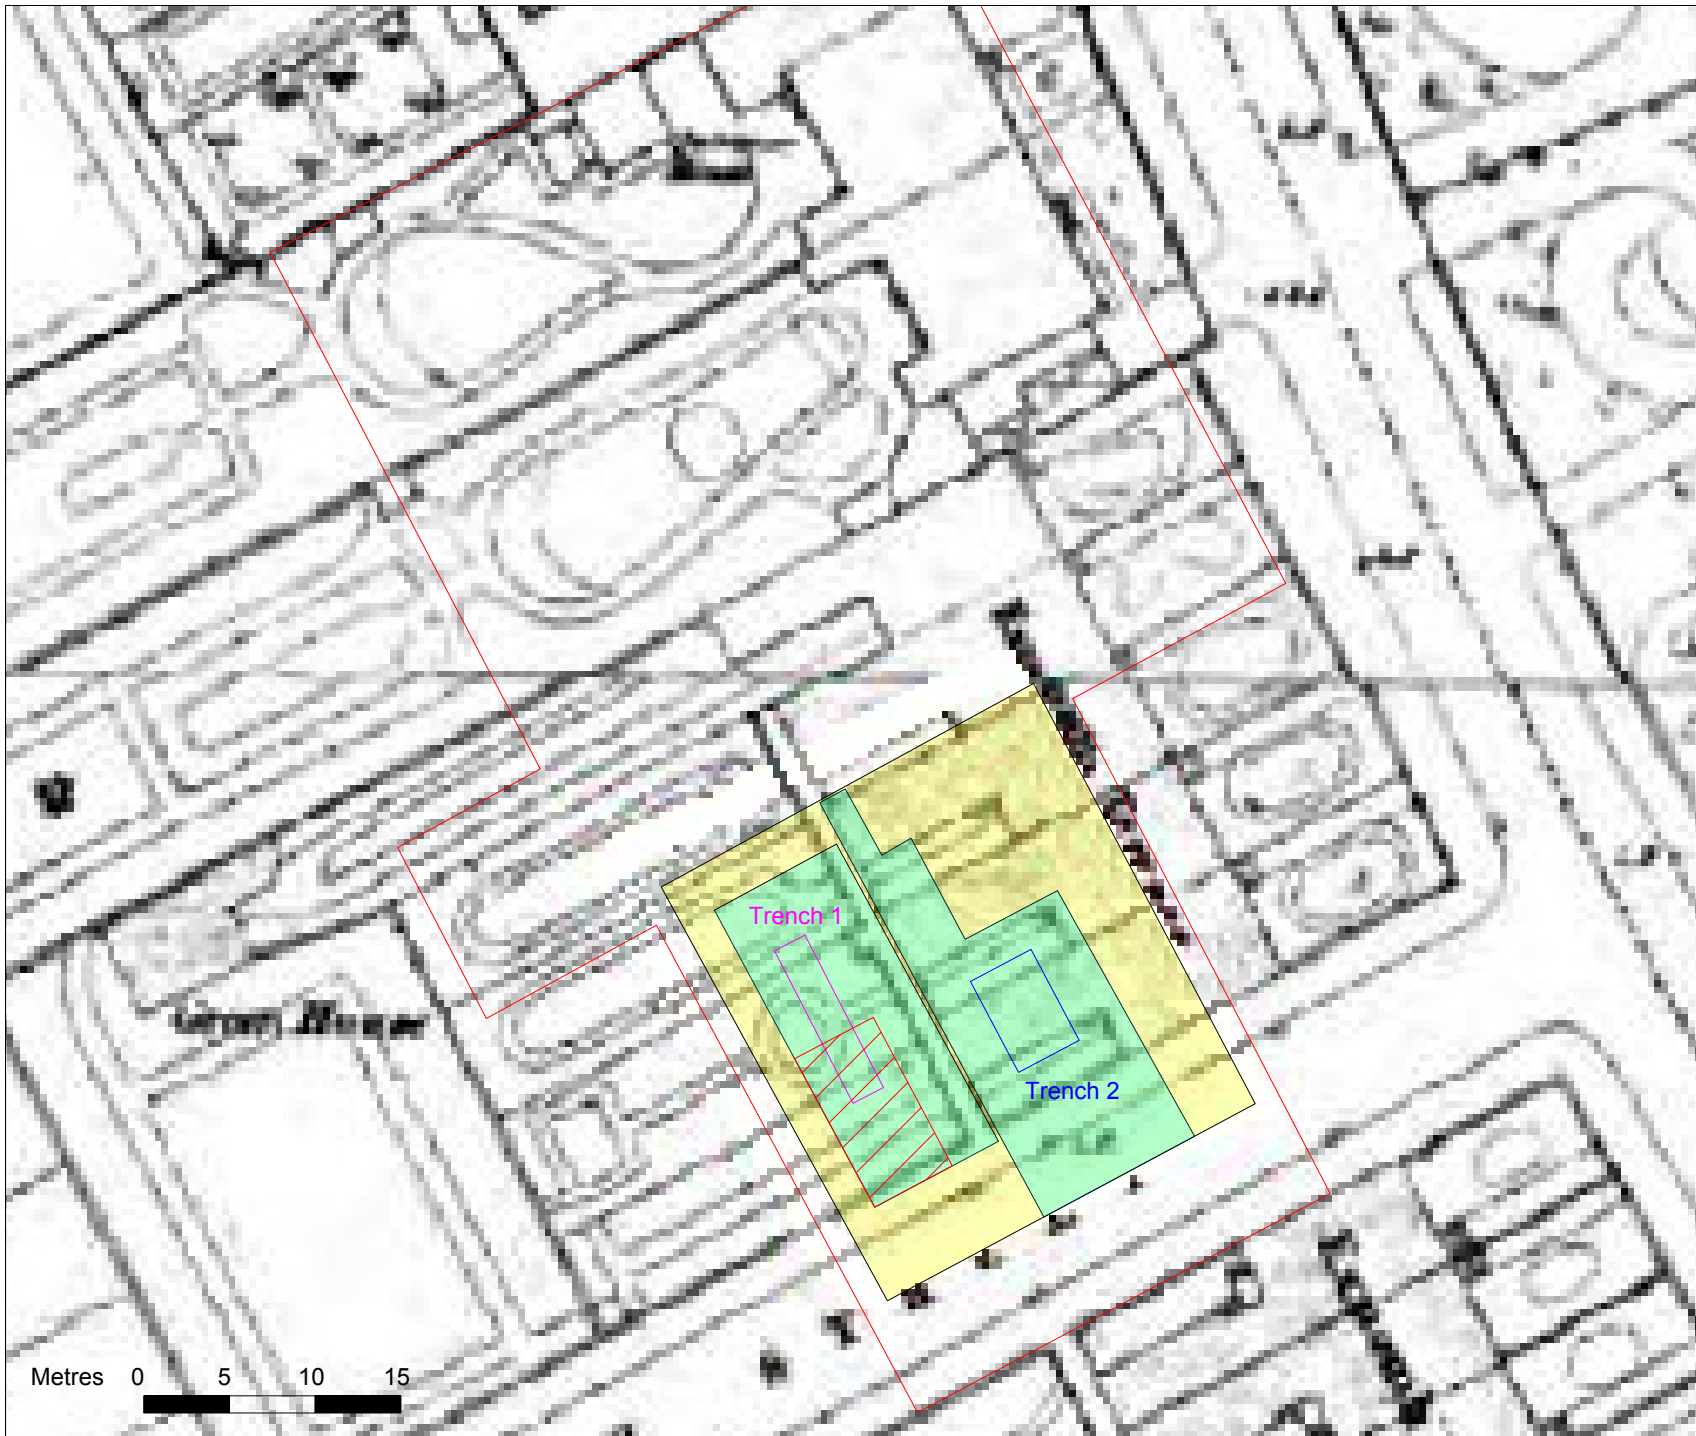
Figure 2  
 Trench location plan overlain onto the  
 1851 OS map.  
 Scale: As shown

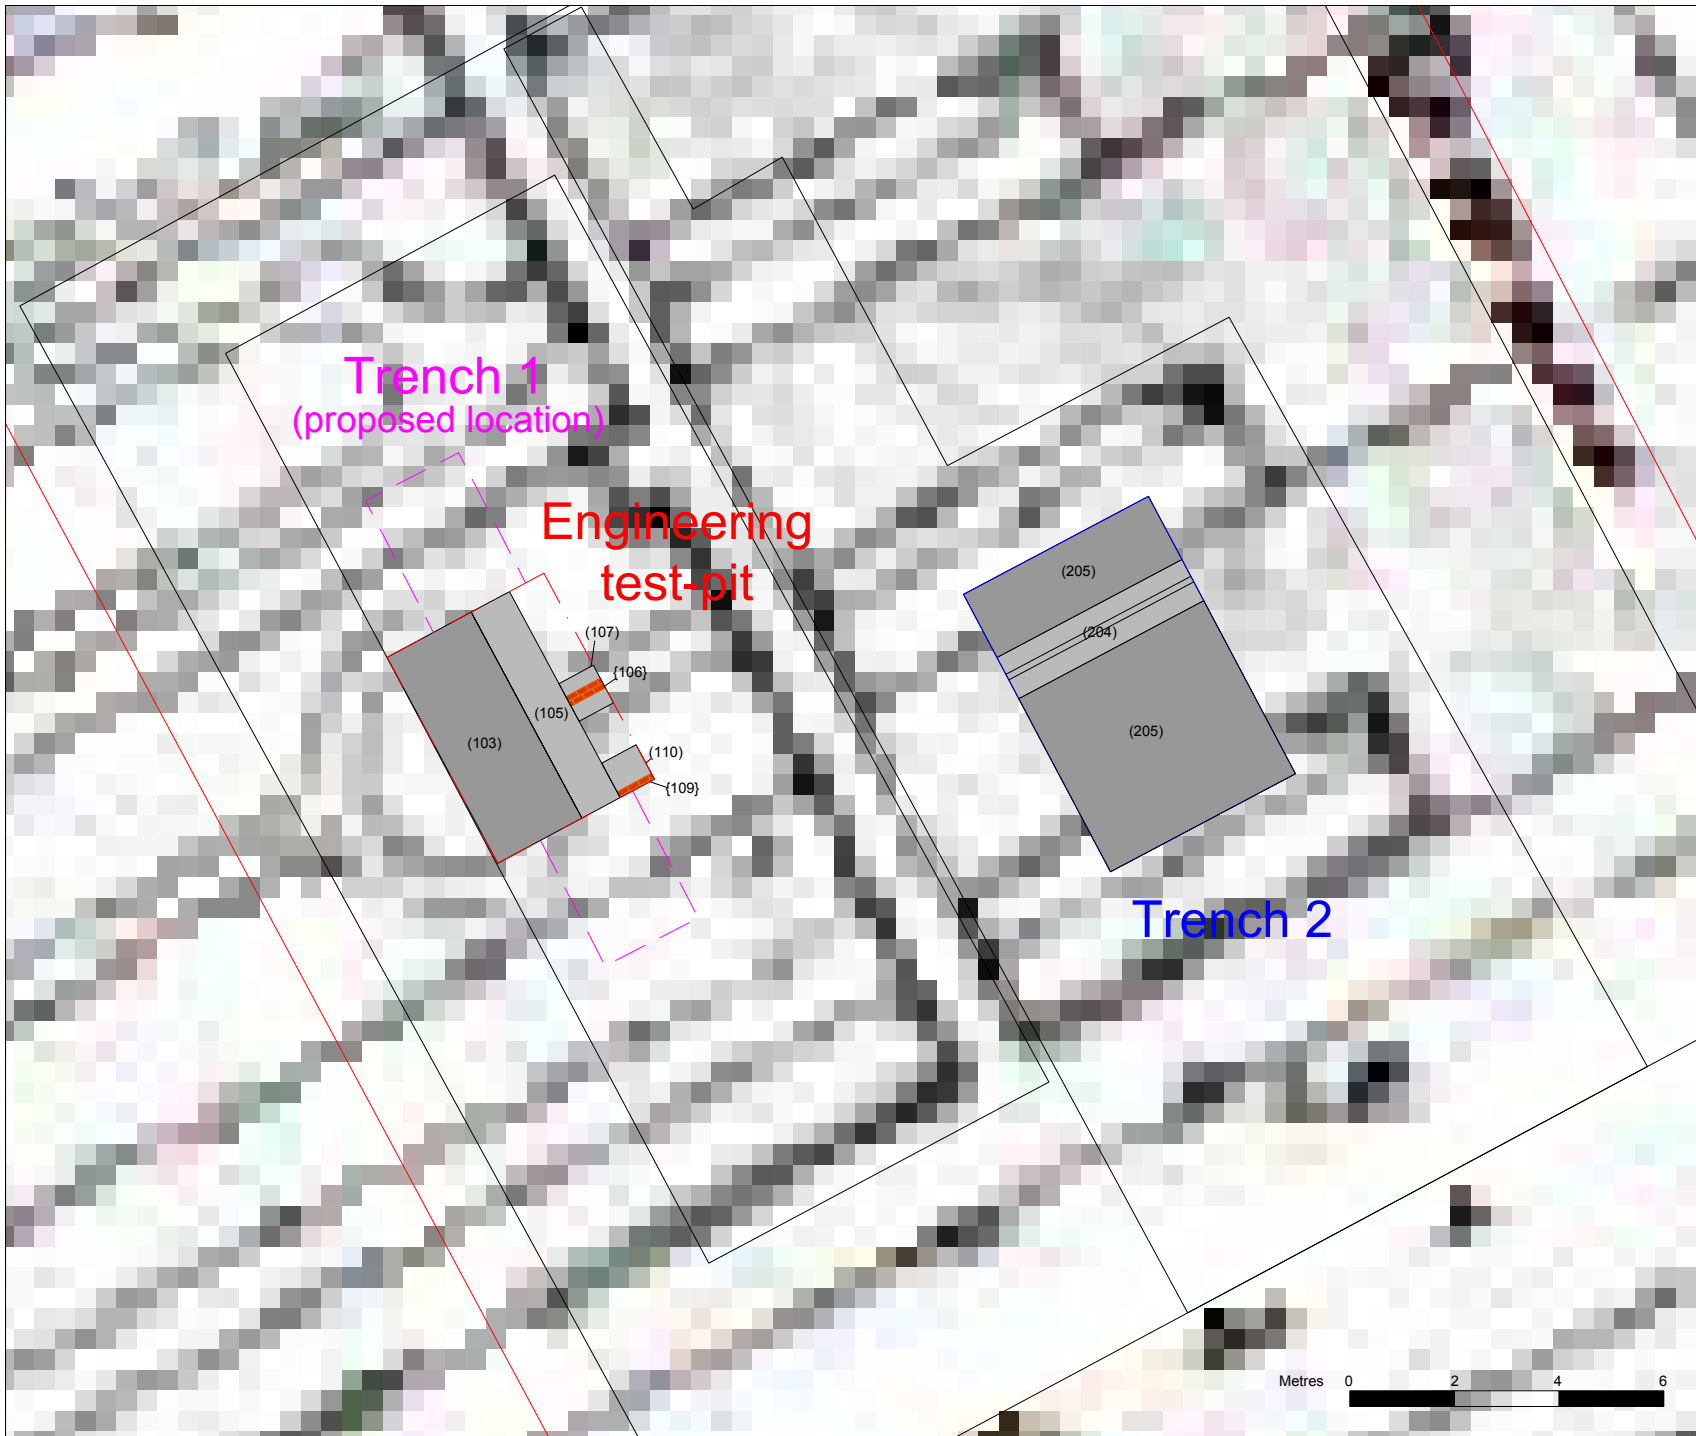
Figure 3

Post-excavation plan showing the locations of trenches and identified surfaces/foundations. Overlain onto the 1851 OS map.

(Figure 3, Appendix II)

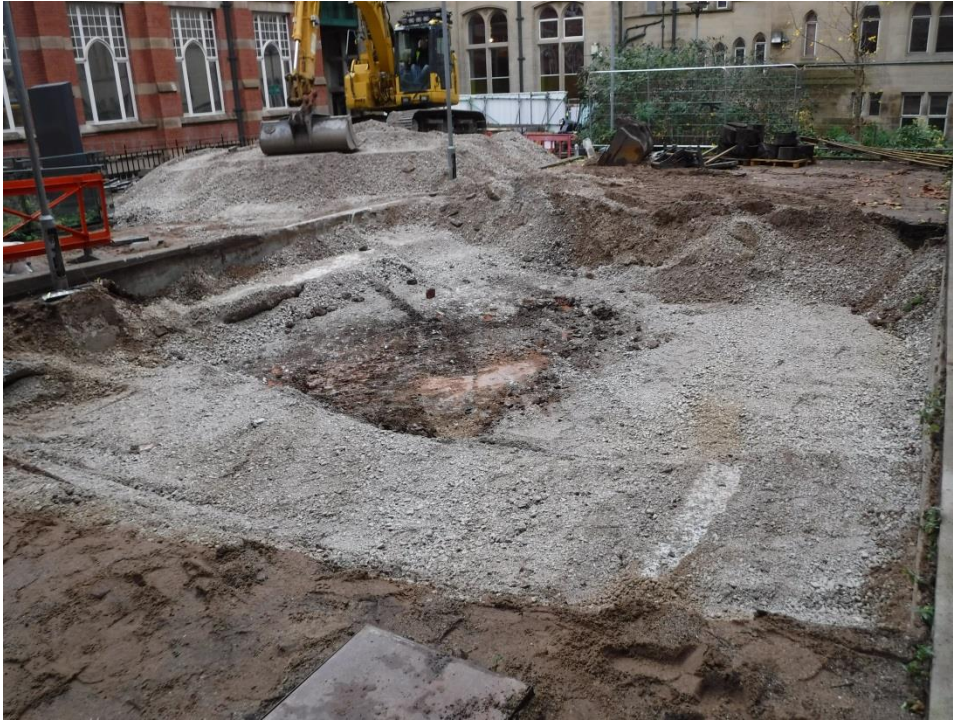
Figure 4. Overview of the south-western area of the courtyard following reduction of the modern ground surface by 1m. Looking south-east.

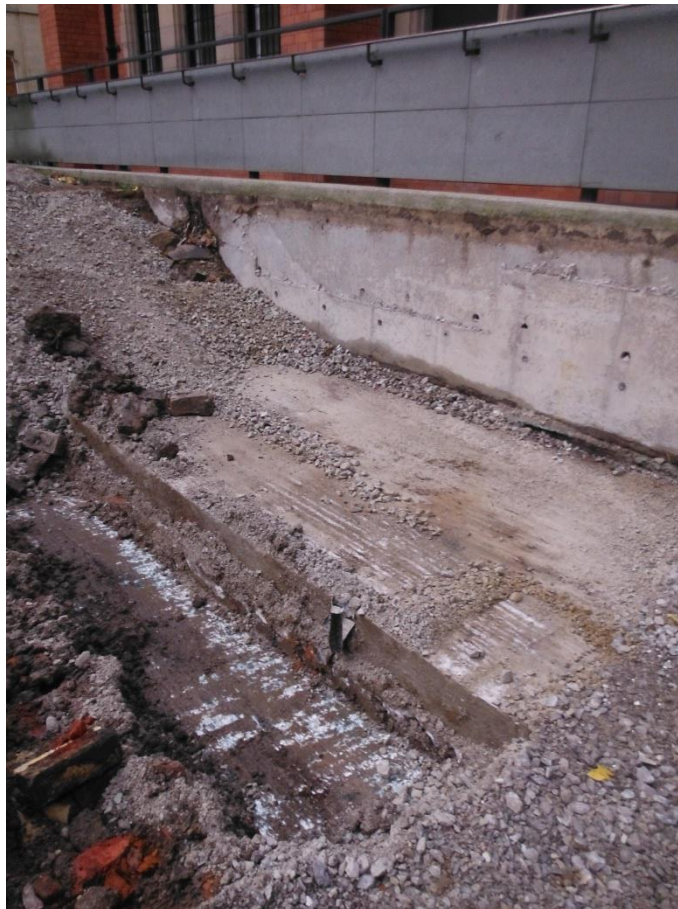
Figure 5. Foundation slab (103) for parapet wall around the courtyard, overlying lower slab (105) Found prior to excavation of the engineering test-pit. Looking south-west.

6.2.4 At 0.8m below existing ground level a concrete slab (103) was encountered abutting the interior face of the concrete retaining parapet wall around the courtyard. This was 0.2m thick, 1.92m wide and resting on a thin layer of cement, (104), which bonded slab (103) to a lower slab (105). This lower slab was also 0.2m thick and protruded out from beneath slab (103) by 0.76m (Appendix II, Figure 5). This lower slab appeared to be resting on natural clay (114) except in the middle of the trench where it sat on an earlier brickcrete foundation (107). This foundation slab was 0.2m thick and 0.81m wide. A brick wall {106}, constructed of machine made bricks laid in stretcher bond with cementitious mortar ran along the centre of foundation slab (107) but had

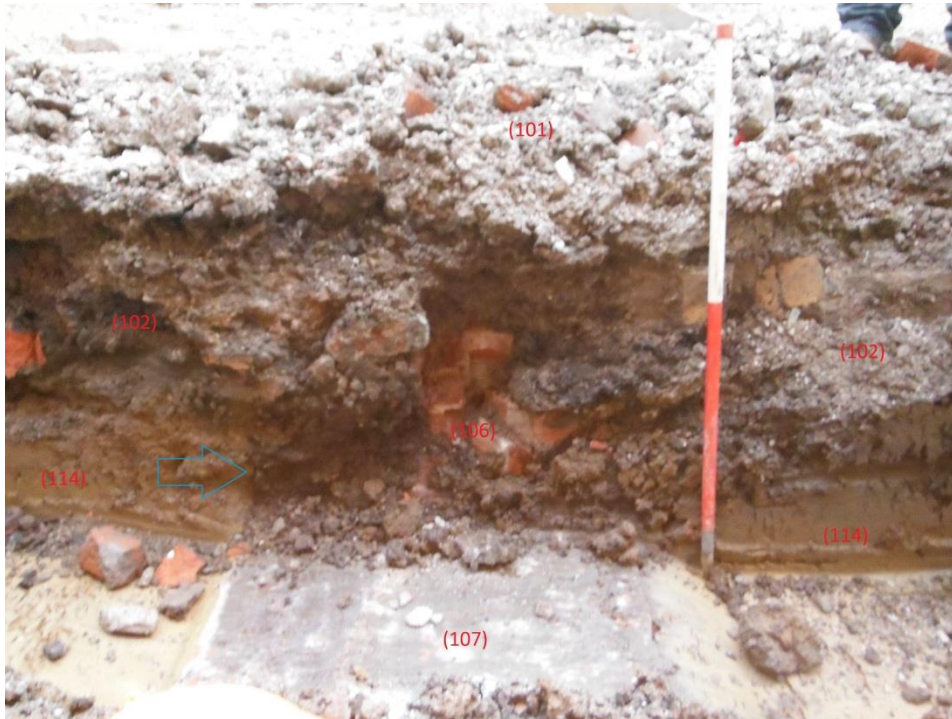
Figure 6. South-west facing section (annotated) showing wall (106) on foundation beam (107) within construction cut [108] (blue arrow). Construction is cut through natural clay (114). Scale: 1m.

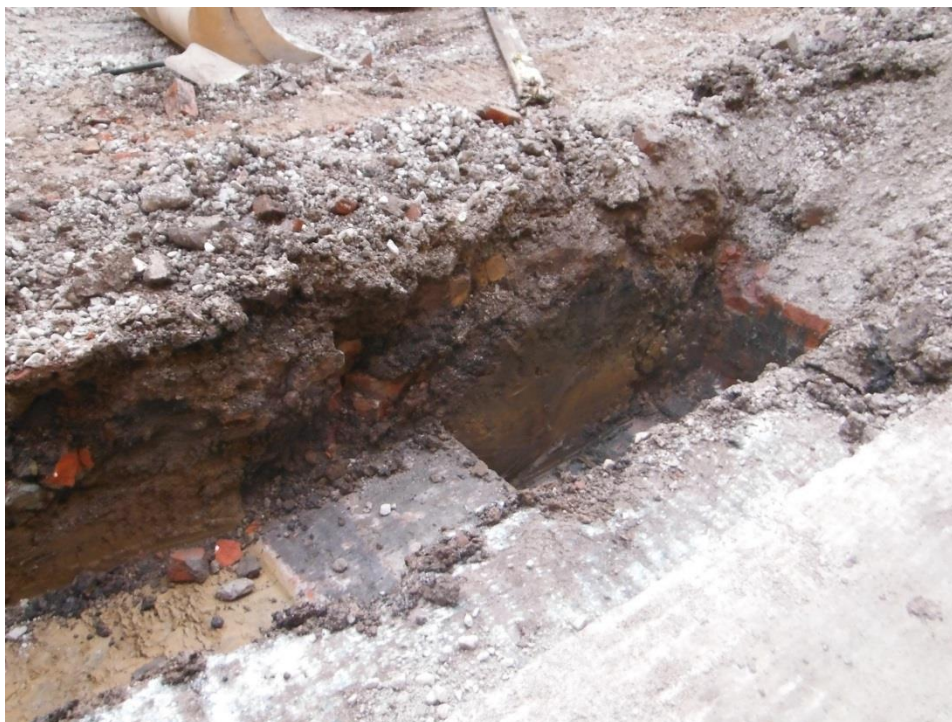
Figure 7. Oblique view of the south-west facing section during excavation of the engineering test-pit. Concrete slabs (103) and (105) visible in foreground. Brickcrete beam (107) and wall (106) visible in the centre. Wall (109) on concrete beam (110) visible on the right hand side of the photograph (south-east end of test-pit).

6.2.5 A second similar foundation slab (110) protruded from the south-eastern section of the test pit. This was also of brickcrete, 0.19m thick and protruding by 0.61m from a wall {109} which was built on top of it. The top of brickcrete foundation (110) was 0.17m lower than that of foundation (107). Both 20<sup>th</sup> century walls were sealed by clay/rubble layer (102) probably representing demolition/construction debris (Figure 7, Appendix II). It is unclear what these walls represent but they are likely associated with an earlier building depicted within the courtyard area on historic mapping up until at least 1992.

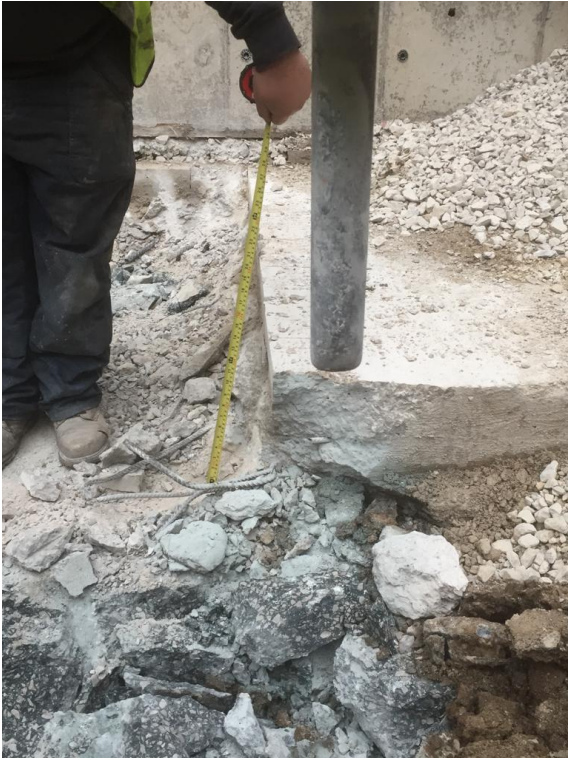
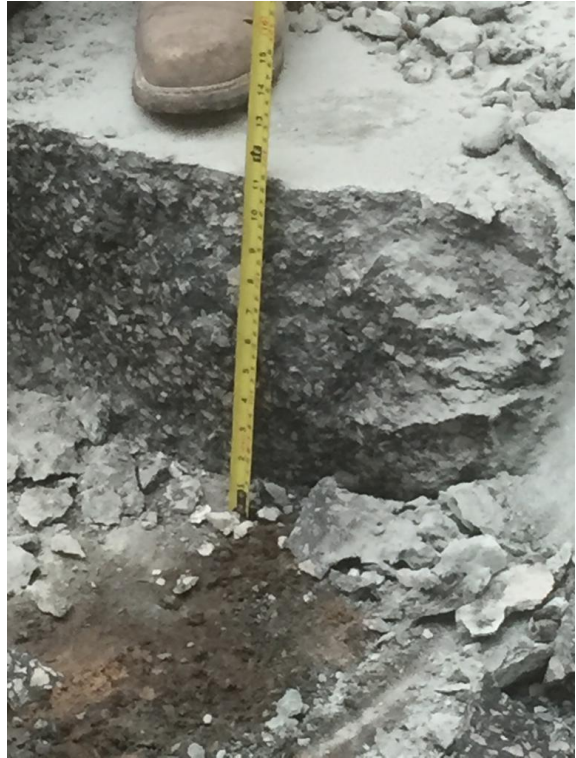
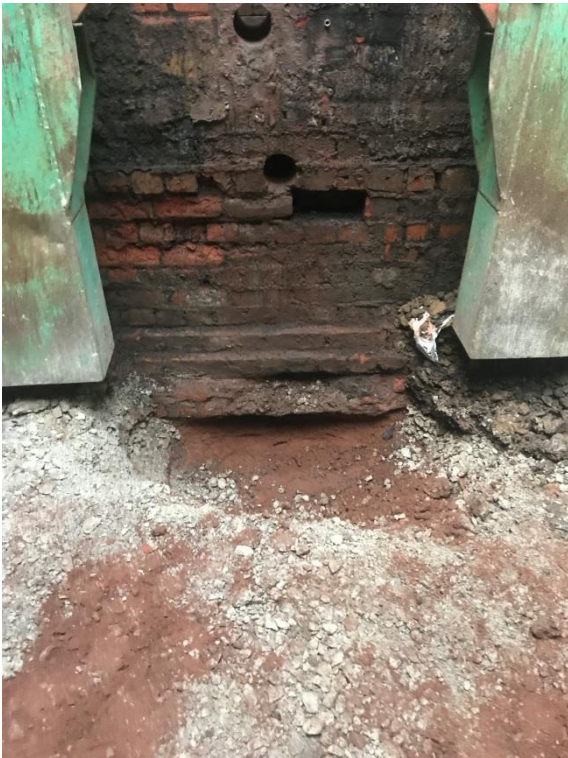
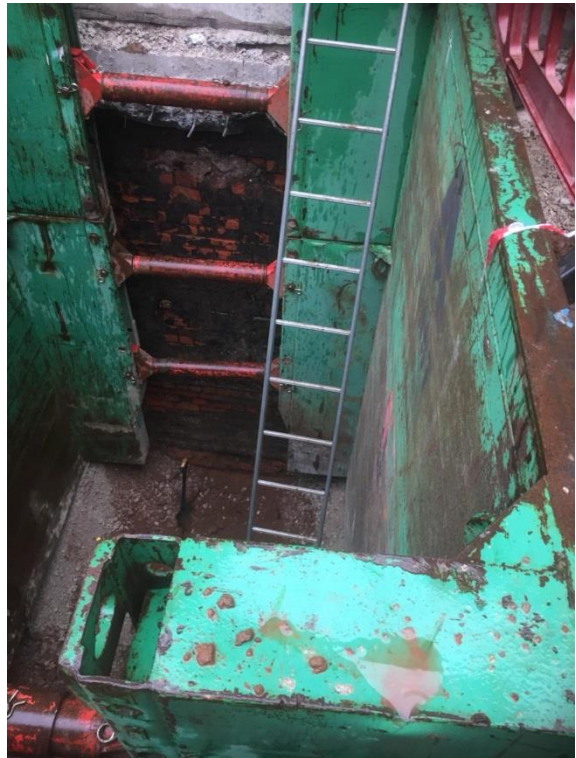
Removal of upper slab (103)

Removal of lower slab (105)

Stepped foundation of courtyard retaining wall, cut through and overlying natural clay

Depth of test-pit following removal of concrete slabs, made-ground deposits and natural clay to expose foot of wall

Figure 8. Excavation of the engineering test-pit after removal of the upper parapet wall foundations. Photographs supplied by MBC Building Contractors NW Ltd.

6.2.6 Removal of the concrete foundation slabs and brickcrete beams took place the week after ARS Ltd's second attendance on-site. The test pit was excavated down to the footing of the courtyard retaining wall at a depth of around 4m below ground level. The removed ground was formed of disturbed clay with demolition inclusions, coming down onto clean red/brown natural clay. The disturbed clay is likely to be associated with the build-up of the courtyard following the completion of construction of the museum buildings. Figure 8 comprises a number of photographs supplied by MBC Building Contractors NW Ltd following excavation of the test-pit below the concrete slabs and beams observed by ARS Ltd (Appendix II).

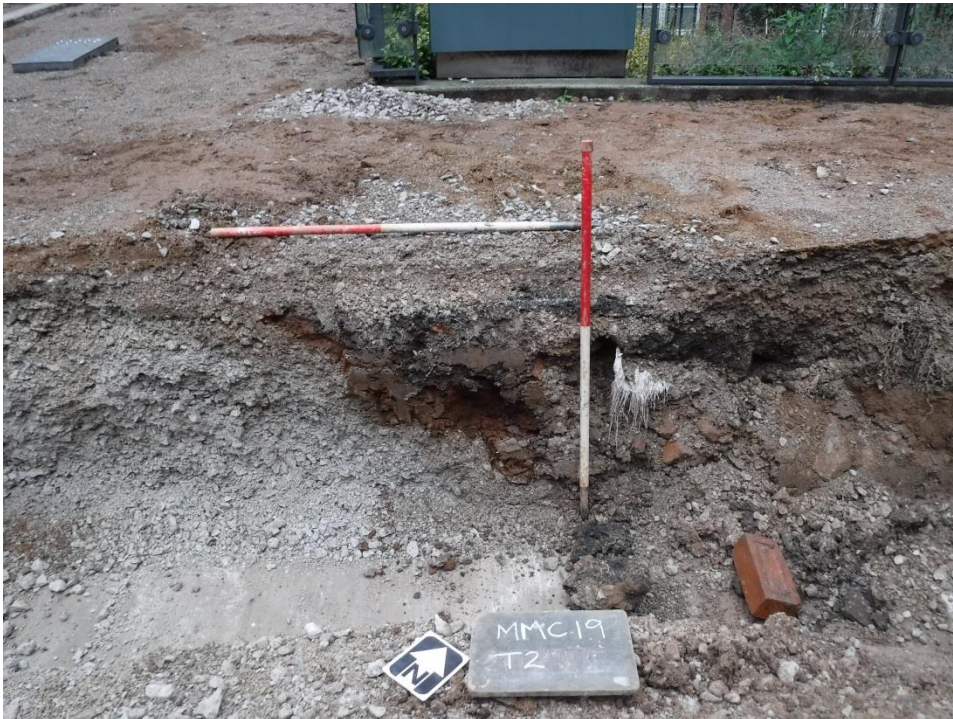
Figure 9. South-east facing section of Trench 2 showing re-deposited tarmac (201) and clay backfill (202) within the gravel levelling deposit (203) found over concrete slab (205). Scale: 2x1m.

6.3.4 At a depth of 0.9m the upper surface of a level concrete foundation slab (205) was encountered. The depth below ground-level corresponded with the depth of foundation slab (103) from the engineering test-pit and it is likely that the slab was associated with the concrete parapet wall found around the perimeter of the courtyard. Unlike slab (103), concrete surface (205) did not have a visible edge and was encountered across the base of the full area of the trench, though due to the slope of

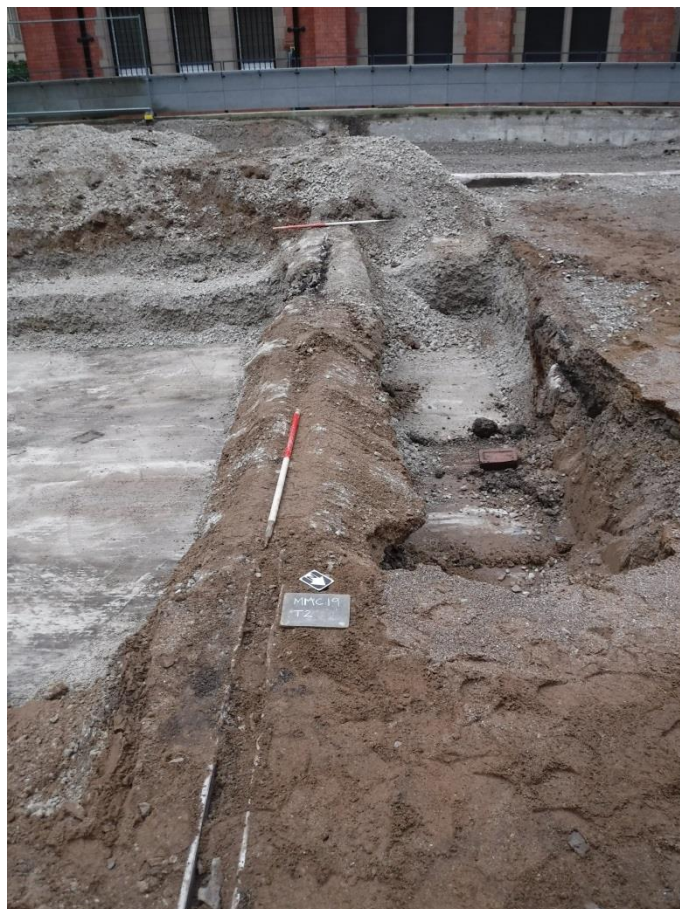
Figure 10. Concrete beam (204) carrying surface channel drain north-east/south-west across the courtyard. Scale: 2x1m.

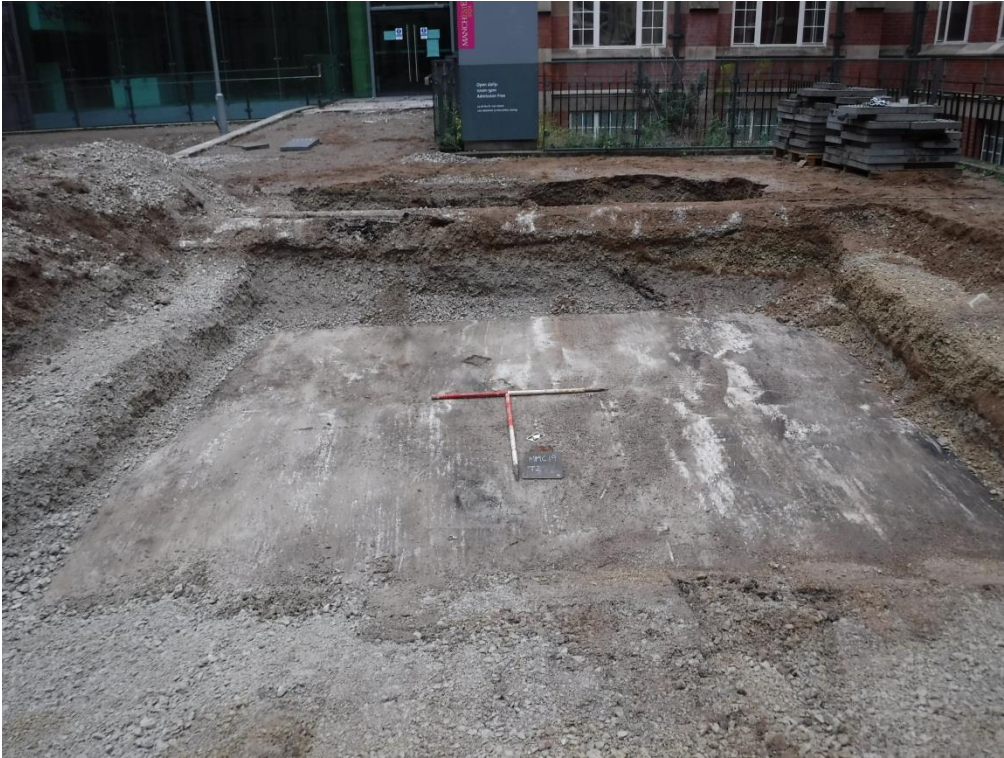
Figure 11. Trench 2, post-excavation. Slab (205) visible across the base of the entire trench. Scale: 2x1m.

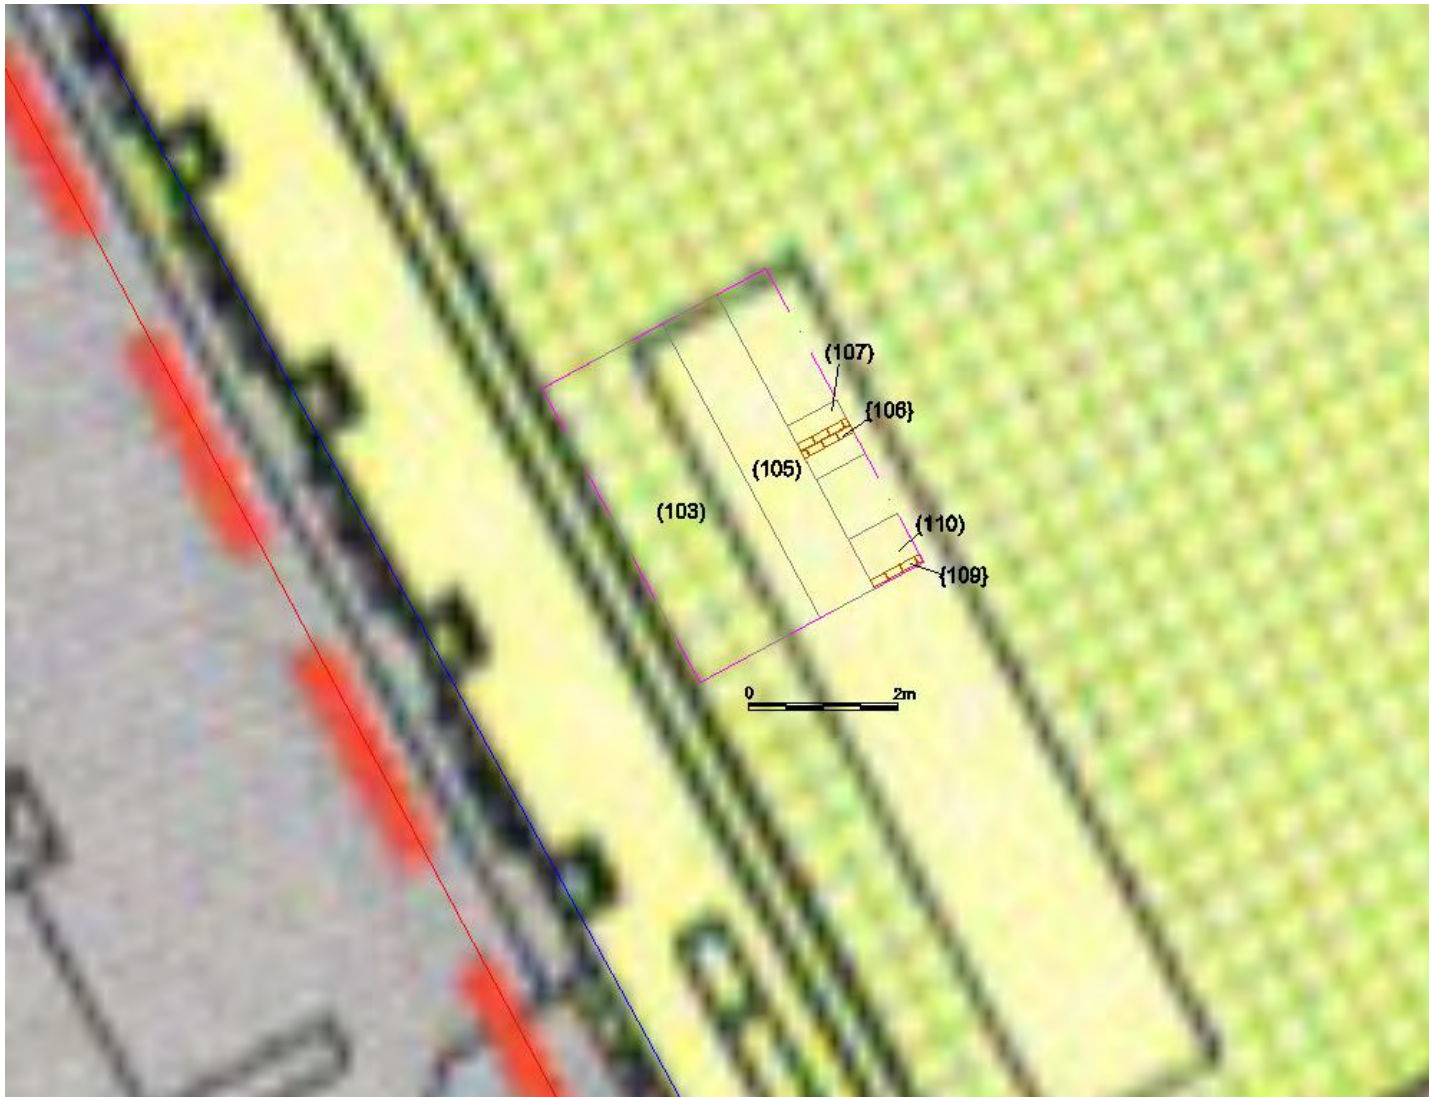
Figure 1. Plan showing location of test pit and features within it. Existing building is shown in grey.

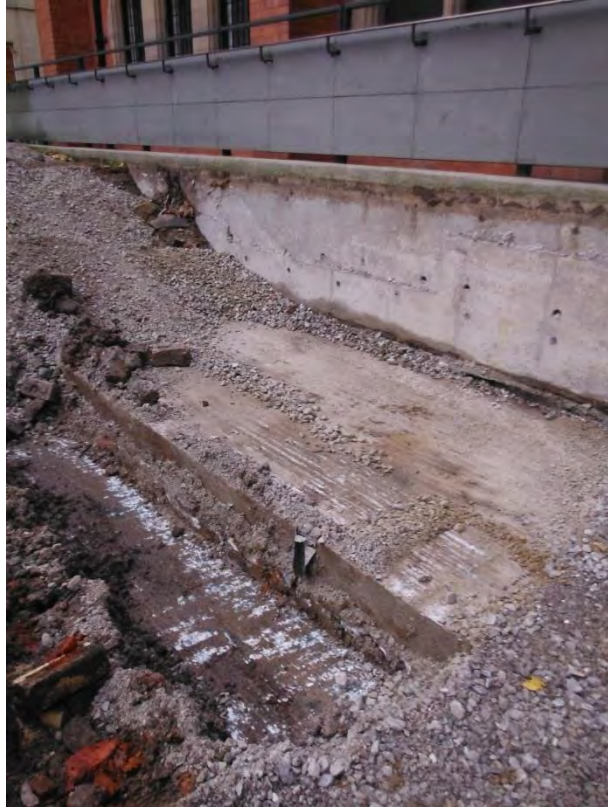
Figure 2. Concrete slabs (103) and (105) looking south.

1.2 At 0.8m below existing ground level a concrete slab (103) was encountered abutting the interior face of the concrete retaining wall around the courtyard. This was 0.2m thick, 1.92m wide and resting on a thin layer of cement, (104), which bonded slab (103) to a lower slab (105). This lower slab was also 0.2m thick and protruded out from beneath slab (103) by 0.76m. This slab appears to be resting on natural clay (114) except in the middle of the trench where it rests on an earlier brickcrete foundation (107). This foundation slab is 0.2m thick and 0.81m wide. A brick wall {106}, constructed of machine made bricks laid to a stretcher bond with cementitious mortar ran along the centre of this foundation slab but had been truncated by the insertion of the concrete slabs. The construction cut for this wall was through natural clay. A second similar foundation slab (110) protruded from the south-eastern section of the test pit. This was also of brickcrete, 0.19m thick and protruding by 0.61m from a wall {109} which was built on top of it. The top of foundation (110) was 0.17m lower than that of foundation (107). Both walls were sealed by a clay/rubble layer (102) probably representing demolition/construction debris. It is unclear what these walls represent but they are likely associated with earlier buildings within the courtyard area shown on historic mapping up until at least 1992.

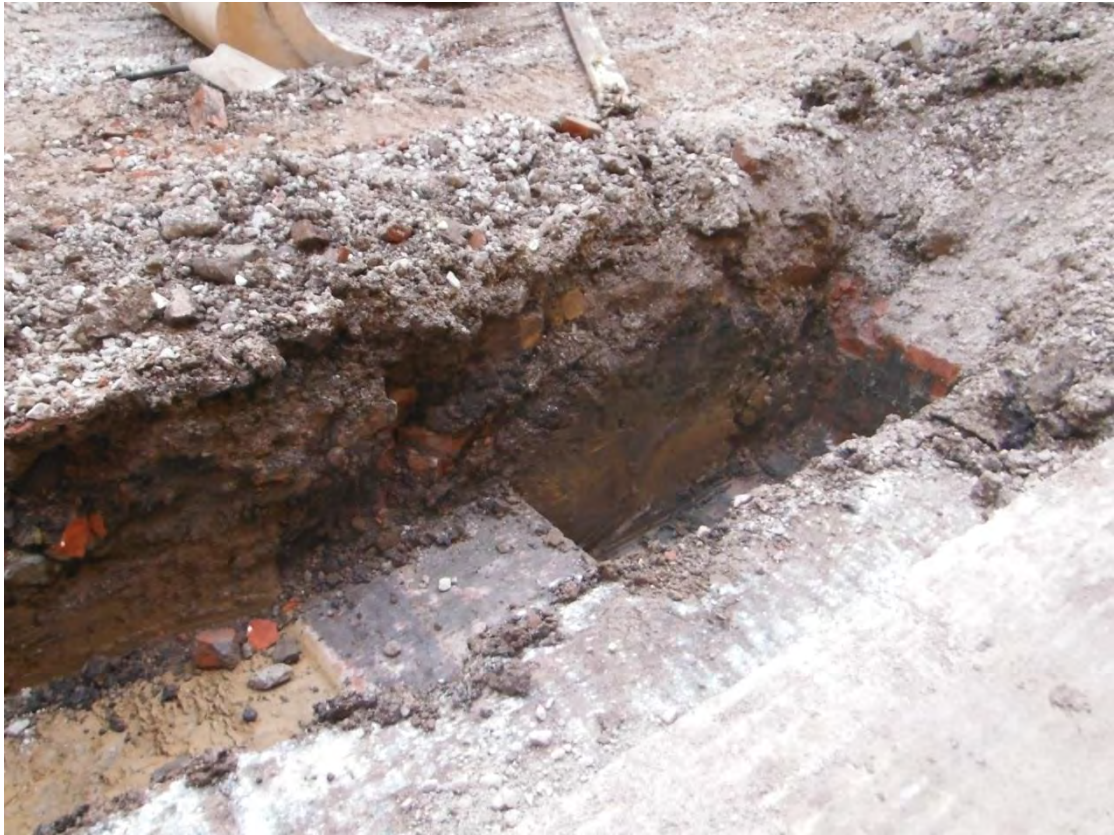
Figure 3. South-west facing section showing brickcrete foundation (107) with wall (106) above and wall (109) on the right, both sealed by clay/rubble overburden (102).
