# Archaeological Works at St. John's Church, Alkington, Derbyshire

**ARS Ltd Report 2019/62**  
**Oasis No. archaeol5-346570**

## **Archaeological Works at St John's Church, Alkington, Derbyshire**

*Archaeological Research Services Ltd was commissioned by Mr Paul Mendham Stonemasons Ltd to undertake a scheme of archaeological mitigation during development works on St. John's Church, Alkington, Derbyshire.*

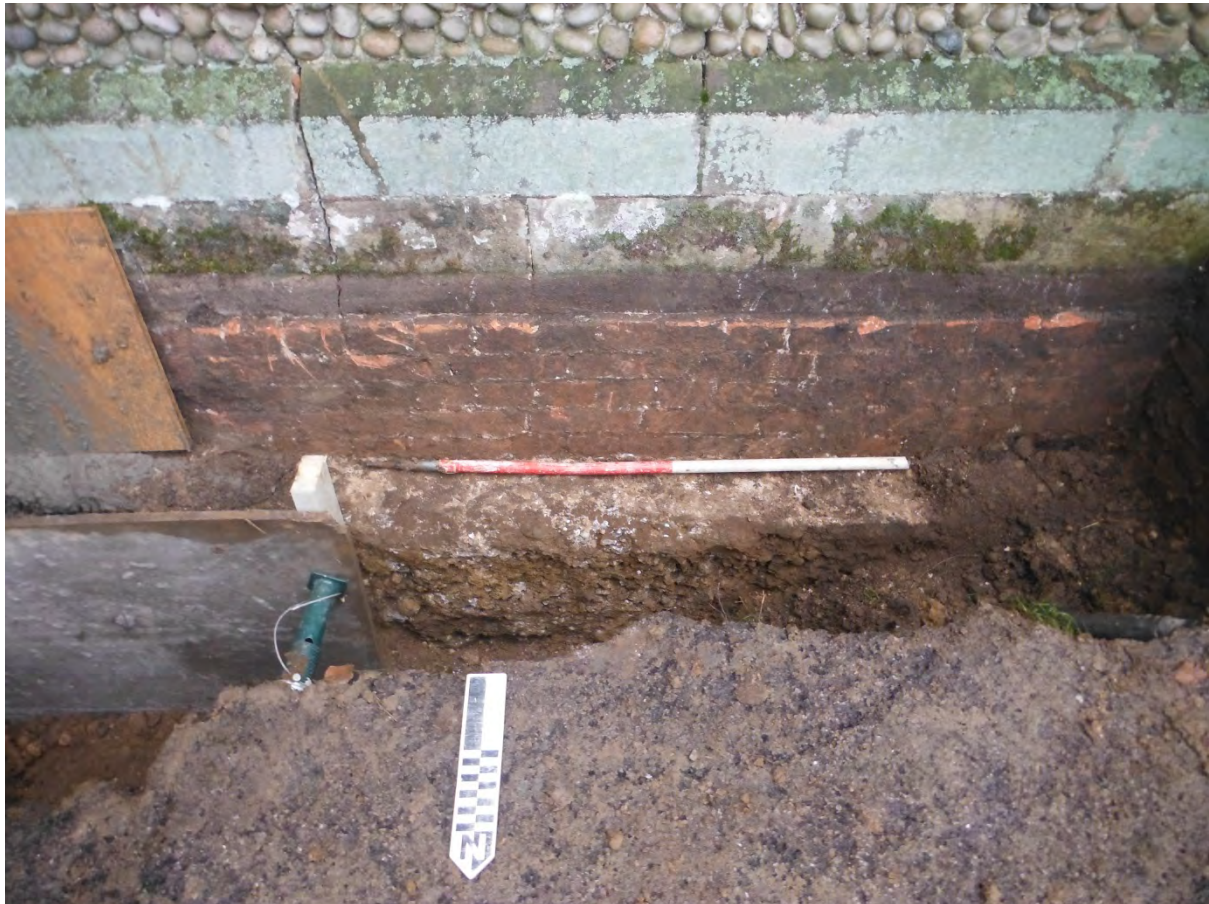
**Figure 4 Brick foundation (006) and concrete underpinning (005) of north wall of nave**

4.2.2 The foundation substructure of the outer north wall of the nave consists of three distinct construction layers (Figure 4). The first comprises a thick block of plain concrete (005) measuring 800mm deep and 5m thick, overlaid by five courses of handmade orangey bricks (006) laid on bed facing north, bonded with a whitish grey mortar. The brick work forms an English Bond and is overlain by two courses of finely dressed limestone (007) forming an ashlar bond with carefully chamfered dressed masonry. For measurements see Appendix 1.

5.2 The concrete underpinnings found beneath the foundations appears to be later additions, representing an attempt to enhance either the stability of the walls (necessary, presumably, because of ground subsidence) or their capacity to resist loading or both. The concrete underpinnings under the nave can be securely classified as a later addition, as Portland cement concrete was first used in Britain in the 1850s, postdating the initial construction of the church by a few years.

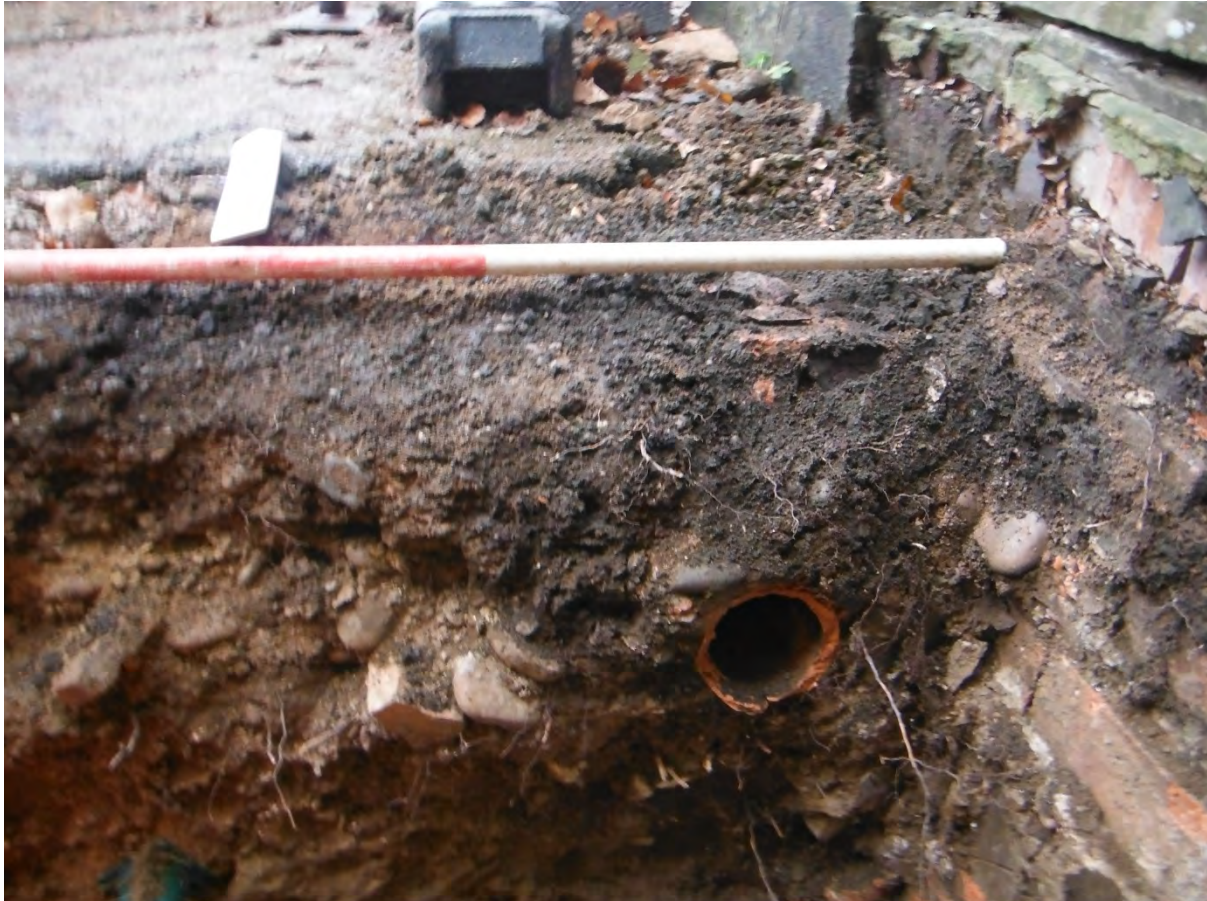
Figure 5 South facing section of trench [011] and drain [008]

4.2.3 The north church churchyard, as shown in Figure 5, comprises a sequence deposits above the subsoil. The natural clay geology (004) is overlaid by a yellowish brown stony sandy silt layer, identified as subsoil (003). On top of that a mixed layer (002) (composed of

loose spread of material including cobbles and bricks mixed with redeposited topsoil was encountered. The last layer is represented by an asphalt layer flooring (001).

4.2.4 At the east site of the underpinning (close to the boiler wall) a ceramic drain (009) was detected running north-east away from the church wall. The trench was cut through made ground (002), backfilled with redeposited topsoil (010) and overlaid by asphalt layer (001).

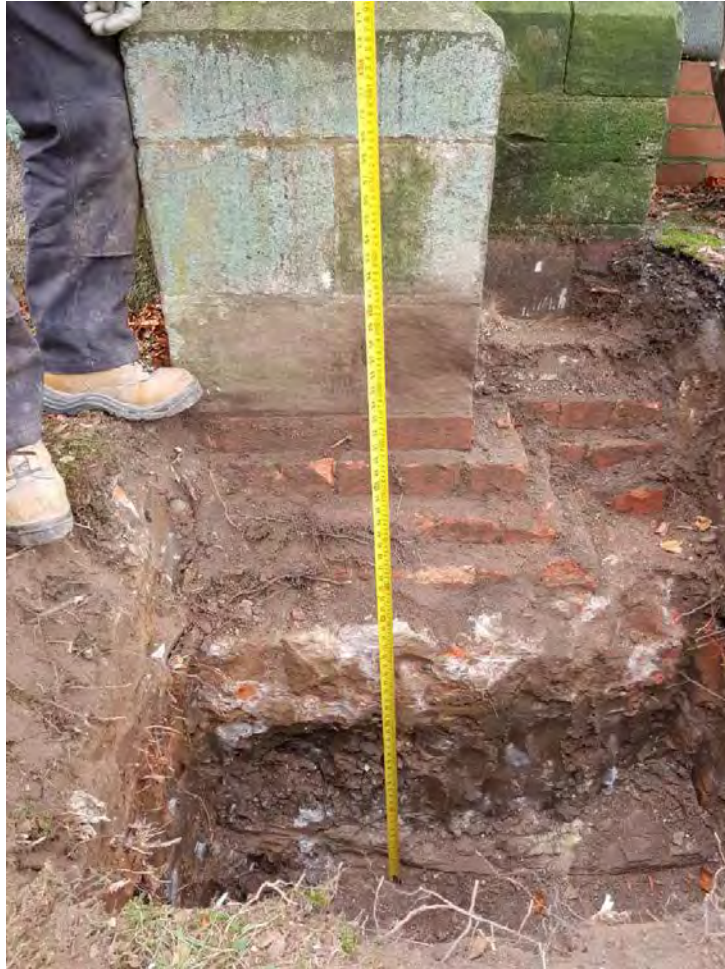
**Figure 6 Stepped brickwork and concrete underpinning foundation underneath the east wall © Paul Mendham Stonemasons Ltd**

4.3.1 The east underpinning trench was located by the east wall of the chancel (Figure 2). The trench had already been excavated and refilled with concrete by the time ARS archaeologist arrived on site. A photographic record collected by the construction team revealed that the foundation comprises concrete overlain by four courses of stepped brickwork in a stretcher bond underneath three courses of chamfered limestone ashlar blocks.

5.8 The chancel, being a later addition, is structurally different to the nave in several respects. The concrete floor of the nave overlaying the heating system, the stepped brickwork foundation of the east wall, and the three limestone ashlar courses on top are all in contrast to the construction methods used for the nave.

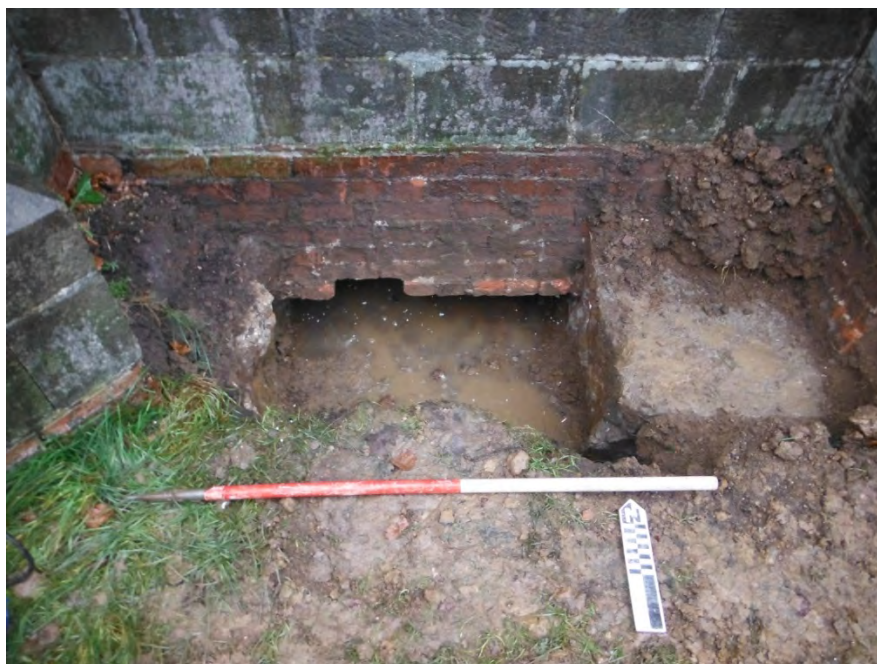
**Figure 7 South wall brick foundation**

4.3.2 Unlike the four courses stepped brickwork identified on the east wall of the chancel, the south wall comprises a seven-course foundation of hand-made bricks laid on bed facing south (014). The brickwork is bonded with a light grey mortar forming an English Bond and is superimposed by two courses of finely finished ashlar limestone blocks (015) (Figure 7 and section 1 in Figure 14).

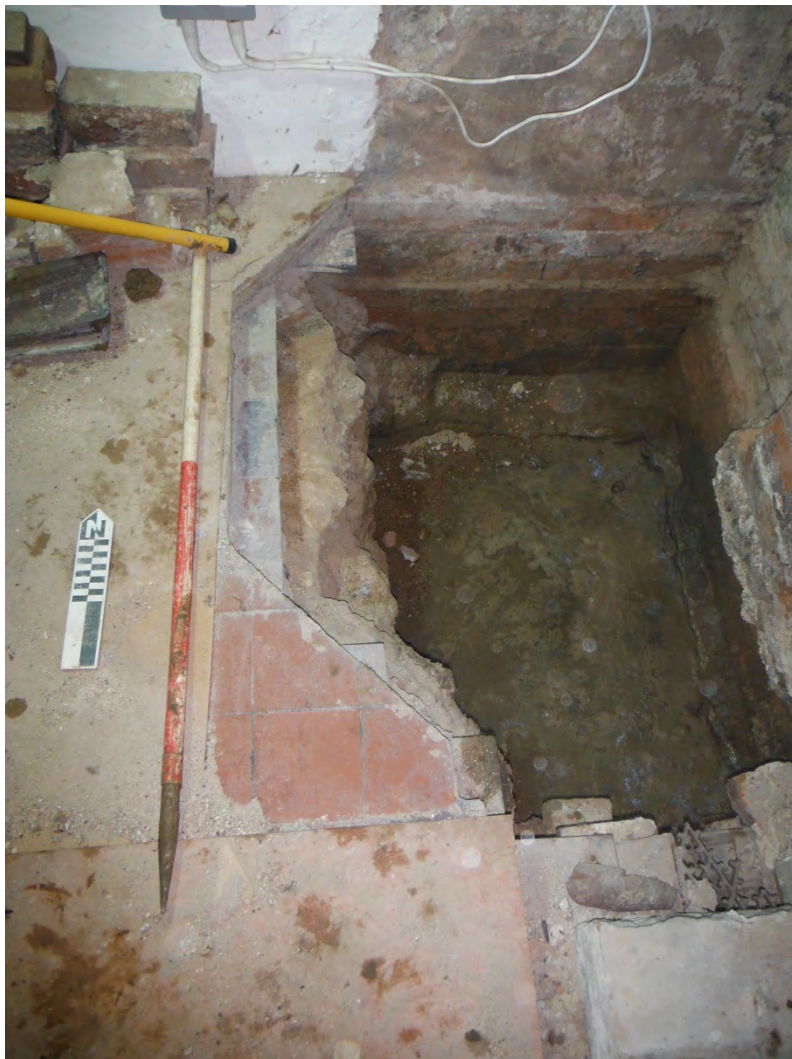
**Figure 10 Floors {023} and {025}**

4.4.2 The east facing section of the underpinnings revealed floors in two different levels. The lower floor {023}, comprising alternate blue and red rectangular floor tiles, was situated on top of a thick layer of concrete {022}. The higher-level floor {025} consisted of red rectangular tiles forming a simple straight lay pattern (Figure 10). Both floor levels were placed on thin (20mm) foundations, (026) and (024), consisting of concrete compound.

5.5 Two floors, {023} and {025} were encountered inside the church nave, indicating refurbishment works. The new floor shares stylistic similarities with the old (shape and the size of tiles). The new surface has a dissimilar design, consisting of squared red tiles, as opposed to the previous design of alternate dark blue and red tiles. (Figure 9).

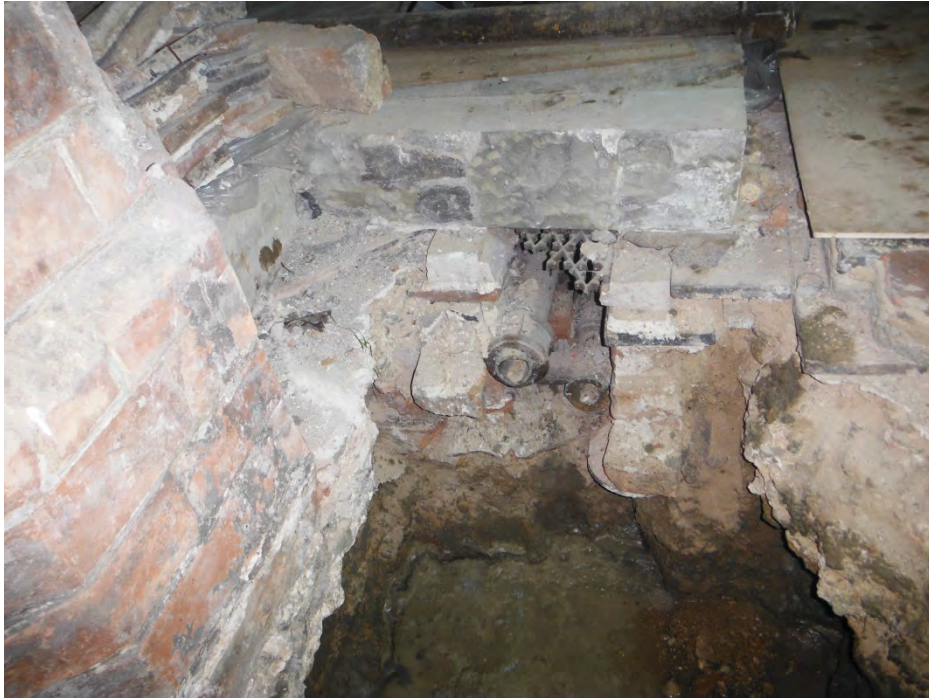
**Figure 11 Heating duct [020] system overlaid by the concrete floor of the chancel**

4.4.3 The north facing section revealed a heating system housed within a brick sited channel [020] covered with a metal grate (Figure 10 and plan 1 in Figure 14). The channel comprises three courses of bricks laid in stretcher bond and runs along the north-south axis of the church between the nave and the chancel. The heating system cuts through the primary floor of the nave (026) and it is overlaid by a thick concrete block forming the floor of the chancel.

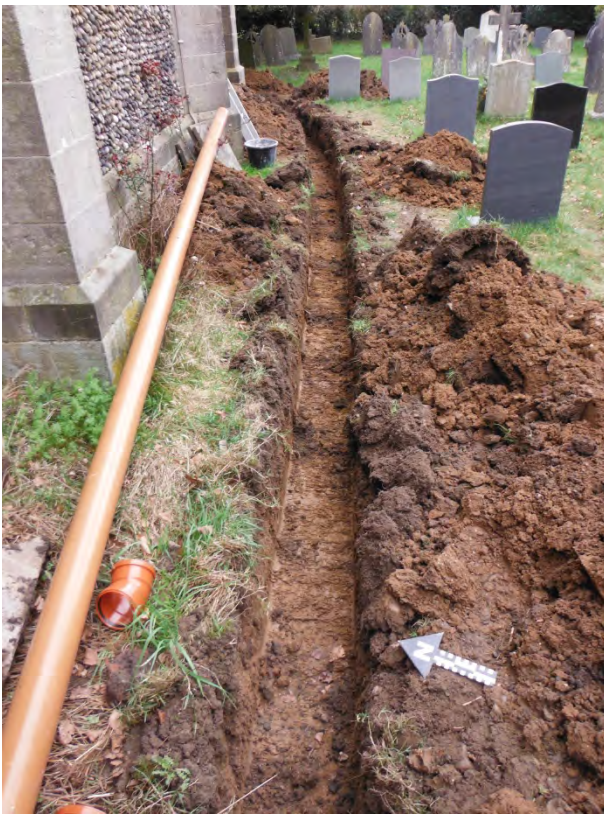
**Figure 12 Trench for new storm drain, looking east**

4.5.1 The trench for the new storm drain starts directly to the east of the church porch and it runs approximately 1 meter off the church wall along the south and east side (Figure 2). The excavation revealed multiple phases of drainage.

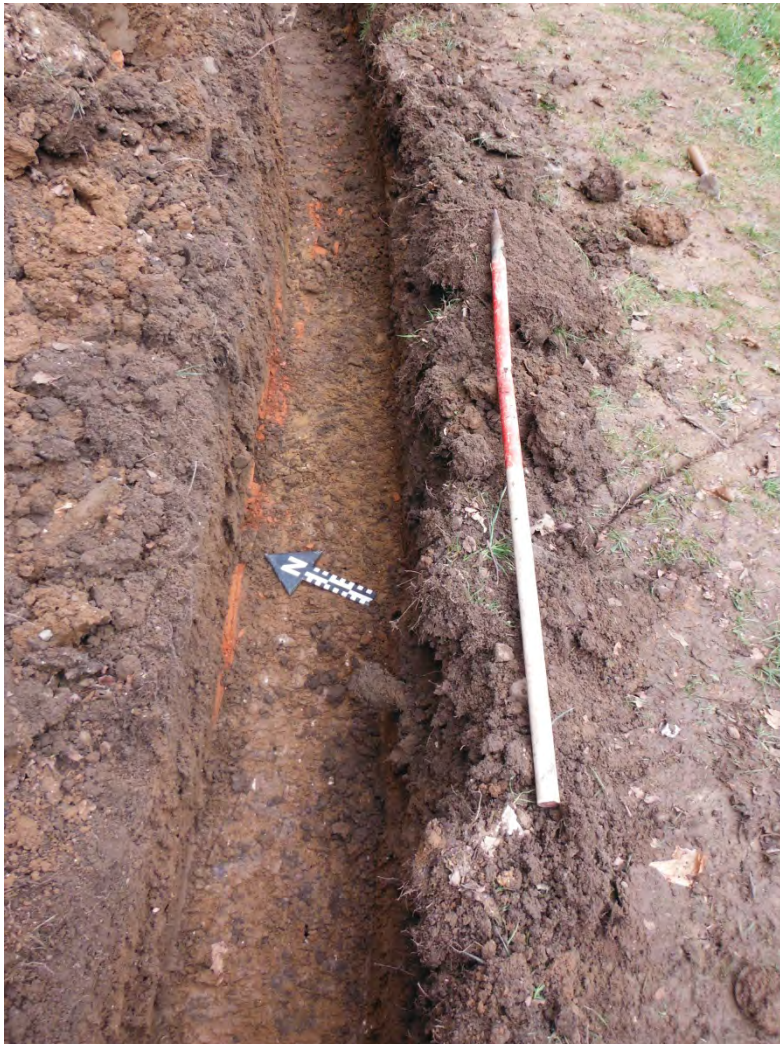
Figure 15 Drain (034) visible in the trench for the new storm drain, looking east

4.5.3 A third drain (034) was identified in the new trench on an east to west alignment. This poorly preserved drain was observed for a distance of 1.5m.
