## Archaeological Evaluation Trenching at Bleaklow Hall, Hawkshaw, Greater Manchester

**ARS Ltd Report No.** 2019/96

May 2019

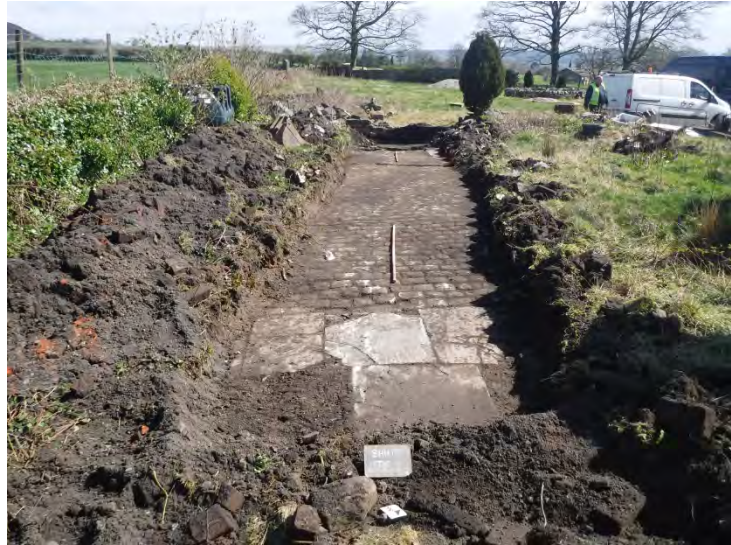
Flagged and cobbled surface in Trench 6, looking east.

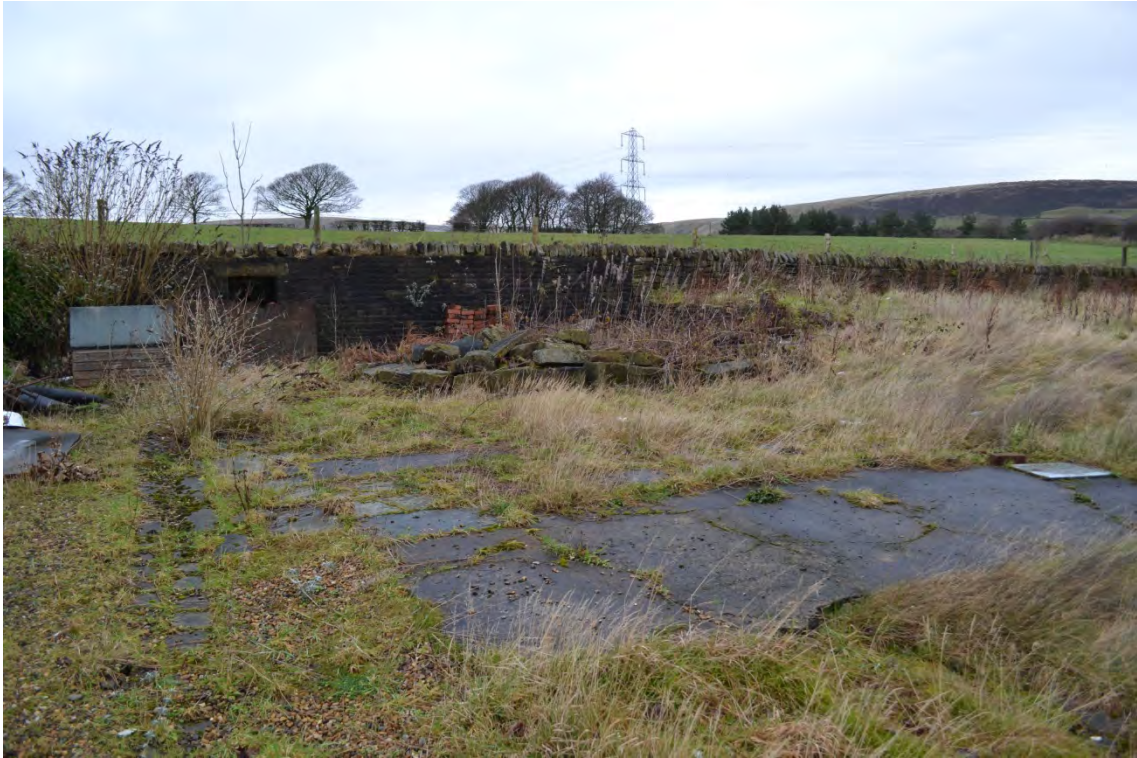
Figure 3. Stone surfaces to the north-east of the bungalow, edged with stone gutters and occasional granite setts. Looking north-east.

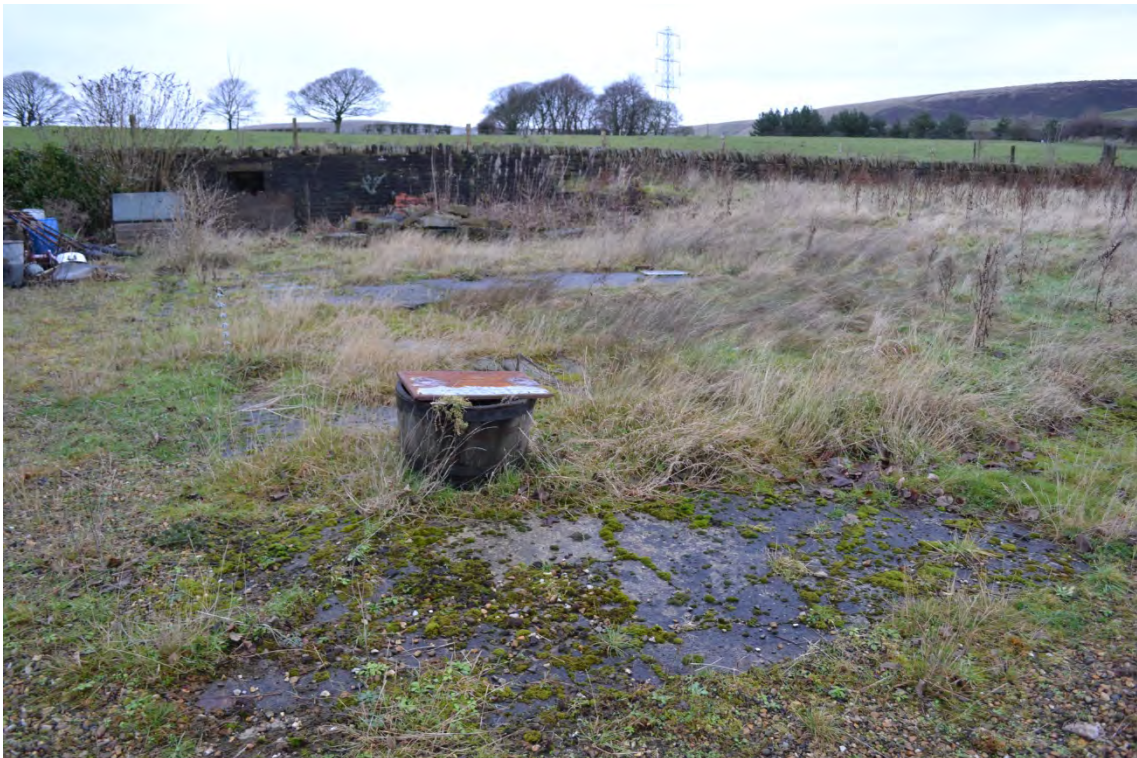
Figure 4. Overgrown remains of former surfaces belonging to buildings dating to the mid-19th century. Some showing evidence of concrete re-surfacing. Looking north-east.

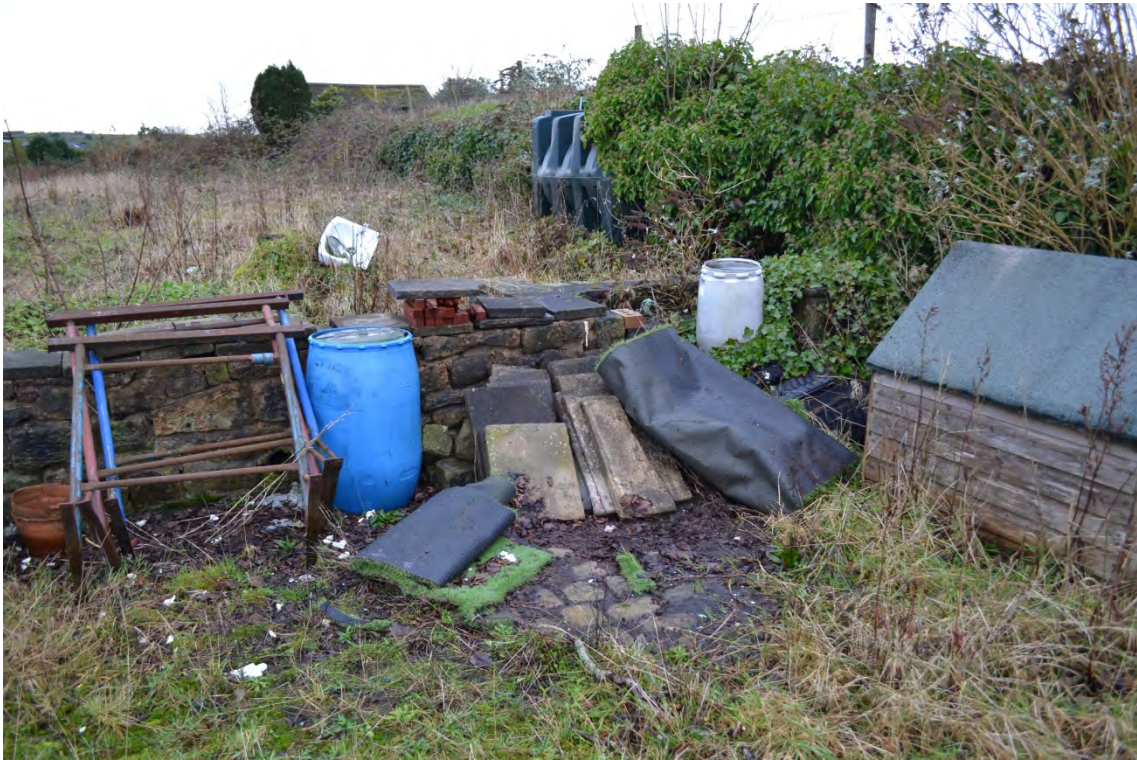
Figure 5. Small area of granite setts immediately east of the raised garden wall to the north of the bungalow. Looking north-west.

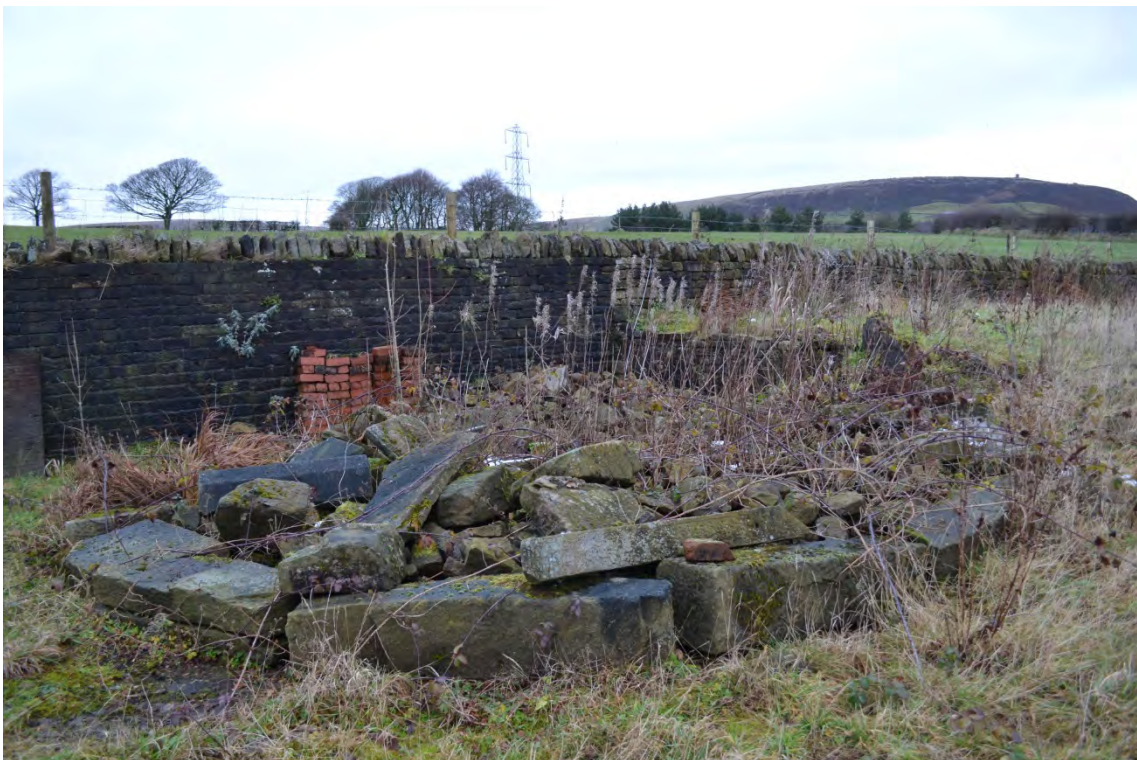
Figure 6. Clearance/storage stone pile, potentially overlying surfaces of former buildings on site. Looking north-east.

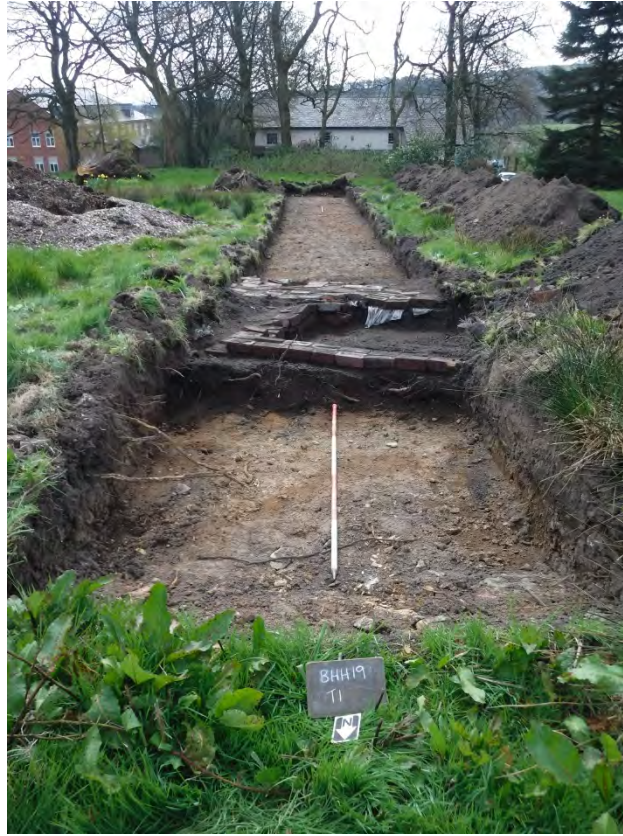
Figure 8. Trench 1, looking south-south-east. Scale: 2x2m.

5.1.1 Trench 1 was orientated north-north-west/south-south-east and located on the south-west side of the bungalow on a gentle slope from north to south. The trench was excavated through 0.32m of mid-grey/brown silty topsoil (101) with a high clay content and a shallow fine clay subsoil (108) (maximum depth 0.11m at the northern end), removal of which revealed the underlying natural substrate (105), formed of firm light grey/yellow clay with occasional fragmented sandstone inclusions (Figure 8, Appendix I).

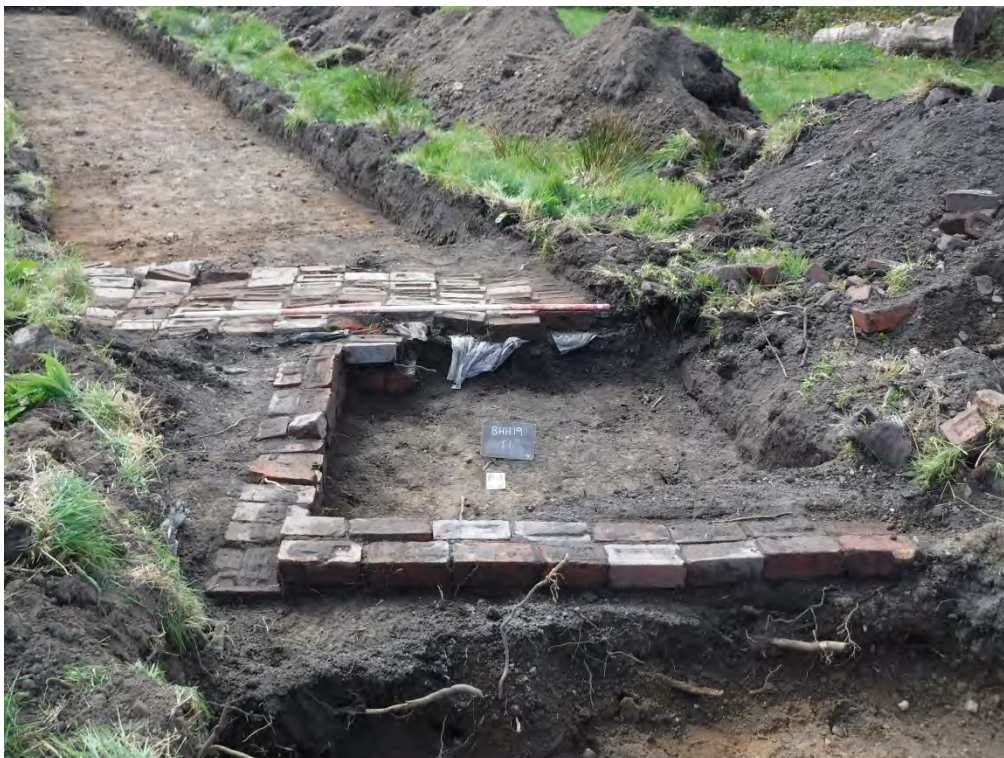
Figure 9. Structure F107 showing wall lines constructed on subsoil and adjacent path laid on plastic sheets. Scale: 2m.

5.1.2 The foundation courses of a rectangular structure (F107) were identified towards the northern end of the trench laid directly onto subsoil (108). Walls (102), (103) and (106) were all constructed of 2-skins of red bricks bonded with friable sandy cement surviving to a height of 2 or 3 courses. The bricks were a mixture of hand-made and machine-made whilst the construction exhibited various use of alternating header/stretcher coursing but also, in the case of wall (103), with the incorporation of occasional rowlock laid bricks. The walls enclosed an exposed area of around 2x2m but the structure is likely to continue to the west beyond the limit of the trench (Figure 9, Appendix I).

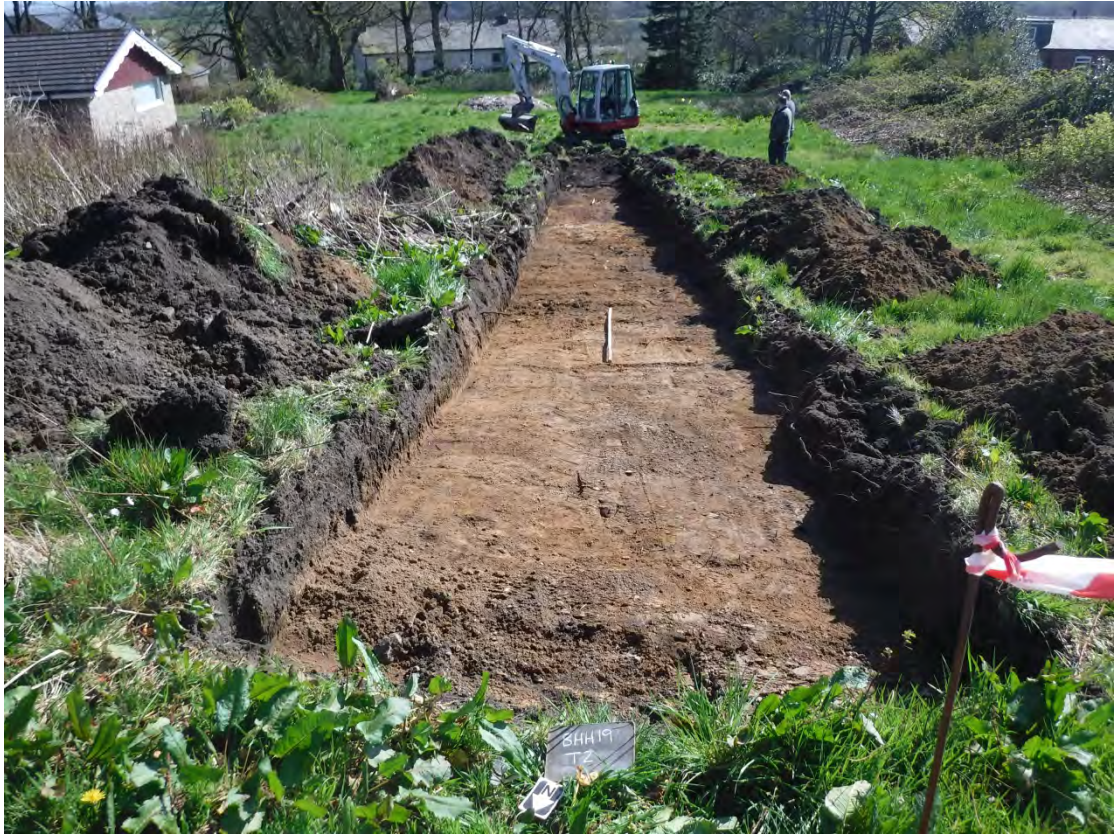
Figure 10. Trench 2, looking south. Scale: 2x2m.

5.2.1 Trench 2 was orientated north/south and located in the north-west part of the site on a slope from north to south (Figure 10, Appendix I). The trench was excavated through 0.2m of mid-grey/brown silty topsoil (201) with a high clay content and light brown clay subsoil (207) (variable depth up to 0.25m), removal of which revealed the underlying natural substrate (206) formed of firm light grey/yellow clay with occasional fragmented sandstone inclusions.

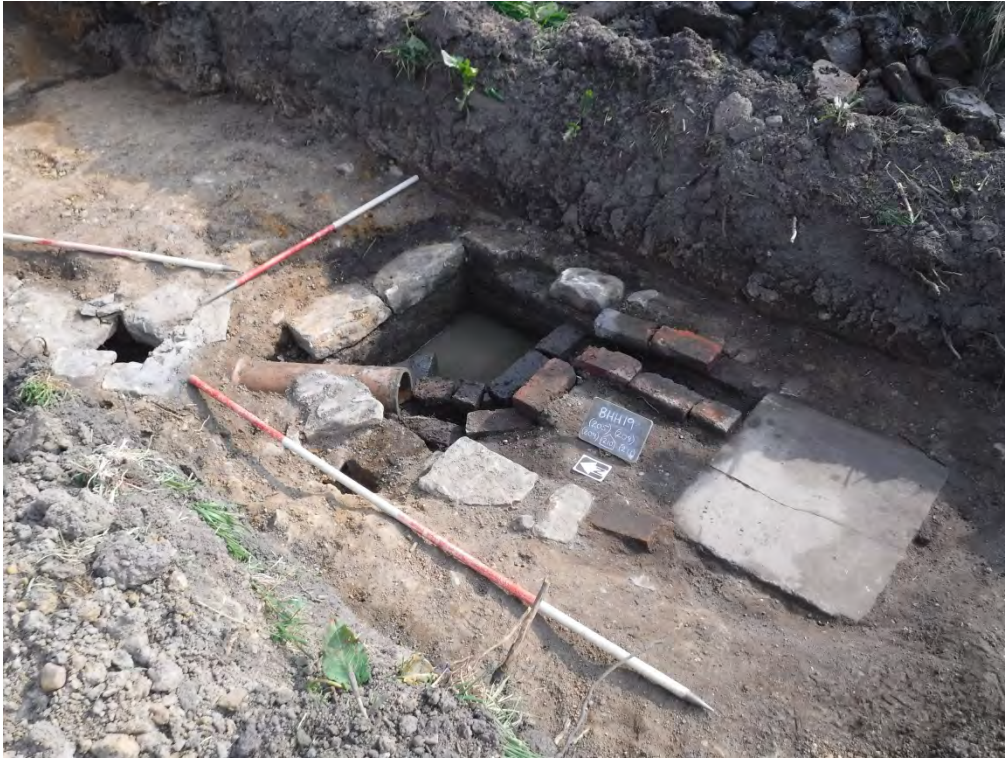
Figure 12. Culvert (205) on the left, repaired with pipe (208) that directs water into brick channel (209) through stone-lined sump/tank (210). Cap for lower chamber of tank visible on the right. Scale: 0.5m graduations.

5.2.3 An east/west, stone-capped culvert (204) was identified less than a metre south of the ditch whilst a further north-west/south-east orientated culvert (205) was found just over a metre further south through the trench. The south-east end of culvert (205) had been adapted/repared with the insertion of a short length of salt-glazed ceramic pipe (208) that was concreted into position to guide water into a brick-lined channel (209) and, eventually, a stone-lined sump (210). The sump had internal dimensions of 1.4m x 0.7m, with a depth of 0.4m in its northern chamber and a deeper chamber to the south that was capped with a flat stone slab (211) measuring 0.71m x 0.61m. Standing water was observed in the base of the sump which suggested that the drainage feature was still functioning so it was not investigated further (Figure 12, Appendix I). It is possible the feature dates to the 19<sup>th</sup> century but with evidence of 20<sup>th</sup> century repairs/maintenance.

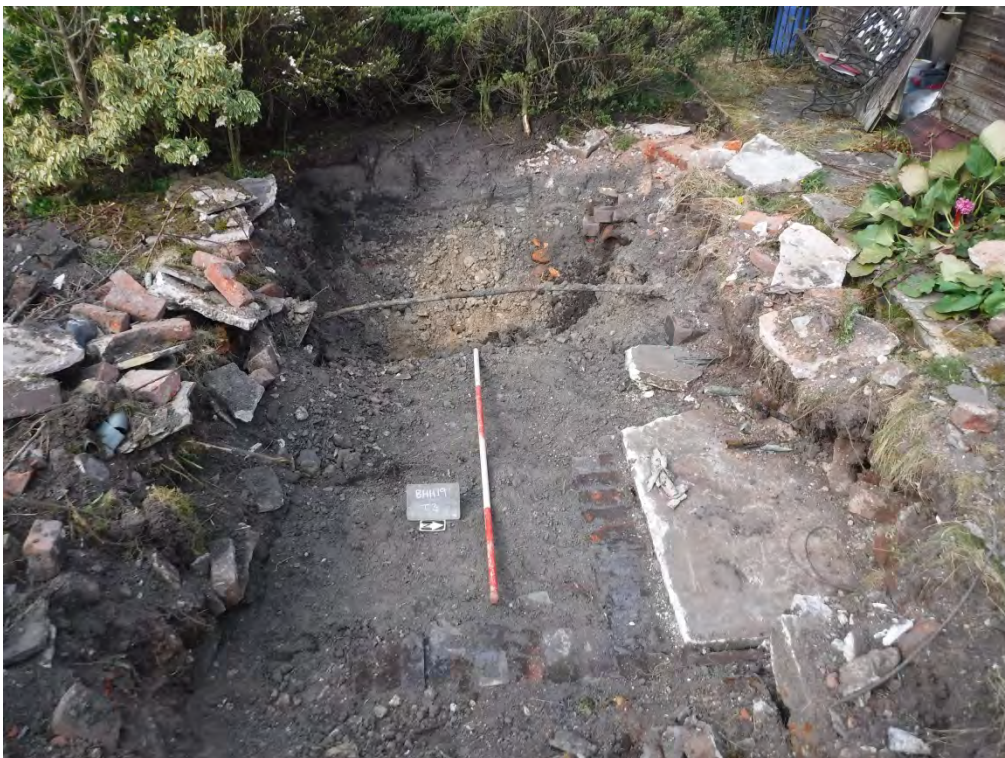
Figure 13. Trench 3, showing remains of a demolished 20th century building to the rear of the bungalow, looking west. Scale: 2m. Foundation courses of walls visible in the foreground alongside a concrete slab (304). Fragments of corrugated asbestos panelling observed in fill (some visible on edge of concrete slab), so trench was abandoned.

5.3.2 Excavation into made-ground (303) revealed that it consisted of soil, rubble fragments and debris indicative of demolition. At the western end of the trench this deposit was found to be burying a 20<sup>th</sup> century ceramic drain with a brick casement (309) at a depth of 0.4m below brick path (302). The made-ground had a maximum depth of 0.88m, overlying the natural sandy clay substrate (307). As excavation continued to the east a service pipe was encountered (probable water supply for the shed) and the made ground deposit was found to include broken-up pieces of corrugated asbestos-containing cement panels from a depth of around 0.5m below ground level. This was at the same level that a broken concrete slab (304) and three truncated 20<sup>th</sup> century walls ((305), (306) and (308)) were identified but the trench was not taken any deeper so as not to disturb any asbestos fibres. The walls were all constructed of 2-skins of machine-made and frogged red bricks bonded with hard black mortar. Walls (305) and (306) consisted of 1 course of stretcher laid bricks, whilst wall (308) (only visible as a stub in section abutting the western edge of slab (304)) was constructed of bricks laid on edge in a rowlock bond (Figure 13, Appendix I).

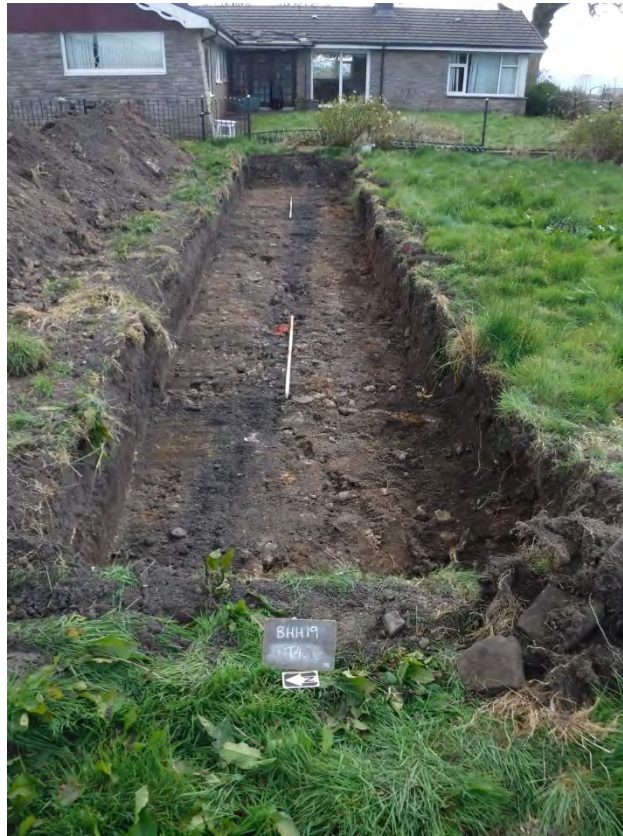
Figure 14. Trench 4, showing cut and fill of drainage soakaway [403]/(404) in the base, heading towards the modern manhole chamber of a foul-drain at the eastern end, looking east. Scale: 2x2m.

5.4.2 Removal of topsoil with a consistent depth of 0.3m revealed the upper horizon of a dark grey/brown levelling deposit (402) that was made up of moderate to small fragments of demolition rubble and refuse. This deposit was found to have a varied depth, deeper towards the western end of the trench (0.25m), tapering to the east as the natural ground rose up slightly. Removal of the levelling deposit revealed the cut [403] and mineralised, gritty fill (404) of a soakaway drain that ran the full length of the trench (14m), with a width of 0.4m and a small north/south orientated offshoot towards the western end of the trench. The drain was cut into subsoil (406) that had a variable depth between 0.2m at the eastern end of the trench and just 70mm to the west. The underlying natural substrate (405) was formed of light yellow/grey clay which was also cut by the soakaway trench (Figure 14, Appendix I).

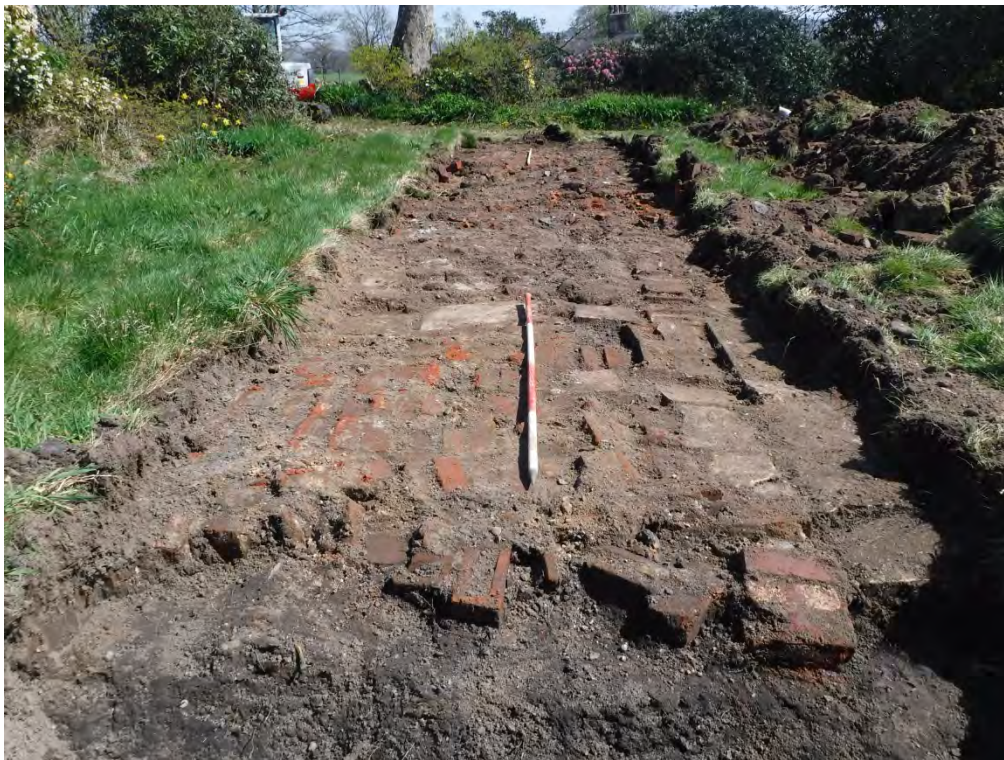
Figure 15. Brick surface (503) identified just beneath topsoil in Trench 5, looking east. Scale: 2x2m.

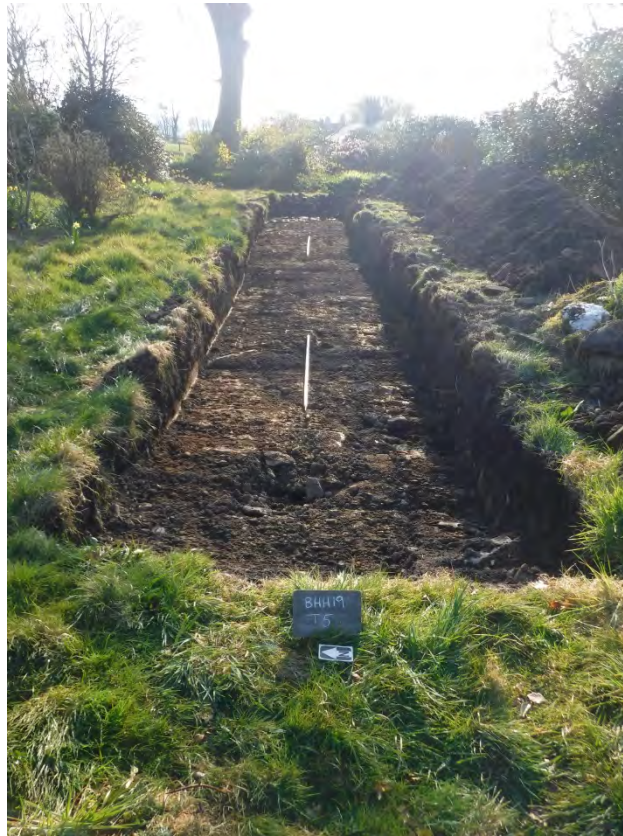
Figure 16. Trench 5, looking east. Collapsed culvert [506]/(507) visible in the foreground cut into the natural substrate. Scale: 2x2m.

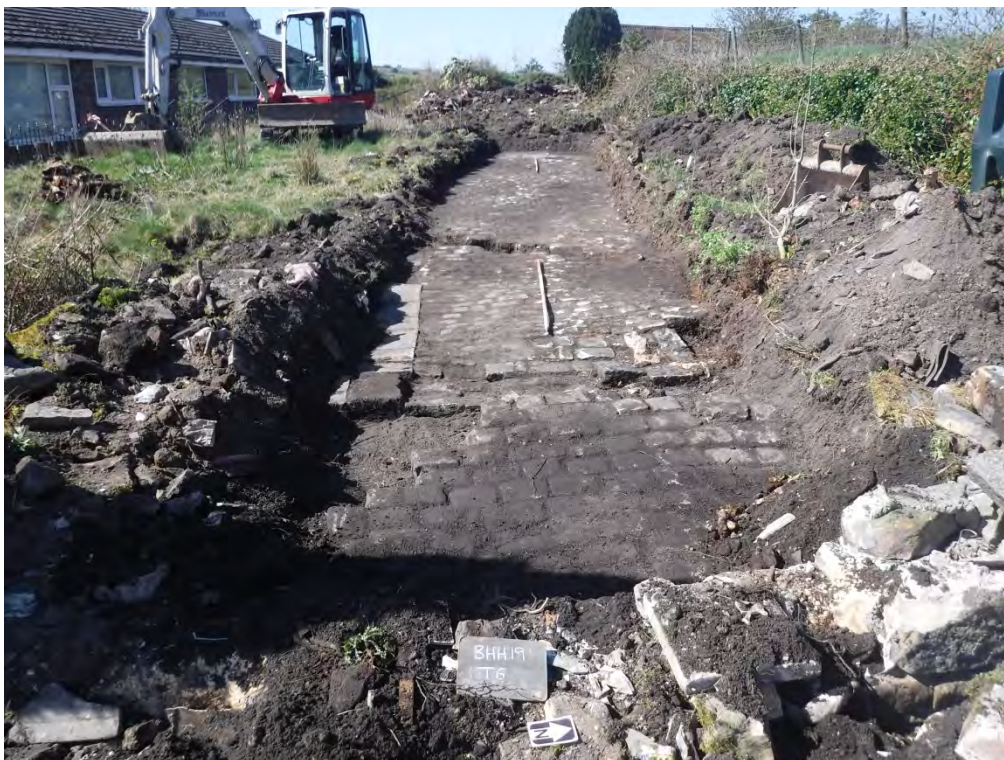
Figure 17. Trench 6, looking west. Road surface of granite setts (603) covering much of the trench, partially edged on the southern side by kerb stones (604). Cut through centre of surface is modern and housed a redundant oil pipe linking the bungalow to the tank at the right of the photo. Scale: 2x2m.

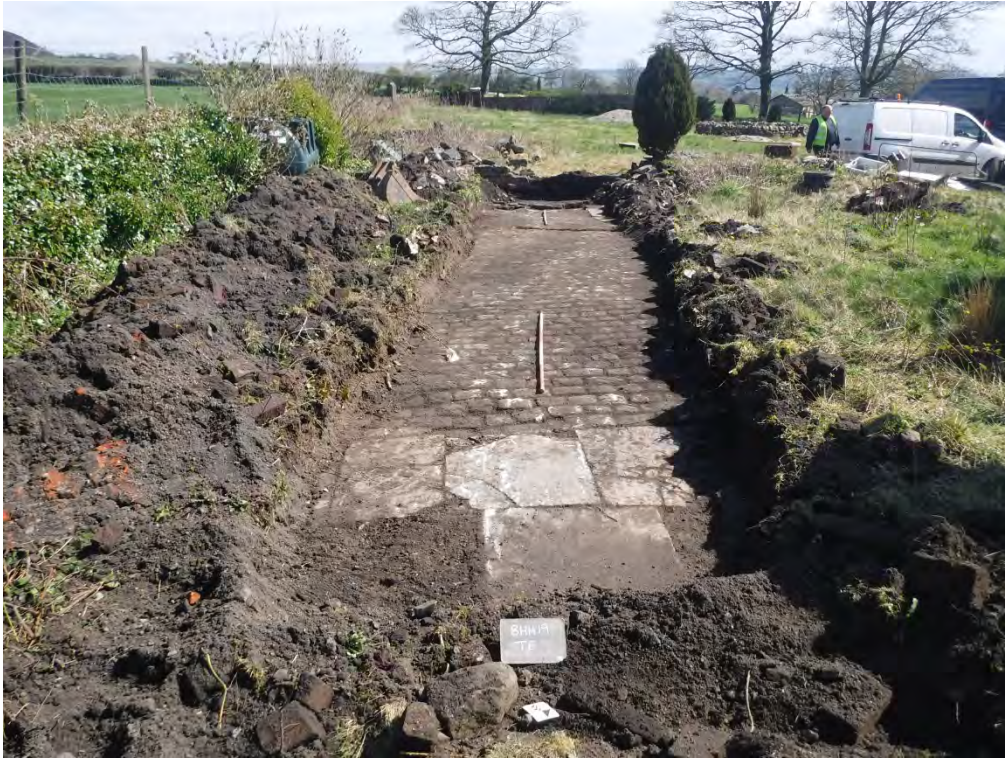
Figure 18. Trench 6 looking east. Flagstone surface (605) is contemporary with the cobbled surface. Scale: 2x2m.

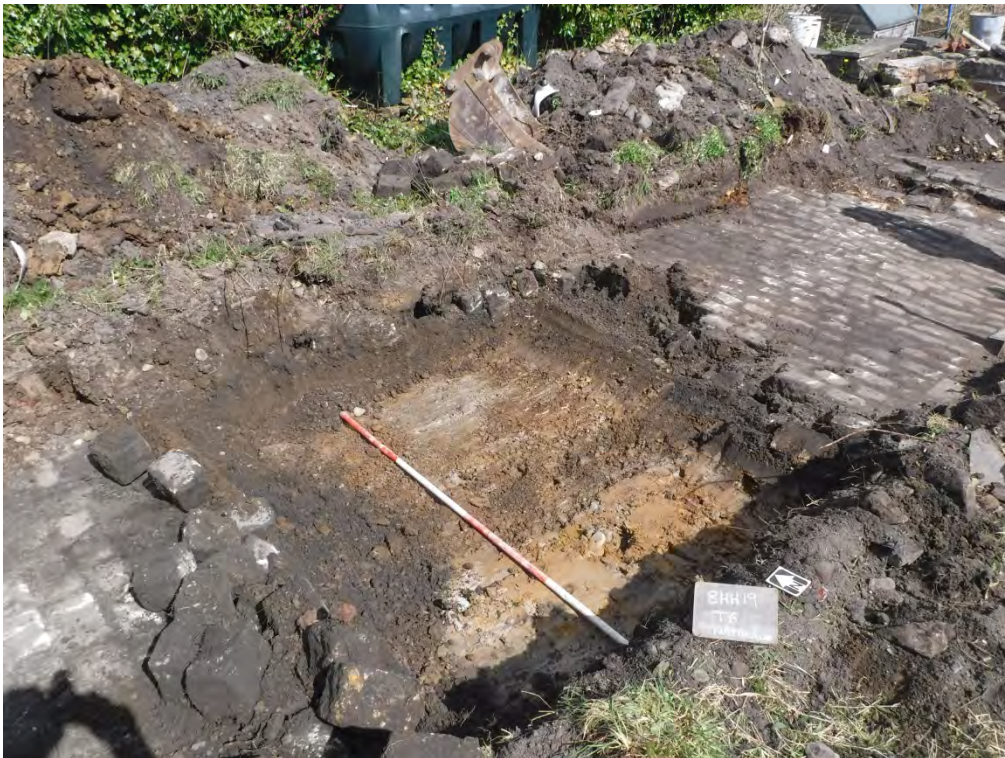
Figure 19. Removal of a portion of the granite setts was undertaken in order to reveal any hidden remains of earlier structures that might correspond with a building depicted on the 1842 Lower Tottington Tithe map. No such features were identified.

5.6.3 A partial kerb (604) formed of three observed sandstone blocks, each measuring 0.3m wide and 0.6m long, was observed along the southern edge of the setts and a ceramic drain cover was also observed in-line with a slightly recessed row of cobbles to facilitate drainage. These features suggest that the surface is a former road/access route. It is likely that the road dates to the 19<sup>th</sup> century and is contemporary with the mid-19<sup>th</sup> century complex of Bleaklow Hall and its associated farm structures rather than the 1842 building from the Tithe map. A 2m length of the cobble surface was removed from east to west using an absent line of cobbles as a starting point (clearly removed since construction of the bungalow for the insertion of an oil supply pipe between the house and an oil tank in the garden), so that the area beneath the cobbles could be observed in the area where the former wall of the 1842 building should have been located. No such wall was identified, only the undisturbed upper horizon of the underlying gravelly clay substrate (607) (Figure 19, Appendix I).

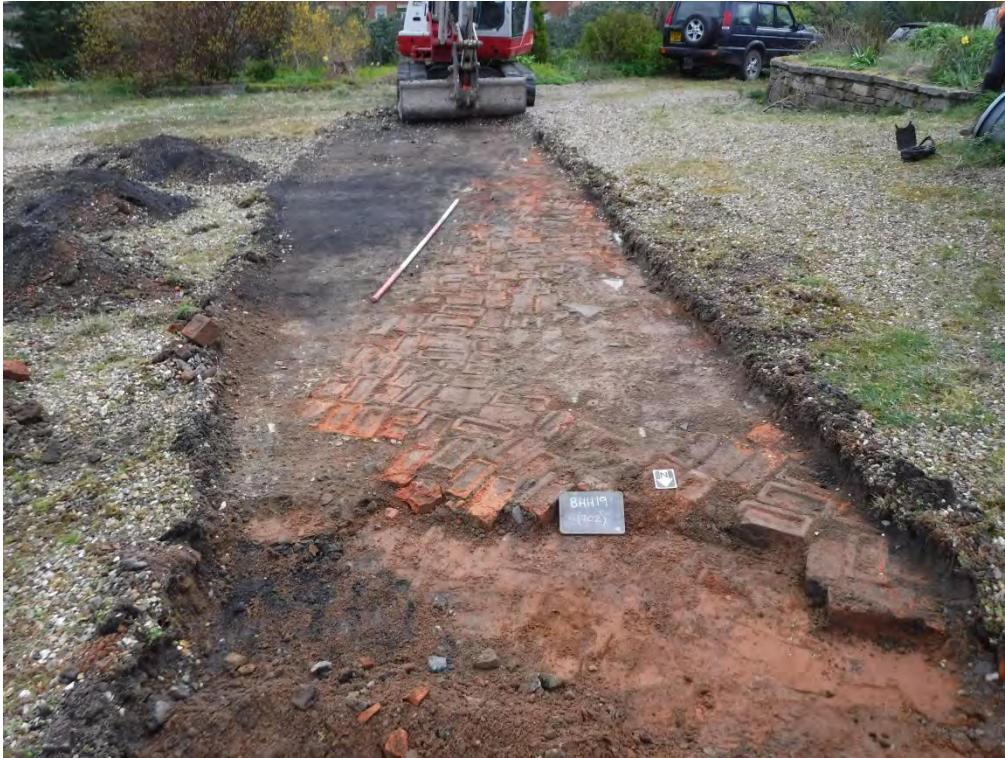
Figure 20. Trench 7, looking south-south-east. Rough brick surface (702) identified just under the modern surface, with sand deposit (703) in the foreground and compacted black, gritty surface (704) adjacent to bricks in the background. Scale: 2m.

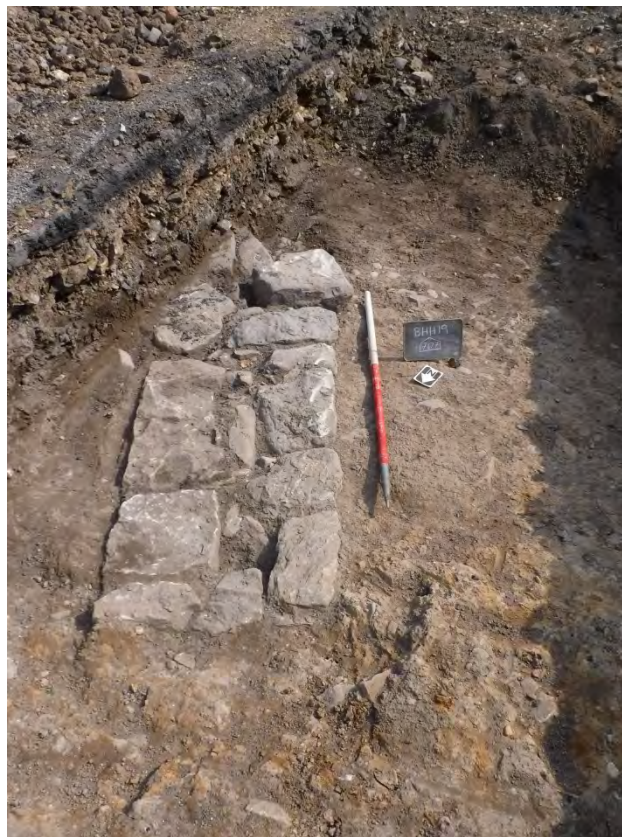
Figure 21. Wall (707) identified within construction cut [708] towards the southern end of Trench 7. Fill (709) of cut contained pottery dating between the 17<sup>th</sup> and 19<sup>th</sup> centuries. Scale: 1m.

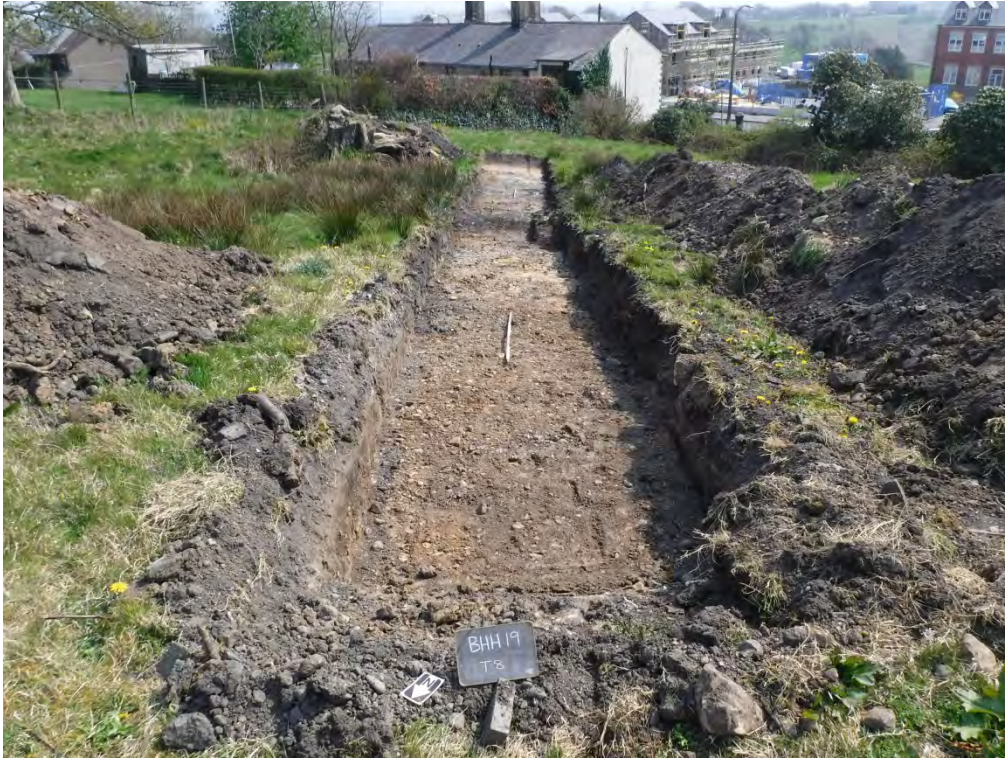
Figure 22. Trench 8 looking south-east. Natural substrate much stonier upslope compared to further down in the garden. Scale: 2x2m.

5.8.1 Trench 8 was located on sloping ground that occupies the south-eastern part of the DA in an area that was heavily wooded as recently as the early 21<sup>st</sup> century (Burpoe 2018, Appendix 6). The majority of the trench was excavated through 0.3m of silty grey topsoil and 0.26m of brown silty clay subsoil which overlay the natural clay till substrate (804). The substrate was much stonier in the north-west (uphill) part of the trench, becoming wetter and softer downslope to the south-east (Figure 22, Appendix I).

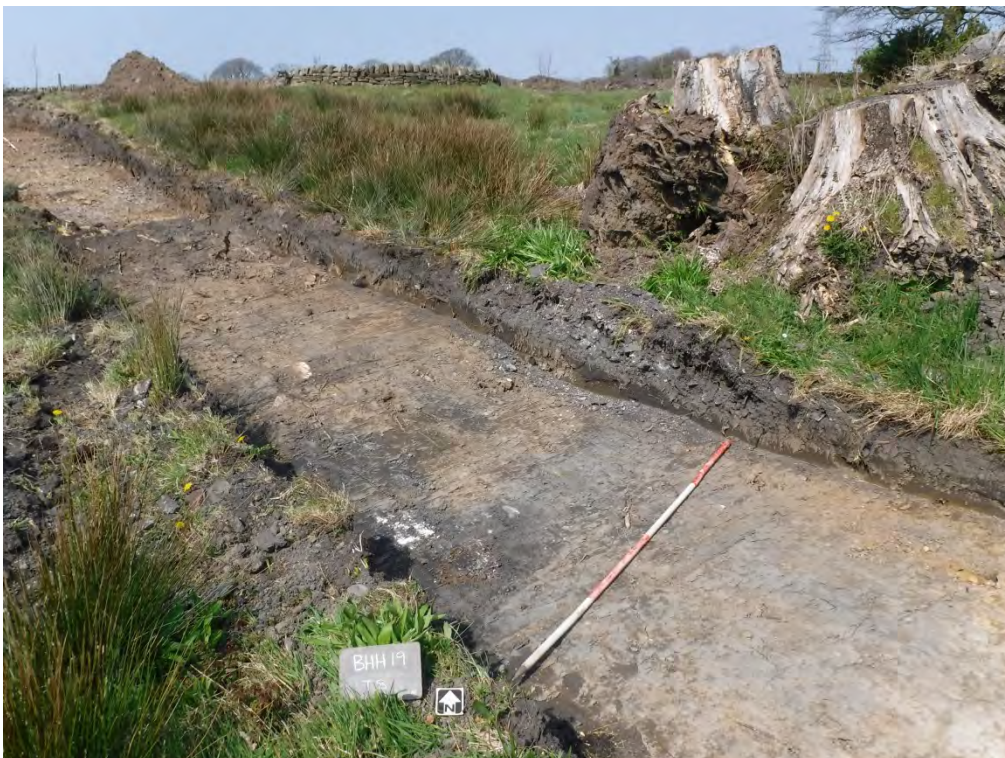
Figure 23. Deposit of modern debris (803) filling a natural gully in the hillslope. Scale: 2m.

5.8.2 A naturally occurring, broad, shallow gully crossed the slope on a north-north-east/south-south-west orientation. This was crossed by Trench 8 towards its southern end and the gully was found to be filled with a deposit of demolition debris (803) that was visible within the topsoil at the surface and had a depth of 0.55m (Figure 23, Appendix I).

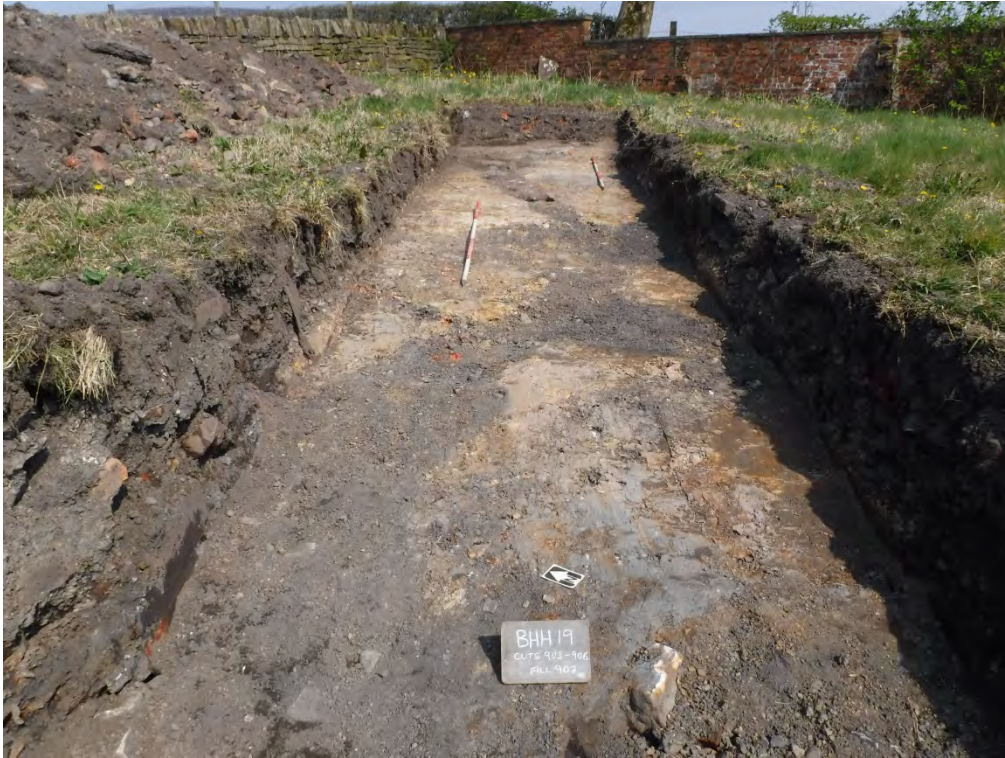
Figure 24. Numerous linear cuts of soakaway trenches identified at the north-east end of Trench 9, looking north-east.  
Scale: 2x2m.

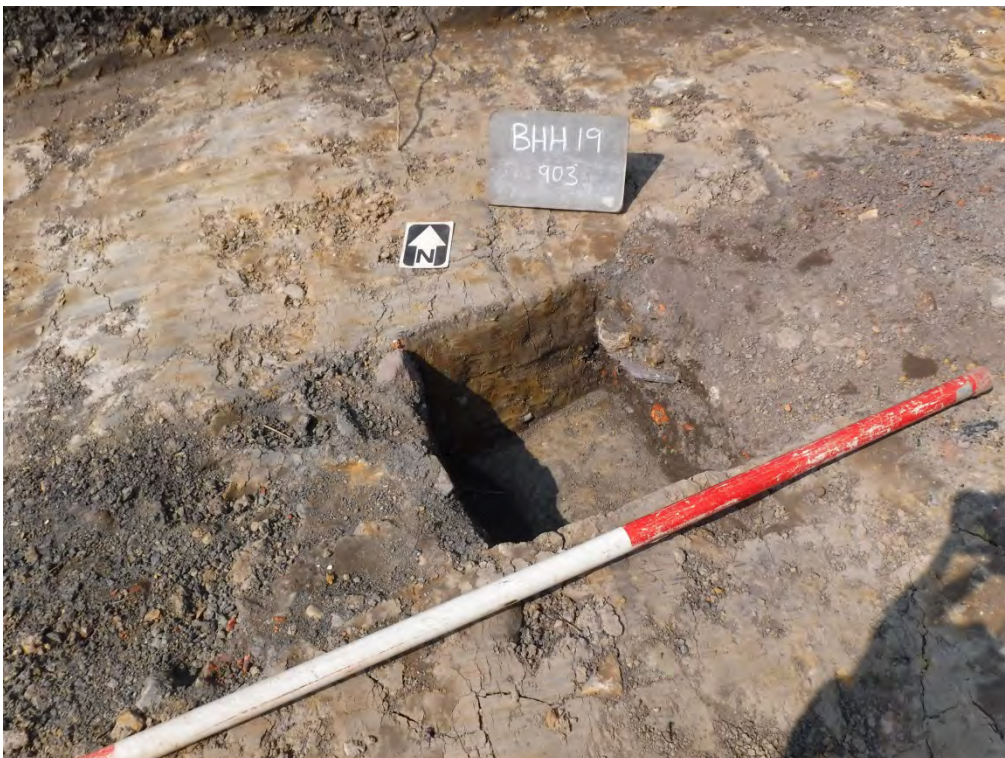
Figure 25. Investigation into soakaway [903]. Imported demolition fill (907) overlies a stone-lined base of the feature.  
Scale: 1m.

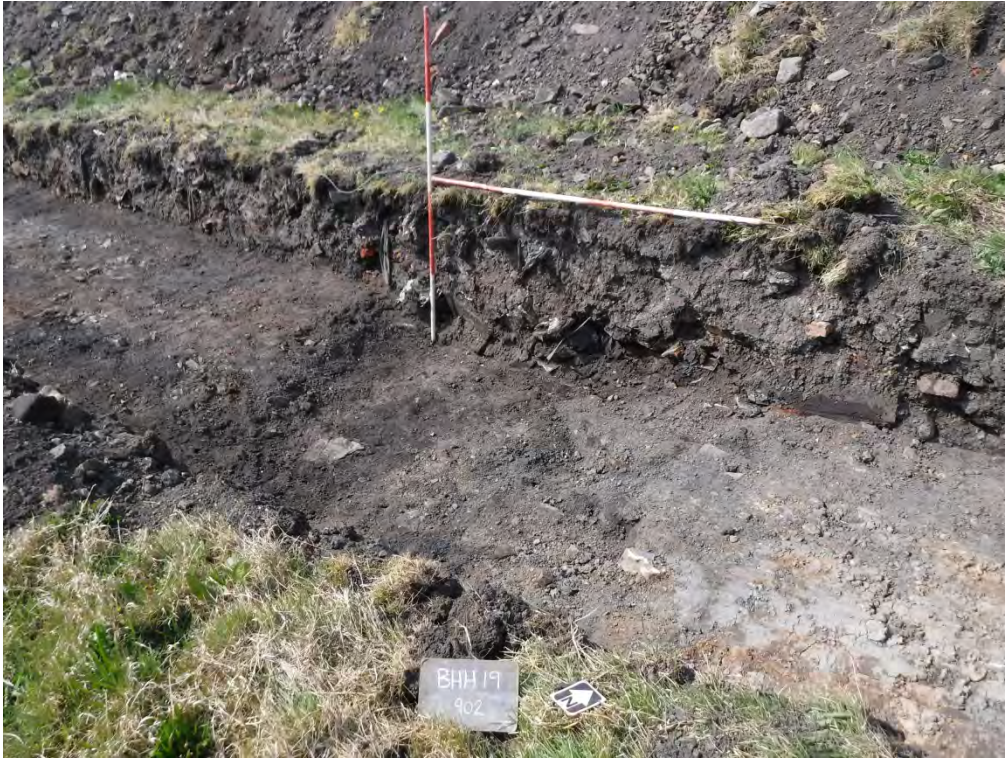
Figure 26. South-east facing section through imported deposit (902) in the central area of the trench. Deposit filling a depression in the natural substrate (visible on the right), stepping up again on the left-hand side. Scale: 2x2m.

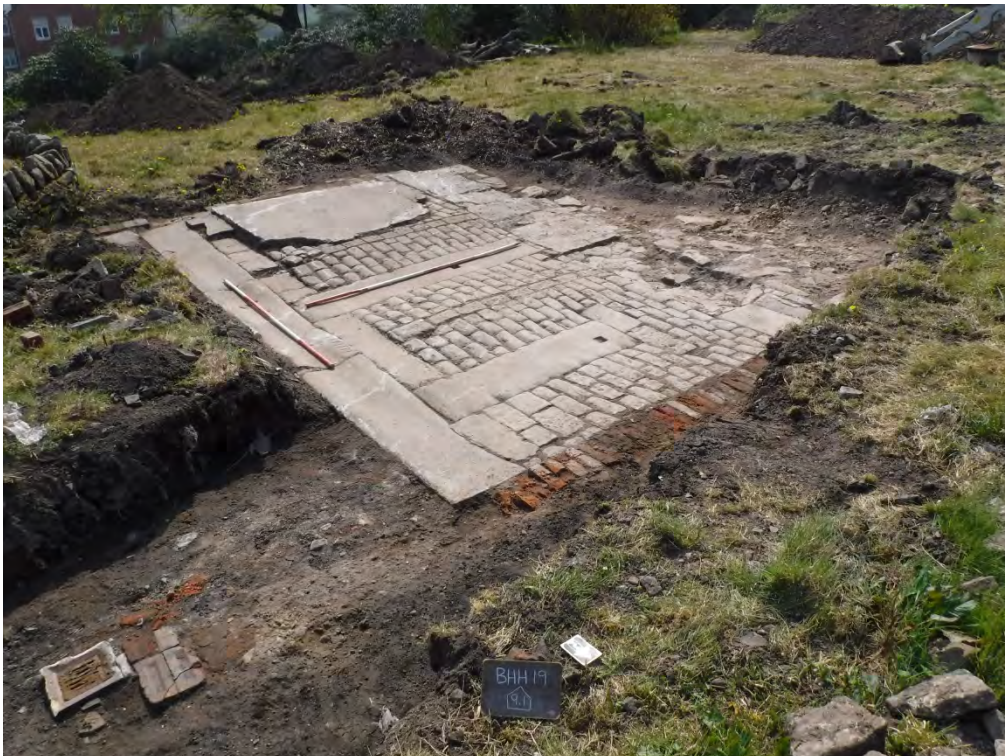
Figure 27. Structure 9.1 at the south-west end of Trench 9. Mid-19<sup>th</sup> century, 3-bayed stable with *in-situ* floors and wall foundations, looking south-west. Scale: 2x2m.

5.9.6 The foundations and floors of a three-bayed barn/stable were revealed, with east/west orientated hand-made red brick walls (909), and (919) to the north and south, an external rear stone wall (911) to the west, an internal stone walkway (912) alongside the rear wall, three cobbled floors (913), (915), and (918) (the latter resurfaced with concrete (917)), and a linear stone gutter along the front side of the building to the east. The cobbled floors of the bays were sloped either side of a central floor slab to facilitate drainage into the centre of each bay and out to the front gutter whilst each bay was separated by a narrow cobbled 'spine' ((914) and (916)) that might once have supported some form of superstructure (Figures 27 and 28, Appendix I).

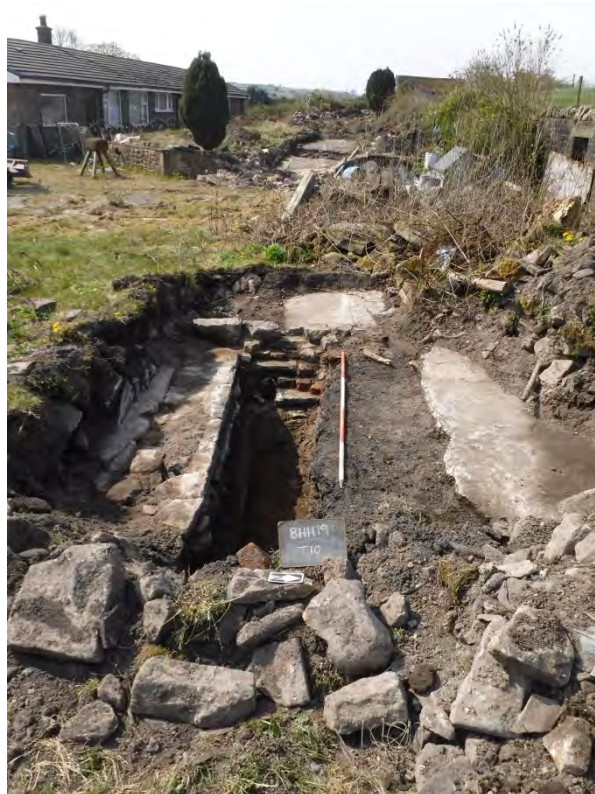
Figure 29. Trench 10, looking west. Two portions of a broken slab ((1003) on the left and (1007) on the right) overlay wall (1004) and infill deposit (1009). Steps (1005), wall (1006) and surface (1008) visible towards western end of trench. Scale: 2m.

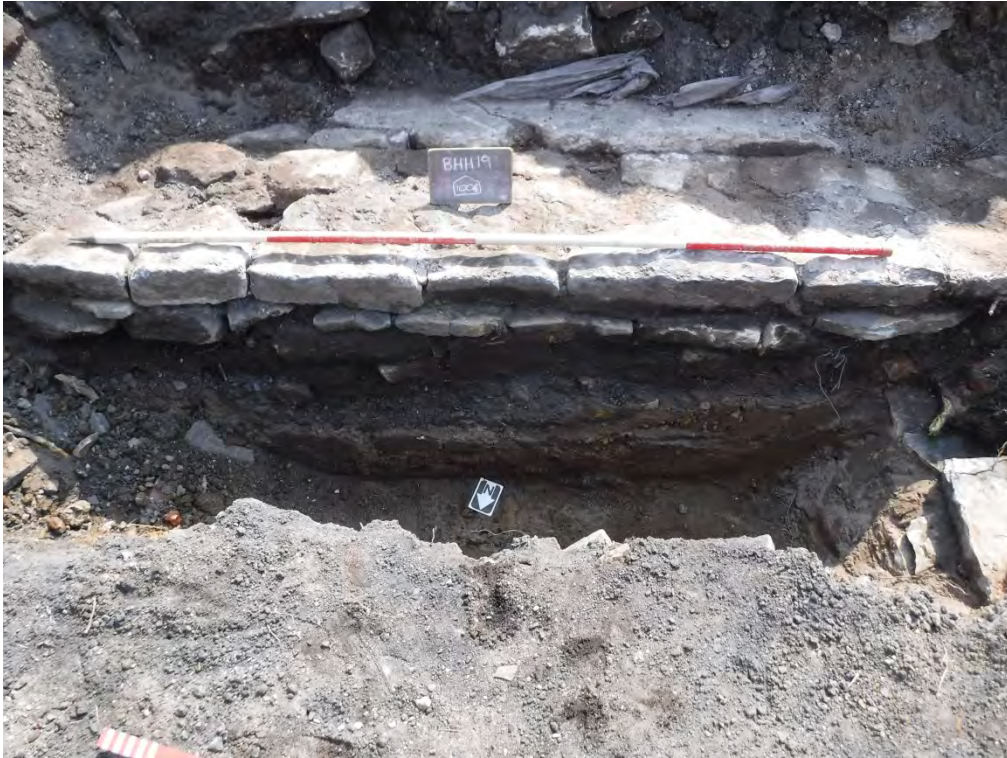
Figure 30. View into investigation sondage through deposit (1009) (visible in the foreground, 0.6m deep), revealing the northern face of wall (1004) showing 3 stone courses overlying natural substrate. Scale: 2m.

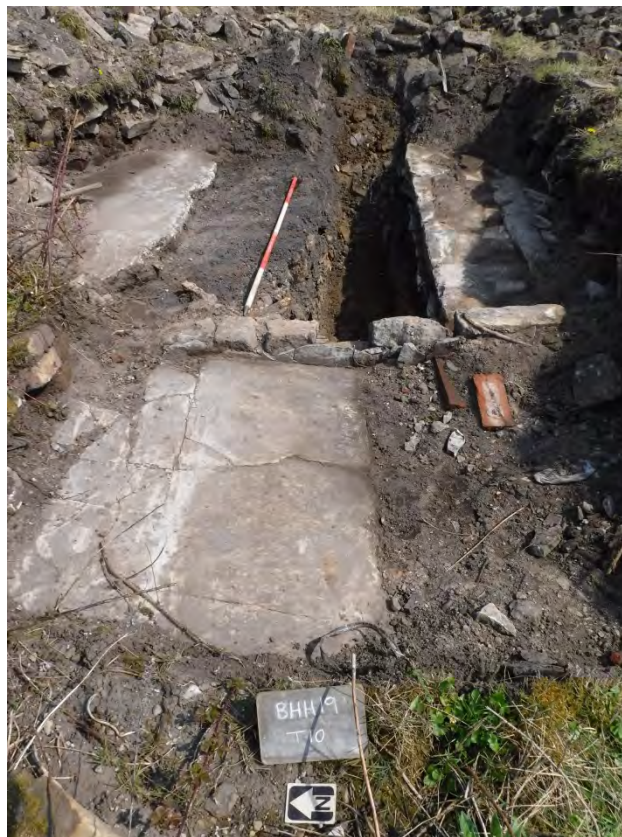
Figure 31. View of Trench 10, looking east. Concrete surface (1008) in the foreground, abutting the western face of earlier stone wall (1006) which is rendered with cement. Scale: 2m.
