Archaeological Excavations at Bleaklow Hall, Hawkshaw, Greater Manchester

ARS Ltd Report No. 2019/146

**Archaeological Excavations at Bleaklow Hall,
Hawkshaw, Greater Manchester**

July 2019

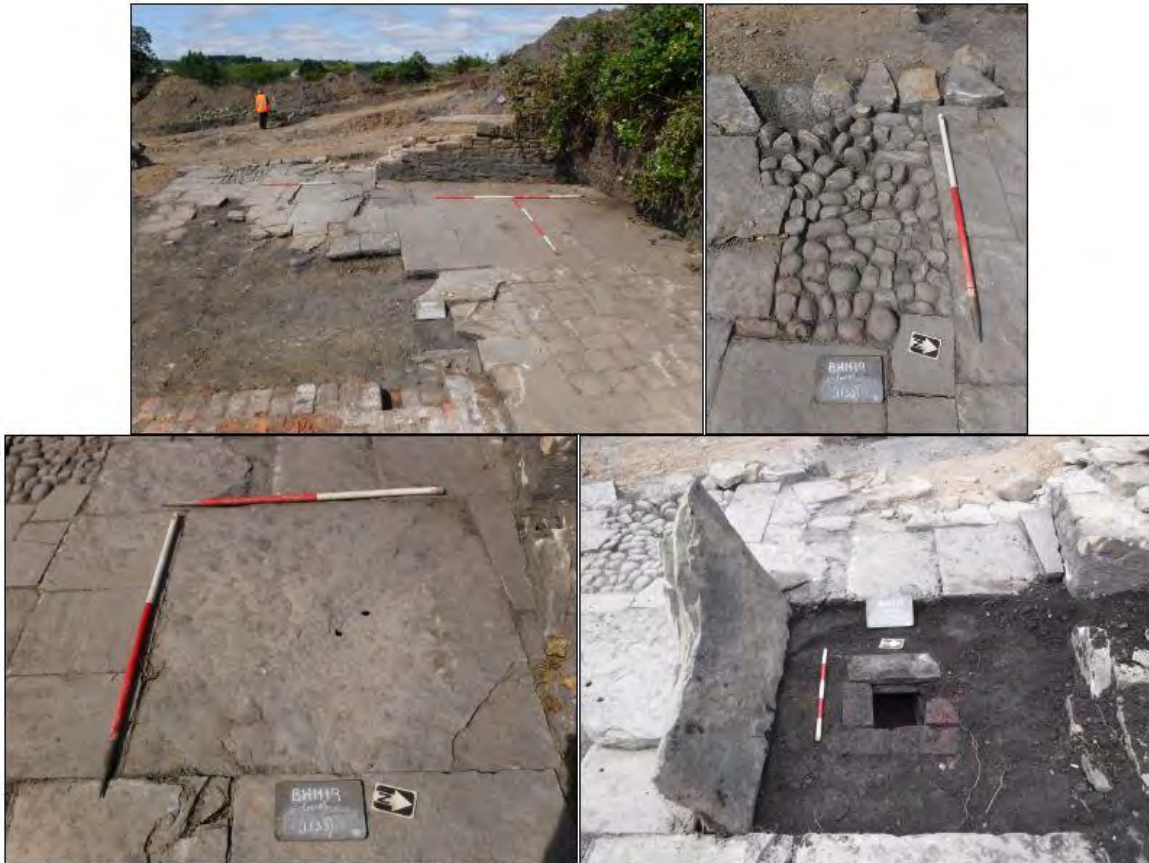
Figure 7. (Top left) Looking west across of flagged area (1133), bound by wall (1132) to the west (scale: 0.5m graduations); (top right) detail of a small area of rounded cobbles, potentially being used as a soakaway against wall (1132) within paved surface (1133) (scale: 0.5m graduations); (bottom left) one of the flagstones within surface (1133) with a shallow carved channel and two holes (scale: 0.5m graduations); (bottom right) culvert (1192) identified beneath the slab with the holes (scale: 0.1m graduations).

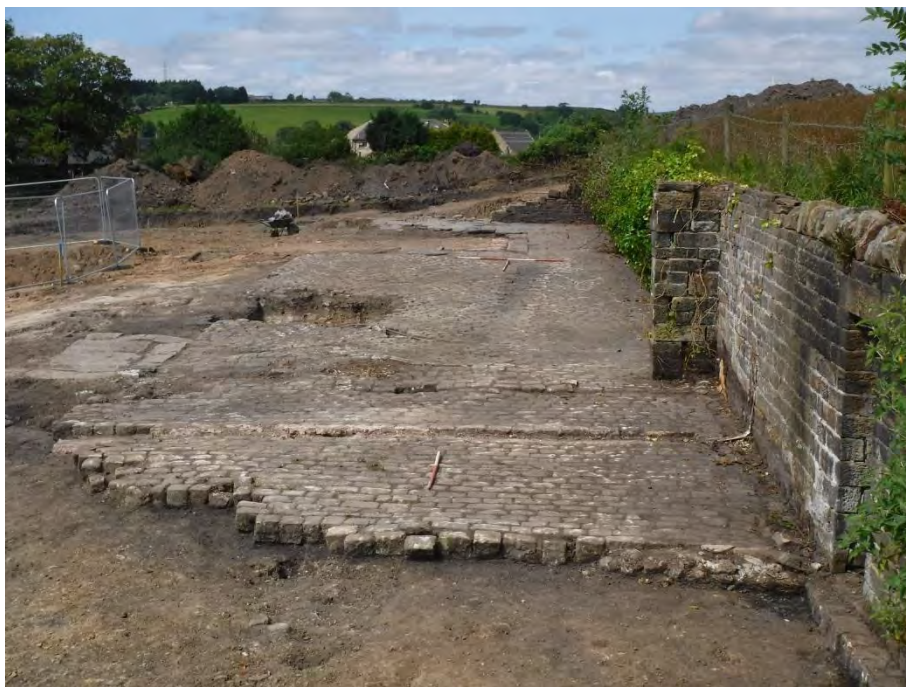
Figure 8. Overview of the cobbled road, looking west. Sunken alignment of setts visible running east/west through the surface. Scale: 0.5m graduations.

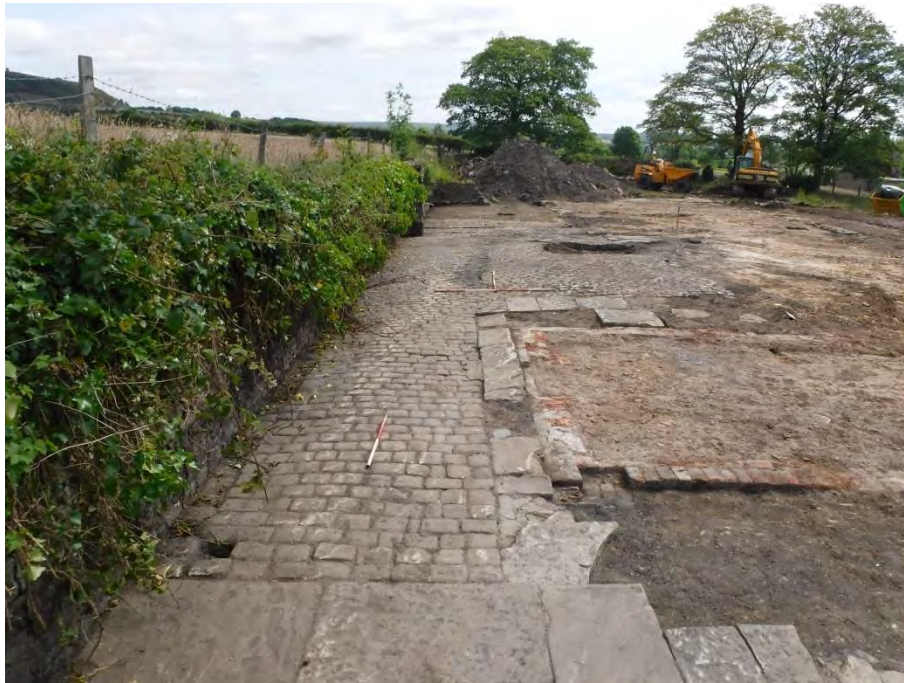
Figure 9. Overview of the cobbled road, looking east. Setts in the foreground respect the eastern edge of paving (1133) as well as the kerbstones (1137) that are laid alongside the northern brick foundation of Structure 3. Scale: 0.5m graduations.

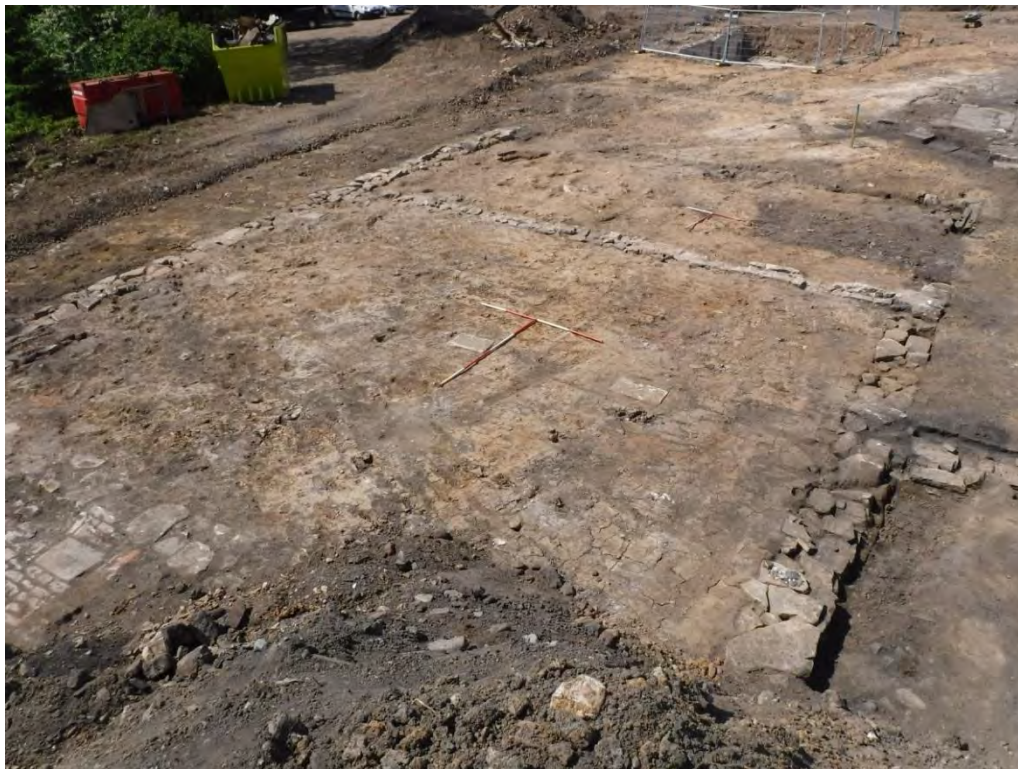
Figure 11. Overview of Structure 4, looking south-west. Scales: 0.5m graduations.

4.3.2 Structure 4 consisted of the foundation courses of four outer stone walls ((1160), (1161), (1162) and (1163)) and an internal dividing stone wall (1164) that created two rectangular rooms (Figures 10 and 11). The walls of the structure were constructed in a similar fashion to the walls of Structure 1, with flat facing stones on the interior and exterior faces, smaller packing stones within the core of each wall and occasional chink stones used to support the interior and exterior faces. All walls sat within broad cuts with near vertical sides and flat bases. The north (1160), west (1161) and east (1163) walls had average widths between 0.55-0.58m whilst the southern wall was slightly thicker at 0.66m. The internal partition wall (1164) was the thinnest at 0.46m in width and was the only wall to exhibit any remains of mortar (lime based with flecks of charcoal).

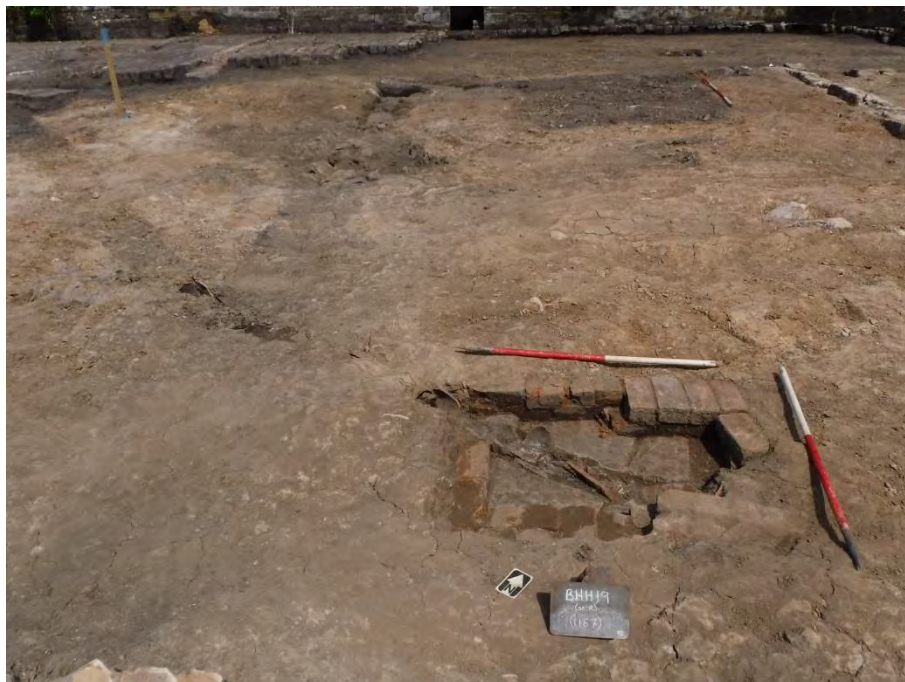
Figure 12. Brick-built and stone lined drainage chamber cut into the natural clay within the western room of Structure 4. Drainage trench [1147] is visible to the north-west running through the possible entrance through wall line (1161). Scale: 2x1m.

possible that they served as pad-stones for the vertical supports of a roof structure or a raised floor. The drainage chamber (1.08m x 0.92m) within the western room was located at the south-eastern extent of a drainage trench [1147] that extended from beneath the cobbled road to the north-west and into the structure through the possible doorway (Figure 12). No further internal doorways or structural elements were observed due to the fact that only the lowest portions of the wall foundations had survived. The maximum height of any of the surviving walls was 0.3m (north facing elevation of wall (1160)).

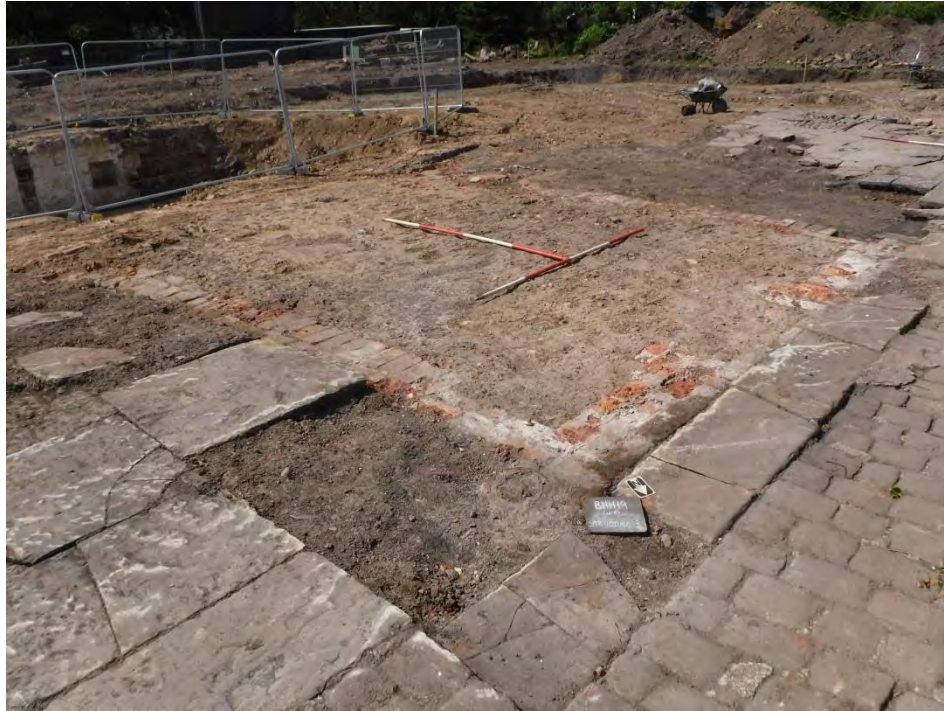
Figure 13. Overview of Structure 3 showing the brick walls enclosing an area of natural clay. Cobbles (1136), kerbstones (1137) and flagstones (1138) around the outside are bedded onto a shallow levelling deposit (1135) that abuts the exterior faces of the structure but was not observed inside. Scale: 2x2m.

4.4.1 As mentioned previously, Structure 3 was identified as a number of brick walls enclosing a rectangular area (c. 3.73m x 4.56m) of undisturbed natural clay (1003) along the northern edge of the site. Walls (1139), (1140), (1141), (1142) and (1143) were all constructed of hand-made red bricks (9¼" x 4½" x 3") bonded with soft, white lime mortar with charcoal flecks. A maximum of two courses of bricks had survived in the majority of the walls and the structure is likely to represent the ground-floor foundation of the northern entrance to Bleaklow Hall (see the 1850s OS footprint outlined on Figure 3). The main walls ((1140), (1141) and (1142)) were constructed of 3-skins of bricks; although two portions of brickwork in wall (1141) projected into the structure with a fourth skin on either side of a 0.97m wide area that only had a single skin of bricks aligned up against an external stone kerb (1137). This is likely to represent the entrance into the hall from the cobbled road (1136) (Figures 3, 6, 13 and 14).

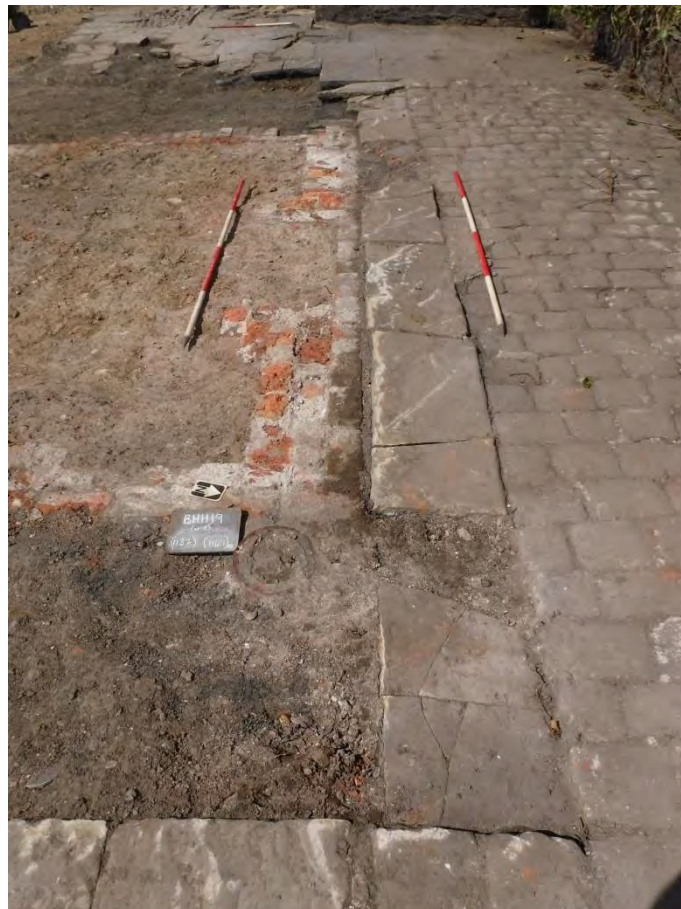
Figure 14. Detail of northern wall (1141). A probable entrance is represented by a single skin of bricks flanked by two interior pillars/butresses that were keyed-in to the main wall line. Scale: 2x2m.

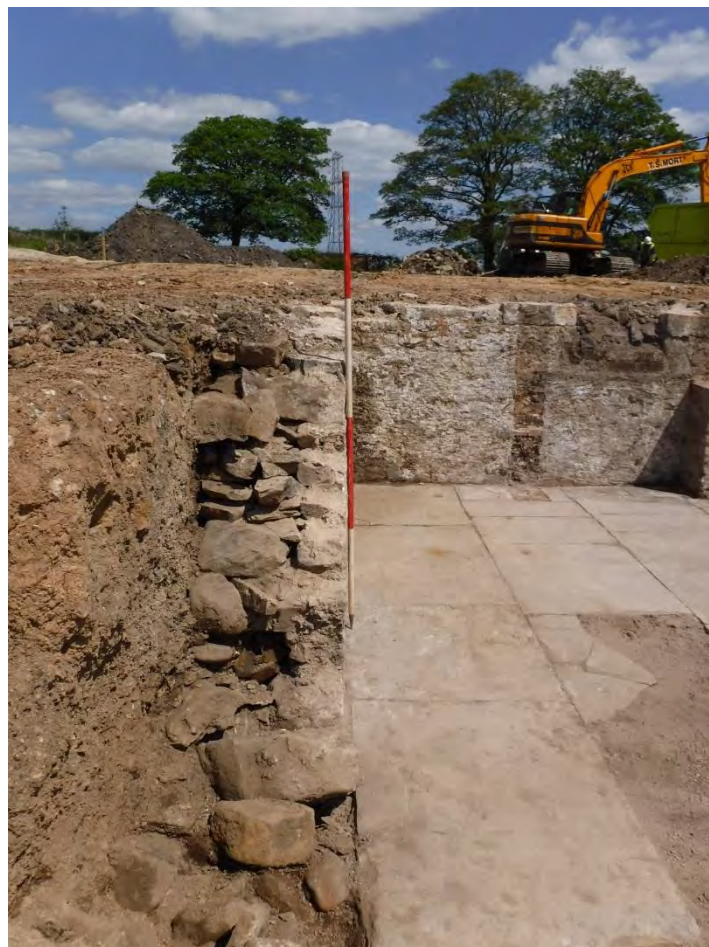
Figure 17. View through truncated wall (1175). Section shows the construction of the wall with a finished internal face and a rougher finish against the construction cut. Scale: 2m.

4.4.4 The northern ((1171) and (1175)), western (1172) and eastern (1174) walls of the cellar all had thicknesses between 0.52m and 0.6m, whilst the southern wall (1173) was thicker at 0.9m. The internal partition walls ((1179) and (1180)) and staircase walls ((1170) and (1176)) were all slightly thinner at 0.35m and 0.44m respectively. Walls (1171) and (1172) had only survived as a single course of foundation stones whereas the remaining outer walls all had heights of 1.5m or more (Figure 16). The walls were constructed of large, flat-sided and whitewashed facing stones on the interior elevations, with rubble cores and rough-finished exterior faces that were built up against the vertical construction cut [1169] within the natural clay (Figure 17).

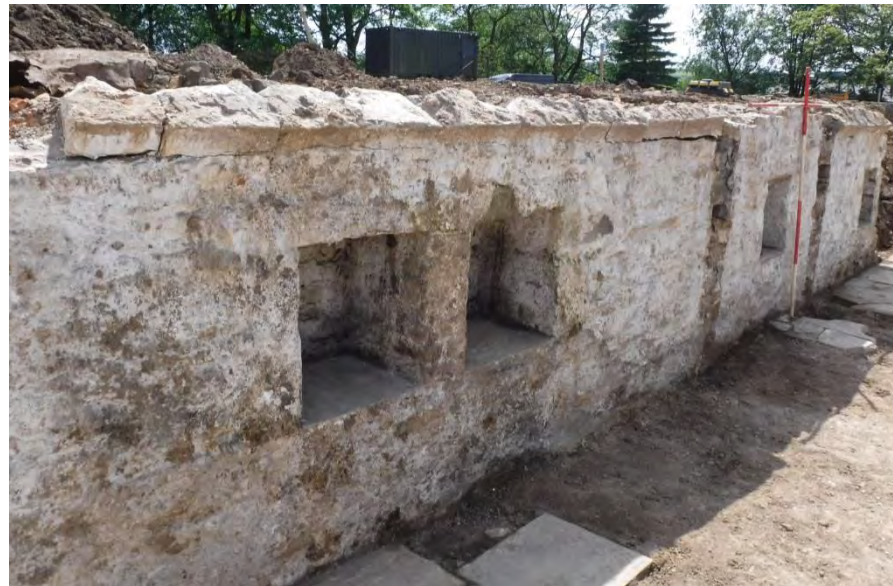
Figure 20. Oblique view along the southern wall of the cellar, looking south-west. Scale: 2m.

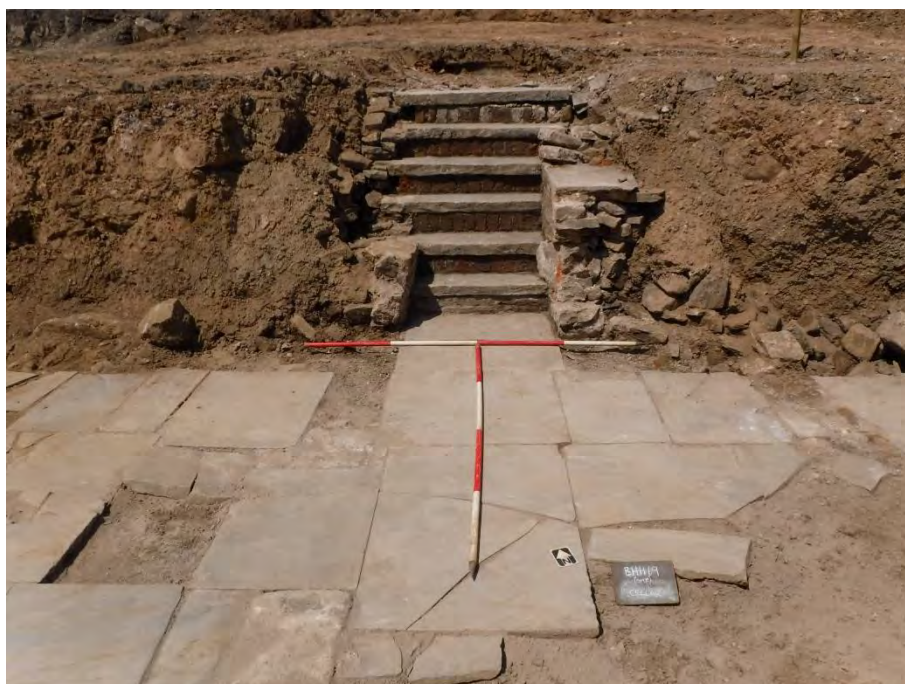
Figure 21. Brick risers (1182) and stone treads (1183) of the cellar staircase. Scale: 2x2m.

4.4.9 On the northern side of the cellar, a staircase formed of six brick risers (1182) and six stone treads (1183) enabled access into the cellar from the ground floor. It is possible that there were once more stairs but these would have been removed during demolition of the hall in the 1960s to make way for the construction of the bungalow. The stone treads had a maximum width of 1.24m but their ends sat upon stonework of the staircase side walls ((1170) and (1176)). This suggests that the treads were once keyed-in to the walls and that the staircase was constructed as part of the single-episode construction of the cellar. The brick risers were formed of rows of rowlock headers bound with lime mortar. The bottom step was still keyed-in to both side walls of the staircase creating an access that was 0.83m wide (Figure 21). Each step (riser + tread) had a maximum height of 0.2m.

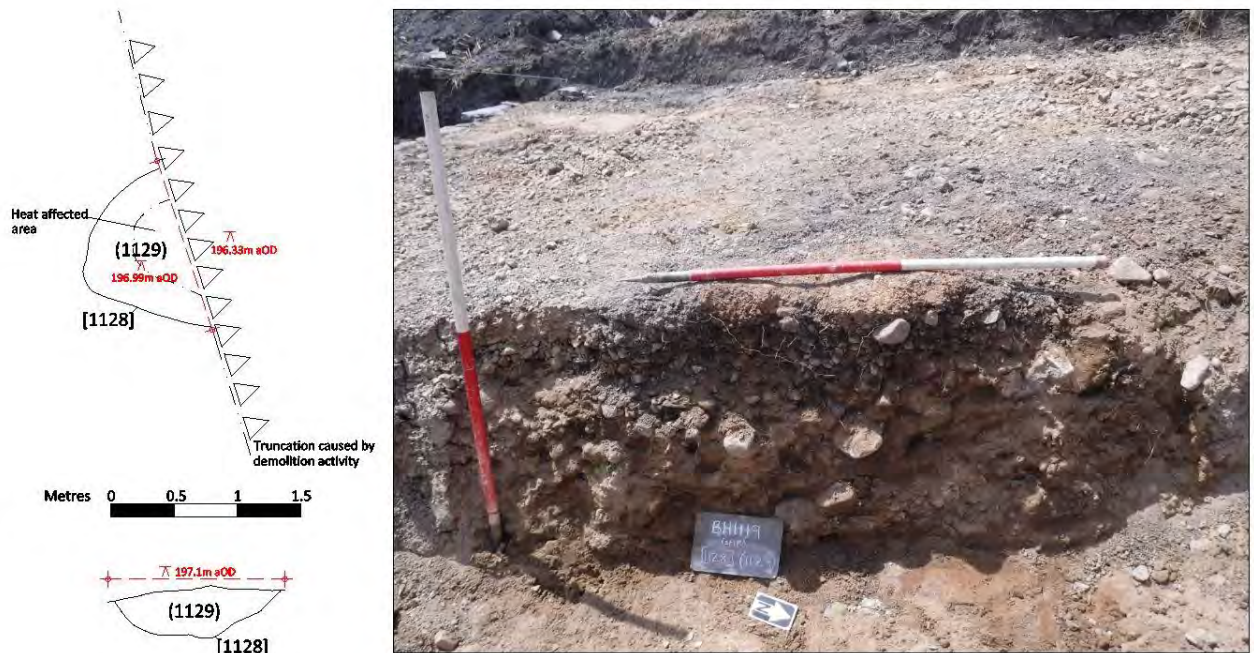
Figure 22. Plan, east facing section and photo showing the truncated remains of pit [1128]. Scale: 2x1m.

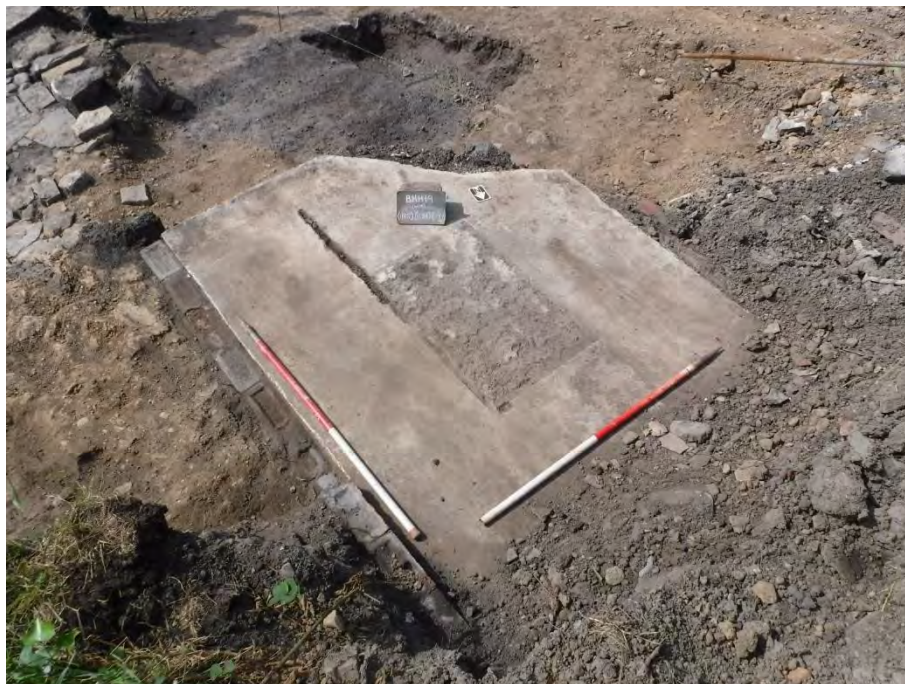
Figure 24. Concrete (1187) and brick (1186) remains of a 20th century outhouse, bedded onto a levelling deposit that is likely to be derived from the demolition of earlier buildings in the same area. Scale: 2x1m.

4.6.2 One was found immediately adjacent to and 0.5m higher up in the site stratigraphy than the northern edge of pit [1130] (visible in the background of Figure 24). Structural remains consisted of a concrete surface (1187) with a single-skin wall (1186) formed of machine-made, frogged bricks along its eastern edge. Part of this structure was observed in Trench 3 of the evaluation phase of the archaeological works, but subsequently the area had been badly truncated by demolition activities associated with a shed that once stood nearby. The wall and the concrete were both laid onto a 0.5m deep deposit (1188) of made ground that had not been affected by the demolition. When overlaid with the footprints of buildings from historic mapping (Figure 3), the structural remains in this area are on a different alignment and are of a much later date than the footprint of a small rectangular building depicted on the 1893 OS map. The concrete and brick structure is more likely a remnant of a short-lived outhouse associated with the 1960s bungalow.

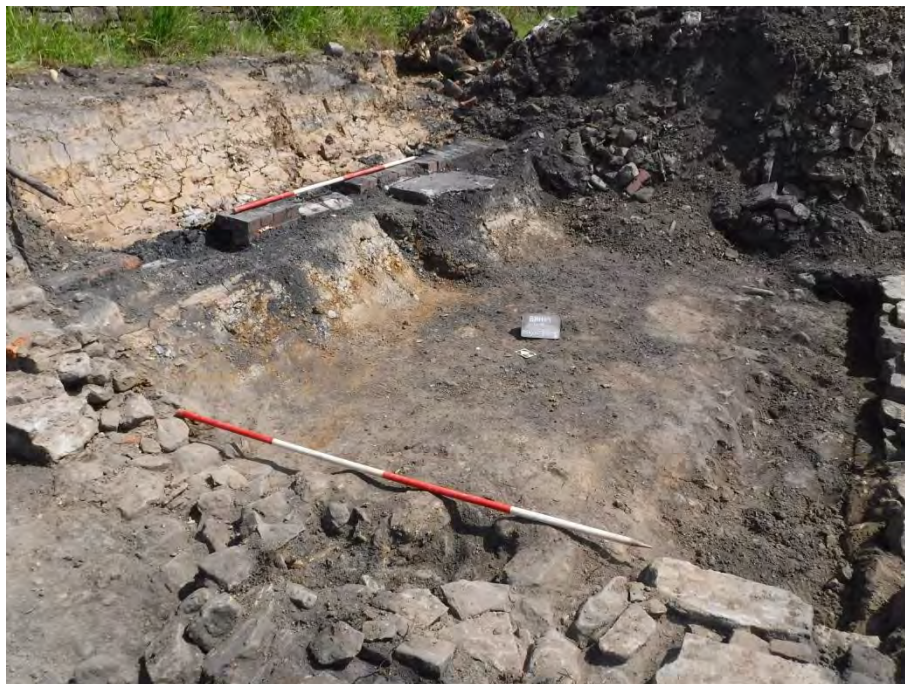
Figure 25. Exposed footprint of a building depicted on the 1938 OS map, which made use of existing stone walls (foreground and right hand side), but also with the addition of a northern brick wall and concrete floor. Disturbance alongside wall (1160) (right hand side of photo) represents the investigation sondage dug through made-ground deposit (1158) during the evaluation. Scale: 2x2m.

wall (1154). When viewed in relation to the footprints of buildings from historic maps (Figure 3), it is clear that the northern wall of Structure 4 and the spur of the retaining wall actually form the southern and western sides of a building first depicted on the 1938 OS map. The northern wall of this building was revealed by the excavations as the foundation course of a 2-skin wall formed of machine-made, frogged, red bricks (1156) bonded with cementitious mortar (Figure 25). A small area of concrete flooring (1157) butted up against the south face of the wall and was bedded onto the ash-rich deposit previously recorded in the evaluation (relabelled as context (1158)). The function of the building still remains unknown, but its location and shared use of walls associated with the farm suggests that it had an agricultural function during the early to mid-20th century life of the farmstead.

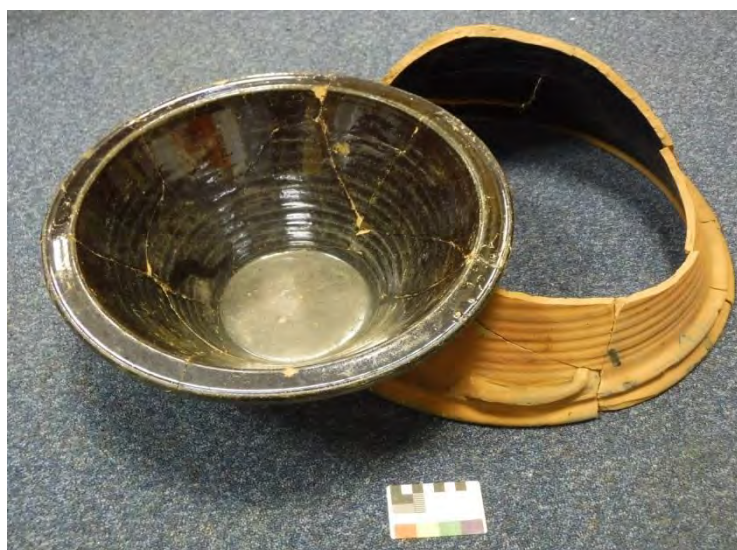
Figure 26. Reconstructed pancheons from fragments recovered in pit [1130].

5.2.3 The earliest types were glazed coarseware pancheons and bowls which ranged in date from the 18th to the 19th centuries. These types are difficult to date with accuracy as they have such a long lifespan. Pancheon fragments from pit [1130] represented $\frac{3}{4}$ of a large handled rim as well as a complete vessel (reconstructed in Figure 26). This pit also produced several partially reconstructed transfer-printed whiteware vessels in 'Willow and Two Temples' design of a mid-19th century date (Figure 27).

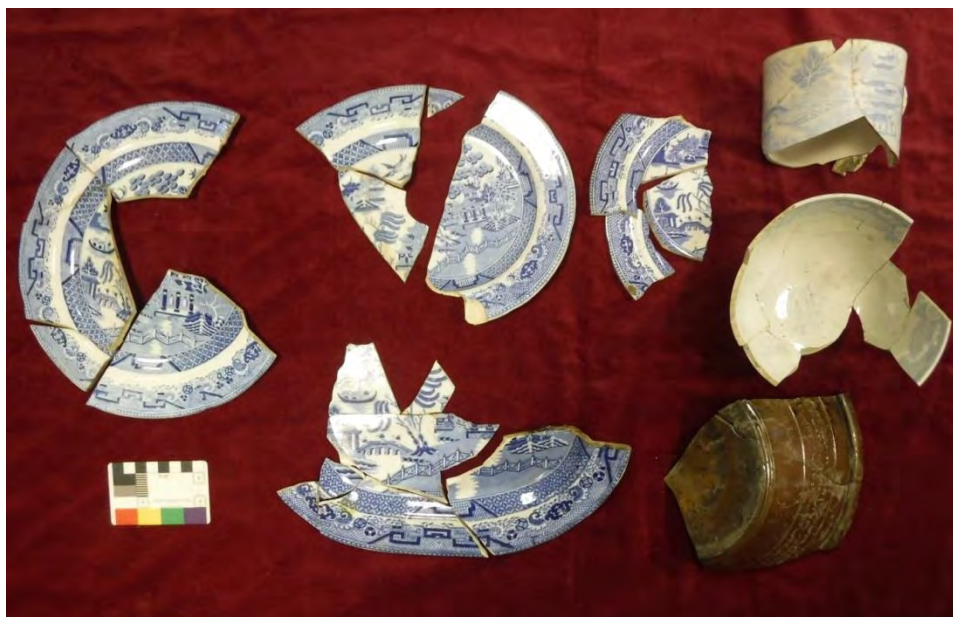
Figure 27. Partially reconstructed vessels from pit [1130].

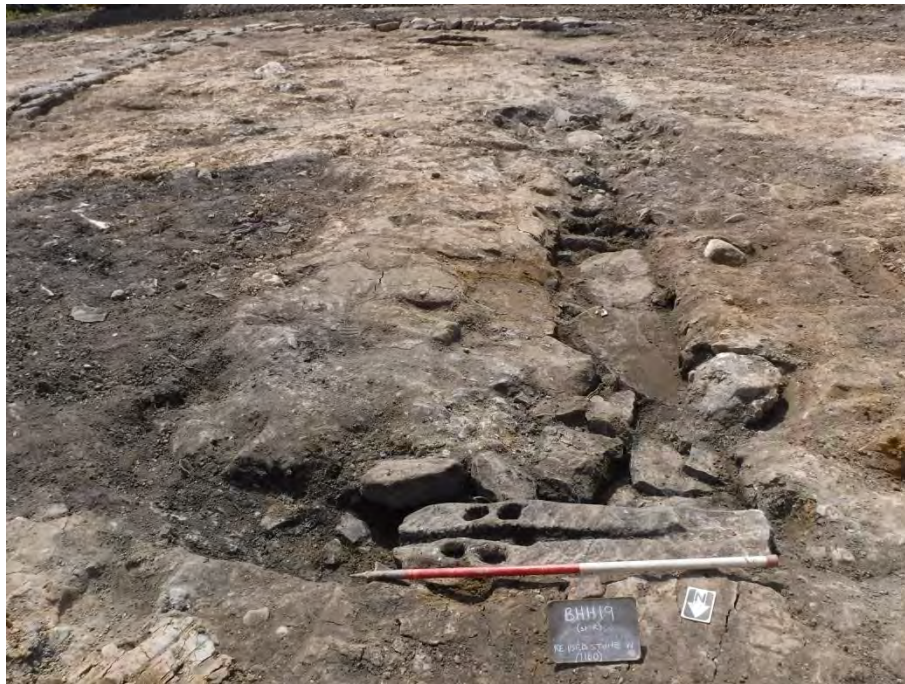
Figure 28. Re-used stone potentially from the entrance of a former building on the site. Scale: 1m.

farmstead. This was a common occurrence in the examples excavated on the numerous farm sites of the Kingsway development at Rochdale (Clark 2006), where use of the sites often spanned a number of centuries. A large stone with a long carved notch and numerous circular rebates was found within the foundation courses of stone at the north-west corner of Structure 4. The notch is likely to represent a groove that housed a sliding door or partition surface whilst the rebates represent the recesses for drop-bolts that held the sliding material in place, either open or shut. The stone was found in a location that would not lend itself to the positioning of an entrance or gatepost in the new building (Figure 28).
