**Stanley Works, Rutland Road,
Sheffield**

**Report on an
Archaeological Evaluation**

ARS Ltd Report No. 2007/77
January 2008

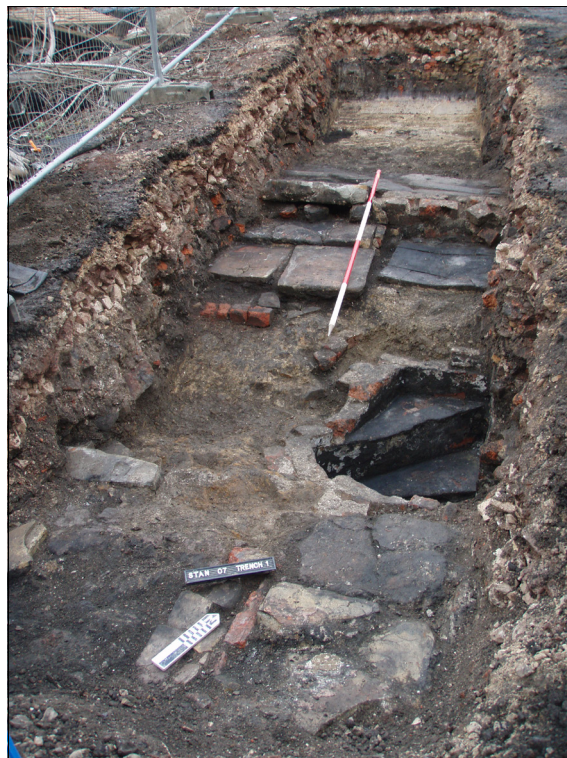
Fig. 3 Trench 1: View of Trench 1, looking north west (Scale: 2m)

- 6.1.1 Area A was contaminated with modern rubbish and oil drums containing chemicals, diesel *etc.* which meant that the location of the trenches was restricted to the central strip of Area A. Trench One was located closer to the access road than Trench Two. The majority of the deposits in this trench consisted of rough construction rubble (*e.g.* 101 and 102) representing the remains of the buildings that were demolished in 1960. The natural substratum across the site was a homogenous yellow-brown (10YR 7/6) till deposit encountered at different depths (Appendix 2).
- 6.1.2 Trench 1 was found to contain the internal remains of a red brick house as well as a pavement and road on the outside of the building (Figs 3 & 12). The steps to a cellar were also uncovered and partly excavated.

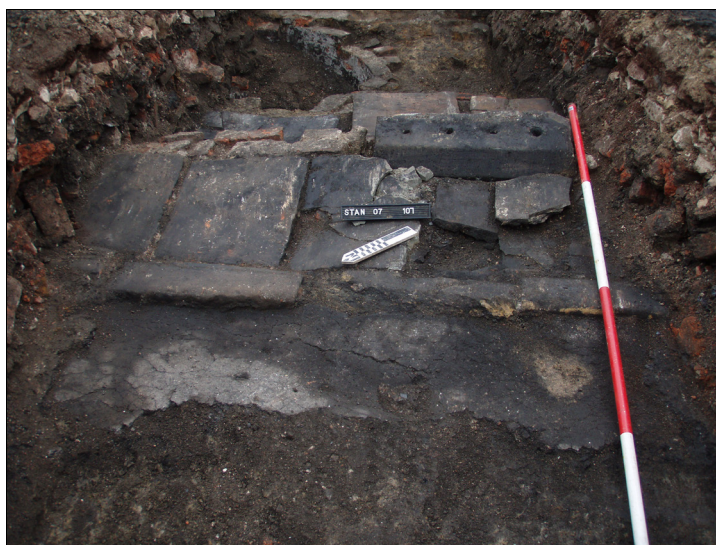
- 6.1.3 A layer of tarmac (105) was located 2m from the north of the trench and 0.8 m below the modern ground level which had been truncated to the north. To the south the tarmac abutted a line of sandstone sets (106) which in turn abutted a row of sandstone flags (107). This group of features has been interpreted as a road with an adjoining pavement (Fig. 4). This road directly abuts a brick wall (109) believed to be the external wall of a terraced house. The doorway of the house, believed to be located at the west side of the trench has since been filled with a large moulded sandstone block (108).

Fig. 4 Trench 1: Tarmac (105), and flags (107), looking south east. (Scale: 0.5m)

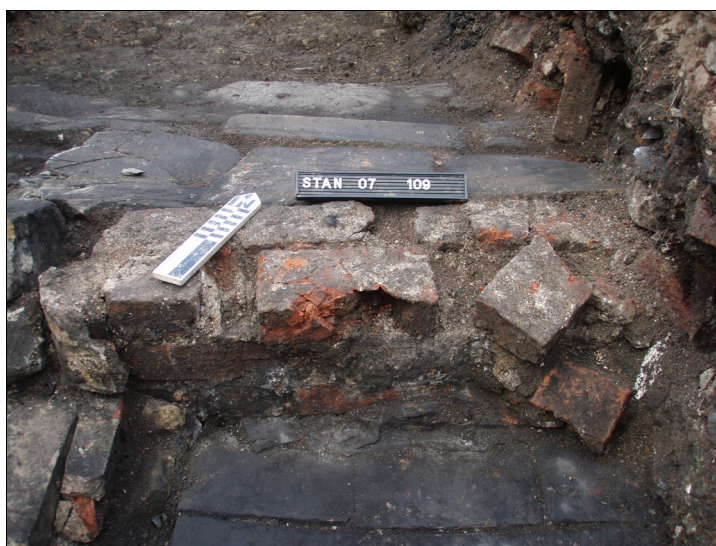
- 6.1.4 The brick wall (109) has been interpreted as an external wall as it faces out on to the road (Fig. 5). The wall was two courses wide and survived to three courses high. The bricks measured 0.24m x 0.13m x 0.07m. The bricks were rendered using a lime mortar and were whitewashed on the south (interior) face. On the side of the presumed doorway the edge of the wall had been plastered to create a rounded edge giving credibility to the idea that this was an entrance.

Fig. 5 Trench 1: Wall (109), looking north west. (Scale: 0.25m)

109	1	External brick wall of a house that faced onto the paved area (107). The wall survives to two courses high and is two courses wide. The bricks are rendered with a thick lime mortar and have been whitewashed on the south (interior) face. The wall terminated 0.92m from the east side of the trench suggesting that there was a doorway where the sandstone block (108) is currently positioned.
110	1	Area of sandstone flagged floor inside the building. Remains of a degraded linoleum on the surface of the flag stones.
111	1	Area of sandstone flagged floor to the east of (110). There was probably a small dividing wall at some point between these two floor levels.
112	1	Redeposited natural clay found below flagged floor levels (110) and (111). Contained broken brick, glass and pottery.
113	1	Small line of two bricks found at the south end of the flagged floor level (110) – redeposited clay banked up against them. The line probably continues into the west side of the trench. May represent a small internal wall.

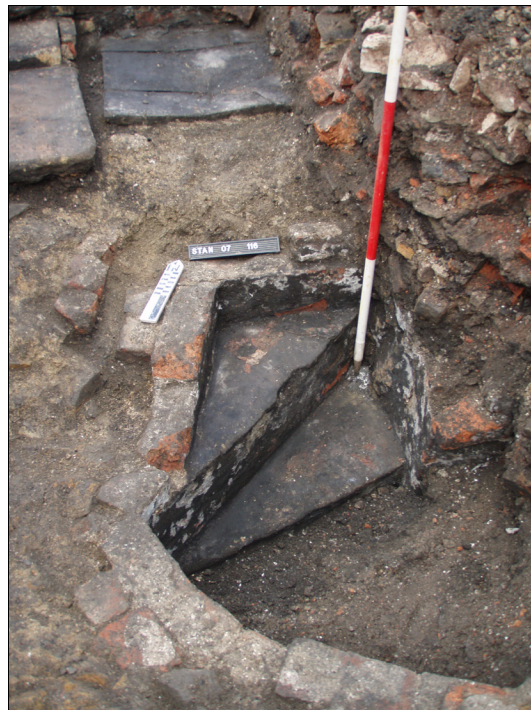
- 6.1.6 The entrance to the cellar was located on the east side of the southern part of the trench (Figs. 6 and 7). The cellar wall consisted of whitewashed bricks two courses wide and consisted of a curved wall (115) that abutted a straight wall (122) that extended into the east baulk. The cellar steps (116) were located in the corner where the two walls abut. The cellar was in filled with building rubble (117) which was removed to reveal two of the triangular shaped steps. The steps measured 0.8m x 0.3m x 0.22m and were constructed using a sandstone slab on top of two courses of bricks. A modern plastic hand bag was located on the top step of the cellar entrance.

Fig. 6 Trench 1: Cellar steps (116), looking north west. (Scale: 0.5m)

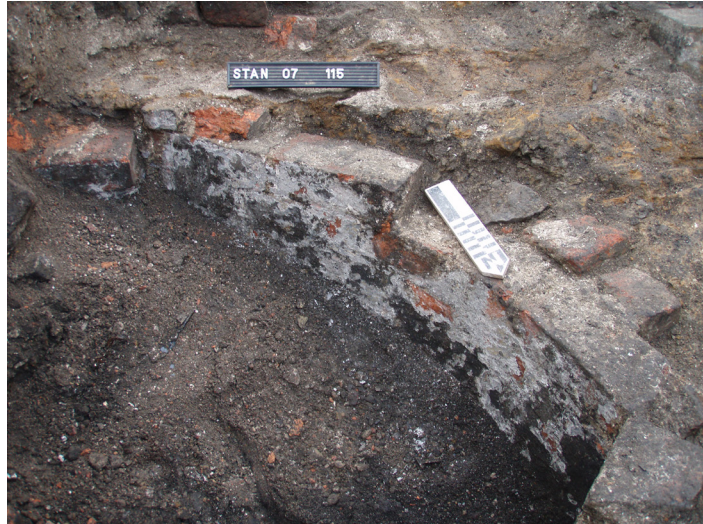
Fig. 7 Trench 1: Cellar wall (115), looking south west. (Scale: 0.25m)

114	1	Line of slightly curved bricks set into the redeposited clay (112). May represent a disturbed internal wall.
115	1	Entrance to cellar on south east side of the trench consisted of a curved brick wall two courses wide and excavated to a depth of four courses. The bricks were whitewashed on the interior and laid on bed in a stretcher pattern. The cellar entrance was infilled with rubble.
116	1	The cellar was accessed by a series of triangular steps which descended from the north corner of the cellar wall (115). Two steps were exposed during excavation. Remains of a degraded linoleum was found on the surface of the steps as well as a modern handbag. The steps were constructed from a sandstone flag that sat on top of two courses of bricks.
117	1	Building rubble found infilling the cellar entrance.
118	1	Brick wall to the south of the trench which originally ran the width of the trench but was disturbed by the digger. Wall comprised of a single courses of bricks. May represent a dividing wall or the end wall of the house.

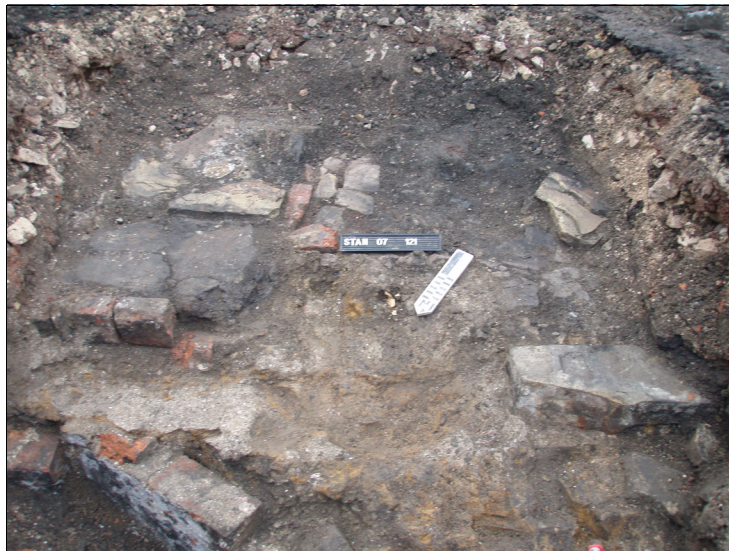
6.1.7 Directly south of the cellar entrance was a brick wall that originally ran across the width of the trench but was disturbed by the machine during the initial excavation (Fig. 8). The wall (118) consisted of a single course of whitewashed bricks and has been interpreted as an internal wall or the back wall of the house. Another degraded area of flagging (120) was present, albeit heavily disturbed, on the other side of this wall. This could potentially be the interior of the same dwelling or an external area of flagging.

Fig. 8 Trench 1: Remains of wall (118), and flagged floor level (120), looking south east. (Scale: 0.25)

119	1	Rectangular shaped sandstone block set in to redeposited clay (112). The block is positioned in line with the brick wall (118). The block has a square indent possibly for a post.
120	1	Disturbed flagstone floor layer on the south side of the brick wall (018). May represent floor level of another adjoining house.
121	1	Disturbed area at south end of trench – is probably the deposit below the flag stones (120).

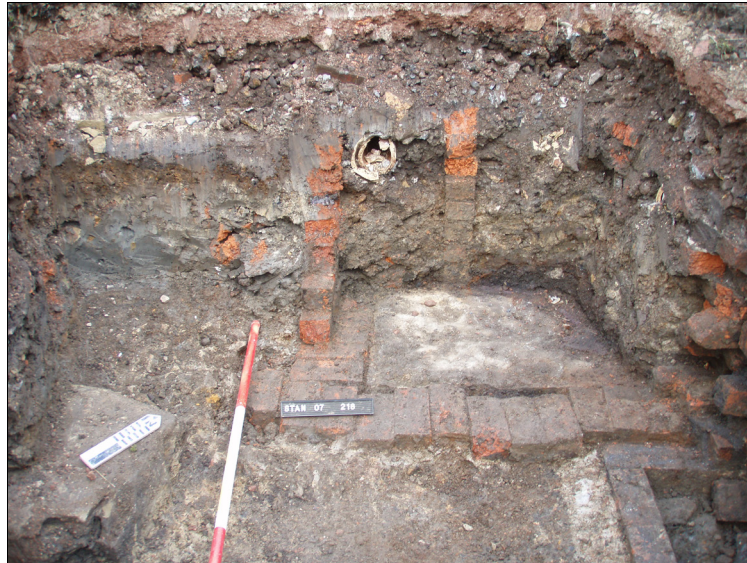
- 6.2.2 At the north end of Trench Two a series of red brick walls (219 and 218) were excavated to reveal a square feature with a sandstone slab base (Fig.9). The bricks were machine made with a dark grey cemented mortar. Three ceramic drains appeared to converge at this point which appear to have been later insertions. It is possible that the structure represents an outbuilding for the terraced houses that stood on this site until the 1960s.

Fig. 9 Trench 2: Walls (218) and (219), looking north west. (Scale: 0.5m)

216	2	Construction cut for (215).
217	2	Fill of construction cut for (215). (10Yr 5/4).
218	2	Brick wall two courses wide excavated to nine course in depth alternating header, stretchers on bed. Part of a rectangular feature that surrounded three drainage pipes

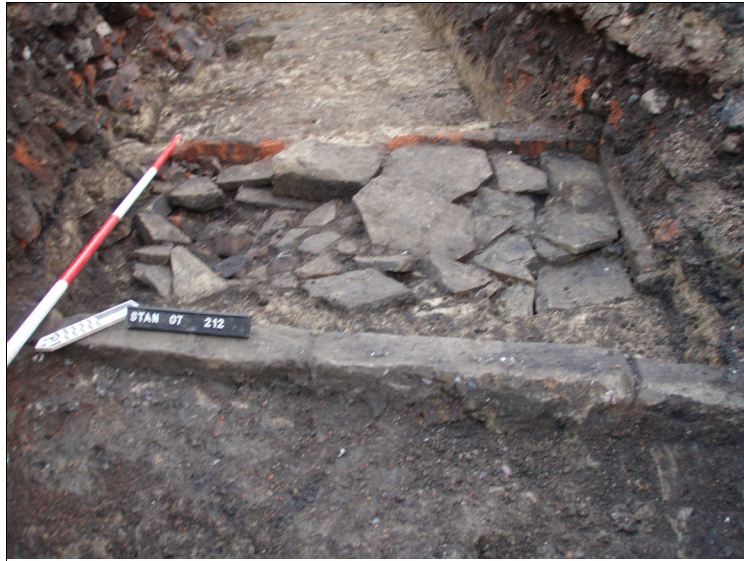
- 6.2.3 An area of sandstone rubble (208) along with a sandstone wall (212) and a brick wall (207) was located three metres from the north end of the trench (Fig.10). The feature has been interpreted as an infilled structure, possibly a cellar. The sandstone rubble was capped had been capped with a layer of tarmac possibly as a path between two houses.

Fig. 10 Trench Two: Sandstone rubble (212), looking south east. (Scale: 0.5m)

208	2	Area of sandstone flags that appears to be a rubble infill also contains brick, dust and mortar. Either a rubble infill or a disturbed sandstone capping area between walls.
209	2	Very compact aggregate deposit over (210). Capping deposit over (208).
210	2	Rubble/slag deposit over (208). Possibly a levelling layer. (10YR 4/1).
211	2	Redeposited clay over and abutting (208). (10YR 6/6).
212	2	Sandstone wall abuts clay (211) and overburden (214). Sandstone blocks are more likely to be flagstones set of their side. The wall is possibly part of a structure including (207).
213	2	Layer of tarmac over (209) possibly a road or a pathway or a cap for (208).
214	2	Compact redeposited clay in north west of trench under (202).
215	2	Brick wall single course wide alternating stretcher on bed excavated for six courses in depth. Wall abuts (218) and tagged on (not keyed in to) (218). Wall possibly associated with drainage as two ceramic pipes appear to be related to the structure.

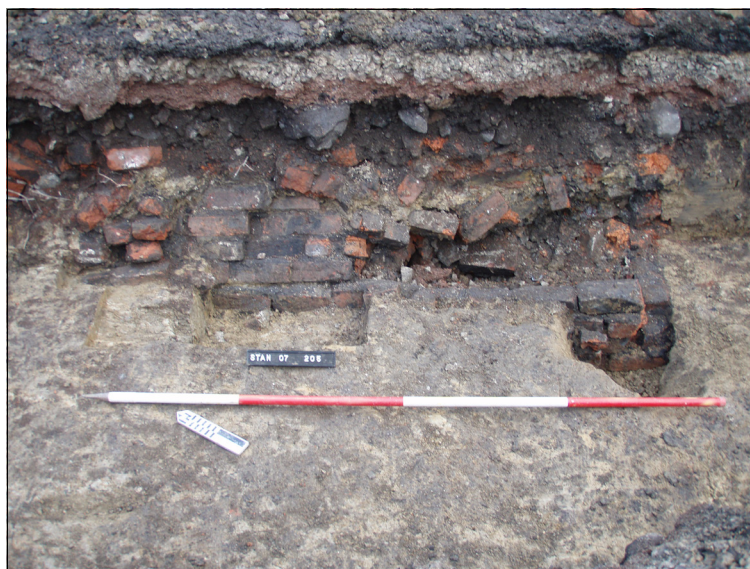
6.2.4 On the south east side of the trench 1.5m south of the sandstone rubble was a red brick wall that had previously collapsed and now lay at an angle into the side of the trench (Fig. 11). The wall was a single course wide and survived in places up to four courses in height. The wall (205) was keyed in to the returning wall (204) that continued in to the baulk of the trench. The structure had been built against the clay deposit (203) with no discernable construction cut. This structure may be related to the brick wall (207) but as the two features are discontinuous this can not be confirmed. The structure may represent the corner of a building or cellar.

Fig. 11 Trench Two: Walls (204) and (205), looking east. (Scale: 2m)

200	2	Tarmac found across the site.
201	2	Hardcore (Type 1 building rubble).
202	2	Demolition rubble below (101) comprised mainly of bricks.
203	2	Alluvial clay found approx. 0.8m below the modern ground level (10YR 7/6).
204	2	Brick wall single course wide excavated to three courses deep. Bricks were whitewashed on the north west face. The walls abuts and is keyed in to (205) with the same black mortar. There is no visible construction cut for the wall built up against (203). Wall represents part of a structure, possibly an outbuilding relating to the terraced houses.
205	2	Brick wall single course wide excavated to four courses deep – alternating stretchers on bed. Keyed in to (204) to the south. Part of a structure, possibly an outbuilding.
206	2	Rubble infill of (204) and (205).
207	2	Brick wall running across the trench. Single course visible possible north south return in the south west section of the trench. Wall abuts (208) – sandstone rubble/structure to the north west.
