**13 – 19 Market Street, Eckington, Derbyshire
Report on an Archaeological Watching Brief**

13 – 19 Market Street, Eckington, Derbyshire

ARS Ltd Report 2008/51

July 2008

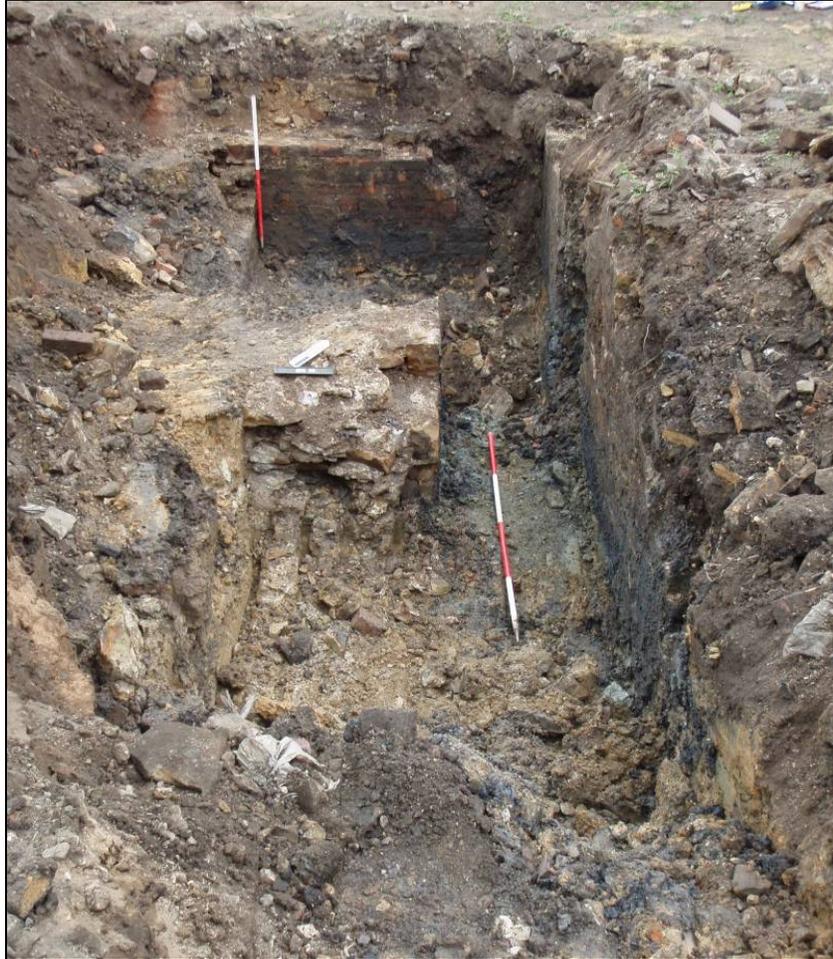
- 6.2.1 Hydrocarbon contamination discovered in test pits 3 and 4 required excavation of a trench measuring 9.6m x 2.7m (Fig. 4). A representative from Archaeological Research Services Ltd was present throughout to observe for any archaeological features.

Fig. 4: Trench excavated to remove contamination. Facing west.

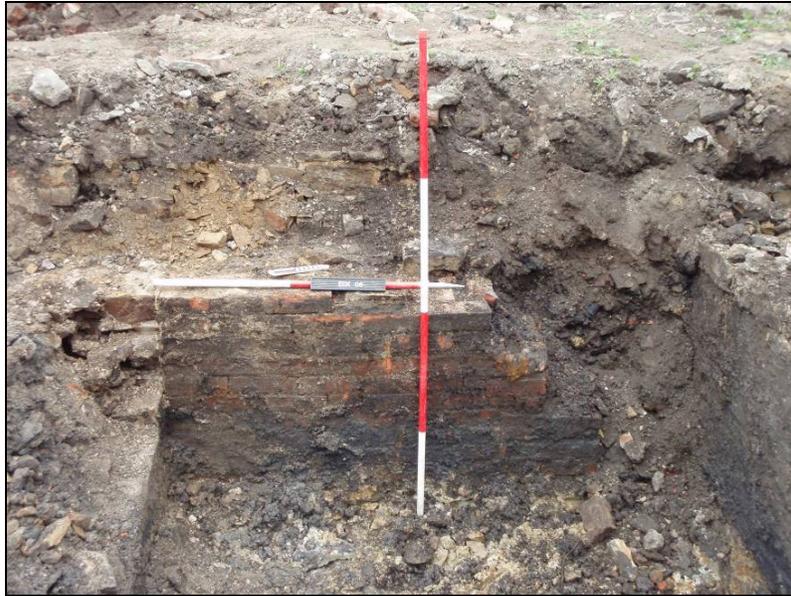
- 6.2.2 These excavations confirmed that earlier buildings on the site had been demolished and the site had been levelled using this debris. The upper layer of sandy soil and demolition debris had a depth between 0.25m and 0.63m and overlay a series of small walls, differing backfill and natural clay. A red brick wall (context 004) was revealed to the west of the trench, standing ten courses high 1.2m above the lowest excavated level (Fig. 5). Built using Imperial bricks (9½" x 4¼½ x 2¾) laid in an irregular stretcher pattern and bonded by a firm light grey mortar. These cannot be more closely dated than mid to late 19th century. Running north to south, the wall was terminated at its northern end before contact with wall (005) and continued into the north facing section of the trench. An east to west running sandstone wall (006) abutted wall (004) at the southern extent of the trench, wall (004) being bonded to (006) by the mortar observed in (004). The remains of (006) extended 1.72m east with a maximum height of 0.39m and formed part of the trenches north facing section.

Fig. 5: East facing section of wall (004)

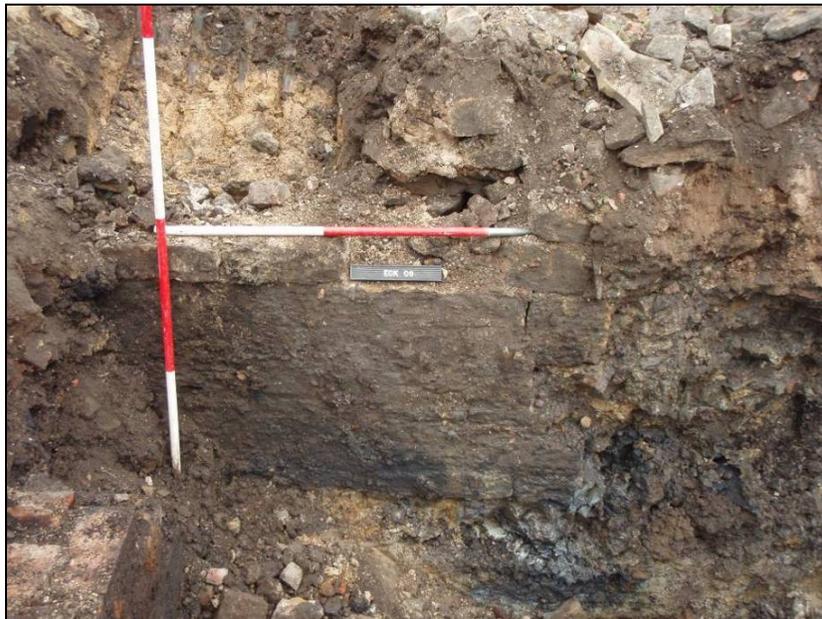
- 6.2.3 The south facing section of the trench contained two sections of sandstone wall (005) and (008). (005) can be seen terminated at its eastern end (Fig. 6) and continuing west out of the excavation area. The wall was built onto the natural layer of yellow clay (010) with blocks approximately 0.3m x 0.16m and existing to a height of 1.12m. Wall (008) contemporary to (005) was found 1.4m east; (008) was constructed of the same sandstone blocks and existed 2.9m in length x 1.5m high. Another small section of sandstone wall (007) opposed wall (008) 0.8m to

Fig. 6: Sandstone wall (005) in south facing section of the trench. Facing north

the south, forming a small corridor between the walls. Of comparable construction to (005) and (008) the wall measured 1.65m in length and 1m in

height, excavation was not required to the south of this wall. Walls (005) and (006) (Fig. 2) are possible features of buildings shown on an 1898 historic map (Fig. 7), while the construction of wall (004) and its poor bond to (006) would suggest this wall to be of a later date.

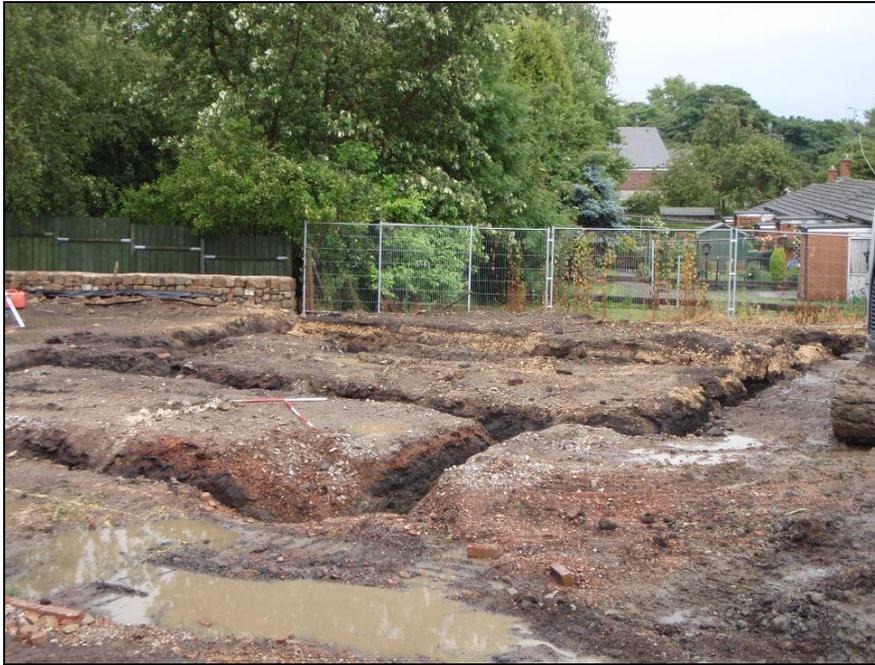
- 6.3.1 Two months after phase 1 and the removal of the contaminated material, excavation of the trenches for the block and beam foundations began. Two plots each related to three houses and each plot required the excavation of approximately 67m of trenching. Plot 1 was positioned to the east of the site. The ground in the area of plot 1 was made ground; a light covering of brown sandy soil overlay a layer of sandstone hardcore material to the east and crushed red brick to the west (Fig. 8). Underlying the above was general industrial and demolition debris overlying natural yellow clay. The trenches were excavated to a depth of 1m to 1.2m with a metal bar the only feature revealed (Fig. 9). The bar was located in the furthest eastern trench (Fig. 2) and was set in concrete, extant to a height of 0.72m and width of 60mm. A chain link was attached to the bar and 0.2m to the south-east a chain link was set into the concrete with an attached link. Adjacent to the post were irregular shaped blocks which did not have any constructional significance.

Fig. 8: Overlying ground conditions of plot 1. Facing north-east.

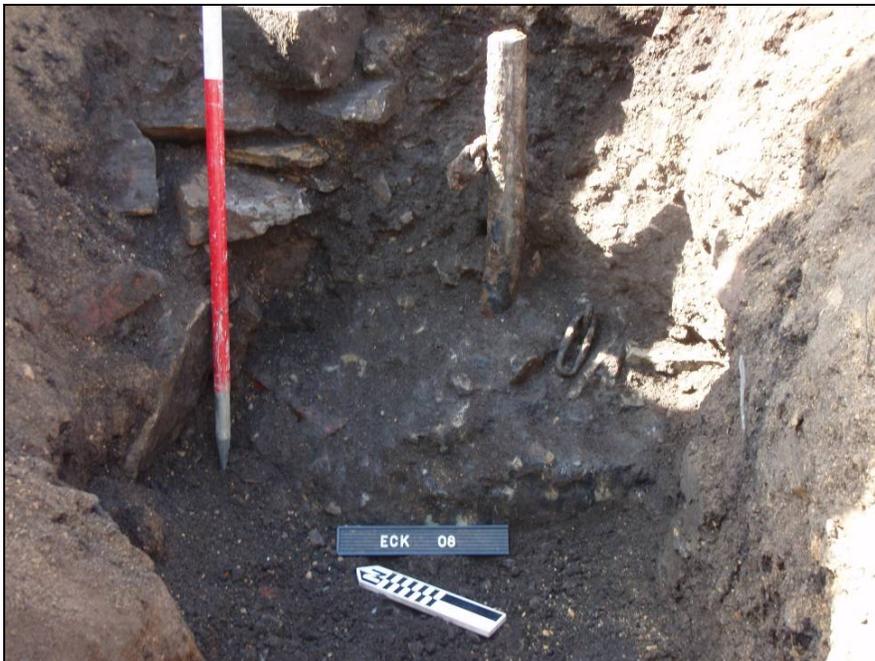
Fig. 9: Metal bar and chain located in plot 1. Facing north

Removal of the concrete revealed a mass 1m deep x 0.75 wide, a substantial anchoring point.

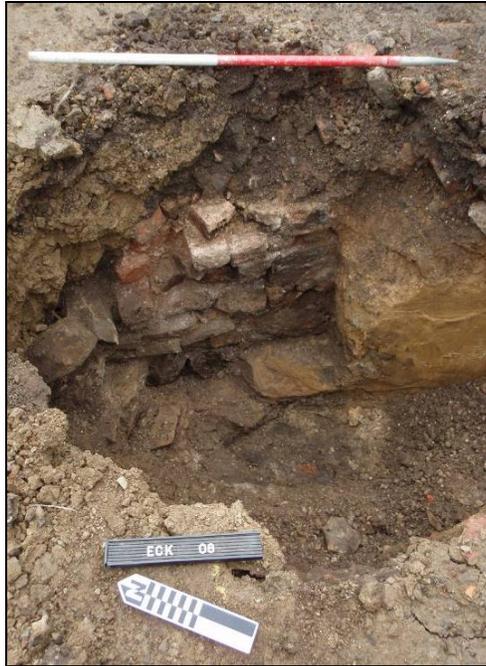
- 6.3.2 Plot 2 was situated approximately 1m west of plot 1, the northern extent of the trenches overlapping the backfilled area of the contamination trench (Fig 2). Excavation at the northern extent revealed the southern face of wall (006) and evidence of the bonding between red brick wall (004) and wall (006), which

suggests the wall (004), terminates at this junction (Fig. 10). The backfilling of the earlier excavated contamination trench presented unstable ground conditions within this area, this required a larger area than intended to be excavated. Extending north created a trench of approximately 2.6m wide and 1.7m deep, wall (006) was completely removed during this course of action.

Fig. 10: Southern face of wall (006) and adjoining wall (004). Facing north

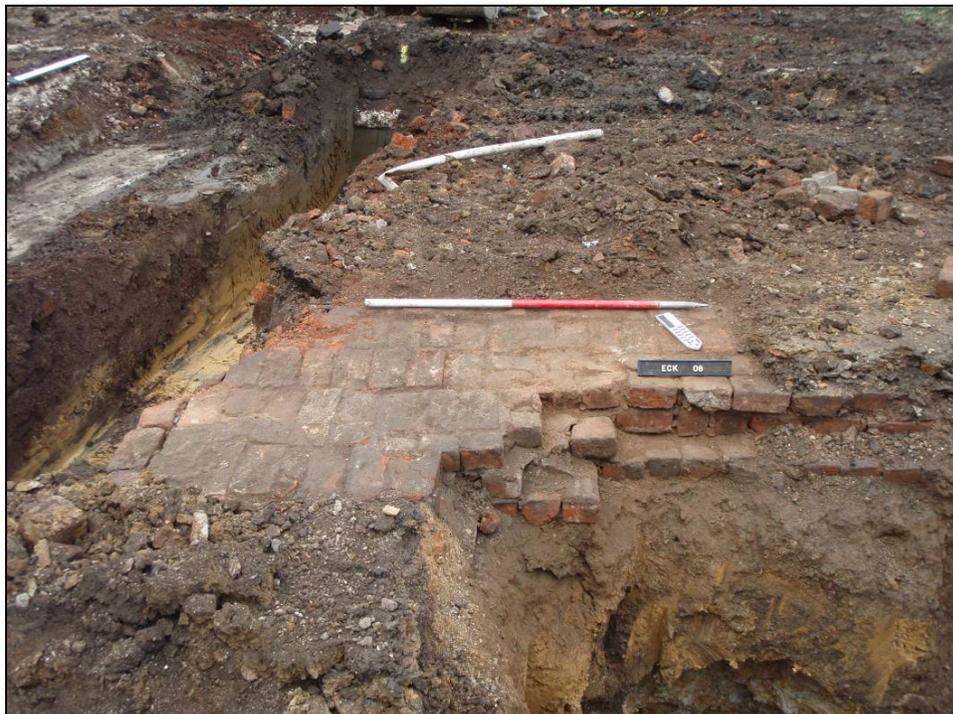
Fig. 11: Floor level (013). Facing east

At the eastern end of the trench in its north facing section a red brick floor level (013) was identified (Fig. 2). The surface layer underlay 0.15m of made ground and was constructed using imperial solid red brick (9" x 3" x 4"), laid in an irregular stretcher bond orientated north-south 1.3m, its total width was unknown (Fig11). Manufactured using coal measures clay the bricks were wire cut, mid orange in colour and were a standard brick associated with the mid 19th century. Truncation of a section revealed the floor to be three courses deep, laid onto the natural yellow clay (010) and bedded and bonded using a friable light grey mortar which contained small pieces of charcoal.

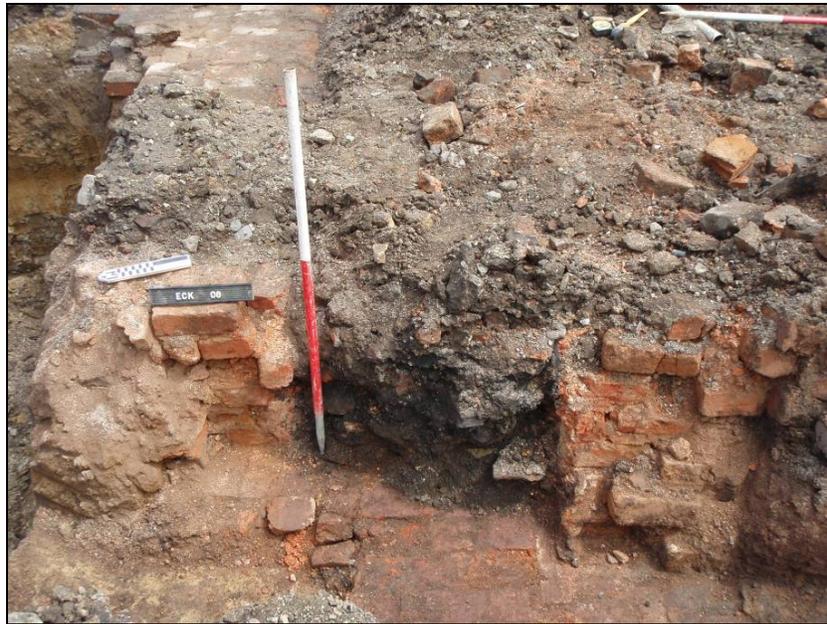
- 6.3.3 Excavation south from the eastern corner created trench D. After 1.8m the floor level stopped at which point a u section feature was revealed (014), the feature became clearer when trench C was excavated (Fig. 12). A channel formed by the construction of two red brick walls was traced east-west across trenches B, C and D. A layer of fine sandy silt (015) up to 30mm thick was observed on the base, of a dusky brown colour 10YR 2.5/2.

Fig. 12: Channel (014). Facing east

The channel was built at the southern extent of the brick floor level (013) with the base of the channel five brick courses below floor level; the base was 0.7m wide with a five course opposing wall to the south. The base was one course deep laid on (010) and underlay the side walls which were built to a thickness of 0.2m (Fig 12). No evidence of this channel was observed in trench A which suggests it terminates between trenches A and B.

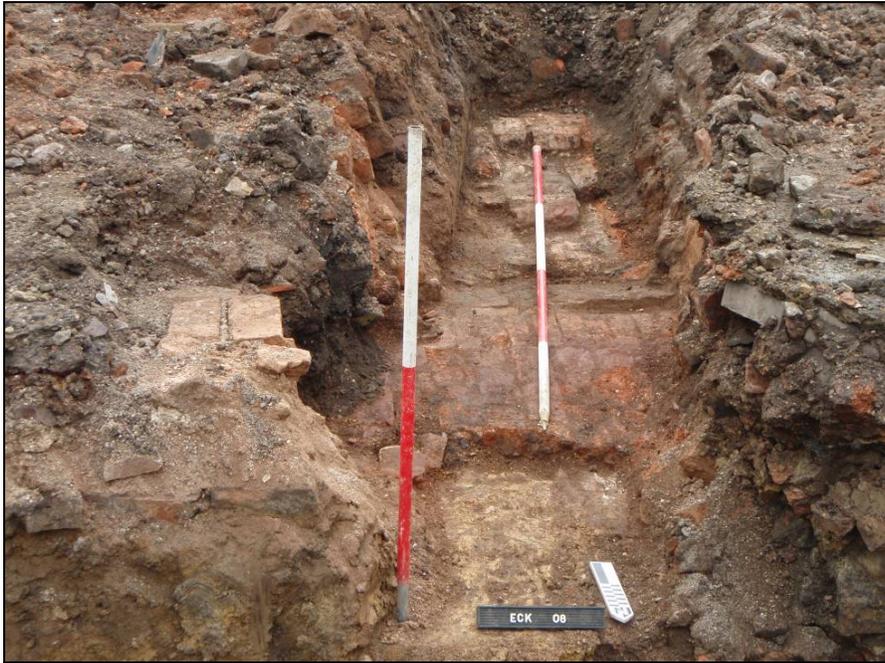
In trench C, a rough floor level (016) was identified extending south for 1.8m, constructed using sandstone blocks overlain by two courses of red brick (Fig. 13). This floor level was possibly disturbed in earlier phases of construction or demolition.

Fig. 13: Floor level (016) located in trench C. Facing south

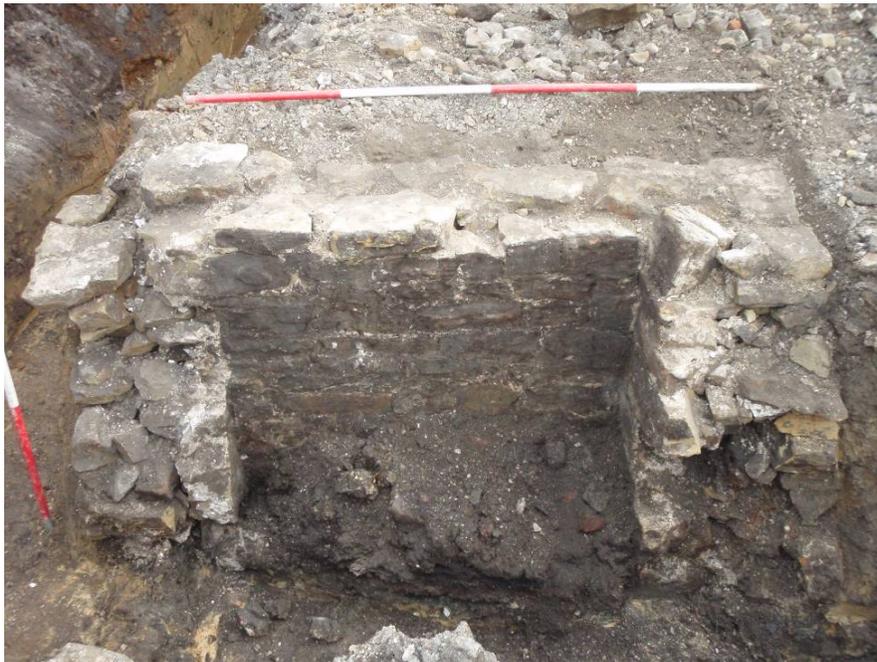
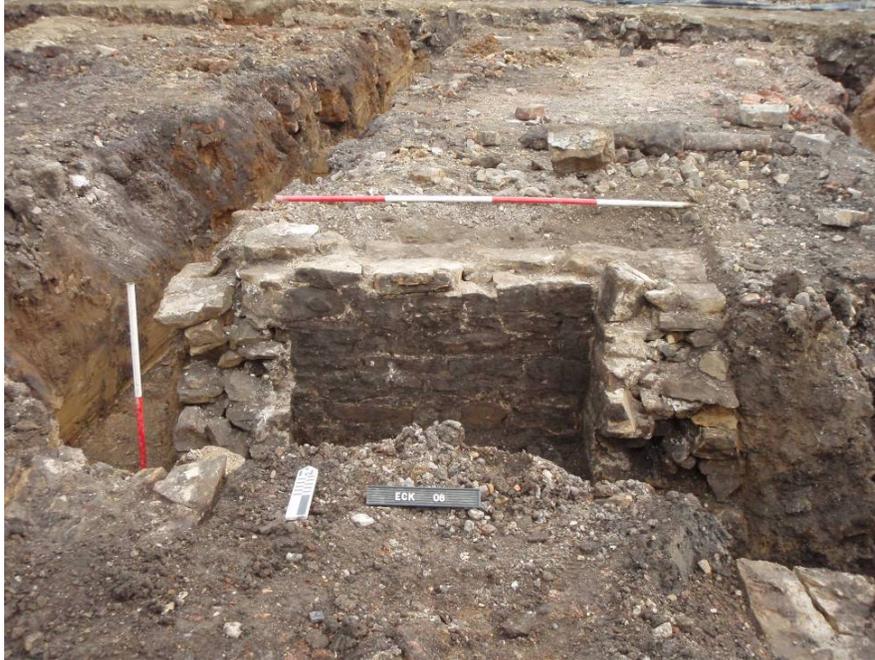
- 6.3.4 At the southern extent of trench B within the east-west running trench sandstone walls (018) were revealed, the loose fill of the trench sides enabled an area outside the trench width to be recorded (Figs 14 & 15). An end wall of 2.35m ran east-west, walls tied into it at each corner ran perpendicular into the north facing section of the trench and continued for an unknown distance. The walls were approximately 0.5m thick and standing to a height of 1.1m, laid directly onto (010). Constructed from sandstone blocks measuring 0.4m x 0.25m x 0.14m

Fig. 14: Sandstone walls of (018) Facing north

Fig. 15: Sandstone walls of (018) Facing north

to 0.4m x 0.17m x 0.2m they are double walled with smaller sandstone infill and the occasional cross block. The internal width measured 1.4m and the blocks had been dressed to produce a flat surface whilst the outer walls had been left in a natural uneven state, there was no evidence of a stone floor surface.

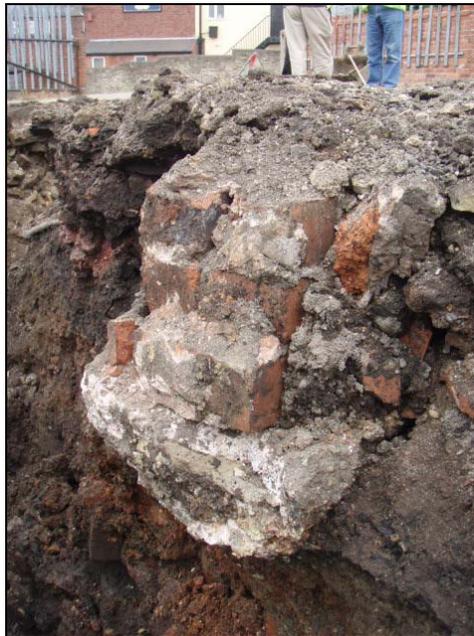
2.36m north of (018) were the remains of a later red brick wall (017), this was set in concrete foundations extant to three courses high (Fig 16).

Fig. 16: Later wall (017) located in trench B. Facing west
