## **An Archaeological Watching Brief at the Church of St Michael and All Saints, Brimington, Derbyshire.**

**ARS Ltd Report 2008/10**  
February 2008

Planning ref: MB/MB/2315

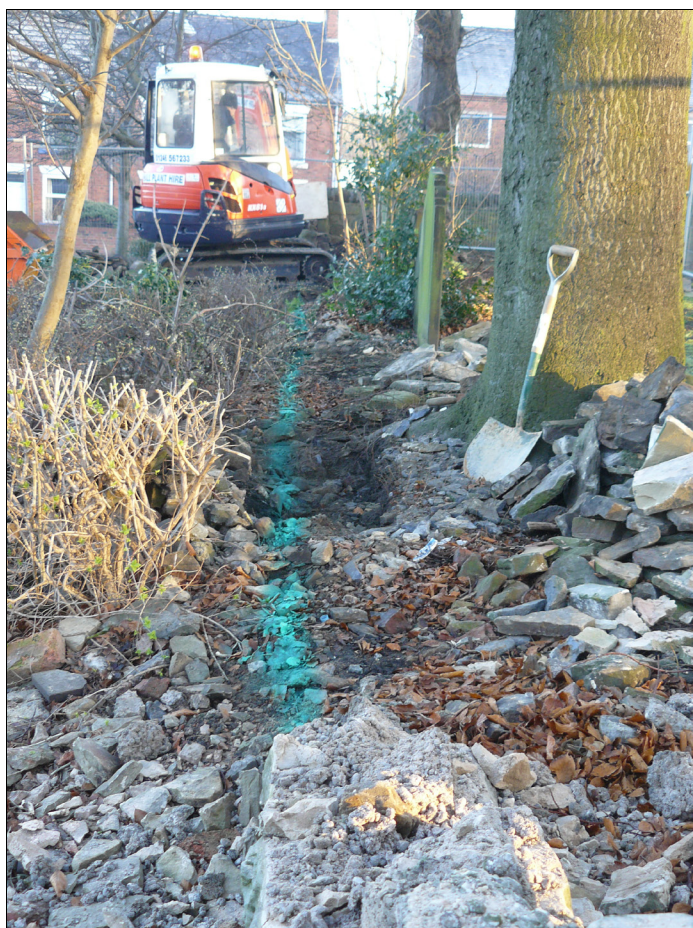
- 3.1 The removal of loose wall stones exposed an area made up of loose topsoil and small pieces of sub rectangular sandstone (Fig. 3).

Fig 3: Trench line to be excavated. Facing north

The topsoil (001) was fine sandy silt black in colour 7.5YR 2.5/1 and covered the area east of the wall line into the churchyard. To the west of the wall line redeposited topsoil (002) had been used in the landscaping of an area containing bushes and small trees, this was dark greyish brown in colour 10YR 3/2.

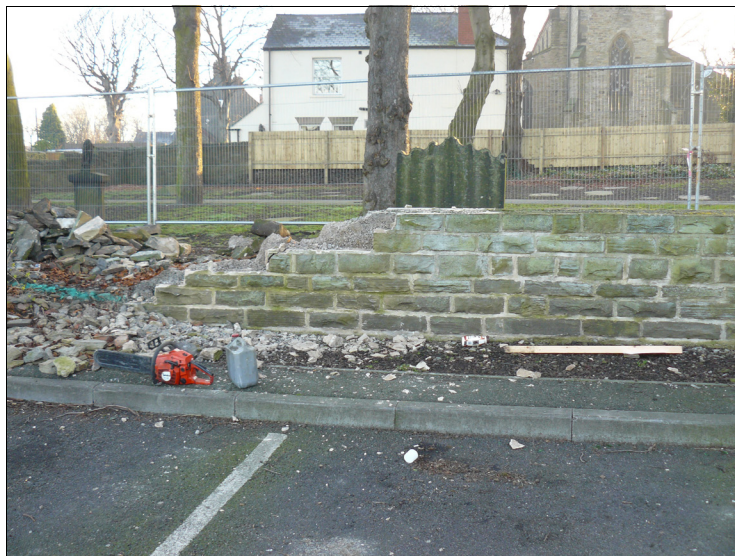
- 3.3 The trench was excavated below ground level on the west side; this level was established as a tarmac pavement abutting the car park (Fig. 4).

Fig 4: Tarmac pavement. Facing east.

- 3.5 A modern wall as seen in fig. 4 was demolished by machine. The existing foundations abutted the excavated trench, which were left in situ and would connect to the new foundations laid in the trench

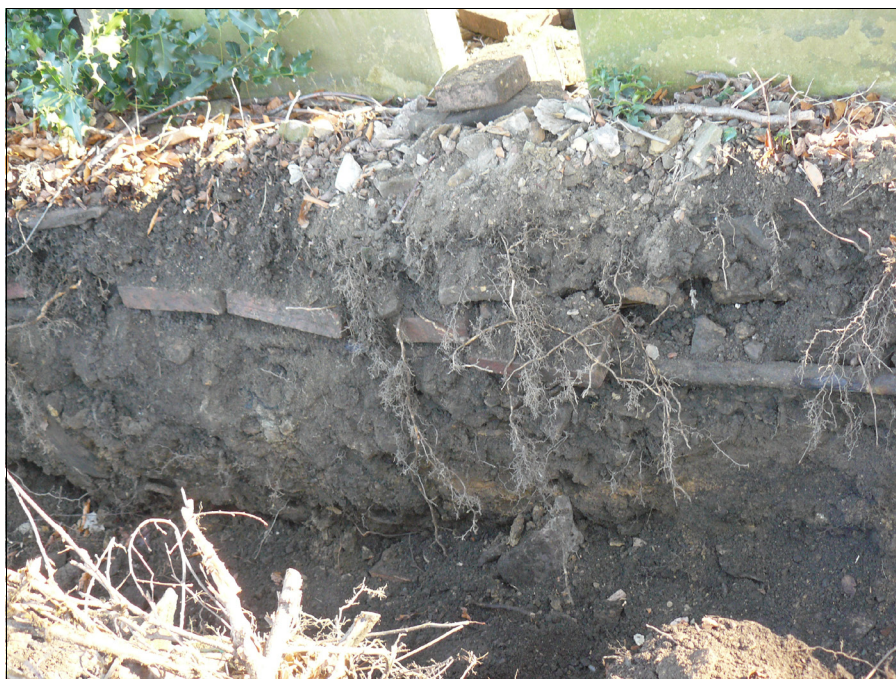
Sub rectangular stone of various sizes which constituted the lower level of the existing wall was removed by hand and machine. This exposed a trench approximately 0.25m below the tarmac level and exposed a face of 0.9m on the eastern churchyard side (Fig. 5).

Fig 5: West facing elevation of trench. Facing east.

The cable was positioned west of a row of headstones that came within 0.25m of the trench edge. The fill of the trench that housed the cable was topsoil context (001) with inclusions of sandstone fragments, modern pottery and bottles. This fill had a maximum depth of 0.65m and overlay sandy clay subsoil (003), brown in colour 10/YR 4/3. A maximum of 0.25m was removed from the subsoil; this was variable due to an upward slope of the ground from north to south (Fig 5).

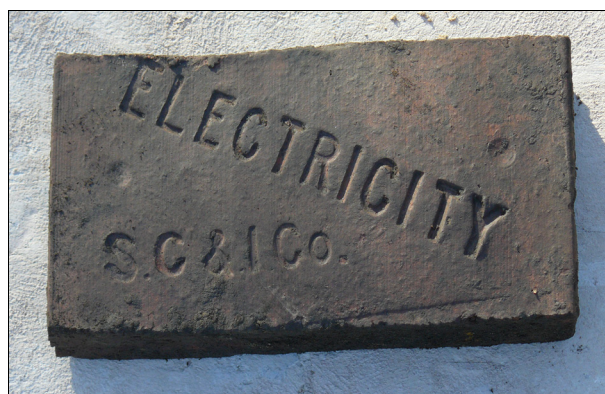
- 3.2 The trench excavation uncovered the route of an electric cable overlain by detailed electricity bricks (Fig 6). This cable had not been identified on any plans or discovered by cat scanning. It was presumed to be a disused line, but care was taken to keep the cable buried.

Fig 6: Bricks overlaying electric cable.

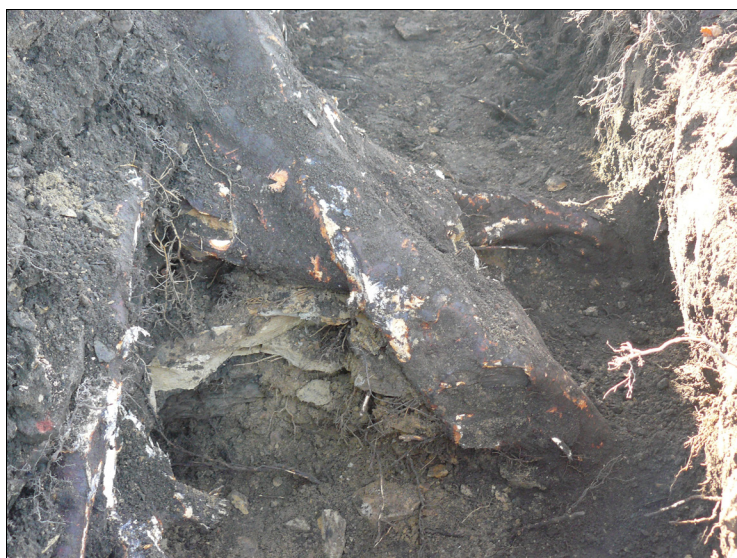
- 3.3 The roots of a large tree 14.2m from the northern boundary wall intruded into the trench (Fig 7), this was left in situ and will be bridged to accommodate the wall foundations.

Fig 7: Tree roots intruding into the trench. Facing south.
