**United Methodist Chapel
Mansfield Road, Creswell,
Derbyshire
Photographic Survey**

**ARS Ltd Report No. 2008/9
January 2008**

- 1.1 This survey was undertaken by Archaeological Research Services Ltd on behalf of Brett Oils Ltd prior to the demolition of all buildings and structures associated with the former Methodist Chapel, Mansfield Road, Creswell.

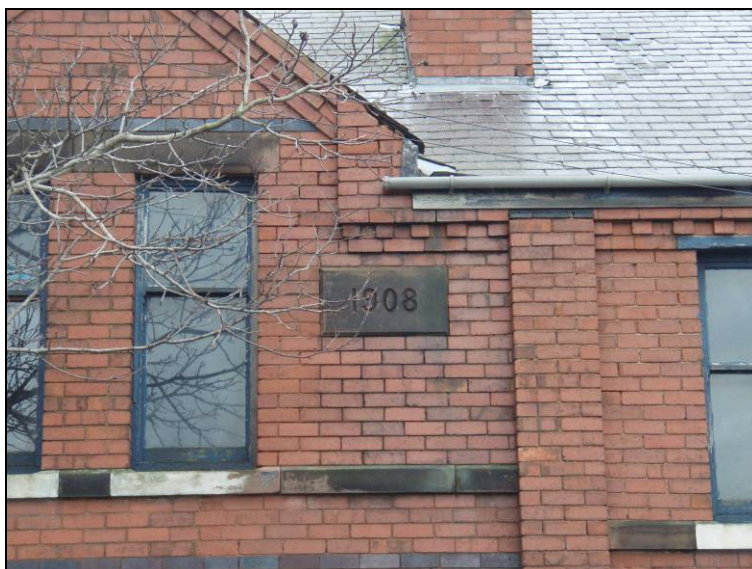
Fig. 4 Stone plaque dating the latest extension of the building.

- 6.2 The chapel was extended to the north and east at an unknown date between 1897 and 1908. The extension work demolished part of the northern end of the original chapel, probably where the ground plan is indented on the OS map, along with the toilet block. This is confirmed by the fact that the school room only measures 12m today, in contrast to the 17m it measured in 1897. Subsequently, a larger chapel was attached to the northern end of the school room along with a rectory which was attached to the rear of the building. This is how the building appears in the above photograph (Fig. 3).
- 6.3 Another extension was made to the south of the school room. A stone plaque between the upper floor windows dates this extension to 1908 (Fig. 4). The 1913-1914 OS map shows the ground plan for the chapel as it remains today (Fig. 5).

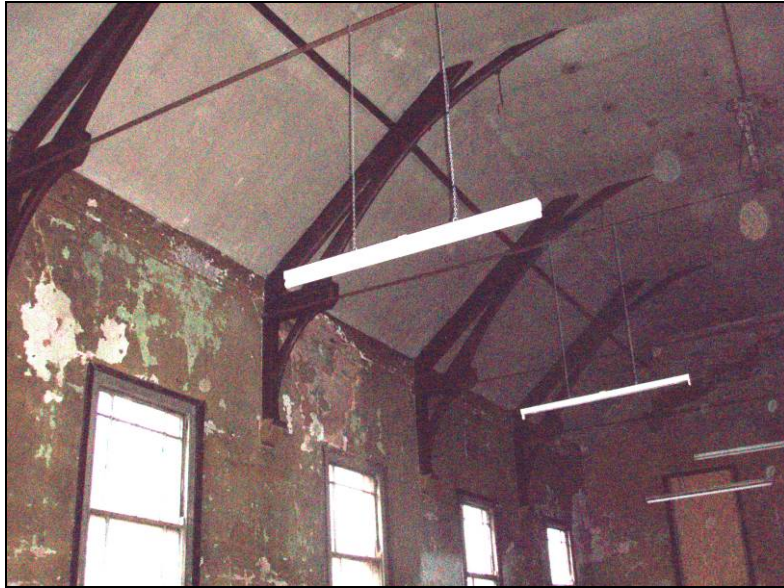
The chapel is the major building encompassing the whole of the north end of the building (Fig. 8 below). It is a large rectangular building measuring 11m x 18m which abuts the original school room at its west end and the rectory to the east (Fig. 8). The walls rise directly to a high ceiling that is partially arched with carved wooden support beams which disappear into the plasterboard ceiling. The beams are connected across the width of the room with metal poles for extra support (Figs. 6 and 7).

Fig. 6 Interior of the Chapel showing wooden ceiling beams and windows on the north side.

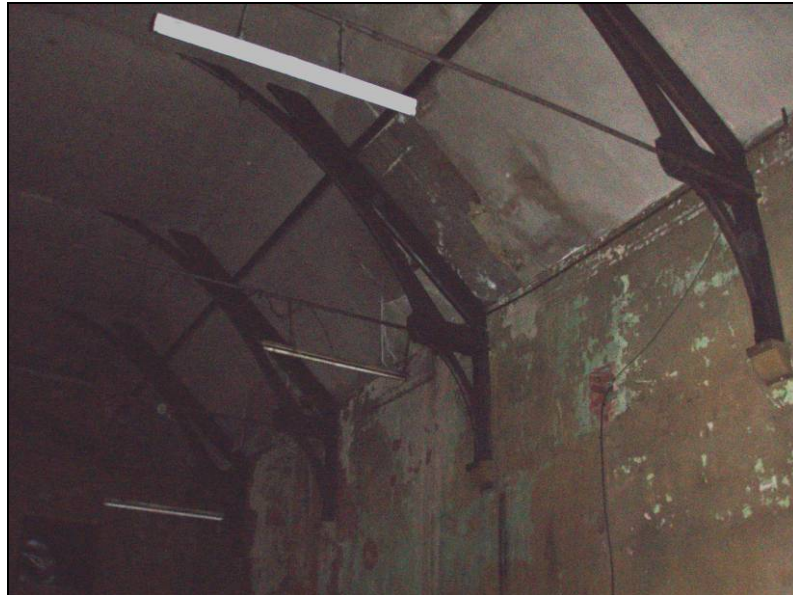
Fig. 7 Interior of Chapel showing the wooden ceiling beams on the south side.

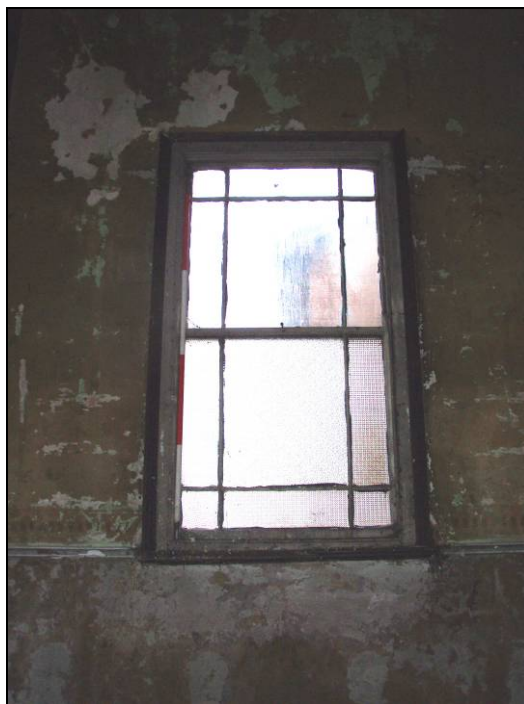
7.1.2 Along the north wall are ranged five, evenly spaced, rectangular sliding sash windows measuring 1.52m in width and approximately 2.4m in height (Fig. 9). Set into the eastern wall are three of the same rectangular windows, above and to the side of where the altar would have been. The central window is slightly smaller than the two flanking it. The three windows have since been boarded up. The south wall adjoins the school room and the rectory and as such does not have any windows.

Fig. 9 One of the northern walls rectangular sash windows.
(Scale: 2m)

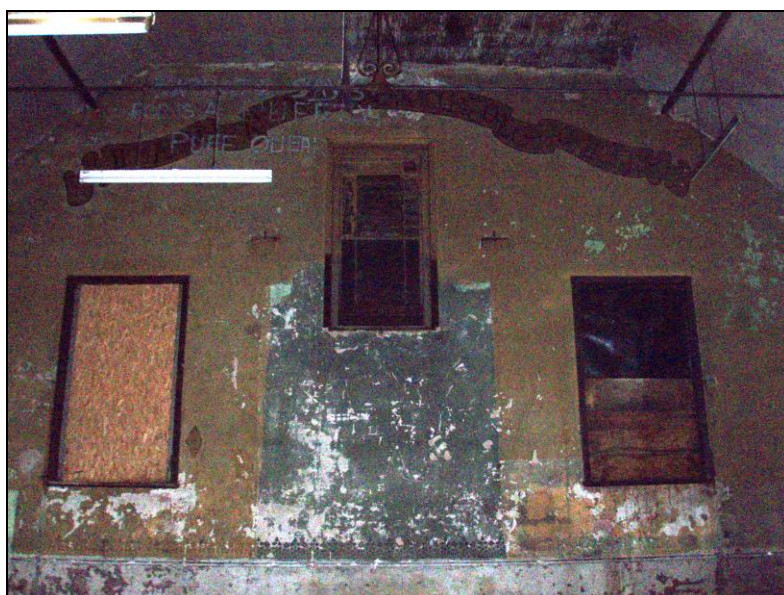
Fig. 10 East wall of the chapel showing the three boarded up windows.

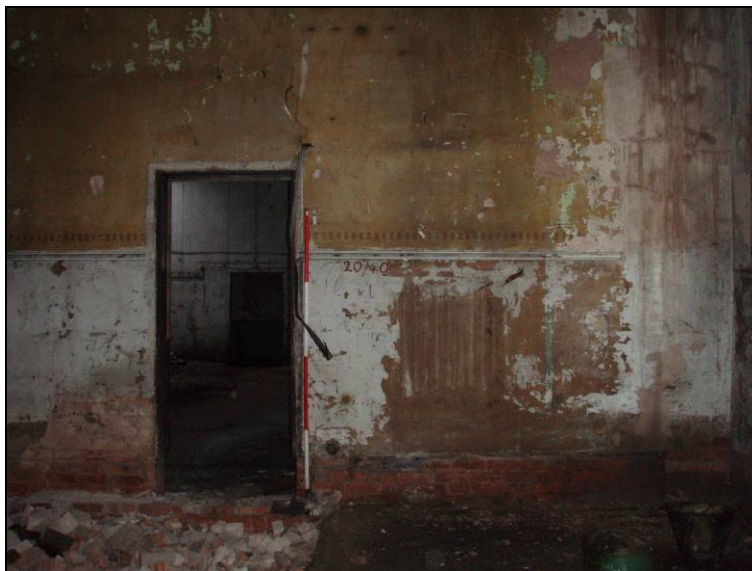
7.1.4 Apart from the main entrance the chapel would have been accessed by two other doorways positioned in the south wall. The first (western) door gave access between the chapel and the schoolroom and the second gave access from the chapel to the part of the rectory presumably used as a vestry for the minister (Figs. 13 and 14). A third larger doorway positioned 1.2m east of the vestry doorway is a later insertion allowing access to the modern passage. The large doorway measures 2m across and probably dates from when the building was amended for industrial use by Velvetone Ltd.

Fig. 13 Western doorway in the south wall giving access to the chapel from the school room. The brickwork at base of wall demotes height of original sloping floor level. (Scale: 2m)

7.1.5 The plaster found on the south and north walls indicates that the original floor sloped down from the doorway at the west end towards the altar (Fig 13). This would have meant that the congregation at the back of the chapel would have had an elevated position and therefore a clearer view of the altar. The simple decoration on the walls consists of a dado rail that runs flush with the base of the lower windows of the north wall. Above the dado rail there are the remains of a buff/mustard plaster with a brown rectangular pattern that may be either a stencil design or the holes left by the removal of a more ornate form of decoration. Below the dado rail the plaster appears to have been painted plain white (Fig. 15). The only other form of decoration can be seen on the east wall above the altar. There is a flower motif painted above the dado rail on to the plaster behind the altar and a painted scroll across the top of the wall bearing the legend “How amiable are thy tabernacles O Lord of Hosts” (Fig. 10). This biblical quote comes from Psalm 84 and roughly translates as “How lovely is this place of worship O Lord of Hosts”.

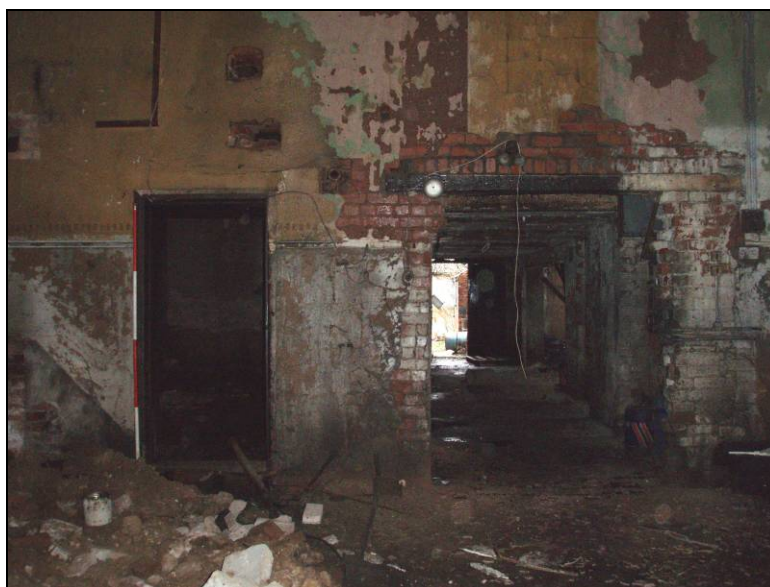
Fig. 14 The second smaller doorway in the south wall adjacent to the modern entrance to the passage. (Scale: 2m)

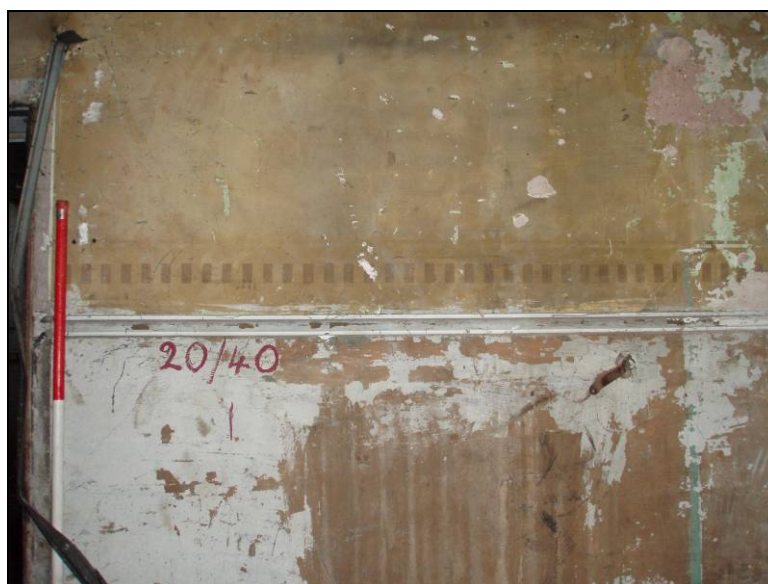
Fig. 15 Remains of the decorated plaster on the south wall.
(Scale: 0.5m graduations)

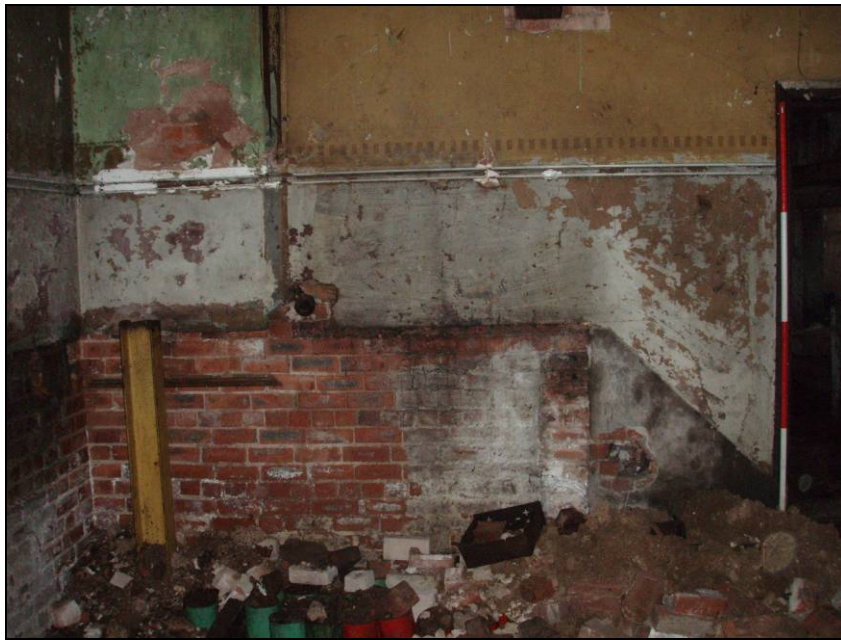
7.1.7 The floor of the chapel takes the form of a concrete slab which is broken in places. The floor is particularly broken up and contaminated in the area below the altar platform. The concrete floor was probably inserted when the chapel was taken over in 1961 by Velvetone Ltd who used the space for oil blending and storage. The original floor of the chapel is likely to have been wooden.

Fig. 16 South-west corner of the chapel showing the line of the steps and the height of the altar.
(Scale: 2m)

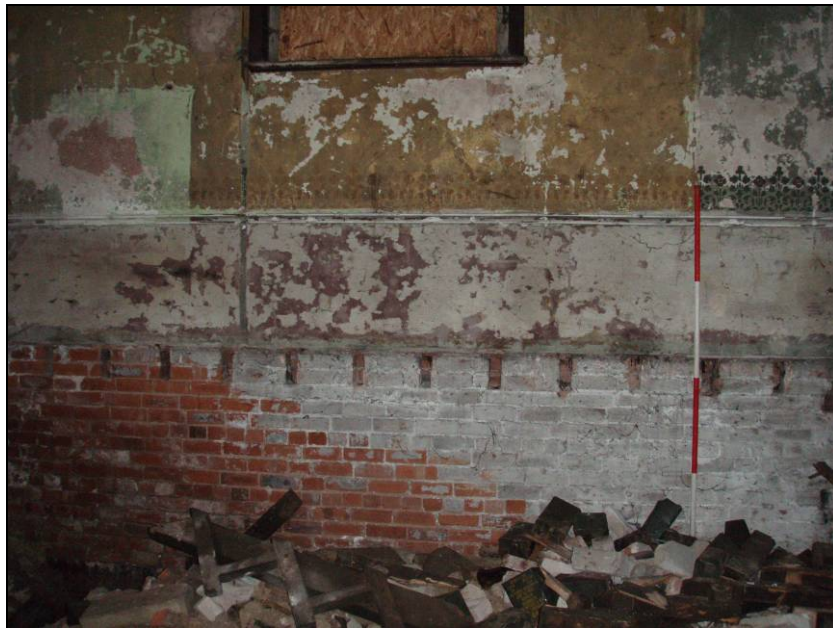
Fig. 17 East wall of the chapel showing the height of the altar and the position of the supporting struts.
(Scale: 2m)

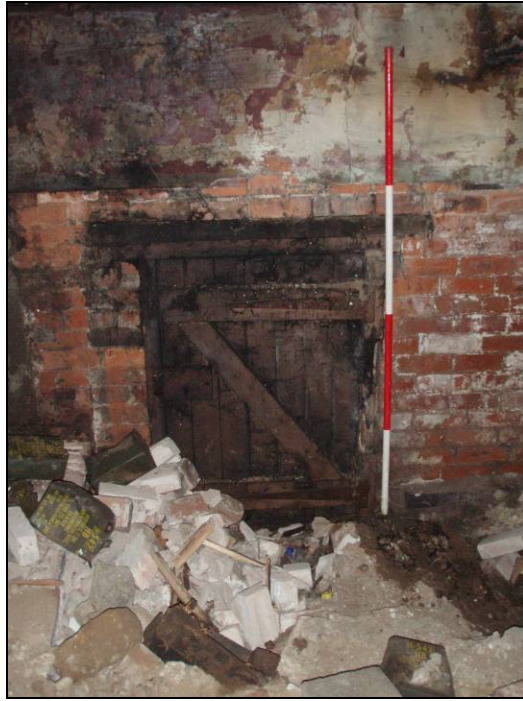
Fig. 18 Wooden doorway that gave access to the space below the altar platform.
(Scale: 2m)

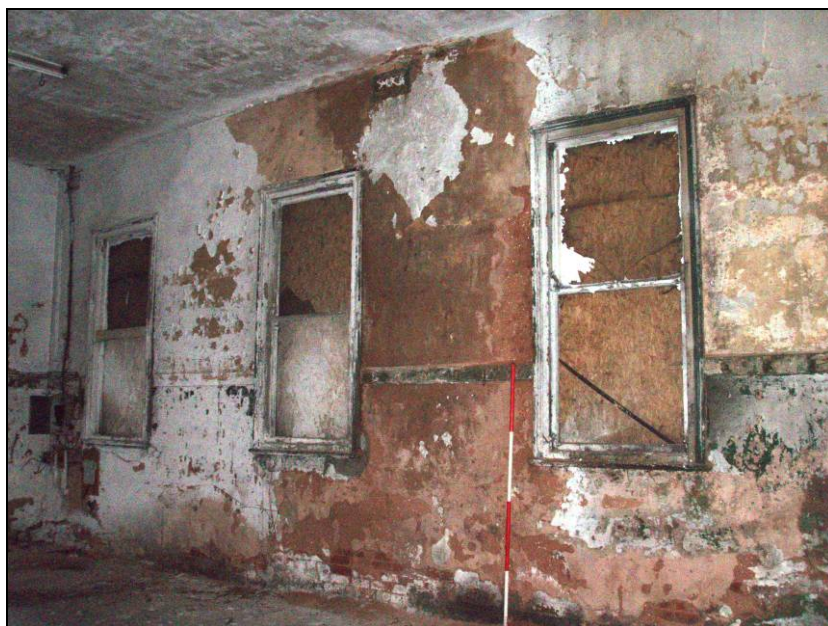
- 7.2.1 Adjoining the southern wall of the chapel, at the western end, is the schoolhouse (Fig. 8). This building was part of the original chapel built in 1897 and now measures 12.3m x 9.5m. The north wall is featureless as it adjoins the south wall of the chapel except for the doorway that provides access to the chapel. The west wall contains four large rectangular sash windows identical to the ones found in the chapel (Fig. 19). One of the panes contains the fragmentary remains of frosted glass. These four windows appear in the same position as they do in the undated early photograph of the chapel (Fig. 3) and can therefore be assumed to be original.

Fig. 19 The west wall of the schoolhouse showing three of the four sash windows.
(Scale: 2m)

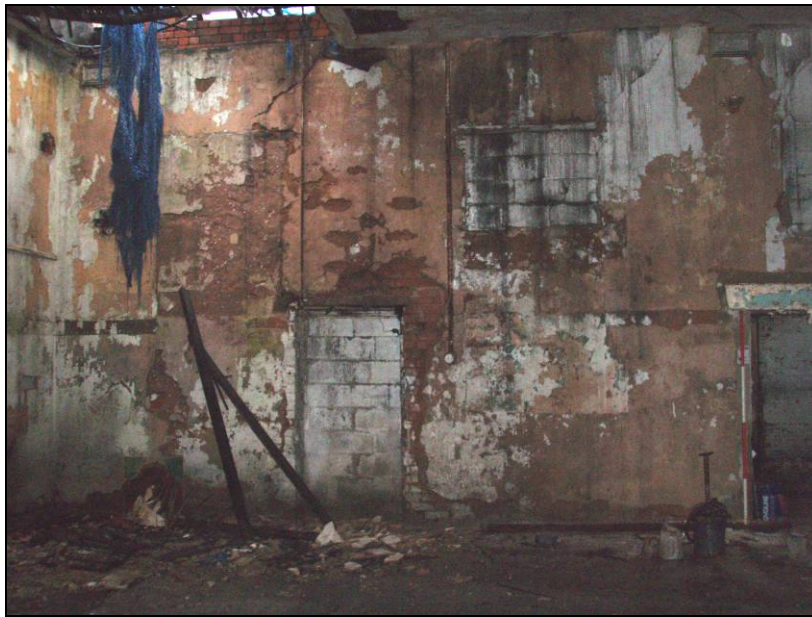
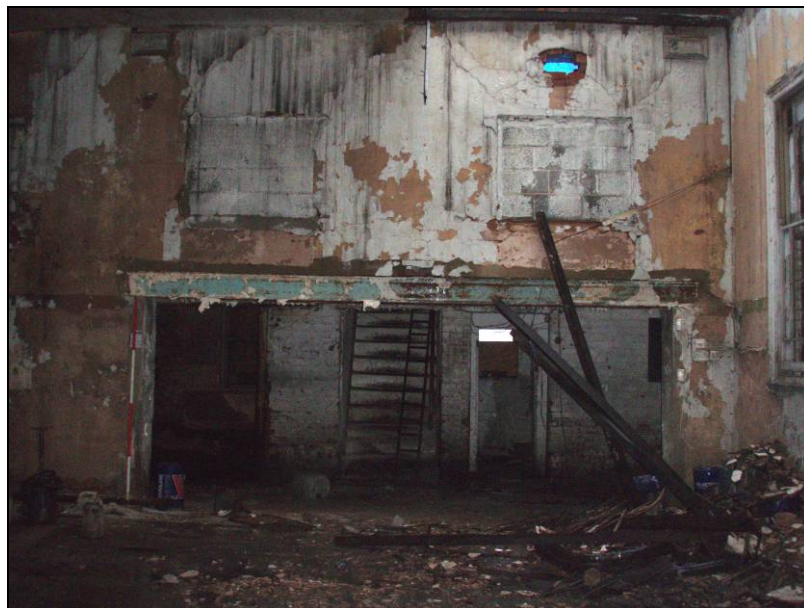
- 7.2.2 In the opposite east wall are symmetrical window 'ghosts' now in-filled with bricks (Figs. 20 and 21). The northernmost window has been totally in-filled with bricks and red plaster. This window has also been cut by a later doorway that gave access to what was the boiler room (Fig. 20). The other three windows have only had their lower halves in-filled with bricks and red plaster at this point. The upper halves of these windows were subsequently in-filled later with concrete and breeze blocks, probably at the same time as the boiler room door (Fig. 21). In addition, a large entrance with a reinforced steel joint lintel was created in the east wall (Fig. 21). The entrance measures 5m in width and 2m in height and was probably created when Velvetone Ltd took over the building as they would have required more access space.

Fig. 20 The east wall of the schoolhouse showing the in-filled windows and doorway.
(Scale: 2m)

Fig. 21 The east wall of the schoolhouse showing the in-filled windows and the new entrance.
(Scale: 2m)

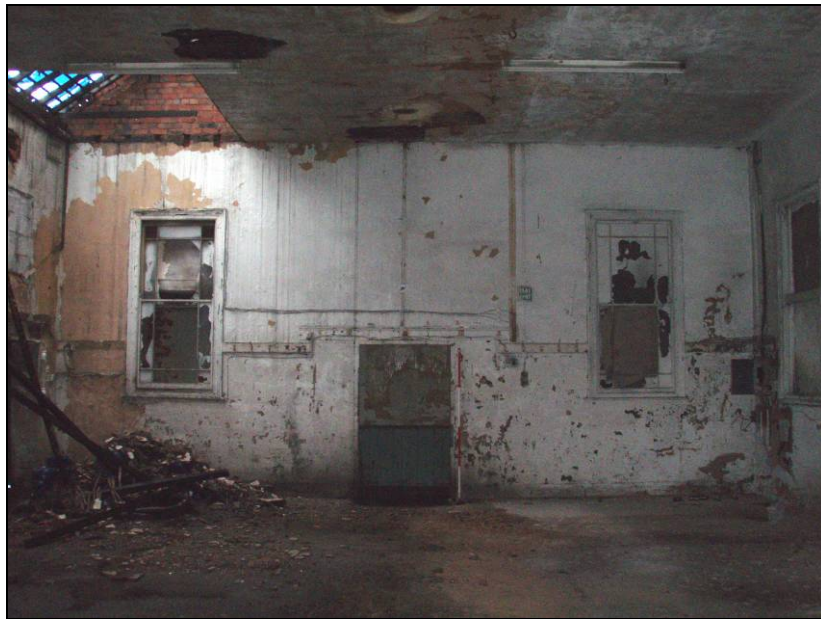
7.2.3 The south wall contains the original entrance to the schoolroom which is flanked by two more identical rectangular sash windows (Fig. 22). The doorway leads to a passage between the original exterior of the schoolhouse and the new southern extension. The walls in the schoolroom are painted white and have the remains of wooden boards with coat hooks affixed to them. The plaster obscures the corners of the room which makes it impossible to clearly identify if the walls between the schoolroom and the chapel abut or key in to each other. Map evidence indicates that the schoolroom was probably part of the original chapel building and therefore the walls are likely to abut.

Fig. 22 South wall of the schoolhouse with the entrance at the centre.
(Scale: 2m)

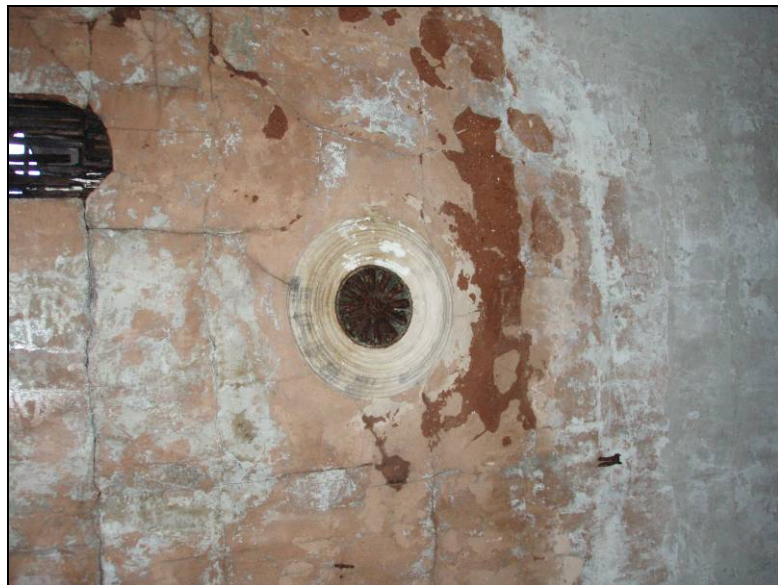
7.2.4 The ceiling in the schoolroom which is constructed of lath and plaster is in a poor state of repair with the east side having completely collapsed. There are decorative moulded air vents along the centre of the ceiling. The floor of the schoolroom consists of a concrete slab which, again, was probably installed by Velvetone Ltd.

Fig. 23 Moulded air vent on the ceiling in the schoolhouse.

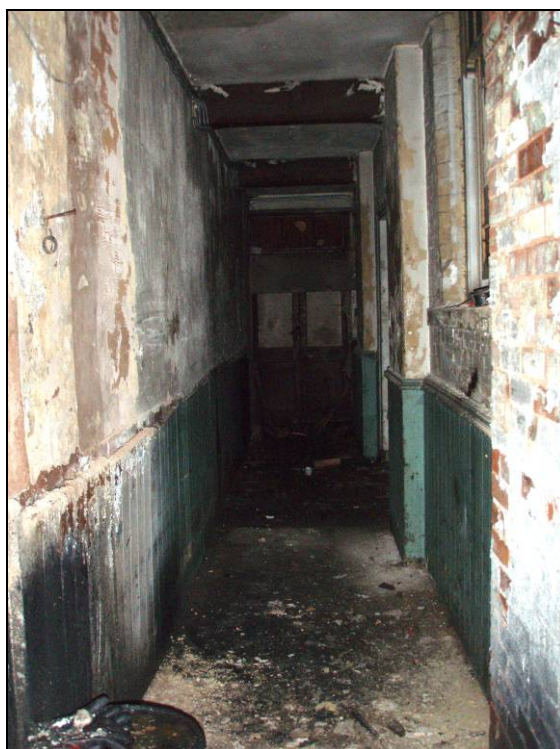
7.3.1 The schoolhouse was extended during the last phase of construction in 1908. A passage was created that divided the school building from the extension that was to become living accommodation to the south. The passage runs along the original exterior façade of the school house, as shown in the undated early photograph of the chapel (Fig. 3). There are no remains of the porch or extra window shown in the photograph which would have been positioned where the doorway is today. Wooden panelling has been attached to the lower part of the wall presumably to give the passage the indication of being an interior space (Fig. 24). The east end of the addition connects with the modern passage that runs in between the schoolroom and the rectory (Fig. 8). The addition also created an entrance to the school from the street.

Fig. 24 The passage between the schoolhouse and the new living accommodation (looking west).

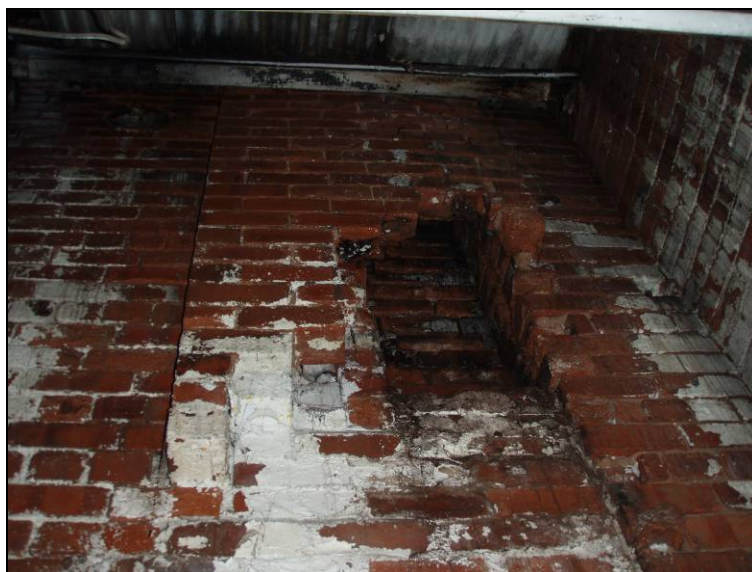
7.4.1 The boiler house is a small rectangular section at the end of the modern passage between the schoolroom and the rectory which now acts as the main entrance to the chapel in its south wall. It would have been constructed at the same time as the chapel and the rectory. There are remains of a brick chimney breast on the south side of the south wall of the chapel above the large modern entrance (Fig. 25). The boiler house has a lean-to roof which has been constructed from corrugated plastic and asbestos. The original roof was probably demolished during the construction of the modern passage.

Fig. 25 Chimney breast located on the other side of the south wall of the chapel above the large entrance.

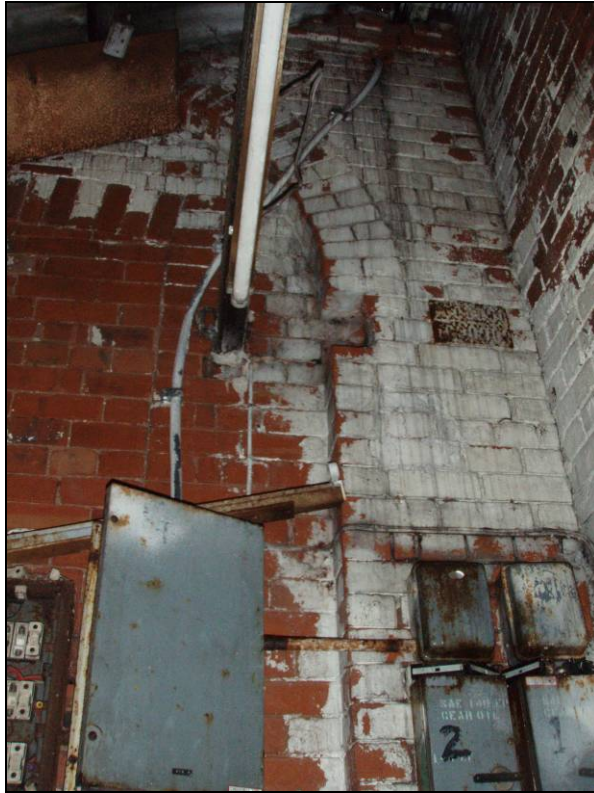
7.4.2 A decorative brick arch on the external east wall of the schoolhouse has been in-filled to create the west wall of the boiler room (Fig. 26). This arch would have framed one of the original windows to the schoolroom. It is now obstructed with the buildings fuse boxes and other machinery related to its use as a boiler room. The walls in the boiler room are not plastered making it possible to see that the walls of the schoolhouse, chapel and rectory are not keyed in to each other. The south wall of the chapel abuts the northern wall of the schoolhouse at this point.

Fig. 26 Brick arch which would have framed an original window of the schoolhouse.
Also note that the walls in the corner are not keyed in.

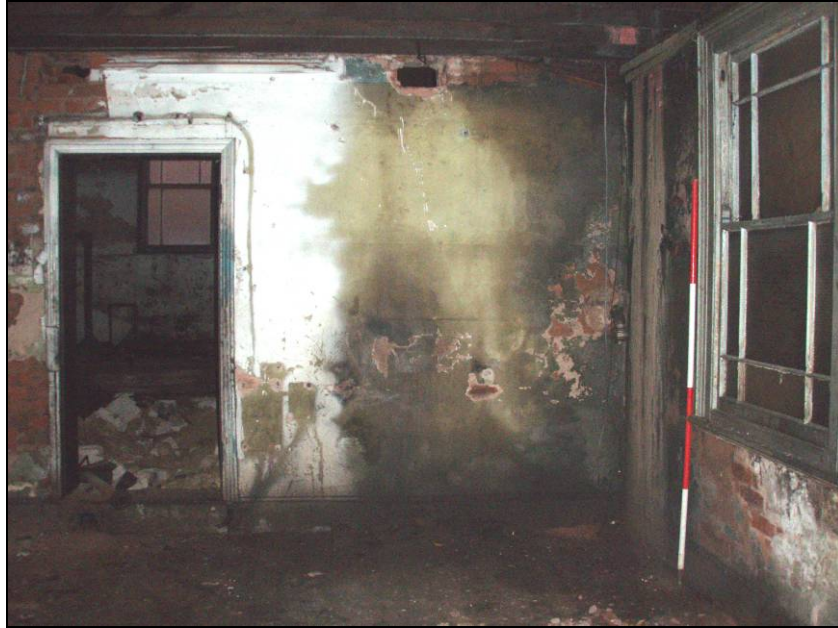
The rectory is a two-storey rectangular building that abuts the chapel building at its south east end and measures 7.8m x 4.45m. The chapel is accessed from the rectory by a small doorway in the south wall of the chapel (Fig. 27). The east wall of the rectory has the remains of a chimney breast flanked by two rectangular sash windows, now boarded up (Figs. 28 and 29). The walls were plastered with the remains of green wallpaper. The room is currently in a very poor state of repair.

Fig. 27 North wall of the rectory showing the doorway in to the chapel.
(Scale: 2m)

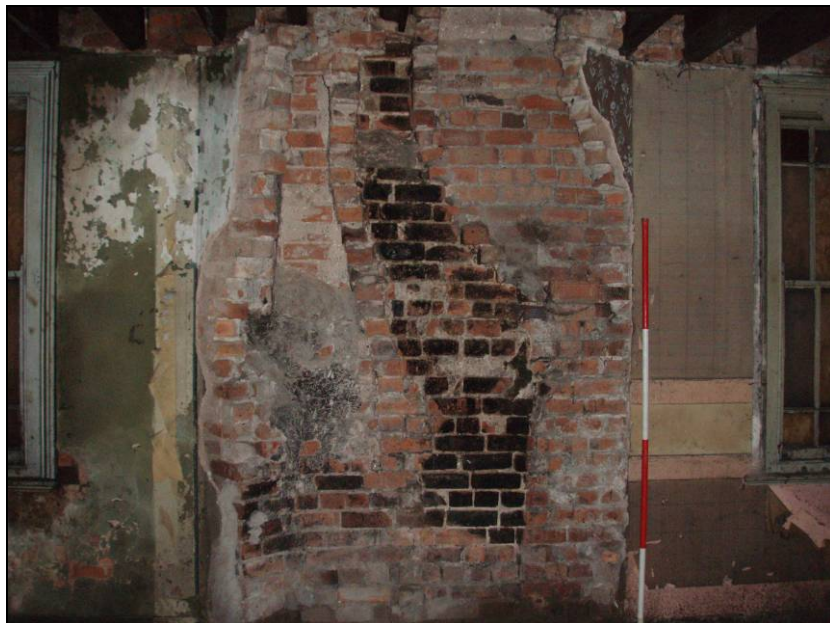
Fig. 28 East wall of the rectory showing the damaged central chimney breast.
(Scale: 2m)

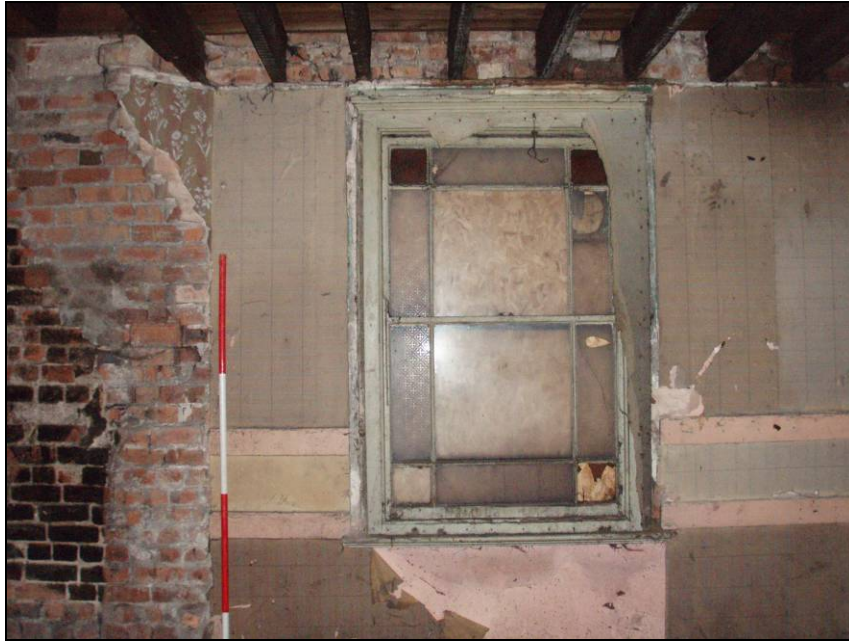
Fig. 29 One of the sash windows flanking the chimney breast on the east wall of the rectory. (Scale: 0.5m graduations)

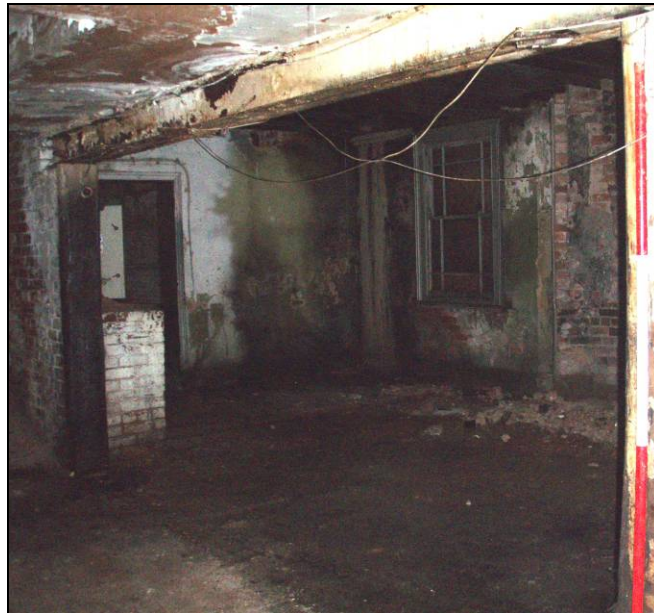
7.5.2. A large entrance has been created in the west wall that once divided the rectory from the boiler house (Fig. 30). The entrance has been reinforced with a steel joist and measures 4.43m across. As with the other later entrances mentioned in this report it was probably constructed when Velvetone Ltd took over the building in 1961. The creation of the entrance now means that the rectory opens out in to the modern passage, probably created at the same time as the entrance.

Fig. 30 Modern RSJ entrance to the rectory from the modern passage. (Scale: 0.5m graduations)

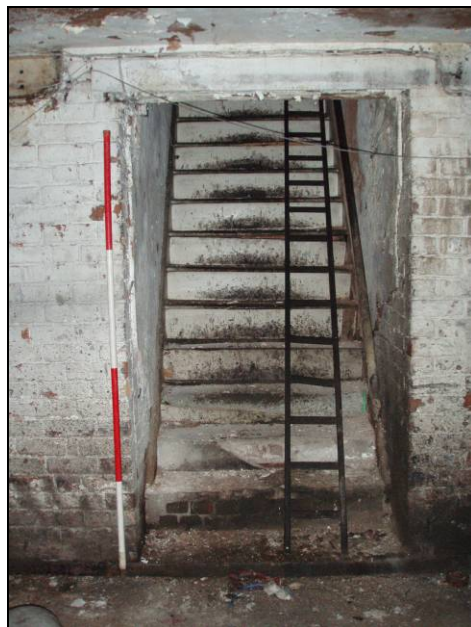
The upper storey of the rectory is accessed by a staircase that is positioned to the south of the ground floor room (Fig.31). The stone staircase would originally have been accessed by an external doorway on the end of the building. The ground floor room of the rectory would have been accessed by a separate doorway that has since been lost. The reason for the separate doorways may have been that the upper floor of the rectory was initially used as the minister's private accommodation and therefore the separate doorway gave him more privacy.

Fig. 31 Staircase to the upper floor of the rectory.
(Scale: 2m)

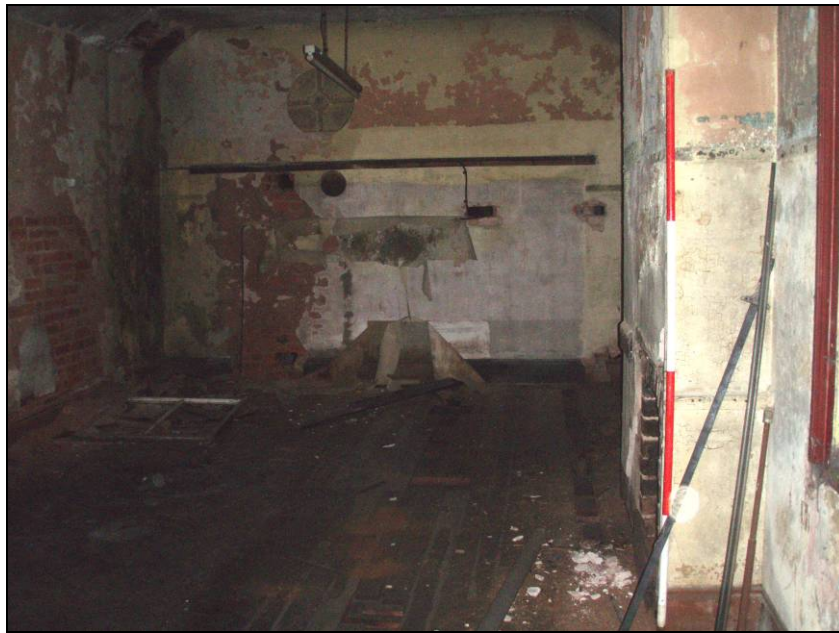
7.5.4 The staircase leads to a single rectangular room that is the same size as the ground floor room of the rectory (Fig. 32). The room has a chimney breast which is flanked by two sash windows in the same position as the ground floor (Fig. 33 and 34). The walls have been plastered and wallpapered with asymmetrical floral design. The ceiling was constructed in a lath and plaster style with curved edges at the sides. The original wooden floorboards were in a poor state of repair, some of which were missing in places making access difficult.

Fig. 32 View of the upper floor of the rectory, looking north. (Scale: 2m)

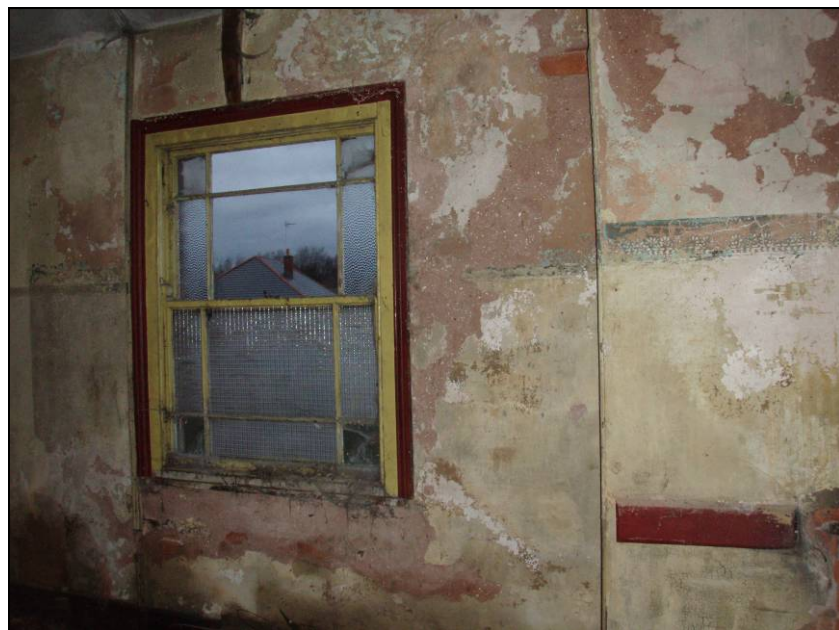
Fig. 34 Sash window on the east wall of the upper storey of the rectory.

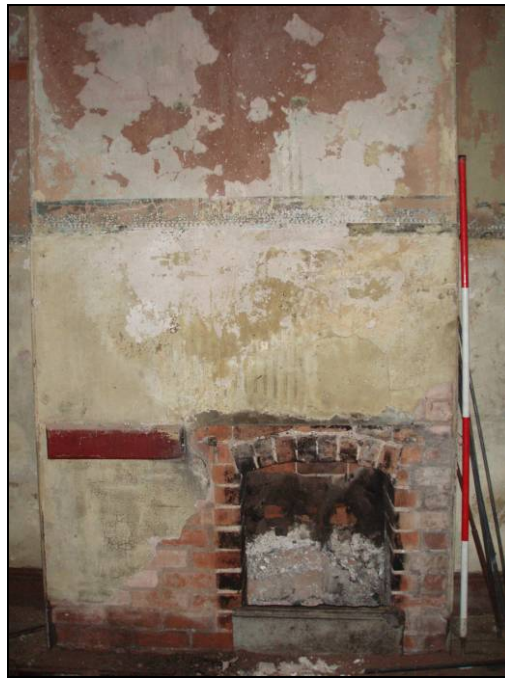
Fig. 33 Fireplace located on the east wall of the upper storey of the rectory.
(Scale: 2m)

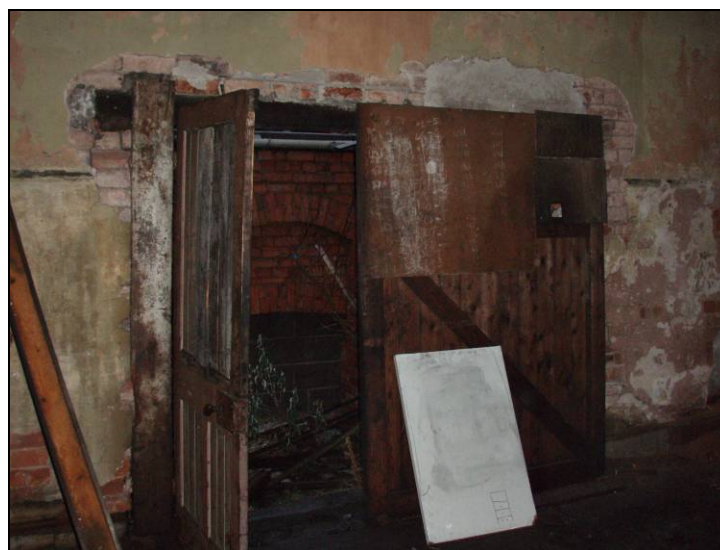
7.5.5 On the west wall there is a large opening with wooden support beams and wooden doors (Fig. 35). The doorway has a small door attached to the south end of the frame but the actual opening is much wider at 3m. Whether the doorway was originally this wide or widened later is unclear. Today the doorway opens out on to the flat roof of the modern passage but may originally have been the doorway to another room, perhaps a bathroom that would have been positioned on top of the boiler room (Fig. 36). However, there is no evidence of the boiler room having an upper storey in the external brickwork. It is also possible that the doorway led to a set of external steps but there is no evidence for these either, although the evidence could have been lost through later renovation work.

Fig. 35 Doorway in west wall of the upper storey of the rectory.

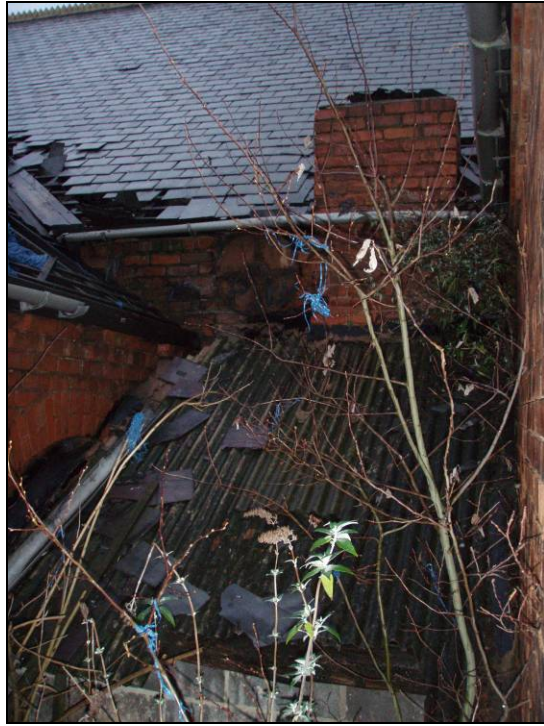
Fig. 36 View from the doorway overlooking the boiler room (note chimney).

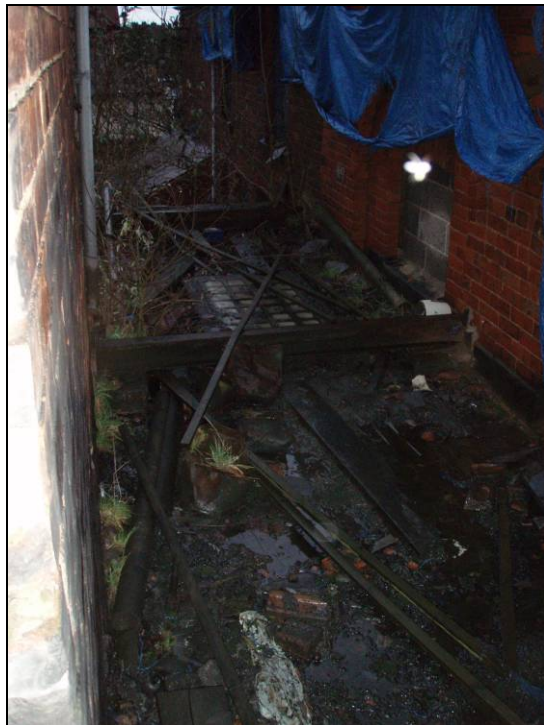
Fig. 37 View from the doorway overlooking the modern passage roof.

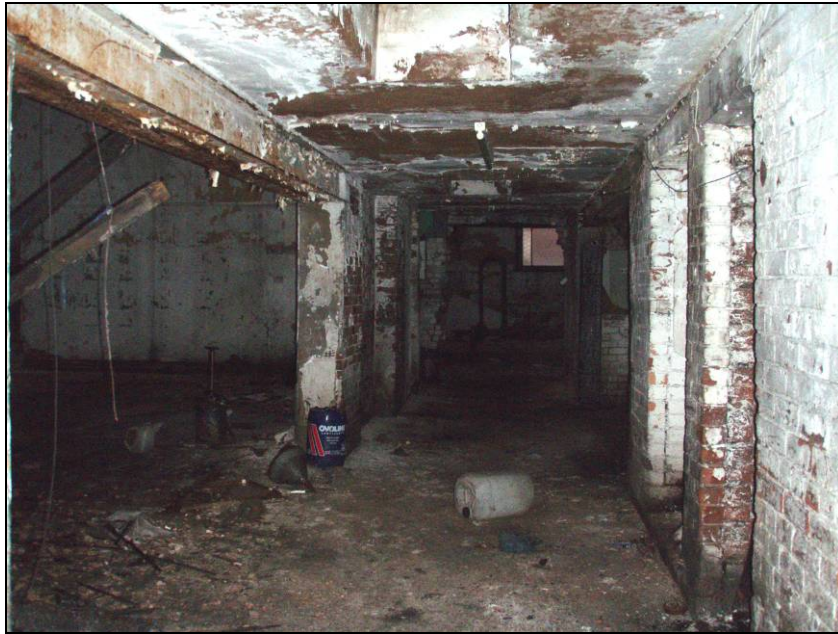
7.6.1 The passage is a long thoroughfare that was created when the chapel was converted for industrial use (Fig. 38). The space, which measures approximately 10m x 2.5m, is essentially the gap between the schoolroom's east wall and the rectory's west wall running up to the boiler room. The 1913-14 OS map (Fig. 5) clearly shows a space existing between the buildings. This space was capped by Velvetone Ltd in the 1961 with flat concrete roof and created a new large entrance to the building. The passage was created at the same time as the large entrances in to the schoolroom, chapel and rectory were created. They were created, presumably, to give the company more space and manoeuvrability.

Fig. 38 Modern passage looking north towards the chapel.
(Entrance to the schoolroom to the left).

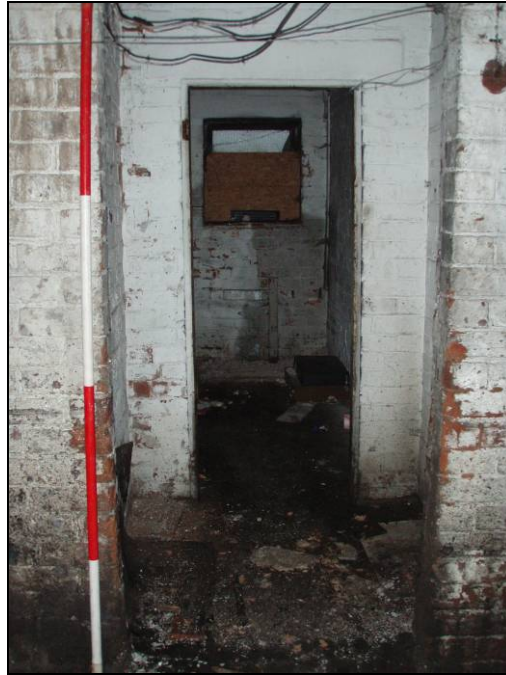
7.7.1 At the same time as the passage was created an extension was made to the south end of the rectory (Fig. 39 and 40). The extension was a single storey building that houses a small office area and a toilet block to accommodate the Velvetone Ltd staff. One of the offices is positioned below the staircase of the rectory (Fig. 40). The walls are not keyed in to the exterior wall of the rectory.

Fig. 39 Entrance to the office area.

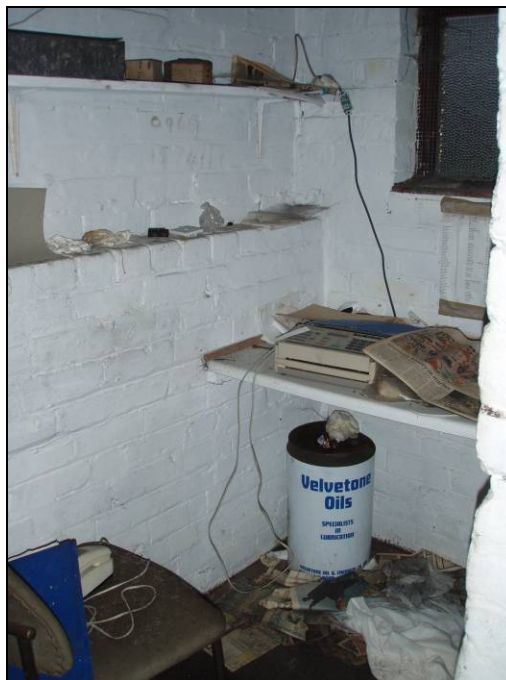
Fig. 40 Office below the rectory staircase.
(Scale: 0.5m graduations)

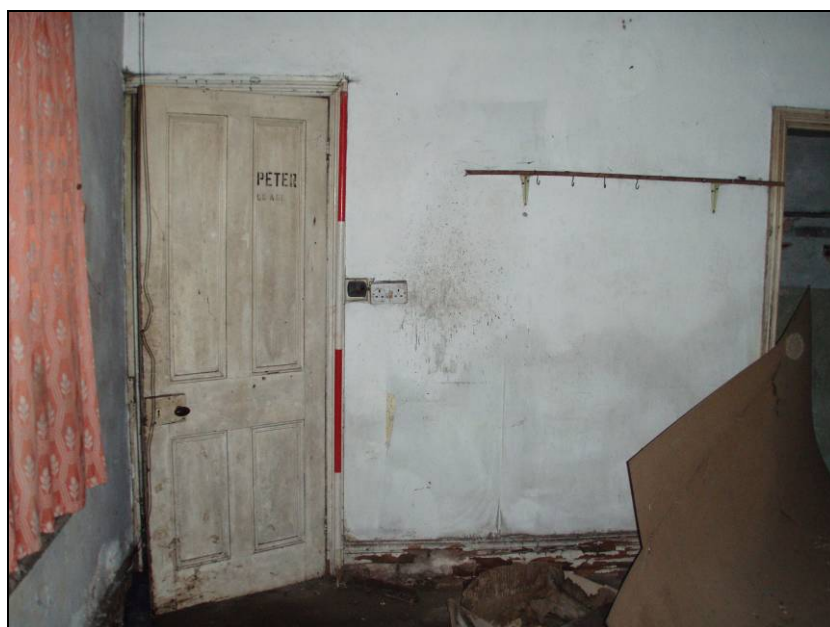
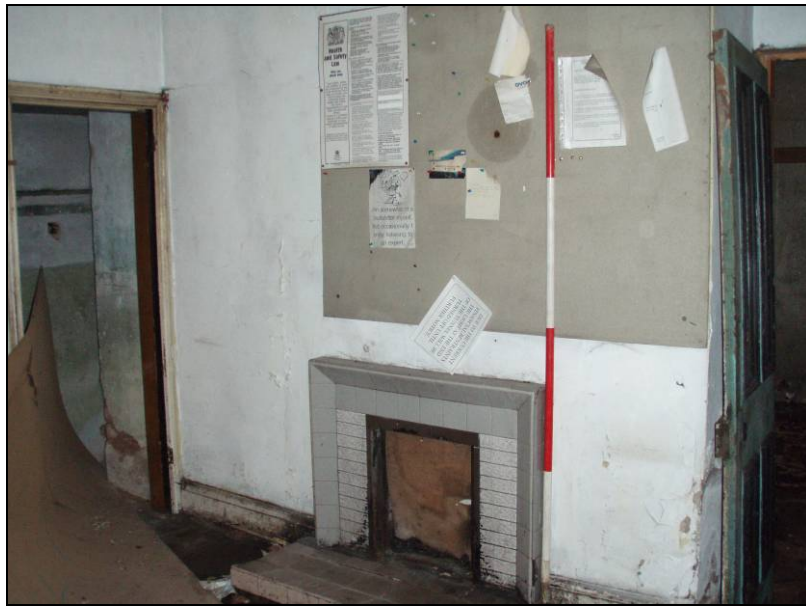
7.8.2 Room One was accessed from the rear of the building via a small porch and measured 3.6m x 3.5m (Figs. 41 and 42). The room had a modern ceramic fireplace and contained various items relating to when the building was used as an office space for Velvetone Ltd. In the south-west corner of the room was a doorway that led to a central staircase and Room Two (Fig. 41). A later extension to the east wall of the building created a small room accessed from Room One. The room measured 2.5m x 1.1m, was tiled and had a sink area (Fig. 43).

Fig. 41 Room One, looking west.
(Scale: 2m)

Fig. 42 Room One, looking north west.
(Scale: 2m)

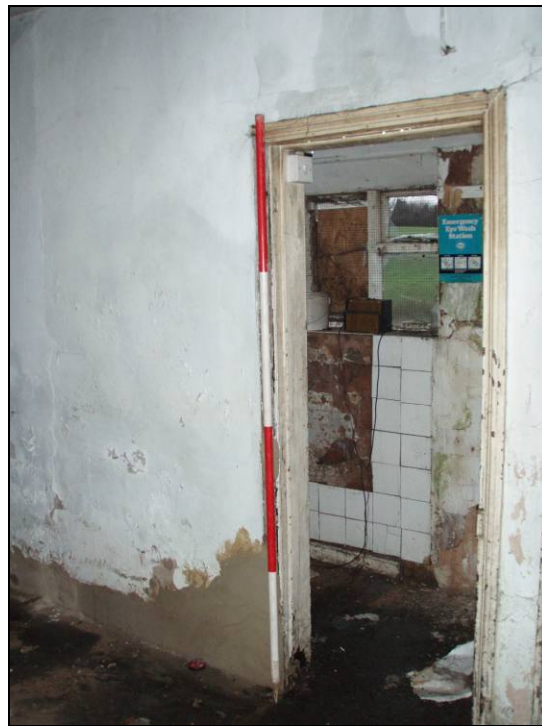
Fig. 43 Doorway to small extension on the east side of Room One.
(Scale: 2m)

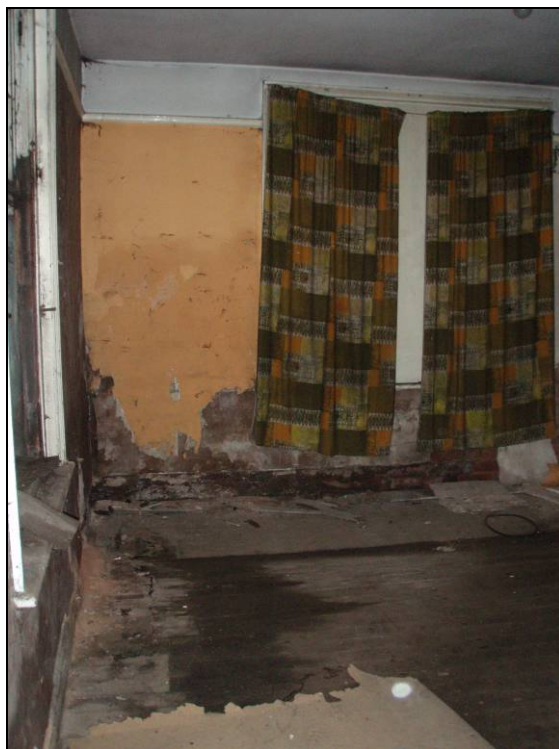
7.8.3 The main entrance to the house was located centrally, opposite the staircase, between Rooms One and Two. Room Two was positioned at the front of the house and measured 4.8m x 3.5m. Access to this room was not possible as the floorboards were in a poor state of repair. The room had a large window in the south wall and another in the west wall overlooking the road (Fig. 44). Both of these windows were boarded up which prevented any natural light from entering the room, also making it difficult to record. There appeared to be a number of

Fig. 44 Room Two of the 1908 extension looking west.

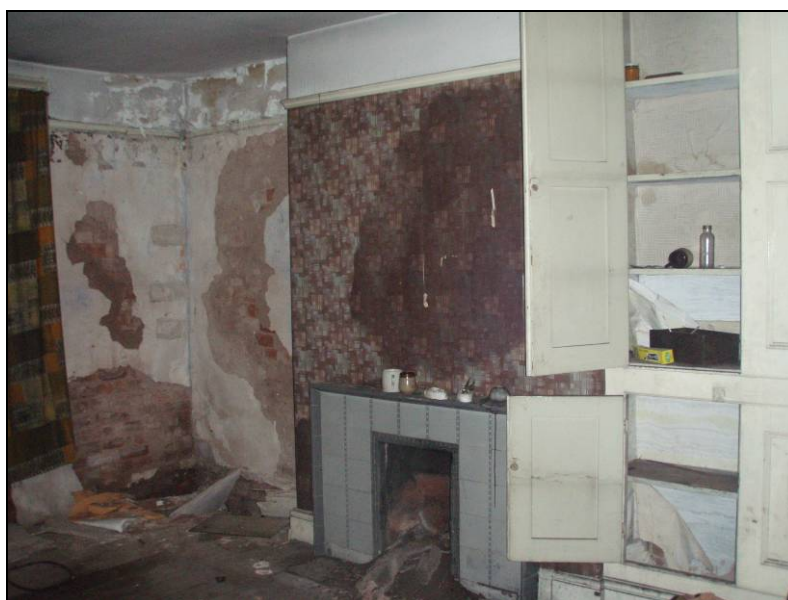
modern features such as a ceramic fireplace and a fitted cupboard (Fig. 45). The room had been decorated with patterned wallpaper and curtains.

Fig. 45 Room Two of the 1908 extension, looking north-west.

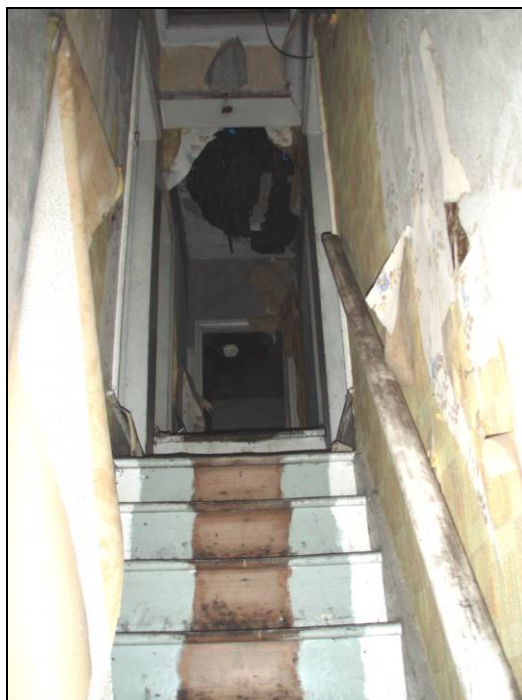
The staircase was positioned opposite the main entrance on the south side of the house and led to a hallway that in turn led to four bedrooms and a bathroom (Figs. 47 and 48). The ceiling above the staircase had collapsed which meant it was not possible to accurately record the top storey of the house (Fig. 46).

Fig. 46 Staircase in the 1908 extension showing the collapsed roof.
