**United Methodist Chapel
Mansfield Road, Creswell,
Derbyshire
Photographic Survey**

**ARS Ltd Report No. 2008/9
January 2008**

- 1.1 This survey was undertaken by Archaeological Research Services Ltd on behalf of Brett Oils Ltd prior to the demolition of all buildings and structures associated with the former Methodist Chapel, Mansfield Road, Creswell.

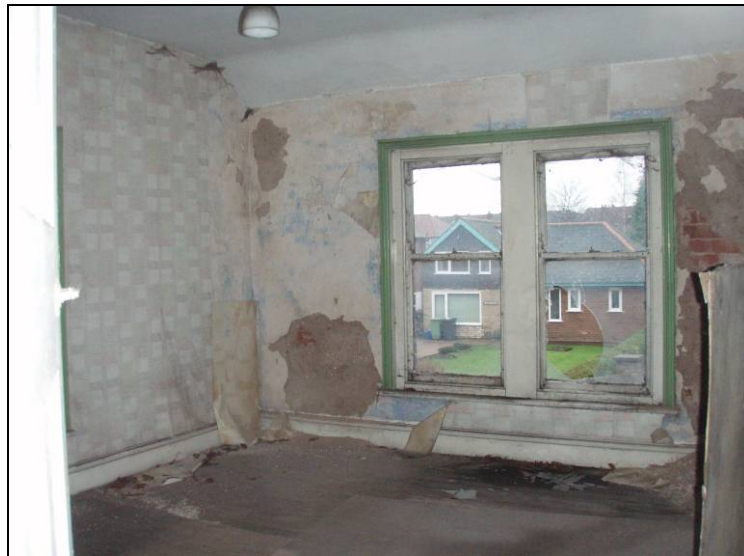
7.8.6 The bedrooms positioned at the top of the staircase were on a slightly lower level than the rest of the upper storey. An extra step in the hallway after the first two rooms denotes where the split level occurs. The upper storey walls had all been decorated with patterned wallpaper. The roof on the west side of the building had been removed causing the walls on this side of the building to be very damp and dilapidated.

Fig. 47 Bedroom One of the 1908 extension.

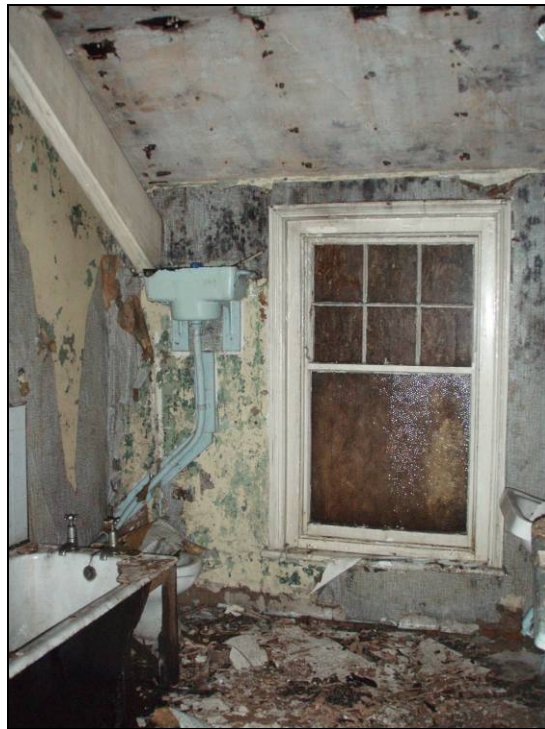
Fig. 48 The bathroom in the 1908 extension.

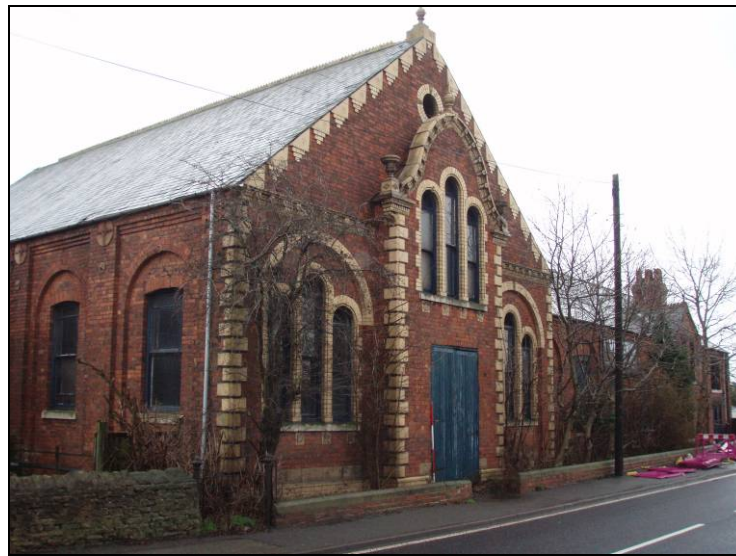
8.1.1 The chapel has been constructed from red brick with a slate roof and has terracotta and yellow sandstone detailing on the main entrance area. The main entrance of the chapel is located on the west side of the building facing the road (Fig. 49). The entrance has an arched porch area that stands 0.6m proud from the main exterior wall. The vertical edges of the porch and the main building have been framed with yellow sandstone blocks and the frieze at the top of the porch has been elaborately decorated. Two carved sandstone urns flank the porch area with a central ball and spike terracotta roof finial (Figs. 50 and 51). An asymmetrical leaf and flower design in sandstone and terracotta runs along the top edge of the porch and across the main wall above the window line (Fig. 52). The roof line has been decorated with angular sandstone blocks and terracotta bricks with a matching roof ball and spike finial (Fig. 51).

Fig. 49 View of the Chapel, looking south-east. (Scale: 2m)

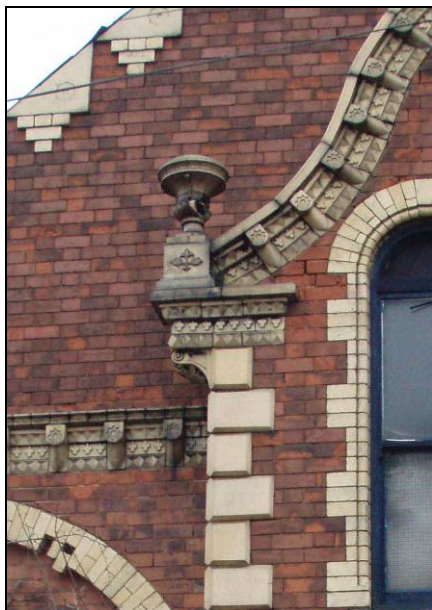
Fig. 50 Detail of porch frieze showing the urn.

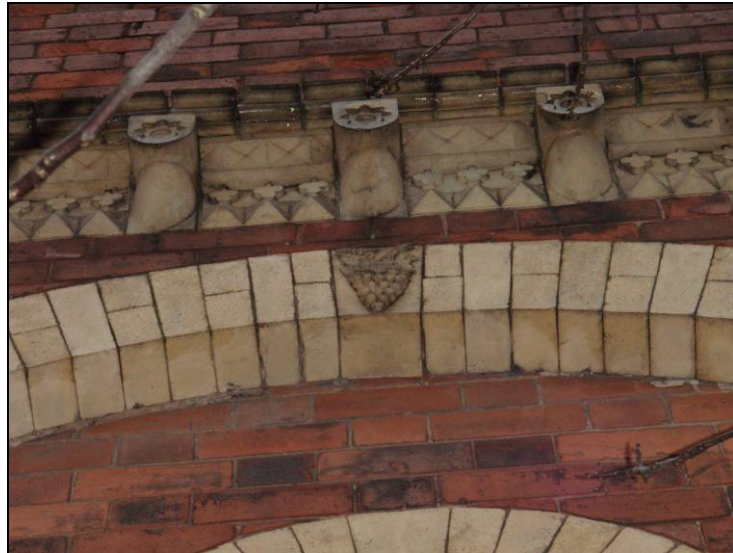
Fig. 52 Detail of the window frame showing the carved grapes detail.

8.1.3 Carved sandstone blocks have been inserted in to the brickwork below the window lintels. These blocks have been carved with a symmetrical leaf pattern and are evenly positioned below each window (Fig. 52). Initials have been carved in to the brickwork below the lower windows probably to commemorate some of the patrons of the chapel. Larger commemorative stones containing the patron’s full names run along the front of the entire building (Figs. 55 and 56).

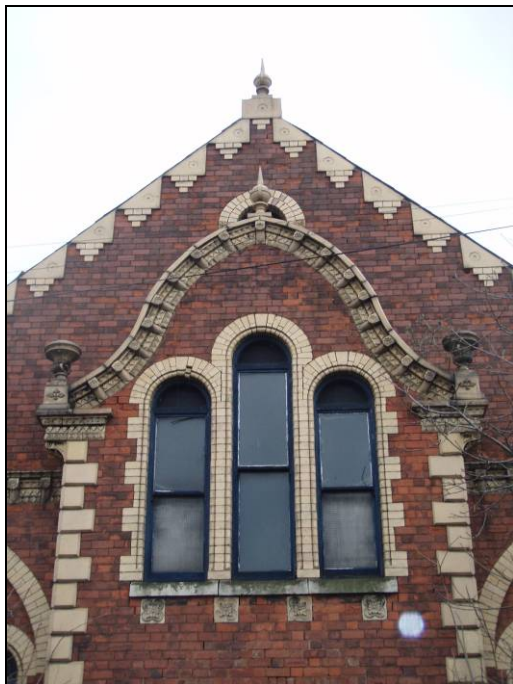
8.1.2 Within the arch of the porch sits one of the three large arched windows, the other two windows flank the porch and sit within their own terracotta brick arches (Figs. 53 and 54). Each individual window pane has been edged with terracotta bricks and has a sandstone sill (Fig. 51). Stones carved with grapes have been inserted in to the arches that surround the two lower windows (Fig. 52). The grape carvings possibly represent religious imagery relating to the Fruit of God's Spirit. In John 15:5 it is stated "I am the vine, you are the branches. He who abides in Me, and I in him, bears much fruit; for without Me you can do nothing".

Fig. 53 Entrance porch with arched window.

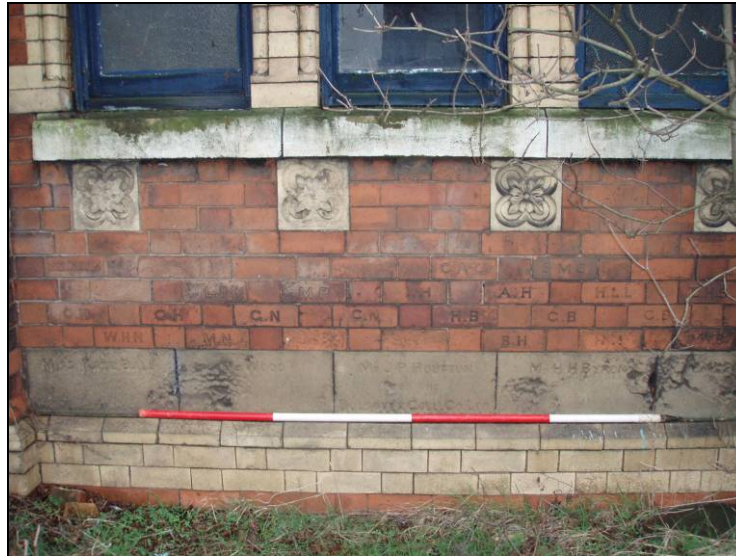
Fig. 55 Carved sandstone blocks below window frames on Chapel entrance. (Scale: 2m)

9.1.3 The interior of the building retained some of the original features related to the schoolhouse, chapel and rectory but the majority of the building is in a poor state of repair. However, some of the carved decorative stones found on the front of the chapel are worth preserving, along with some of the commemorative plaques.

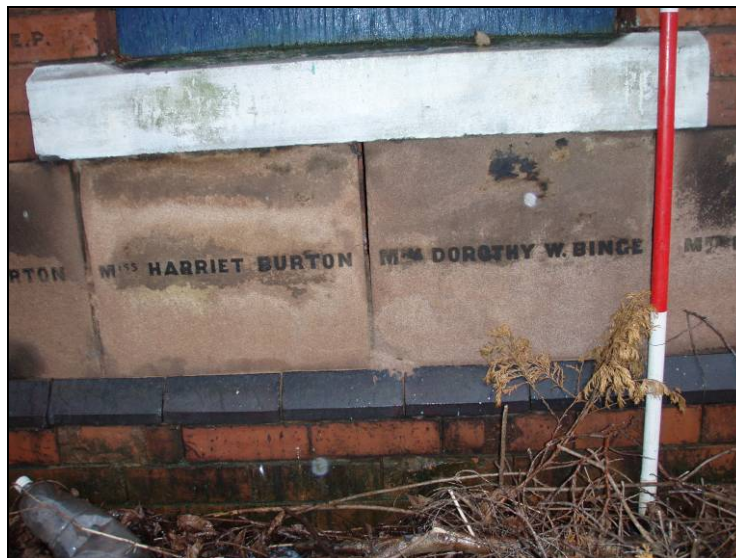
Fig. 56 Commemorative plaques. (Scale: 0.5m graduations)

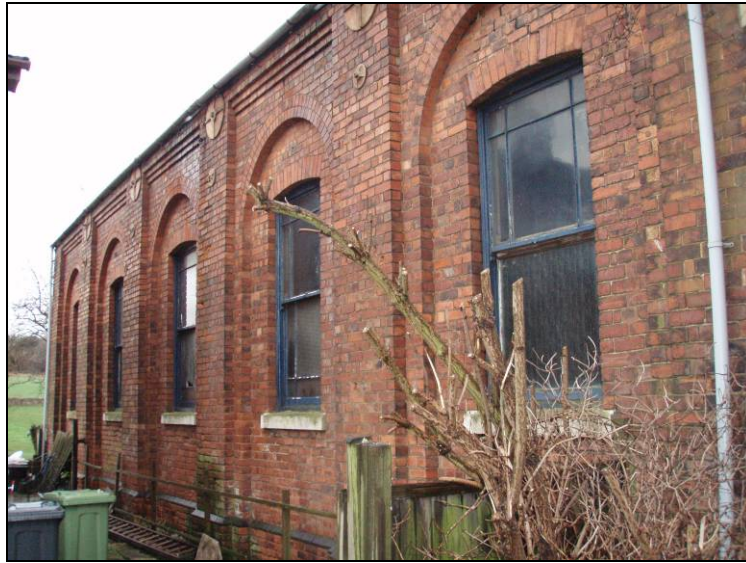
8.1.4 The rest of the external chapel building is undecorated. The large sash windows on the north wall are surrounded with simple brick arches (Fig. 57). A drainpipe obscured the join between the chapel and the schoolhouse but it was evident that the two buildings abutted each other rather than being keyed in. The rear of the building is located on the bank of the stream. The three rectangular sash windows echo the position of the arched windows on the front of the building (Fig. 58). A small circular window is positioned in the roof gable. The

Fig. 57 North exterior elevation of the chapel.

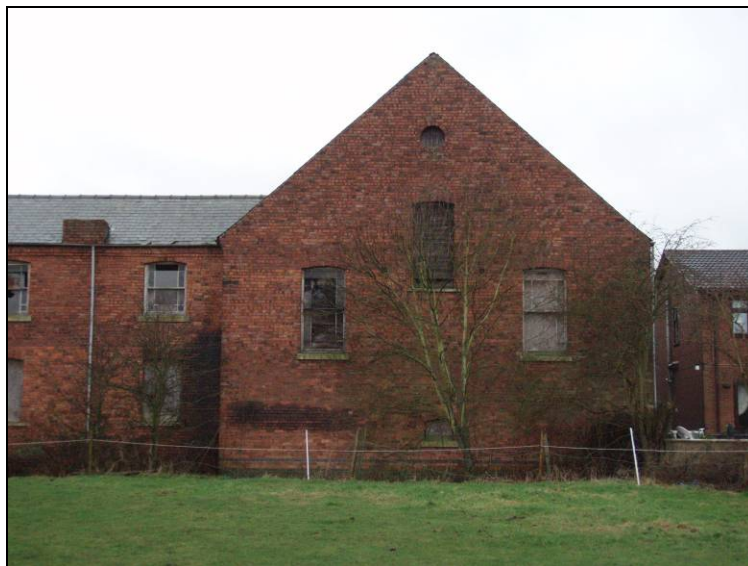
window was not visible on the interior of the chapel as the lath and plaster ceiling has been lowered.

Fig. 58 East exterior elevation of the chapel.

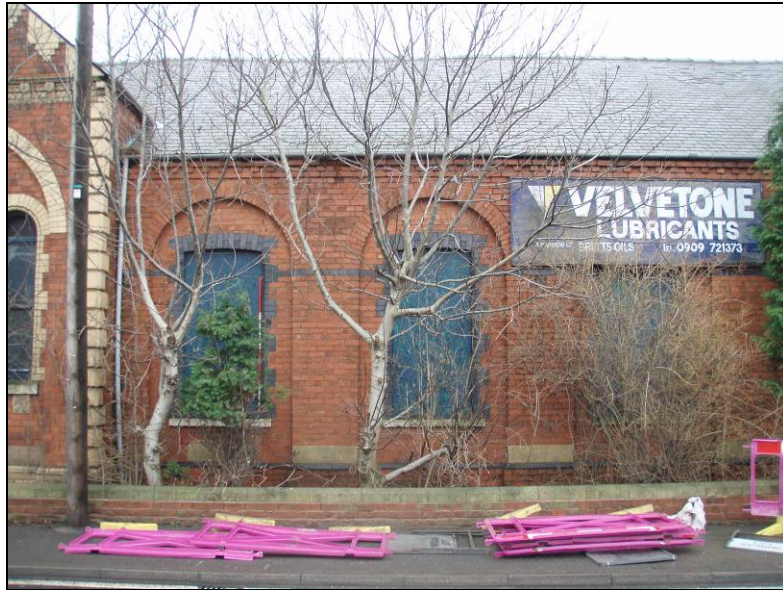
8.2.1 The schoolhouse has been constructed from red bricks with a slate roof and has a simple decoration of blue bricks. The four rectangular windows have been surrounded with red brick arches (Fig. 59 and 60). Blue bricks edge the window frames and there is a single course of blue bricks running horizontally across the length of the building. The roof line has been patterned with bricks laid a mixture of header and stretcher with some positioned slightly proud. The 1908 extension directly abuts the south end of the building but attempts have been made to match up the two buildings design. The large Velvetone Ltd sign is still present on the front of the building.

Fig. 59 West exterior elevation of schoolhouse, looking east.
(Scale: 2m)

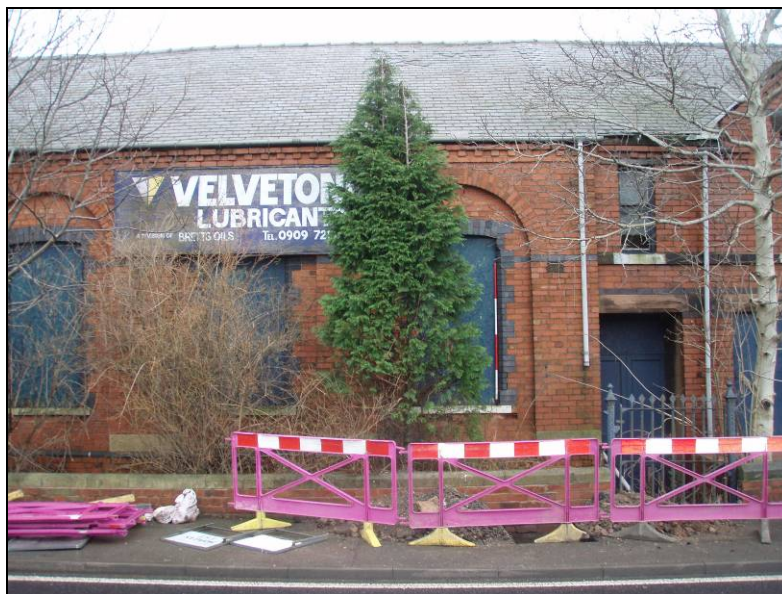
Fig. 60 West exterior elevation of schoolhouse, looking east.
(Scale: 2m)

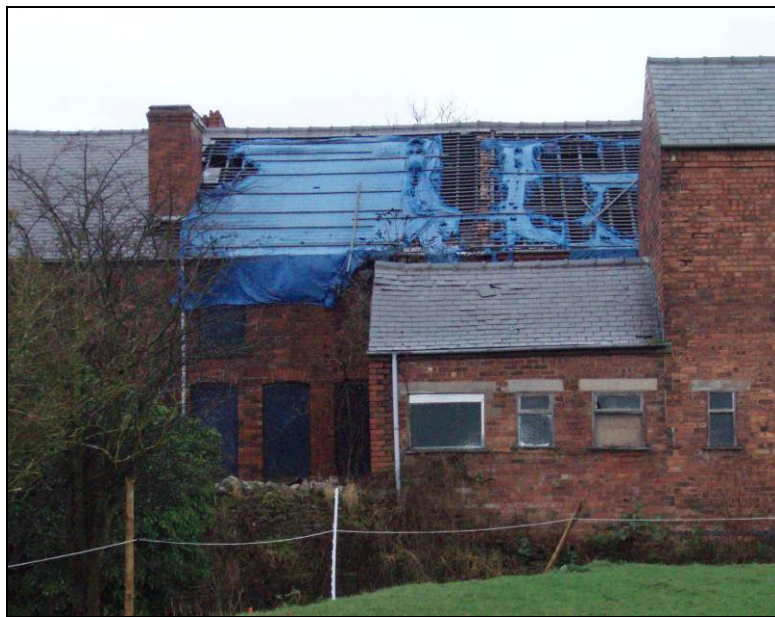
8.2.2 Evidence that the schoolhouse was the original building is apparent through the fact that the chapel and the 1908 extensions abut rather than key in to the schoolhouse. There is also a slight raise in the roof line between the chapel and the schoolhouse which also indicates where the buildings were joined (Fig. 61). Furthermore, the roof of the schoolhouse appears older and in a poorer condition than the roofs of the chapel, the rectory and the 1908 extension. The roof of the schoolhouse has now been completely removed to the rear of the building. It is not clear whether this was because the roof had become dangerous or if some of the slates had been stolen as some of the 1908's roof is also missing (Fig. 62).

Fig. 62 East side of the schoolhouse roof showing damage.

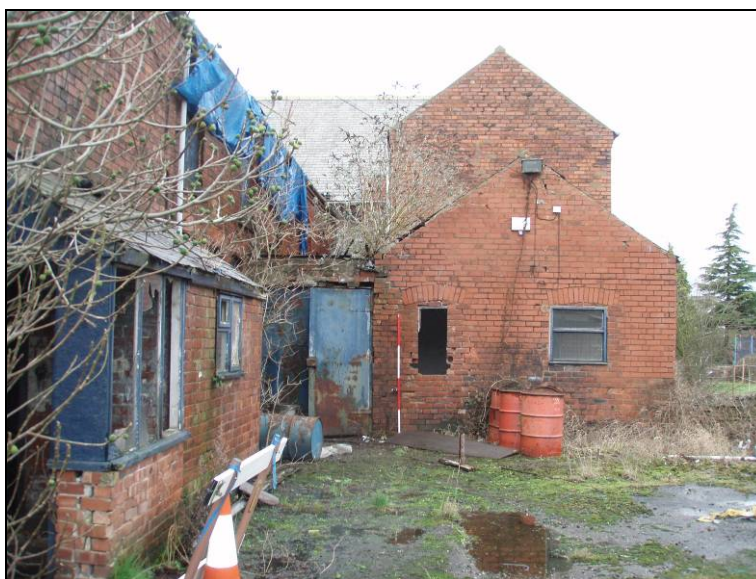
8.4.1 The modern passage, along with the small office and toilet block, were all created at the same time when Velvetone Ltd took over c. 1961 (Fig. 64). The building had been constructed from red bricks and had a slate roof. The walls of the office directly abut the walls of the rectory (Fig. 65). The sympathetic construction of the extension using the same building materials means that it matches well the existing rectory and chapel buildings.

Fig. 64 South elevation of the toilet block, looking north.

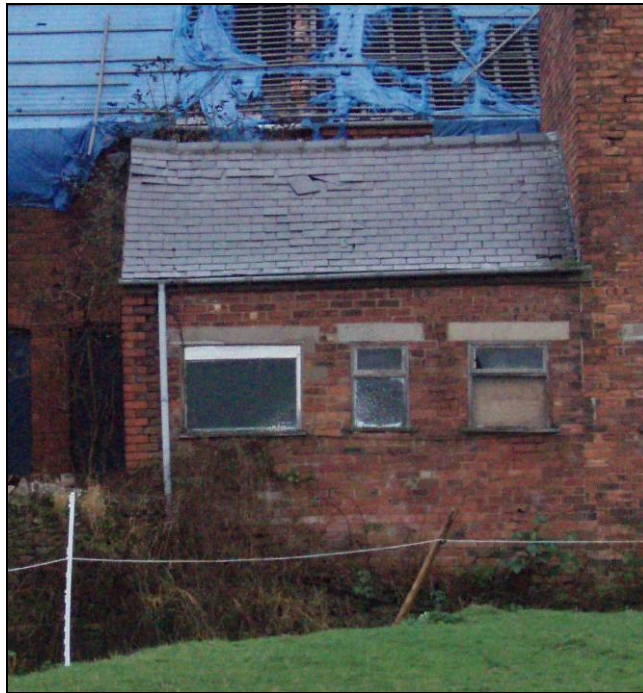
Fig. 65 East elevation of the office and toilet block showing where the wall abuts the rectory wall.

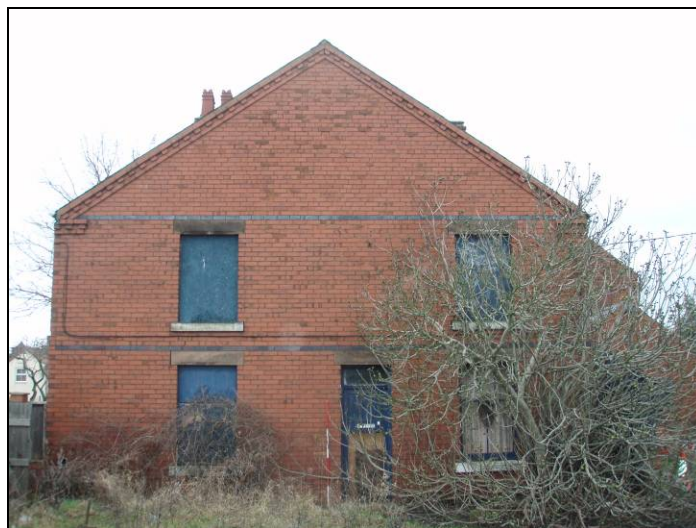
8.5.1 The extension to the southern end of the schoolhouse, made in 1908, was also constructed from red and blue bricks with a slate roof. The southern end of the building contains four rectangular windows with sandstone lintels and the main entrance to the house. A single blue brick dentil string course denotes the floor level of the house as well as being a decorative feature (Fig. 66). The roof line has the same patterning found on the chapel, rectory and schoolhouse (Fig. 66).

Fig. 66 South elevation of 1908 extension, looking north.
(Scale: 2m)

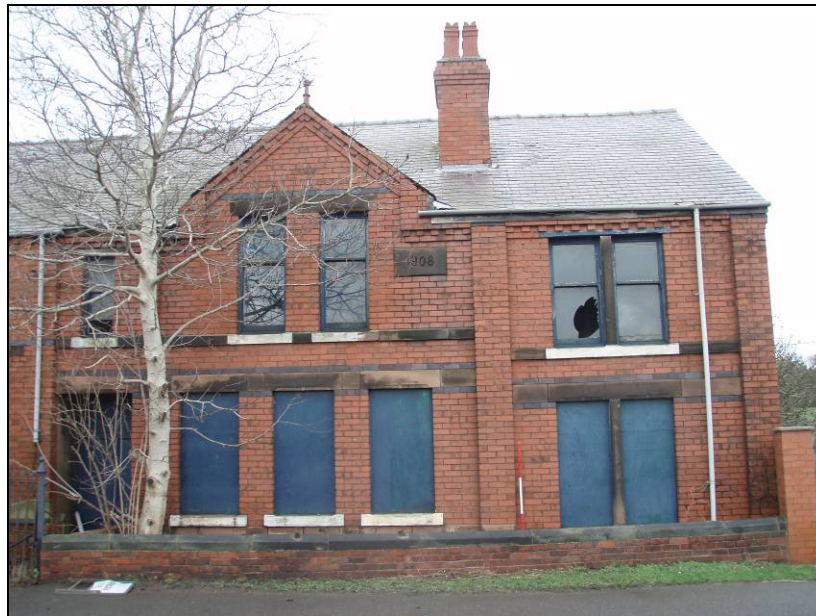
8.5.2 The west elevation of the house overlooks the road and has a small roof gable with decorative ball-shaped roof finial above the double window of the master bedroom. The blue brick dentil string course on this elevation clearly illustrates the upper storeys split level (Fig. 67). The upper storey windows are also on differing levels. The extension has a large red brick chimney stack with four square-shaped spiked ceramic chimney pots on top (Fig. 67). The schoolhouse passage is to the north of the last set of ground floor windows. The upper storeys northernmost master bedroom uses the space over the passage and has a smaller window positioned over the passage entrance (Fig. 67).

Fig. 67 West elevation of 1908 extension.
(Scale: 2m)

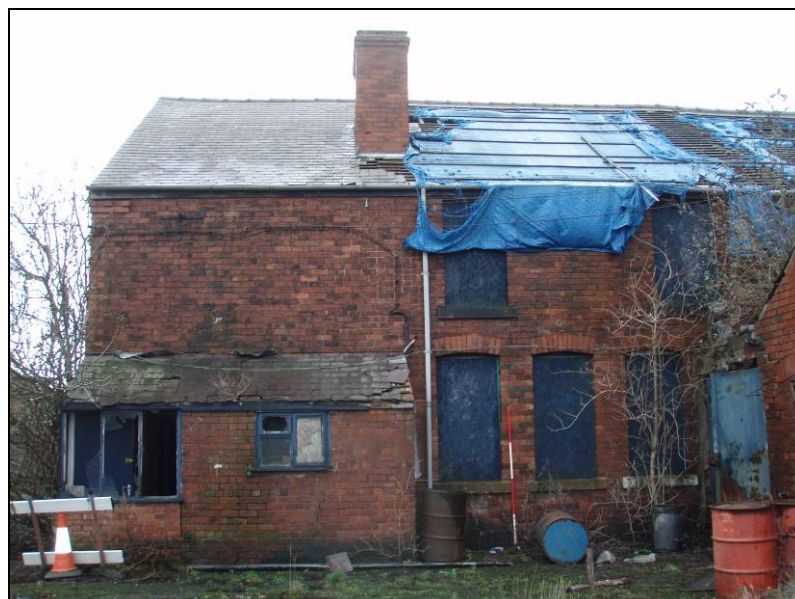
Fig. 68 East elevation of 1908 extension, looking east.
(Scale: 2m)

8.5.3 The east elevation of the 1908 extension to the rear of the building has no dentil string course detailing the floor levels. The small porch addition has a slate roof and a small window (Fig. 68). The south end of the elevation has no windows on the upper storey while to the north the elevation has two rectangular windows with sandstone lintels. The lower storey has three similar shaped windows positioned close together at to the north of the porch (Fig. 68). The roof over the northernmost upper storey bedrooms is missing and has been covered with tarpaulin. The chimney stack on this side of the building is much less ornate (Fig. 68).
