# An Archaeological Evaluation on land at Hilton Lane, Walkden, Greater Manchester

**ARS Ltd Report 2020/5**  
December 2019  
OASIS ID: archaeol5-379977

<b>Project Name:</b>	An Archaeological Evaluation on land at Hilton Lane, Walkden, Greater Manchester
<b>Site Code:</b>	HLW19
<b>Planning Authority:</b>	Salford City Council
<b>Planning Reference:</b>	18/72845/FUL
<b>Location:</b>	Hilton Lane, Walkden
<b>Parish:</b>	Walkden
<b>Geology:</b>	Mudstone, siltstone, and sandstone of the Pennine Middle Coal Measures Formation
<b>NGR:</b>	SD 72707 02539
<b>Date of Fieldwork:</b>	16/12/19 – 17/12/19
<b>Date of Report:</b>	December 2019

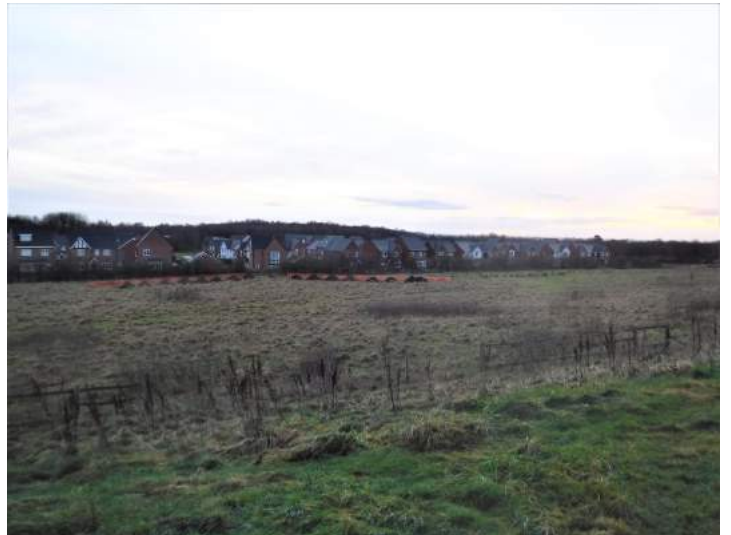
View looking south towards Trenches 3 and 4

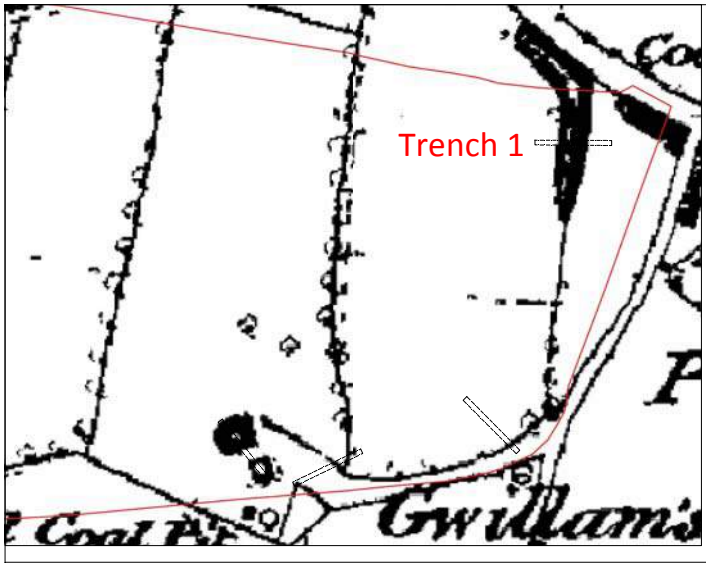
Figure 4.

Trench 1 plan, overlain onto the  
1st Edition 1:10,560 OS map, 1850.

Approx. location of investigative  
sondage through industrial  
deposits

5.2.3 A distinct, straight-edged cut [104] was encountered 8.87m from the western end of the trench. The other side of this feature was much more diffuse and was encountered 10.65m further east. The width of the feature corresponds with the mapping data (Figure 3) and it probably represents the remains of an open-cast mining pit that extended into the site from the north (Figure 4).

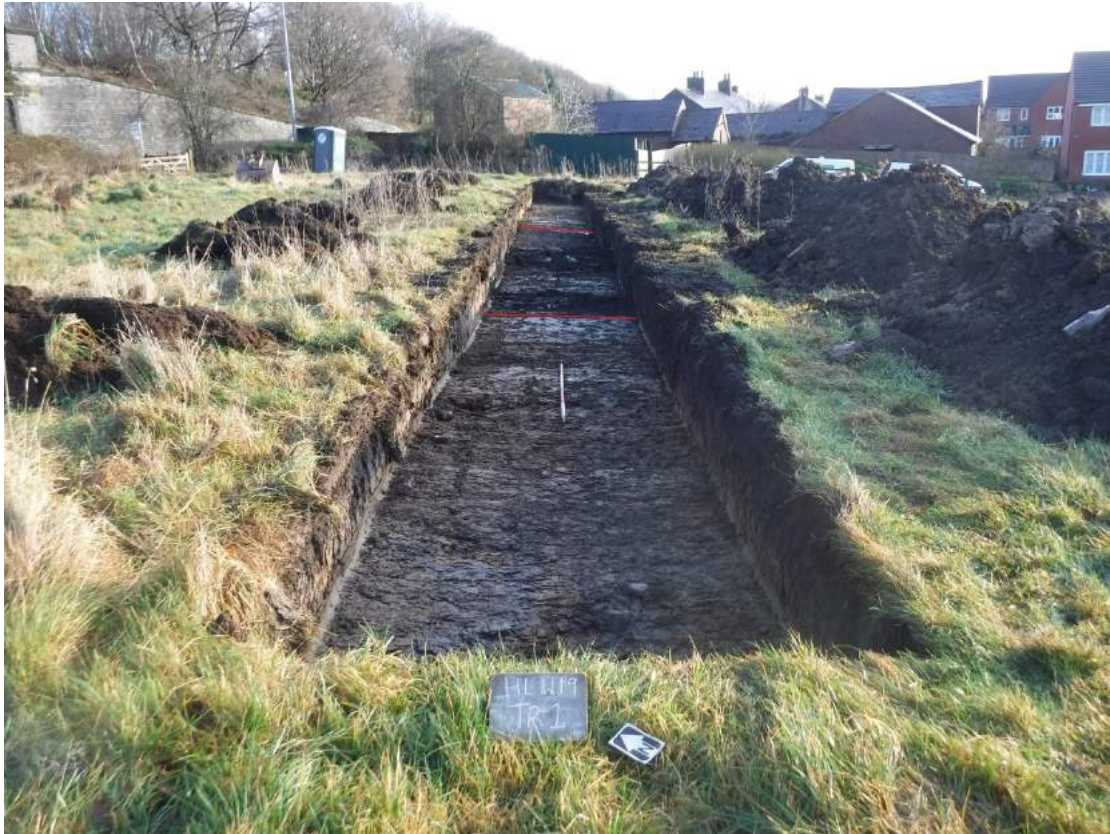
Figure 5. Trench 1 looking E. Edges of the open cast pit [104] are marked in red. Scale 2x2m.

5.2.4 In plan the feature had a number of distinct fills and two bands of clay used as capping material. Fills (105) and (107) were almost black in colour, containing a high proportion of coal fragments, ash, clinker and brick fragments as well as modern plastic and metal waste. It is likely that the modern waste was incorporated into the upper portion of the fill when the pit was capped-off with clay deposit (106) some time in the 20<sup>th</sup> century. Fill (109) against the western cut of the pit did not contain modern waste and was separated from fill (107) by another band of clay capping material (108).

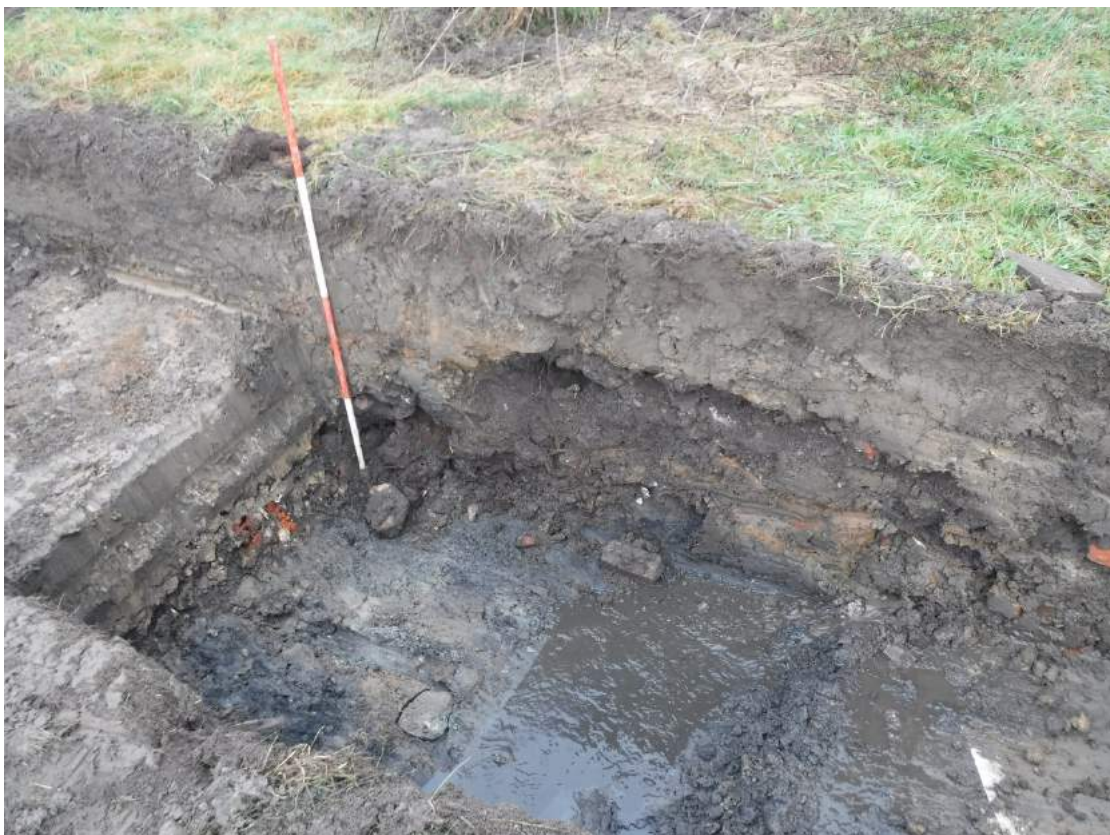
Figure 6. Sondage through open cast pit [104] showing variable depth of capping clay deposit (108) and a natural clay base. Scale: 2m.

5.2.5 A sondage was excavated through the central portion of the pit in order to determine its depth and to reveal any further fills. Excavation revealed that the modern waste was only spread across the very top of the pit and that fills (105), (107) and (109) were all composed of the same material. The pit had a depth of 1m and the base was formed of natural clay substrate (103), encountered at c.68.4m aOD. Discolouration of the clay at the base of the deposit is either from contact with the waste that was filling the pit but could also derive from remnant coal deposits within the geology.

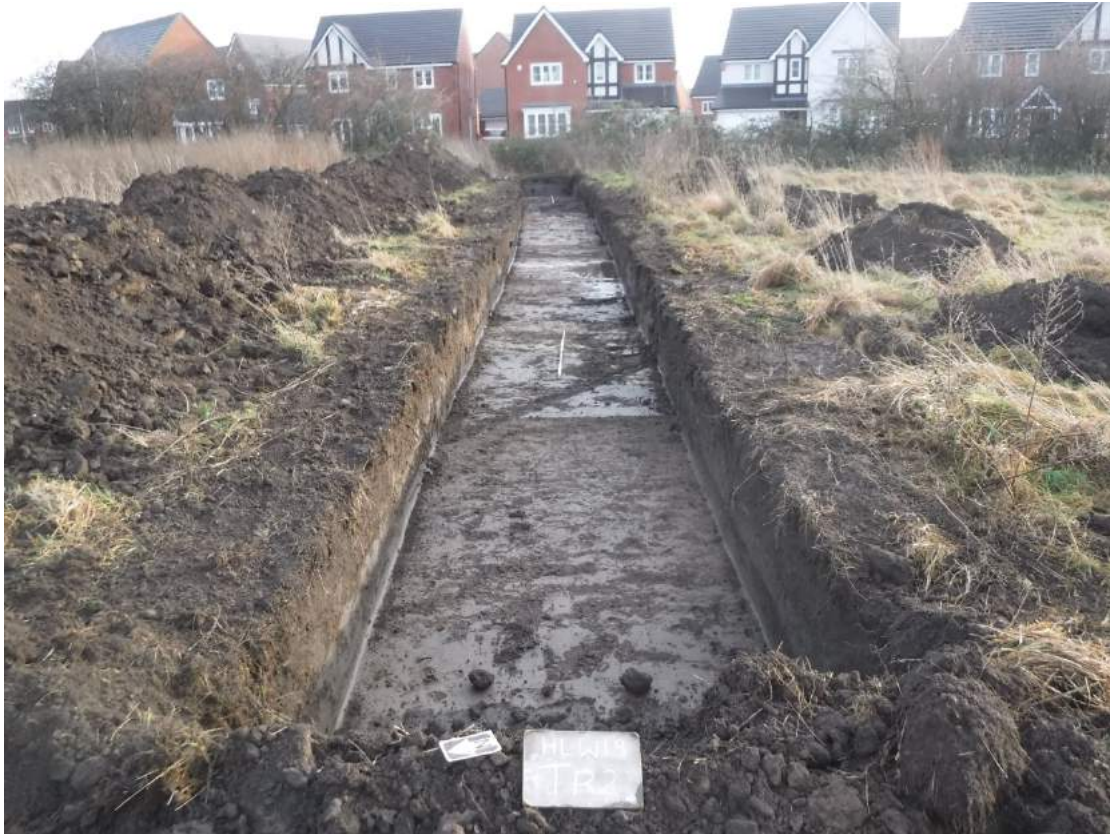
Figure 8. Trench2 looking SE. Land drain (205) visible towards the near end. Capping deposit (204) visible as the lowest band of deposits in each section. Scale: 2x2m.

5.2.2 The trench was excavated through 0.25m of dark brown topsoil consisting of silty clay with numerous coal fragments, ash and clinker inclusions (201) and up to 0.3m of grey-brown silty clay subsoil (202) with occasional gravel inclusions. A layer of much darker silty clay (204) was found beneath the subsoil across the length of the trench that contained frequent small fragments of coal, ash and clinker. This deposit had a uniform depth of 0.2m and is likely to represent an intentional deposit of capping or levelling material over the top of the former ground surface (Figure 7).

5.2.3 Removal of deposit (204) revealed the upper horizon of natural clay till (203) which was frequently disturbed by land drains at a depth around c.0.7m below ground level. Drains (205), (212) and (213) consisted of sections of ceramic pipe (3" diameter) laid within narrow slot trenches and backfilled with clay, whilst drain (206) is likely to have been formed of sandstone capping stones laid across two parallel sides of smaller stones, but this had collapsed and was no longer functioning. A much larger drain (211) was observed at the south-east end of the trench that was found at a similar depth below ground level as the other drains but laid within a wide construction cut [210]. It is probable that this is a carrier drain that runs along the southern edge of the field, linking up the smaller feeder-drains.

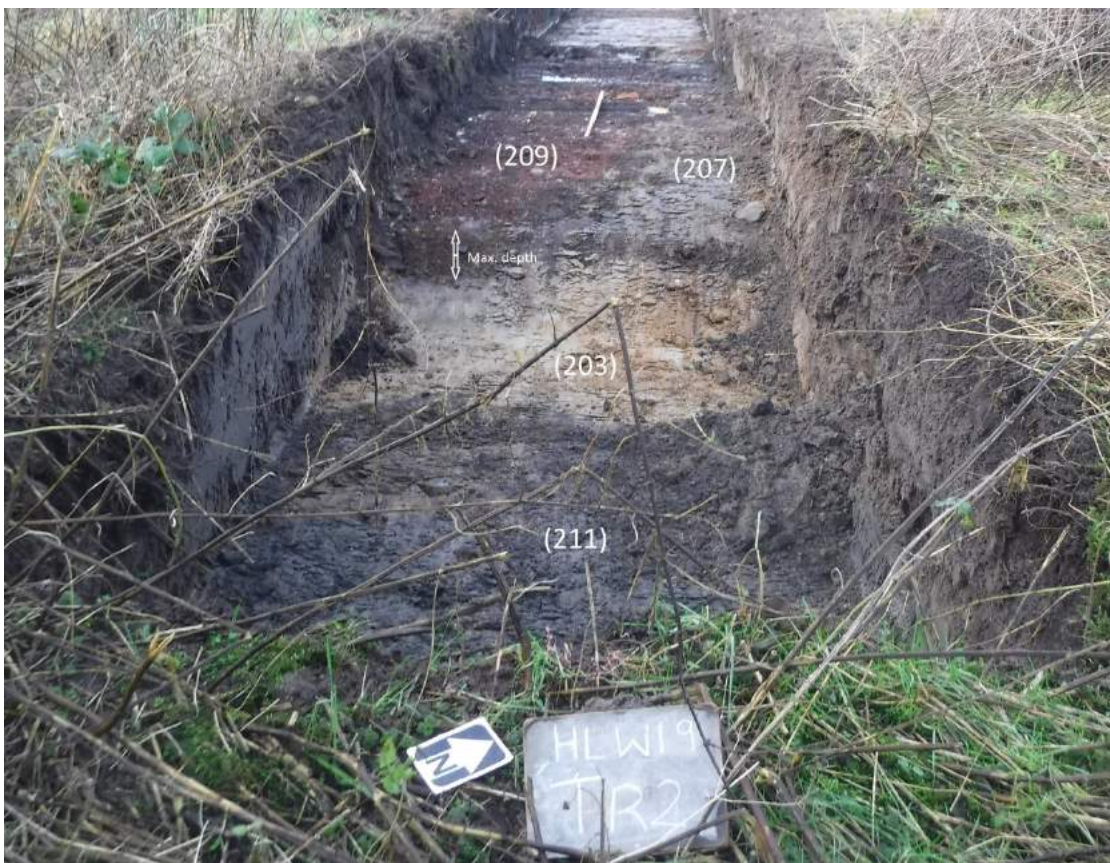
Figure 9. SE end of Trench 2 showing fill of carrier drain (211) and probable trackway surface (209)/(207). Scale: 2m.

5.2.4 The only archaeological feature was represented by a very shallow surface formed of compacted brick, slate and stone fragments towards the south-eastern end of the trench. This surface (209) had a maximum depth of 0.14m, pushed into the upper horizon of the natural clay till substrate (Figure 8). At its maximum extent the surface had a width of 6.2m, and this is comparable with the width of the trackway depicted in this area on the 1850s OS map (Figure 6). When overlaid onto the mapping data the surface only partially overlies the very northern edge of the trackway, but it is likely that they are the same feature. An area of compacted and discoloured clay alongside the trackway (207) is likely to be part of the same feature though the surface material had not survived. The surface was cut by ceramic pipe land drain (212).

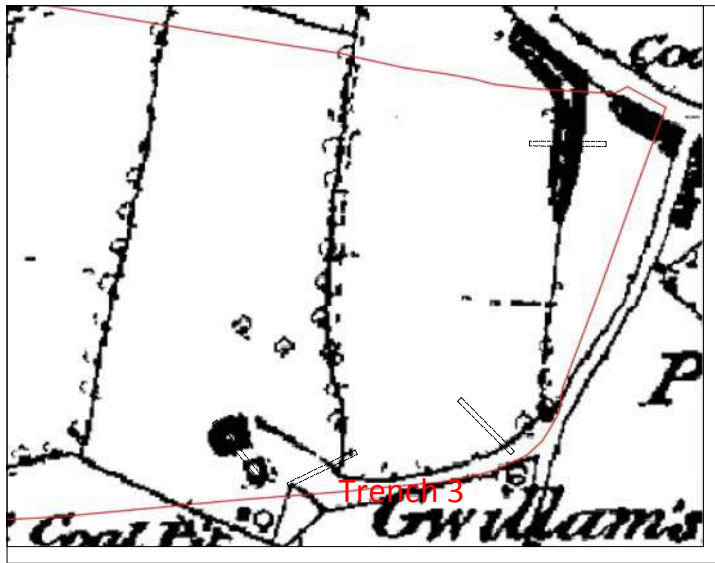
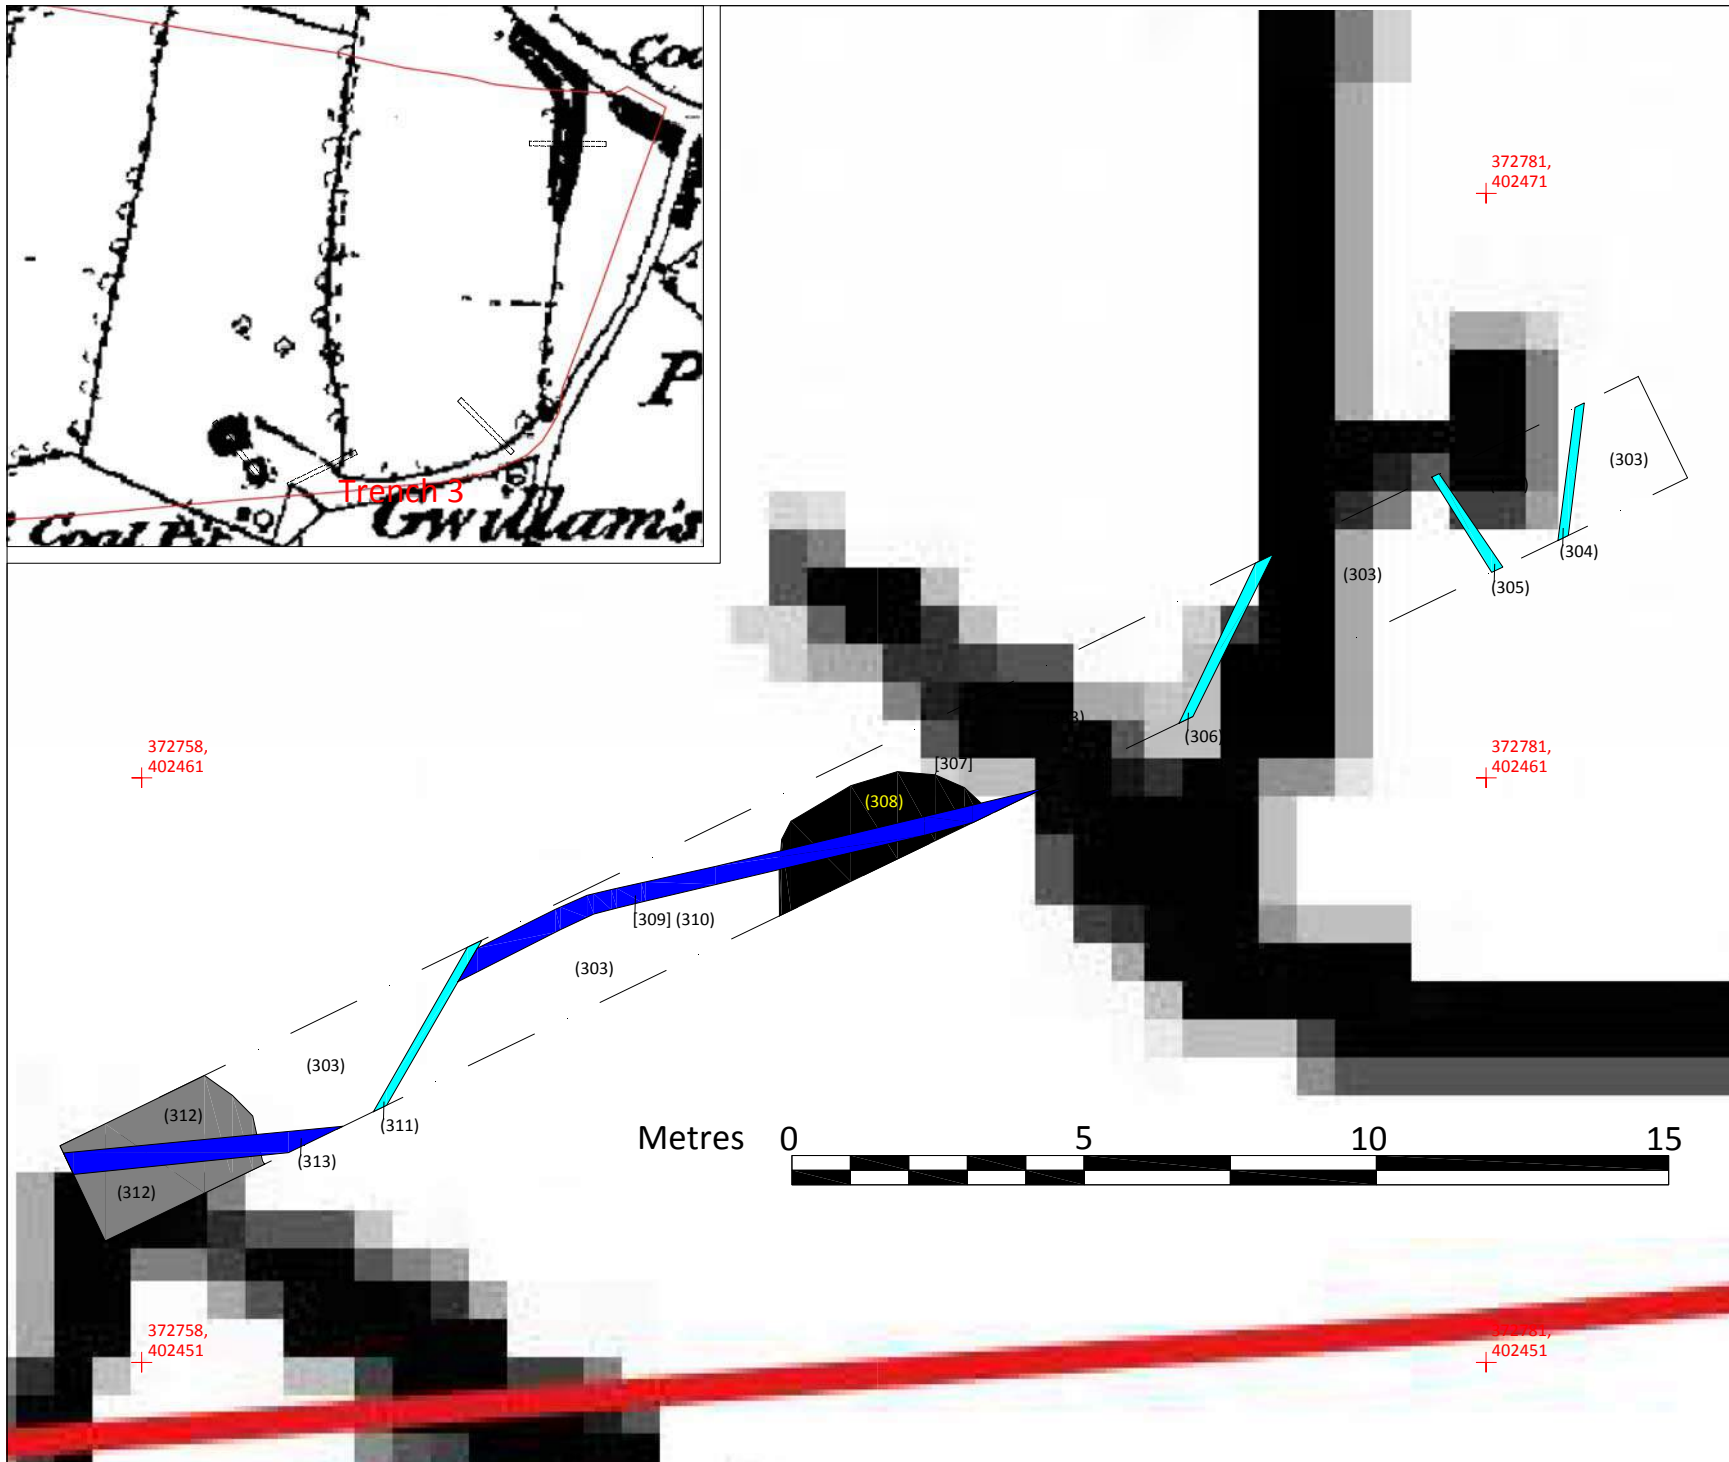
Figure 10.  
Trench 3 plan, overlain onto the  
1st Edition 1:10,560 OS map, 1850.  
Scale: As shown.

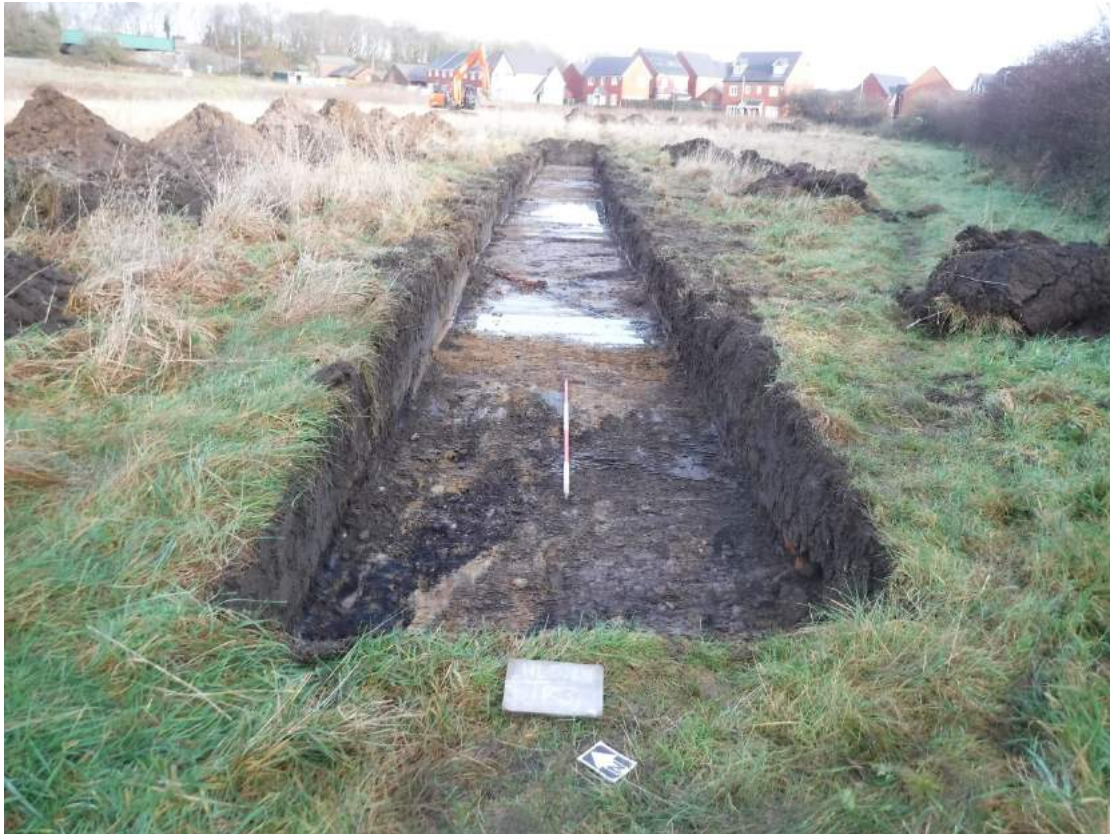
Figure 11. Trench 3, looking ENE. Remnants of former trackway (312) visible in the foreground, truncated by agricultural service trench (313). Scale: 2x2m.

5.4.3 At the west-south-west end of the trench, an area of disturbance (312) was encountered that resembled the compacted clay (207) of the trackway identified in Trench 2. Occasional small stones were identified that were pushed into the underlying clay substrate (303). It is likely that this deposit represents a very fragmented part of the former trackway but only the basal remnants had survived and even these were truncated by the modern agricultural trench (313) (Figure 10).

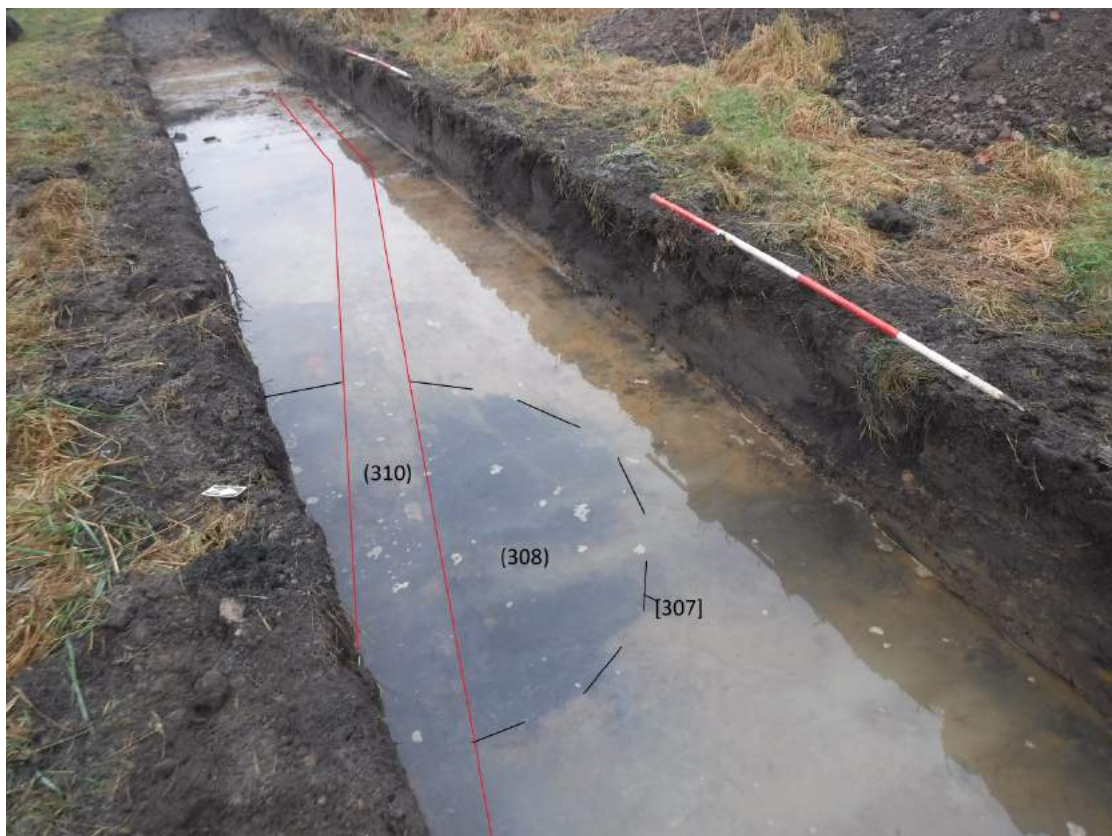
Figure 12. Pit/shaft [307], truncated by modern trench (310), looking W. Scale 2x2m.

5.4.4 Towards the centre of the trench, half of a probable circular pit extended into the trench by 1.5m from the south-south-east edge (identified at 61.3m aOD). The pit has a probable diameter of c.3.7m (based on the exposed portion) and had a dark, clay silt fill that was quickly submerged by water that was entering the trench from land drain (306) further east. The pit was also truncated by agricultural service trench (310) (Figure 11). This feature is likely to represent a small pit shaft associated with the Burgess Land Coal Pits, though it is not depicted on the 1850s OS map.

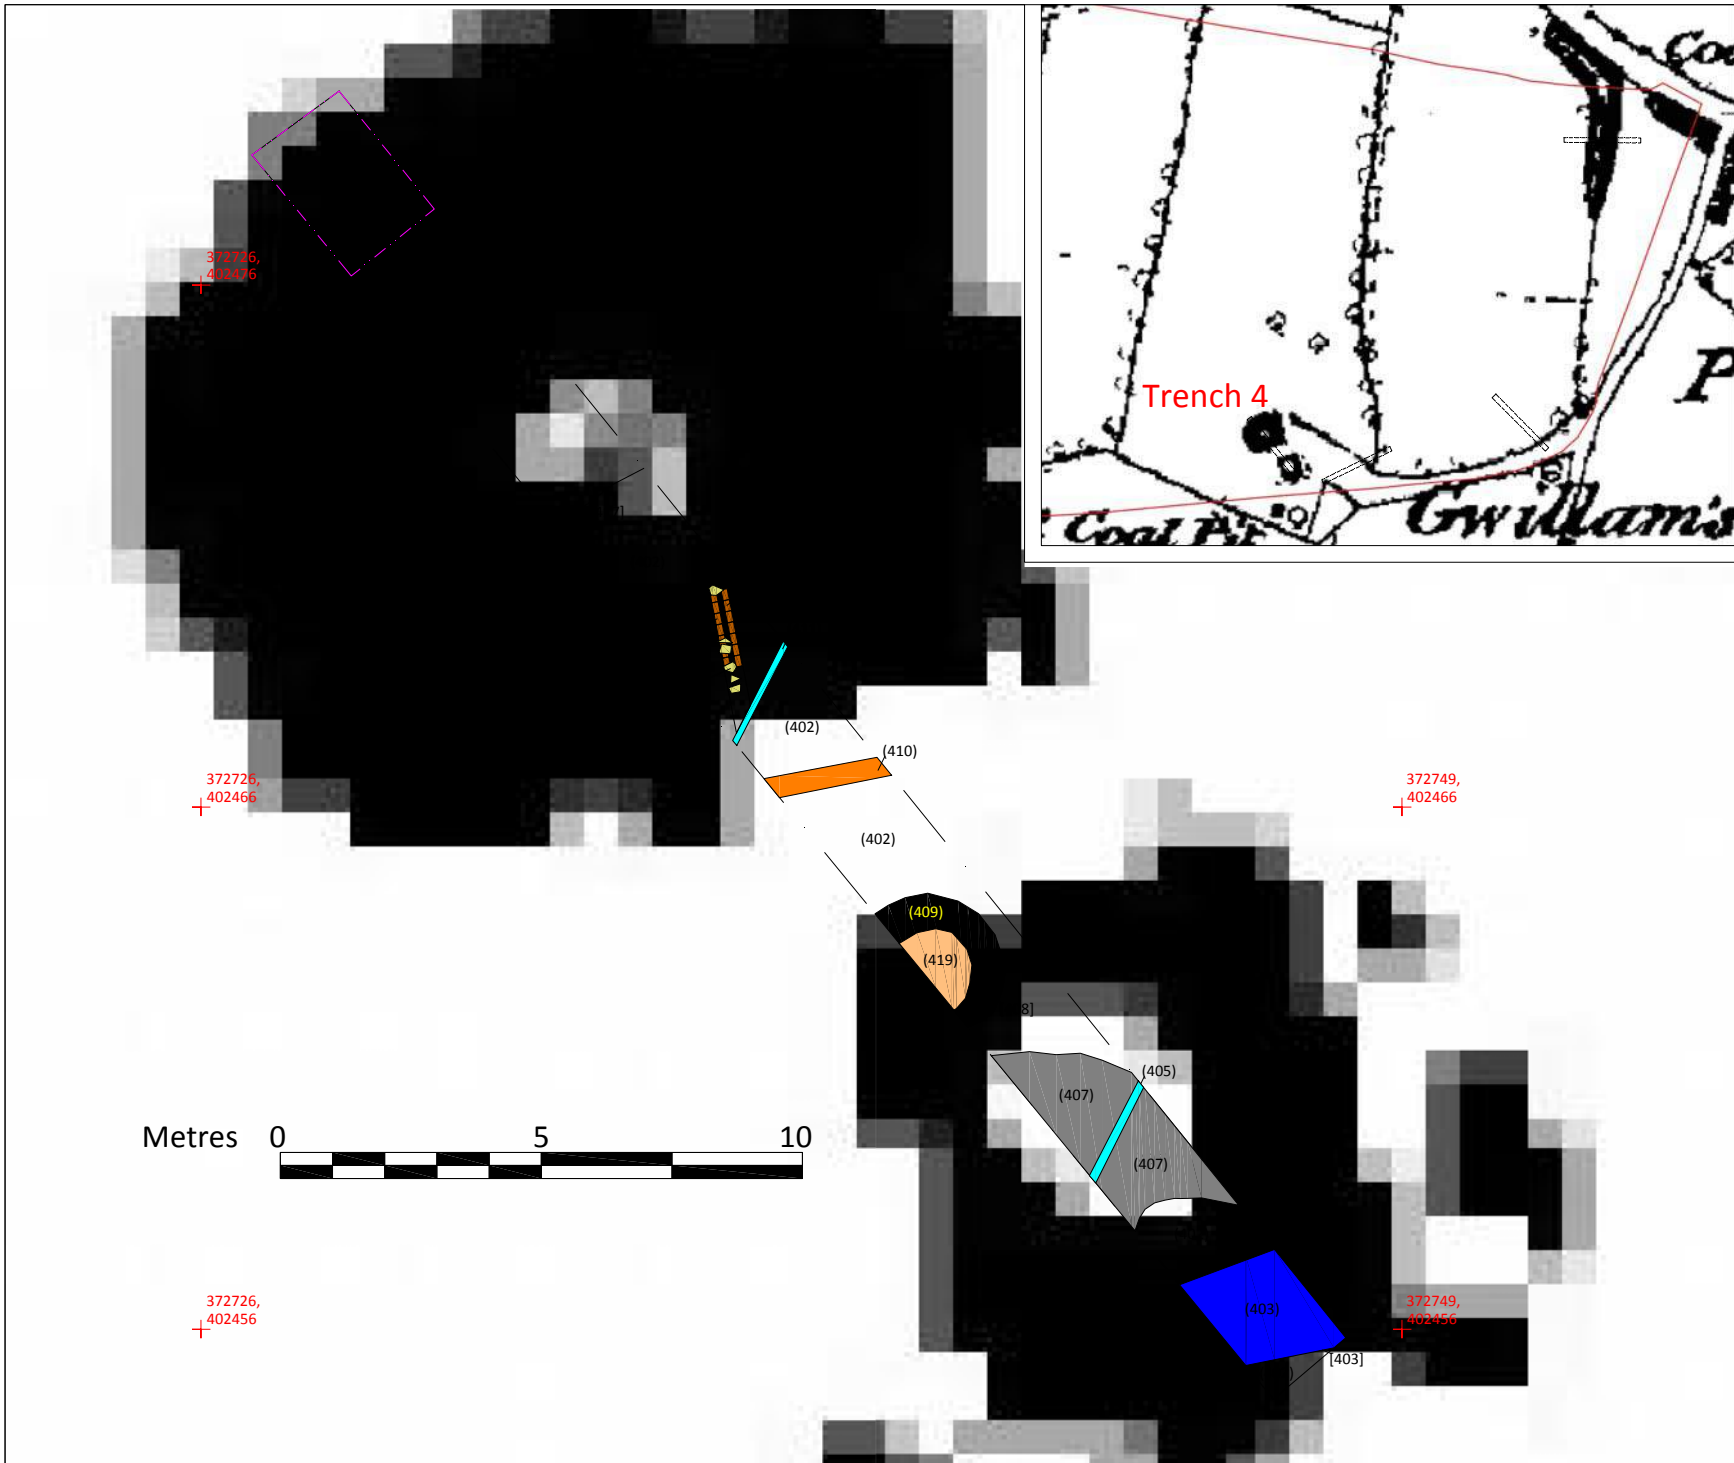
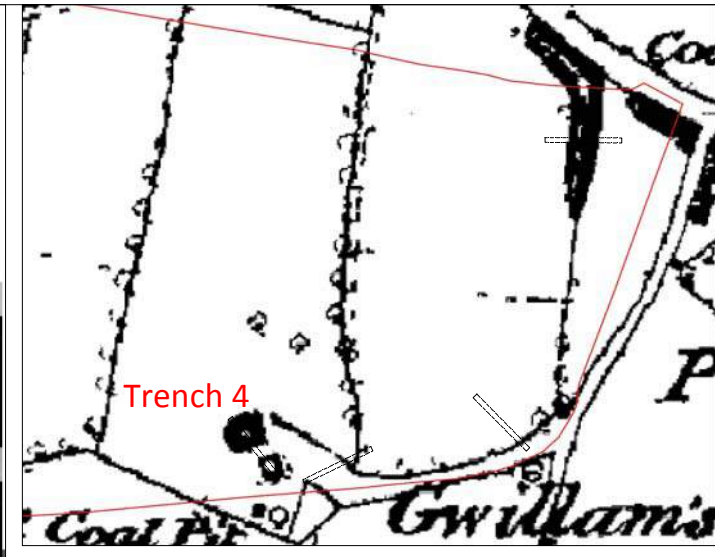
Figure 13.  
Trench 4 plan, overlain onto the  
1st Edition 1:10,560 OS map, 1850.  
Scale: As shown.

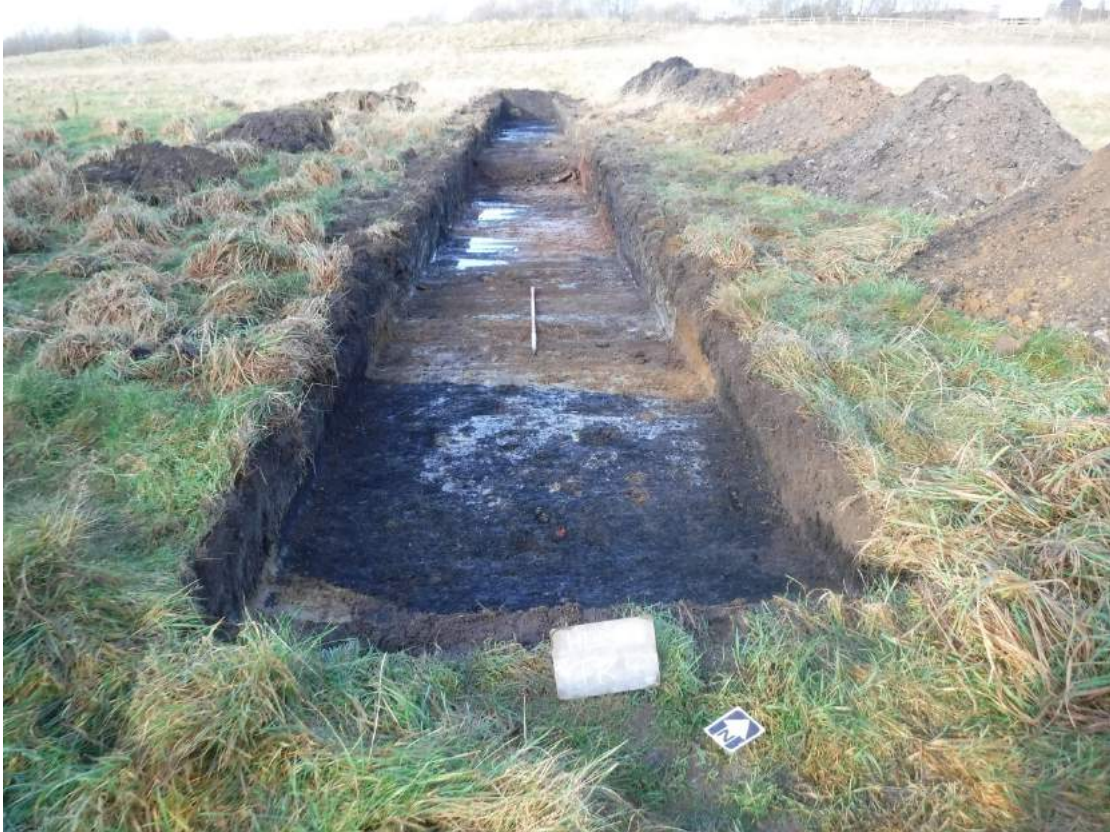
Figure 14. Trench 4 looking NW. Probable modern backfilled trench [403] in the foreground. Scale: 2m.

5.5.2 The trench was excavated through 0.3m of dark brown topsoil consisting of silty clay with numerous coal fragments, ash and clinker inclusions (401). Across the southernmost 13.75m of the trench the topsoil was overlying a poorly compacted deposit of silty clay with ubiquitous fragments of mining waste contained within it (420), whilst further north the topsoil directly overlay the upper horizon of the natural clay till substrate (402) or deposits within industrial features. At the south-east end a straight-sided linear feature was observed [403], which was 1.96m wide, filled with a hard compacted deposit of bituminous material that resembled a metalled tarmac surface. In conversation with a representative of Bellway Homes whom visited the site during the evaluation, it was mentioned that a foul drain is known to cross the southern part of the site but the exact location is not marked on service plans. The feature was recorded and surveyed but not further excavated (Figure 13).

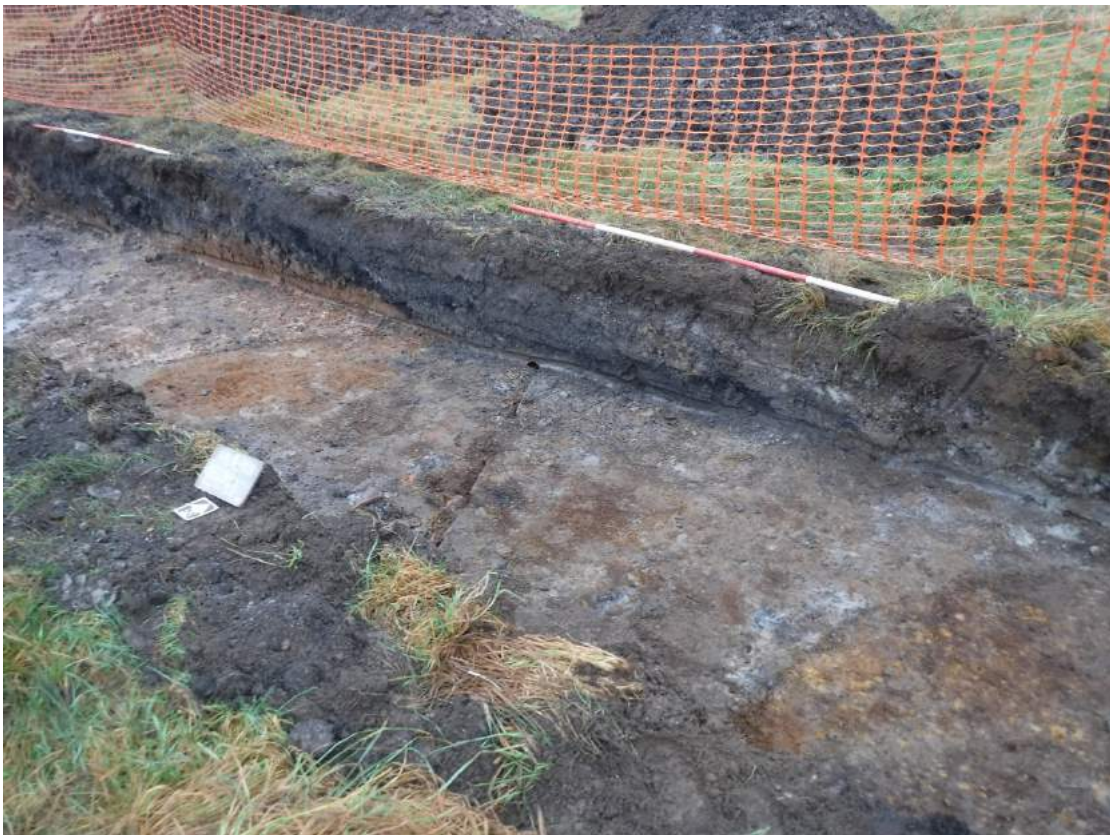
Figure 15. Remnants of possible former trackway (407) with a distinct curve on the southernmost edge. Identified beneath waste deposit (420). Scale: 2m.

5.5.3 Less than 2m further to the north-west a compacted deposit of stony sand and clay (407) was encountered that continued for 3.4m and resembled a curving surface. In places the underlying natural substrate was visible where the deposit had not survived and a land drain (405) cut across the area on a north-east to south-west alignment. The deposit was very similar to the disturbed surface at the south-west end of Trench 3 (312) and might represent a continuation of the former trackway that led to the coal pits from Hilton Lane in the north (Figure 14), but this was not conclusive.

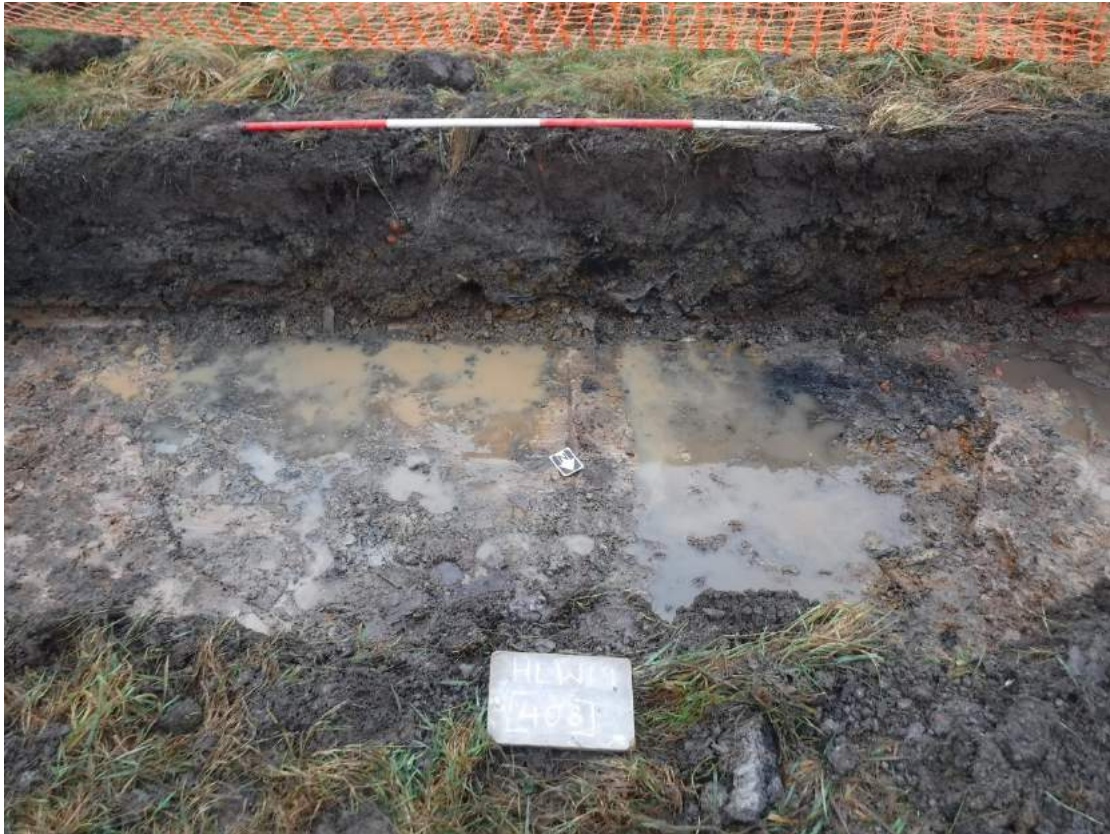
Figure 16. Possible pit/shaft [408] (outline scored-in for clarity), looking SW. Scale: 2m.

5.5.4 Another possible pit shaft [408] was identified less than a meter to the north-west of deposit (407), cut into the natural clay substrate (402). Unlike the black coal-rich fill of the pit in Trench 3, the fill (409) of this 2.83m wide circular feature was much paler, with a mottled brown/pink/red colour and a gravelly rather than silty consistency (Figure 15). A circular deposit of re-deposited natural (419) was observed in the top of the pit that was likely used as a capping deposit, very similar to one of the pits observed during the evaluation to the south in 2014 (Wardell Armstrong 2014). When viewed in relation to the

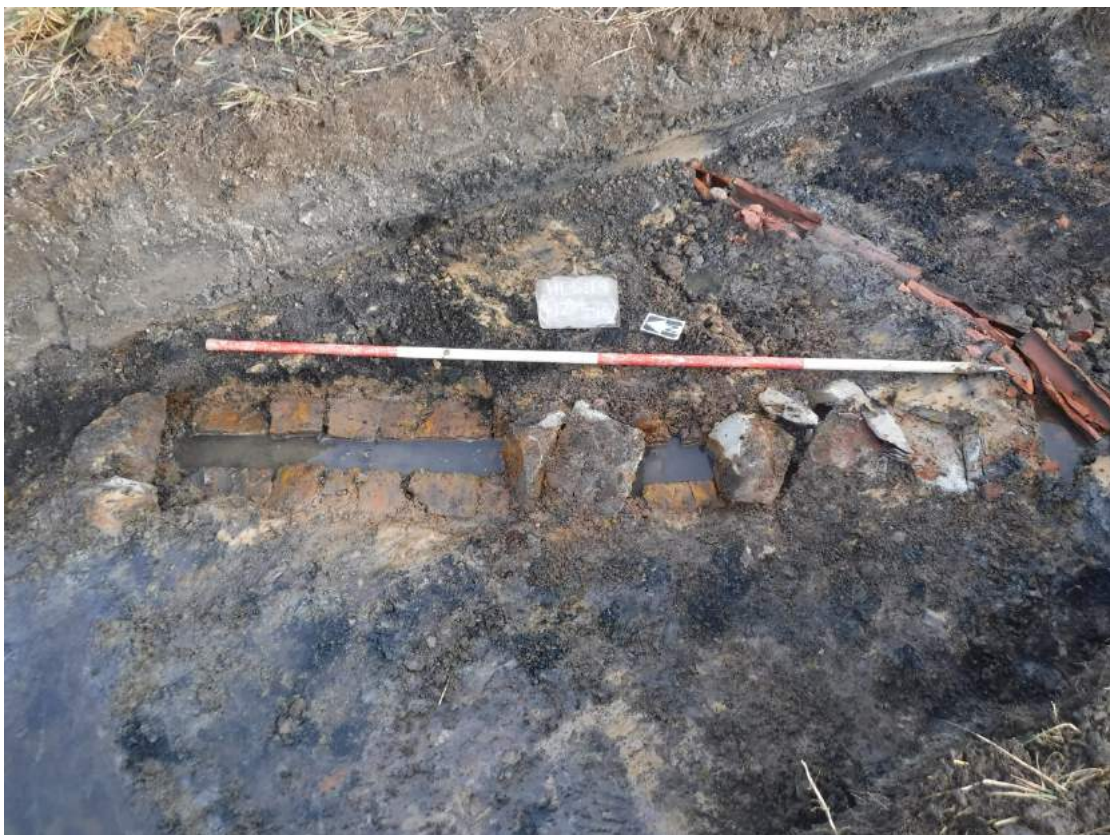
Figure 17. 19<sup>th</sup> century brick-constructed culvert with sandstone capping, laid within construction cut [412], truncated by ceramic land drain (411). Scale: 2m.

5.5.5 A number of 20<sup>th</sup> century land drains were encountered through the central part of the trench, including a narrow 3" diameter ceramic pipe drain (411), a larger carrier drain (410) that was on the same alignment as, but further north than, the carrier drain identified in Trench 2, and a truncated 19<sup>th</sup> century brick-built culvert ((414), (415), (416)) with sandstone capping (Figure 16). The culvert sat within a construction cut [412] that cut into the natural clay substrate. It is probable that the culvert was associated with drainage around the top of a large pit or open-cast mining area identified at the north-western end of the trench.

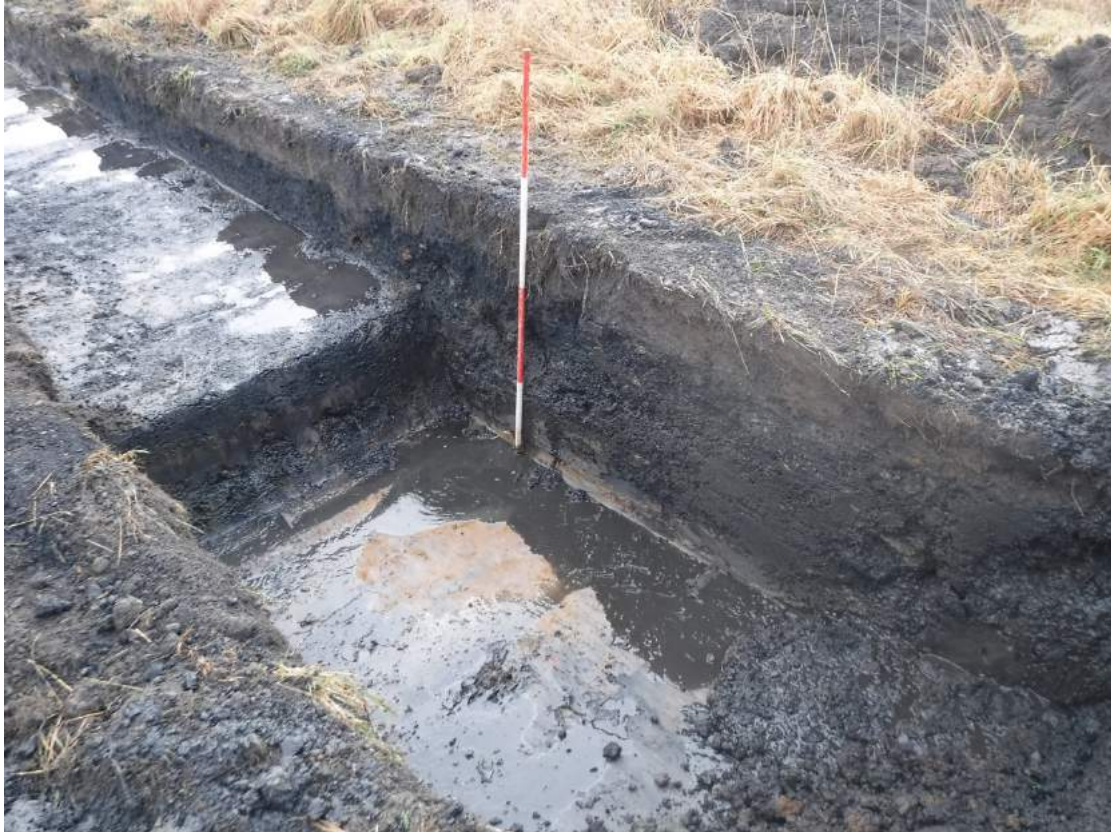
Figure 18. Sondage through pit/open cast area [417] showing uniform depth of coal-rich fill (418) and a natural clay base. Scale: 2m.

5.5.6 The cut [417] and coal rich fill (418) of this mining area were identified just below topsoil level and were investigated by the excavation of a sondage (Figure 17). The fill was found to be 1m deep and was homogenous from below topsoil down to the natural clay base that was revealed at 60.98m aOD. When viewed in relation to the 1850s map of the site the feature is within the larger of two pit features marked within the Burgess Land Coal Pit works at the western extent of the access road.

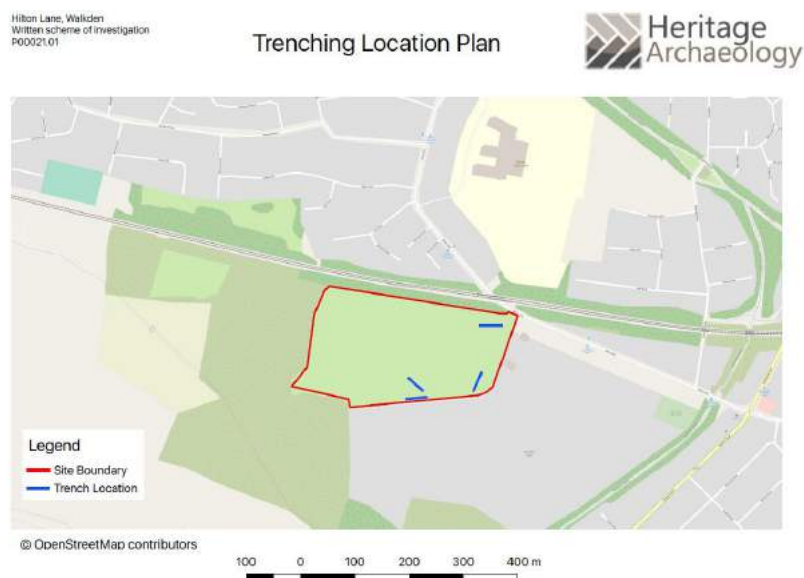
Figure 3: Indicative trench locations (not to scale)

- 4.3. The four 30m x 2m trenches have been designed to adequately sample the archaeological potential of the site in order to define a sampling strategy for future mitigation in relation to the Burgess Land Coal Pit. The precise dimension and location of the proposed trenches will be confirmed on site and in consultation with GMAAS and will be located with reference to the first edition 1:10,560 Ordnance Survey map to include the annotated location of the Burgess Land Coal Pit.

- 4.2. The trench evaluation will comprise the excavation and recording of four trenches, each measuring 30m by 2m.
