Archaeological Watching Brief at Fenham Reservoir, West Road, Newcastle Upon Tyne

ARS Ltd Report 2020/17

Project Name: Archaeological Watching Brief at Fenham Reservoir, West Road, Newcastle Upon Tyne

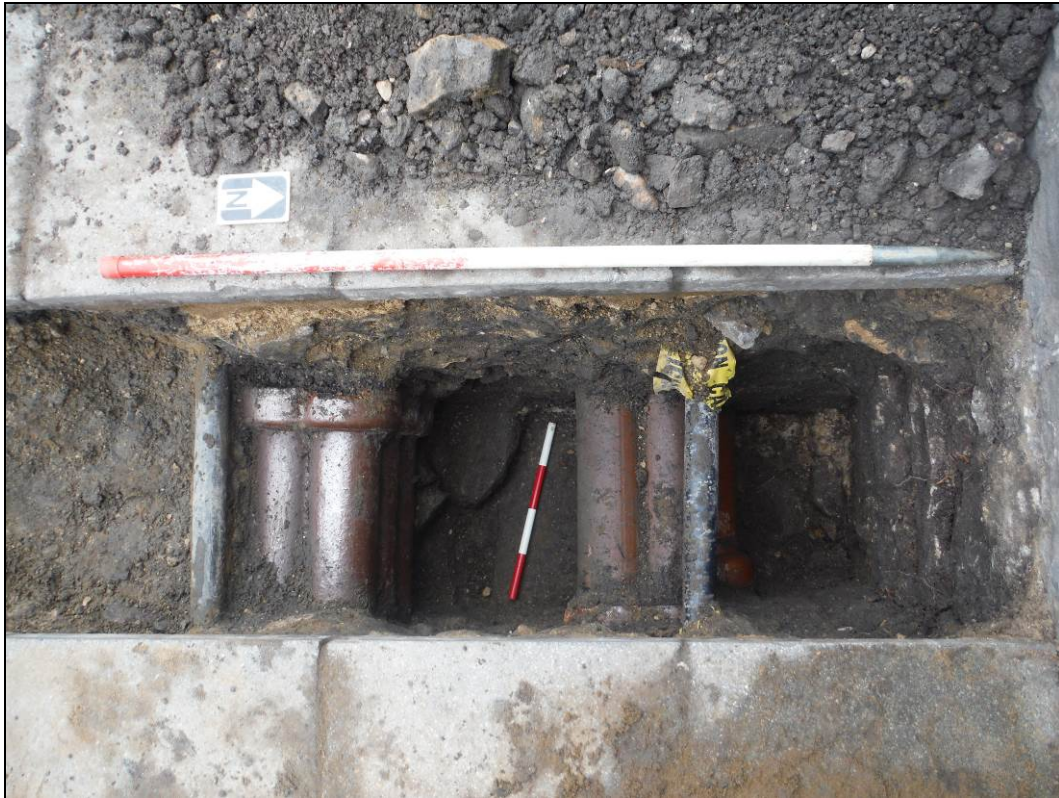
Figure 3. Plan view of Test Pit 1, including sandstone wall foundations (110) within the base of the test pit (Scale = 1 x 1m in 0.5m graduations at top; 1 x 0.4m in 0.1m graduations at base).

4.2.2 The concrete pavement slabs (101) sealed a modern sand and gravel subbase (102), which was removed revealing the backfill ((108), (104), (106) and (111)) associated with modern utilities trenches ([114], [115], [103] and [116] respectively). The northernmost utility trench [103] was excavated against the external boundary wall [112] of the reservoir complex exposing roughly hewn sub-angular sandstone wall foundations [110]. These were initially interpreted as the remnants of an earlier phase of wall construction as the truncation of associated deposits by the service trench eliminated the adjacent stratigraphic sequence above the sandstone wall foundations [110].

4.2.3 Further investigation of these structures identified a dark brown yellow clay silt (113) sealed by reservoir wall [112] and overlying the sandstone wall [110] separating the two walls stratigraphically. No dating evidence was recovered from clay deposit (113) limiting interpretation. This clay-silt (113) might relate to either the removal of the sandstone wall associated with the foundations (110) or the initial construction of the reservoir wall (112). No dating evidence pertaining to the sandstone wall was recovered from its interstices. Although broadly south-east to north-west, the alignment of the sandstone wall foundations did not match that of the reservoir wall. This is further evidence that it is unlikely to represent foundations for the reservoir boundary wall or possible earlier iterations.

4.2.4 Given the constraints imposed by the small size of the test pit, a true alignment for the sandstone wall could not be ascertained but it appears to have an approximate co-axial alignment with the presumed orientation of the outer walls of Condercum Fort. Therefore it might represent the truncated remains of a contemporaneous structure sited within the fort. The base of the trench did not extend below the exposed upper limits of the sandstone foundations (110). The natural substrate was not observed within the trench.

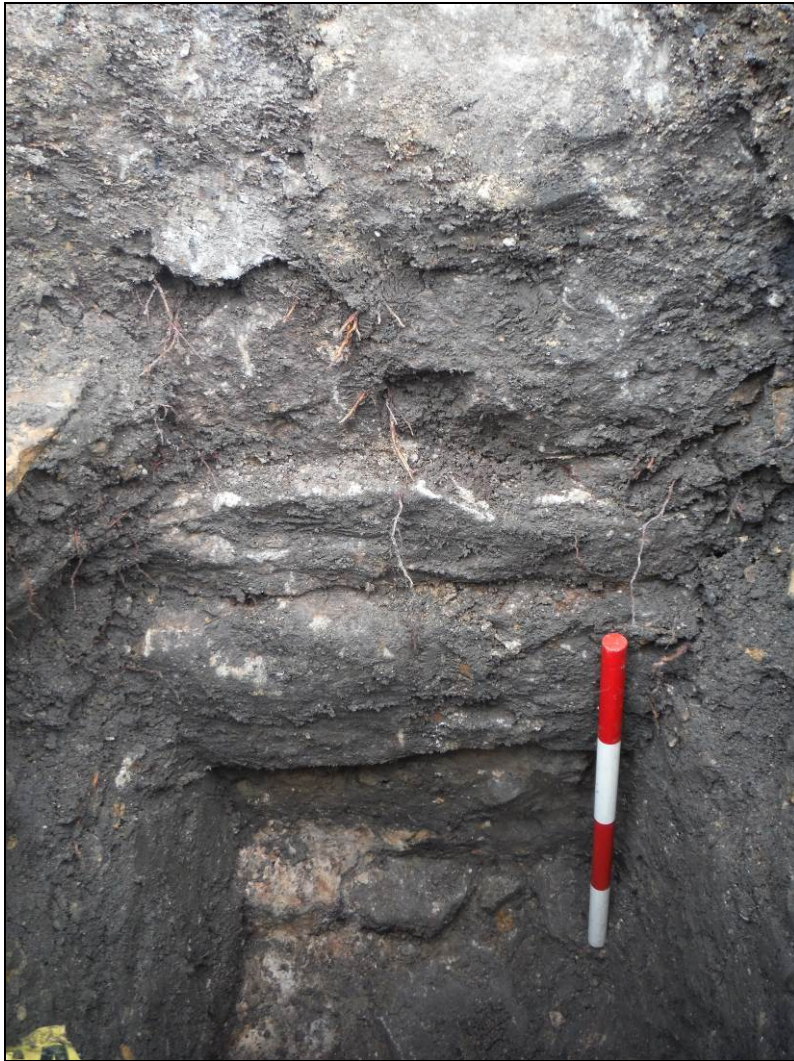
Figure 4. South facing section of wall (112), deposit (113) and structure (110) within test Pit 1 (Scale = 1 x 0.4m in 0.1m graduations).

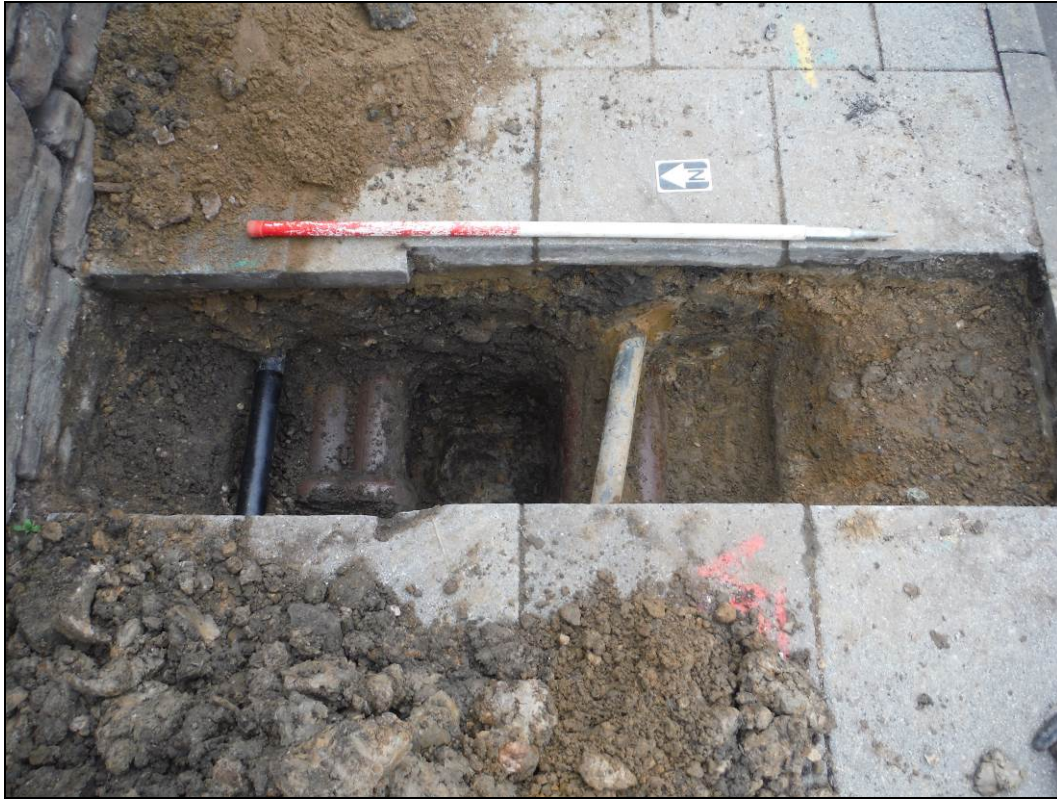
Figure 5. West facing section through Test Pit 2 (Scale = 1 x 1m in 0.5m graduations).

4.3.2 The depositional sequence within Test Pit 2 was broadly similar to the stratigraphy identified in Test Pit 1 detailed above. The test pit was excavated through modern concrete pavement slabs (201), followed by an underlying modern sand and gravel base layer (202), which in turn sealed a series of superimposed, mixed backfill deposits within modern service trenches abutting the southern external reservoir wall. The natural substrate, a mid-brown clay (215), was observed at the base of the trench. The sandstone wall foundations [110] observed within Test Pit 1 were not seen within Test Pit 2. The

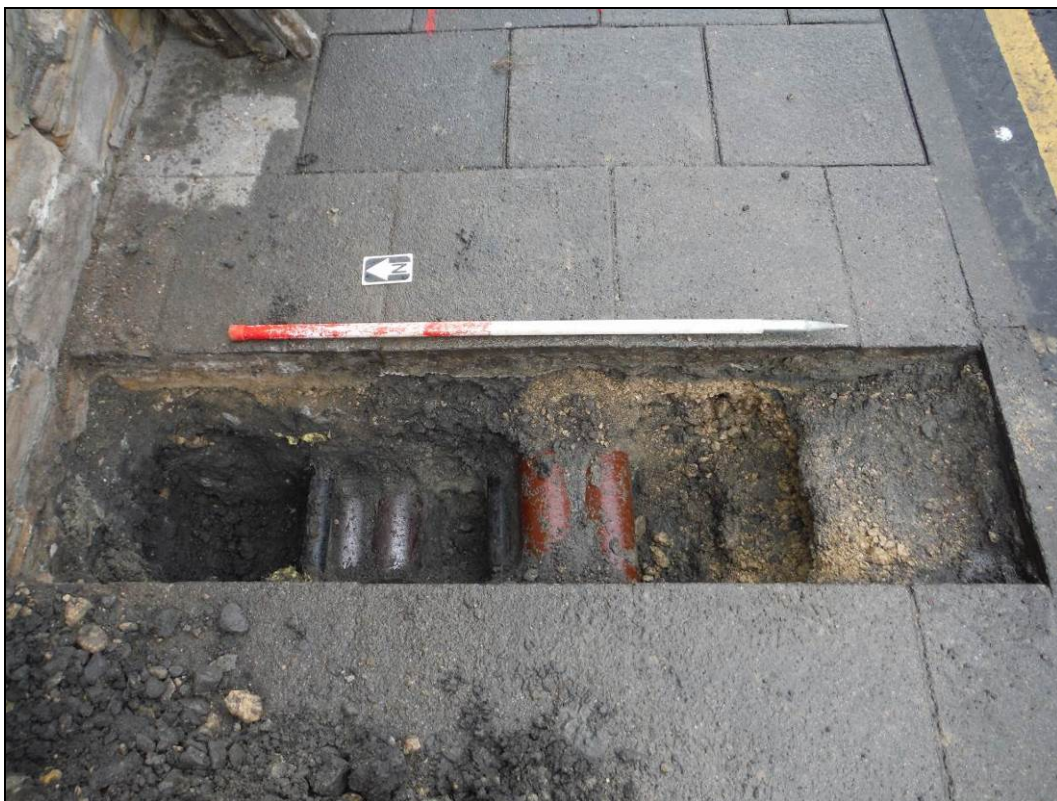
Figure 7. West facing section through Test Pit 3 (Scale 1 x 1m in 0.5m graduations).

4.4.1 Test Pit 3 measured 1.86m long and 0.44m wide and was excavated to a maximum depth of 0.50m below the present ground surface and 124.49m above Ordnance Datum (aOD). The test pit was sited 30m west of Test Pit 2, 2.5m east of Test Pit 7, within the pavement against the southern boundary of Fenham Reservoir complex. A similar depositional sequence to that encountered in Test Pits 1 and 2 was identified within Test Pit 3. The modern concrete pavement slabs (301), sealed an underlying modern sand and gravel base layer (302), which in turn sealed a series of superimposed, mixed backfill deposits within modern service trenches that abutted the southern external reservoir wall. The natural substrate was not observed within the trench.

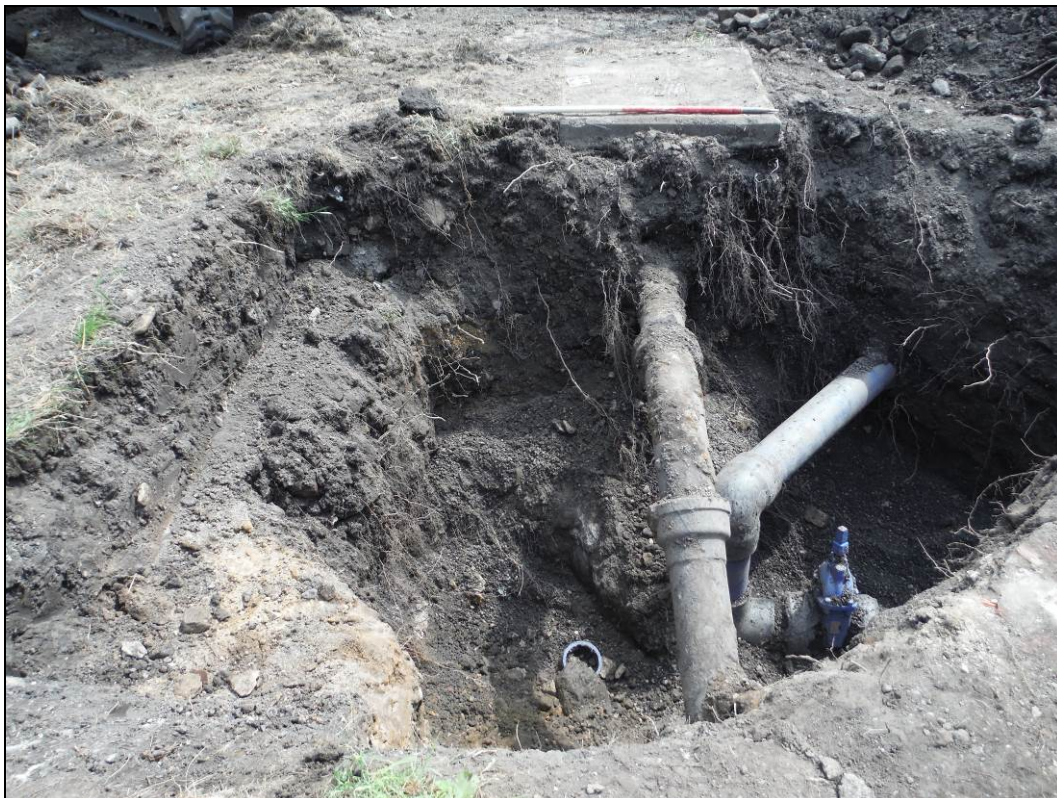
Figure 9. North-west facing section of Test Pit 4 (Scale = 1 x 1m in 0.5m graduations).

4.5.2 The same deposition sequence was noted in both Test Pits 4a and 4b and as such, the stratigraphy of both has been combined in the following description: the uppermost deposit comprised a dark brown topsoil and turf (401), which overlaid backfill (402) within a modern utilities trench [403]. In addition, three other utilities were noted bisecting the trench. The natural substrate was not observed within the trench.

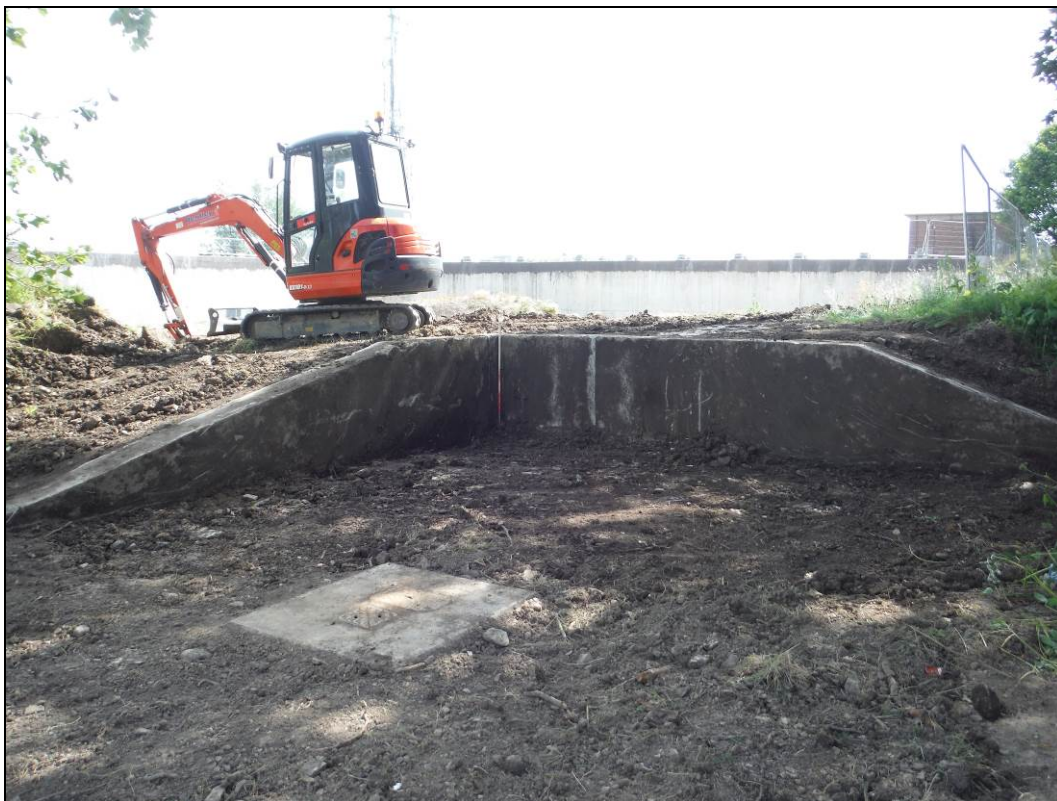
Figure 11. View looking west of concrete structure (505) (Scale = 1 x 1m in 0.5m graduations).

4.6.2 Test Pit 5 was excavated through modern redeposited natural clays (501) that constituted a spoil tip to presumably bury two structures: an inspection pit (504) and concrete revetment (505). In addition, the redeposited clays (501) sealed topsoil (502) which abutted structures associated with the reservoir ((504) and (505)). The revetment (505) comprised the upstanding remnants of an L-shaped structure, approximately 1m high made of concrete, against which was abutted by the majority of redeposited clay dump (501). The concrete revetment (505) enclosed a rectangular brick-built inspection pit (504), which measured 2.2m long, 1.15m wide and 1m deep. This contained the *in-situ* remnants of pipework. The natural substrate was not observed within the trench.

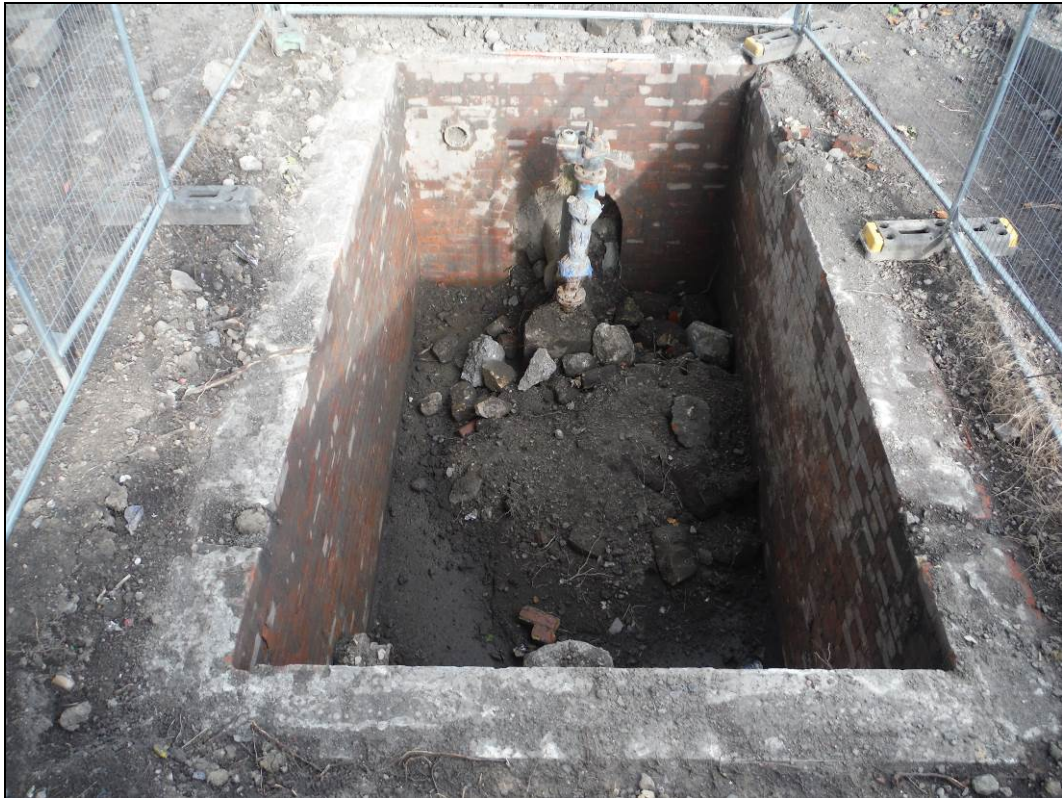
Figure 12. View looking east into inspection pit (504) (Scale = 1 x 1m in 0.5m graduations).

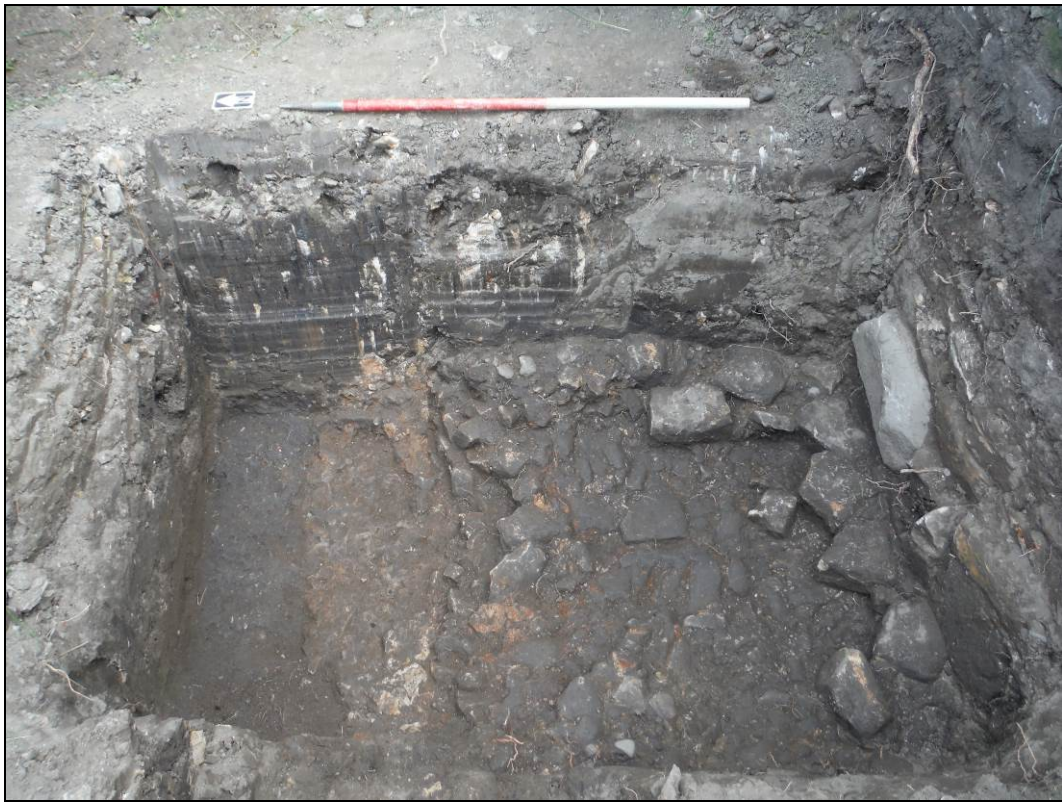
Figure 13. West facing section through Test Pit 6 (Scale = 1 x 1m in 0.5m graduations).

4.7.3 The mixed clay and clinker levelling deposit (602) sealed a sandstone floor/road surface (603) at a depth of 1.4m below the ground surface, which in turn sealed an earlier phase of construction (604). The uppermost Roman surface consisted sub angular roughly hewn sandstone with a total thickness of 0.13m which was identified across both Test Pits 6 and 7. The lowermost surface (604) consisted of a compacted layer of smaller sub angular sandstone fragments. This lowermost sandstone surface (604) was situated at the limit of excavation and any further construction deposits below could not be identified. Roman ceramic material was identified in associated with the surfaces: a single sherd of Dressel 20 olive-carrying amphora, dating from 1st to 3rd century AD, was recovered from the top of surface (603).

4.7.4 These surfaces were truncated by the construction of the reservoir wall (608) to the north and the installation of modern services. The reservoir tank construction cut [606] truncated this mixed levelling deposit (602) and the underlying surfaces (603 and 604). The reservoir tank itself was situated to the north beyond the bounds of Test Pit 6 but the construction cut was backfilled by two successive deposits of dark grey clay (607) and (609). The latter of which contained a small fragment of locally produced *mortarium*. The external reservoir boundary wall was constructed upon the truncated remnants of levelling deposit (602).

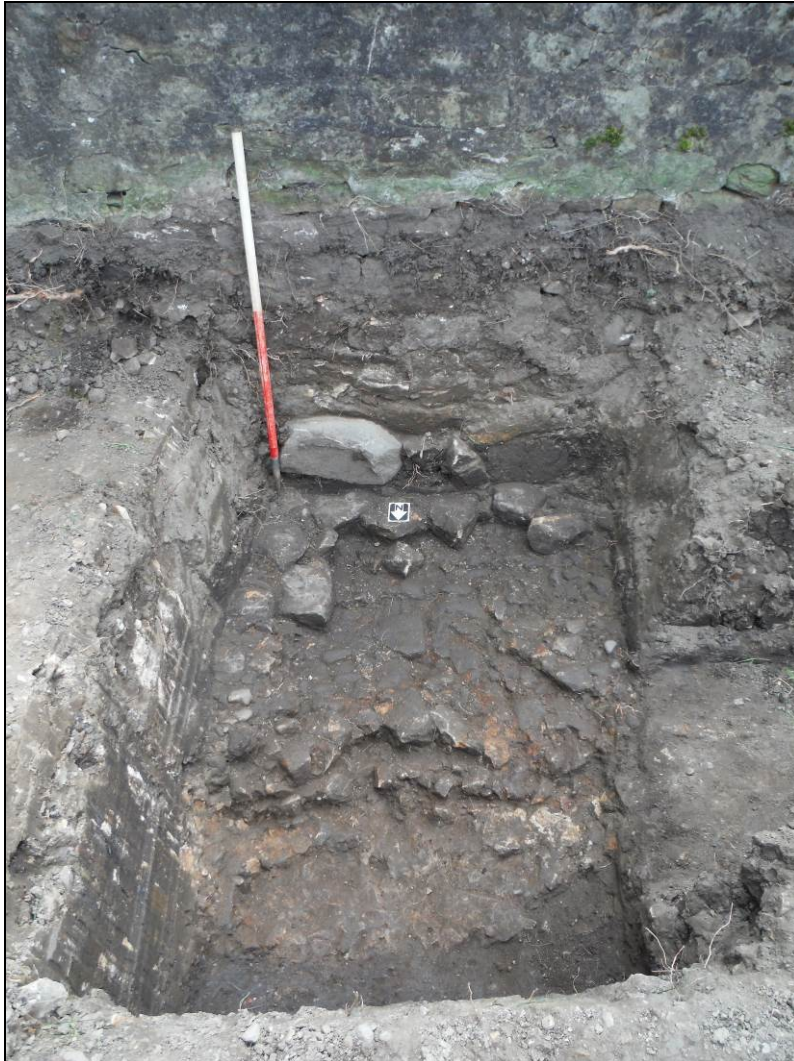
Figure 14. North facing section of wall (604) above Roman sandstone surface (603) (Scale = 1 x 1m in 0.5m graduations).

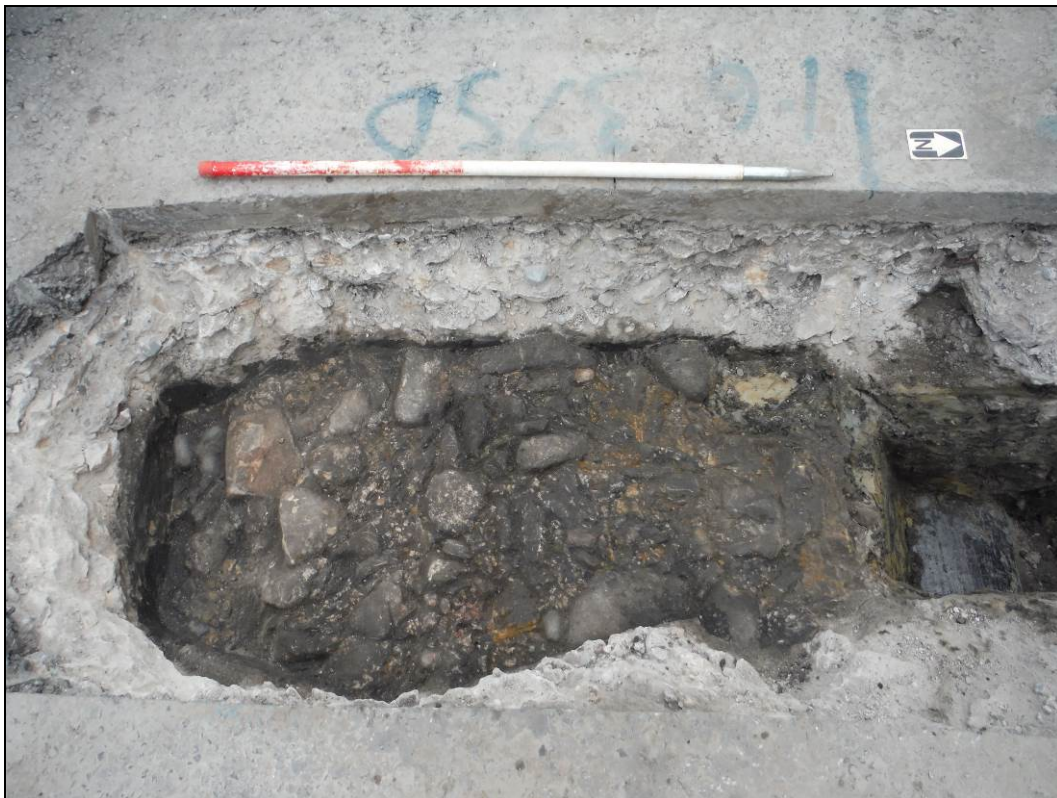
Figure 15. Stone surface (704) within Test Pit 7 (Scale = 1 x 1m in 0.5m graduations).

4.8.3 The base of a utility trench truncated a possible sandstone surface (703), similar to surface (603) observed in Test Pit 6 to the north. The surface overlay a bedding deposit of compacted sandstone fragments (704) which in turn sealed redeposited natural clay levelling layer (705).

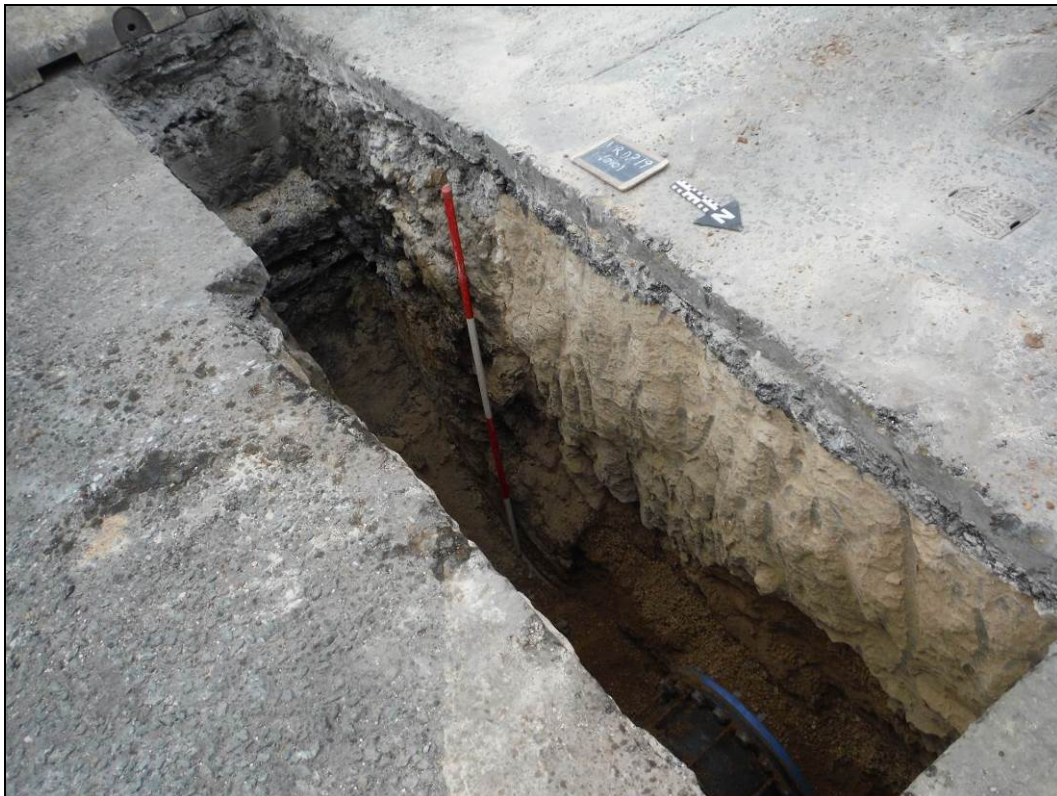
Figure 16. East facing section through Test Pit 8 (scale = 0.5m graduations).

4.9.3 The depositional sequence consisted of the uppermost asphalt road surface (801) sealing a concrete bedding layer (802). This lower bedding layer (802) was truncated by a utility trench [807] containing the water main. Two further utility trenches were identified below the concrete bedding (802). The first [809] was truncated by the water main [807] and in turn truncated another utility trench [817]. All three utility trenches contained a sequence of successive mixed backfill deposits.

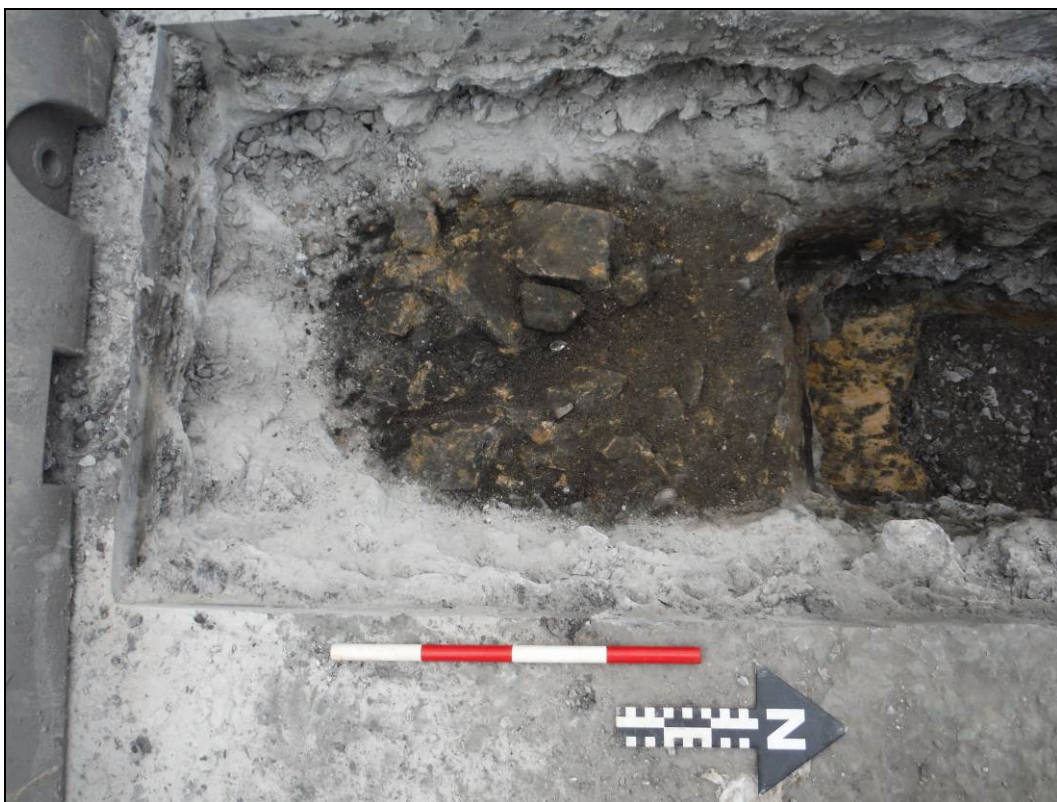
Figure 17. Plan view of structure (813) within test pit 8 (Scale = 1 x 0.4m in 0.1m graduations).

remains of an internal structure within the fort. This interpretation must remain tentative as no dating evidence was recovered from structure (813).

4.9.5 Below structure (813), a dark brown silty loam (814) was identified that may represent the burial of a former topsoil or occupational deposit. This dark brown silty loam (814) sealed redeposited clay natural (815), which contained inclusions of sandstone fragments. This material might represent a bedding/levelling deposit for subsequent surfaces. The redeposited natural substrate (815) sealed another levelling-up deposit of grey clay (816) that in turn overlaid the natural substrate (810), observed at a depth of 0.71m within the test pit. No dating evidence was recovered from this succession of deposits (814), (815) and (816).

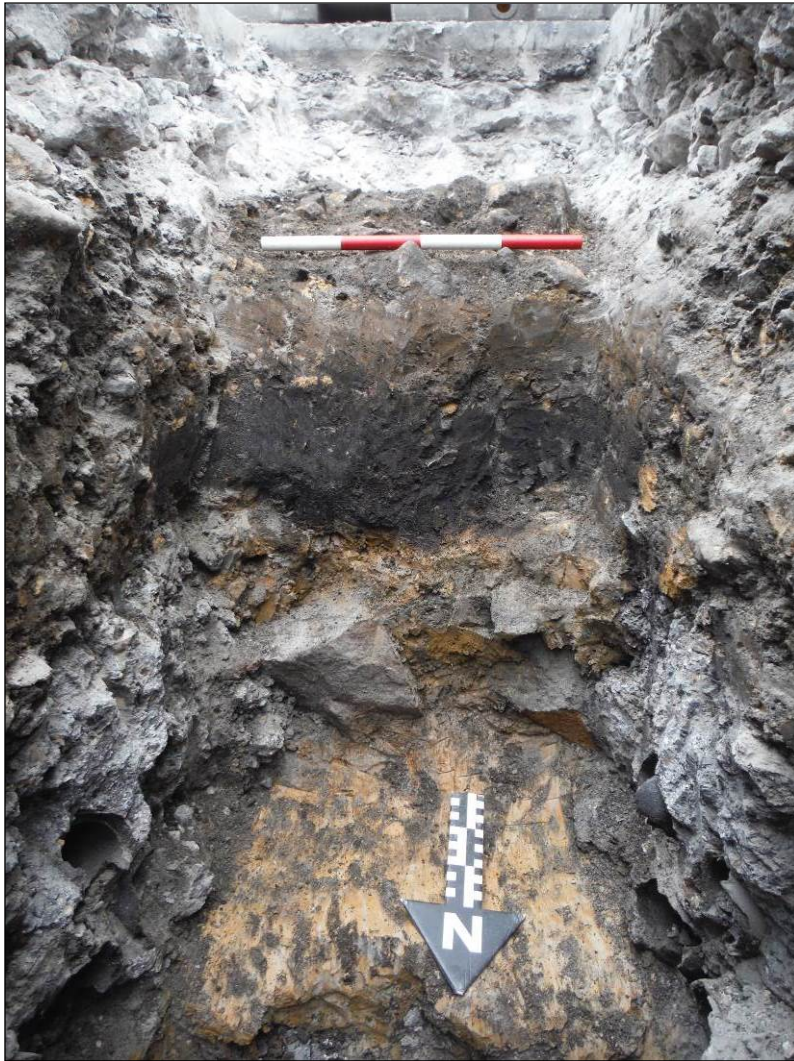
Figure 19. North facing section through deposit (813) and associated levelling deposits (Scale = 1 x 0.4m in 0.1m graduations).

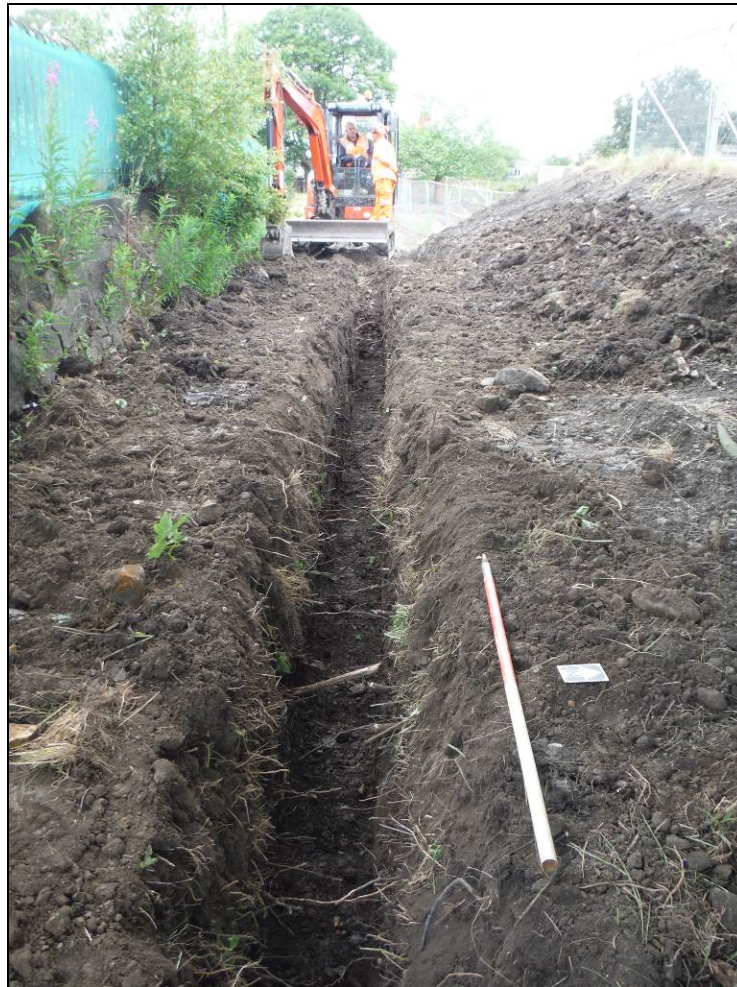
Figure 20. View looking west across Trench 1 (Scale = 1 x 1m in 0.5m graduations).

4.10.2 The trench was excavated between Test Pits 5 and 6 with a limited depth of excavation so as to minimise the impact to potential in-situ archaeological remains. The uppermost deposit identified within the trench comprised mixed clay and clinker (1001), similar to the material identified in Test Pits 5 and 6. This likely represents the same depositional event which covered the inspection pit and revetment in Test Pit 5. As in those test pits, the mixed clay and clinker (1001) partially buried topsoil (1002). This topsoil (1001) sealed a mixed backfill of clay and soil (1002) likely deposited following the

installation of the reservoir tank directly to the north of the trench. This material extended below the limit of excavation for Trench 1 and the natural substrate was not encountered.

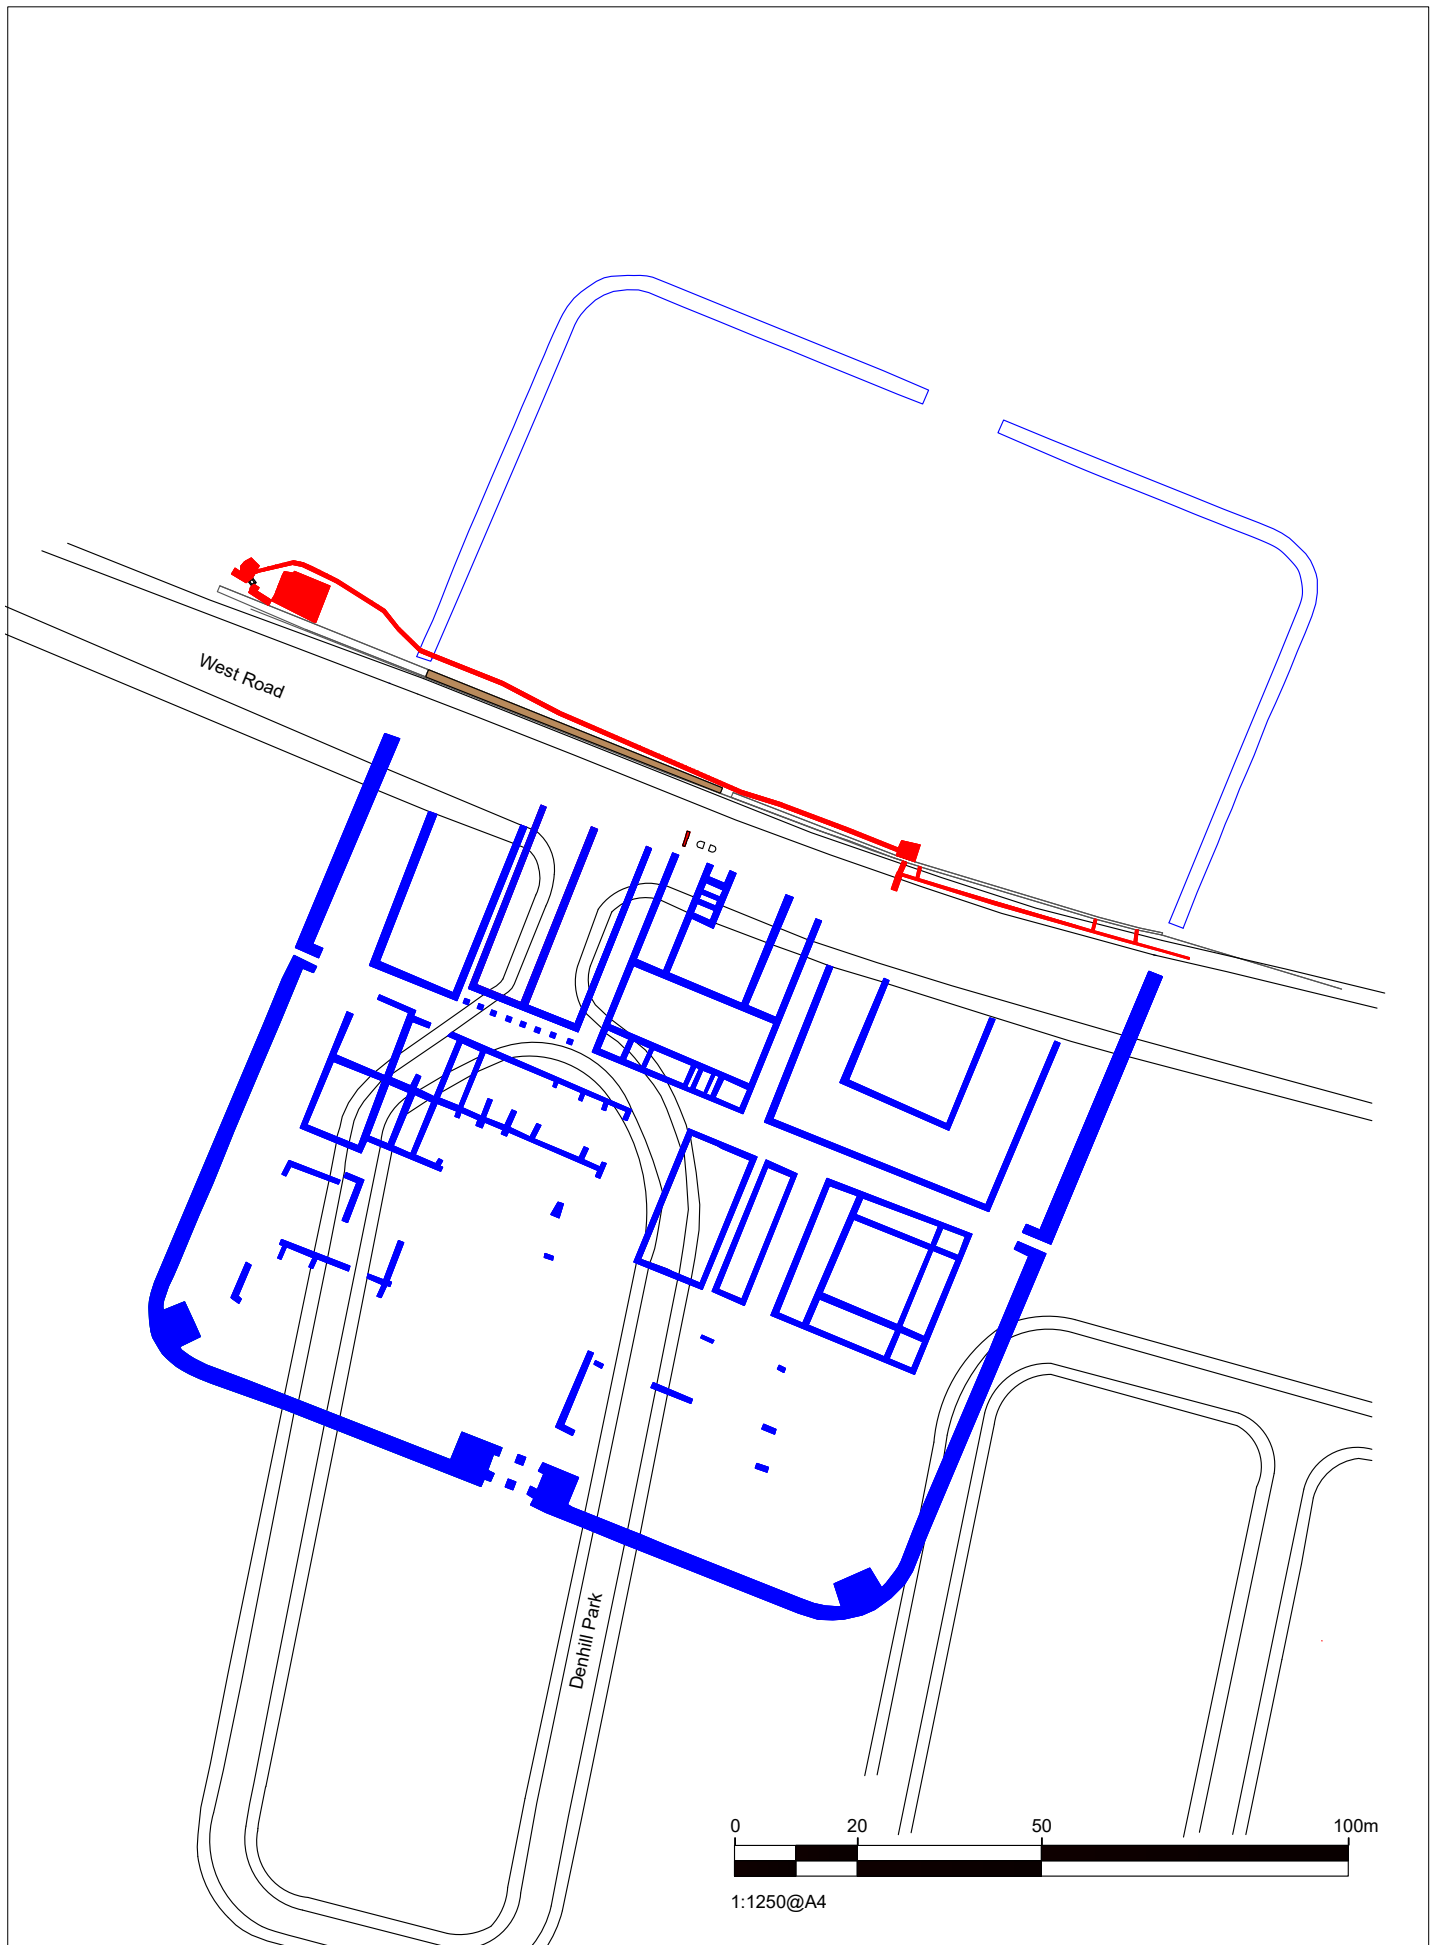
Figure 21. Plan of Condercum Fort overlain by the current road layout, and service trench locations

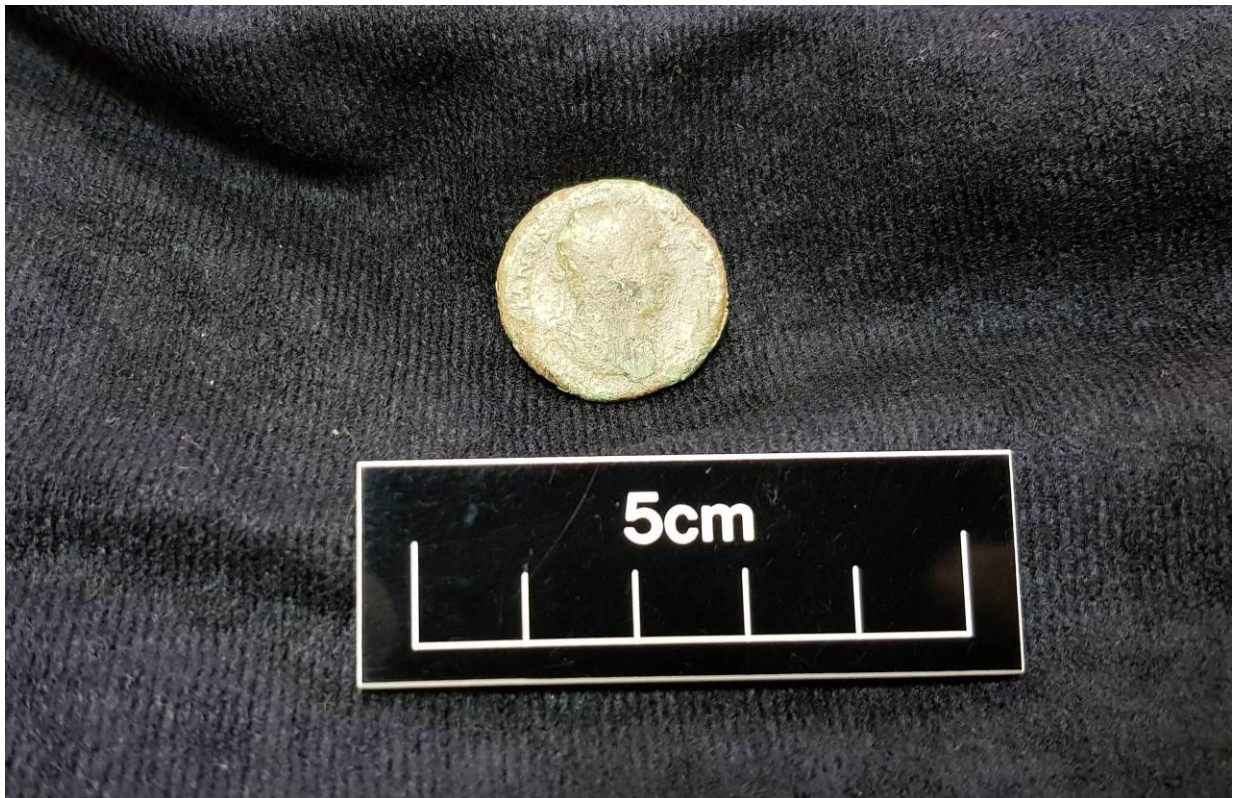
Figure 22. *Sestertius* of Hadrian AD 134 – 138 (Roman Coin)

5.4.1.1 A single Roman coin (8.3g) was recovered from a 19th century landscaping deposit (602) that predated the construction of the reservoir. The coin is a *sestertius* of Hadrian, AD 134 – 138 (RIC II Hadrian 749d). The obverse depicts a bust of Hadrian, laureate, right, with writing ‘...ANVS’ the likely remnants of ‘HADRIANVS’. The reverse shows *Felicitas*, draped, standing left and possibly holding *cornucopia* and *caduceus*.
