**North Yearle Steadings, Earle,
Northumberland
Historic Building Recording**

ARS Ltd Report 2020/14
OASIS ID: archaeol5-383376
January 2020

Planning Reference: 19/01978/FUL

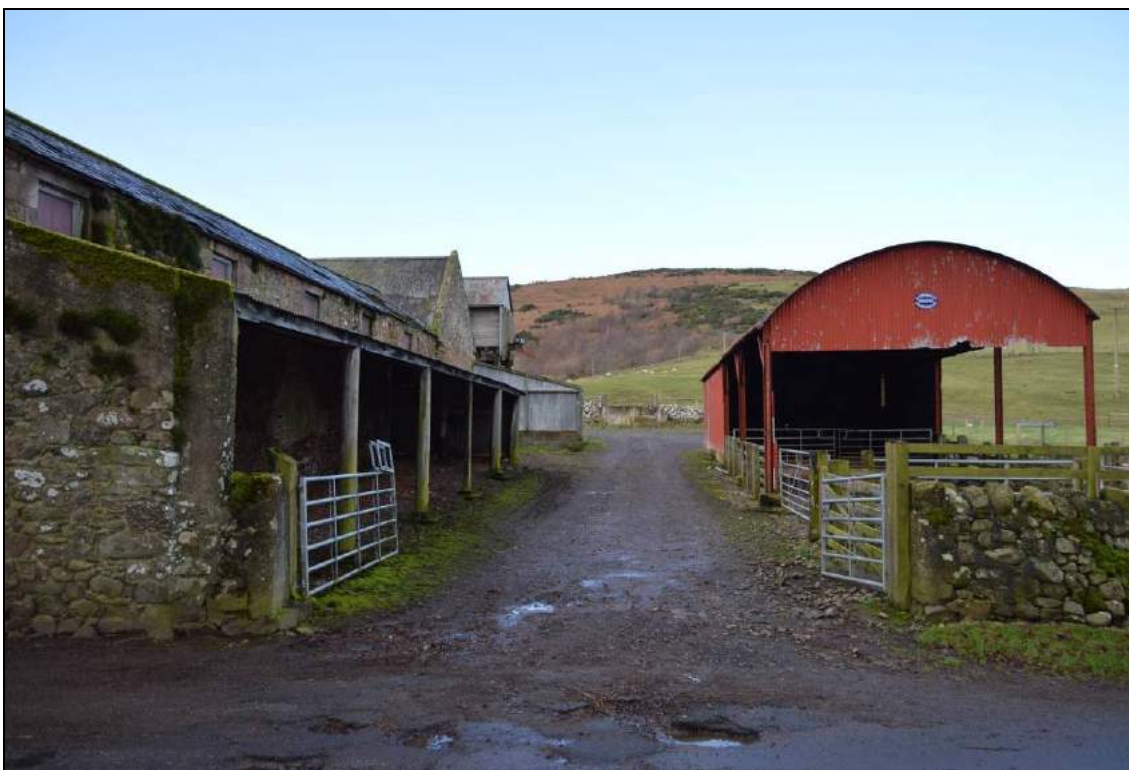
Plate 2: North entrance leading to the rear farm yard area. The corrugated metal Dutch barn to the right is outside the bounds of the PDA. Scale 2m.

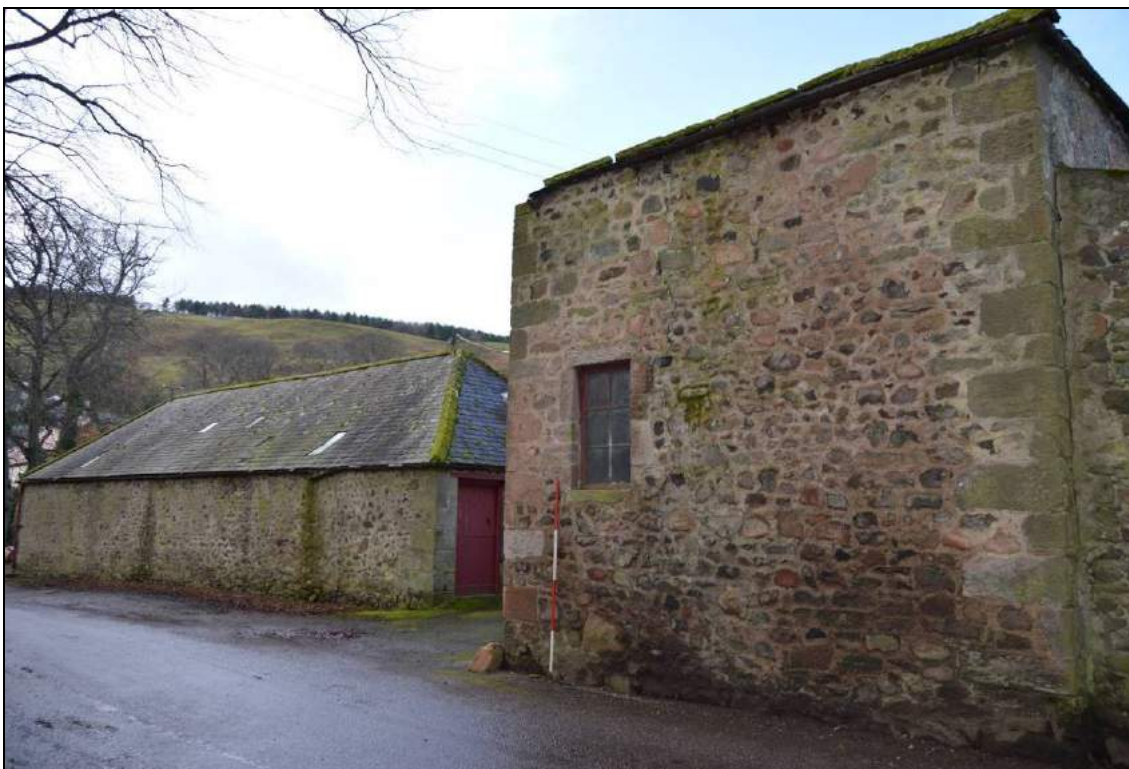
Plate 3: The farm buildings along the east perimeter of the site, from the north road entering the hamlet of Earle. Scale 2m.

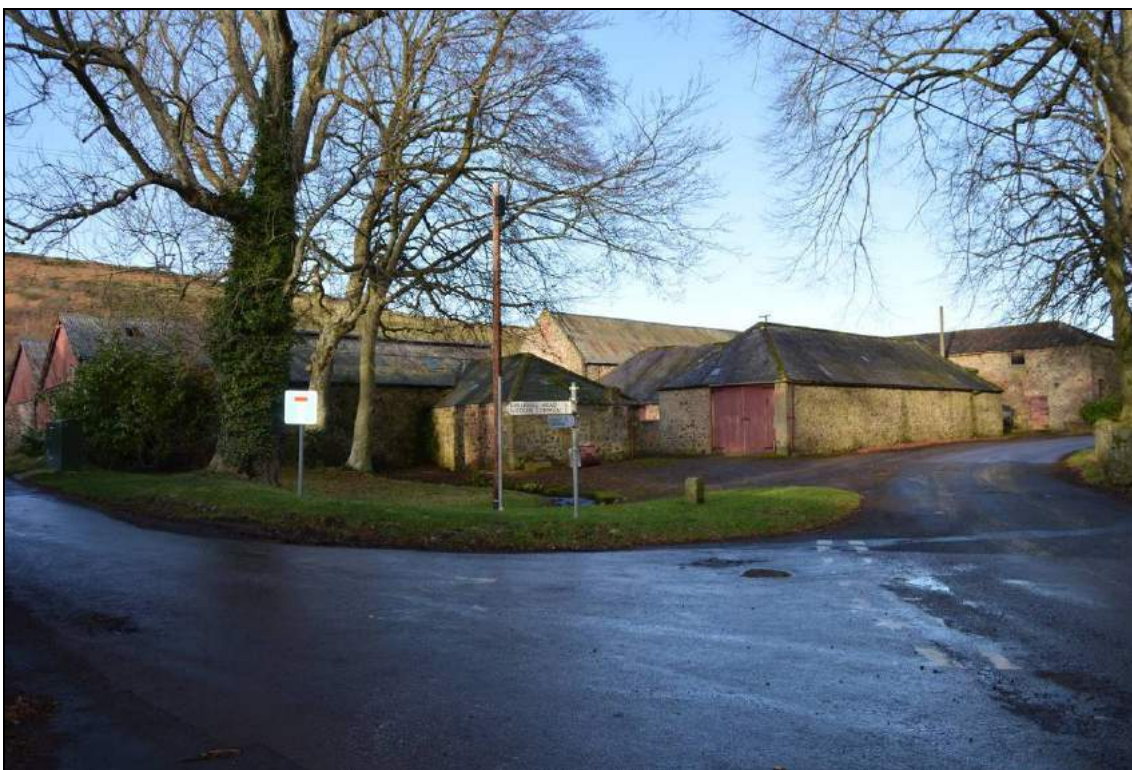
Plate 4: View of the farm buildings (facing north west) at the centre of Earle. The listed farm boundary stone is seen in the foreground.

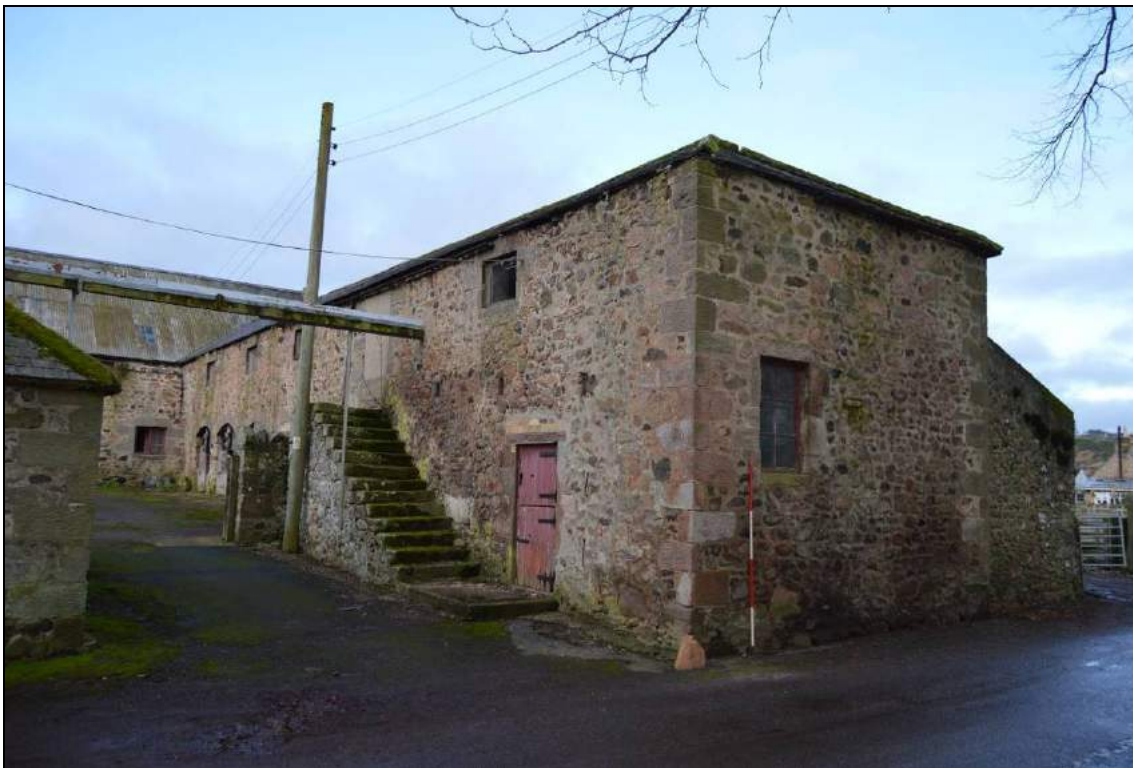
Plate 6: Oblique view of east and south elevations of the Granary/Cow-house range (facing north west). Scale 2m.

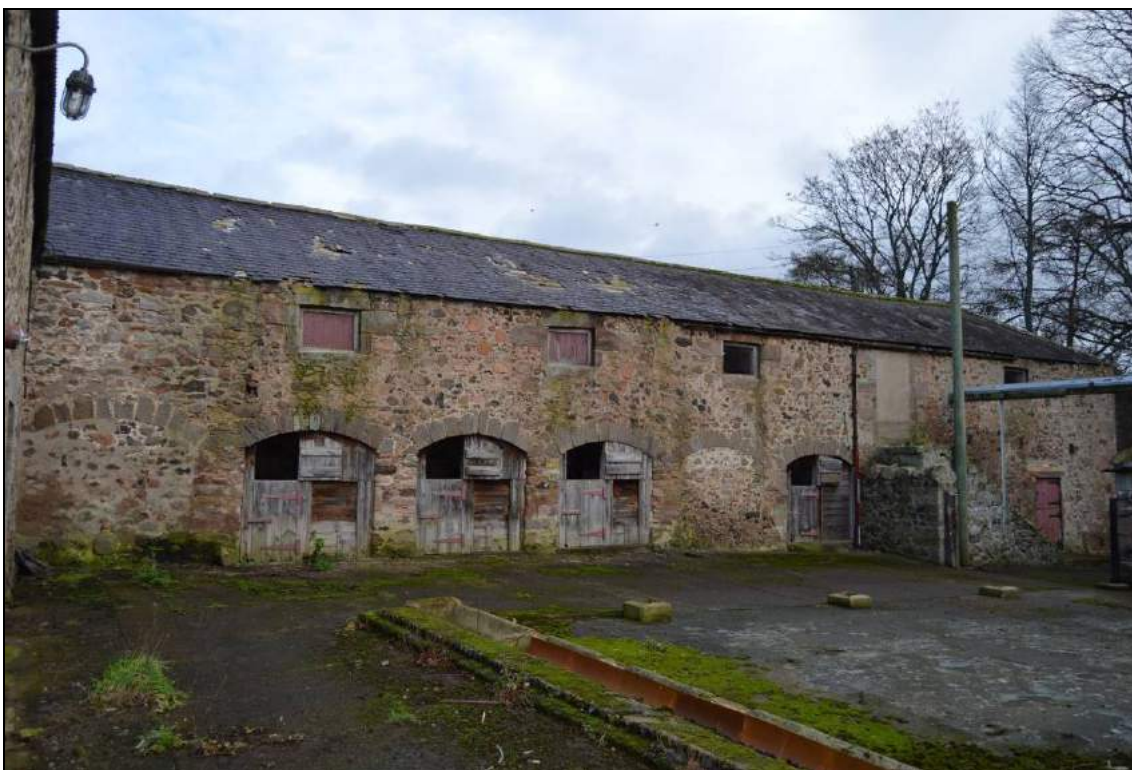
Plate 7: South elevation of the granary/cow-house from within the north foldyard. Scale 2m.

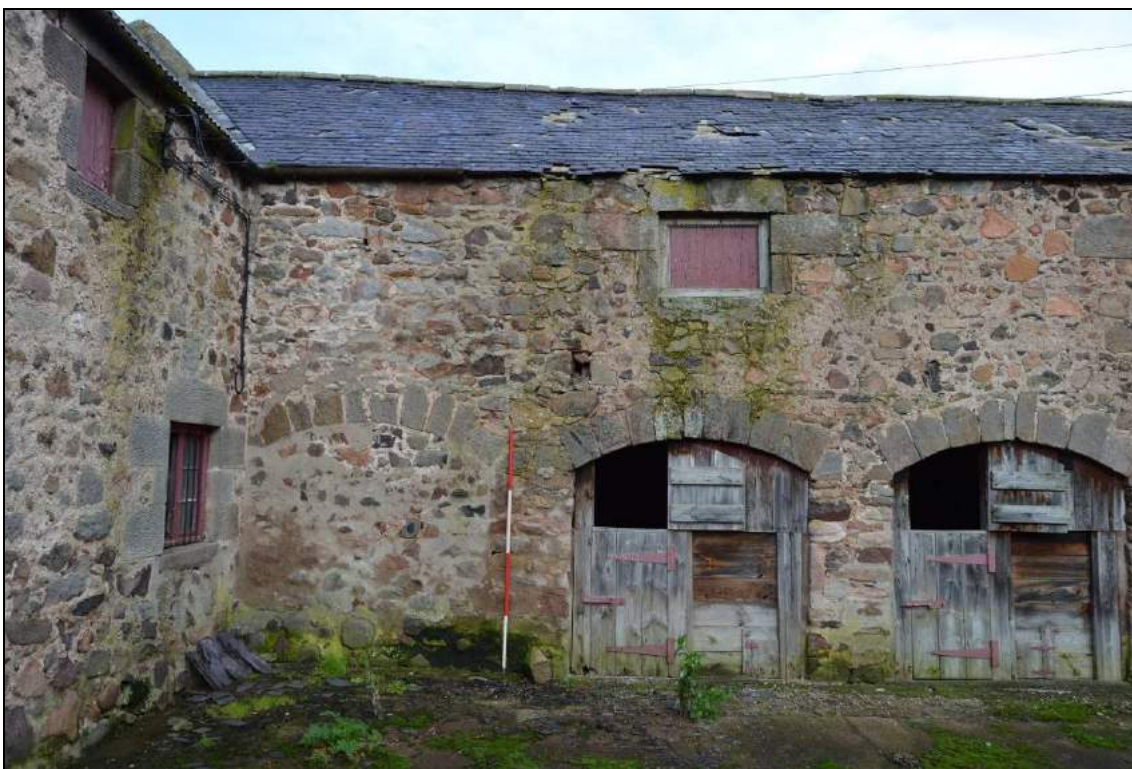
Plate 8: South elevation of the granary/cow-house with three of the former cattle entrances (facing north).
Scale 2m.

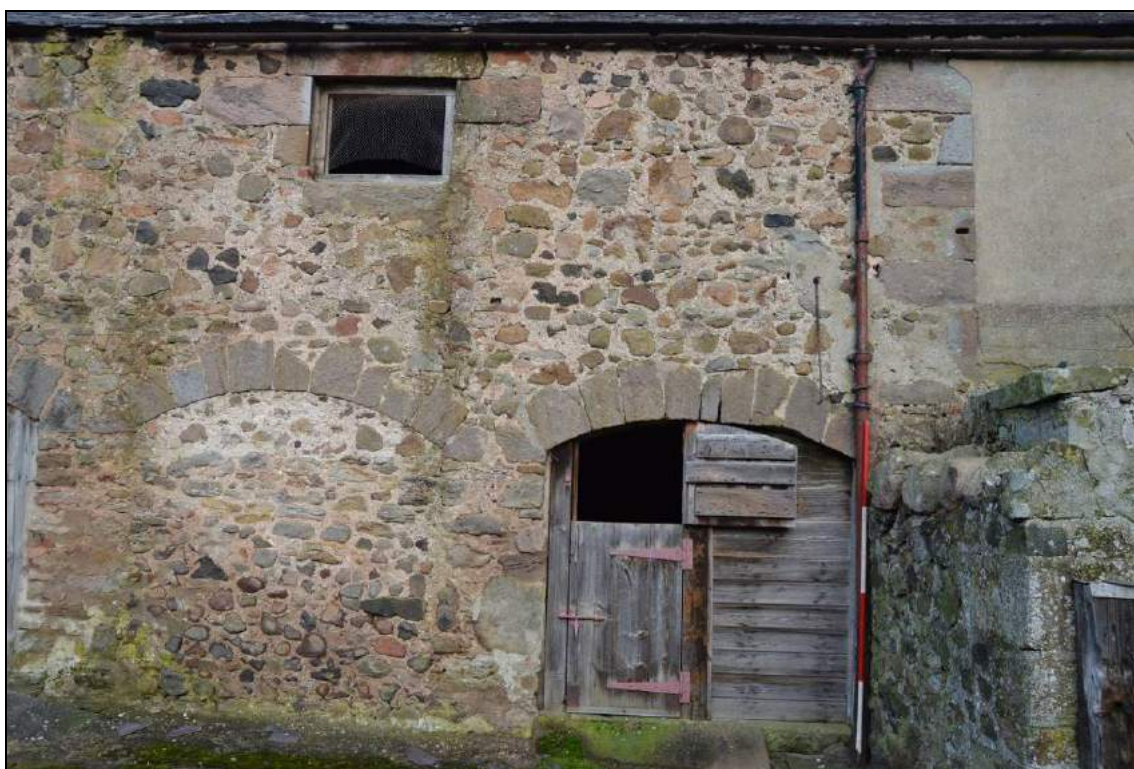
Plate 9: South elevation of the granary/cow-house with two of the former cattle entrances (facing north). Scale 2m.

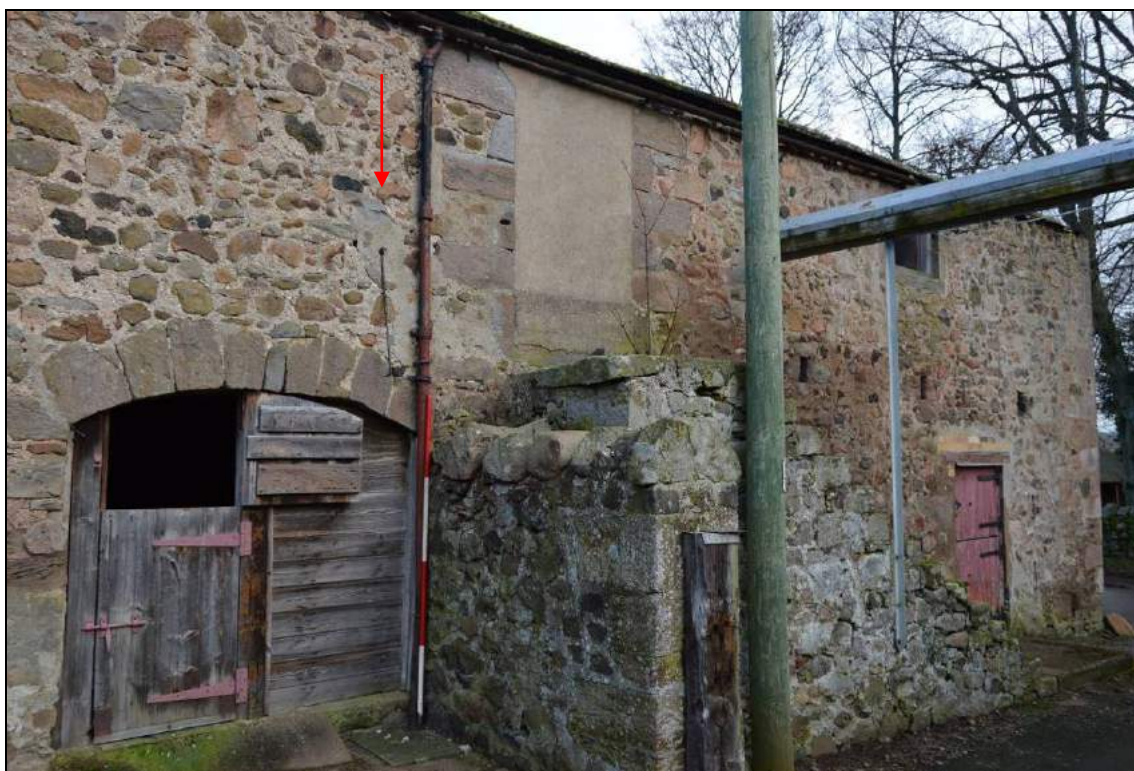
Plate 10: South elevation (facing north east) towards the east section of the granary/cow-house. Note the cement rendered blocked doorway to the first floor. Scale 2m.

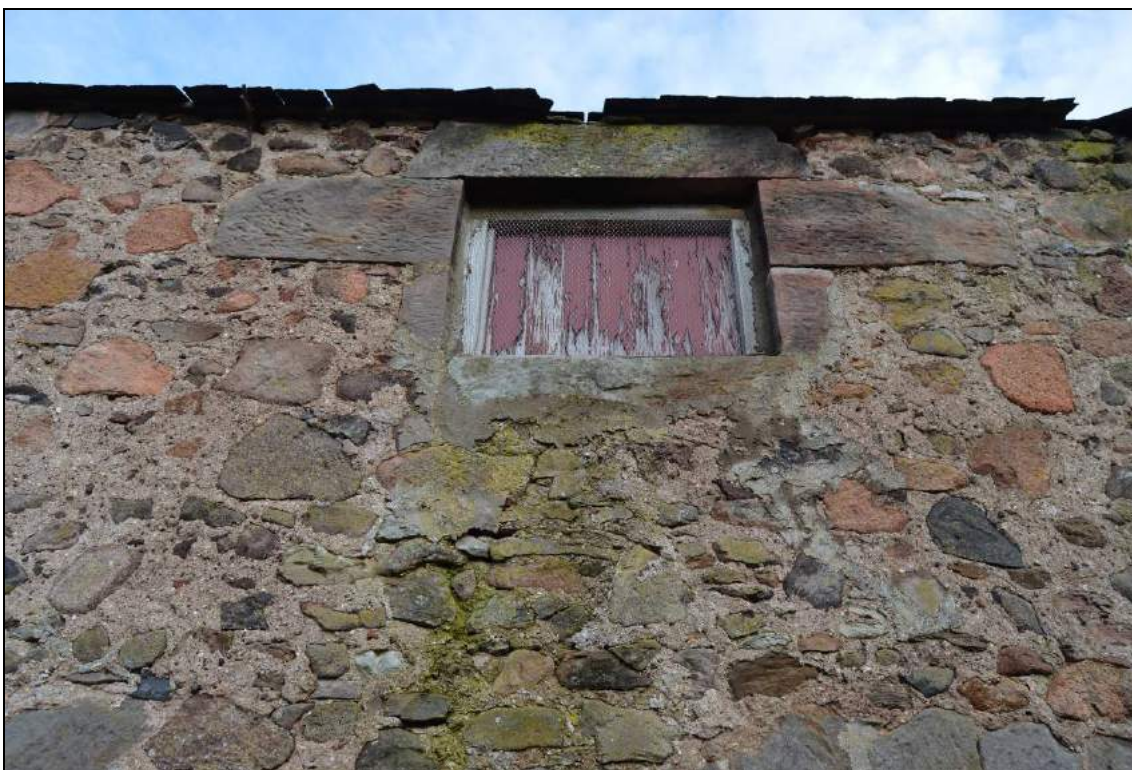
Plate 13: First floor window in east elevation (facing west).

5.2.4 The eastern elevation fronts the public highway and is punctuated by a single window set between the ground and first floor level. The window retains a glazed timber casement, two over three large panes. The surrounding fabric comprises dressed stone lintels and quoins.

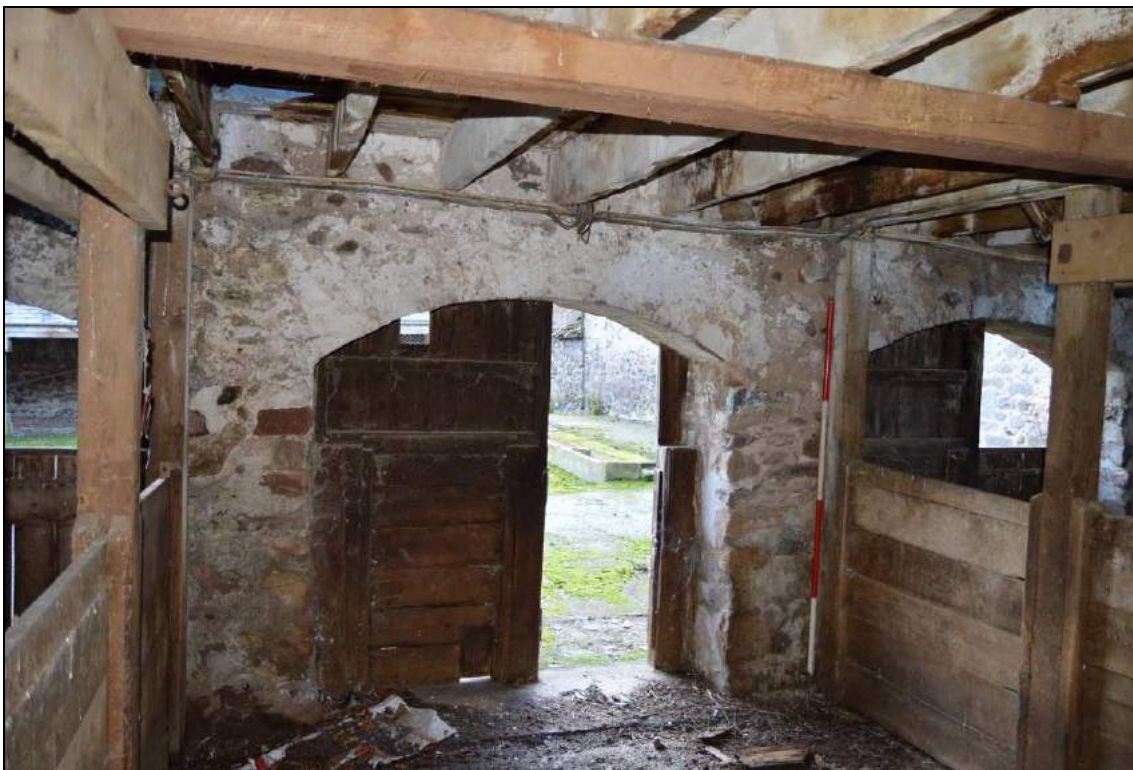
5.3.1 Predominantly the ground floor interior of the building houses a series of animal loose boxes with a largely open, first floor/loft level above. At ground level, three of the arched cattle openings lead to a single large room where series of timber stalls bisect the internal space presently into three areas (Plates 20 to 25). A series of timber stanchions, some of which connect to first floor joists, carry slots which in turn timber slats can be dropped or removed if required.

Plate 20: Division of animal stalls inside cow house (facing east). Scale 2m.

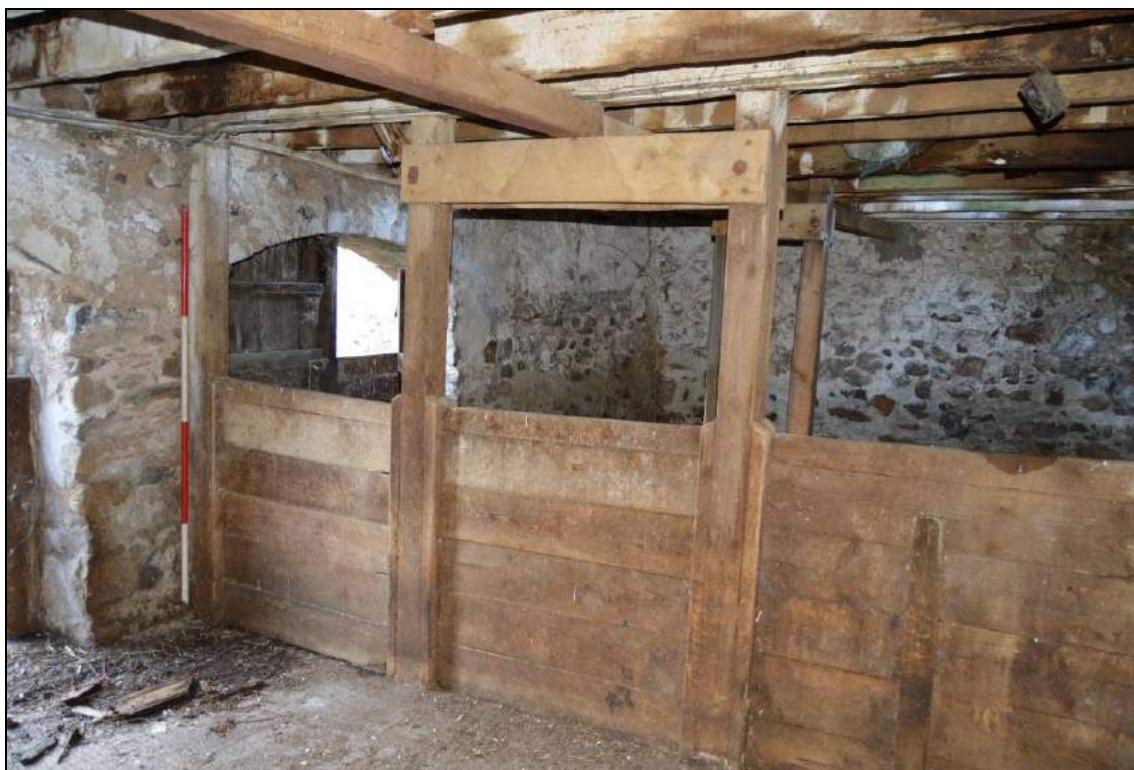
Plate 21: Animal stalls to west (facing west), with the blocked door contributing to a larger space. Scale 2m.

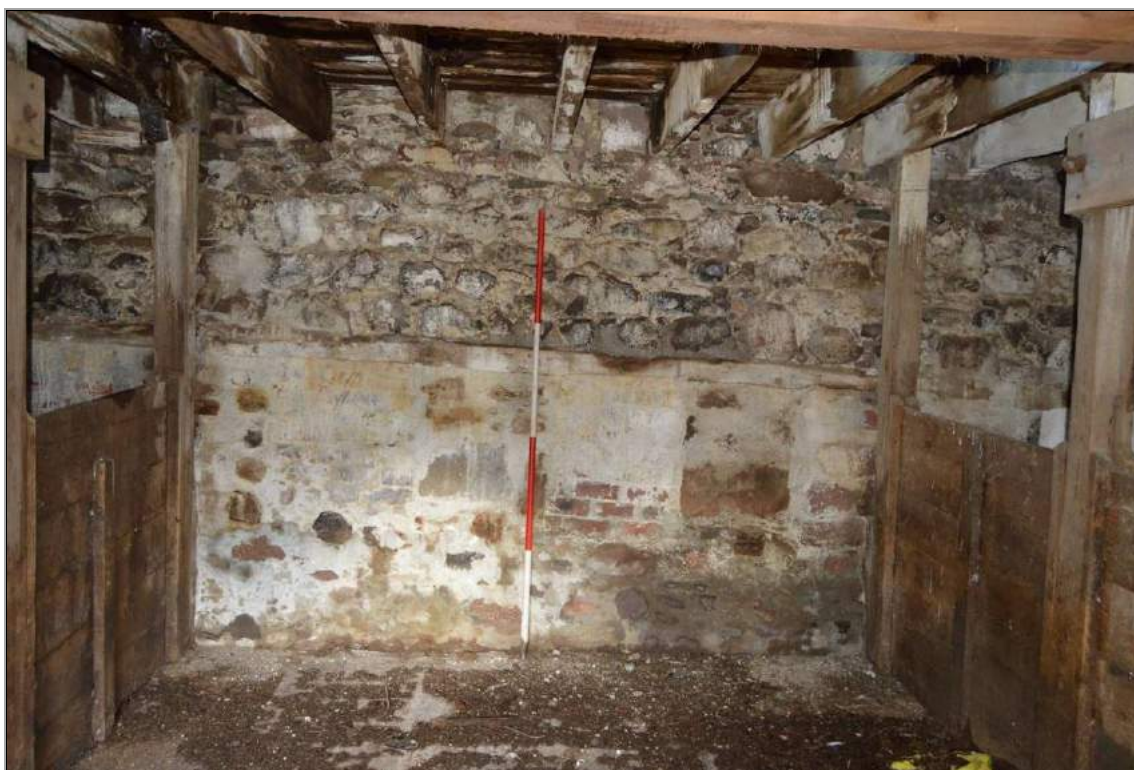
5.3.2 The internal face of the north elevation shows the blocked apertures noted to the exterior surface. These are comprised of red brick internally and a roughly finished timber lintel extends across the top. To the east, is a separate animal stall divided by stone internal walls (Plate 26). The remainder of the ground floor rooms to the east (beyond the single stable door) could not be accessed at the time of survey.

Plate 23: South room with blocked apertures (facing south east). Scale 2m.

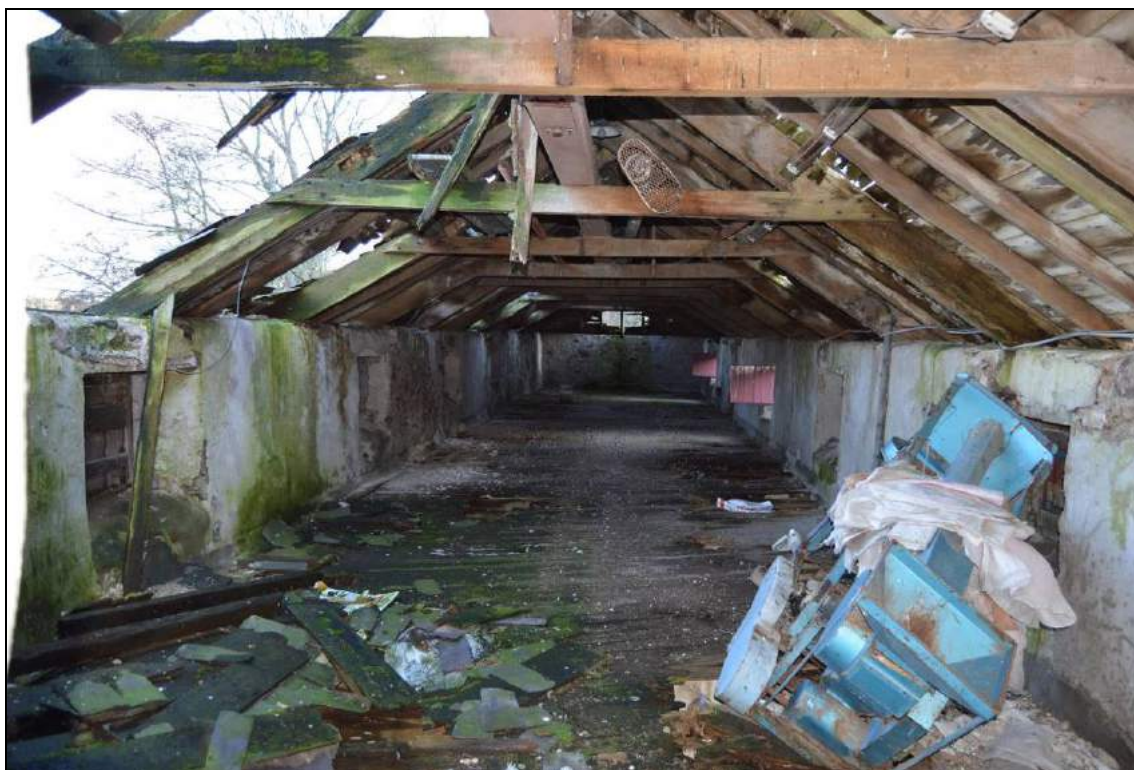
5.3.3 The first floor area of the building presently forms a single open space, likely utilised for animal feed and/or grain packing and storage (Plate 27). The space is accessed via a doorway in the internal dividing wall to the west, access facilitated through the upper level of the barn (Building 2). Access was limited due to the poor state of the granary building's upper floor and roof. The roof is constructed of raised tie timber trusses fixed with metal pins, the lapped joints having carpenter's marks (Plate 28). The walls were plastered and white washed. The windows, or pitching hatches, have curving, plastered cills to their inside edges. Some modern, grain processing machinery remains along with a wooden conveyer conduit (as observed externally) set within the apex of the roof space.

Plate 27: Granary first floor (facing east). Scale 2m.

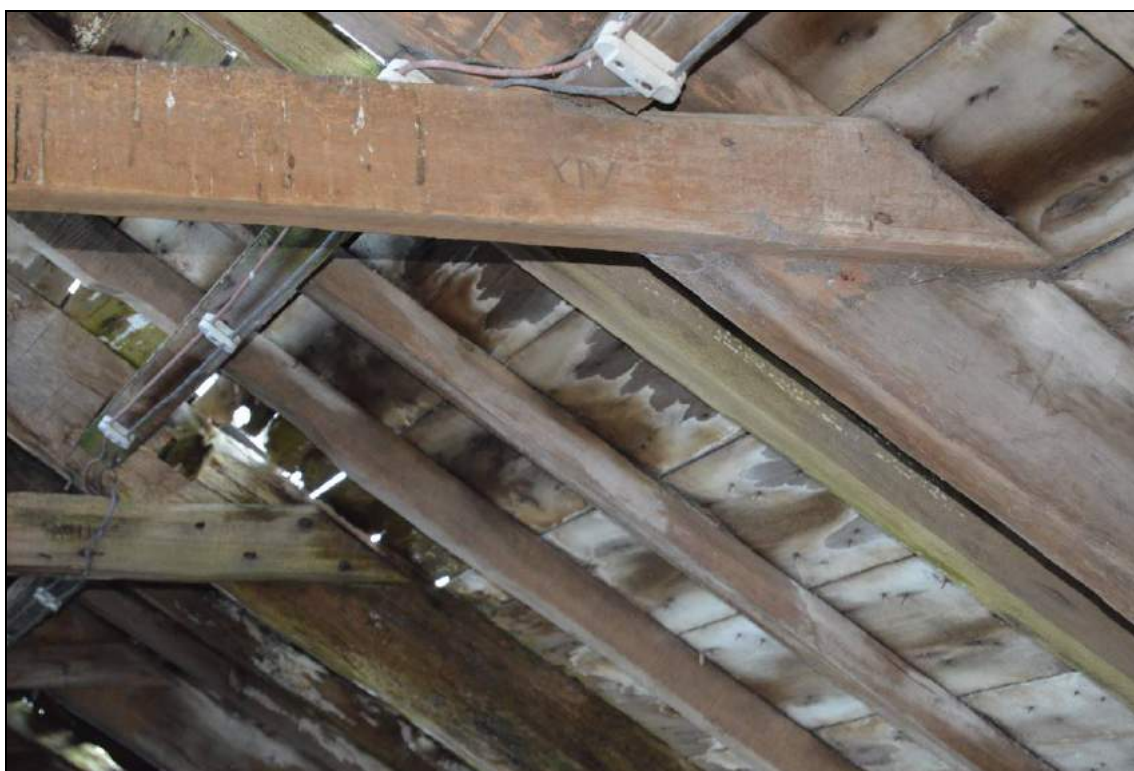
Plate 28: Detail of wooden truss over the granary level (facing east).

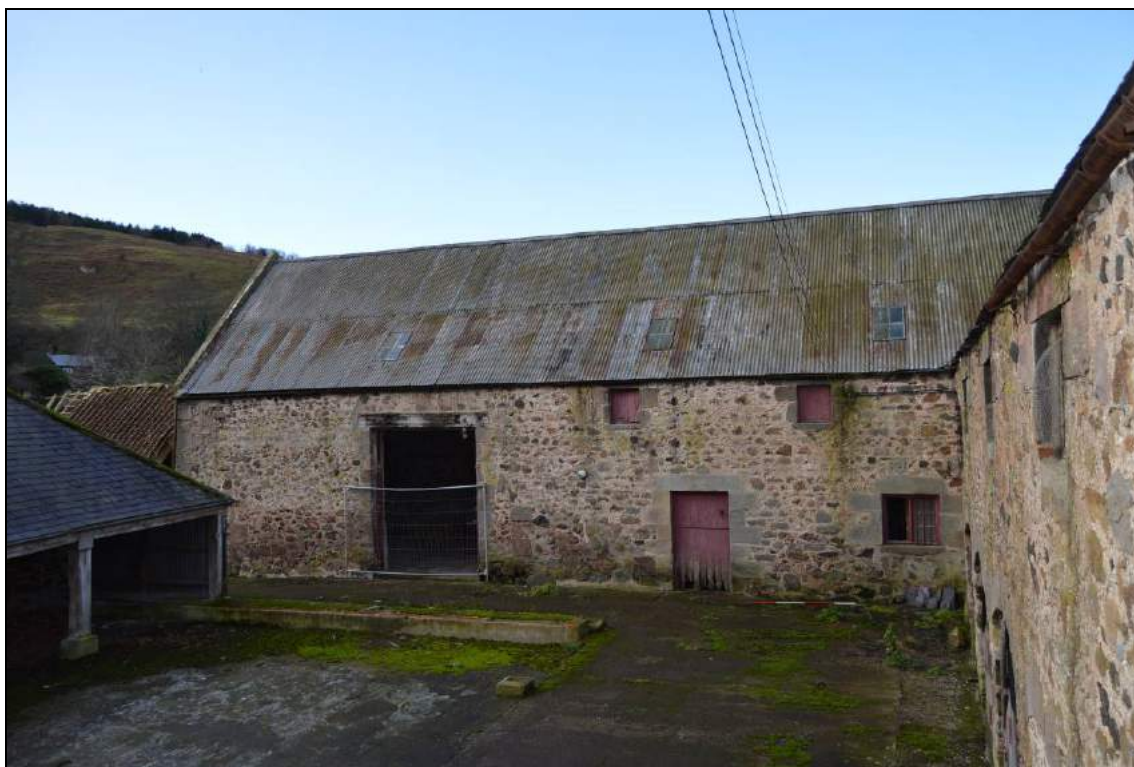
Plate 29: East elevation of the barn (facing west). Scale 2m.

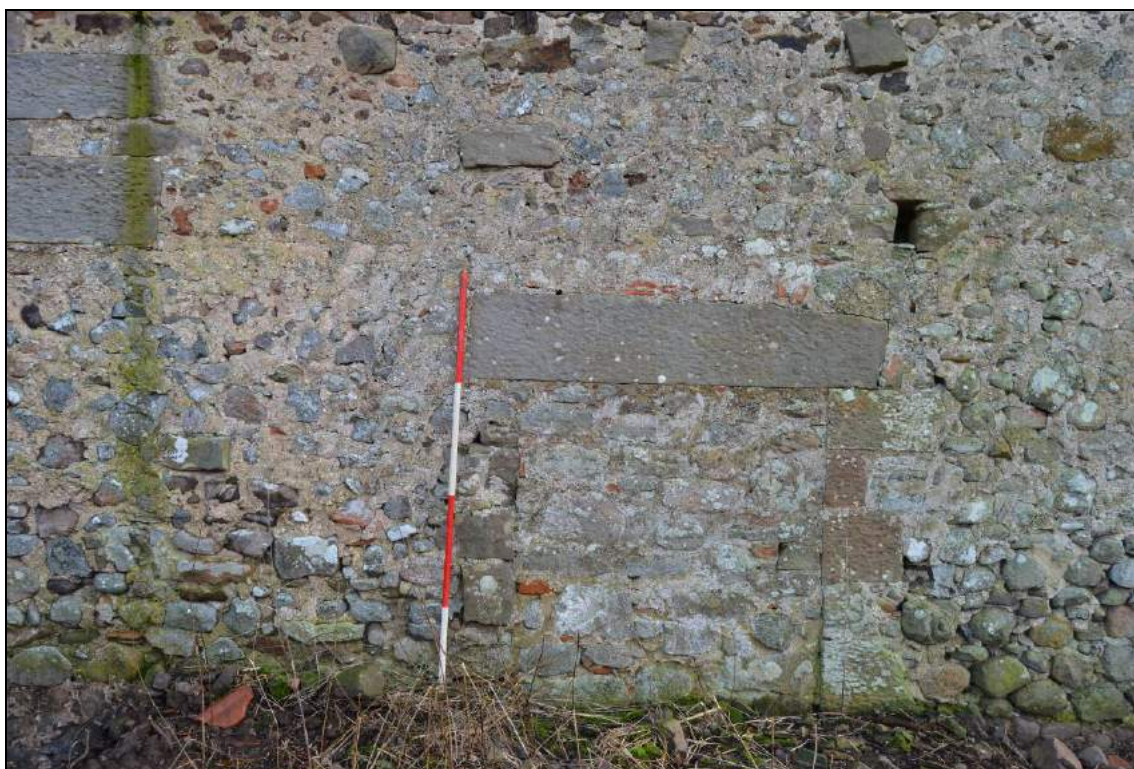
Plate 36: Blocked apertures in west elevation. Scale 2m.

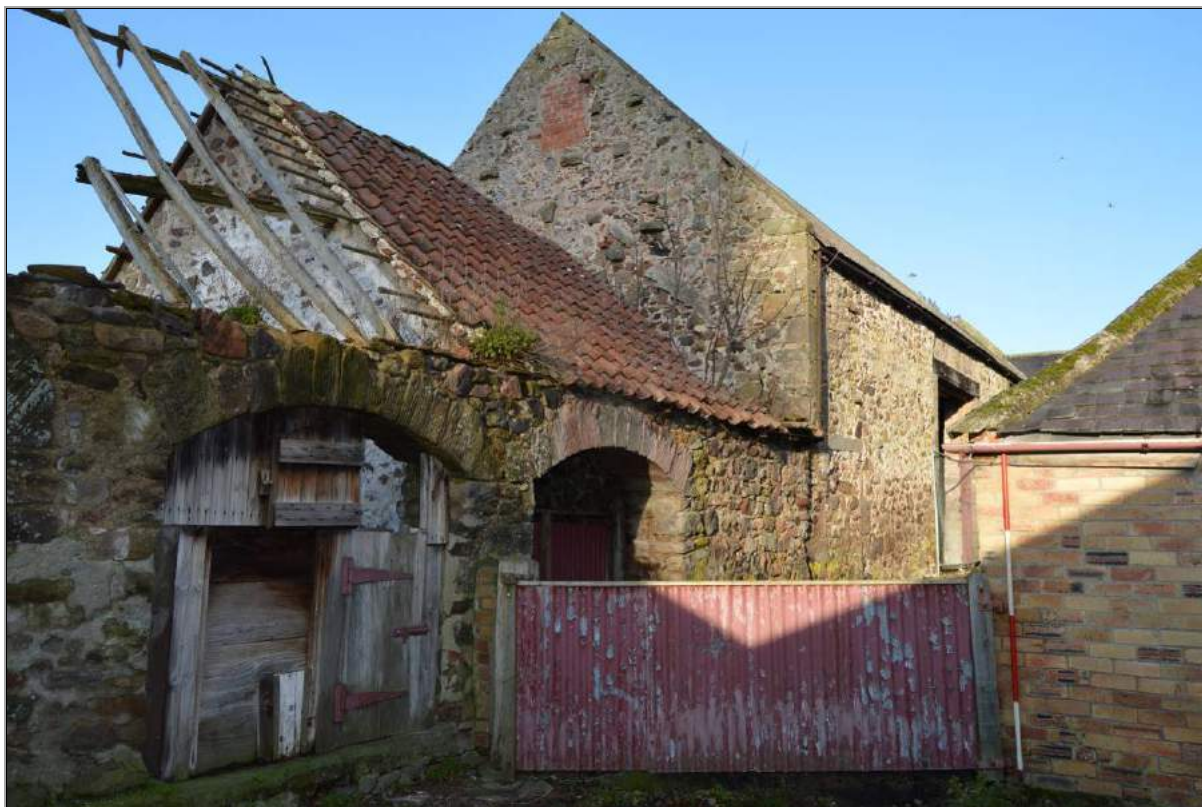
5.6.2 The south and north elevations of the building are formed by neighbouring buildings, the barn to the north and the south animal accommodation/shed to the south. Due to the condition of the building access to the interior was limited. The hemmel/cow-house structure is differentiated to the other buildings on the site by having a pan tile roof (Plate 54).

Plate 54: Hemmel building (facing north west). Scale 2m.

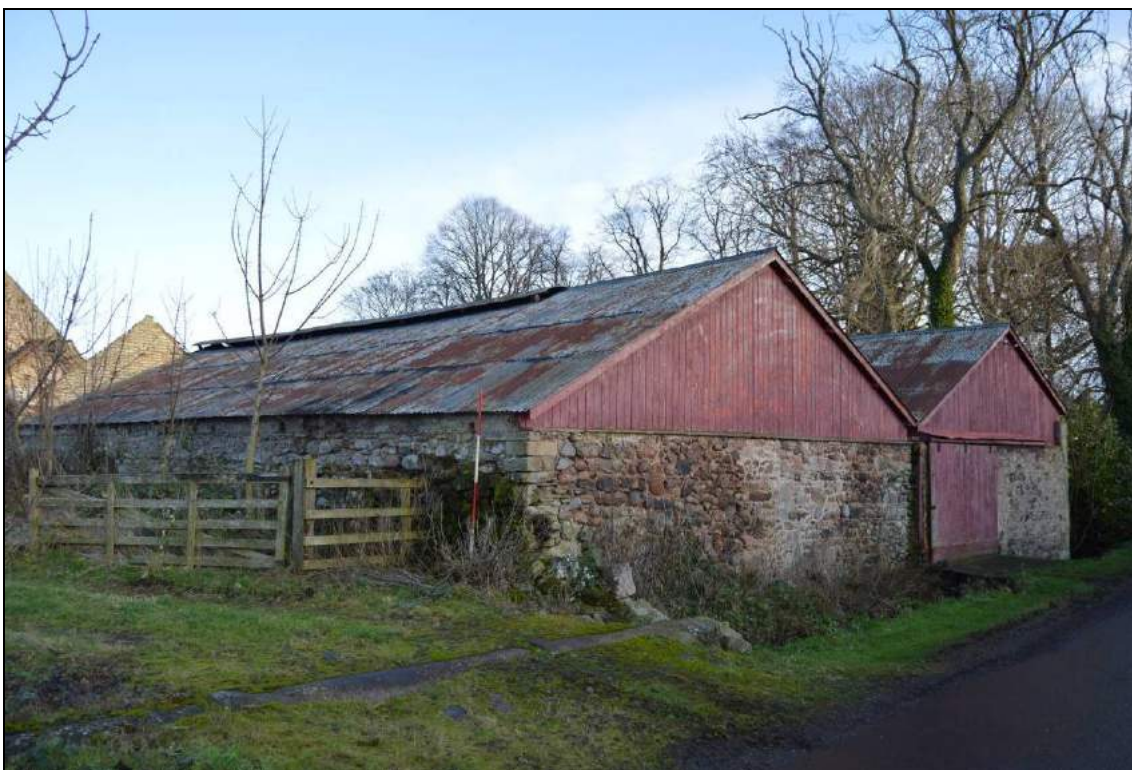
Plate 72: Concrete bridge (over former mill race) south elevation of south animal shed showing (facing north west). Scale 2m.

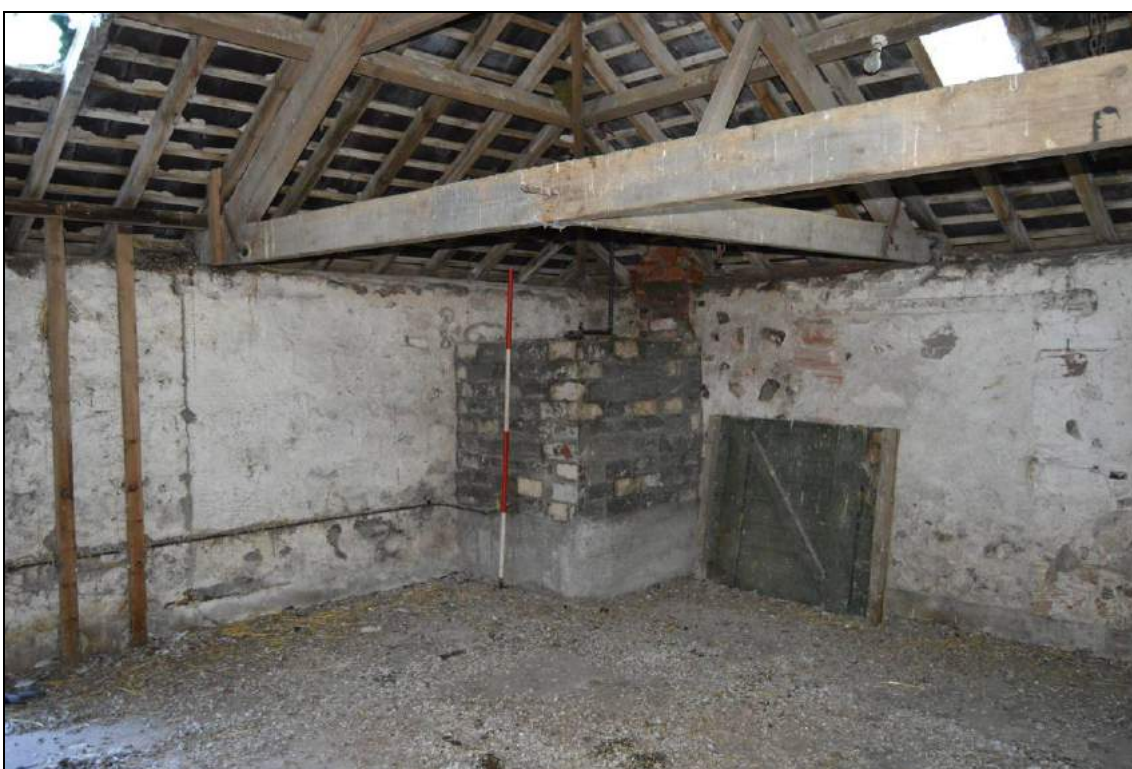
5.9.3 The east elevation contributes an internal doorway through to the eastern pavilion structure. The interior of this building is empty apart from a brick and concrete structure associated with the flue observed externally (Plate 79). This was likely used heating water.

Plate 79: Interior of the project wing of the south animal accommodation (facing north east). Scale 2m.

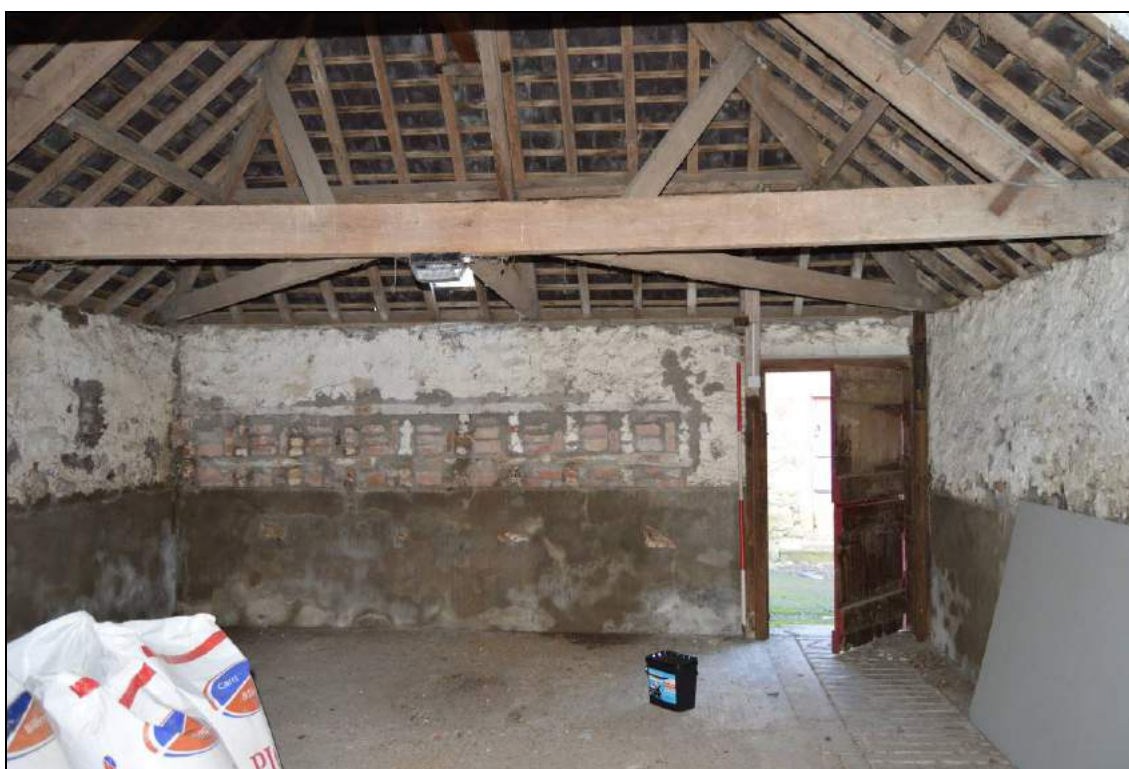
Plate 85: Interior of Building 5 (facing north). Note the brick blocked apertures in the far wall. Scale 2m.

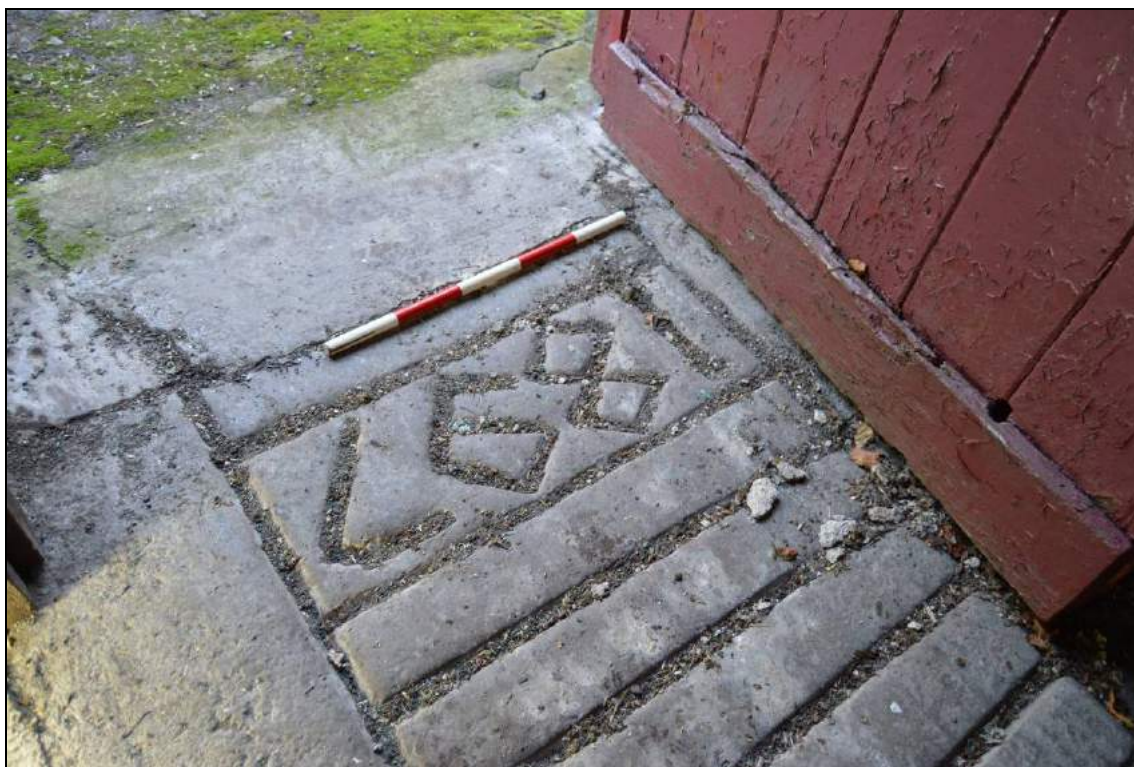
5.11.2 A concrete floor extends the extent of the interior. Interestingly a section of the floor is delineated with treads suggestive of a feeding passage arrangement used in animal sheds. The threshold of the north doorway is imprinted with the date '1897' (Plate 88). Some of the concrete flooring may have been replaced, equally the lower wall portions having been finished in a cement render. The upper exposed stonewalls are lime washed.

Plate 88: Date cast in the concrete floor (facing north east). Scale 0.5m.

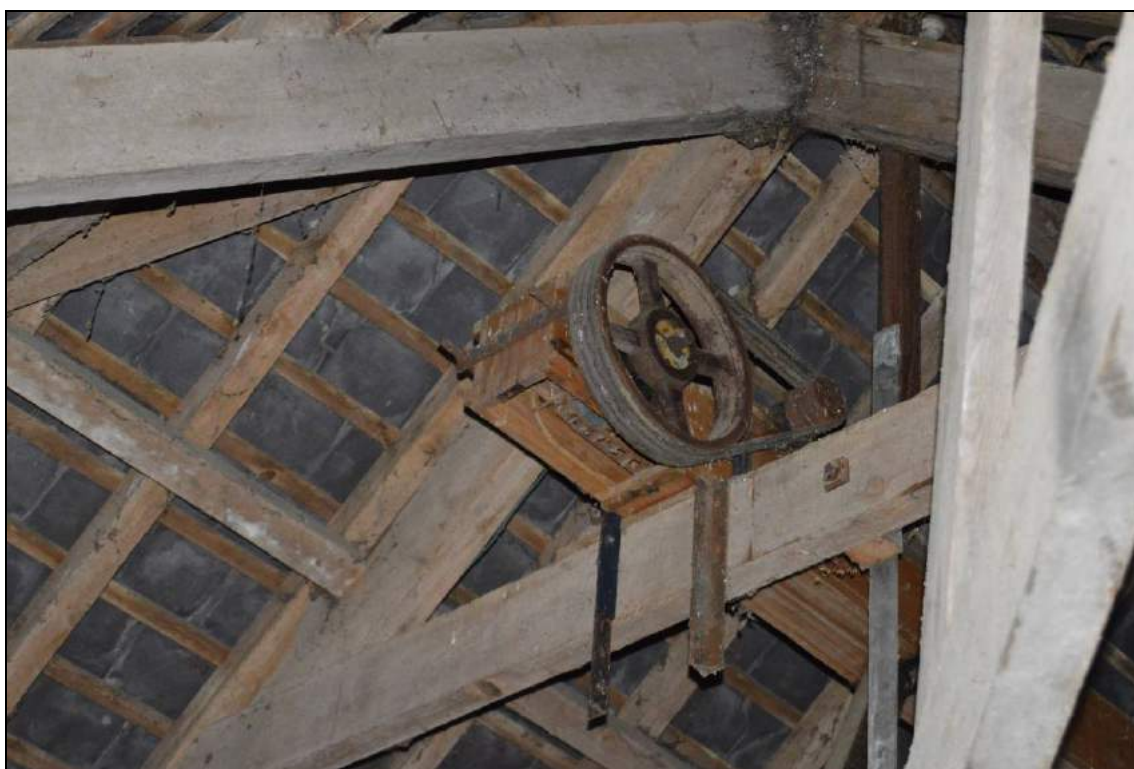
5.11.3 The underside of the roof is exposed revealing a series of timber trusses. Set long the apex of the roof space is a grain conveyer, feeding from the north granary range, which terminates at the south vehicular entrance. An electrically drive belt and pulley mechanism is evident at this location (Plate 89).

Plate 89: Grain conveyer mechanism in roof space of building (facing north west).

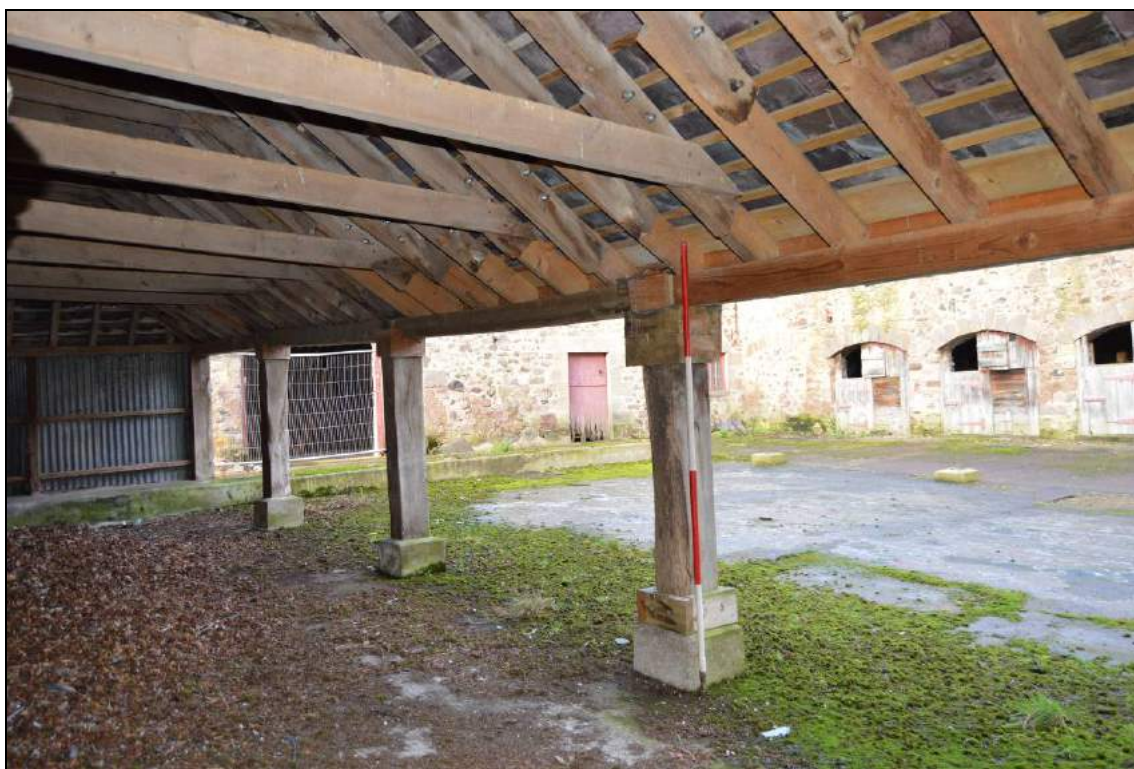
Plate 92: Interior of north shelter shed with supporting columns to front (facing north west). Scale 2m.

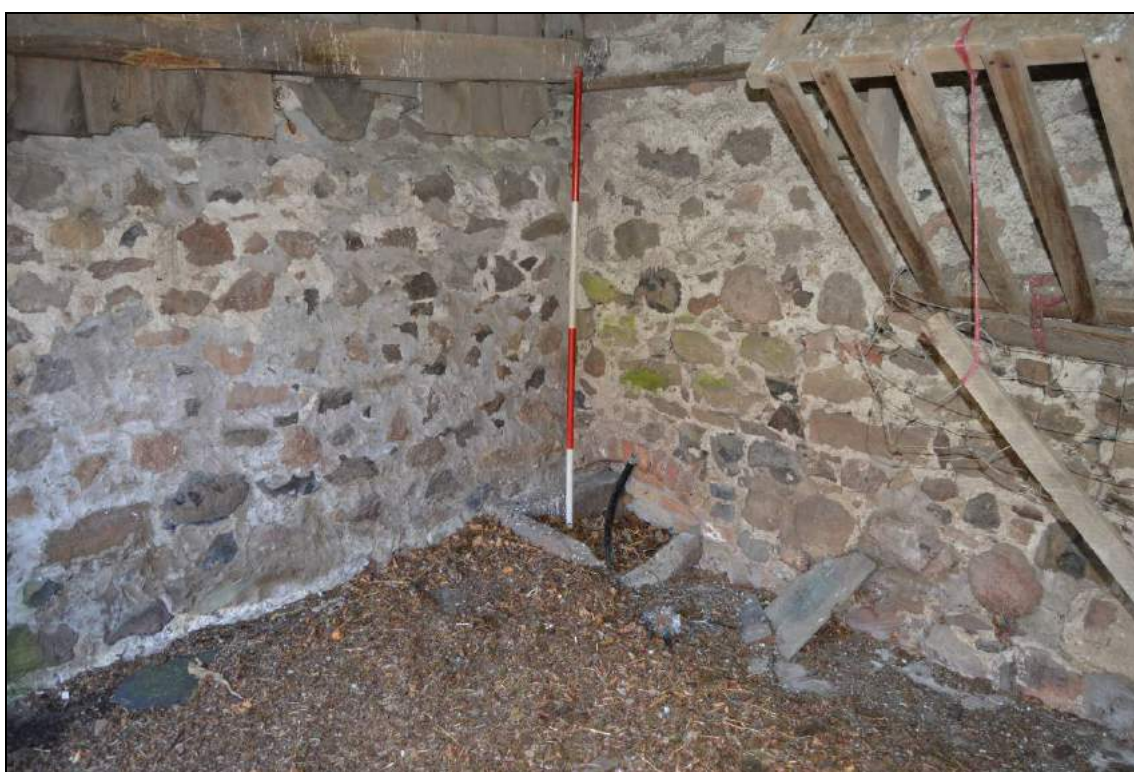
Plate 94: Interior of north shelter shed with drain (facing south east). Scale 2m.
