**North Yearle Steadings, Earle,
Northumberland
Historic Building Recording**

ARS Ltd Report 2020/14
OASIS ID: archaeol5-383376
January 2020

Planning Reference: 19/01978/FUL

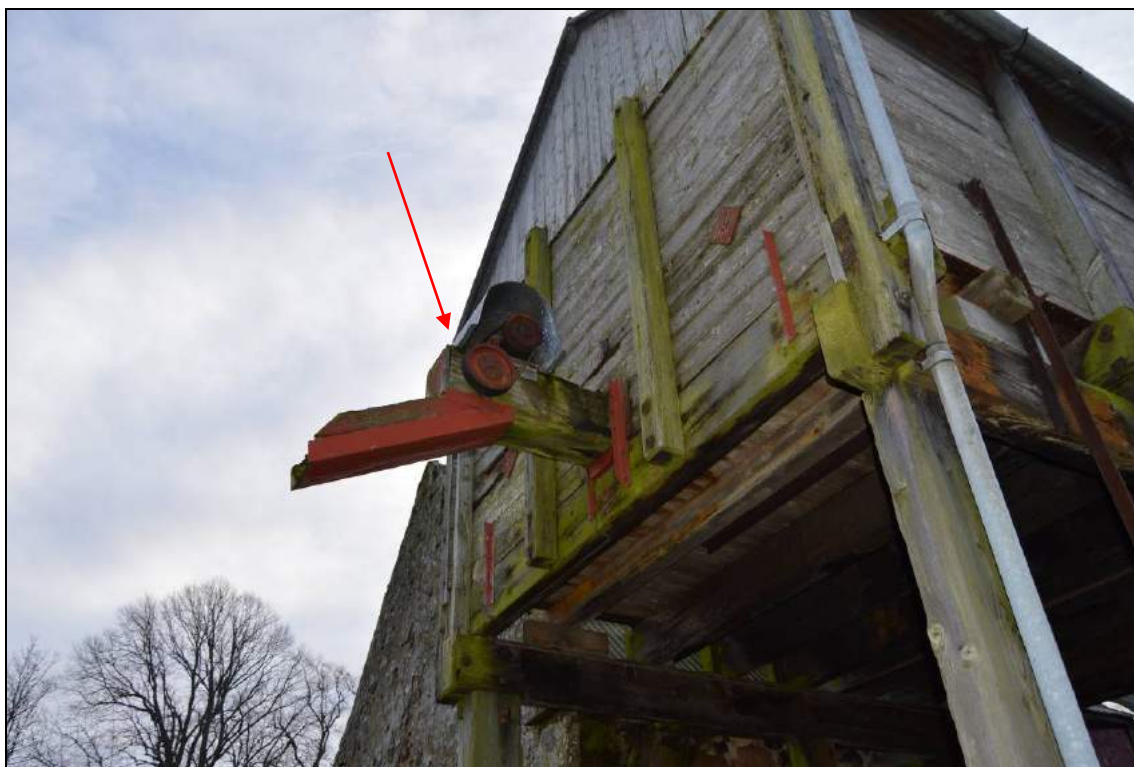
5.13.1 A chute projects from the north elevation (Plate 98) which has a conveyer mechanism. This comprises an electric motor and belt pulleys with a simple metal sheet for a rain cover. The tower was also linked, via a conveyer, to the adjacent barn.

Plate 98: North elevation of grain tower with mechanised conveyor chute (facing east).

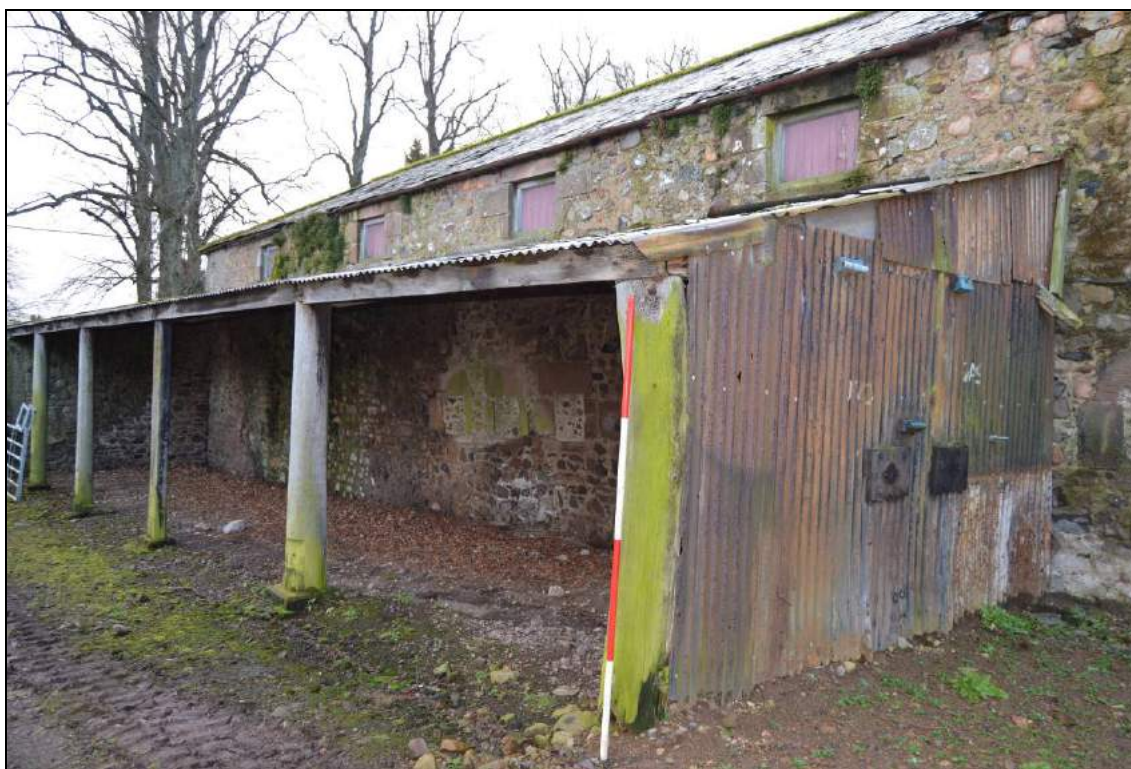
5.14.1 An open fronted shelter structure is located along the north wall of the cow-house and granary building (Building 3). The structure is comprised of a timber frame covered with corrugated metal sheets, of rusted appearance, forming a single pitch roof below the first floor window cill level the adjacent stone building (Plate 100). The open front is supported via five substantial rounded timber columns set on pads. The east elevation for the shelter is a section of stone walling flanking the northern most farm entrance (Plate 101). The west elevation is composed from the timber framing and similarly covered in corrugated metal sheeting.

Plate 100: Timber and corrugated metal shelter along the north elevation of the cow-house/granary (facing south east). Scale 2m.

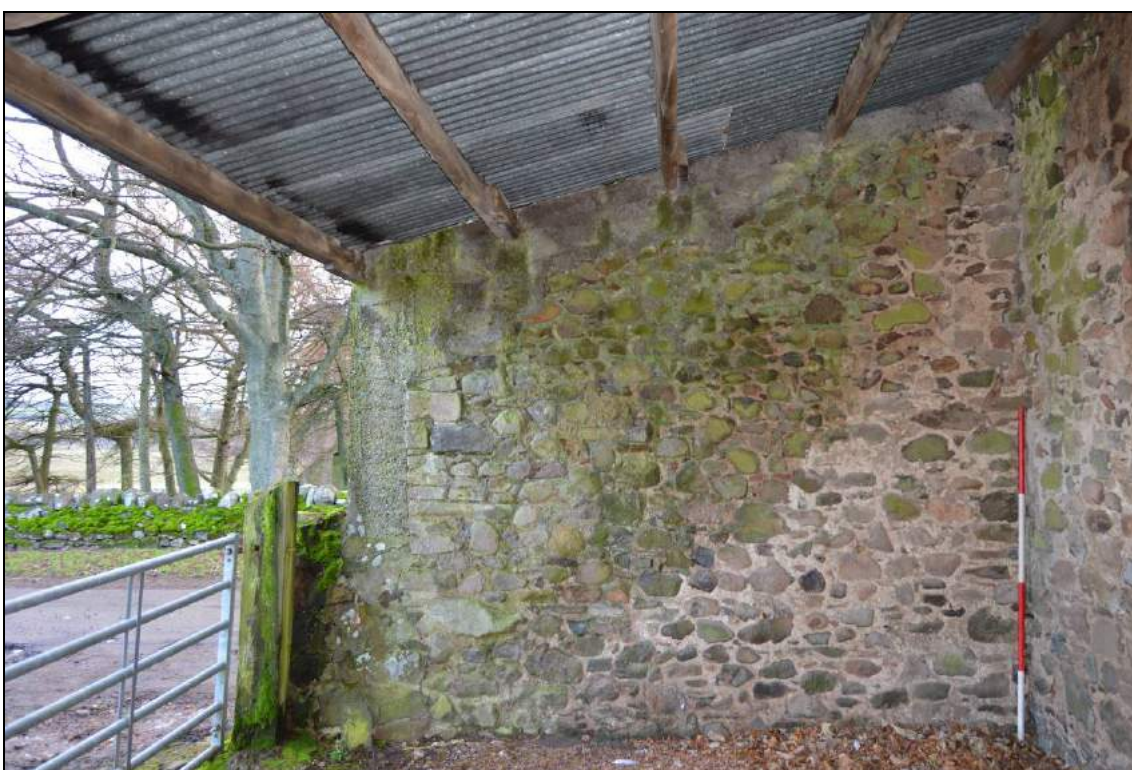
Plate 102: East elevation, of stone construction, of the shelter shed (facing east). Note. Scale 2m.
