Consall Hall, Consall, Staffordshire: historic building recording

ARS Ltd Report 2020/32

January 2020

Prepared on behalf of: Consall Hall Estate Ltd

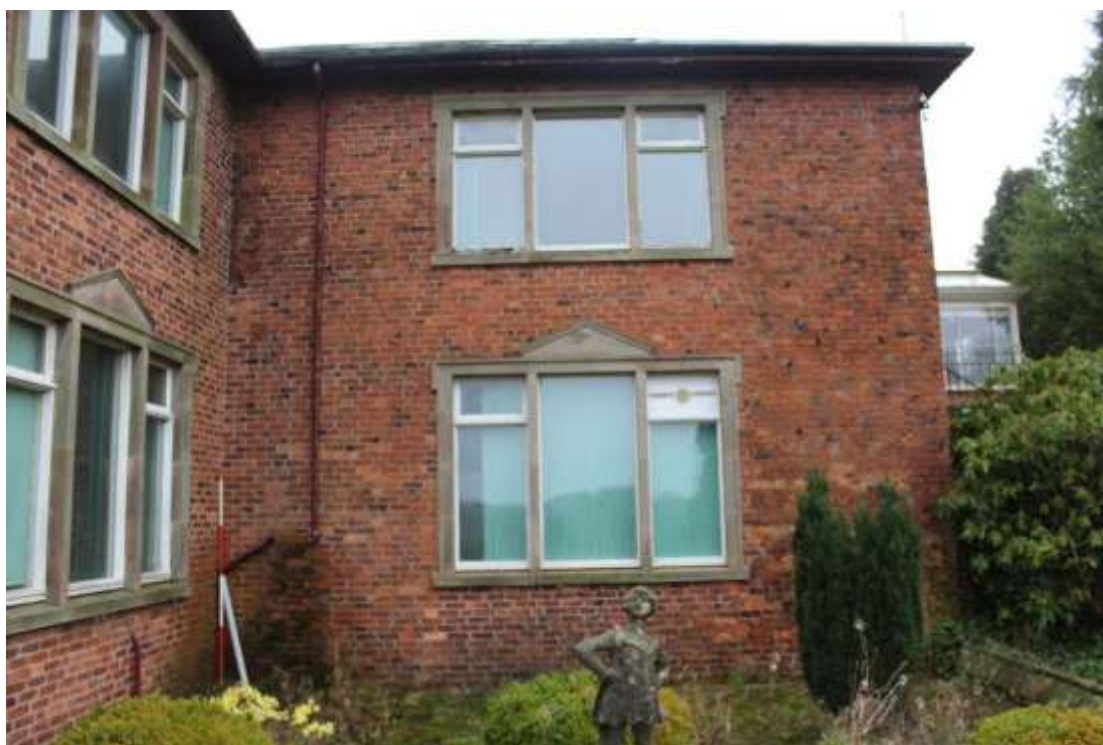
Plate 1: View of the eastern bay of the southern elevation of Block A, facing north. Scale 2m.

6.3 The southern elevation (Plate 1) has been partially obscured on the western side by Block B. What remains in the eastern bay are two, three-light mullioned windows with label moulding. The ground floor window central light is covered with a pointed pediment.

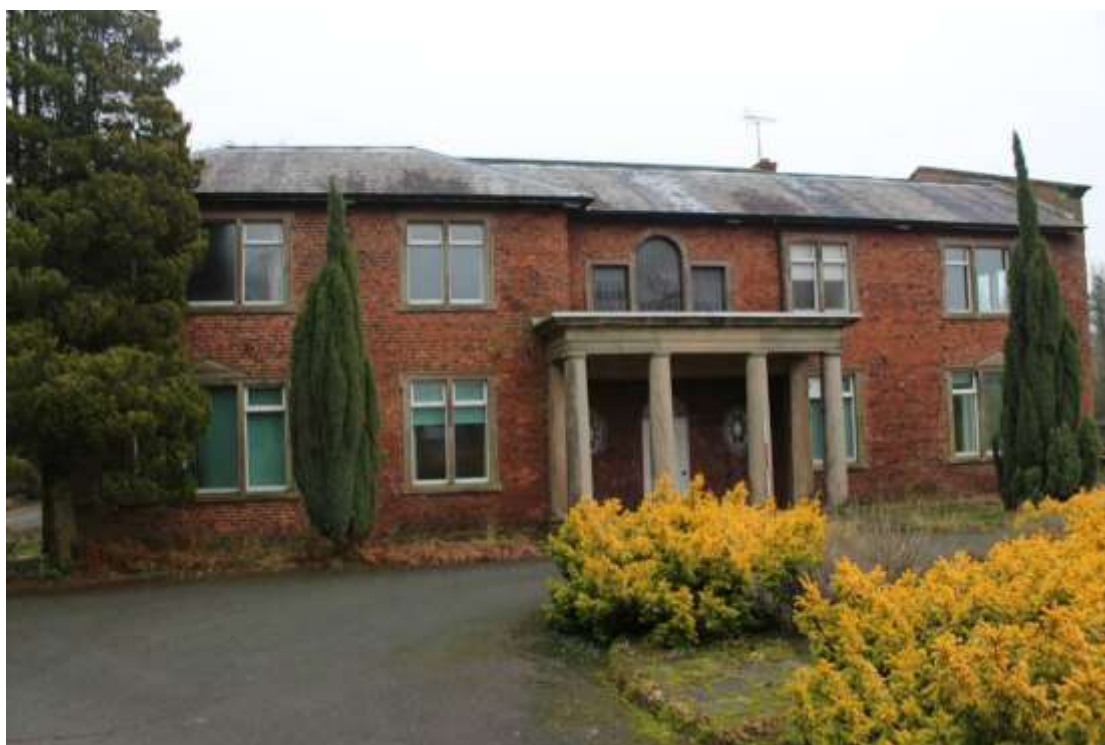
Plate 2: View of the western elevation of the hall, note the portico linking Block A (to the left) and Block B (to the right), facing south east. Scale 2m.

6.4 The west facing elevation (Plates 2 & 3) is of two bays and is abutted on its southern extent by Block B and the portico added between the two blocks in the 1950s. The northern bay consists of a three-light mullioned window with concrete surrounds and a pointed pediment. Above this, at first floor level, is another three-light mullioned window resting just below the eaves. To the right of these two sets of windows are two, two-light windows at ground and first floor level.

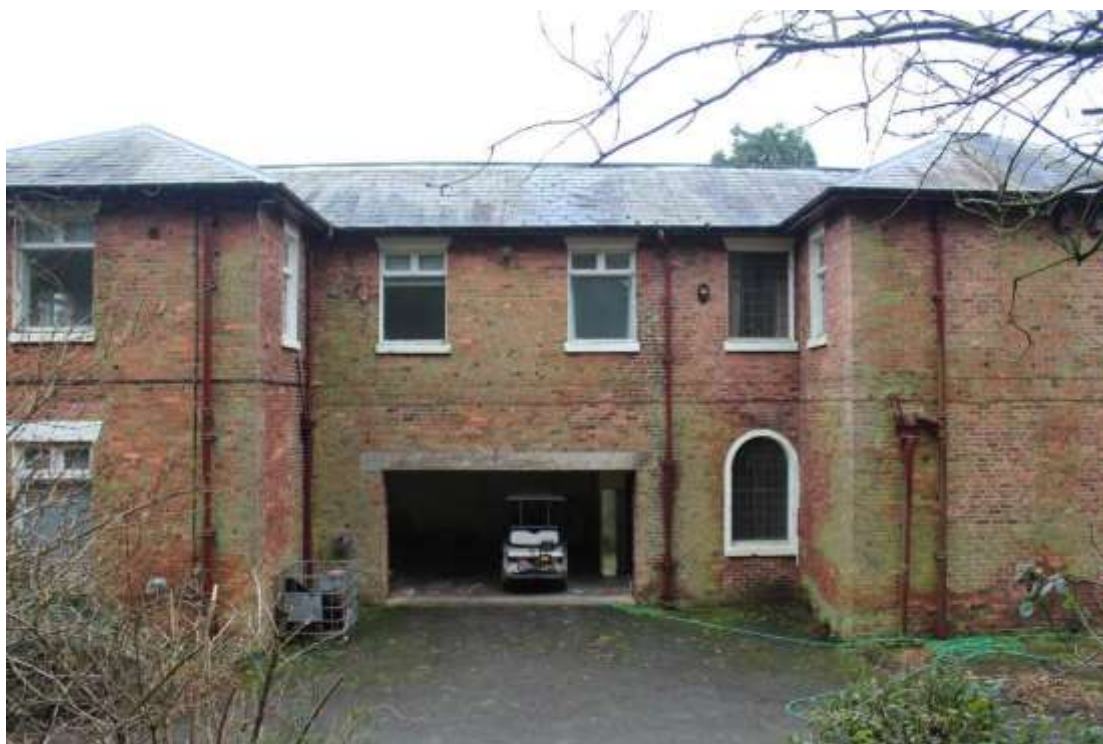
6.5 The northern elevation (Plates 4, 5, 7 & 8) is where the original U-shaped Georgian plan form is most apparent. It is clear that this was never intended as the principal façade of the building, as this end is asymmetrical. The elevation consists of a three bayed central elevation flanked by two projecting wings. The western projecting wing (Plate 5) houses four blocked windows, two on each of the ground and first floors. These are similar in size to the other, likely original, windows in this elevation. At the base of this elevation are the remains of a three-centered arch (Plate 6), likely indicative of a former opening to the basement. The central elevation (Plate 7) consists of a large garage-style opening covered with a concrete lintel. Immediately to the south of this opening is a single light leaded window with a three-centered arch and stained glass decoration. This is the only round-headed window in this elevation. Directly above this is a square-headed window that is also leaded, with stained glass. This window has a stone, flat arched lintel. To the left of this are two identical windows which are very similar in style; however, these have later three-light casements inserted. The two windows in the eastern projecting bay (Plate 8) mirror these later casement windows. At first floor level the inward facing elevations (Plate 9) of the projecting bays house more casement windows; these are much narrower than the former and are leaded with stained glass panes.

Plate 4: View of the northern elevation of Block A, facing south. Scale 2m. This is what remains of the original late Georgian U-shaped house, with the central northern elevation flanked by the eastern and western wings.

7.3 The northern elevation is what remains of the original structure, containing original window openings and evidence of the former use of the space. These windows are in a loosely classical style, with flat arches above the windows (Plate 4). This classical style has been emulated in the modern southern aspects of the building. However, the northern elevation has been somewhat modernised, particularly through the obscuring of original features, updating windows and altering access. At ground floor level the access has been expanded in order to create a garage space; this corresponds with the changing internal function of the space.

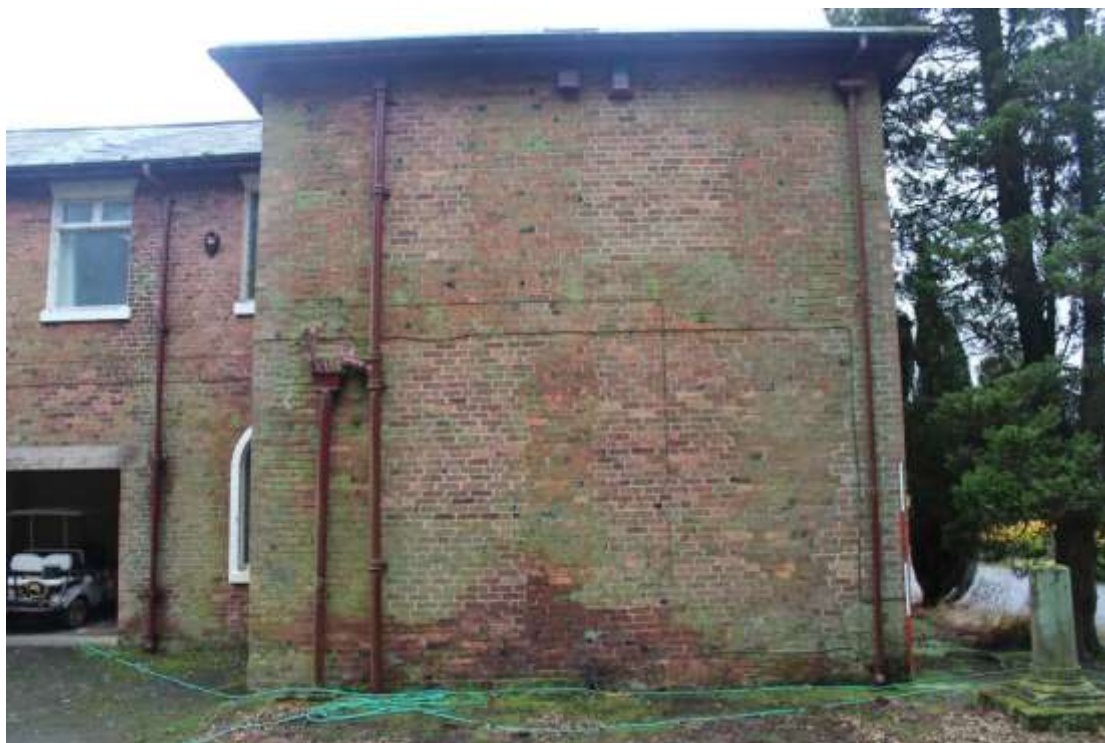
Plate 5: View of the western wing's northern elevation, facing south. Scale 2m.

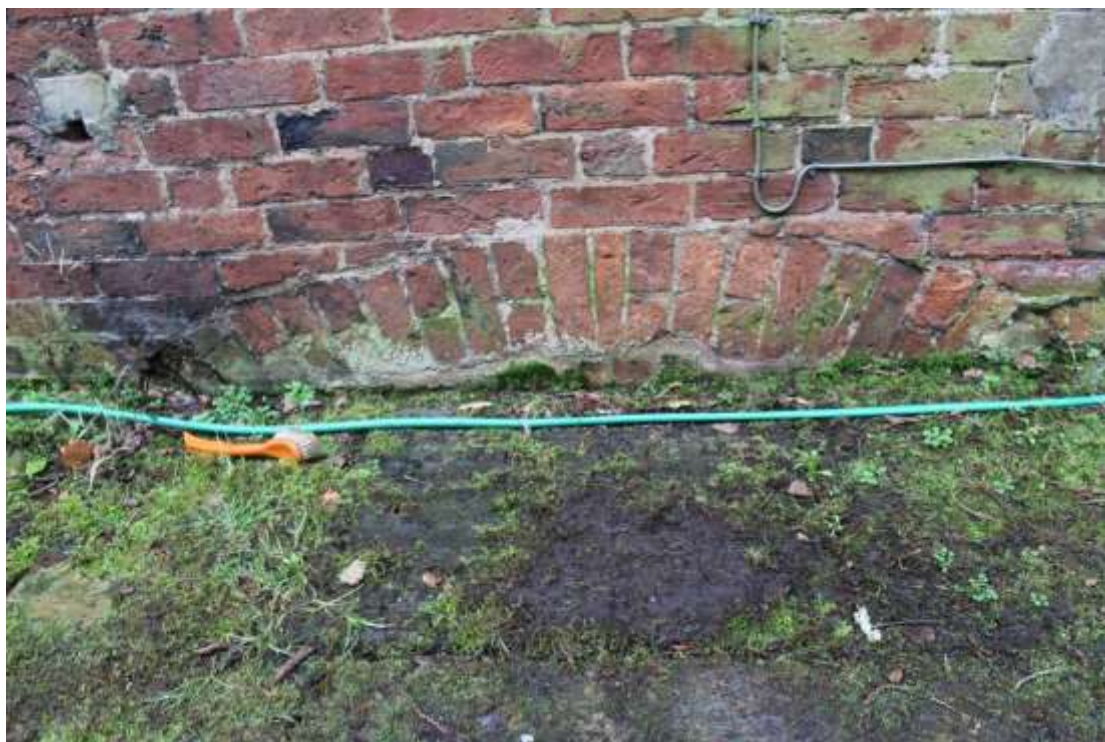
Plate 6: Detailed view of the blocked opening at the base of the northern elevation of the western wing, facing south.

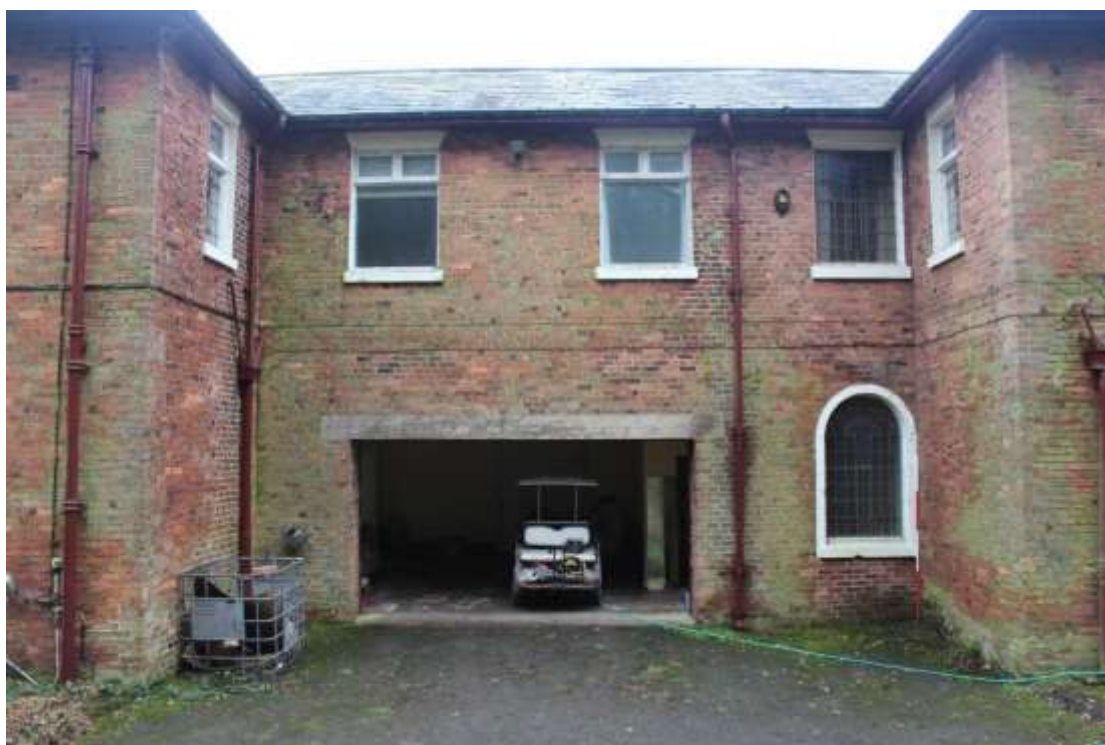
Plate 7: View of the central northern elevation of Block A, facing south. Scale 2m.

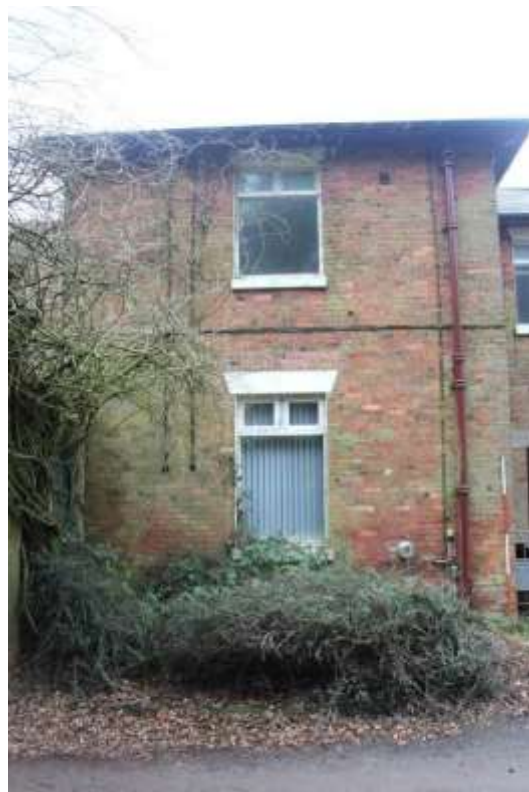
Plate 8: View of the eastern wing's northern elevation, facing south. Scale 2m.

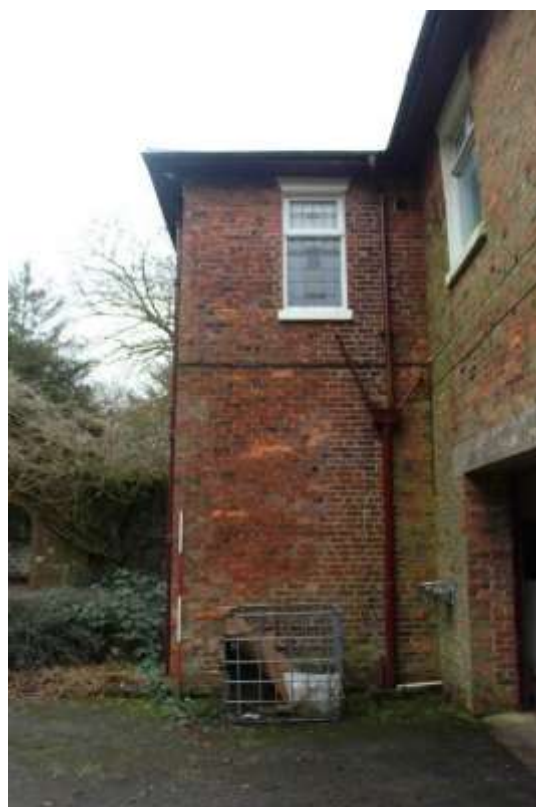
Plate 9: View of the inward facing, western elevation of the eastern wing, visible from the northern side of the hall, facing east. Scale 2m.

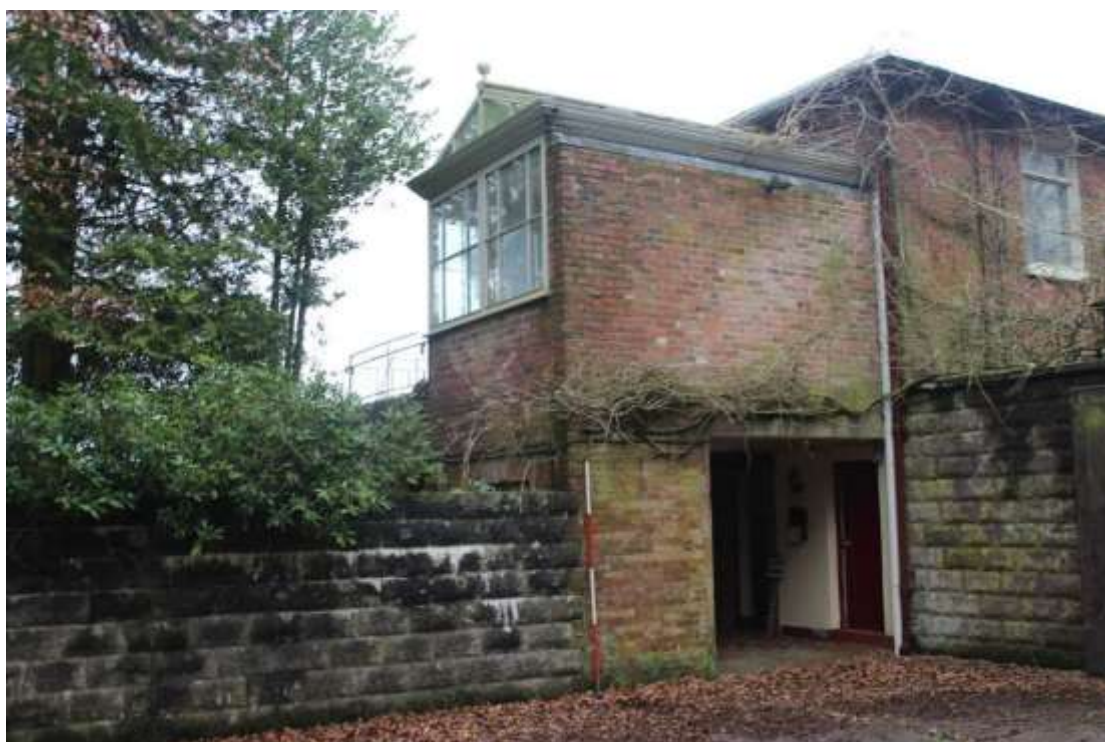
6.6 The eastern elevation now houses an extension (Plate 10) dating to the late 20th century when this part of the site was converted into a separate dwelling. This is also of red brick, matching the rest of the building. The north face (Plate 10) of the extension houses another garage-style entrance with a stone lintel. On the southern side (Plate 11) a staircase leads to a raised patio area bordered by metal railings. It is from here where a door leads to the first floor conservatory. This conservatory has a brick base and solid brick wall on the northern elevation; the rest is glazed. In the wall at the top of the stairs are the remains of another flat arch that would have been the top of a ground floor window (Plate 12). To the left of this is what appears to be the remains of a chimney stack. Another two-light window remains at first floor level here (Plate 13); this is identical in style to the other windows found in the southern part of the hall building. Immediately to the left of this is another blocked window. At ground floor level the extension houses two smaller windows in the east elevation (Plate 14), both with flat stone lintels, and a door immediately to their left, again with a flat stone lintel.

Plate 10: View of the northern side of the eastern extension added to Block A, facing south west. Scale 2m.

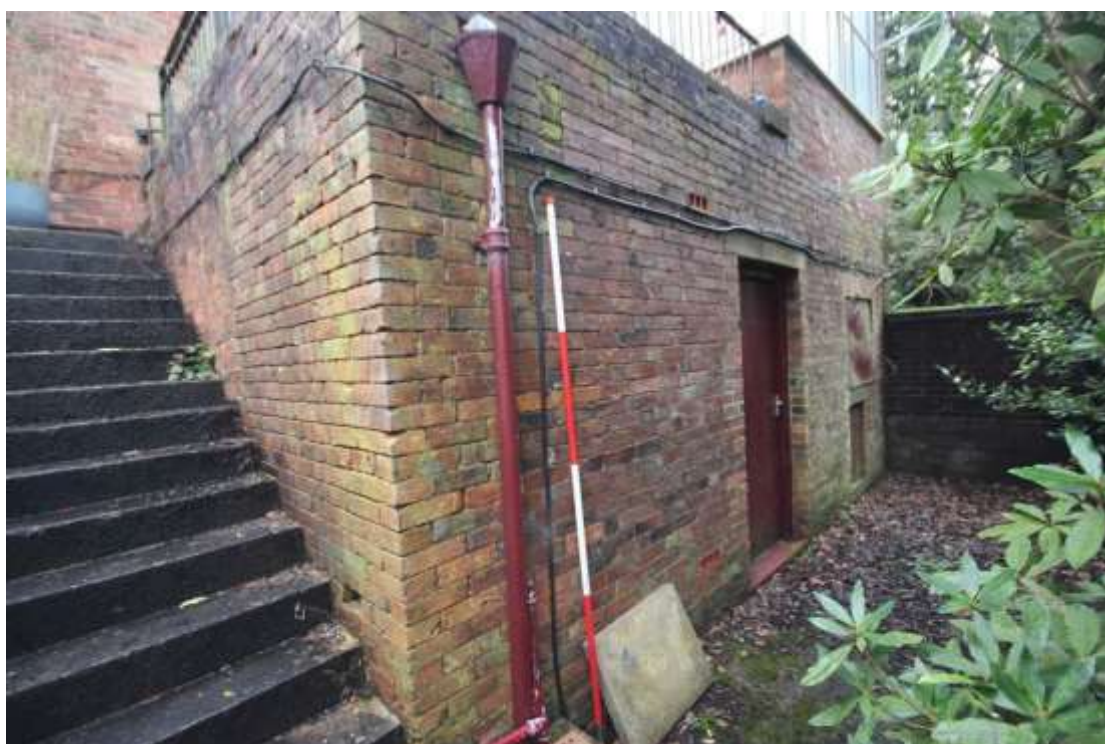
Plate 11: View of the southern side of the eastern extension added to Block A, facing north west. Scale 2m.

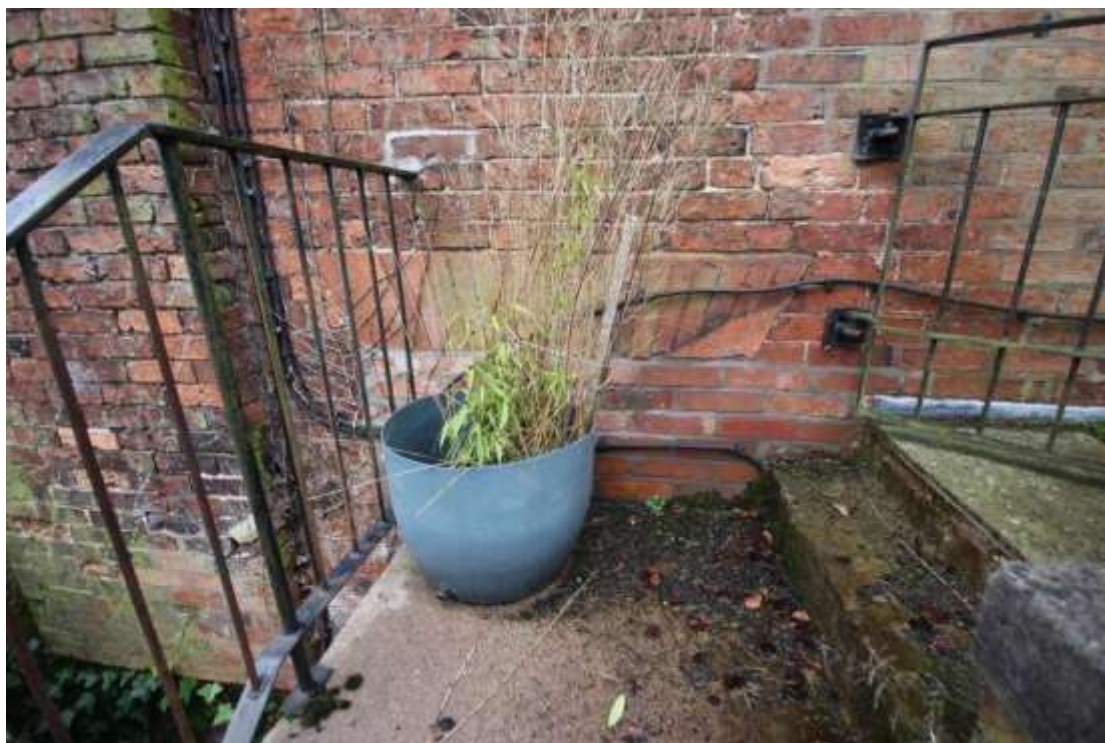
Plate 12: Detailed view of the now blocked ground floor window visible at the top of the stairs, facing west.

relocated the front entrance to the western elevation, creating a site almost indistinguishable from its original form. These factors show that the development of the Hall can be defined by two significant phases: the original construction and the mid-20th century remodelling. A blocked window in the eastern elevation of Block A (Plate 12) is in a similar style to those found in the northern elevation, suggesting the fenestration was once relatively uniform.

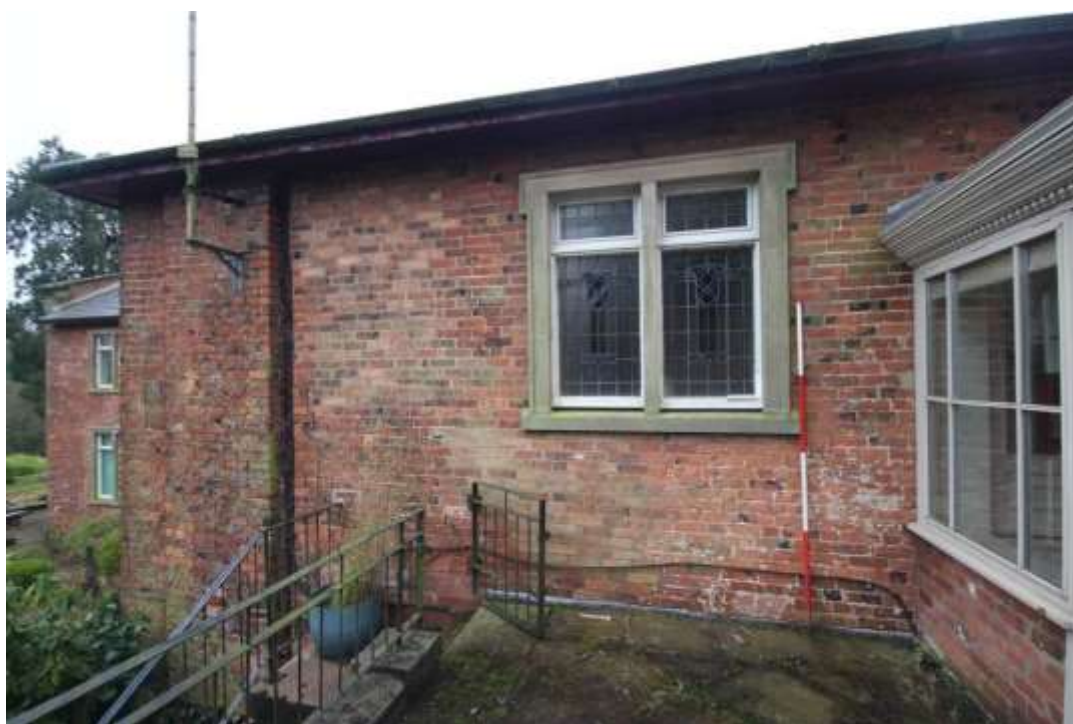
Plate 13: View of the eastern elevation of Block A from the patio on the eastern extension, facing west. Scale 2m.

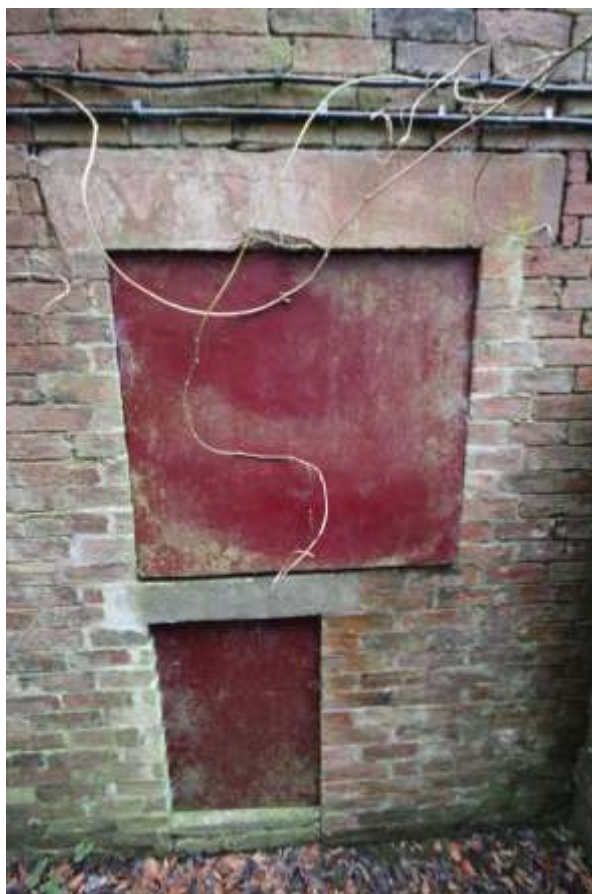
Plate 14: Detailed view of the openings in the eastern extension to Block A, facing west.

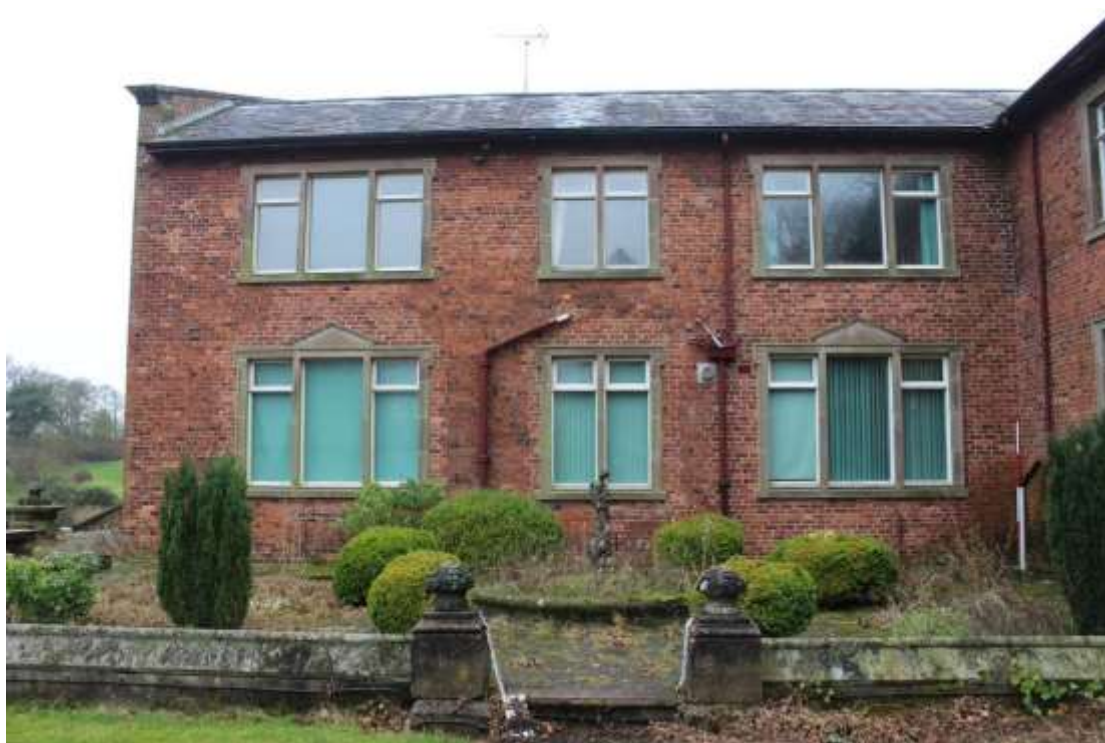
Plate 15: View of the eastern elevation of Block B, facing west. Scale 2m.

6.7 The east facing elevation is of three bays and abuts Block B on its northern side. The central bay consists of two-light windows at ground and first floor level; these are very uniform and similar in style to the rest of the windows situated in this block. Either side of this central window are two windows, each of three lights, and directly below each of these is another three light window with pointed pediments. It seems that much of the brickwork in this elevation has either been repaired and replaced or repointed, as there are various patches of changing brickwork.

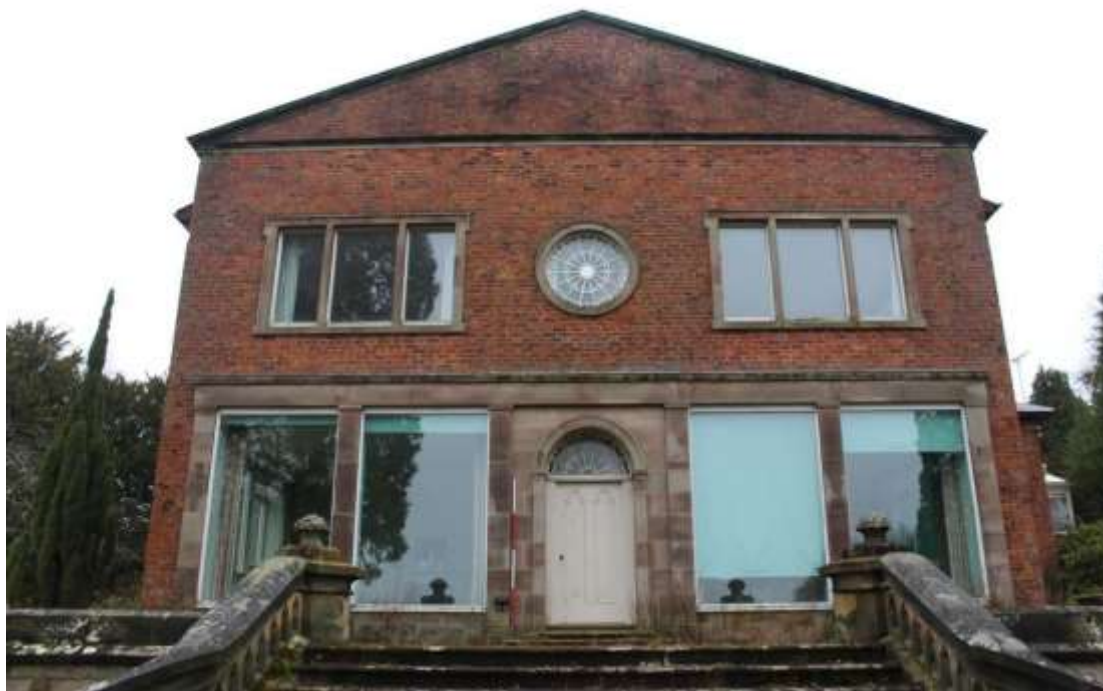
6.8 The southern elevation overlooks the tiered formal garden and grounds. At ground floor level a central doorway with leaded fanlight is situated in a concrete surround. On both its left and right flanks are two large windows divided by square Doric columns, of which there are five in total. On top of this rests a relatively plain architrave with cornice, similar in look and style to the other openings in this block. Above this is a central round window with leaded panes. Either side of this are two three-light mullioned windows. A string course is also visible at the base of the gable.

Plate 16: View of the southern elevation of Block B, taken from the tiered garden facing north. Scale 2m.

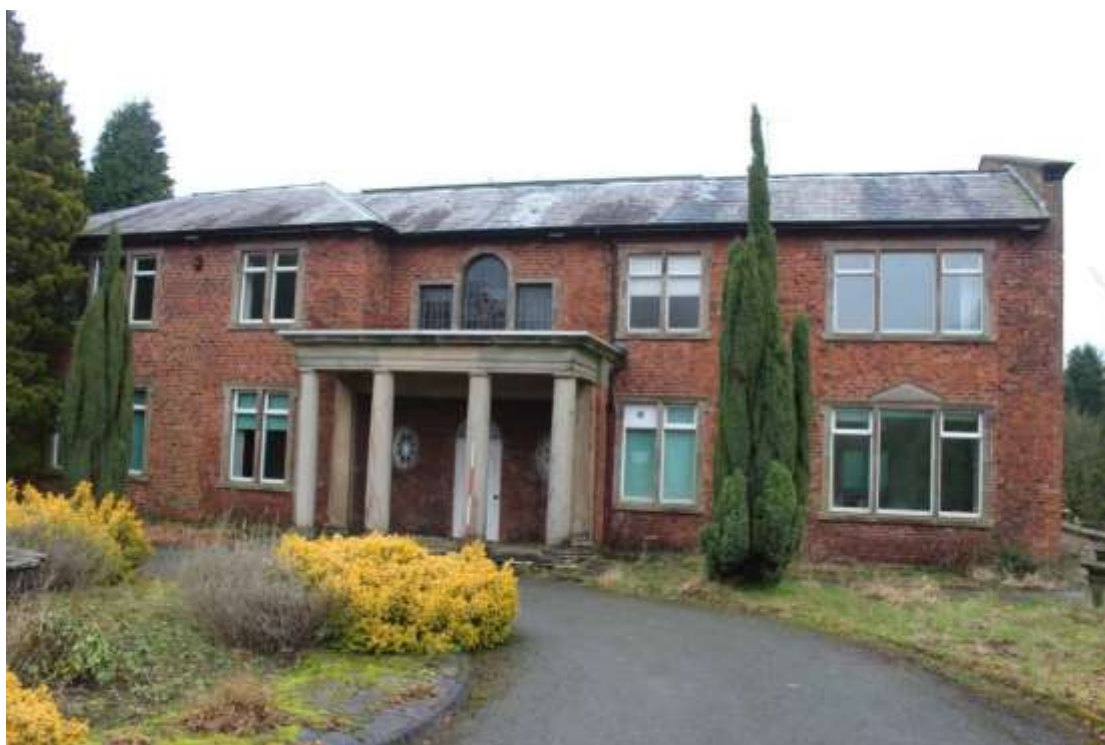
*Plate 17: View of the western elevation of Block B and its relationship to Block A, facing north east.
Scale 2m.*

6.9 The west facing elevation of Block B is of three bays and abuts Block A on its northern side. This elevation is similar in layout to that of the eastern elevation; however, the northern bay has been altered. At ground floor level this bay now houses a portico supported by four Doric columns: an inscribed date in the architrave shows that the portico was added in the 1959 (Plate 20). Underneath this portico is a wooden doorway with leaded fanlight, covered by a three-centered arch with brick voussoirs on corbels. Either side of this doorway are two oval windows with faux leaded panes.

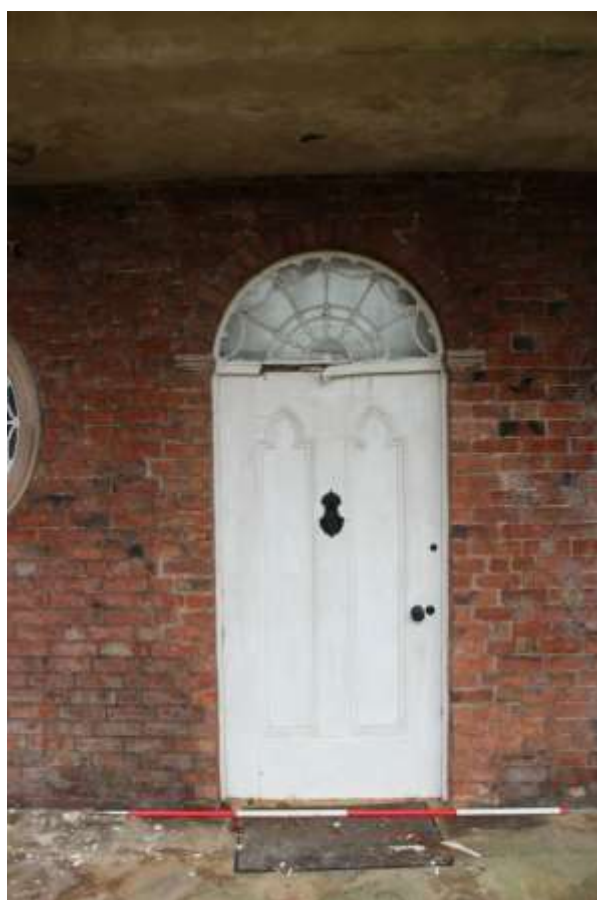
Plate 18: Detailed view of the western front door, facing east. Scale 2m.

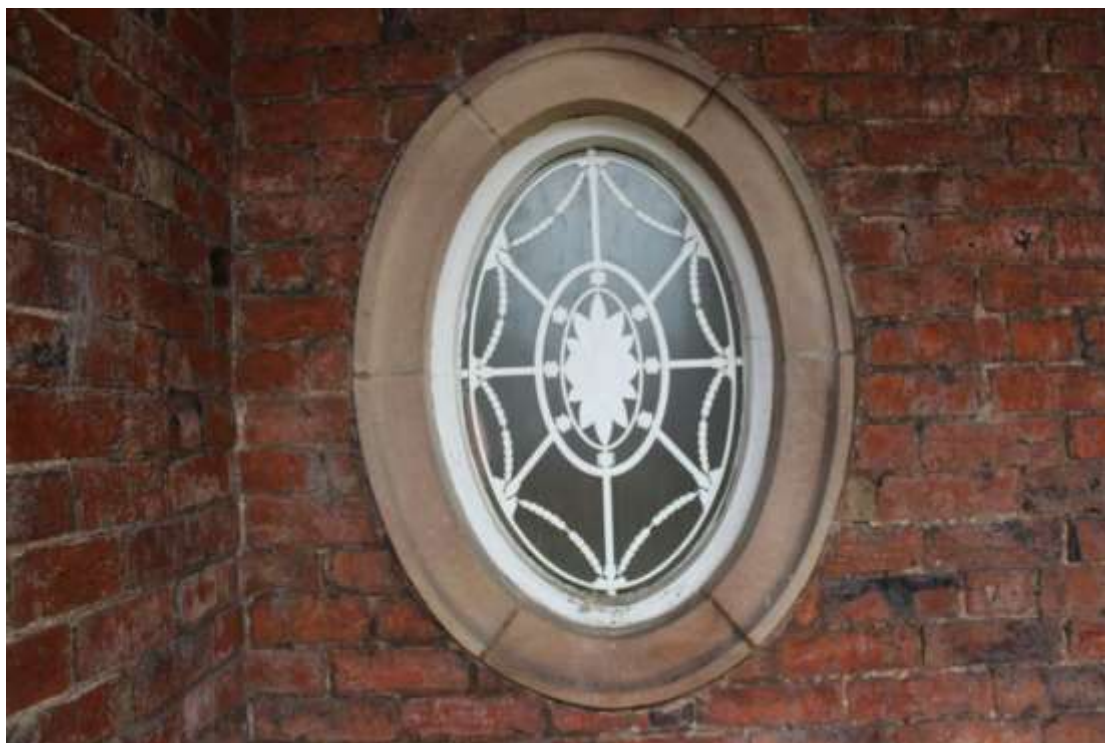
Plate 19: Detailed view of one of the oval windows flanking the main western doorway in Block B, facing east. Scale 2m.

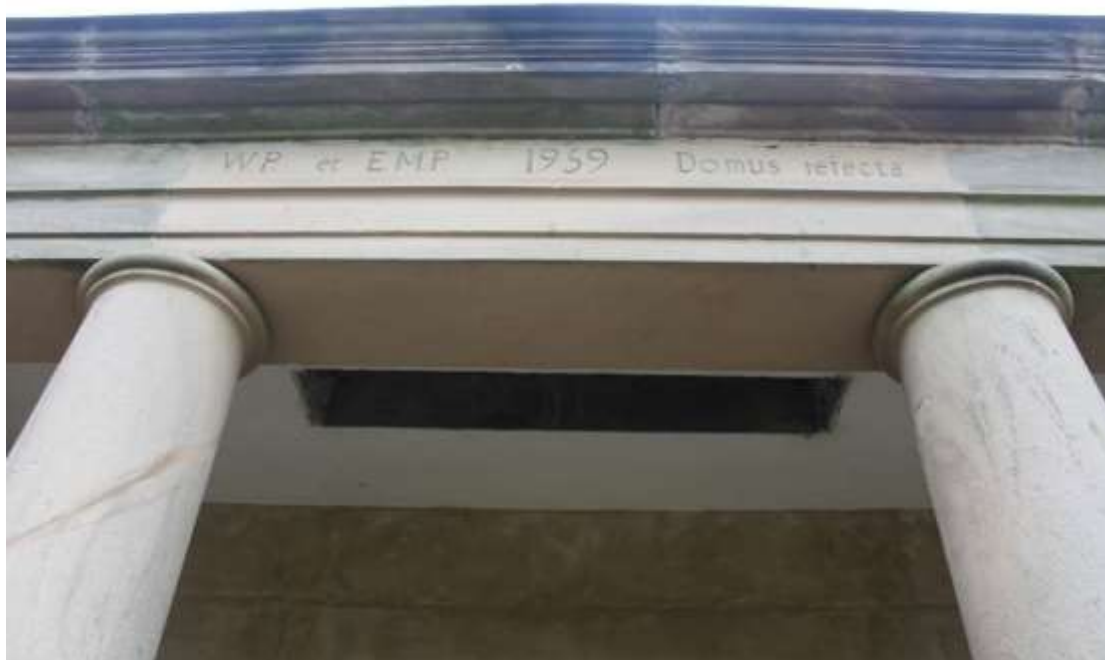
Plate 20: Detailed view of the architrave of the western portico, facing east.

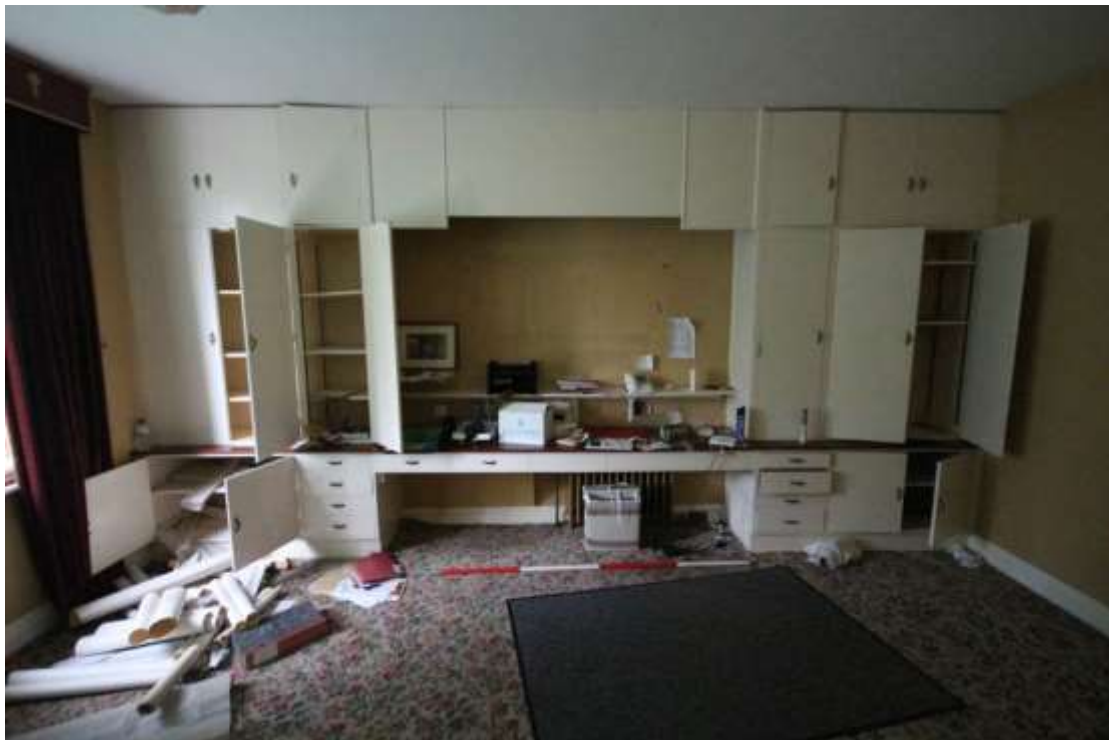
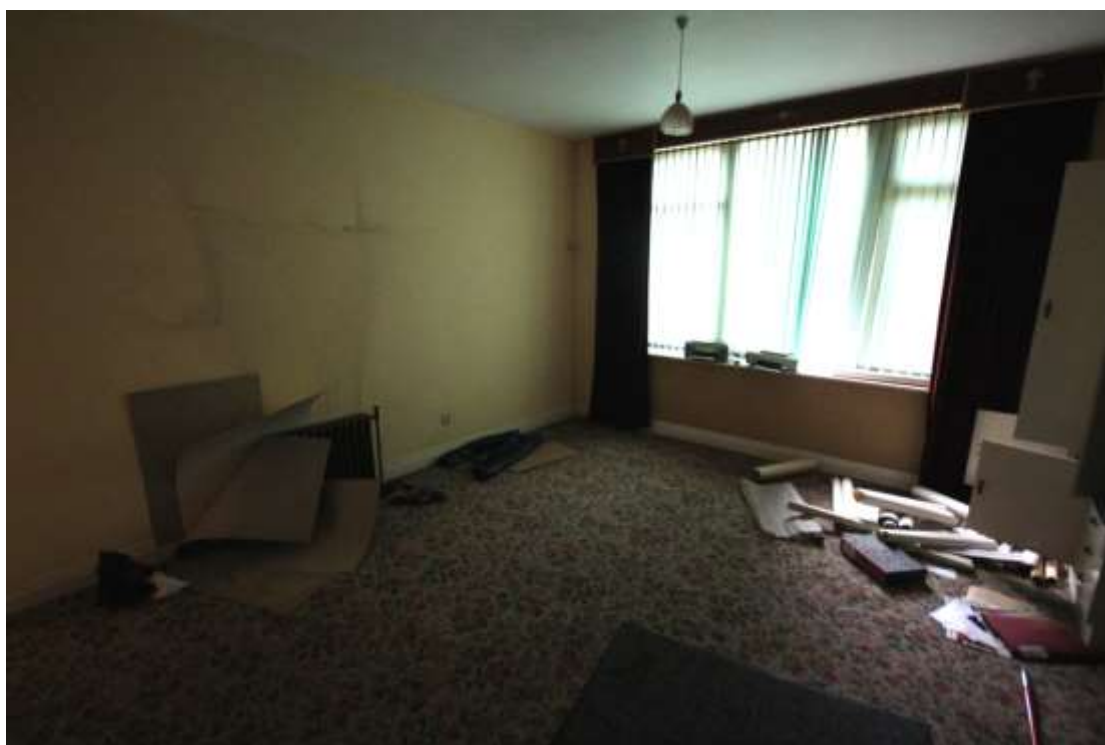
6.11 The study (Plates 21 & 22) is accessed by the central hallway running north-south through the centre of the building; it is in the north western extent of the hall. The room itself was originally known to be the scullery and later the laundry room (REF), although no evidence of these functions remains. All signs of original features have been plastered over and painted, with a large desk and adjoining cupboards added to the northern wall. All signs of original features have been plastered over and painted, with a large desk and adjoining cupboards added to the northern wall.

Plate 21: View of the interior of the study, facing north. Scale 2m.

Plate 22: View of the interior of the study, facing south west.

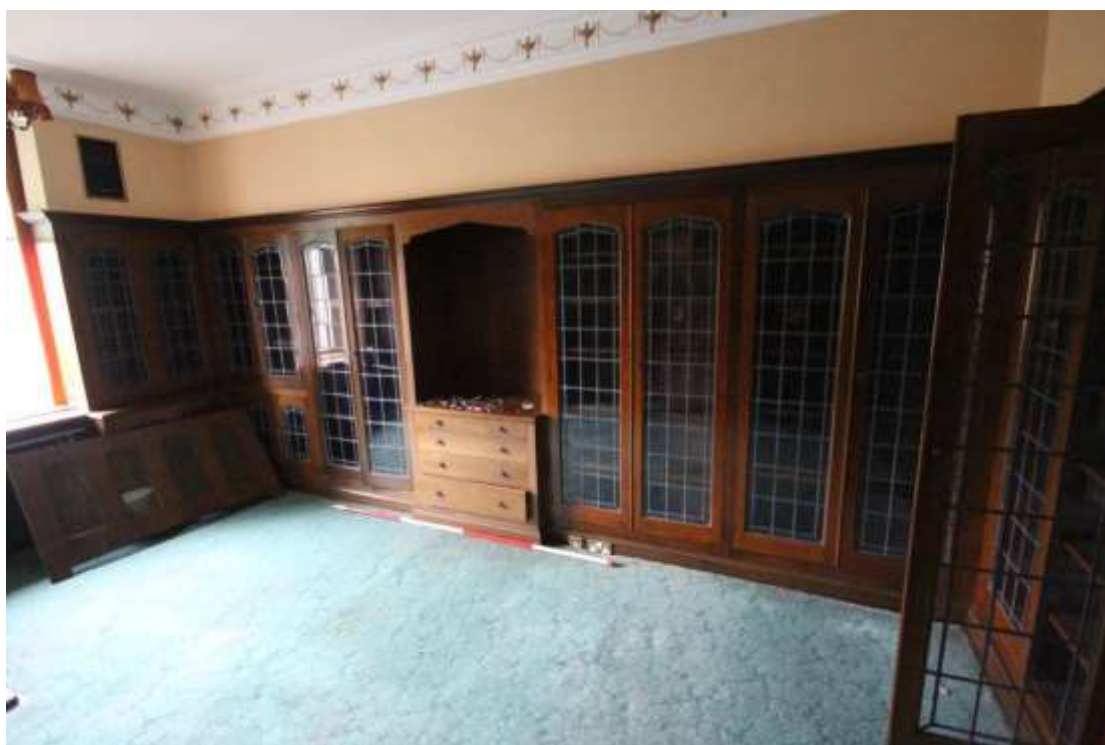
Plate 23: View of the library, facing north west. Scale 2m.

6.12 Immediately to the south of the study is the library (Plates 23 & 24), which contains a mass of glass paned display cupboards in heavy wooden frames occupying each wall. The northern wall houses a chest of draws set within an alcove, covered with a wooden pointed arch. To the right hand side of the doorway in the southern wall rests a false bookcase, which opens up to a space occupied by two metal safes. A cornice, decorated with gold-painted trophies, is situated in this room.

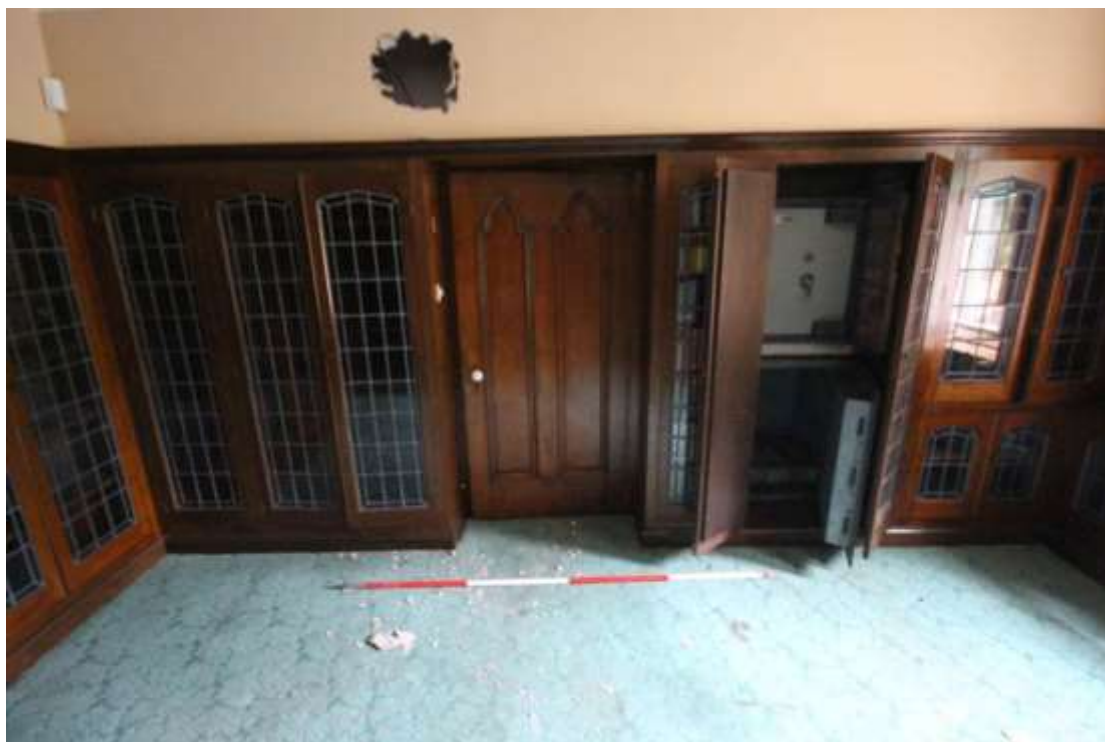
Plate 24: View of the library, facing south. Scale 2m.

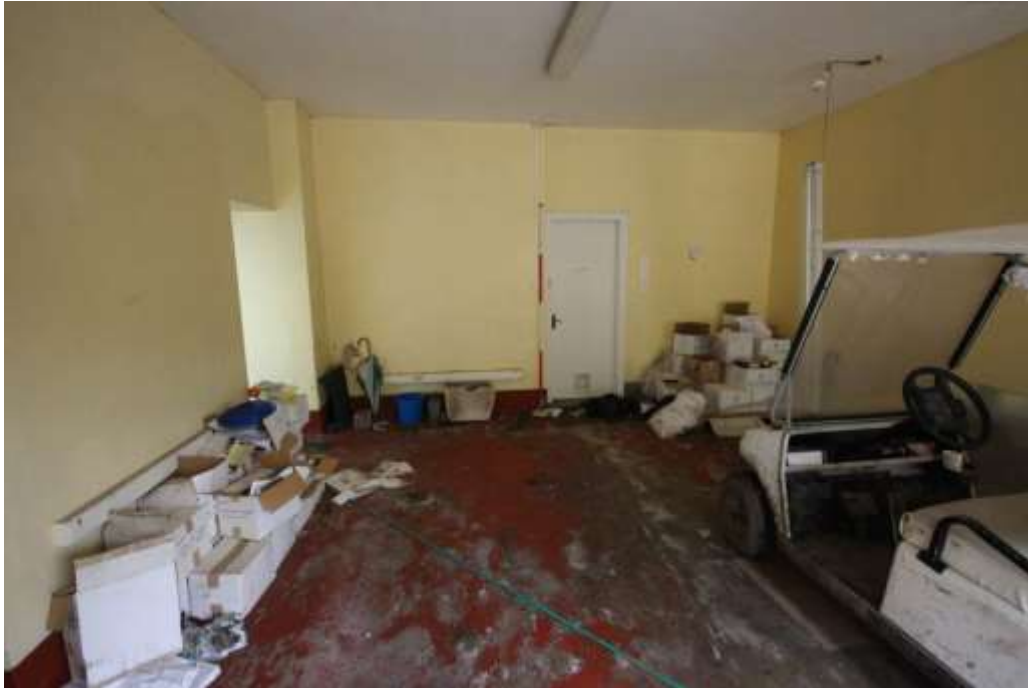
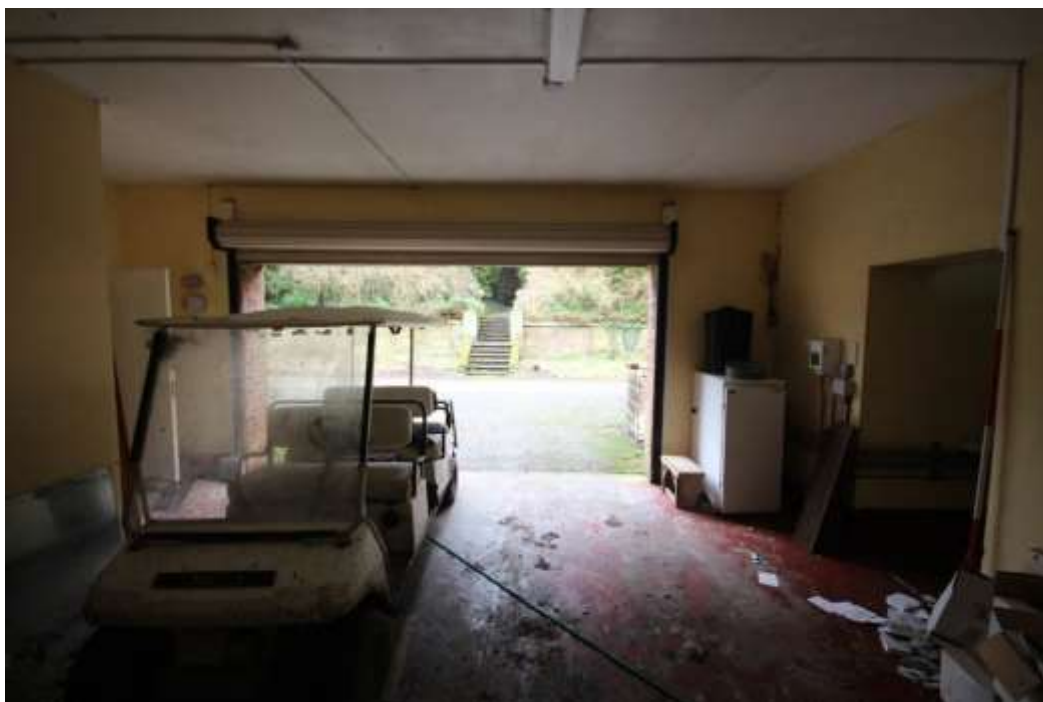
6.13 Opposite the entrance to the study is a doorway leading to the garage (Plates 25 & 26), which occupies what was once the kitchen (from 1911-1959). Again, no evidence of this survives as the walls have been plastered and painted. Some modern utilities have been inserted in the eastern wall that monitors gas and electricity. The floor is likely to be at the original level, although it is possible that it was repainted as the site was being remodeled in the 1950s/1960s.

Plate 25: View of the southern half of the garage, facing south. Scale 2m.

Plate 26: View of the northern half of the garage, facing north.

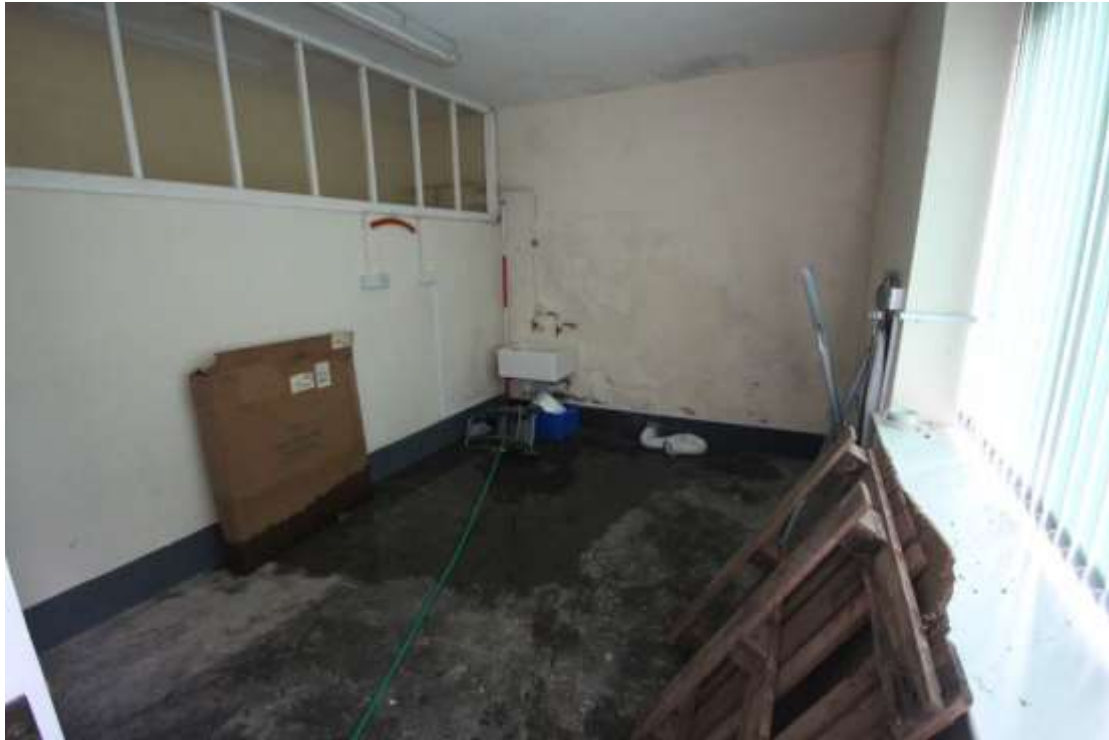
6.14 A door in the south east corner of the garage leads to the laundry room (Plate 27). The northern wall of this room has a series of windows at ceiling height, likely as a means to provide light to the adjacent hallway. The large window in the southern wall of this room leads one to suggest that this may have once been living space; however, it has most likely been used as a utility throughout the 20th century.

Plate 27: View of the laundry room, facing north east.
