Consall Hall, Consall, Staffordshire: historic building recording

ARS Ltd Report 2020/32

January 2020

Prepared on behalf of: Consall Hall Estate Ltd

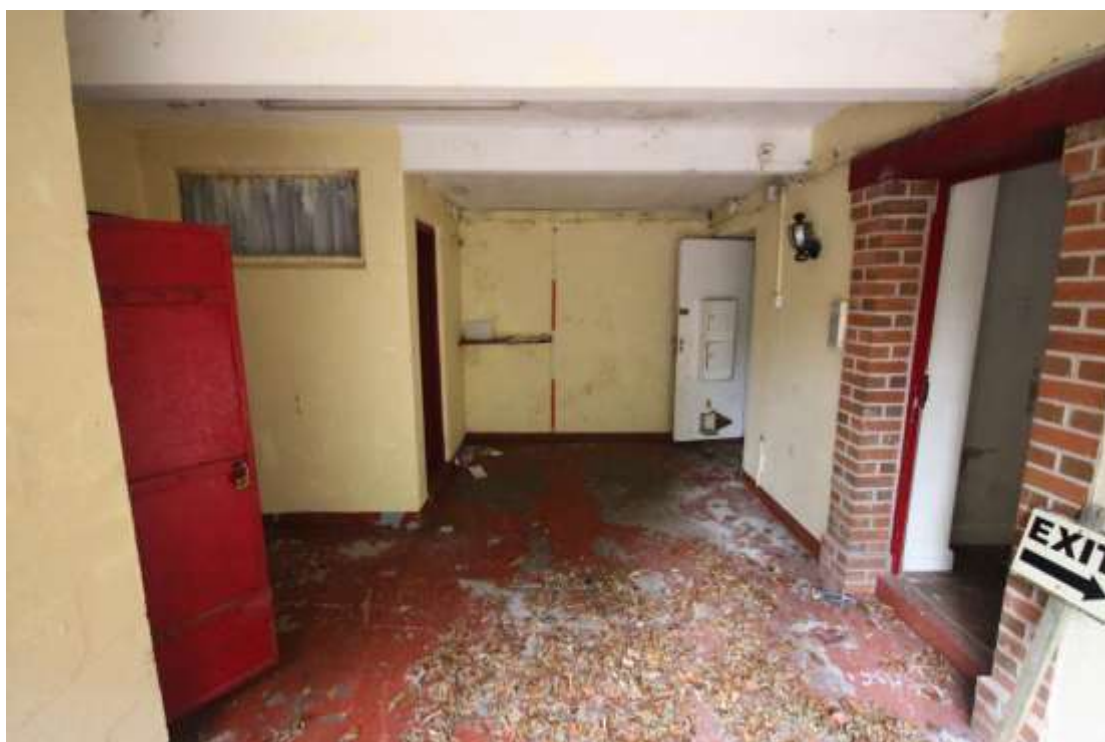
6.15 The area labelled as 'store' (Plates 28 & 29) was constructed in the latter half of the 20th century as further garage space, in this case serving the house that this half of the hall became around this time. Three doorway openings are visible in the west elevation (Plate 29), which may occupy original apertures. However, it is more likely they were once windows. The rest of this space is occupied by a storage closet in the north east corner and a w/c in the south east corner.

Plate 28: View of the store, facing south. Scale 2m. The elevation on the right side of this photograph was once the original exterior wall of Block A.

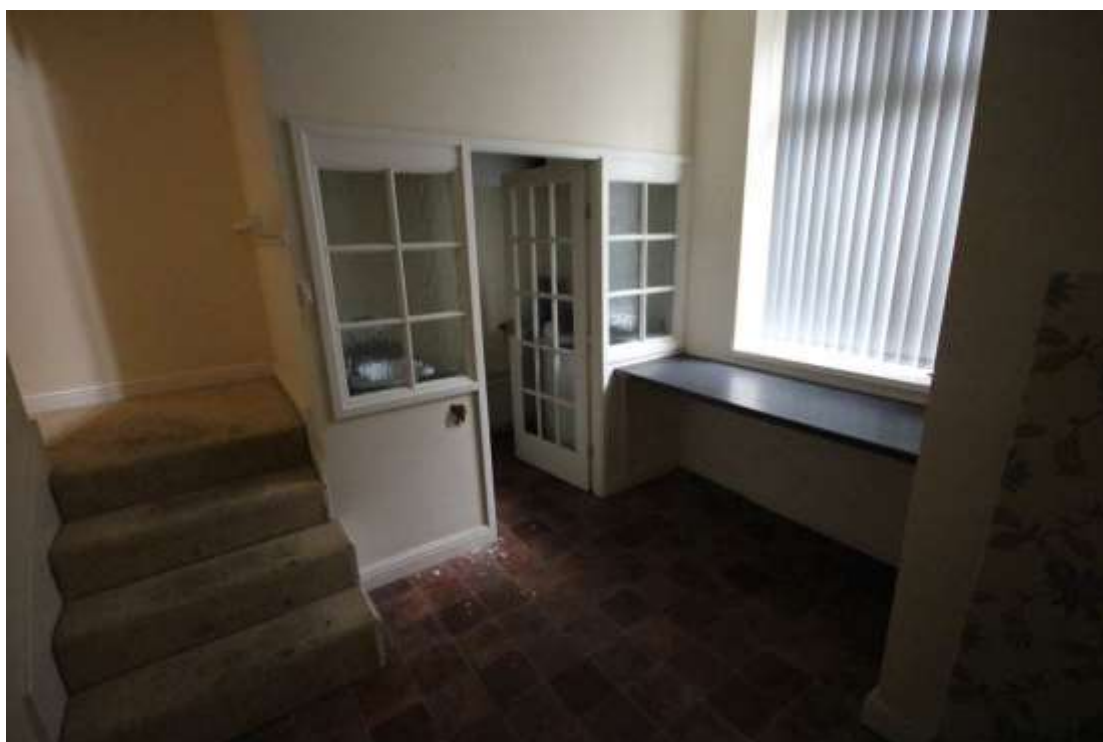
6.16 A doorway in the western wall of the store leads to another entrance hall (Plate 30), which serves the separate dwelling in the east wing of the house. The room houses little to no historic fabric, meaning it is difficult to discuss phasing here. It is likely that many of the walls here are original: the large cupboard area in the western wall leads one to suggest that this may once have been a storage space, serving the household.

Plate 30: View of the entrance hall in the separate, eastern dwelling in the eastern wing of Block A, facing north east.

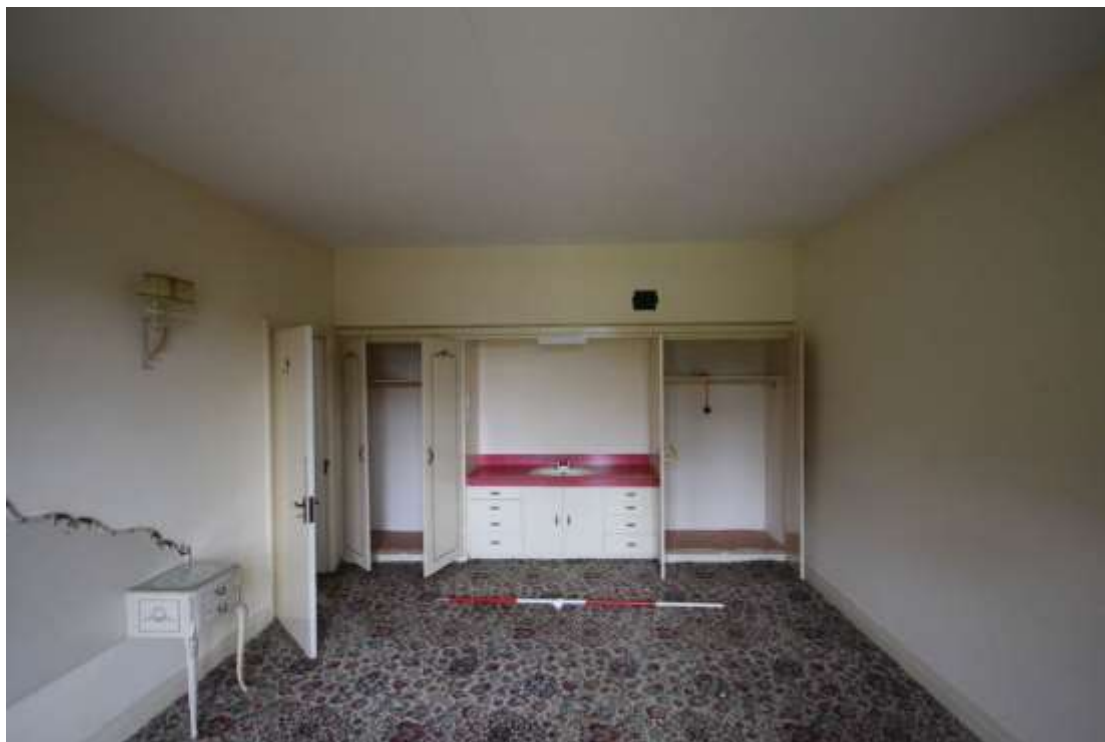
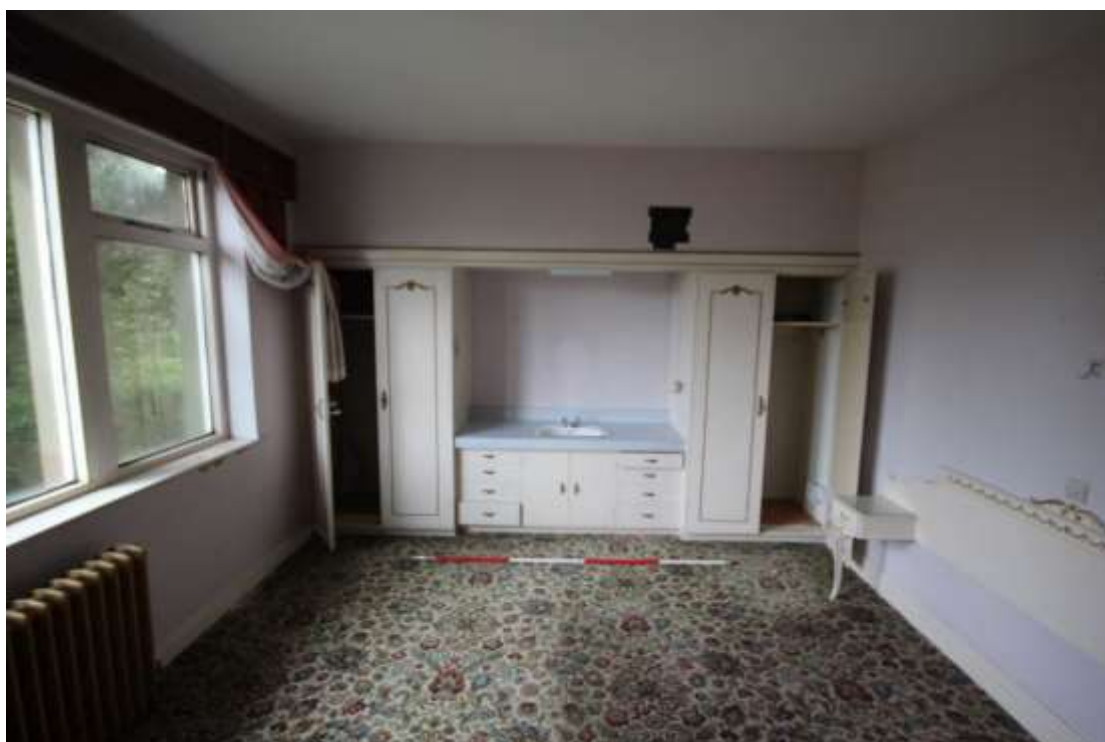
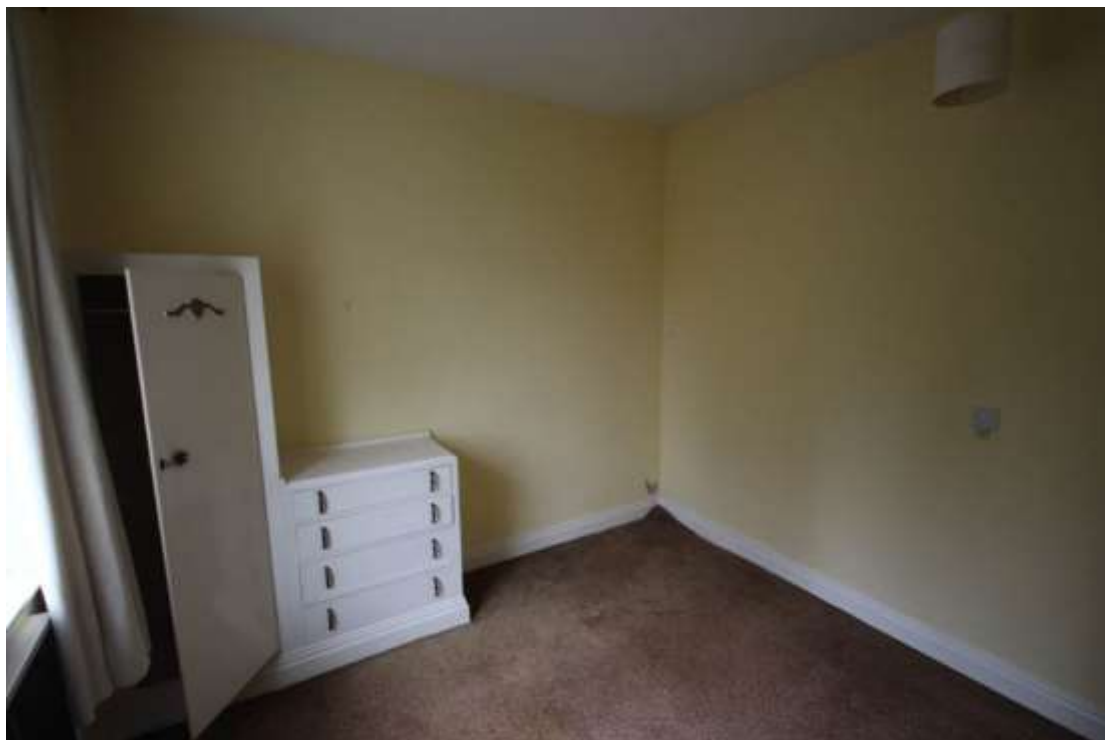
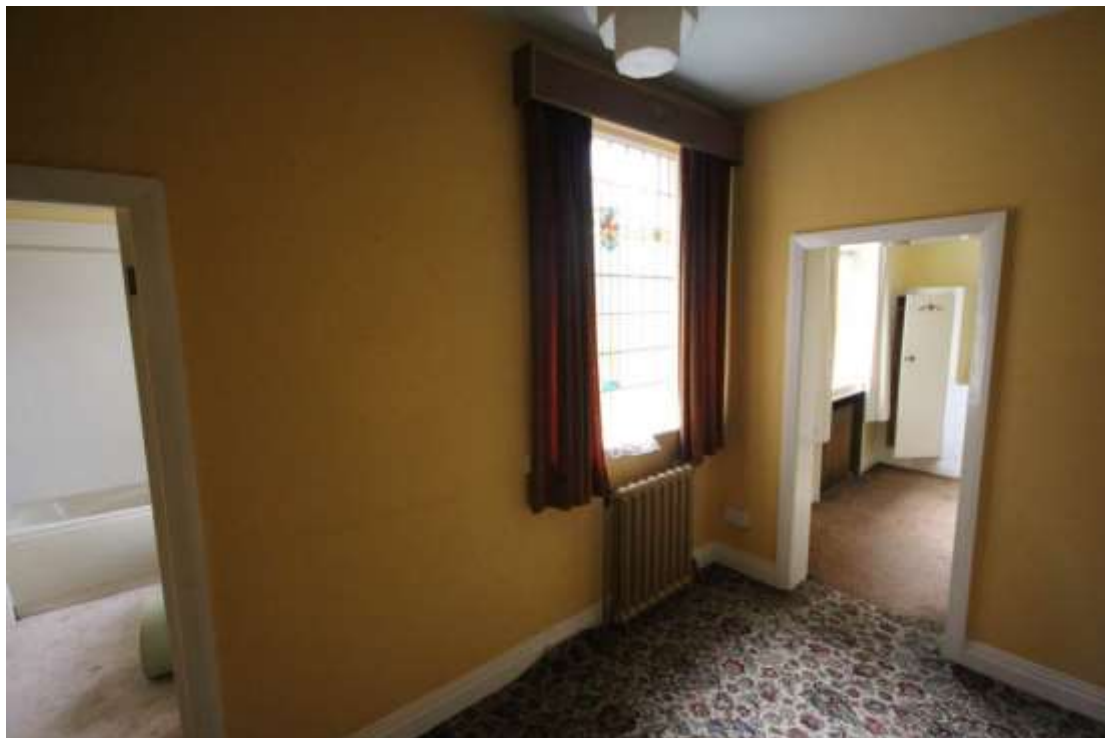
6.18 The main area is accessed by the galleried landing in Block B to the south and leads into hallway (Plate 34) with doors leading to three bedrooms labelled Bedrooms 4, 5 and 6 (Plates 31-33), as well as a bathroom (Plate 35). These are all modern bedrooms containing built-in wardrobes and sinks. No historic fabric is visible in these spaces; however, this half of the building likely preserves the original floor plan of the site.

Plate 31: View of the eastern half of Bedroom 4, facing east. Scale 2m.

Plate 32: View of the northern half of Bedroom 5, facing north. Scale 2m.

Plate 33: View of Bedroom 6, facing south east.

Plate 34: View of the Hallway in the western part of the first floor of Block A, facing north east.

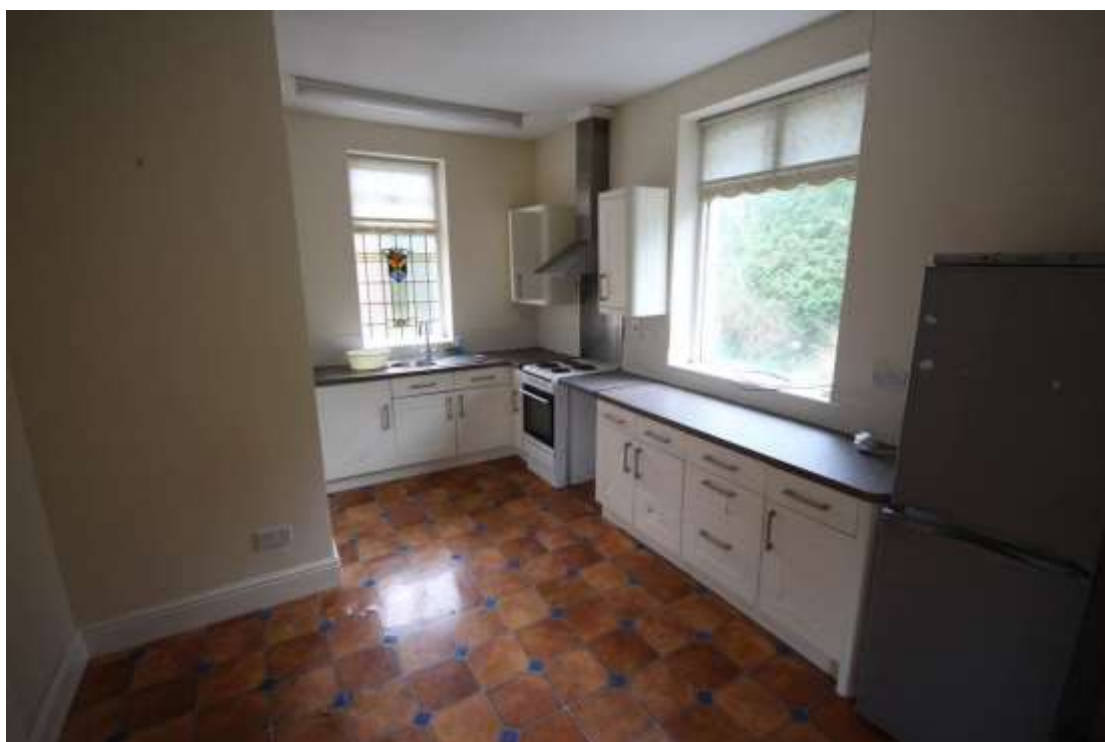
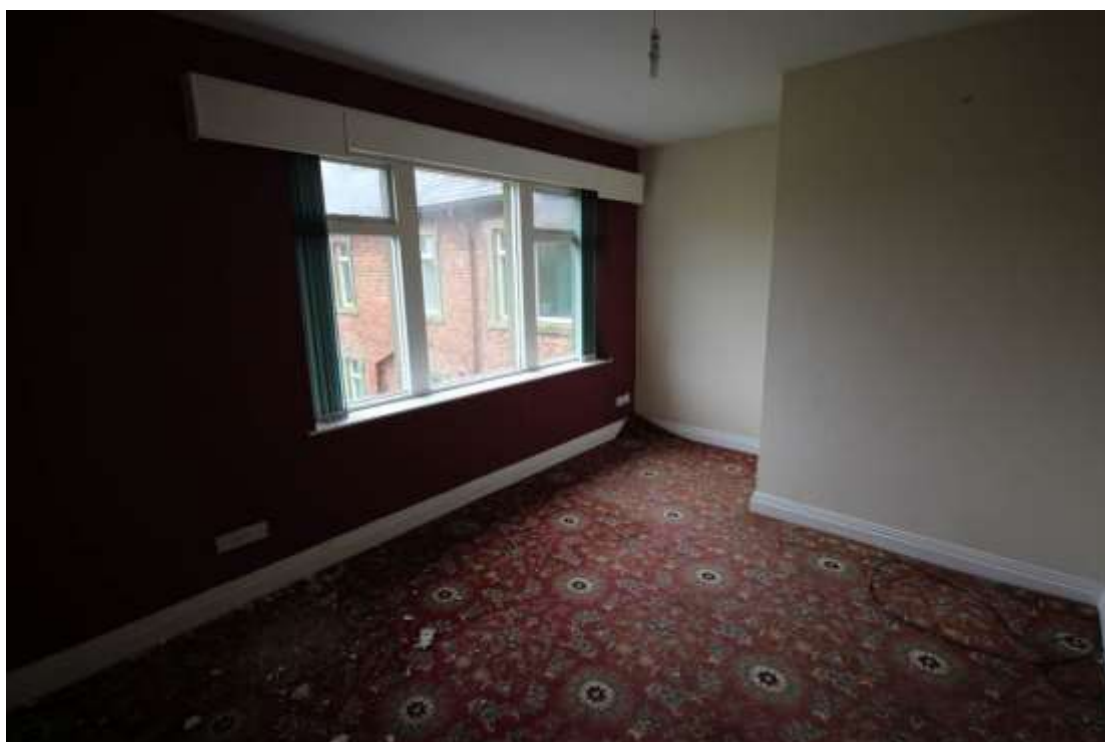
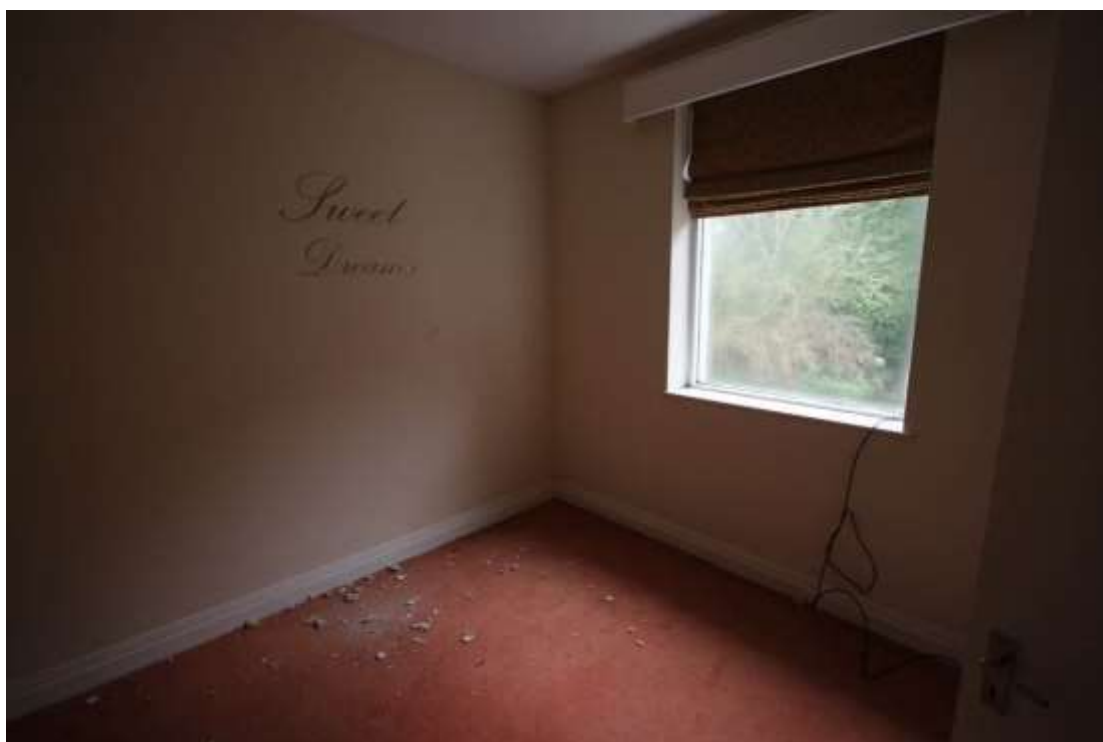
6.19 The eastern extent of the first floor of Block A has been divided into a separate dwelling. This consists of a kitchen (Plate 36), sitting room (Plate 37) and one bedroom (Plate 38), with the conservatory extension to the east. All of these areas contain modern fixtures and fittings obscuring any original fabric. It is also very likely that the organisation of the rooms in this space has been drastically altered in order to create a modern, livable space.

Plate 36: View of the first floor Kitchen in the eastern part of Block A, facing north west.

Plate 37: View of the first floor Sitting Room in the eastern part of Block A, facing south west.

Plate 38: View of the first floor Bedroom in the eastern part of Block A, facing north west.

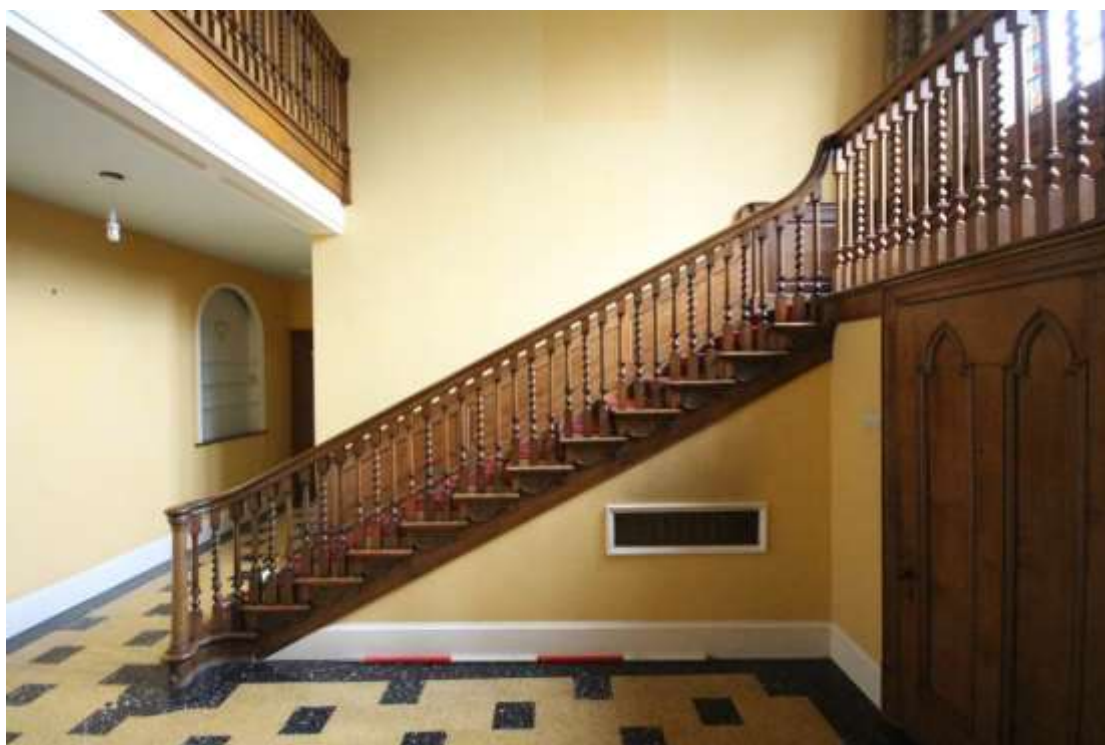
Plate 39: View of the southern elevation of the Reception Hall in Block B, facing south. Scale 2m.

6.21 The reception hall is situated in the north western corner of this block and is now dominated by the grand oak dog-leg staircase (Plate 39) with half landing, taken from Wootton Hall (CTD Architects 2019, 17). This has alternating plain and twisted balusters, carved closed strings and a round-topped handrail. A polished tile floor (Plate 42) adorns this part of the building, which also runs down the corridor to the south. The north elevation (Plate 40) houses a fireplace surround, now containing an electric fireplace. A paneled doorway (Plate 41) leads to an internal porch area (Plates 43 & 44), likely created when this staircase was added in the mid-20th century. The space is primarily a storage area.

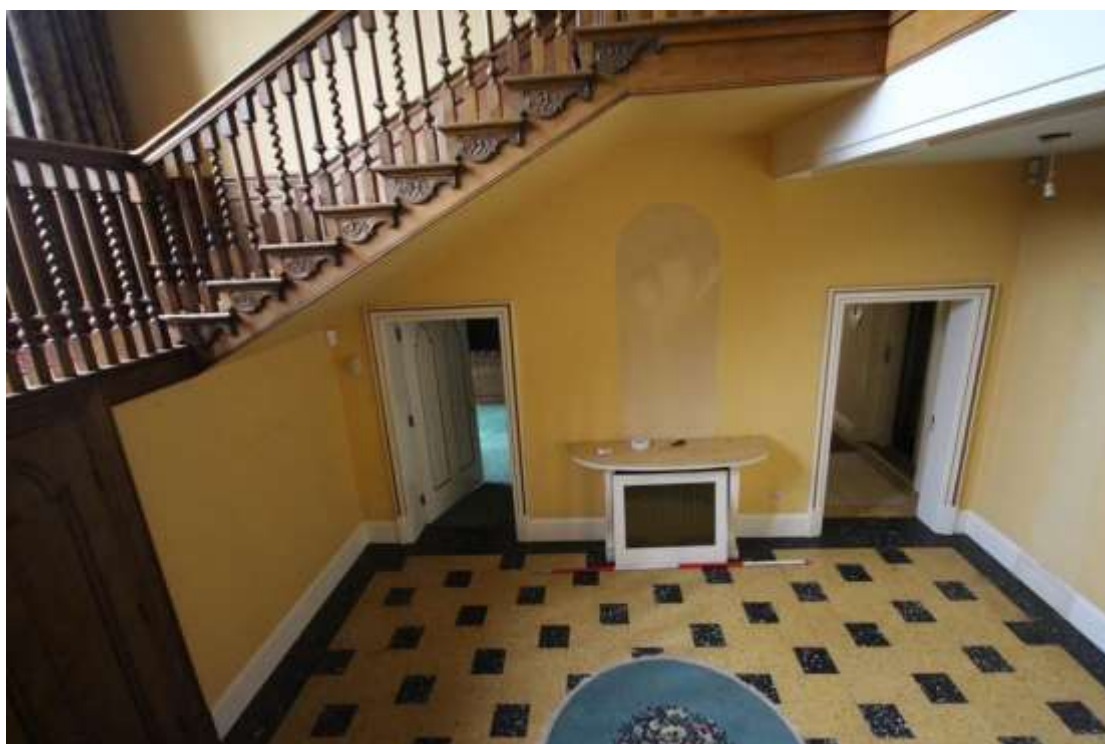
Plate 40: View of the northern elevation of the Reception Hall in Block B, facing north. Scale 2m.

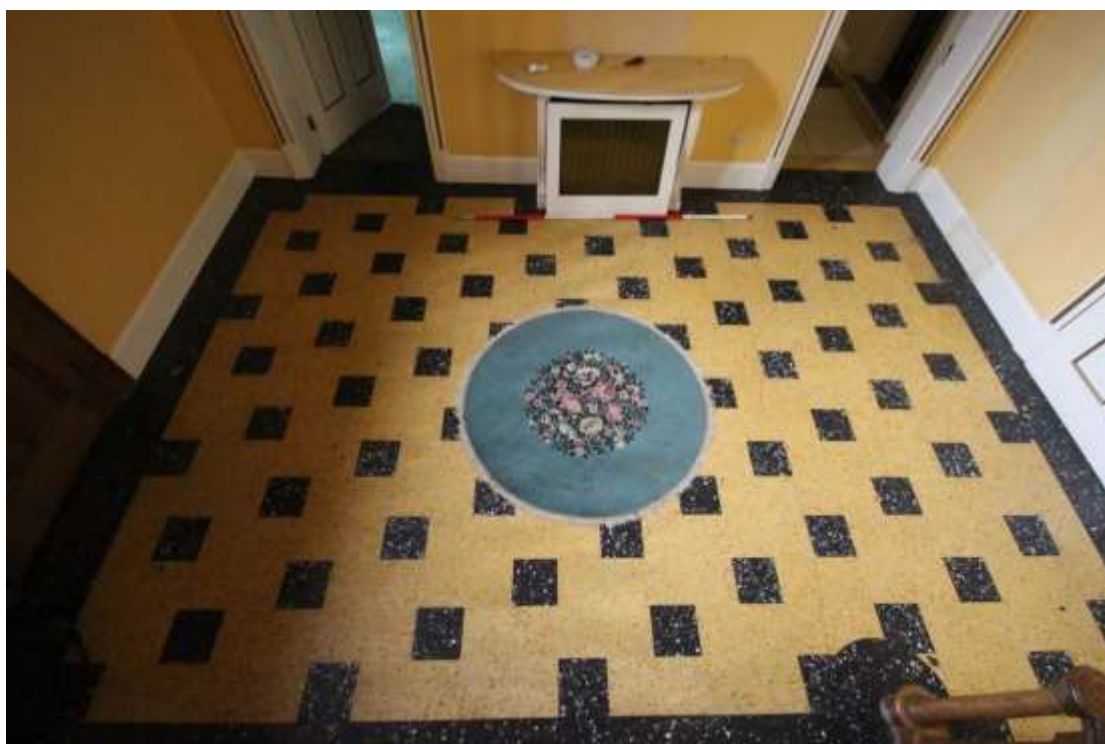
Plate 42: View of the floor of the Reception Hall in Block B, facing north. Scale 2m.

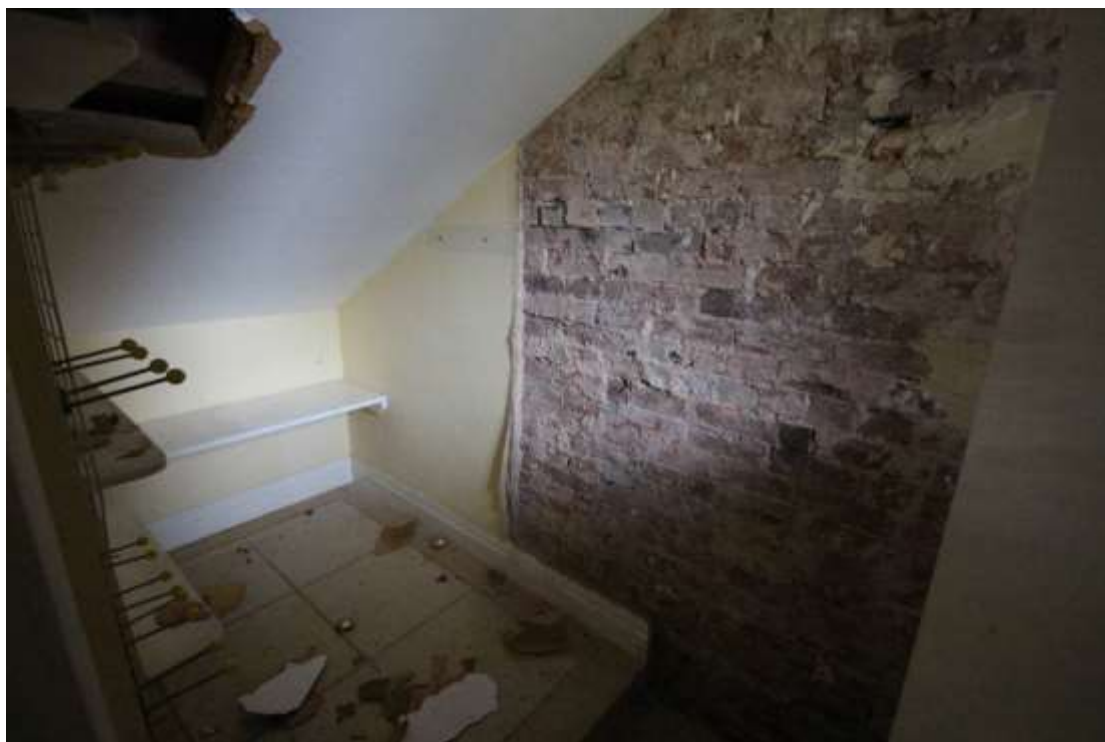
Plate 44: View of the storage area in the Porch, facing east.

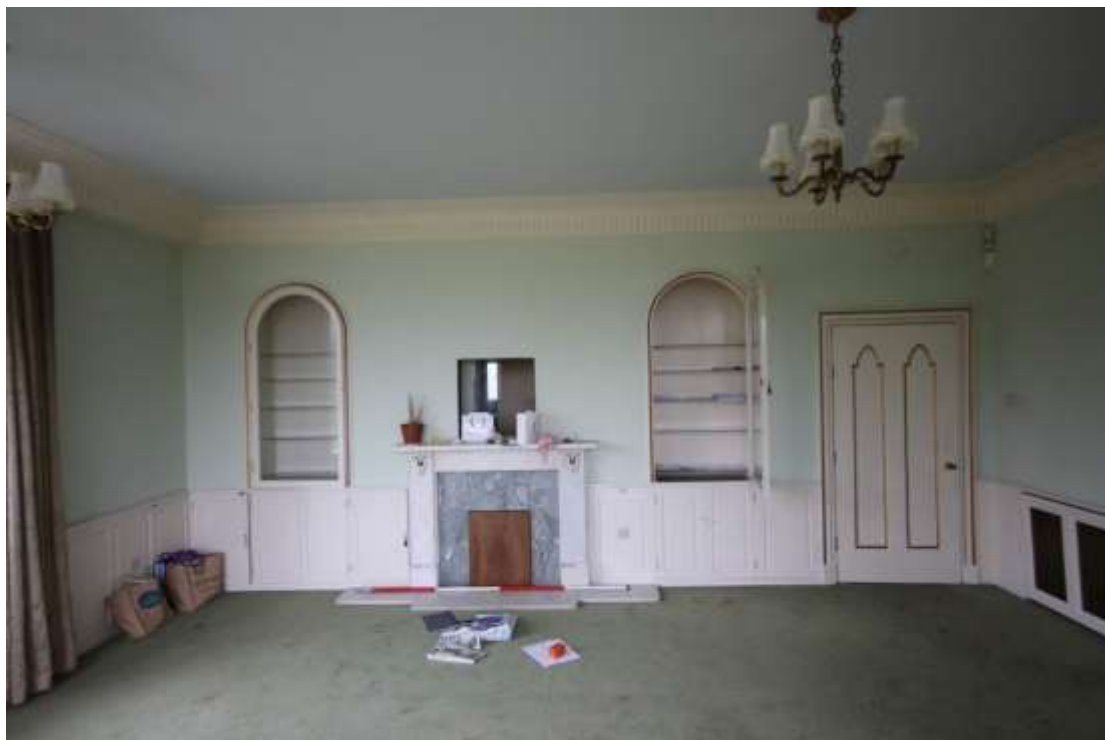
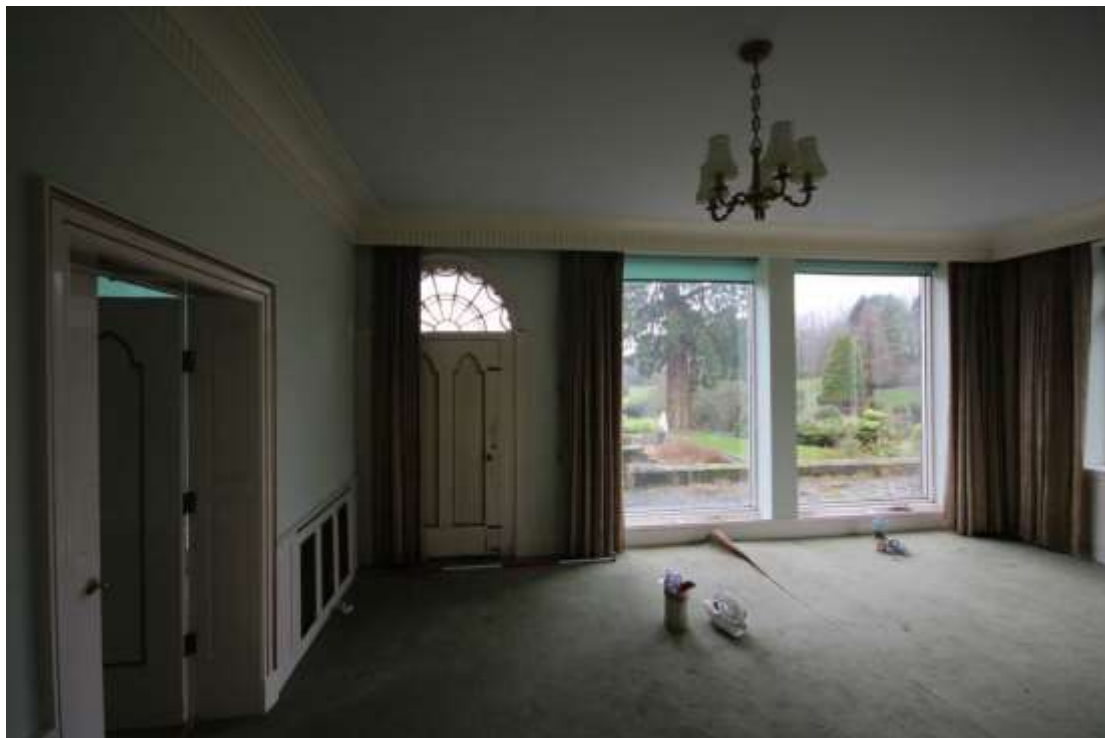
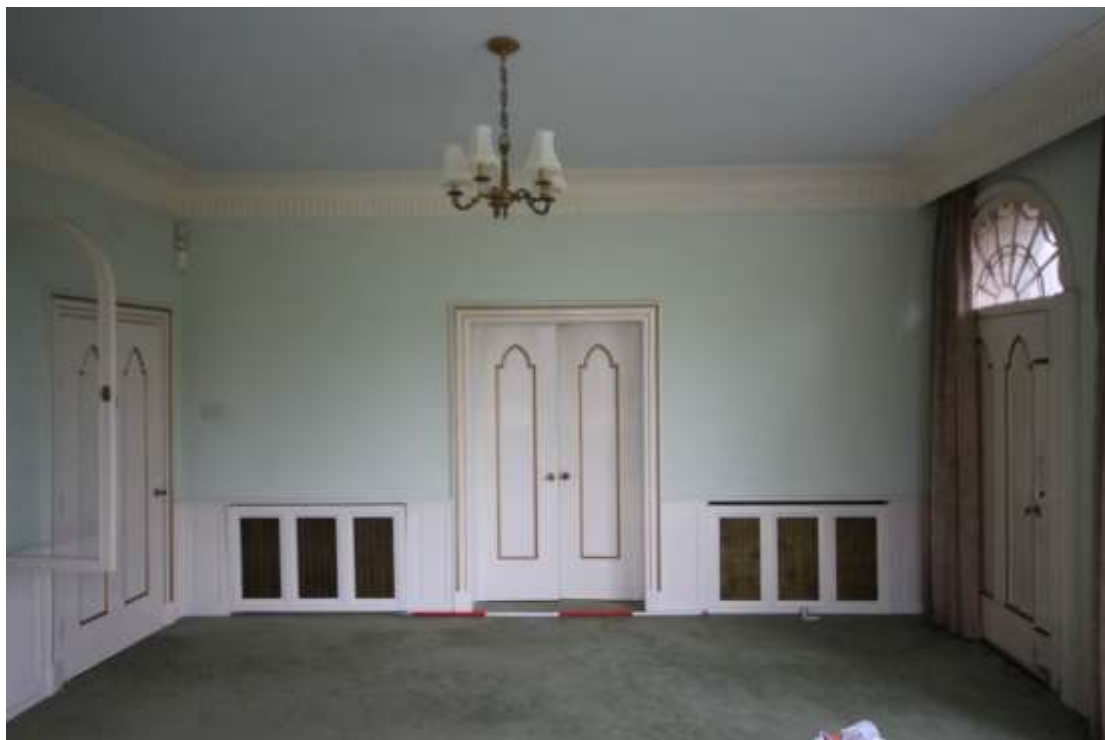
6.23 The main hallway from the reception hall leads south to the drawing room. This contains a much greater proportion of original fabric than many other internal spaces in the Hall. In the north wall there is a fireplace in the original position: this has a marble surround with a square headed lintel, flat mantel and square column-style jambs with pedestals. This is likely a 20th century addition to the room. Around the north and west walls are low cupboards at floor level, with two large, three-centered arched display cases set within the wall either side of the fireplace. The wall is topped with a dog-tooth cornice. A set of white, paneled double doors lead to the dining room to the east. These doors are similar to the others situated in this block and have gold lined moulding; they also contain the shadow of the original moulded handle plate (Plate 49).

Plate 46: View of the northern elevation of the Drawing Room in Block B, facing north. Scale 2m.

Plate 47: View of the southern elevation of the Drawing Room in Block B, facing south. Scale 2m.

Plate 48: View of the western elevation in the Drawing Room in Block B, facing west. Scale 2m. The central doorway here leads into the Dining Room.

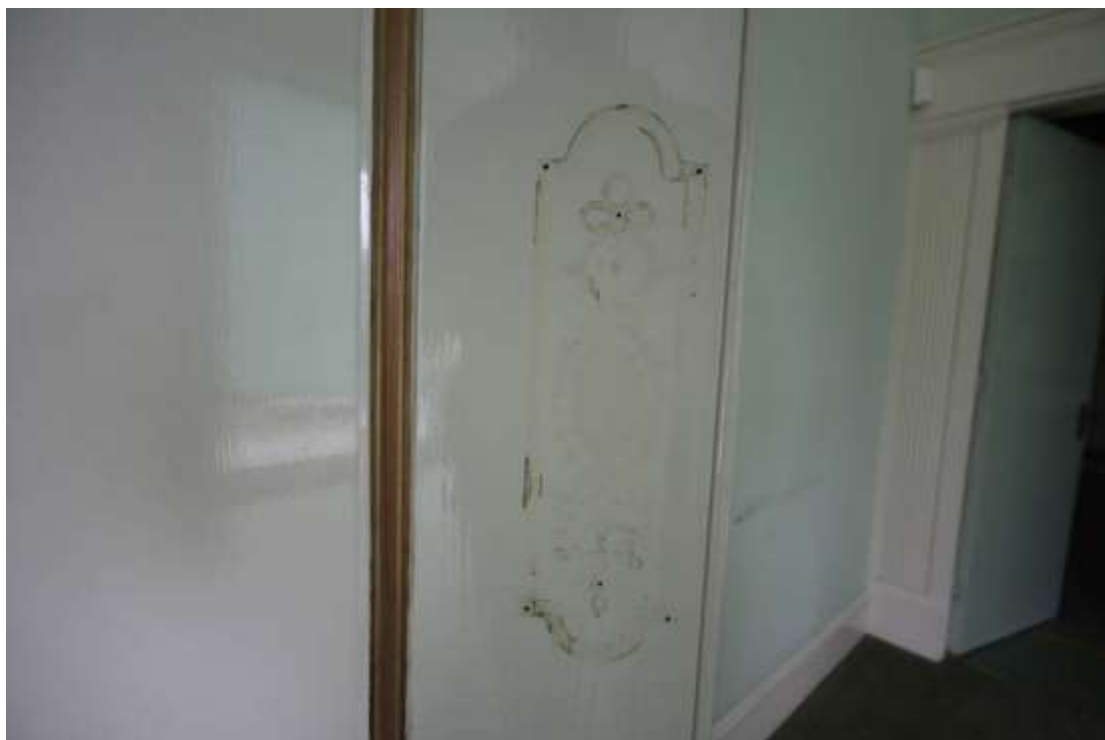
Plate 49: Detailed view of the shadow of the former handle plate on the doorway between the Dining Room and Drawing Room in Block B.

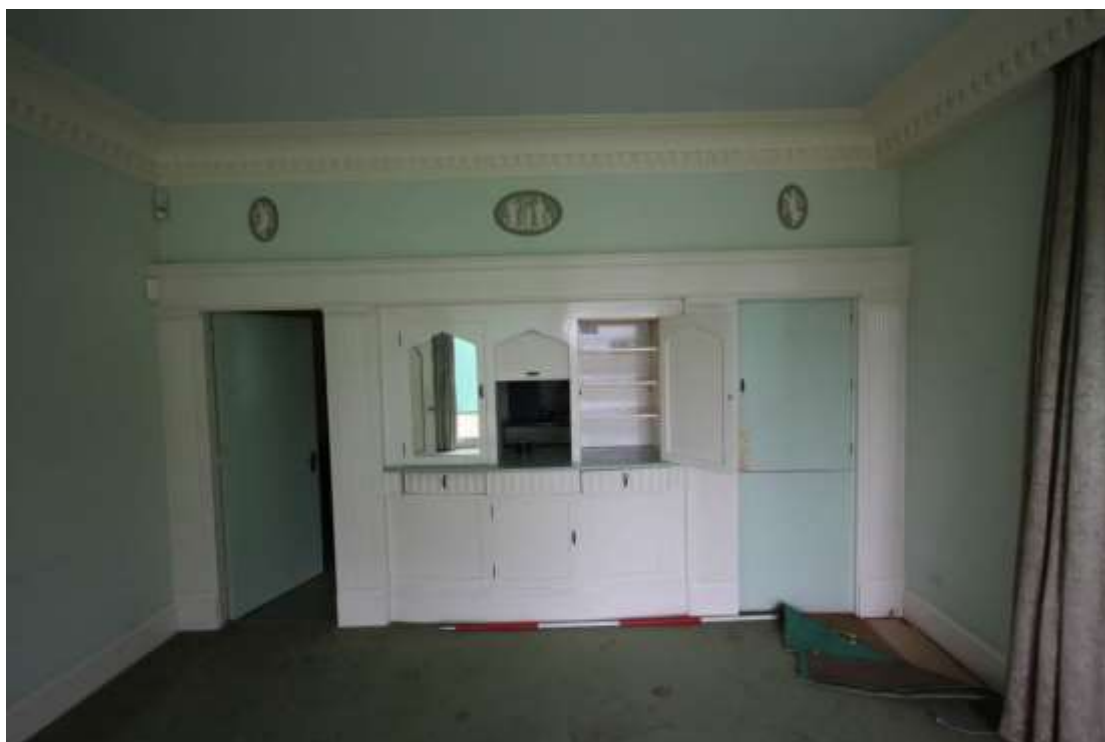
6.24 The dining room is similar in style to that of the drawing room, with white wooden features and a dog-tooth cornice. The northern wall contains a large cabinet centerpiece set into the wall with cupboards and a hatch that links to the adjacent kitchen to the north. A doorway on the left side leads to the kitchen, and it is possible that a second doorway was once situated on the right side. It is possible that this feature is original to the construction of this room in the 19th century; however, it is likely that the details have been altered, such as the cupboards themselves. Above this are three roundels depicting classical figures and scenes.

Plate 50: View of north elevation of the Dining Room, facing north. Scale 2m.

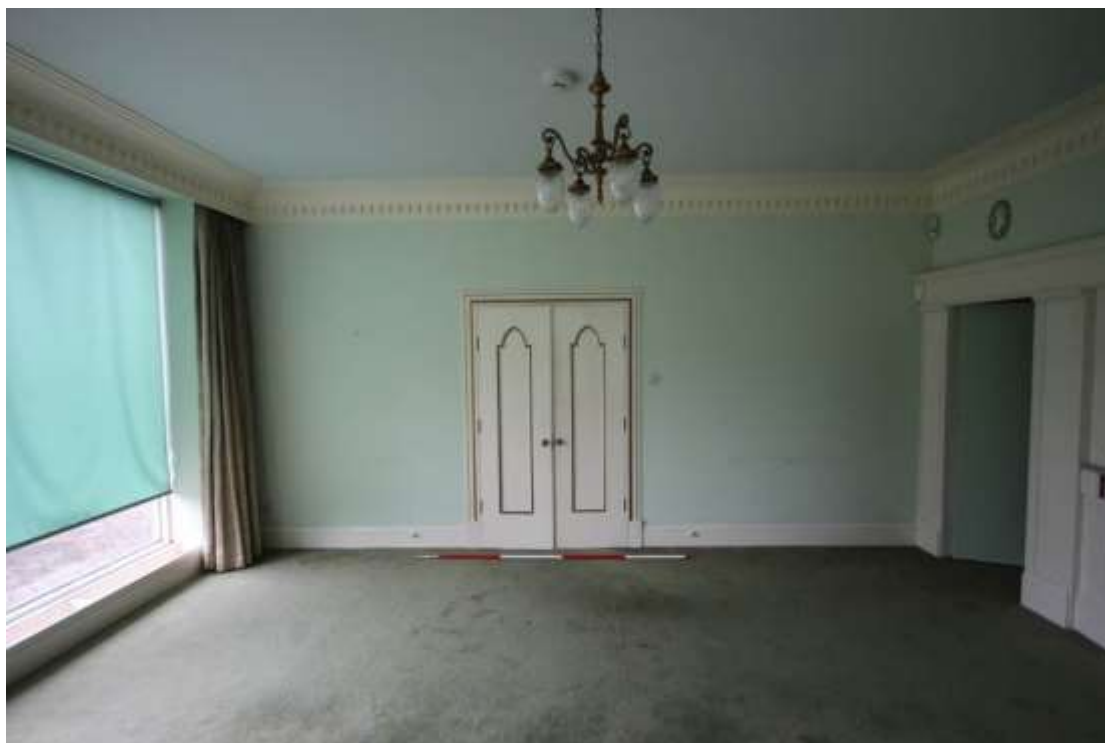
Plate 51: View of the west elevation of the Dining Room, facing north. Scale 2m.

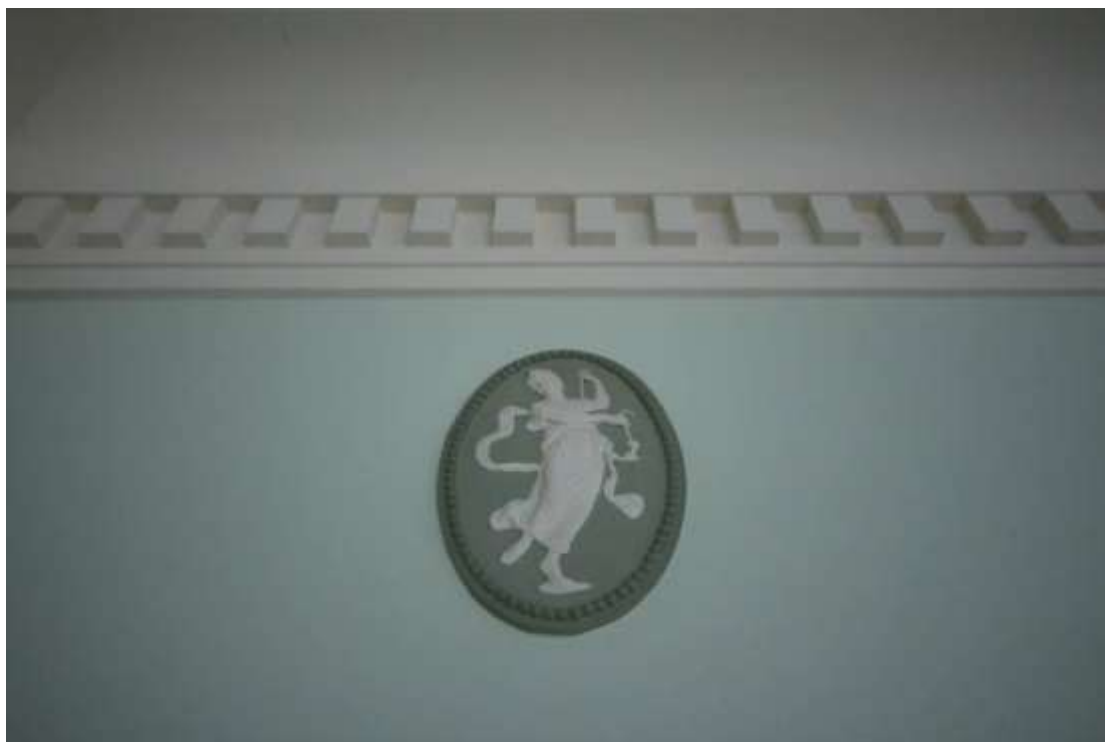
Plate 52: Detailed view of the dogtooth cornice and plaster roundel in the northern elevation of the Dining Room, facing north.

7.4 Due to the continued use of the site well into the 20th/21st centuries, the internal areas have been adapted and modernised to suit changing living requirements. As a result, very little original fabric survives internally. Most rooms contain modern features emulating historic architectural styles, for example in the southern ground floor rooms of Block B, such as dogtooth cornices (Plate 52).

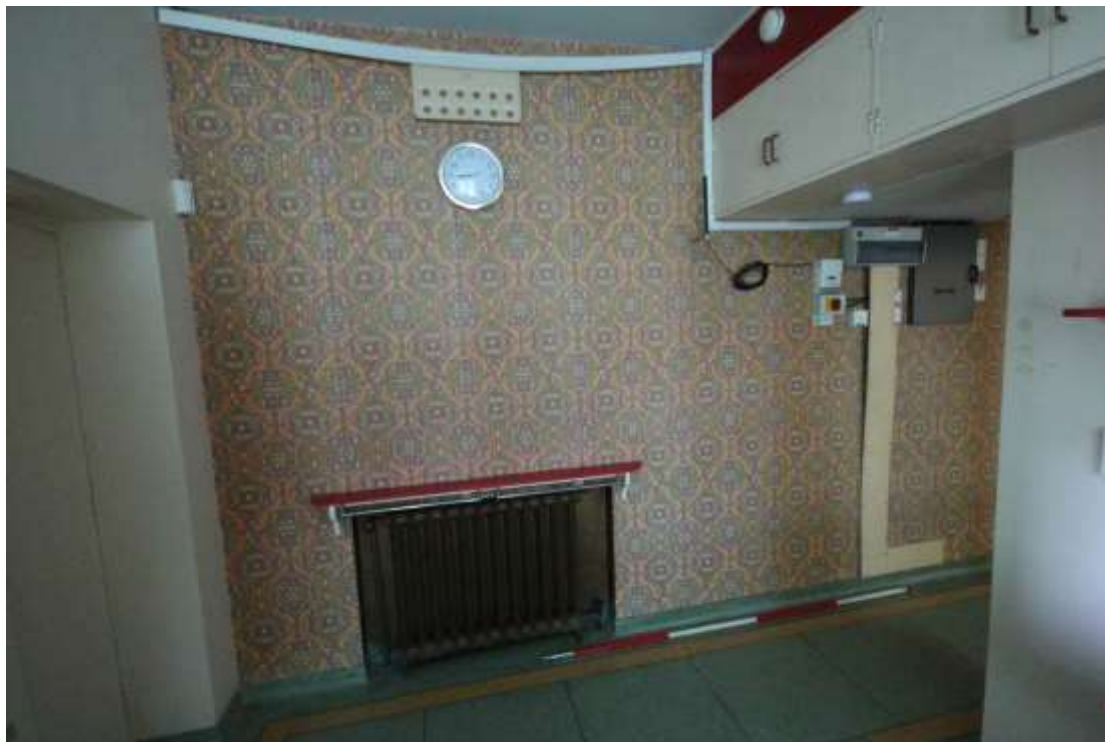
6.25 To the north of the dining room is the kitchen and utility area (Plates 53-56). This consists of a relatively modern looking kitchen and utility room, both with modern fixtures and fittings. Between these is a large pantry with floor to ceiling wooden shelving on the northern wall and cupboards on the southern.

Plate 53: View of the western wall of the Utility Area, taken from the Kitchen facing west. Scale 2m.

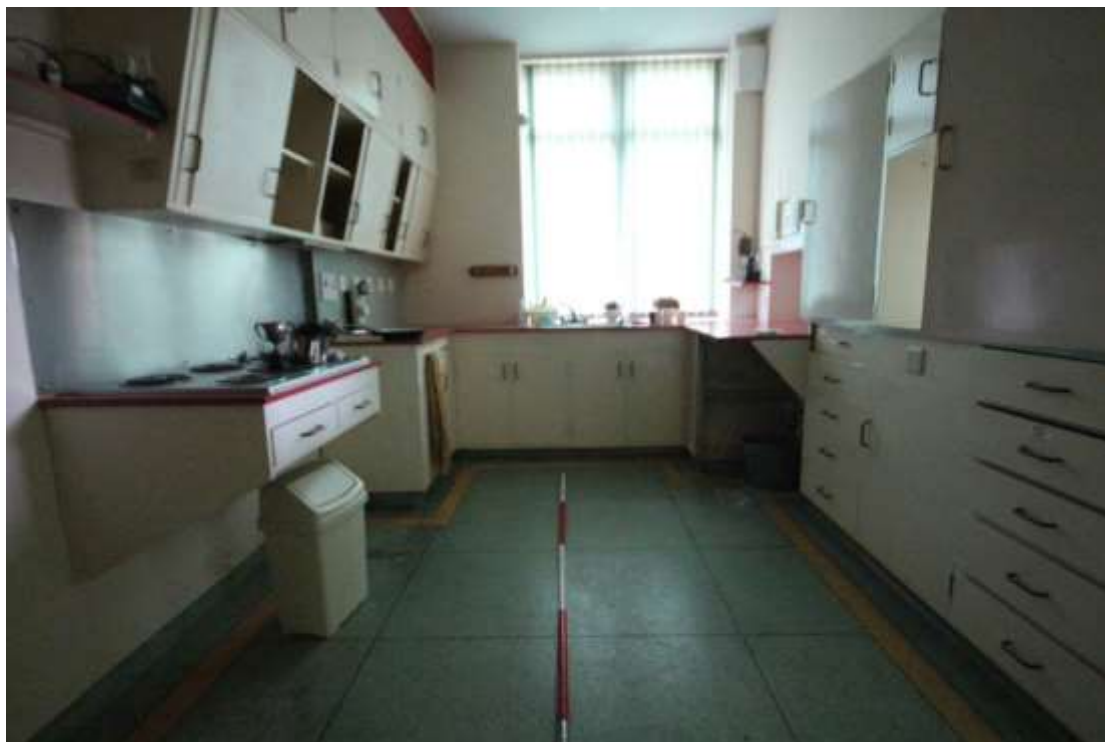
Plate 54: View of the Kitchen in the Utility Area, facing east.

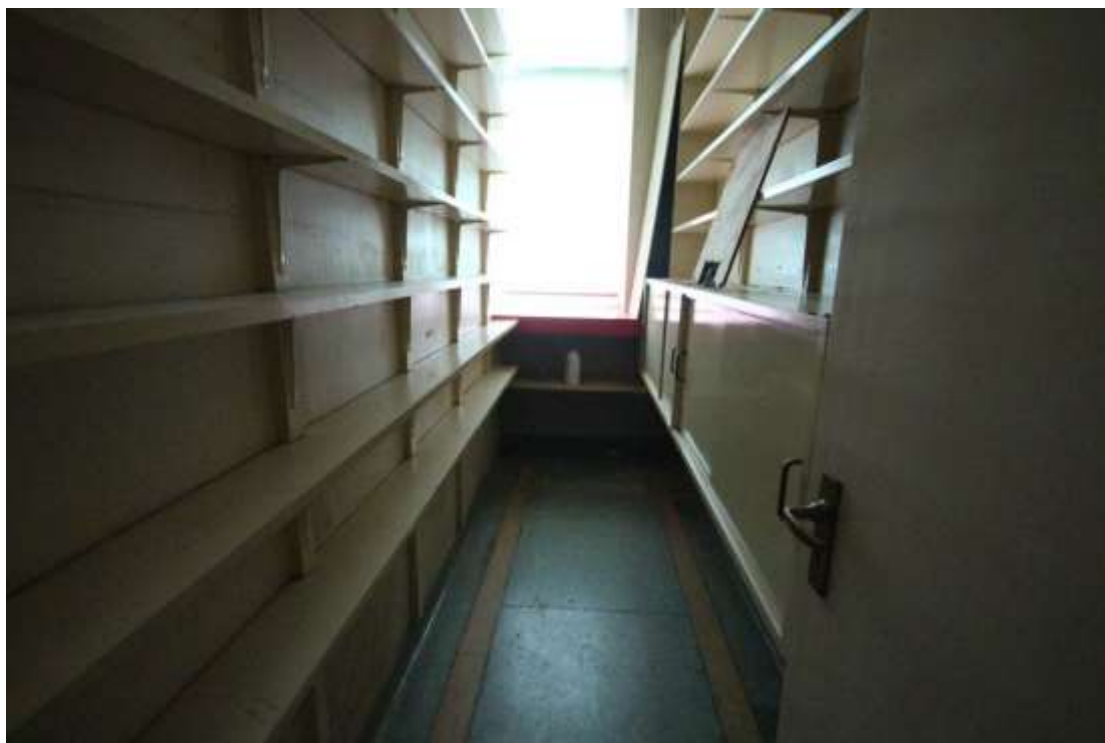
Plate 55: View of the Pantry, facing east.

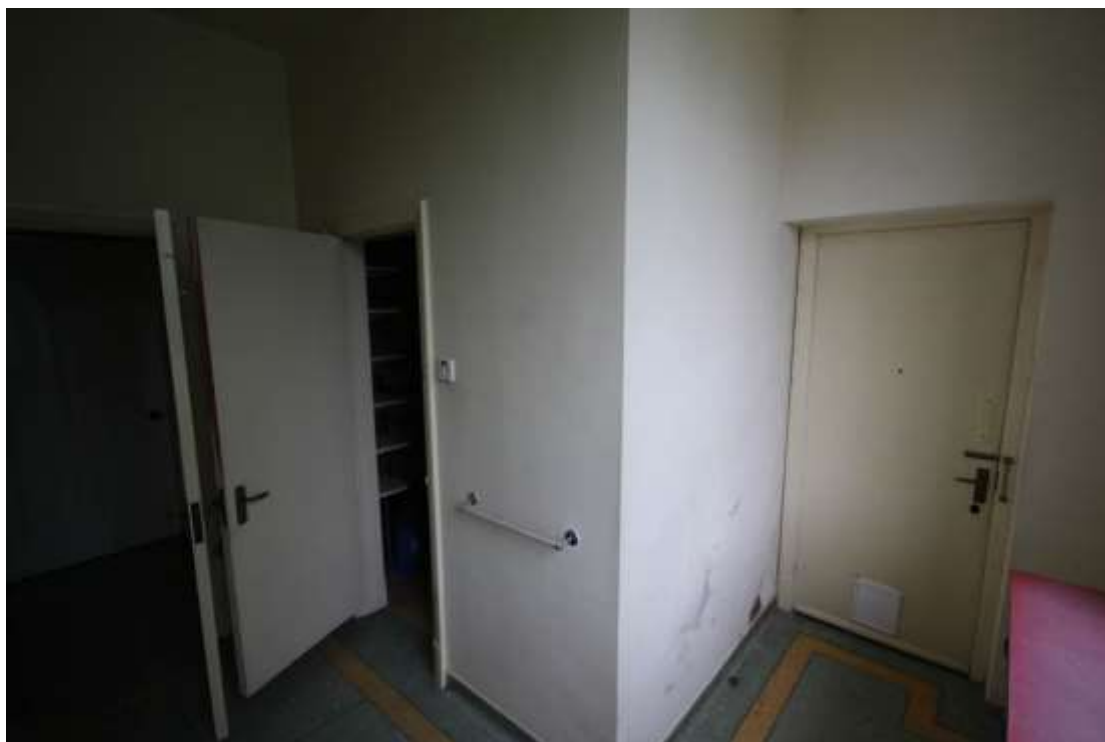
Plate 56: View of the Utility Room, facing north west.

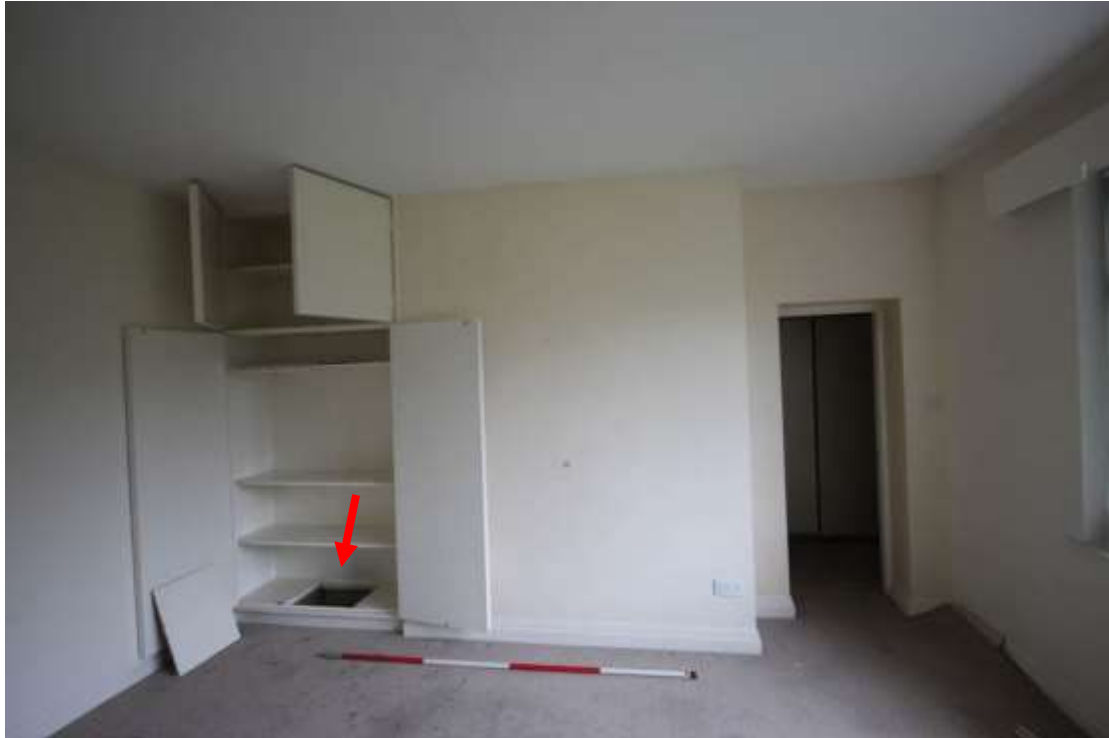
6.27 Directly opposite the balustrade in the galleried is a doorway leading to Bedroom 3 (Plates 59 & 60). This room houses a built in set of modern drawers on the southern wall, with a sink in the centre. A built in wardrobe on the north wall houses a hatch leading to a crawl space between the ground and first floor (Plate 61). Looking into this crawl space a low brick wall is visible; this may be evidence of one of the original dividing walls in this southern wing of the Hall.

Plate 59: View of the northern part of Bedroom 1, facing north. Scale 2m. The arrow indicates the access to the Crawl Space underneath this room.
