Consall Hall, Consall, Staffordshire: historic building recording

ARS Ltd Report 2020/32

January 2020

Prepared on behalf of: Consall Hall Estate Ltd

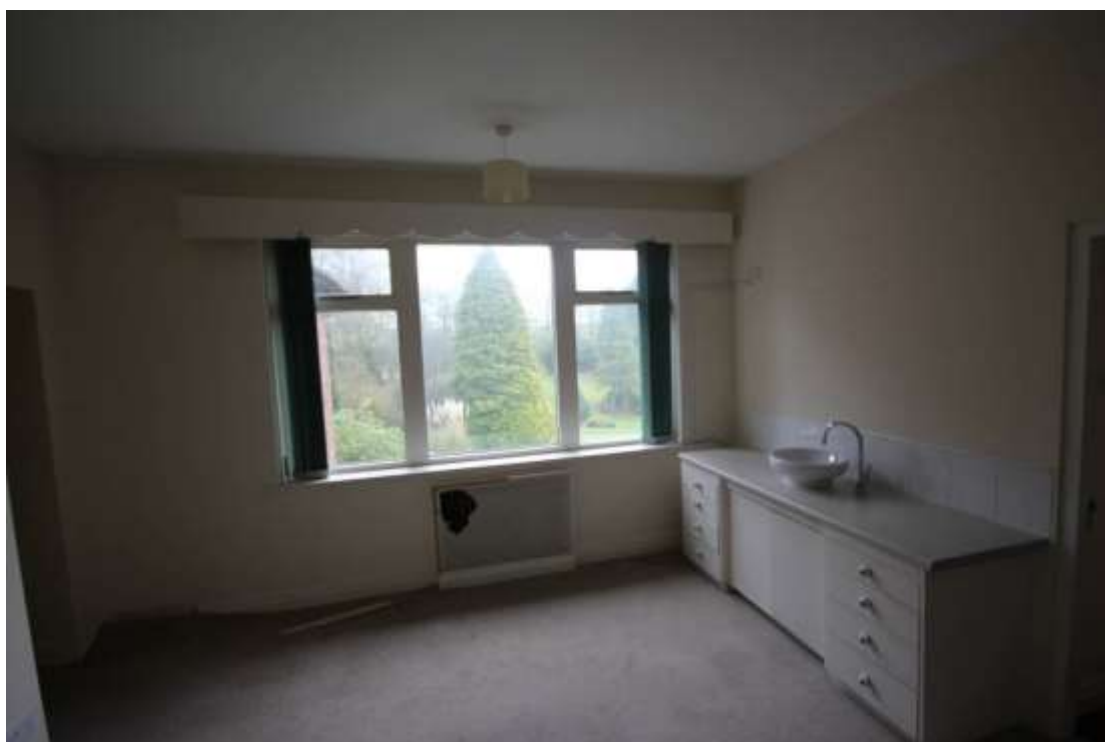
Plate 60: View of the south eastern part of Bedroom 1, facing south east.

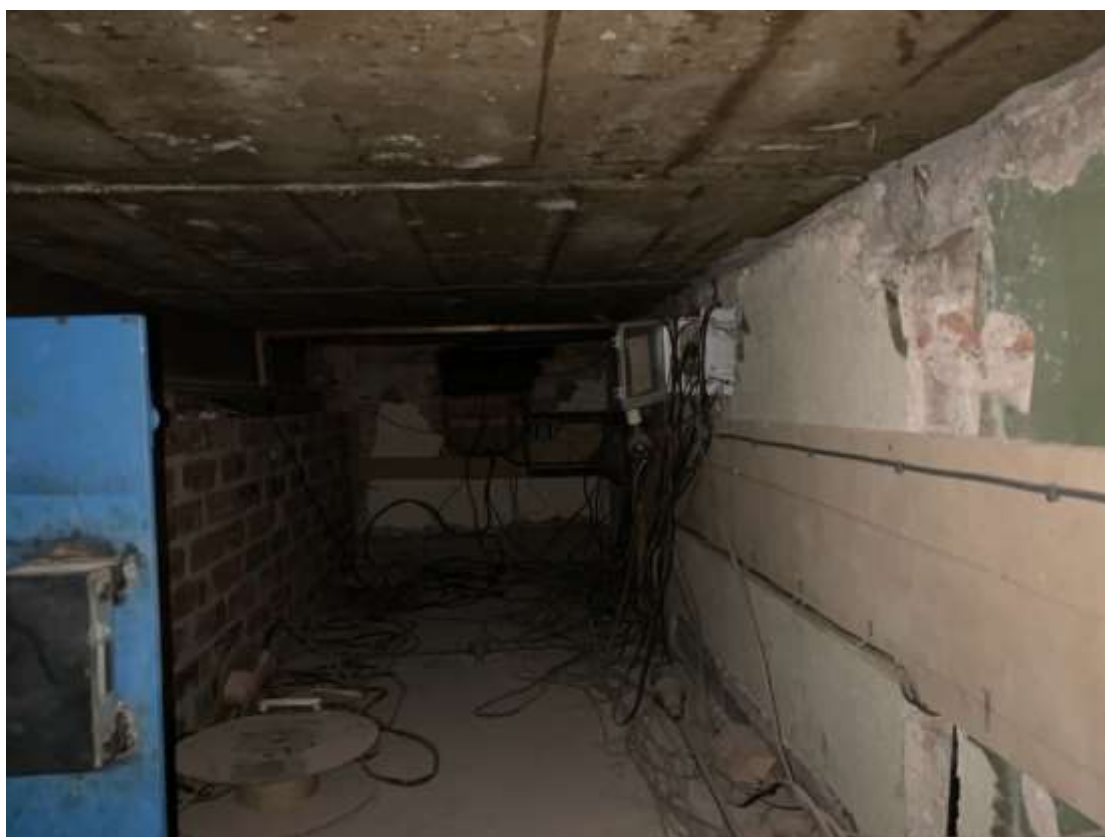
Plate 61: View of the Crawl Space directly underneath Bedroom 1, facing south. The wall on the left side of this photograph is most likely remnants of the original dividing walls in this wing of the hall building.

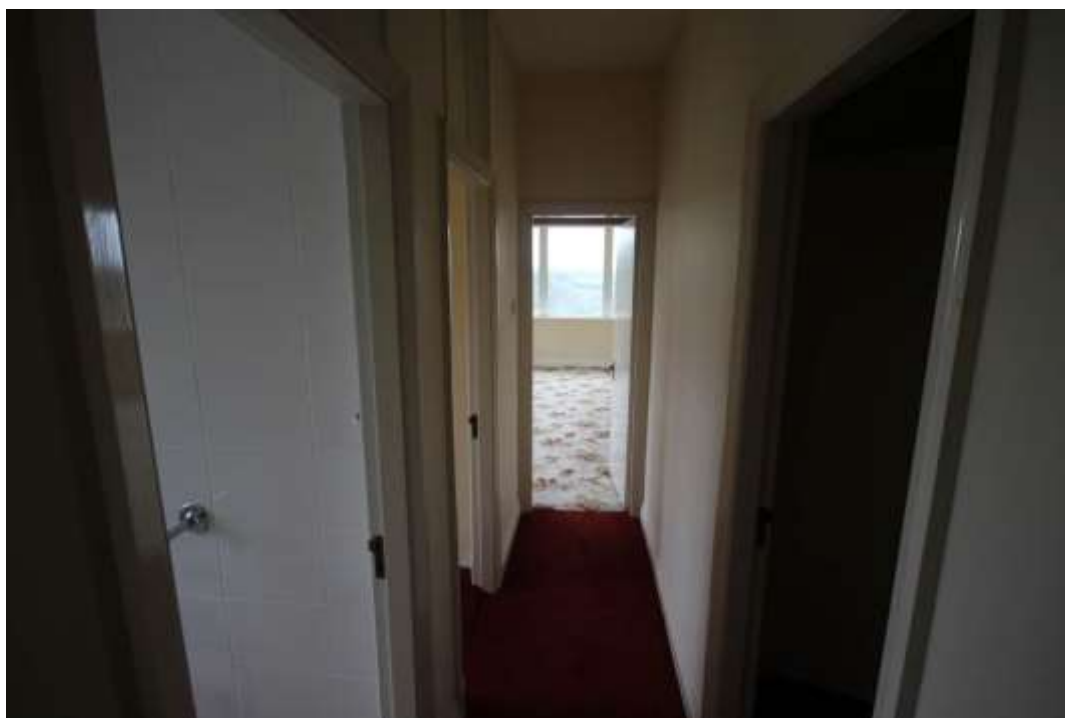
6.28 A small corridor (Plate 62) separates bedroom 1 and 2. In this corridor are doors leading to the shower and w/c (on the east side) and dressing room (on the west). It is likely that these smaller dividing walls are original, as they likely defined original dressing room/wash room spaces. As with other areas of the house it is difficult to be certain, as the doorways and walls all appear very modern.

Plate 62: View of the corridor linking Bedrooms 1 and 3, facing south looking into Bedroom 1.

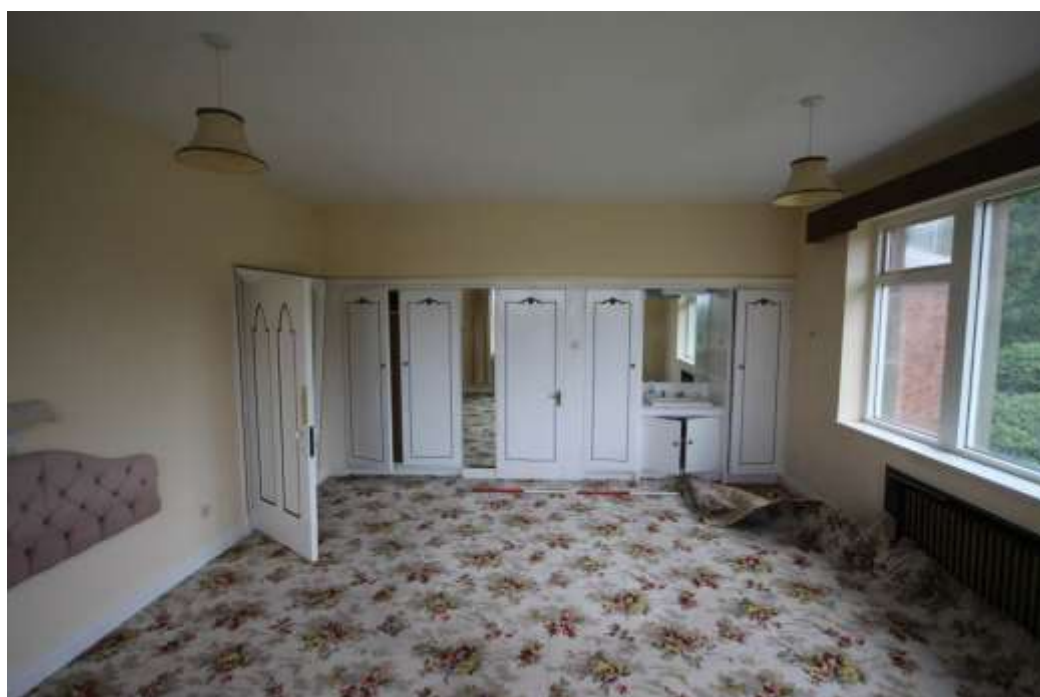
6.29 Bedroom 1 is accessed through the corridor leading from Bedroom 3, with the doorway being set within a modern built in wardrobe. This bedroom has windows in the eastern and southern walls, giving views across the grounds. Bedroom 2, situated across the corridor to the east, mirrors this. The dressing room in Bedroom 2 also houses a central round window. It is probable that these two bedrooms were the higher status, master bedrooms of the house.

Plate 64: View of the northern part of Bedroom 1, facing north.

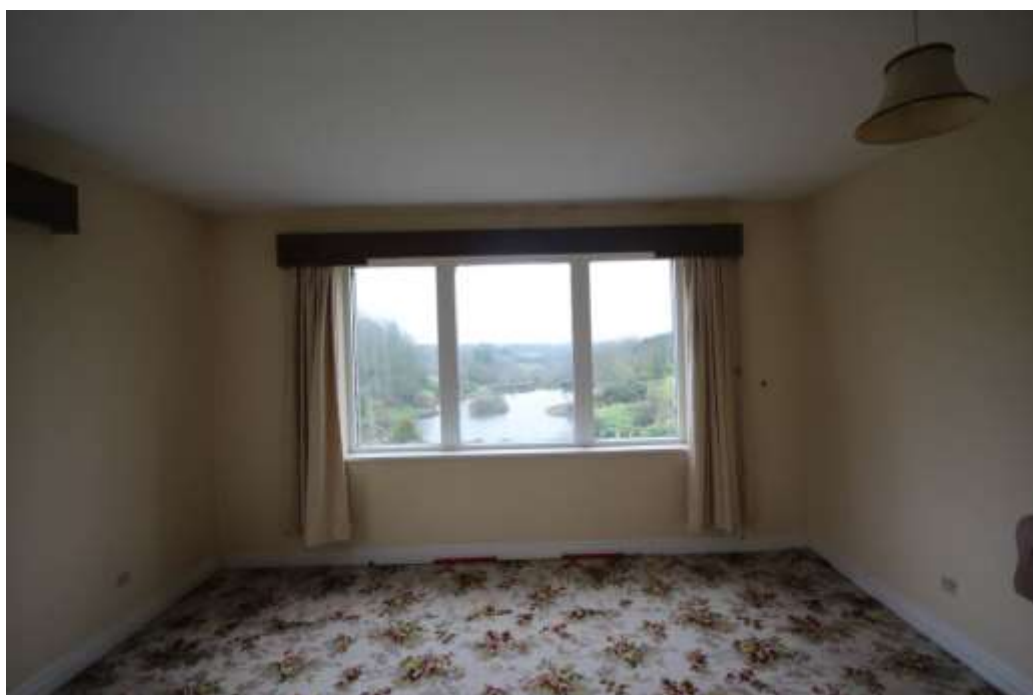
Plate 65: View of the southern elevation of Bedroom 1, facing south.

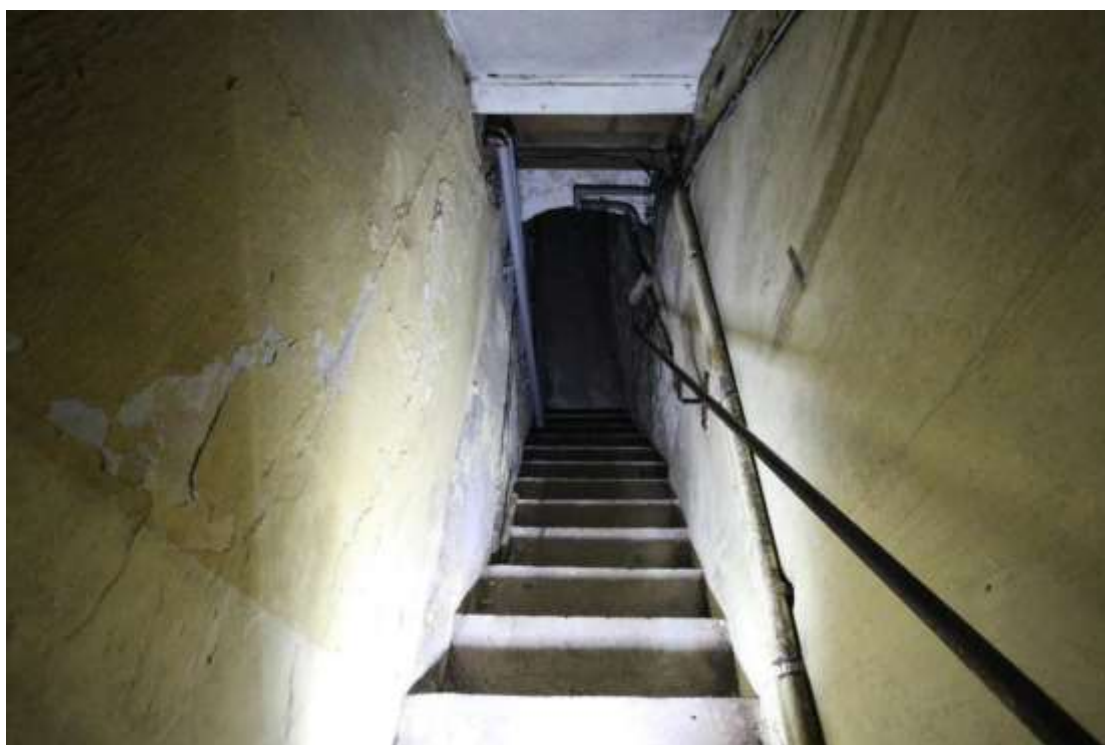
Plate 66: View of the staircase leading from Block A into the Basement, facing west.

6.30 The basement is accessed by a staircase (Plate 66) from the ground floor hallway in the eastern wing of Block A. The staircase area is plastered and painted yellow, leading down to a doorway covered with a three-centered brick archway. An L-shaped corridor leads down from the stairs and then turns south (Plate 68), under what is Block B. The corridor (Plate 67) is lined with un-dressed, neatly coursed sandstone ashlar topped with a vaulted ceiling of brick. There appears to have been a significant re-organisation of the space in the basement, most likely occurring when the southern wing was expanded in the late 19th century, creating Block B. The line of masonry at the base of the north-south corridor (Plate 69) suggests that the floor level has been raised. A small area divides the corridor and the northern store room; the southern wall in this small space between the corridor and the store contains a low, blocked doorway (Plate 70) covered with a three-centered arch with the remains of iron pintels in the brick jambs.

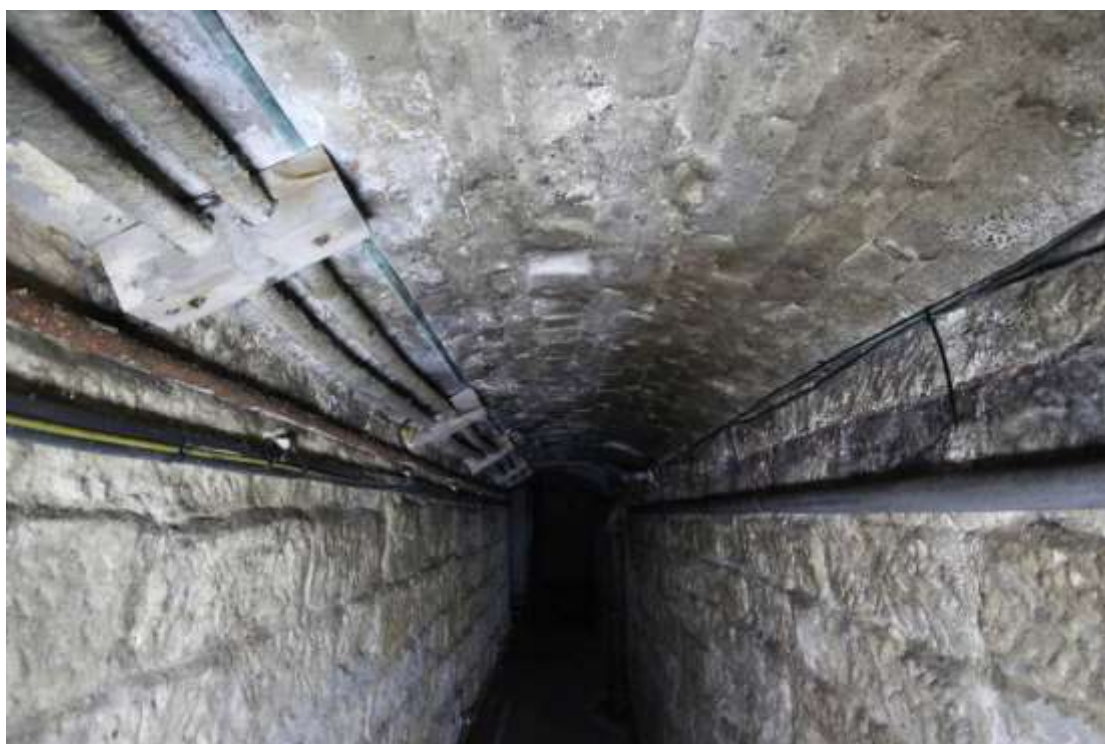
Plate 67: View of the corridor running east-west in the Basement, facing west.

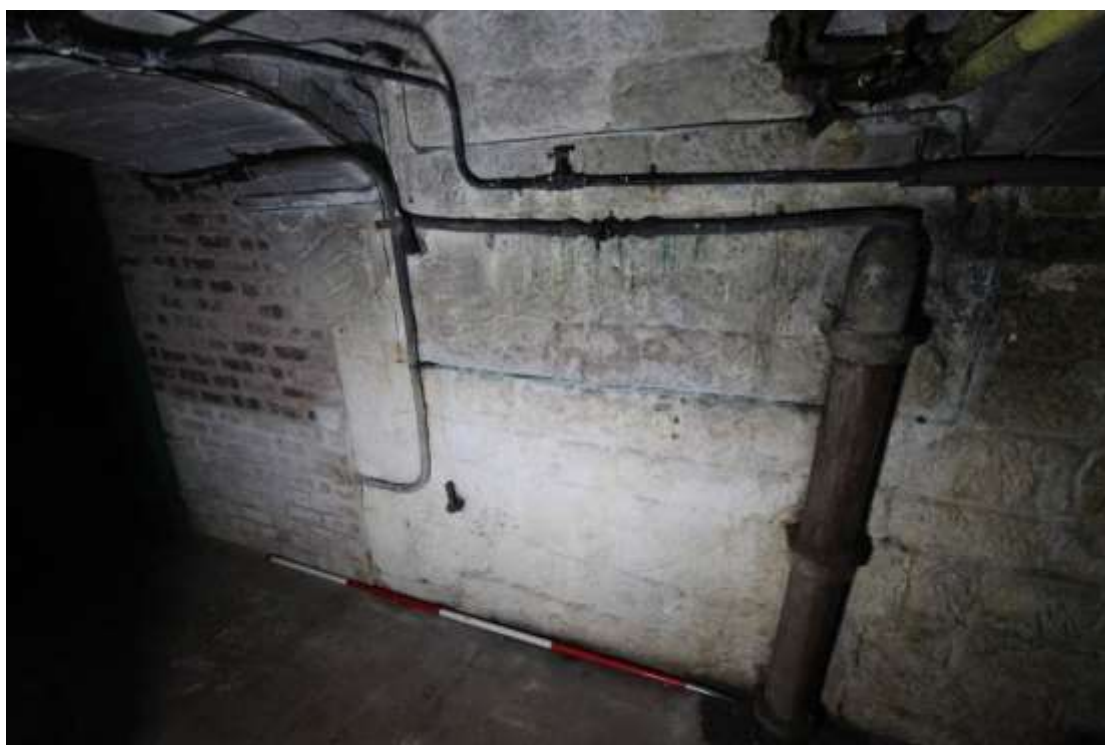
Plate 68: View of the opening to the store from the corridor, facing north west. Scale 2m.

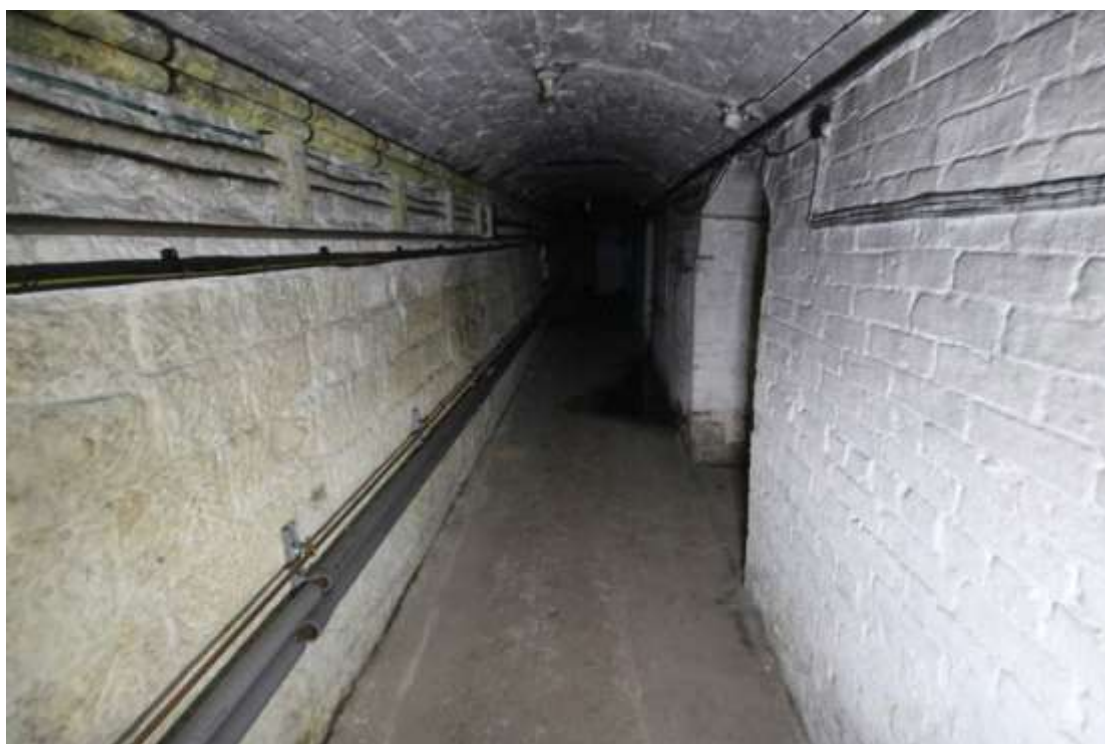
Plate 69: View of the north-south corridor in the Basement, facing south. Note the way in which the concrete floor here seems to cover a line of masonry, suggesting it has been raised.

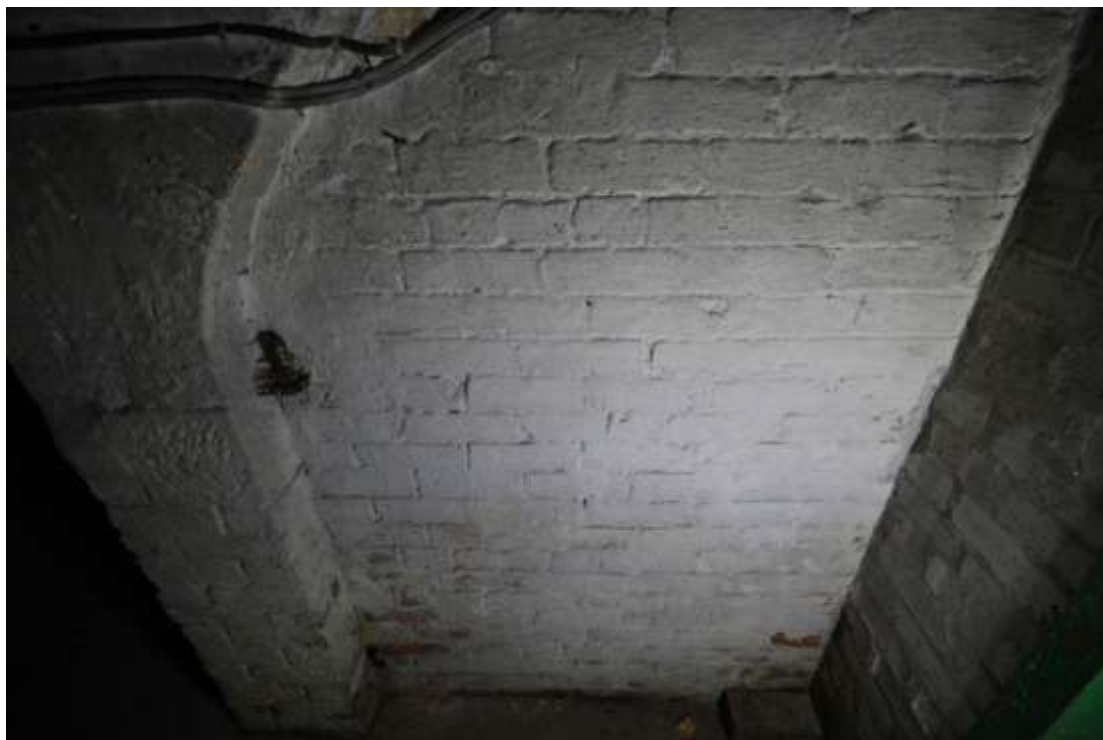
Plate 70: Detailed view of the blocked opening next to the entrance to the store, facing south.

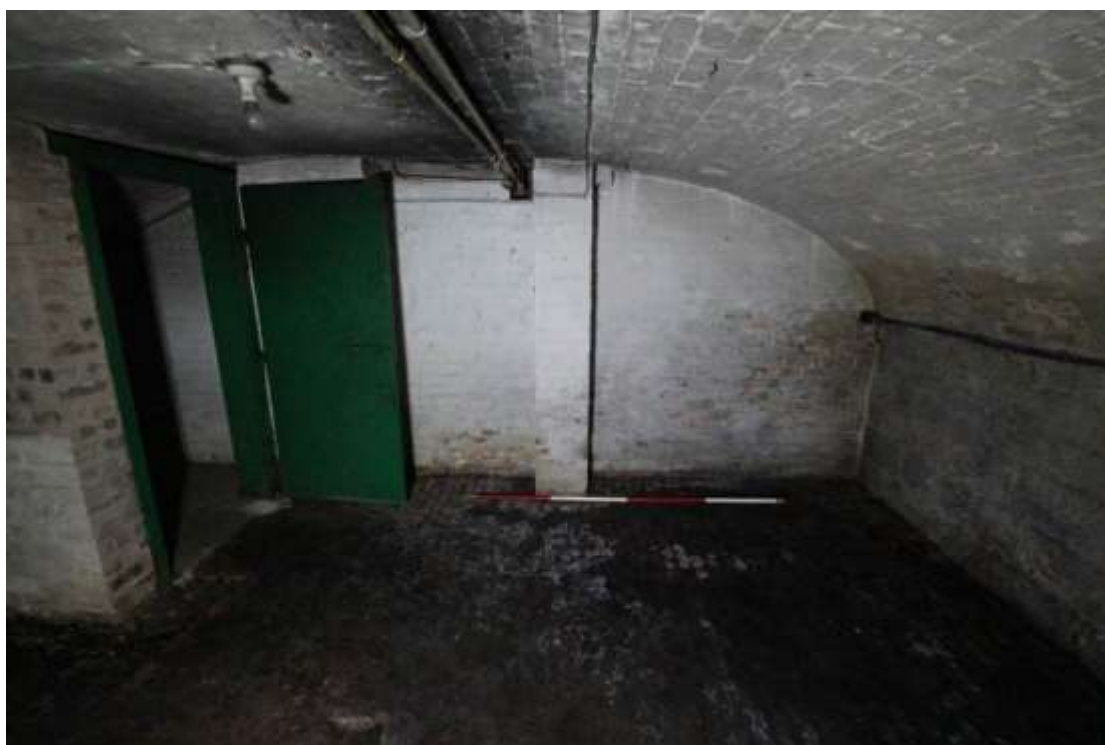
Plate 71: View of the southern elevation of the northern Store, facing south. Scale 2m.

6.31 The red brick floor area of the store looks to be original, with a central grate for drainage. A central buttress adorns the southern wall (Plate 71) of this storage space, with a second immediately to the left, behind the door. The north wall (Plate 73) houses an alcove in the eastern corner (Plate 74) that corresponds with a covered arch visible on the external northern wall (see paragraph 6.5). This has a step leading up to it and a hatch in the ceiling: it is likely that this was never a doorway but instead an opening to aid in the movement of goods into the basement directly from the outside. This was once covered with a door, as an iron pintel and latch fastener (Plates 75 & 76) are also visible here.

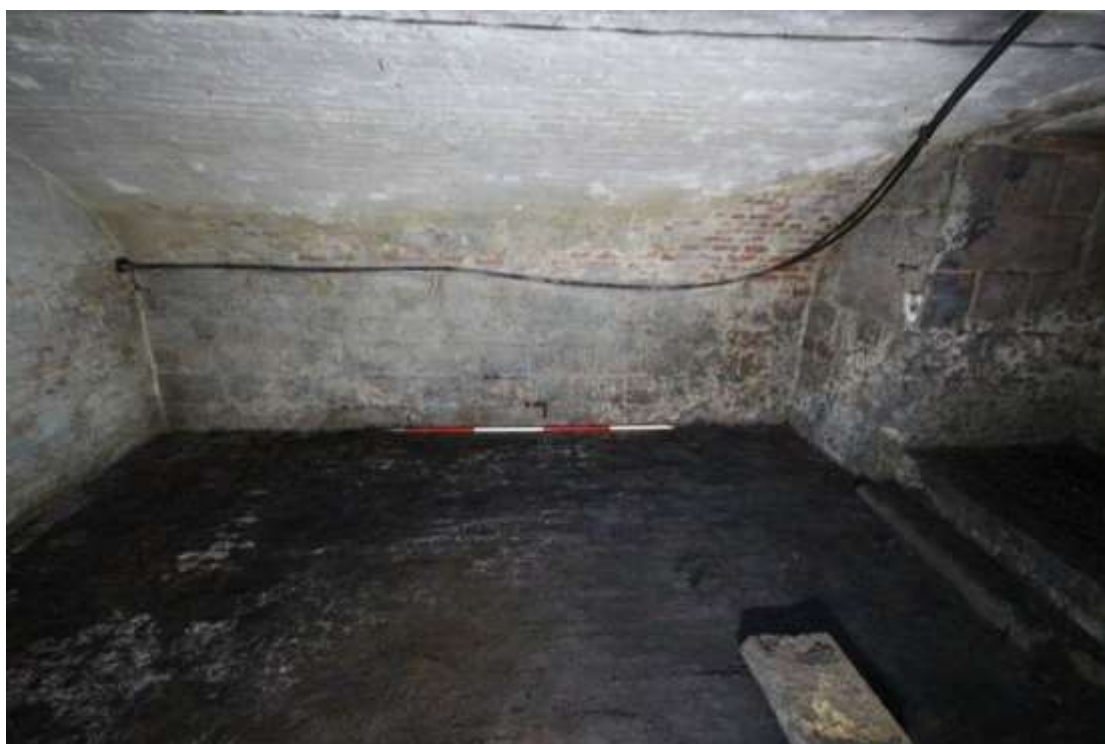
Plate 72: View of the western elevation of the northern Store, facing west. Scale 2m.

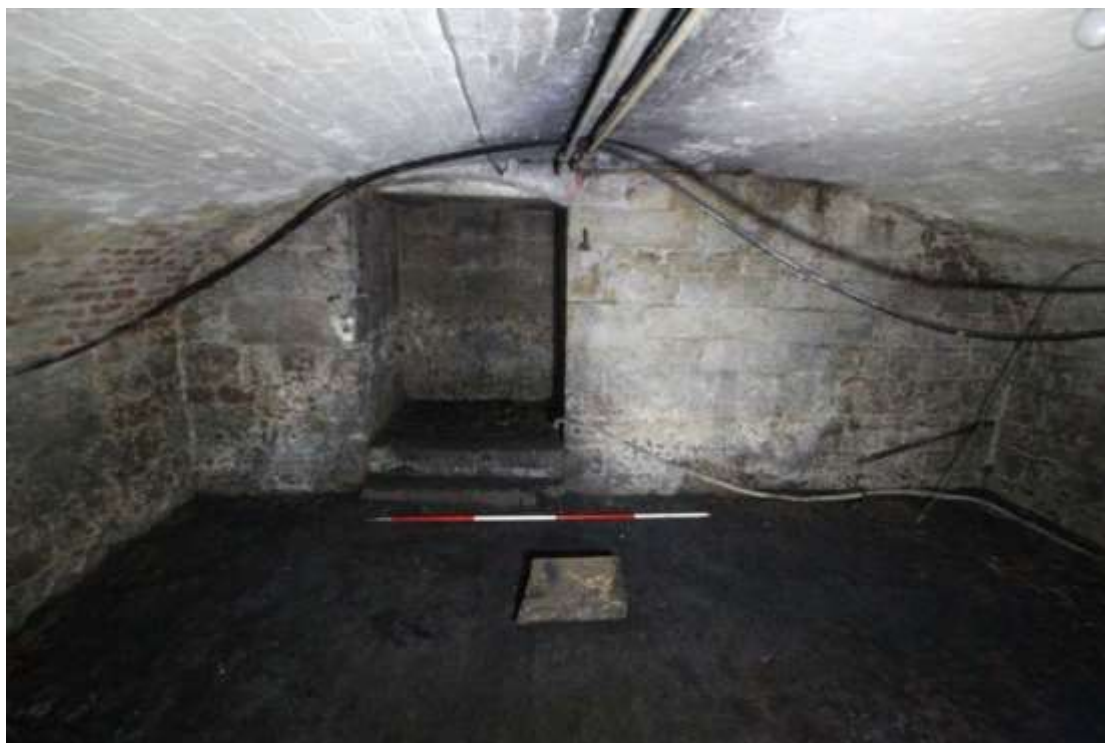
Plate 73: View of the northern elevation of the northern Store, facing north. Scale 2m.

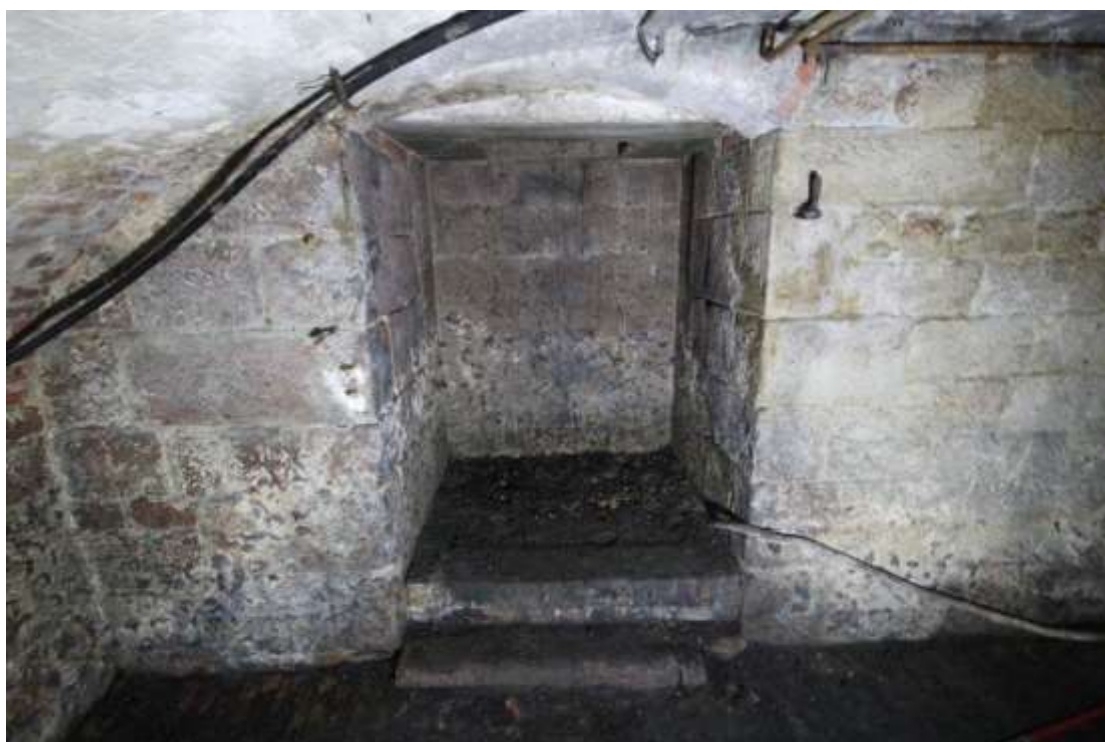
Plate 74: Detailed view of the alcove and former doorway in the northern elevation of the northern store, facing north. Scale 2m.

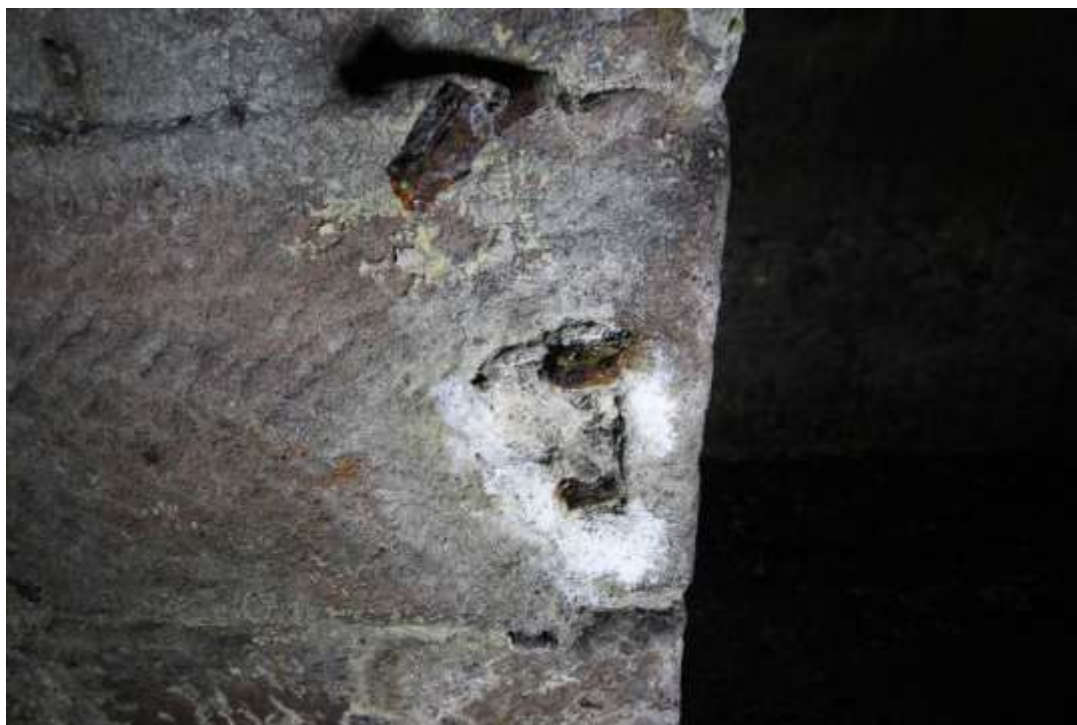
Plate 75: Detailed view of the latch fastener visible in the northern elevation of the north Store, facing north.

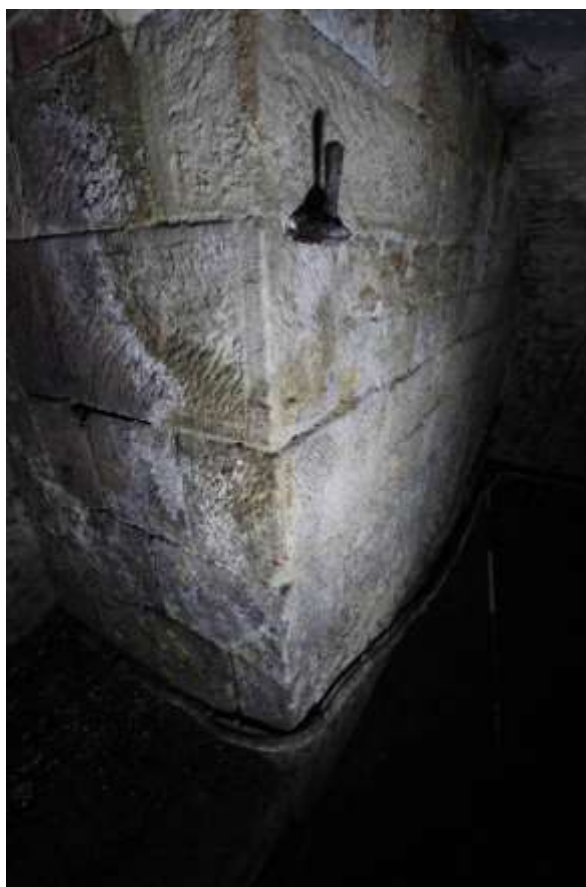
Plate 76: Detailed view of the iron pintel visible in the northern elevation of the north Store, facing north east.

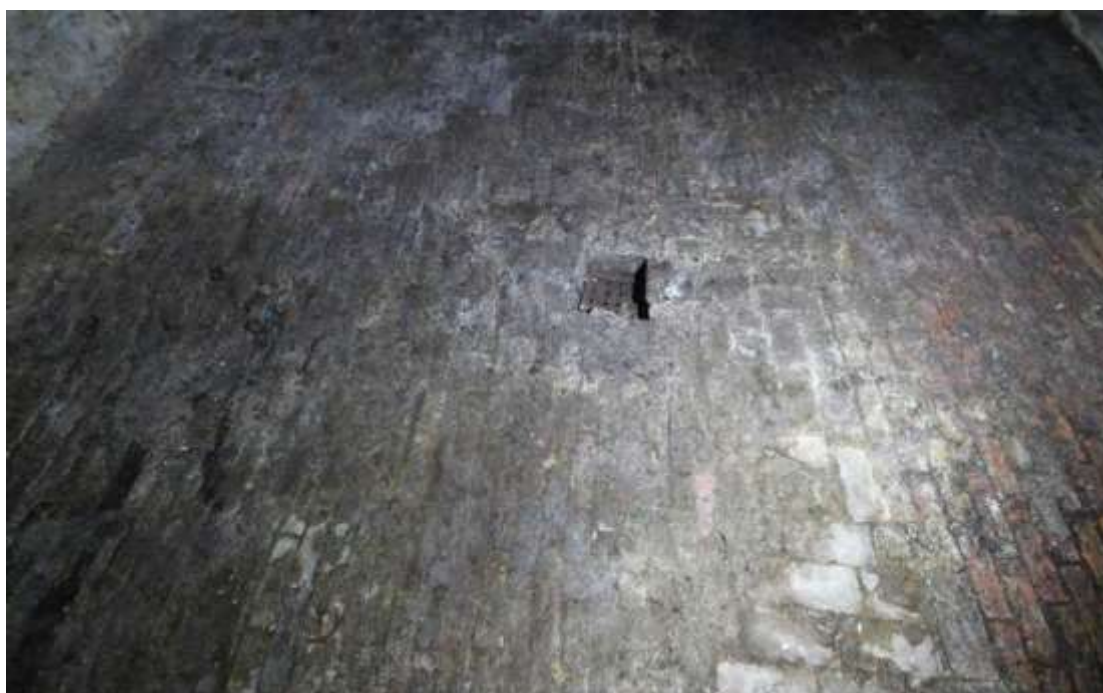
Plate 77: View of the central grate in the floor of the northern Store room, facing north.

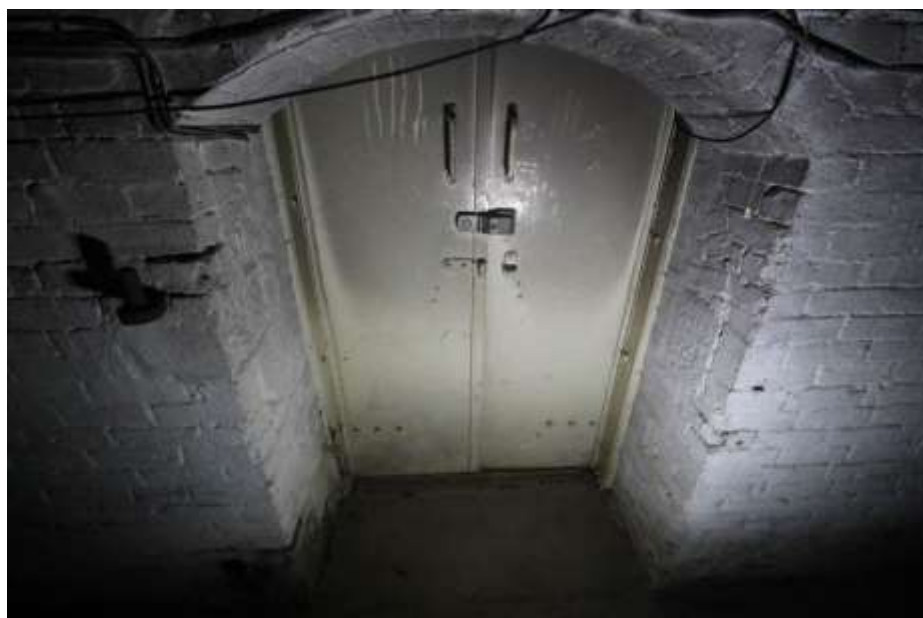
6.32 The entrance to the wine cellar is covered with a 20th century iron door (Plate 77) that is much larger than that of the opening. Evidence of an original doorway comes in the form of another iron pintel to the left of the opening. Another blocked doorway visible in the northern wall of this door opening (Plate 77), mirroring the once discussed above (see paragraph 6.30).

Plate 78: View of the doorway leading into the wine cellar, facing west. Note the iron pintel visible to the left of this opening.

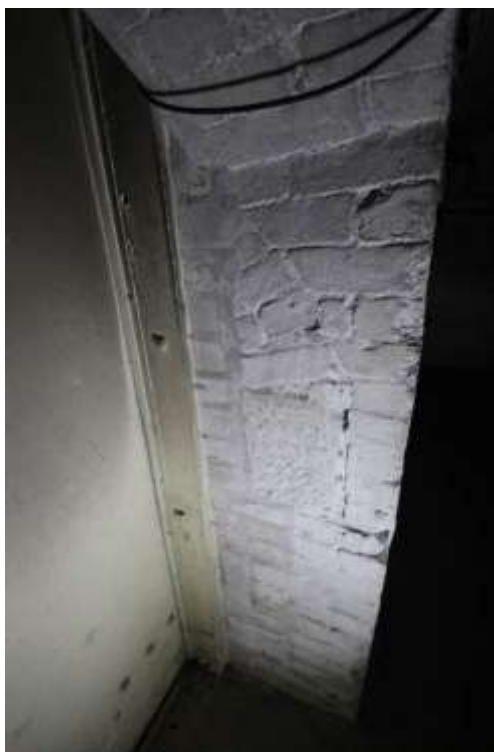
Plate 79: Detailed view of the blocked opening visible immediately next to the Wine Cellar doorway, facing north west.

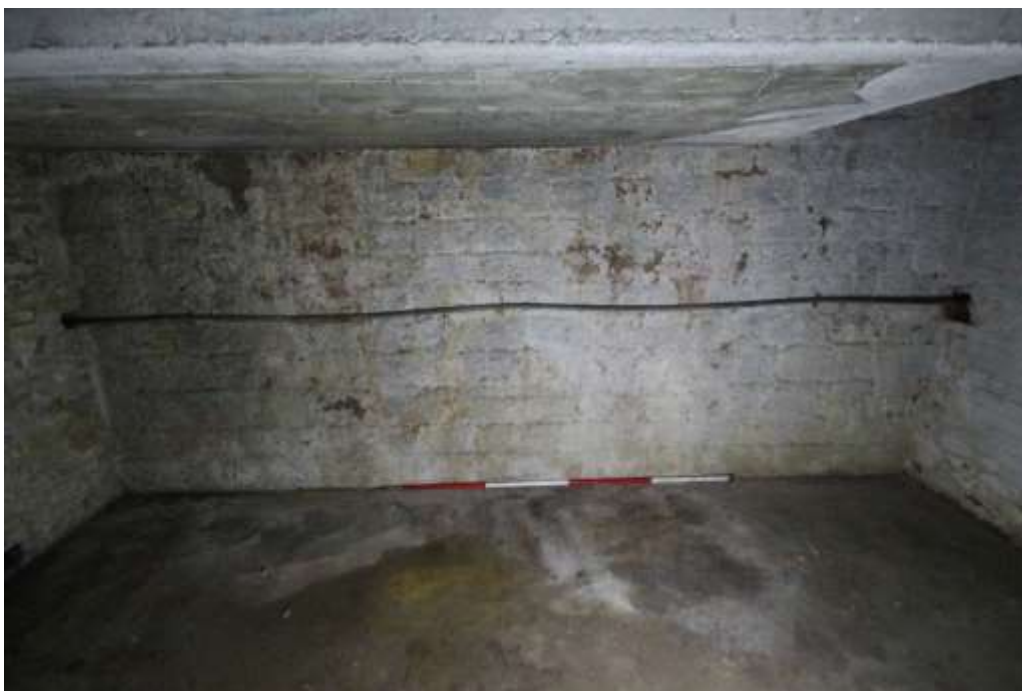
Plate 80: View of the western elevation of the central Store room, facing west. Scale 2m.

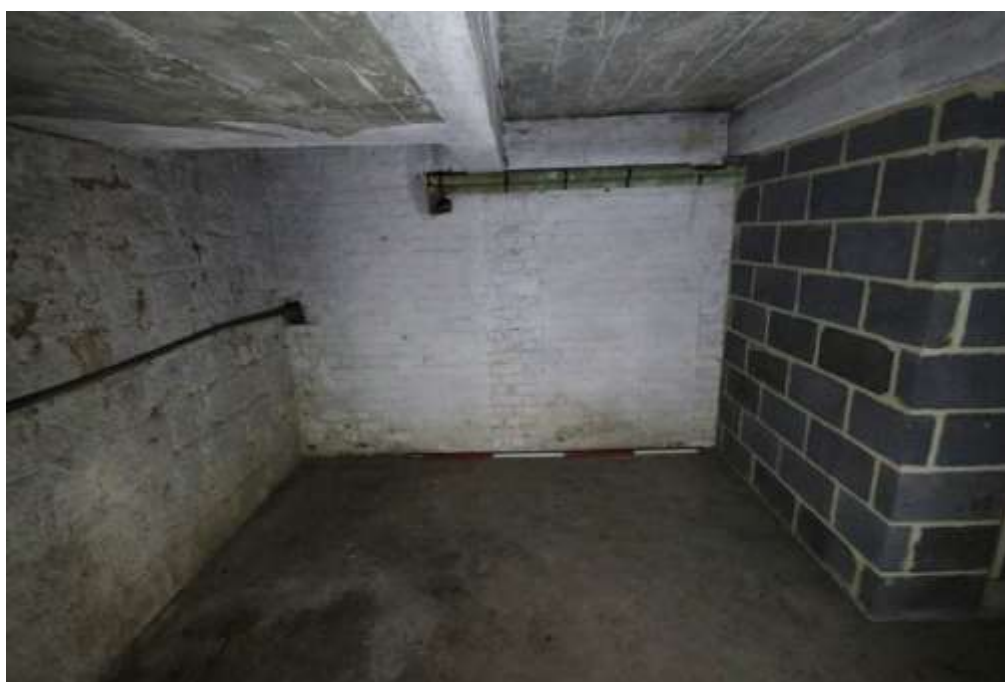
6.33 The central store room has a concrete floor and a later inserted breezeblock storage area in the north eastern corner (Plate 80). The western wall is of coursed sandstone, thus likely being an original feature. At ceiling height the floor structure of the drawing room above is visible, unlike most other rooms in the basement that have vaulted ceilings of brick. The double doorway in the eastern wall is tall and of iron, set within a red brick opening (Plate 81).

Plate 81: View of the northern elevation of the central Store room, facing north. Scale 2m. Note the later inserted breezeblock space to the right.

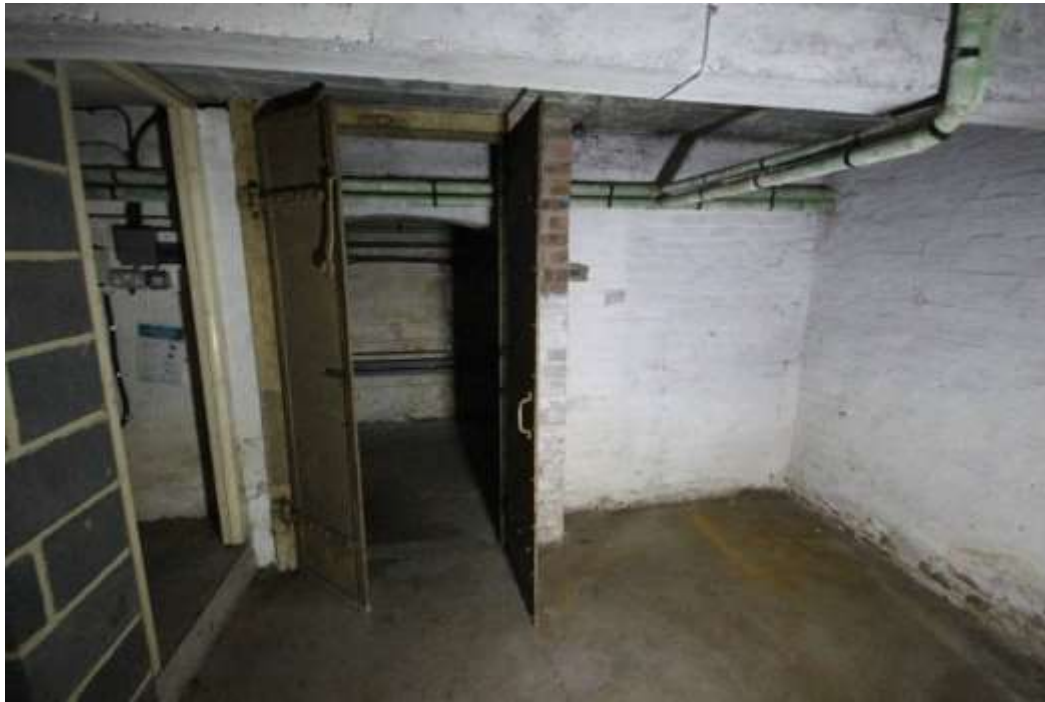
Plate 82: View of the eastern elevation in the central Store room, facing east.

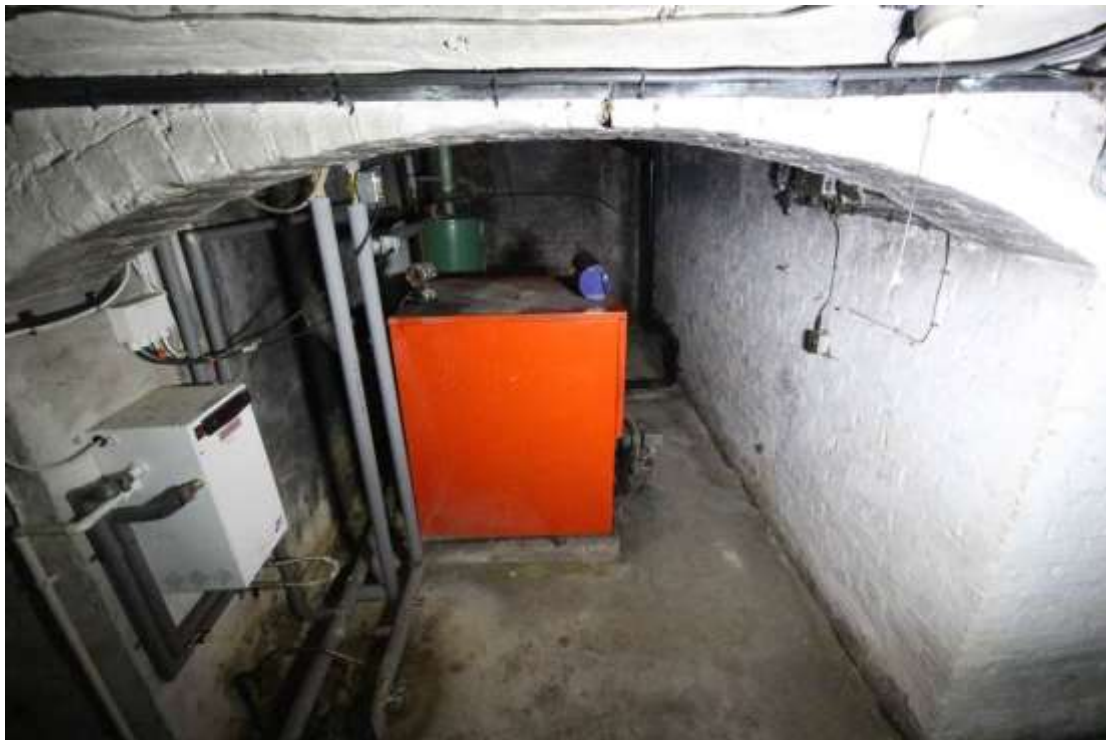
6.34 Immediately to the south of the central store area is an open area entered through a three-centered arch (Plate 82). This space also has a flat roof and a concrete floor, similar to the central store room. In the western wall is an opening in the masonry wall with a sandstone lintel, now blocked with brick. The majority of this space is occupied by modern boilers and pipe work.

Plate 83: Looking into the Boiler Room from the corridor, facing west.

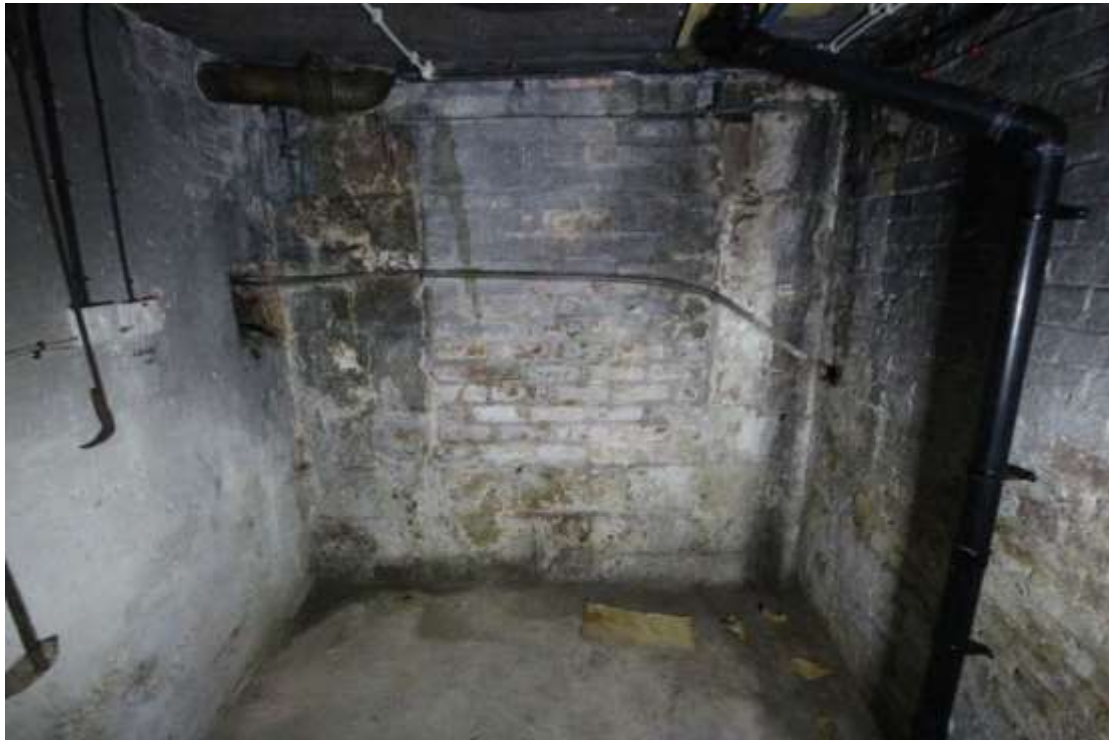
Plate 84: View of the western wall containing the blocked feature in the Boiler Room, facing west.

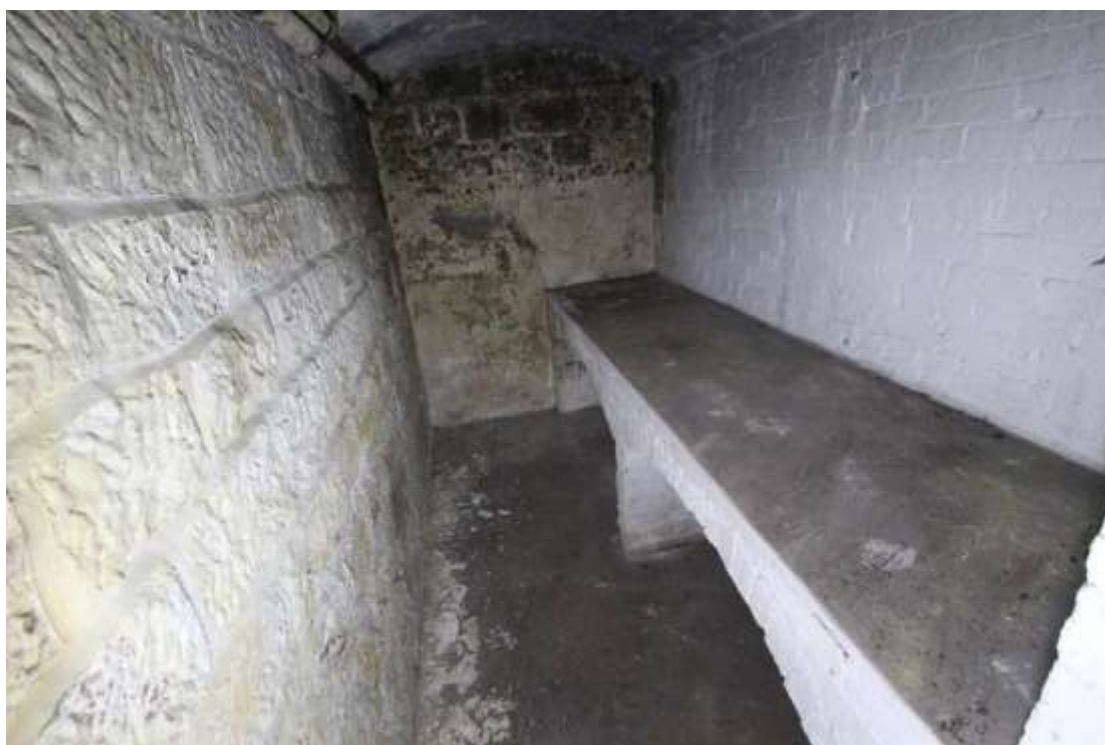
Plate 85: View of the southernmost extent of the north-south corridor containing the salting bench, facing south.

6.35 The southern extent of the corridor (Plate 85) is a narrow storage area with a stone topped salting benches resting on two three-centered arches. Adjacent to this is the third store room, accessed from the corridor by another arched doorway. This doorway again has evidence of a former door, in the form of iron pintels and a latch fastener (Plate 90). The southern wall houses another bench with a heavy stone top supported by three relieving arches (Plates 86 & 87). There is evidence of another alcove in the western wall (Plate 88) that has now been blocked with brick; it has a sandstone lintel and sill. A puncture in the top left of the blocked feature reveals that it is only c.300mm deep. The northern wall (Plate 89) consists of a series of brick projections linked to ash boxes, likely linked to the network of flues linking to the fireplaces directly above.

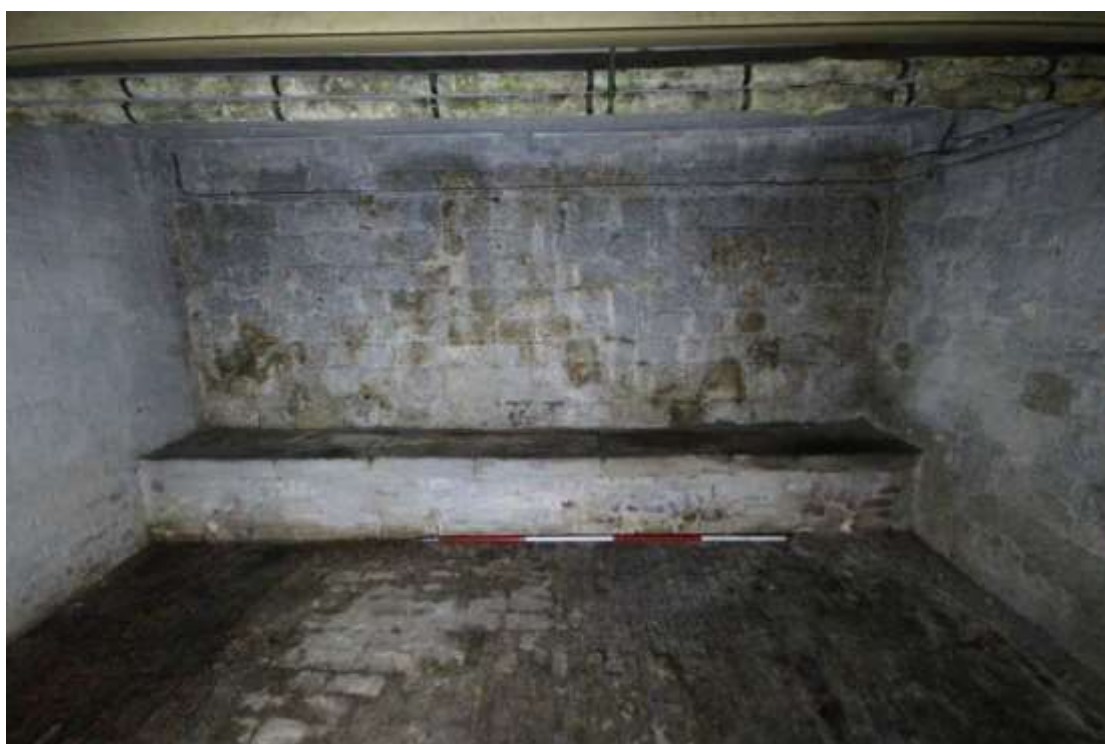
Plate 86: View of the southern elevation of the southern Store room, facing south. Scale 2m. The raised bench visible here contains three relieving arches.

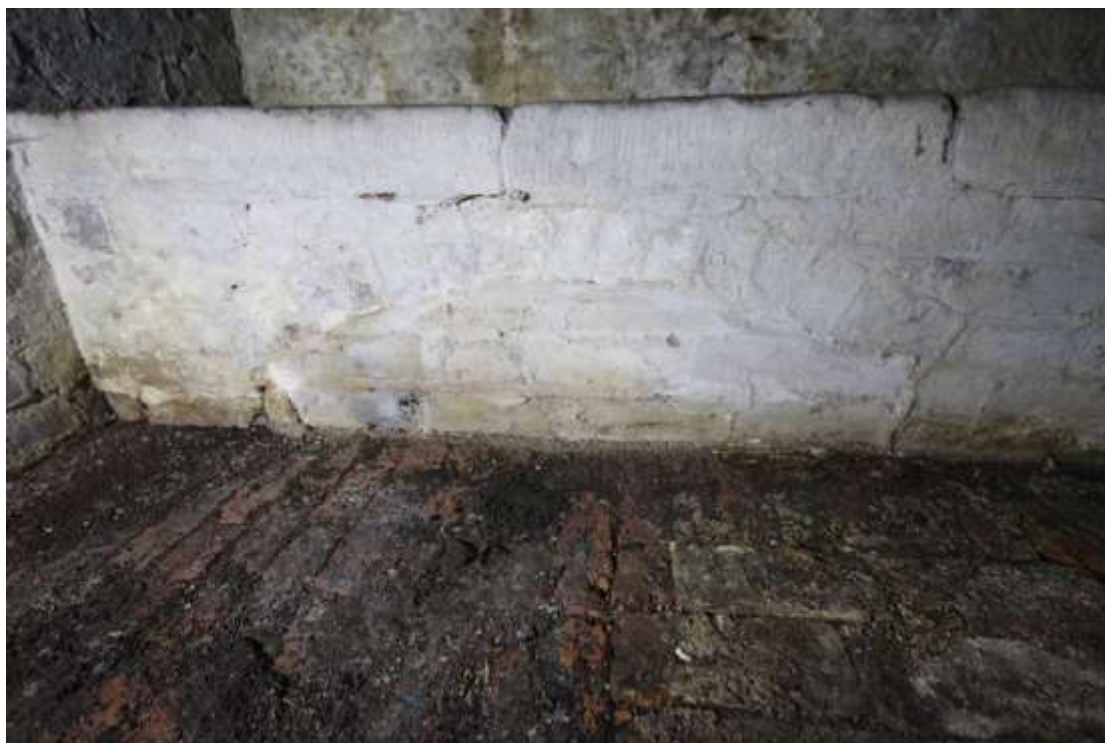
Plate 87: Detailed view of one of the relieving arches underneath the bench in the southern Store room, facing south.
