Consall Hall, Consall, Staffordshire: historic building recording

ARS Ltd Report 2020/32

January 2020

Prepared on behalf of: Consall Hall Estate Ltd

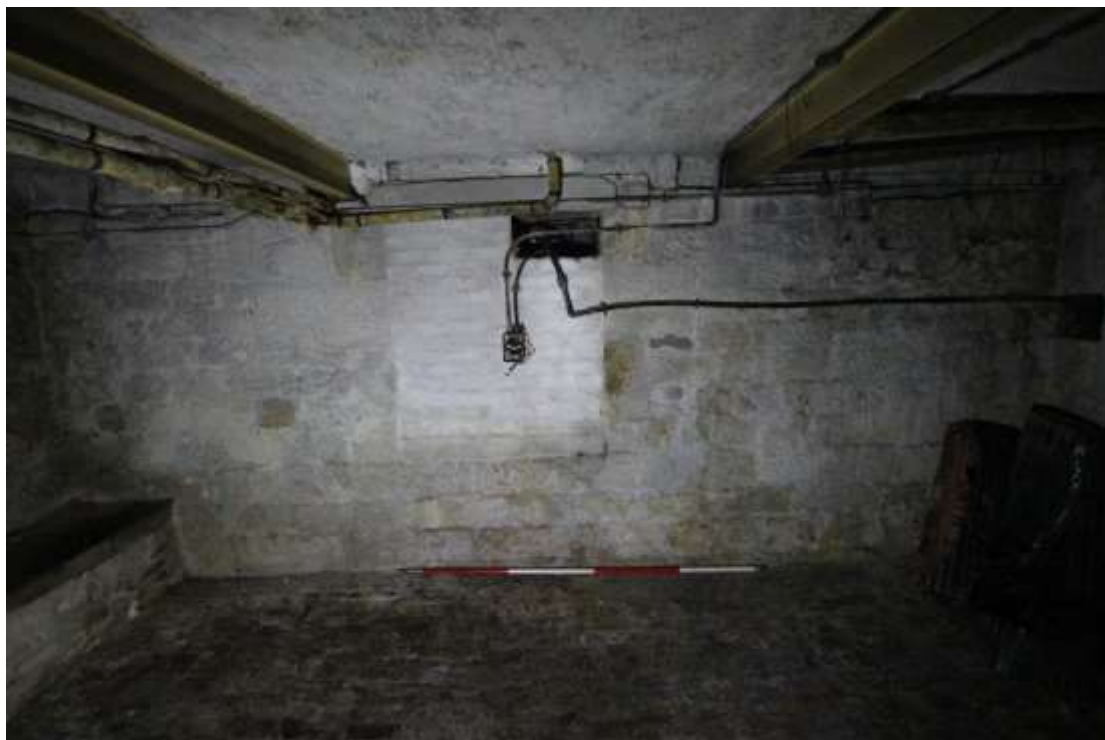
Plate 88: View of the western elevation in the southern Store room, facing west. Scale 2m.

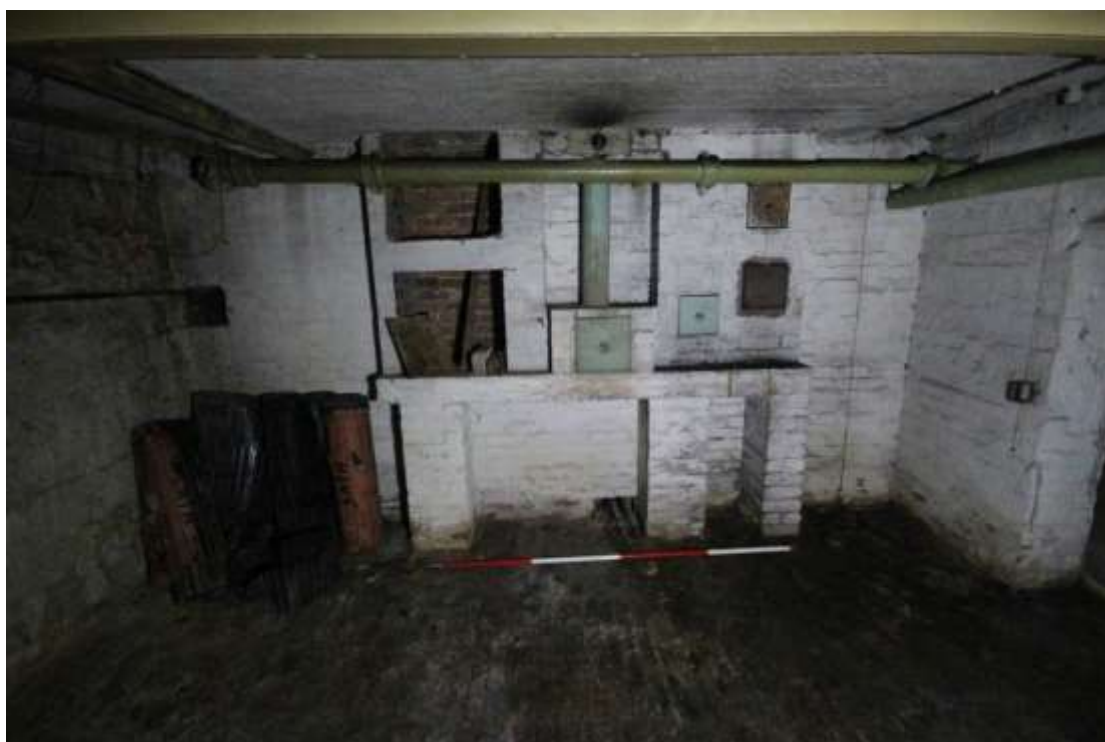
Plate 89: View of the northern elevation in the southern Store room, facing north. Scale 2m. These hatches are likely ash boxes, linked to the flue network.

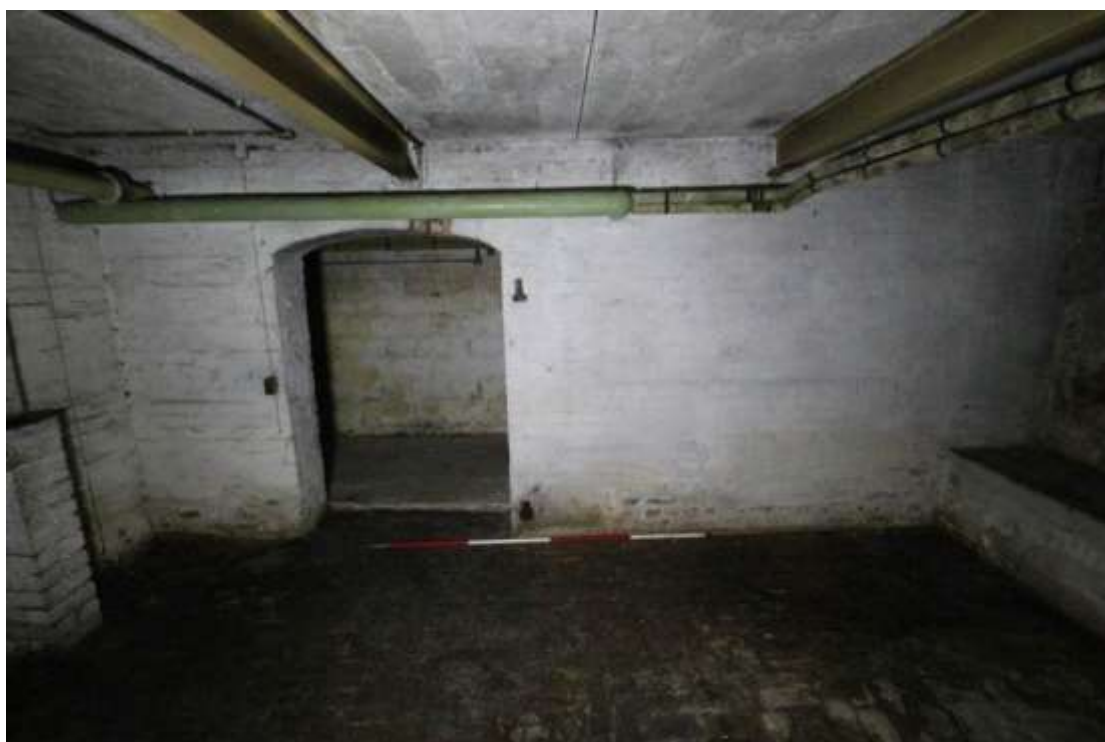
Plate 90: View of the eastern elevation of the southern Store room, facing east. Scale 2m. Note the remaining iron pintel and latch fastener, this is evidence of a former doorway.

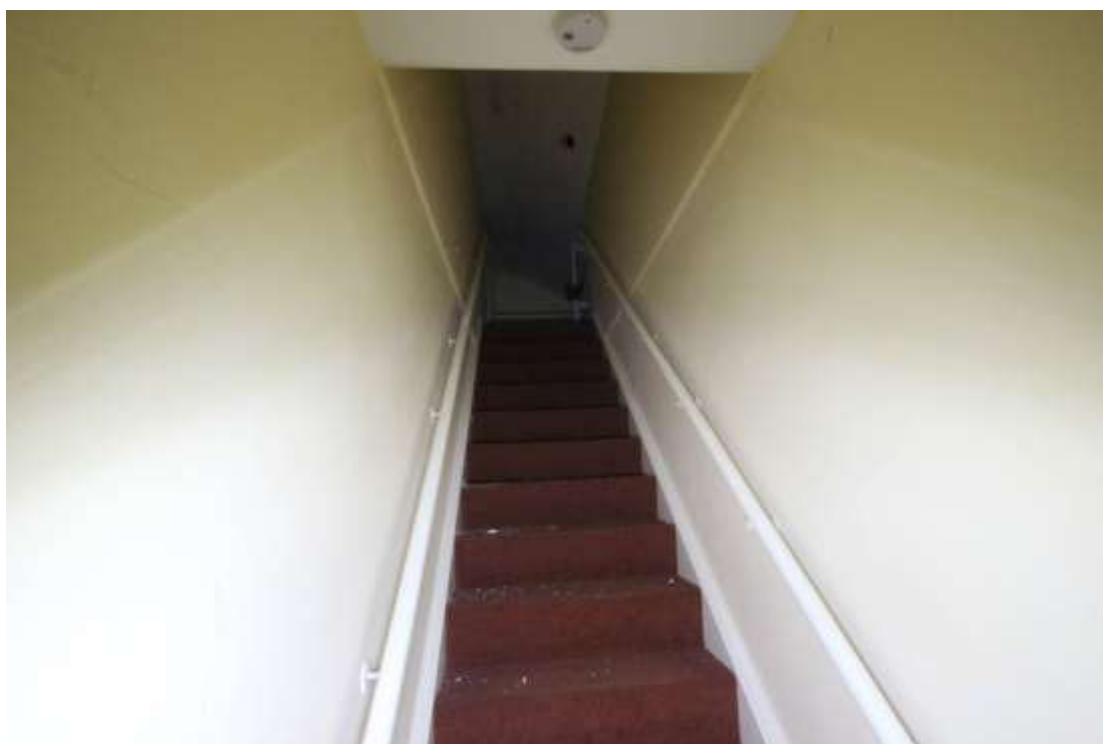
Plate 91: View of the staircase in Block A leading to the attic, facing east.

6.36 The attic is accessed by the staircase in the central wing of Block A (Plate 91). This whole floor appears to have been a remodeled in the 20th century, likely when the roof was replaced was part of the mass alterations that took place in the 1950s and 1960s. The landing area at the top of the stairs has a very modern feel, as it is carpeted and plastered. A doorway leads into the main roof space (Plate 92) that has had new wooden flooring added and plaster walling, creating more storage space. A hatch in the western extent looks into the unconverted attic space, showing the mid-20th century timber roof structure that is supported on central, load-bearing brick walls (Plate 93).

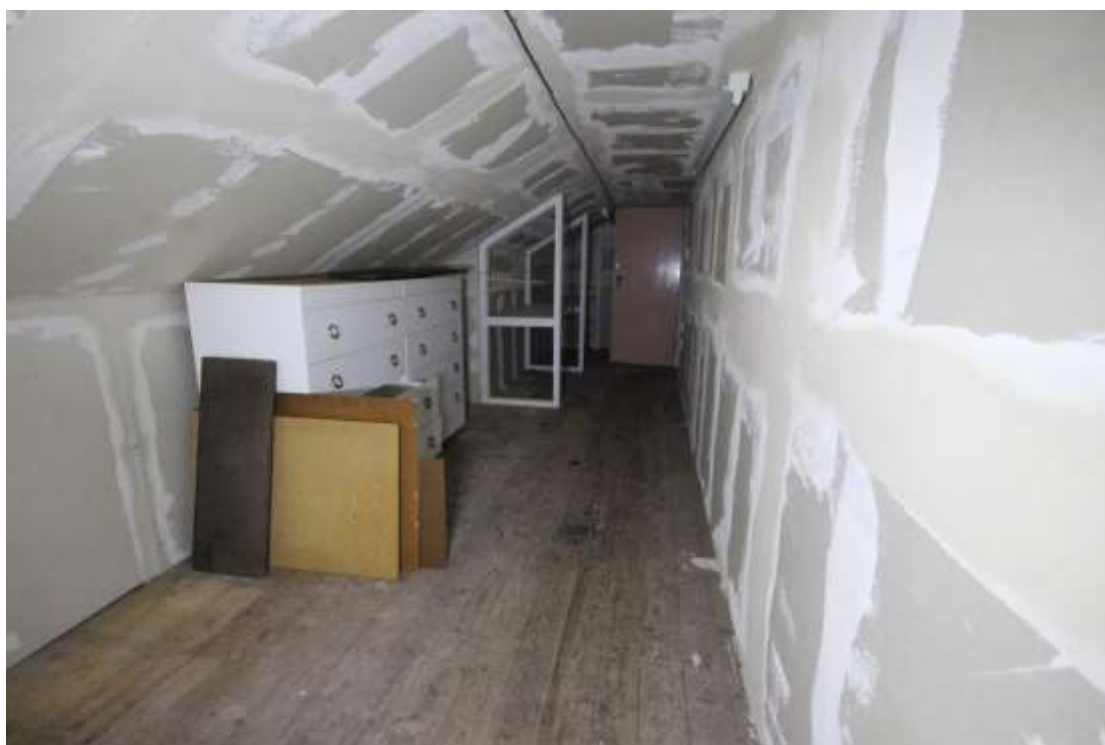
Plate 92: View of the converted Attic space, facing east.

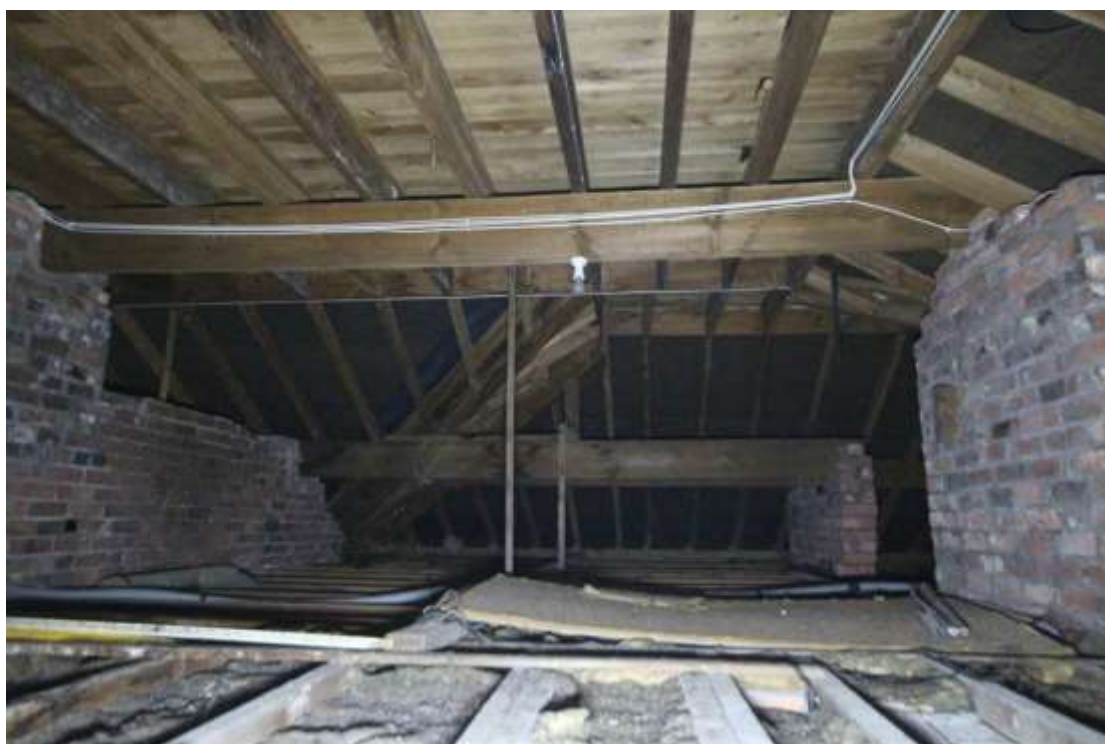
Plate 93: View of the unconverted attic space above the western part of Block A, facing west. These brick walls carrying the roof timbers are part of the original construction of the hall in the early 19th century.

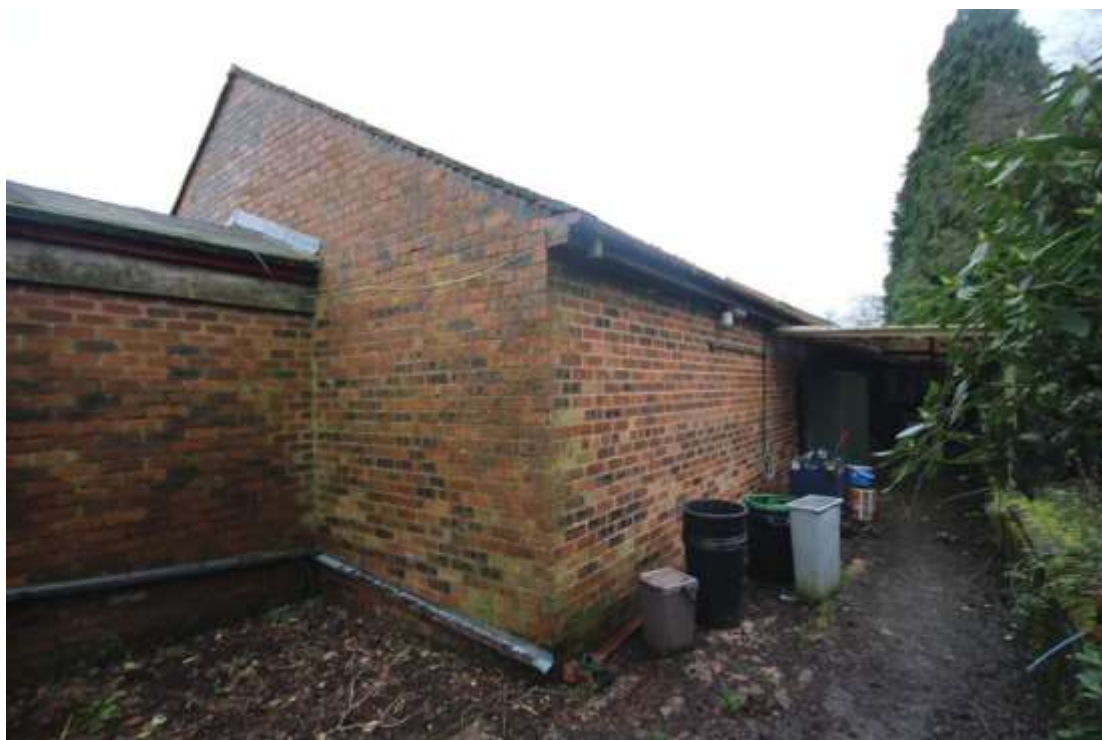
6.37 The Halcyon Room, or former wedding venue, is a modern construction (Plates 94-98) that was built over a former stable block some time between 1968 and 1973; this is visible in historic mapping and aerial photographs (CTD Architects 2019, 30 & 31). Aerial photographs indicate a U-shaped stable complex, bordered by the Coachman's Halt on the east side and a now lost structure on the west, creating two projecting wings. The central block remains standing and has been converted into the wedding reception area (Plate 98). The north facing elevation (Plate 97) reveals two blocked windows that would have been part of this original building. The southern wall on the other hand appears to have been rebuilt. The western wall of this original part of the building (Plate 96) sits flush with the south western extent of the Walled Garden.

Plate 94: General view of the southern elevation of the south western extent of the Halcyon Room, facing north east. This is part of the late 1960s/early 1970s construction.

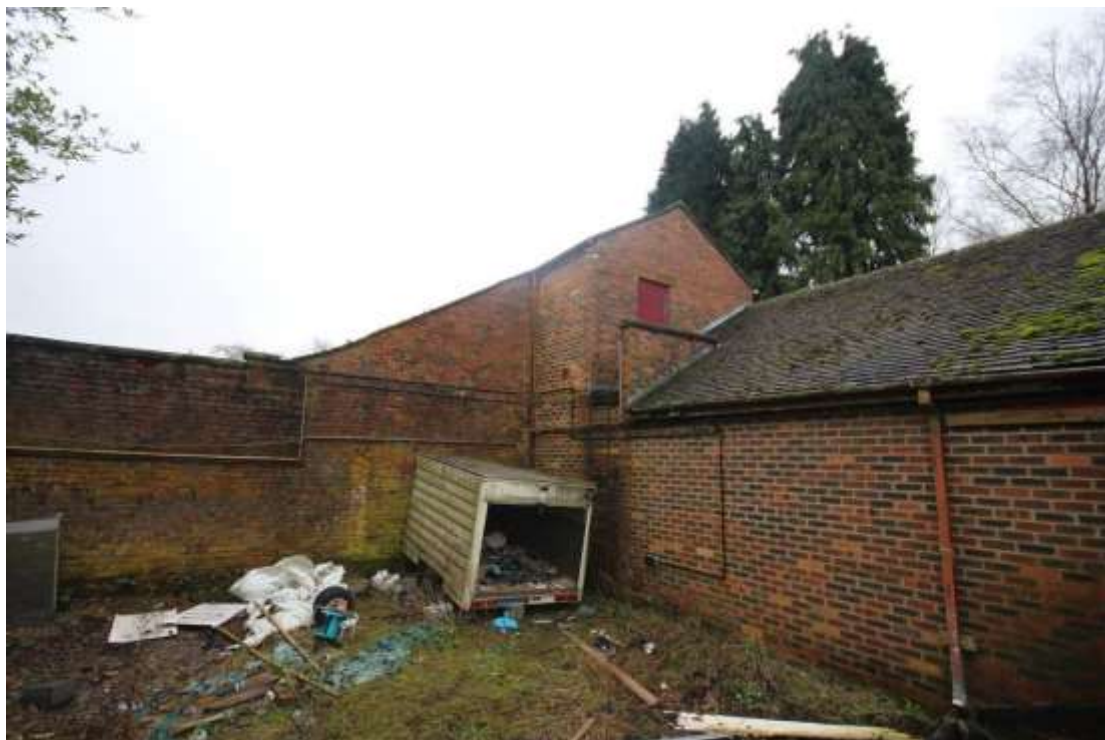
Plate 95: View of the north western extent of the Halcyon Room, facing south east. This is part of the late 1960s/early 1970s construction.

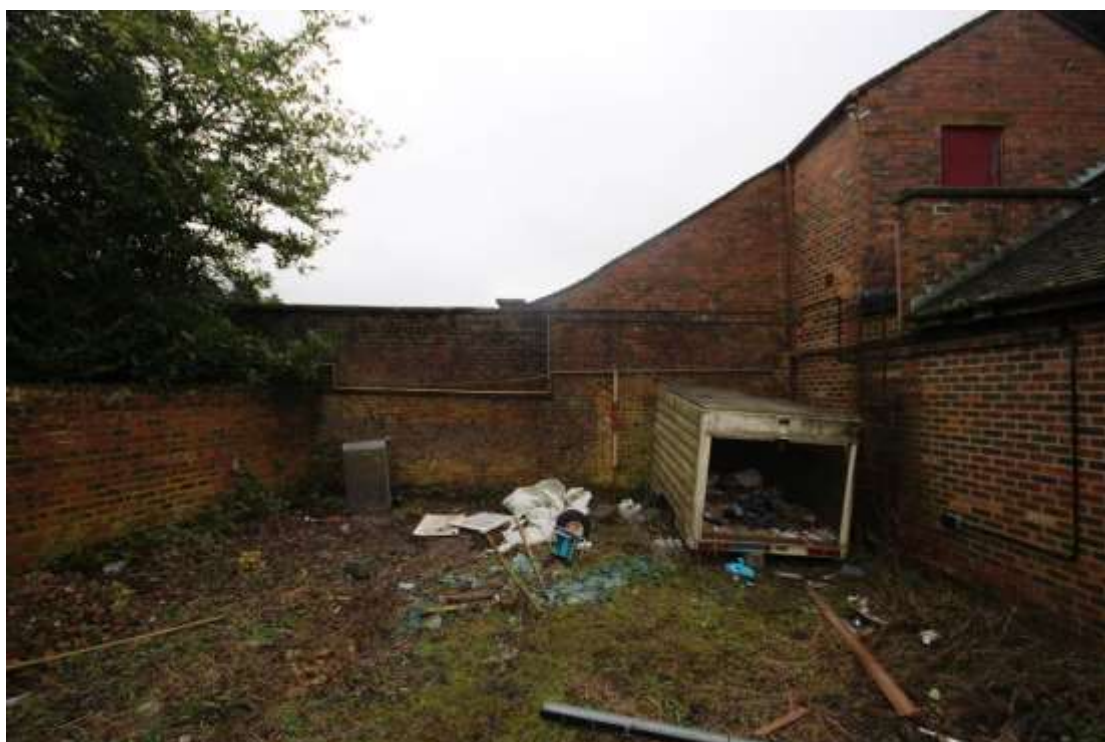
Plate 96: Photograph showing the relationship between the Halcyon Room and the Walled Garden, facing east. The Halcyon Room (picture right) has been built into this south western corner of the Walled Garden.

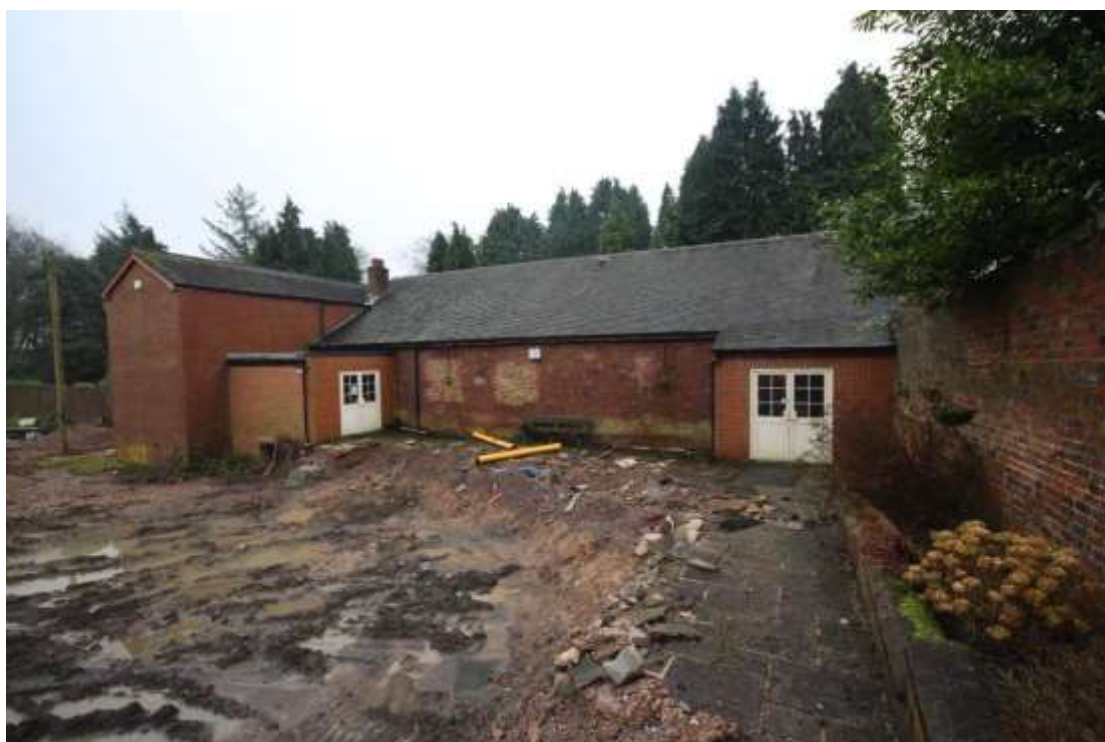
Plate 97: View of the northern elevation of the Halcyon Room, facing south. This northern wall has been reused and is likely part of the original stable block that once stood here.

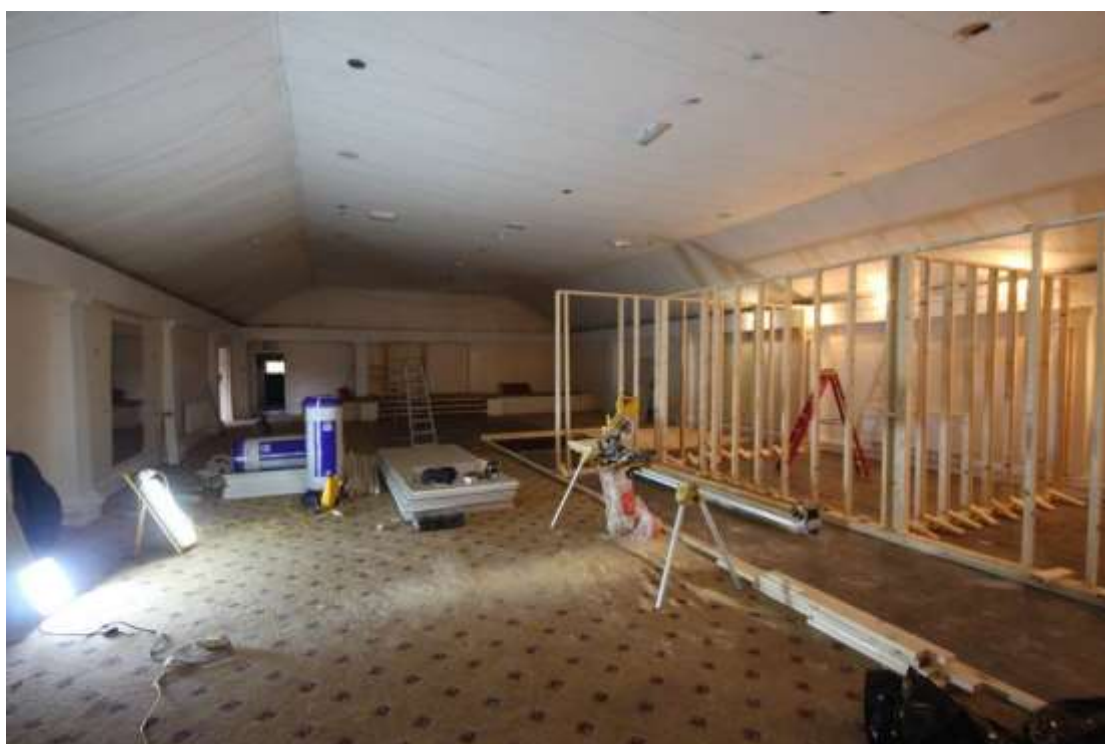
Plate 98: View of the interior of the Halcyon Room, facing east. This space is entirely modern and once served as the main wedding reception area.

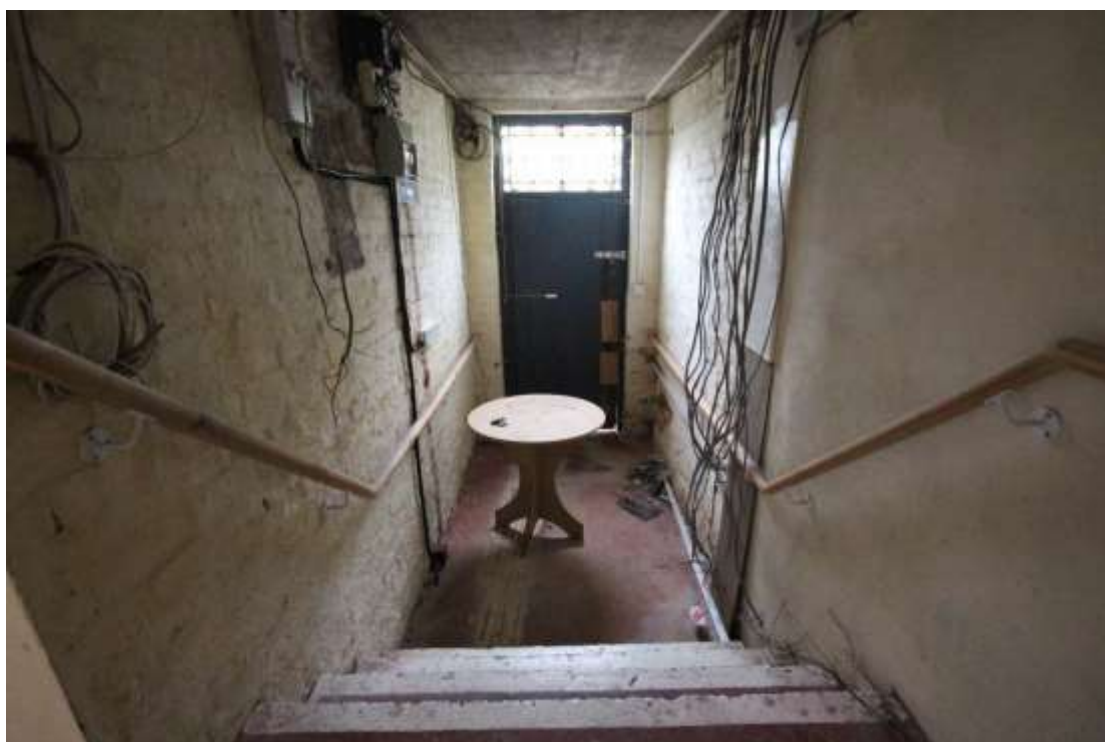
6.38 The interior is almost entirely modern, with any signs of existing subdivision in the main surviving block now completely lost. A corridor (Plate 99) with a red floor of small tiles (Plate 101) to the east leads down to a doorway, facing out on the same elevation as the Coachman's Halt (Plate 127). This area likely provided direct access into the stable block from this part of the site. To the north of this is a room in a modern wing (Plate 100), occupying the north eastern extent of this structure.

Plate 99: View of the northern corridor leading out of the Halcyon Room, facing east. This is likely an original part of the building and leads to the Coachman's Halt.

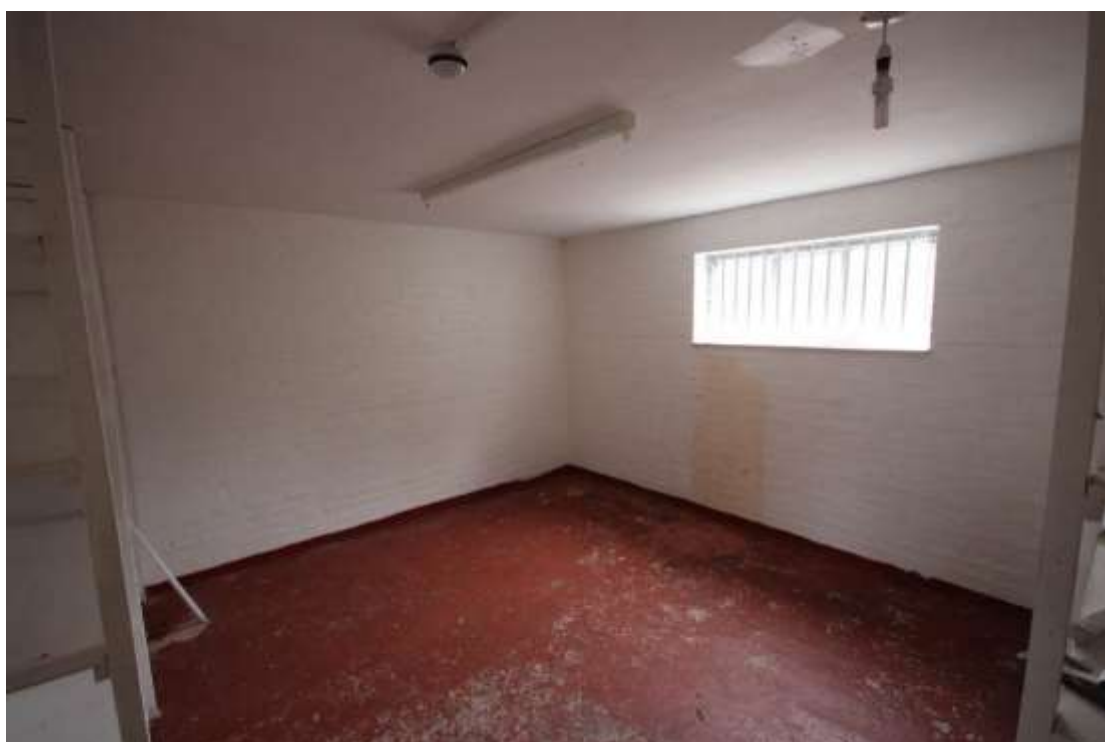
Plate 100: View of the north eastern room in the Halcyon Room, facing north east. This forms part of the modern extension that is to the north of the Coachman's Halt.

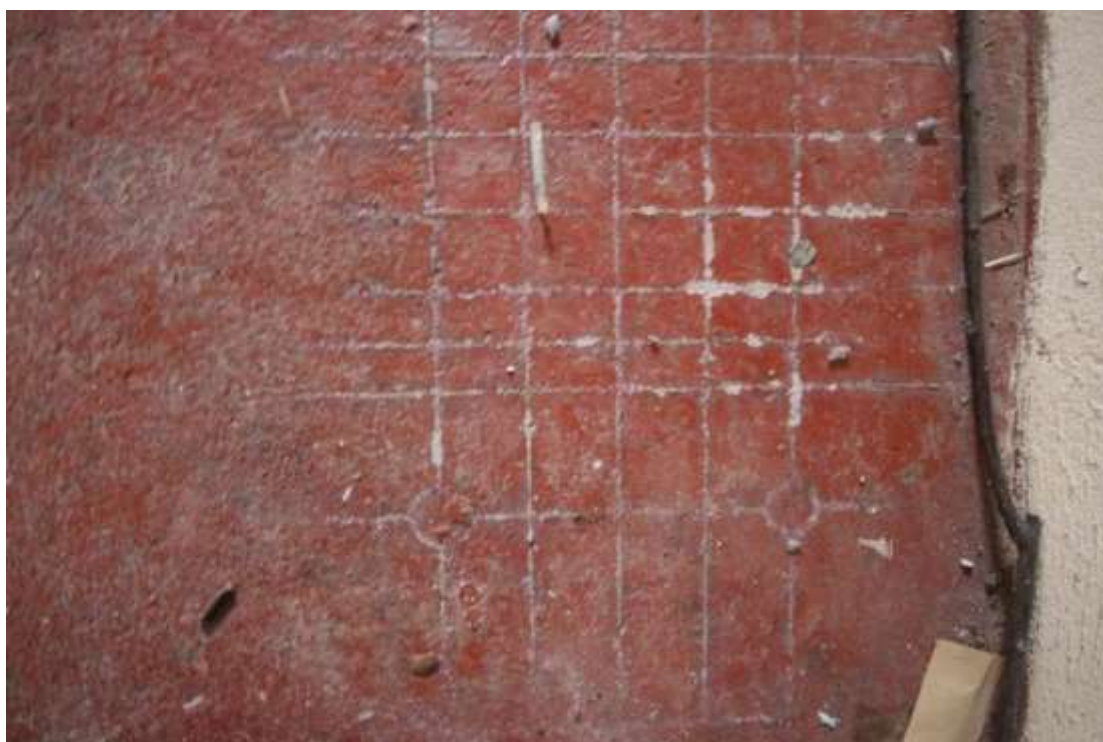
Plate 101: Detailed view of the small square tiles in the corridor leading from the wedding reception area to the Coachman's Halt.

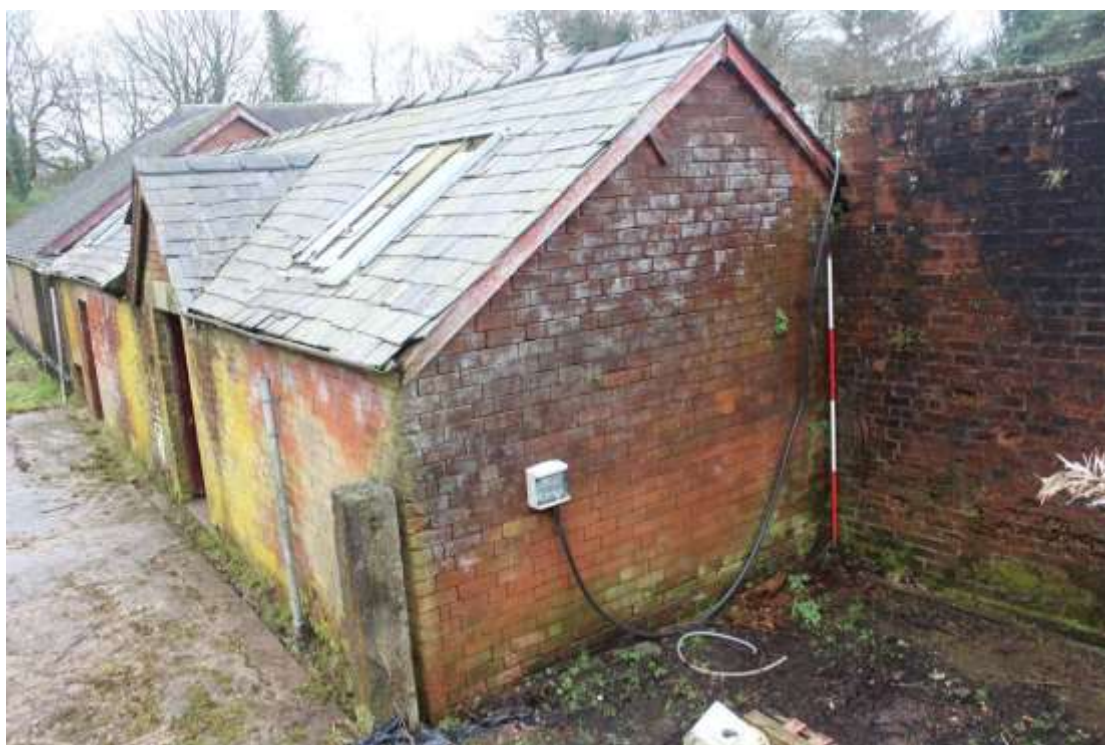
6.40 The Potting Shed is a small, single storey, three roomed structure of red brick that abuts the Walled Garden on the western gable end (Plate 102). The northern elevation (Plate 103) consists of a central doorway set underneath a small gable; the southern doorway is not gabled (Plate 105), although it is similar in design to that of the northern doorway. These doorways have sandstone lintels. In the eastern end of the northern elevation is another doorway, next to a smaller opening at ground floor level (Plate 104), and both have sandstone lintels. The roof is covered with slate and is steeply pitched, with three skylights facing north and one facing south. On the north western corner of the building is a wooden gatepost with surviving iron fixtures (Plate 102).

Plate 102: View of the western gable end of the potting shed, facing south east. Scale 2m. Note the relationship between this and the Walled Garden.

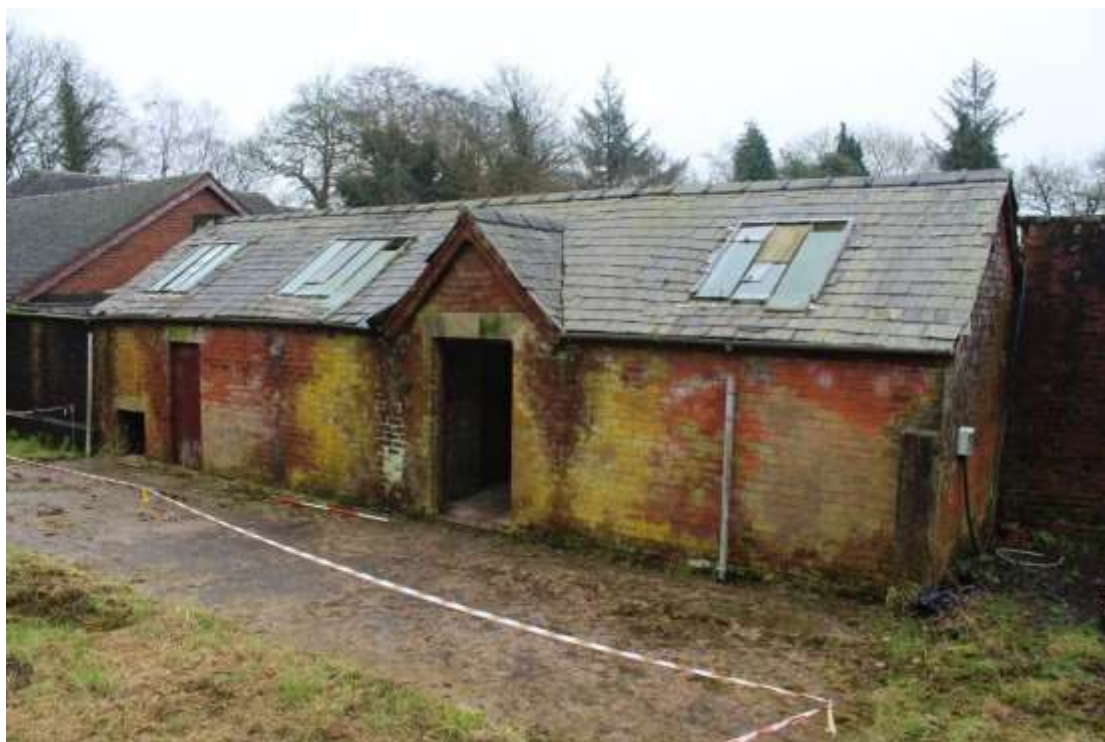
Plate 103: View of the northern elevation of the Potting Shed, facing south. Scale 2m.

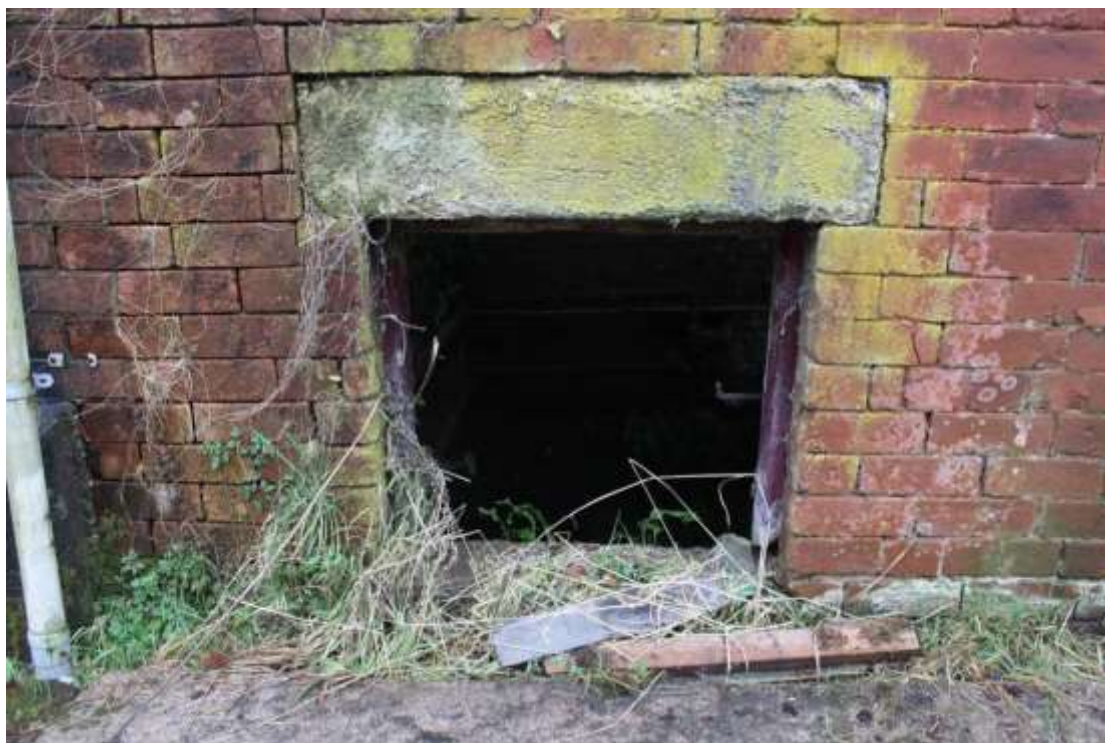
Plate 104: Detailed view of the low opening in the eastern side of the northern elevation, facing south.

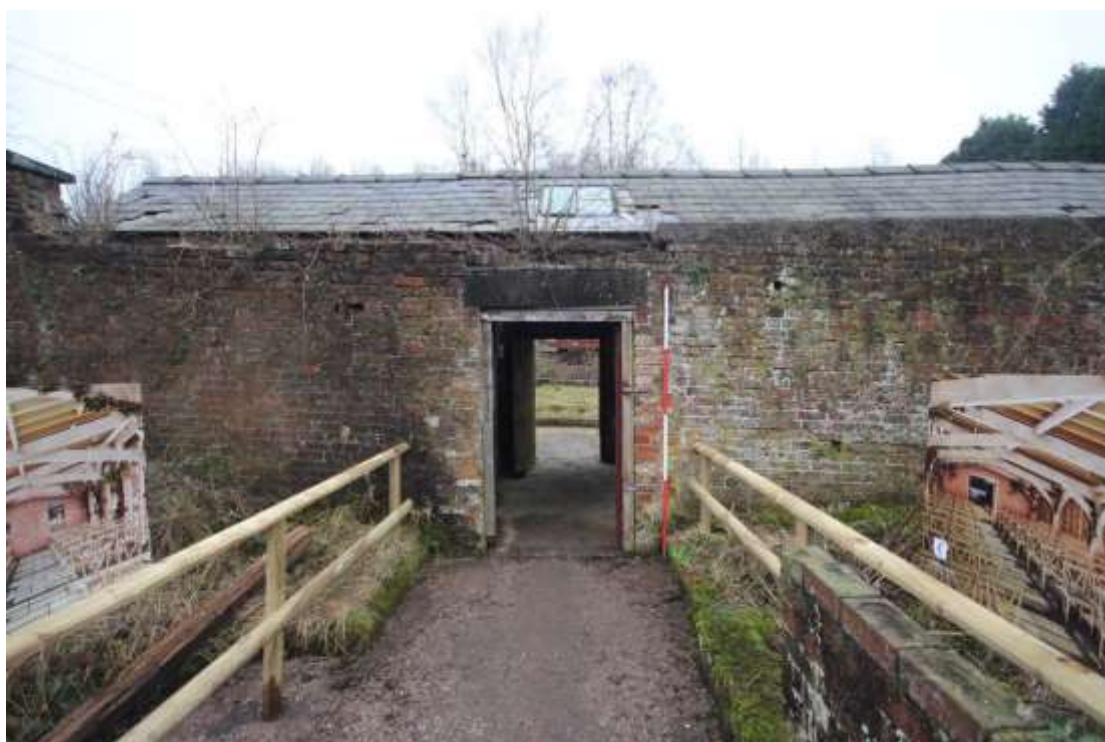
Plate 105: View of the southern elevation of the Potting Shed taken from inside the Walled Garden facing north. Scale 2m.

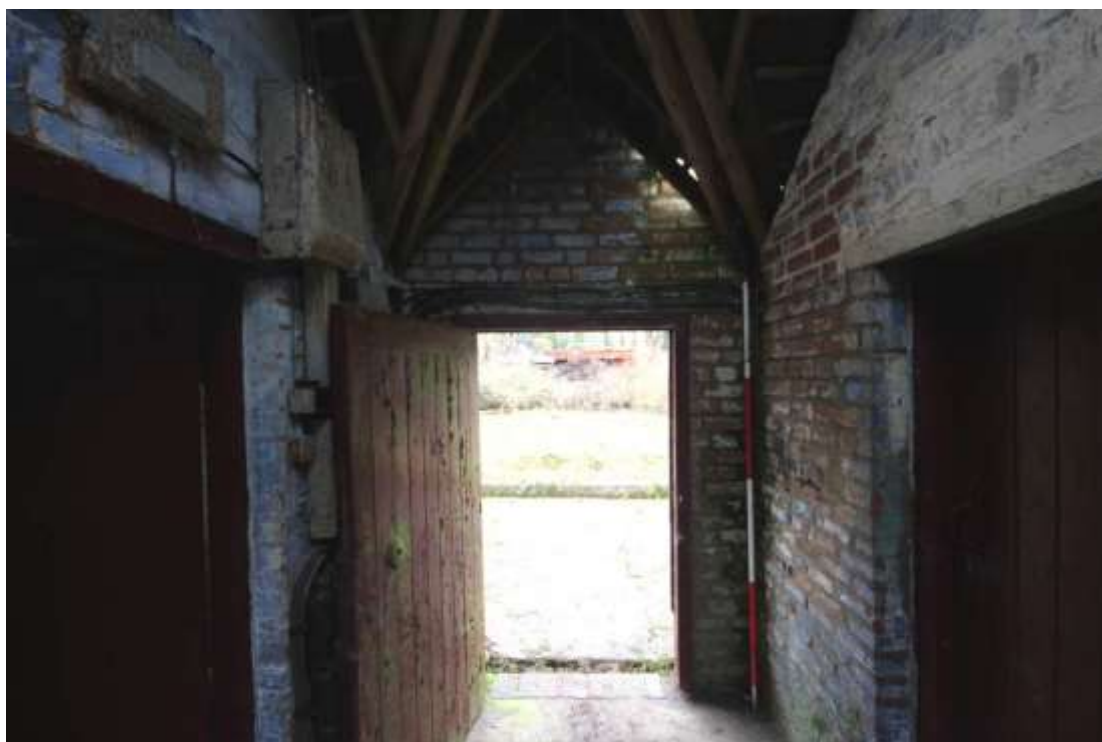
Plate 106: View of the northern doorway leading into the central corridor of the Potting Shed, facing north. Scale 2m.

6.41 Internally, the Potting Shed consists of a central hallway running north-south, with two rooms either side to the east and west respectively. Each room is accessed by wooden doors set within brick dividing walls which each carry the weight of the roof structure. Relieving arches adorn the top of each doorway in order to distribute the weight around the doorways wooden lintels. The western room is relatively plain, with some evidence of former timber fixtures on the walls. The eastern room is blocked but most likely mirrors that of the western. At the eastern extent of the Potting Shed is third, partially subterranean room. This is not accessible; however, it is possible to look in to the room from the northern window that is open. The room itself seems be of later construction than that of the two rooms to the west as there is a clear break in the brick work visible internally between the southern wall and western. It appears that this room once housed some kind of pump or boiler, or potentially both, as there is a series of pipework and a hatch in the eastern wall that seems to connect to a chimney. This chimney is visible in the western shed of the Gardener's Workshop and was likely made redundant when this block was added to the site in the 20th century. It is possible that this was initially used as a means of heating the Walled Garden with a system of pipework running through the walls themselves. These pipes appear to run into the complex of the walled garden in the southern wall that is the exterior face of the garden wall.

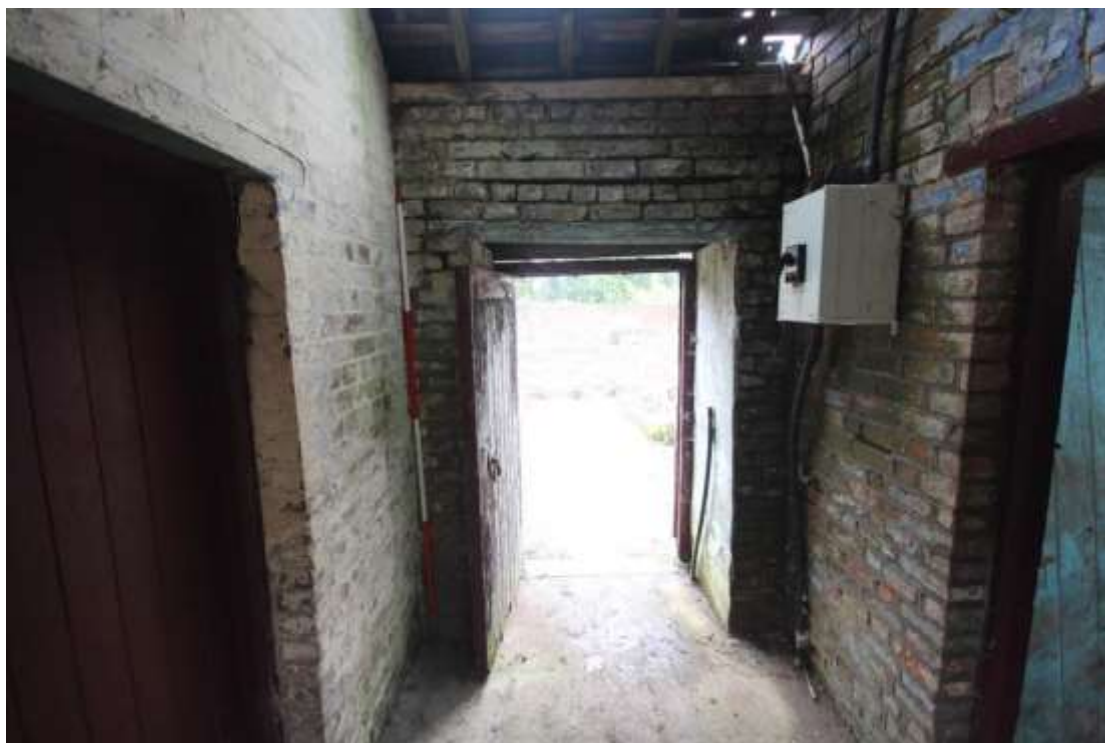
Plate 107: View of the southern doorway leading into the central corridor of the Potting Shed, facing south. Scale 2m.

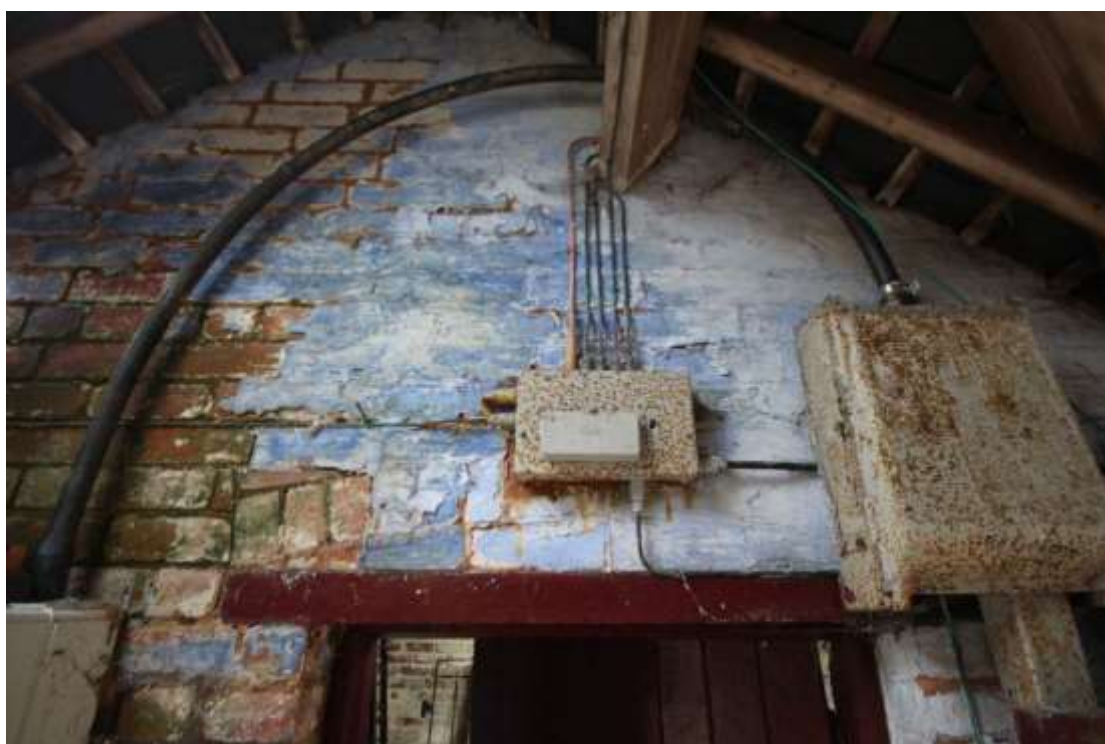
Plate 108: Detailed view looking above the doorway to the western room of the Potting Shed, facing west. Note the relieving archway above the door.

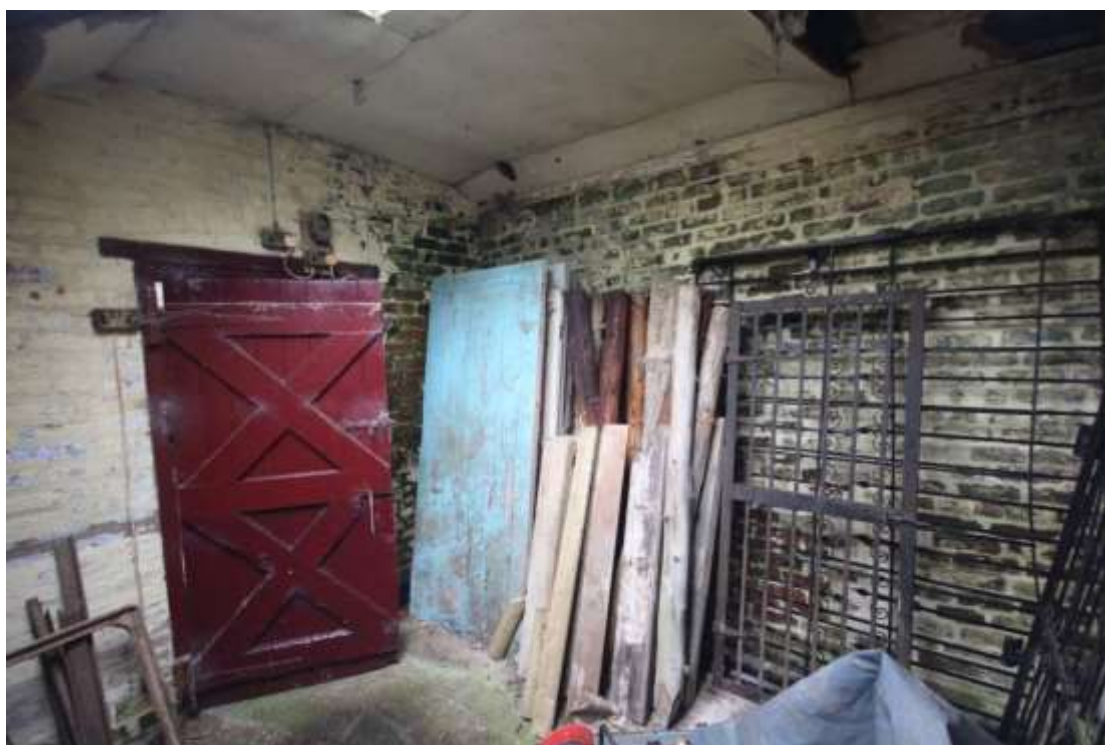
Plate 109: General view of the western room of the Potting Shed, facing south east.

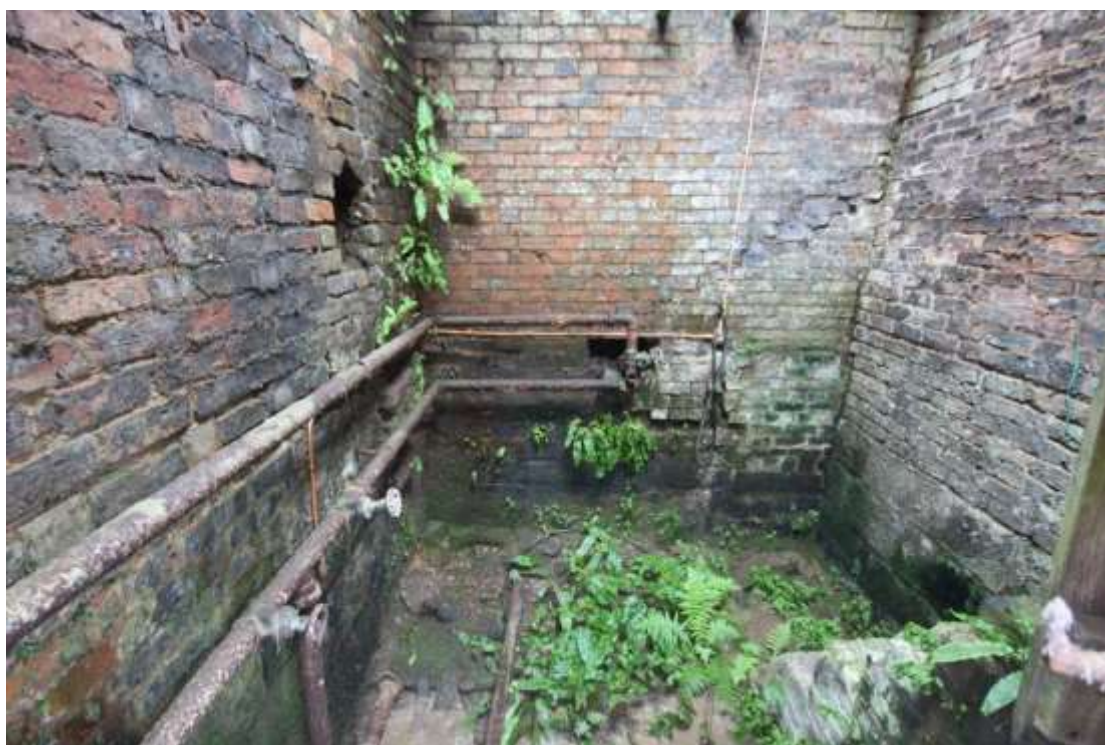
Plate 111: General view of the lower part of the southern interior wall of the eastern 'boiler room' adjacent to the Potting Shed, facing south.

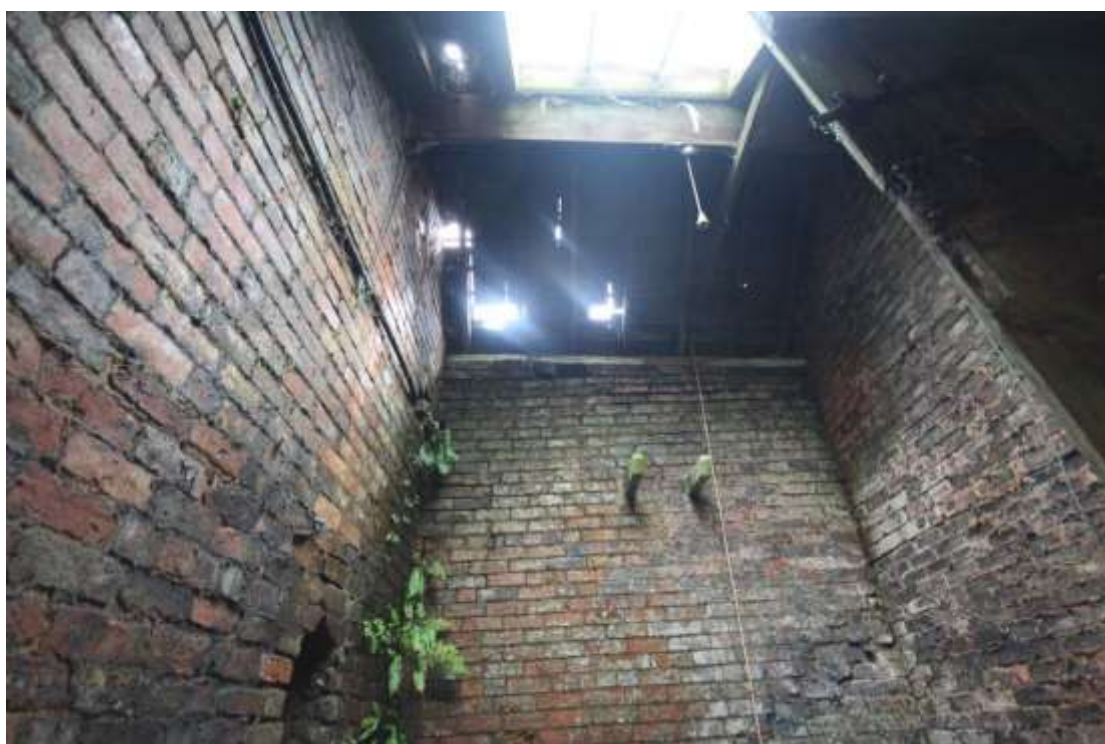
Plate 112: General view of the upper part of the southern interior wall of the eastern 'boiler room' adjacent to the Potting Shed, facing south.

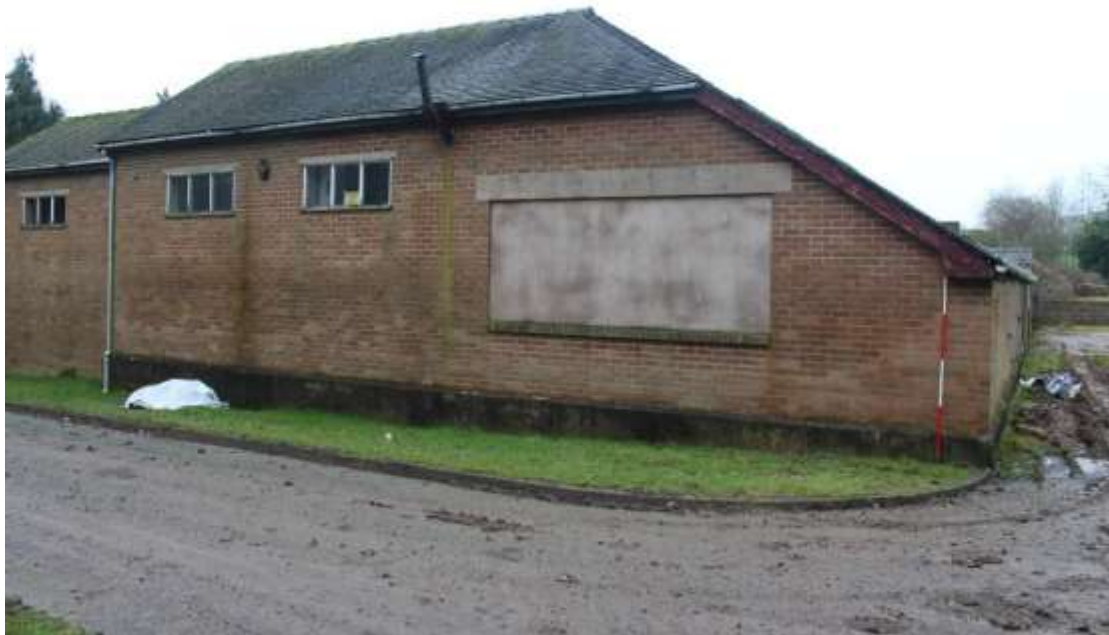
Plate 113: View of the northern part of the eastern elevation of the eastern block of the Gardener's Workshop, facing south west. Scale 2m.

6.42 Immediately to the west of the Potting Shed are the Gardener's Workshop buildings. This is a much later construction, likely being added to the site when the landscape was drastically altered in the 1950s and 1960s. It takes the form of an L-shaped block of red brick under a pitched roof covered with Staffordshire blue, plain clay tiles. The eastern elevation (Plates 113 & 114) faces onto the main road leading into the site and contains three, three-light windows at first floor level, with a large window (now blocked) in the northern bay. The southern gable (Plate 115) consists of a large garage doorway under a concrete lintel. The western elevation (Plate 116) houses a series of large openings (Plate 117) under a large concrete lintel, creating covered storage areas with internal rooms above. These are defined by four, three-light windows with concrete lintels and wooden sills. Some of the dividing walls between these ground floor areas show signs of previous internal access in the form of blocked doorways (Plate 118).
