Consall Hall, Consall, Staffordshire: historic building recording

ARS Ltd Report 2020/32

January 2020

Prepared on behalf of: Consall Hall Estate Ltd

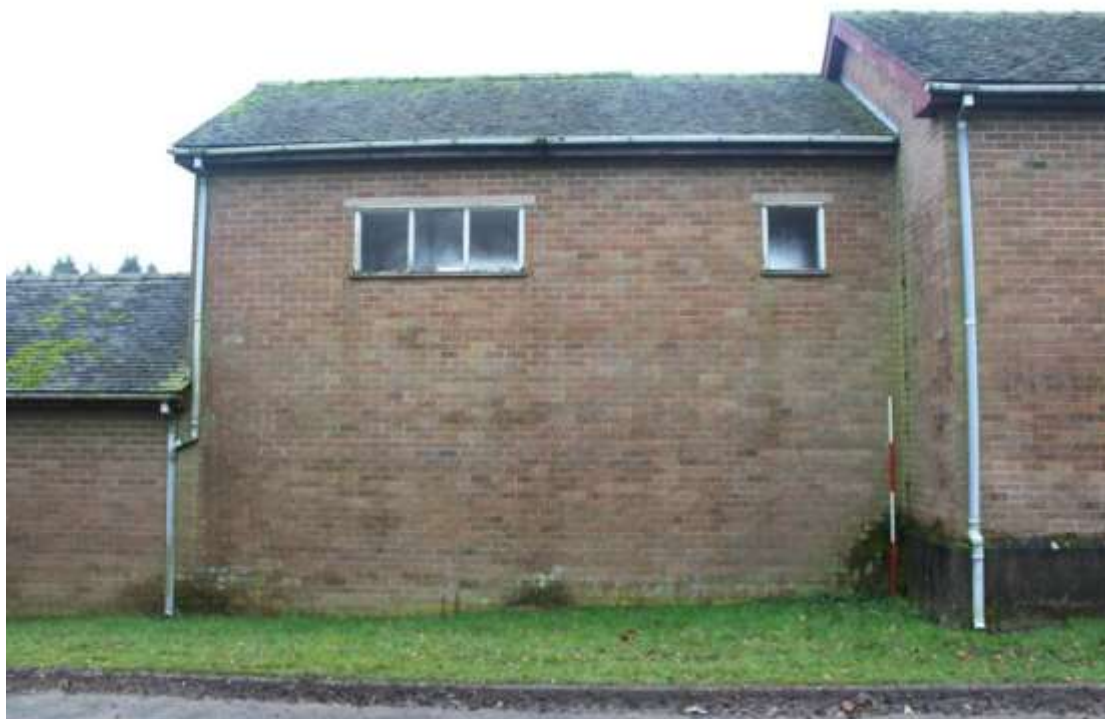
Plate 114: View of the central part of the eastern elevation of the eastern block of the Gardener's Workshop, facing west.

6.42 Immediately to the west of the Potting Shed are the Gardener's Workshop buildings. This is a much later construction, likely being added to the site when the landscape was drastically altered in the 1950s and 1960s. It takes the form of an L-shaped block of red brick under a pitched roof covered with Staffordshire blue, plain clay tiles. The eastern elevation (Plates 113 & 114) faces onto the main road leading into the site and contains three, three-light windows at first floor level, with a large window (now blocked) in the northern bay. The southern gable (Plate 115) consists of a large garage doorway under a concrete lintel. The western elevation (Plate 116) houses a series of large openings (Plate 117) under a large concrete lintel, creating covered storage areas with internal rooms above. These are defined by four, three-light windows with concrete lintels and wooden sills. Some of the dividing walls between these ground floor areas show signs of previous internal access in the form of blocked doorways (Plate 118).

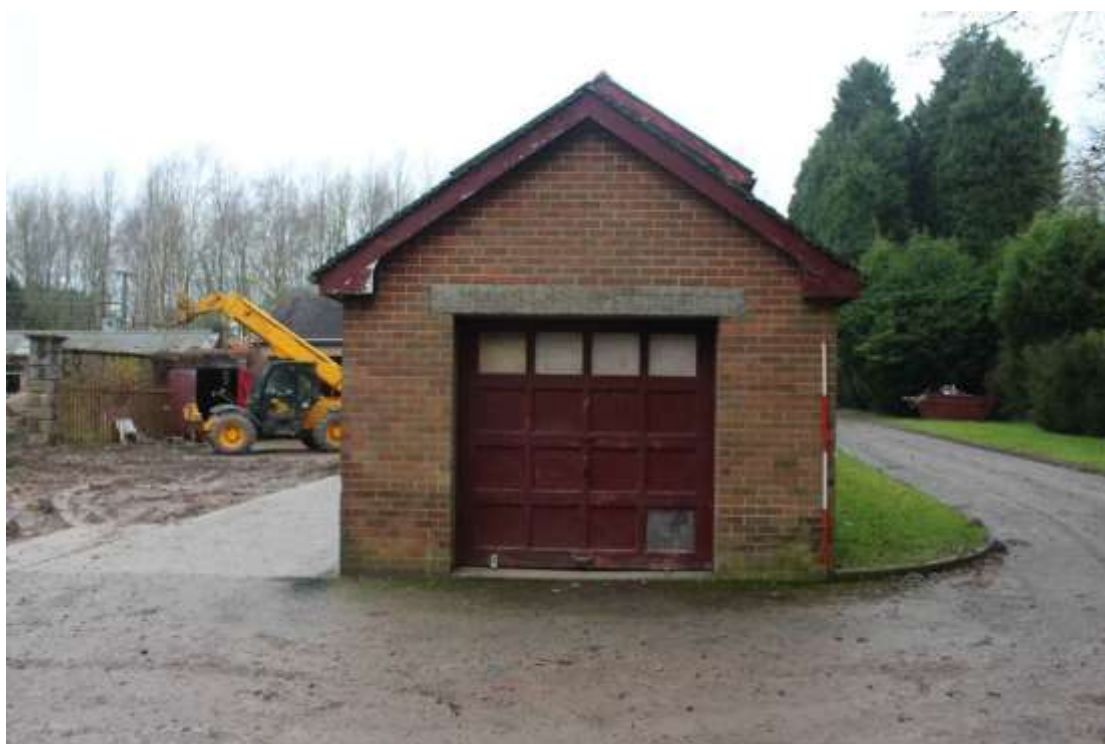
Plate 115: View of the southern gable end of the eastern block of the Gardener's Workshop, facing north.

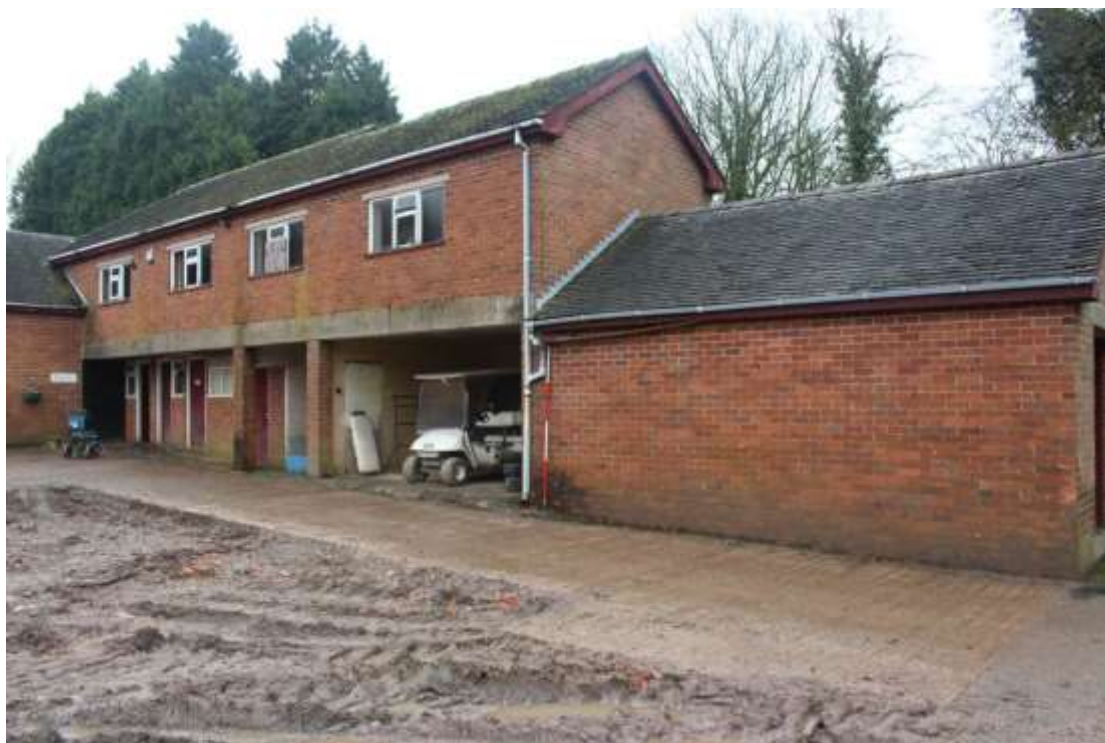
Plate 116: View of the western elevation of the eastern block of the Gardener's Workshop, facing north east.

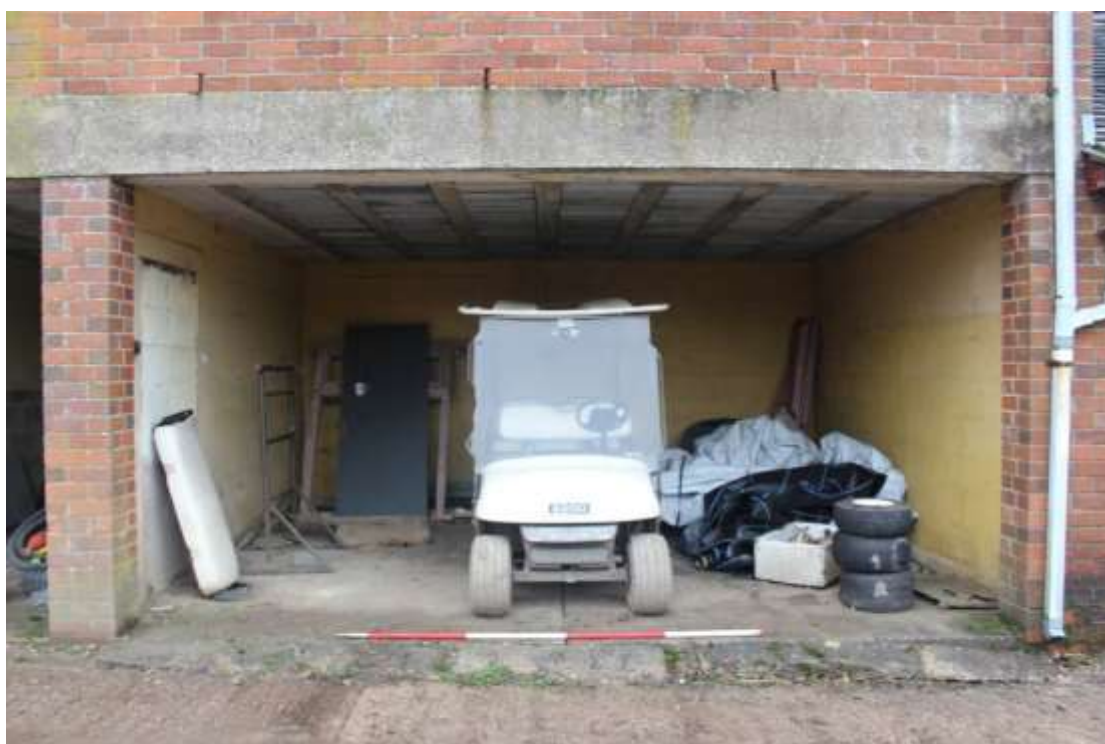
Plate 117: View of one of the open storage areas at the ground floor level of the eastern block of the Gardener's Workshop, facing east.

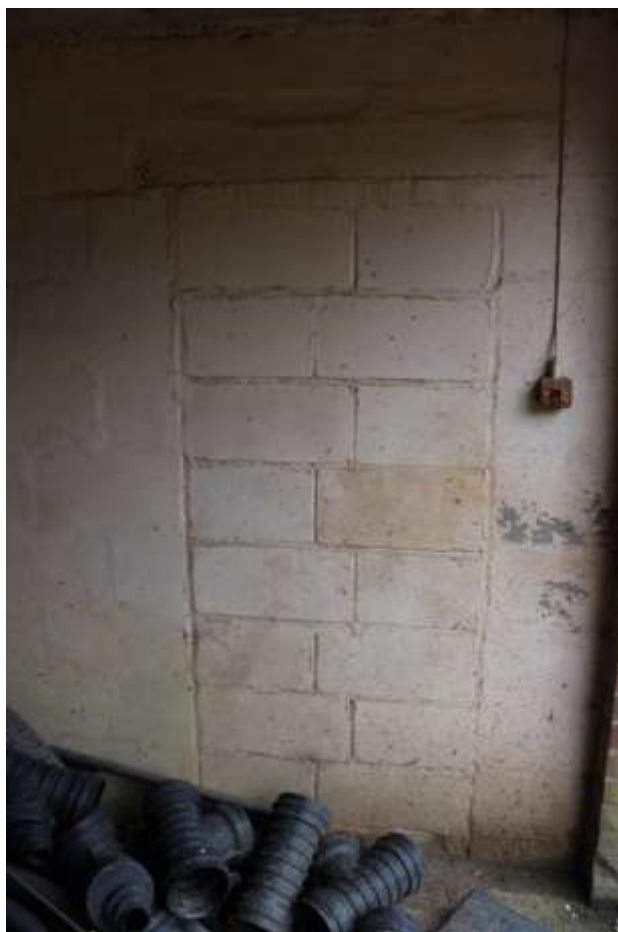
Plate 118: Detailed view of one of the ground floor blocked doorways in the eastern block of the Gardener's Workshop, facing south.

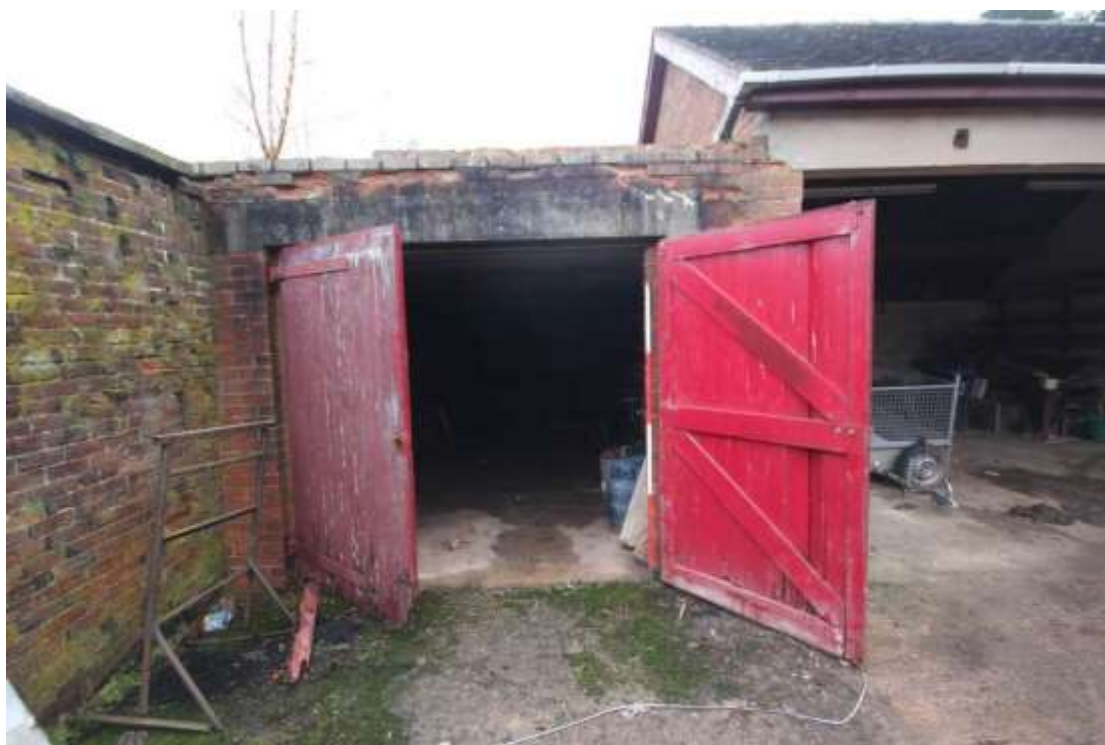
Plate 119: View of the small workshop building immediately to the west of the Gardener's Workshop, facing north. Scale 2m.

6.43 The northern block of the Gardener's Workshop abuts another, small workshop on its western side (Plates 119-121), which is accessed by a large opening in the southern elevation (Plate 119). This is an earlier building of red brick, with a flat roof. This is accessed by another wooden, hinged garage style double door with a large concrete lintel. Internally, the western elevation houses a red brick flue with a square hatched opening. This would once have been covered and now faces into the easternmost, subterranean room that is part of the Potting Shed. The left half of this western internal elevation appears to be what was once the external face of the Walled Garden, with the right half being of later construction. These are defined by a building break.

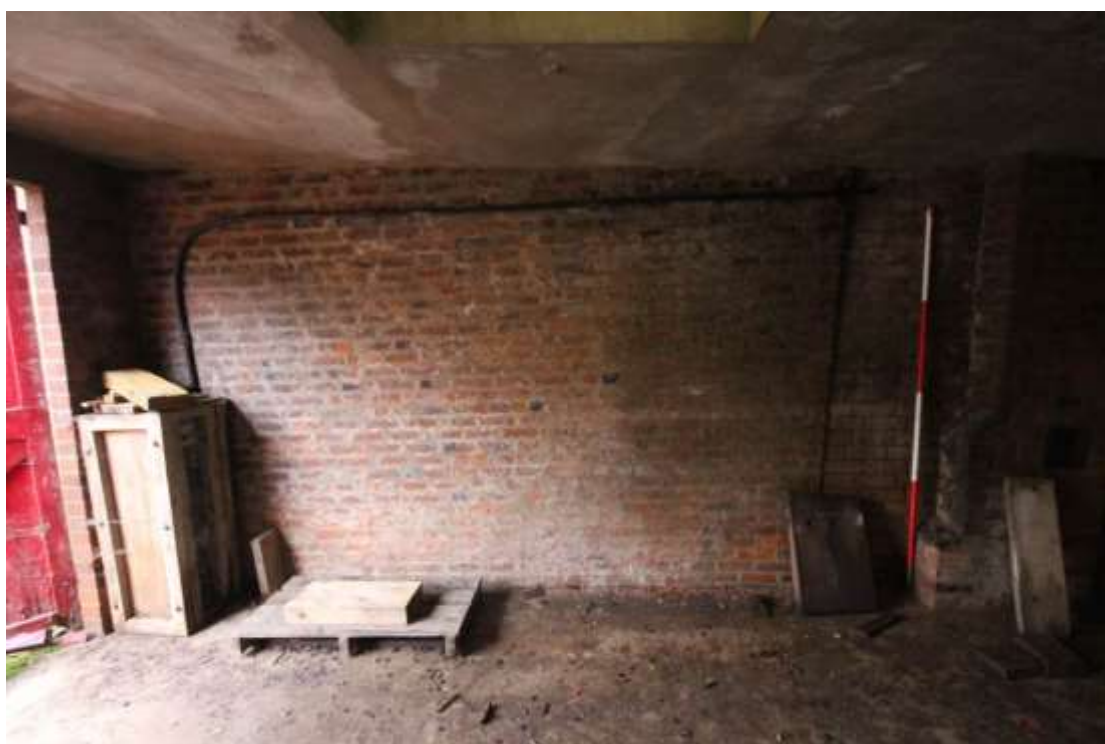
Plate 120: View of the southern side of the western wall inside the small workshop building, facing west. Scale 2m.

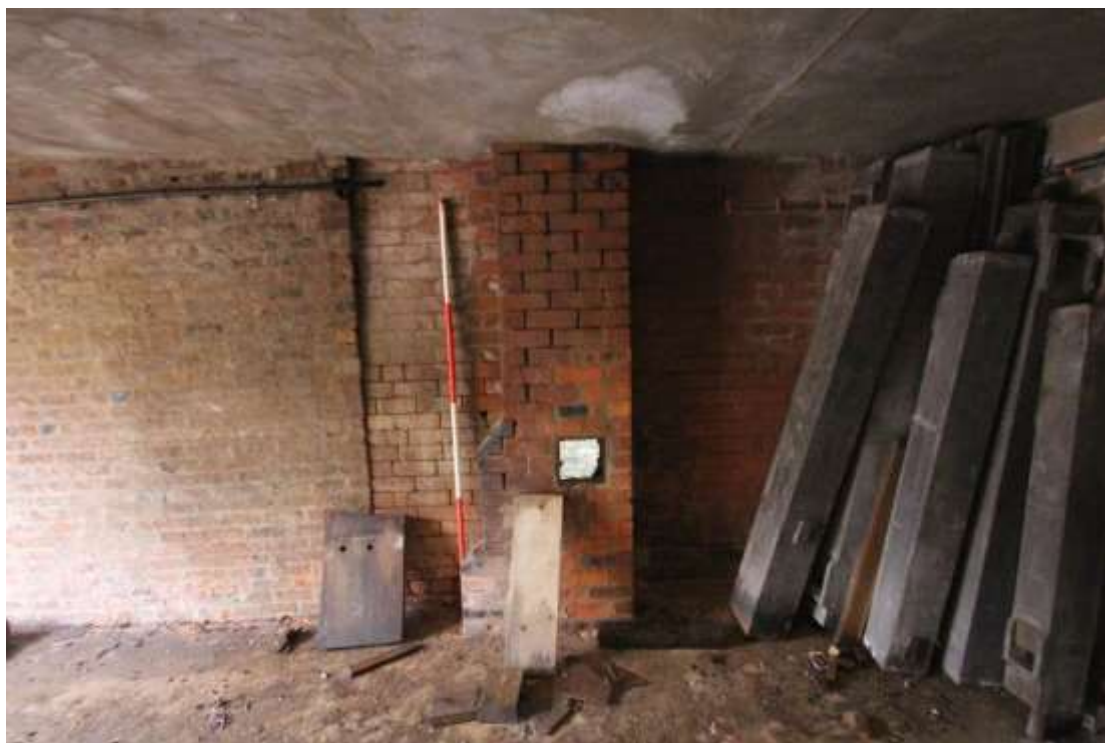
Plate 121: View of the northern side of the western wall inside the small workshop building, facing west. Scale 2m. Note the building break to the left of the scale, defining the original wall and the newly built extension.

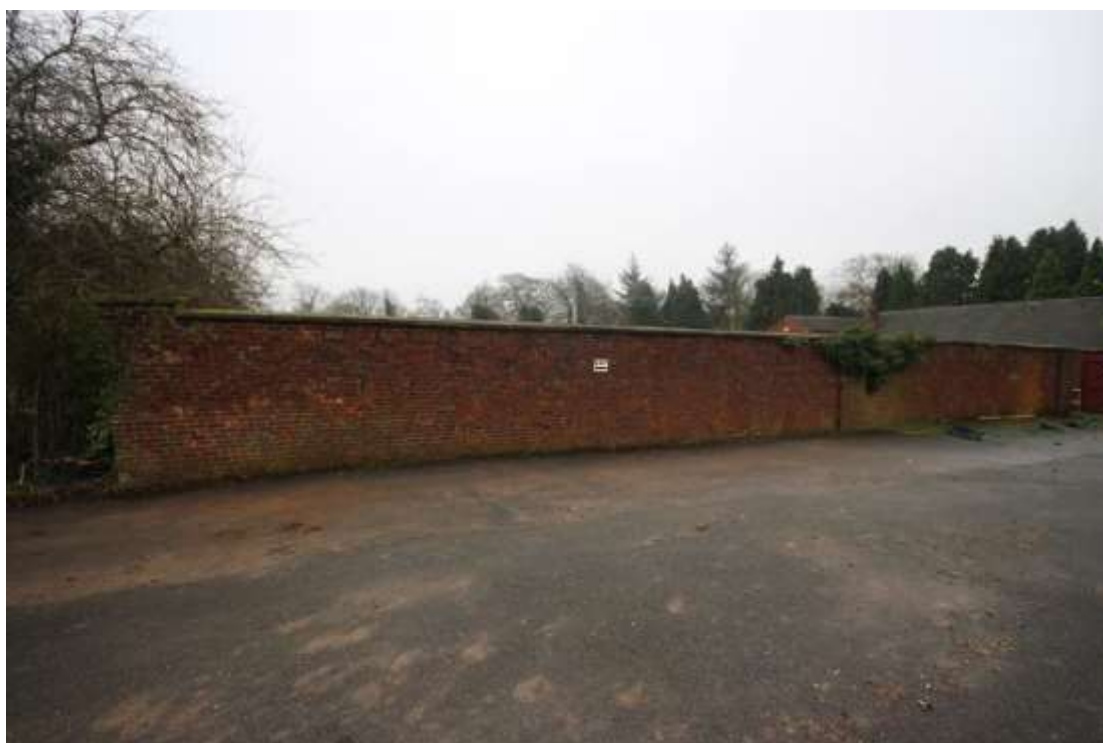
Plate 122: Exterior view of the western wall of the Walled Garden, facing south east.

6.44 The Walled Garden (Plates 122-125) sits to the north east of the hall and is bounded on its north east and south west corners by the Potting Shed/Gardener's Workshops and the Halcyon Room respectively. The wall itself is of red brick and topped with concrete caps; the bonding in this wall is obscure and is similar to a Flemish stretcher bond. There is an entrance to the garden in the eastern side (Plate 125) defined by two posts of rusticated reconstituted stone. The Walled Garden itself appears on a sales plan dating to 1835 (CTD Architects 2019, 6) making it (and the Potting Shed) the two oldest structures on the site in their full original form. Along the interior of the northern wall of the garden are the remains of the 19th century glasshouse bases (CTD Architects (2019, 26). These are red brick bases that have largely been lost as the interior of the walled garden has been landscaped.

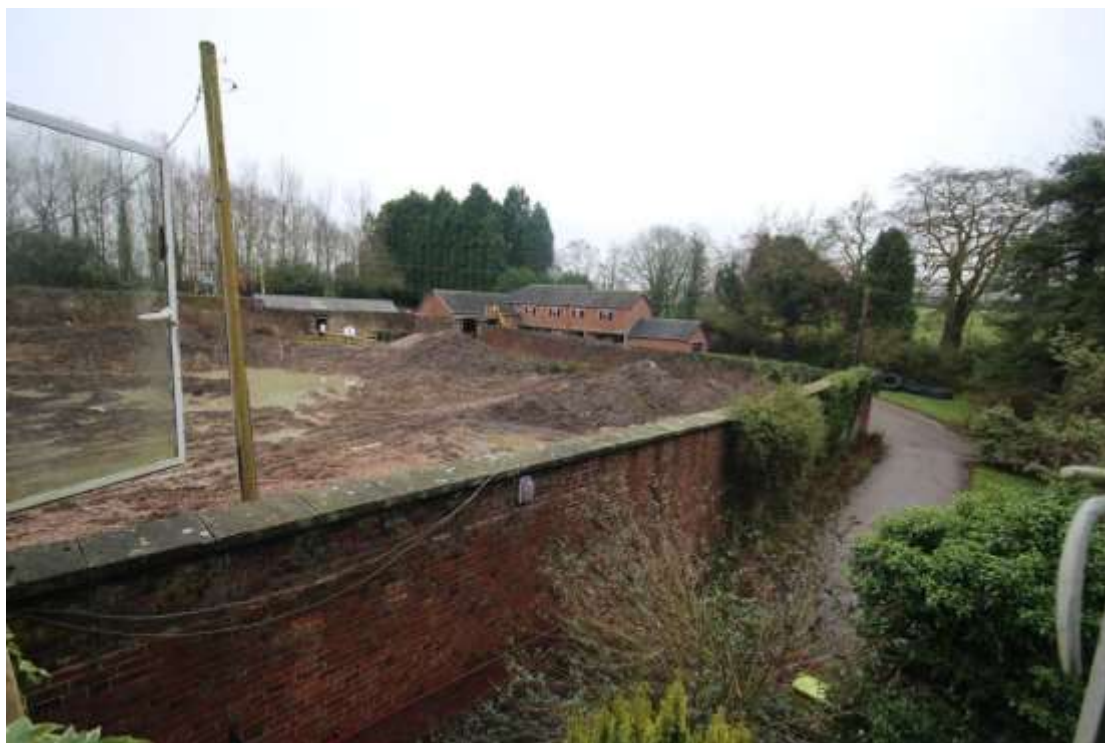
Plate 123: View of the south eastern quarter of the Walled Garden, facing north east. This photograph was taken from the first floor of the Coachman's Halt.

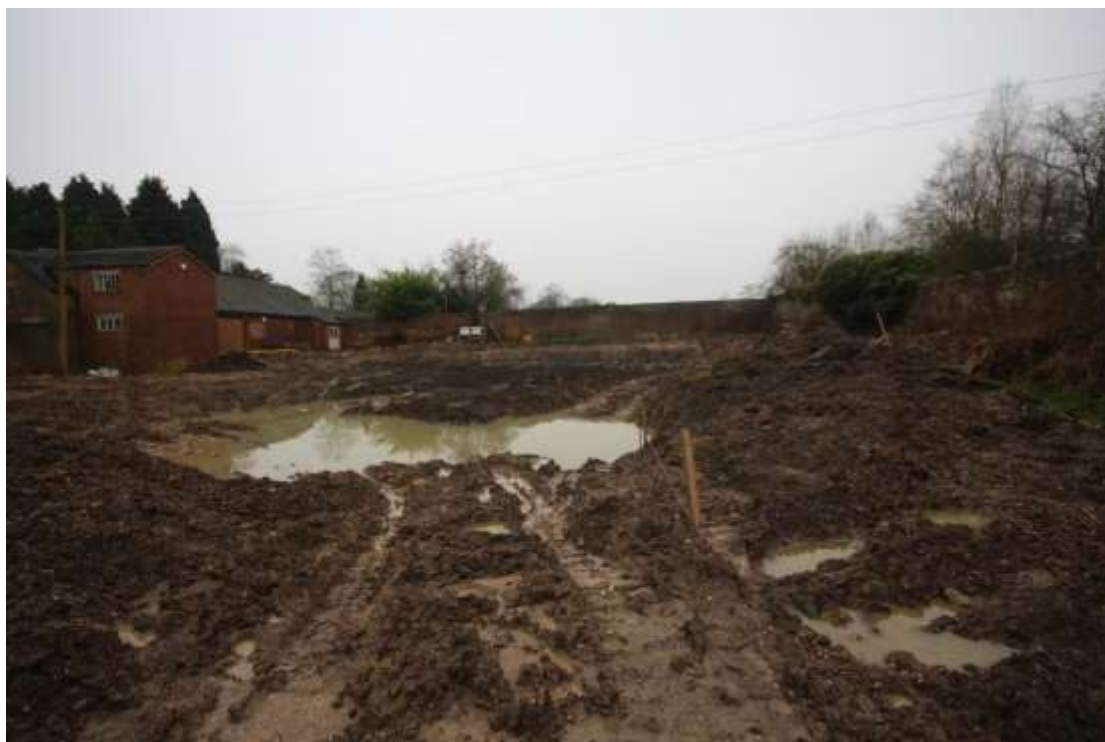
Plate 124: View of the interior of the Walled Garden, facing west.

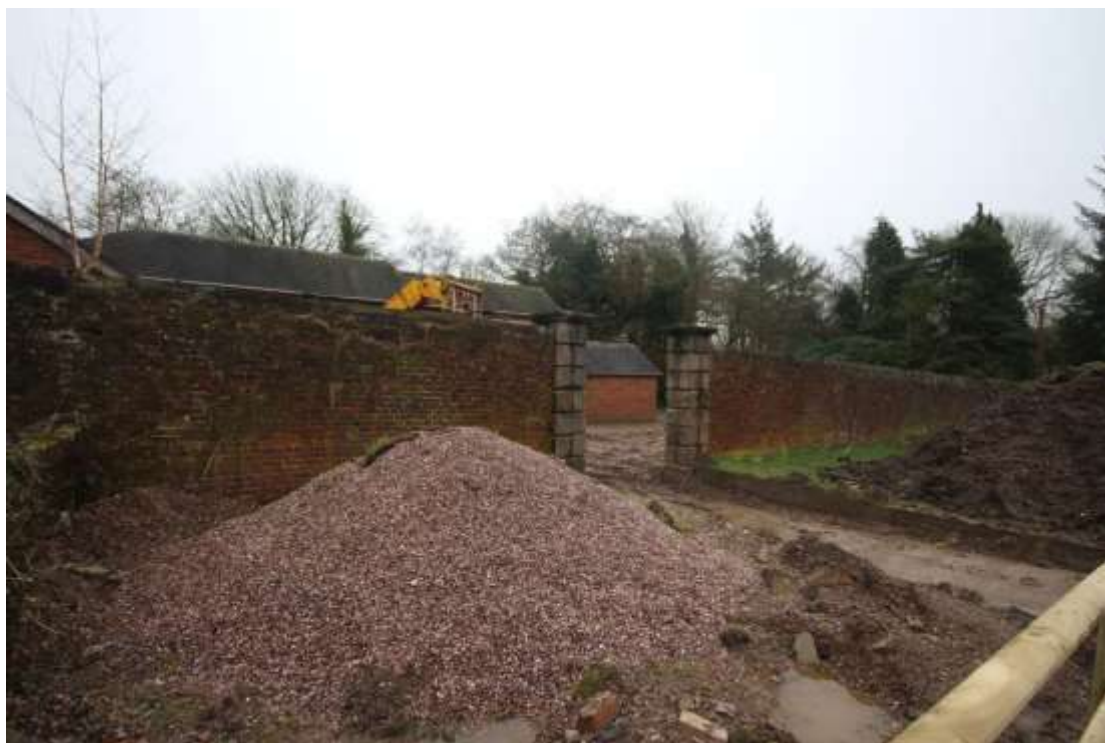
Plate 125: Interior view of the eastern wall of the Walled Garden, facing south east.

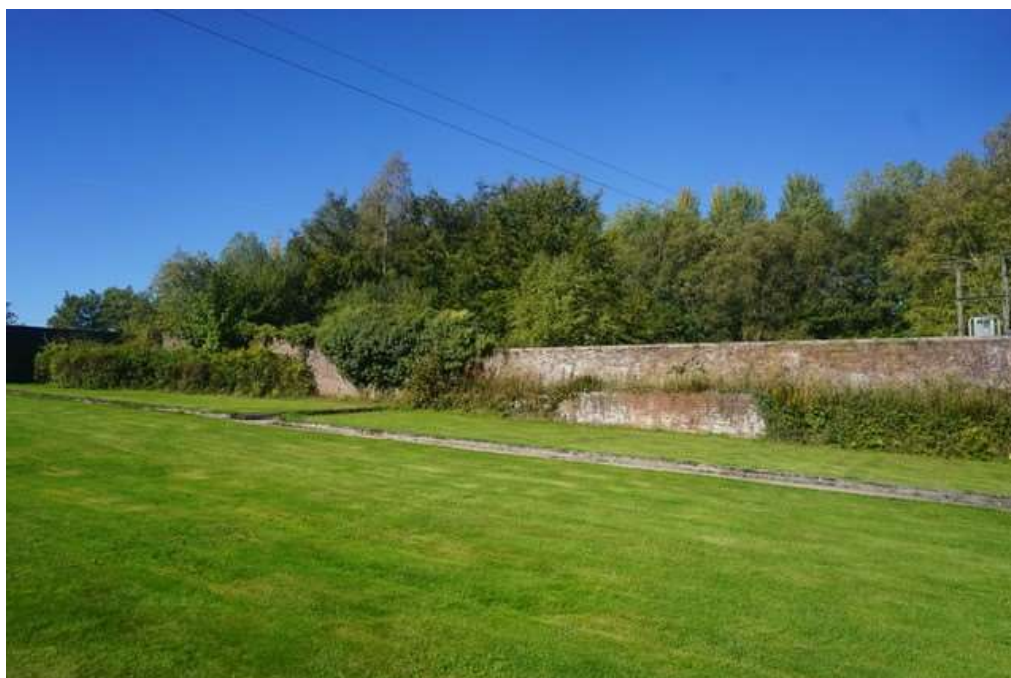
Image 1: The glasshouse bases along the internal northern wall of the Walled Garden, facing north west. Source: CTD Architects.

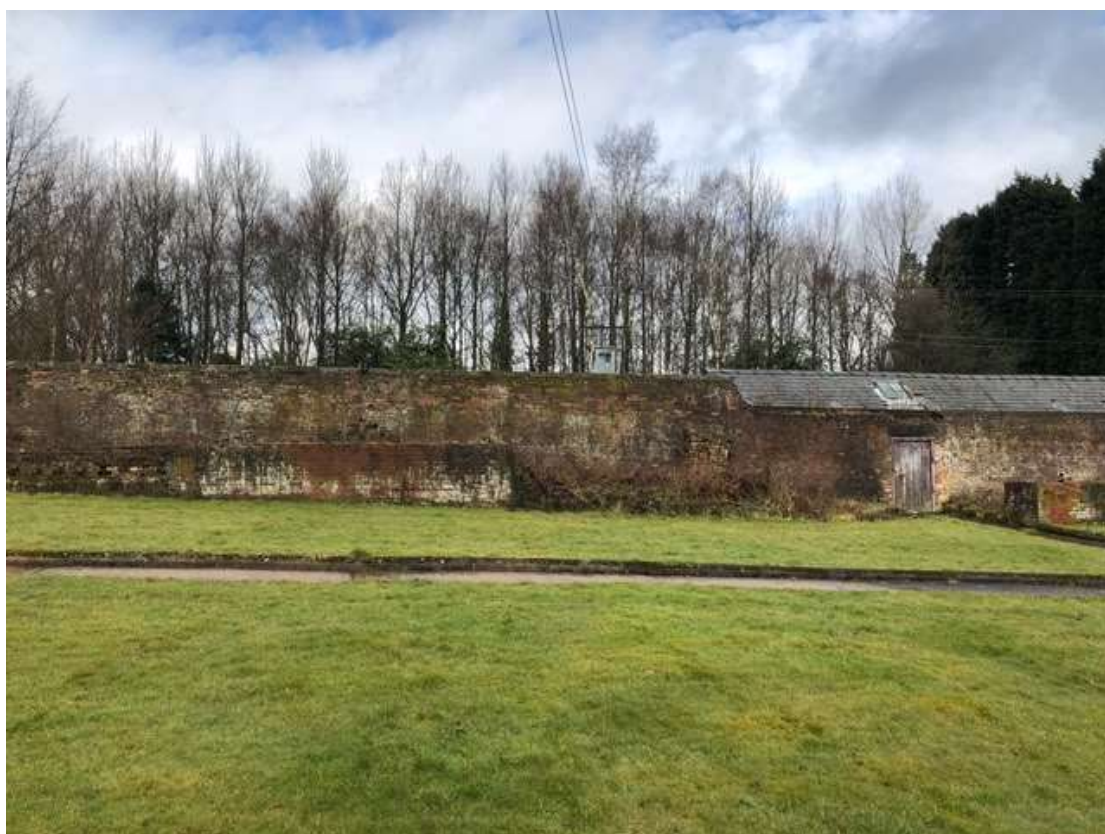
Image 2: Another view of the glasshouse bases along the internal northern wall of the Walled Garden, facing north. Source: CTD Architects.

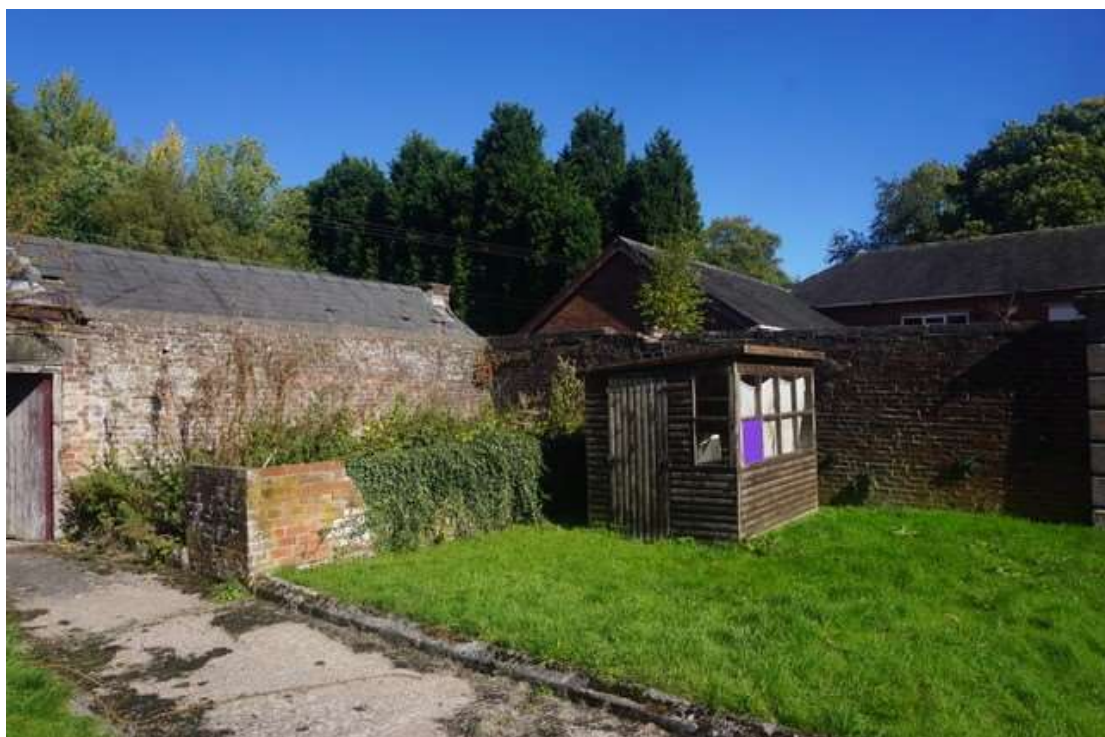
Image 3: View of the north eastern corner of the walled garden, including the remains of the now lost glasshouse base, facing north east. Source: CTD Architects.

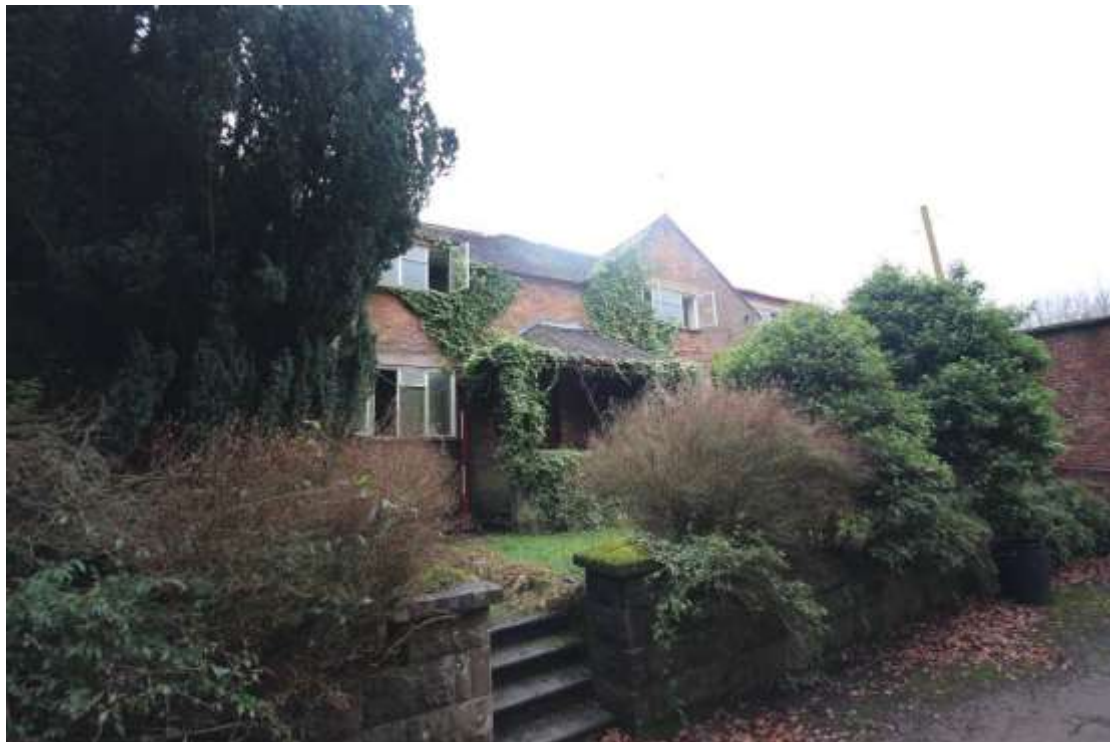
Plate 126: View of the eastern elevation of the Coachman's Halt, facing west. Scale 2m.

6.46 The eastern façade (Plate 126) is gabled on the northern side (Plate 127), and has two windows at ground floor level either side of the front door. These are three light casement windows in wooden frames, with concrete lintels and wooden sills. A porch protrudes from the central bay of this elevation, this has a tiled roof. This elevation appears to have been rebuilt almost entirely, likely when the stable block that it was attached to was remodeled in the late 20th century.

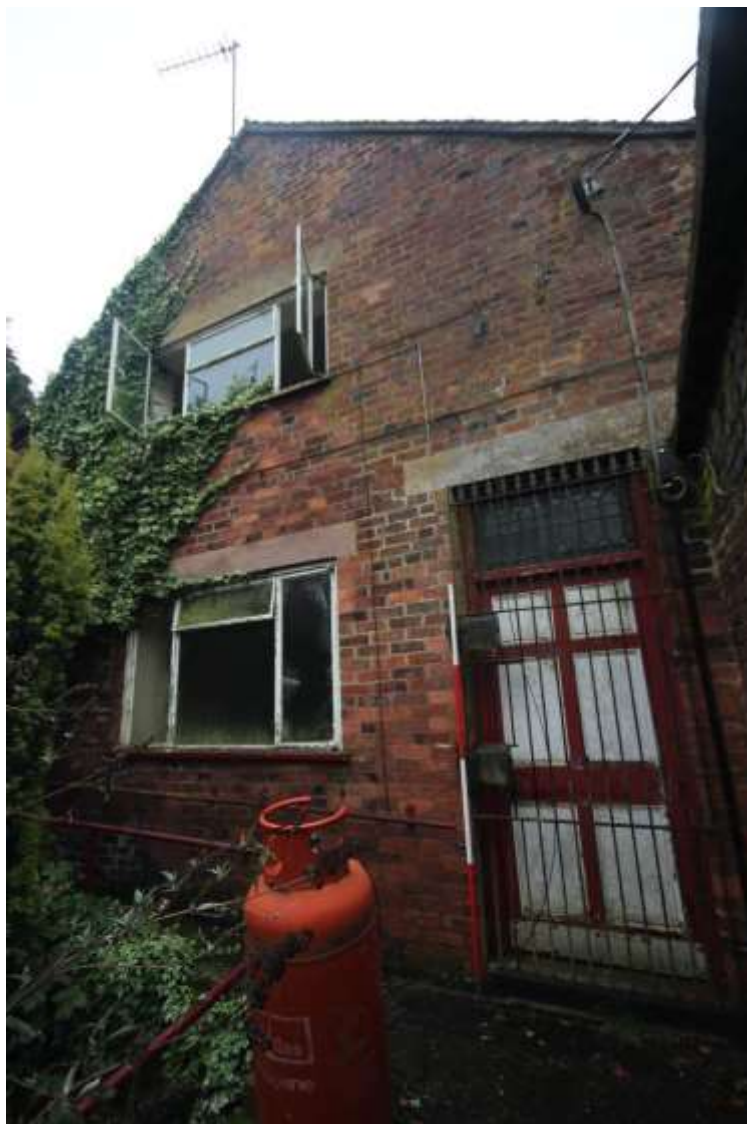
Plate 127: View of the northern section of the eastern elevation of the Coachman's Halt, facing south west. Scale 2m.

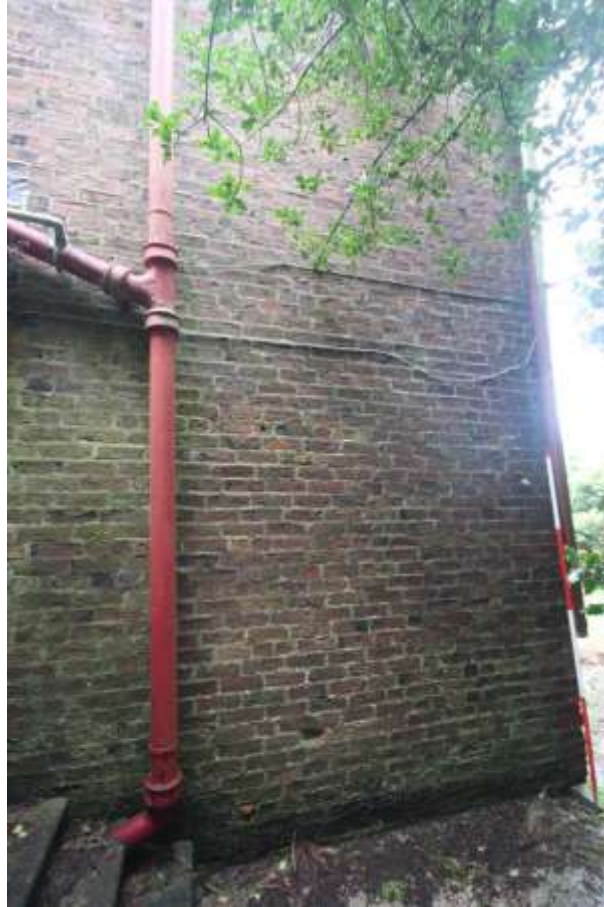
Plate 128: View of the southern elevation of the Coachman's Halt, facing north east. Scale 2m.

6.47 The southern elevation (Plate 128) looks to be original, as the brickwork here is very similar to that of the older parts of the former stable block. A small, single story lean-to has been built against this elevation. The front of the building has a raised garden surrounded by a low wall of coursed sandstone ashlar.

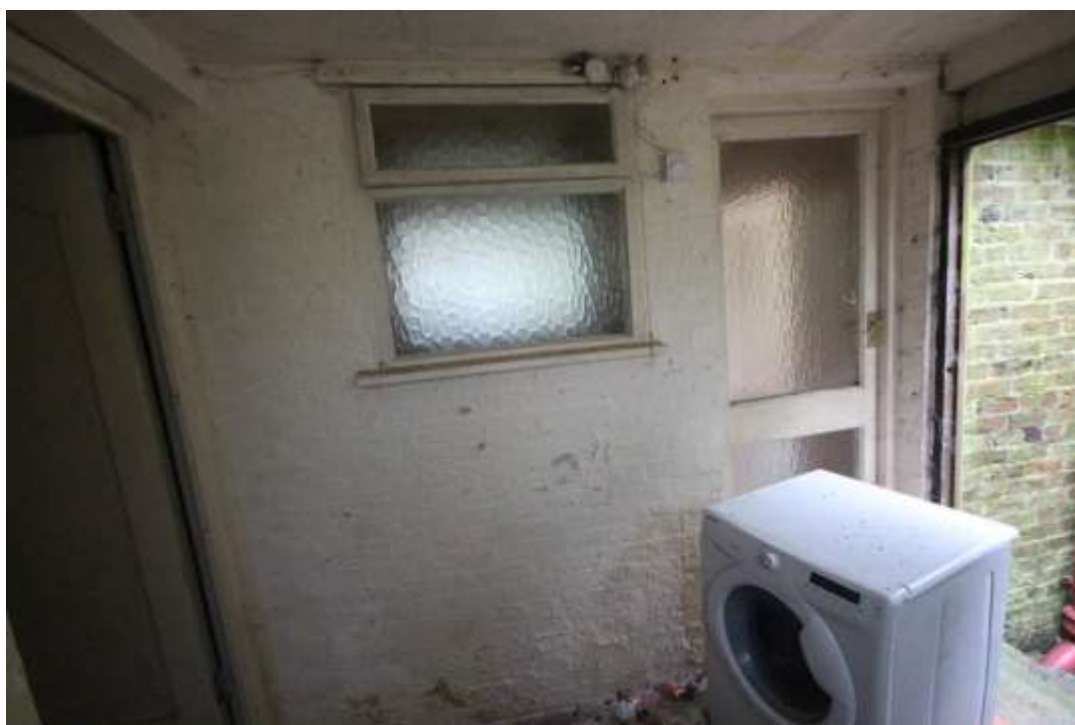
Plate 129: General view of the western side of the southern elevation of the Coachman's Halt, facing north. This part of the elevation is now obscured by the lean to structure.

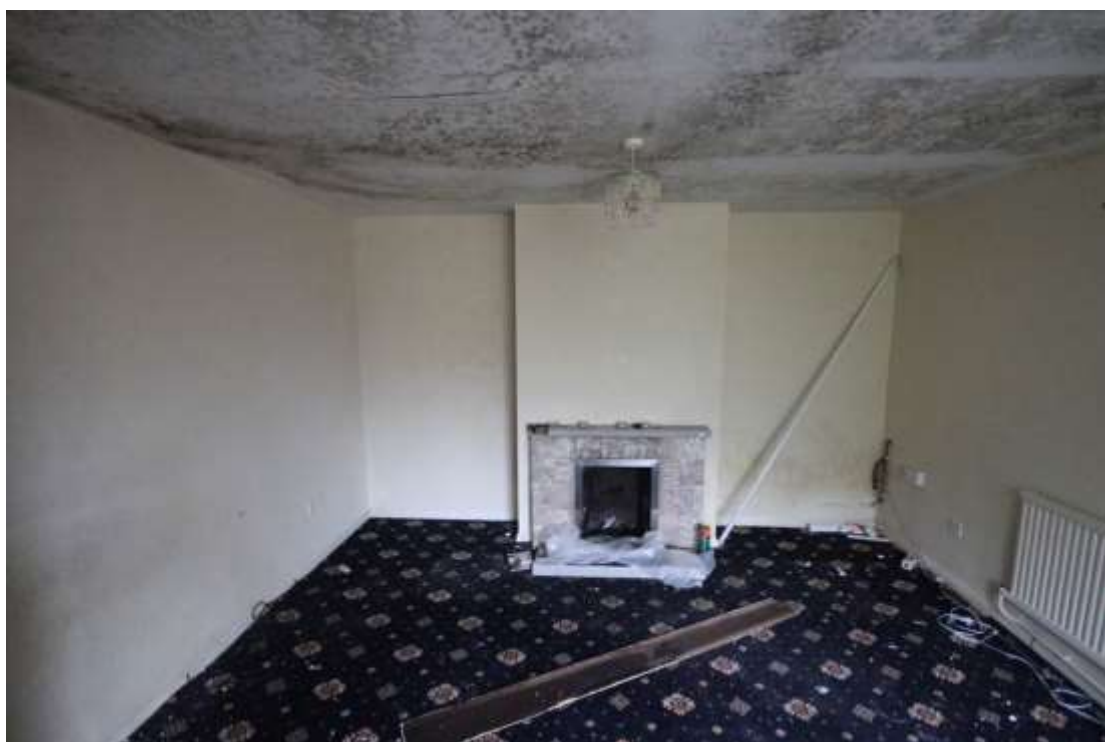
Plate 130: View of the living room in the Coachman's Halt, facing west.

6.48 Internally the space has been remodeled to create a modern home; again this is likely the result of late 20th century alterations to the building and is not representative of the plan-form that would have been evident when this was a stable block. In terms of fixtures and fittings everything in the building is very recent. At first floor level there is a joist visible in the two front bedrooms, which has been covered with plasterboard and is likely the result of the late 20th century rebuilding of the roof.

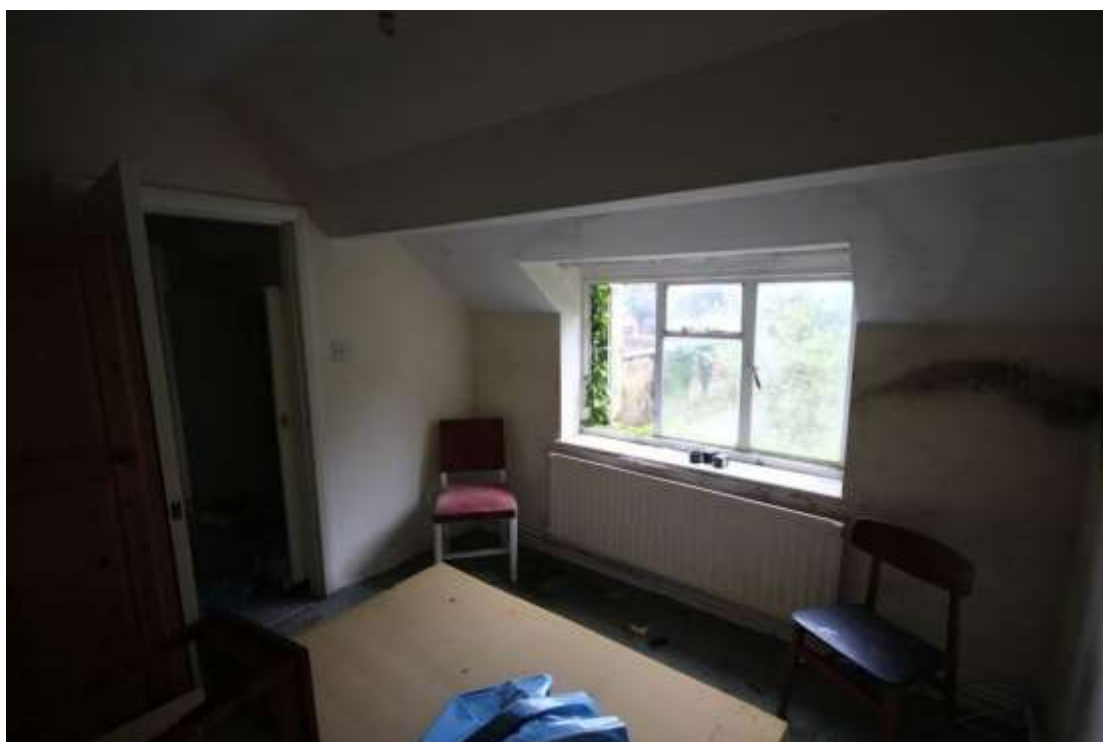
Plate 132: View of the first floor southern bedroom, facing north east. The original roof timbers have been covered here by plasterboard, visible above the window.

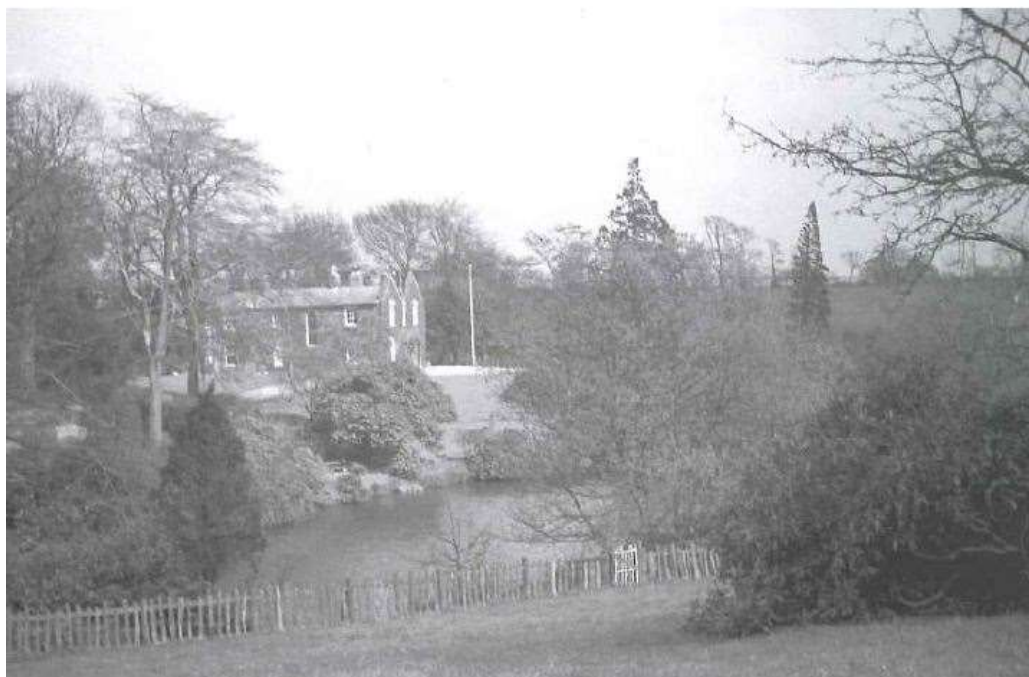
relocated the front entrance to the western elevation, creating a site almost indistinguishable from its original form. These factors show that the development of the Hall can be defined by two significant phases: the original construction and the mid-20th century remodelling. A blocked window in the eastern elevation of Block A (Plate 12) is in a similar style to those found in the northern elevation, suggesting the fenestration was once relatively uniform.

Plate 133: View of the southern projecting wing of the Hall c.1930, showing the original double-gabled southern elevation and the original fenestration on the western elevation. Source: Podmore 2007, 14.
