**Highfields Farm Barn, Stoney
Middleton, Derbyshire
Historic Building Recording**

Historic Building Recording

Archaeological Research Services Ltd Report 2020/56

Prepared on behalf of: Property Renovators (UK) Ltd

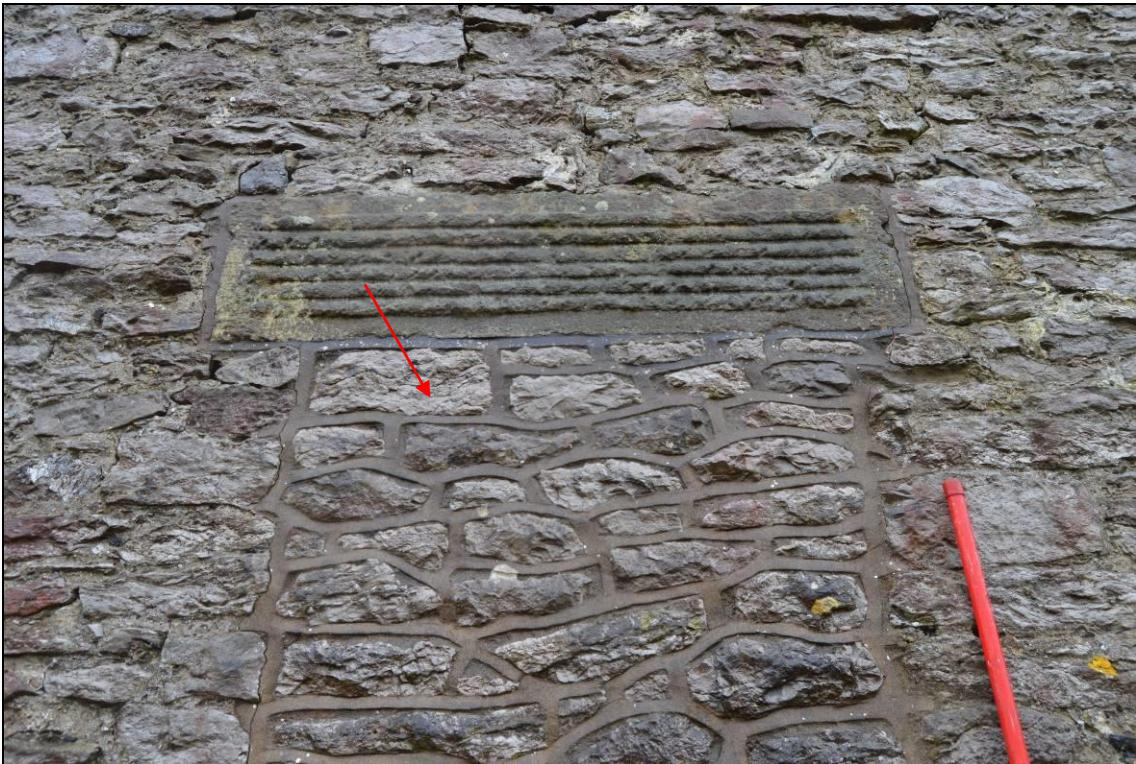
Plate 6: Moulded stone lintel to east doorway in north elevation (facing south). Scale 2m.

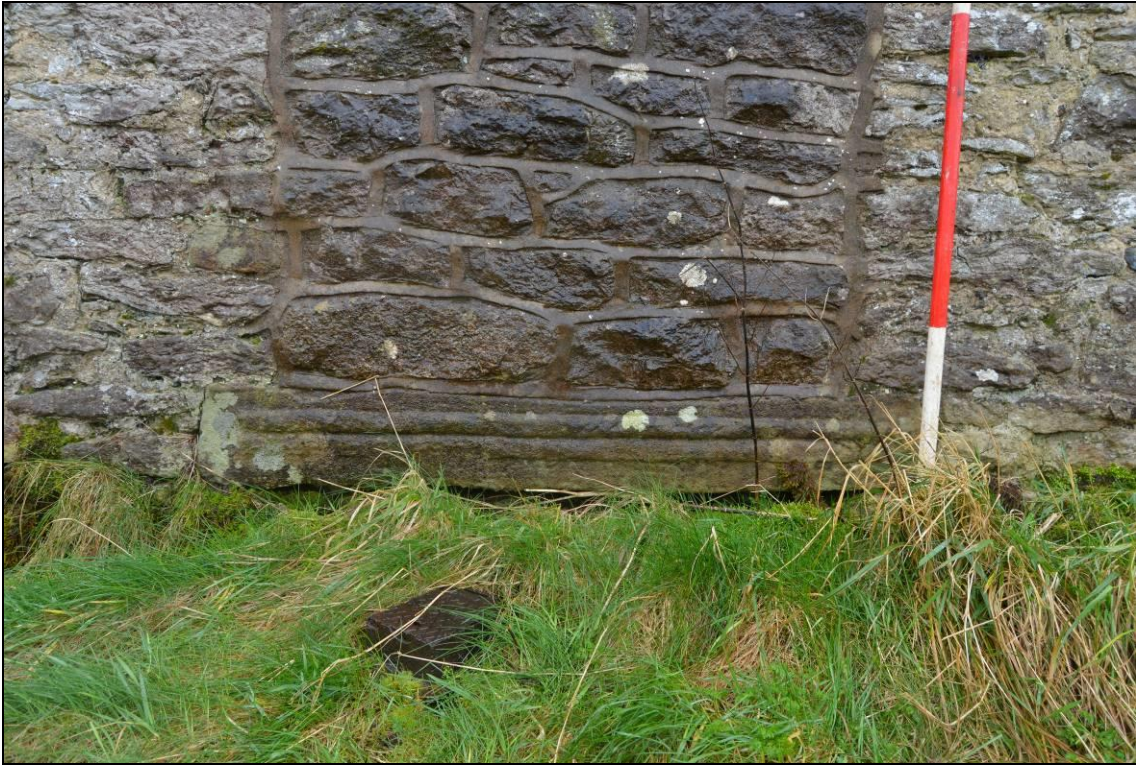
Plate 7: Moulded stone step to blocked doorway in north elevation. Scale 2m.

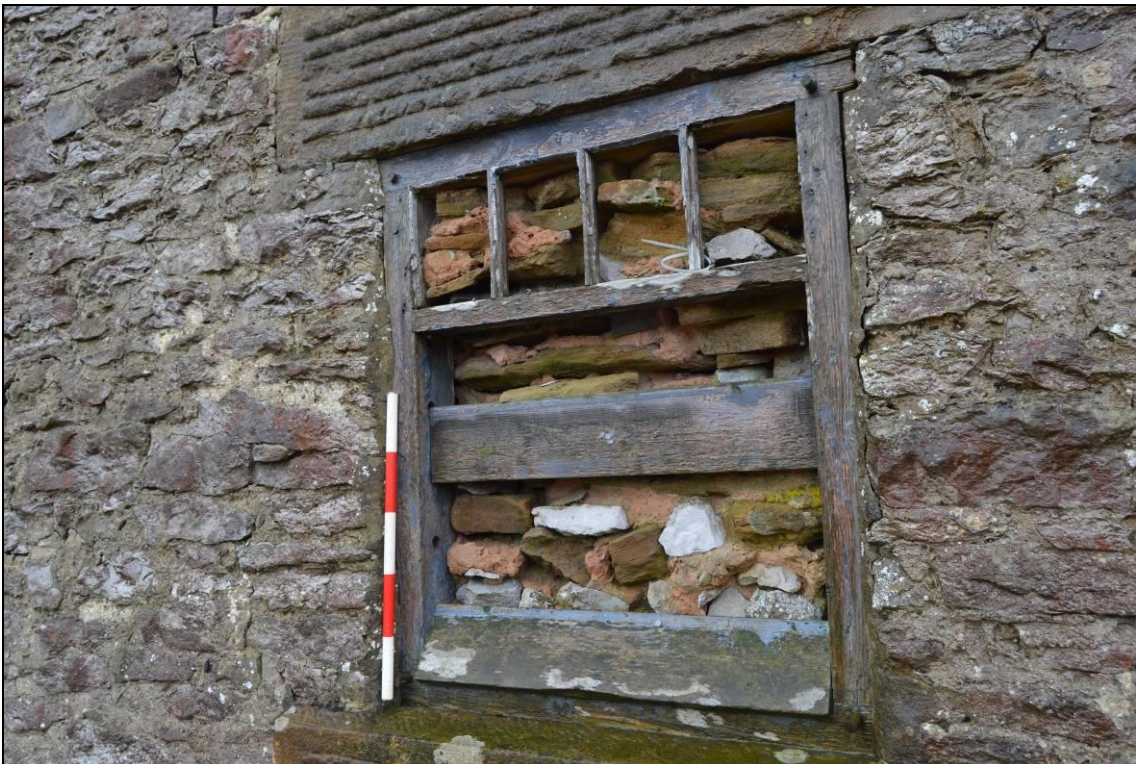
Plate 8: Retained window casement with louvered vents in north elevation (facing south east). Scale 0.5m.

4.2.3 The west aperture presents a blocked window opening which retains a timber frame exposed to the outside face (**Plate 8**). The casement formerly comprised four glazed panels to its upper portion above five louvered vents. The casement is constructed with wooden peg fixings. The aperture has been crudely blocked with an assemblage of field stones and brick.

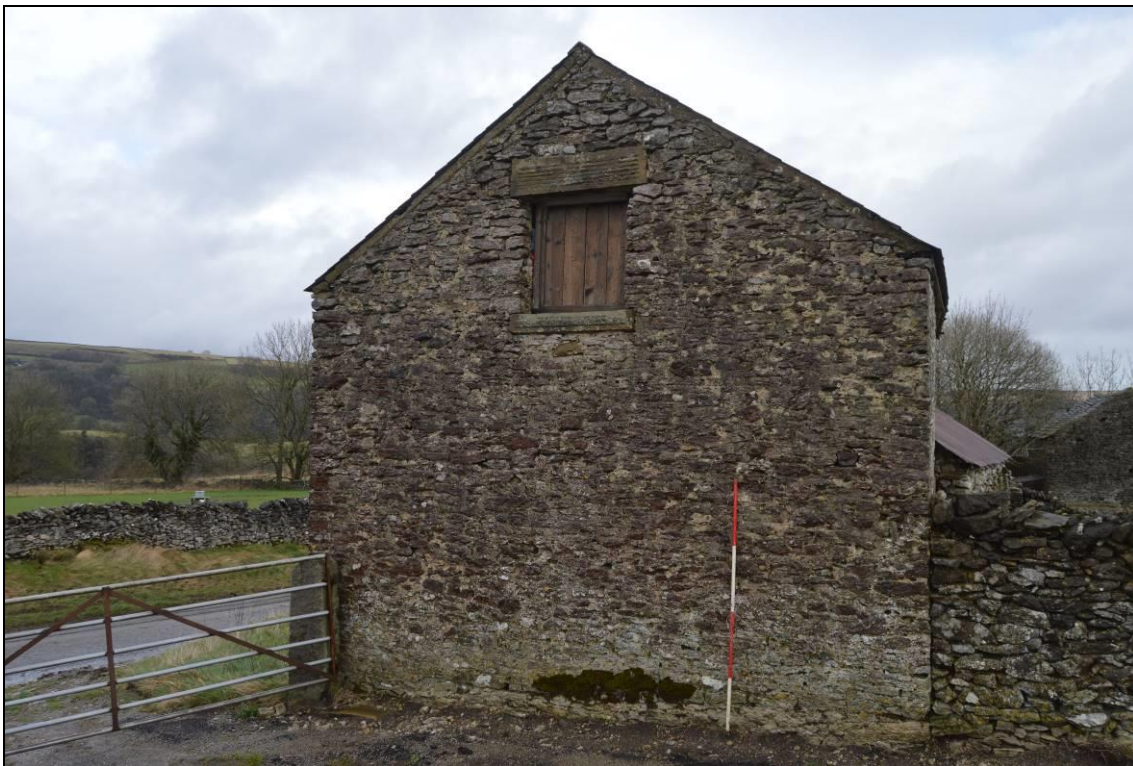
Plate 9: West elevation of the cow house (facing east). Scale 2m.

4.2.5 The west elevation flanks the tracked entrance way into the site (**Plate 9**) which is preceded by a stone gate post with modern, galvanised metal 6-bar gate (**Plate 10**). The west wall of the building presents a mostly featureless gable wall with a single pitching door at upper floor level. The opening is punctuated through use of a stone lintel and cill, both with a moulded reed pattern to the outer faces. The aperture holds a replacement softwood plank door.

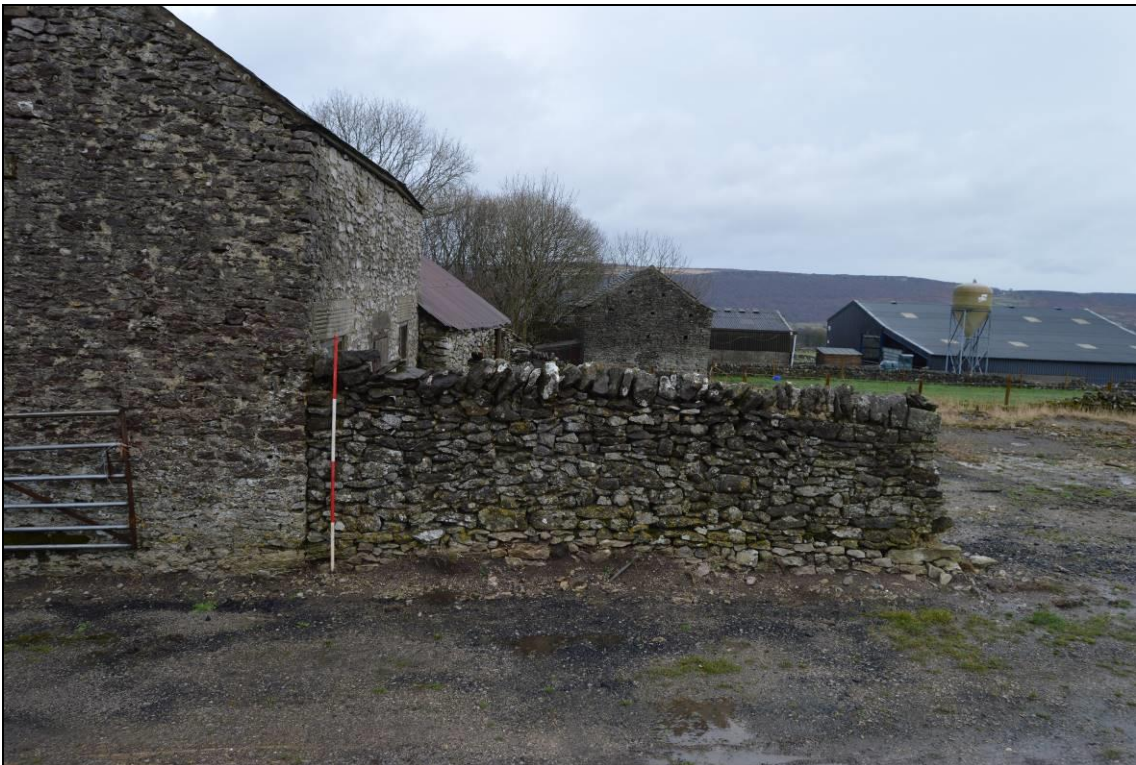
Plate 11: Section of stone walling abutting the south west (east) cow-house. Scale 2m.

4.2.7 A section of dry stone walling (with sparsely applied mortar) adjoins the south west corner of the building, which projects c.6m to the south into the main foldyard (**Plate 11**). This likely formed a weather break for the south cattle entrances.

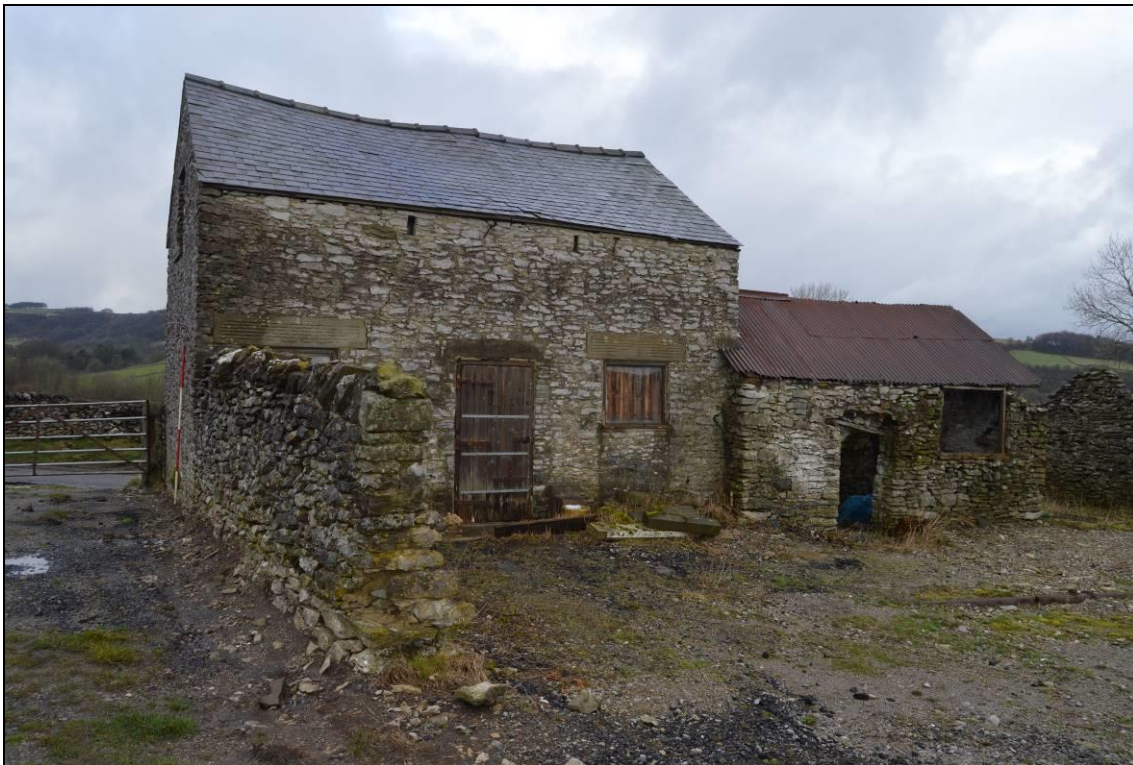
Plate 12: South elevation of building 1, with buildings 2 and 3 to the right (facing north). Scale 2m.

4.2.8 The south elevation flanks the larger foldyard enclosure with the section of stone walling abutting from the north west corner of the building (**Plate 12**). The wall is punctuated by a door towards the centre of the wall which is not original to the building. The inserted modern entrance is flanked with two historically blocked doorways, the eastern of which constituted a cross passage in conjunction with the doorway in the north elevation.

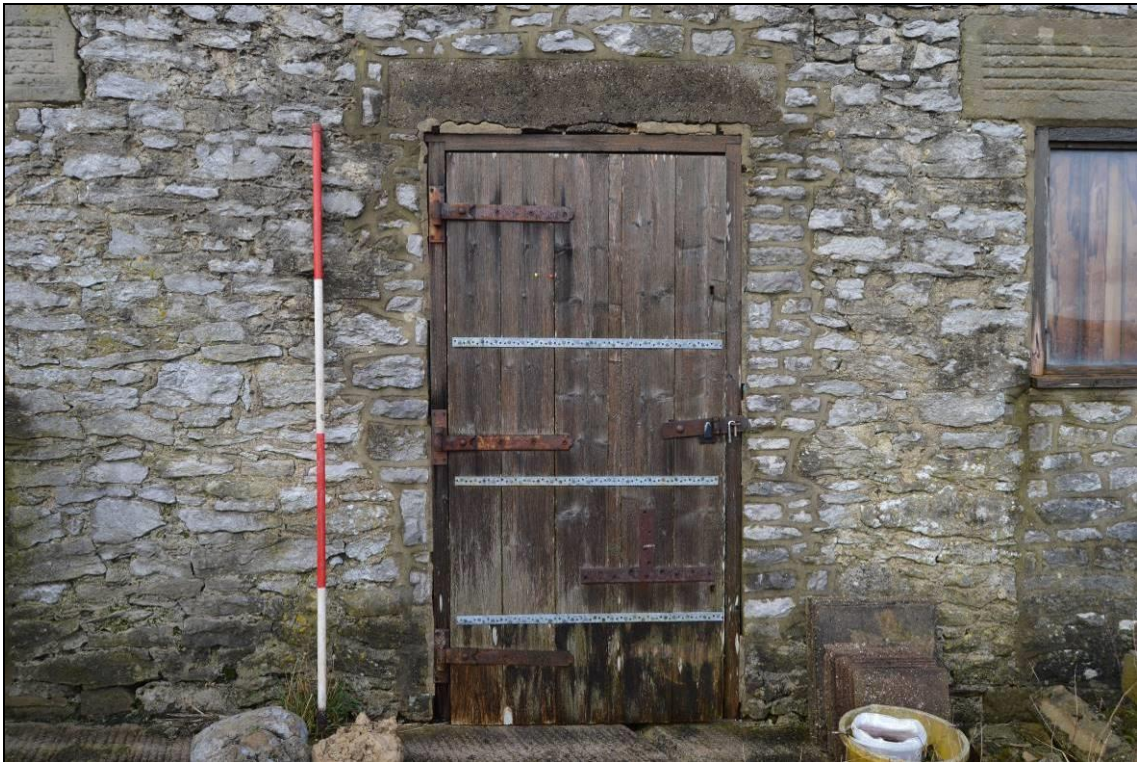
Plate 17: Five of the cow-house apertures to the north elevation of the granary range (facing north west). Scale 2m.

4.2.10 The inserted doorway, with concrete lintel and cement mortared jambs, has a simple timber, plank door with strap hinges and hasp and staple for locking (**Plate 17**). The door has been reinforced with modern galvanised straps fixed with nails and crosshead screws.

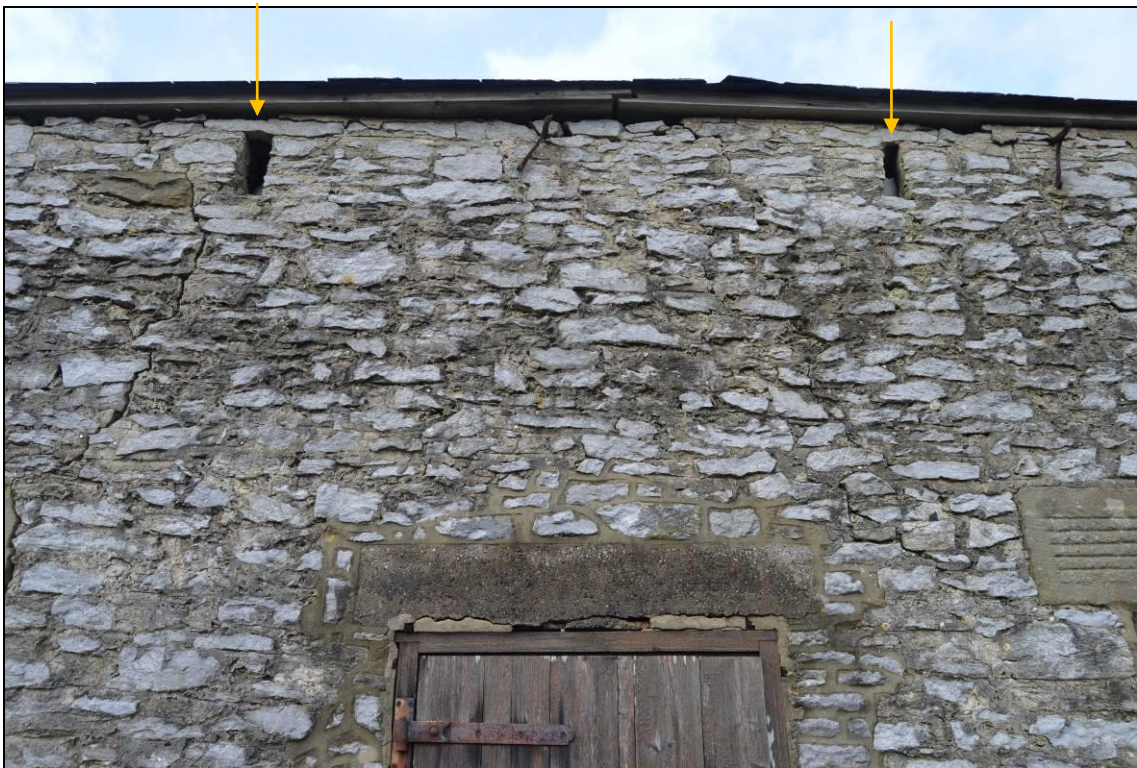
Plate 18: Detail of cow-house apertures to the north elevation (facing north).

4.2.11 Just below the eaves are two small vent slots (**Plate 18**) below an exposed timber wall plate, with no rainwater fittings, beneath the grey slate roof.

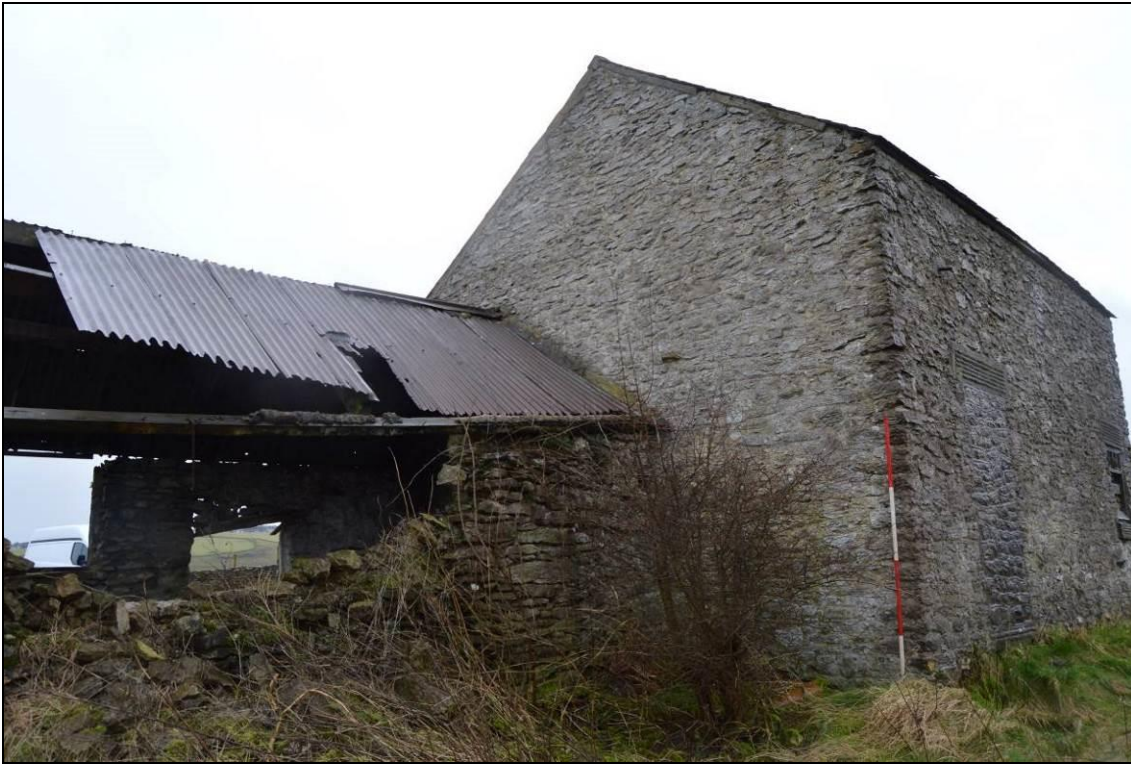
Plate 19: Oblique view of east elevation from the lane (facing south east). Scale 2m.

4.2.12 The east elevation of building 1, presenting a mostly featureless gabled face, partly fronts the public highway (**Plate 19**). Some of the extent of the west elevation is obscured by a single storey, open fronted shelter shed with pitched corrugated iron roof (building 2).

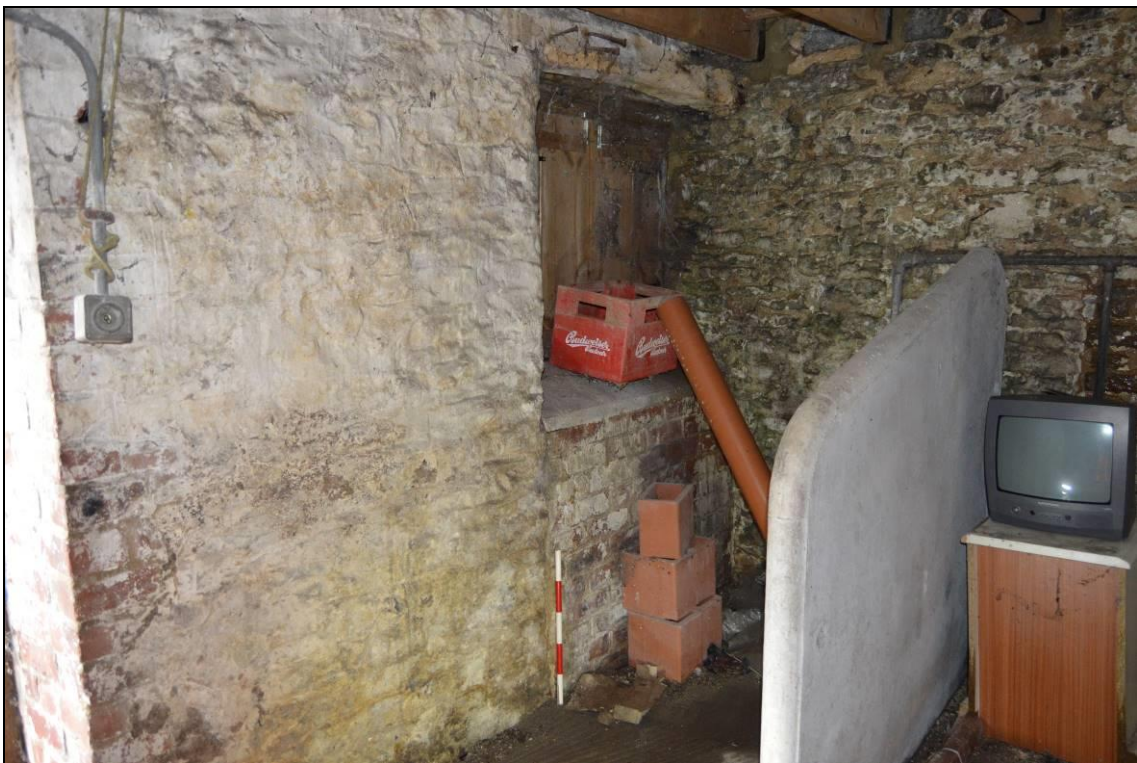
Plate 25: Interior of blocked door to south elevation (facing south east). Scale 0.5m.

4.3.2 The internal face of the north and south elevations reveal the blocked, historic apertures noted to the exterior surface (**Plates 24 to 26**), which are composed of a red brick internally. Roughly finished timber lintels extend across the top of the original openings. Internally the south aspect windows have timber plank shutters of modern origin in keeping with modern single pane casements.

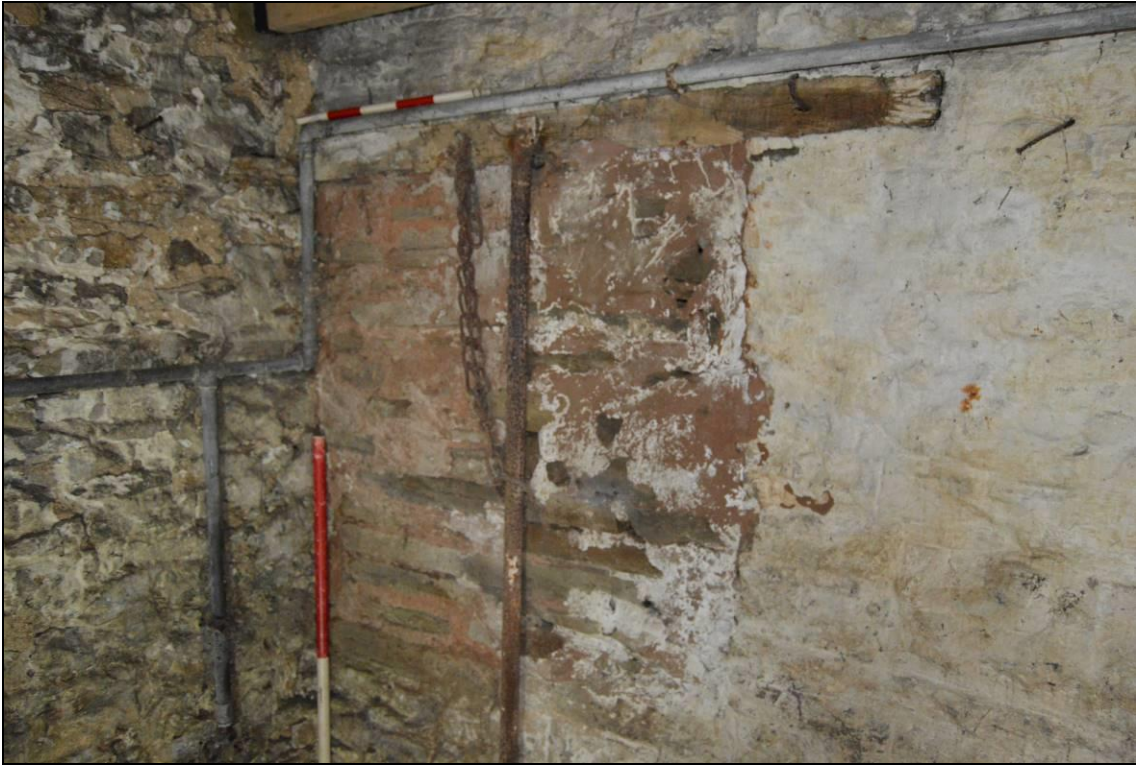
Plate 26: Interior of blocked window to north elevation (facing north west). Scale 1m.

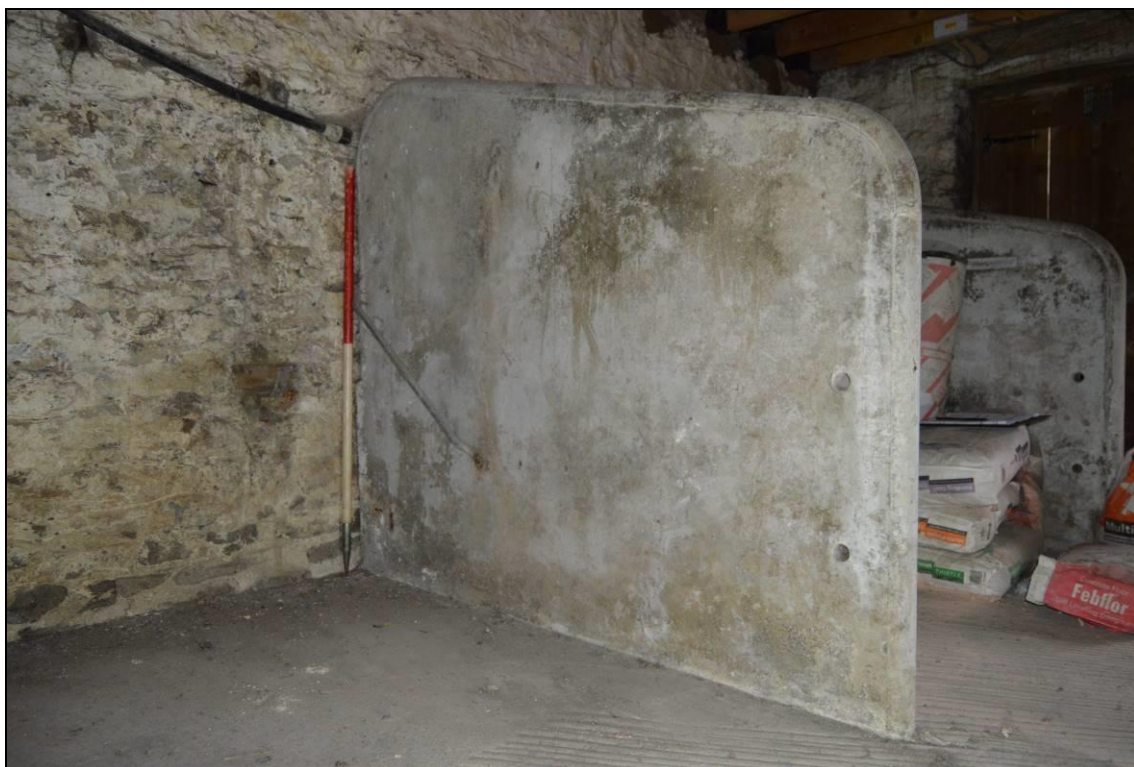
Plate 28: Concrete stall partition and additional features. Note the halter bar and remnants of a cow drinker (facing east).

4.3.3 The interior of the building's ground floor currently comprises modern cattle accommodation cast in concrete, with two sets of stalls flanking a sloped central floor with drain channel. The drain exits from a channel formed in the central doorstep (**Plates 27**). Related fixtures include a galvanised metal tank mounted within the stairwell opening, which likely fed the extant plastic and metal pipework (some of which serve as cow drinkers in the stalls), with a mix of 20th century electrical fixtures (**Plate 28 to 30**).

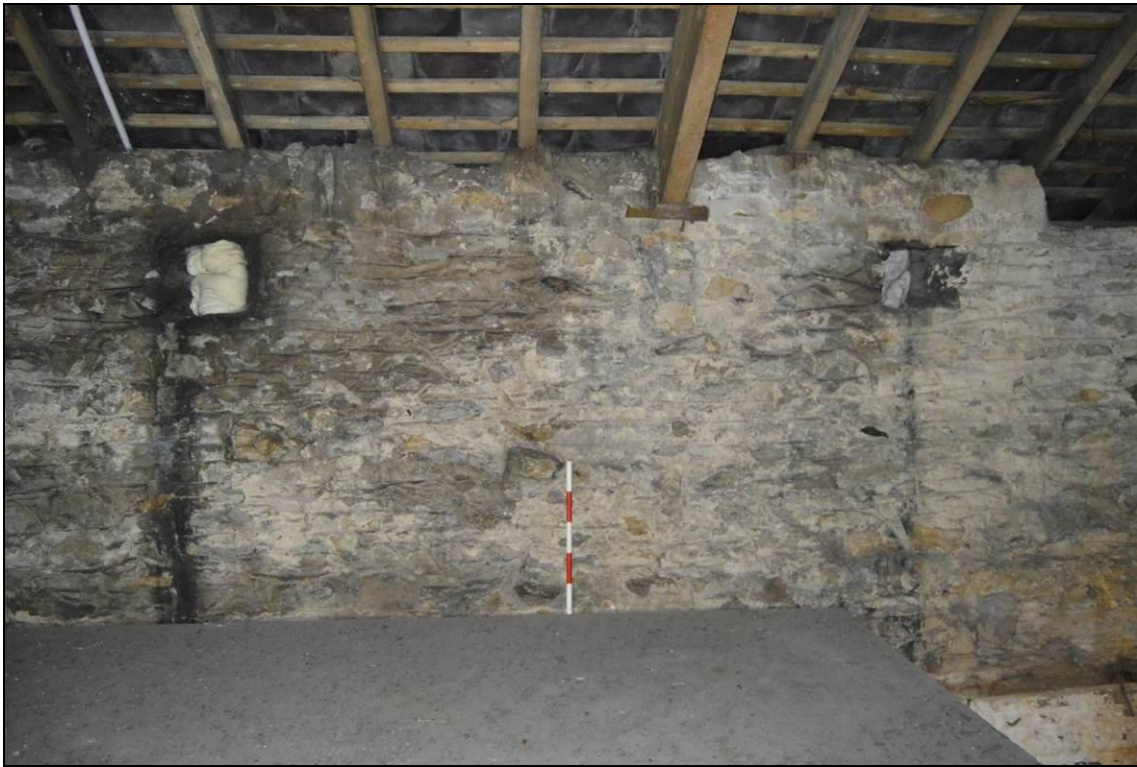
Plate 34: Interior of north elevation, first floor of the barn (facing north) showing the splayed vent openings. Scale 0.5m.

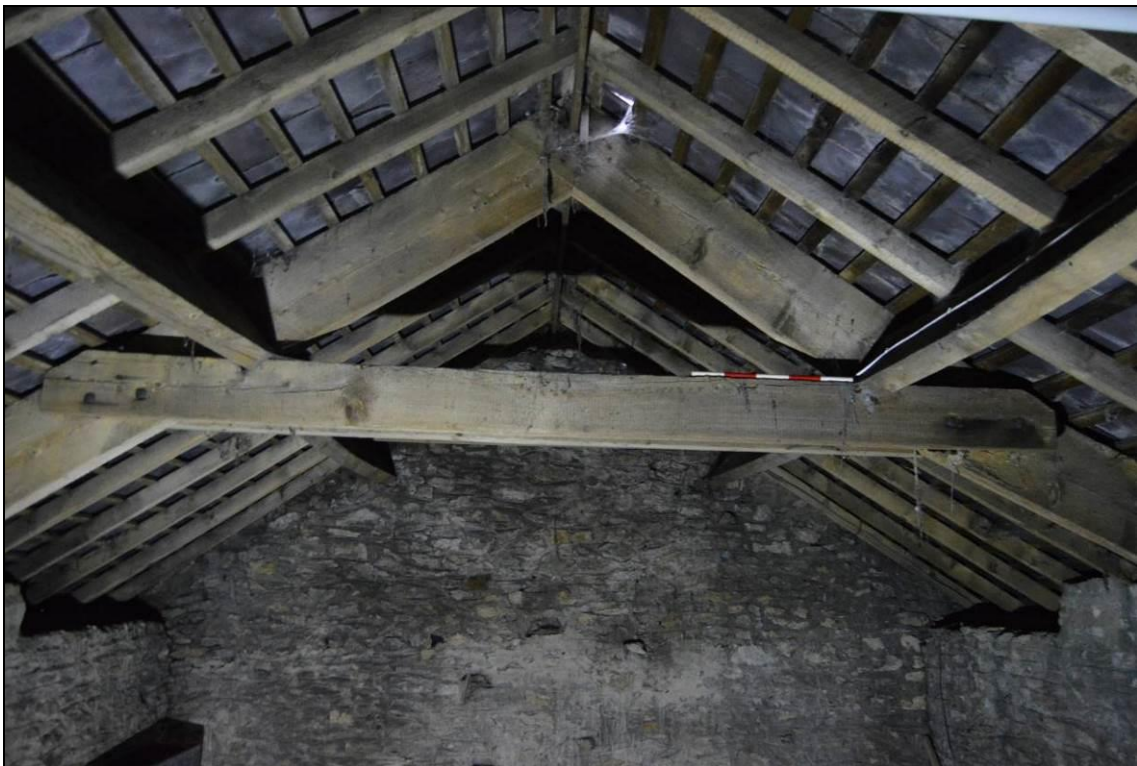
Plate 35: Roof structure of the barn (facing west). Scale 0.5m.

4.3.4 Above, the first floor structure comprises a largely modern replacement, with softwood joists overlain with a modern chipboard floor (**Plate 31 to 33**). The first floor area of the building forms a single open space, likely utilised for hay storage for feeding the cattle. A stairwell formed over the north east corner although no ladder or steps remain. No natural light permeates the space, with the pitching door closed. The north and south walls are punctuated with splayed recesses for the ventilation slits, observed externally (**Plate 34**). The roof is constructed of a single raised tie timber truss, fixed with metal pins, with a series of common rafters, all of modern appearance (**Plate 35**).

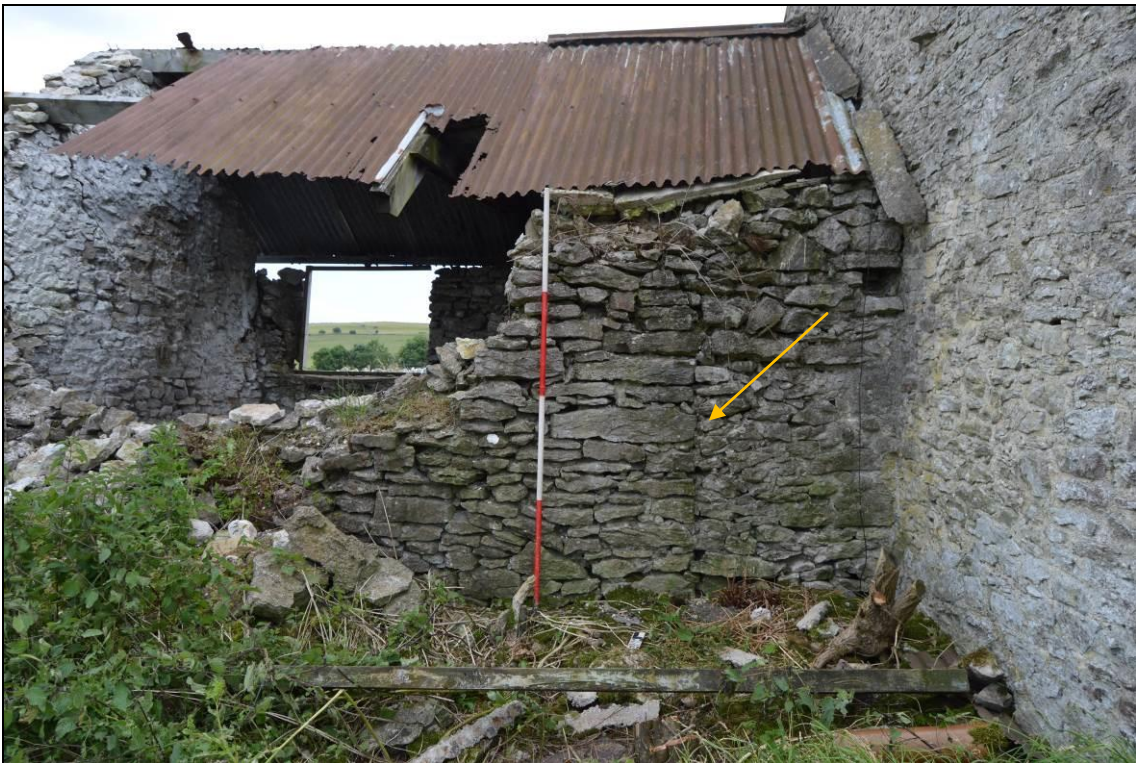
Plate 38: The collapsed north elevation of building 2 (facing south). A vertical break is evident to the right (indicated). Scale 2m.

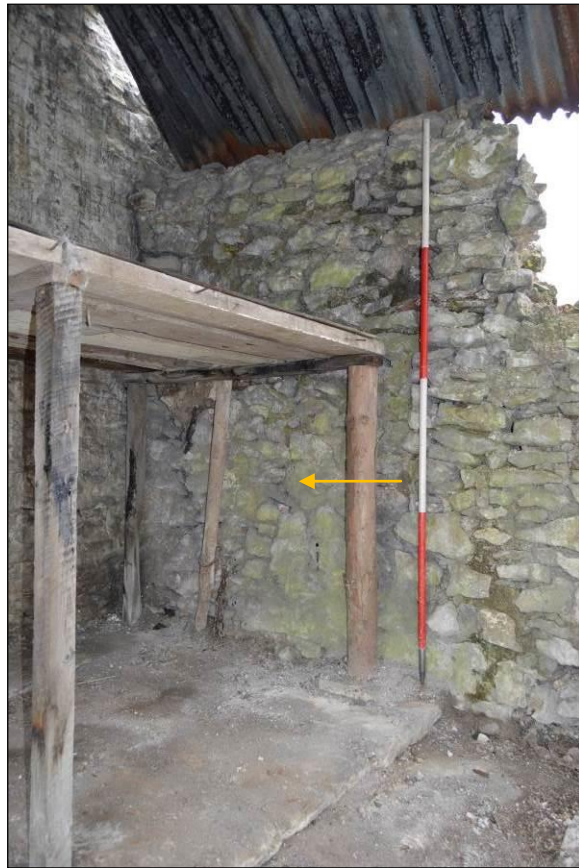
Plate 39: Interior of building 2 with construction break (indicated) adjoining possible wall core to right (facing north west). Scale 2m.

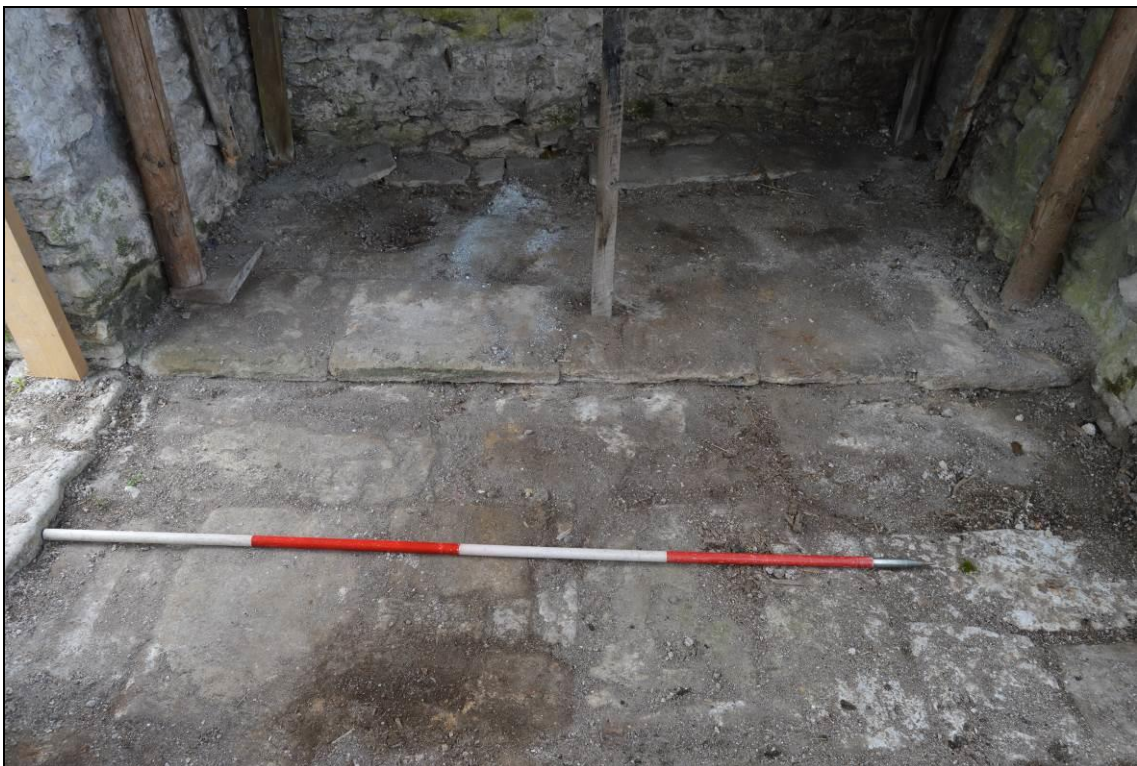
Plate 42: Interior of building 2 with remains of cattle stall flooring (facing west).

4.4.4 The interior of the building presented the remains of a stepped flag stone floor, probably the original floor, showing that in the 19th century the interior was arranged as a series of cattle stalls along the east and west walls with a central feeding passage (**Plates 40 to 43**). The roof structure comprises a single timber truss with single purlin (**Plate 44**). The wall plate is supplemented with forged metal bracing, with a mortar seal and sheeting bolts for the roof covering being evident.

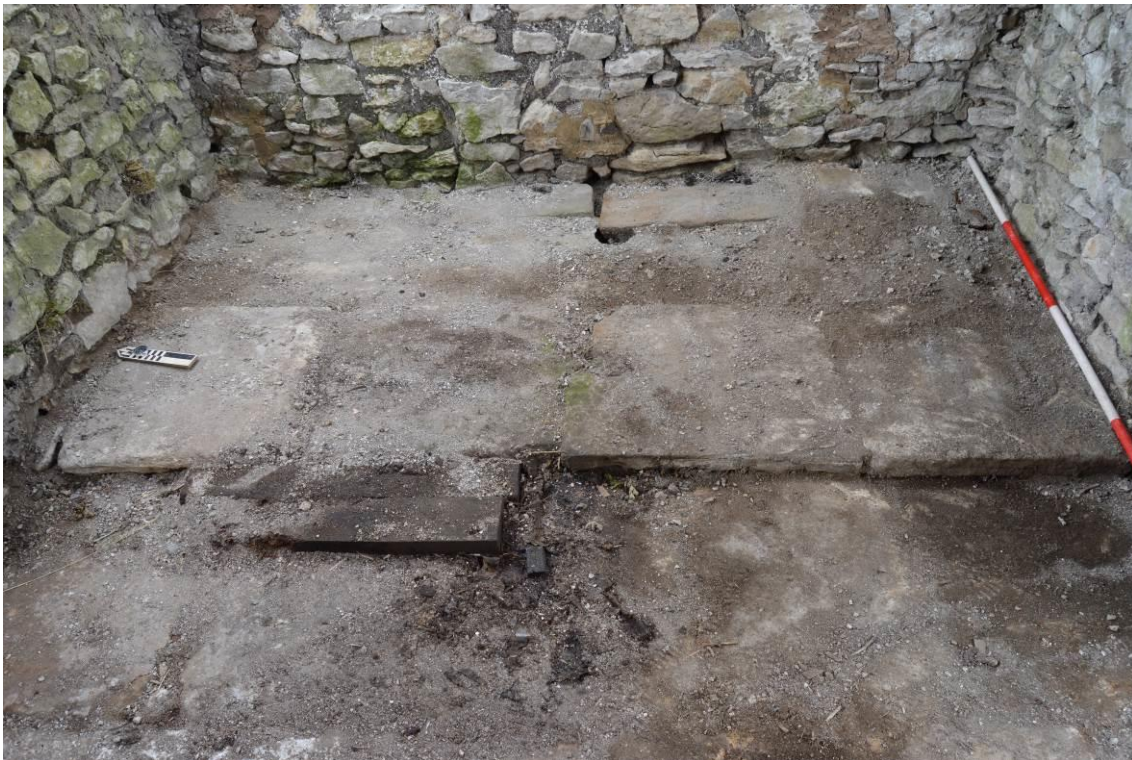
Plate 43: Interior of building 2 with remains of cattle stall flooring (facing east).

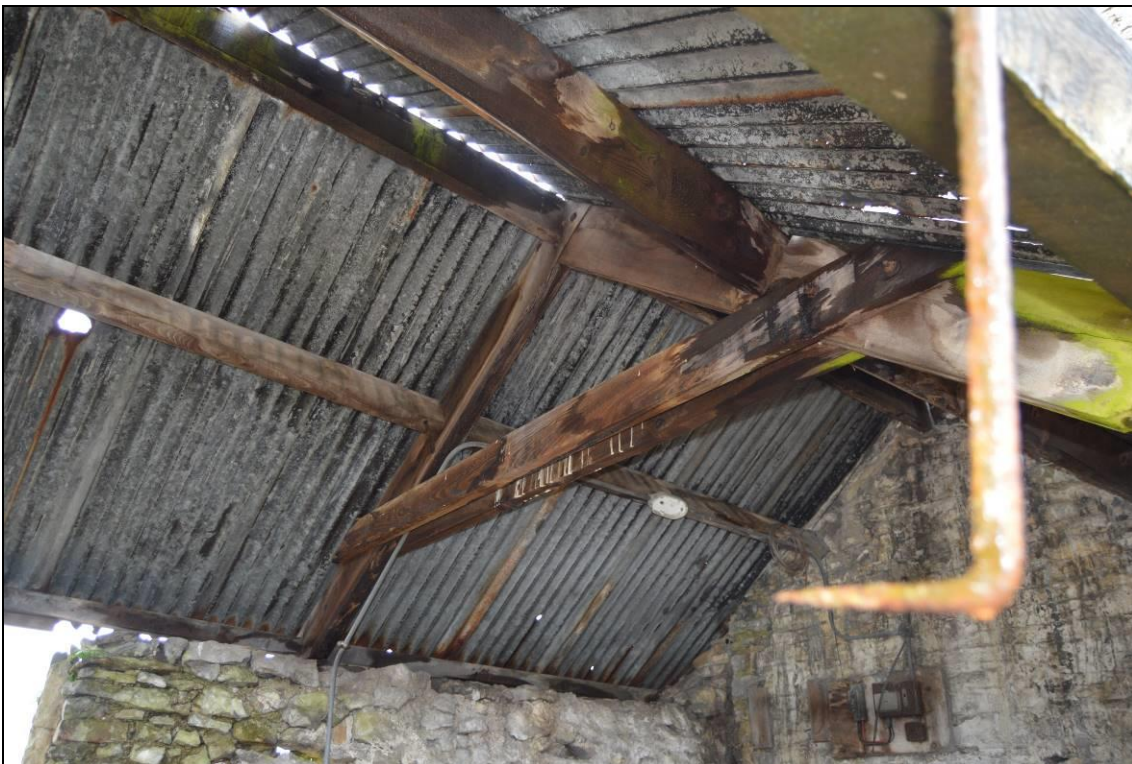
Plate 44: Building 2 roof structure with single tied truss. Note the iron bracket to the foreground which supported the wall plate. Scale 2m.

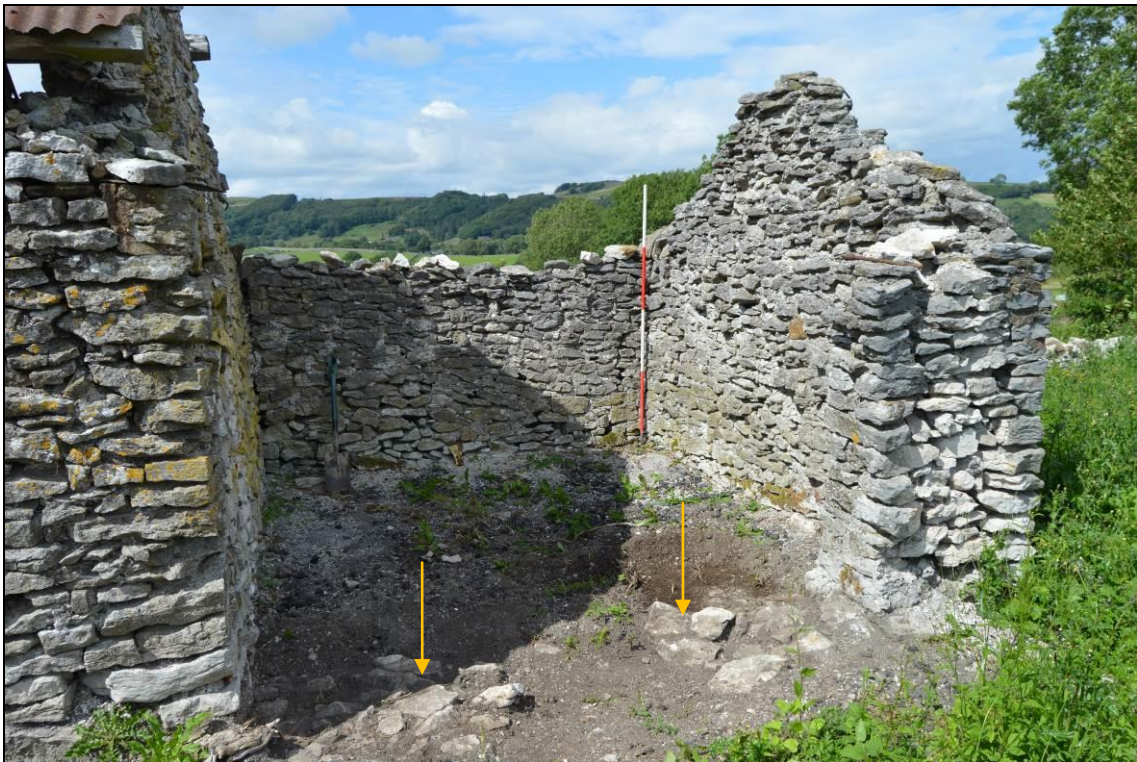
Plate 47: View from the yard into building 3 with foundations (indicated) for a south wall with smaller doorway (facing north east). Scale 2m.

4.5.2 On clearance of the collapsed roof structure a floor surface composed of clinker, earth and stone was revealed. Consequently, foundation stones of the earlier south elevation was exposed which would have provided a narrower doorway to the small building (Plate 47).

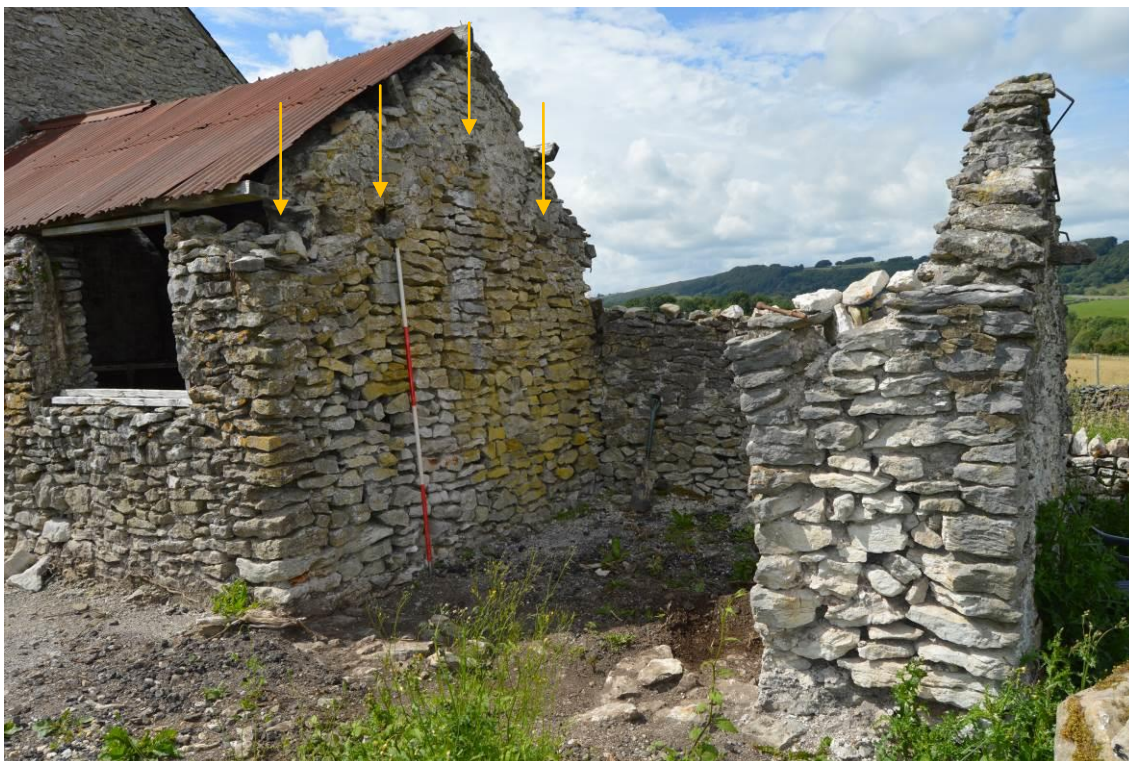
Plate 48: The adjoining gable wall between buildings 2 and 3. Note the sockets (indicated) for the former roof of building 3, with bag-rubbed lime mortar pointing above (facing north west). Scale 2m.

4.5.3 The north elevation has been built abutting the building to the west (building 2), with a clear construction break being evident. As noted, the shared gable wall retains a series of sockets for the timber purlins of building 3. These sockets show that the corresponding roof of building 3 was set at a lower height than the earlier building. Above this roof line, the originally-exposed section of the shared gable has been pointed with bag-rubbed lime mortar (Plate 48).

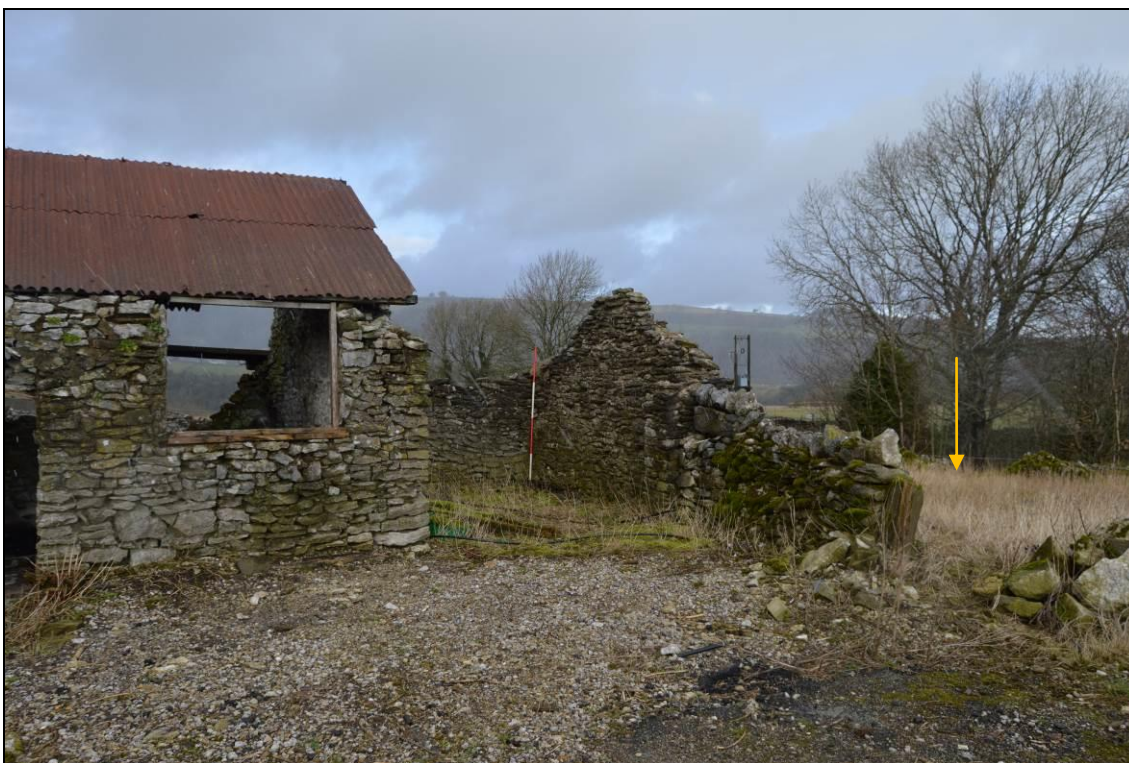
Plate 49: Building 3 and part of the enclosure wall (facing north east). To the right, the small eastern enclosure (indicated) which building 3 originally adjoined. Scale 2m.

4.5.5 According to historic mapping, the building was shown to be originally inside the small, eastern enclosure. In this case, the foldyard wall will have been rebuilt to occupy its present location (Plate 49).
