Historic Building Recording of Totley Hall Farm, Sheffield

ARS Ltd Report 2020/164

October 2020

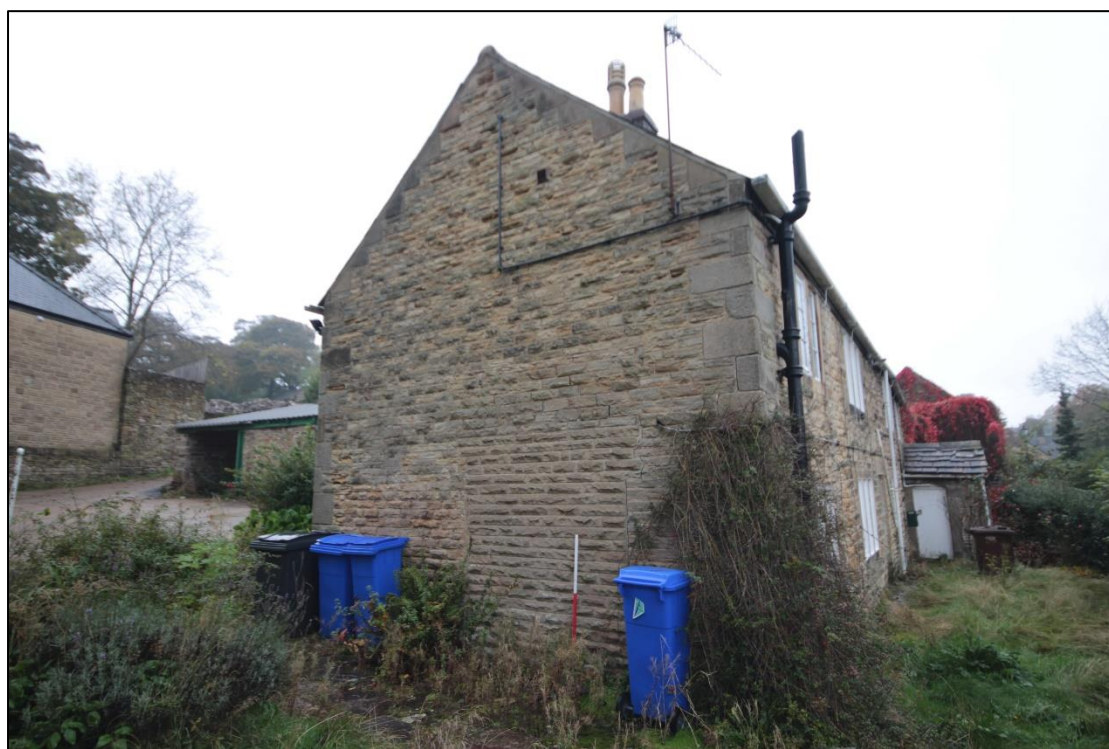
6.4 The southern gable end of the farmhouse features a blocked doorway to the centre of the façade. The ashlar quoins and dressings are prominent on each side of the southern exterior. The southern portion of the western elevation features a doorway to the utility room to the south, which is bordered with jambs featuring singular adjacent quoins and a lintel of ashlar masonry. The six-paneled timber doorway is much more modern and features overlapping wood paneling to its right. Above the doorway is a four-light timber window with transom bar, which also features jambs and a window sill of ashlar masonry. Further to the north there are two small windows featuring sills and lintels of ashlar masonry.

Plate 5: Southern gable of the farmhouse facing north-west, with 1m scale.

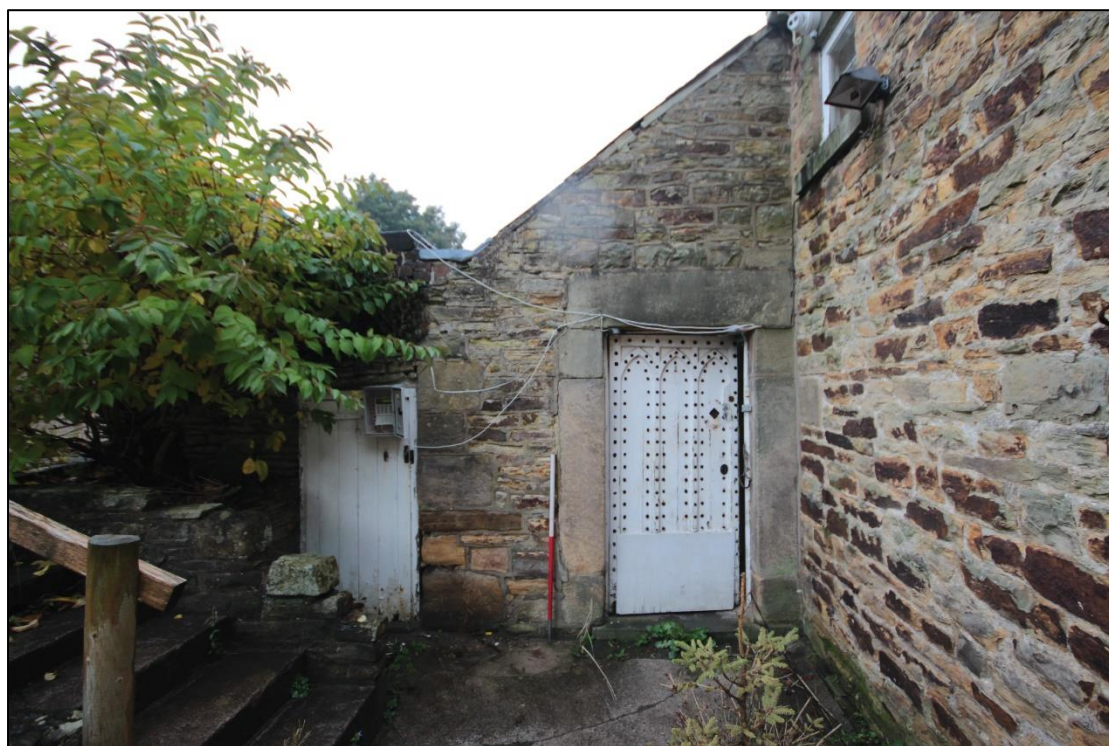
doorway is a rear entrance to the farmhouse, with jams and lintel of ashlar masonry. The door itself is timber with decorated metal studs, and features three gothic blind arches. To the west of this door there is a small doorway to an external store, which has six timber planks and features surrounding quoins and a lintel. The external store is constructed of stone rubble and features modern brick from more recent repair work. There is a large opening on the western side of the external store. The store is built into a coursed rubble stone wall. This runs parallel along the western elevation, wraps around to the northern extent of the catslide roof, continues along the remainder of the western elevation and around to the northern gable end. The ground floor of the northern extent is subterranean, with two small windows not visible. A larger, modernized window of the ground floor is visible, owing to a break in the stone wall, which features connecting metal bars. A small three-light window with internal bars features towards the centre of the northern extent. The northern gable elevation of the farmhouse has been rendered in concrete. The chimney stack, which sits on the northern edge of the gable, is constructed of modern brick in a stretcher bond.

Plate 9: View of the rear entrance to the farmhouse, featuring the decorated timber doorway. Taken facing north-west, with 1m scale.

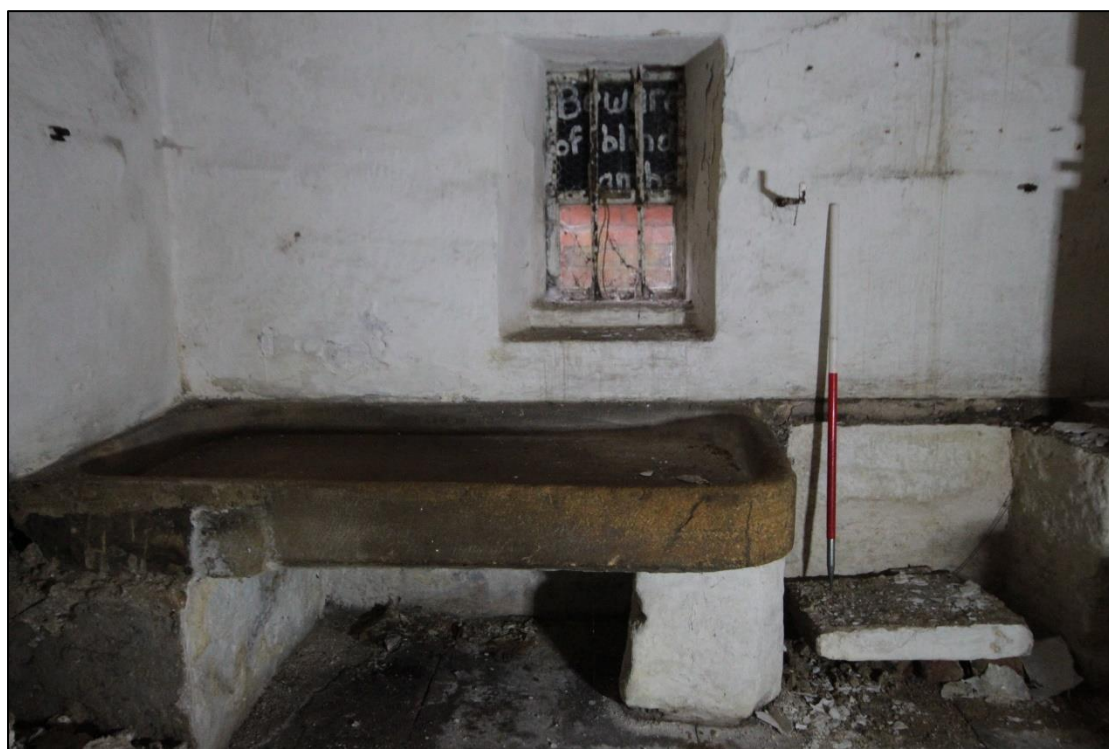
6.10 The utility room that is accessed to the north-west corner of the kitchen is part of the rear extension under the catslide roof. There is a small boarded-up window with metal bars on the northern wall, and the floor has large stone slabs, which appear to be original. Beneath the window, there is a large historic sink, constructed of stone, and resting on stone plinths. The southern wall of the rooms features stone slabs resting upon plinths, which appear to be used for salting.

Plate 25: View of the northern wall of the utility room, featuring historic sink, with 1m scale.

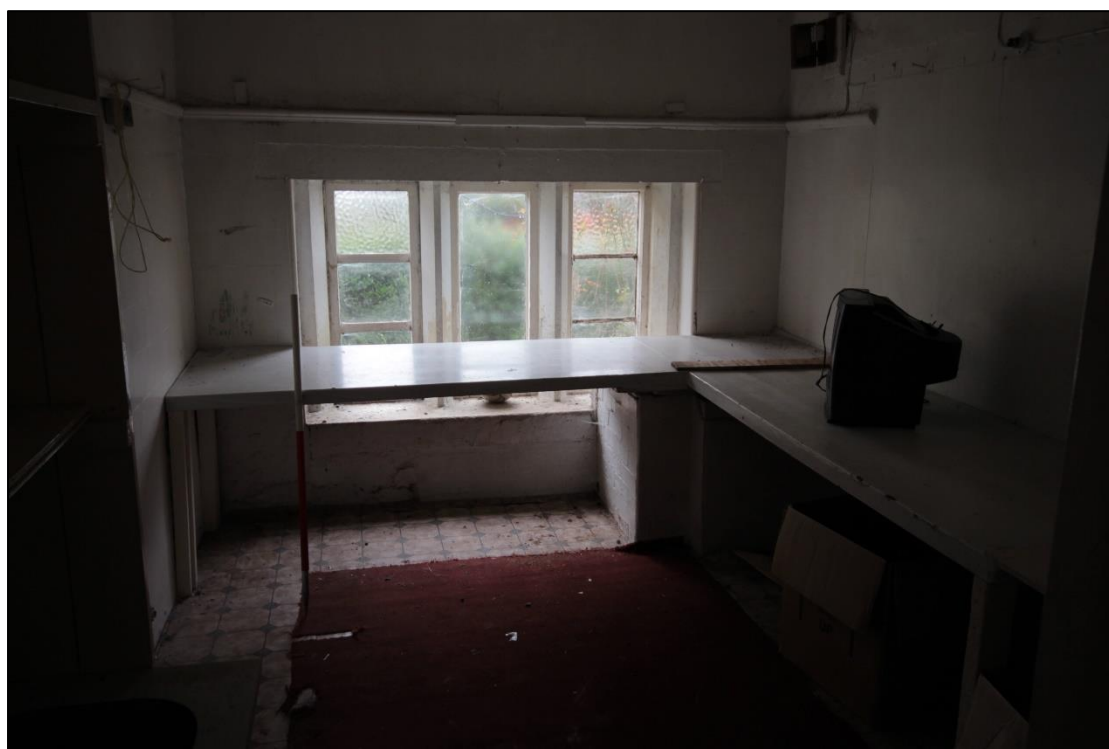
6.12 The southern-most room on the ground floor of the farmhouse is a utility room, which is only accessed via an external door on the southern extent of the western elevation. This room features a three-light mullion window on the east wall and is relatively plain in its interior. There is evidence in the fabric of a previous doorway on the south wall, and the exterior of the fabric matches this evidence.

Plate 31: View of the utility room to the south of the farmhouse, with 1m scale.

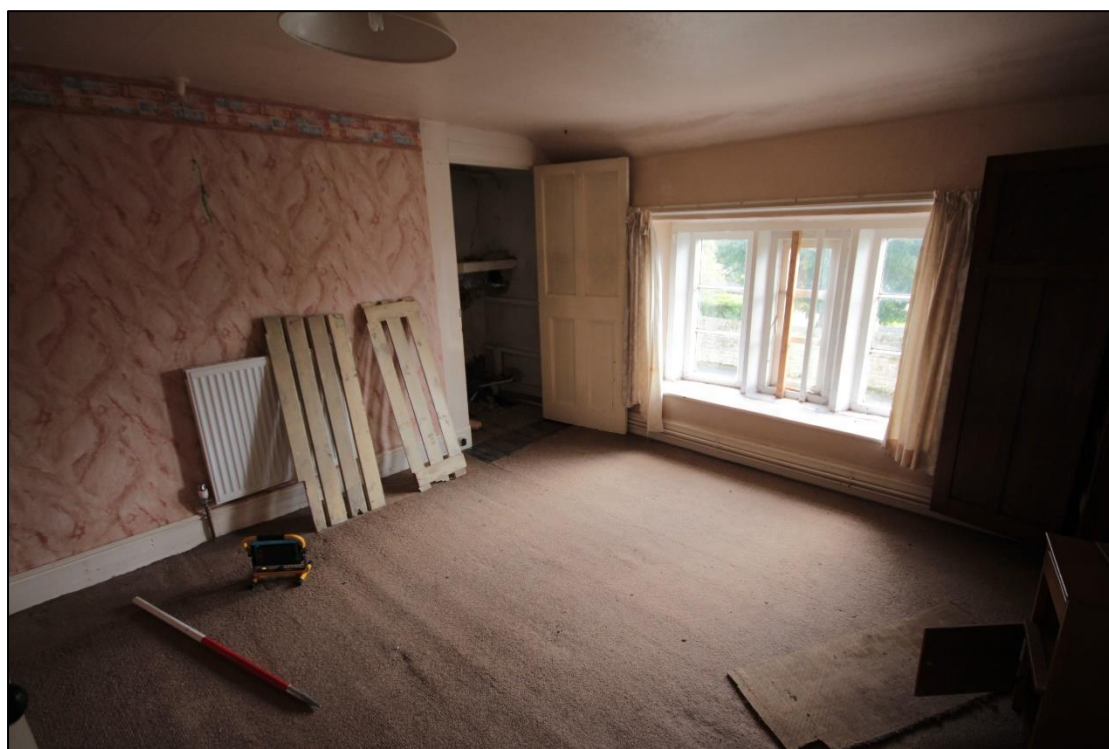
6.18 The southern-most bedroom on the first floor is accessed via a landing through the north door of the central bedroom, which passes the southern staircase. Within the bedroom, there is a three-light window on the eastern wall and a small storage cupboard built into the north wall in the north-east corner. The north wall of the bedroom features a plain timber fireplace, which has been boarded up.

Plate 46: First floor bedroom to the south of the farmhouse, taken facing north.

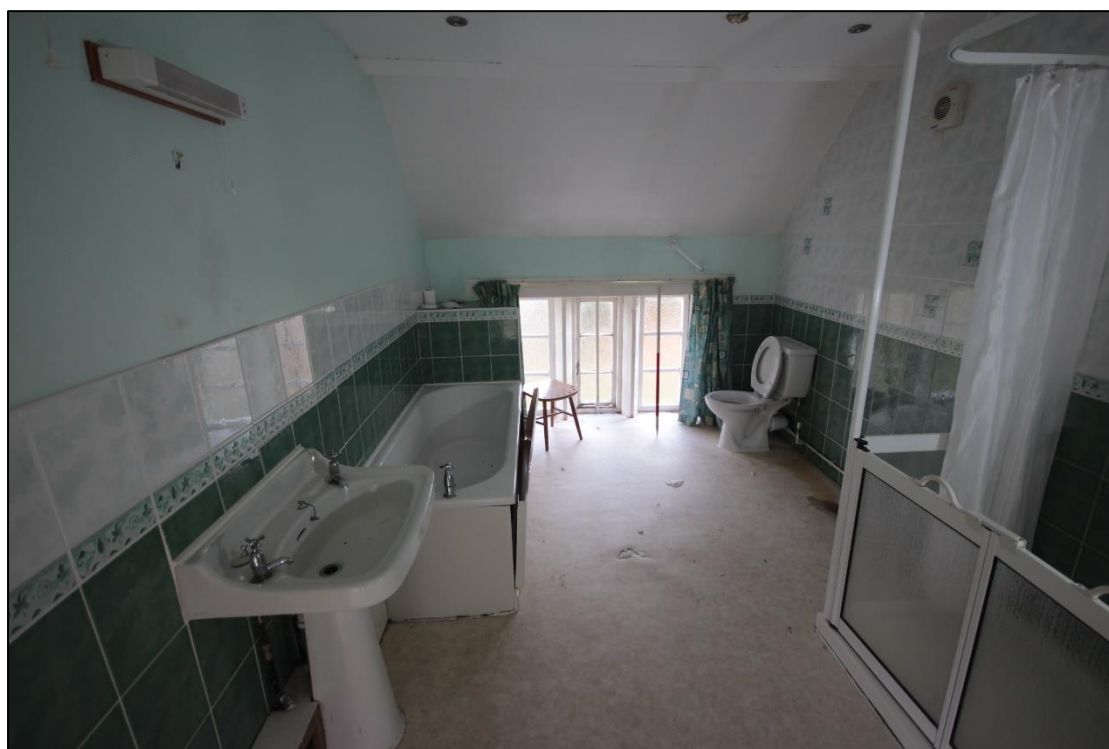
6.19 The main bathroom of the property is situated at the southern end of the farmhouse. This room is larger in height and has been built into the roof. There is a three-light window on the eastern wall and a two-light, modernized window on the western wall, both of which are at floor level. The bathroom features green and white tiles and has modern bathroom features including a toilet in the east corner, a bath in the north corner, a sink to the left of the bath and a gated shower on the north wall.

Plate 49: Main bathroom of the farmhouse, taken facing east with 1m scale.

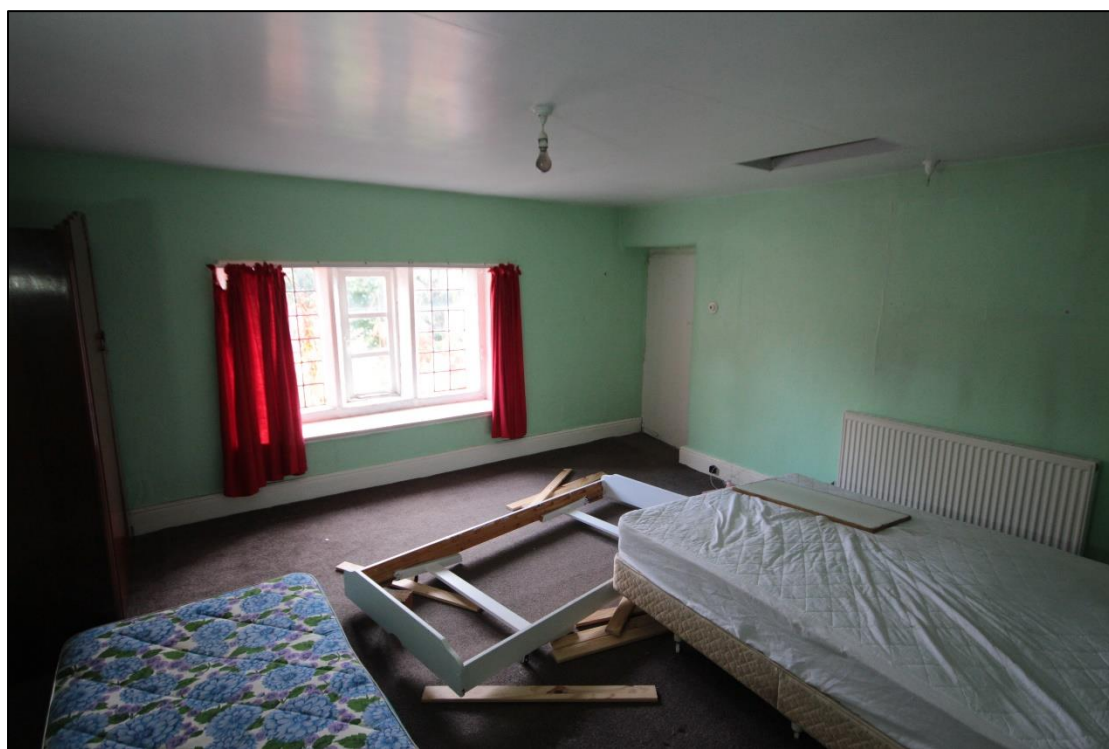
6.21 The first floor bedroom on the northern end of the farmhouse is large and has a three-light window, two of which have lead tracing. The bedroom is relatively plain, barring the fireplace on the north wall. This is constructed of timber and has surviving metal grills within the fireplace, surrounded by brick infills.

Plate 54: View of the three-light window and doorway of the northern-most bedroom of the farmhouse, taken facing east.

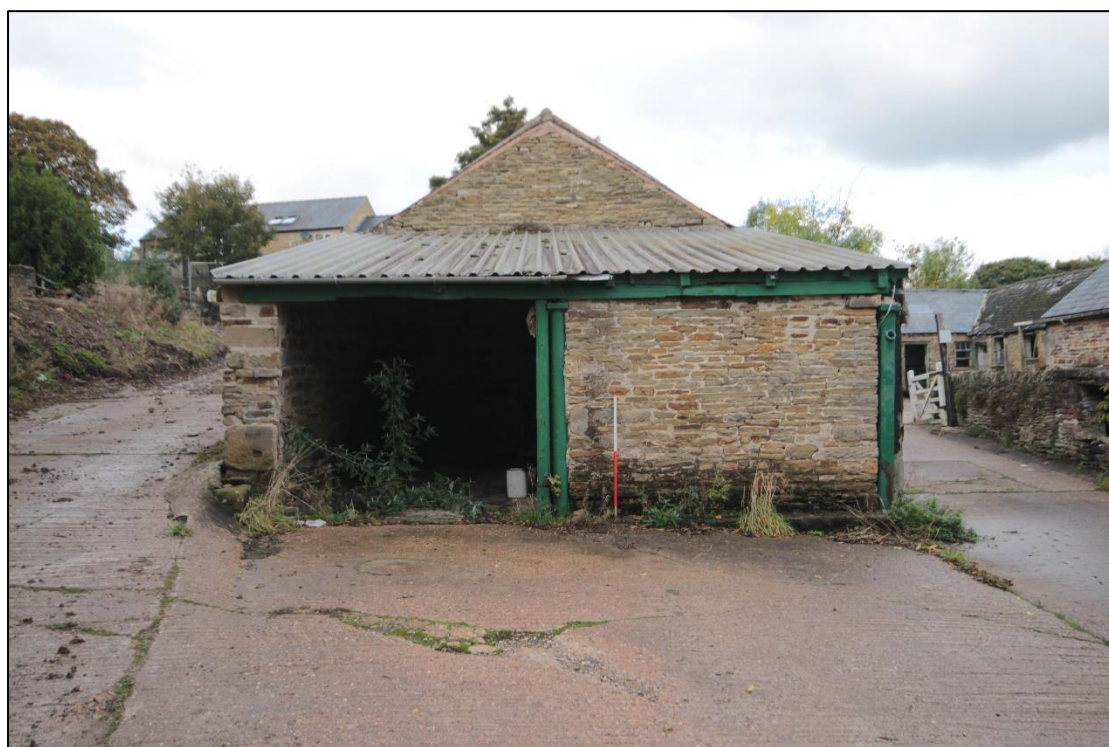
6.26 The southern-most end of the western wing is a later extension constructed of coursed rubble. It features a sloping corrugated metal roof, supported by steel columns, and its south elevation features a large opening on the left. The eastern elevation is constructed of timber paneling and features two doors. This extension appears to be present within the 1930 OS map, but it is not until the 1950 OS map that its real size is reflected.

Plate 67: View of the end south elevation within the farmyard complex, with 1m scale.

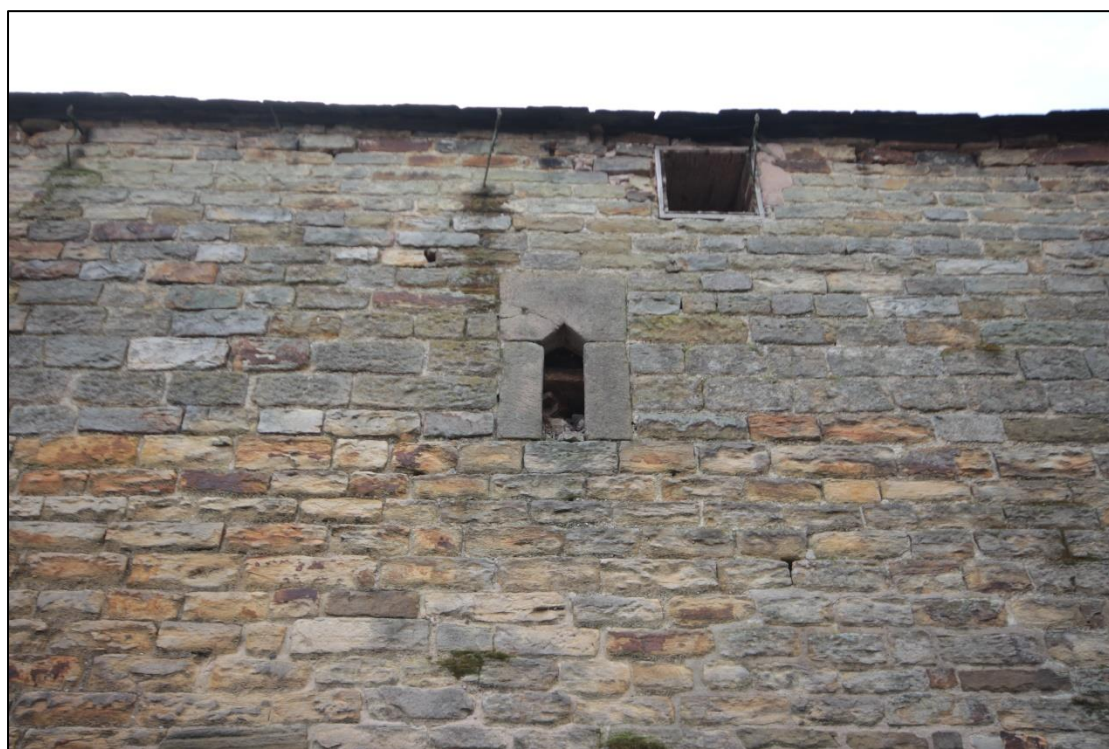
Plate 74: Ventilation slit on the internal eastern elevation of the western wing.

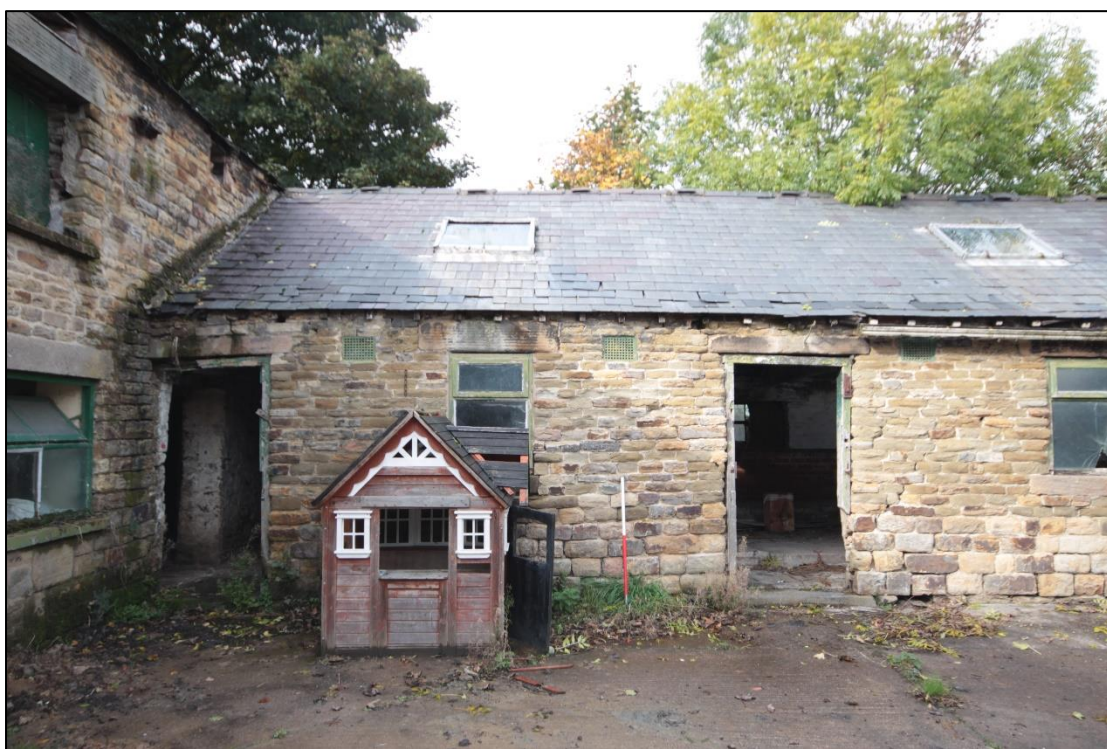
6.28 The internal south elevation of the northern wing is a single storey building, constructed of coursed sandstone. This features three timber framed door openings with stone lintels, to the left, centre and the right. The door on the left is built into the western wing and may be of a later date. There are also three small windows across the elevation, the left and centre are timber framed and appear to be of a later date. The window to the right, while in a poor state of repair, appears to have been a 9-light timber framed window with lintel and sill. There are also four ventilations grills along the length of the elevation. The roof of the building is slate, features three roof lights and has been repaired more recently.

Plate 75: View of the western end of the single storey building within the farm yard, with 1m scale.

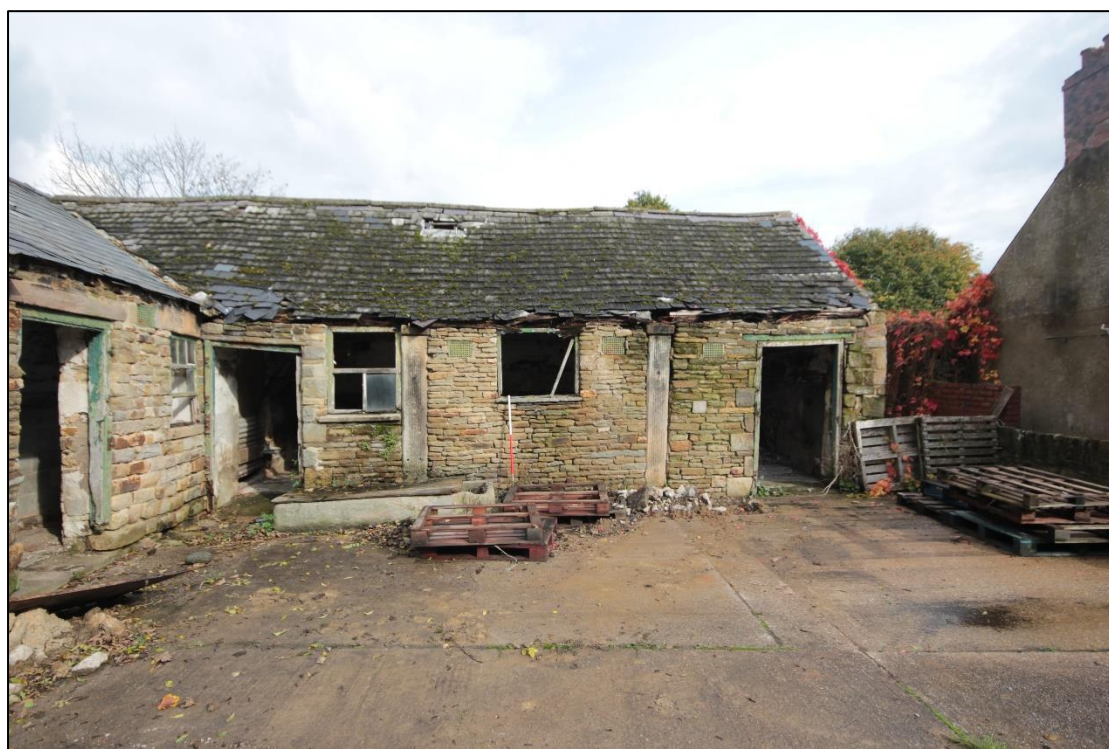
6.29 The east internal elevation of the farmyard complex of buildings is single storey and connects with the northern wing. The fabric is enlightening as to the former use of this building. There is a central timber framed window opening, flanked by two sandstone pillars. These pillars highlight that this building was likely used as a shelter shed for cattle, with the central area open. This has now been blocked with sandstone. To the left and right of these pillars there are two timber framed doorways and the left also features a timber framed window with stone sill. Quoins are visible from the insides of these doors, indicating that the building had formerly been smaller and had been extended outwards at each side. Historic mapping prior to the 1950s OS map indicates that the eastern corner of the building had been smaller and this was extended to the current scale after the 1930s. The south elevation of the east wing is gabled and this is built into the outer wall. The area in between the farmhouse and the east wing contains a deep vat of water.

Plate 78: The internal west elevation of the farmyard complex of buildings, featuring plinths from previous shelter shed, with 1m scale.

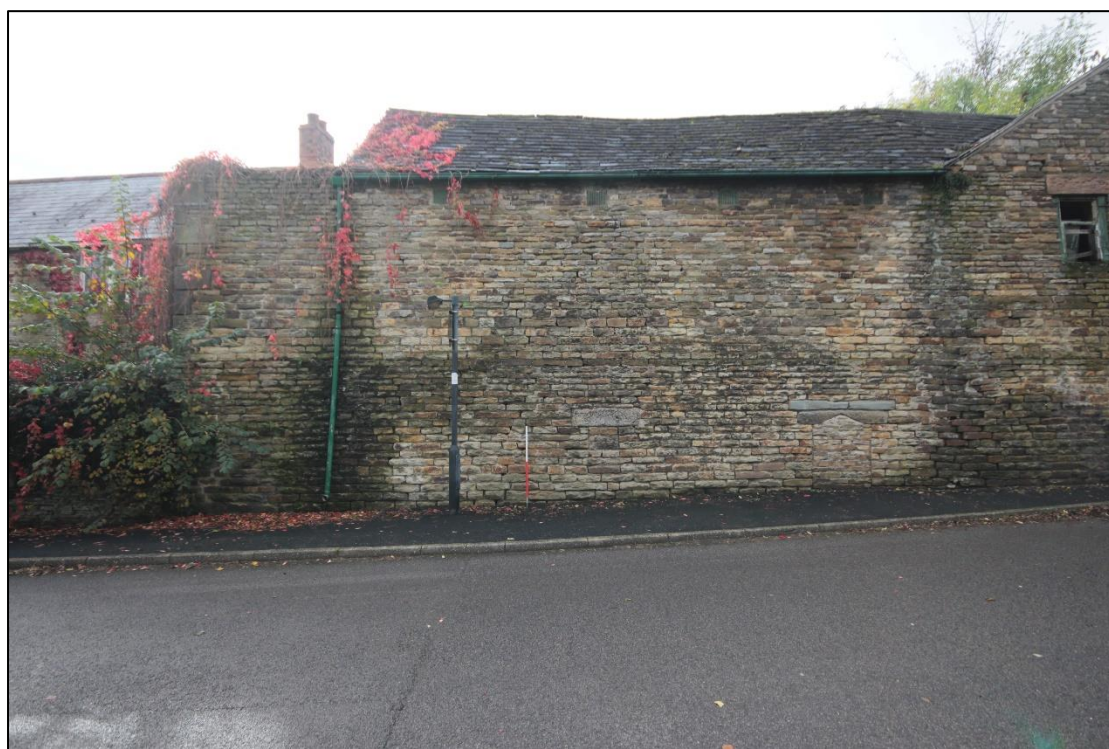
6.30 The western elevation of the farmyard complex of buildings viewed from Totley Hall Lane features a wall connecting the buildings to the farmhouse to the left, and has large ashlar quoins. The central portion of this elevation relates to the eastern wing. The ground floor of this features two blocked openings, with lintels, which may have been used as drainage. To the right, there is the gable end of the northern building wing, and this contains ashlar quoins connecting to a garden wall to the right and a small two-light timber framed window with ashlar lintel. Across the length of the elevation there is a long line in the fabric, which may indicate that the building extended outwards towards the road at this level, but this is unclear.

Plate 80: Totley Hall Lane view of the east elevation from the farmyard complex of buildings, with 1m scale.

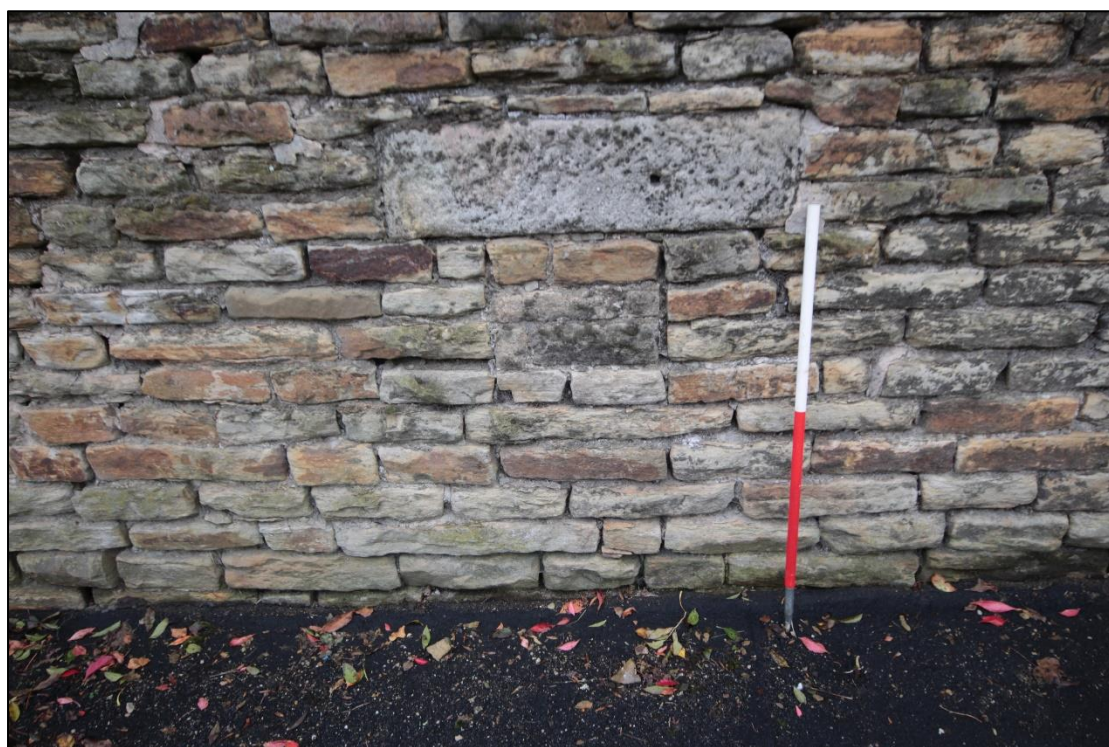
Plate 83: Blocked opening with lintel on the east elevation of the farmyard complex of buildings, with 1m scale.

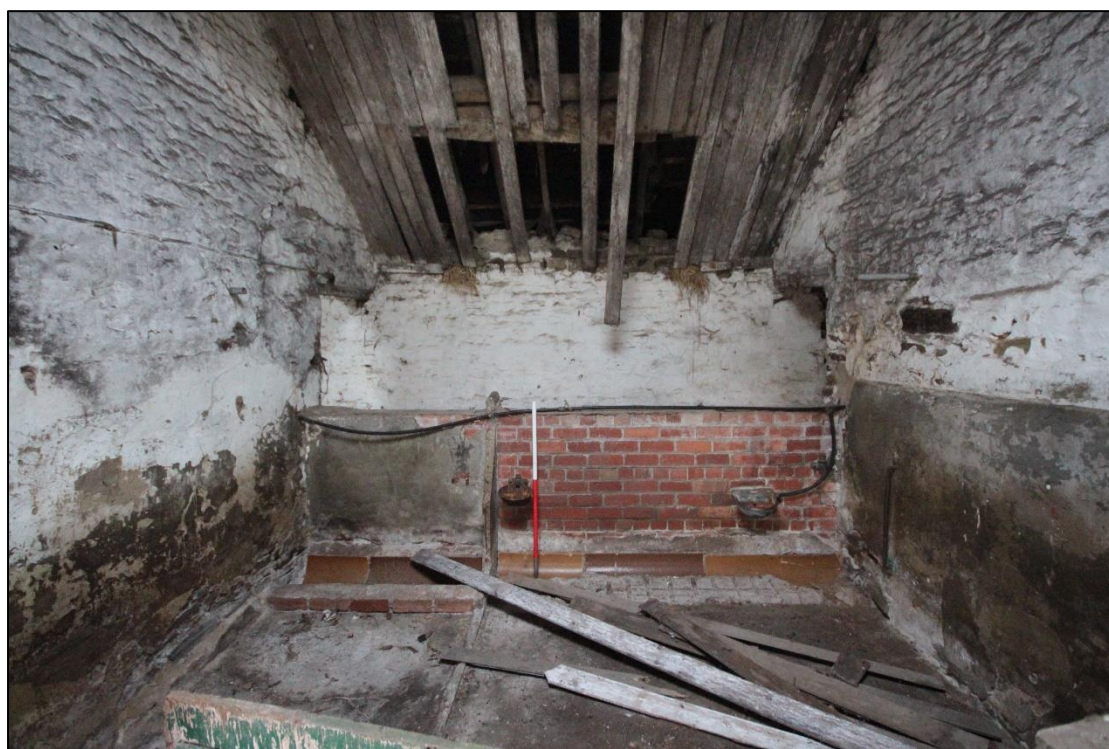
6.33 The area to the west is flanked by the corridors to the north and south, and two internal walls to the east and west. This is a gated area with a low concrete moulded wall, featuring a timber gate and a low brick-built wall to the north. The area features a metal cow tie, connected water feeders and ceramic trough. There is evidence of the previous concrete partition, but this has been removed. The floor has also been covered in concrete and, in some areas, there is the evidence of scratched concrete, which would have helped with the grip for the cattle.

Plate 93: Small area with low brick wall, ceramic trough within the northern wing, with 1m scale.

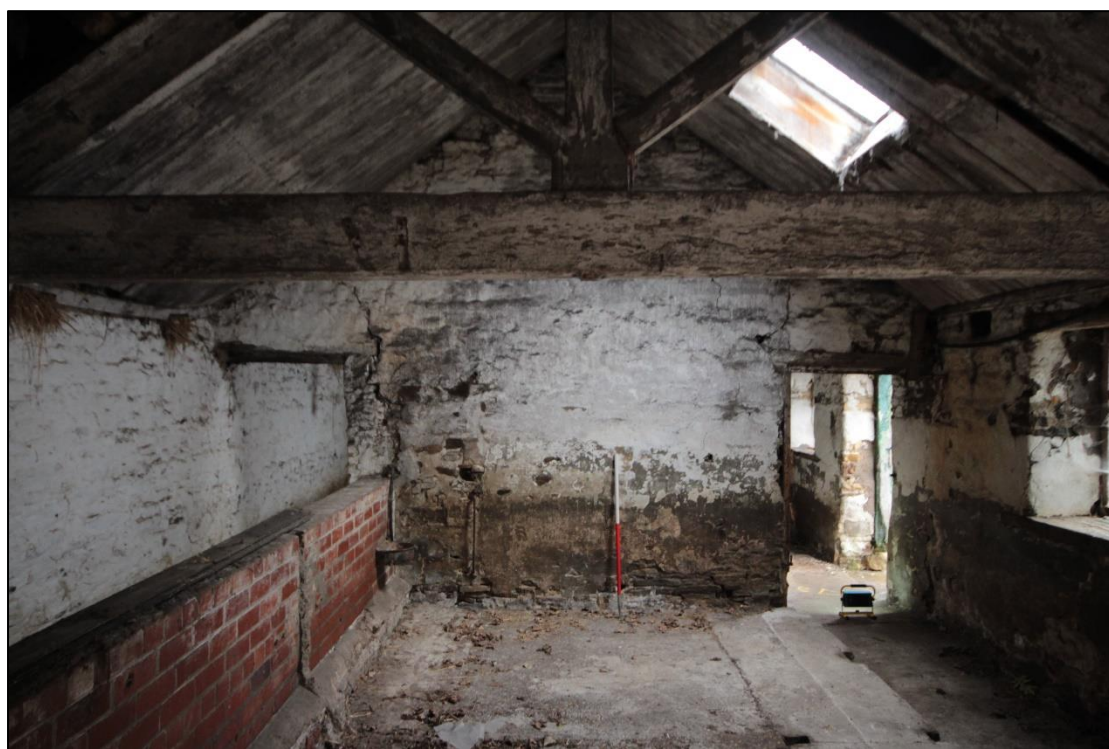
6.34 The central area within the northern wing is the largest and was used as the main cow house. This features a low brick-built wall, which has evidence of the previous concrete partitions. The floor is of concrete and has a drainage channel to the south. There is a connected water feeder and a metal cow tie, and evidence in the fabric that more of these once existed. The northern wall features a timber door and a small window. The roof features timber paneling and framing with king posts, as well as roof lights to the south. The northern aisle connects with the east and western ends of the northern wing.

Plate 96: View of the north-east wall within the large central area of the northern wing, with 1m scale.

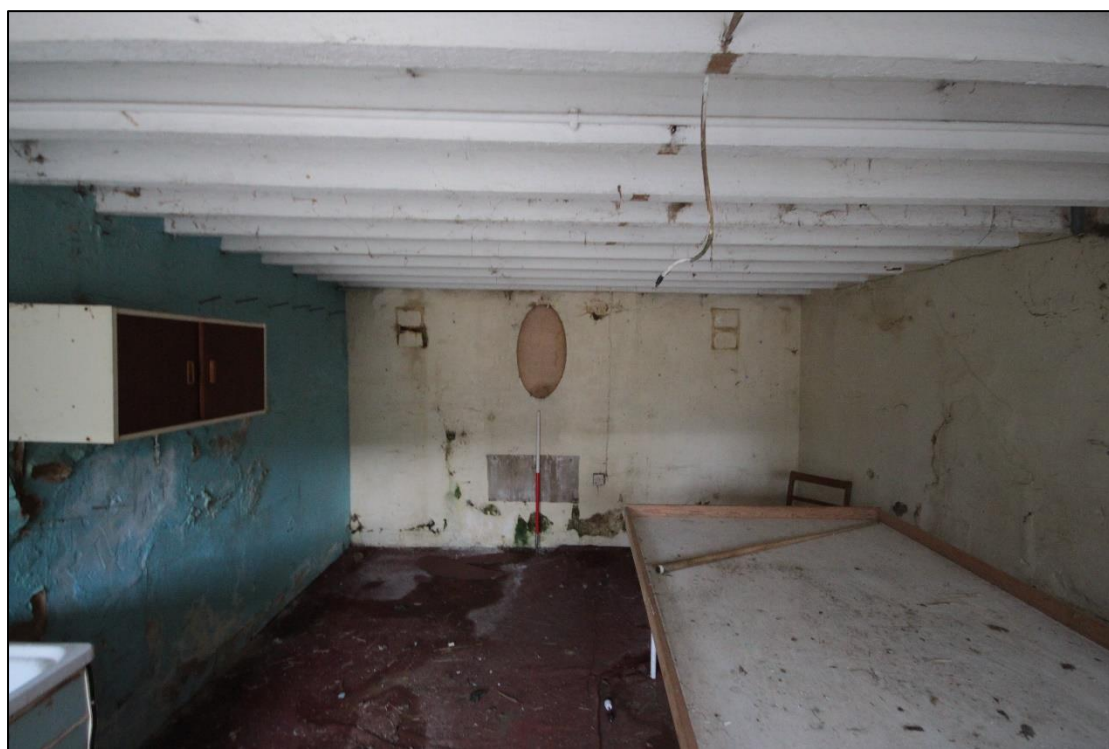
6.36 The interior of the main western wing of buildings has three main rooms. The two to the north-west have low roofs and are relatively plain in their interior. Each feature a four-light timber framed window and timber framed door. Within the central room there is evidence in the fabric of a previous door, which would have connected to the cow house to the south-east. This cow house has a low roof with large steel support beams. The concrete in this area is moulded and appears to be of more recent construction. There are three concrete partitions on a raised concrete platform, with a drainage channel to the east. Within the concrete partitions, there are ceramic troughs and metal cow ties.

Plate 107: View of the western wall of the plain northern room within the western wing, with 1m scale.
