**An Archaeological Watching Brief At
Balmoral Hotel, Worley Street, Westgate
Road, Newcastle**

Archaeological Research Services Ltd Report 2008/39
April 2008

An Archaeological Watching Brief at Balmoral Hotel, Worley Street, Westgate Road, Newcastle

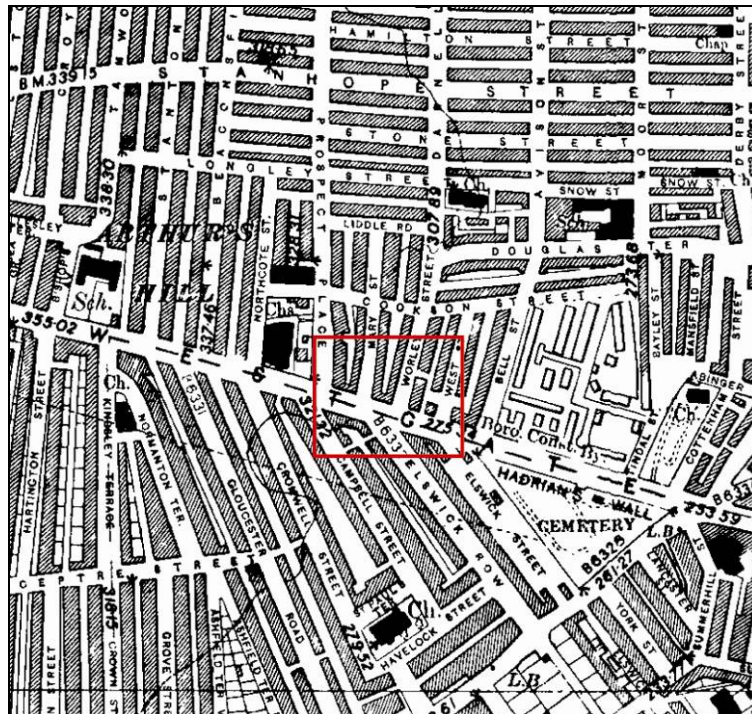
Fig. 4 1949 map showing housing on the study area

During the 19th century the area was developed intensively to house the increasing population of Newcastle. Terraced houses were built on and around the study area that existed until around 1970 when the area was cleared and the Balmoral Hotel (which now occupies the site) was constructed.

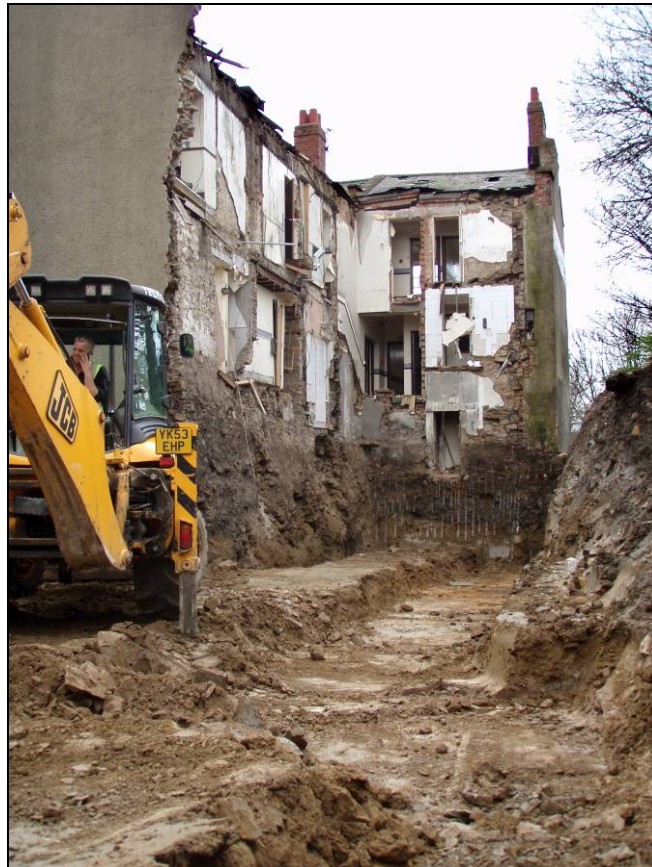
Fig. 5 Rear of the Balmoral hotel showing demolition and depth of excavation.

- 4.1. The demolition to the rear of the Balmoral hotel was undertaken before the excavation phase took place. Once the building was secure the earth was removed from the entire site down to a level 2m below the top of the slope (fig. 5).

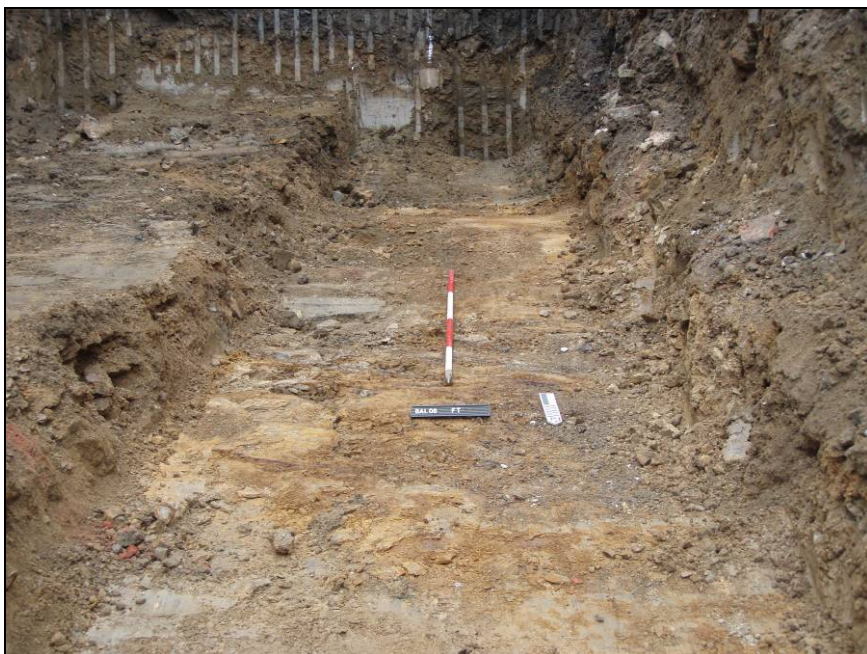
Fig. 6 Part of the foundation trench showing bedrock at the southwest side of the study area.

- 4.2 Topsoil existed to a 1m depth around the site, being replaced by orange silty/sandy natural clay which contained sandstone. The foundation trench (fig. 3) around the site was excavated to around 2.5m below the original surface (fig. 6), which was .50m below the already lowered ground. The ground was excavated until the natural bedrock was located (fig. 7). At the north side of the site there is evidence of modern made ground. Building rubble, bricks, tarmac and concrete exist to a depth of 1.5m (Fig. 8).

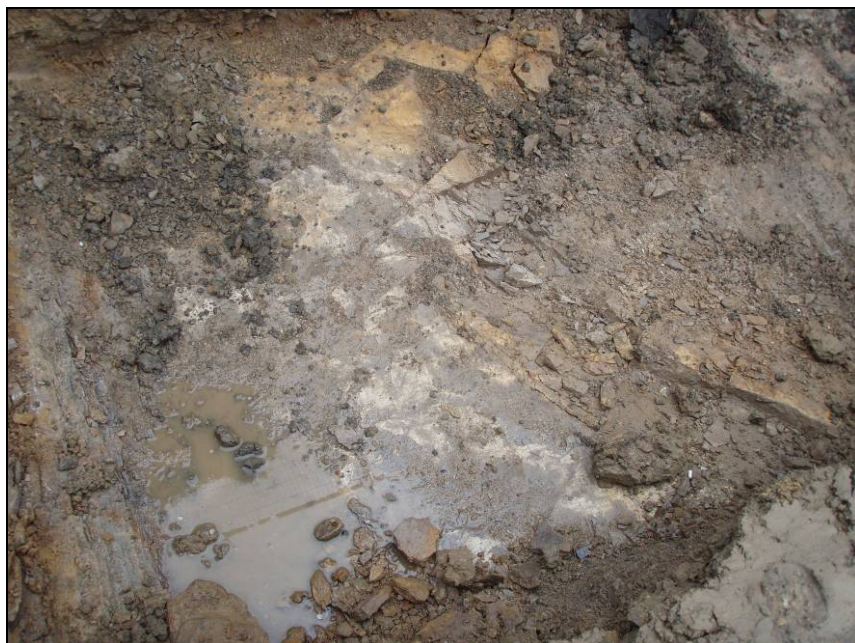
Fig. 7 Sandstone bedrock in the north section of the study area.

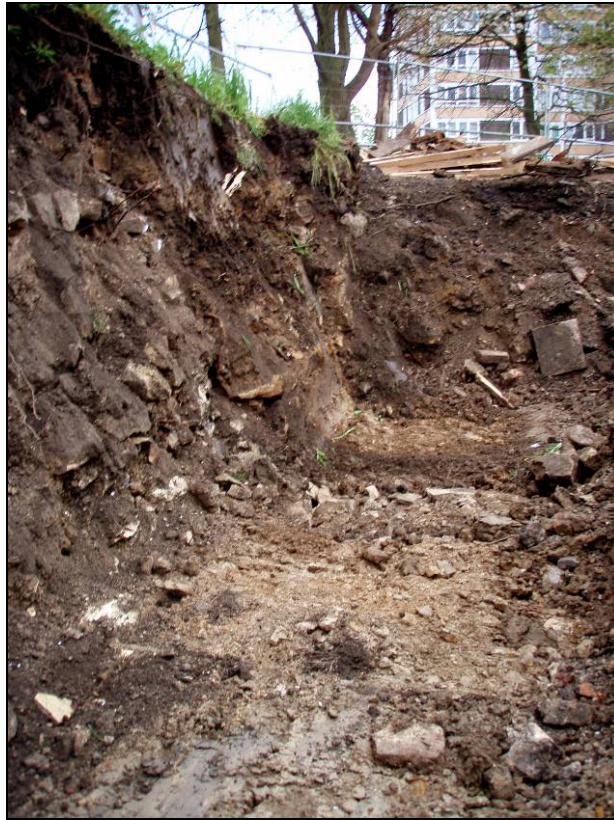
Fig. 8 North edge of site showing building debris in topsoil.

- 5.1 No archaeological remains were encountered during the excavation of the foundation trench. The only deposit encountered was that of the building debris at the north side of the study area, this is most certainly the backfill from the demolition of the houses which occupied the site up until the 1970s and their construction and consequent demolition may account for the lack of any archaeological evidence.
