Archaeological Building Appraisal at Birchover Quarry, Derbyshire.

East elevation of redundant shed at Birchover Quarry

ARS Ltd Report 2009/36

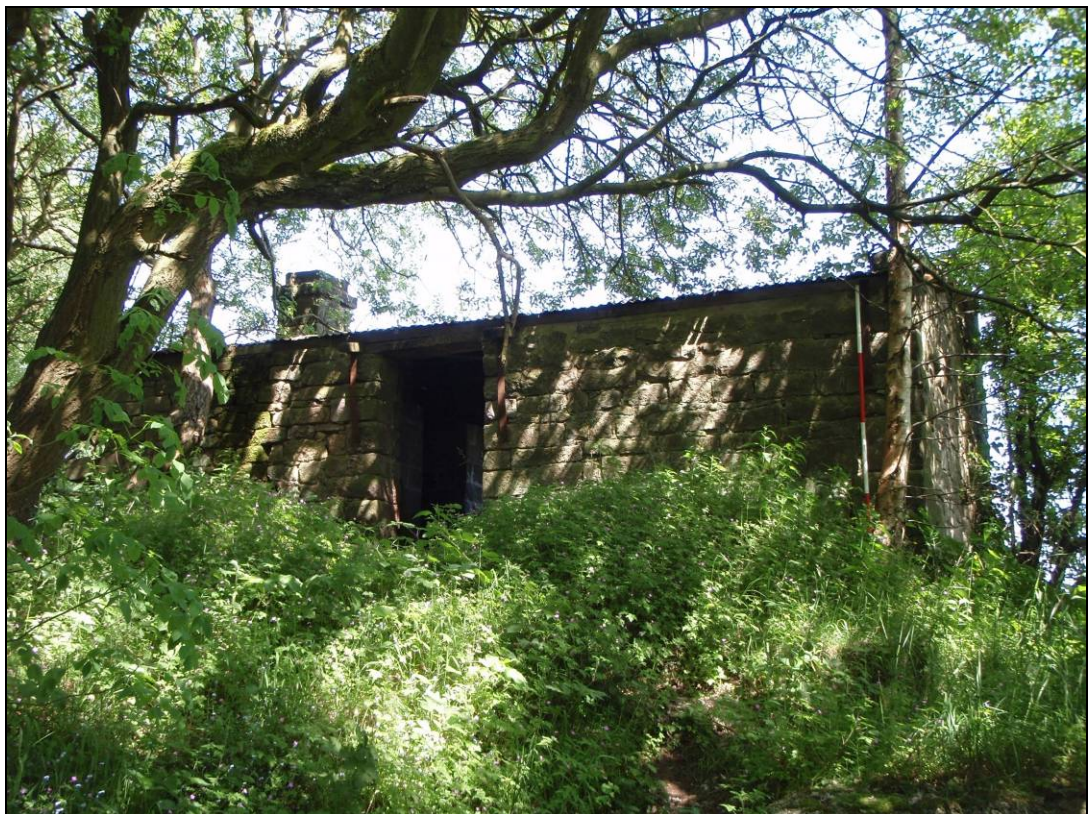
Figure 3: West elevation

The west elevation has a central doorway (1.9 m height x 1 m wide) with a stone lintel and flanked by two iron braces attached to the wall and two projecting timber purlins which would have supported a canopy (Fig. 3). There is no sign of guttering.

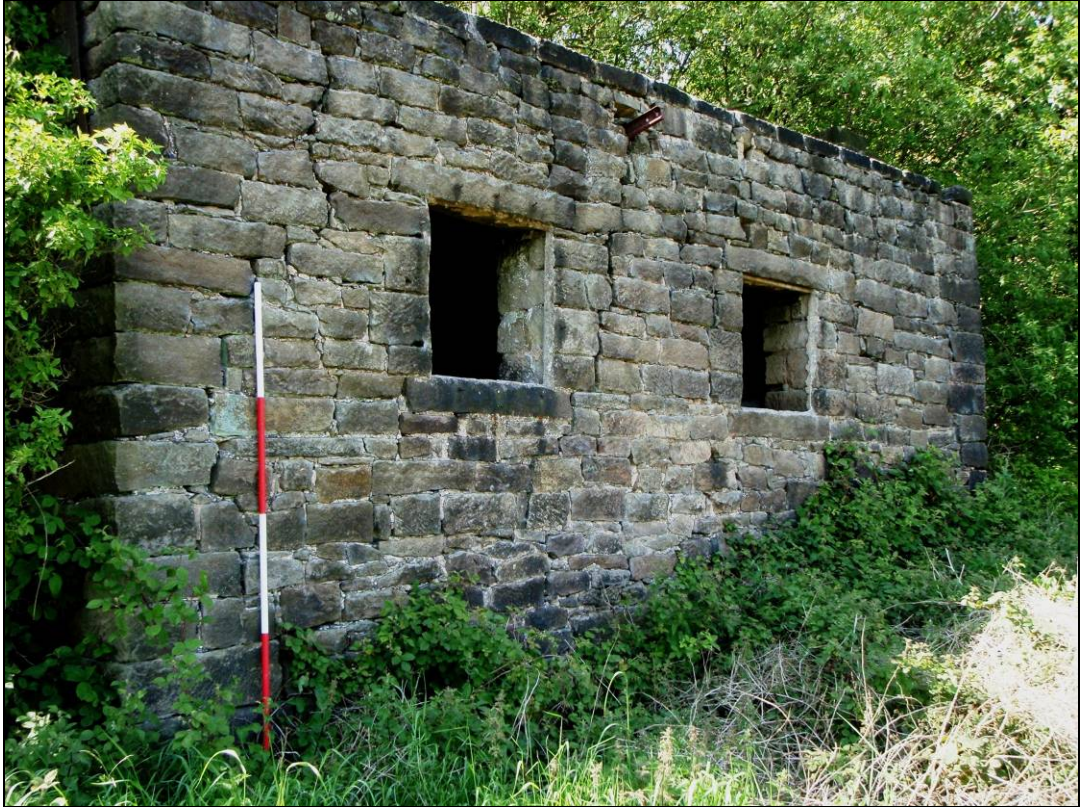
Figure 4: East elevation

The east elevation has two window openings with flush stone lintel and sill (Fig. 4). The roof coping is also flush with the wall. There is a later small opening from which an iron rail projects out slightly. There are several fractures in the stonework on this elevation.

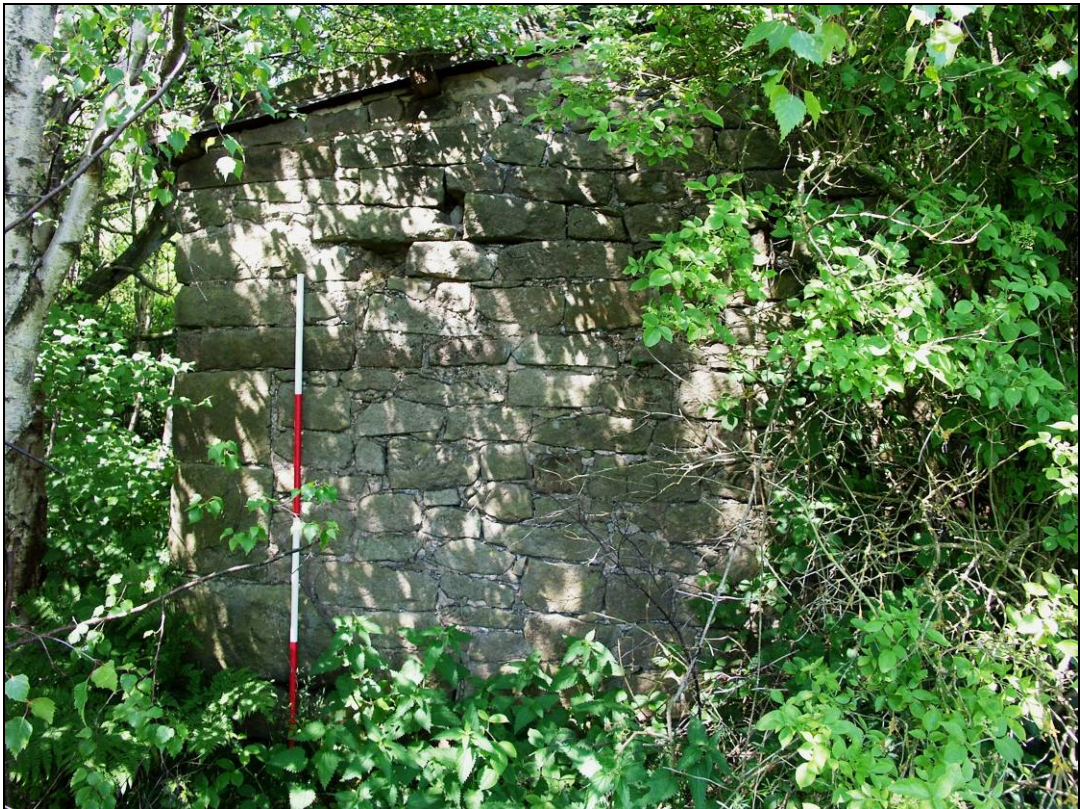
Figure 5: South elevation

The south elevation is composed of smaller and fairly irregular rubble with quoins on the east and west edges (Fig. 5). The corrugated sheeting roof and two supporting timber purlins project out slightly from the wall. The stone coping is laid over the metal sheeting.

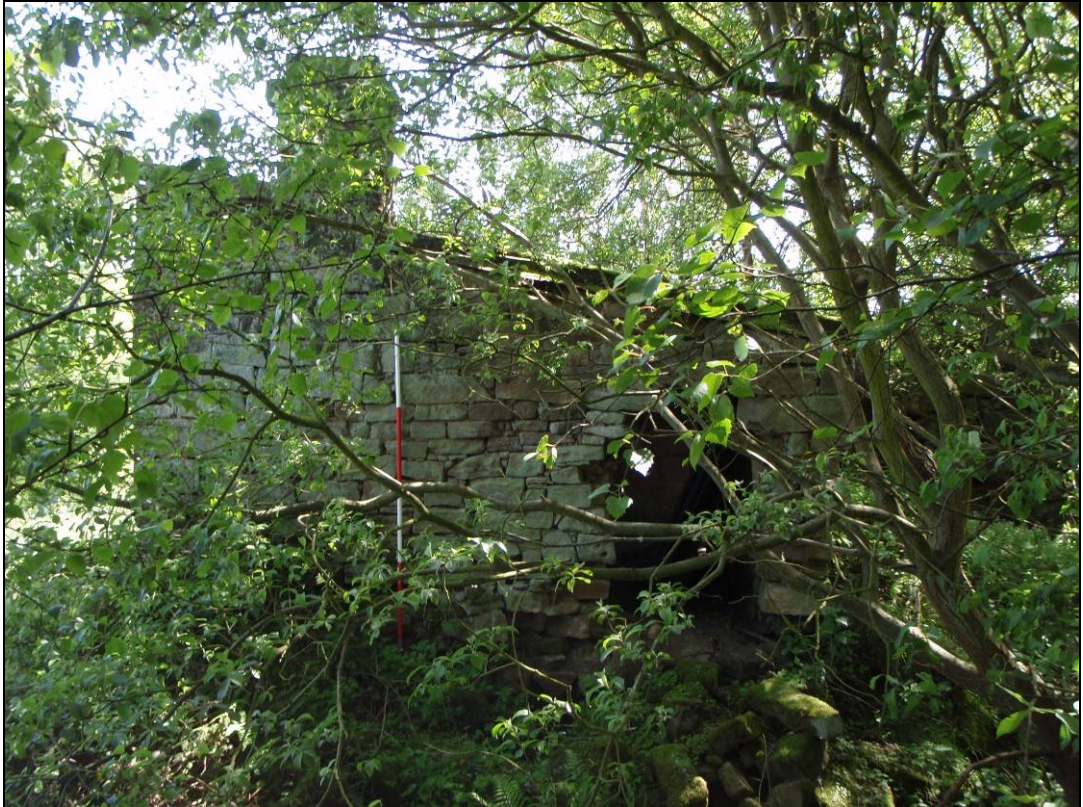
Figure 6: North elevation

The north elevation is similar to the south wall but a large area on the western side of the wall has been knocked down, creating a substantial opening (Fig. 6). There is a well-preserved chimney stack which projects upright from the roof on the eastern side of the wall (Fig. 7).

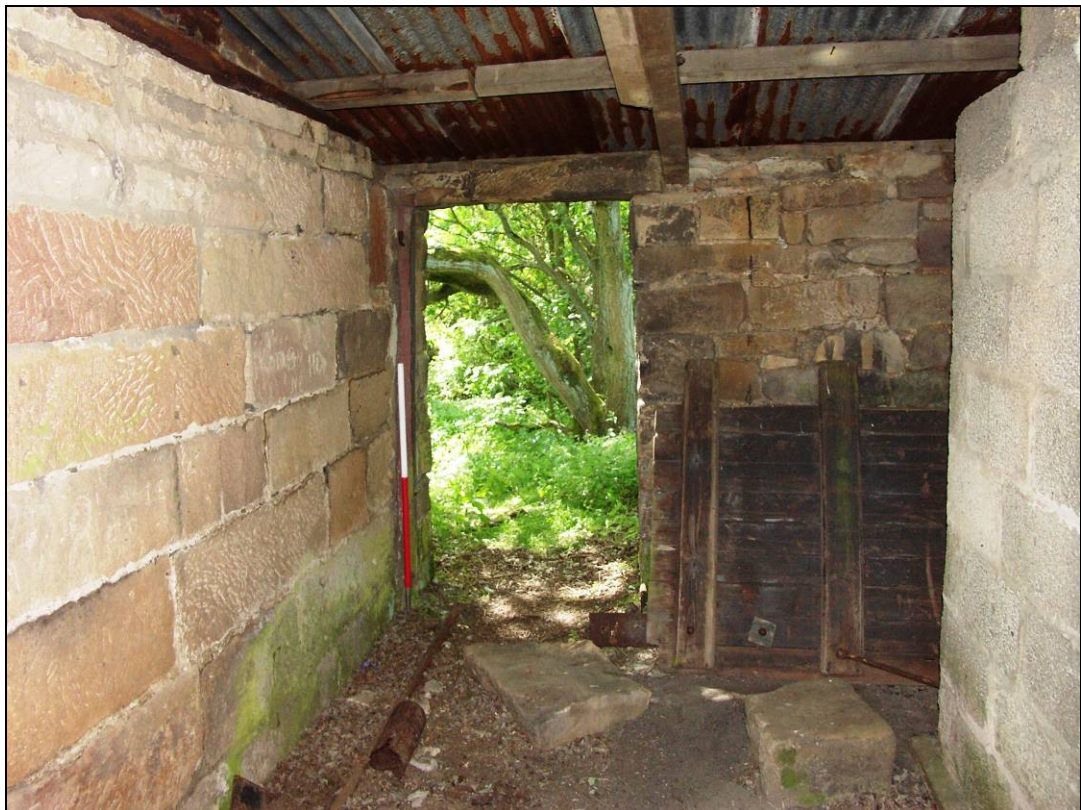
Figure 8: Central hallway (looking west)

In the central hallway there is an iron pipe at ground level which runs across the entire building and projects out to the eastern side of the building. The doorway has the remnants of a timber door frame. The original wooden door lies on the floor next to the entrance (Fig. 8).

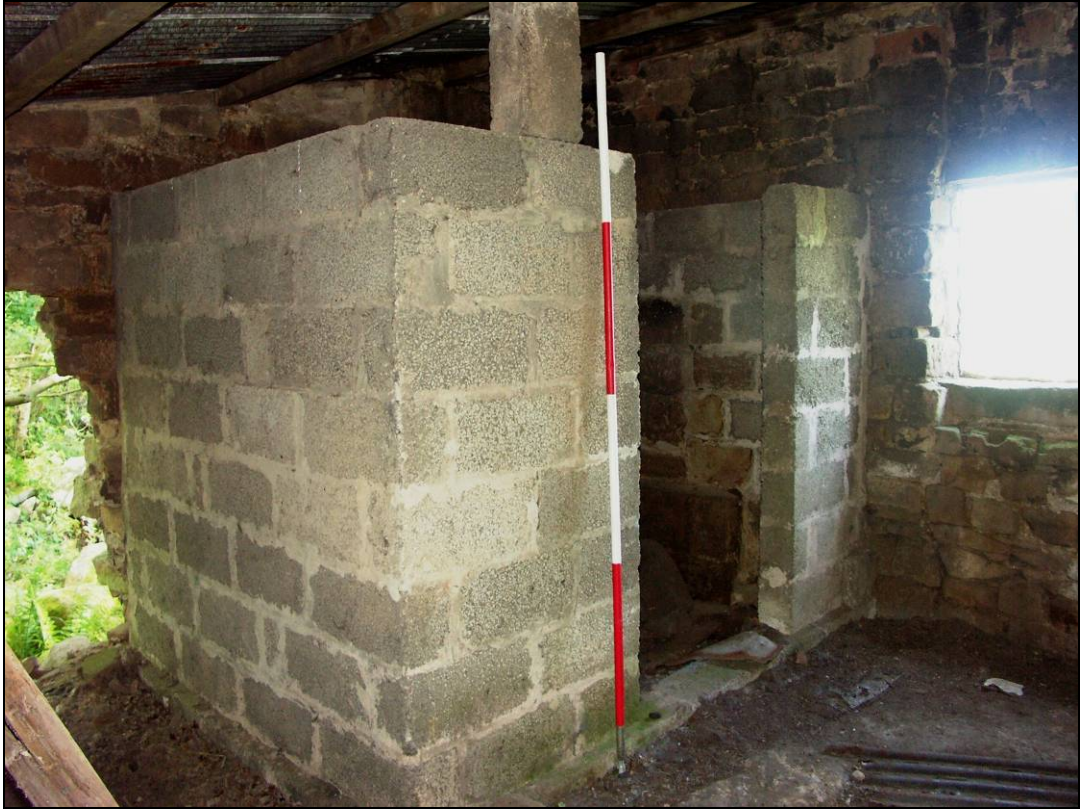
Figure 9: Northern room (looking north-east)

The northern room is a small sub-division made of breeze blocks which measures c. 1.3 metres high and thus does not extend to the ceiling height (Fig. 9). The northern end is built against the main wall which would have involved dismantling the internal masonry structure of the chimney.

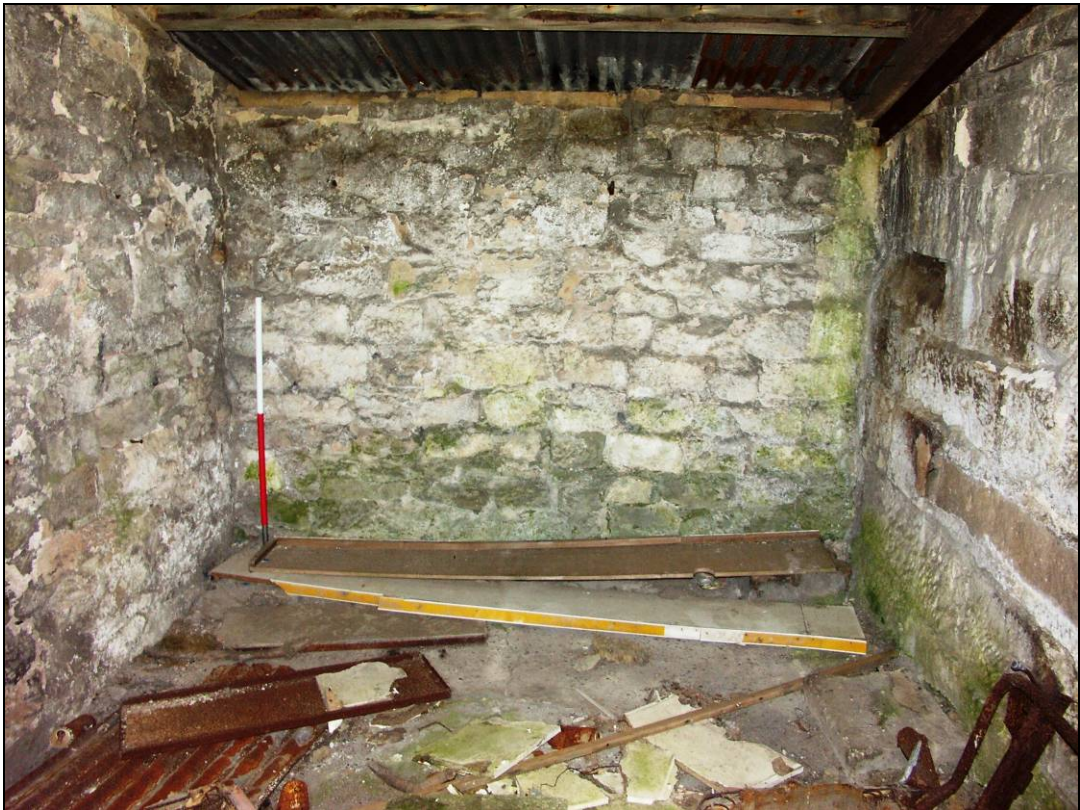
Figure 10: Inside the southern room (looking west)

The southern room has a partition wall made of gritstone with a doorway on the eastern end. The interior walls are partially coated with lime wash (Fig. 10). The room has a central concrete platform and above it and there is a small circular hole on the roof. The platform might have been the base for a burner and the hole would have allowed a smoke pipe to project beyond the roof. This room has a great deal of debris including decayed car seats, blankets, cans, etc. These remains may suggest that the building was occupied by squatters in fairly recent times.

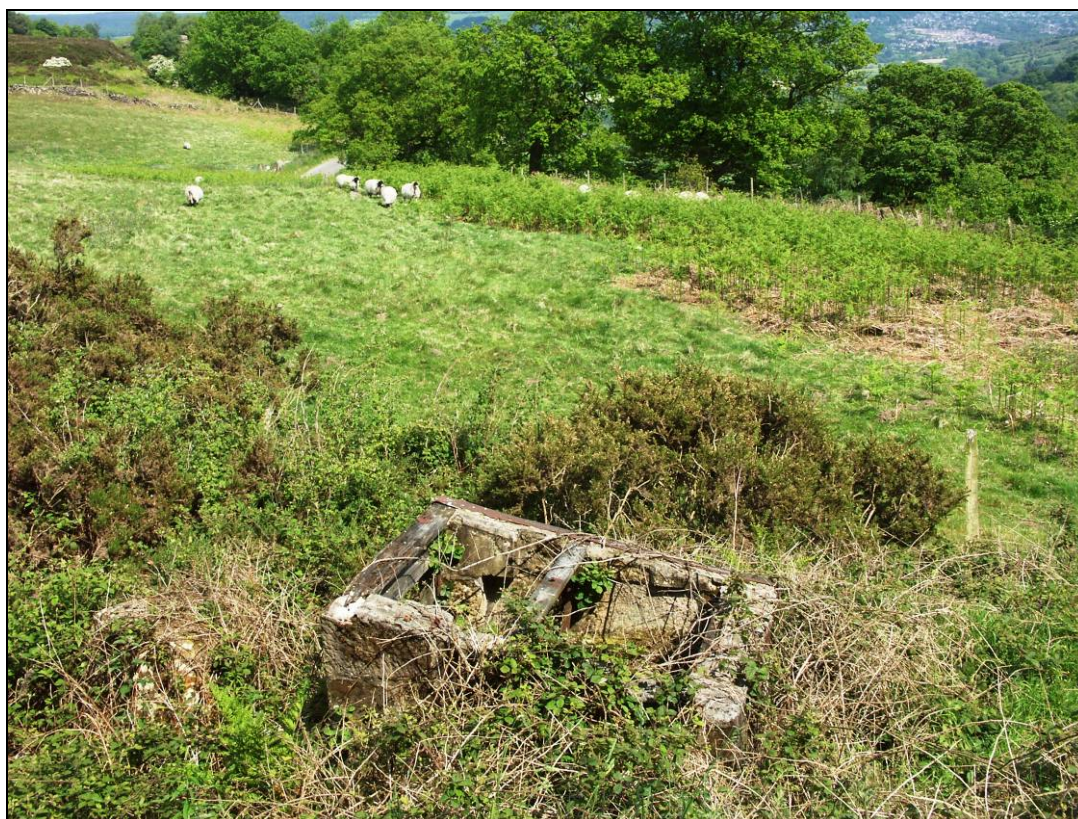
Figure 11: Toilet block beyond the north-east corner of the main building

There is a small structure situated 5.1 metres east of the north-east corner of the redundant building which seems to be a toilet block (Fig. 11). Access was restricted due to a large amount of vegetation within the outbuilding, however it was possible to record basic elements. The structure is made of the same fabric and architectural style as the main building. The roof and door no longer exist. It measures 1.9 metres long (north/south), 1.4 metres wide (east/west) and the interior is 1.8 metres high.
