## A Contour Survey and Archaeological Evaluation of Birchover Quarry, Matlock.

**ARS Ltd Report 2007/73**  
June 2008

# A Contour Survey and Archaeological Evaluation of Birchover Quarry, Matlock.

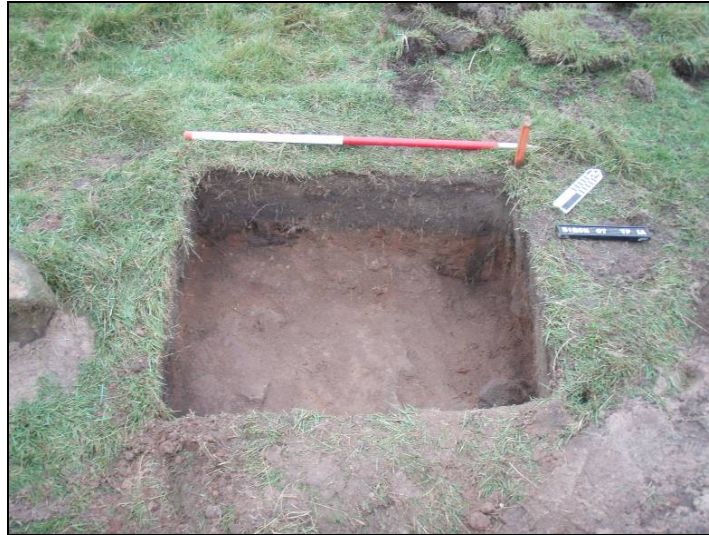
- 3.2.2 The stratigraphy of the test pits did not vary significantly. The topsoil was mainly a fine, mid brown (10YR 4/3) sandy soil with a maximum thickness of 0.5m at the south of the site where it was deepest. The topsoil had sandstone inclusions throughout. The subsoil consisted of a mixture of the natural sand (004) and the topsoil (001) and had a maximum thickness of 0.1m. The natural alluvium consisted of a fine, brown mottled (7.5YR 4/6) sand (003) that had large sandstone blocks within it (Fig. 5), and an orange sand (5YR 5/8) that was compacted with sandstone inclusions (004) (Fig. 6). Both contexts (003) and (004) were found across the site.

Fig. 5 Test Pit 01, looking north west. (Scale: 1m).

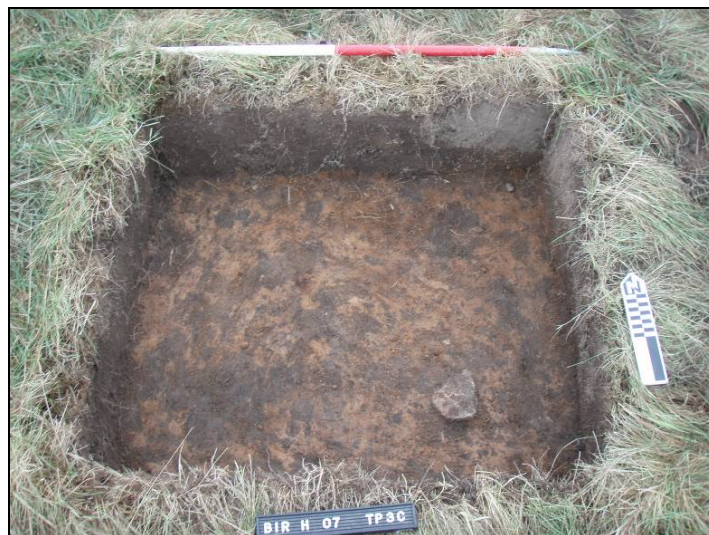
Fig. 6 Test Pit 3C, looking north. (Scale: 1m).

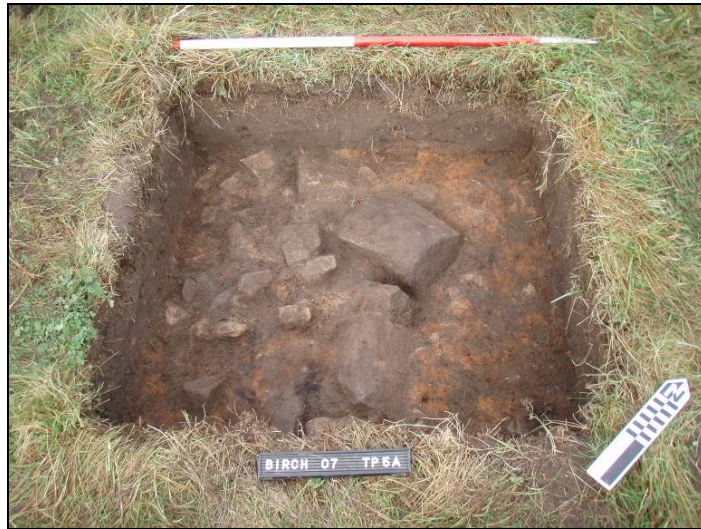
- 3.2.3 The test pit bases varied from being level with no sandstone inclusions to being uneven and predominately made up of large to medium sized sandstone blocks (Figs. 7 and 8). The natural deposits in the pits that contained sandstone blocks had often become discoloured from the stones causing dark patches within it.

Fig. 7 Test Pit 5A showing the uneven sandstone base, looking north west.  
(Scale: 1m).

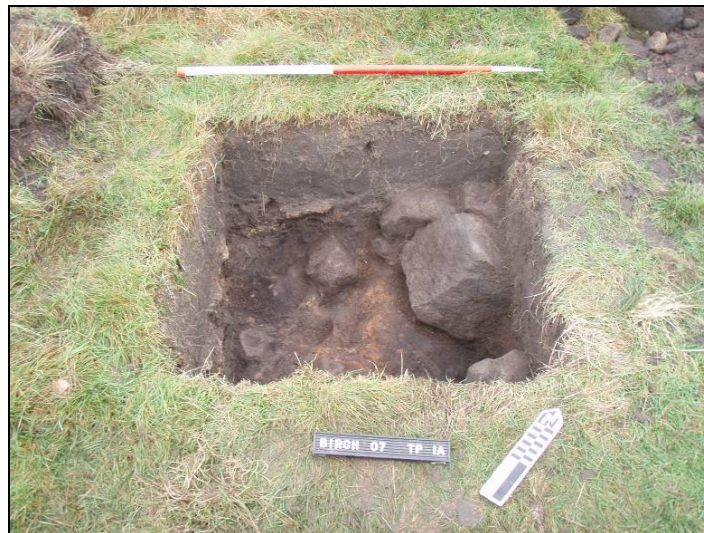
Fig. 8 Test Pit 1A showing the size of the sandstone blocks, looking north west.  
(Scale: 1m).

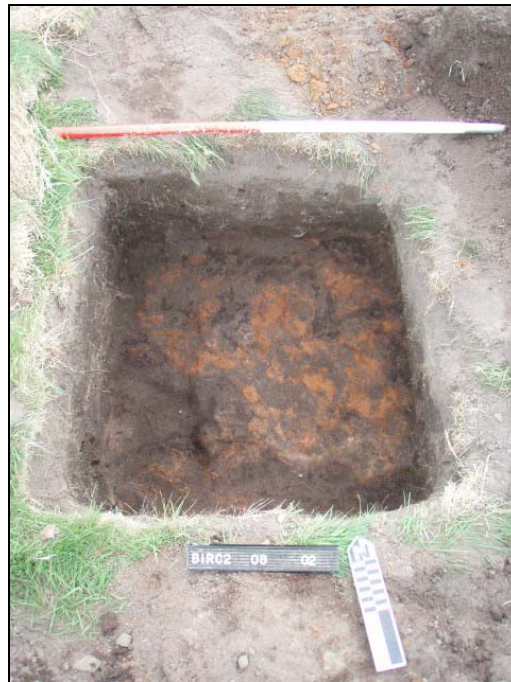
- 6.1 The stratigraphy of the ten test pits was consistent with the results obtained in Phase One. Below the turf the topsoil (001) was mainly a fine, mid brown (10YR 4/3) sandy soil with a maximum thickness of 0.48m at the south of the site where it was deepest (TP10). The topsoil was found to contain modern pottery sherds, two clay pipe stems, glass and metal items such as nails. The topsoil overlay the natural sand (002) which had sandstone inclusions throughout. The sand was mottled in colour (7.5YR 3/4 -10YR 4/4) and had dark patches due to staining from the sandstone (Fig. 12). The sandstone bedrock (003) was encountered in test pits 5 & 6.

Fig. 12 Test pit 02 showing the natural sand (002) (Scale: 1m).

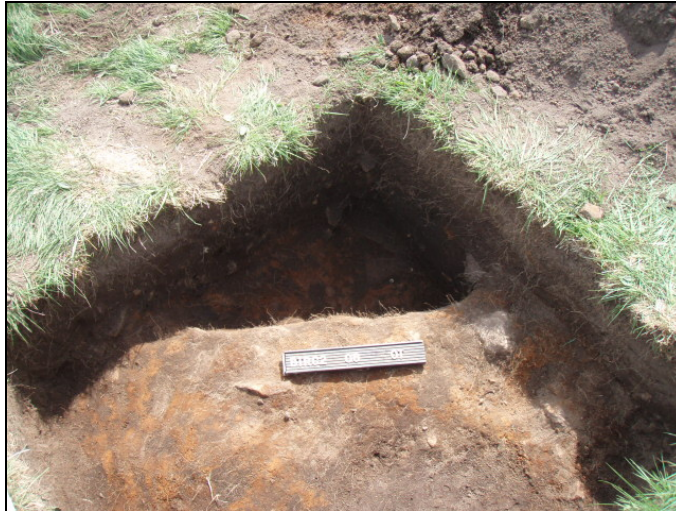
- 6.2 Test pit 01 was found to contain a steep sided hollow (004) that measured 0.42m x 0.83m x 0.55m. The area did not appear to be a cut feature as it did not contain a separate fill but contained topsoil (001). The test pit did not reveal the full size of the hollow which is believed to be a stone hollow from quarrying activity, possibly for a nearby wall (Fig. 13).

Fig. 13 Test pit 01 showing the stone hollow (004), looking south.

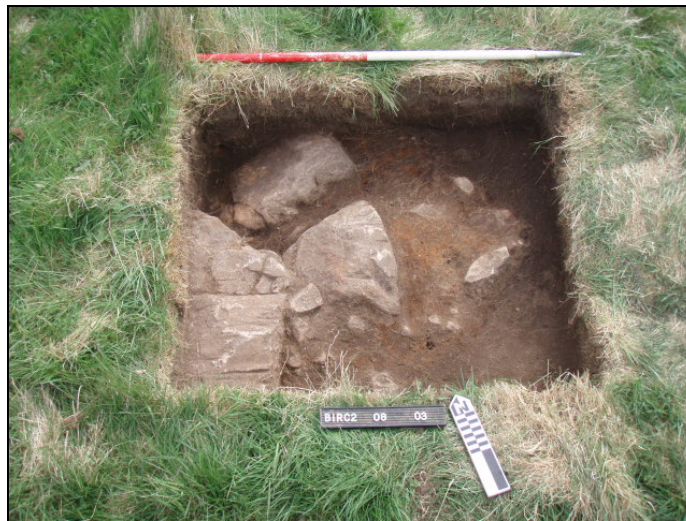
- 6.3 Large sandstone blocks (003) found within the natural sand (002) were uncovered in test pits 03, 04 and 06 (Figs. 14 and 15). The blocks in test pit 03 were found to have been cut by earlier plough activity (Fig. 14).

Fig. 14 Sandstone blocks in test pit 03 found to have plough marks. (Scale: 1m)

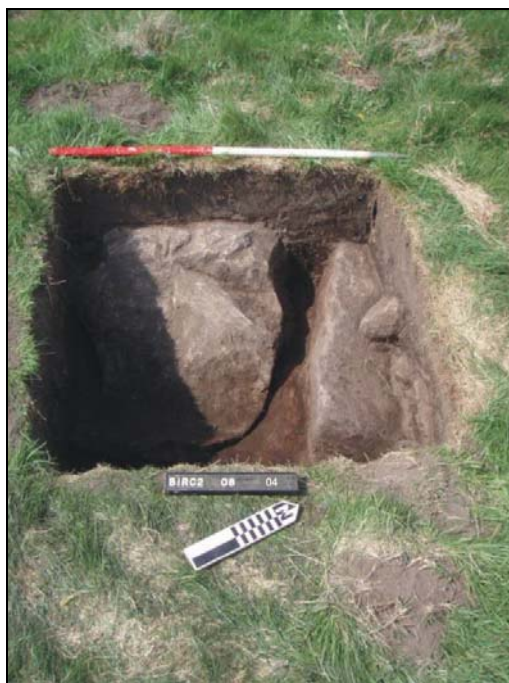
Fig. 15 Sandstone blocks in test pit 04. (Scale: 1m)

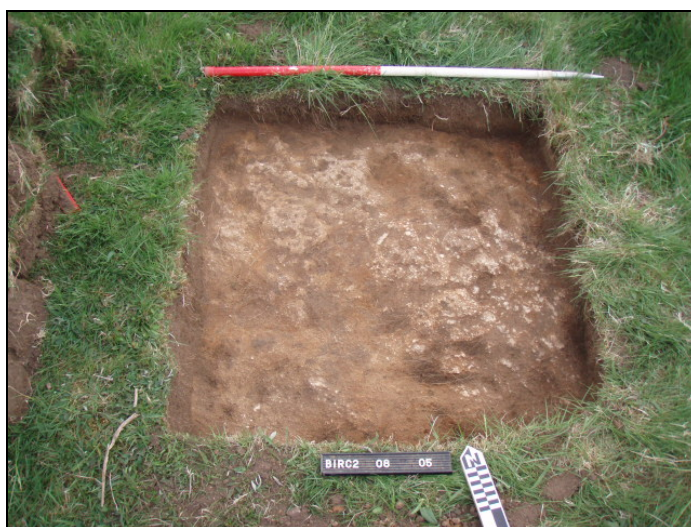
- 6.4 An outcrop of sandstone was revealed in test pits 05 and 07, approximately 0.15m below the surface of the ground (Fig. 16).

Fig. 16 Sandstone bedrock in test pit 05. (Scale: 1m)
