Carsington Pasture, Derbyshire

Report on Pre-Determination Archaeological Evaluation Work

ARS Ltd Report No. 2008/23

February 2008

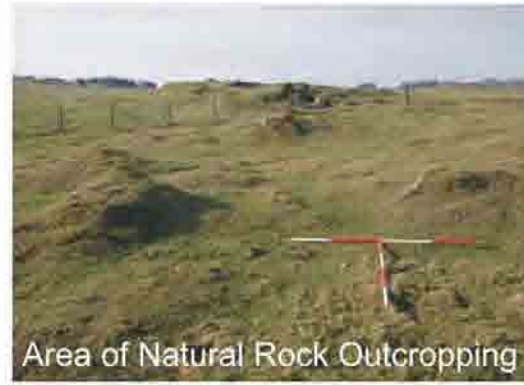
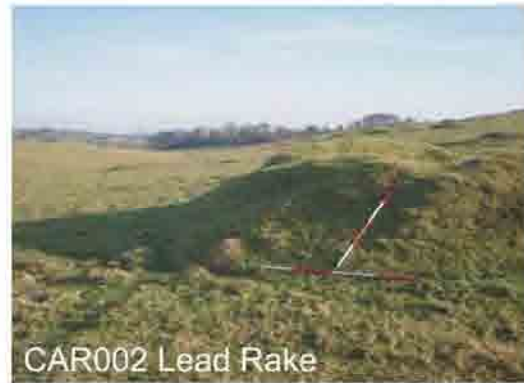
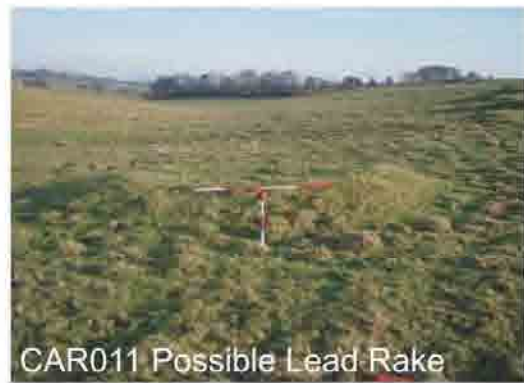
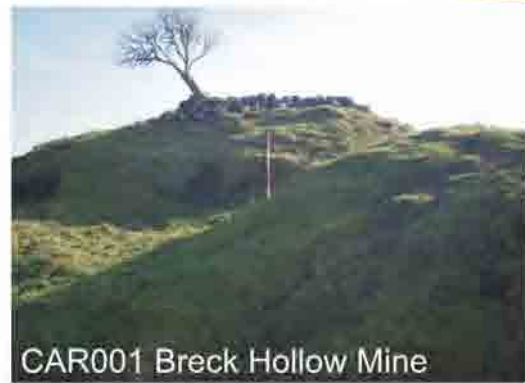
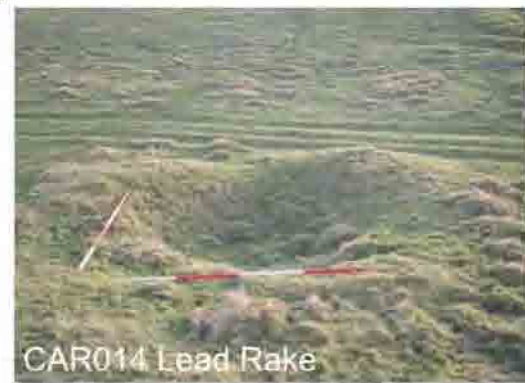
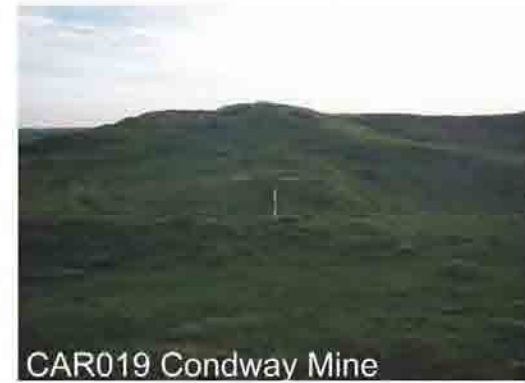
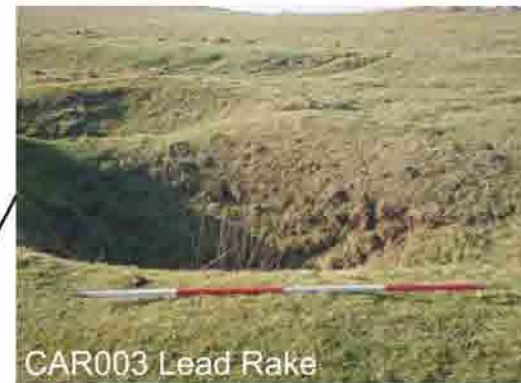
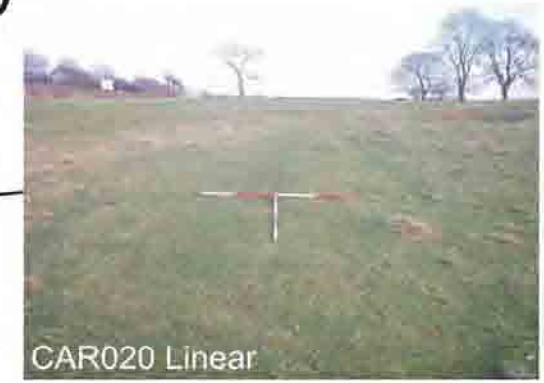
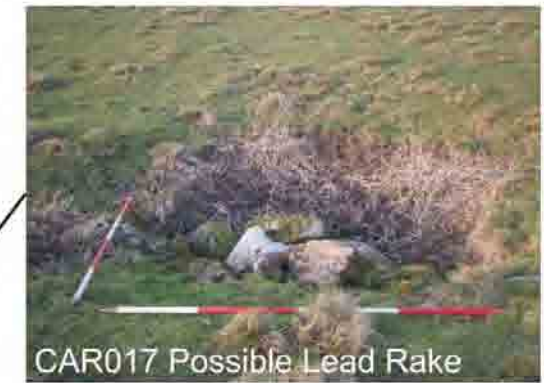
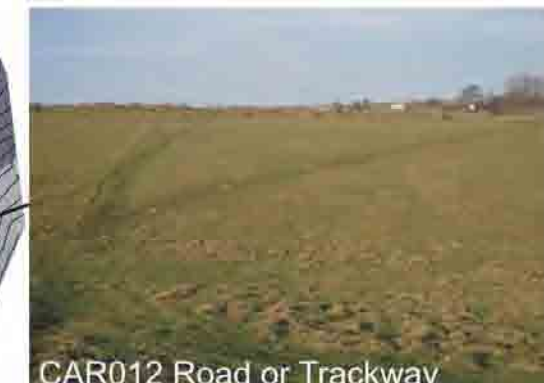
Carsington Pasture Field Survey Summery

- 6.1 The contour survey identified both positive and negative earthworks of several different types within the survey area. The main features encountered during the contour survey were 11 lead rakes and suspected lead rakes mainly concentrated within the road corridor linking Turbines 2 and 3 (Fig. 2). It should be noted that the term 'lead rake' is used to refer to mineral hillocks and associated features as defined in Barnatt and Penny (2004, 7). Additionally, the Mine heads of the Breck Hollow and Conday Mines fall partially within the survey area and are present as positive earthworks within the TIN and contour plots. The first linear feature (CAR020) that crosses the site runs roughly east-west, just north of the survey area at Turbine 4, and just enters the survey area west of Turbine 1. This linear feature consists of a bank which is visible for the majority of its length, and associated ditches to either side which are only observable as earthworks along portions of the linear. The linear feature varies in width, but is approximately 2.7m wide on average. The second linear feature (CAR012) consists of a road or track way of probable post-medieval date running approximately north-south and crossing the survey area in the road corridor linking Turbines 2 and 3 east of the power lines. This track consists of two banks and associated shallow ditches which run parallel approximately 18m apart.

- 6.2 The walkover survey identified 20 earthworks, or features comprised of a group of associated earthworks. The majority of the earthworks were of a similar form and appeared to be the upstanding remains of lead rakes and capped mine shafts. The results of the walkover survey are summarised in Appendix One. The walkover survey was also able to confirm that several areas identified in the TIN and contour plots as potential features, were in fact natural geological features rather than being of anthropogenic origin. The walkover survey also noted that portions of the survey area included remains of 'ridge and furrow' cultivation. Though ephemeral on this site, 'ridge and furrow' represent the remains of medieval and post-medieval agriculture.

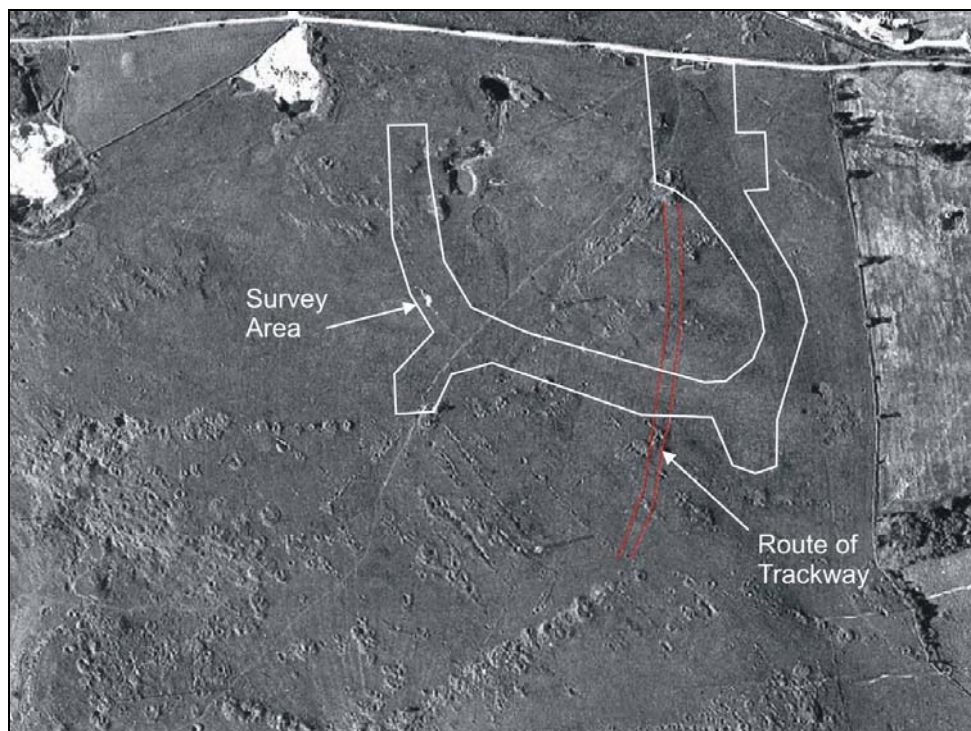
Fig. 4 Aerial photograph showing survey area & route of the linear trackway, suspected to be post-medieval (Photograph Copyright Derbyshire County Council)

- 6.4 The aerial photograph below (Fig. 4) clearly shows all the earthworks and ridge and furrow mentioned above, and also indicates the extent and size of the linear trackway feature aligned north-south. This aerial photograph indicates that the trackway (CAR012) begins at the Condway Mine in the north and runs south, bearing to the south west and appears to terminate at a concentration of lead rakes south of the survey area (Fig. 4).

- 6.3 The 'ridge and furrow' noted during the walkover survey is evident over much of the site on Aerial Photographs taken in 1954 (Photo Ref. MAL 54082V 9455, 60-61). The aerial photographs also clearly show the areas of earthworks around the Condway Mine, the Breck Hollow Mine and the smaller clusters of lead rake earthworks observed along the 'corridor' between Turbines 2 and 3. The east-west aligned linear feature along the north of the survey area is visible as a narrow earthwork that coincides with what is observable on the ground; but the north-south aligned trackway is not visible on the aerial photographs.

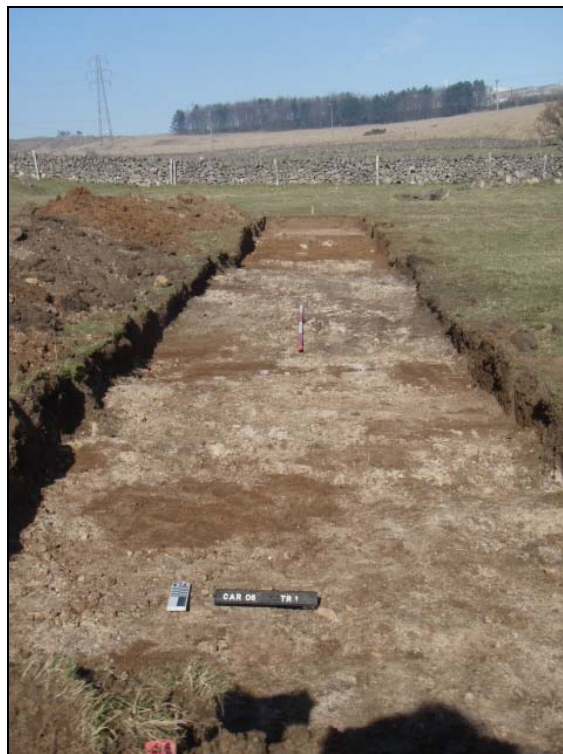
Fig. 6 Trench 1 before the excavation of a sondage (looking north).
Scale: 2m

Trench one was located in the north-eastern section of the development site lying to the north-west of the proposed site of Turbine 1 and was positioned in order to investigate an ephemeral east-west linear feature (CAR 020) identified during the walkover survey (Fig. 5). The trench was aligned on a north-south axis and measured 25m in length and was 2.3m wide (Fig. 6). The fine sandy-silt topsoil (001) existed to a depth of 0.15 - 0.25m below ground level and underlying this was a layer of yellowish-brown clayey-silt (002) which had a maximum thickness of 0.2m. Beneath this was a coarse fractured limestone (003) with a maximum depth of 0.47m which abutted rising outcrops of irregularly shaped limestone bedrock (004). A sondage measuring 10m in length by 1m wide was excavated midway along the eastern side of the trench into these two deposits in order to confirm that they were natural (Fig. 7). Despite a careful check no evidence for the east-west linear was identified and it was concluded that this was a natural feature caused by the underlying geology.

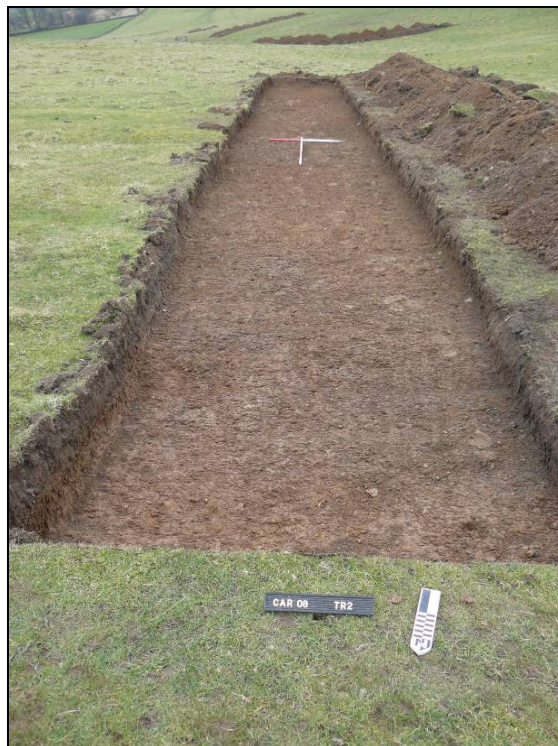
Fig. 8 Trench 2 (looking south).
Scale: 1m & 2m

Trench two was located in the north-eastern section of the development site lying to the north of the proposed site of Turbine 1 and was also sited in order to investigate the ephemeral east-west linear (CAR 020) identified during the walkover survey (Fig. 8). The trench was aligned on a north-south axis and measured 25m in length and was 2.3m in width. The fine sandy-silt topsoil (001) existed to a depth of 0.2m beneath ground level and underlying this was a layer of yellowish-brown clayey-silt (002) across the trench.

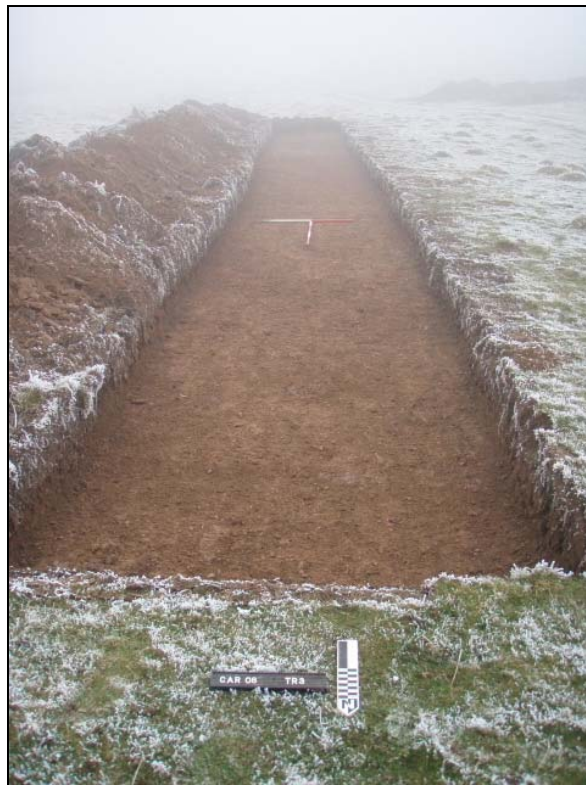
Fig. 9 Trench 3 (looking south)
Scale: 1m & 2m

Trench three was also situated in the north-eastern section of the development site and lay halfway between, and to the south of, trenches one and two which was also to the north-west of the proposed site of turbine 1 (Fig. 5). The trench was sited in an area where no features were identified during the walkover survey. It was aligned on a north-south axis and measured 25m in length and 2.3m wide (Fig. 9). The fine sandy-silt topsoil (001) was observed to a maximum depth of 0.25m and underlying this was yellowish-brown clayey silt (002) observed to a maximum thickness of 0.2m to the base of the trench. The underlying clay/silt here was found to contain small natural pebble inclusions.

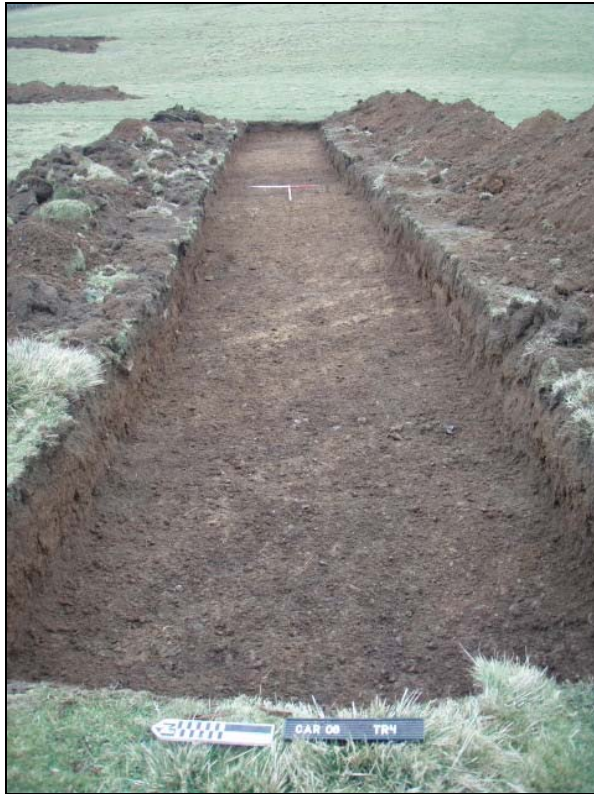
Fig. 10 Trench 4 (looking east)
Scale: 1m & 2m

Trench four was located to the south-west of trench three and to the west of the proposed site of turbine 1 (Fig. 5). The trench was sited in order to examine the uneven ground to the immediate north-east of the Condway Mine Head (CAR019) and was aligned on a north-east by south-west axis (Fig. 10). The topsoil (001) was observed to a maximum thickness of 0.25m. No archaeological features were identified within this trench save for some irregular deposits of limestone fragments in the topsoil which had caused the irregular land surface. Directly underlying the topsoil and pockets of crushed limestone to the south-western and north-eastern extents of the trench only was the yellowish-brown clayey silt (002). This clayey-silt was observed to a maximum depth of 0.35m where it met with the natural clay (005) which had areas of gravel inclusions within it.

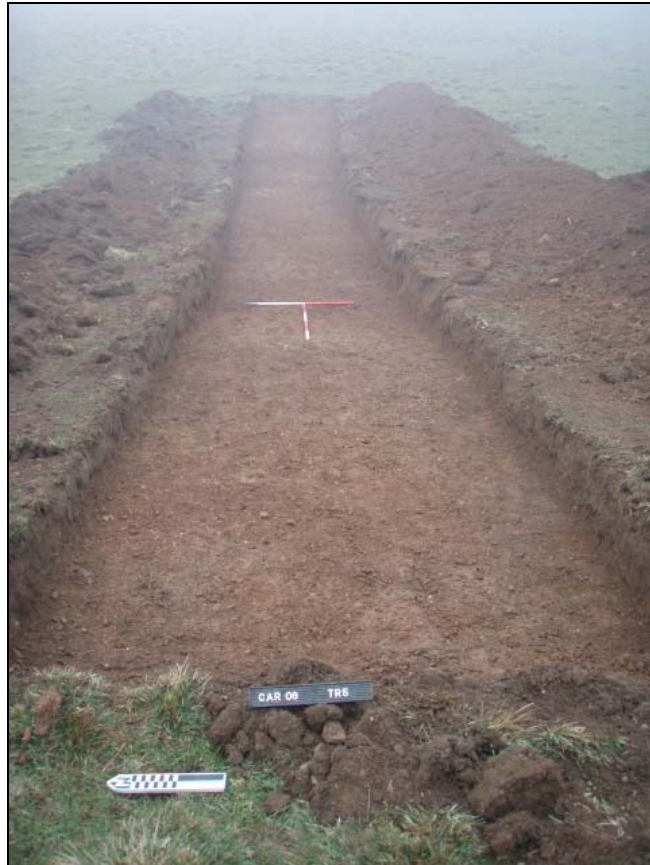
Fig. 11 Trench 5 (looking east)
Scale: 1m & 2m

Trench five was situated to the south-east of trench four and lay directly to the west of the proposed site of Turbine 1 (Fig. 5). The trench was aligned on a north-east by south-west axis and measured 25m in length by 2.3m in width (Fig. 11). The trench was sited in a location where no potential archaeological features were identified during the walkover survey. The topsoil (001) existed to a maximum depth of 0.3m along the whole length of the trench. Below this was a layer of clayey-silt (002) which also had a maximum depth of 0.3m. This clayey-silt was only observed along three quarters of the section length and was absent at the south-western extent. Underlying (002) was the natural clay (005) which had pebble inclusions at the south western section of the trench.

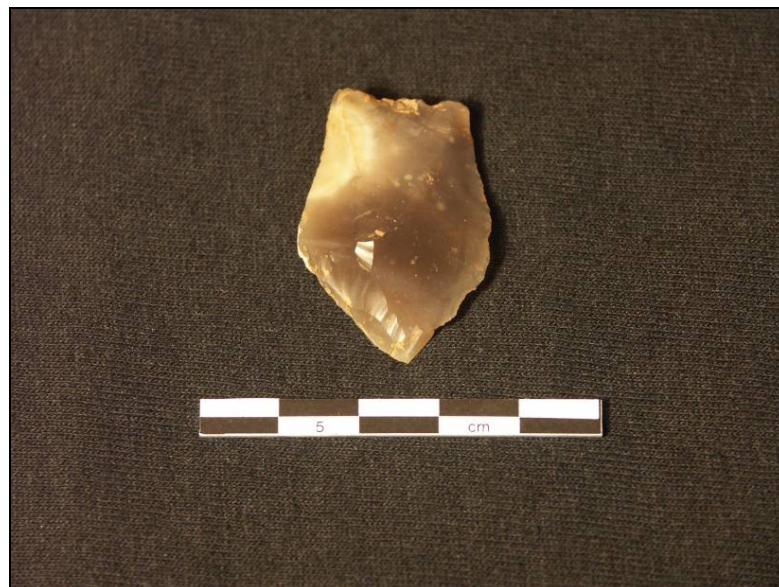
Fig. 12 Lithic artefact
Scale: 5cm

- 7.5.1 A retouched flint flake, possibly an awl, dating to the late Neolithic to early Bronze Age was recovered from the subsoil (002) of trench five (Fig.12). The flint was the sole artefact recovered from all the evaluation trenches.

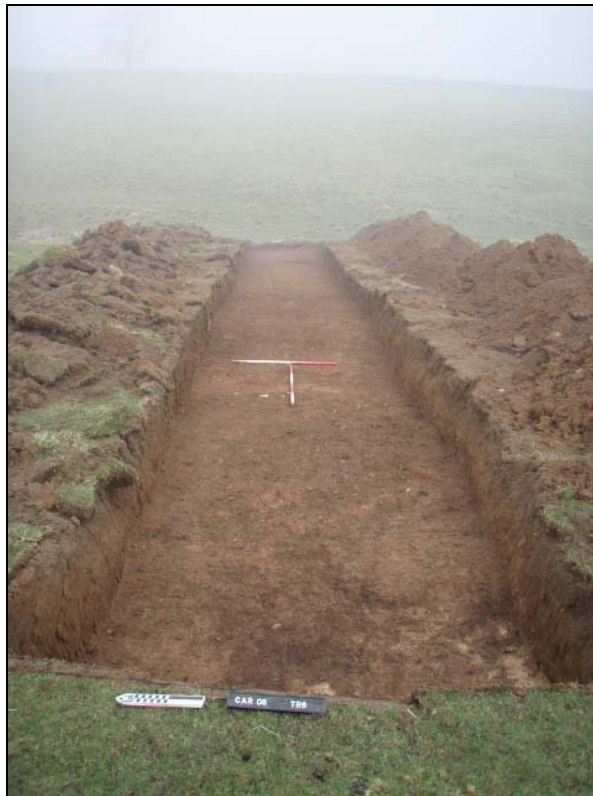
Fig. 13 Trench 6 (looking north-east).
Scale: 1m & 2m

Trench six was located to the south of trench five lying approximately one third of the way south along the route of the proposed access road between turbines 1 and 2 (Fig. 5). This trench was also aligned on a north-east by south-west axis and measured 25m in length by 2.3m wide. The trench was sited in a location where no potential archaeological features were identified during the walkover survey. The topsoil (001) ranged from 0.17m to 0.2m in depth and existed along the whole length of the trench. Underlying this and also observed along the full length of the trench was a layer of yellowish-brown clayey-silt (002) which was observed to a depth of up to 0.4m. Beneath this was the natural clay (005) which ran along the base of the trench. This clay abutted an outcrop of soft natural dolomite limestone observed at the far south-western extent of the trench running for a length of 1.4m by 1.4m in width into the trench section (Fig. 13). At the north-eastern end of the trench cut into (005) a sub-oval feature [013] was identified and half-sectioned (Fig. 14). The feature measured 0.83m in length by 0.45m wide and had an irregular sloping base with a depth of 0.35m to the south and just 0.08m to the north. The cut was filled with fine grey-brown (10YR 4/2) clay containing gravel and large stones. Given the irregular nature of the cut and the lack of finds it has been provisionally identified as a small tree bole.

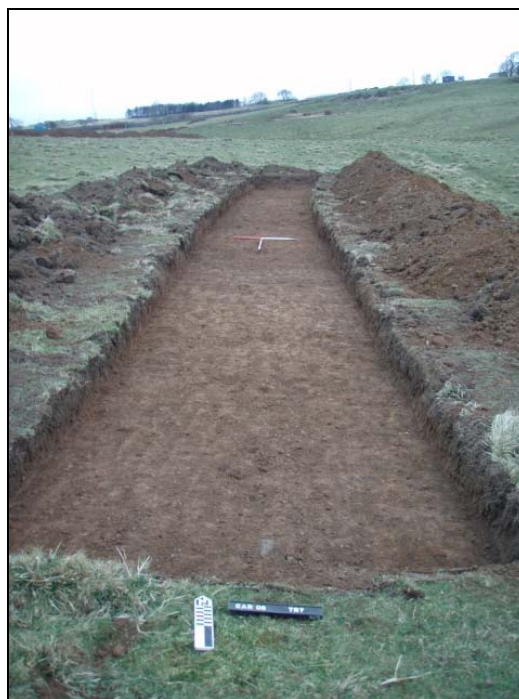
Fig. 15 Trench 7 (looking north)
Scale: 1m & 2m

Trench seven was situated to the south-east of trench six, lying approximately two thirds of the way along the route of the proposed access road between Turbines 1 and 2 (Fig. 5). This trench was aligned on a north-south axis and measured 25m in length by 2.3m in width (Fig. 15). The trench was sited in a location where no potential archaeological features were identified during the walkover survey. The topsoil (001) was observed to exist to a maximum of 0.2m in depth and underlying this was a layer of clayey-silt (002) which had a maximum thickness of 0.4m deep. Below (002) and observed along the base of the trench was natural clay (005).

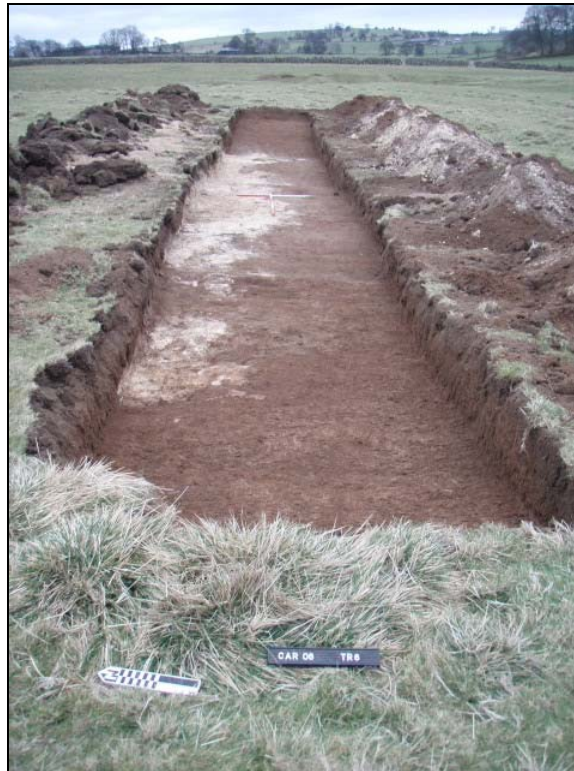
Fig. 16 Trench 8 (looking east)
Scale: 1m & 2m

Trench eight was located to the south-west of trench seven and directly to the north of the proposed site of Turbine 2 (Fig 5). The trench measured 25m in length by 2.2m wide and was aligned on an east-west axis. The trench was sited in a location where no potential archaeological features were identified during the walkover survey. The topsoil (001) was observed along the whole length of the trench and ranged in depth from 0.12-0.28m. Below the topsoil was a layer of clayey-silt (002) which existed to a maximum thickness of 0.35m to the base of the trench (Fig. 16). Below (002) in the northern central section of the trench were a series of soft dolomite outcrops (008). Abutting these dolomite outcrops was the natural clay (005).

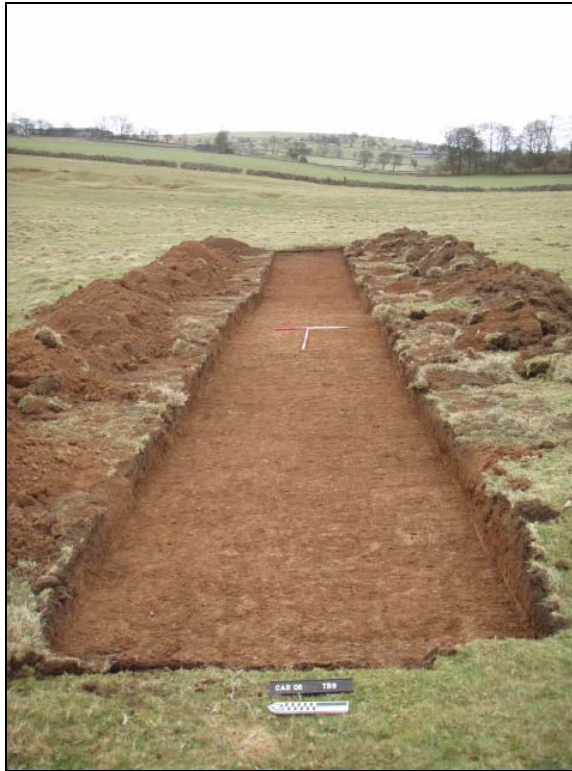
Fig. 17 Trench 9 (looking east)
Scale: 1m & 2m

Trench nine was situated directly to the south of trench eight and lay directly across the proposed location of Turbine 2 in the far south-east of the development area (Fig. 5). The trench was aligned on an east-west axis and measured 25m in length by 2.3m wide. The trench was sited in a location where no potential archaeological features were identified during the walkover survey. The topsoil (001) extended over the whole length of the trench and measured 0.07m to 0.15m in depth. Below the topsoil was a layer of clayey-silt (002) with a maximum thickness of 0.2m and which similarly ran along the whole length of the trench (Fig. 17). Underlying (002) along the base of the trench was a deposit of natural colluvial clay (005).

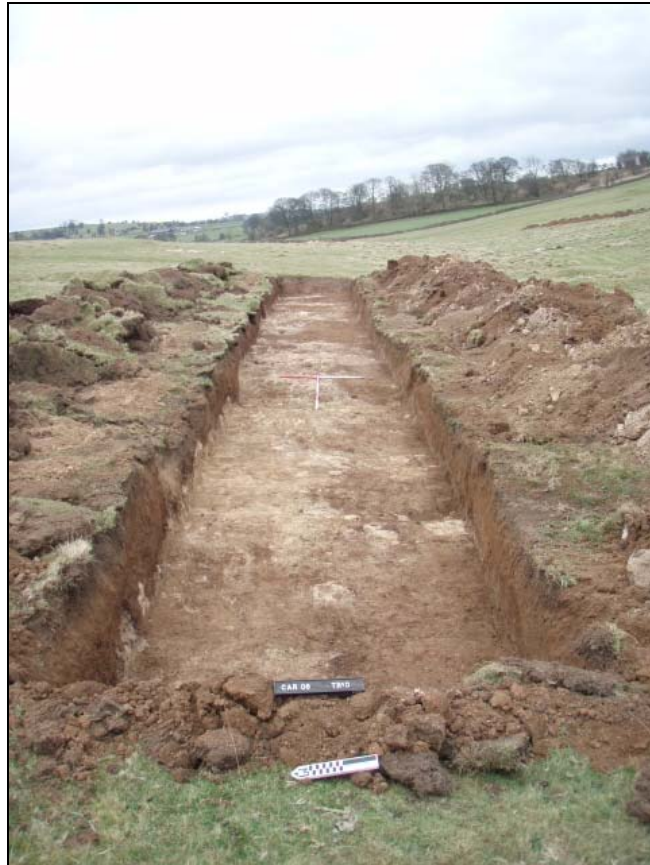
Fig. 18 Trench 10 (looking east)
Scale: 1m & 2m

Trench 10 was located in the southern section of the development area to the west of trench nine (Fig 5). The trench was deliberately positioned on a north-west-west by south-east-east axis in order to allow the examination of a linear earthwork running from the north-north-east to south-south-west which had been identified during the topographical survey and on aerial photographs (CAR012) (Fig. 18). During excavation of the trench no features could be identified such as a track surface or any other deposits. The linear feature was observed in section to consist of two raised banks (0.28m in height) with very shallow internal ditches abutting the banks. The bank and ditch on both sides was approximately 1.8m wide with a distance between them of approximately 15.5m (Figs. 19 and 28). The topsoil (001) was observed along the full length of the trench to a maximum depth of 0.15m. Underlying the topsoil was the clay/silt deposit (002). Beneath (002) and along the base of the trench a deposit of natural dolomite limestone (008) was observed with intermittent patches of natural clay (005) between these limestone outcrops (Fig. 18). The fill of the two ditch cuts (009) to the east and (010) to the west consisted of a fine silty deposit which could not be distinguished from (002) when the trench was being excavated. The banks of the linear feature had no stone within them and appeared to have been created by the excavation of the ditches. The linear feature has been interpreted as the remains of field breaks created in the post medieval period (Hart Pers. Comm.). However, the area between the field breaks would certainly have provided an access route between the fields and the possibility that the internal space between the banks acted as a trackway in the post medieval period. This linear feature certainly appears to pre-date some of the mine workings as mine waste deposits overlay the feature to the south. The feature has been preserved because of the absence of intensive ploughing in more recent times.

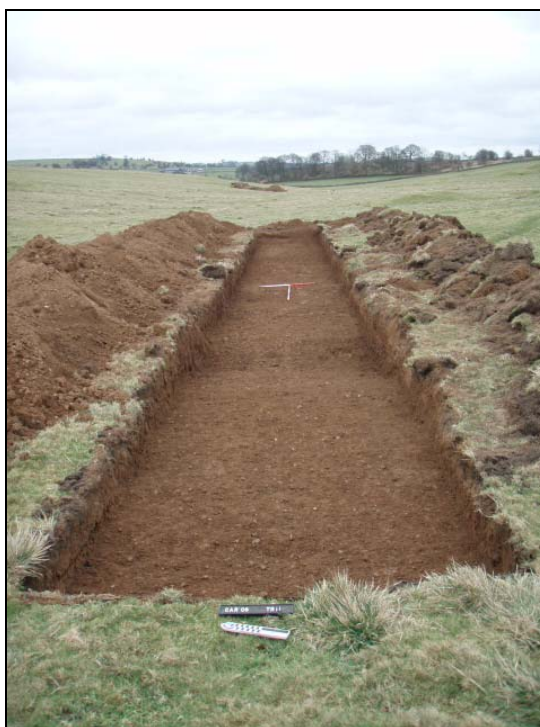
Fig. 20 Trench 11 (looking east)
Scale: 1m & 2m

Trench 11 was situated to the west of trench 10 along the site of the proposed access route between Turbines 2 and 3 (Fig. 5). The trench was aligned on a north-east by south-west axis and measured 25m in length by 2.5m wide. The trench was sited in a location where no potential archaeological features were identified during the walkover survey. The topsoil layer (001) extended the whole length of the trench and had a maximum depth of 0.15m. Below the topsoil was a clayey-silt layer (002) to a maximum depth of 0.3m and beneath this was the natural clay with gravel inclusions which extended beyond the depth of the trench (Fig. 20).

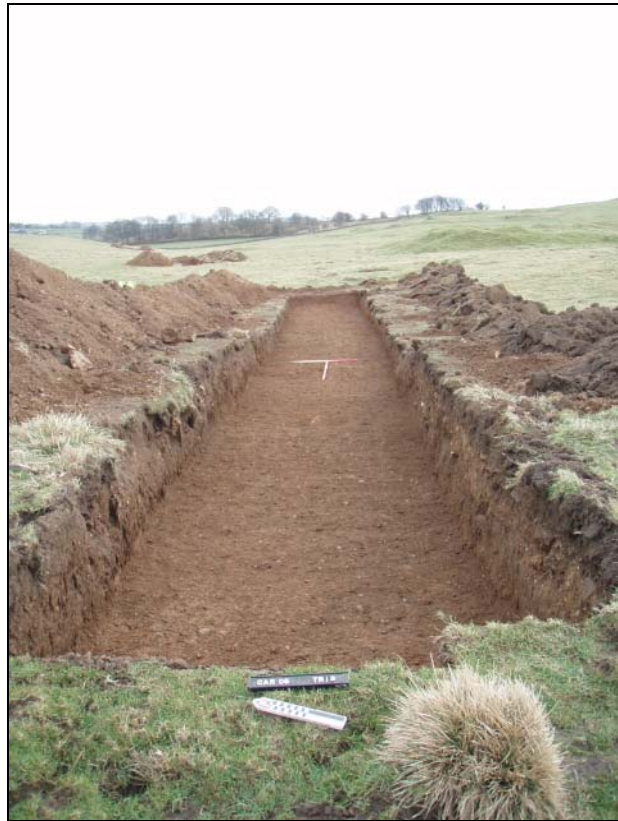
Fig. 21 Trench 12 (looking south-east)
Scale: 1m & 2m

Trench 12 was located to the west of trench 11 and lay along the site of the proposed access road between Turbines 2 and 3 (Fig. 5). The trench measured 25m in length by 2.5m wide and was located on a north-west to south-east axis (Fig. 21). The trench was positioned in order to examine a linear feature running roughly north-east to south-west which had been previously identified on aerial photographs and also as an upstanding feature during the topographical survey (CAR). The topsoil (001) was observed to exist up to a depth of 0.2m. Directly beneath this topsoil at the western extent of the trench were the remains of the linear feature which consisted of a single deposit containing numerous medium sized angular stones (011). This feature can be interpreted as the remains of a trackway measuring 6.4m in width and up to 0.35m in depth (Fig. 22). Below the trackway and directly beneath the topsoil, in the eastern half of the trench, was the same clayey-silt (002) observed across the whole site. This subsoil was

observed up to a maximum depth of 0.4m and below this was the natural clay (005).

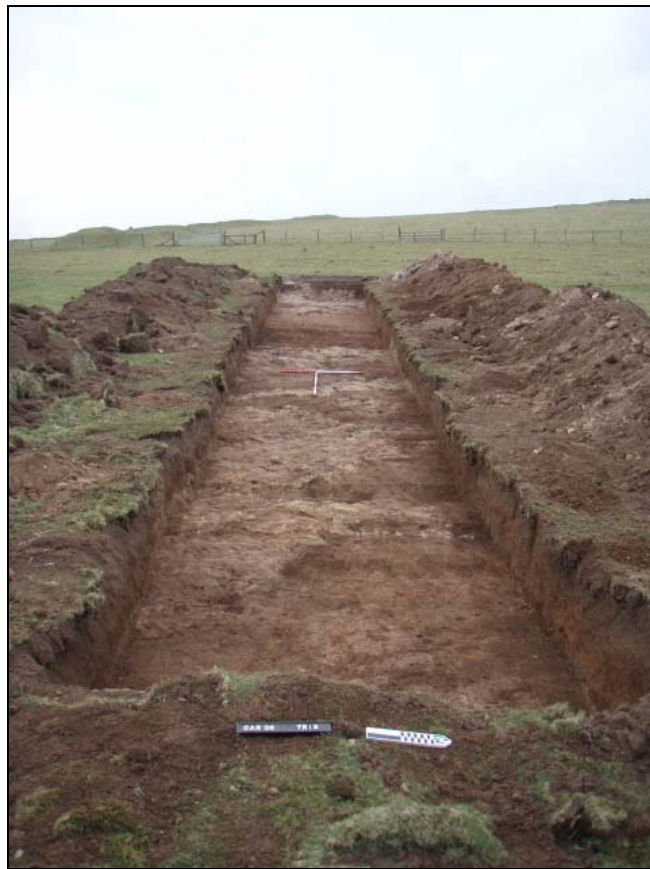
Fig. 23 Trench 13 (looking south-east)
Scale: 1m & 2m

Trench 13 was situated in the far south-west of the proposed development site within the footprint area of Turbine 3 (Fig. 5). The trench was aligned on an east-west axis and was 25m long by 2.5m wide. The trench was sited in an area where no features were identified during the walkover survey. The topsoil (001) ranged in depth from 0.15 - 0.2m deep and was underlain by (002) which existed to a depth of up to 0.3m. Beneath (002) were a number of soft dolomite limestone outcrops (008) with patches of natural clay (005) in between (Fig. 23).

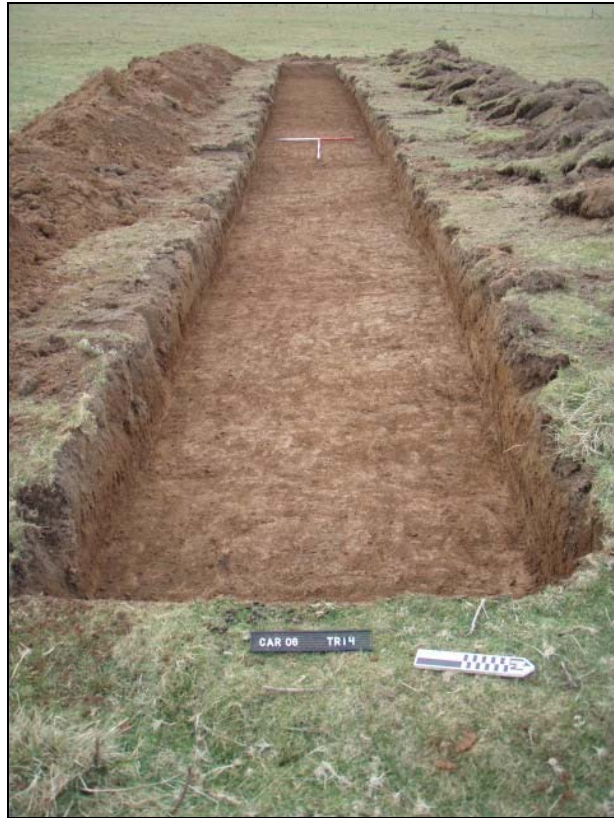
Fig. 24 Trench 14 (looking west)
Scale: 1m & 2m

Trench 14 was located to the north-east of trench 13 in the south-western section of the proposed access route way (Fig. 5). The trench was aligned on an east-west axis and measured 25m in length by 2.2m wide. The trench was sited in an area where no features were identified during the walkover survey. The topsoil layer (001) was observed to exist to a maximum depth of 0.2m and underlying this was a layer of clayey-silt (002) to a maximum depth of 0.3m (Fig. 24). Below (002) the trench came down onto natural consisting of clay with gravel inclusions (005).

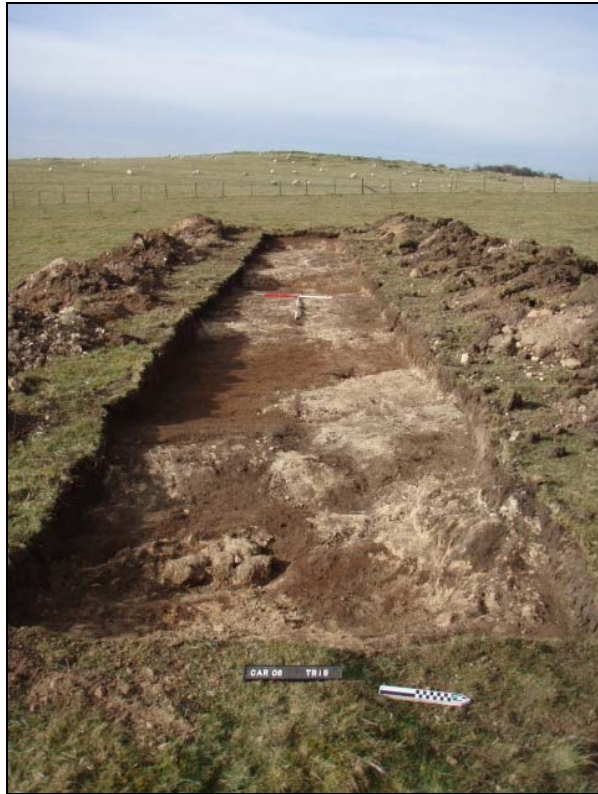
Fig. 25 Trench 15 (looking west)
Scale: 1m & 2m

Trench 15 was sited to the north-west of trench 14 and lay along the proposed access route between Turbines 3 & 4 (Fig. 5). The trench was aligned on an east-west axis measuring 24m in length by 2.6m wide. The trench was sited in an area where no features were identified during the walkover survey. The topsoil (001) was observed to exist to a maximum depth of 0.2m, directly below this was the natural (Fig. 25). The natural deposits consisted of irregular outcrops of soft dolomite limestone (008) which was overlain in patches, especially along the centre of the trench, with shallow deposits of natural clay (005).

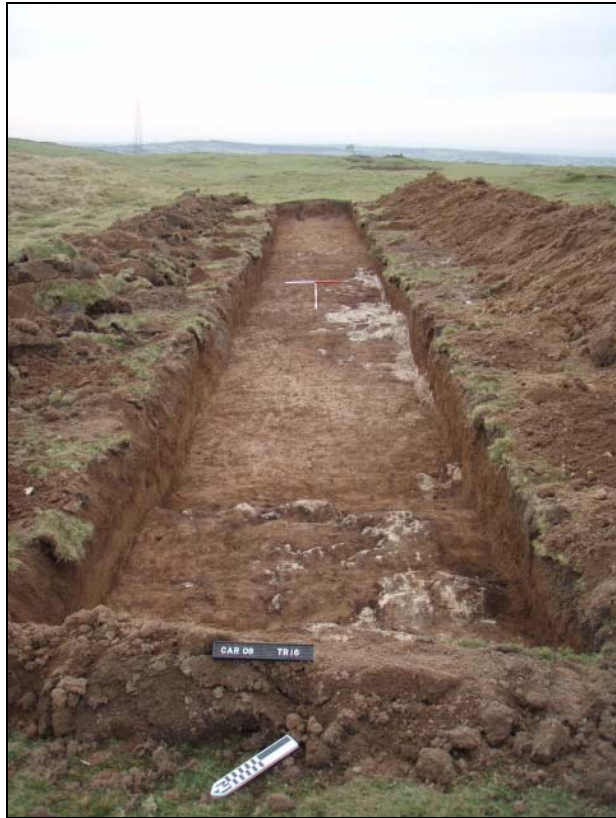
Fig. 26 Trench 16 (looking south)
Scale: 1m & 2m

Trench 16 was located to the north of trench 15 at the northern limit of the access route leading to Turbine 4 (Fig. 5). The trench was aligned on a north-south axis and measured 24m in length by 2.5m wide (Fig. 26). The trench was sited in an area where no features were identified during the walkover survey. The topsoil (001) was observed along the full length of the trench to a maximum depth of 0.2m. Underlying this topsoil was clayey-silt (002) which measured up to a maximum depth of 0.4m. Beneath (002) were natural deposits consisting primarily of clay (005) along the base of the trench with outcrops of soft dolomite limestone (008) observable both in section and in patches along the floor of the trench, especially at the northern limit of excavations.

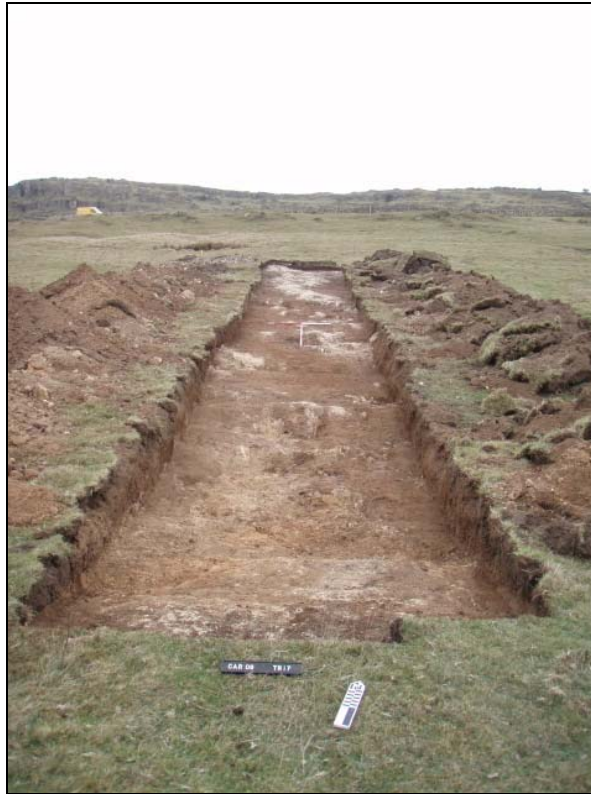
Fig. 27 Trench 17 (looking north)
Scale: 1m & 2m

Trench 17 was situated in the far north-west of the development site in the proposed location of Turbine 4 to the north-north-west of trench 16 (Fig. 5). The trench was aligned on a north-south axis and measured 24.5m in length by 2.1m wide. The trench was purposely sited at the northern limit of the evaluation area in order to sample the area as close as possible to the southern limit of an ephemeral east-west linear (CAR020) identified during the walkover survey which lay just to the north of the development area. No archaeological features were identified within this trench. The topsoil (001) existed to a maximum depth of 0.2m deep. In the northern extent of the trench the topsoil came down directly onto the soft dolomite limestone natural (008) but in the southern half of the trench the topsoil was underlain by a layer of clayey-silt (002) which existed to a maximum depth of 0.22m and which in turn was above the natural dolomite (Fig. 27). This irregular natural limestone was also overlain, in patches, with small deposits of natural clay (005).

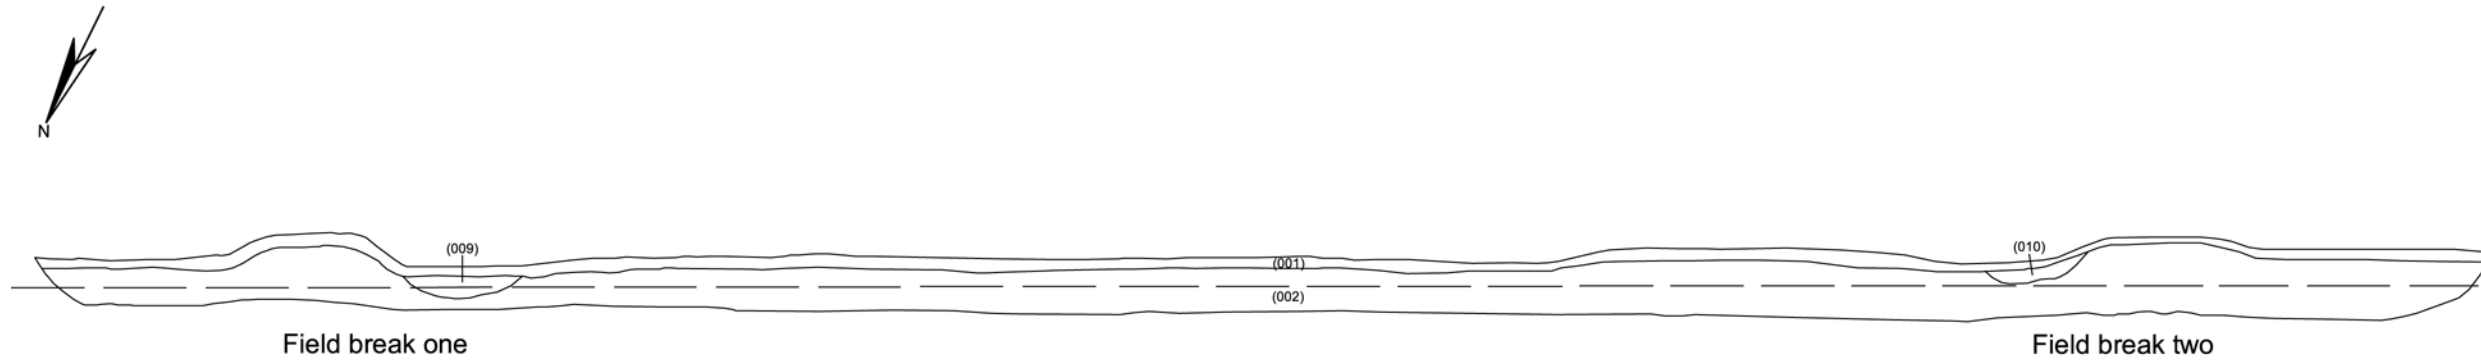
South facing section of Trench 10 showing the field breaks.

Scale 1: 75

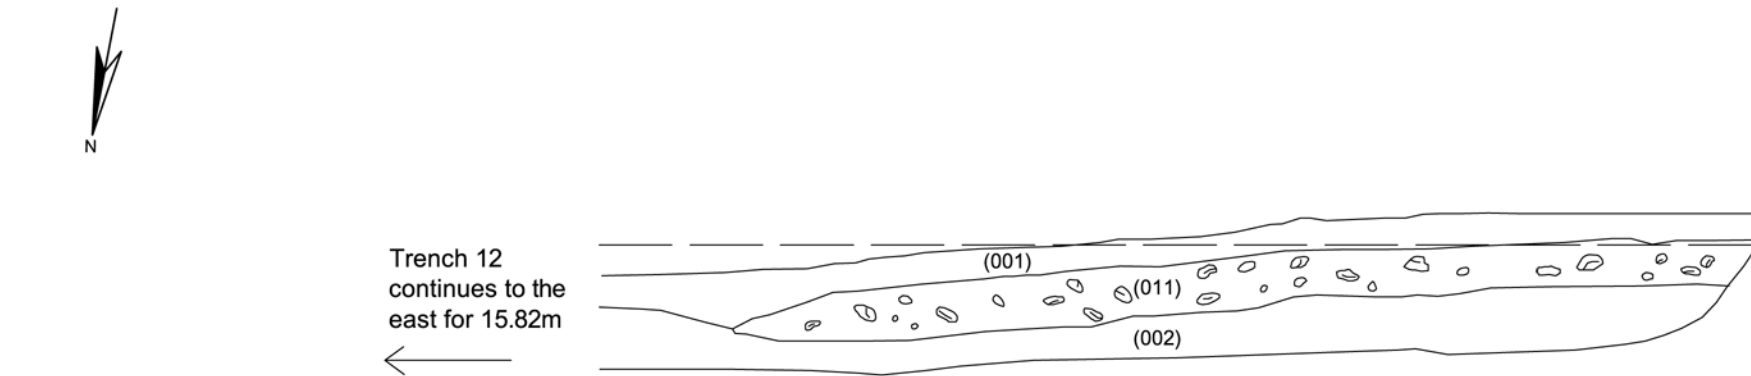
Partial south facing section on Trench 12 showing the path (012)

Scale: 1:50

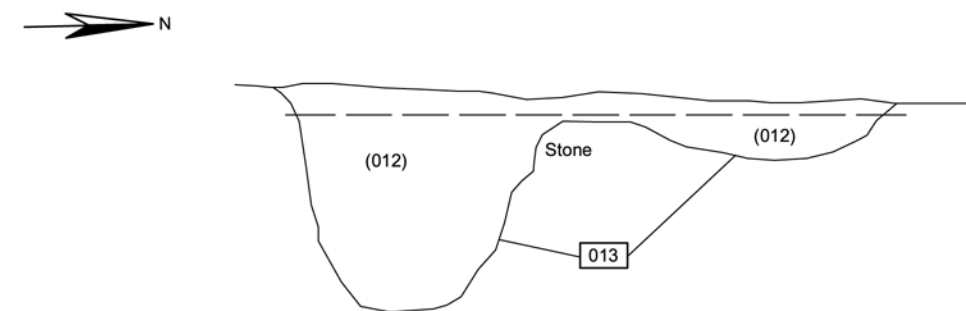
West facing section of feature (012) located in Trench 6

Scale: 1:10

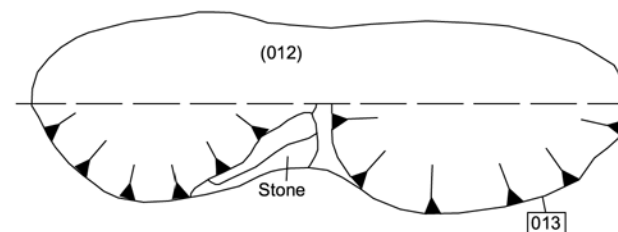
Plan of feature (012) located in Trench 6

Scale: 1:10
