New Road, Darley Abbey, Derby  
Watching Brief and Building Recording

The Hollies, Darley Abbey, Derbyshire

**ARS Ltd Report 2008/56**  
July 2008

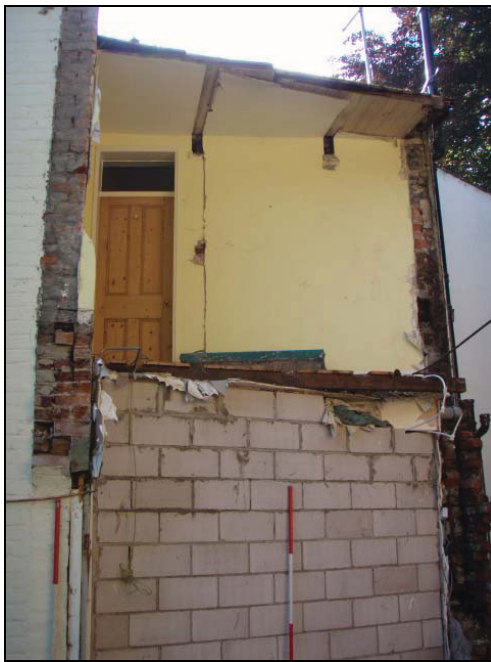
Fig. 3 Evidence of the demolished kitchen, utility room and bedroom (facing east)

6.1 The dismantled kitchen, utility room and bedroom (Fig. 3) had been built of modern red bricks measuring 229mm x 60mm x 115mm. Observation of the walls which remained after demolition of the rooms revealed part of a early 19<sup>th</sup> century red brick arch which had been previously demolished at an unknown date (Fig. 4). It had probably been an arched doorway leading to the back of the house. After the rooms were dismantled, a modern wall constructed of breeze blocks had been built to enclose the house (Fig. 3). Other than the arch, no architectural features of archaeological interest were exposed.

- 6.8 The excavation of the southern footing encountered the footings of the demolished extension (Fig. 3). The footings included a red brick wall (012), six bricks in height from ground level and bonded with concrete mortar. Underneath this was a 0.22m deep concrete base (013) for the wall.

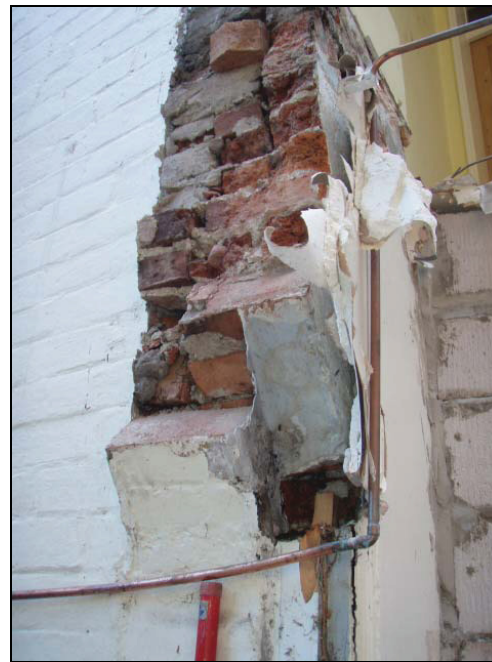
Fig. 4 Arch revealed after the demolition of the modern kitchen, utility and bedroom (facing south)

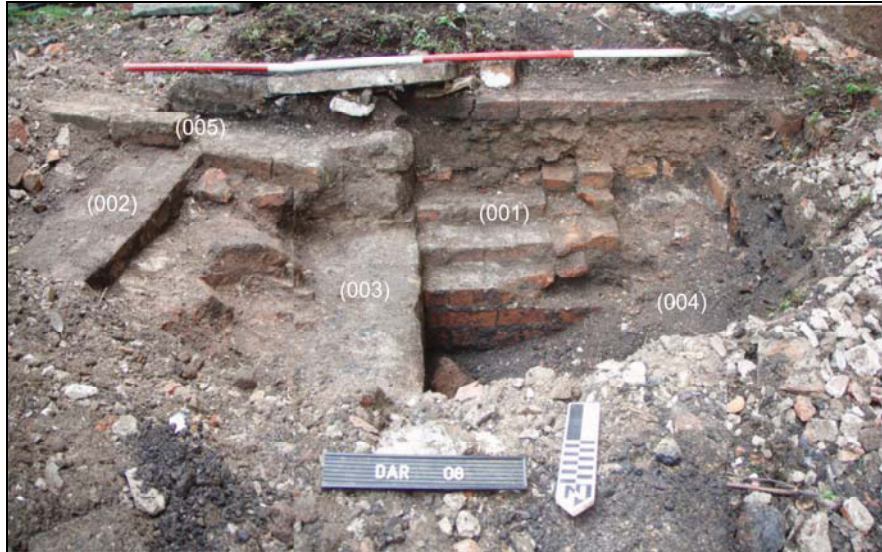
Fig. 6 Section of (001), showing locations of (002), (003), (004) and (005) (facing south)

- 6.3 The ground surface consisted of rubble associated with the demolition of the kitchen, utility room and bedroom. Underneath this, whilst excavating the southern footing, a red brick wall (001) running east to west was revealed (Fig. 6). The bricks measured 204mm in length x 109mm in width x 65mm in height. These bricks approximate to the Stature size of 1770 (8½ x 4 x 2½ inches) (Hammond 1998). Brick size cannot be used as a reliable indicator of age in isolation from other characteristics. However, due to the uniform nature of the wall, the uneven bonding and the use of lime-mortar, the most likely date for this wall is between 1770 and 1820. The wall possibly formed the boundary between two properties. Alternatively, it may have been a wall of an outbuilding associated with the property.

Beneath this wall (001) were dressed sandstone blocks (008) which provided the base for (001) (Fig. 7). Abutting (001) and running north to south is a wall constructed of sandstone blocks (003). (Fig. 6). The wall was approximately 1.1m in height. The sandstone blocks were approximately 350mm in length x 250mm in width x 220mm in height. Abutting this wall and aligned on south-east to north-west direction was a red brick wall (005), very similar in construction to (001) with bricks of the same size and probably the same date (Fig. 6). This wall may be an extension to the boundary wall of context (001). At a right angle to (005) was a red brick wall (002) aligned on a north-east to south-west direction (Fig. 6). The wall was constructed in the same way as (001) and (005), with the same type of bricks.

- 6.4 A black subsoil (004) 1.1m in depth lay to the south of (001), to the east of (003) and above (006) (Figs. 6 and 7). It contained a large amount of tiny fragments of metal and slag suggesting it was modern industrial backfill. Context (006) was a salt glazed sewer pipe which splits into three at the corner of two footings (Fig. 8). Part of the pipe is of a different colour and glaze suggesting it has been modified at a later date. The southern end of the pipe appeared to continue

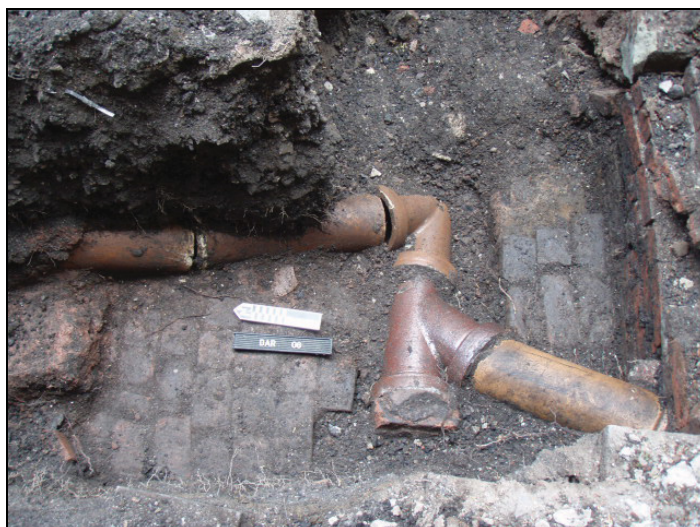
Fig. 8 Sewer pipe (006) and brick floor (010)

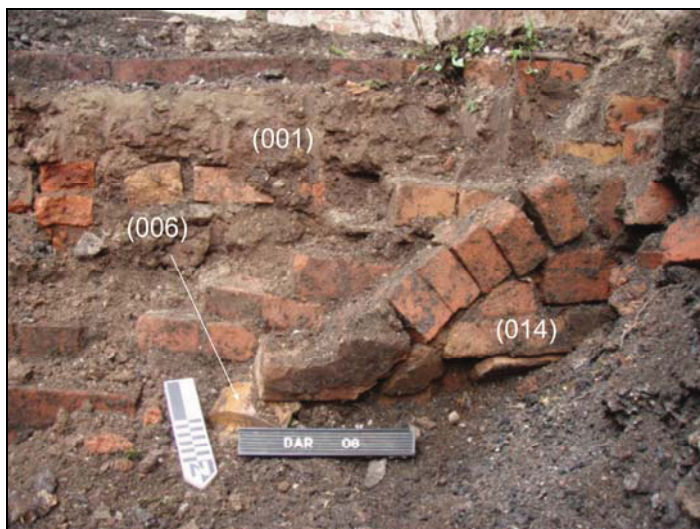
Fig. 9 Sewer pipe (006) and brick arch (014)

through (001) and ran underneath a red brick arch (014) constructed of the same brick type as (001) (Fig. 9). It had been filled in with fragments of red brick.

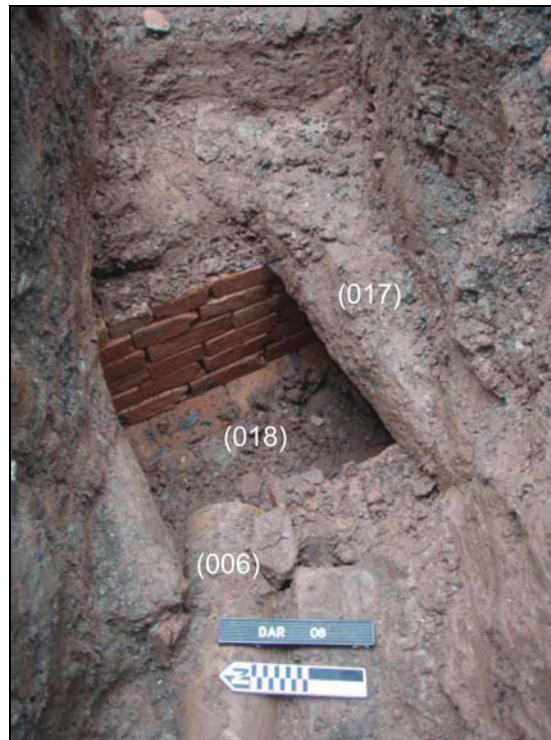
Fig. 10 Photograph of the inside of the culvert (facing east)

- 6.5 Further excavation of the southern footing exposed the eastern extremity of the sewer pipe (006) which extended into a culvert (Fig. 5b). Large sandstone blocks (017) approximately 0.72m in length x 0.52m in width x 0.14m in depth formed the upper layer of the culvert which was 1.3m below ground level. Below the sandstone blocks ran two straight red bricked walls, forming the sides of the culvert and a set of five red bricks which were positioned in a curve to form the base of the drain (Fig. 10). The culvert runs approximately north-west to south-east, although it curves slightly to the east as it continues in a southerly direction. The culvert was exposed in the northern footing at a depth of 1.25m.

- 7.3 The culvert was constructed of red bricks with similar dimensions to the red brick walls and therefore dates from the later 18<sup>th</sup> to early 19<sup>th</sup> century.
