**Report on an Archaeological Watching Brief.
Potworks Barn, Ticknall.**

ARS Ltd Report 2008/52
July 2008
Planning Application no. SD/9/2007/0945/FH

**Report on an Archaeological Watching Brief
Potworks Barn, Ticknall.**

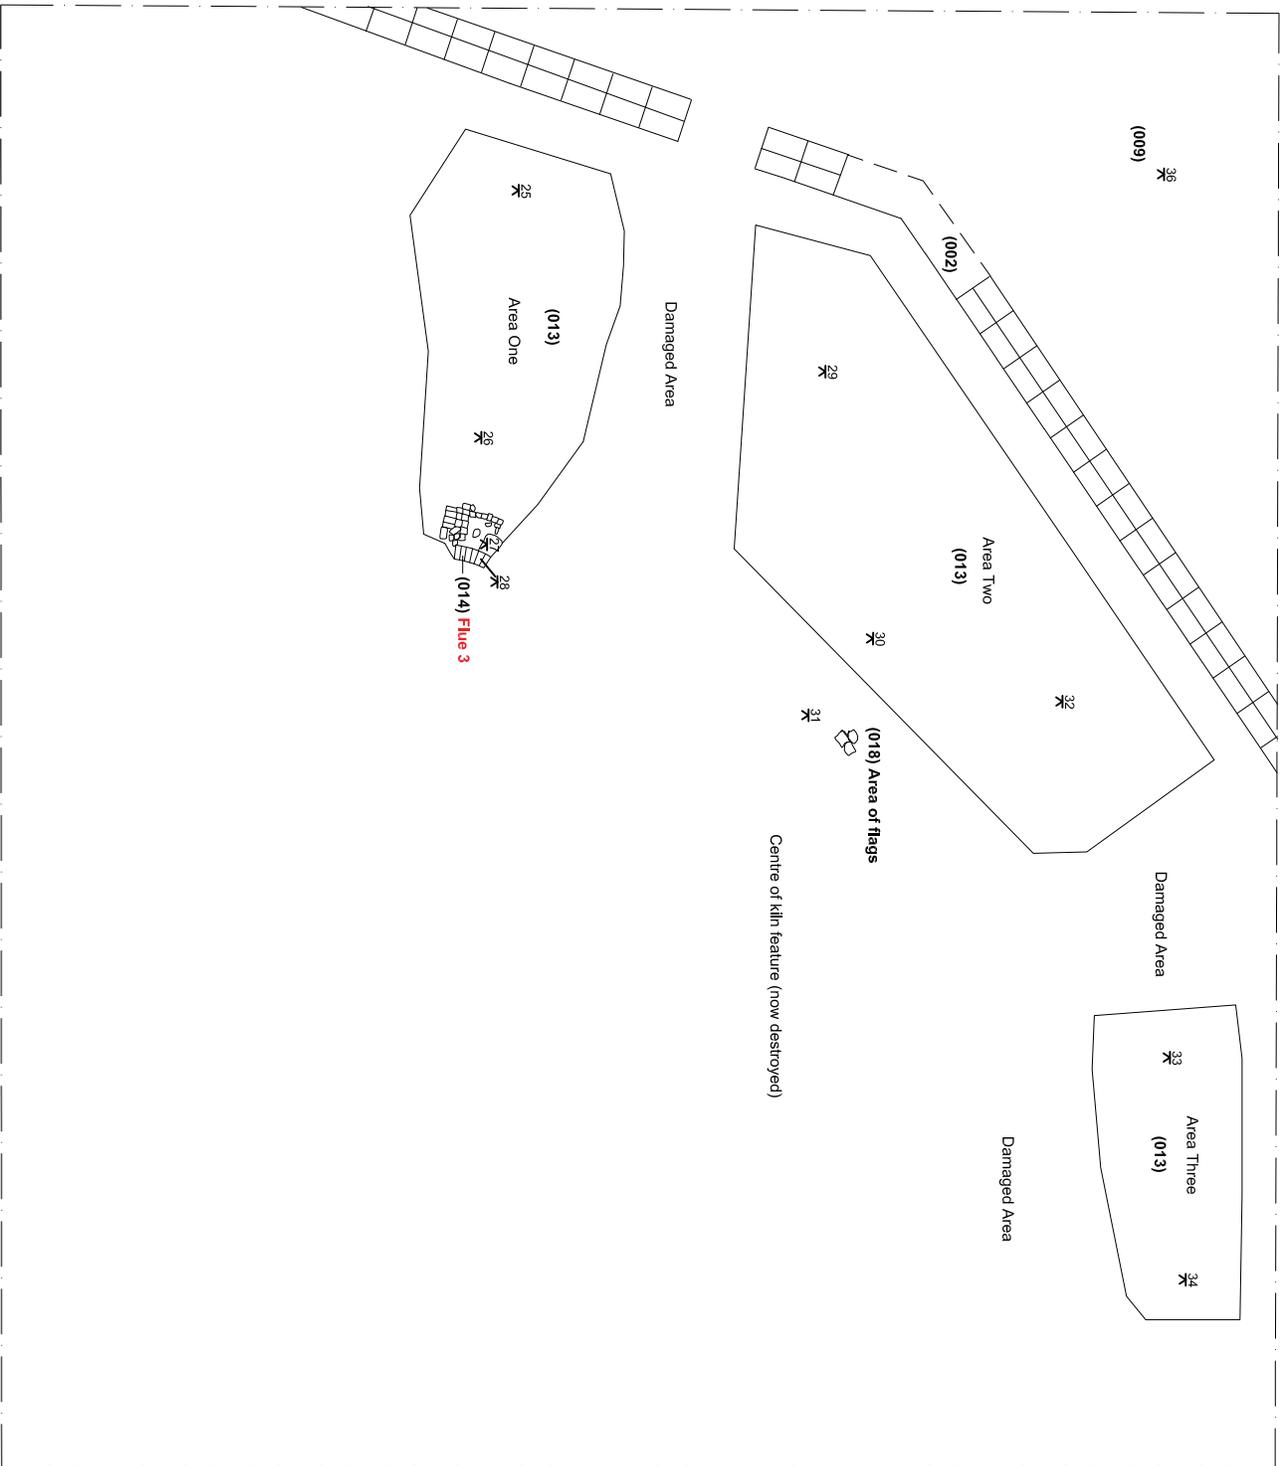
Figure 5: Plan of Phase
 One

- 6.2.1 Remains representing the earliest phase of the building were found to exist in the form of two floor levels (009 and 013) and two possible flues (014 and 015) (Fig. 5). The remains were in a poor state of repair and had been heavily truncated by later activity. No evidence for an external wall for this earlier building was identified (Fig. 7). The internal floor (013) had been damaged by modern services and was therefore divided into three areas. Area one was found to have been constructed of hand made bricks and firebricks, many of which were broken (See 7.1) (Fig. 6). Above the bricks was an intermittent deposit of compacted coal waste (012) that had accumulated over time in the areas close to the flues. The bricks showed signs of wear indicating the floors use over a period of time.

- 6.2.4 At approximately 1.5m south from the wall (002) the floor lowered and appeared to terminate (Fig. 5). A thin layer of modern concrete had been deposited, below which was a level of small flag stones (018) (Fig. 10). Only a small area of these flags could be revealed due to the concrete. The concrete was probably deposited to act as a sealing layer as the flags were loose and roughly arranged. The flags and the floor (013) are probably contemporary as the flags were not found to continue below the cobbles when the floor (013) was excavated later.

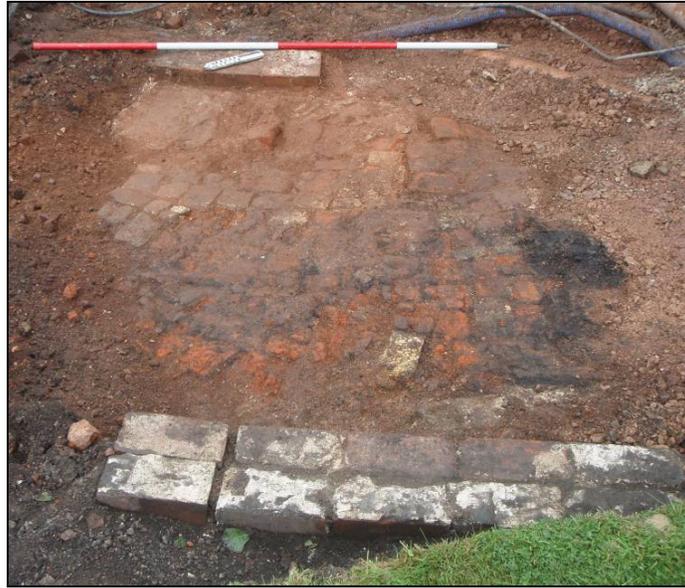
Fig. 6 Area one: Building two. Looking east. (Scale: 2m)

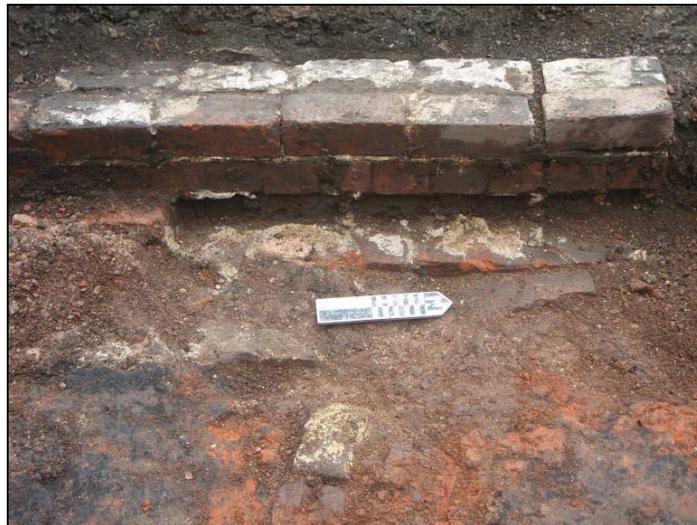
Fig. 7 View of the wall (002) and the earlier floor level (013). Looking west. (Scale: 0.25m)

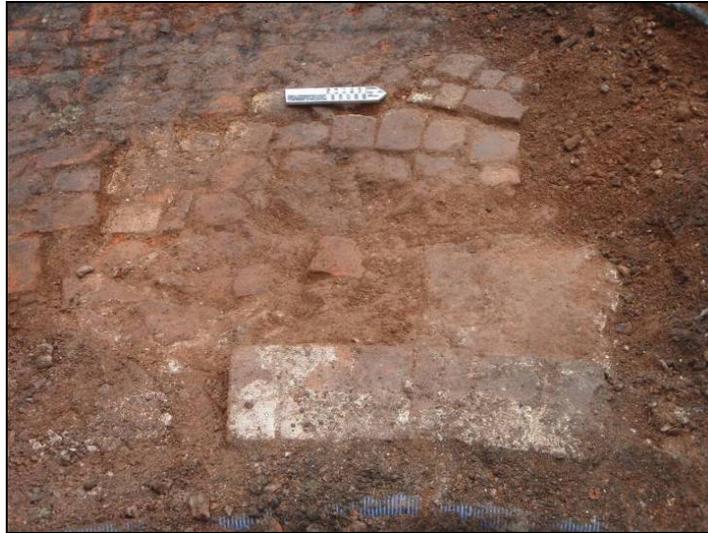
- 6.2.2 The truncated remains of a rectangular feature (014) (flue three) was revealed below the later flue one (Fig. 8). This indicates that the later phase of building followed the same layout as the earlier phase. The flue (014) contained an orange deposit (016) predominately made up of burnt bricks and clay. This context probably formed the base of the flue when it was in use.

Fig. 8 Flue three (014) found below flue two. Looking west.
(Scale: 0.25m)

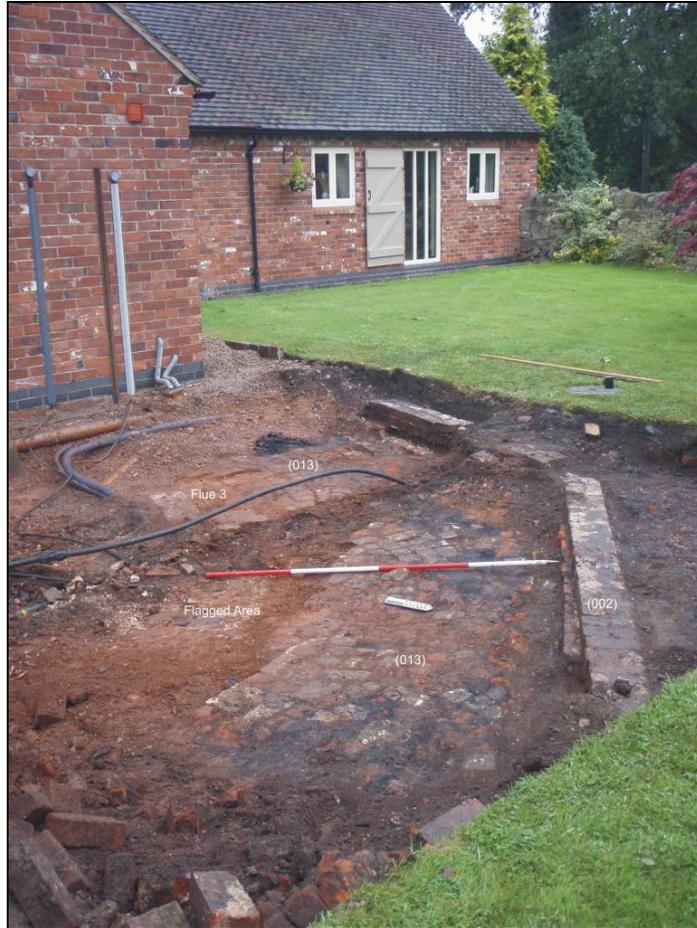
- 6.2.3 Floor (013) in area two was a continuation of that in area one and had no regular pattern but contained a high number of firebricks and patches of black coal waste (012) (Fig. 9). The floor was roughly laid and very worn. The floor had been damaged to the south so it was not possible to determine if an earlier flue had existed below flue two but it is probable due to the amount of the orange burnt brick deposit (016) found in that area.

Fig. 9 Area two: Floor (013), looking west.
(Scale: 2m)

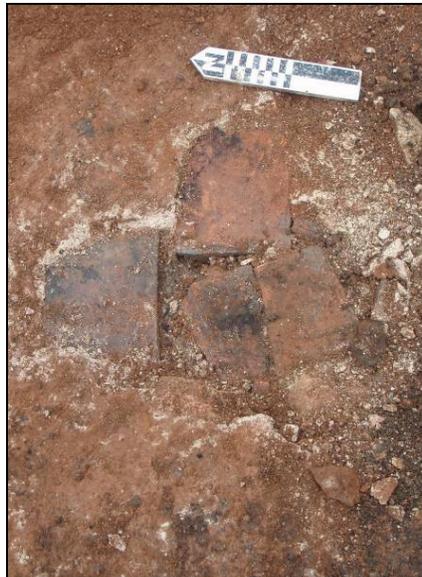
Fig. 10 Area of flags (018) below concrete layer (Scale: 0.25m)

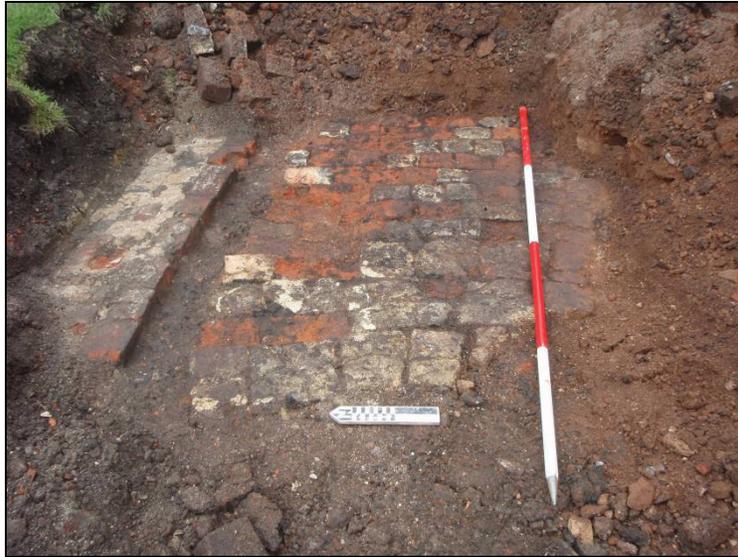
6.2.5 Area three was the final area of the floor (013) to be exposed and was located in the north east corner of the trench (Fig. 11). The floor had been damaged to the south and east by modern services which meant only an area measuring 1.7m by 1.2m remained. The floor in this area contained more firebricks than the other two areas and was found to be two layers thick in places (Fig. 12). Although this could be the remains of an earlier floor, it seems more likely that it represents areas of repair to the floor over time as the bricks below were very similar to the ones above.

Fig. 11 Area three (013), looking east. (Scale: 2m)

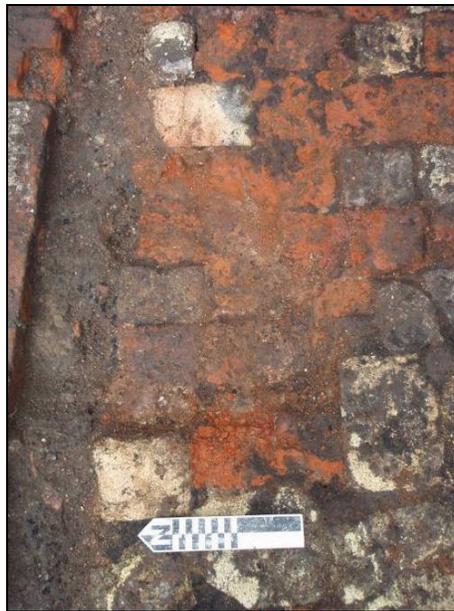
Fig. 12 Area three: Area of floor (013) where two layers of bricks exist. (Scale: 0.25m)

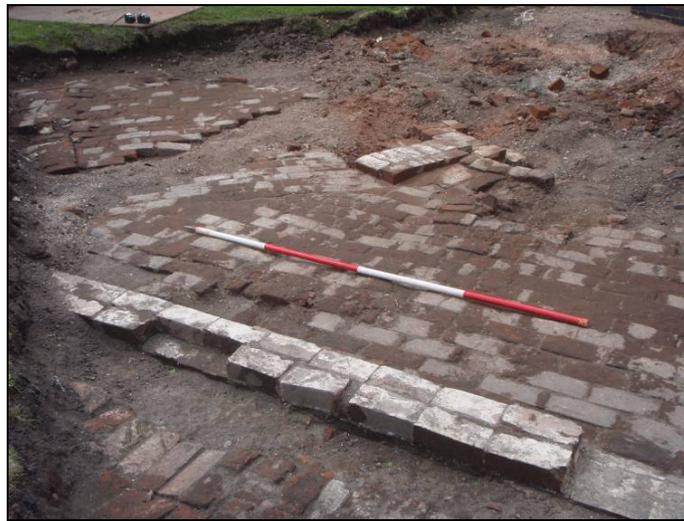
Fig. 14 Building one showing wall (002) and (003). Looking east (Scale: 2m)

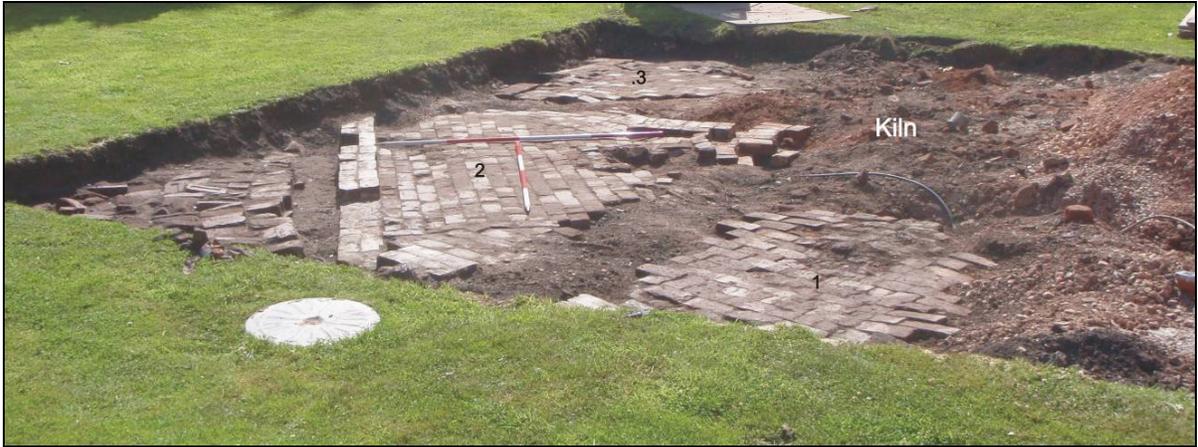
- 6.3.3 Brick floor levels (003 and 004) were exposed on either side of the wall (002) which have been interpreted as interior (003) and exterior (004) floors (Fig.15). The floor (003) had been laid in triangular panels that followed the octagonal shape of the building. The bricks were laid in a stretcher pattern that followed the same alignment as the wall section they abutted. These panels narrowed towards the centre to allow for the circular shape of the kiln and were separated by a single line of vertical bricks. The floor had been damaged by modern services creating three areas of surviving floor level. Areas one and two contained the truncated remains of two small rectangular flue features which were set within the floor.

Fig. 15 Overall view of building one showing the three areas that survived and the probable location of the kiln. Looking north-east (Scale: 2m)

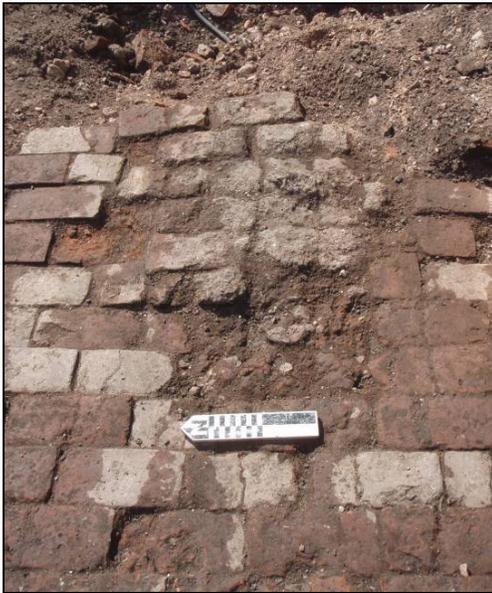
6.3.4 Flue one (007) was located in area one of the floor to the west of the trench area and consisted of a rectangular area of degraded burnt bricks that measured 0.48m by 0.53m (Fig. 16). Although the feature did not have any structural components remaining it is likely it represents an opening in to the kiln (now destroyed) for inserting pots or fuel. Flue two (006) was located within area two of the floor in the centre of the trench and consisted of a small rectangular arrangement of bricks measuring 0.45m by 0.5m (Fig. 17). The feature had been damaged to the south where it would have adjoined the kiln so its exact dimensions could not be recorded. Both flues are integral parts of the kiln structure and can therefore be interpreted as contemporary.

Fig. 16 Flue one (007) (Scale: 0.25m)

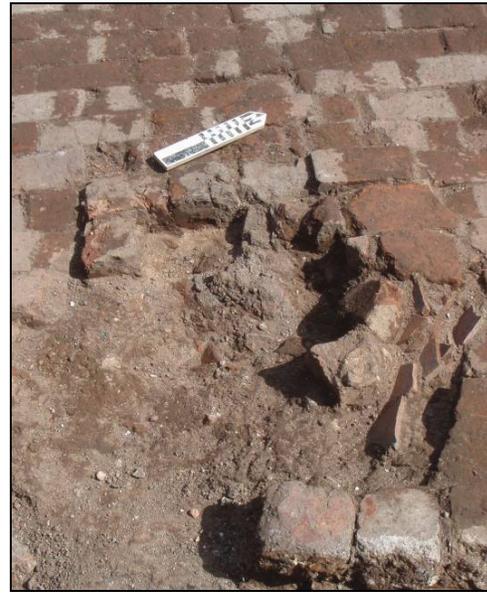
Fig. 17 Flue two (006) (Scale: 0.25m)

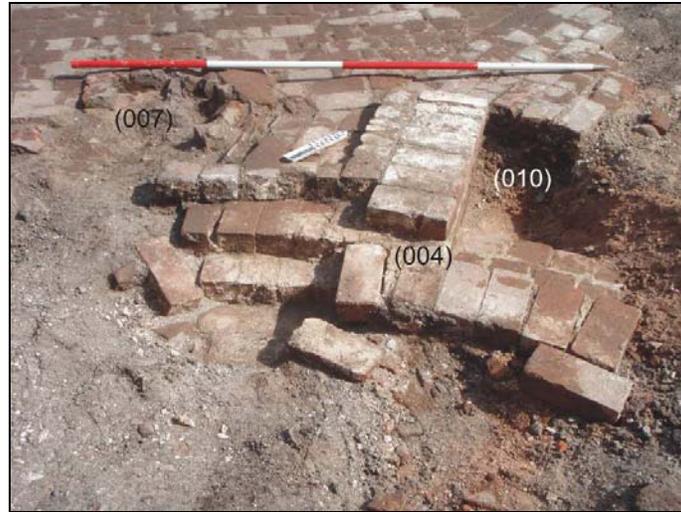
Fig. 18 Remains of the kiln and flue one. Looking North. (Scale: 2m)

- 6.3.6 The surviving area of kiln consisted of a curved wall (004) which measured 1.43m across (Fig. 18). The wall was made up of at least three single courses of bricks laid on bed and aligned north south. The wall was stepped down into the interior of the kiln. Another small area of the curved wall was found near flue two and also at the south east corner of the trench this allowed the diameter of the kiln to be established at 4.3m.

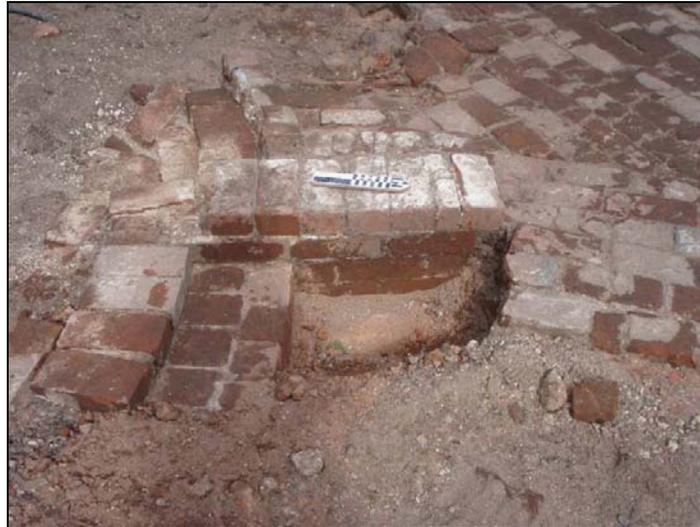
- 6.3.7 A small wall or buttress was keyed in to the curved kiln wall. It was positioned 0.45m east from flue one and measured 0.6m by 0.35m (Fig. 19). This small buttress wall was four courses deep and overlay a compacted metalled surface (010) which was also found to exist at the base on the interior of the kiln. Although the lower courses of the wall had been laid in a stretcher pattern the bricks of the top surviving course were positioned as a single row of bricks laid on bed with a corresponding row of half-bat bricks at the west end of each full brick.

Fig. 19 Kiln feature showing depth of the buttress wall. Looking west. (Scale: 0.25m)

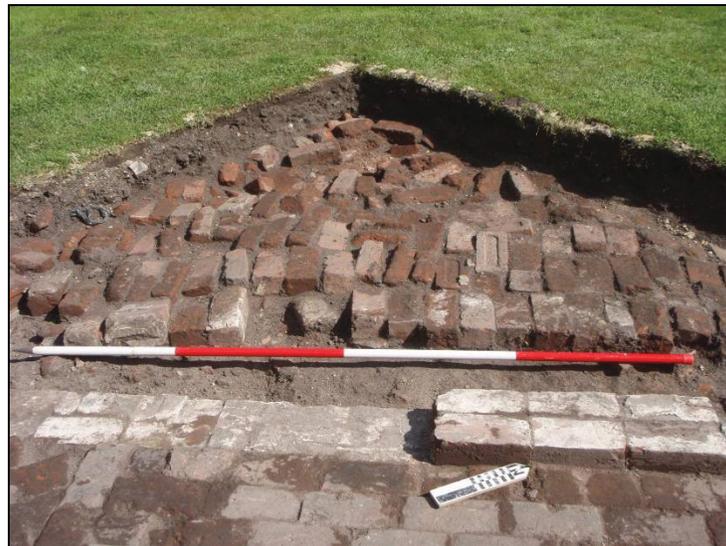
6.3.8 A second floor level (004) was located in the North West corner of the trench on the other side of the wall (002) to the floor level (003) (Fig. 20). The roughly laid area of floor that was exposed measured 4.5m by 2m and comprised of a mixture of bricks being laid on bed and on edge. Some of the bricks were imprinted with the word 'Melbourne' which was a local brick works on the edge of Ticknall (*Pers. Com*) (Fig. 21). Between the floor level and the wall (003) was a 0.3m gap which consisted of a compacted silty fill (008) which contained broken pottery (grog) and clay pipe. The floor level is likely to be an external area contemporary with the other features described, but as only a small area was revealed it is impossible to say this for certain.

Fig. 20 Floor level (004). Looking north west. (Scale: 2m)

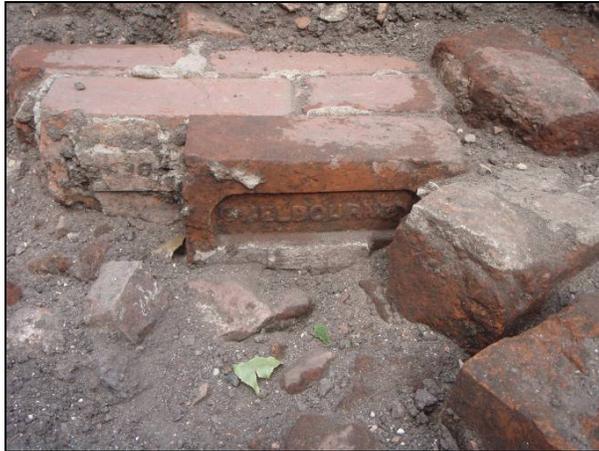
Fig. 21 Brick imprinted with the word 'Melbourne' found within floor (004).

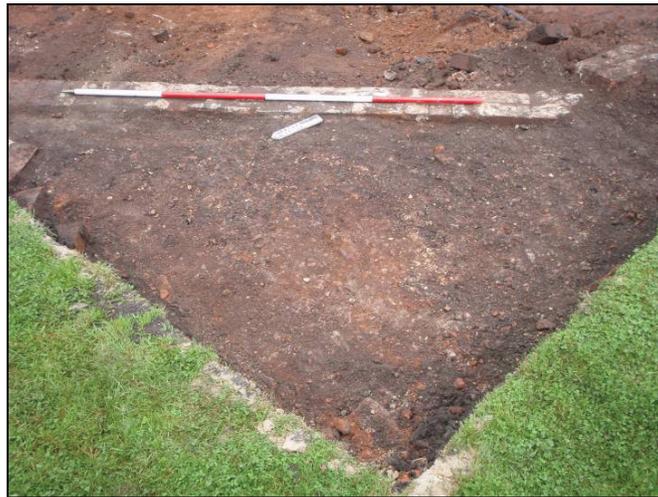
- 6.3.9 Below the external floor level (005) and the silty fill (008) there was a compacted metallised surface (009) that contained a large amount of broken pottery (grog), broken bricks, slag, glass and coal (Fig. 22). This surface is contemporary or later than as it was found to directly abut the wall (002) and was at a higher level to the earlier floor level (013).

Fig. 22 Metallised floor surface (009) below exterior floor level (005), looking south east.
(Scale: 2m)

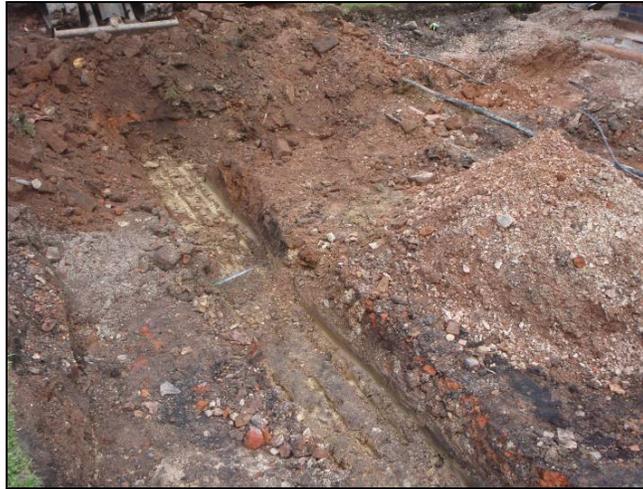
- 6.3.10 Excavation of both phase one and two of the building revealed a layer of building hardcore (017) which was approximately 0.2m in depth and that contained a large amount of broken pottery. As this layer was found to directly overlay the natural alluvial clay (019) it can be interpreted as the earliest archaeological level on site (Fig. 23).

Fig. 23 View of the footings showing the depth of the natural alluvium.
