An Archaeological Building Recording
of Burradon Farm, Burradon Village,
Cramlington, Tyne & Wear.

Archaeological Research Services Ltd Report No. 2008/78
October 2008

**An Archaeological Building Recording
of Burradon Farm, Burradon Village, Cramlington, Tyne & Wear.**

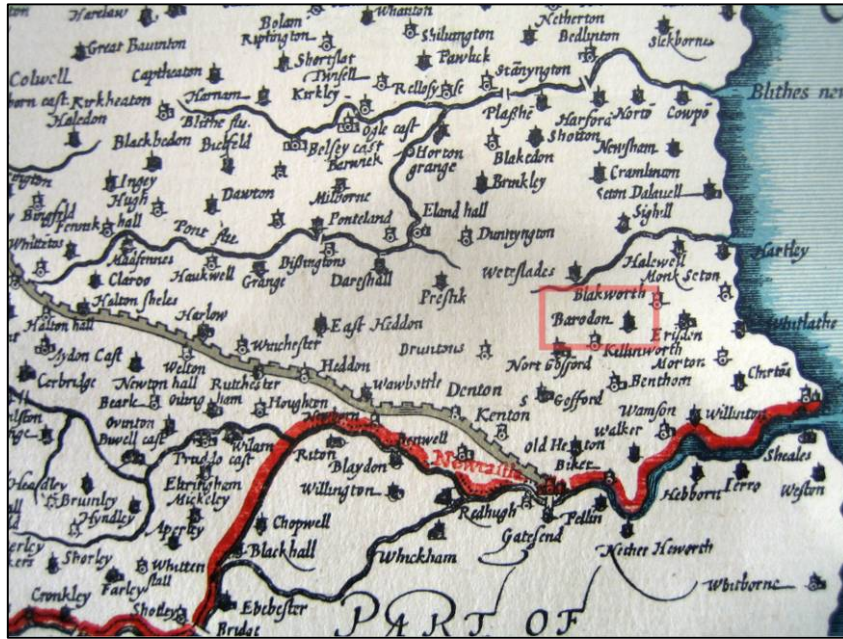
FIG. 2

1.2.1 Burradon Farm is located on Burradon Road, North Tyneside at NZ 275730 (Fig. 2). The landscape is gently undulating and a mixture of agricultural and urban in character, lying to the north of the major conurbation of Newcastle-upon-Tyne. The farm complex is situated at 60m aOD. The bedrock geology of the area consists of Westphalian Coal Measures and the superficial geology is made up of glacial till deposits (British Geological Survey 2007).

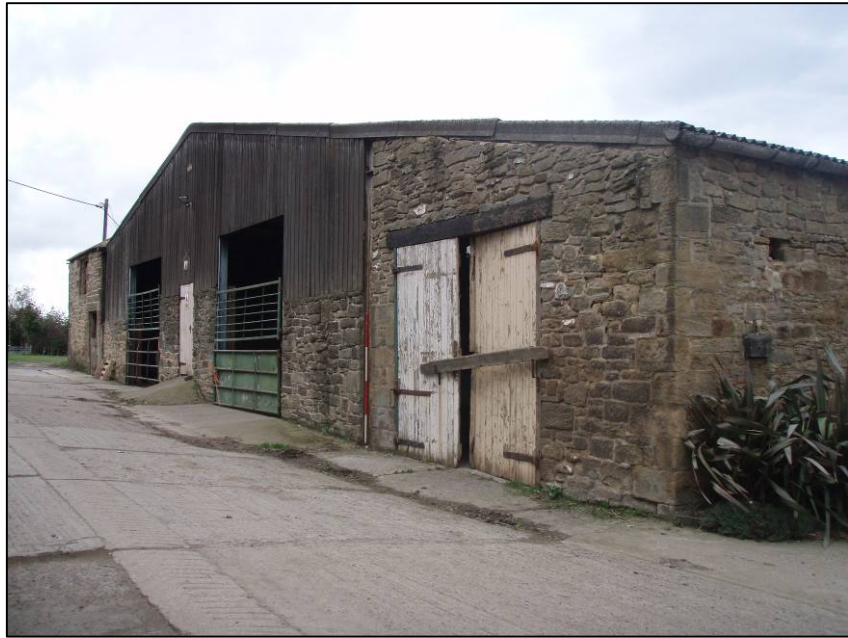
Fig. 15 General shot of south facing elevation exterior.

This elevation comprises elements from Phase II and Phase IV of the construction (Fig. 15). The eastern end of the elevation (Fig. 16), measuring 6m wide, is from Phase II, which has been reduced to one storey tall (approximately 4.5m tall) by the roofing works undertaken in Phase IV and had a large double door fitted centrally, probably at the same time as the Phase IV works, although this is not certain. The walls are built of rough sandstone blocks bedded in a greyish mortar with a modern steel and asbestos roof structure above. The western end of the elevation (Fig.17), measuring 6m wide, is also from Phase II, although it survives much better than the eastern end. Standing two storeys tall it is built of rough sandstone blocks that have been repointed with a pale brown mortar and sandstone ashlar quoins. A door at ground floor level gives access to Room 1 (the stables) and a central window at first floor level gives access to Room 8 (hayloft). Both are built of sandstone ashlar blocks, sandstone lintels and sills with wooden frames. The roof is of modern timber, although the slates may well have been reused. The central section of this elevation is Phase IV (Fig. 18) and comprises three sandstone faced brick piers, surmounted by a wooden lath construction attached to a steel framework. Two large entrances are gated with steel gates. The roof is of steel and asbestos construction.

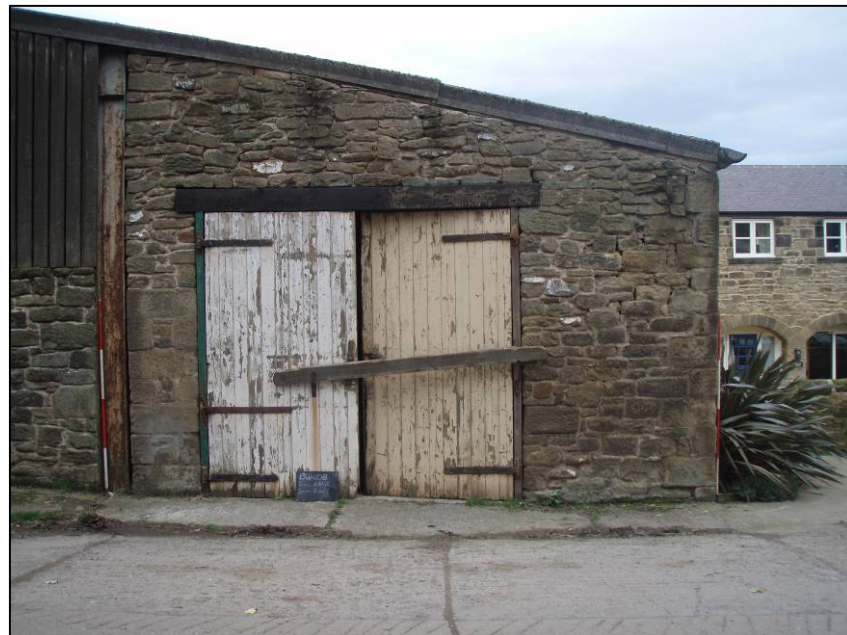
Fig 16. Phase II South elevation, east side exterior.

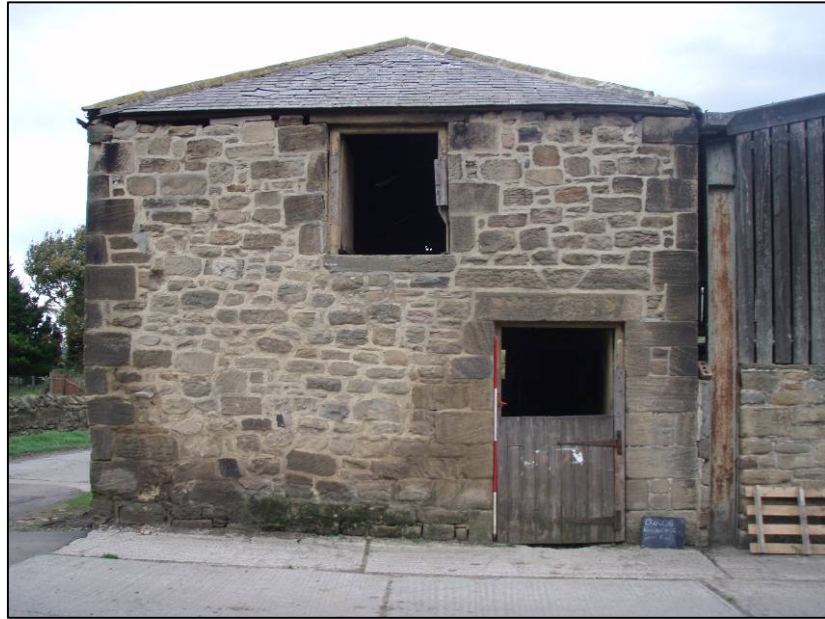
Fig. 17 Phase II south facing elevation, west side exterior.

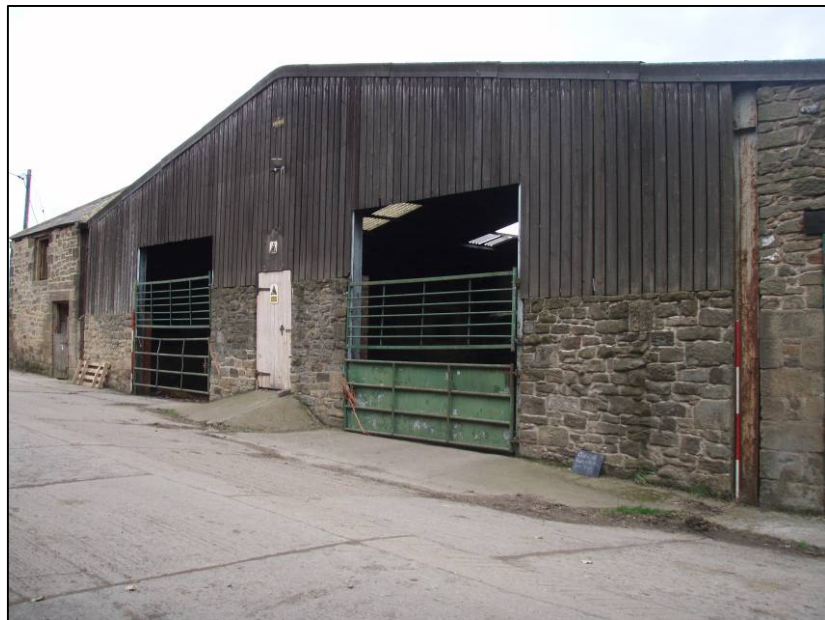
Fig. 18 Phase IV south elevation.

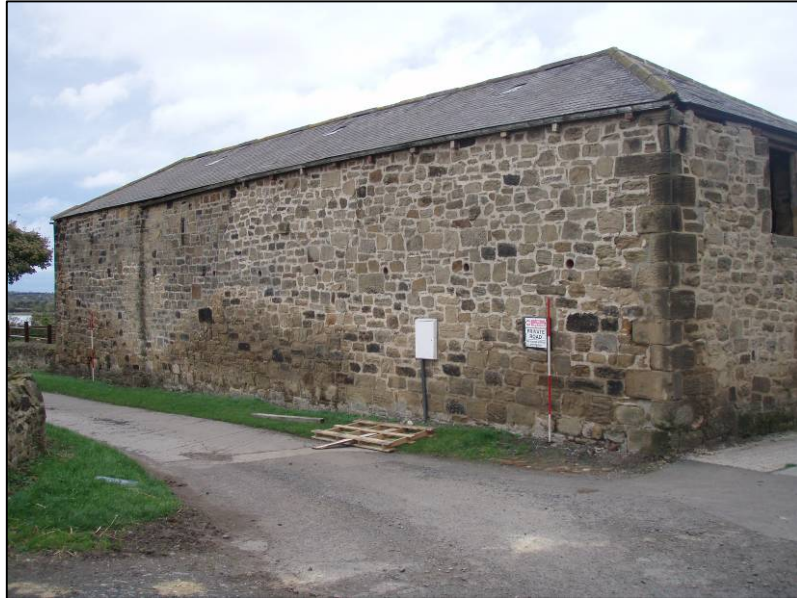
Fig. 19 Phase II west facing elevation, exterior.

This elevation, measuring 21m in width, comprises only elements from Phase II of the construction (Fig. 19). The wall is built of rough sandstone blocks and ashlar quoins bedded in a greyish mortar with a modern timber framed roof, with probably re-used slate covering above. No evidence of any openings are visible in this wall which, at its northern end, is significantly bowed and will need significant remedial works or demolition and rebuilding.

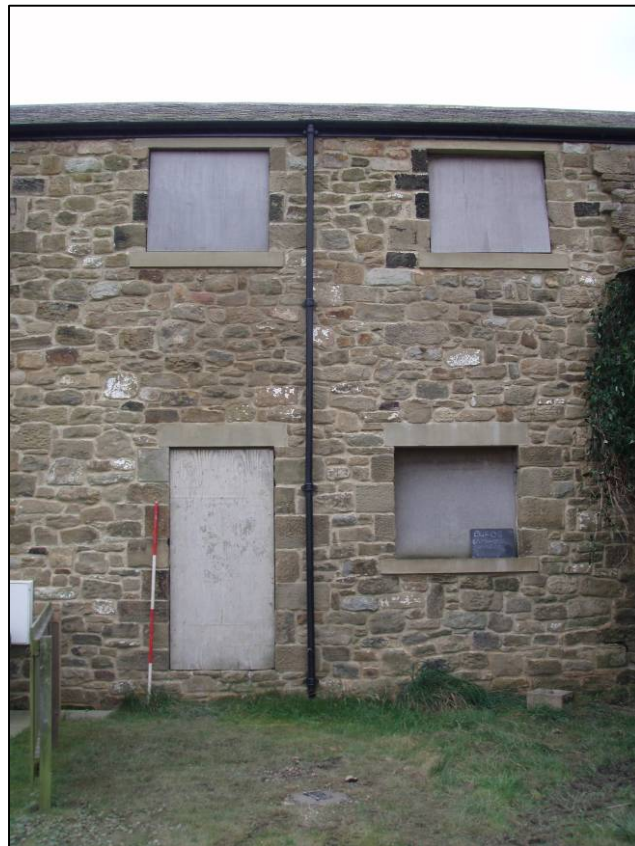
Fig. 20 Phase I north facing elevation, exterior.

This elevation comprises elements from Phase I, Phase II and Phase III of the construction. The eastern end of the elevation, measuring 15m in width, is from Phase I (Fig. 20) and is built of rough sandstone blocks and ashlar quoins bedded in a greyish mortar with a modern timber framed roof, with probably re-used slate covering. At the eastern end of the Phase I structure a doorway and window at ground floor level and two windows at first floor level have all had their lintels and sills replaced with modern sandstone blocks, which are in keeping with the character of the building. The ground floor openings give access to Room 5. At the western end of the Phase I structure two windows at first floor level retain their original sandstone sills and lintels and give access to the upper room in this building. A modern brick lean-to has been built against the face of this elevation (Fig. 21). The west of this elevation is from Phase II (Fig. 22), measures six metres wide and is of rough sandstone blocks bedded in a greyish mortar with a modern timber framed roof, with probably re-used slate covering. A doorway and window at ground floor level, both of sandstone ashlar blocks and wooden frames, give access to Room 2 and a window at first floor level, also of sandstone ashlar blocks and wooden frame construction gives access to Room 8. Between the Phase I and Phase II buildings a third phase of construction is evident (Fig. 23), measuring 9.5m in width and built of rough sandstone blocks in a light

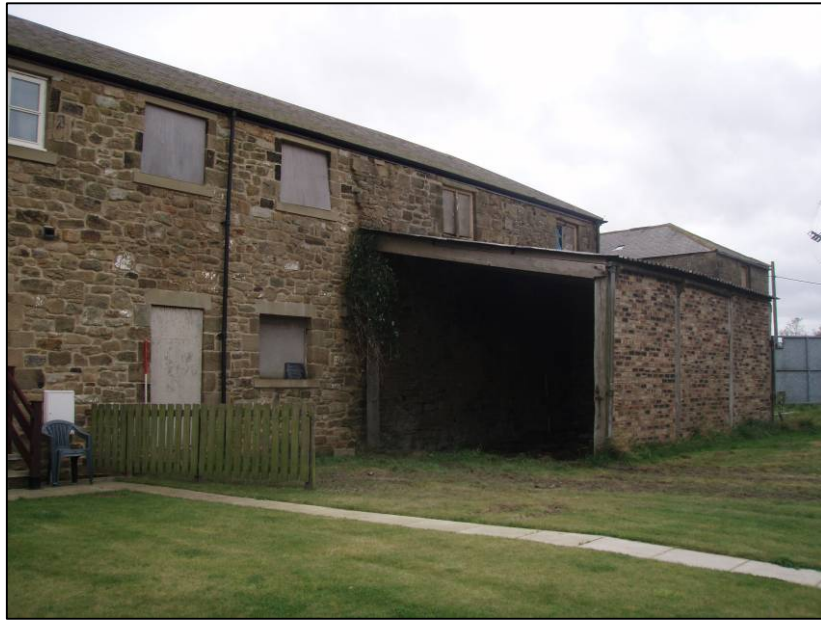
Fig. 21 Modern lean to on north elevation.

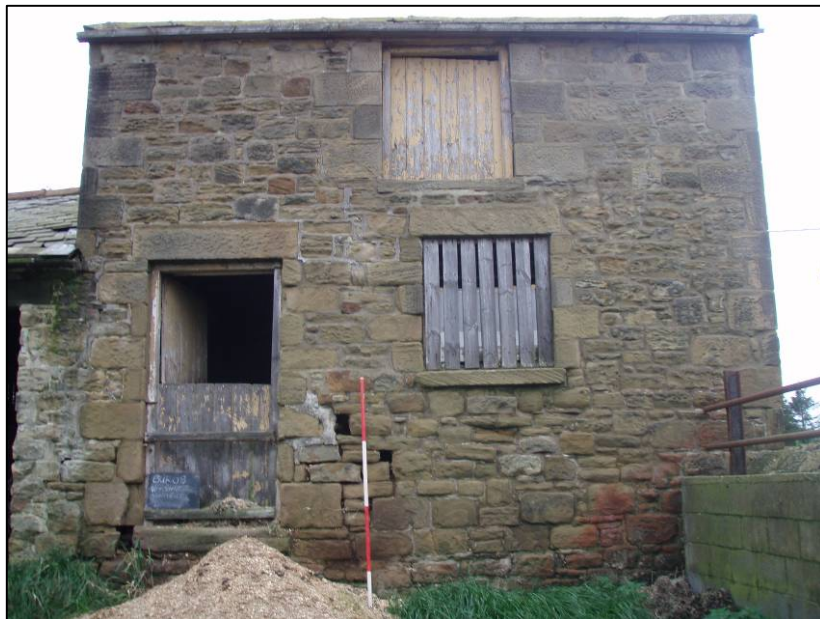
Fig. 22 Phase II north facing elevation, exterior.

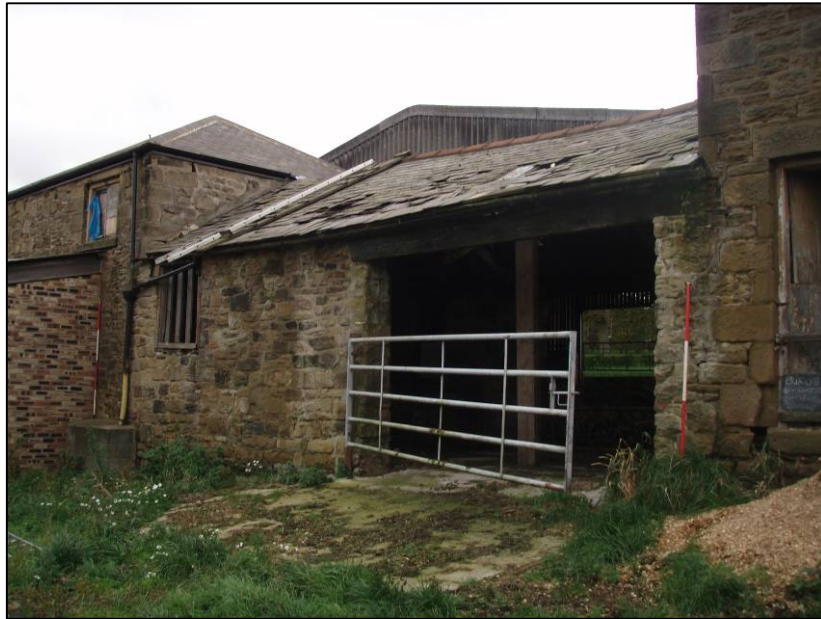
Fig. 23 Phase III North facing elevation, exterior.

grey/white mortar that abuts the face of the Phase I structure but has been keyed into the Phase II structure. It is surmounted by a modern timber and slate roof, which is in danger of imminent collapse.

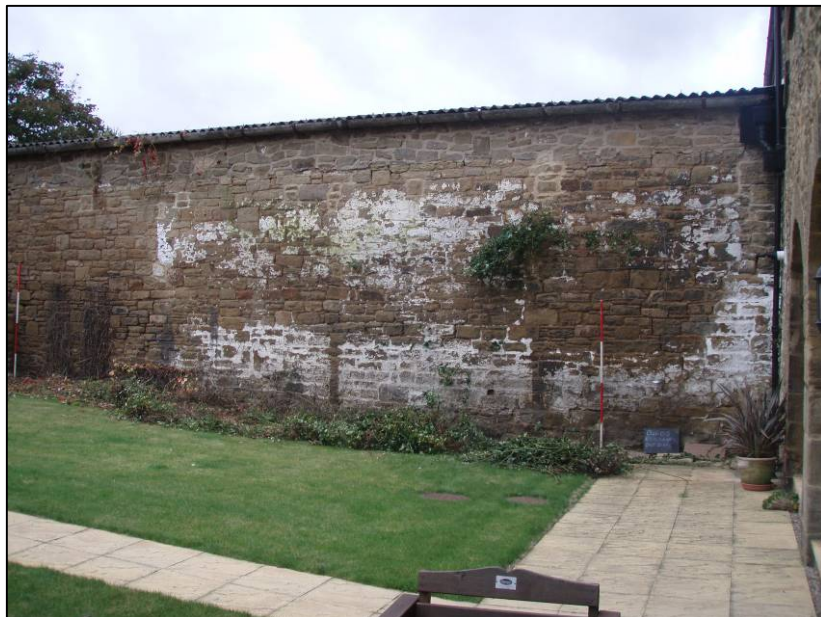
Fig. 24 East facing elevation, exterior.

This elevation comprises only elements from Phase II of the construction and abuts the Phase I structure to the north (Fig. 24). The wall is built of rough sandstone blocks with ashlar quoins bedded in a greyish mortar with a modern timber framed roof, with probably re-used slate covering above. A doorway (Fig. 25), blocked with rough sandstone blocks is visible at its northern end and two square holes at the southern end, blocked from inside by modern brickwork, are thought to be old pigeon access holes.

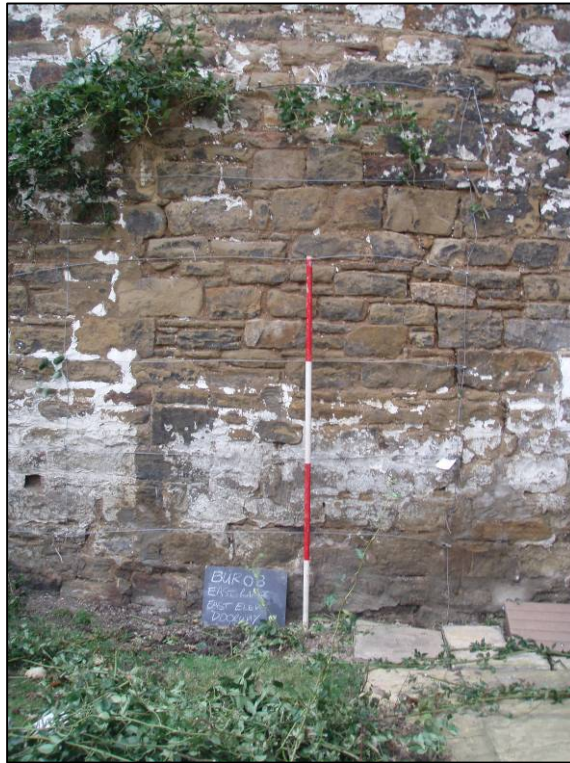
Fig. 25 Phase II east facing elevation, exterior doorway.

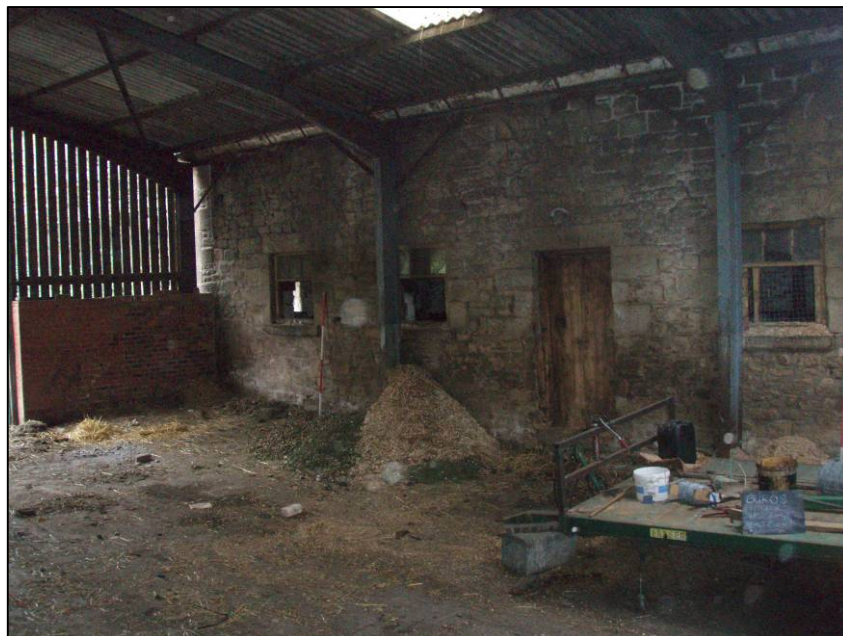
Fig. 26 Phase II east facing elevation, interior.

This elevation comprises only elements from Phase II of the construction (Fig. 26), with a wall from Phase II abutting the elevation 5.5m from the northern end. The wall is built of rough sandstone blocks with ashlar quoins bedded in a greyish mortar with a modern timber framed roof, with probably re-used slate covering above. Four windows and one doorway, all at first floor level, built of sandstone ashlar blocks, lintels and sills with wooden frames give access to Room 1.

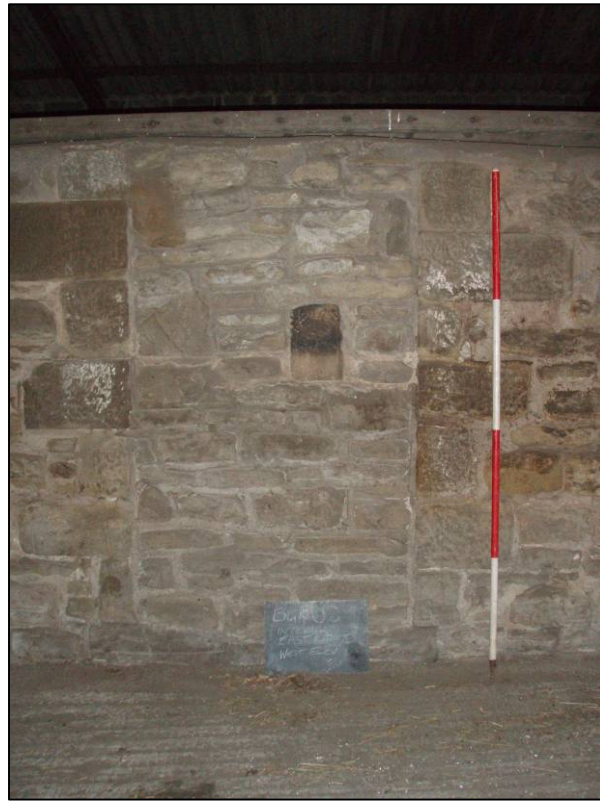
Fig. 27 Phase II west facing section, interior.

This elevation comprises only elements from Phase II of the construction and abuts the Phase I structure at its northern end (Fig. 27). The wall is built of rough sandstone blocks bedded in a greyish mortar and has been reduced to around 2.2m in height. Four windows and one doorway, all at first floor level, built of sandstone ashlar blocks, lintels and sills which originally gave access to Room 6 have been reduced in height and blocked with modern blockwork. The style of construction of this elevation is identical to that of the western stable block indicating that they were built at the same time.

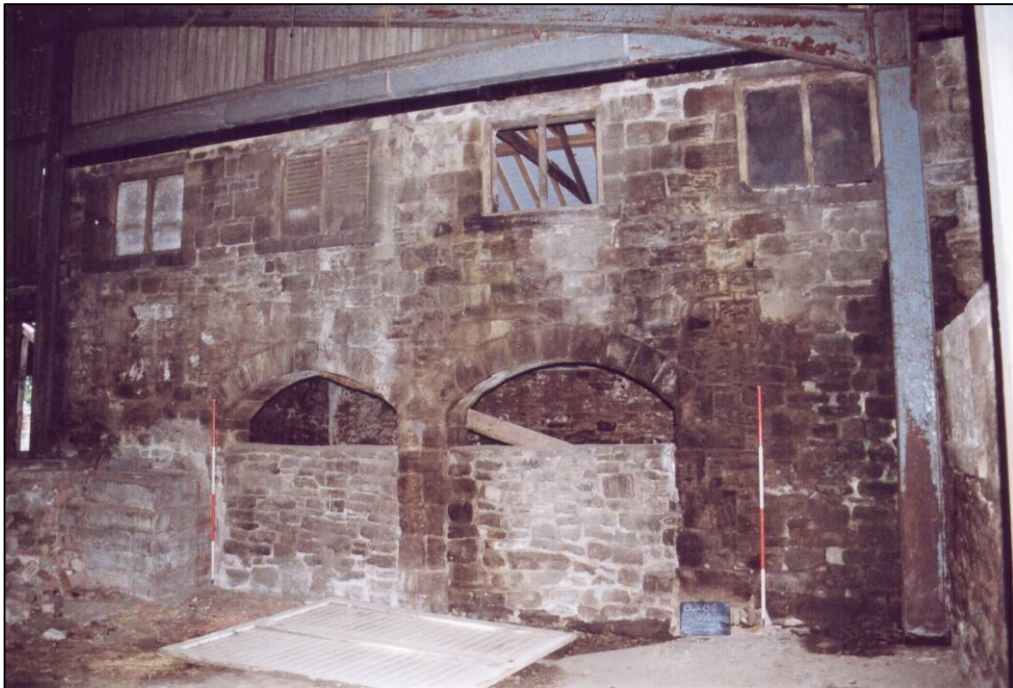
Fig. 28 Phase I south facing elevation, interior.

This elevation comprises elements from Phase I and Phase III of the construction. To the east the Phase I structure (Fig. 28) is built of rough sandstone blocks and ashlar quoins bedded in a greyish mortar and is abutted by the eastern Phase II structure at eastern extent. Two large arched doorways (Fig. 29), measuring 2m in width and 2.3m in height at their centre, are built of sandstone blocks and have been infilled to a height of 1.5m by a wall of rough sandstone blocks bedded in a light grey/white mortar, similar to that used in the Phase II construction, suggesting they were blocked off at this time. The archways originally gave access to Room 4. At first floor level are four windows, built of sandstone ashlar blocks, lintels and sills with wooden frames.

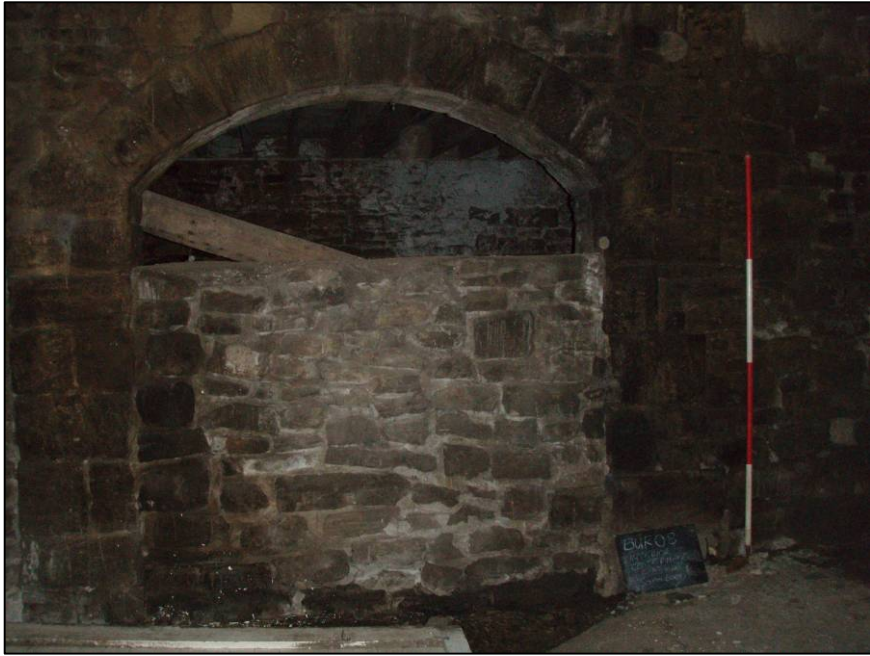
Fig. 29 Phase I in-filled archway.

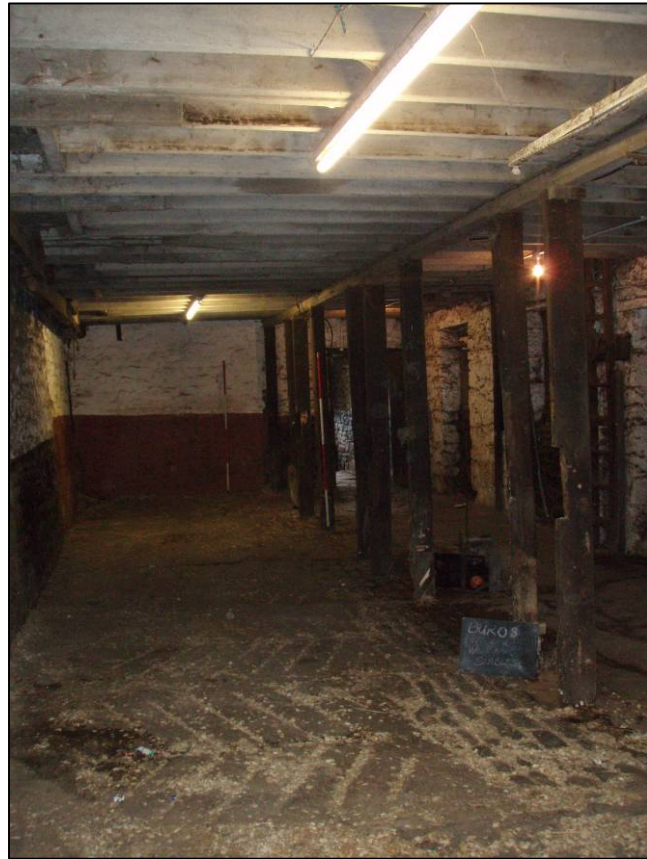
Fig. 31 Interior of room 1.

This room is situated at the southern end of the western Phase II structure on the ground floor. This formed the stables to the complex, although the stalls have been almost entirely removed, leaving just the central line of roof supports in place. Patches of the original cobbled flooring, of small rectangular rounded

cobblestones, each measuring around 0.2m long and 0.1m wide were visible down the centre of the floor, although were mostly obscured by a modern concrete surface that overlay them (Fig. 31).

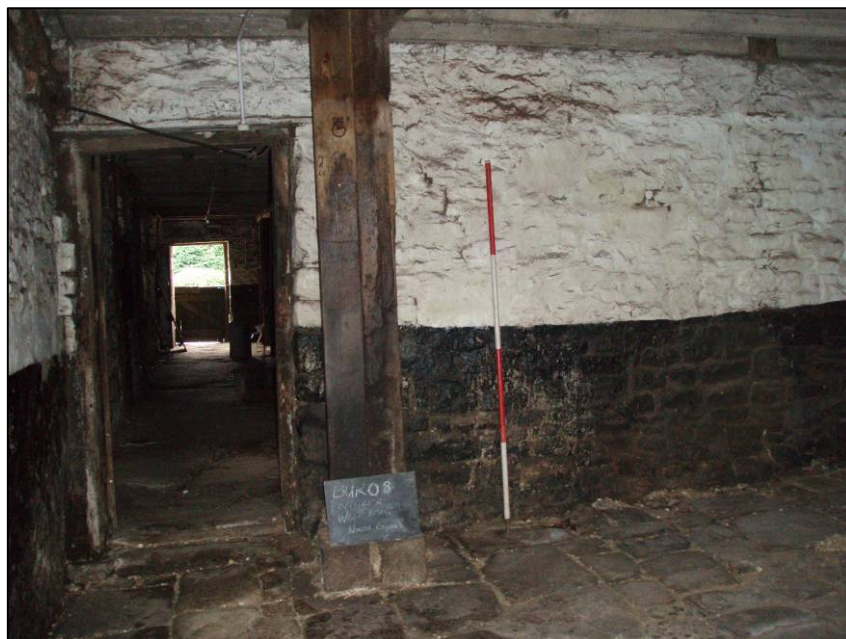
Fig. 32 Interior of room 2.

This room is situated at the northern end of the western Phase II structure on the ground floor. The original paved flooring, or irregular rectangular blocks was visible in this room (Fig. 32). The western wall in this room had a considerable crack running vertically along the partition wall between Rooms 1 and 2.

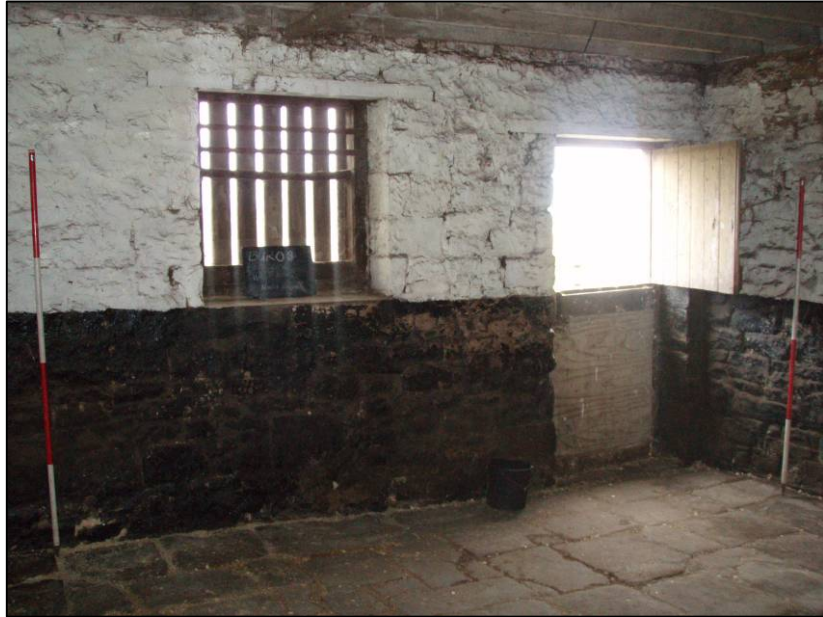
Fig. 33 Interior of room 3 looking east.

This room is situated in the Phase III structure (Fig. 33). The east wall of this room had been obscured to around 0.7m in height with a modern brick wall that would have held cattle feed trough. A doorway of sandstone blocks with a wooden frame situated in the south-east corner of the room gave access into Room 4. No other features of note were seen in this room.

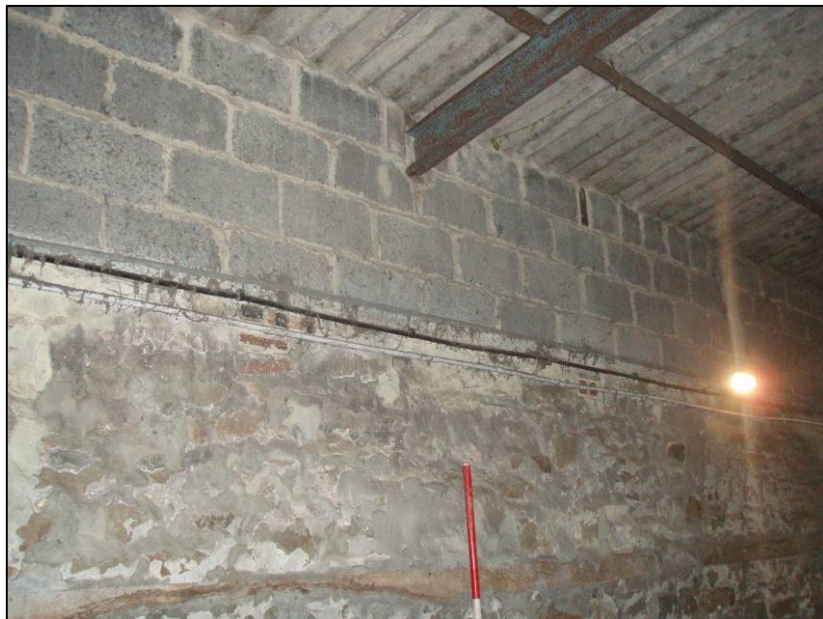
Fig. 34 Interior of room 6 showing remodelling of roof.

This room is situated at the southern end of the eastern Phase II structure on the ground floor. The western wall showed the infilled remnants of the four windows and doorway that have been described in Section 6.1.6 above. A partially blocked doorway in the north wall gave access to Room 5. The upper sections of the east and south wall had been extensively remodelled with modern brickwork to support the modern steel and asbestos roof (Fig. 34) and insert the large double doorway.

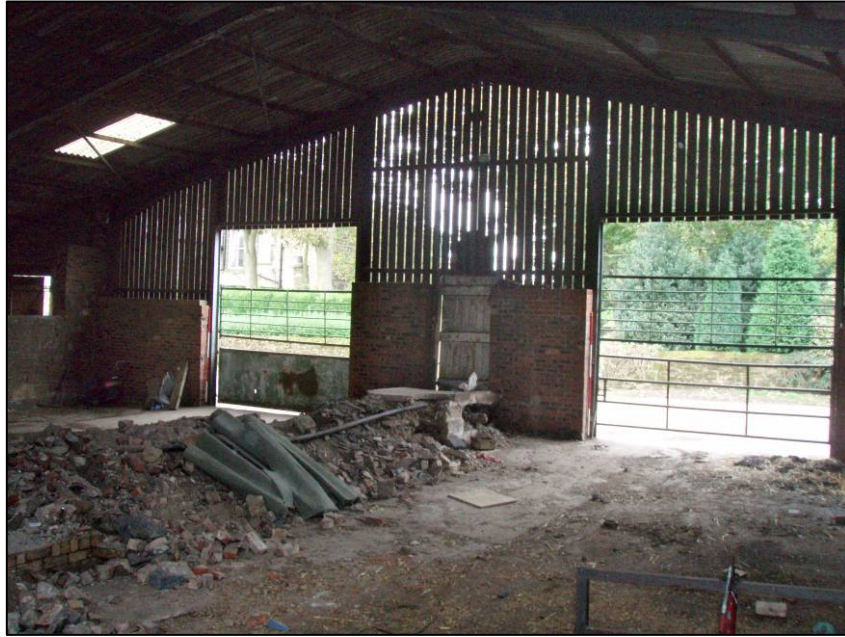
Fig. 35 Interior of room 7.

This room is situated centrally to the complex. Originally the courtyard to the complex, it is now roofed by a modern steel and asbestos roof (Fig. 35). A modern raised brick and concrete feature, running north to south through the centre of the room originally held cattle feed troughs. This, along with the modern roof, is to be removed as part of the development, which will return the courtyard back to its original form.

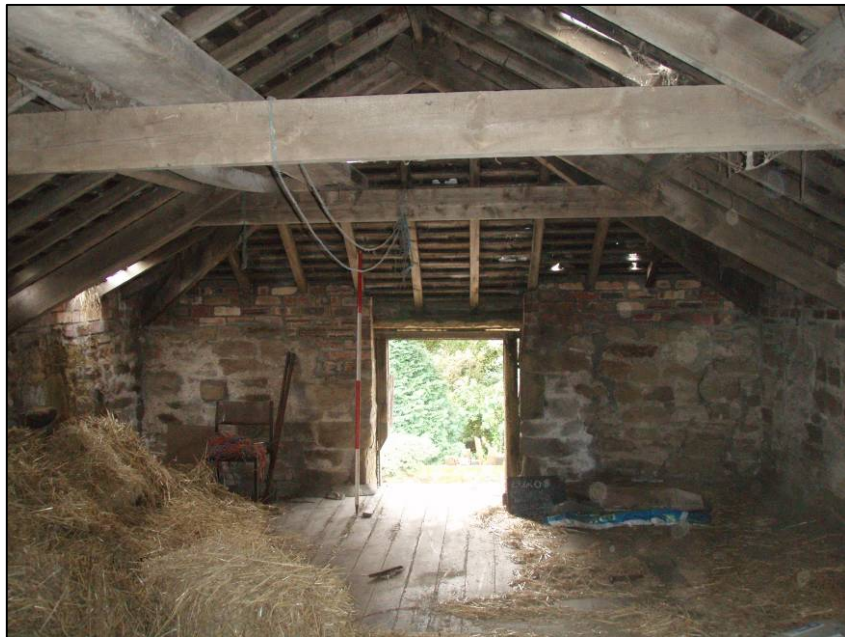
Fig. 36 Interior of room 8.

This room is situated on the first floor of the western Phase II structure. No features of note were visible in this room and the upper sections of the walls had been remodelled with at least four courses of brickwork into which the modern timbers for the roof had been inserted (Fig. 36).
