AN ARCHAEOLOGICAL EVALUATION

Liverpool Street, Pendleton, Salford, Greater Manchester

ARS Report N°: 2023/37
OASIS ID: archaeol5-514517

An Archaeological Evaluation at Liverpool Street, Pendleton, Salford, Greater Manchester

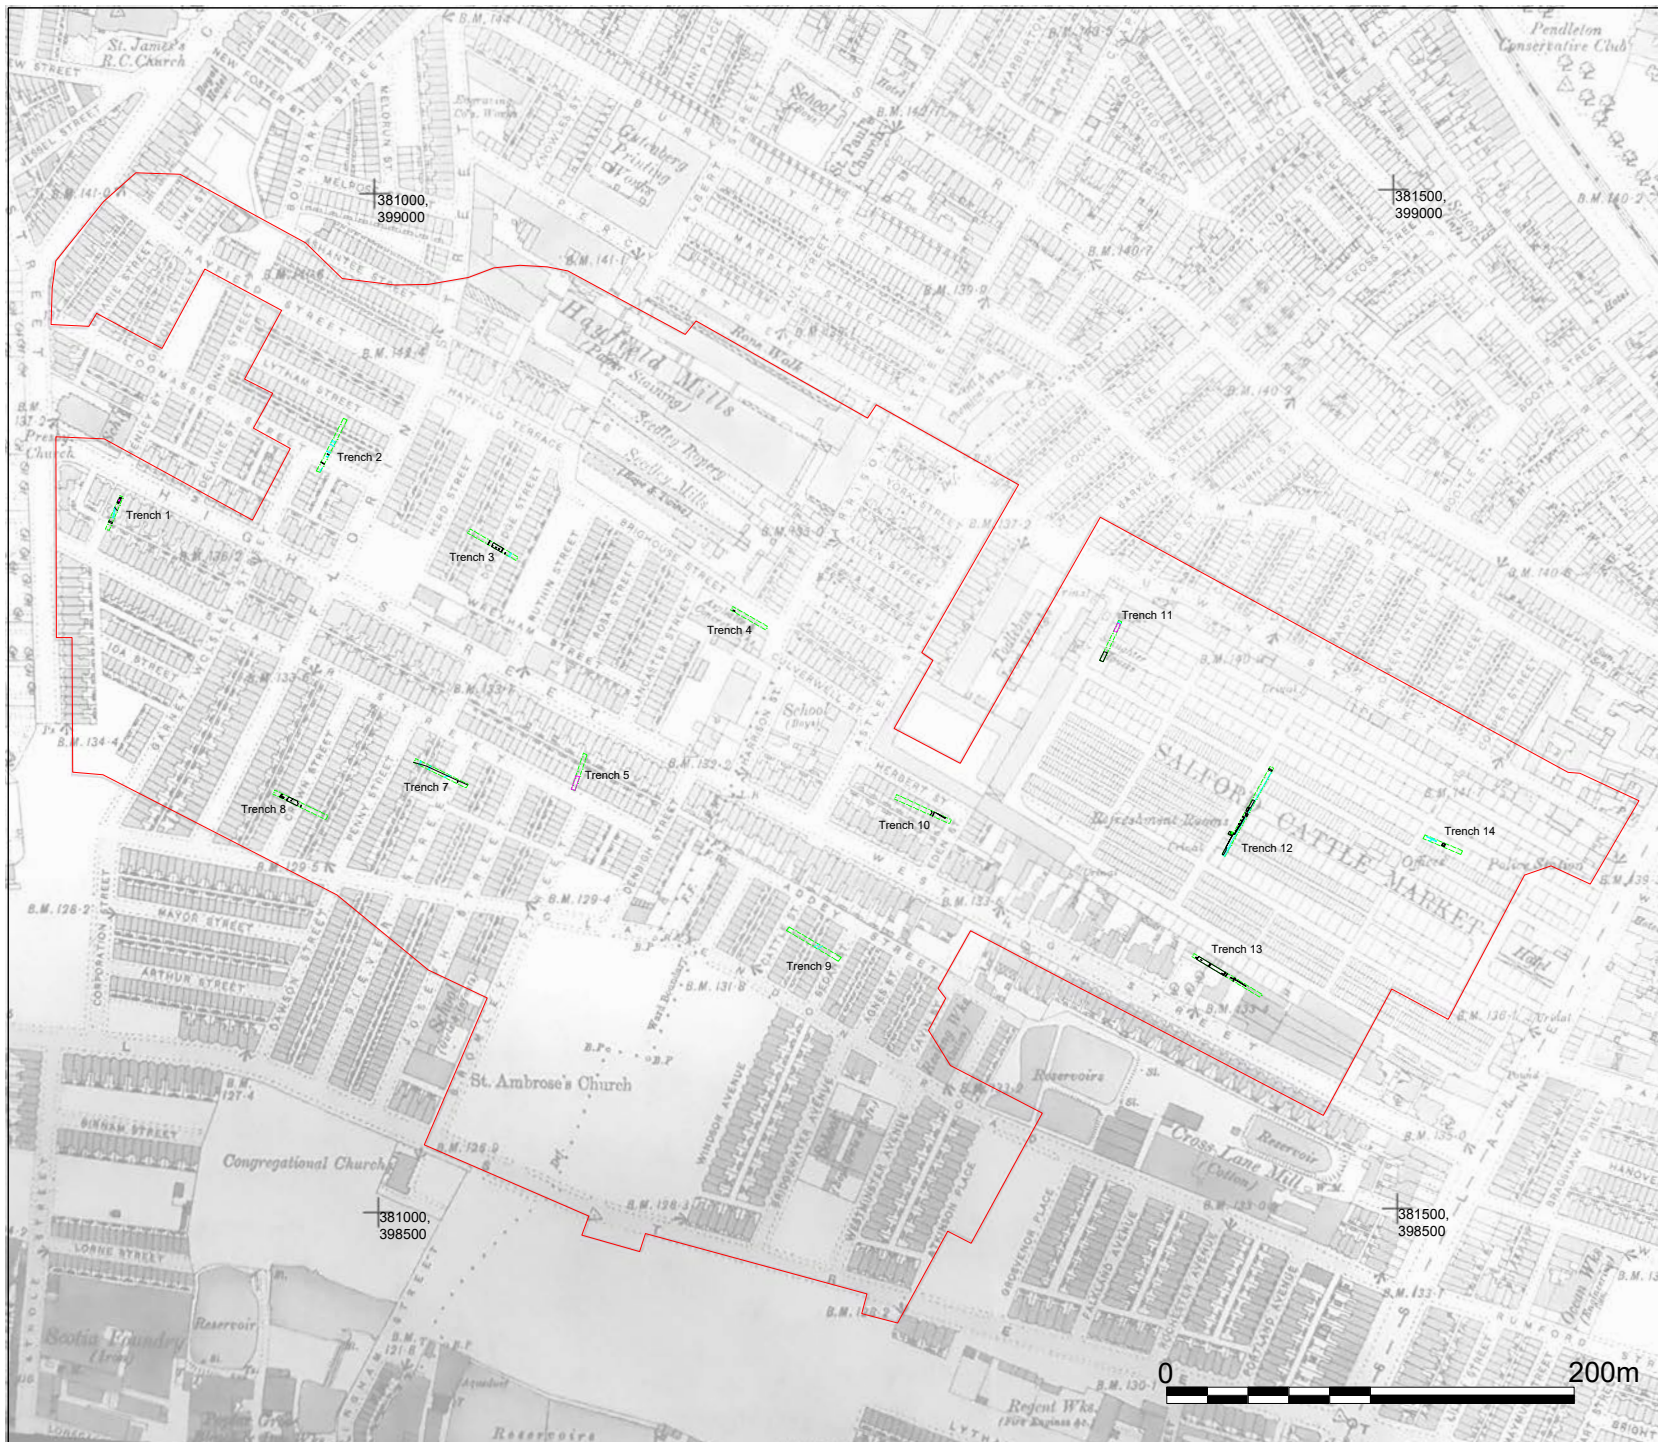
Figure 3: Trench Location Plan overlaid onto 1890 OS map

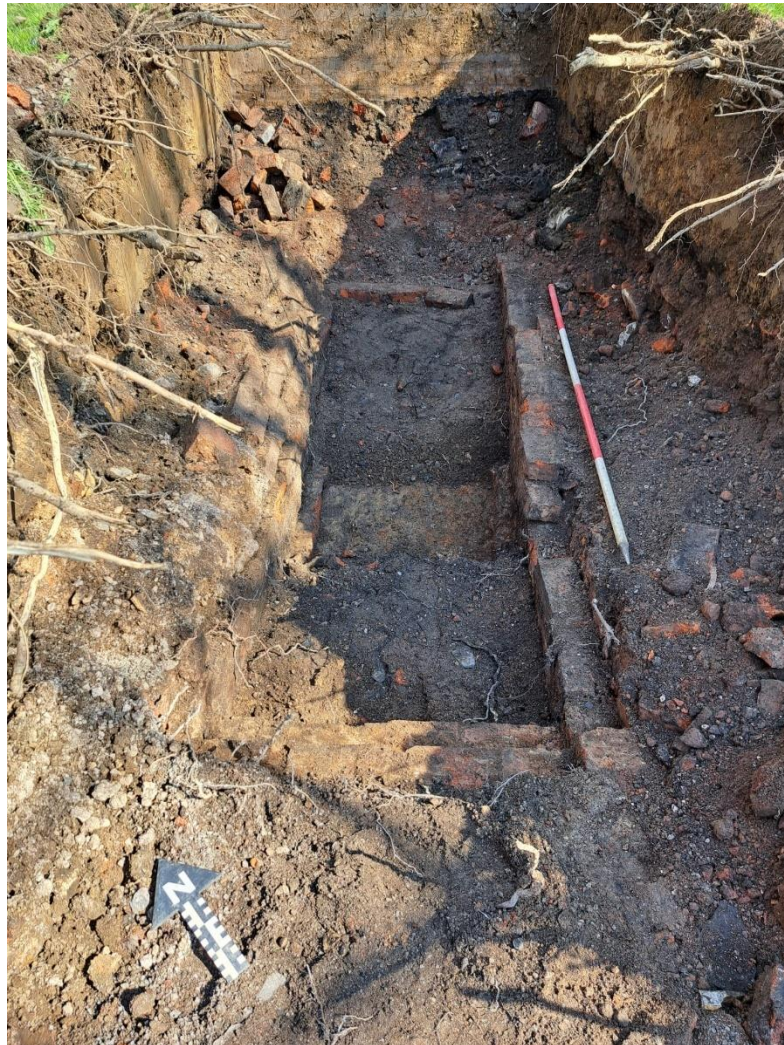
Figure 4: Photograph showing structure {106}, looking north-east. Scale 1x2m in 0.5m graduations.

4.3.3 Trench 1 (Figure 5) was orientated north-east to south-west and targeted terraced housing fronting former High Street and Slater Street and associated privies. Rectangular structure {106} (Figure 4) was constructed onto natural clay substrate (107) and consisted of stretcher-laid handmade red bricks with an ashy lime mortar and is likely associated with the late 19th century terraced houses, probably the base of a staircase based on the size and location.

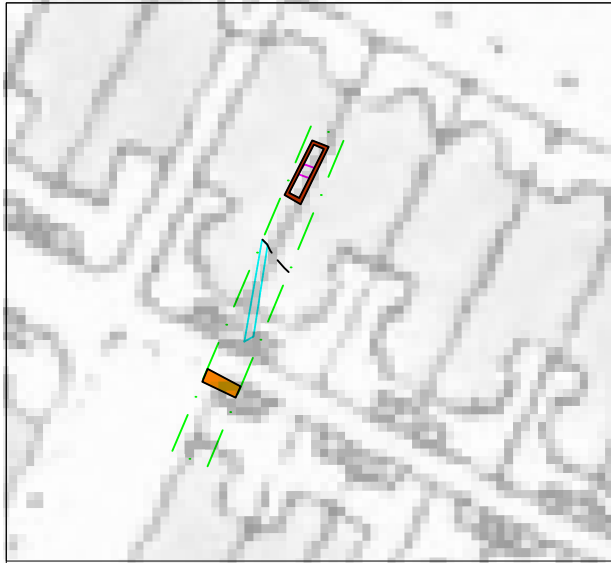
Figure 5: Plan of Trench 1, with inset detail of 1890 OS map

4.3.4 The south-western half of Trench 1 comprised the remains of a concrete wall, demolition deposits and former service trenches associated with the later 20th century council houses and their subsequent demolition. The entirety of the trench was sealed by topsoil deposit (101).

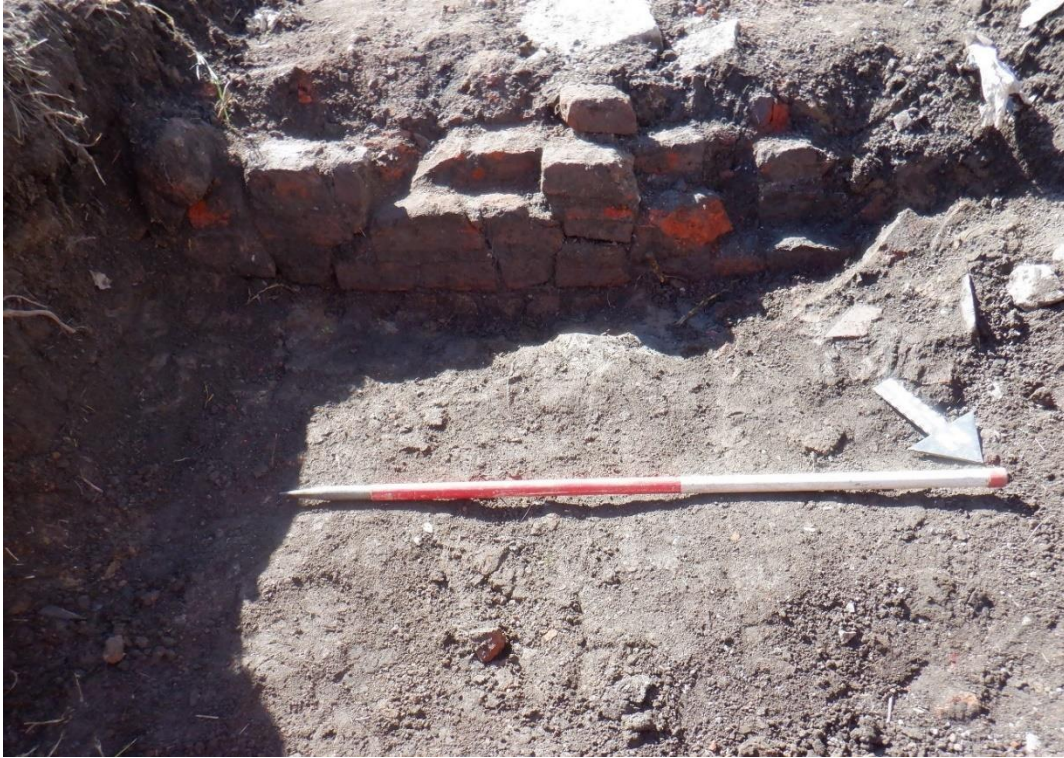
Figure 6: Photograph showing wall {203}, looking south-west. Scale 1x1m in 0.5m graduations.

4.3.5 Trench 2 (Figure 7) was orientated north-east to south-west and targeted terraced housing fronting former Lytham Street, Coomassie Steet and Garnet Wolsey Street and associated privies. The heavily truncated remains of wall {203} was encountered in the southern end of the trench and consisted of stretcher-laid handmade red bricks with a lime mortar (Figure 6) and likely represents the remains of the late 19th century external wall of a terraced house which would have fronted on to Coomassie Street.

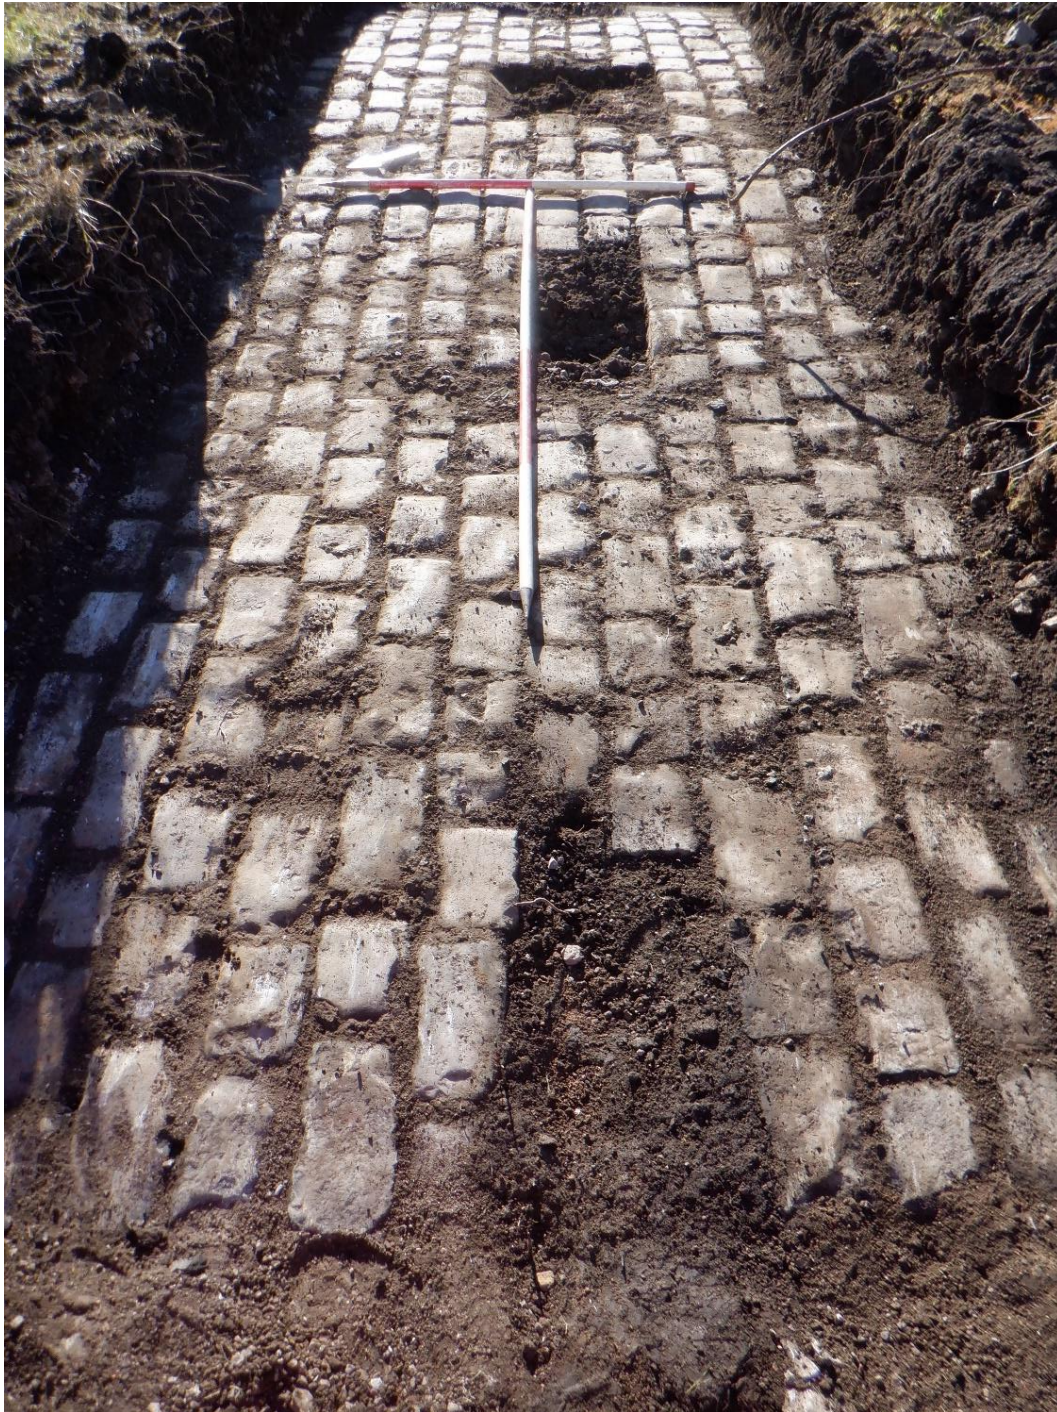
Figure 8: Photograph showing the remains of Doveridge Street (304), looking south-east. Note the four rectangular holes associated with later bollards. Scale 1x1m and 1x2m in 0.5m graduations.

4.3.7 Trench 3 (Figure 9) was orientated north-west to south-east and targeted terraced houses fronting former Herd Street and Doveridge Street and associated privies. The truncated remains of Doveridge Street were encountered (304) (Figure 8) and consisted of a stone sett surface founded directly onto substrate (303). Four, roughly rectangular, holes appeared to have been cut through the surface of (304) and may represent the location of bollards after the area had been rebuilt as a council estate.

4.3.8 Two handmade red brick walls {305} and {306} were uncovered either side of surface (304) and would have both been external front walls for the terraced houses which fronted onto Doveridge Street in the late 19th century. Both walls were heavily truncated and only the foundation course survived, laid onto substrate (303).

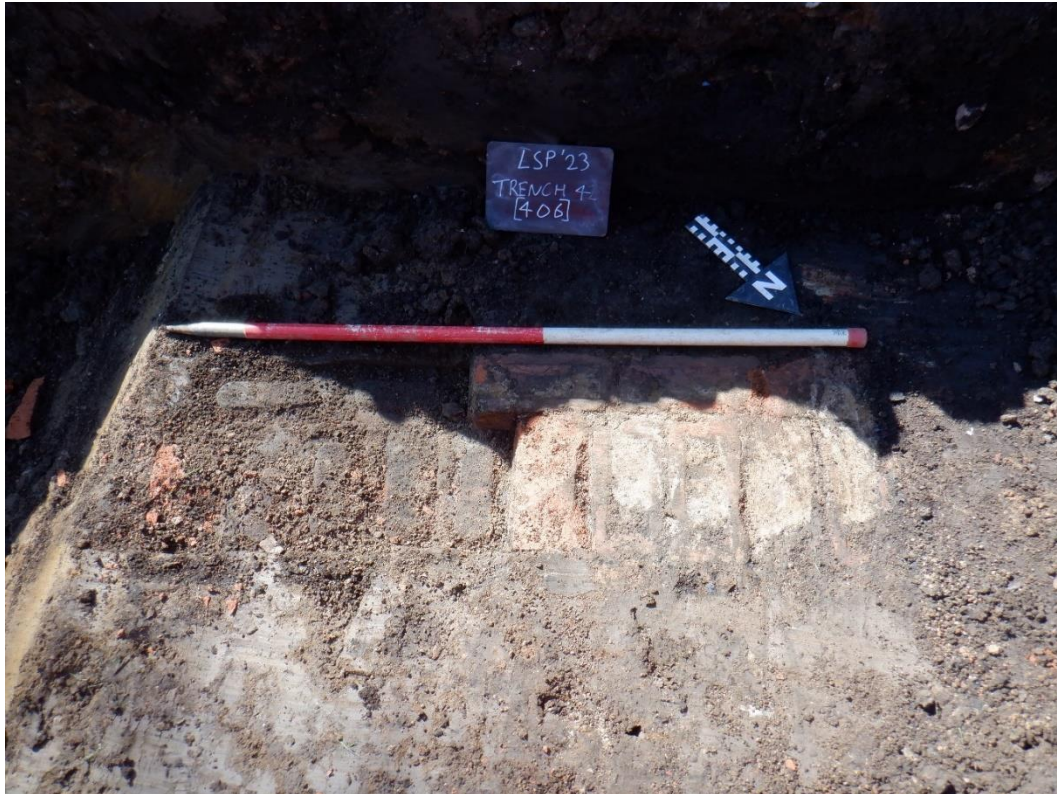
Figure 10: Photograph showing wall {406}, looking south-west. Scale 1x1m in 0.5m graduations.

4.3.10 Trench 4 (Figure 11) was orientated north-west to south-east and targeted the Asphalt and Concrete Works on former Brighthouse Street. In the north-western end of the trench were the remains of a south-east to north-west aligned wall {406} which consisted of three skins of later 19th century, machine made, frogged red bricks bonded with a grey cementitious mortar (Figure 10). This wall likely represents the remains of the northern property boundary wall of the asphalt works which fronted on to Brighthouse Street.

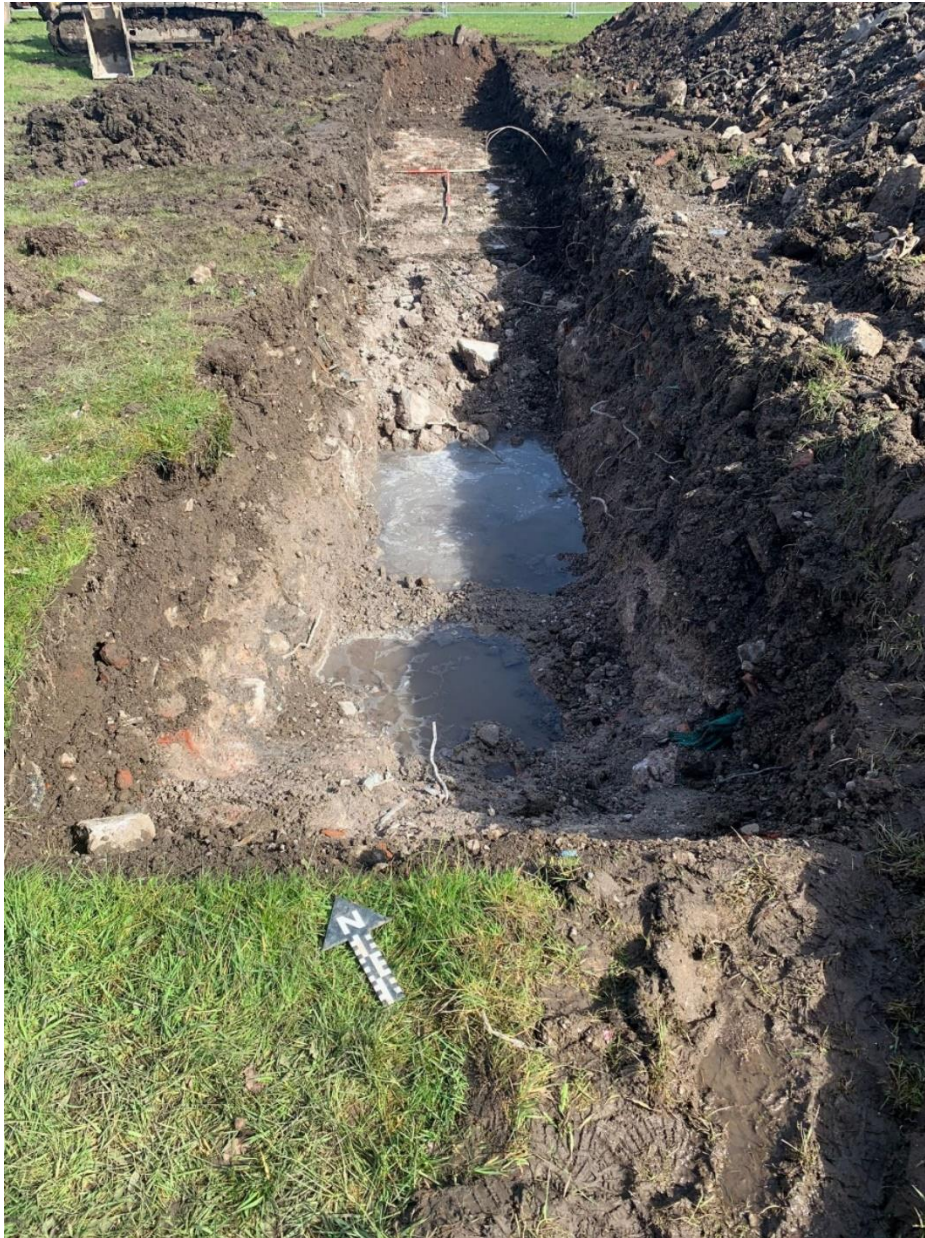
Figure 12: Photograph showing Trench 5, looking north-east. Scale 1x1m and 1x2m in 0.5m graduations.

4.3.12 Trench 5 (Figure 12) was orientated south-west to north-east and targeted terraced houses fronting former High Street and Slater Street and associated privies, although none of these features were encountered in the trench. Beneath topsoil (501) lay a deposit of mixed concrete and demolition rubble (502). Excavation ceased at 1.5m BGL due to safety concerns and rising groundwater. Concrete deposit (502) was not bottomed and may be the result of waste material being dumped following the demolition of the council houses in the 21st century.

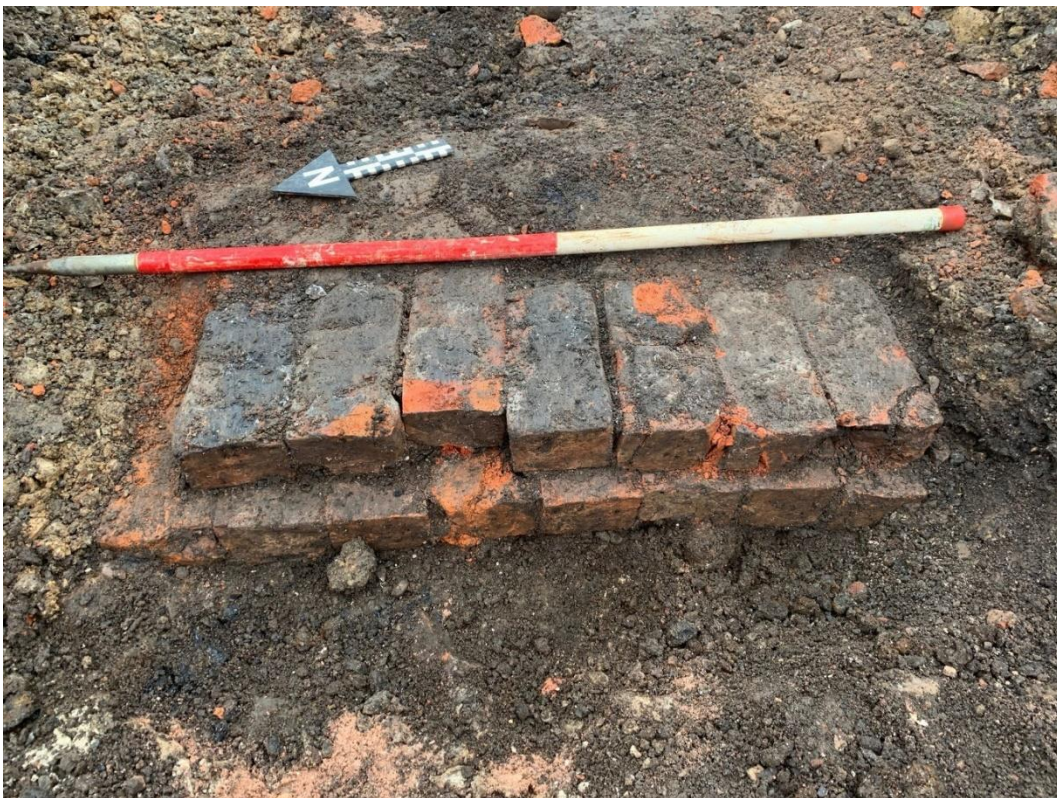
Figure 13: Photograph showing wall {703}, looking south-east. Scale 1x1m in 0.5m graduations.

4.3.15 Trench 7 (Figure 14) was orientated north-west to south-east and targeted terraced housing fronting former Penny Street and Siever Street and associated privies. In the south-eastern end of the trench were the remains of a north-east to south-west aligned wall {703} (Figure 13) which consisted of handmade red bricks with a lime mortar. The wall likely represents the late 19th century remains of an external wall of a terraced house which fronted on to Siever Street.

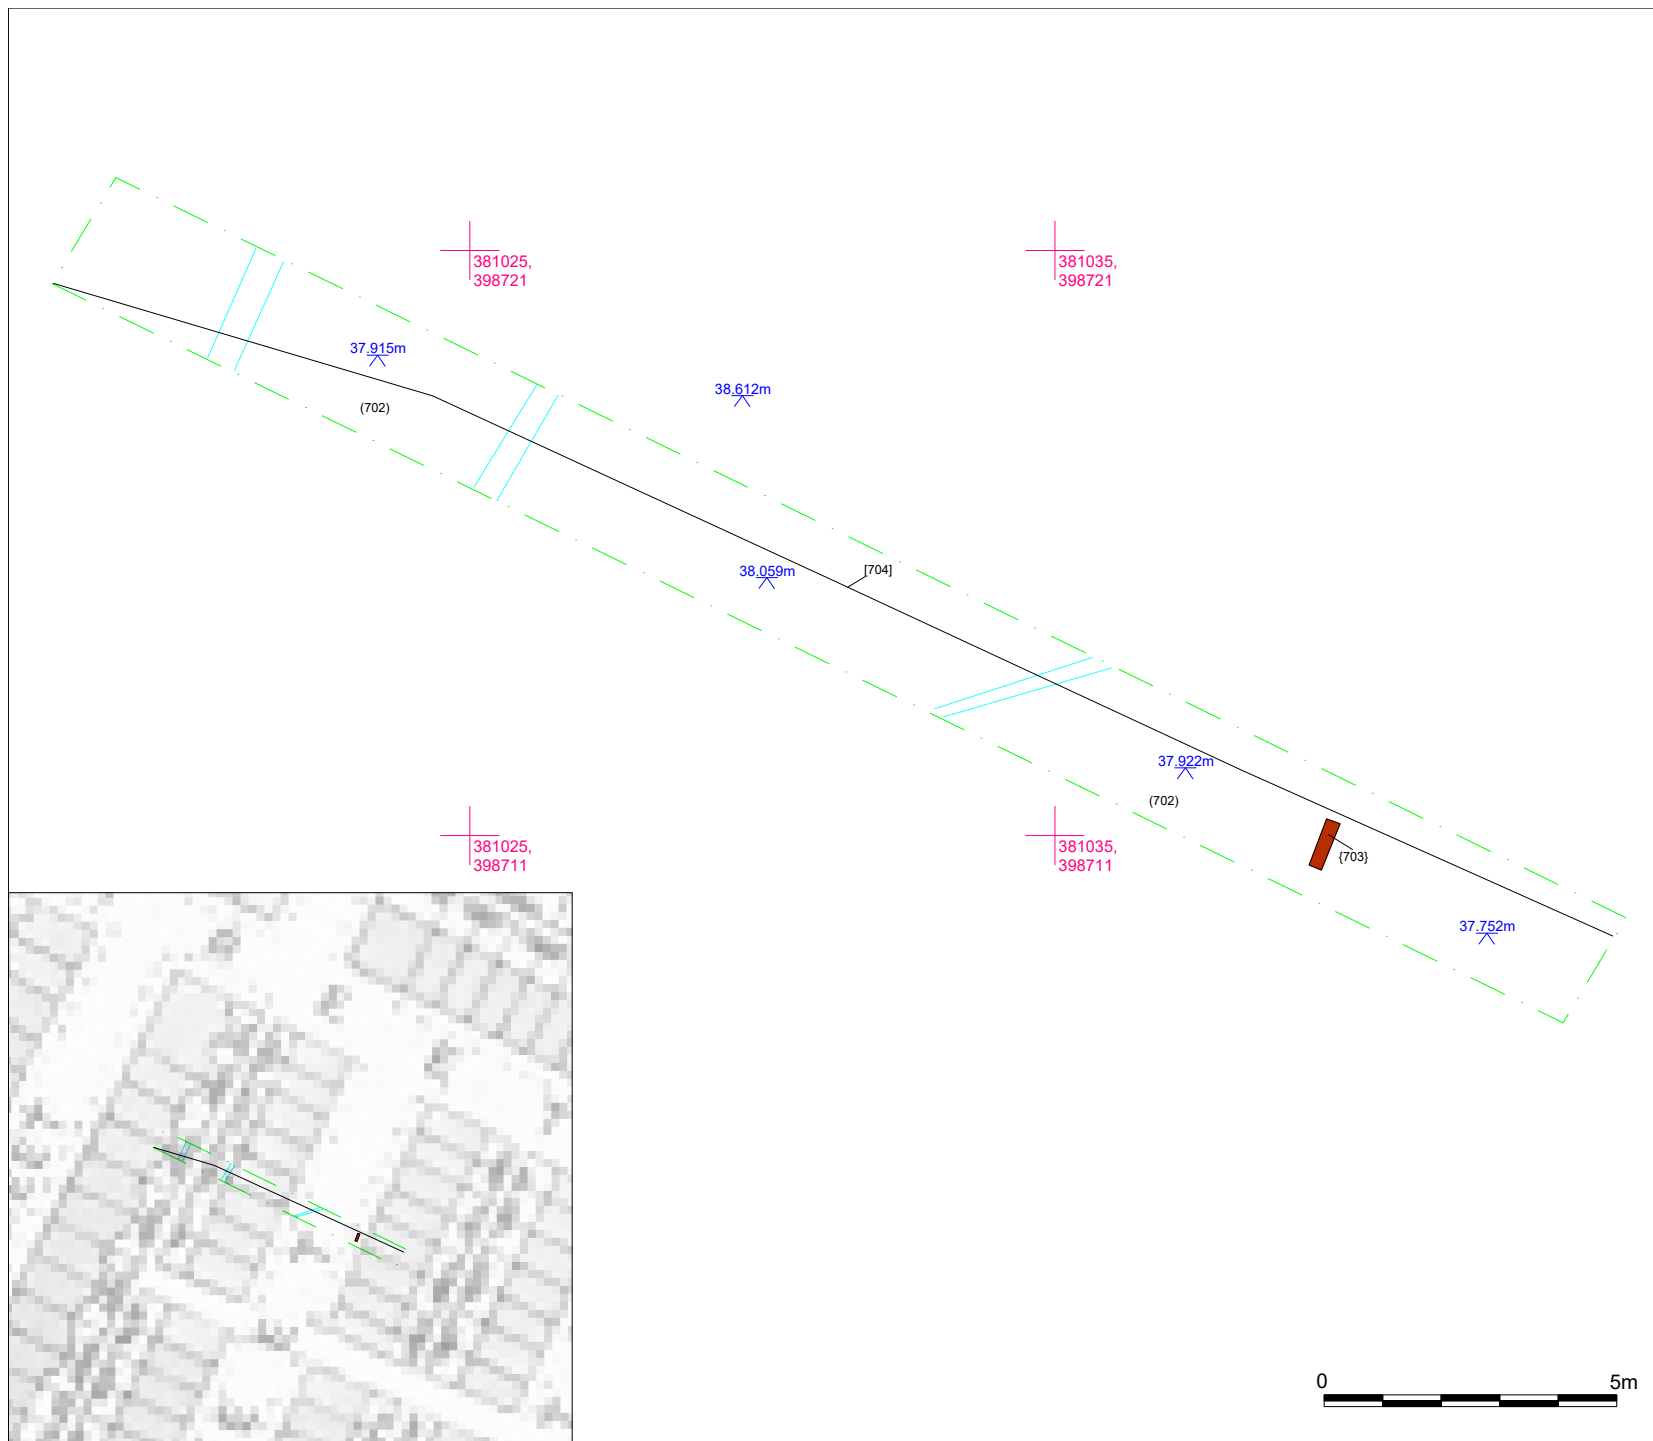
Figure 14: Plan of Trench 7 with inset detail of 1890 OS map

4.3.16 To both the south-east and north-west of wall {703} the remains within the trench comprised former service trenches associated with the later 20th century council houses and deposits associated their recent demolition. The entirety of the trench was sealed by topsoil deposit (701).

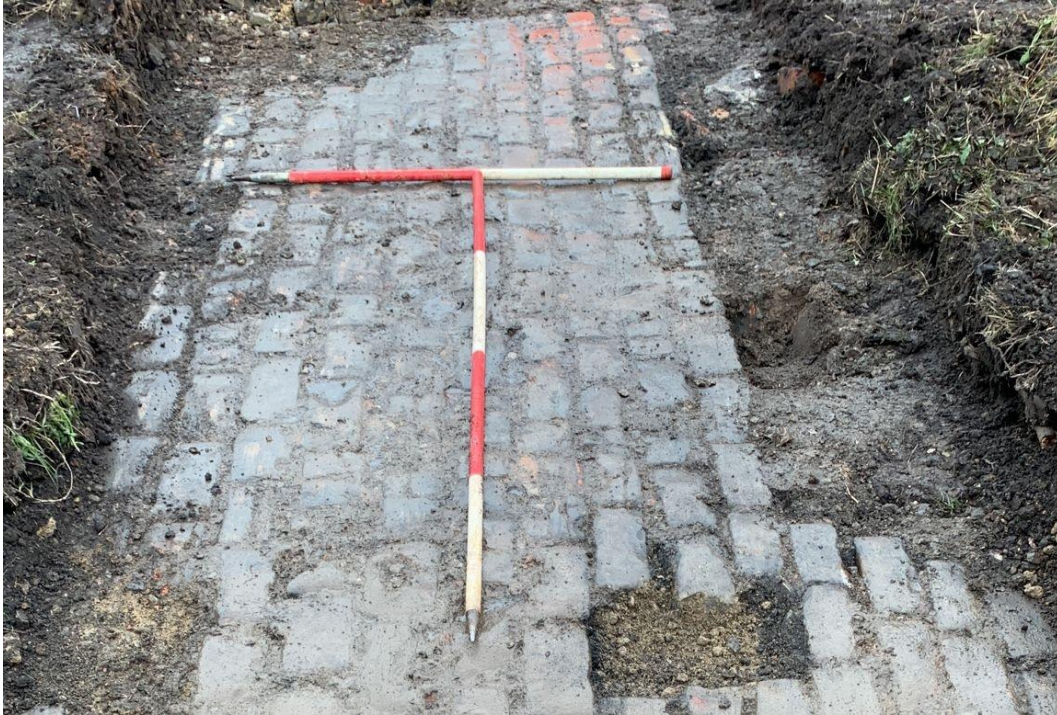
Figure 15: Photograph showing the truncated remains of Crown Street (804), looking north-west. Scale 1x1m and 1x2m in 0.5m graduations.

4.3.17 Trench 8 (Figure 17) was orientated north-west to south-east and targeted terraced housing either side of Crown Street and associated privies. In the centre of the trench were the truncated remains of Crown Street (804) (Figure 15) which consisted of a stone sett surface founded directly onto the natural clay substrate (803). Part of the sandstone paving stone pavement (805) was also encountered on the north-west side of surface (804).

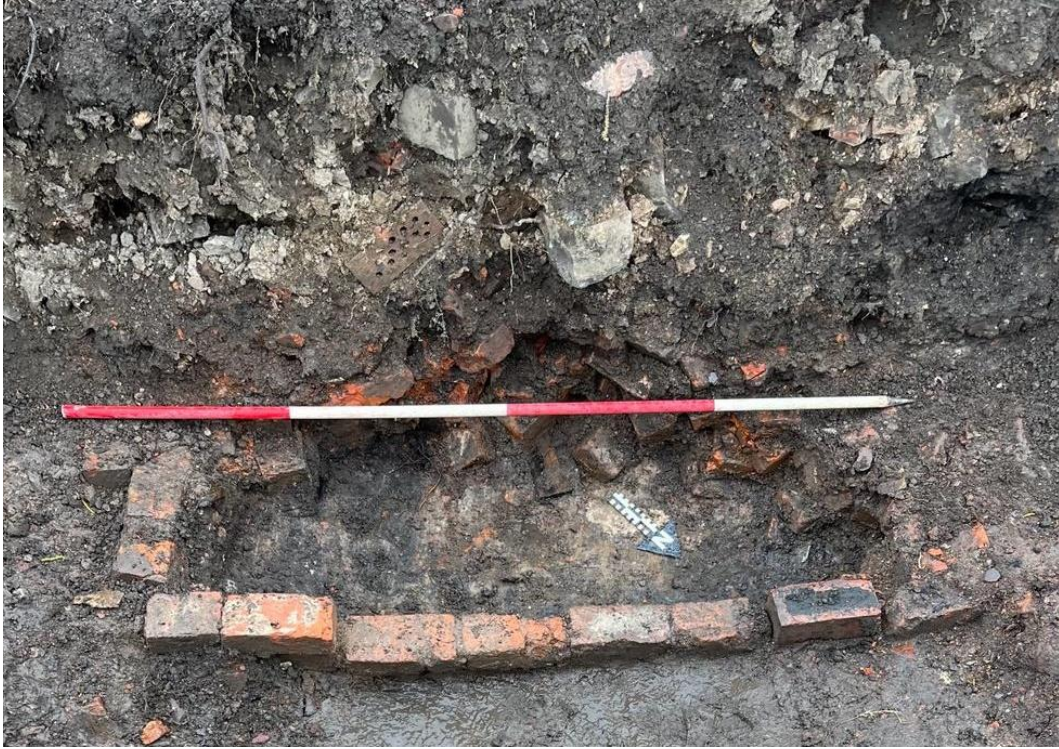
Figure 16: Photograph showing brick structure {806}, looking south-west. Scale 1x2m in 0.5m graduations.

4.3.19 On the north-western side of surface (804) were the remains of a what may be the base of a staircase {806} (Figure 16) associated with one of the former late 19th century terraced houses. This comprised a single skin of handmade red bricks (with a single machine made brick possibly representing a later repair), creating a rectangular structure bonded with lime mortar.

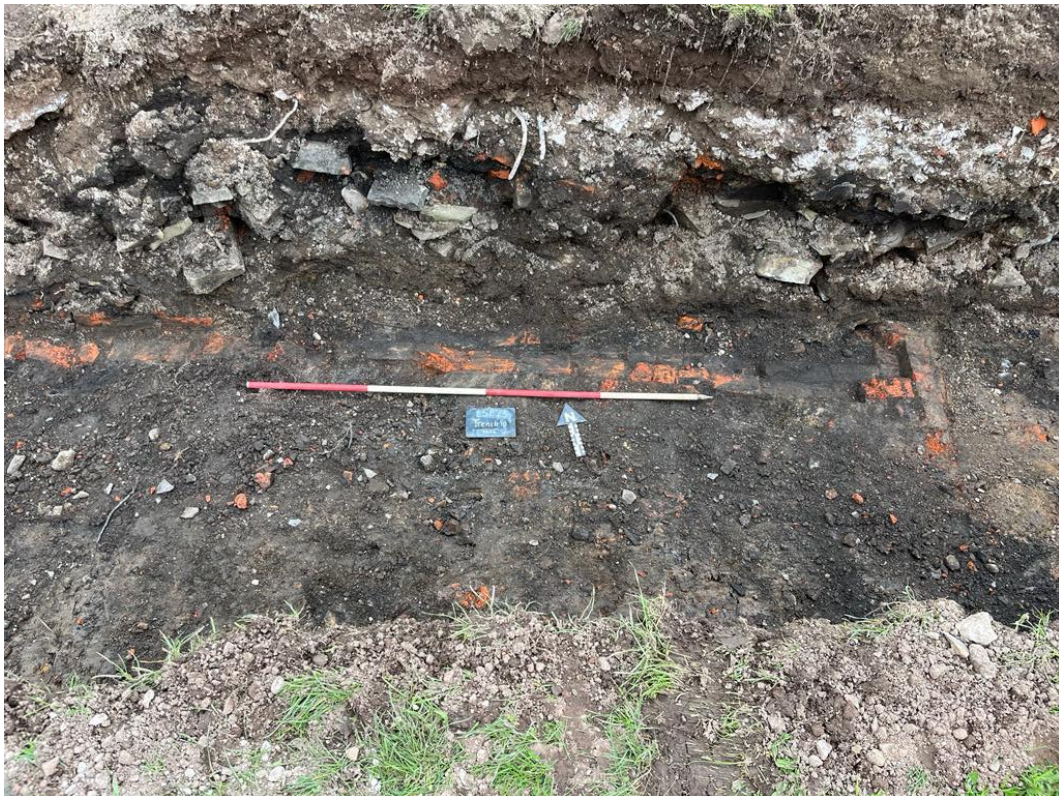
Figure 18: Photograph showing the remains of wall {1006}, looking north. Scaled 1x2m in 0.5m graduations.

4.3.22 Trench 10 (Figure 19) was orientated north-west to south-east and targeted terraced housing fronting former Herbert Street. In the south-eastern end of the trench were the remains of a north-west to south-east aligned wall {1006} which consisted of handmade red brick with lime mortar (Figure 18). The wall likely represents the late 19th century remains of the back wall of a terraced house which fronted on to Herbert Street.

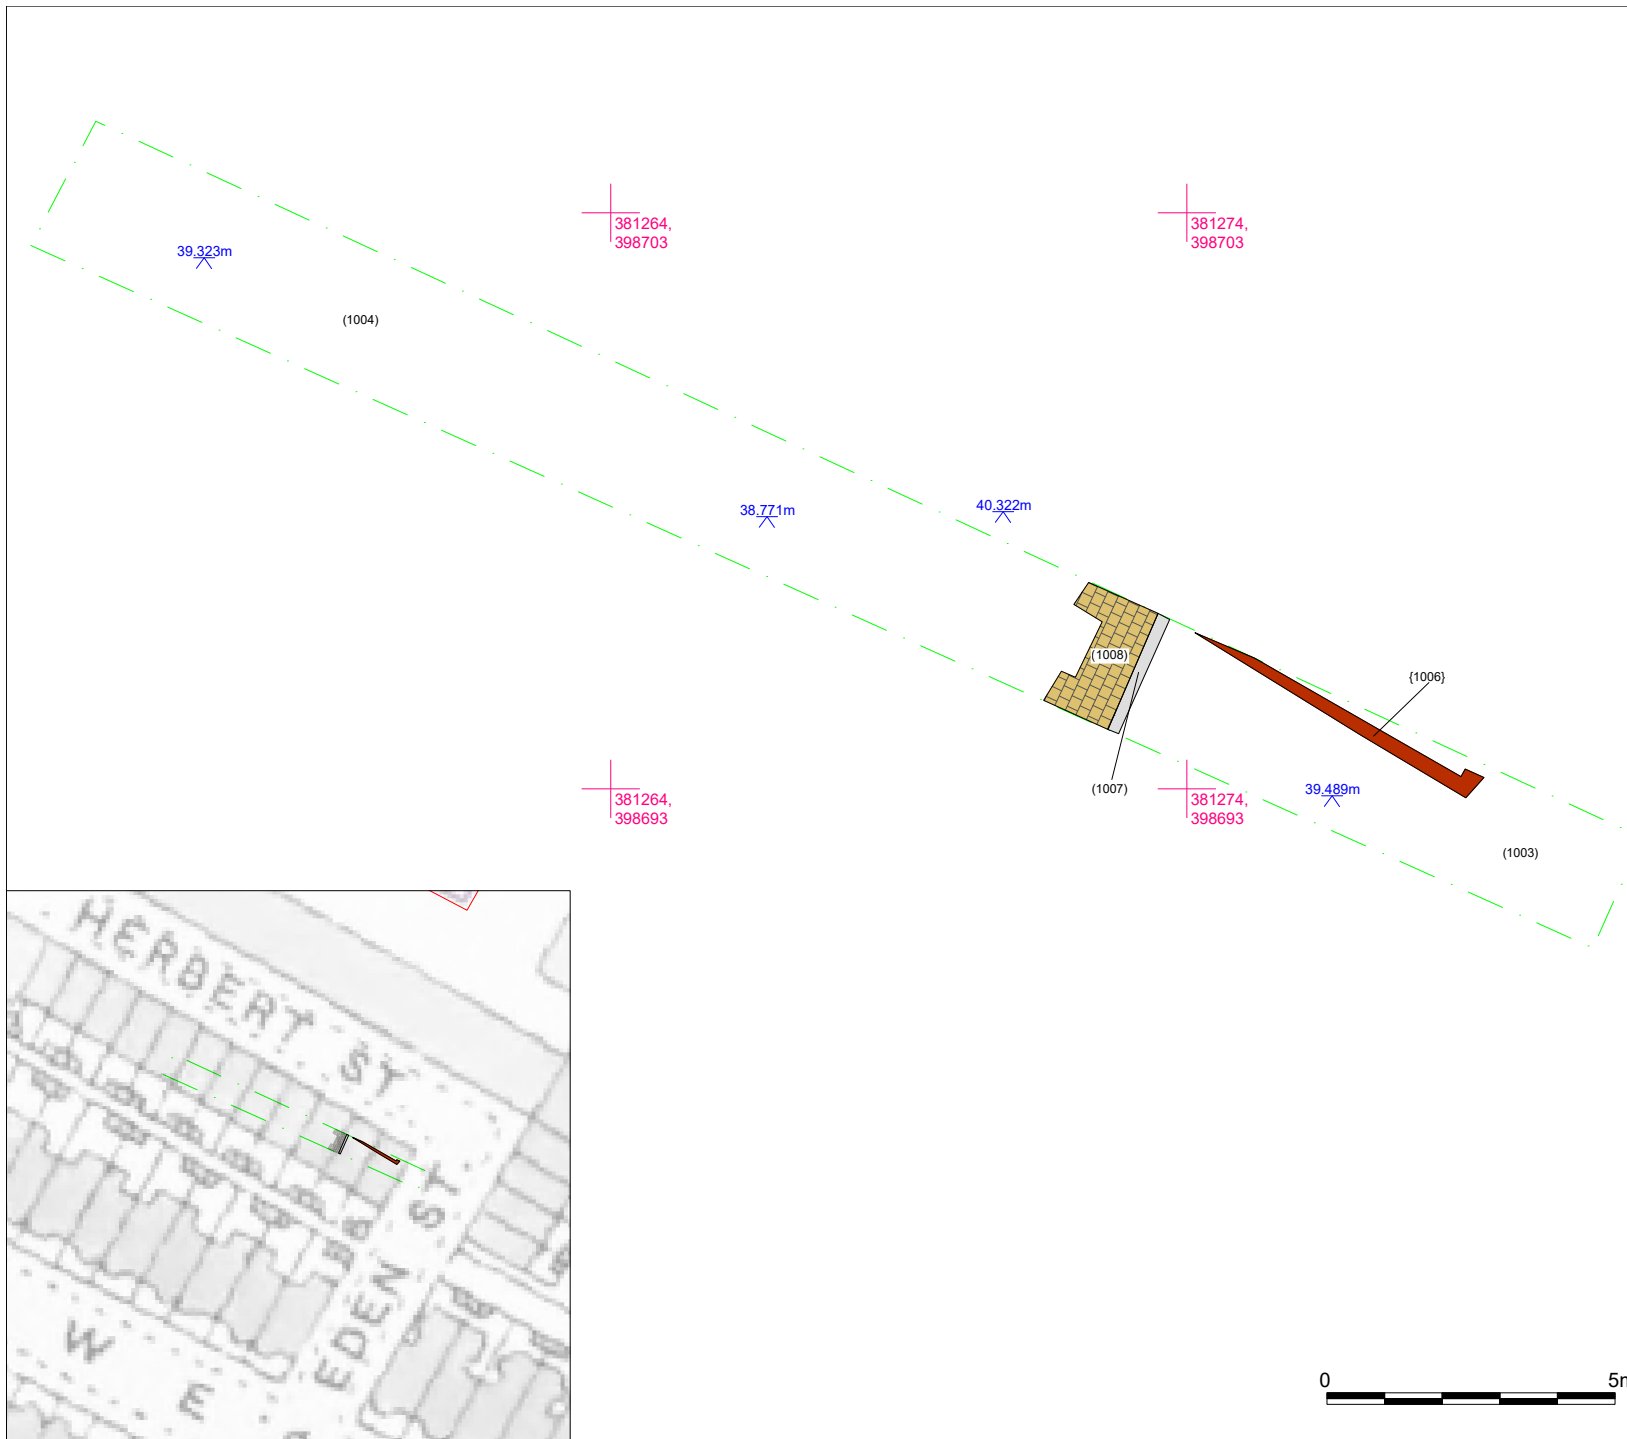
Figure 19: Plan of Trench 10 with inset detail of 1890 OS map

4.3.23 To the north-west of wall {1006} the remains within the trench comprised a surface associated with the later 20th century council houses and deposits associated with their subsequent demolition. The entirety of the trench was sealed by topsoil deposit (1001).

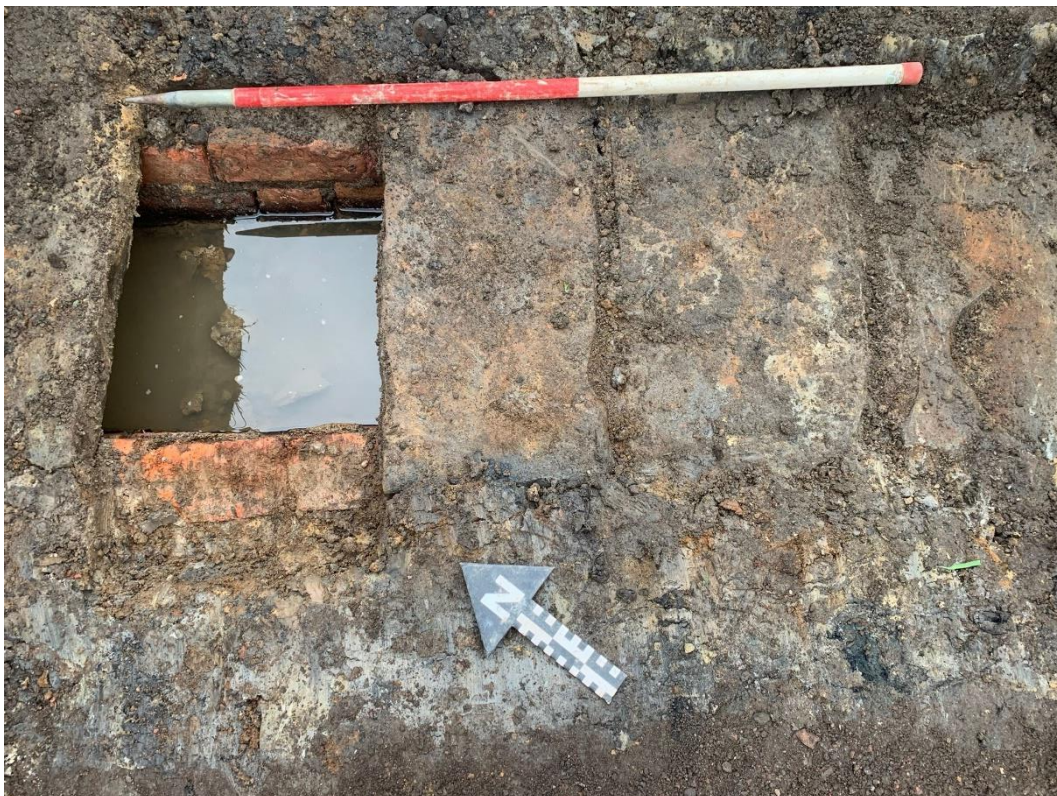
Figure 20: Photograph showing culvert {1205}, looking north-east. Scale 1x1m in 0.5m graduations.

4.3.26 In the north-eastern end of the trench were the remains of a north-west to south-east aligned culvert {1205} which was stone-capped but with brick walls (Figure 20). This was located in one of the pathways between the cattle stalls shown on historic mapping although no surface was found associated with this. A surface laid with stone setts, (1206) was located in the central part of the trench, also associated with one of the pathways between cattle stalls, immediately adjacent to the remains of the refreshment rooms building.

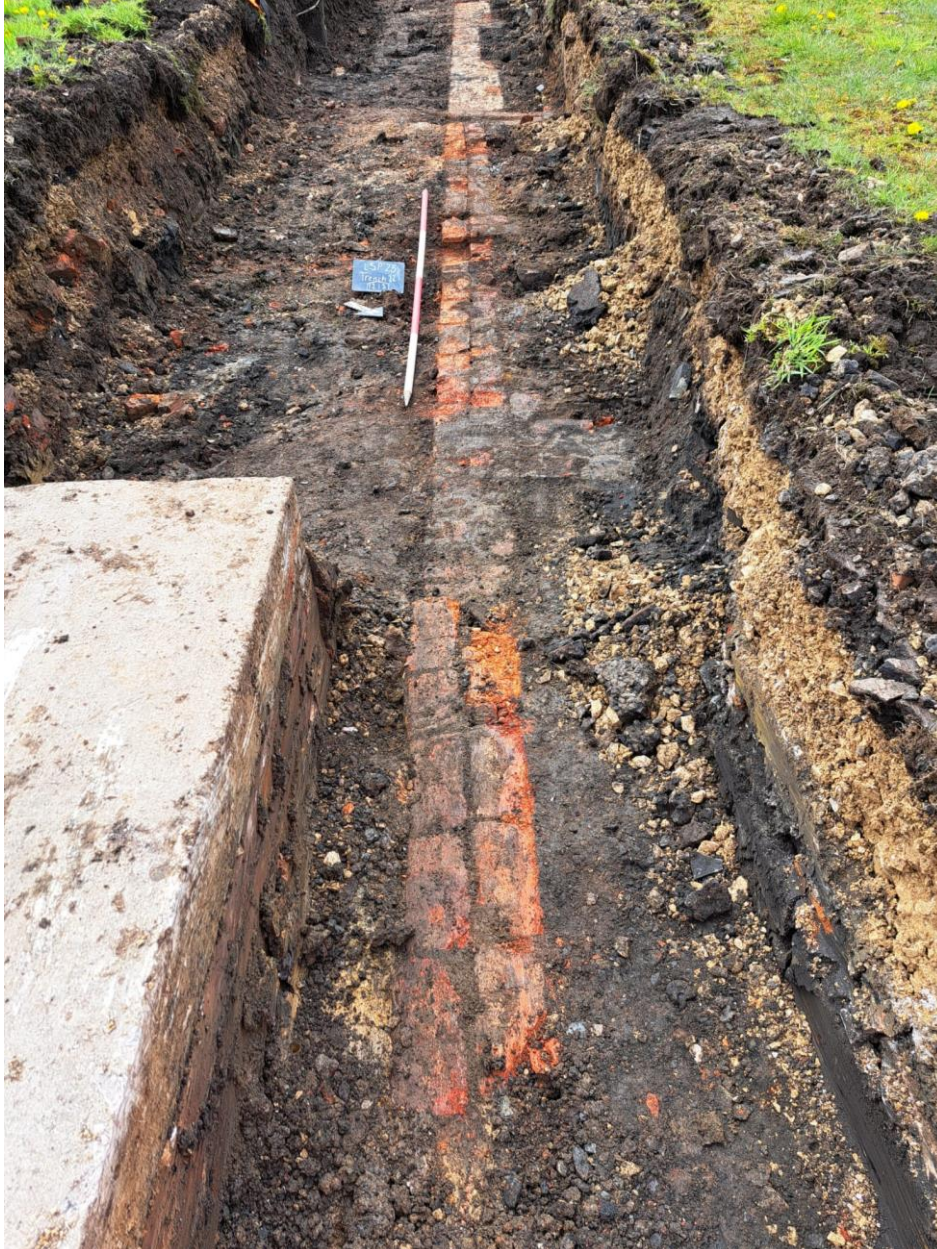
Figure 21: Photograph showing the eastern wall of the former refreshment rooms, looking south-west, with later wall {1213} in foreground, and earlier wall {1218} in background. Scale 1x2m in 0.5m graduations.

4.3.27 In the southern half of the trench the remains related to a brick-built building which was marked on the 1890s town plan map as refreshment rooms which were associated with the former Salford Cattle Market (Figure 21). This building comprised a south-west to north-east aligned wall, {1218}, bonded with lime mortar, with perpendicular walls, {1215} and {1217} at either end. The wall had two slightly projecting sections halfway along which may represent either side of a chimney.

4.3.28 Abutting wall {1217} to the north was a similarly sized structure, comprising eastern wall {1213} with walls {1214} and {1216} perpendicular at either end, and wall {1215} perpendicular halfway along the wall, all bonded with an ashy lime mortar. It is likely that walls {1218}, {1215} and {1217} were the original building with walls {1213}-{1216} added at a slightly later, though still probable 19th century, date. A modern manhole {1212} truncated the northern part of the building but to the north-east of that the northern end of the building was encountered, evidenced by north-east to south-west aligned wall {1208} and perpendicular wall {1209}. A brick surface (1211) abutted the inside of these two walls.

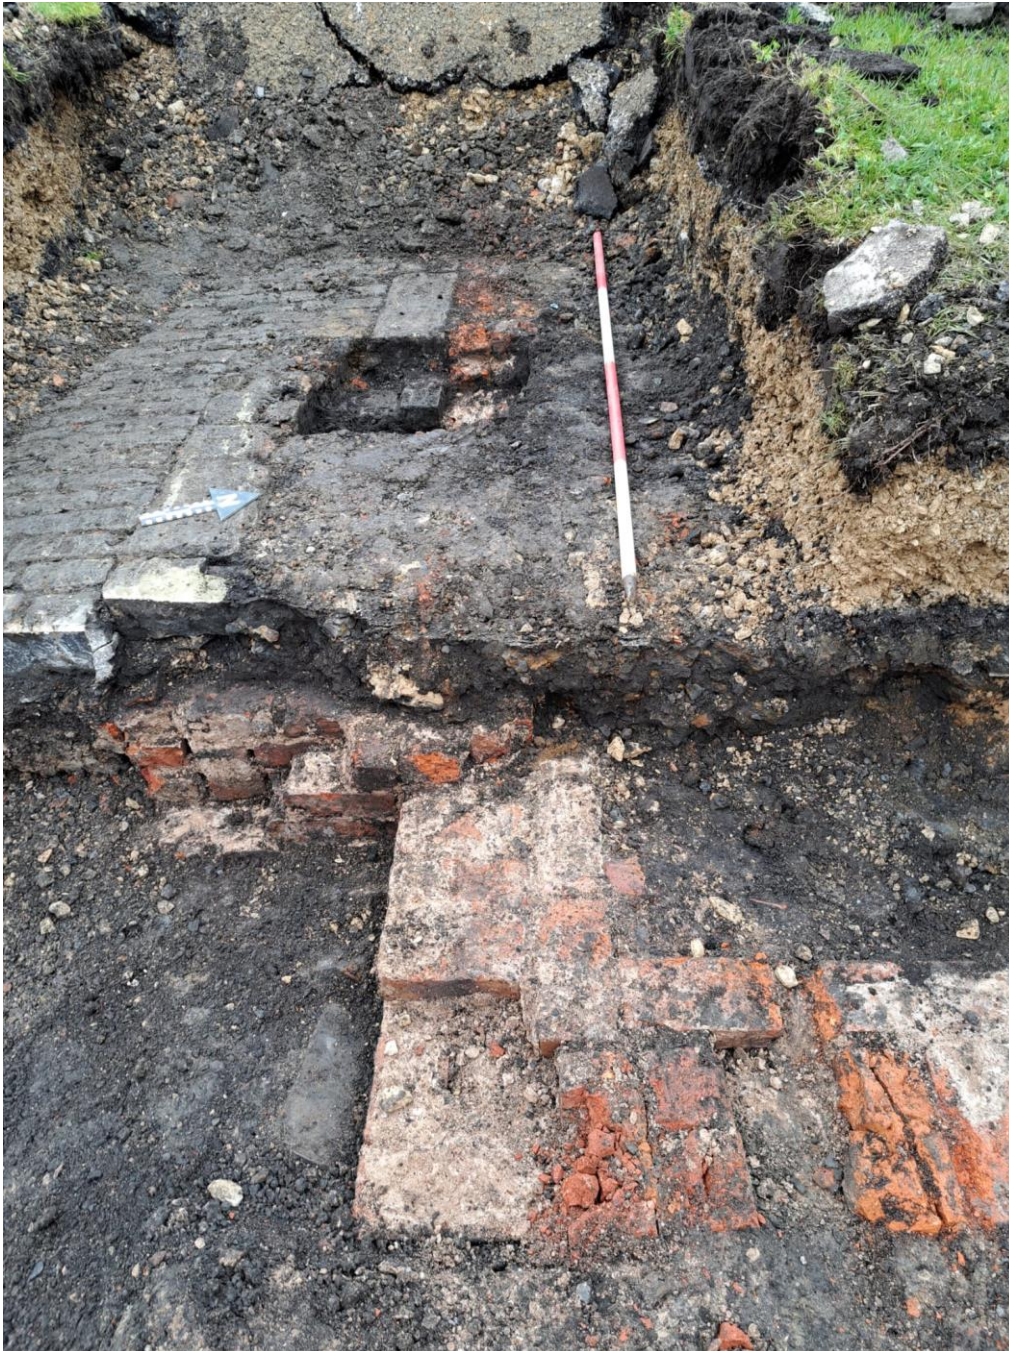
Figure 22: Photograph showing the extension to Trench 12, looking north-west. Foreground: walls {1218}/{1219}; background right: doorway {1220}/{1221}; background left: surface (1207). Scale 1x2m in 0.5m graduations.

4.3.29 On the southern side of the building, within the extension to the trench, there was an entrance which fronted on to another path between stalls laid with stone setts, (1207) (Figure 22). The cut stone threshold (1221) had sockets at either end, possibly for door posts. The threshold

stone was set within a small “porch”, {1220} constructed from handmade red bricks and lime mortar, keyed into wall {1219}.

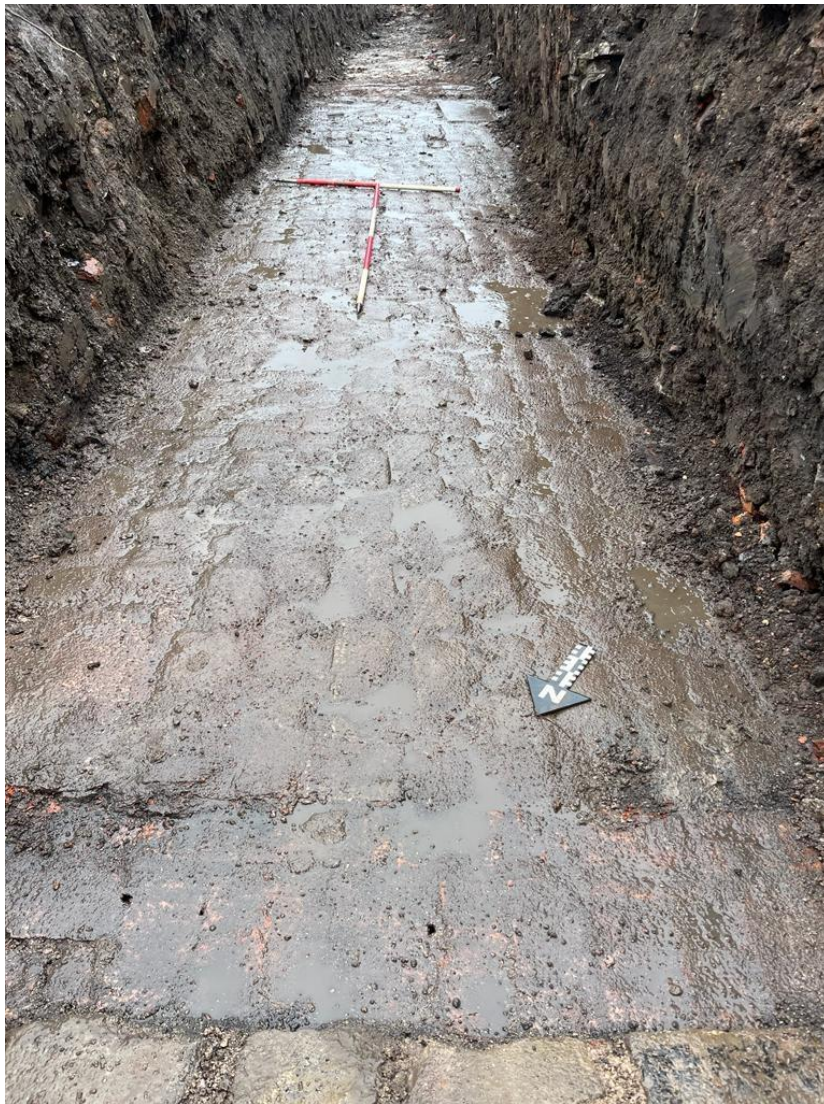
Figure 24: Photograph showing stone sett surface (1308), looking south-east. Note flagstone (1309) at the far end. Scale 1x1m and 1x2m in 0.5m graduations.

4.3.32 To the north-west of wall {1310} were the remains of a stone sett floor (1308) which was a yard surface between the buildings targeted by this trench (Figure 24). A sandstone slab (1309) was placed on top of the setts close to wall {1310}. This had an unknown function but may have been a threshold for a building just outside the trench limits.
