AN ARCHAEOLOGICAL EVALUATION

Liverpool Street, Pendleton, Salford, Greater Manchester

ARS Report N°: 2023/37
OASIS ID: archaeol5-514517

An Archaeological Evaluation at Liverpool Street, Pendleton, Salford, Greater Manchester

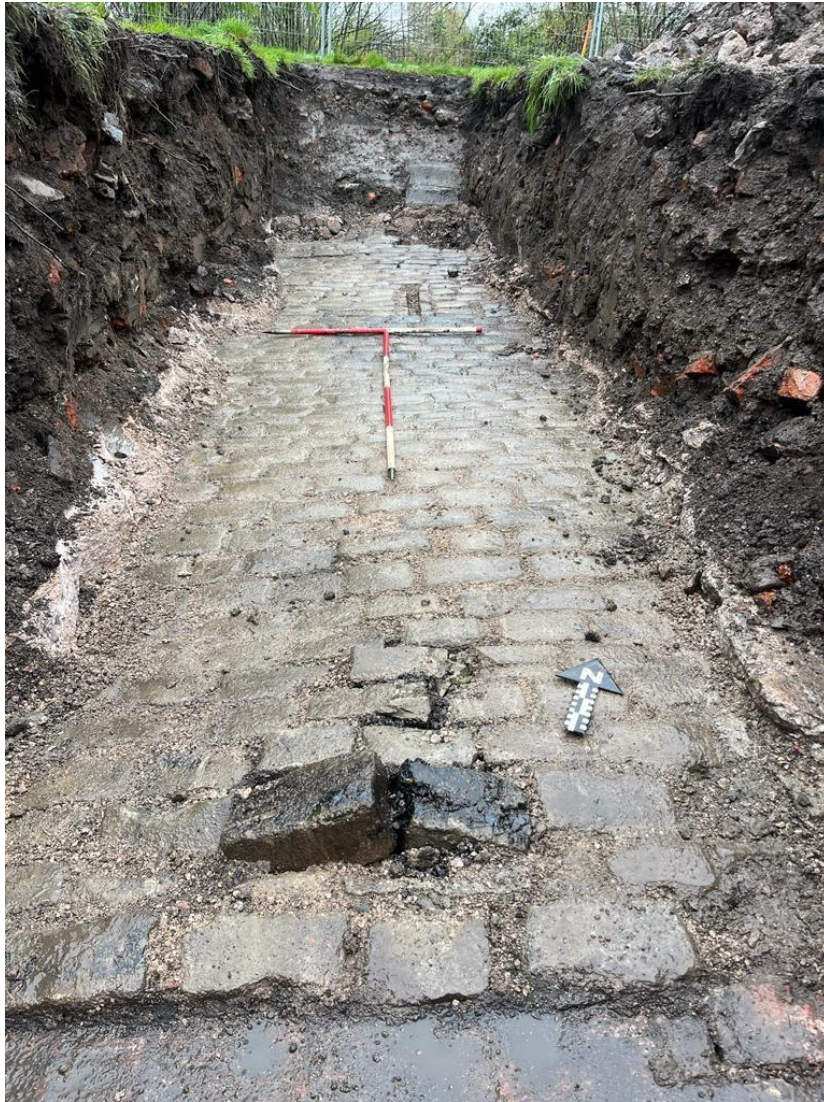
Figure 25: Photograph showing surface (1305), looking north-west. Scale 1x1m and 1x2m in 0.5m graduations.

4.3.33 On the north-west side of surface (1308), a north-east to south-west aligned wall {1307} separated surface (1308) from another stone sett yard surface (1305) (Figure 25). Wall {1307} appears to have originally been a property boundary wall then by the 1908 OS map, the former yard (1305) was enclosed by a building, probably incorporating wall {1307}. Surface (1305) was originally bordered on its north-west side by a north-east to south-west aligned wall {1306}. Wall {1306} was a two-skin thick, handmade redbrick wall. On the north-west, interior, side of wall {1306} was a floor (1304) laid with blue, two-panel, stable paver bricks, probably indicating that this building may have been in use as a stable (Figure 26). At a later stage, wall {1306} was demolished to ground level, and that foundation, as well as surfaces (1305) and (1304), were overlaid with a deposit of poured concrete (1303), creating a single surface throughout. This surface appeared to be post war in date although the exact date is not clear.

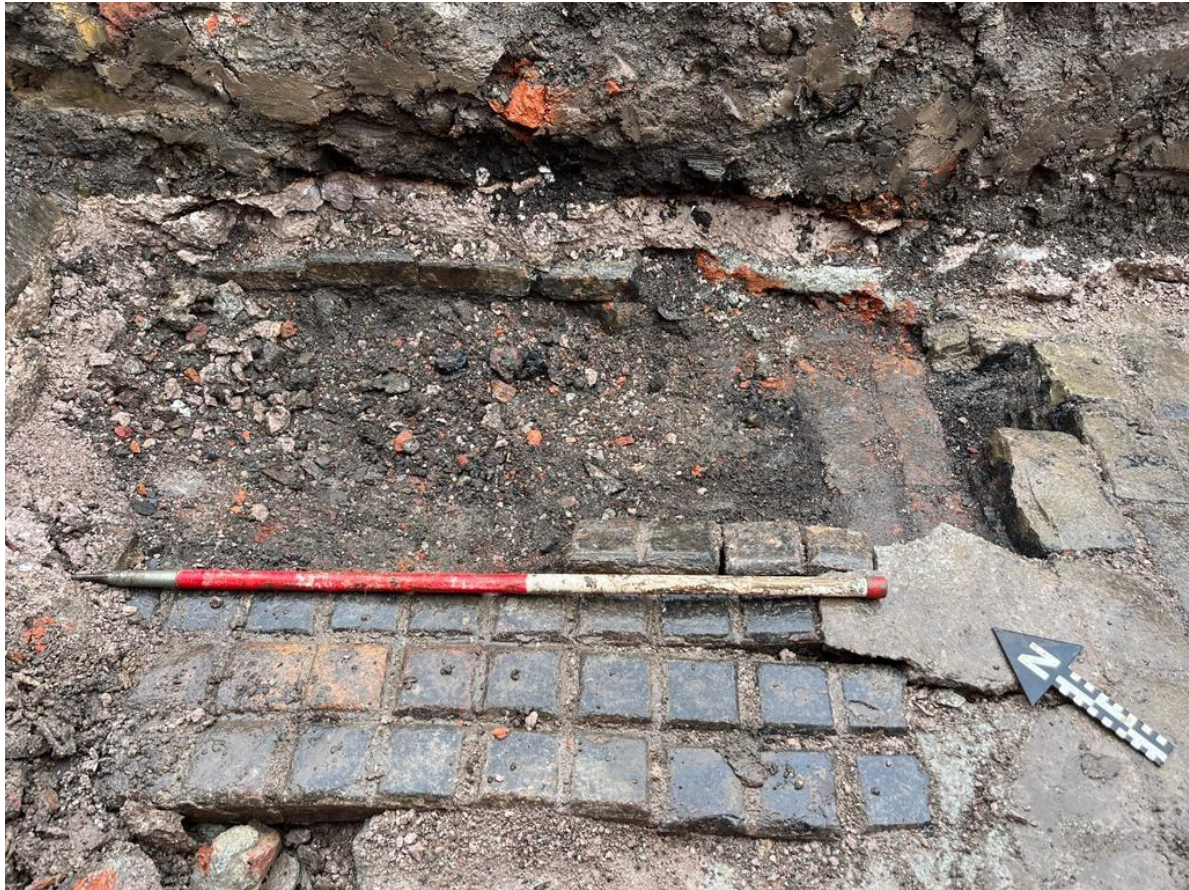
Figure 26: Photograph showing blue brick surface (1304) with concrete (1303) overlying wall {1306}, looking north-east. Scale 1x1m in 0.5m graduations.

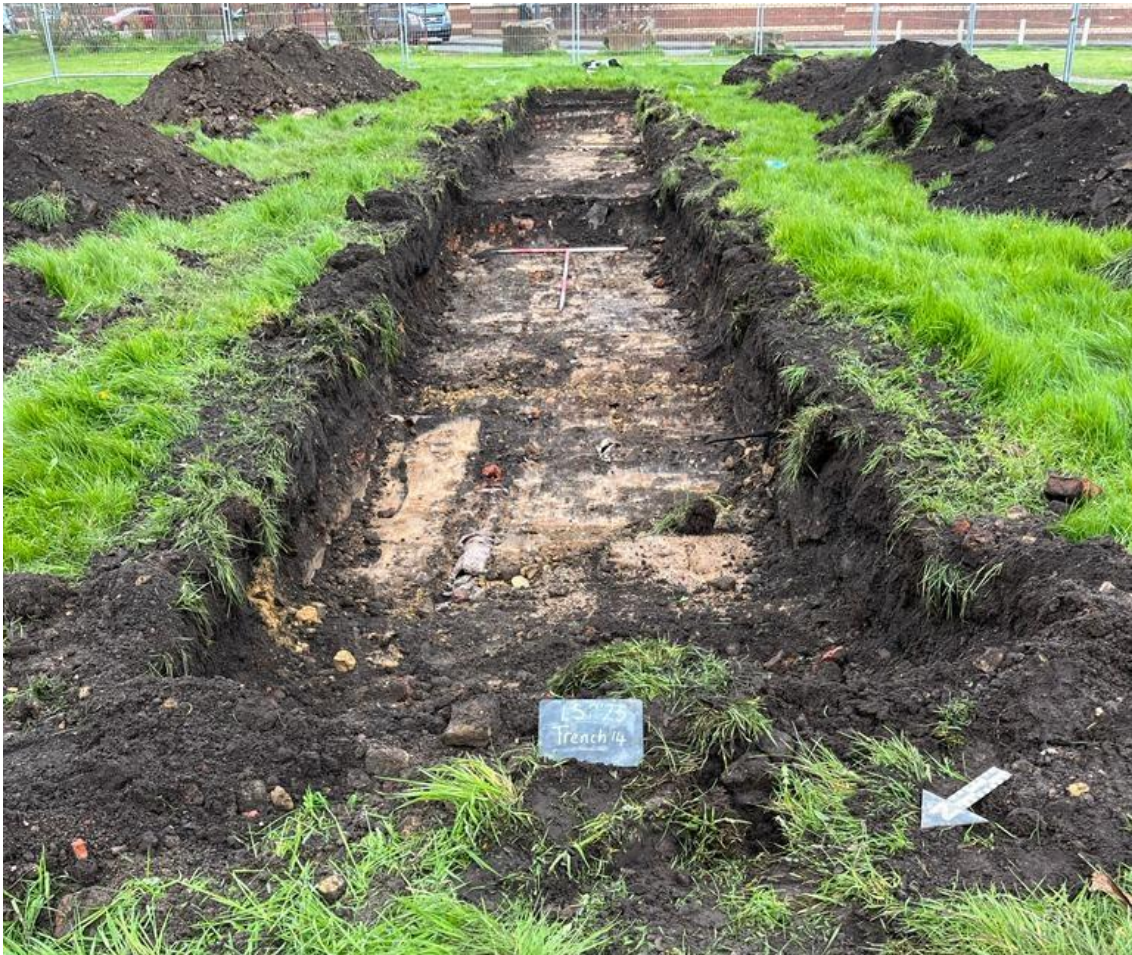
Figure 28: Photograph showing Trench 14, looking south-east. Scale 1x1m and 1x2m in 0.5m graduations.

4.3.35 Trench 14 (Figure 28) was orientated north-west to south-east and targeted buildings and stalls associated with the Salford Cattle Market. The only remains present within the trench was a north-west to south-east aligned ceramic drain and its associated brick-built manhole {1404}. These are likely associated with the former mid-20th century school located nearby as they were cut through demolition material (1402).

4.3.36 No remains associated with the former cattle market were encountered.

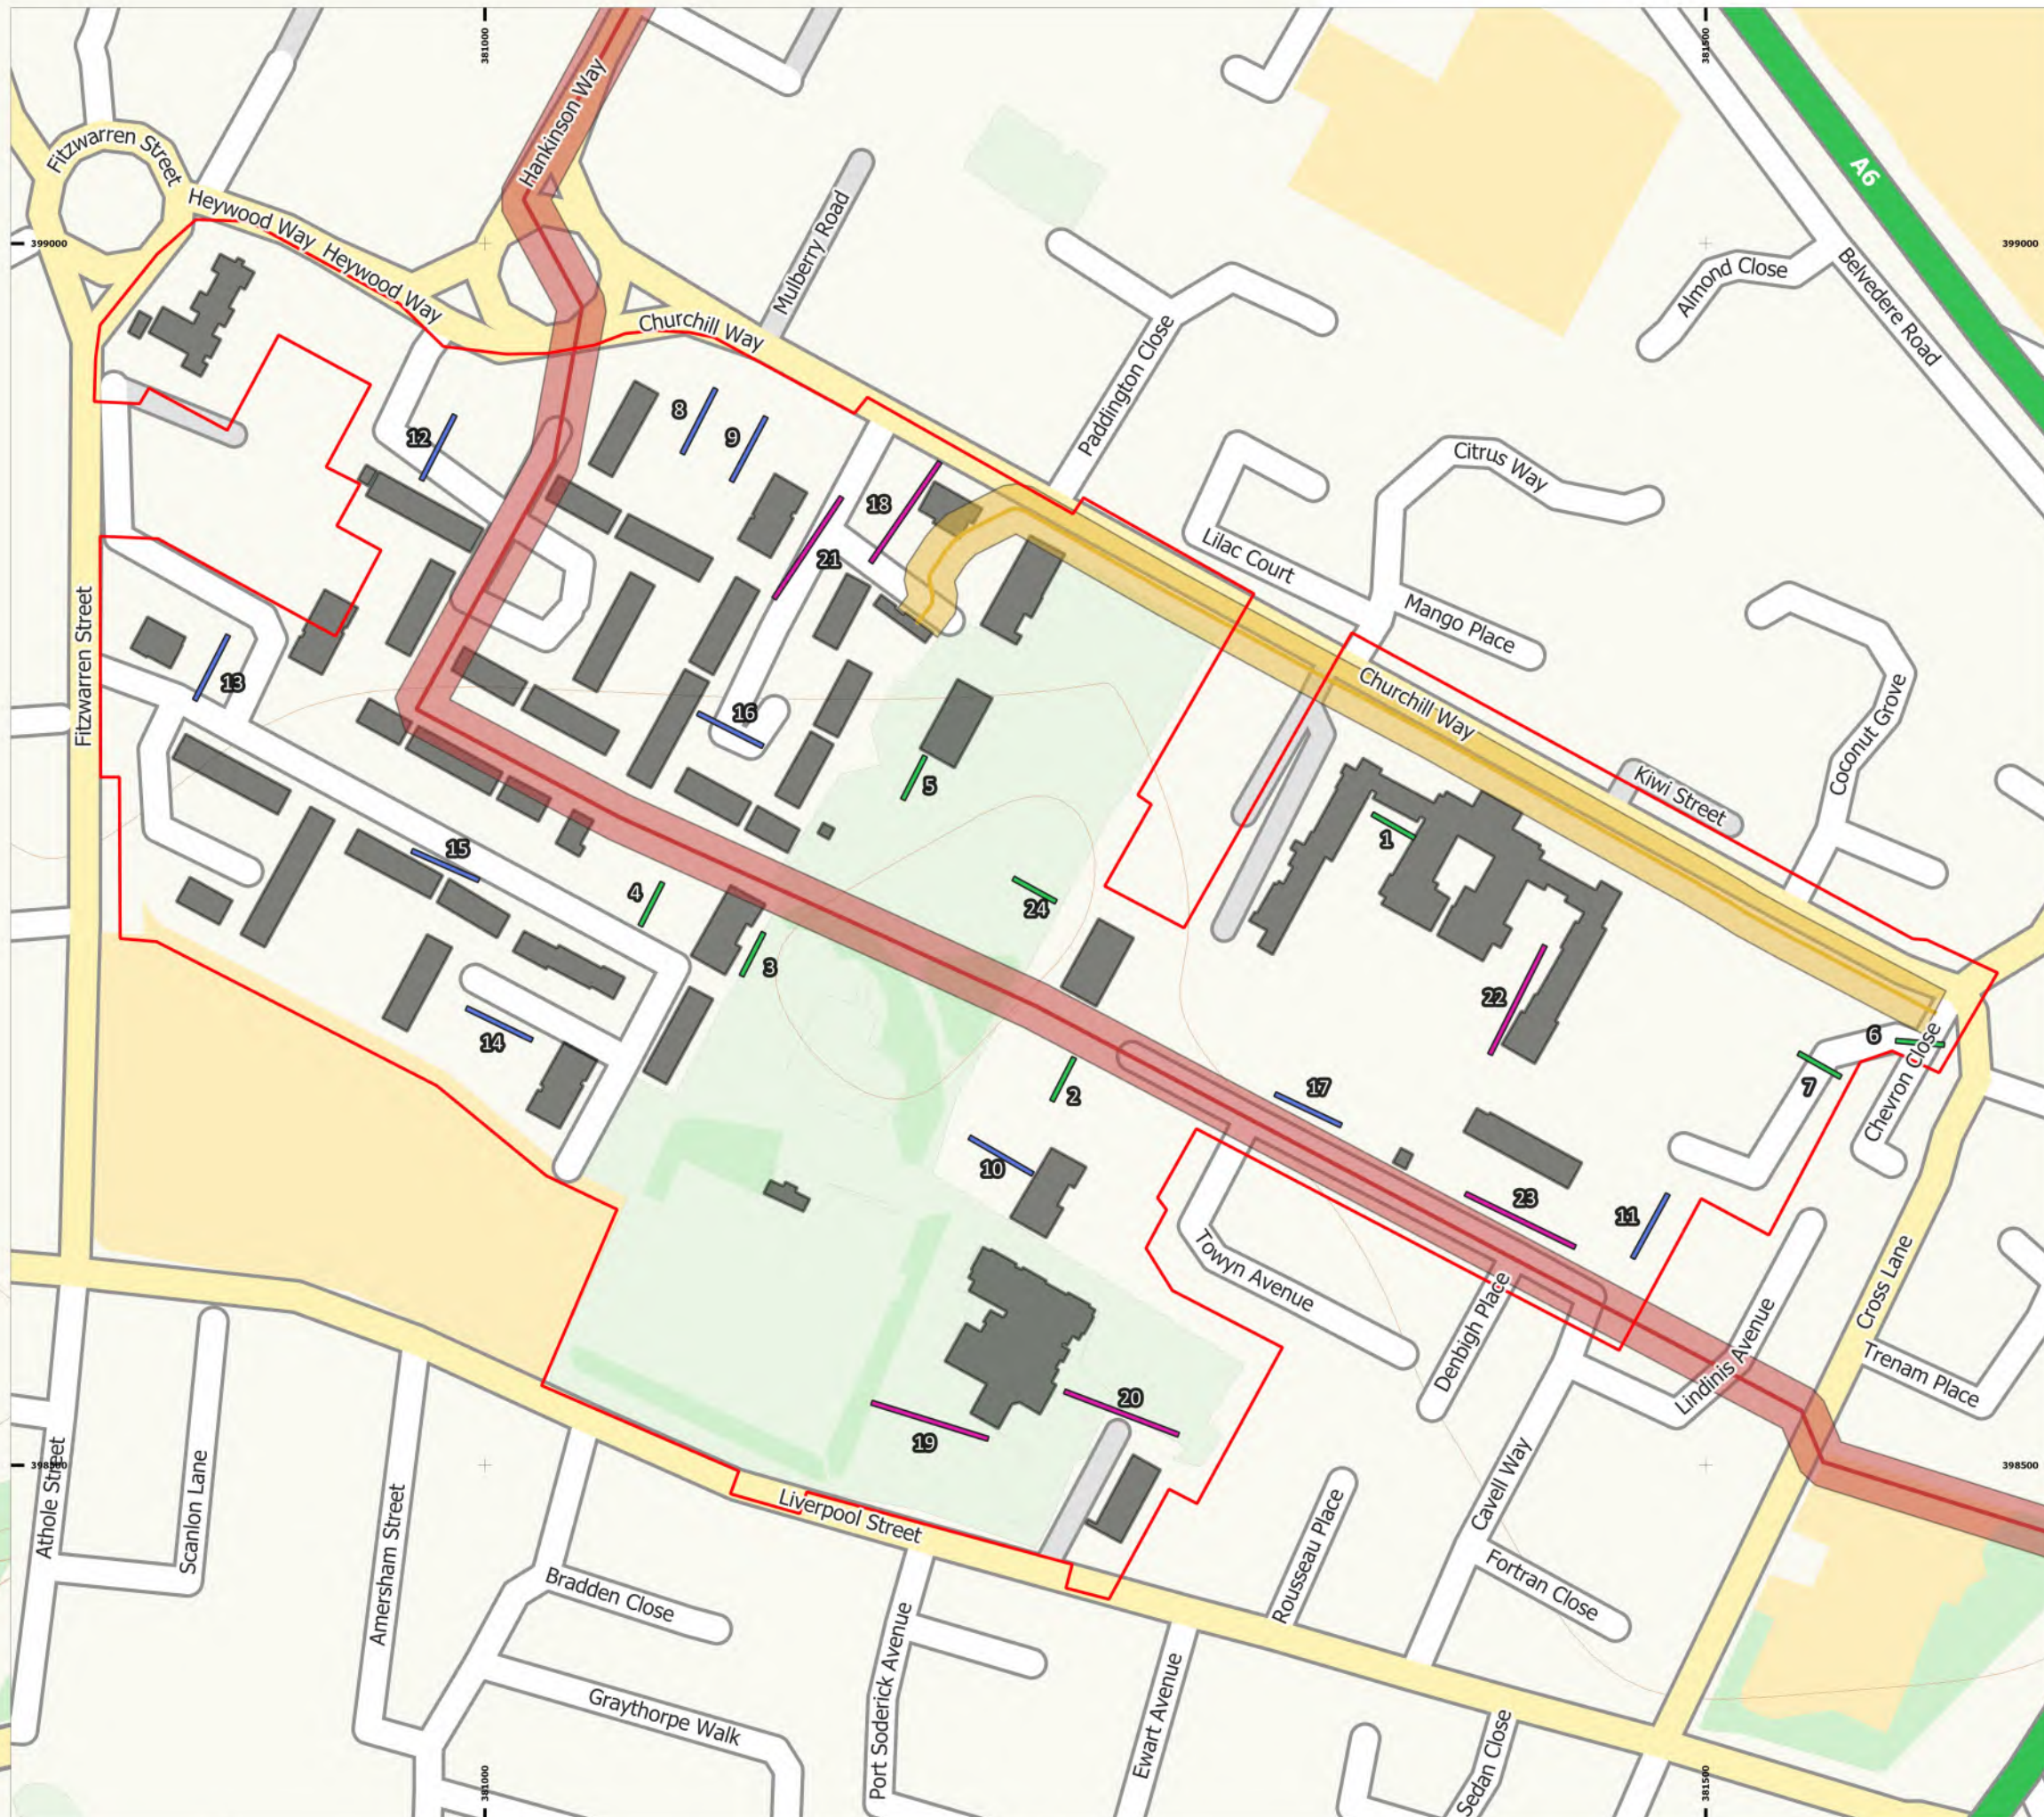
Figure 2: Trench Plan

5.1.1 Nine 30m x 2m, seven 20m x 2m and six 50m x 2m trench plans are to be excavated within the PDA (Figure 2) in order to identify any surviving remains

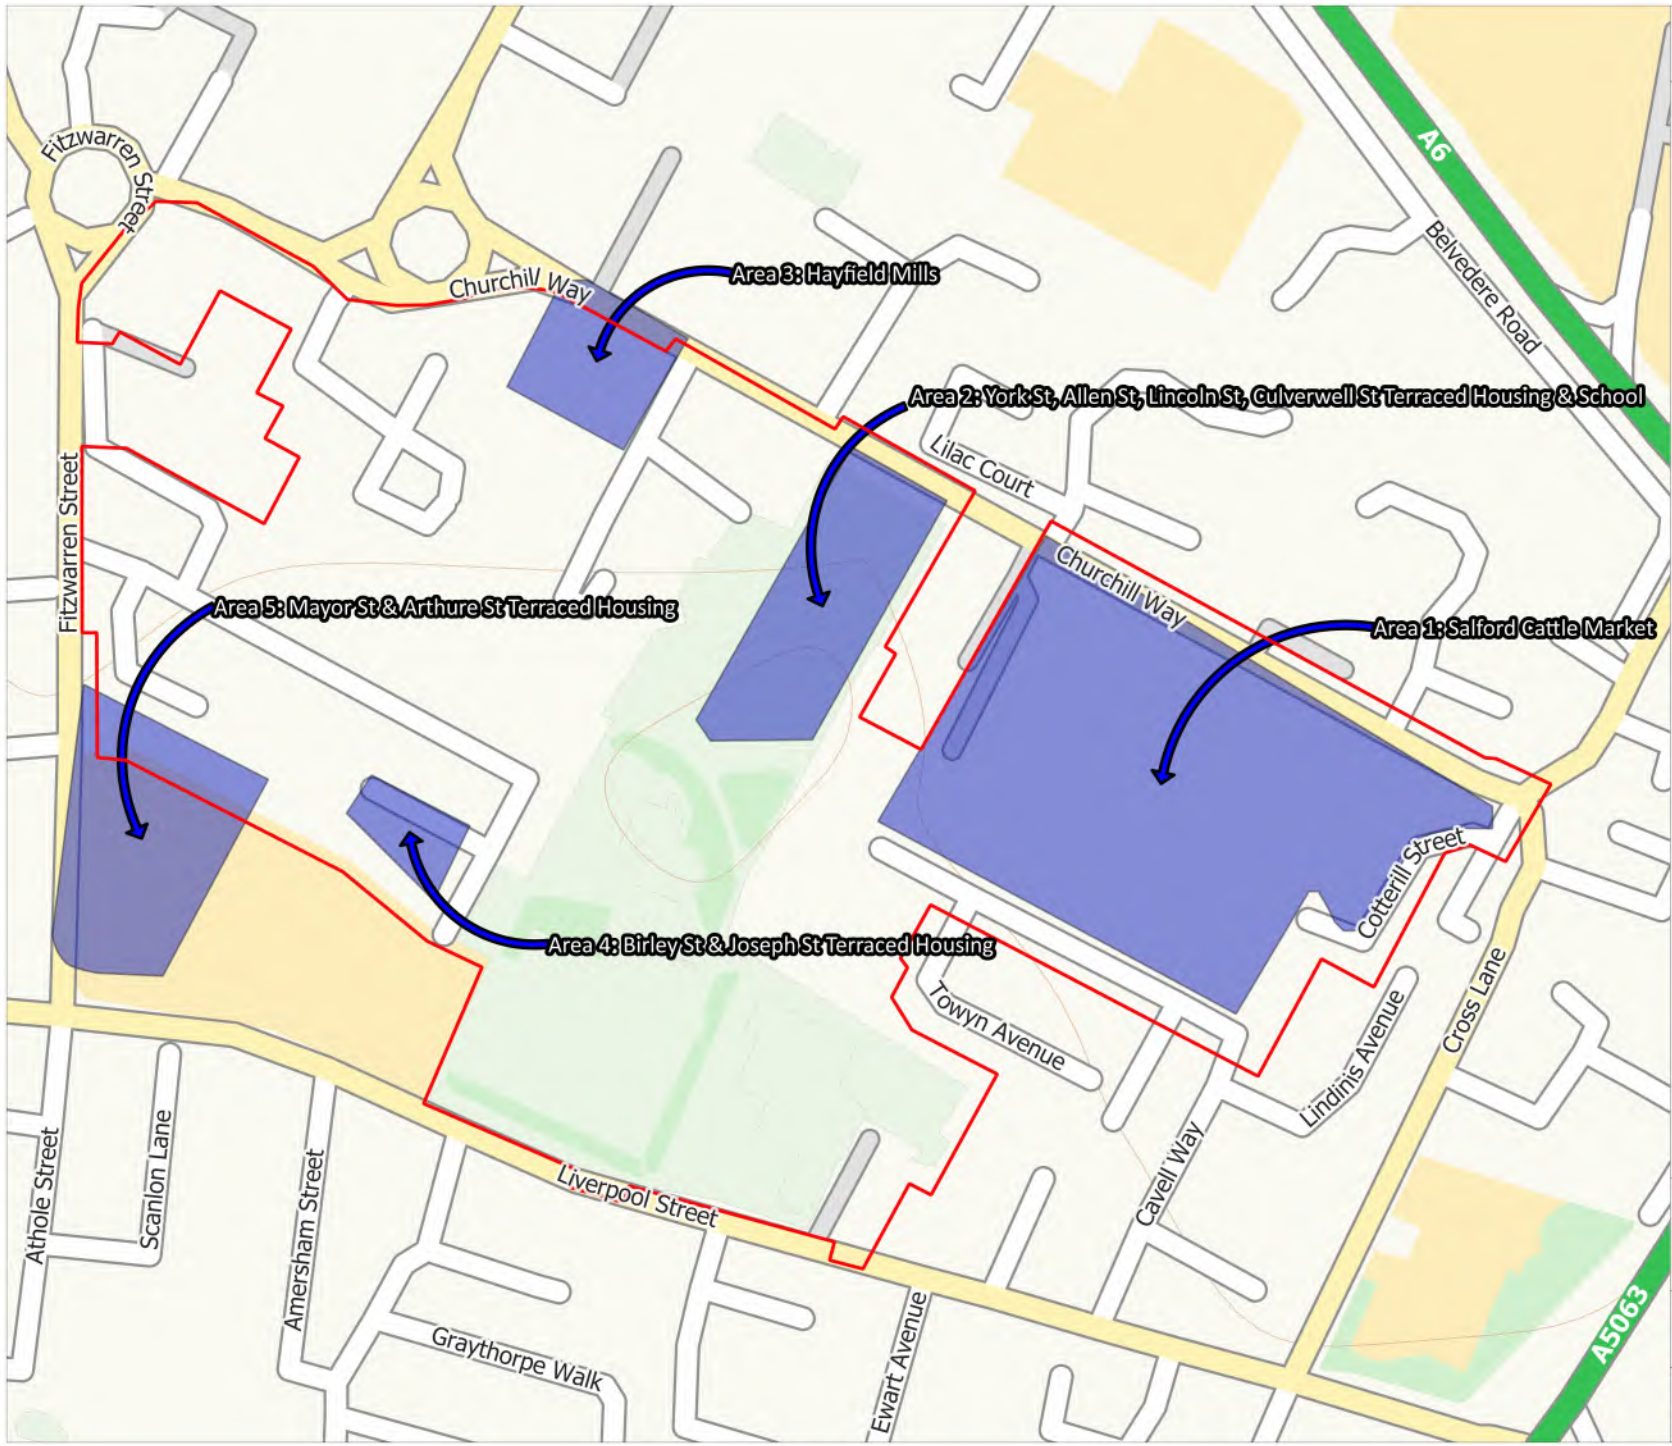
Figure 3: Community Engagement Areas

7.3.2 The 2014 archaeological desk-based assessment (Nash *et al*) highlighted five key areas of the development site that could have the potential, based on the level of preservation, for further excavation and community engagement. These five areas are listed below and illustrated on Figure 3.
