# ARCHAEOLOGICAL WATCHING BRIEF

Hay Farm, Hay Lane, Ashover

ARS Project N°: 24/103  
ARS Report N°:2024/152  
OASIS ID: archaeol5-525957

*A structural watching brief was undertaken of the proposed reconstruction of a former two-storey dwelling house at the site of the former Hay Lane Cottage, Hay Lane, Ashover, Derbyshire, S45 0HF by Archaeological Research Services Ltd on behalf of G. Henshaw in July 2024.*

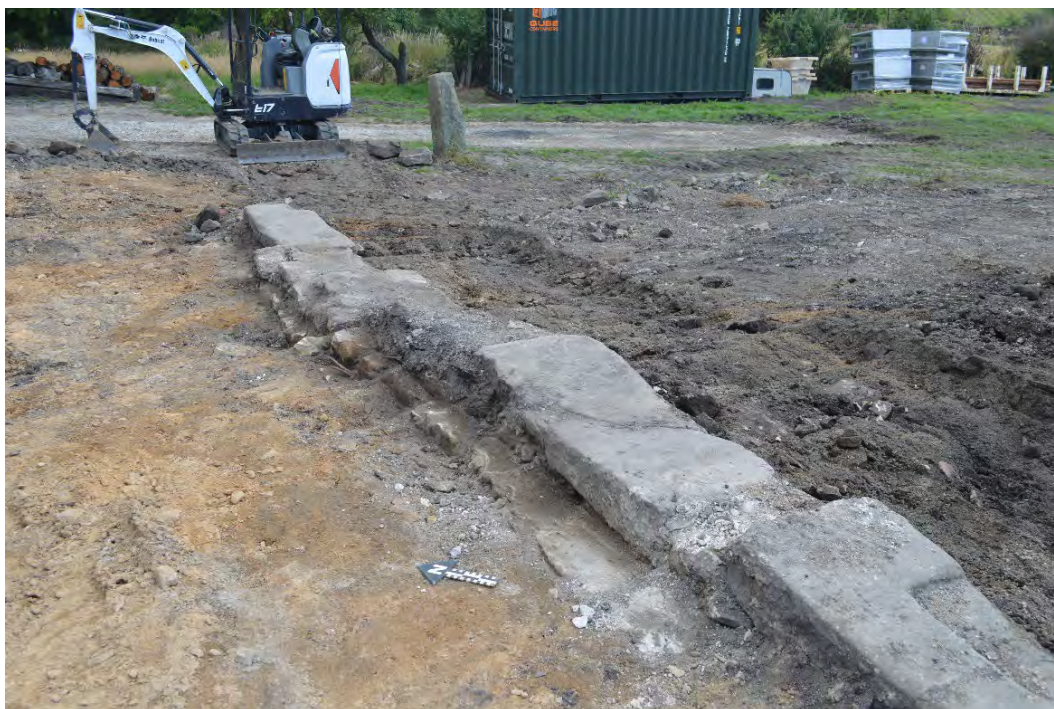
for the main cell of the building were three courses in depth, kick stepped and comprised of roughly hewn sandstone blocks (Figure 5).

*Figure 5. View north-east of wall foundations of main building (scale 1 x 0.15m)*

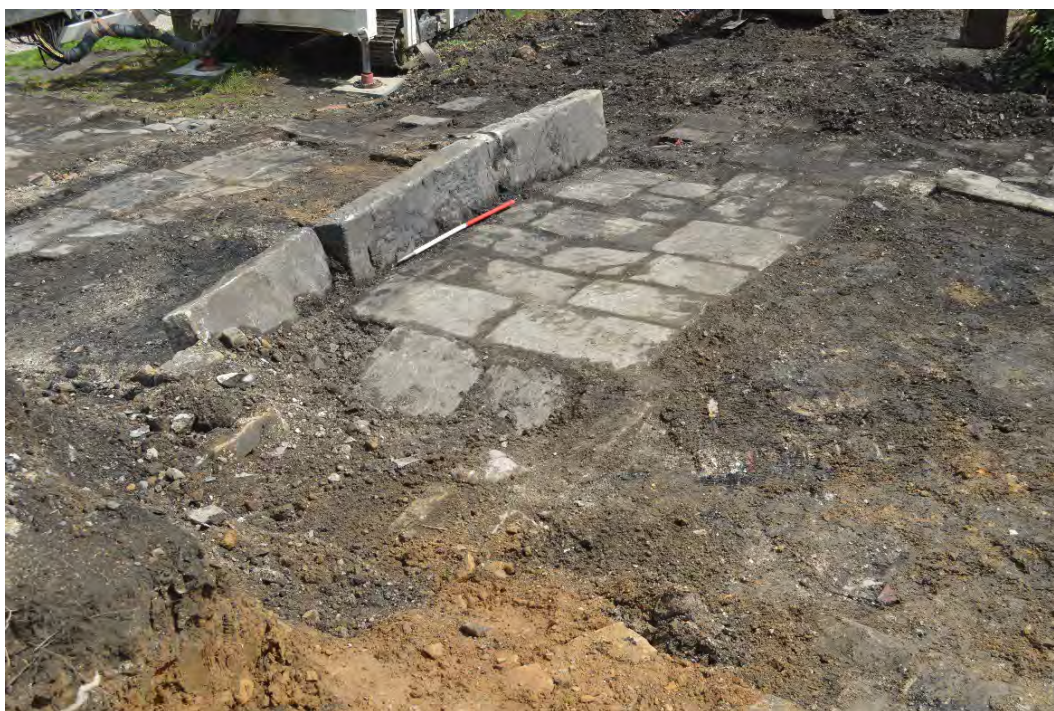
*Figure 6. View north-east of stone floor {008} and {004} divided by wall {007} (scale = 1 x 1m in 0.5m graduations)*

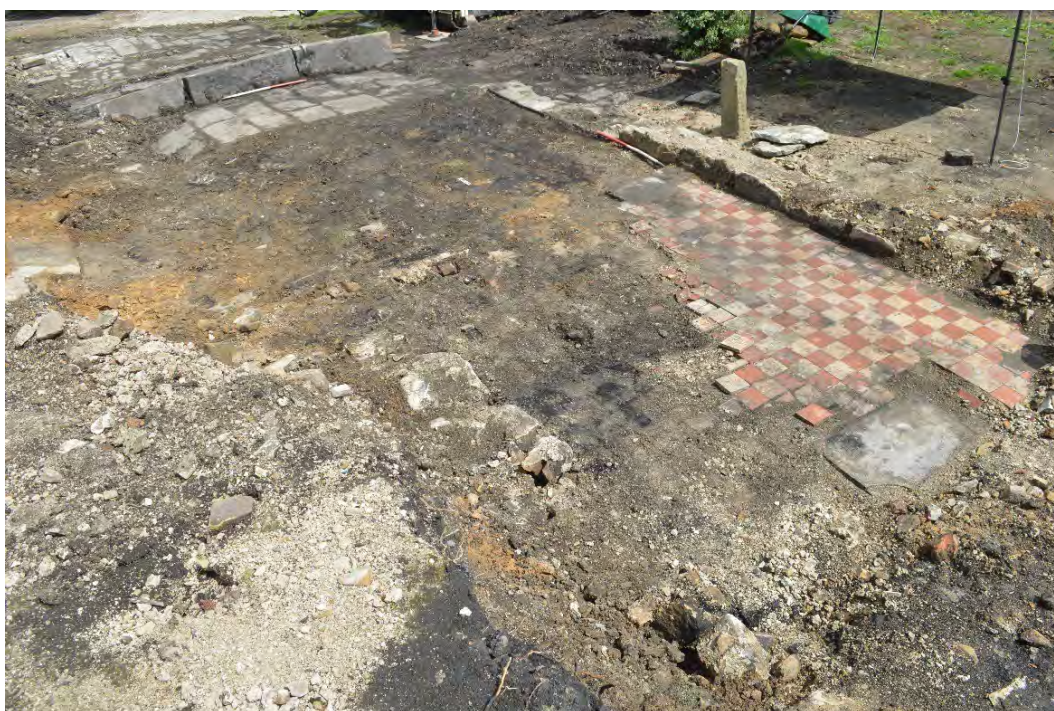
*Figure 7. View north east of stone flagged surface {004} in main part of building and tiled floor {003} in the southern extension (scale = 2 x m1m in 0.5m graduations)*

4.2.7 The extension to the south, created an additional room, which was defined by walls {023} to the east, {005} to the south and {006} to the west (Figure 3). The room measured 4.5m by 3m, on a north to south alignment and encompassed an area of 13.5m<sup>2</sup>. The walls comprised a single course of roughly hewn sandstone blocks, bonded by a portland cement mortar. The northern wall of the room was defined by the foundation remains of the original wall {025} which had been removed and later re-built using machine made bricks (see HBR, section 6.2.8 - 6.2.12). There was no evidence of foundation trench and the wall appeared to have been directly built on to the natural. Internally, the room contained the truncated remains of a terracotta style checkered floor (003) and a fireplace slab stone {014}, both overlaying levelling deposit (032) (Figure 7).

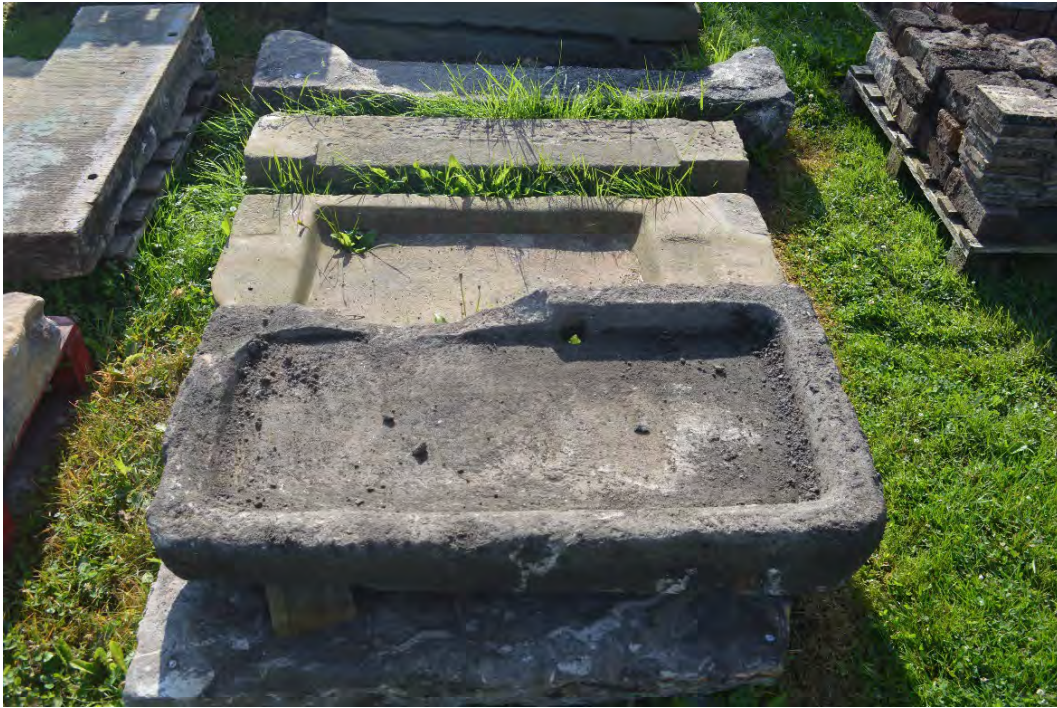
*Figure 8. View of re-used stone from {004} (no scale)*

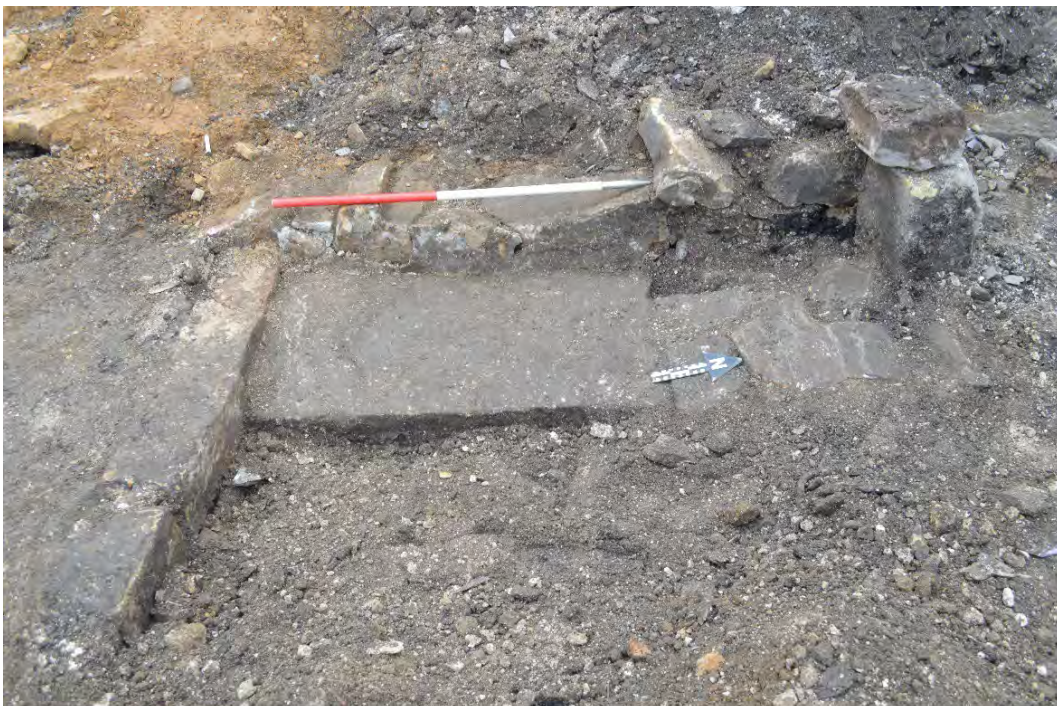
4.2.5 To the south, Room 2 measured 5.66m by 4.41m, and encompassed an area of 24.96m<sup>2</sup>. The internal floors comprised terracotta tiled floors {030} and stone flagged floors {004}. Terracotta tiled floor {030} was identified in the HBR and overlaid levelling deposit (018). Stone floor {004} was construction on a mid-brownish yellow gritty sand (020) that was laid on the natural substrate (Figure 6 and Figure 7). Evidence of slumping was identified on the western side of the floors close to wall {011}, where it had been built on top of the natural coal seam (Figure 9).

*Figure 9. Evidence of stone flagged floor {004} slumping. (scale = 1 x 1m in 0.5m graduations)*

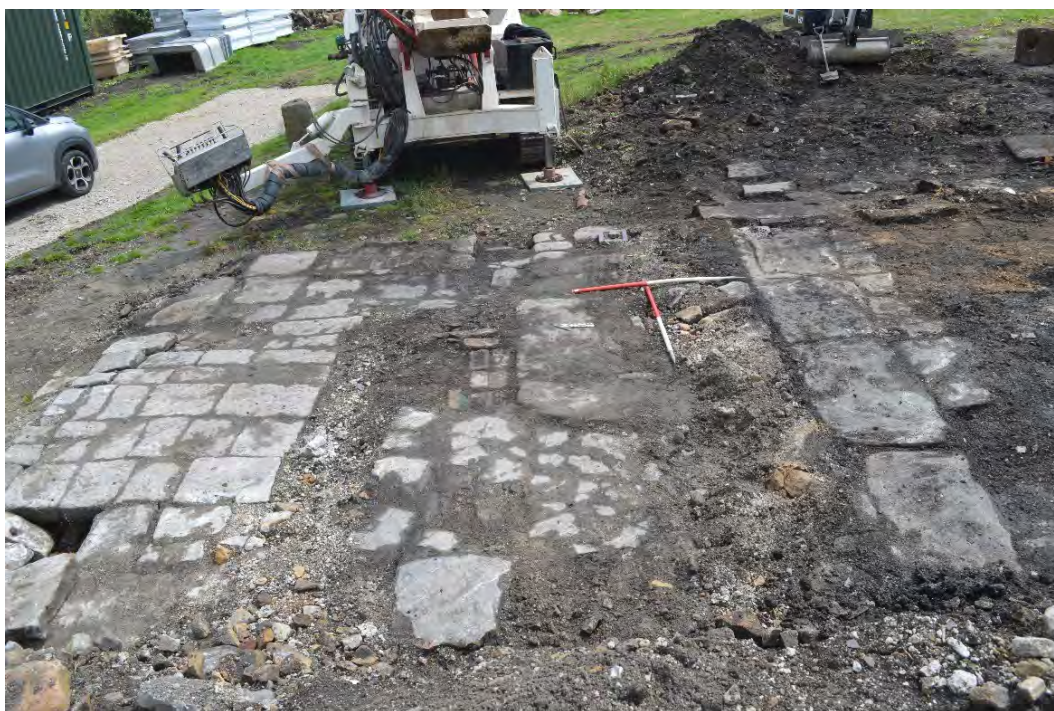
4.2.6 The extension to the north measured 3.8m by 5.3m wide, and created an additional room with an area of 20.14m<sup>2</sup>, consisting of walls {010}, {026} and {027}, and internal floor surfaces {009} and {015} (Figure 3 and Figure 10). The walls comprised of two courses of roughly hewn limestone blocks bonded by a lime mortar. Internal floor {009} and {015} abutted the walls on their internal faces but were separated from one another by a rubble filled drain [020]. The floors comprised roughly hewn sub square shaped gritstone slabs. There was no evidence of bonding material and these were laid directly onto a made ground deposit (029).

*Figure 10. View east of the northern extensions floor surfaces {009}, {015} (scale = 2 x 1m in 0.5m gradations)*

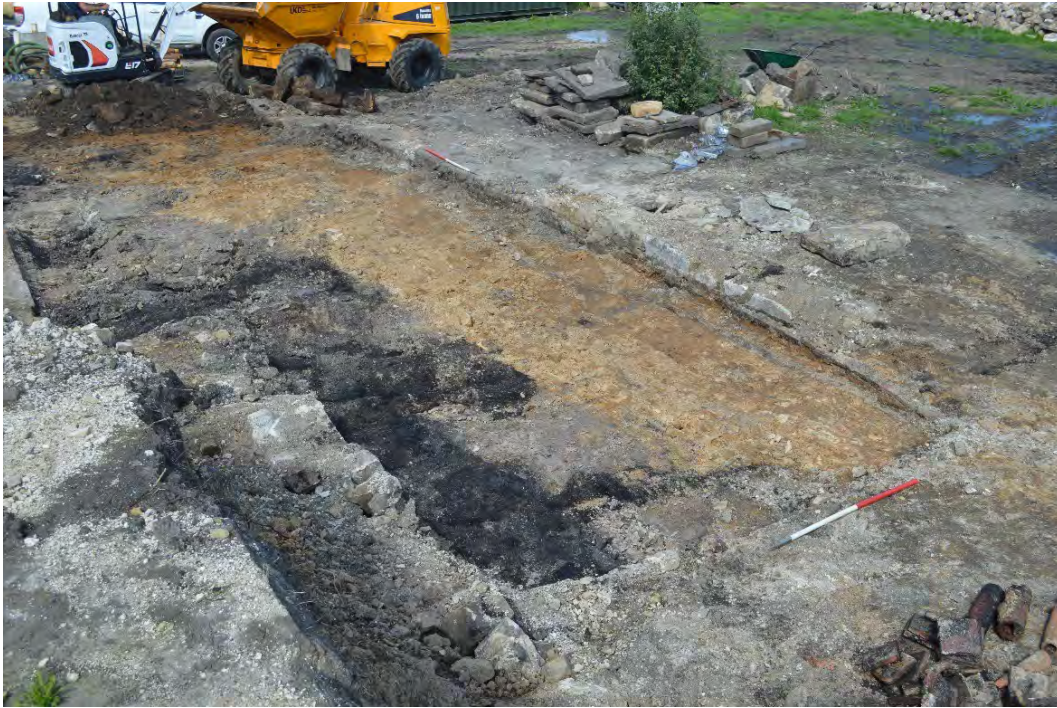
4.2.8 The instability of the walls and floors that were noted in the HBR, were caused by the structure being built on top of a natural coal seam (016) without substantial foundations (Figure 11 and Figure 4).

*Figure 11. View north-east of building after floor removals showing natural (012) and the natural coal seam (scale = 2 x 1m in 0.5m graduations).*

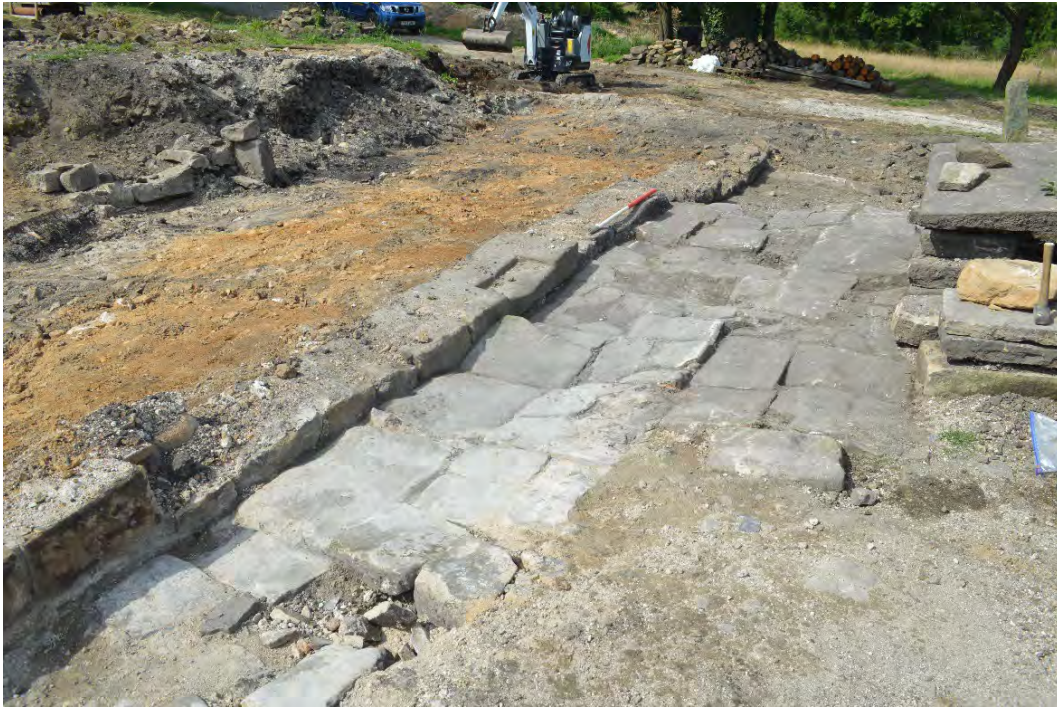
4.2.10 To the east to the building, a stone courtyard surface {002} extended along the length of the building for 9.55m and measured 2.07m wide (Figure 12). It overlaid a buried topsoil (028) which had a thickness of 0.12m, that in turn overlaid the natural substrate (Figure 13).

*Figure 12. View north west of stone courtyard {002} (scale = 1 x 1m in 0.5m graduations)*

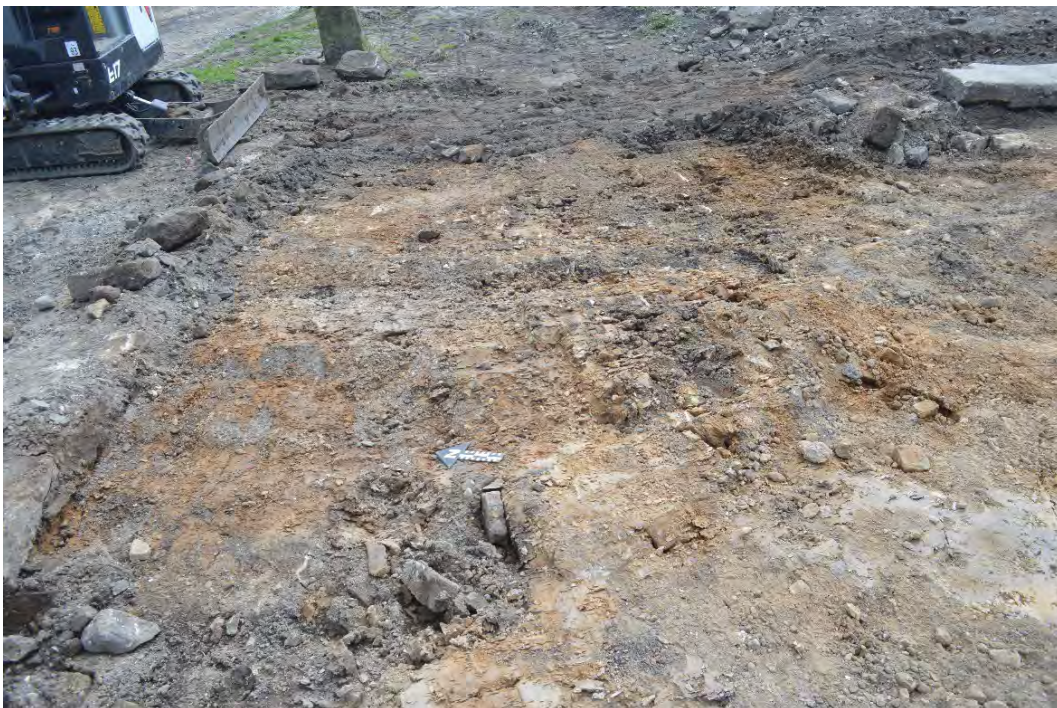
*Figure 13. View of natural after the removal of stone courtyard surface {002} (no scale)*

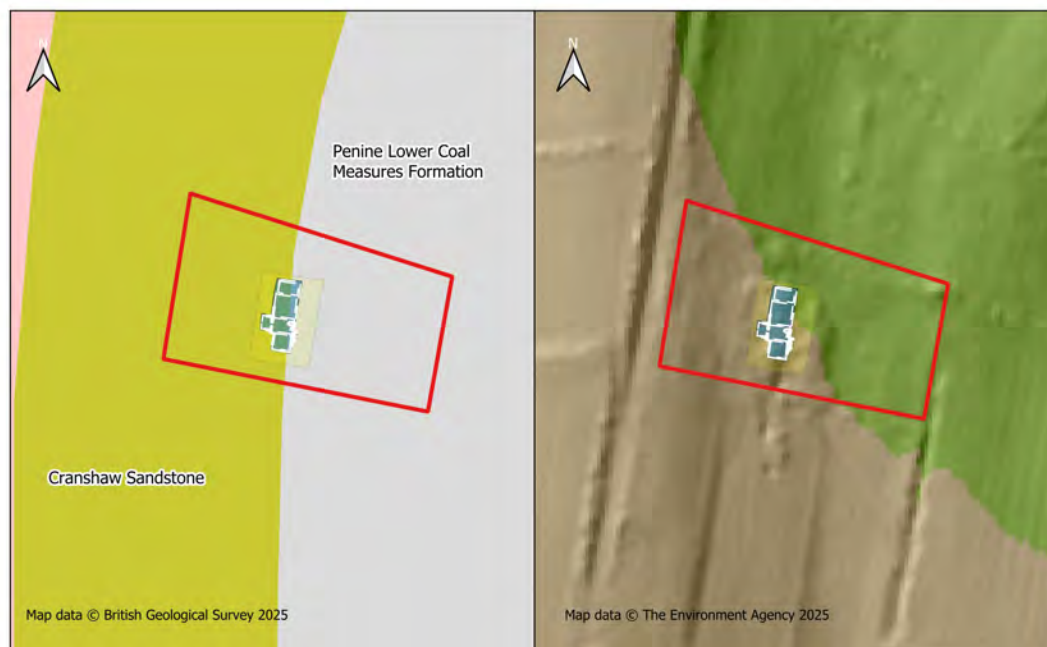
5.1.4 It is noteworthy that the building is located right on top of the change from the Crawshaw Sandstone to the west and Pennine Lower Coal Measures Formation to the east (see Figure 14), with a natural coal seam found during the watching brief oriented north-south along this boundary (see Figure 4). The instability of the ground and remaining structures, as noted in the HBR, is likely due to this geological composition, combined with the lack of substantial footings and foundations.

Figure 14. Hay Farm Cottage overlaid on geological and LiDAR mapping

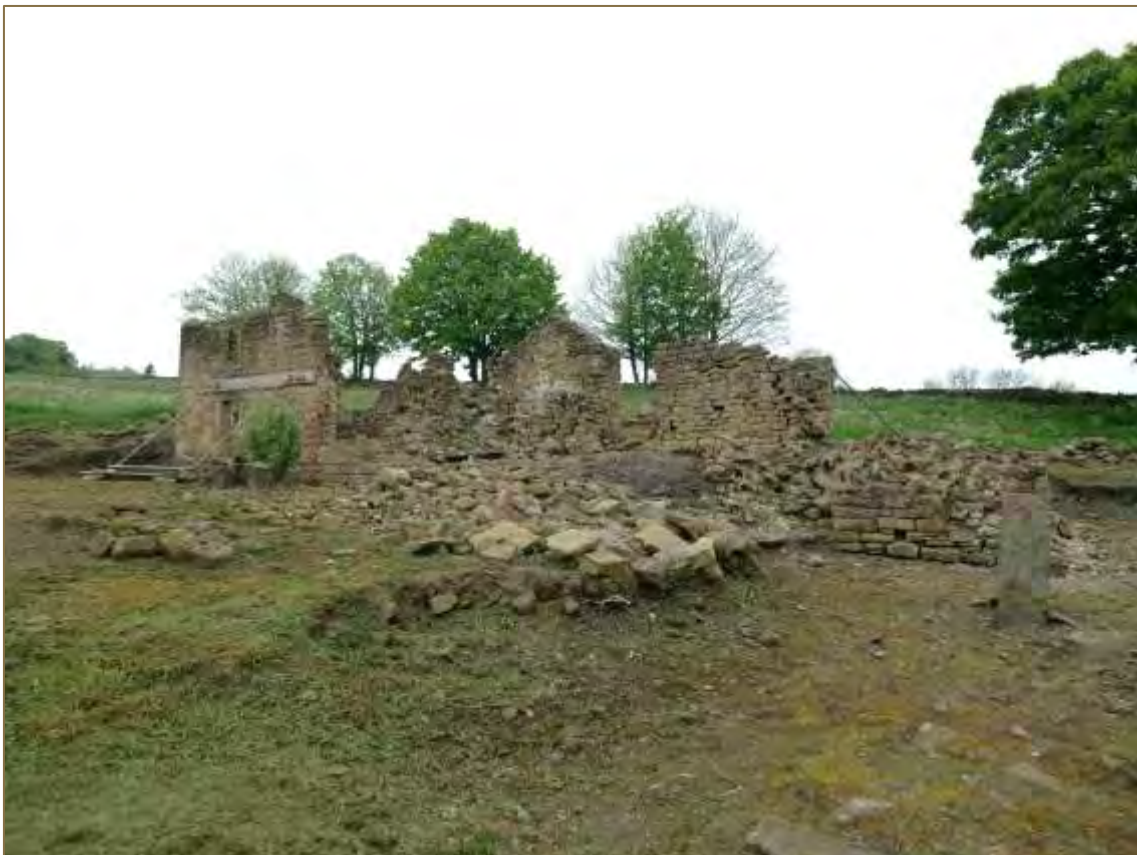
Photograph 2: Settings (indicated). (File: HBR\_11)

- 6.2.3 The historic building survey covers the structure as denoted in **Photograph 2** below.

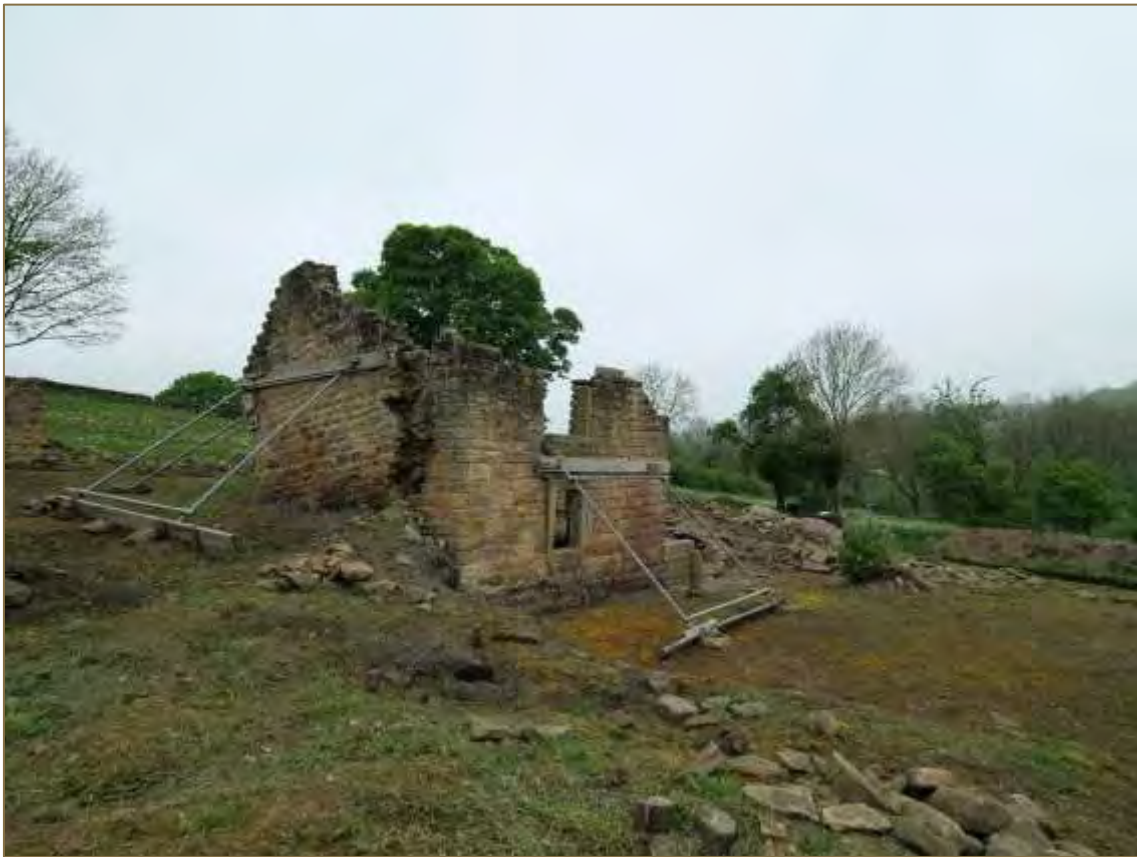
Photograph 5: Overall view of the remains of Hay Lane Cottage (looking north west). (File: HBR\_9)

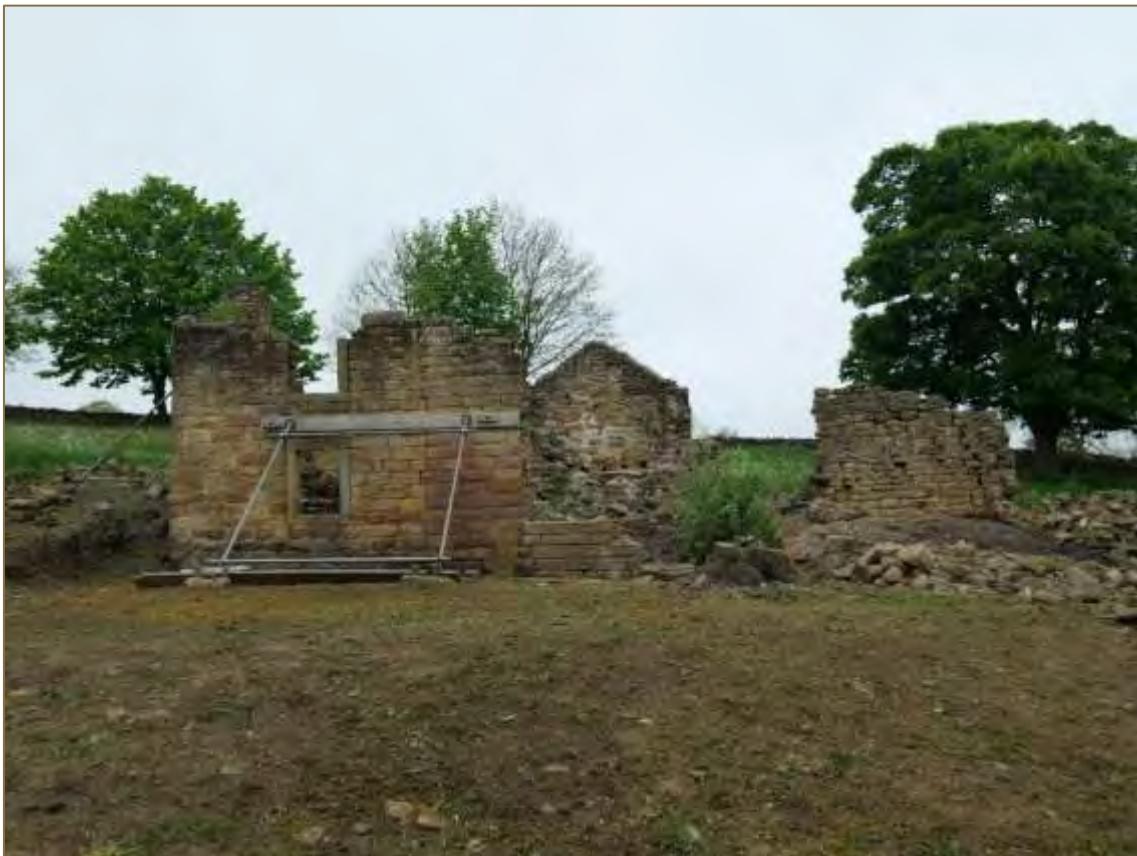
Photograph 6: The east elevation of the remains of Hay Lane Cottage (looking west). (File: HBR\_10)

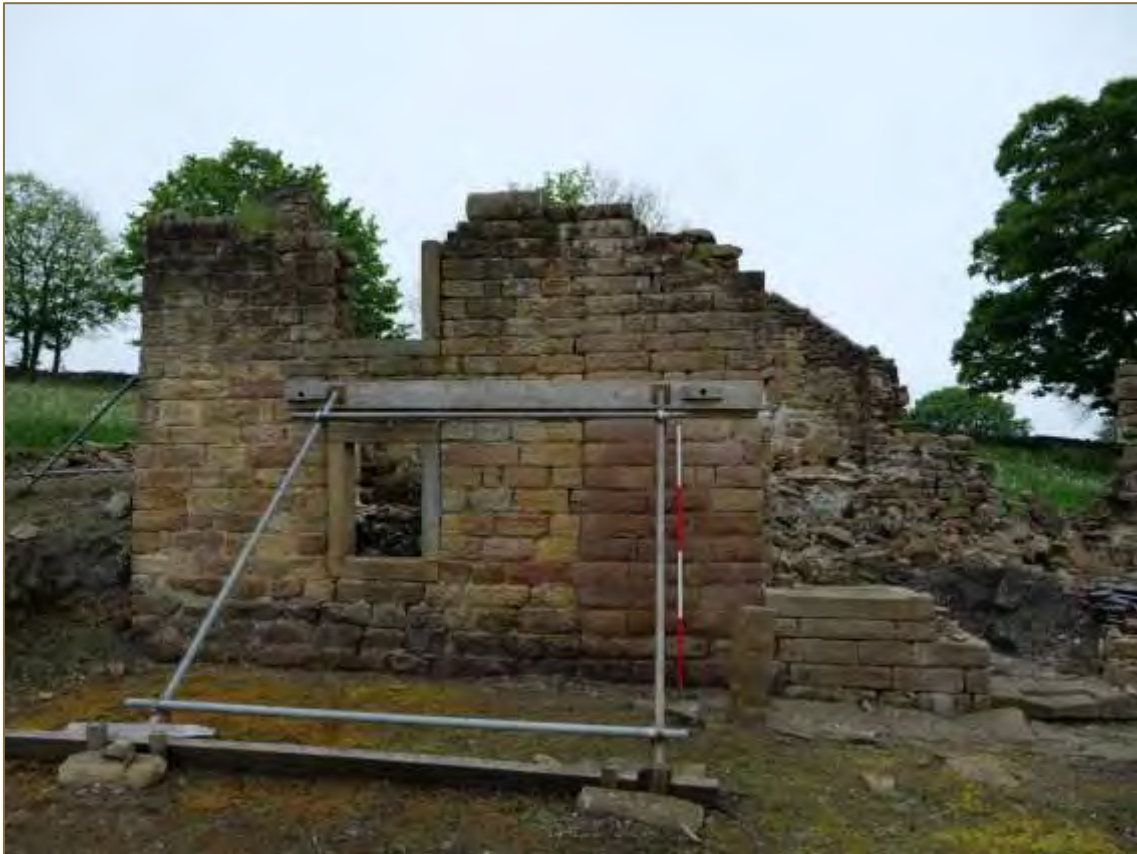
- 6.2.9 Only the south portion of this wall remains *in-situ* to any significant degree, this belonging to the south wing of the original building, which rises to a height of c. 4m and approximately one and a half storeys (**Photograph 7**). The windows are single block lintels, jambs and cills (**Photograph 8**).

Photograph 7: The east elevation of the remains of Hay Lane Cottage (looking west) Scale 2m. (File: HBR\_10)

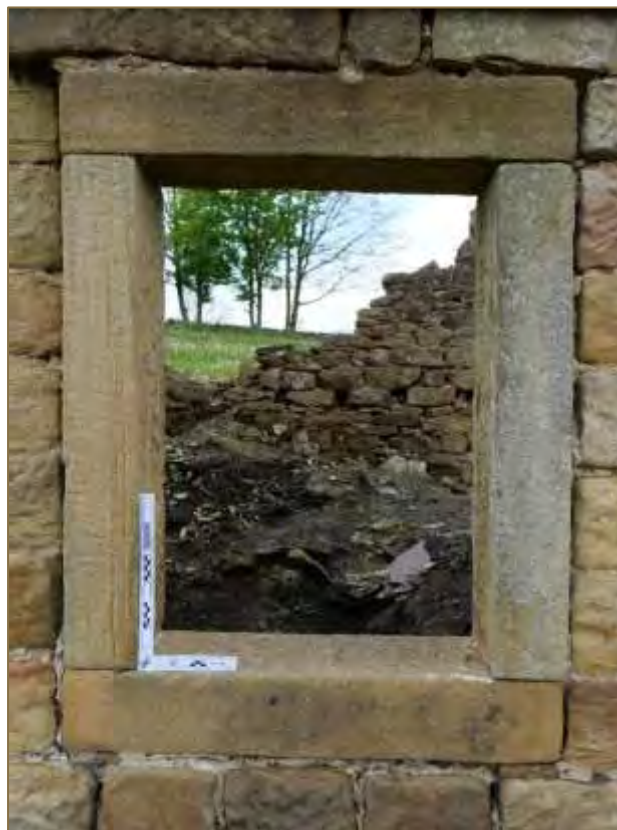
Photograph 8: Detail of the ground floor window of the east elevation (looking west). (File: HBR\_29)

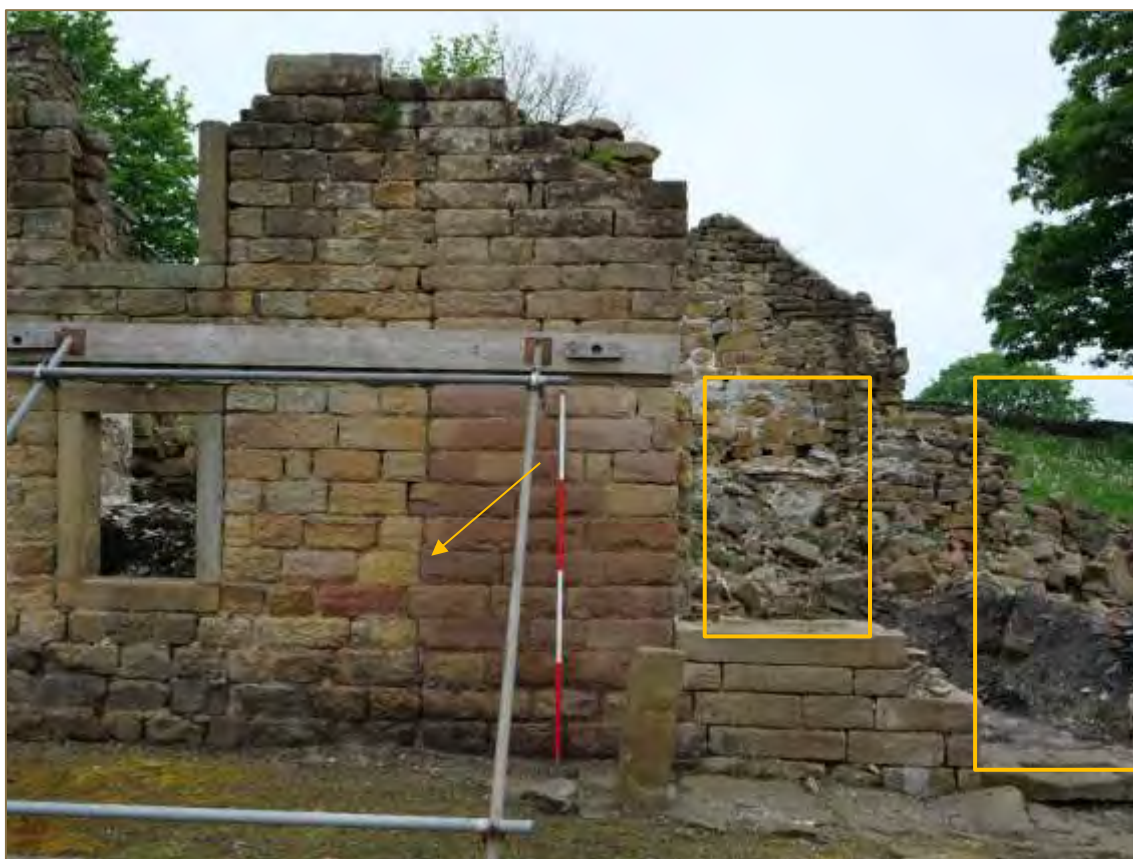
- 6.2.10 The north end of the south wing wall cleanly abuts the south corner of the former centre range. (**Photograph 9**). The remainder of the wall to the right (south) has been reduced to ground level and part-buried. The centre entrance door is marked by its moulded and worn stone step, still in place (**Photograph 11**). A single dressed stone cill remains *in situ* in the east elevation of the centre range (**Photograph 10**)

Photograph 9: The east elevation of the centre range (looking west), with construction joint, window and door apertures indicated. Scale 2m. (File: HBR\_30)

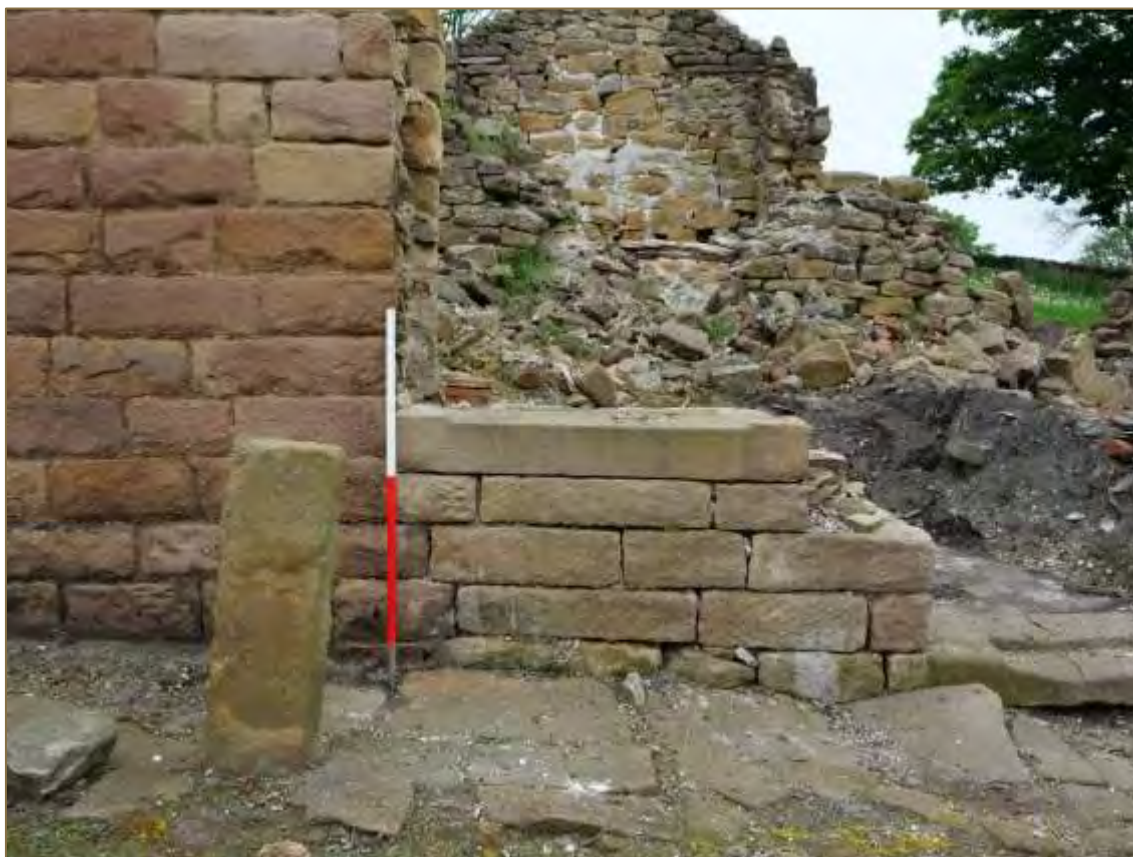
Photograph 10: The in-situ cill to the centre range aperture. Scale 1m. (File: HBR\_112)

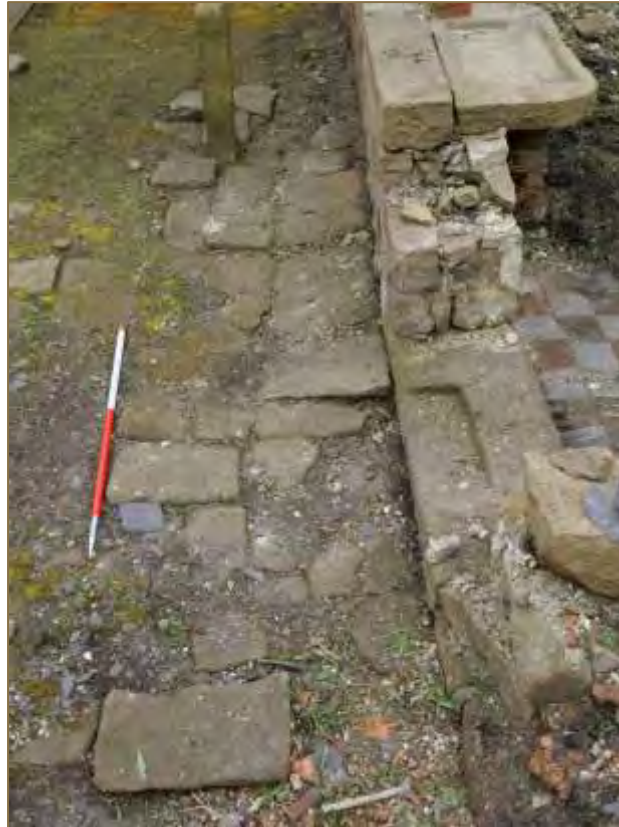
Photograph 11: The east elevation with stone step to entrance and paved area to front (looking south), and sink. Scale 1m. (File: HBR\_75)

- 6.3.3 Immediately adjacent to the front entrance was the *in situ* carved stone sink. This abuts an *in situ* cill. The sink has outward curving sides and a corner plug hole (**Photograph 11, 22**).

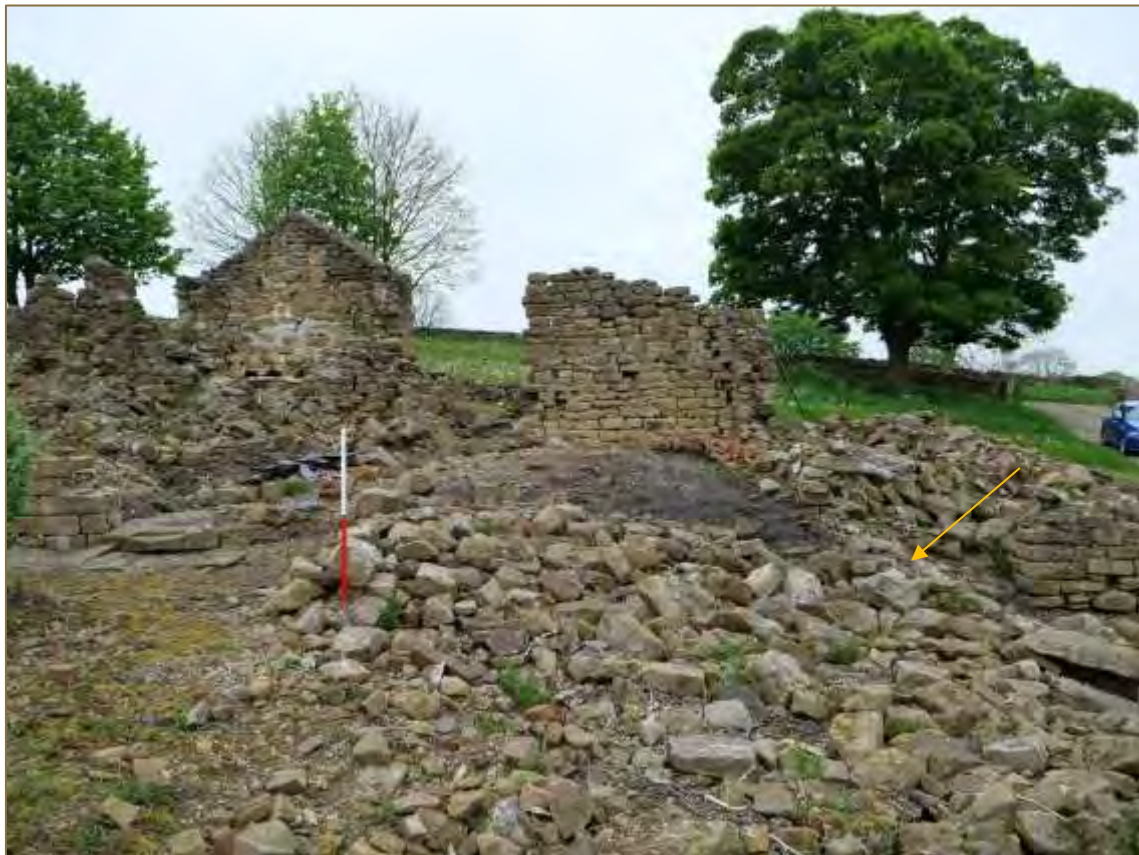
Photograph 12: View showing the approximate north end of the east elevation (to the centre range) indicated (looking west). Scale 1m. (File: HBR\_42)

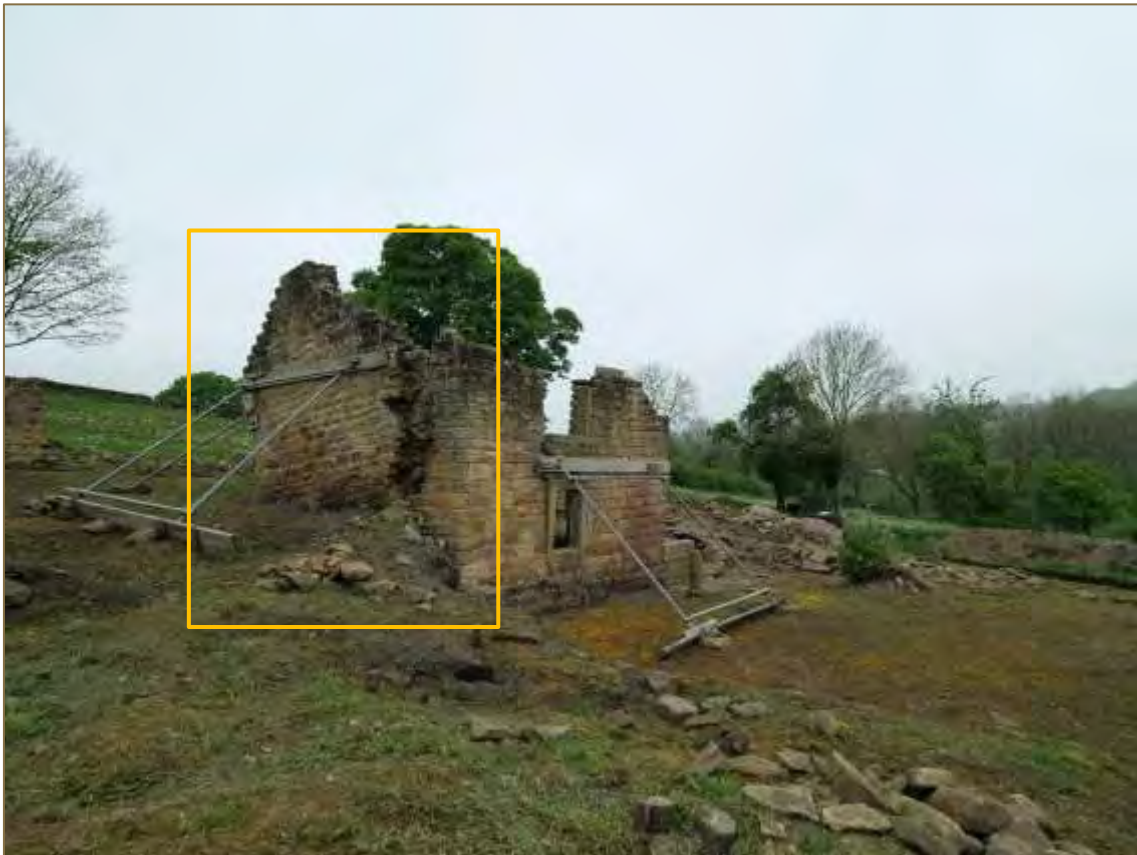
- 6.2.11 The extant south elevation of the building remains constitutes a single bay, gable wall (**Photograph 13 to 15**). The elevation would have been the south facing wall of the south wing of the building after its addition to the central range.
- 6.2.12 The corners of the structure are defined with quoin stones. A degree of ground overburden, sloping upwards to the west, has partly buried the wall. In addition, there has been significant ground movement to this vicinity of the building, the wall being raked downwards to the west. The majority of the elevation has separated from the east facing elevation.
- 6.2.13 The wall incorporates a chimney flue.

Photograph 13: Oblique view of the south elevation (looking north west). (File: HBR\_132)

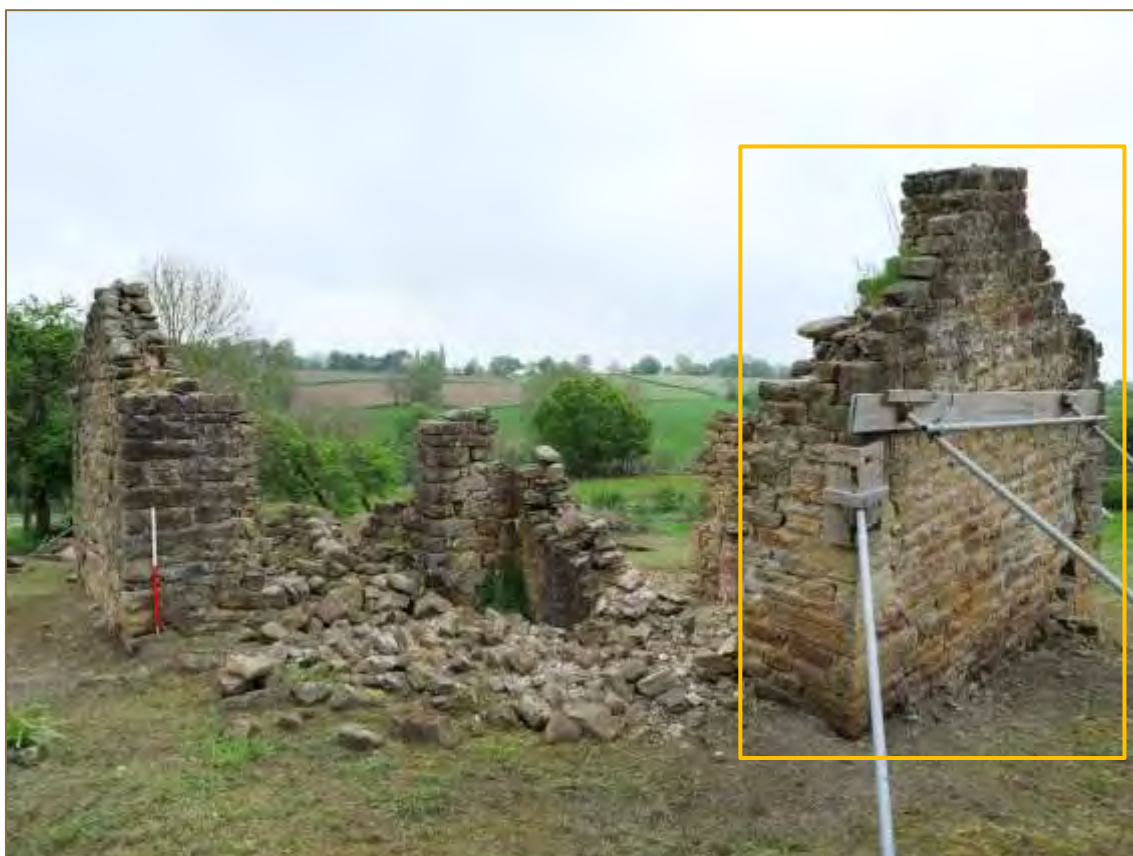
Photograph 14: The south elevation (looking north east). Scale 1m. (File: HBR\_18)

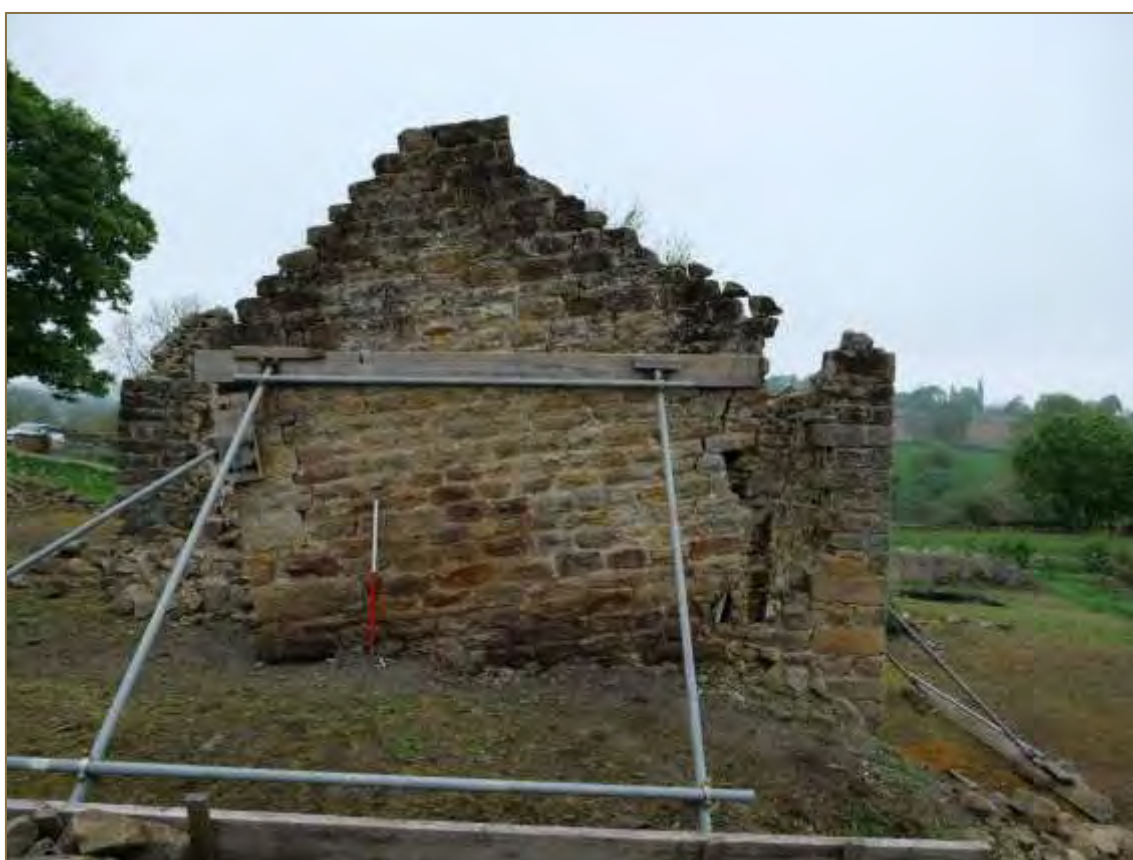
Photograph 15: The south elevation of (looking north). Scale 1m. (File: HBR\_152)

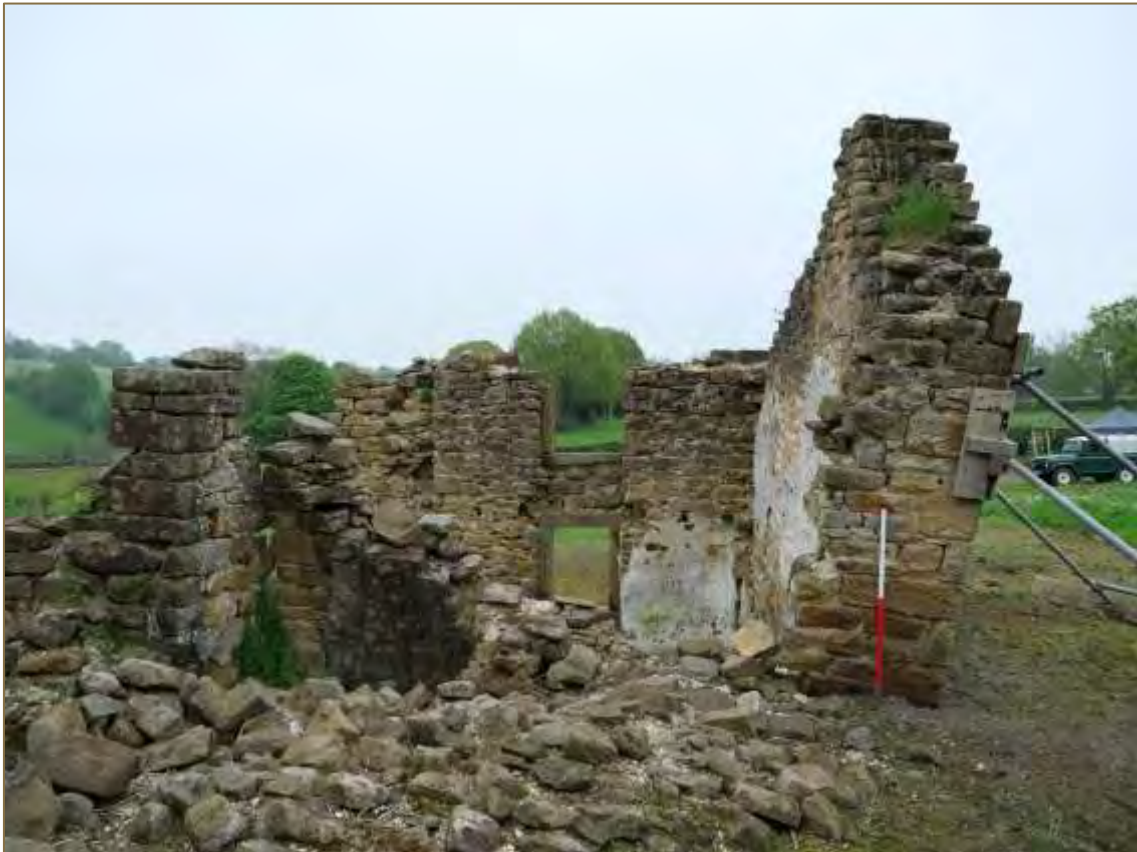
- 6.2.14 A small wing projects outwards from the centre range. The west gable of this wing remains almost to its full height. A change in the roofline can clearly be seen in the west elevation of the extension, raising the height of the gable end from c.2.5 m to 3.2 m. This suggests that this wing was added to the central range before the taller southern range was built. During or after the addition of the southern range, it seems likely that this western wing was raised in height accordingly.

Photograph 16: The west elevation (looking east). Scale 1m. (File: HBR\_140)

- In the west elevation/rear of the building, the upper parts of the wall between the north elevation and the north return to the outshut range retain a section of lime render. **(Photograph 16, 17 and 18).**

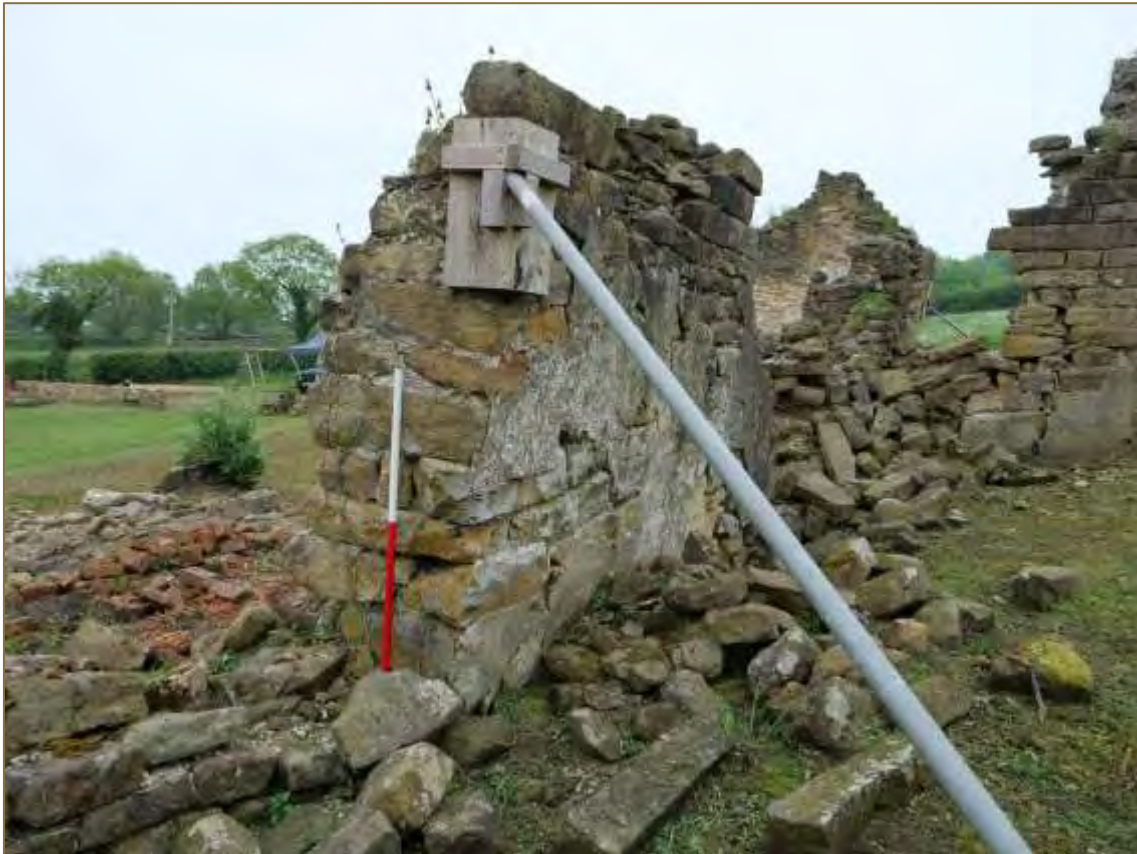
Photograph 17: The west elevation (looking south). Scale 1m. (File: HBR\_152)
