# ARCHAEOLOGICAL WATCHING BRIEF

Hay Farm, Hay Lane, Ashover

ARS Project N°: 24/103  
ARS Report N°:2024/152  
OASIS ID: archaeol5-525957

*A structural watching brief was undertaken of the proposed reconstruction of a former two-storey dwelling house at the site of the former Hay Lane Cottage, Hay Lane, Ashover, Derbyshire, S45 0HF by Archaeological Research Services Ltd on behalf of G. Henshaw in July 2024.*

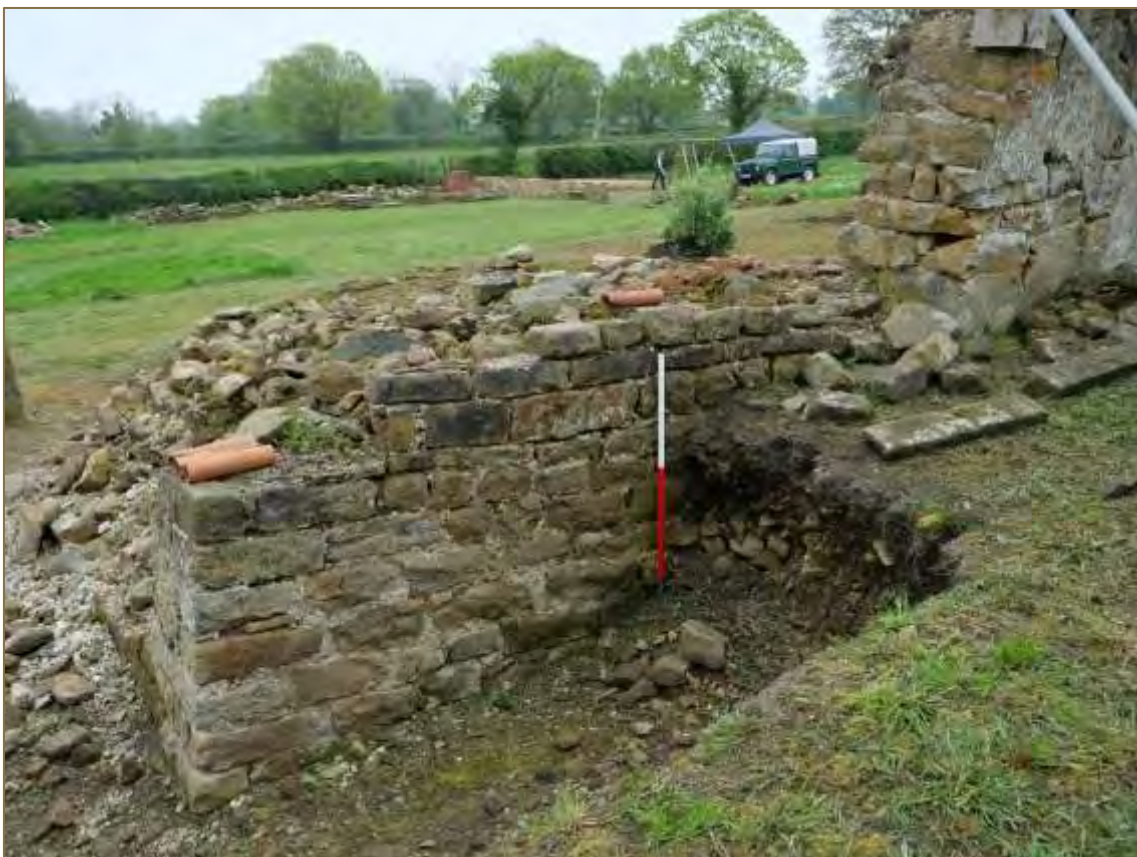
- In the west elevation/rear of the building, the upper parts of the wall between the north elevation and the north return to the outshut range retain a section of lime render. **(Photograph 16, 17 and 18).**

Photograph 18: The west elevation (looking east). Scale 1m. (File: HBR\_152)

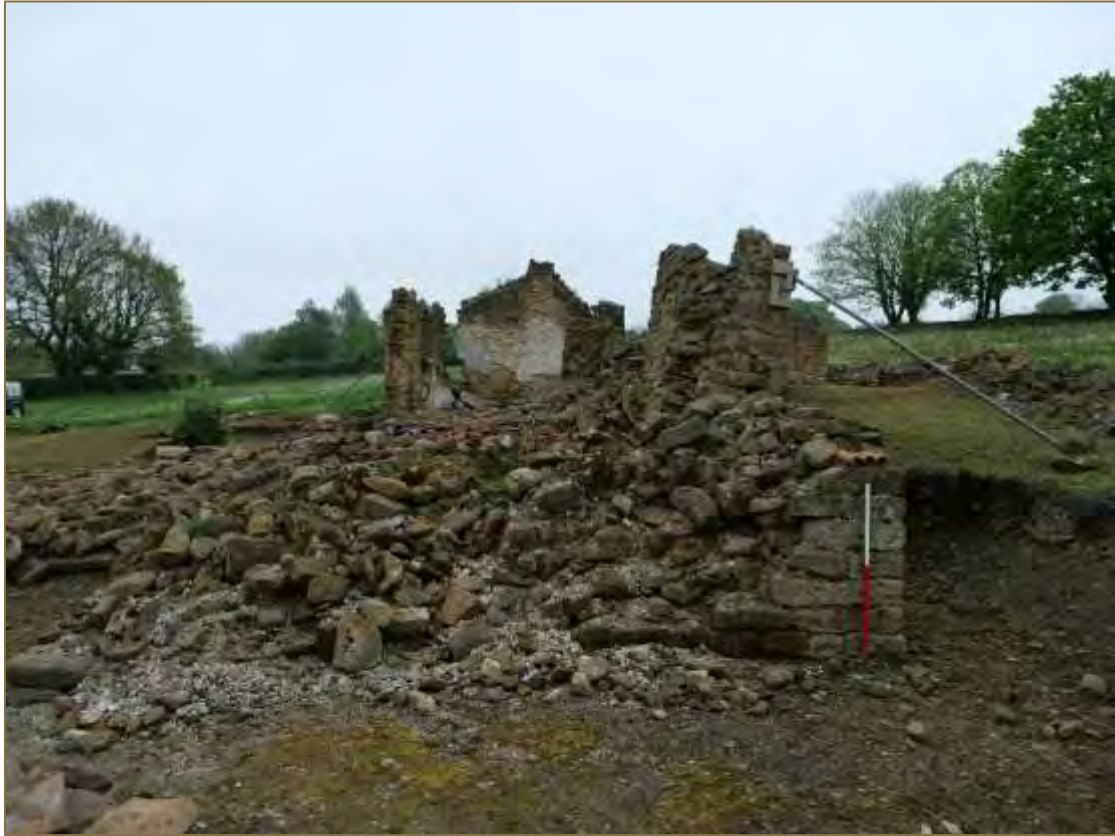
- 6.2.15 The northern aspects of the building were in a particularly ruinous state. From visible remains the north elevation of the centre range could be identified, the footings of which are raised above the height of the adjoining north wing (**Photograph 19**).

Photograph 19: The north elevation (looking west). Scale 1m. (File: HBR\_152)

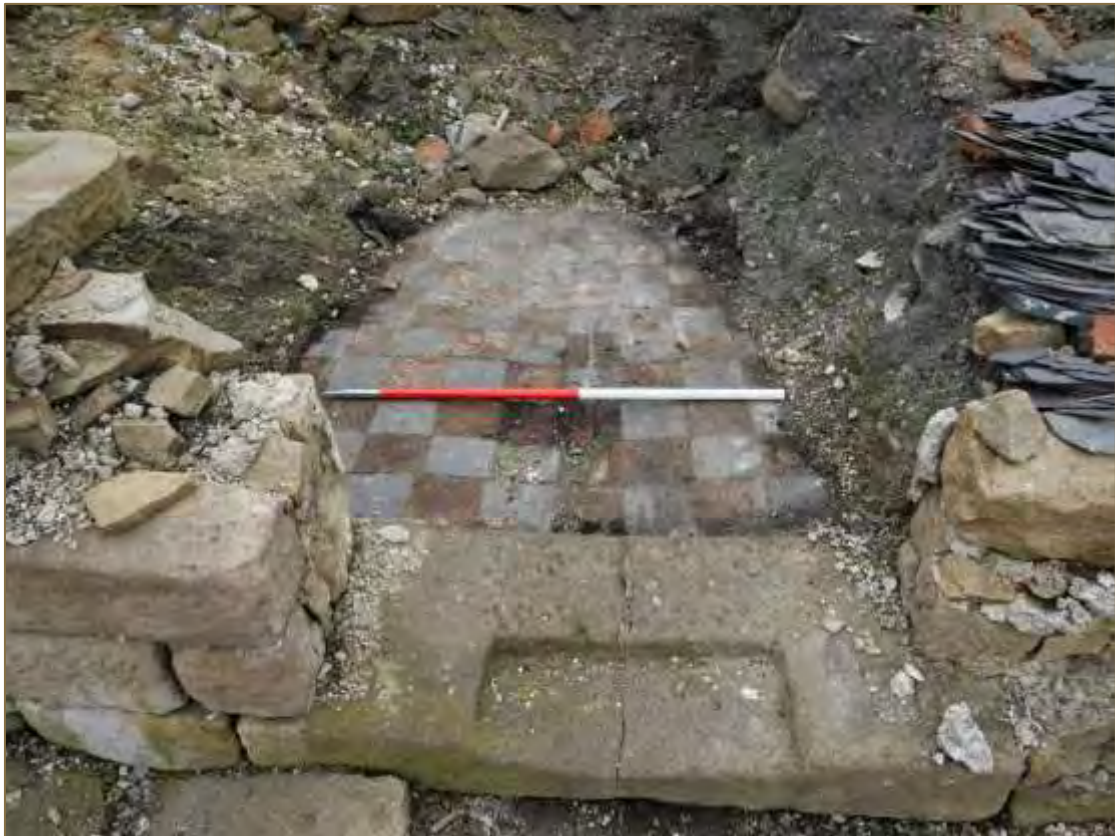
- 6.3.2 Adjacent to the east wall, which retains the doorstep to the front entrance doorway, areas of flooring could be seen *in situ*, comprising terracotta 'checkerboard' tiling (**Photograph 20 and 21**).

Photograph 20: Interior (looking west). Scale 1m. (File: Interior\_54)

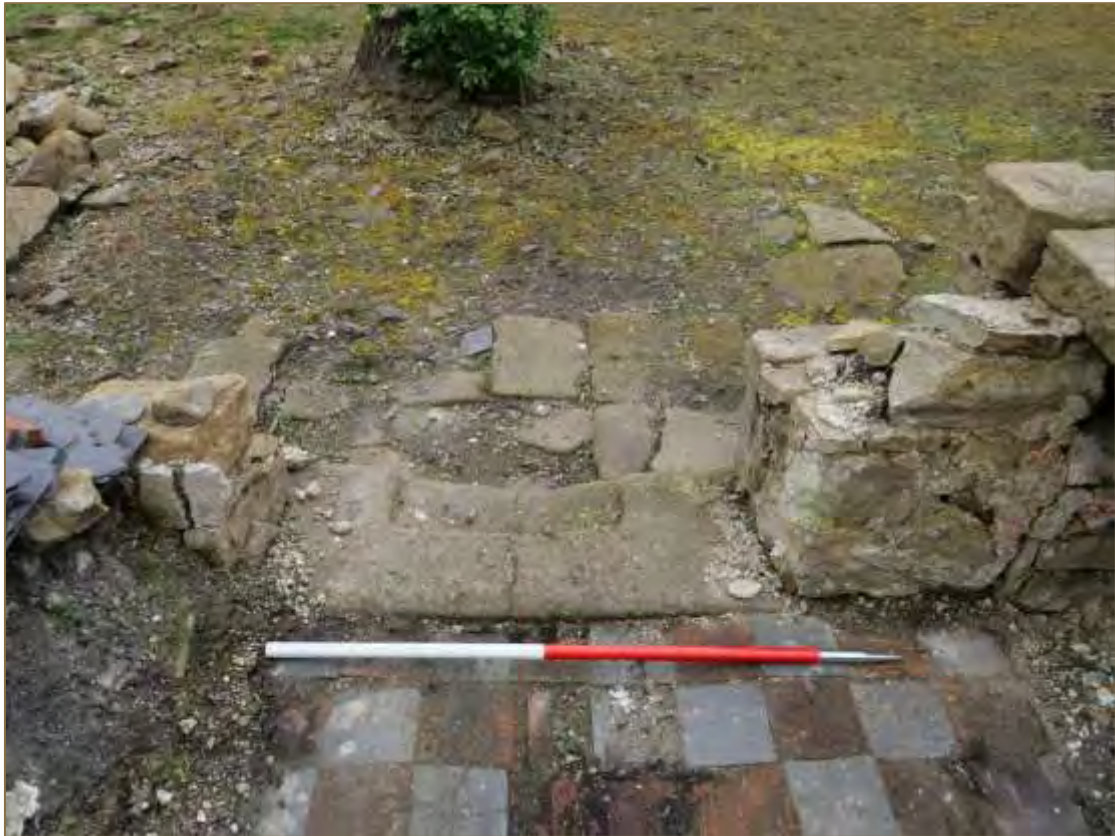
Photograph 21: Interior (looking east). Scale 1m.(File: HBR\_397)

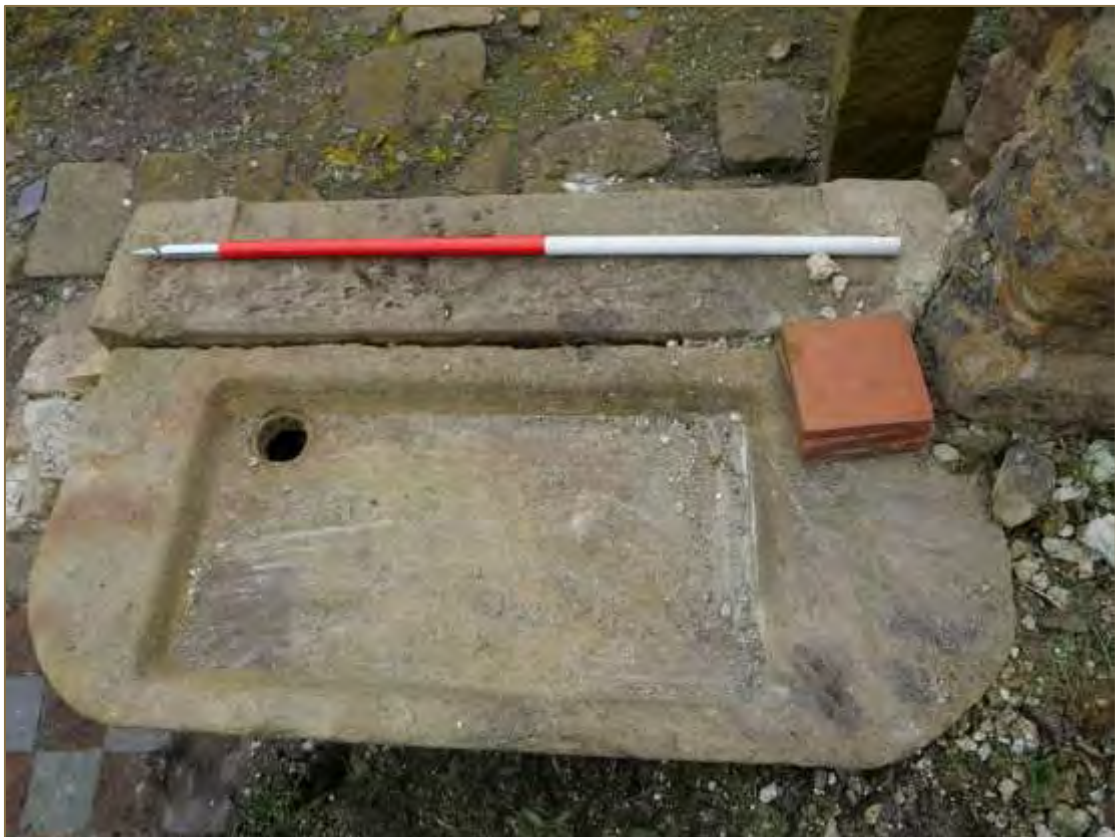
- 6.3.3 Immediately adjacent to the front entrance was the *in situ* carved stone sink. This abuts an *in situ* cill. The sink has outward curving sides and a corner plug hole (**Photograph 11, 22**).

Photograph 22: Interior (looking east). Scale 1m(File: HBR\_71)

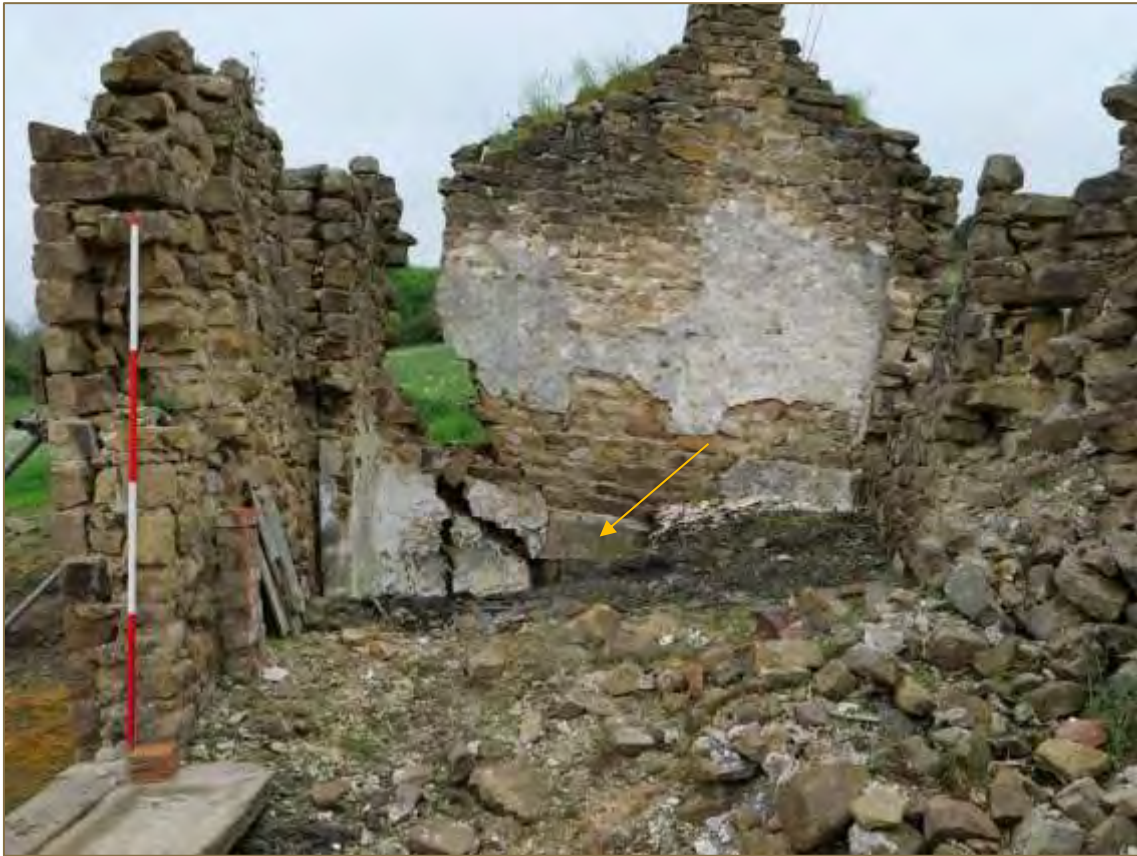
- 6.3.4 In the north wall was a partially buried fireplace in a dressed stone surround, with lime plaster retained on the wall surface, and a cast metal hearth with a semi-circular head (**Photograph 23 and 24**).

Photograph 23: Interior (looking south). Scale 2m. (File: Interior\_75)

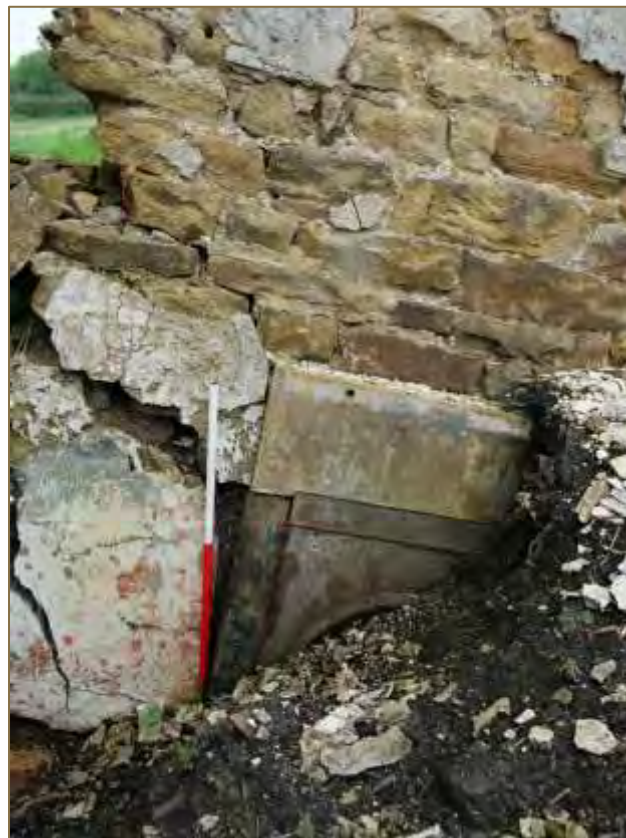
Photograph 24: The interior (looking south). Scale 1m. (File: HBR\_299)

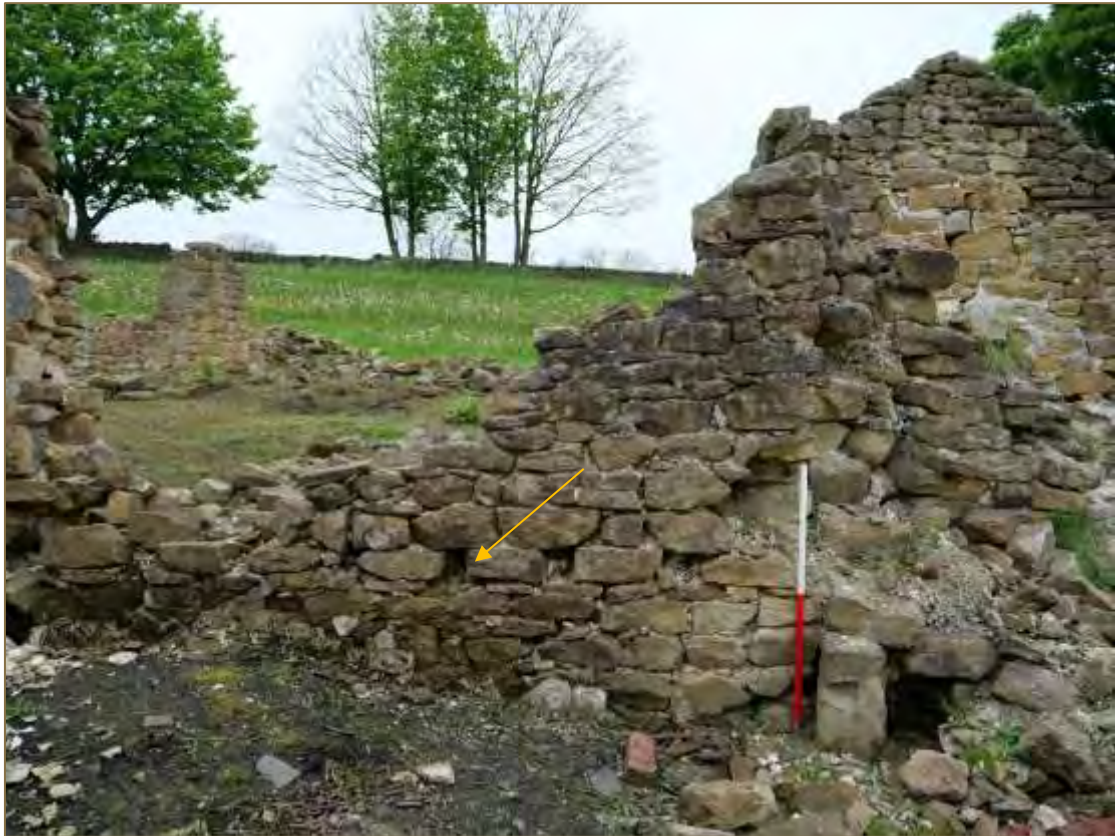
- 6.3.5 The outshut gable retained joist slots which received the beams for supporting the first floor (**Photograph 25**). To the northern extents of the building, part of the demolition rubble contains a quantity of red bricks (**Photograph 26**).

Photograph 25: The interior (looking north), showing beam slots. Scale 1m. (File: HBR\_314)

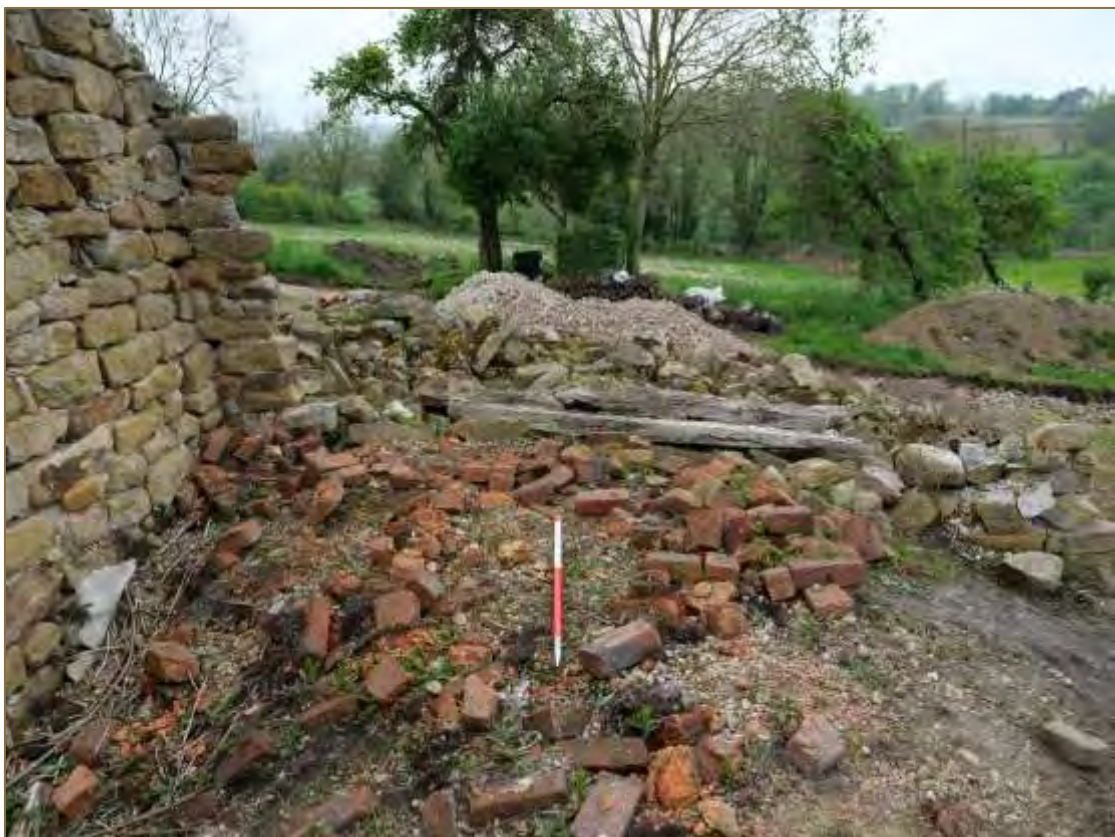
Photograph 26: The interior (looking north). Scale 1m. (File: HBR\_5)
