# ARCHAEOLOGICAL MONITORING AND RECORDING

Old Hall, Littleover, Derby

ARS Report No. 2025/051  
OASIS ID: archaeol5-531773

# Archaeological monitoring and recording at Old Hall, Littleover, Derby

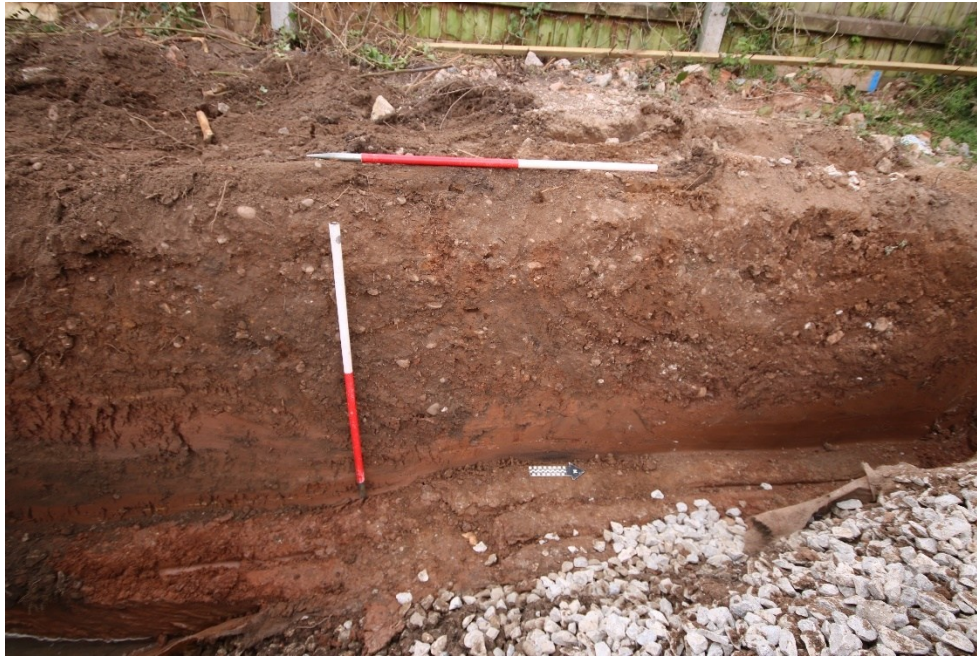
*Figure 3: Representative section of Garage 1 looking west, 2 x 1m scale.*

- 4.2.4 Elsewhere the natural was sealed by subsoil (1001). This subsoil deposit, (1001), was up to 0.6m thick and consisted of mid bright greyish brown silty clay, and occasionally included CBM, gravel and clinker fragments (Figure 3).

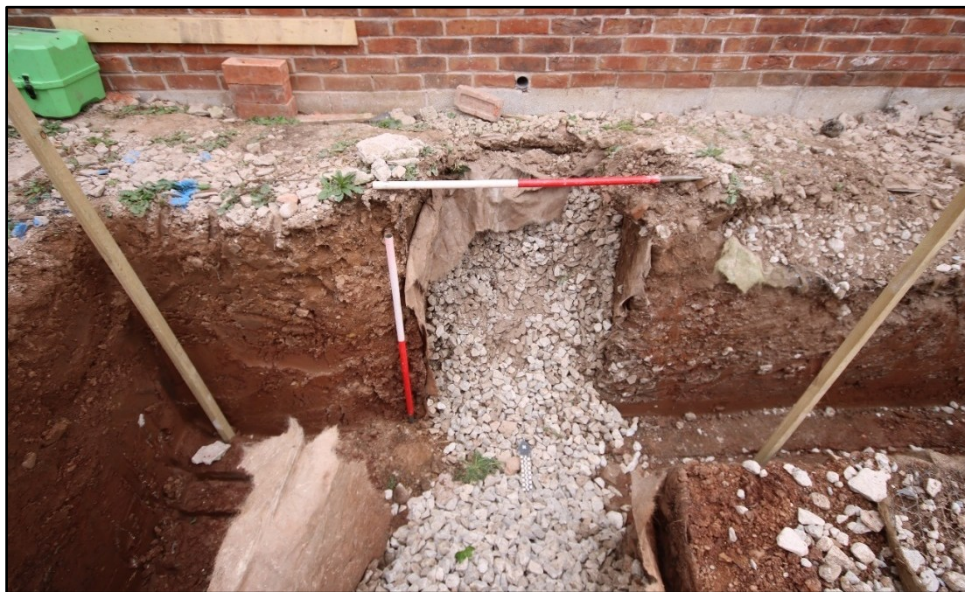
*Figure 4: Section showing service trench [1003], looking north, 2 x 1m scale.*

- 4.2.6 Cutting the topsoil in Garage 1 was a cut of a modern construction trench [1003], which was recorded in the south-west area of the garage (Figure 4 & 7, drawing 2). It measured 0.75m in width and extended beneath the depth of development, and was cut into the natural substrate (1002). It contained one fill (1004), which consisted of a pale brown grey sand and gravel. The same gravel was identified across the surface of the central area of Garage 1, and most of the northern side of Garage 2 sealing the old topsoil layer.

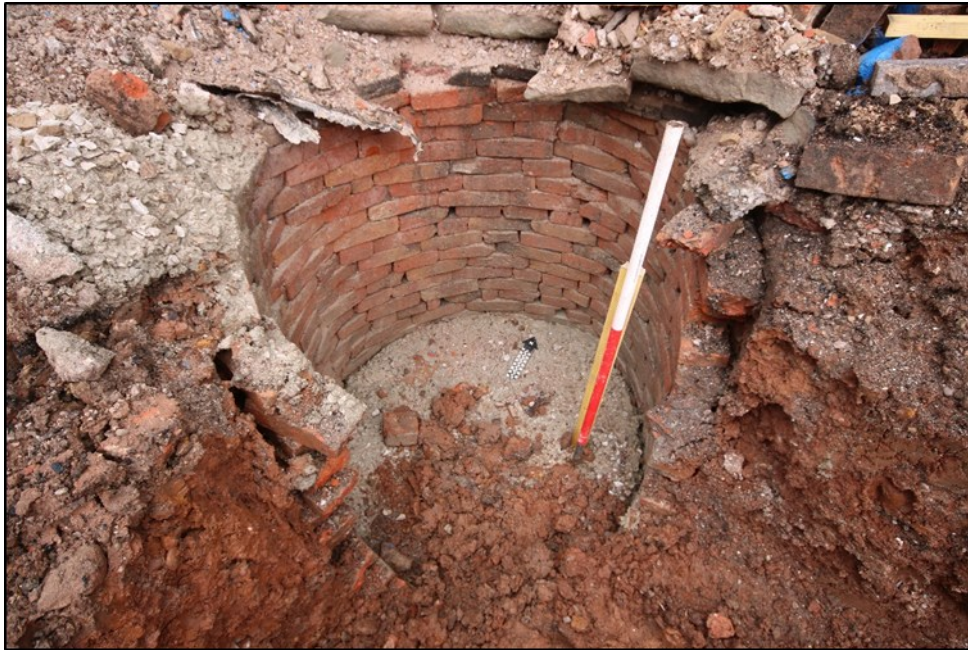
*Figure 5: Red brick well {1008}, looking north-west, 1m scale.*

- 4.2.7 The natural substrate (1002) was recorded across Garage 3. The earliest feature or deposit recorded was a red brick well {1008}, located in the north-western corner of the garage footprint. It was c. 1m in diameter, but no cut for it was visible. The machine had removed both a concrete slab and a thin metal sheet, which had been used as a crude cover sealing the well after disuse. The removal of the later covers showed the well was open, with water still at the base and it had not been backfilled after disuse. Above this water table the well had survived to 13m long, up to the height of the present topsoil (Figure 5). The well was constructed of a single skin of unfrogged and unstamped red bricks with no bonding material. The well was largely round, but it was not precisely

made. Most of the bricks were laid stretcher to stretcher, and where needed, bricks were cut into small pieces to fill gap. It is likely that the bottom of the well had been sealed, but this was not the case for most of the well, presumably because it was above the water table. The well cut Edwalton Member (mudstone), which is largely impermeable (See Section 1).

- 4.2.8 As part of the development the well was largely backfilled by the machine operator for health and safety concerns. Only the top 16 courses were left exposed during this work after it had been largely backfilled (Figure 5).

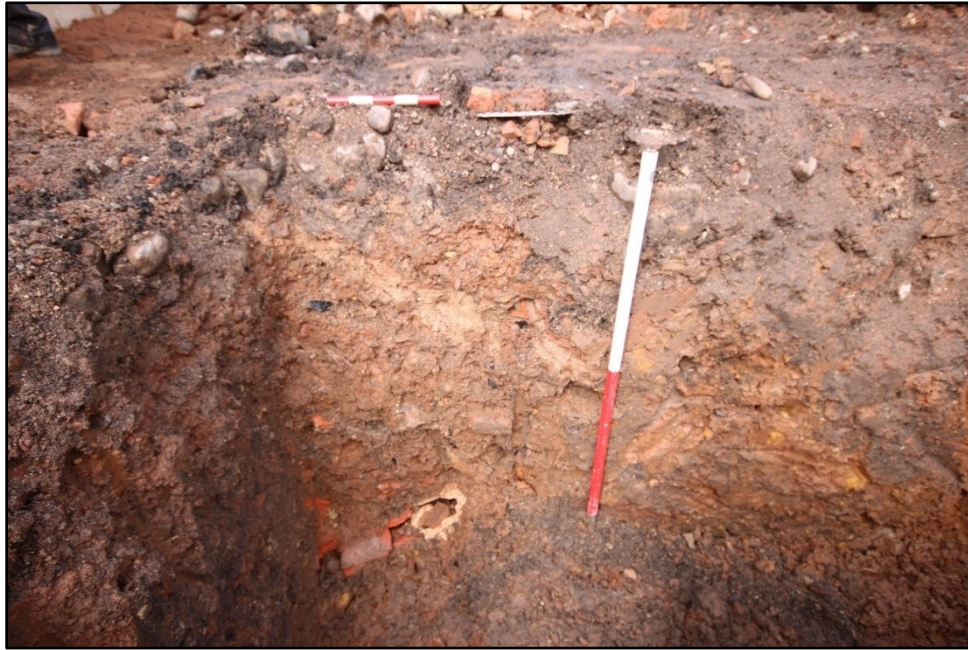
*Figure 6: Section showing (1007), looking west, 0.5m x 1m scale.*

- 4.2.9 On the western corner, sealing the natural was a made ground deposit (1007). It comprised a coarse mid yellowish brown silty clay with infrequent stone inclusions (Figure 6). The deposit was 0.80-0.90m thick. At the base of the deposit, and recorded in section, was a modern ceramic land drain, orientated north to south (Figure 6).
