# HISTORIC BUILDING RECORDING

## Barn at Hill Top Farm, Aldwark, Derbyshire

ARS Ltd Report No: 2025/021

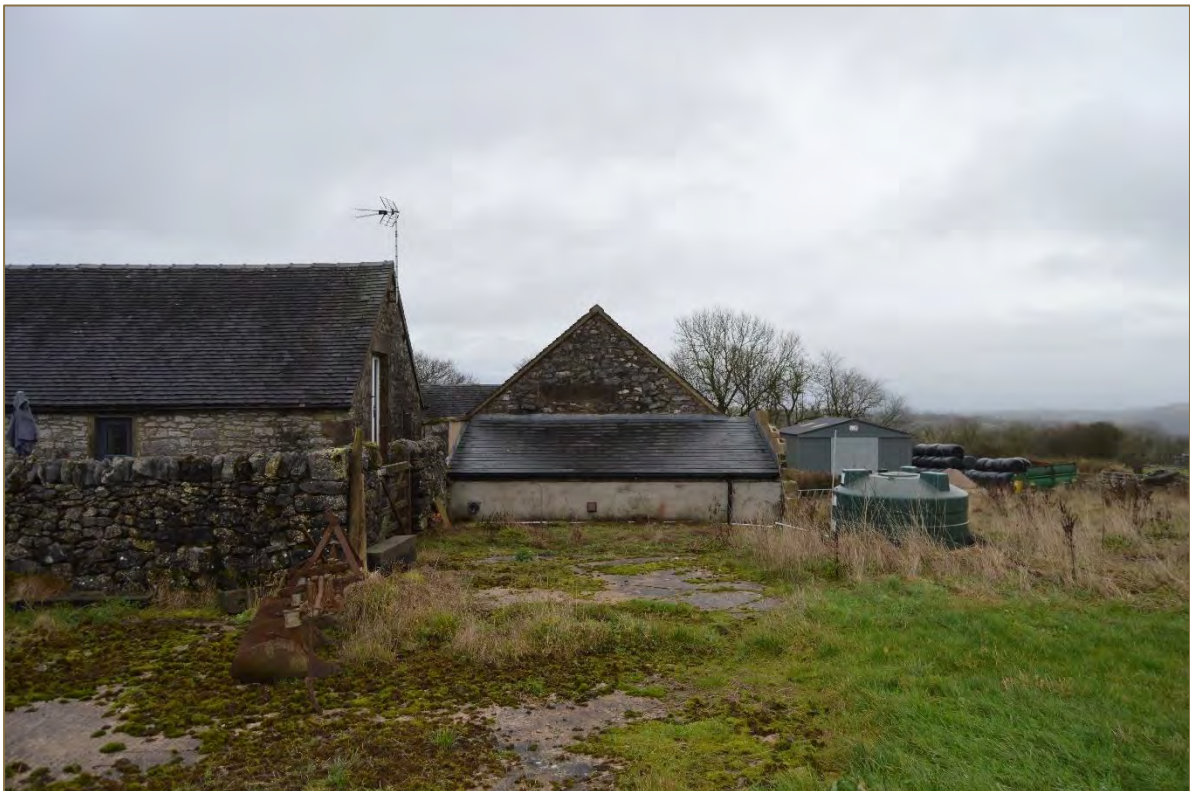
*Photograph 8. View of the eastern end of the barn and its settings from the western enclosure (looking east). Scale 2m. (File: HBR\_13)*

- 6.2.4 The western, eastern and southern settings of the site encompasses a wider area of rolling countryside, affording expansive views of the landscape. The field boundary originates from the historic field pattern. To its western extents, the barn is built into the adjacent hillside. Here, a single storey 'lean-to' type building has been attached to its western gable end (**Photograph 8**).

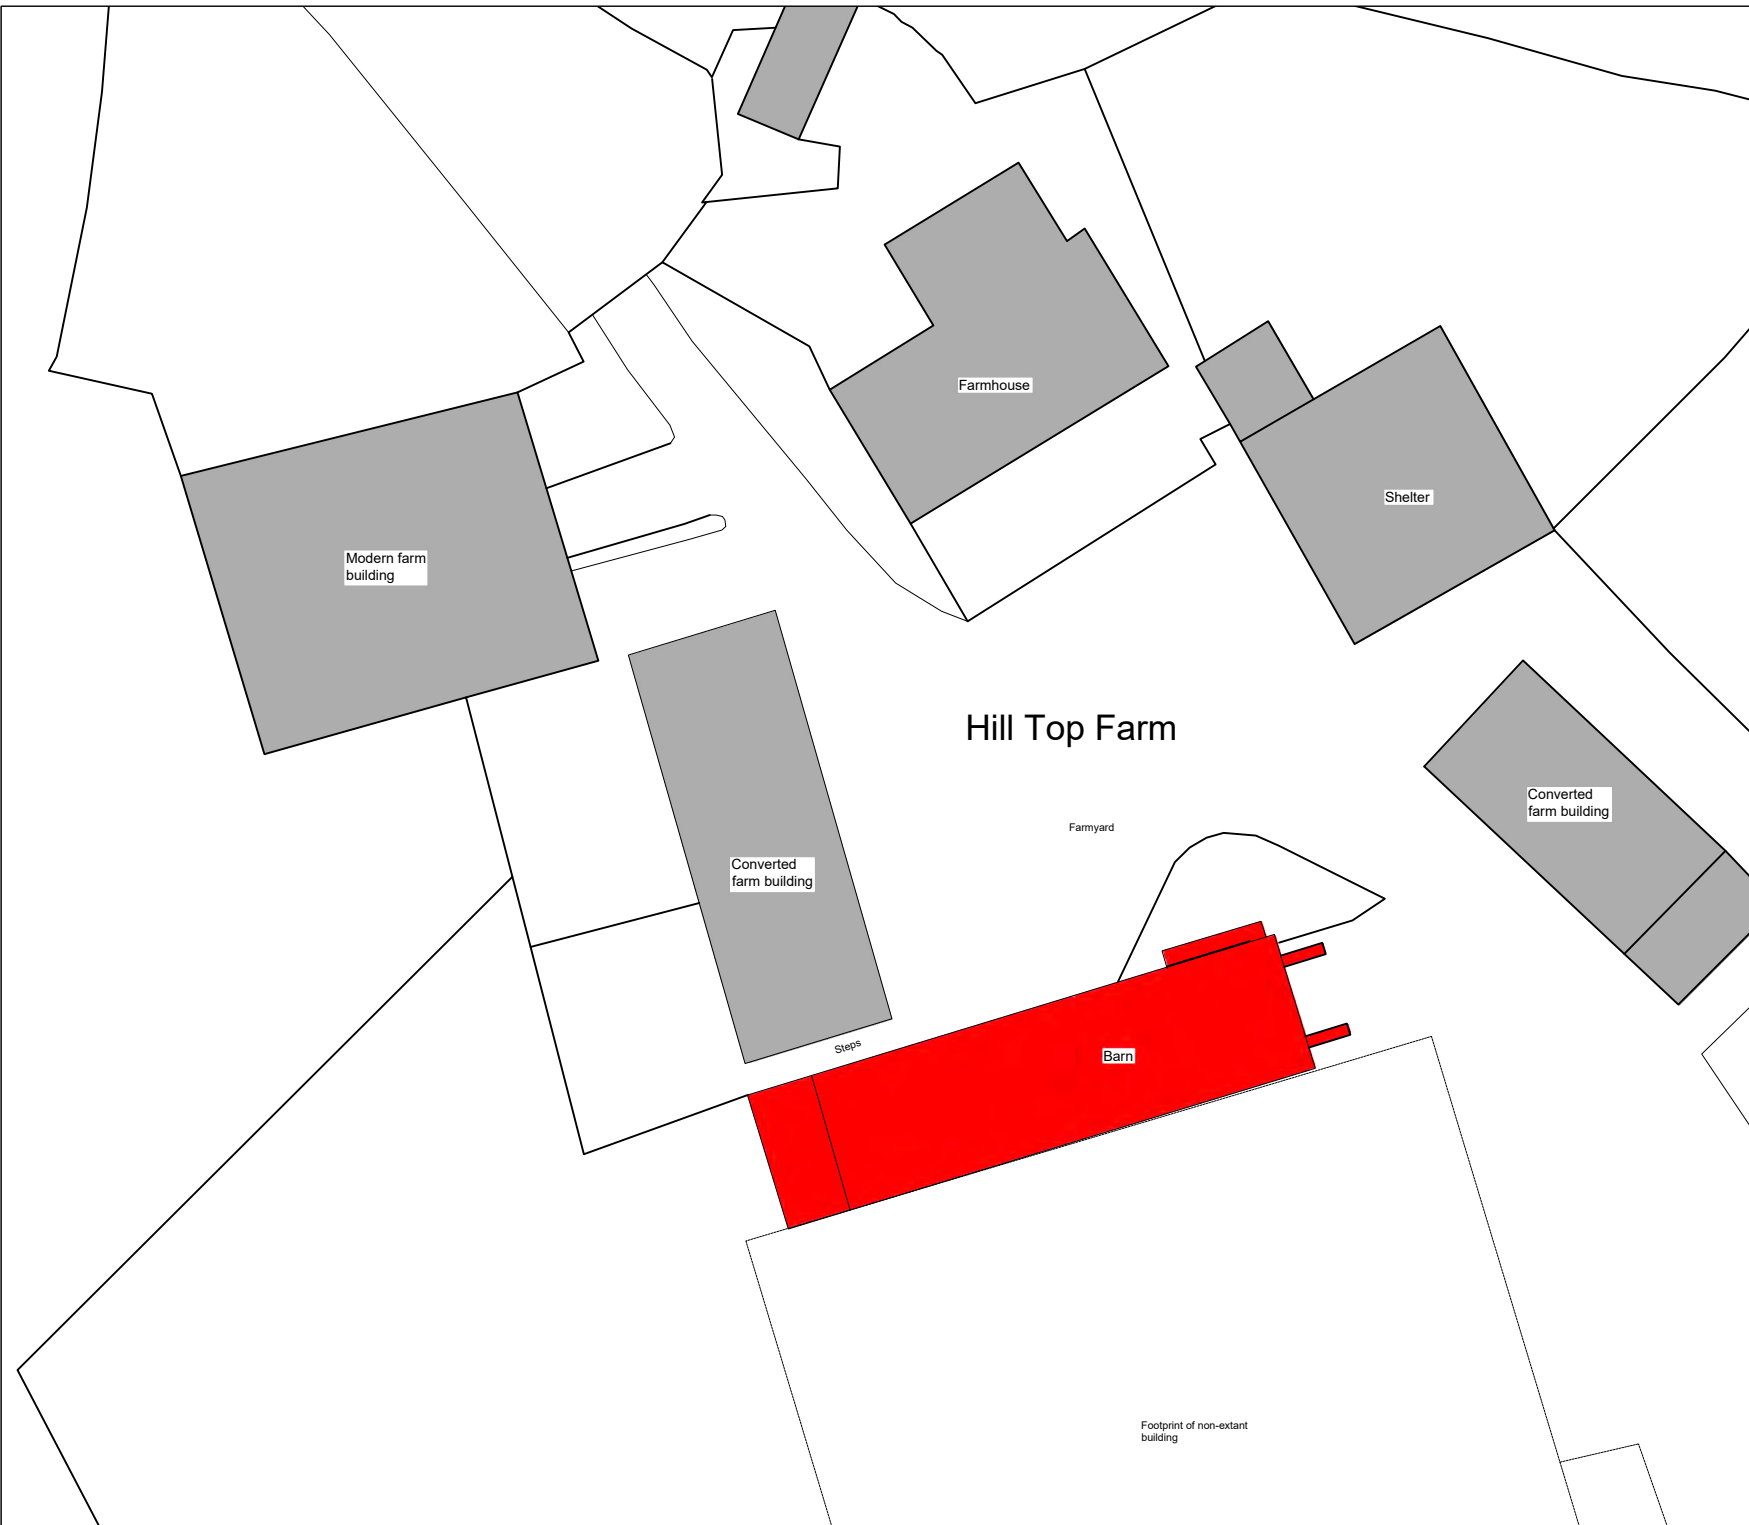
Figure 4: Plan of site with building subject to survey

Building subject to recording

- 6.2.5 The historic building survey covers the structure as denoted in **Figure 4** below.

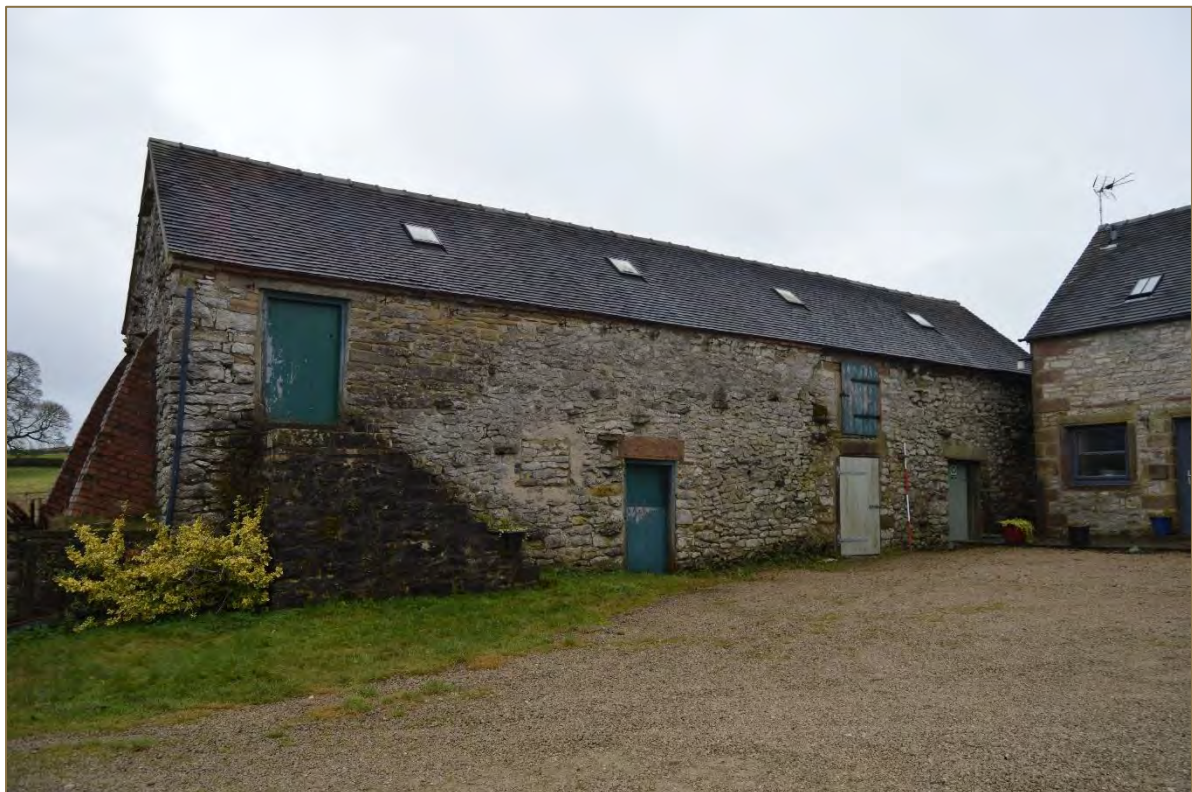
Photograph 9. Overall view of the barn (looking south west). Scale 2m. (File: HBR\_16)

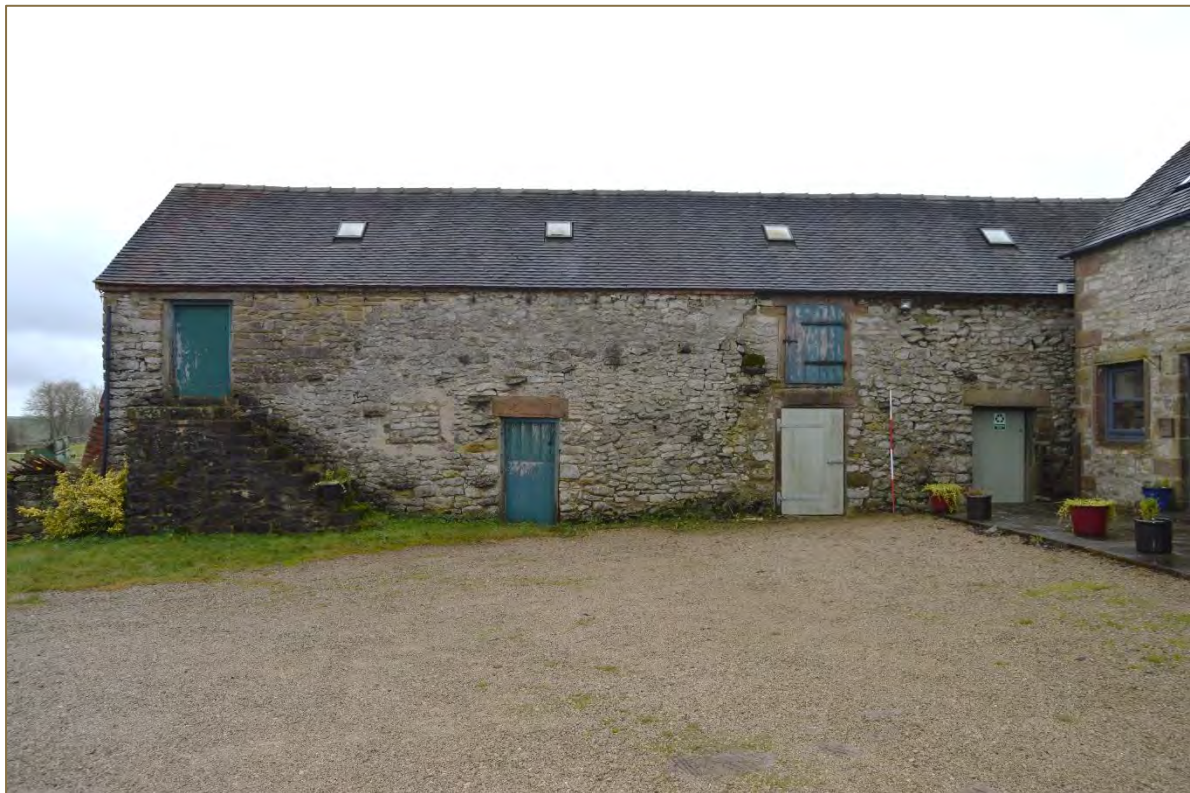
- 6.3.6 The north elevation of the barn is built overall of roughly coursed rubble stonework and presents four bays. The elevation comprises, at ground level, three personnel or narrow livestock doorway apertures (**Photograph 11 to 15**). Large, ashlar lintels are employed above each of these doorways, the type of gritstone, level of erosion and dressing style subtly different across each example, but these are mainly quarry and/or sparrow pecked (punched) faced with a margined surround. The jambs of the doorways are formed via a mix of larger quoins and regularly sized blocks observed in the stonework courses of the wall. Set within wooden frames, the door apertures retain a mix of timber plank doors of differing ages and styles. The easternmost example appears the most historic, this having a split, stable-type form, painted blue, with apparent later 'touch-up' finishes in a light primer. The doors generally have strap hinges and Suffolk latch locks. The pitching aperture at first floor level features a timber plank door with a double layered ashlar lintel above and stone jambs with sparrow pecked (punched) facings and margined surrounds. Adjacent the easternmost doorway there is a single former high cilled window opening now blocked with rubble limestone (**Photograph 15**). To east is a set stone steps to access a personnel door at first floor level (**Photograph 16**).

*Photograph 10. Perpendicular view of the barn's north elevation (looking south) which forms the south side of the farmyard. Scale 2m. (File: HBR\_17)*

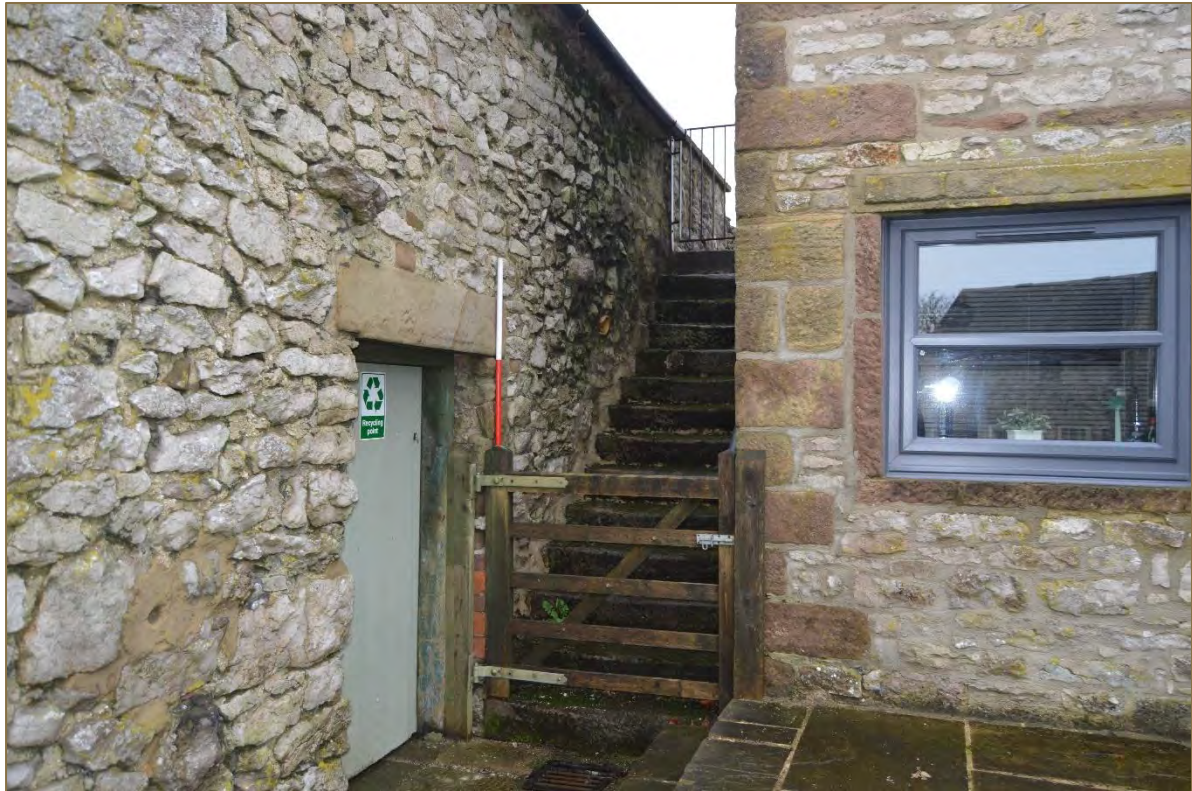
*Photograph 11. View of the westernmost ground floor doorway in the north elevation (looking south west). Note the adjacent building and steps conforming to the rising topography. Scale 2m. (File: HBR\_21)*

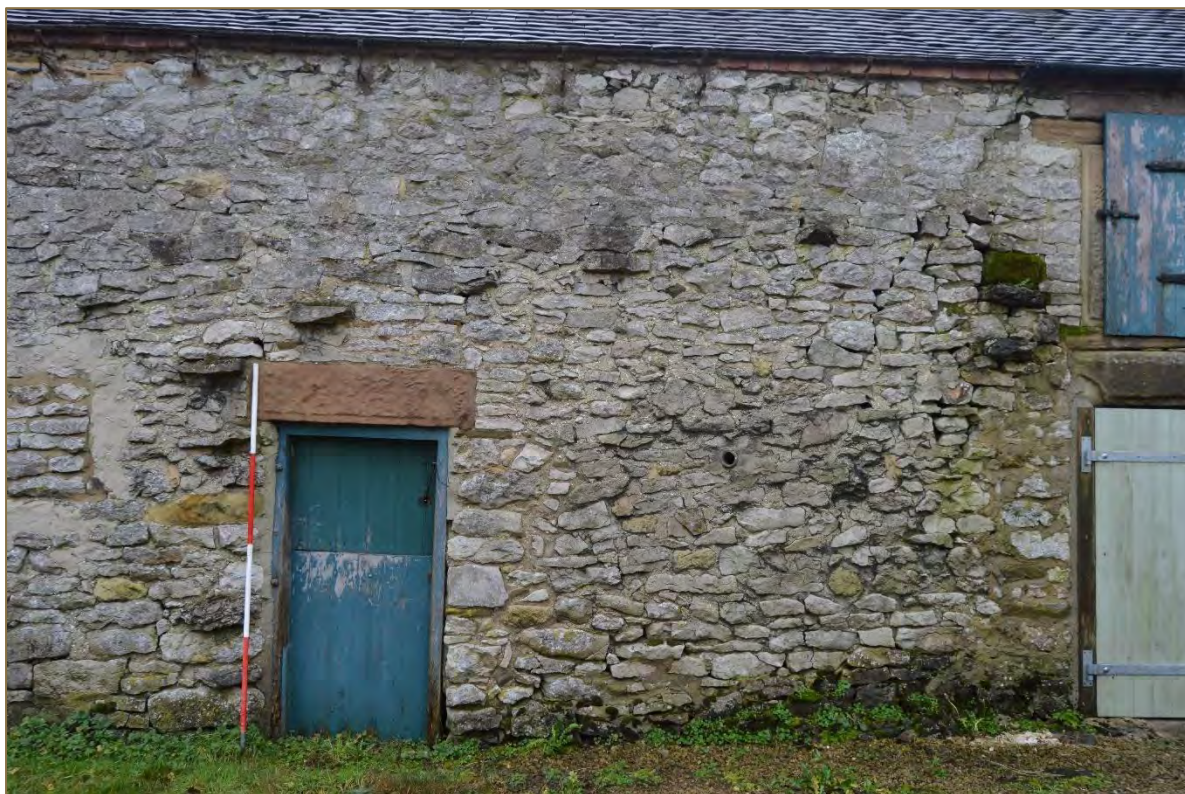
*Photograph 13. View of the centre bay and doorways in the barn's north elevation (looking south). Scale 2m. (File: HBR\_24)*

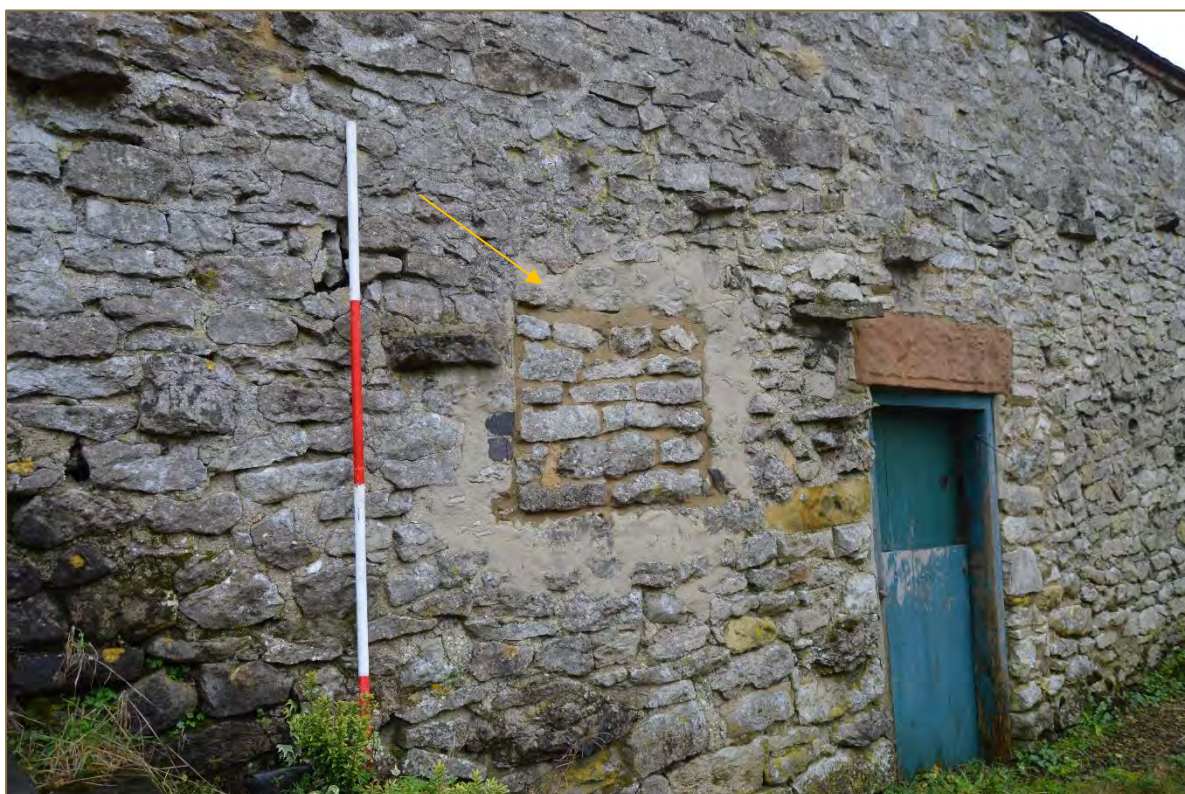
*Photograph 14. View of the eastern extent of the barn's north elevation, (looking south west). Scale 2m. (File: HBR\_18)*

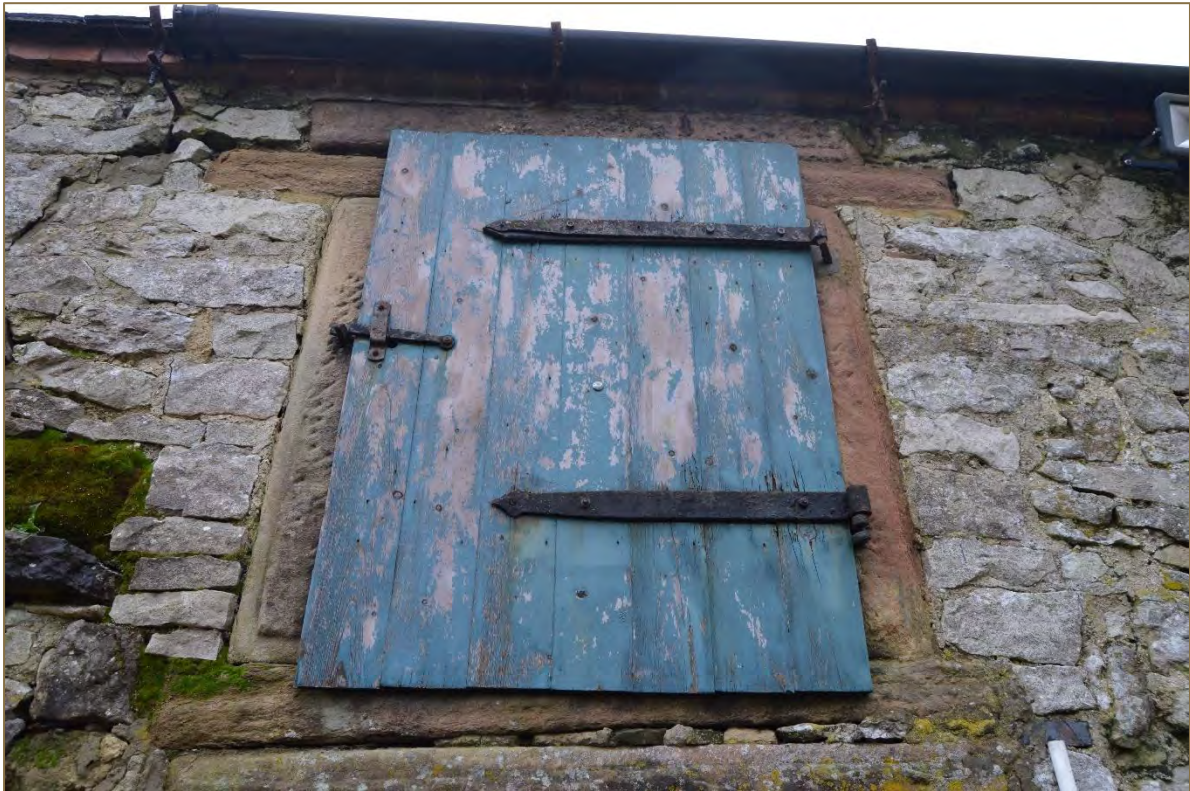
*Photograph 15. Detail view of the pitching door in the the barn's north elevation (looking south).  
Scale 2m. (File: HBR\_42)*

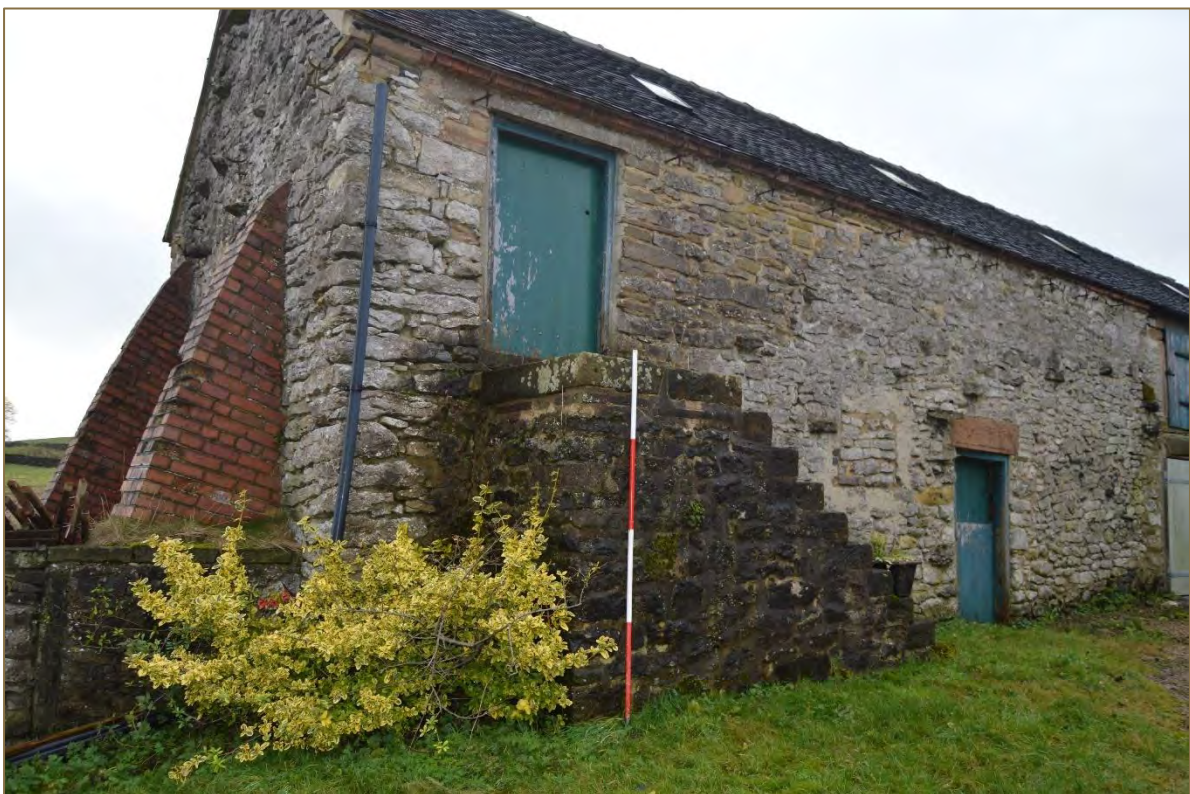
*Photograph 16. View of to the barn's eastern bay in the north elevation (looking south west).  
Scale 2m. (File: HBR\_58)*

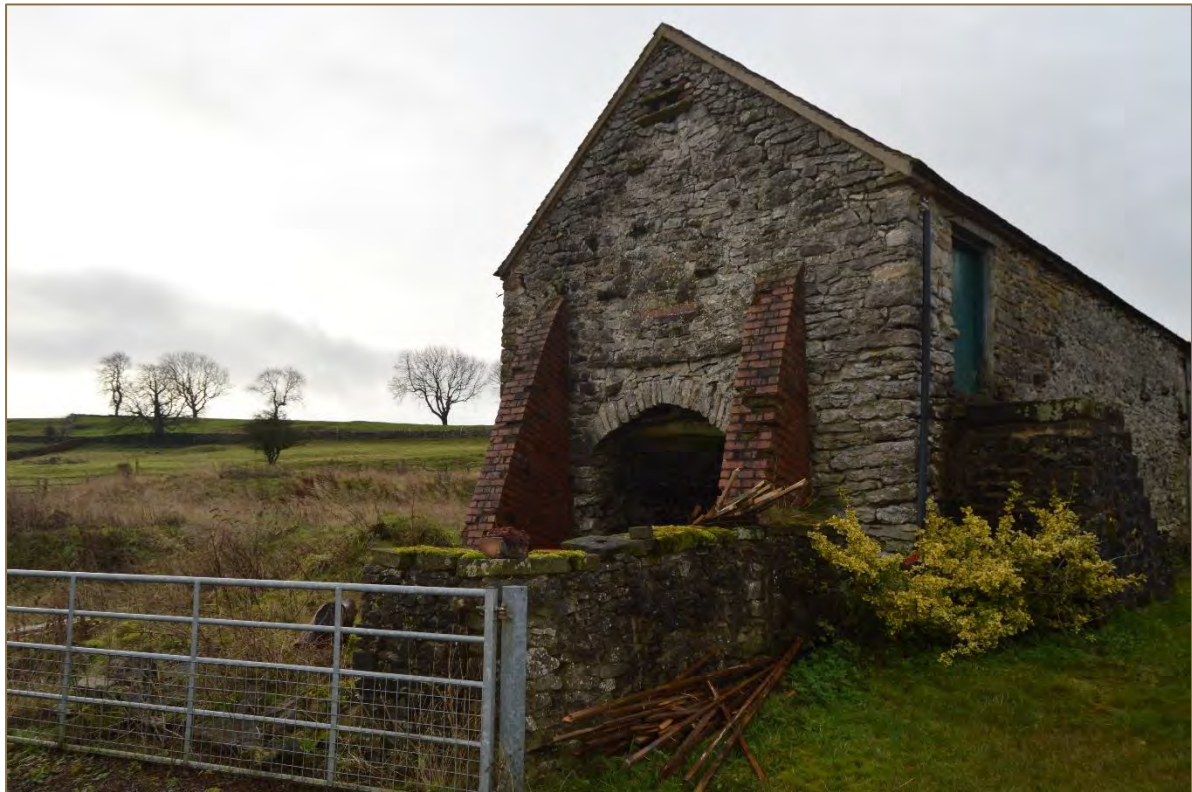
*Photograph 17. Oblique view of the barn's east elevation (looking south west). Scale 2m. (File: HBR\_70)*

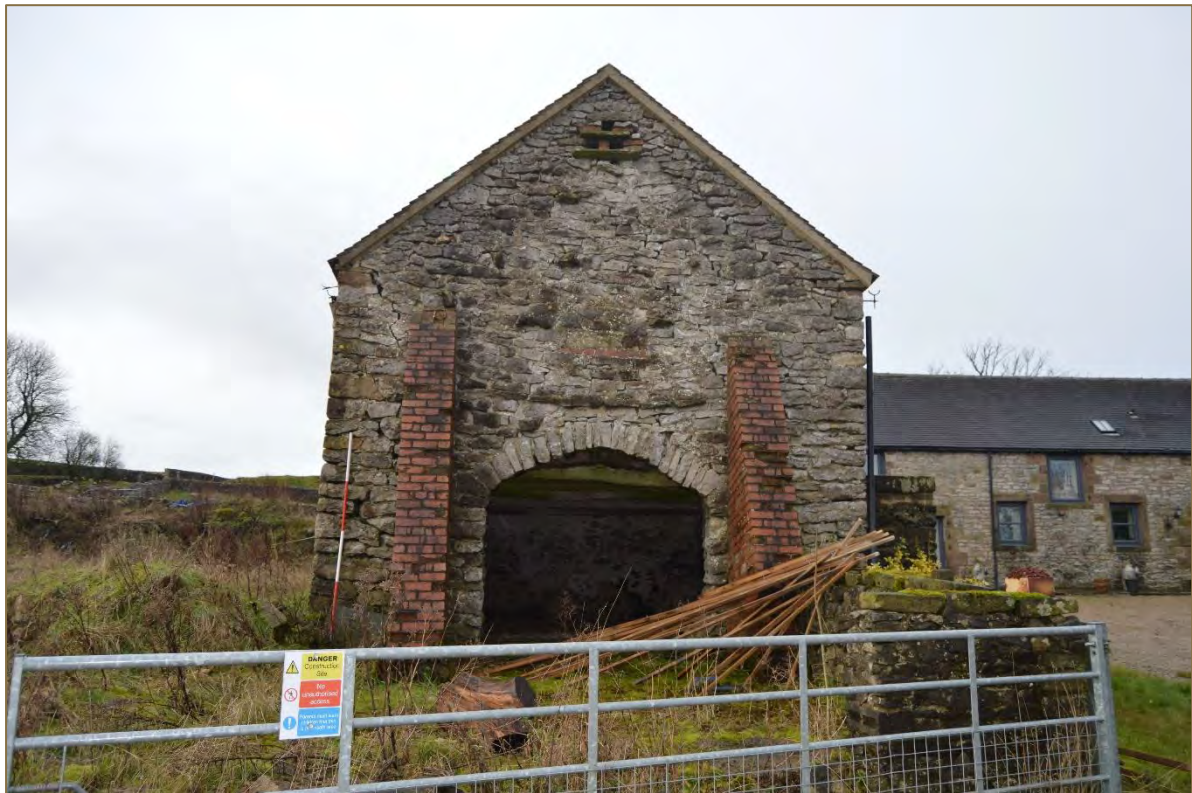
*Photograph 18. Perpendicular view of the barn's east elevation (looking west). Scale 2m. (File: HBR\_69)*

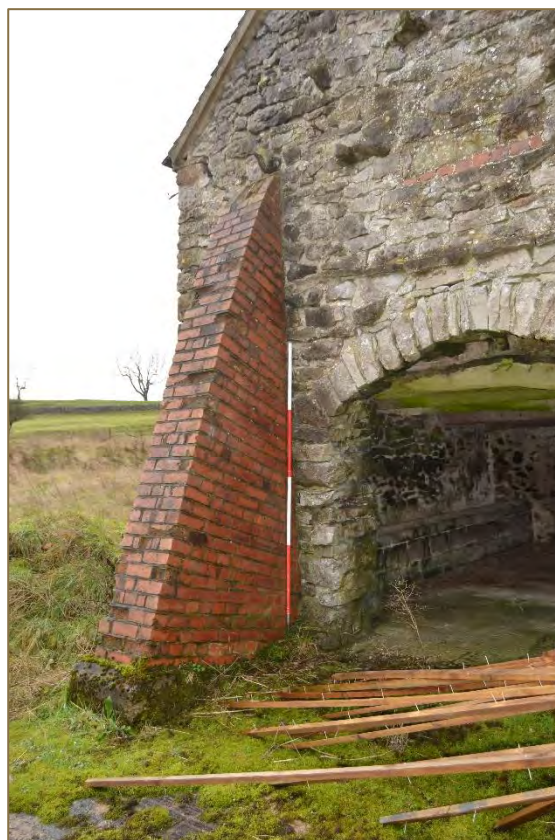
*Photograph 19. View of the left hand brick pier on the east elevation of the barn (looking south west). Scale 2m. (File: HBR\_114)*

- 6.3.8 Flanking this opening are slanting support piers constructed from red brick laid in English garden wall bond (**Photograph 19 and 20**).
- 6.3.9 Above the arched, ground floor opening the upper extents of the wall feature an arrangement of tie stones (**Photograph 21**). Also set into the wall are a row of brick headers; these relate to a blocked opening at first floor level, the aperture being blocked with stone externally whilst internally brick has been used. Set into the apex of the gable is a small pigeon/dove aperture with two protruding perch stones below (**Photograph 22**).

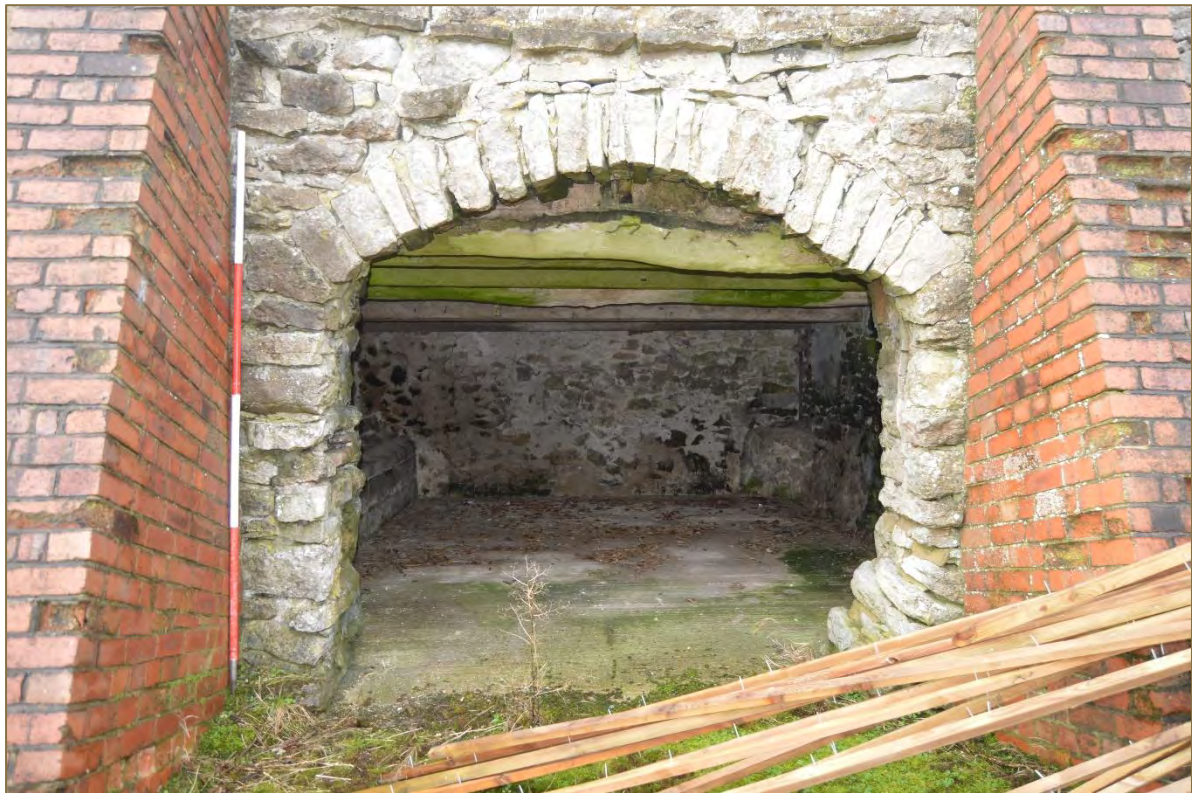
*Photograph 20. Detail view of the wide livestock entrance aperture in the east elevation of the barn (looking west). Scale 2m. (File: HBR\_106)*

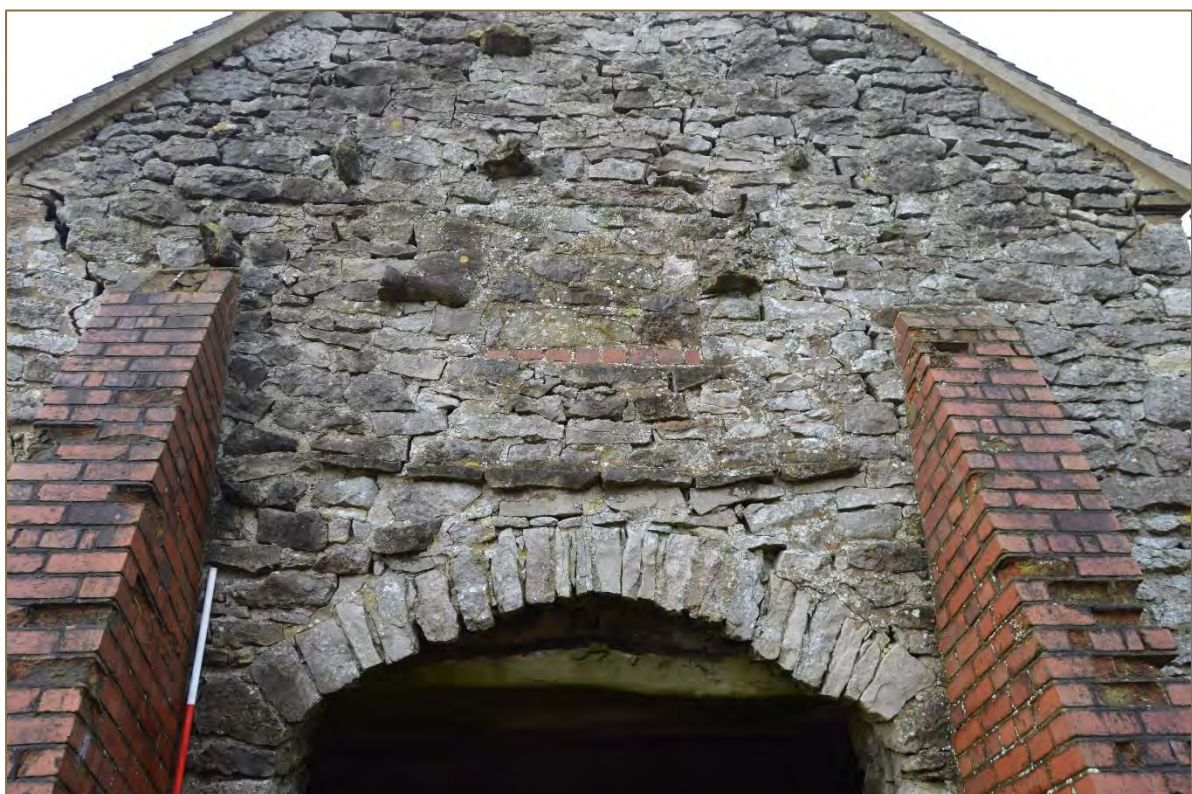
*Photograph 21. Detail view of the upper extent with arrangement of protruding tie stones on the east elevation of the barn (looking west). (File: HBR\_105)*

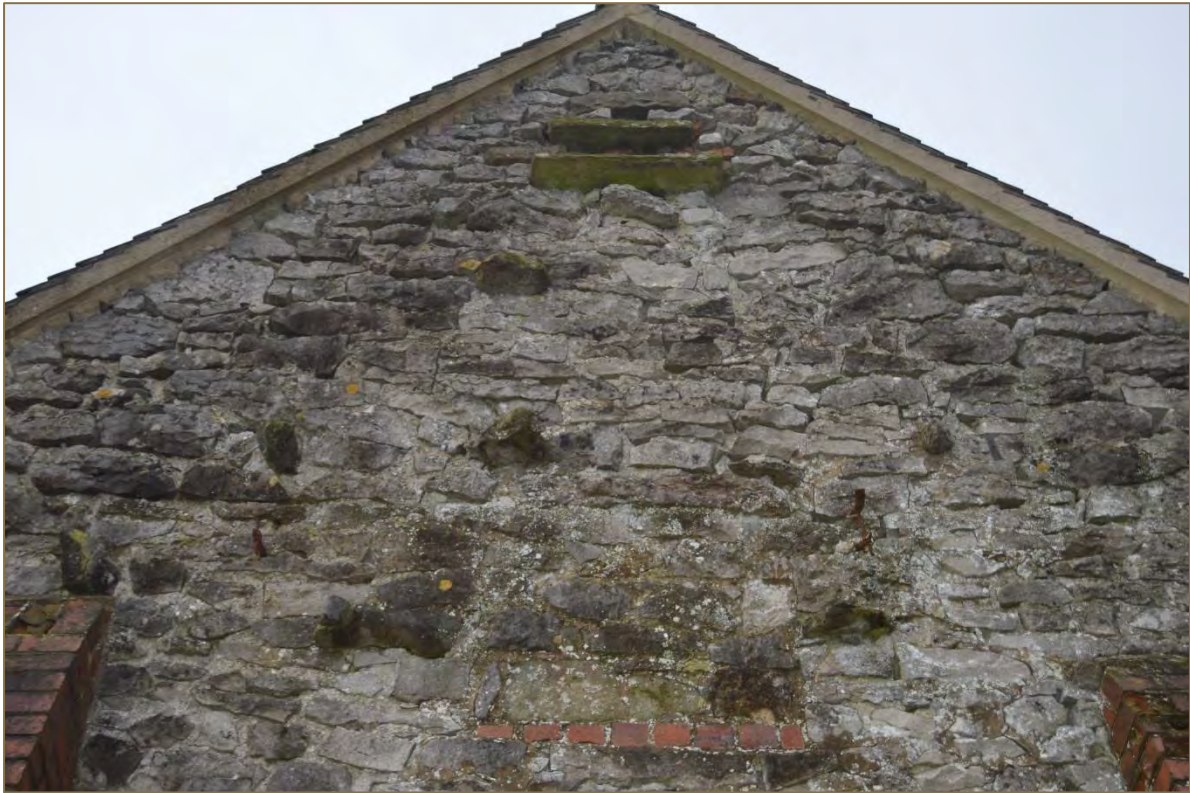
*Photograph 22. Detail of the gable with the bird perches and opening on the east elevation of the barn (looking west). (File: HBR\_74)*

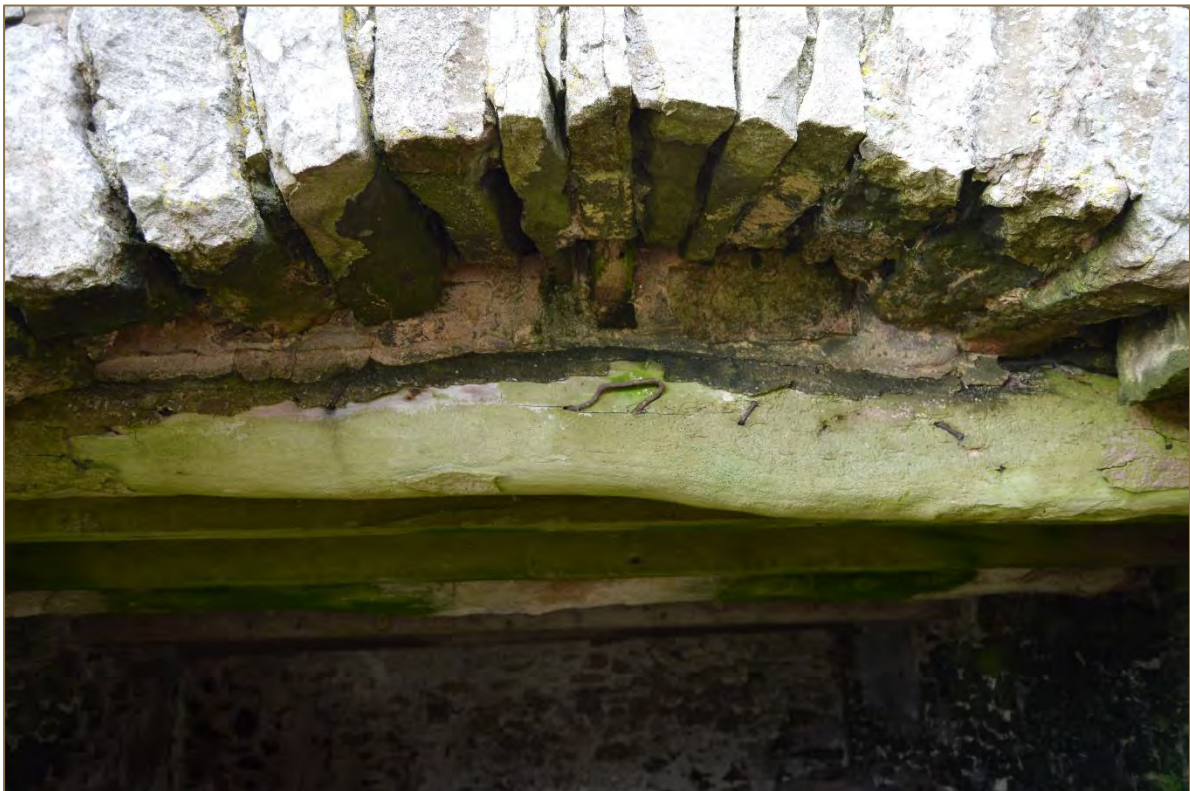
- 6.3.10 Visible behind at the apex of the arch of the entrance are beams supporting the first floor hayloft (**Photograph 23**).

*Photograph 23. Detail of the east elevation archway and internal timberwork arrangement (looking west). Scale 2m. (File: HBR\_97)*

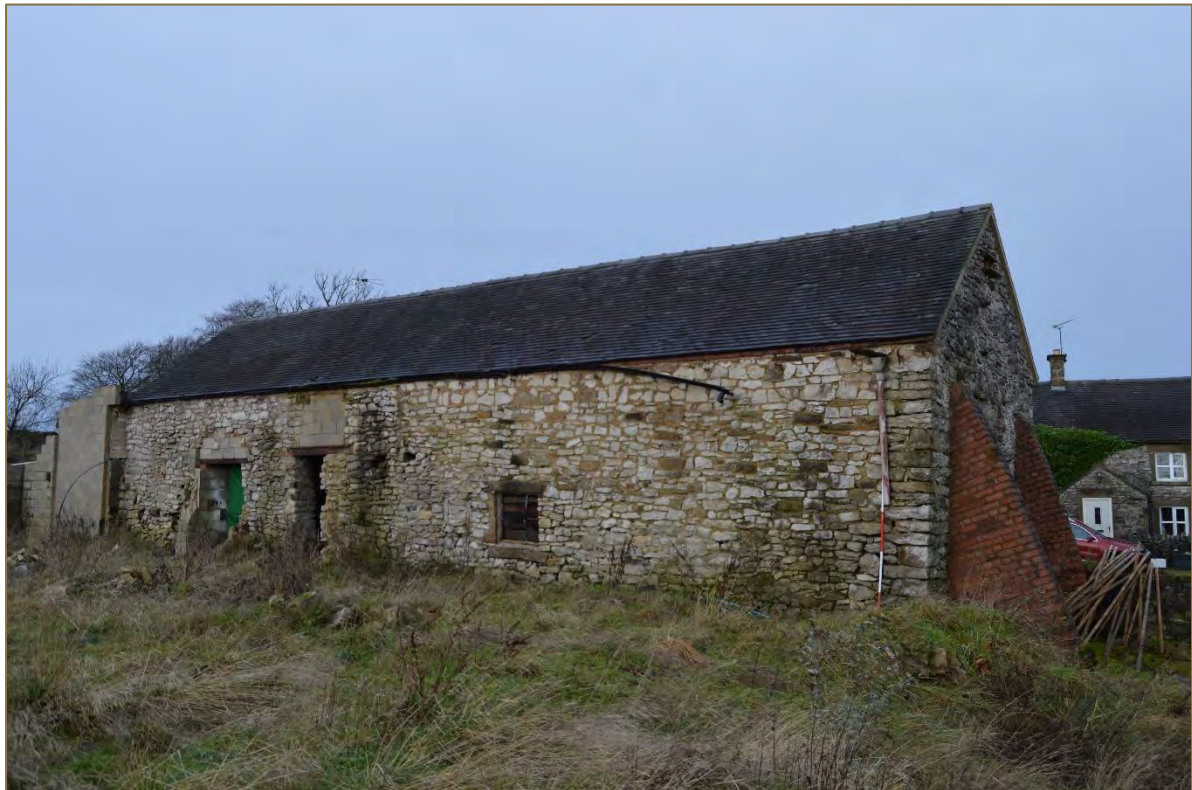
- 6.3.1 The south elevation of the stone barn had been historically abutted by a large 20<sup>th</sup> century cowshed structure, now no longer extant (**Photographs 24 and 25**). The south elevation is again largely built of coursed rubble stonework and is arranged across three bays. The wall appears in a poorer condition than that to the north, having had sections of modern blockwork inserted over the doorways and abutting the western extents of the building (predominantly the area pertaining to the single storey section of the building).

*Photograph 24. Overall oblique view of the barn's south elevation (looking north west). Scale 2m.  
(File: HBR\_119)*

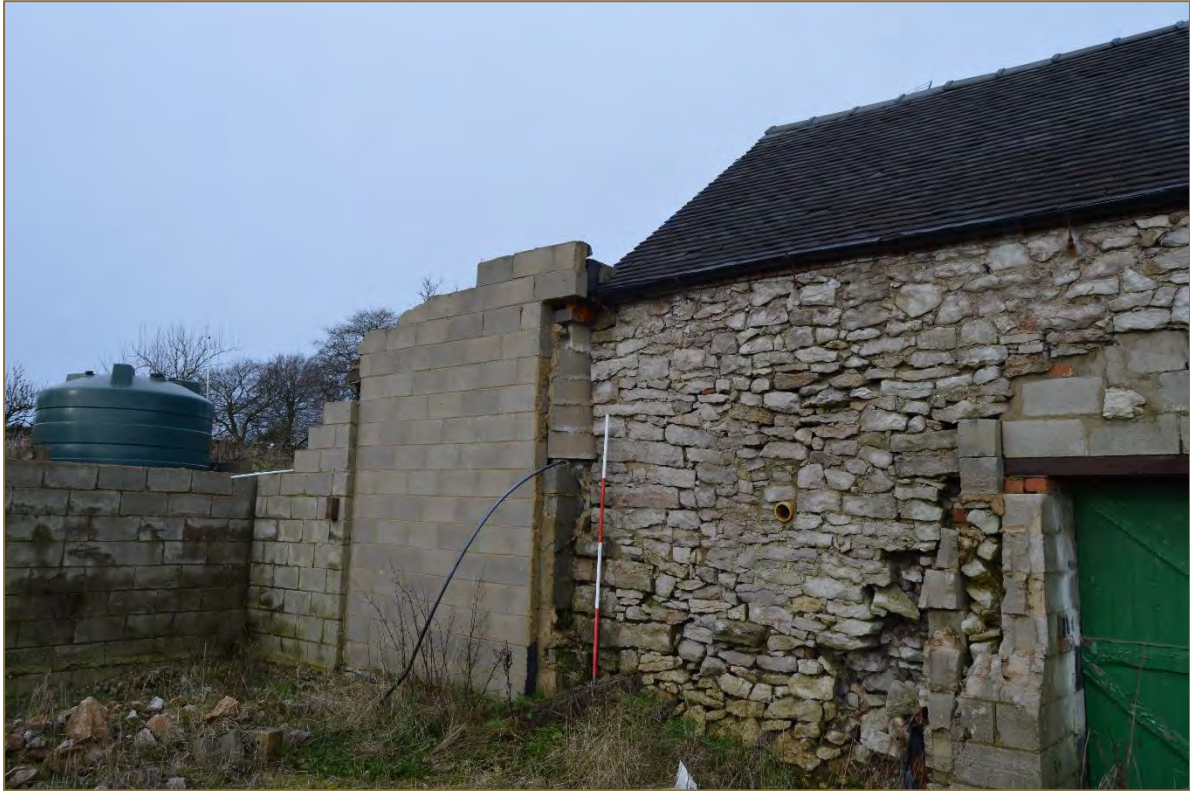
*Photograph 25. View of the barn and lean-to addition (looking north west). Scale 2m. (File: HBR\_124)*

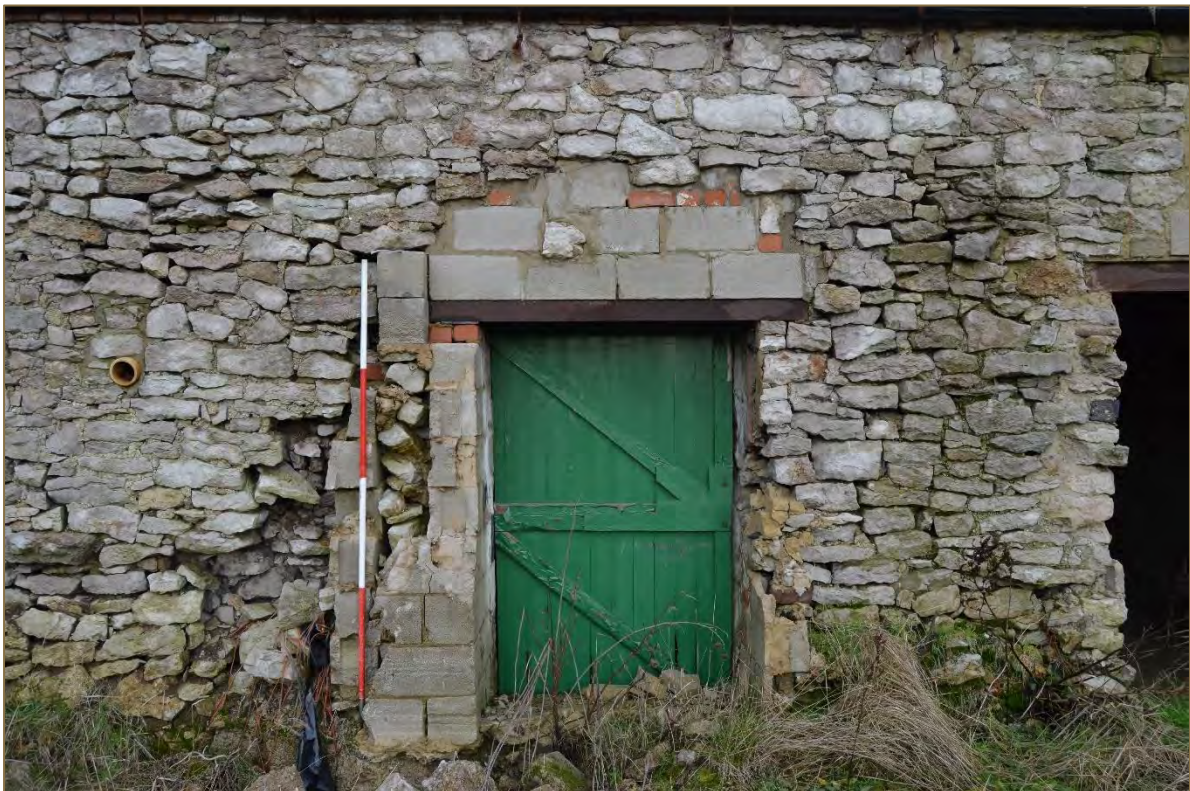
*Photograph 26. View of the westernmost doorway in the barn's south elevation (looking north). Scale 2m. (File: HBR\_119)*

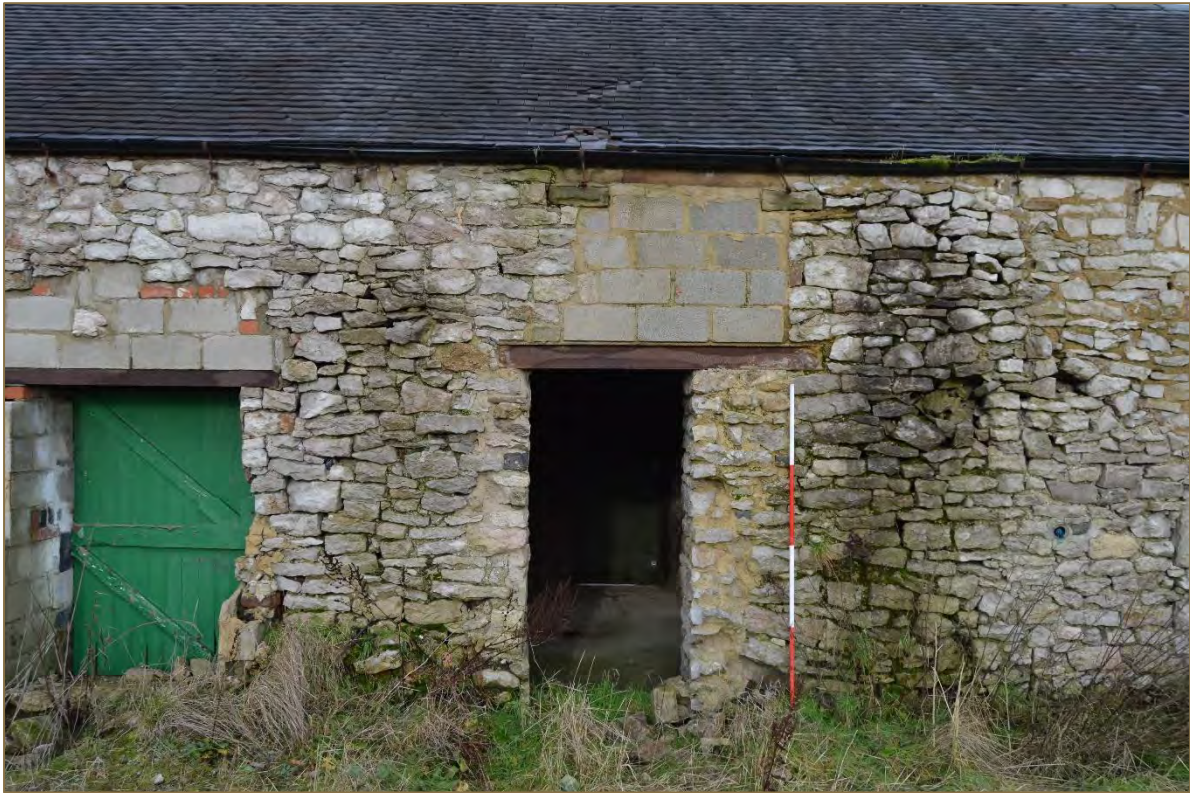
*Photograph 27. View of the easternmost doorway in the barn's south elevation (looking north).  
Scale 2m. (File: HBR\_124)*

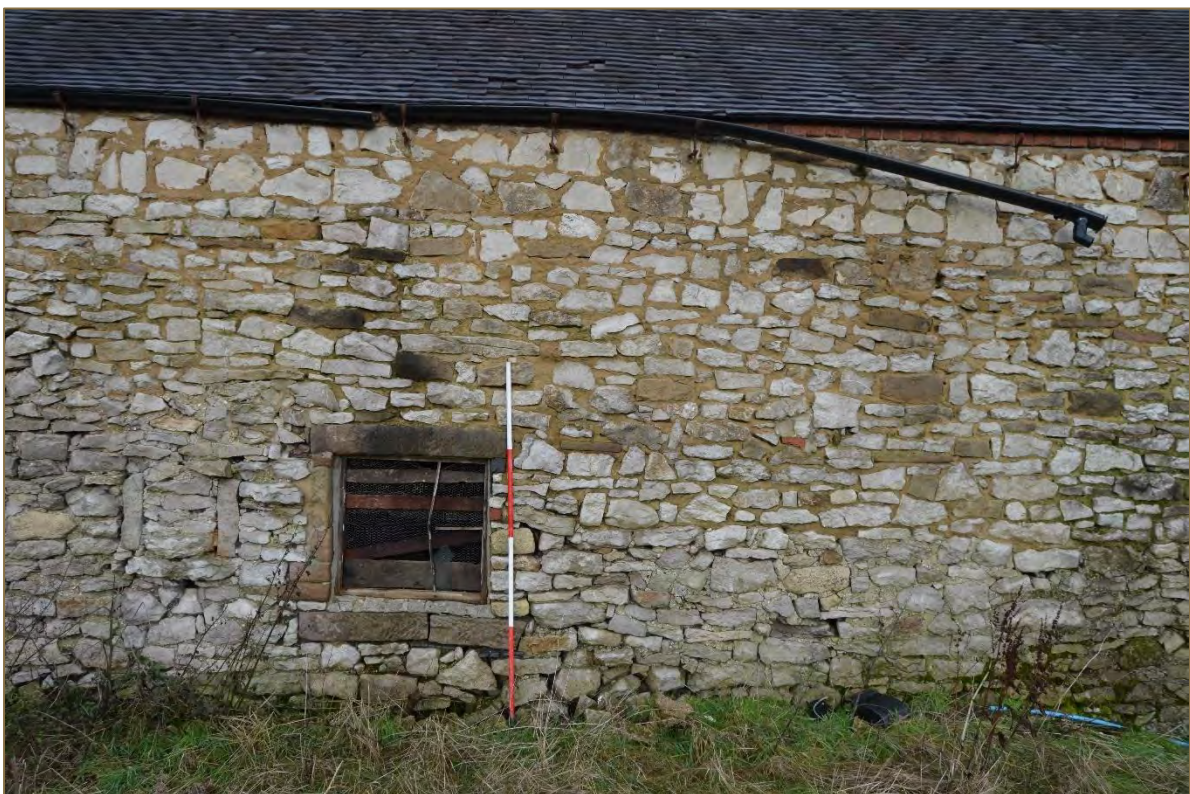
*Photograph 28. View of the single window aperture in the barn's south elevation (looking north).  
Scale 2m. (File: HBR\_338)*
