# HISTORIC BUILDING RECORDING

## Barn at Hill Top Farm, Aldwark, Derbyshire

ARS Ltd Report No: 2025/021

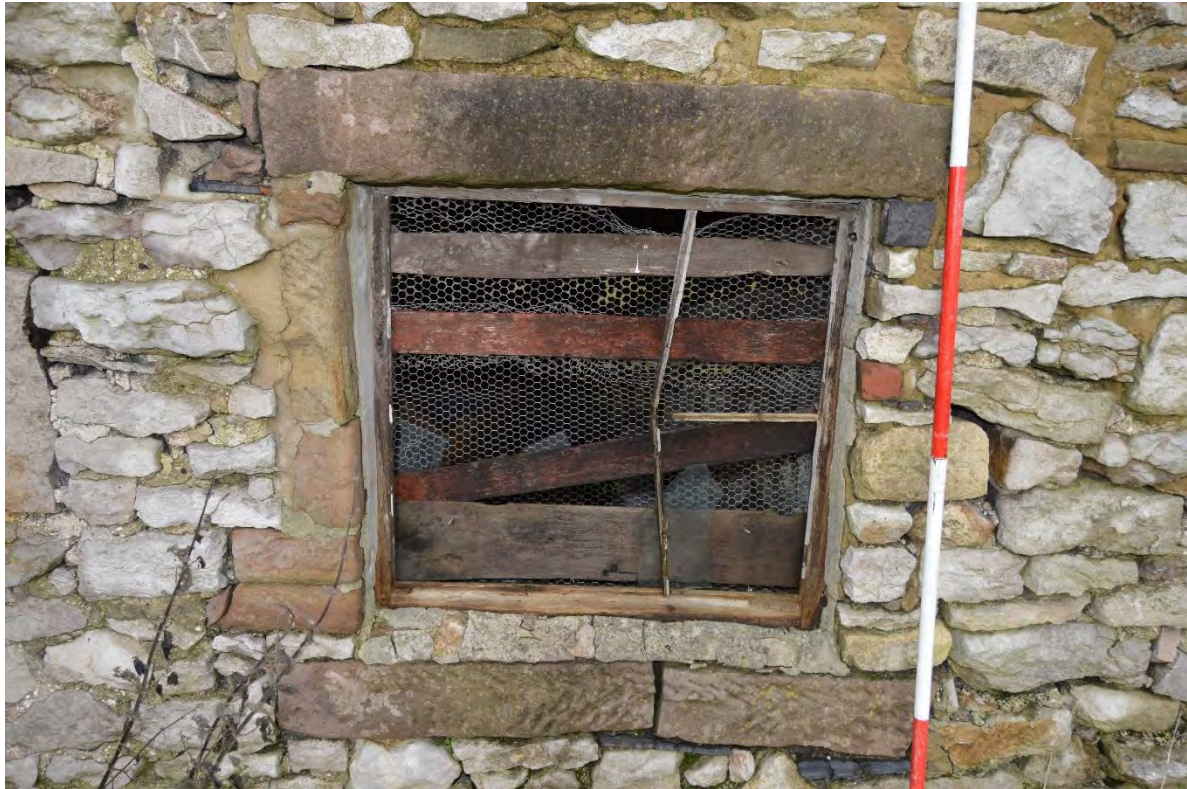
*Photograph 29. View of the single window aperture in the barn's south elevation (looking north). Scale 2m. (File: HBR\_165)*

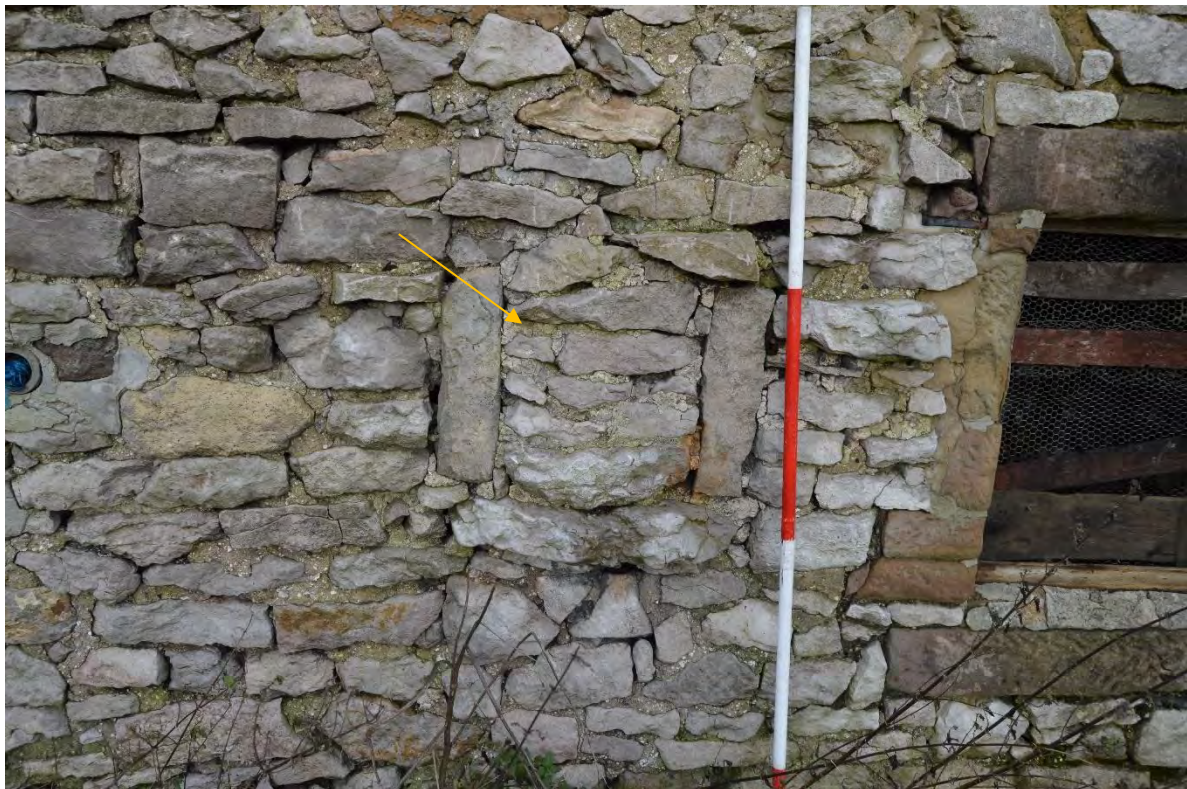
- 6.3.4 To the left of this is a former window or feeding aperture with single stone lintel, jambs and cill, latterly blocked with masonry (**Photograph 30 and 31**).

*Photograph 30. View of the blocked aperture (indicated) in the barn's south elevation (looking north). Scale 2m. (File: HBR\_149)*

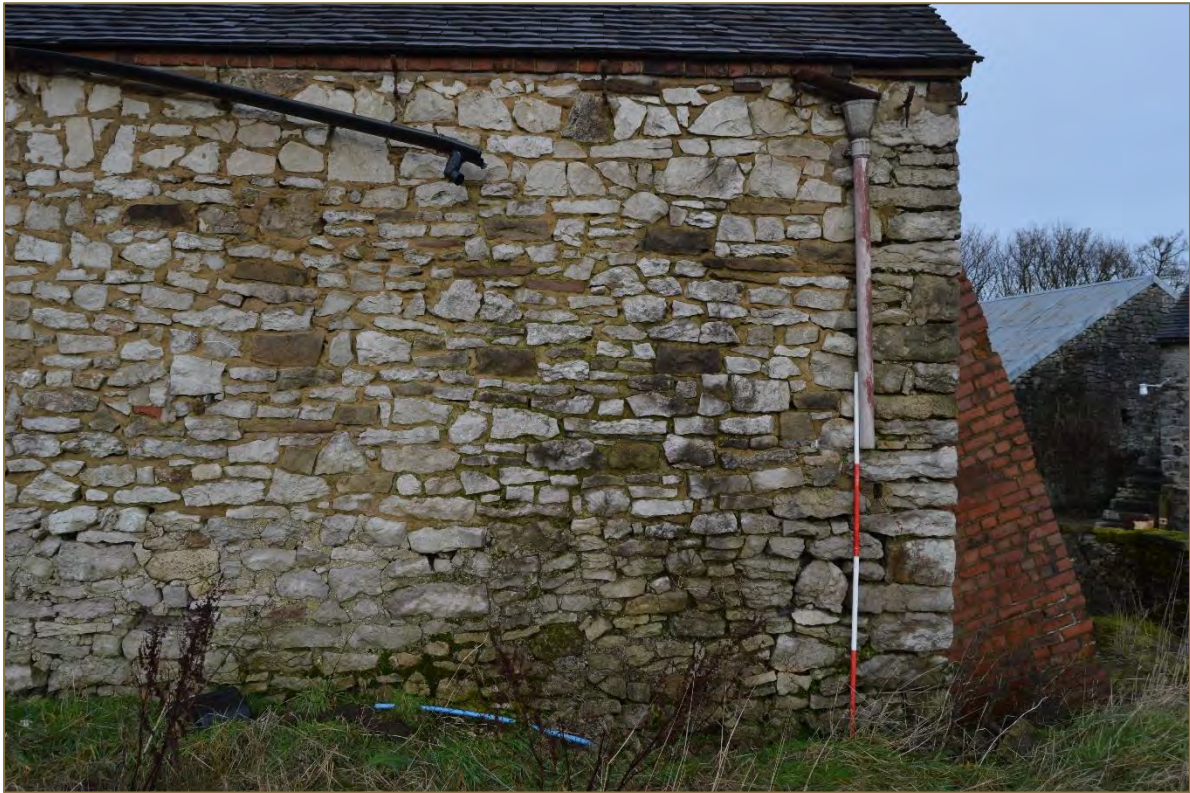
*Photograph 31. View of the barn's south elevation, eastern extents (looking north) (File: HBR\_106)*

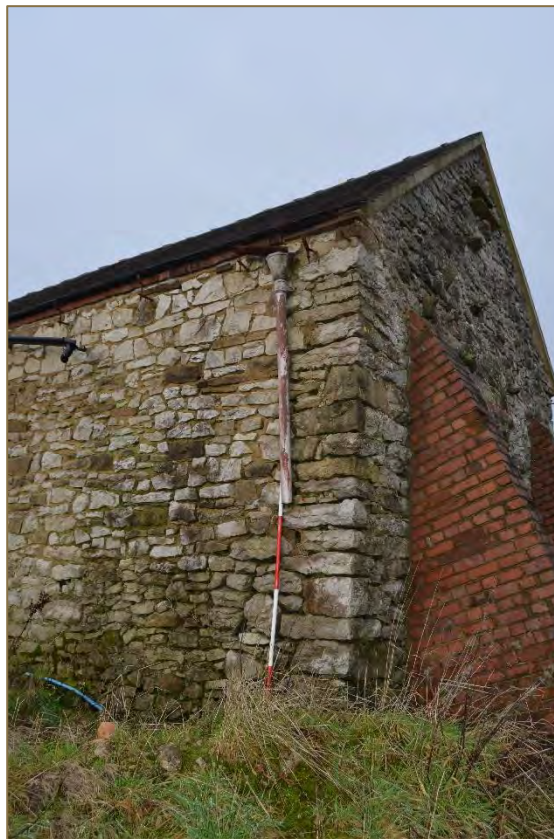
*Photograph 32. View of the barn's south east corner with (looking north west). Scale 2m. (File: HBR\_107)*

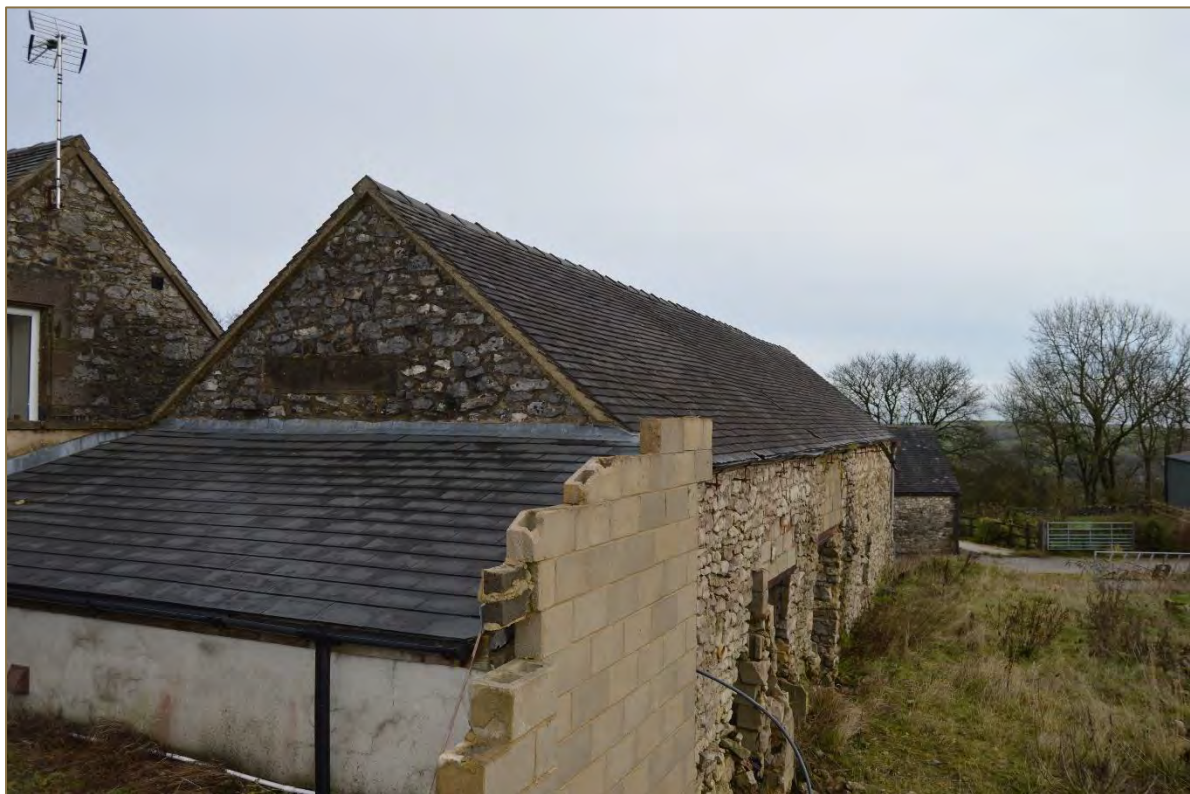
*Photograph 33. Oblique view of the barn's west elevation (looking east). (File: HBR\_131)*

- 6.3.5 The west elevation of the building constitutes a single bay, gable wall relatively devoid of architectural features (**Photograph 33 and 34**). The coursed rubble limestone of the barn and the cap of the gable appears to have been recently repointed. At ground floor level extents of the barn's west elevation are obscured by the single storey addition with its mono-pitch slate roof (**Photograph 35**). Set into the first floor portion of the elevation there is a stone lintel, likely associated with the building's hay loft function prior construction of the western, single storey addition. The lintel has a sawn or smooth finish set within margined edges. The jambs, where visible, are formed from the surrounding stone coursing. The aperture is blocked in similar stone courses.

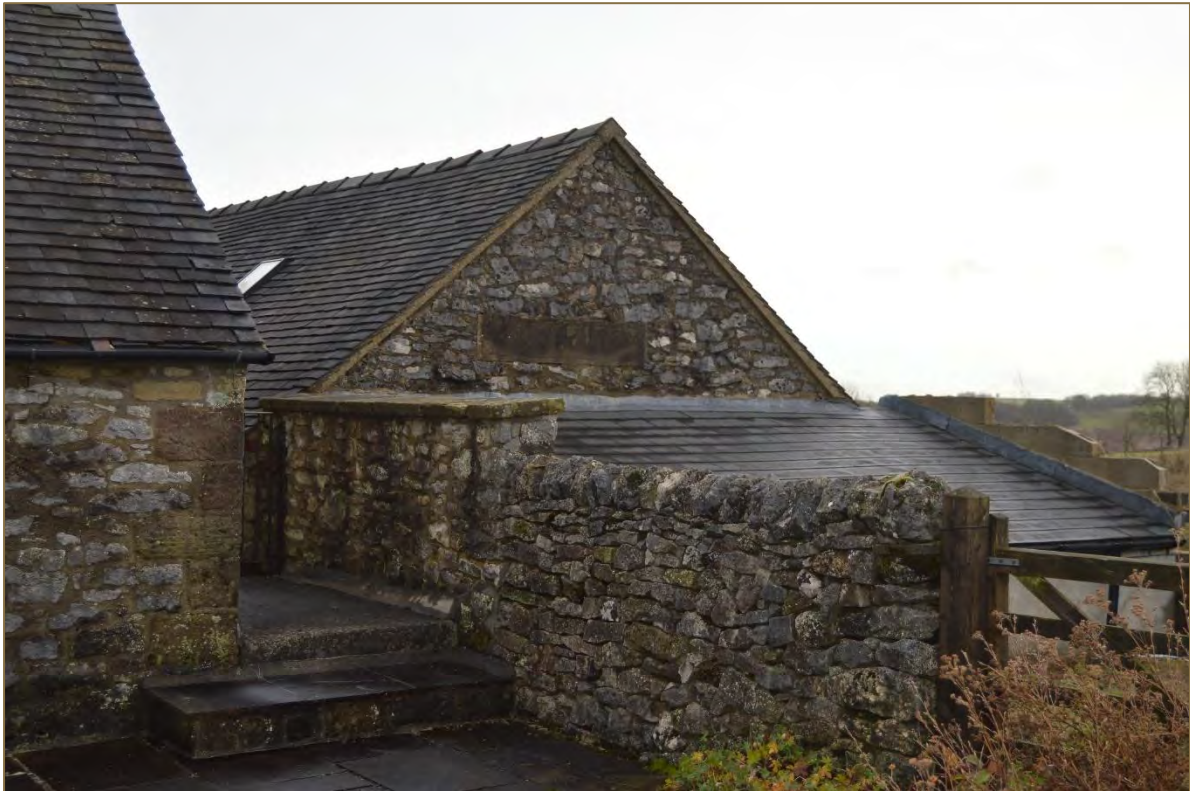
*Photograph 34. Oblique view of the barn's west elevation (looking south east). (File: HBR\_127)*

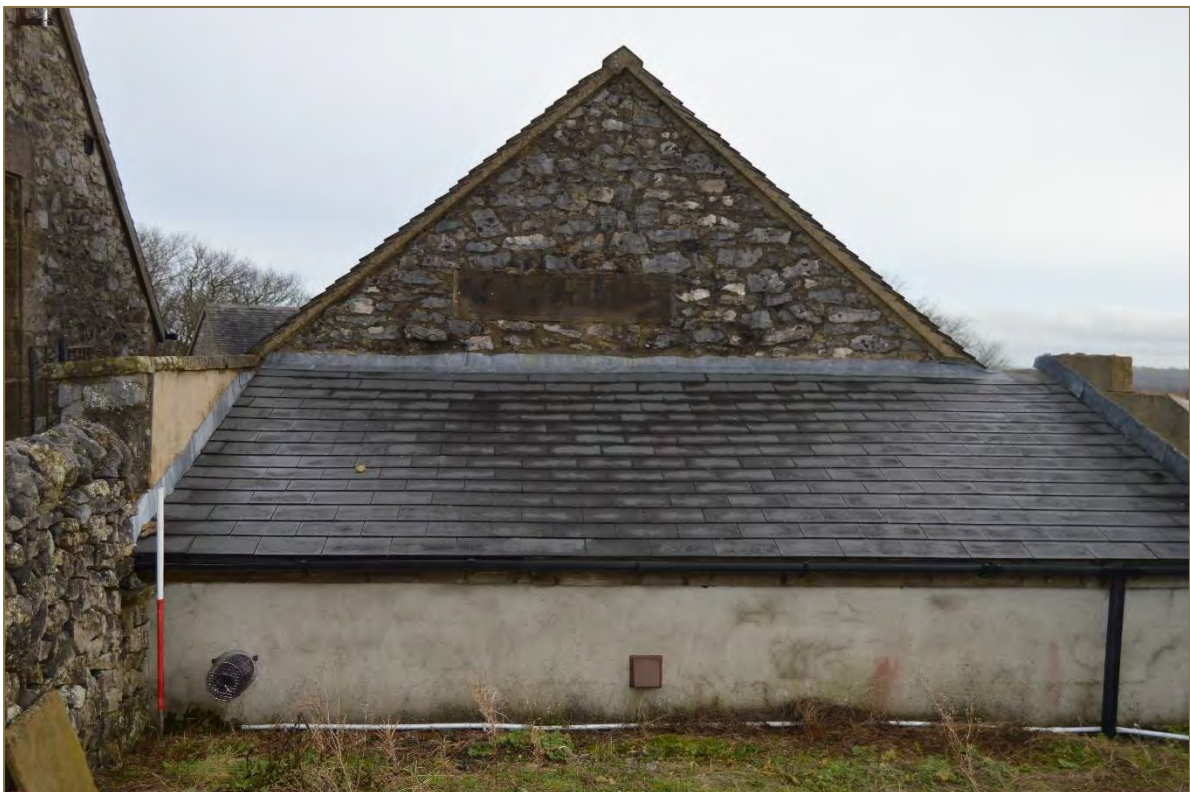
*Photograph 35. View of the barn's west elevation (looking east). Scale 1m. (File: HBR\_128)*

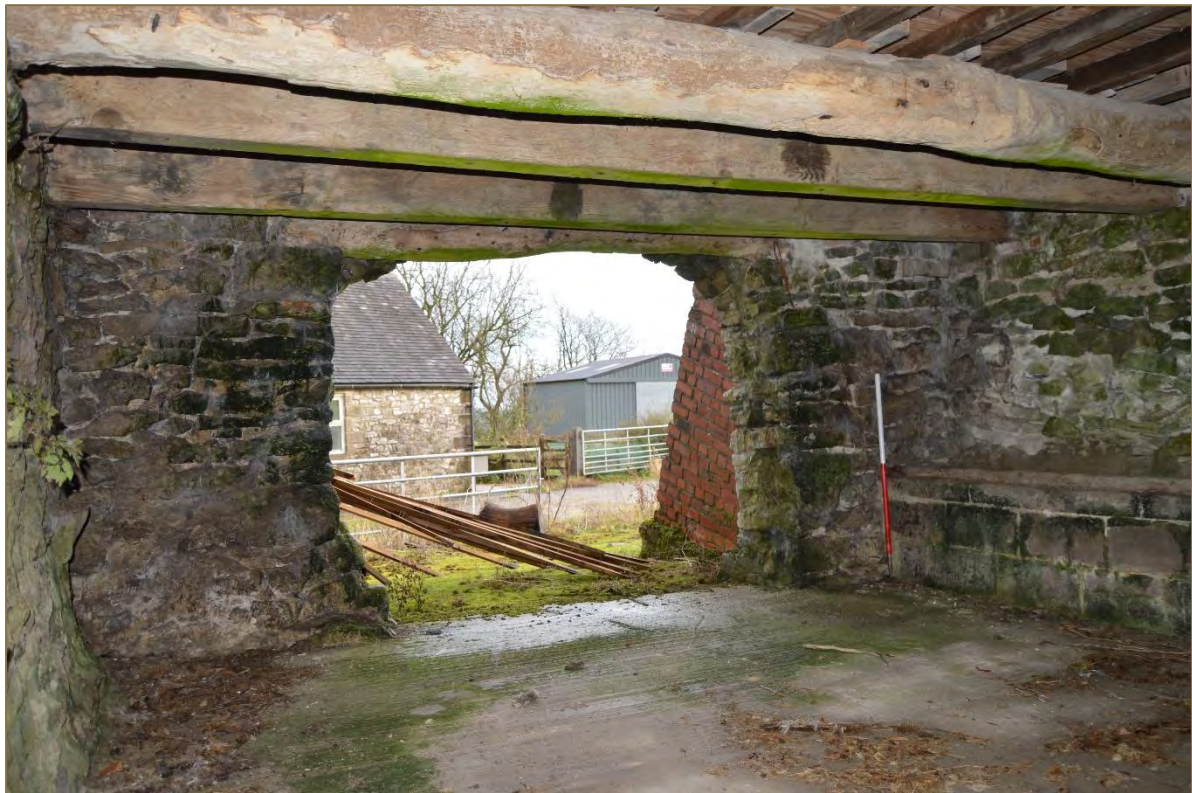
*Photograph 36: View of the ground floor interior of the barn (G1), towards the wide opening in the east wall (looking east). Scale 1m. (File: HBR\_80)*

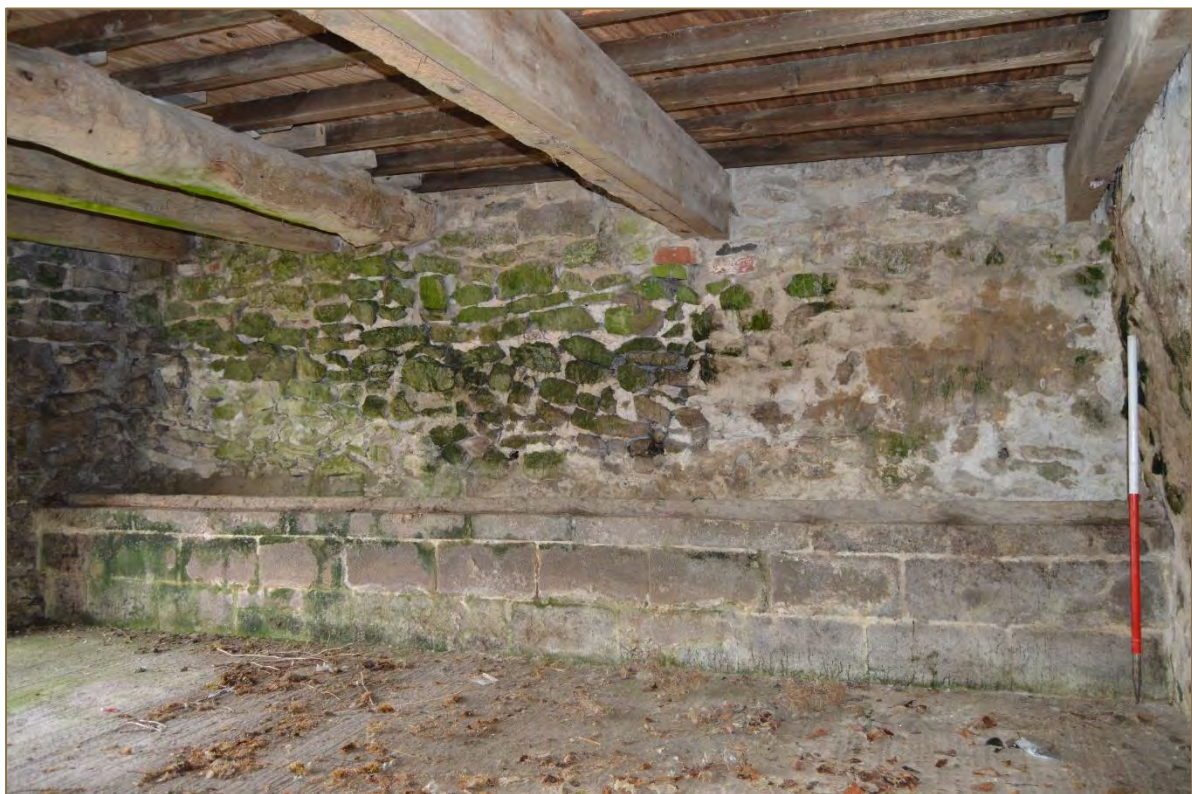
*Photograph 37: View of the south wall of the ground floor room (G1) of the barn with modern cow trough (looking south). Scale 1m. (File: HBR\_83)*

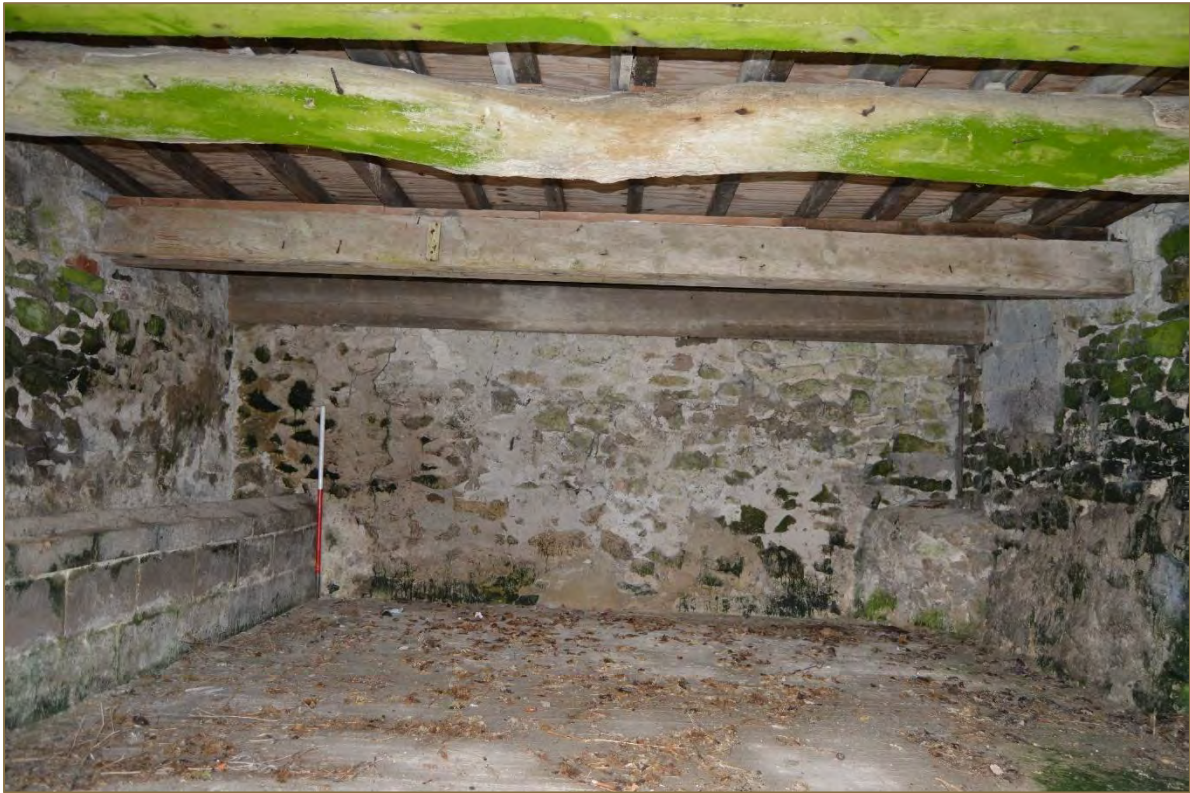
*Photograph 38: View of the west wall of the ground floor room (G1) of the barn (looking west).  
Scale 1m. (File: HBR\_83)*

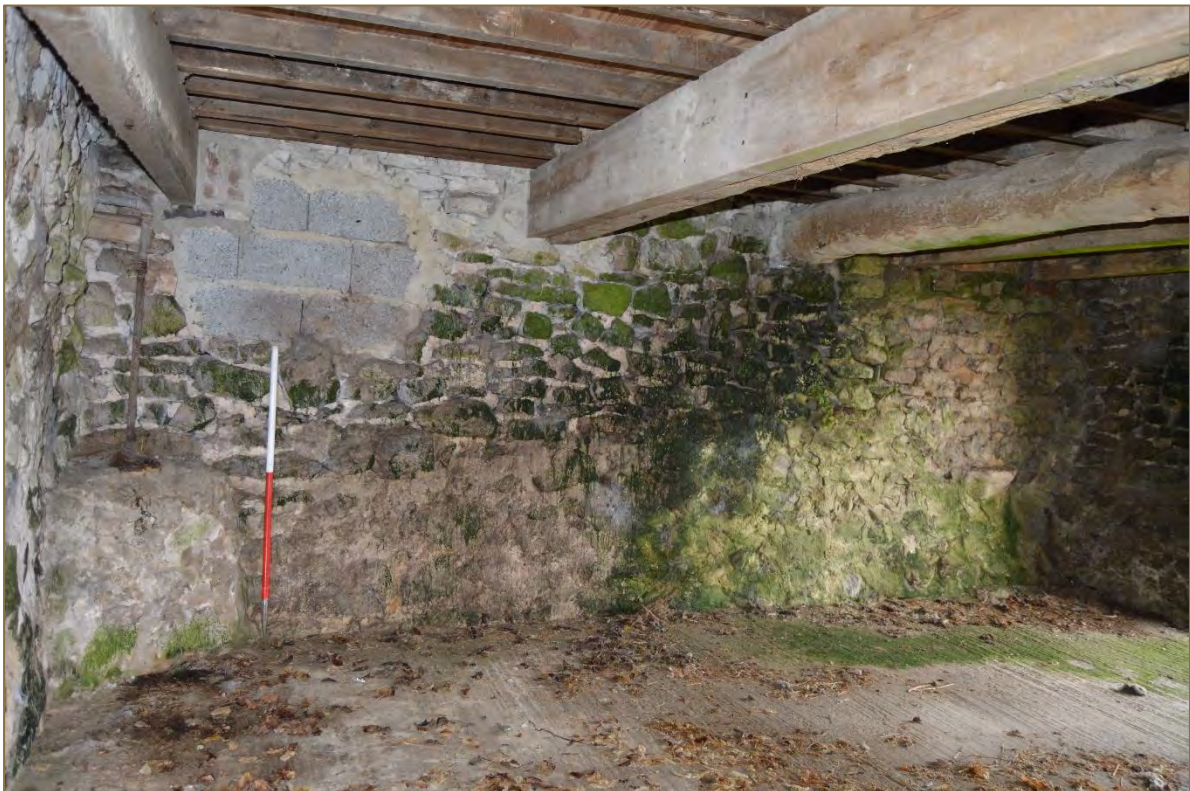
*Photograph 39: View of the north wall of the ground floor room (G1) of the barn (looking north).  
Scale 1m. (File: HBR\_89)*

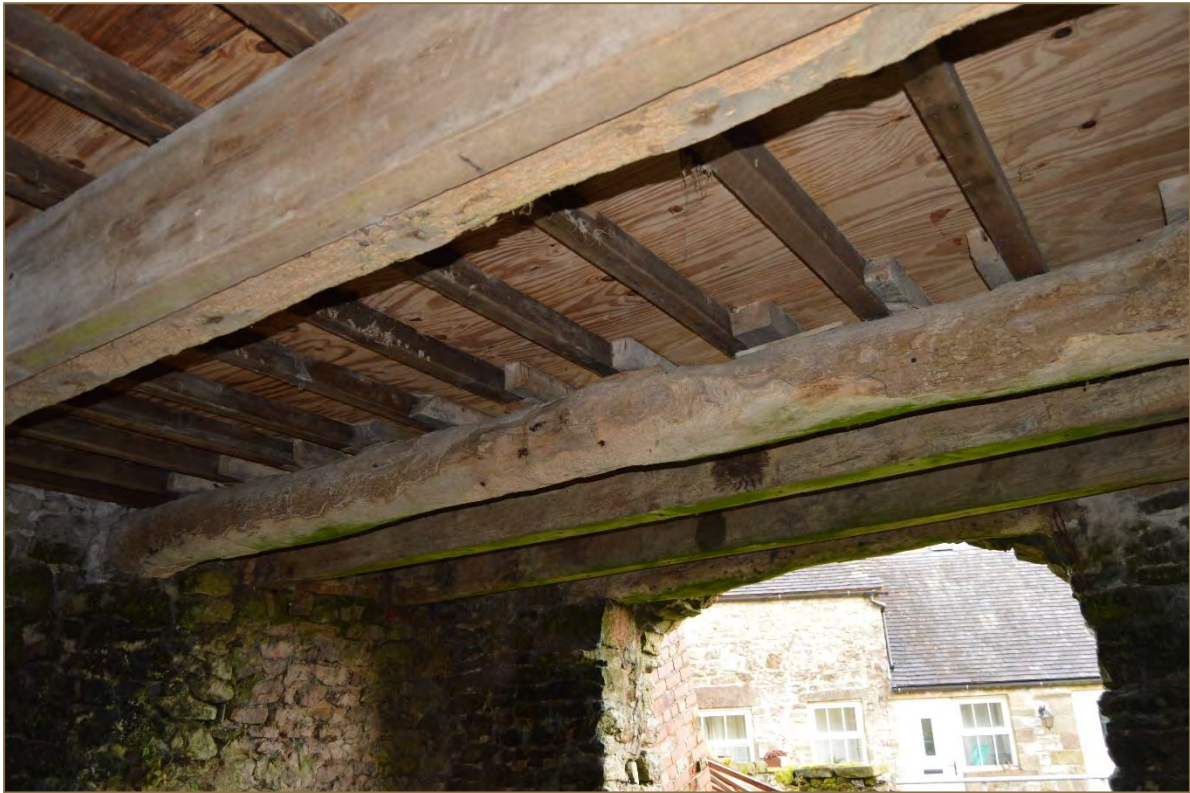
*Photograph 40: View of the ceiling structure above the barn's easternmost ground floor room (G1) (looking north east). (File: HBR\_173)*

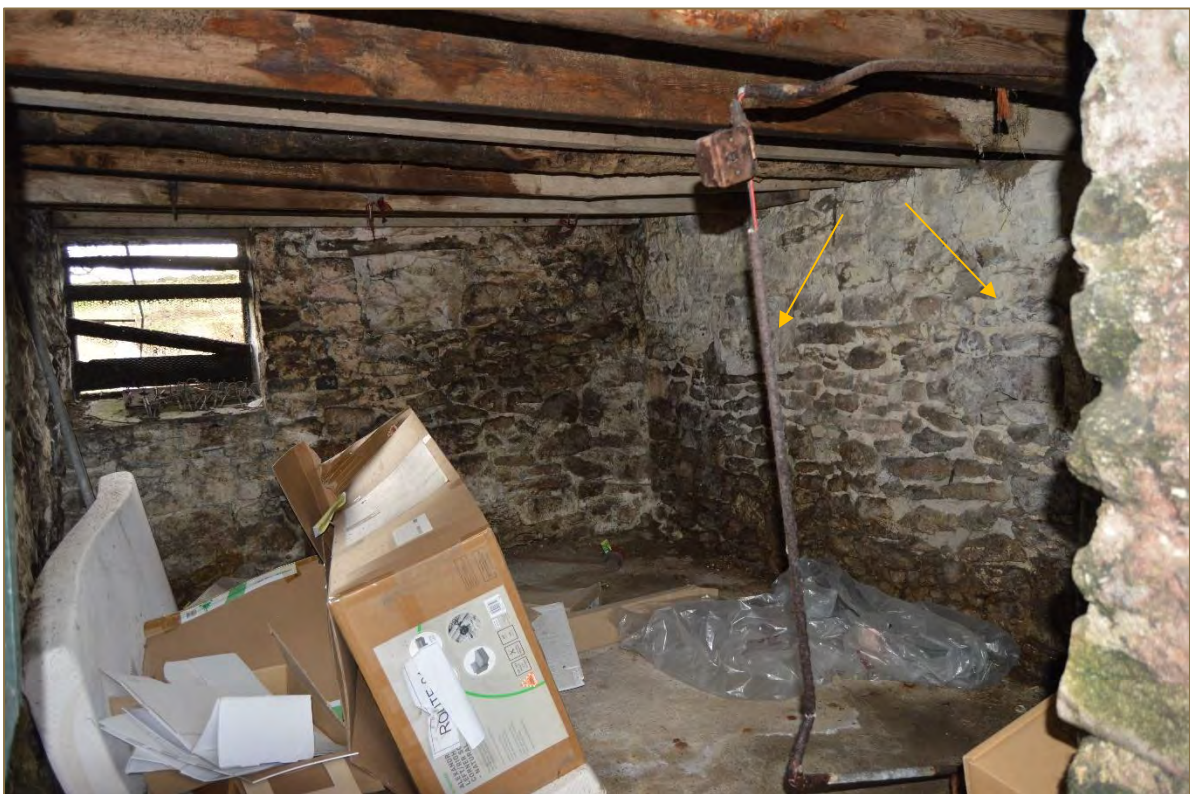
*Photograph 41: View of the ground floor room G2, with blocked aperture features observed in the west wall (looking south). (File: HBR\_134)*

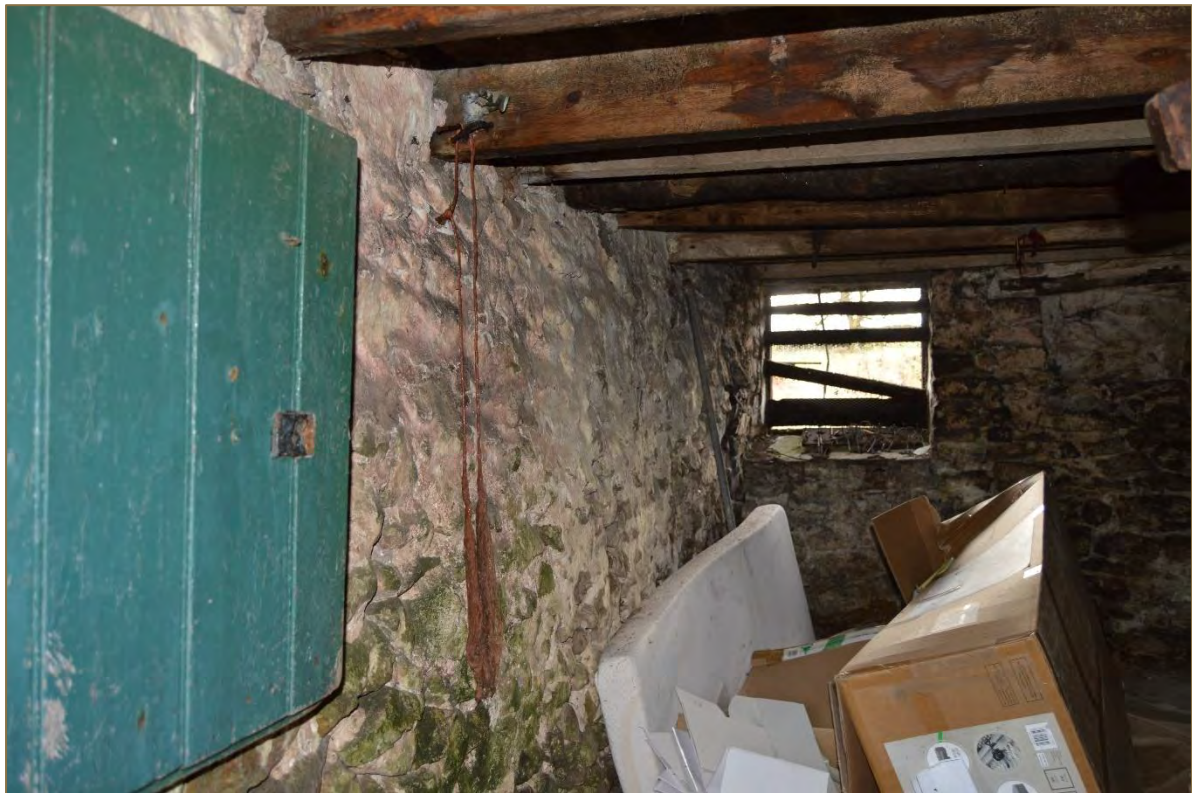
*Photograph 42: View of the ground floor room G2, with the single window aperture in the south wall (looking south). Scale 2m. (File: HBR\_136)*

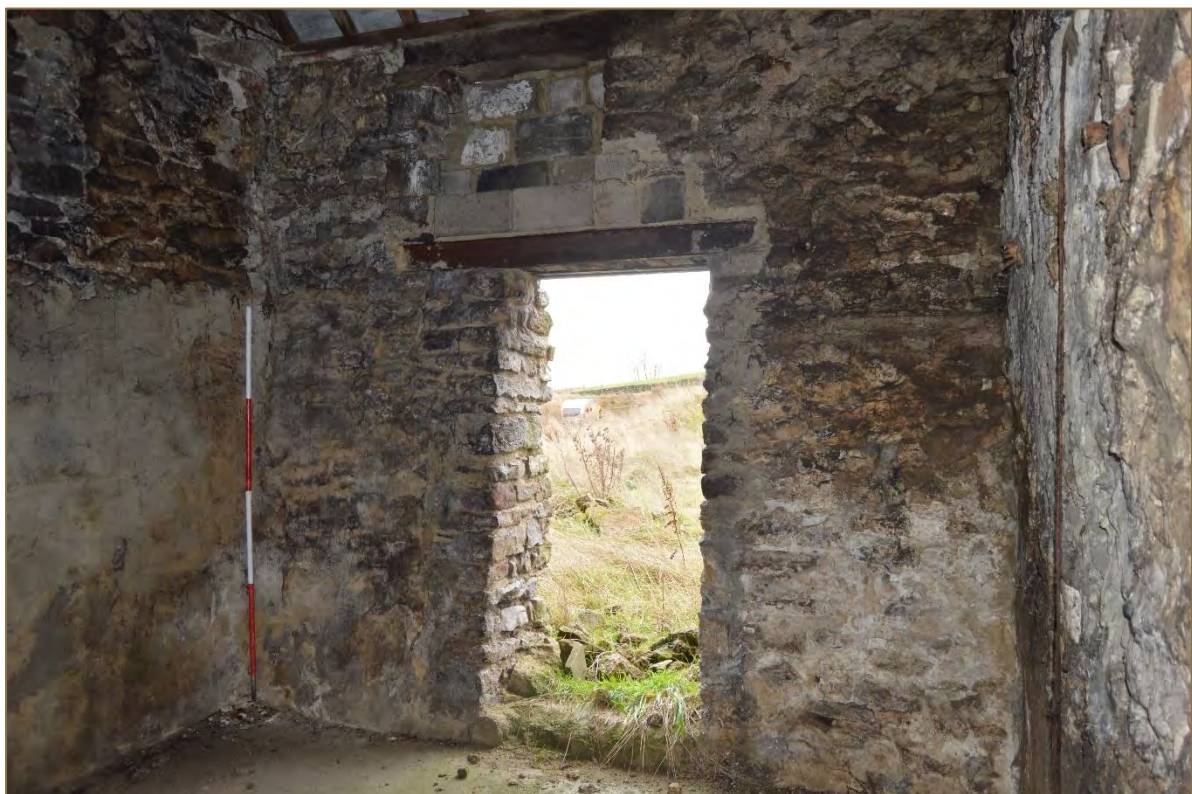
*Photograph 43: View of G3/F3, with detail of apertures on the south wall (looking south east). Scale 2m. (File: HBR\_167)*

- 6.4.4 Next, moving west, is a room accessed from doors in the north and south elevations of the barn (G3). In the central upper portions of the south wall, above the doorway there appears to be a former opening now filled with aggregate blockwork—likely a pitching door (**Photograph 43 and 44**). The north wall contains a similar arrangement of features however these are retained in their original form complete with timber plank doors (**Photograph 47**). The room is open to the roof, however blocked joist sockets visible in the west wall (the east wall having a layer of modern plaster obscuring the corresponding sockets) confirm the room had a first floor (F3) and a continuation of the barn's hayloft. (**Photograph 46 and 47**). For accessing the former first floor space there are remains of doorways in the east and west dividing walls, the west remaining open whilst the east has been blocked with modern material (with an un-worked timber lintel). In the east wall there are additional straight joints in the fabric, possibly associated with a former opening to the right, and a diagonal mortar line to the left—potentially indicative of an earlier roof layout.

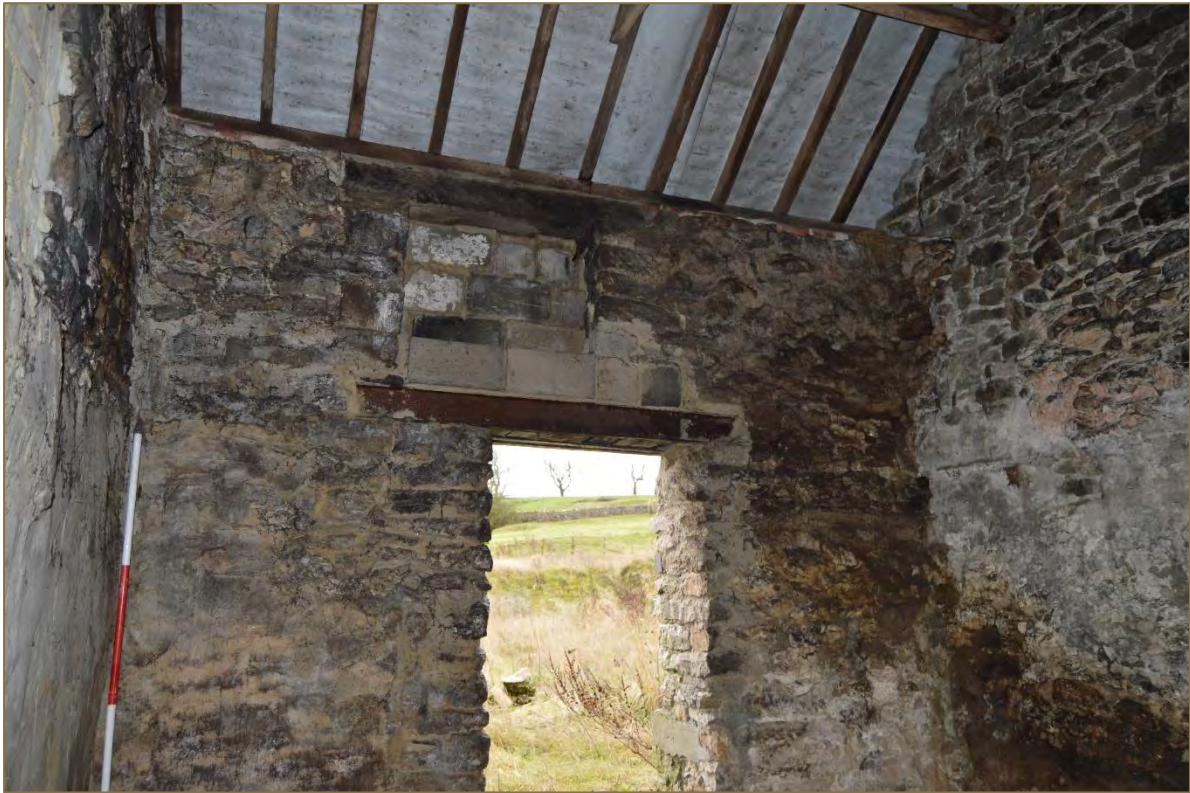
*Photograph 44: View of G3/F3, with detail of apertures on the south wall (looking south west).  
Scale 2m. (File: HBR\_169)*

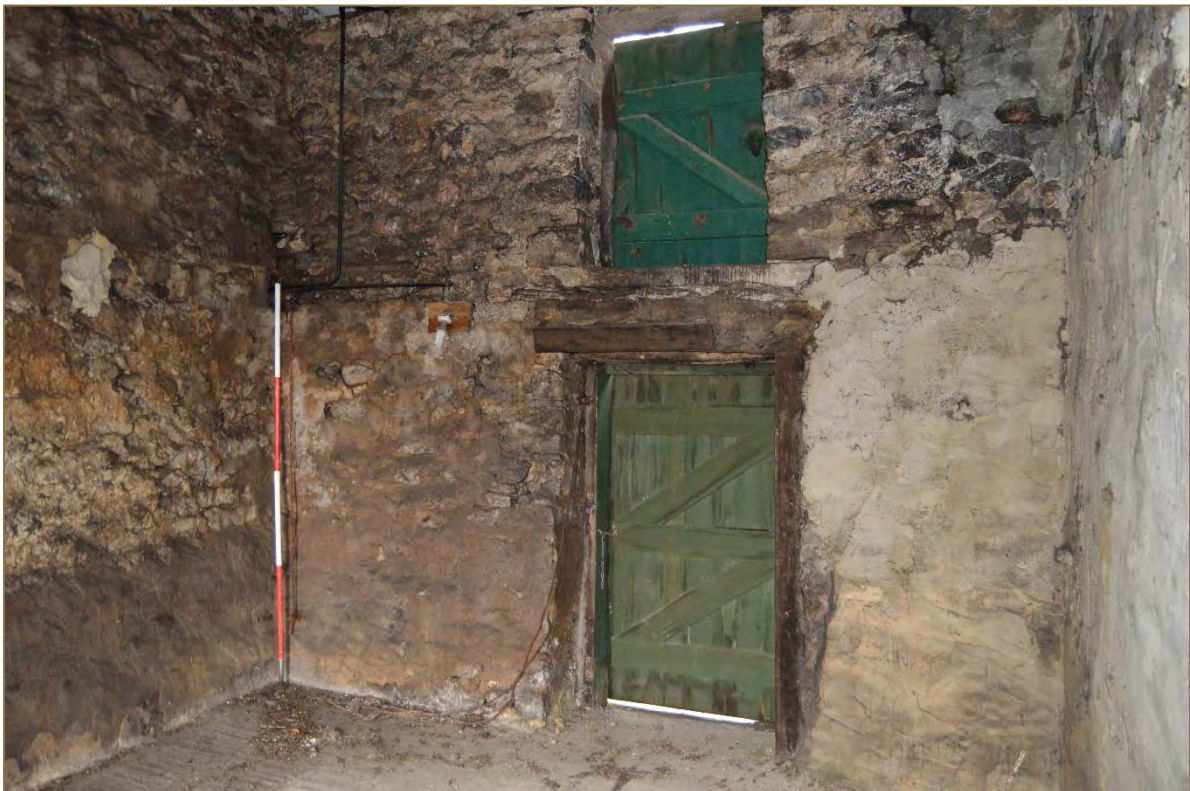
*Photograph 45: View of G3/F3, with detail of apertures on the north wall (looking north west).  
Scale 2m (File: HBR\_158)*

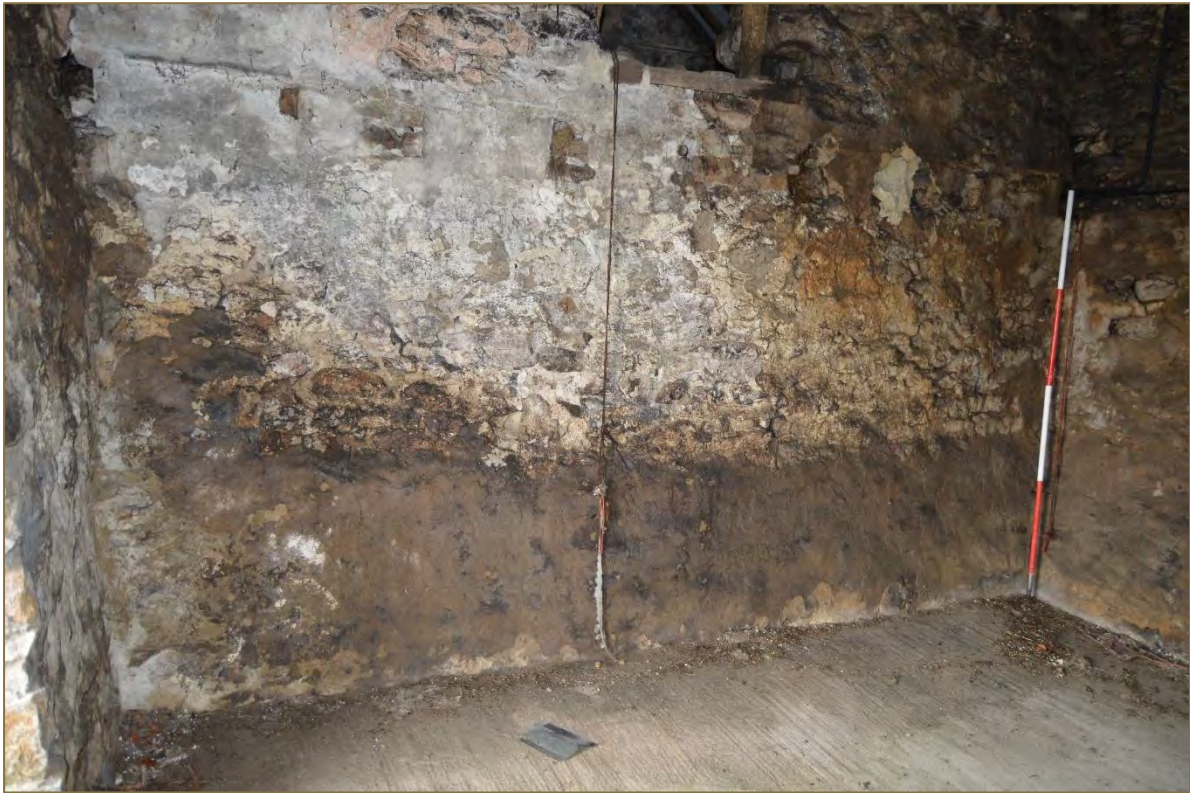
*Photograph 46: View of G3/F3, with detail of the west wall, featuring blocked first floor joist slots with doorway above (looking north west). Scale 2m. (File: HBR\_153)*

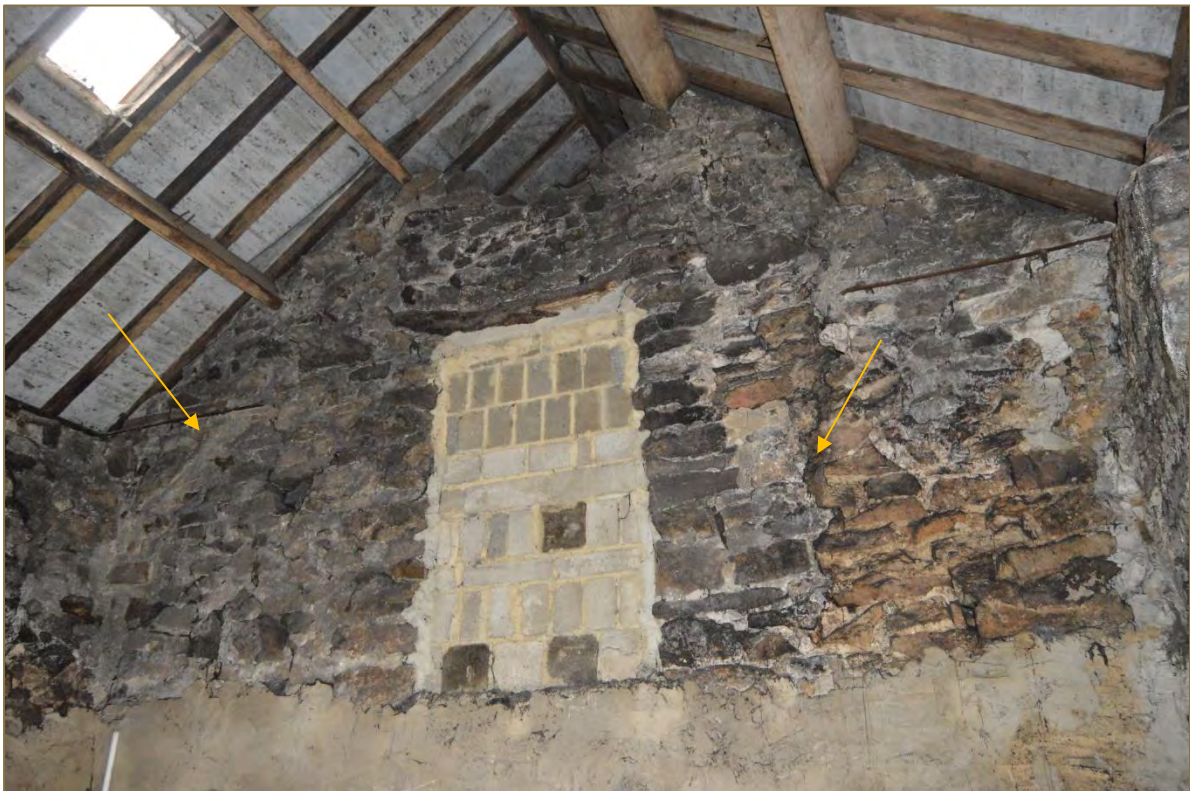
*Photograph 47: View of G3/F3, with detail of the east dividing wall, featuring blocked first floor doorway above the plastering at ground level. Other structural features are indicated (looking north east). (File: HBR\_164)*

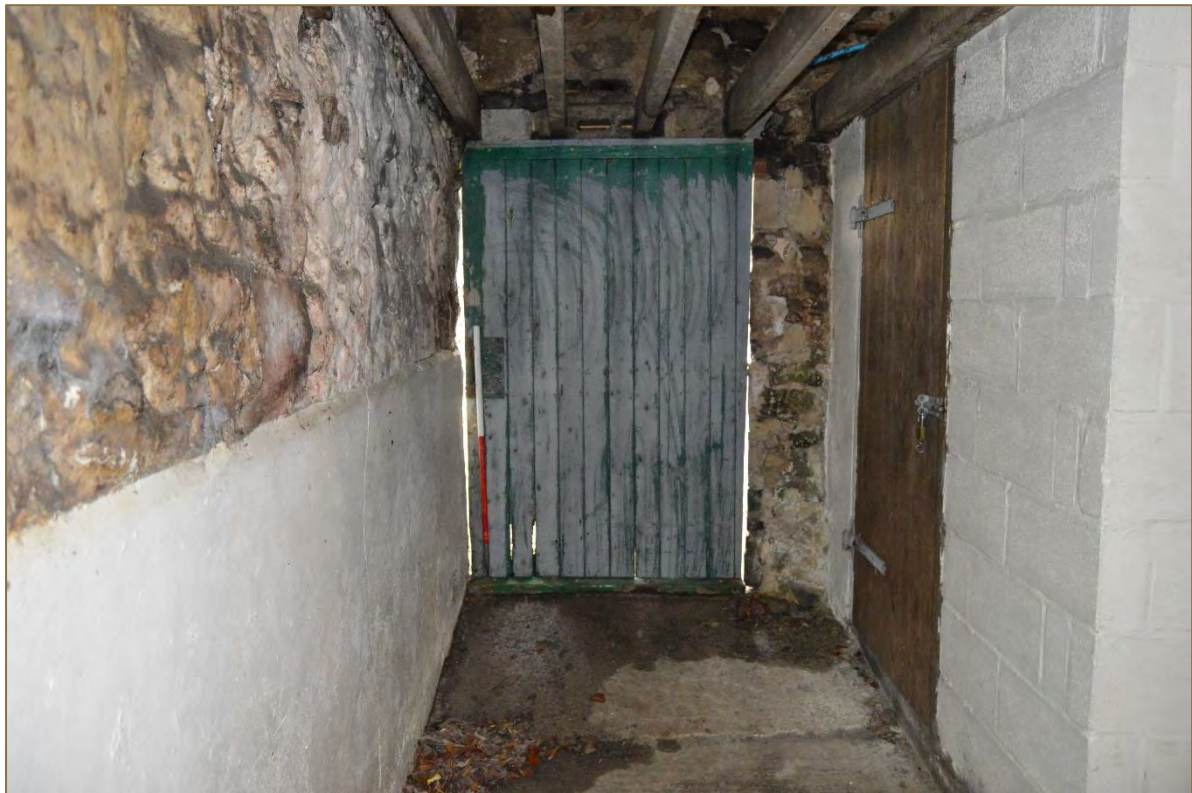
*Photograph 48: View of the barn's ground floor, westernmost room (G4) which has been renovated for modern communal use (looking south). Scale 2m. (File: HBR\_138)*

- 6.4.5 The western, ground floor (G4) room of the barn is mostly devoid of historical features having been altered to serve as a modern communal service space. The barn's north and south ground floor walls feature ledged and braced timber plank door with metal straps, serving as a pass through from the north to the south areas of the farmyard (**Photographs 48 and 49**). To the west is a modern timber plank door leading to the single storey addition adjoining the western gable (**Photograph 51**). The room is open to the roof space but the first floor beams are extant in this case (**Photograph 51**). These beams are machine cut.

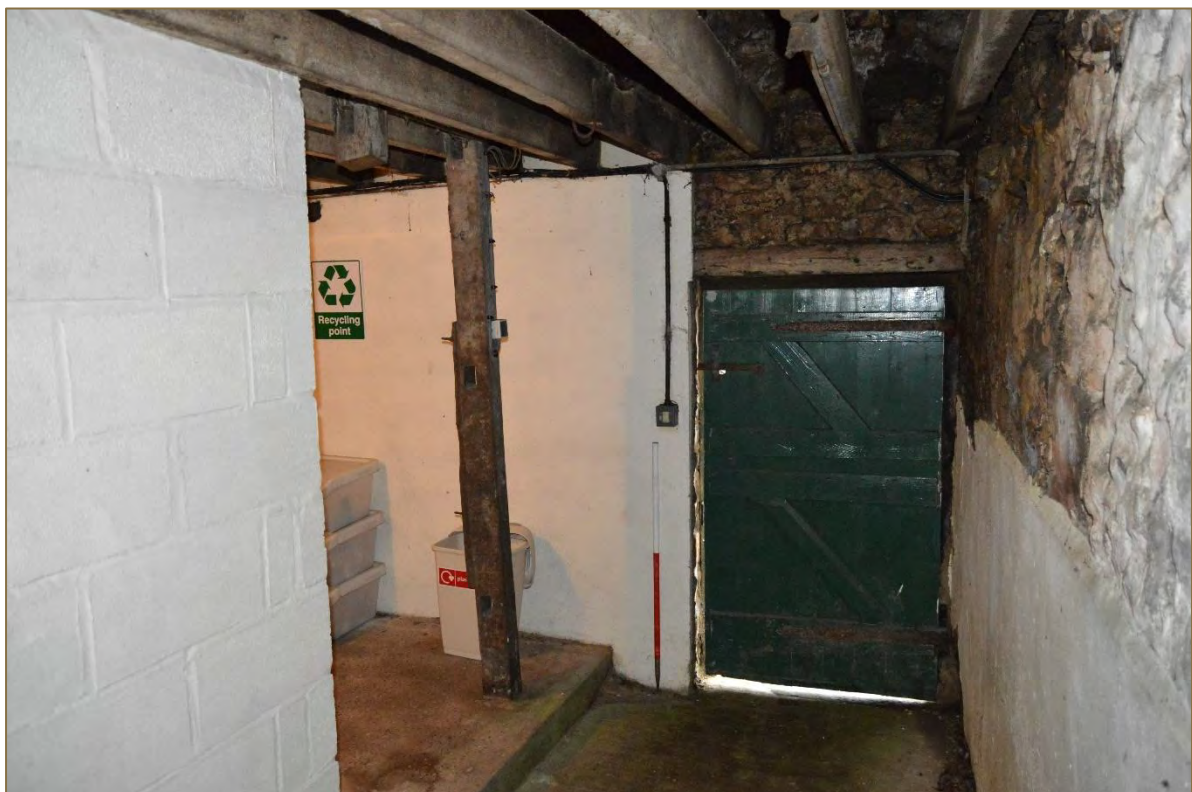
*Photograph 49: View of the barn's ground floor, westernmost room (G4) which has been renovated for modern communal use (looking north). Scale 2m. (File: HBR\_199)*

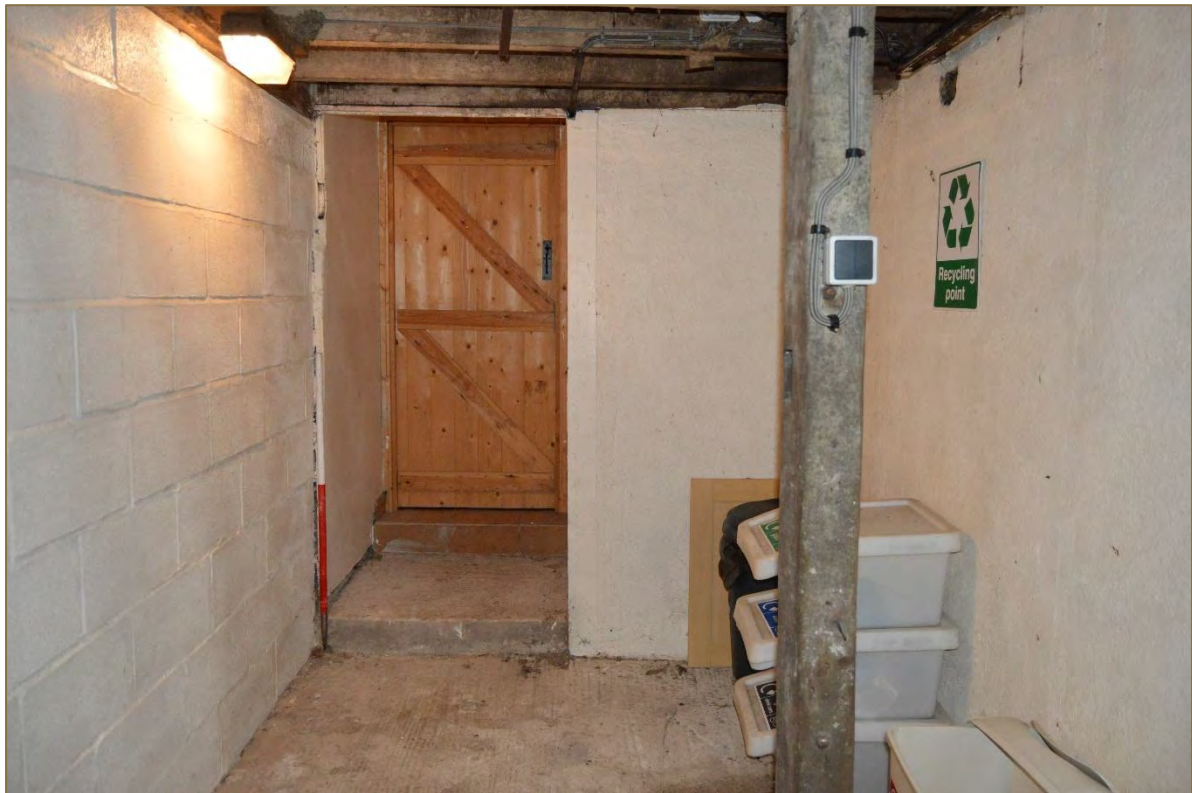
*Photograph 50: View of the barn's ground floor westernmost, room (G4) which has been renovated for modern communal use (looking west). Scale 2m. (File: HBR\_143)*

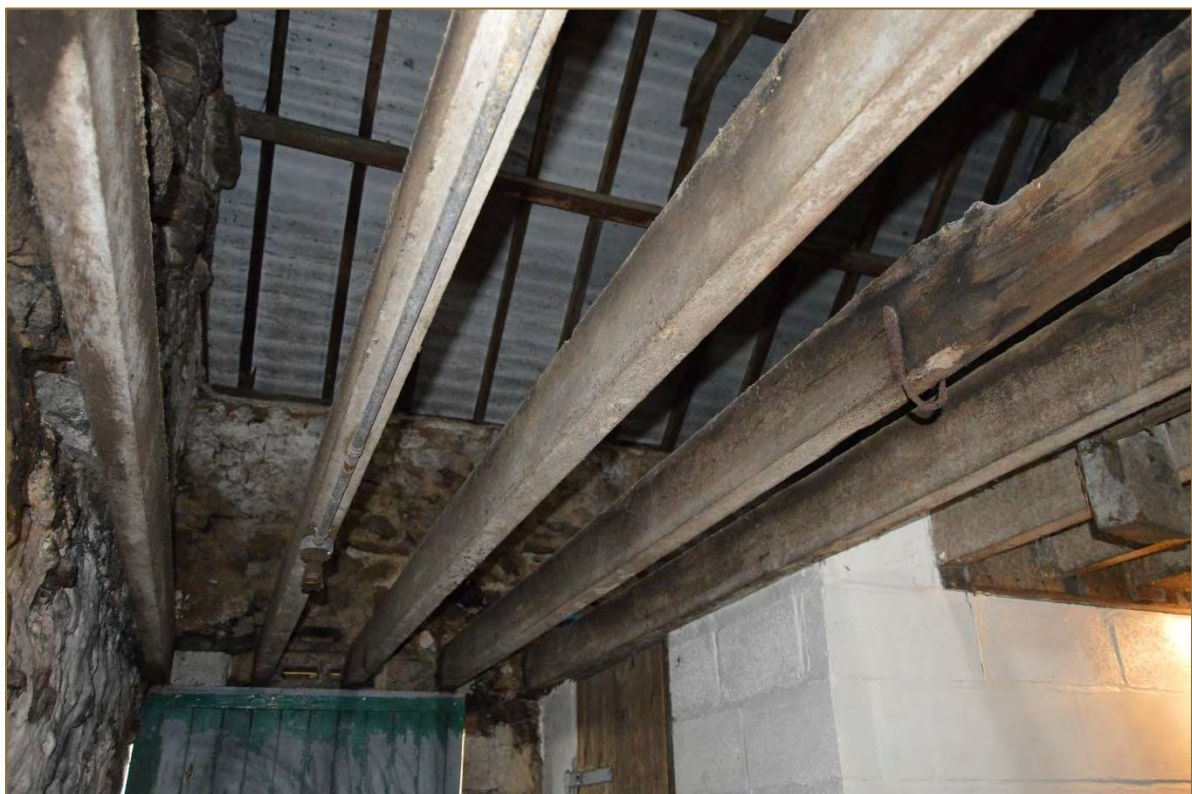
*Photograph 51: View of the barn's ground floor westernmost room (G4) showing the remaining first floor joists (looking south). Scale 2m. (File: HBR\_139)*
